**ALBERTA TRANSPORTATION  
GEOHAZARD ASSESSMENT PROGRAM  
PEACE REGION (PEACE RIVER DISTRICT)  
2022 INSPECTION**

<b>Site Number</b>	<b>Location</b>	<b>Name</b>	<b>Hwy</b>	<b>km</b>
PH060	East Hill	35+680 to 36+180 Site 3	2:60	35.95
<b>Legal Description</b>		<b>UTM Co-ordinates</b>		
W28 & E29-083-21 W5M		11V E 483450	N 6231395

<b>Date</b>	<b>PF</b>	<b>CF</b>	<b>Total</b>
<b>Previous Inspection:</b>	9-Jun-2020	13	4	52
<b>Current Inspection:</b>	25-May-2022	13	4	52
<b>Road WAADT:</b>	3990	<b>Year:</b>		2021
<b>Inspected By:</b>	Ed Szmata, TRANS Roger Skirrow, TRANS Max Shannon, TRANS		Don Proudfoot, TEL Tyler Clay, TEL	
<b>Report Attachments:</b>	<input checked="" type="checkbox"/> Photographs		<input type="checkbox"/> Maintenance Items	
	<input checked="" type="checkbox"/> Plans

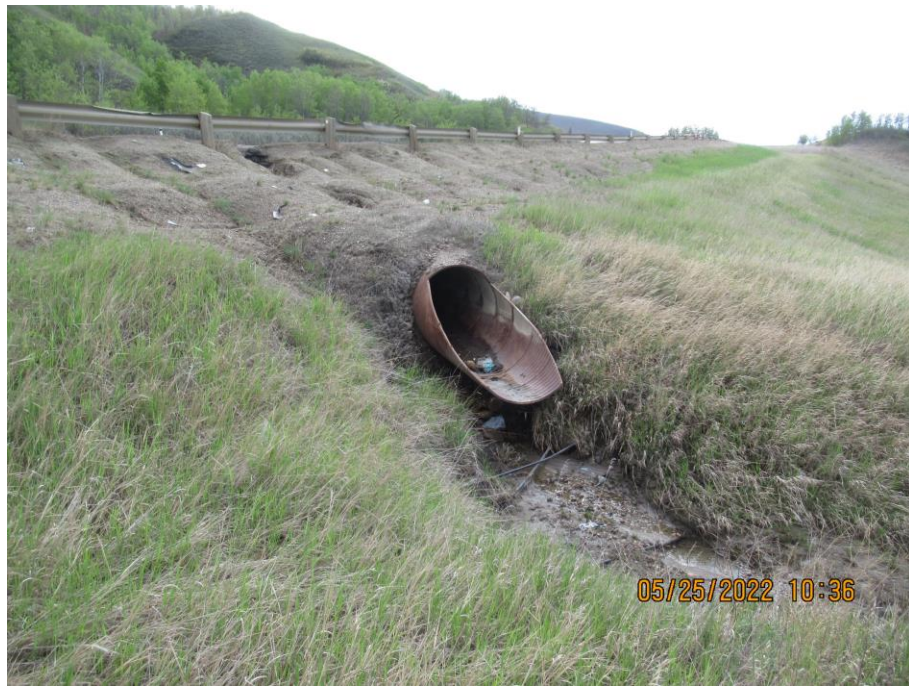
<input type="checkbox"/> Seepage		<input type="checkbox"/>
<input checked="" type="checkbox"/> Bridge/Culvert Distress	<p>Erosion ongoing at culvert outlet at 35+700 which is believed to be at least partially blocked (Photo 60-01). Scour depth beneath the bottom of the culvert outlet is 0.7 m.</p>	<input type="checkbox"/>
<input type="checkbox"/> Other		<input type="checkbox"/>

**Photo 60-01.**  
Close-up of hanging culvert outlet (35+700). Ongoing erosion below culvert and rilling above. Rill erosion slightly deeper but no major change from the 2020 condition. Scour depth below culvert inlet was 0.7 m.

The erosion gully near the culvert outlet at 35+675 should be graded and armored to reduce the rate of the gully headcutting further towards the highway and causing further damage. The culvert here should also be relined or replaced.

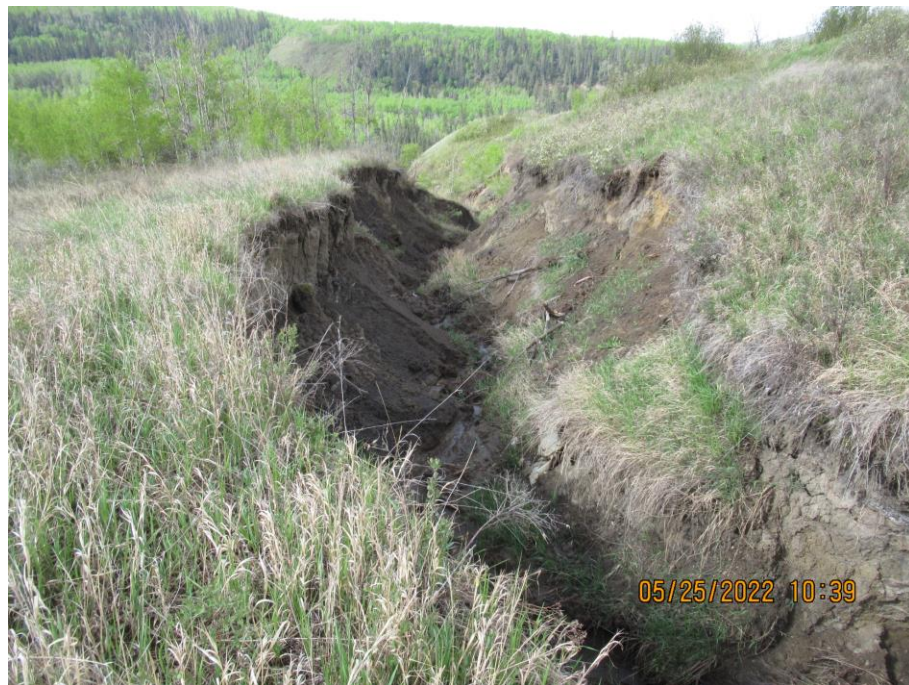
**Photo 60-02.**  
Looking downslope at erosional gully below culvert shown in Photo 60-01 (35+700). Active slumping on gully walls. Worse from the 2020 condition.

The erosion gullies at 36+075 and 35+700 do not threaten the highway in their current state but a drainage structure (e.g. trunk drain) should be considered in the next 5 to 10 years to reduce rate of retrogression.

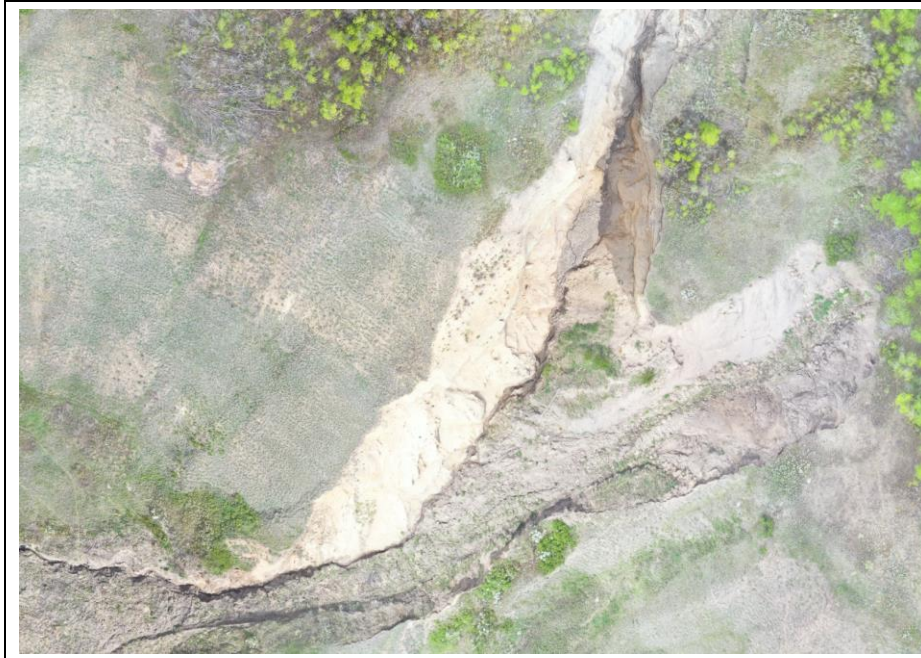
**Photo 60-03.**  
Overhead drone image of gully and slide area below the culvert outlet at 35+700, offset approximately 125 m from the highway. Mass movement occurred in 2016, increased gully incision, ongoing erosion of the flanks and further retrogression of slide on the right (east) side. Gully sidewalls are intermittently stable.

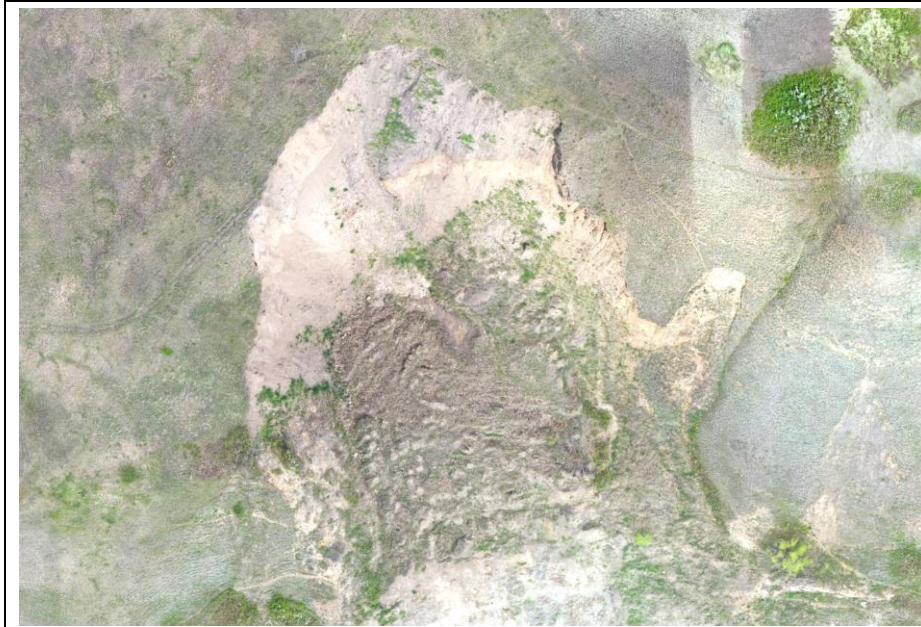
The mass movement near the valley base below 35+900 is expected to retrogress upslope and could cause instabilities that could potentially impact the highway in the future as toe support is lost. No slope instrumentation exists above this area to monitor potential impacts to the highway if movement were to occur.

**Photo 60-04.**  
Overhead drone image of a major slide/earth flow that occurred in 2016. Ongoing erosion of exposed scarp but overall minor retrogression since that time. Slide area is offset approximately 180 m from the highway (35+950).

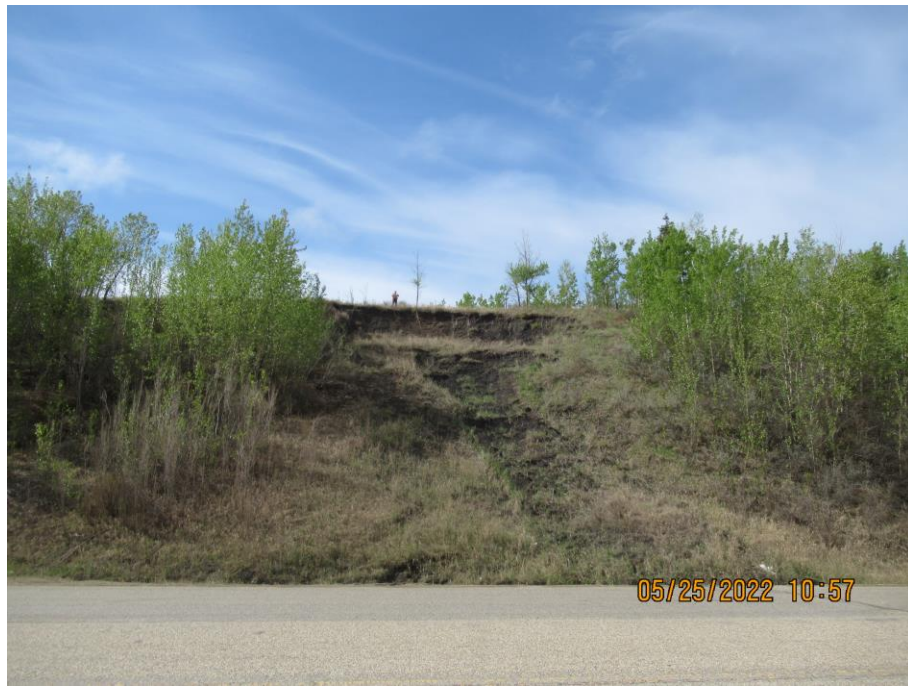
The landslide within the backslope at 35+835 is part of backslope and ditch repair work that has been completed along east hill in the summer of 2022.

**Photo 60-05.**  
Shallow slide/flow within through-cut area on the south cut slope (35+830). First observed in 2016, further displacement of the slide mass since 2020. Backscarp is now 3 m high and the slide toe is partially blocking the ditch.

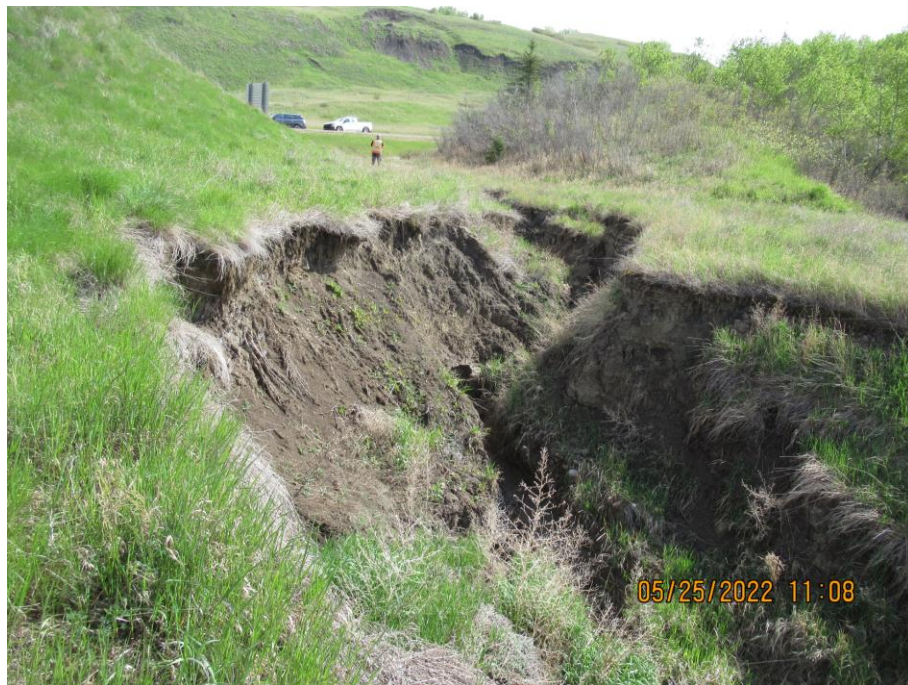
**Photo 60-06.**  
Headcutting and erosional gullying occurring below roadway (36+050).
