**ALBERTA TRANSPORTATION GEOHAZARD ASSESSMENT PROGRAM  
PEACE REGION – PEACE-HIGH LEVEL  
2020 INSPECTION**

<b>Site Number</b>	<b>Location</b>	<b>Name</b>	<b>Hwy</b>	<b>km</b>
PH61	East Hill	36+180 to 37+130 Site 4	2:60	36.7
<b>Legal Description</b>		<b>UTM Co-ordinates</b>		
NW & E29-083-21 W5M		11V E 482790	N 6231755

**PEACE RIVER EAST HILL  
HWY 2:60 (PH61) STA. 36+180 TO 37+130  
LOCATION PLAN**

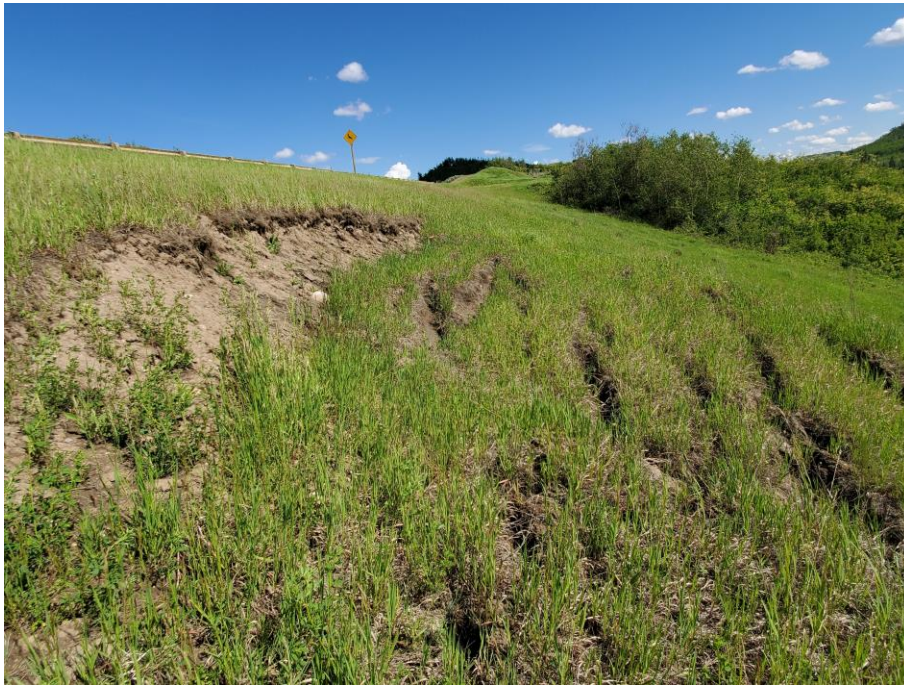
Shallow slide at 36+350 could impact edge of road as the main scarp retrogresses and/or erodes.

**Photo 61-01.**  
Looking east towards the shallow slide scarp approximately 10 m below the highway (36+350). No major change since 2019.

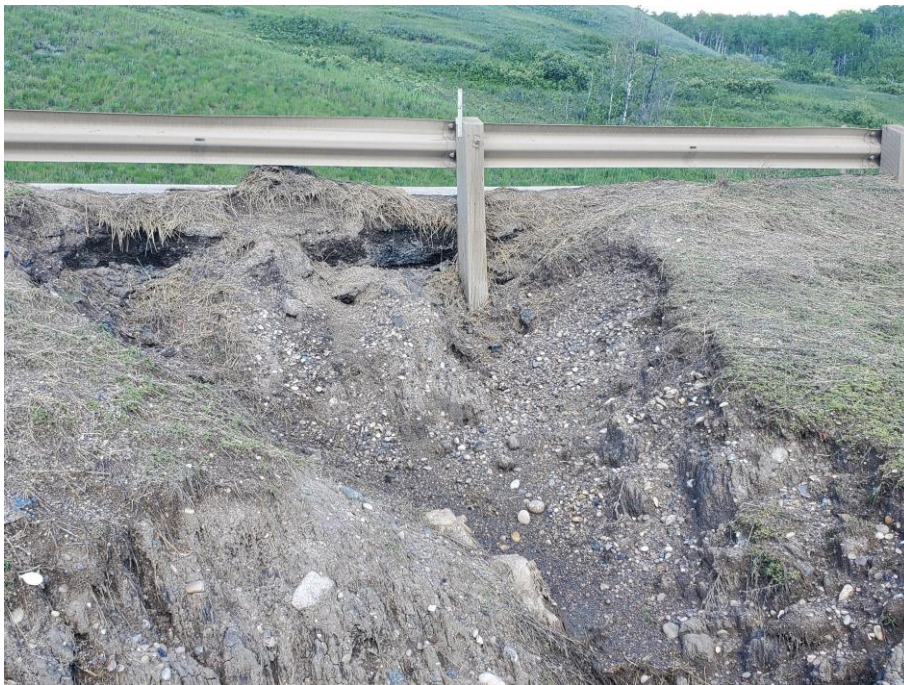
**Photo 61-02.**  
Local erosion around guardrail post and gully of embankment slope below (36+470). Erosion ongoing with minor lateral expansion since the previous inspection.

Consideration may need to be given to diverting ditch flow around 36+200 to existing trunk drain or building new trunk drain to reduce gully expansion below roadway.

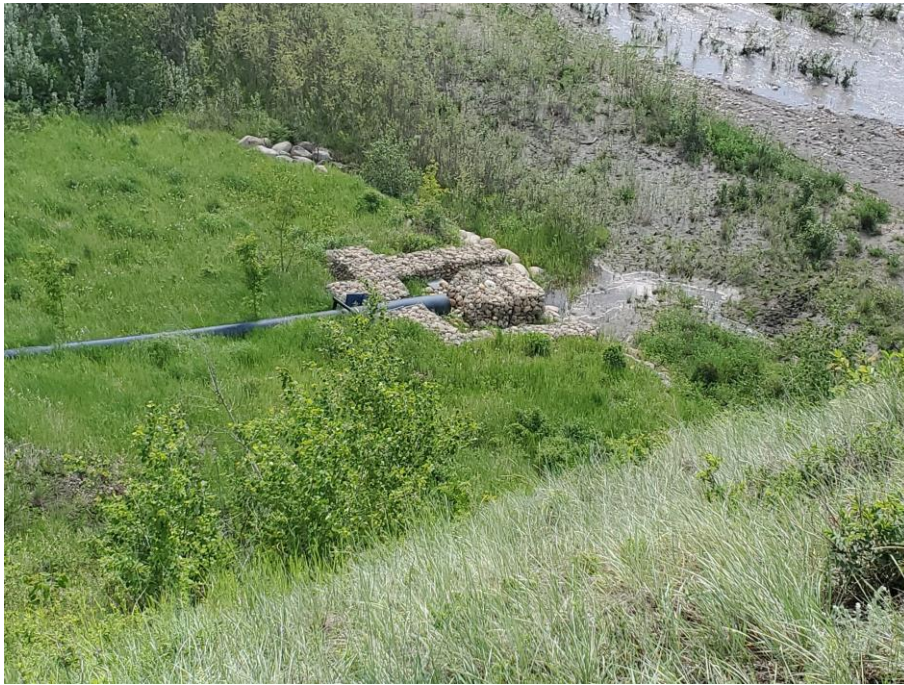
**Photo 61-03.**  
Looking towards trunk drain outlet structure which was functioning as intended.

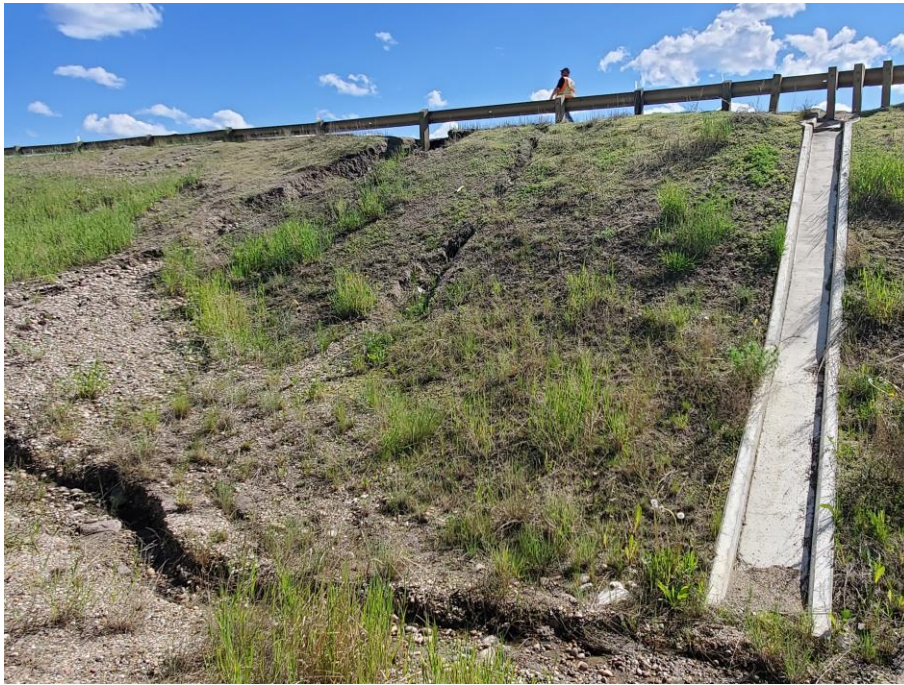
Grading and addition of concrete swale structures are expected to reduce rate of erosion at the bridge abutments from surface runoff. The sand and gravel buildup at the edge of the highway will need to be regularly cleaned to ensure water runoff is not blocked from entering the swale inlets.

**Photo 61-04.**  
Erosion within southeast side of Grouard Bridge abutment slope (37+050). Concrete swale and slope repairs were constructed in 2017/2018. Road runoff is draining over the pavement edge before reaching the swale due to sand and gravel buildup. Gravel and geocell slope repair was effective in select areas but has washed out in others.

Consideration should be given to building an asphalt berm to ensure runoff is directed to the swale.

Remove buildup of sand and gravel at the pavement edges around Grouard Bridge embankments. Ditch grading required around Grouard Bridge.	Maintenance
Continue to monitor instruments twice yearly and undertake annual inspections.	-
Mitigation measures (such as excavation of slide material and replacement with gravel backfill) should be developed and implemented for the shallow slide on west side of elephant trunk at 36+450 and downslope shoulder at 36+350 to minimize potential retrogression into the highway.	\$350,000
Mitigation measures may be required to repair the culvert at 36+230.	\$450,000

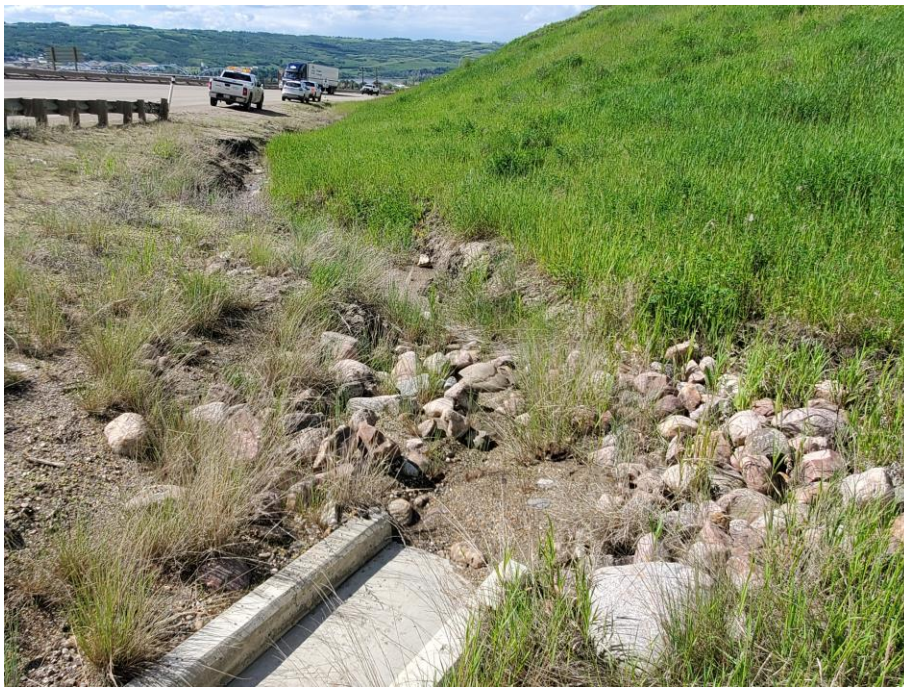
**Photo 61-05.**  
Swale and cobble armor outlet at the northeast side of the Grouard Bridge (37+125). Ditch erosion is active further downstream from outlet.

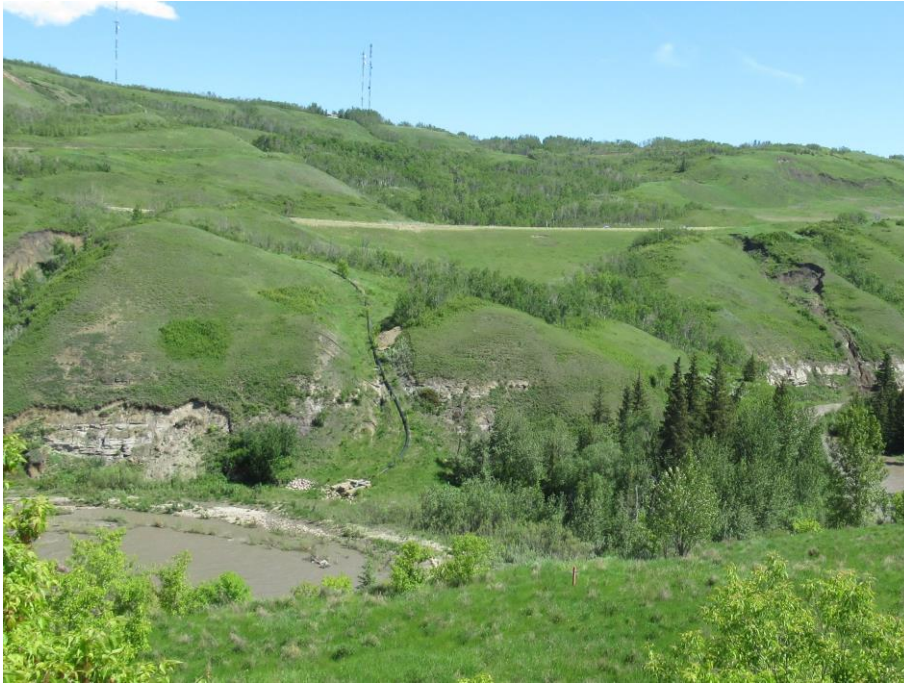
**Photo 61-06.**  
Overall view of the site and lower valley slope from Hwy 744.
