**ALBERTA TRANSPORTATION
GEOHAZARD ASSESSMENT PROGRAM
PEACE REGION (PEACE RIVER DISTRICT)
2022 INSPECTION**

Site Number	Location	Name	Hwy	km
PH2a	East Hill	32+800 to 33+800	2:60	33.5
Legal Description		UTM Co-ordinates		
SW27-083-21 W5M		11V E 485640	N 6230750

Site Number	Location	Name	Hwy	km
PH2b/2c	East Hill	Retaining Wall 33+850 to 34+050	2:60	33.85- 34.0
Legal Description		UTM Co-ordinates		
SW27-083-21 W5M		11V E 485345	N 6230685

Site Number	Location	Name	Hwy	km
PH2d	East Hill	34+100 to 34+780 Site 1	2:60	34.5
Legal Description		UTM Co-ordinates		
SW27 & SE 28-083-21 W5M		11V E 484800	N 6230710

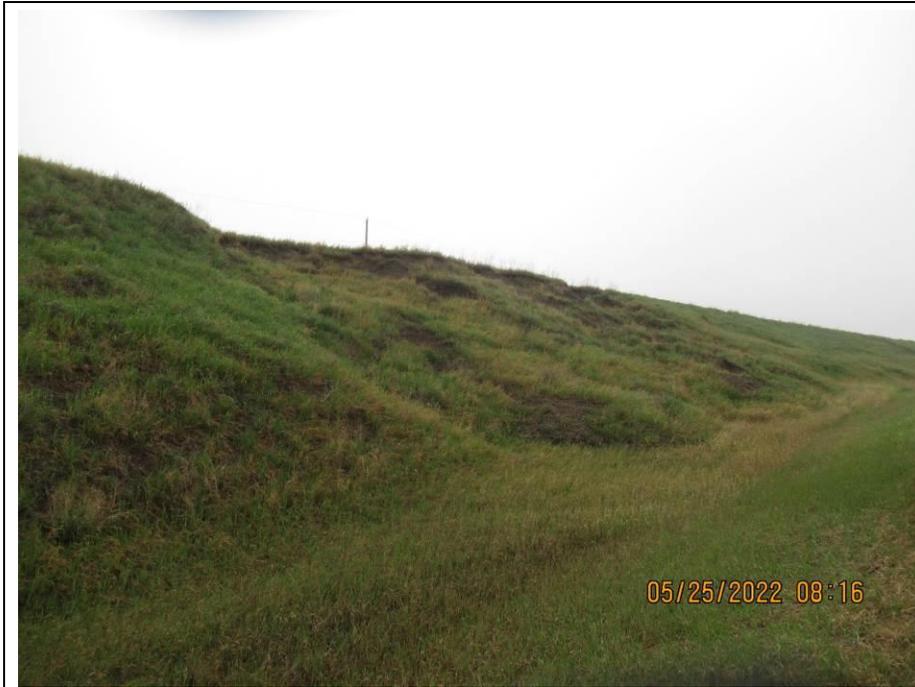
<input checked="" type="checkbox"/> Erosion	Minor local ditch erosion (Photo 2-01). Active erosion was noted on the south side of the highway between 33+300 to 33+700 (Photo 2-04) that was worse than the 2020 condition.	<input checked="" type="checkbox"/>
<input type="checkbox"/> Seepage		<input type="checkbox"/>

Photo 2-01.
Looking northeast at the shallow cut slope slumps on the northeast side of the road (33+100). Backslope regrading and excavation of the slide areas is to be completed this year. No other new slide areas were noted since the 2021 inspection.

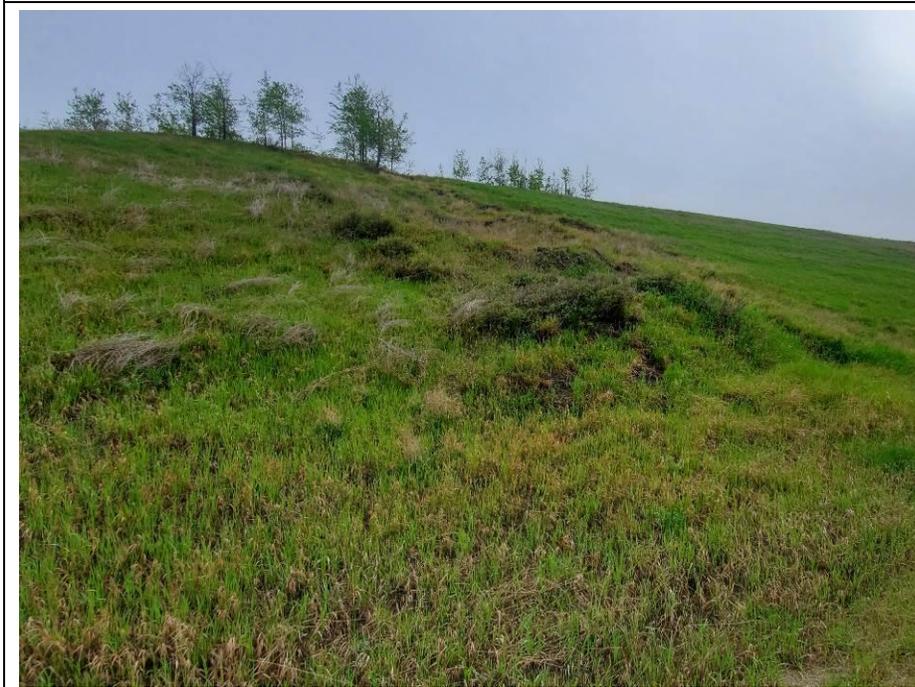
Photo 2-02.
Looking north towards a shallow slide in the cut slope first observed in 2013. No significant expansion or movement since 2016 (33+450).

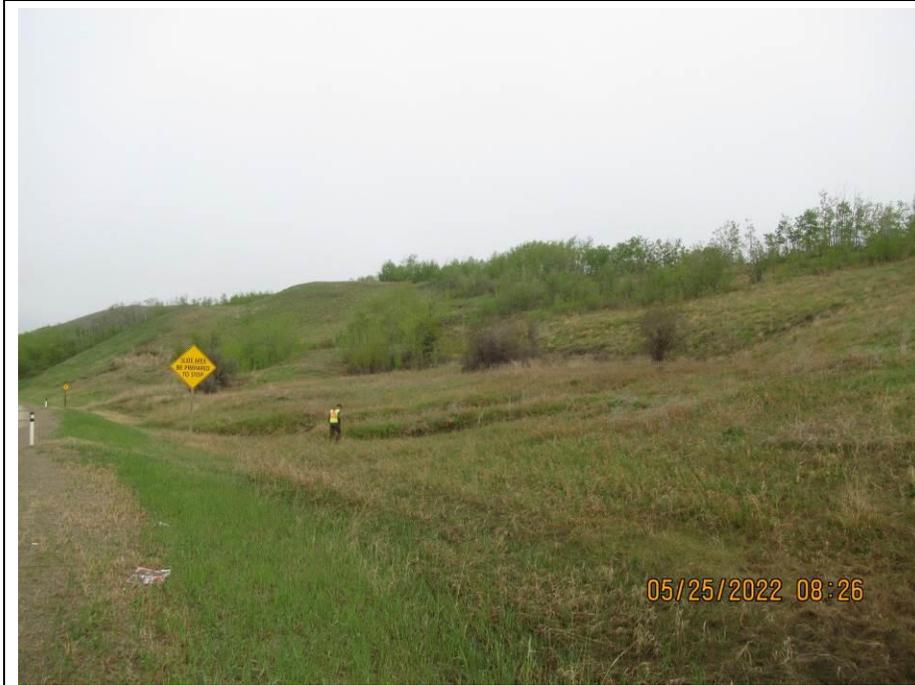
Photo 2-03.
Looking west towards the toe roll of a larger surficial slump (130 m wide) within the cutslope. There has been minor ongoing encroachment into the ditch since the 2017 inspection (33+550). No major changes relative to the 2020 condition.

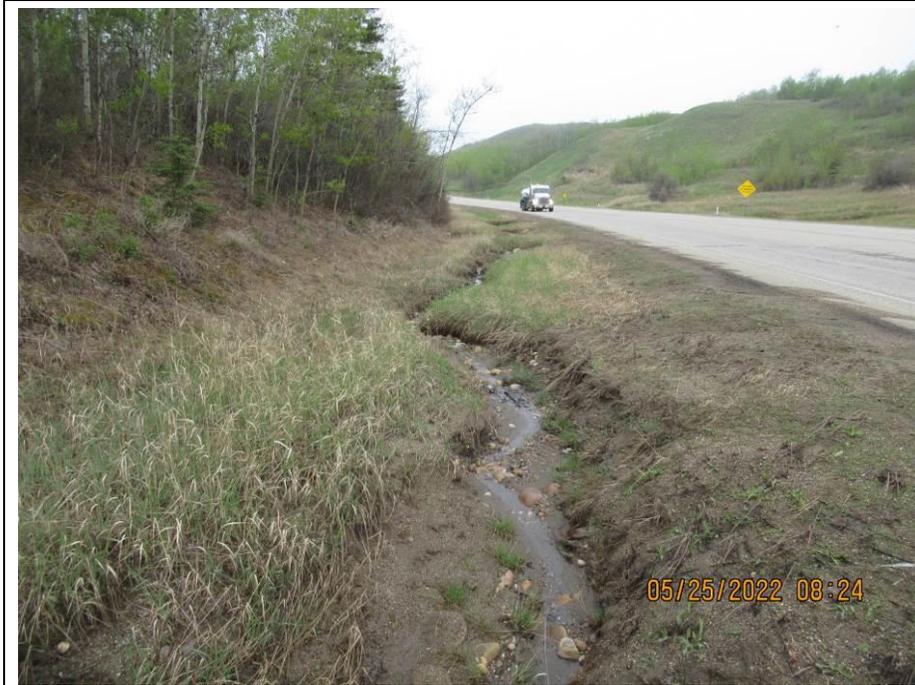
Photo 2-04.
Looking southwest towards the south road ditch with active erosion damage between 33+300 to 33+700. Erosion damage has worsened since the 2020 condition.

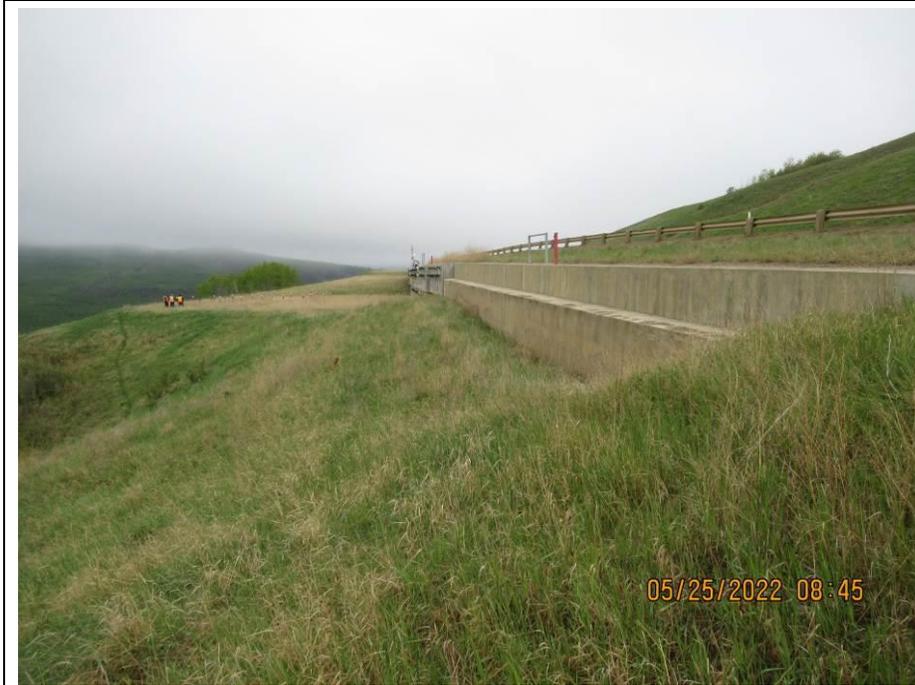
Photo 2-05.
Looking west at
concrete pile
retaining wall at
33+850.

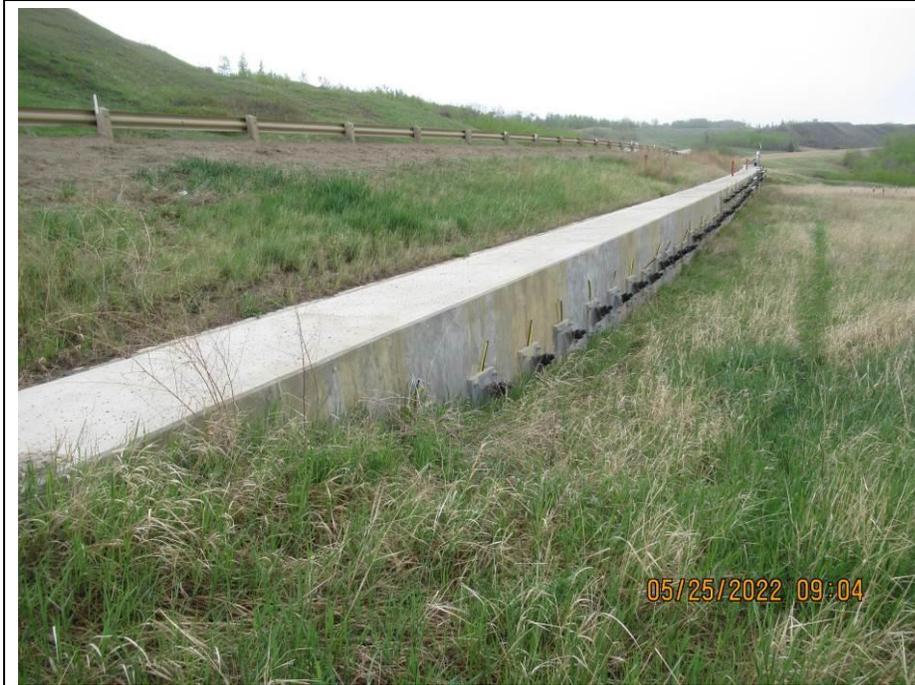
Photo 2-06.
Looking east at the
retaining wall located
at 33+900.

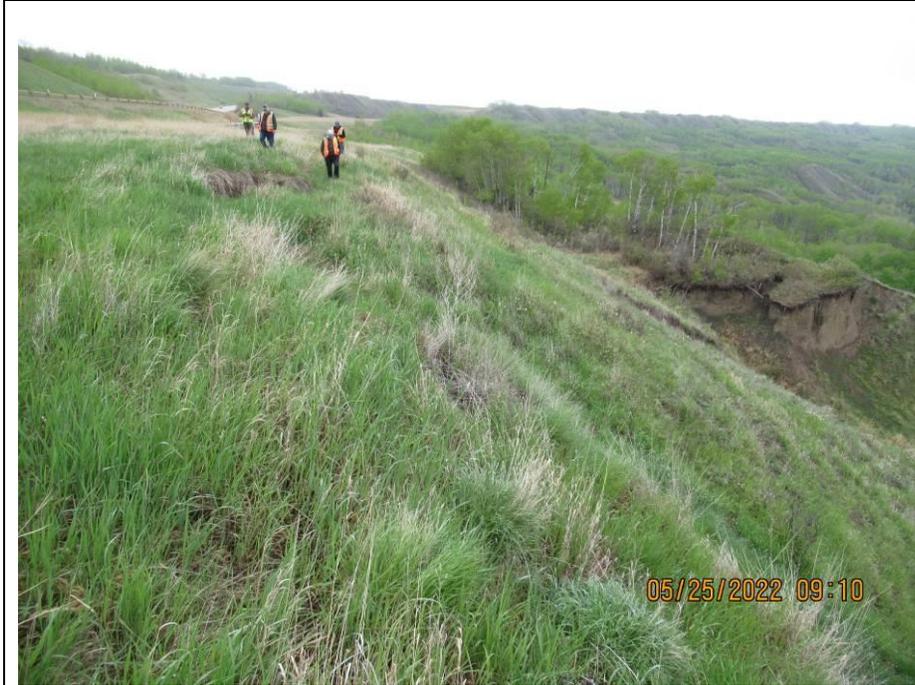
Photo 2-07.
Looking downslope at the large, active landslide below roadway (34+050). There was a more visible scarp with dropdown up to 1.3 m and tension cracks have extended and opened up further relative to the 2020 condition.

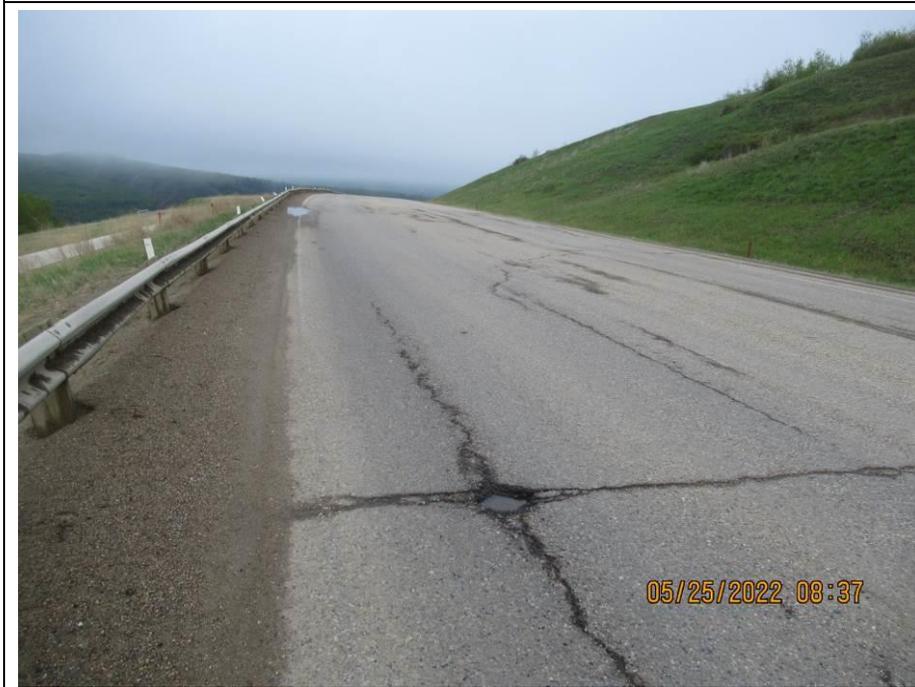
Observations:	Description	Worsened?
<input checked="" type="checkbox"/> Pavement Distress	ACP above the pile wall has minor dips and minor increased settlement from 2020 condition (Photo 2-08).	<input type="checkbox"/>
<input checked="" type="checkbox"/> Slope Movement	<p>The fill slope below the wall and area of previously observed movement has been regraded as part of the pile wall installation work. No newly developed scarps or tension cracks were observed downslope of the pile wall since construction completed (Photos 2-05 and 2-06).</p> <p>Active slide area developing west and downslope of the pile wall at 34+050 has expanded with significant more dropdown at the scarp (up to 0.8 m) and extended tension cracks (Photos 2-07 and 2-14). Width of slide area is approximately 75 m and is offset approximately 26 m from the highway.</p>	<input checked="" type="checkbox"/>
<input checked="" type="checkbox"/> Erosion	Erosion at the end of the armored drainage outlet area at the west end of the pile wall. Minor ditch erosion.	<input type="checkbox"/>

Photo 2-08.
Looking west towards the highway surface above the pile wall at 33+900. Minor dips and cracking is present along previously observed extents. No major changes from the 2020 condition.

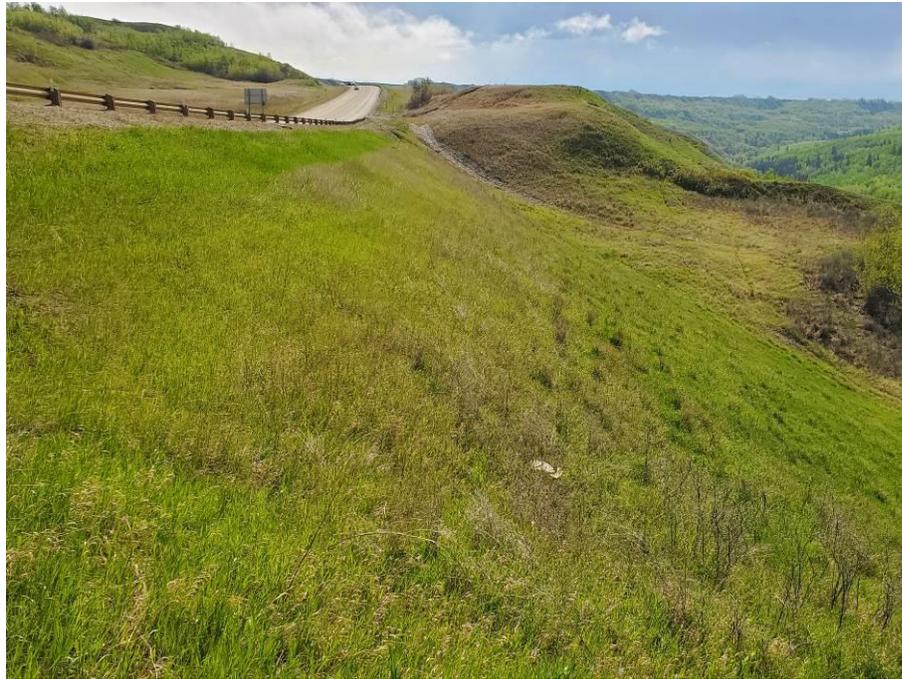
<input type="checkbox"/> Pavement Distress		<input type="checkbox"/>
<input checked="" type="checkbox"/> Slope Movement	Road fill embankment between 34+450 to 34+600 (old Site 1) had no visible signs of new slope movement/instability (Photo 2-09). Shallow slumping is occurring on upslope side of the roadway within Site 1 landslide. Shallow and deep-seated movements are active just below the large road embankment at 34+550 with minor main scarp and flank retrogression (Photo 2-10). Visually, top of scarps below and just west of the embankment appears similar to 2020 condition (Photo 2-11). Shallow earth slide in backslope at 34+400 partially blocking	<input type="checkbox"/>

Photo 2-09.
Looking east towards the road fill embankment between 34+450 to 34+600 (old Site 1).

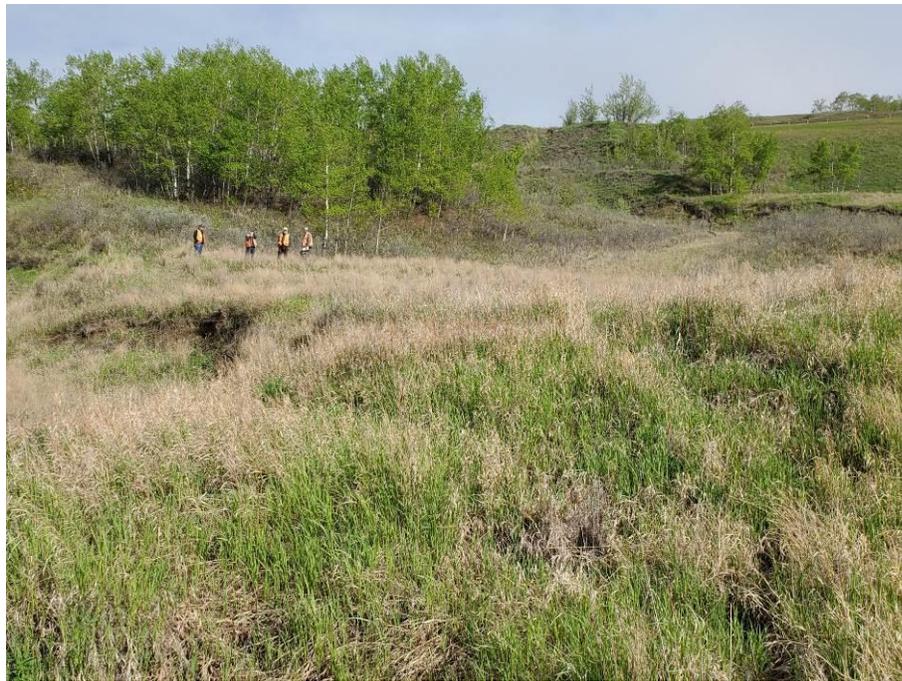
Photo 2-10.
Looking upslope towards the northwest at the active slide area below the highway at 34+550. Minor main scarp and flank retrogression were observed since the 2020 inspection.

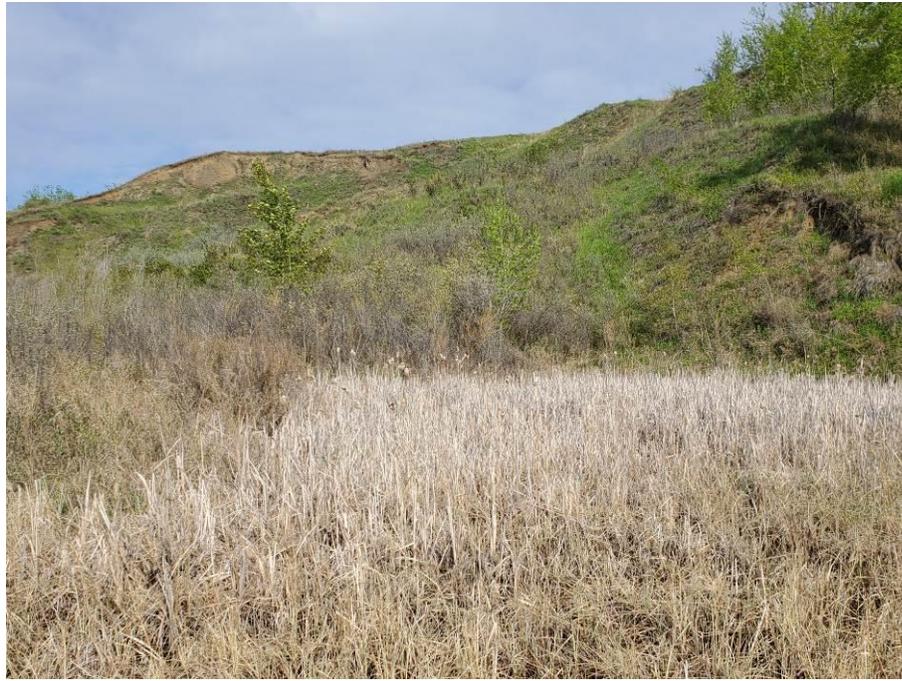
Photo 2-11.
Looking west at the top of the main scarp below the highway at (34+600). No major changes observed from 2019.

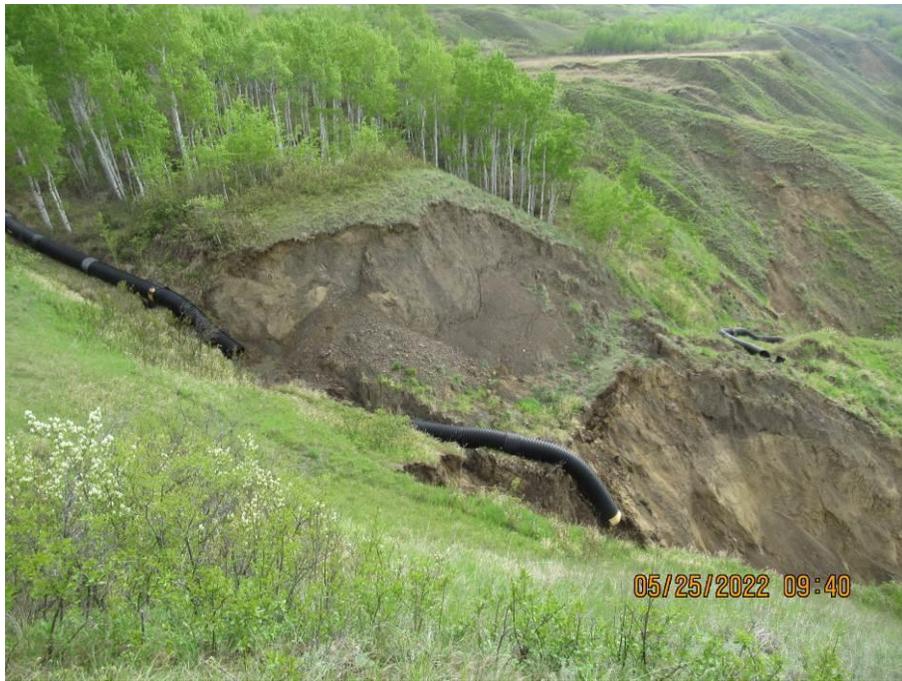
Photo 2-12.
Looking east at the trunk drain breach. Significant gully erosion and landsliding has developed upslope from the initial breach. Terrain is actively eroding and sliding that is expected to continue to retrogress upslope. Diversion of the current trunk drain to a new alignment is required to slow the erosion.

Recommendations:		Cost
Continue to visually monitor as part of annual inspection of PH2. Slope inclinometers should continue to be monitored twice annually.		-
South ditch should be cleared before it eventually becomes blocked at 34+400. North ditch should be cleared of silt buildup between 34+500 to 34+600.		Maintenance
A new trunk drain alignment should be constructed.		\$300k

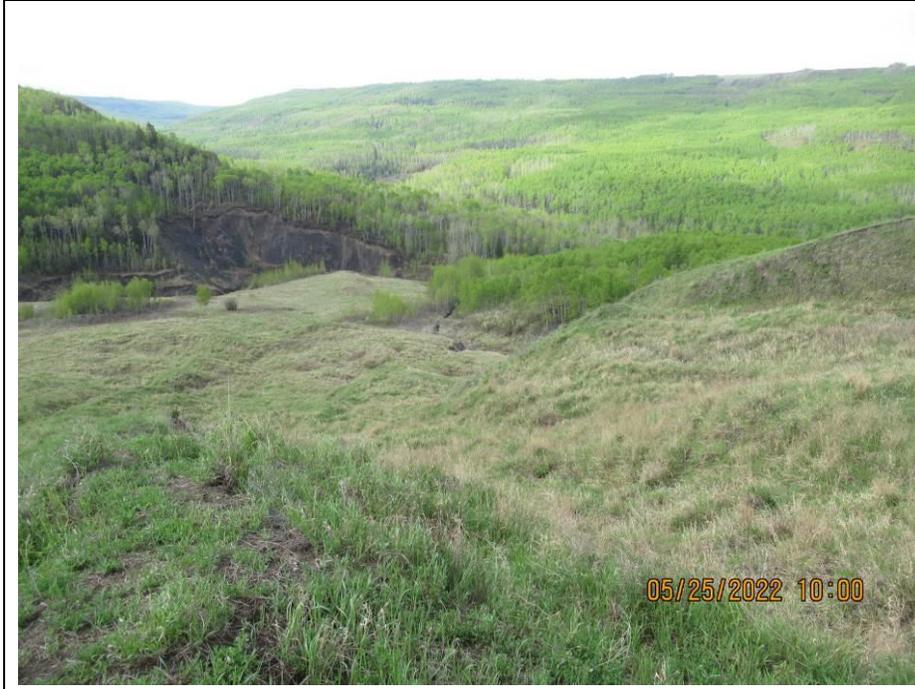
Assessment:		
<p>Deep-seated movements within the old berms on downslope side of roadway continue to be of concern to the stability of the road embankment at 34+550. Mitigation would be required if SI 10-3 began to register ground movements. The upslope portion of the Site 1 landslide is affected by numerous local shallow instabilities in the form of slumps. These slumps typically do not affect the roadway and toe out above the ditch. The possibility of deep-seated creep movement of the old rupture surface cannot be ruled out, although there is no surviving instrumentation to confirm or disprove.</p> <p>Erosion at the breach in the elephant trunk drain has become significantly worse and will continue to retrogress further upslope and destabilize upper portions of the slope closer to the road. The drain itself has become compromised further upslope and has created a new leak origin area. As gulying continues it is expected the trunk drain will undergo further stress and these new leak points will continue to move upslope along the joints if left unmitigated. Diversion of the current trunk drain to a new alignment to the east is required to slow the erosion (Photo 2-13).</p>

Photo 2-13.
View of historic slide terrain east of the trunk drain breach that is proposed as possible re-alignment option for a new trunk drain. Note existing drain visible near bottom of the slope.

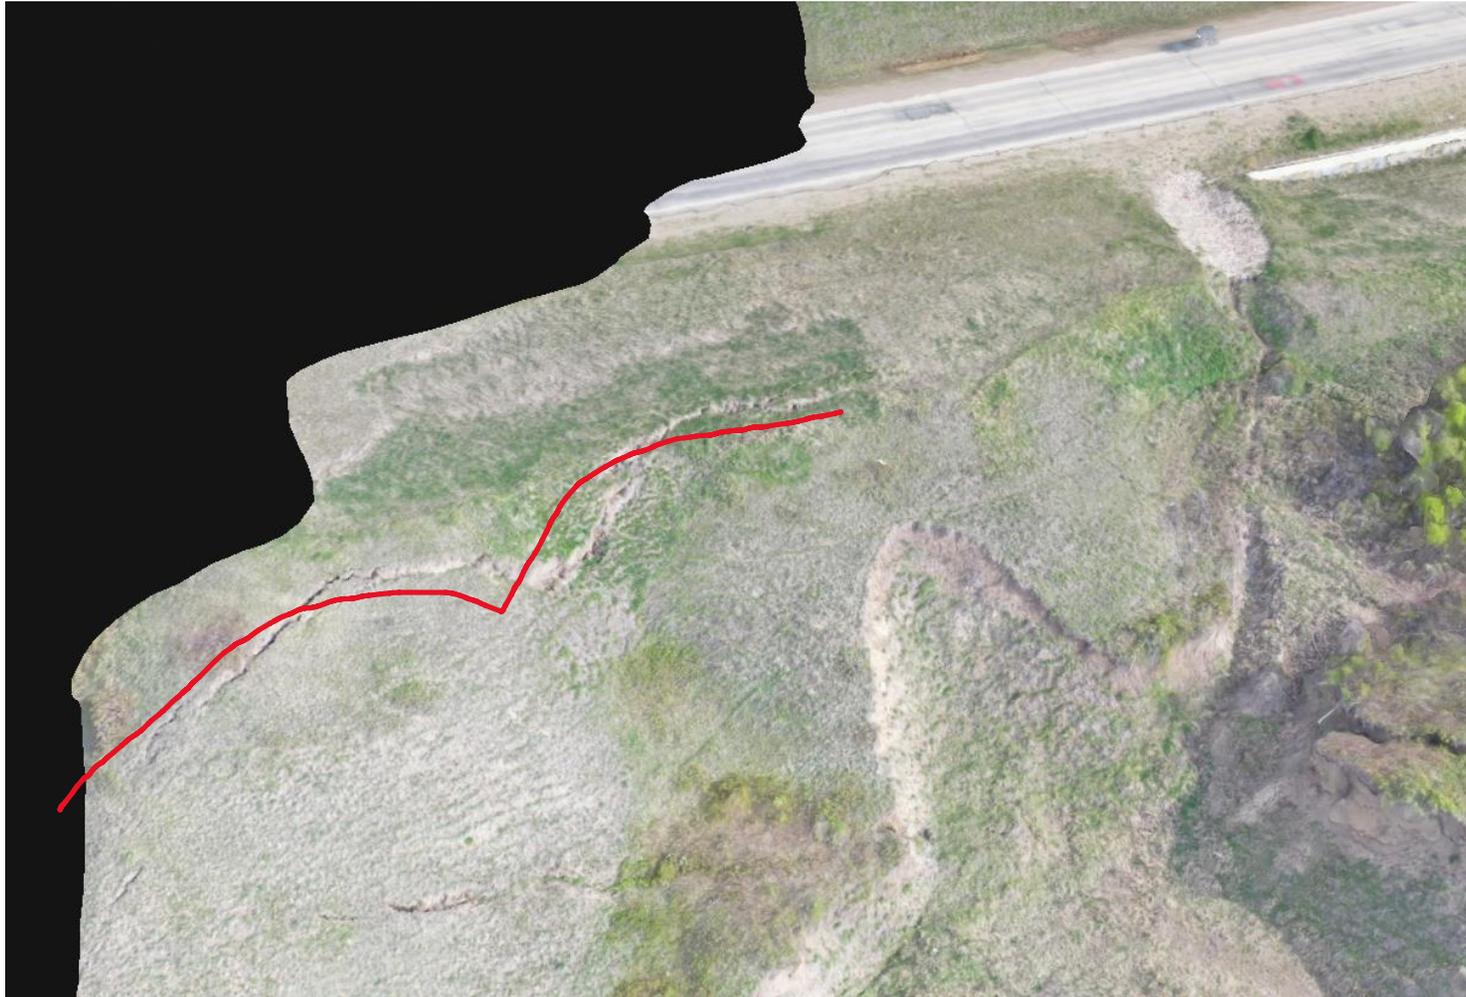
Drone Photo 2-14 –

The slide developing west of the wall has developed a very apparent scarp and is expected to considerably worsen over the next 5 years. Due to its current offset from the highway (approximately 26 m) it is not expected to have an immediate impact to the NBL however future retrogression could cause instability that reaches the road shoulder or further if left unmitigated. The progression of this

Photogrammetric 3D model produced from drone imagery of the slide developing west of the pile wall (KM 34+050) and visible scarp and tension cracks (highlighted red). Slide is approximately 75 m wide and has a minimum offset of 26 m from the highway. View is towards the northeast.

Recommendations:	Cost
Continue to visually monitor as part of annual inspection of PH002 and monitor wall instrumentation to ensure the mitigation is performing as designed.	
Due to the increased movements of the landslide block west of the wall and the creep zone under the wall at S114-2, it is recommended that the visual monitoring of this site be changed from once every 2 years to annually.	-
Should confirm whether the camera monitoring posts need replacement (i.e., damaged Styrofoam balls) and how long the camera monitoring system (installed by Queens University) will be kept in place.	-
Ongoing pavement repairs as required until movement upslope from the wall is reduced.	Maintenance
