July 28, 2022

**ALBERTA TRANSPORTATION GRMP (CON0022164)
PEACE REGION (PEACE RIVER DISTRICT)
INSTRUMENTATION MONITORING RESULTS – SPRING 2022**

**SITE PH070: HWY 2:60, PEACE RIVER EAST HILL
RETAINING WALL SITE (km 33.84)**

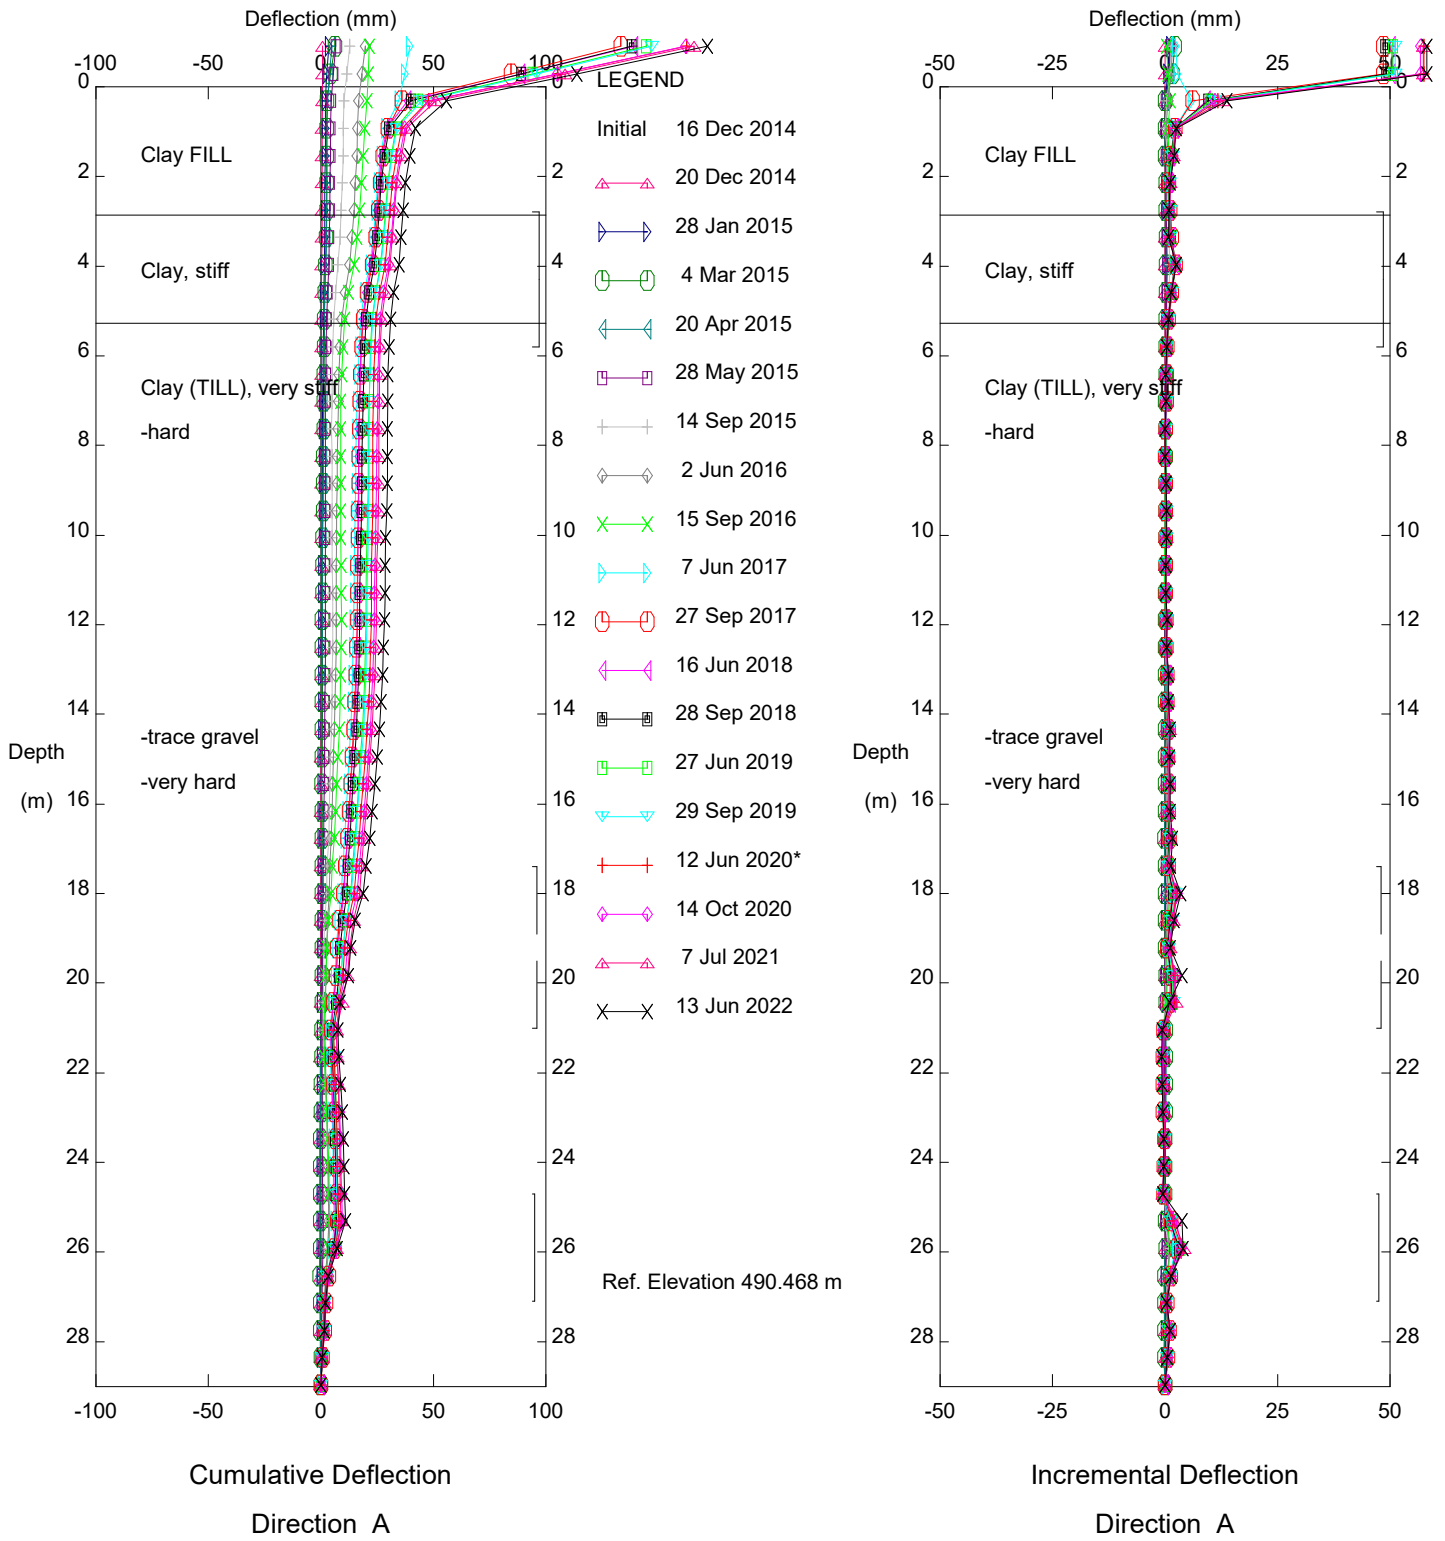
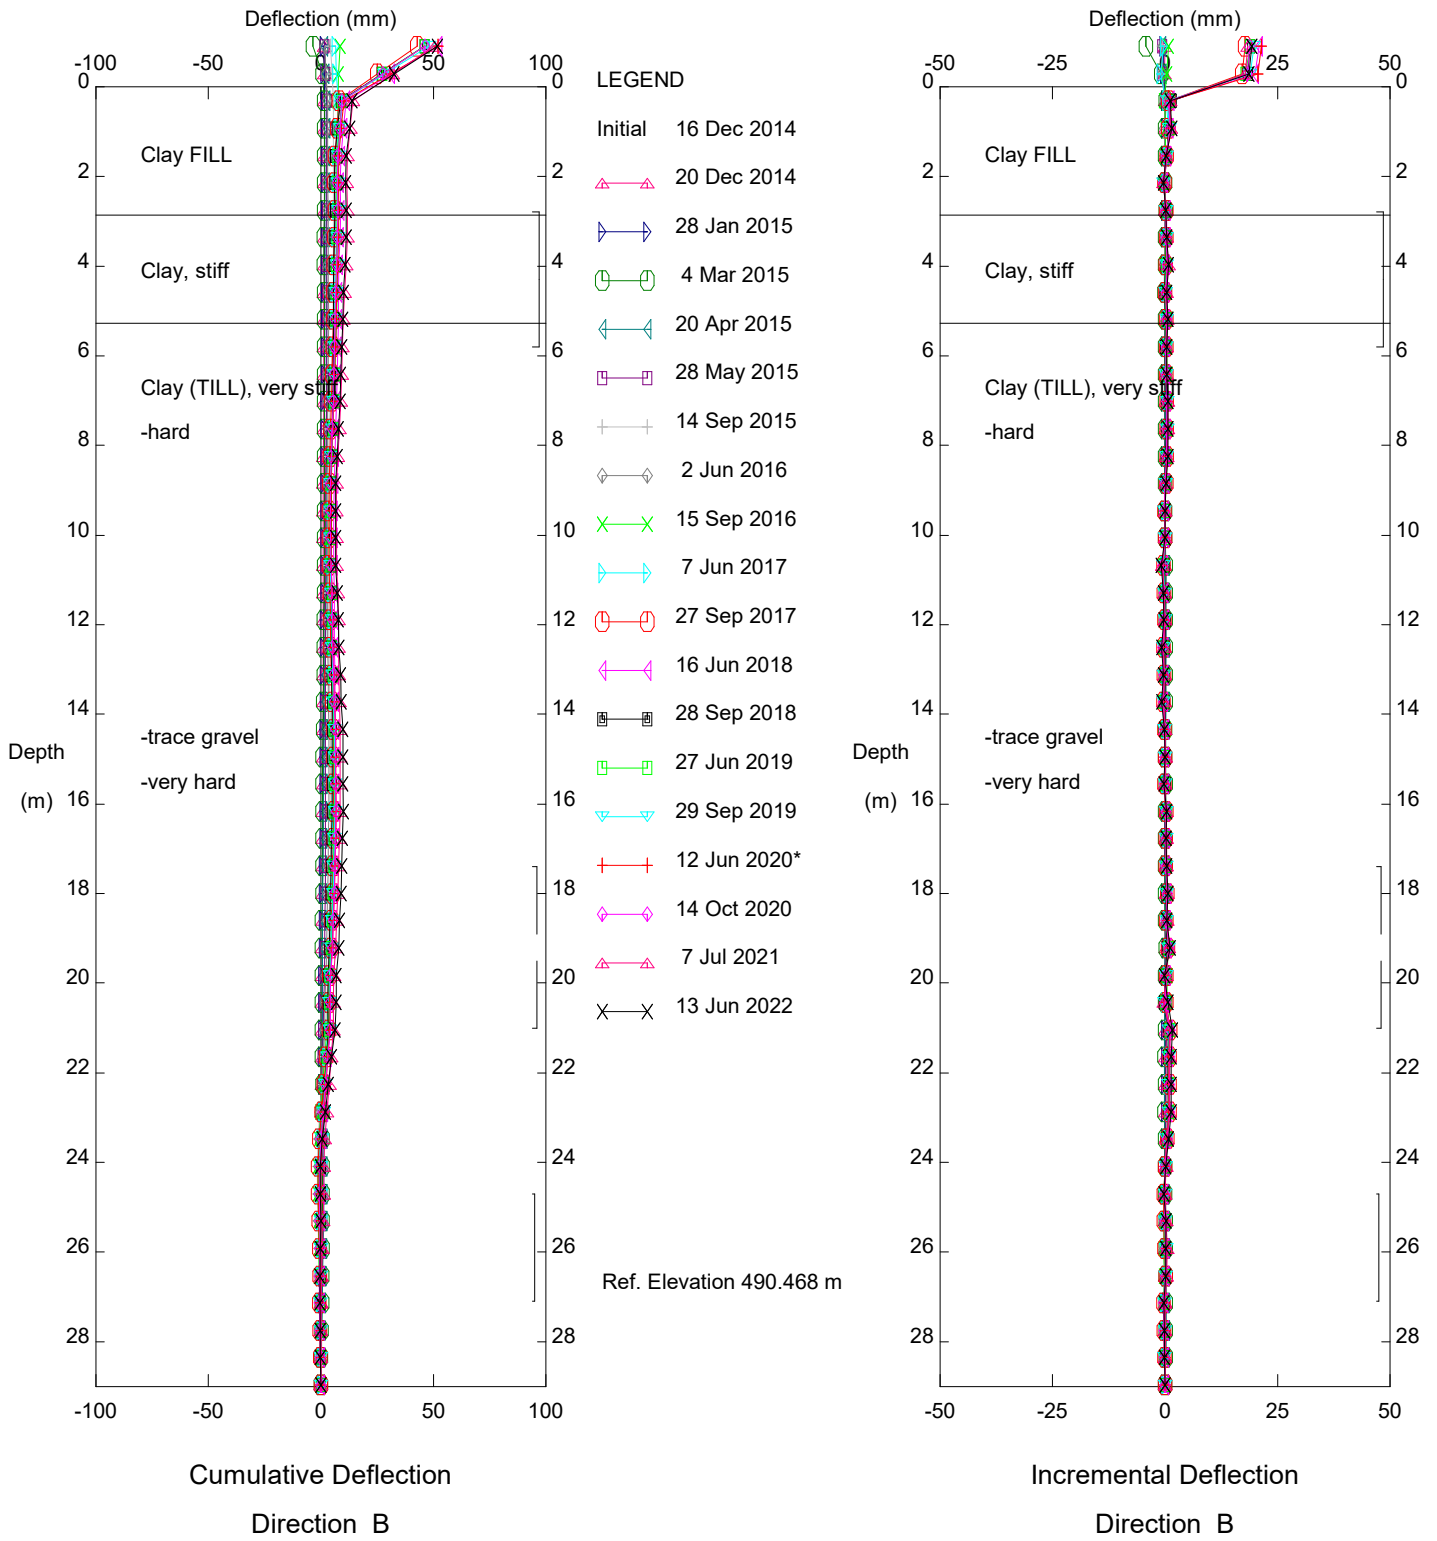
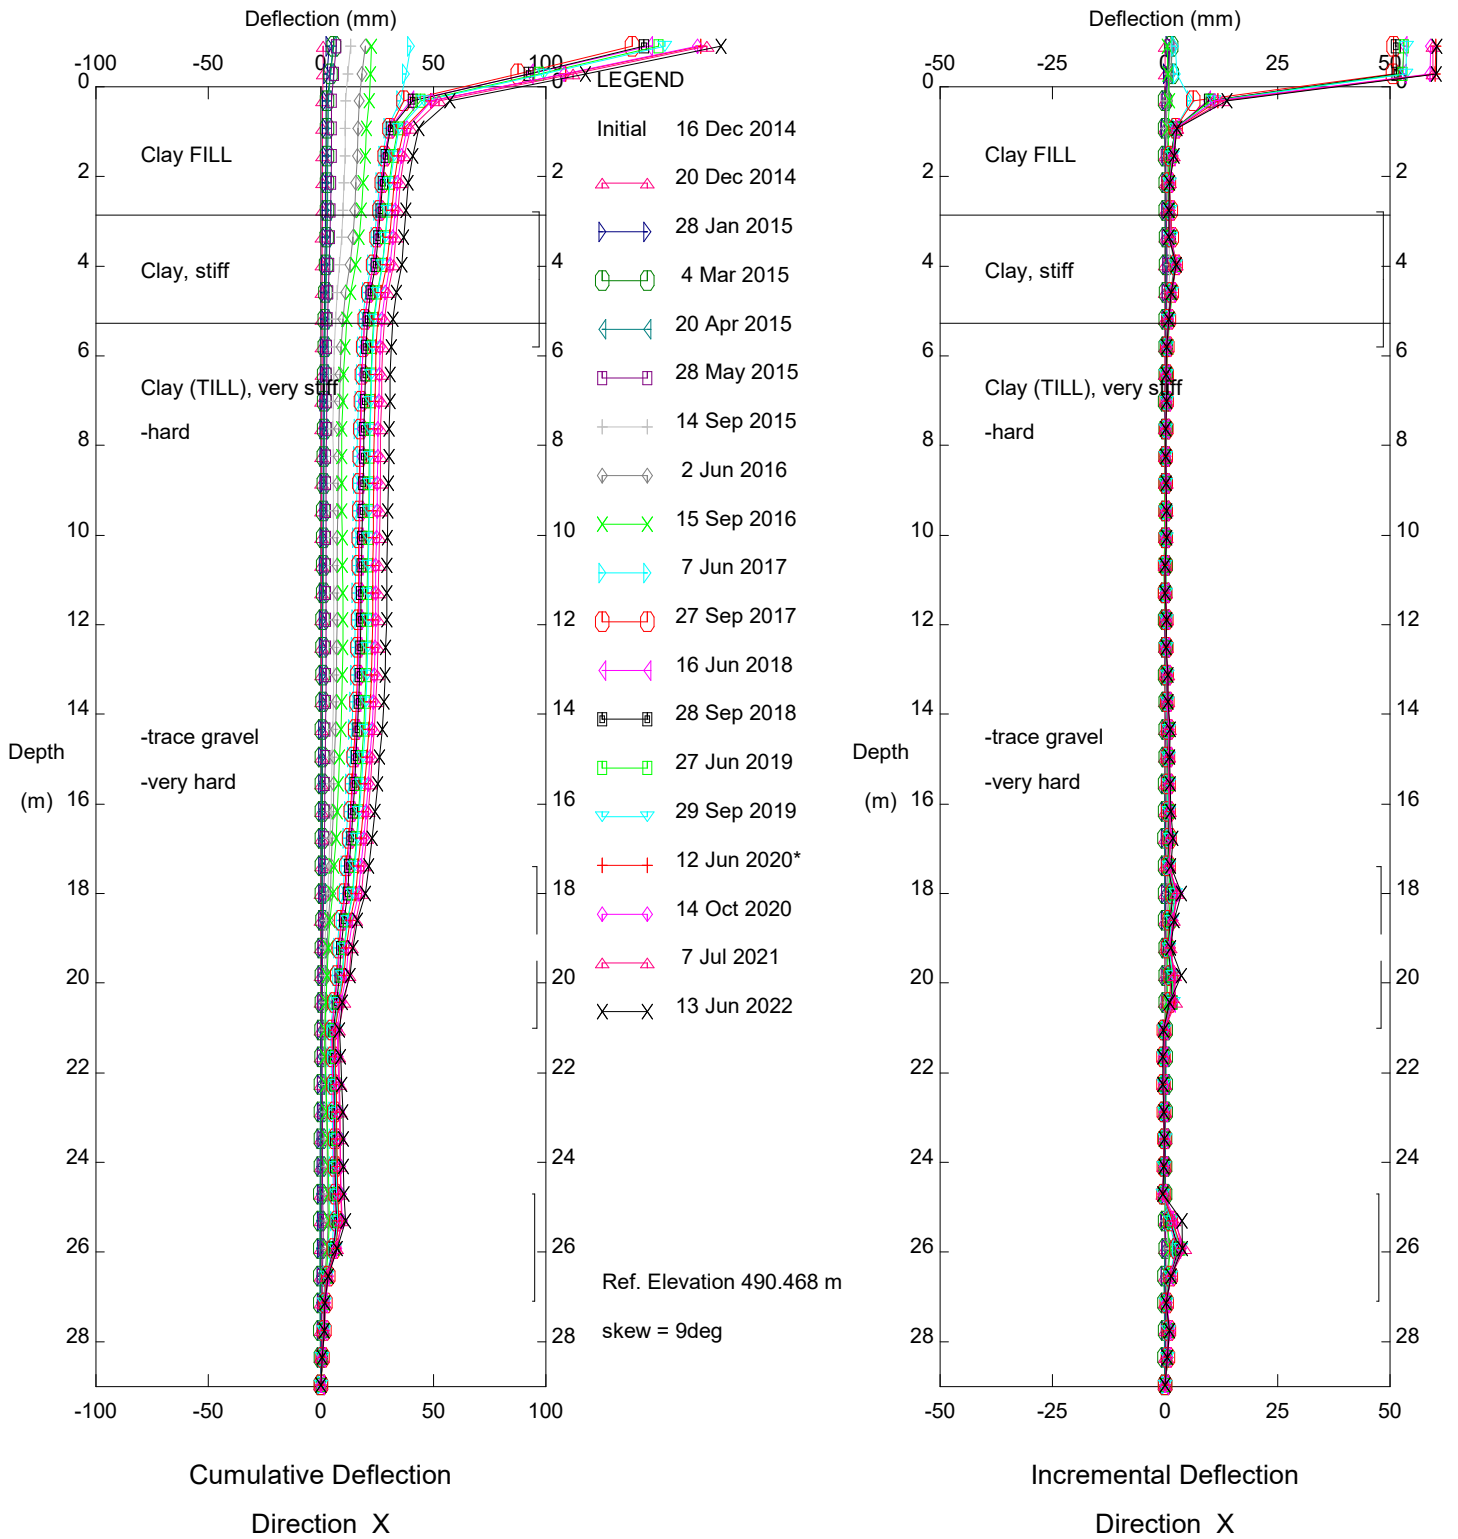
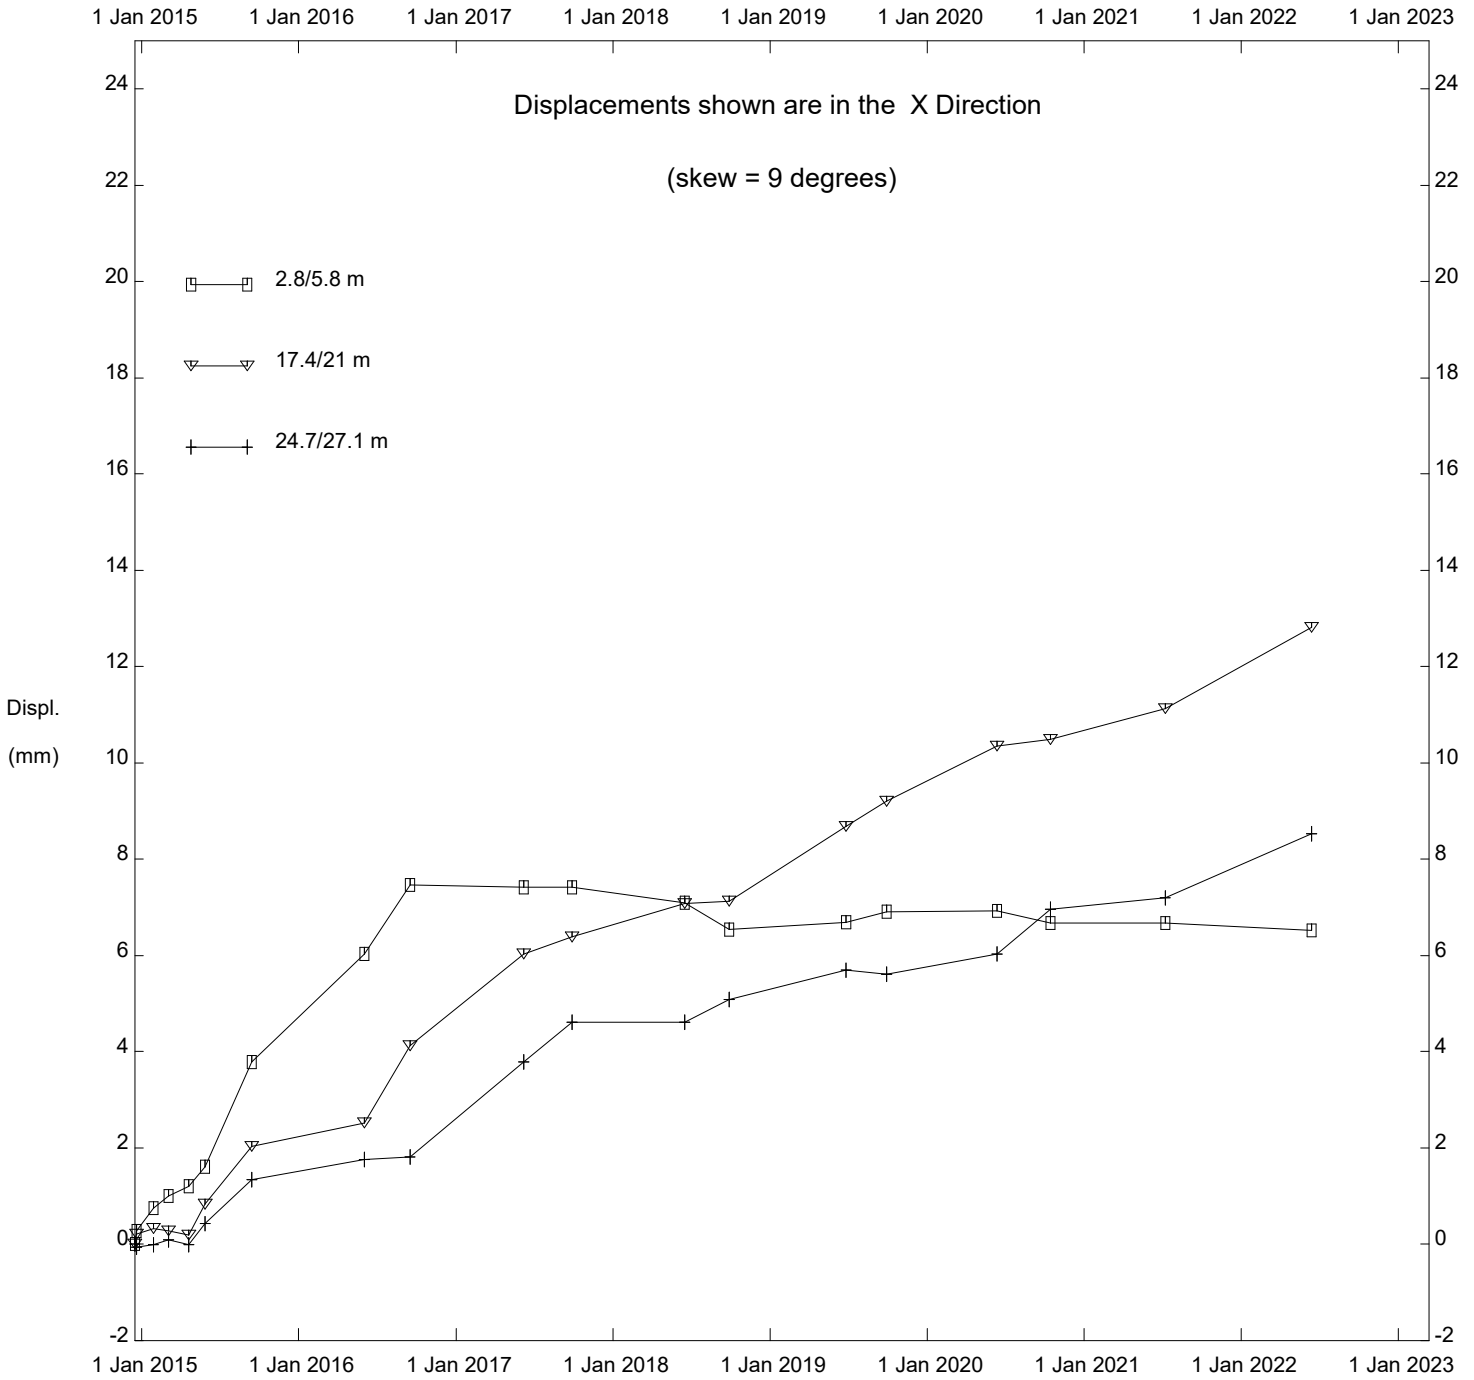
Peace River East Hill PH070, Inclinometer SI14-2

Slope inclinometer SI14-2, located upslope of the new pile wall, showed no discernible movement over 2.8 m to 5.8 m depth, a rate of movement of 1.8 mm/yr over 17.4 m to 21.0 m depth, and a rate of movement of 1.4 mm/yr over 24.7 m to 27.1 m depth since the spring of 2021 readings. Slope inclinometer SI14-3, also located upslope of the new pile wall, showed a rate of movement of 0.9 mm/yr over 3.3 m to 9.4 m depth since the spring of 2021 readings.

Since the new movements noted in SI14-2 are below the tips of the pile wall, special attention should be paid when reviewing future readings to check for potential increases in the rate of movement. Although the movement to date had been very small, the road surface should also be visually monitored at this location to check for any subsidence or new cracks.

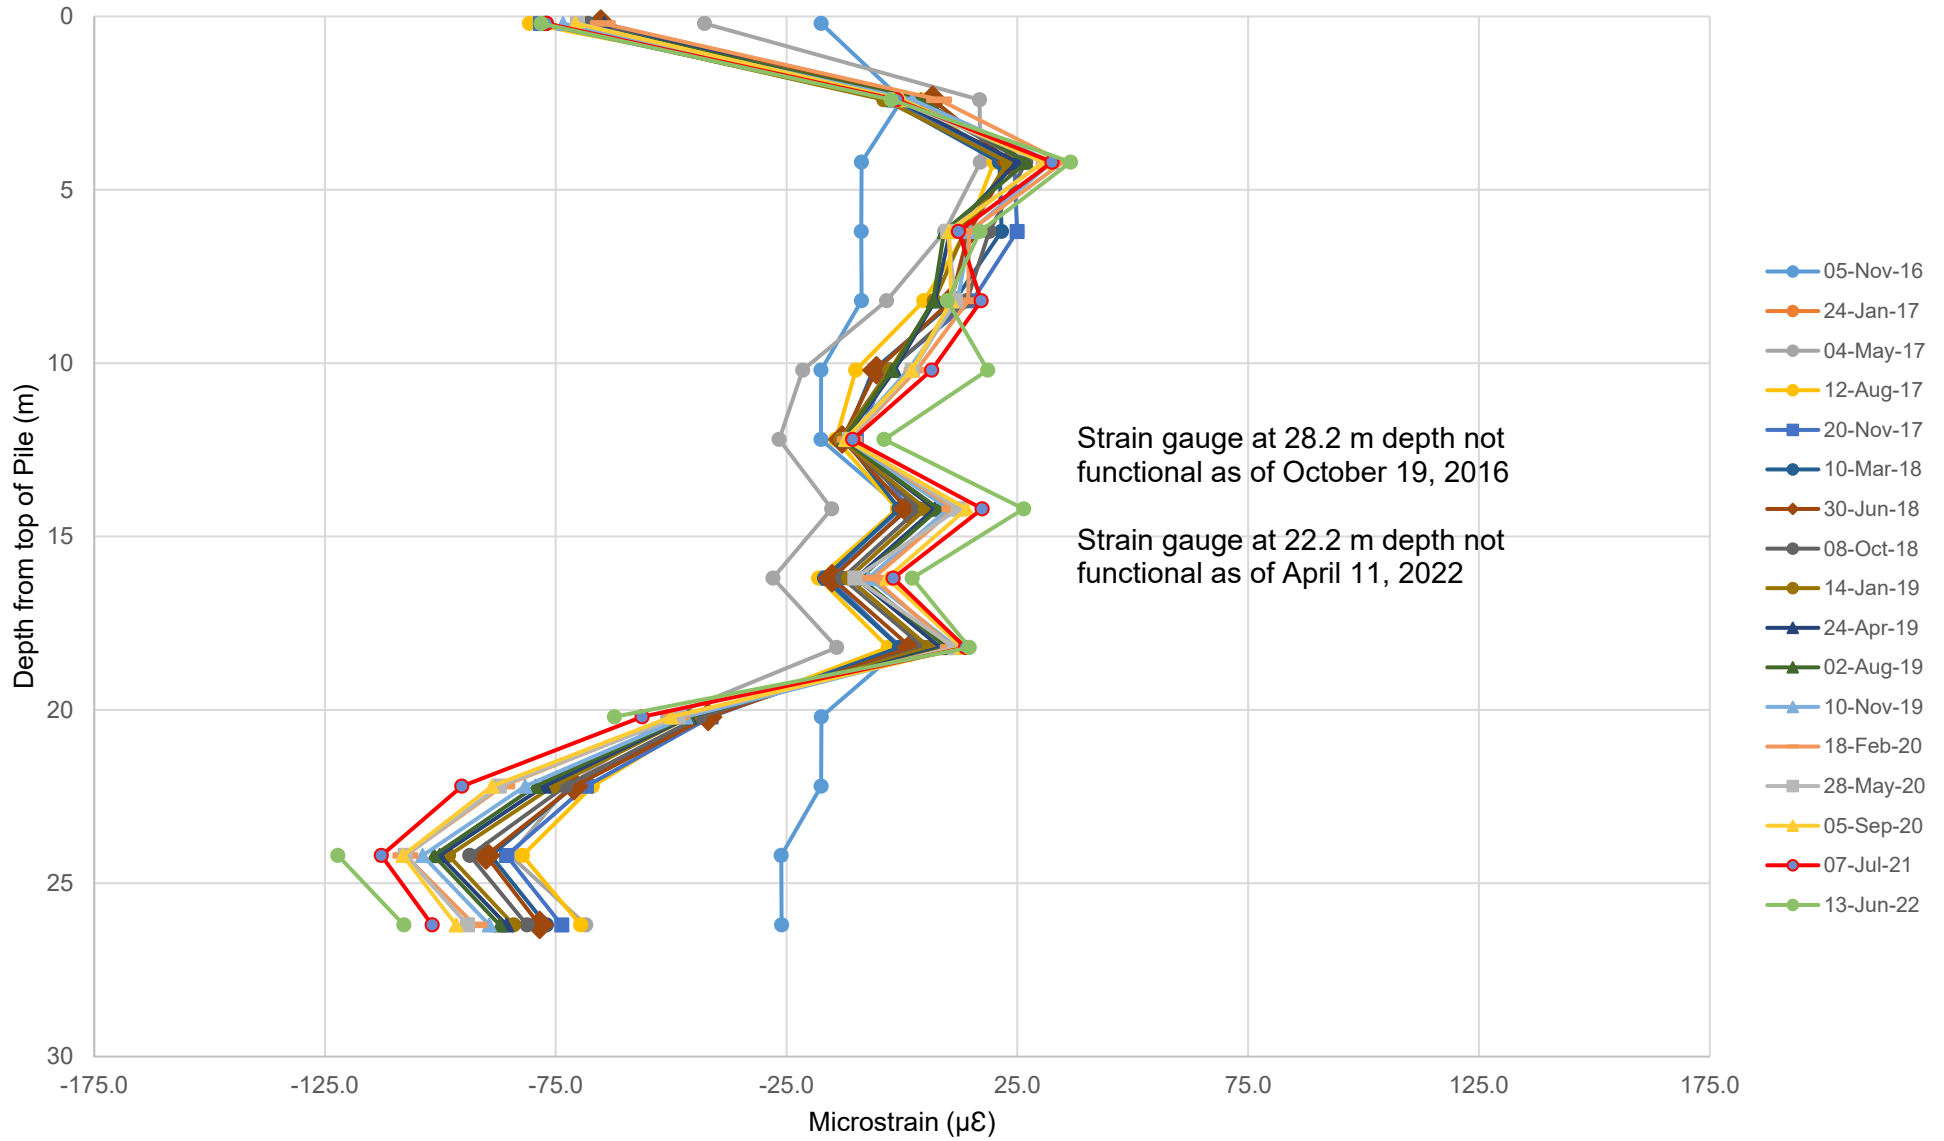
FIGURE PH070-1
HWY 2:60 PEACE RIVER EAST HILL RETAINING WALL SITE (km 33.84)
PILE P74 DOWNSLOPE SIDE STRAIN GAUGE VALUES VS DEPTH

The strain gauge readings are summarized in Table PH070-3 and plotted on Figures PH070-1 and PH070-2 included in Appendix A. In general, the strain gauges showed small increases in negative (compressive) strain on the upslope pile face, while the strain gauges on the downslope pile face showed small increases in positive (tension) stress. The maximum change in microstrain since the previous readings was $-13.0 \mu\epsilon$.

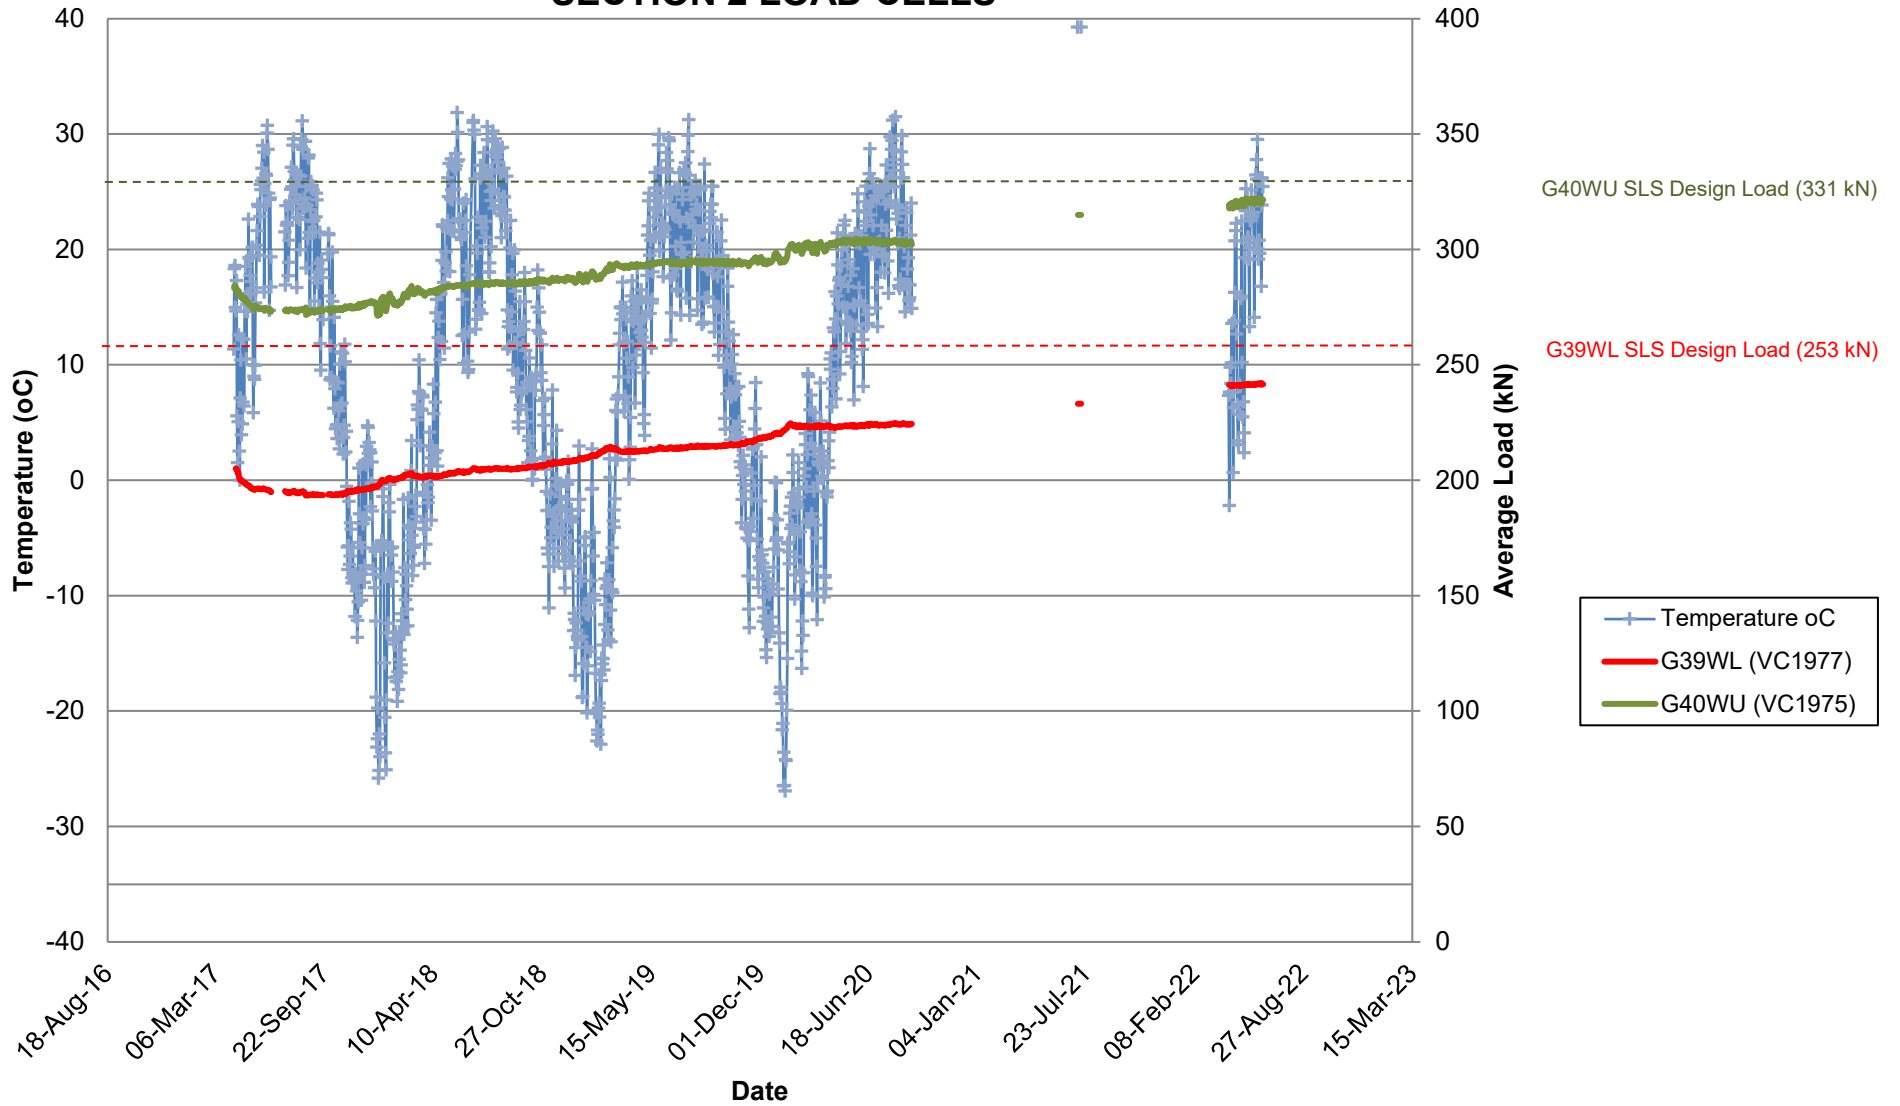
**FIGURE PH070-5
HWY 2:60 PEACE RIVER EAST HILL RETAINING WALL SITE (km 33.84)
SECTION 2 LOAD CELLS**

Overall, the load cells show a trend of relatively stable loads. Anchors G39WL and G40WU in Wall Section 2 currently show a trend of gradually increasing load, although these loads are still below the SLS design loads. Anchor G190PL, in the bottom (fifth) row of anchors in Wall Section 4, also shows a trend of slowly increasing load, however the design of the wall assumes that the anchors installed through the piles in this wall section will pick up load over time. Some of the load cells have also shown somewhat higher load values during the winter months, similar to what has been observed in other tied-back pile walls of similar configuration.

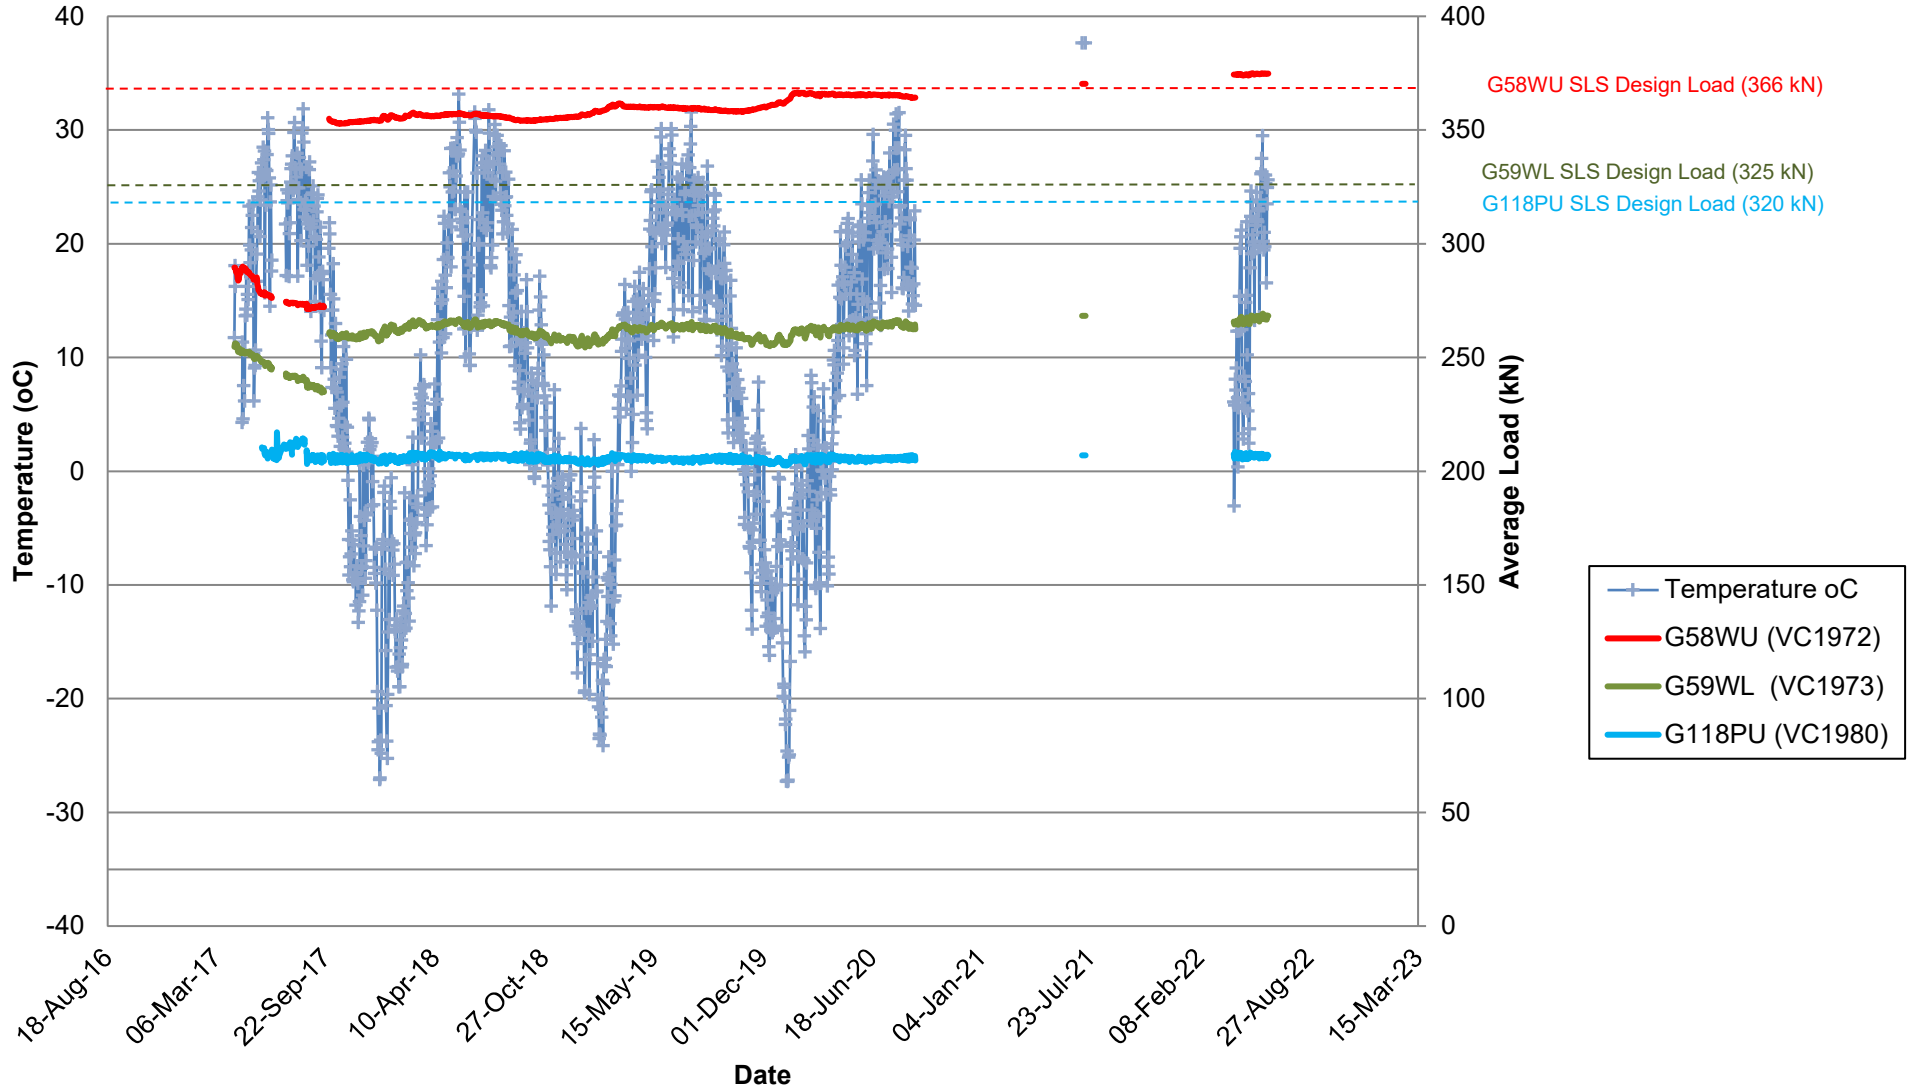
**FIGURE PH070-6
 HWY 2:60 PEACE RIVER EAST HILL RETAINING WALL SITE (km 33.84)
 SECTION 3A LOAD CELLS**

would slacken over time. It should also be noted that anchor G58WU, in Wall Section 3A, is currently showing a load that is 8.82 kN above its SLS design load.
