| Site Number | Location | Name | Hwy | km |
| PH070 | HWY 2:60 C1 33.840 | East Hill Retaining Wall Site | 2:60 | Km 33.84 |

| Current Monitoring: | 25-Sep-2025 | Previous Monitoring | 9-June-2025 |

Table PH070-1 Fall 2025 – Hwy 2:60 Peace River East Hill Retaining Wall Site (Km 33.84) Slope Inclinator Instrumentation Reading Summary

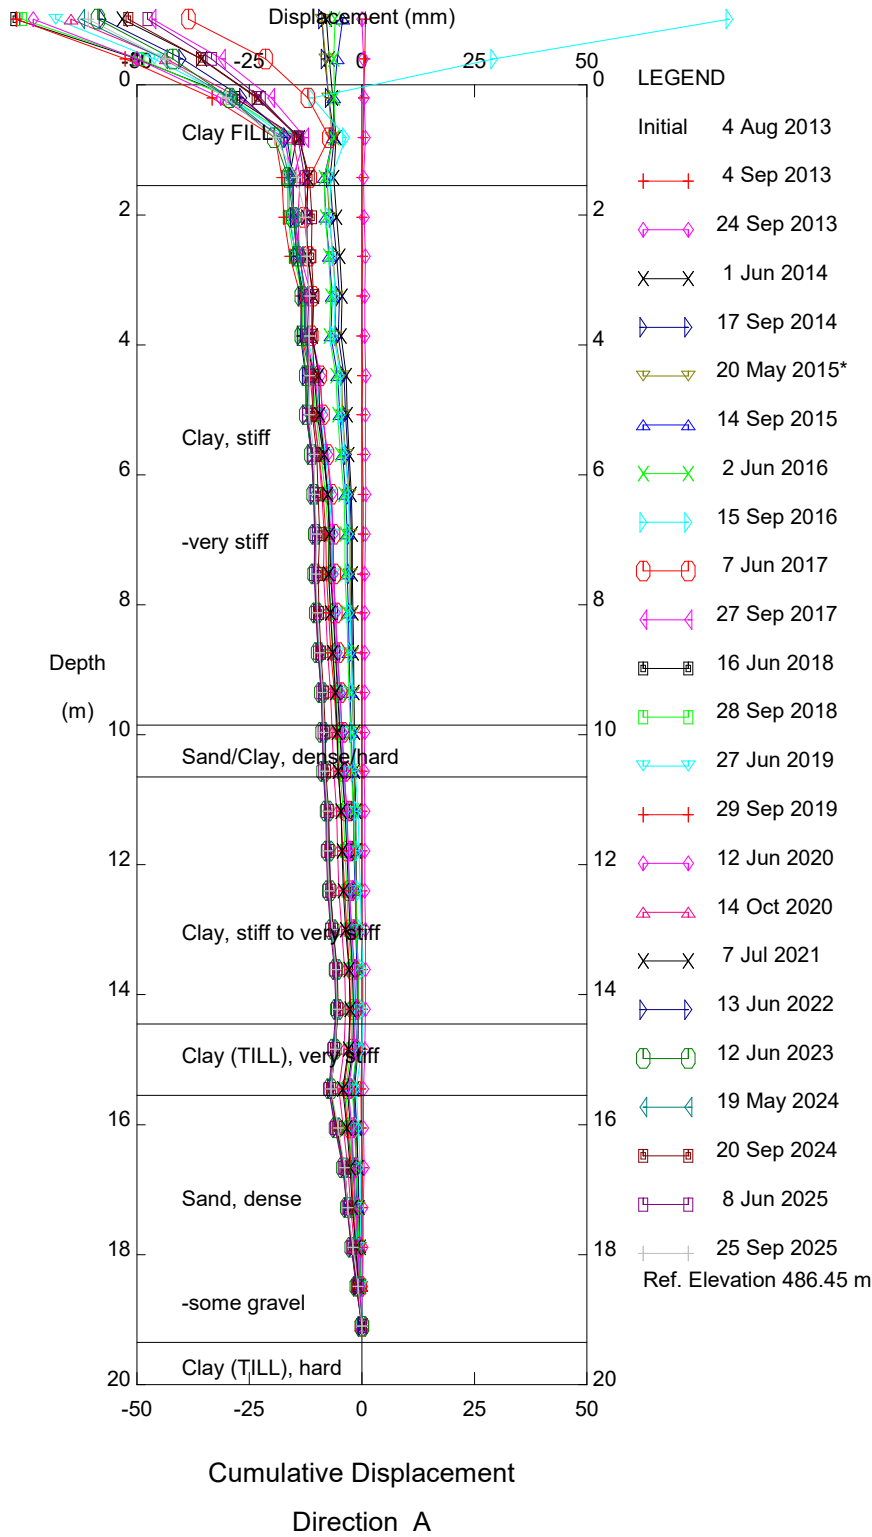
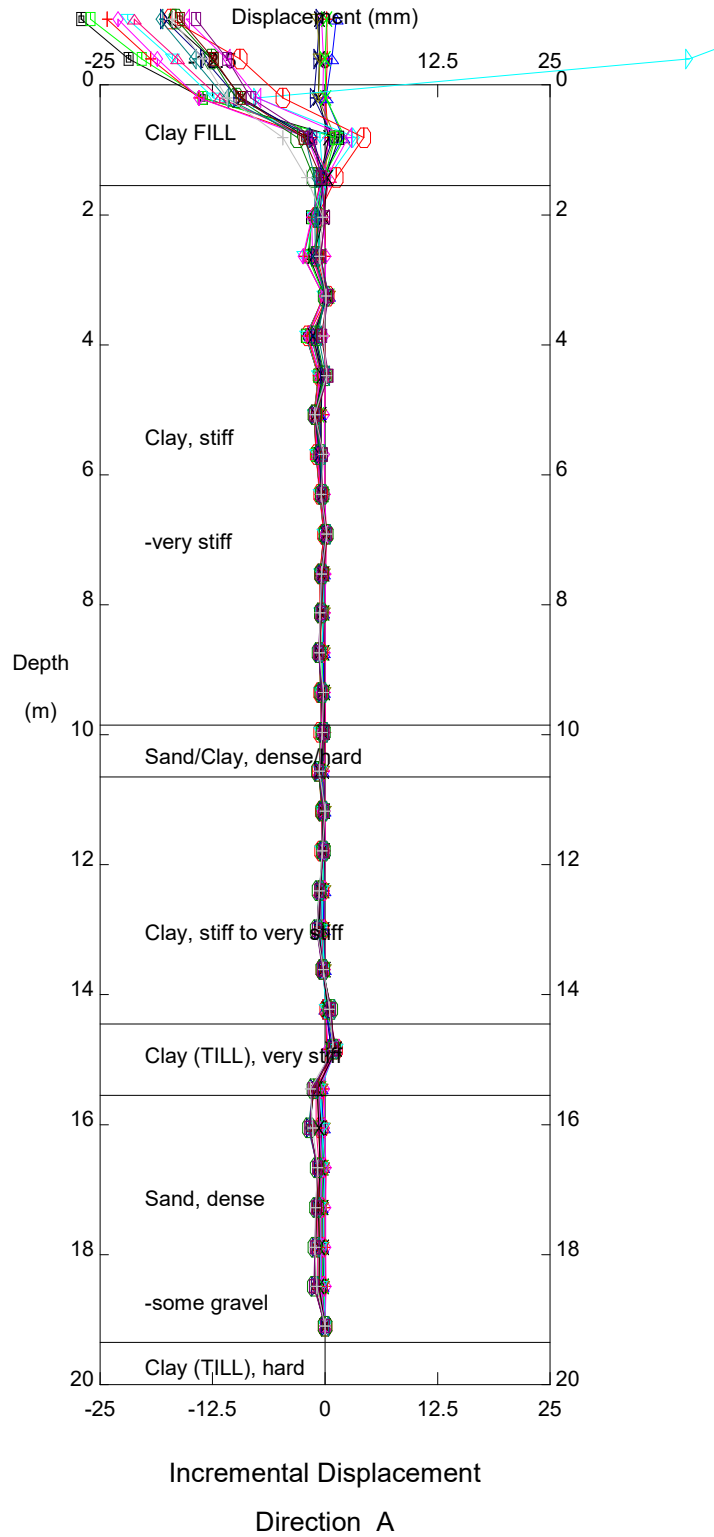
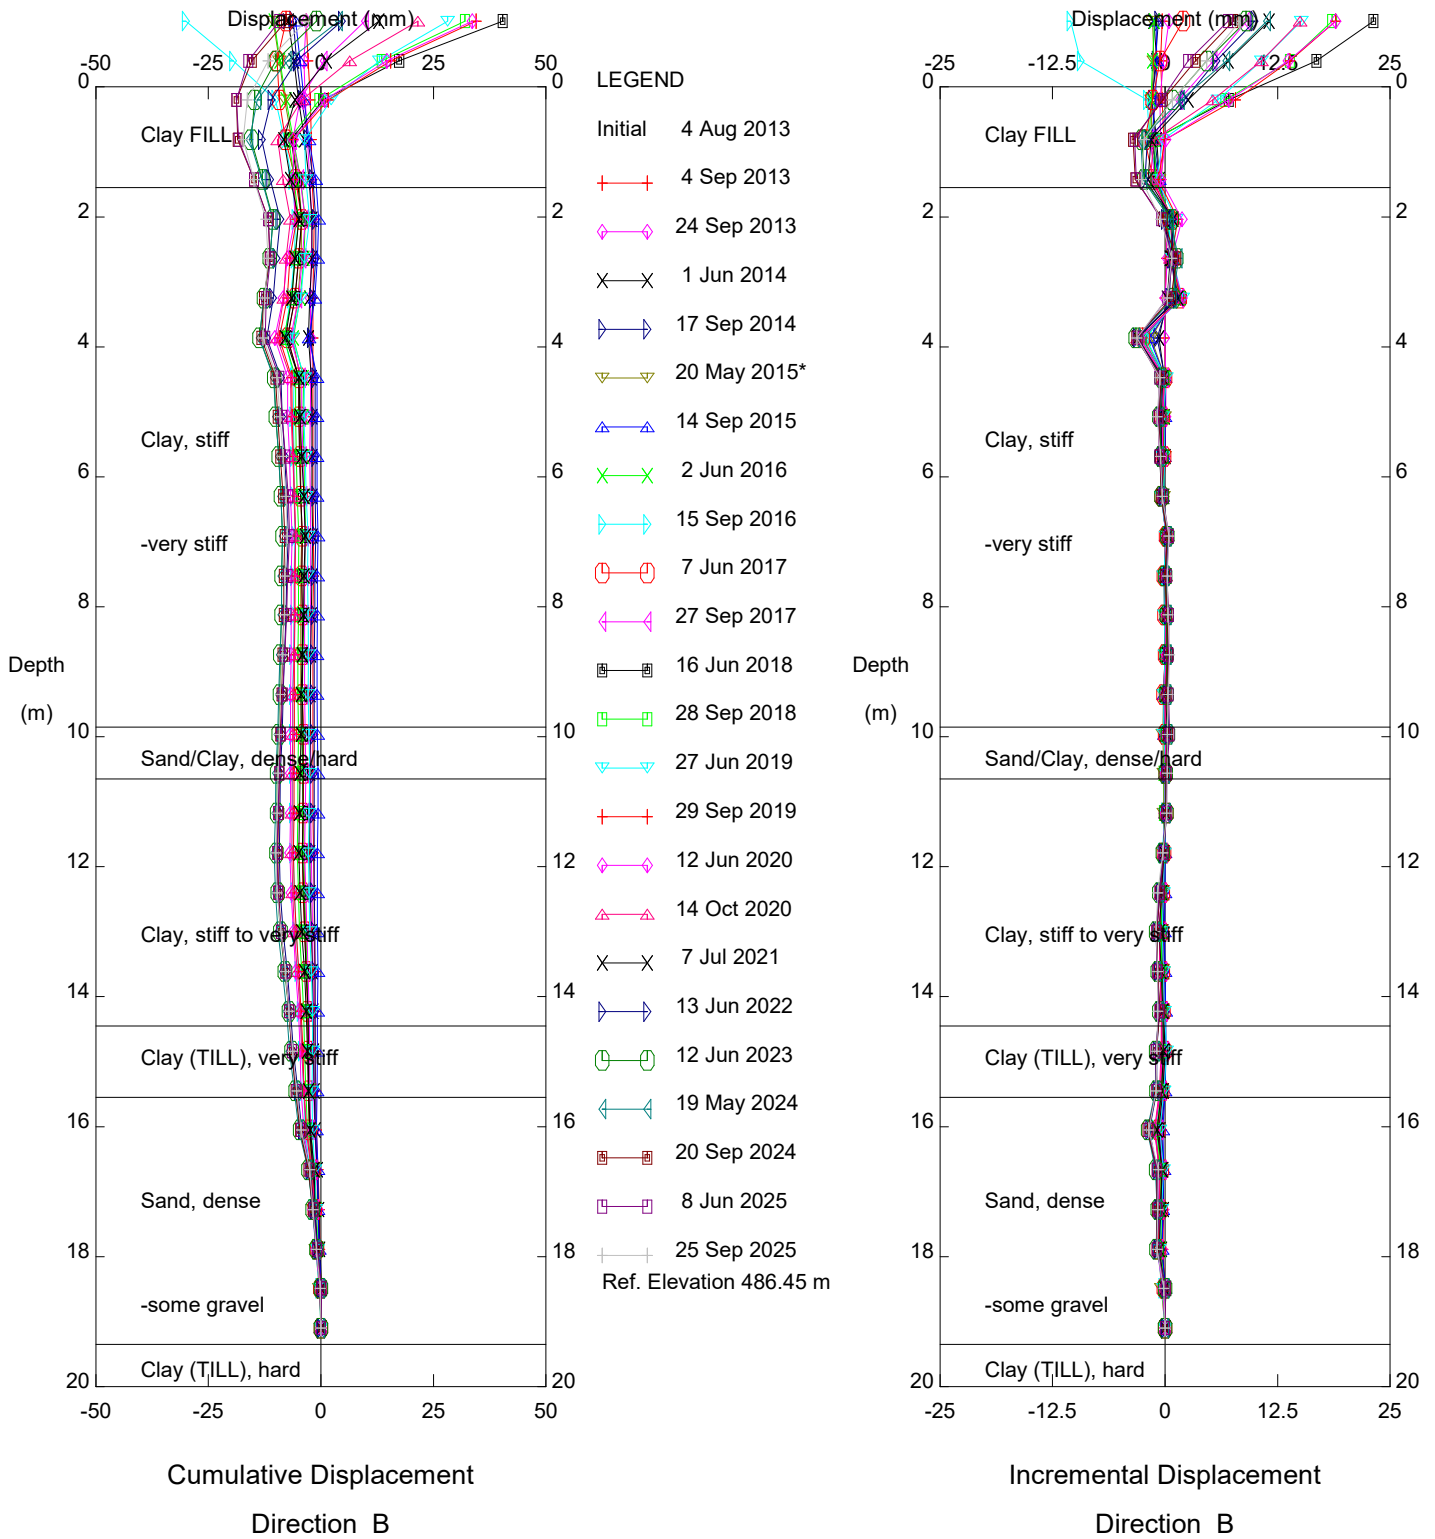
Peace River East Hill PH070, Inclinator SI13-3

| Discussion | |
|--|---|
| Interpretation of Monitoring Results: | <p>SLOPE INCLINOMETERS AND SAA</p> <p>SI13-3, located downslope of the new pile wall, continued to show some minor movement zones at 4 m and 16 m depth. Based on the instrument readings and previous assessments, SI13-3 is not installed deep enough to intercept the basal shear surface of the landslide.</p> <p>Slope inclinometer SI14-2, located upslope of the new pile wall, showed no discernable movement over 2.8 m to 5.8 m depth, 17.4 m to 21.0 m depth, and 24.7 m to 27.1 m depth since the spring of 2025 readings.</p> |

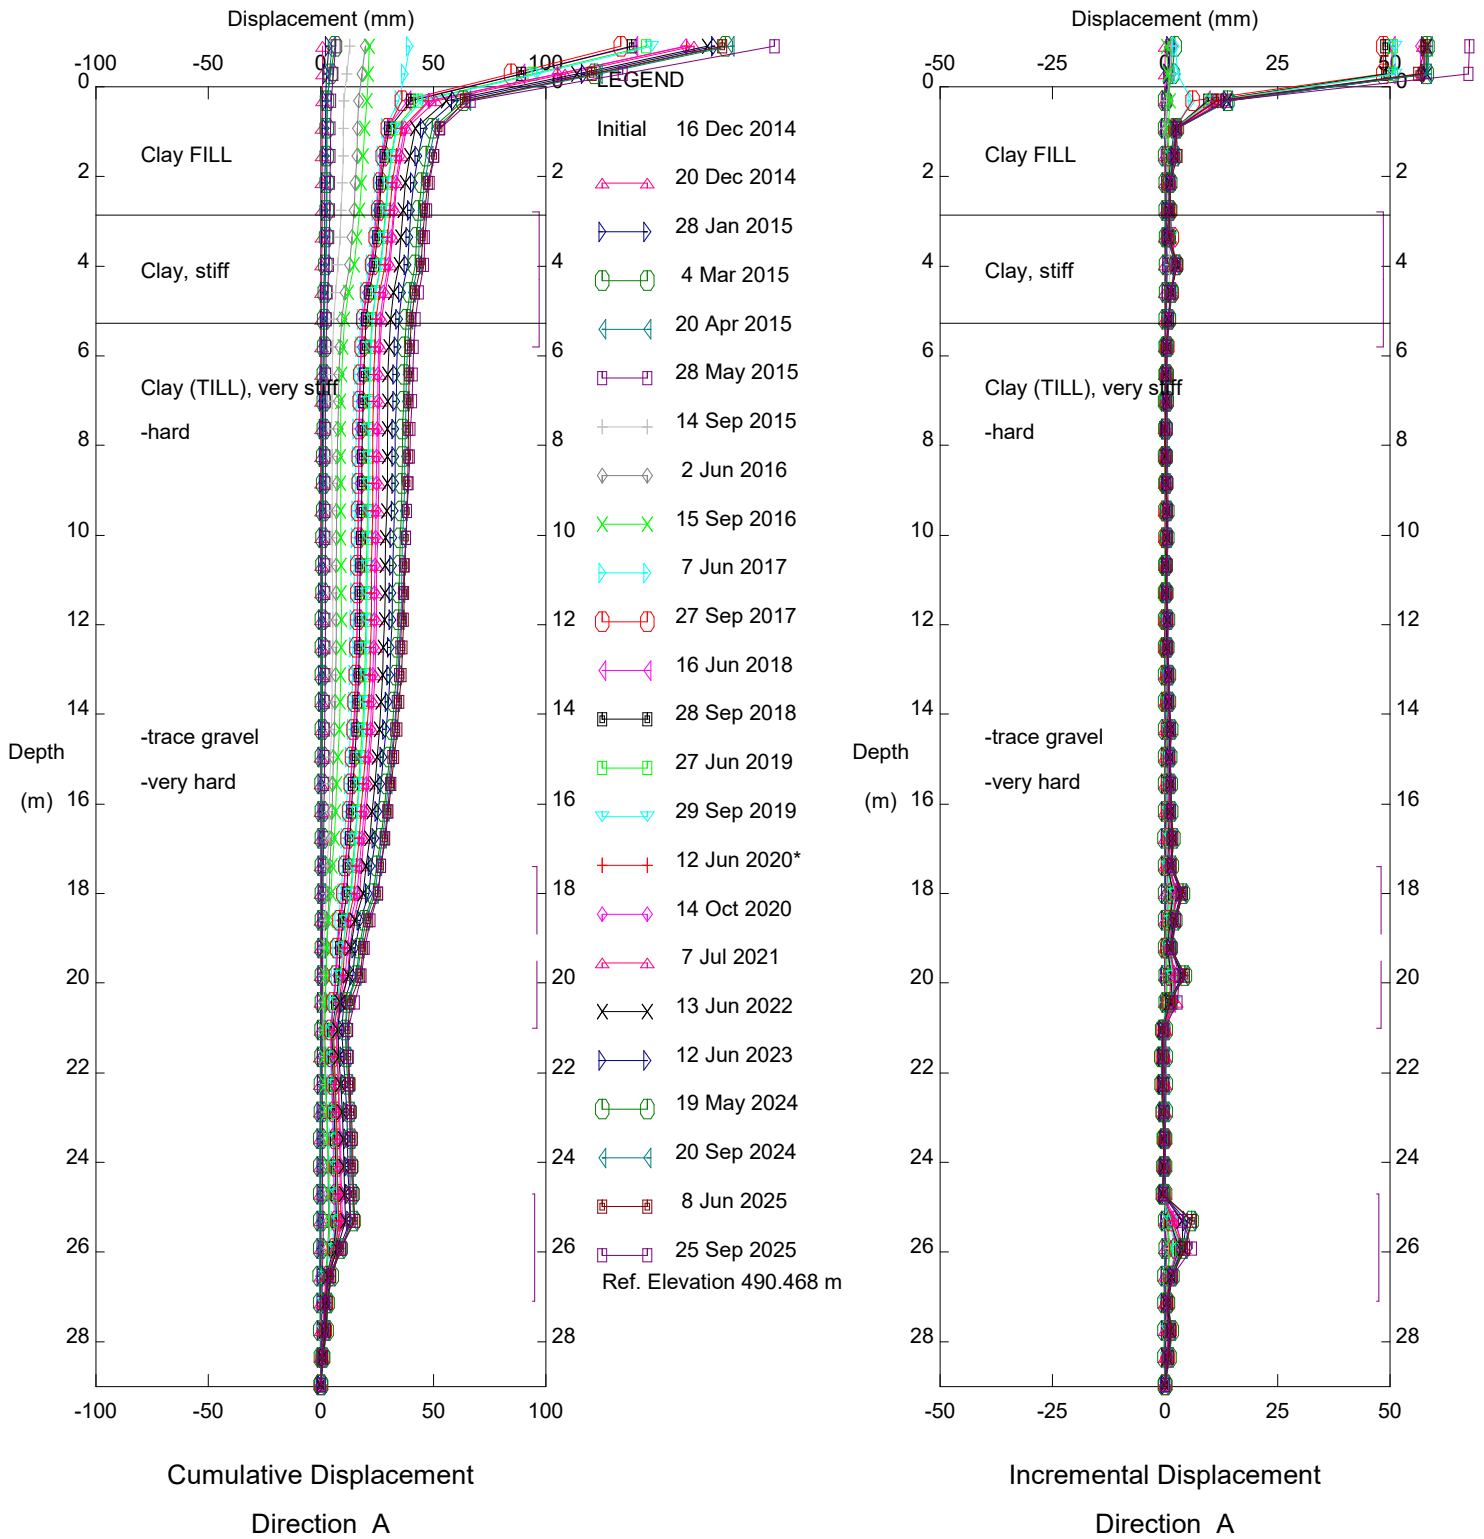
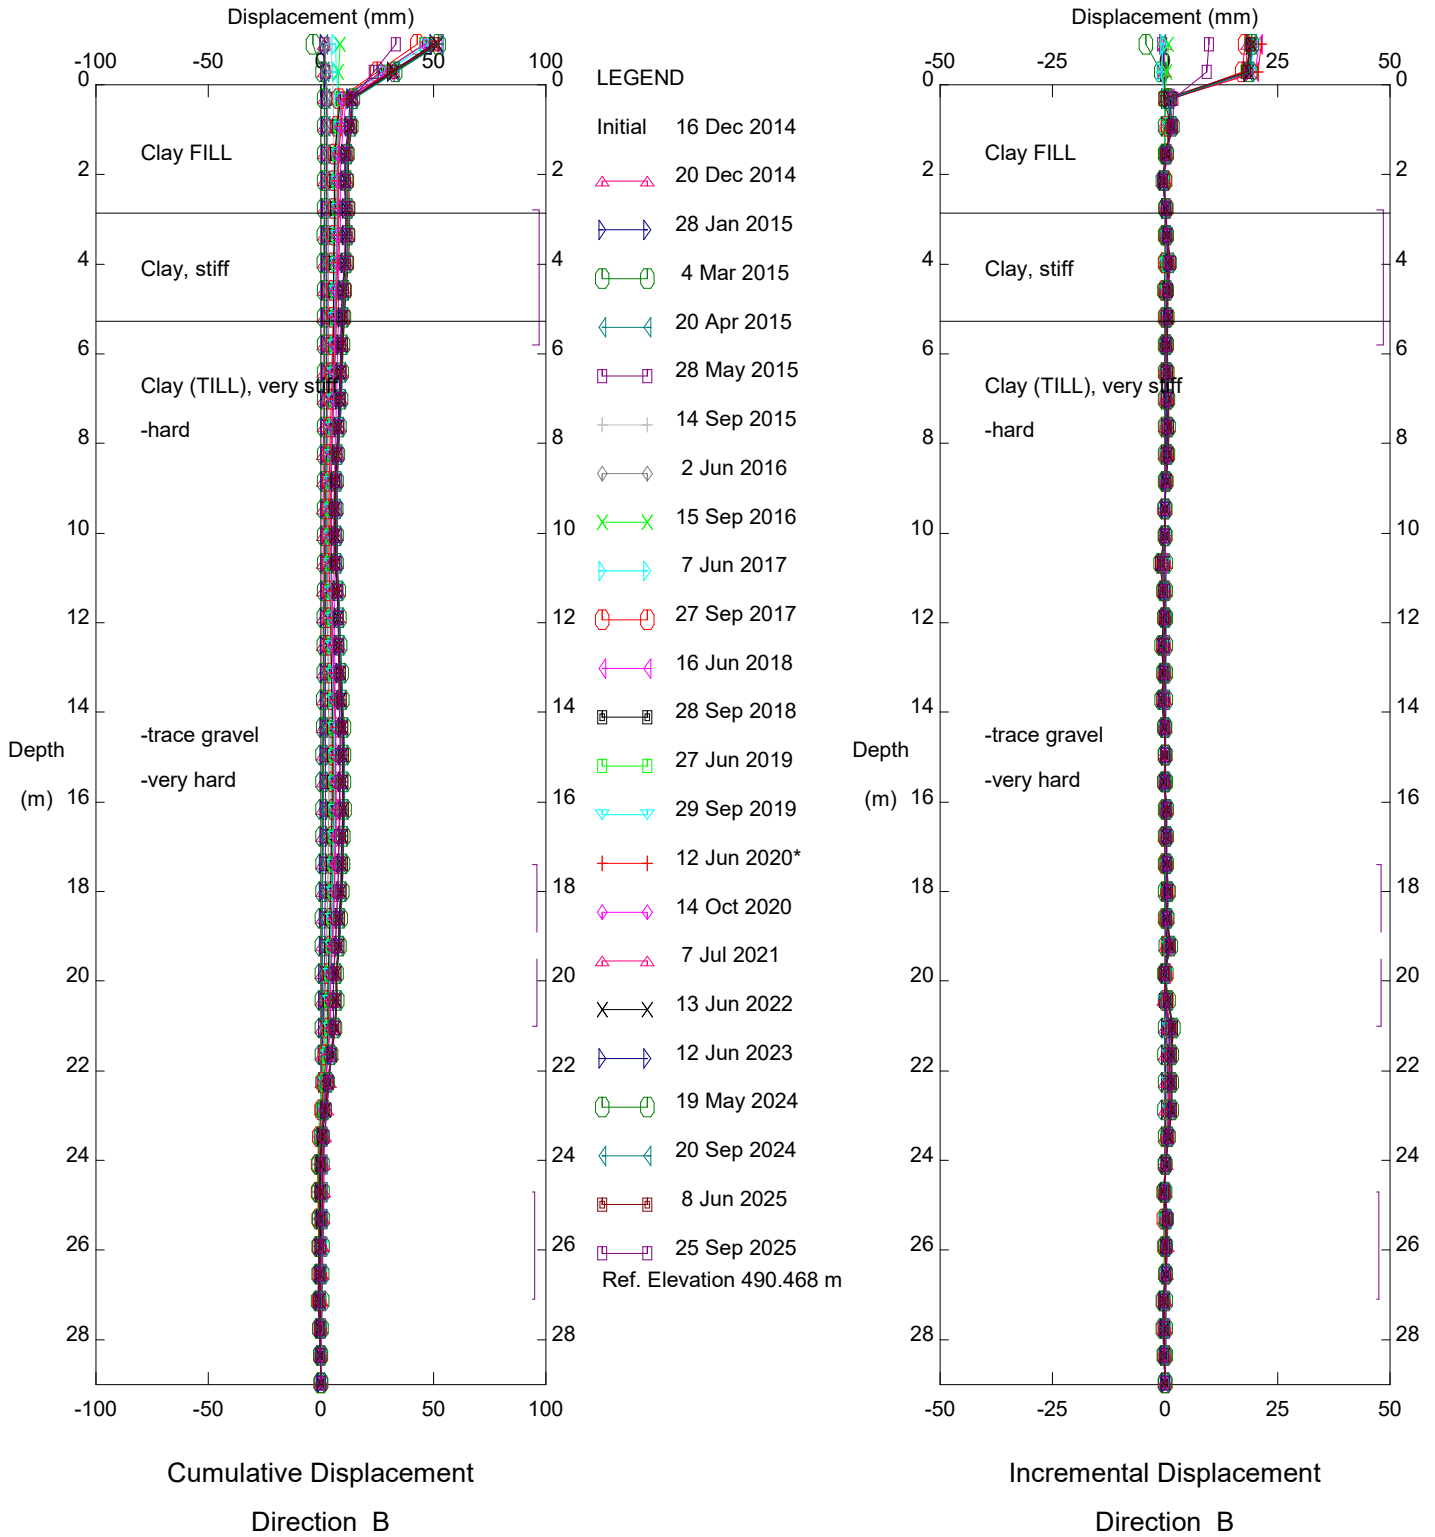
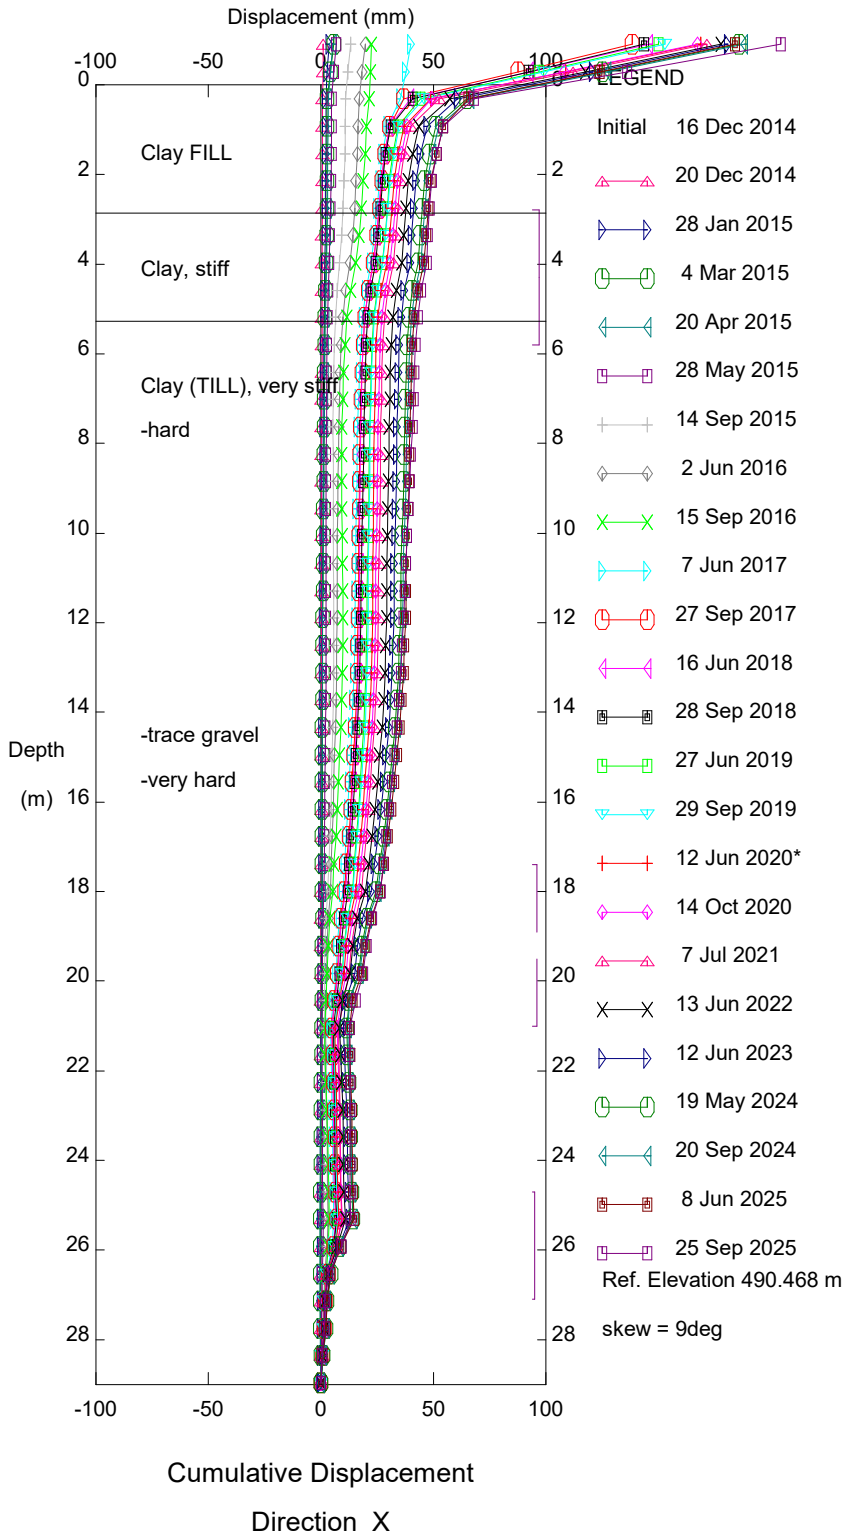
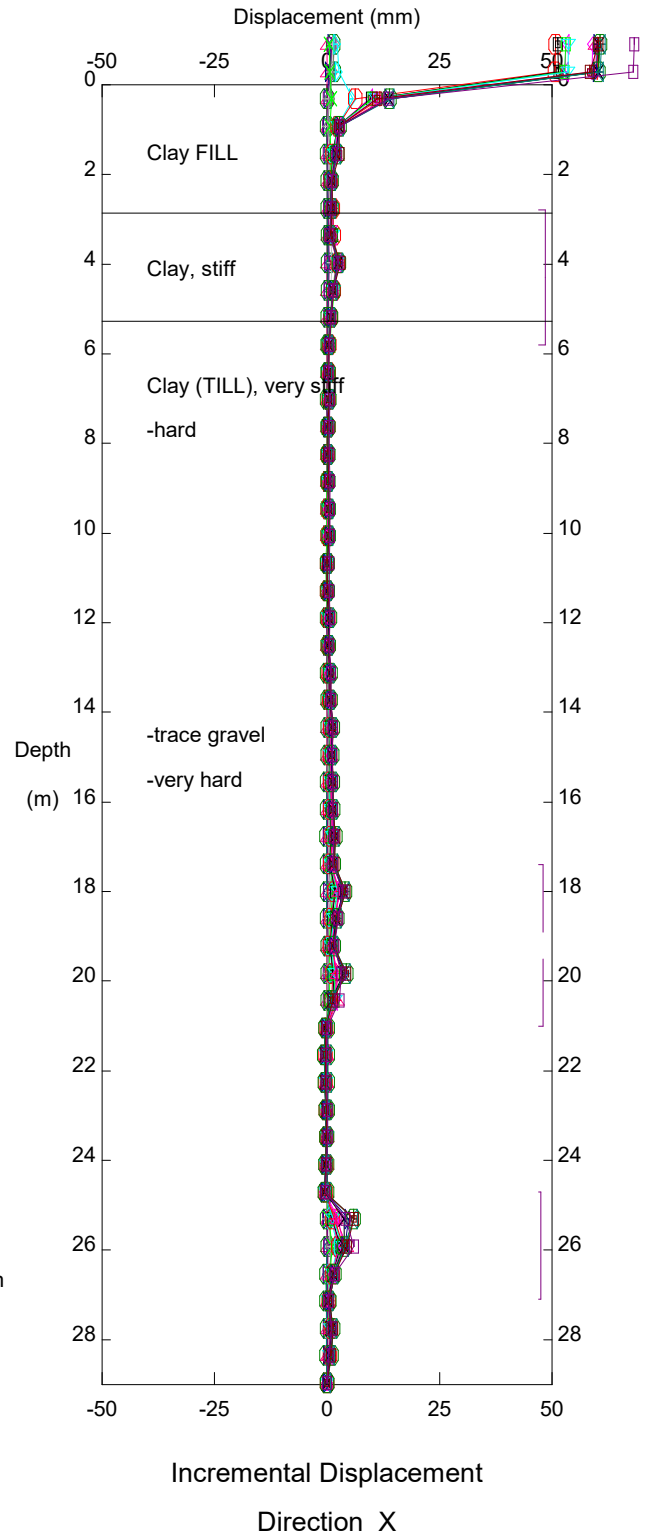
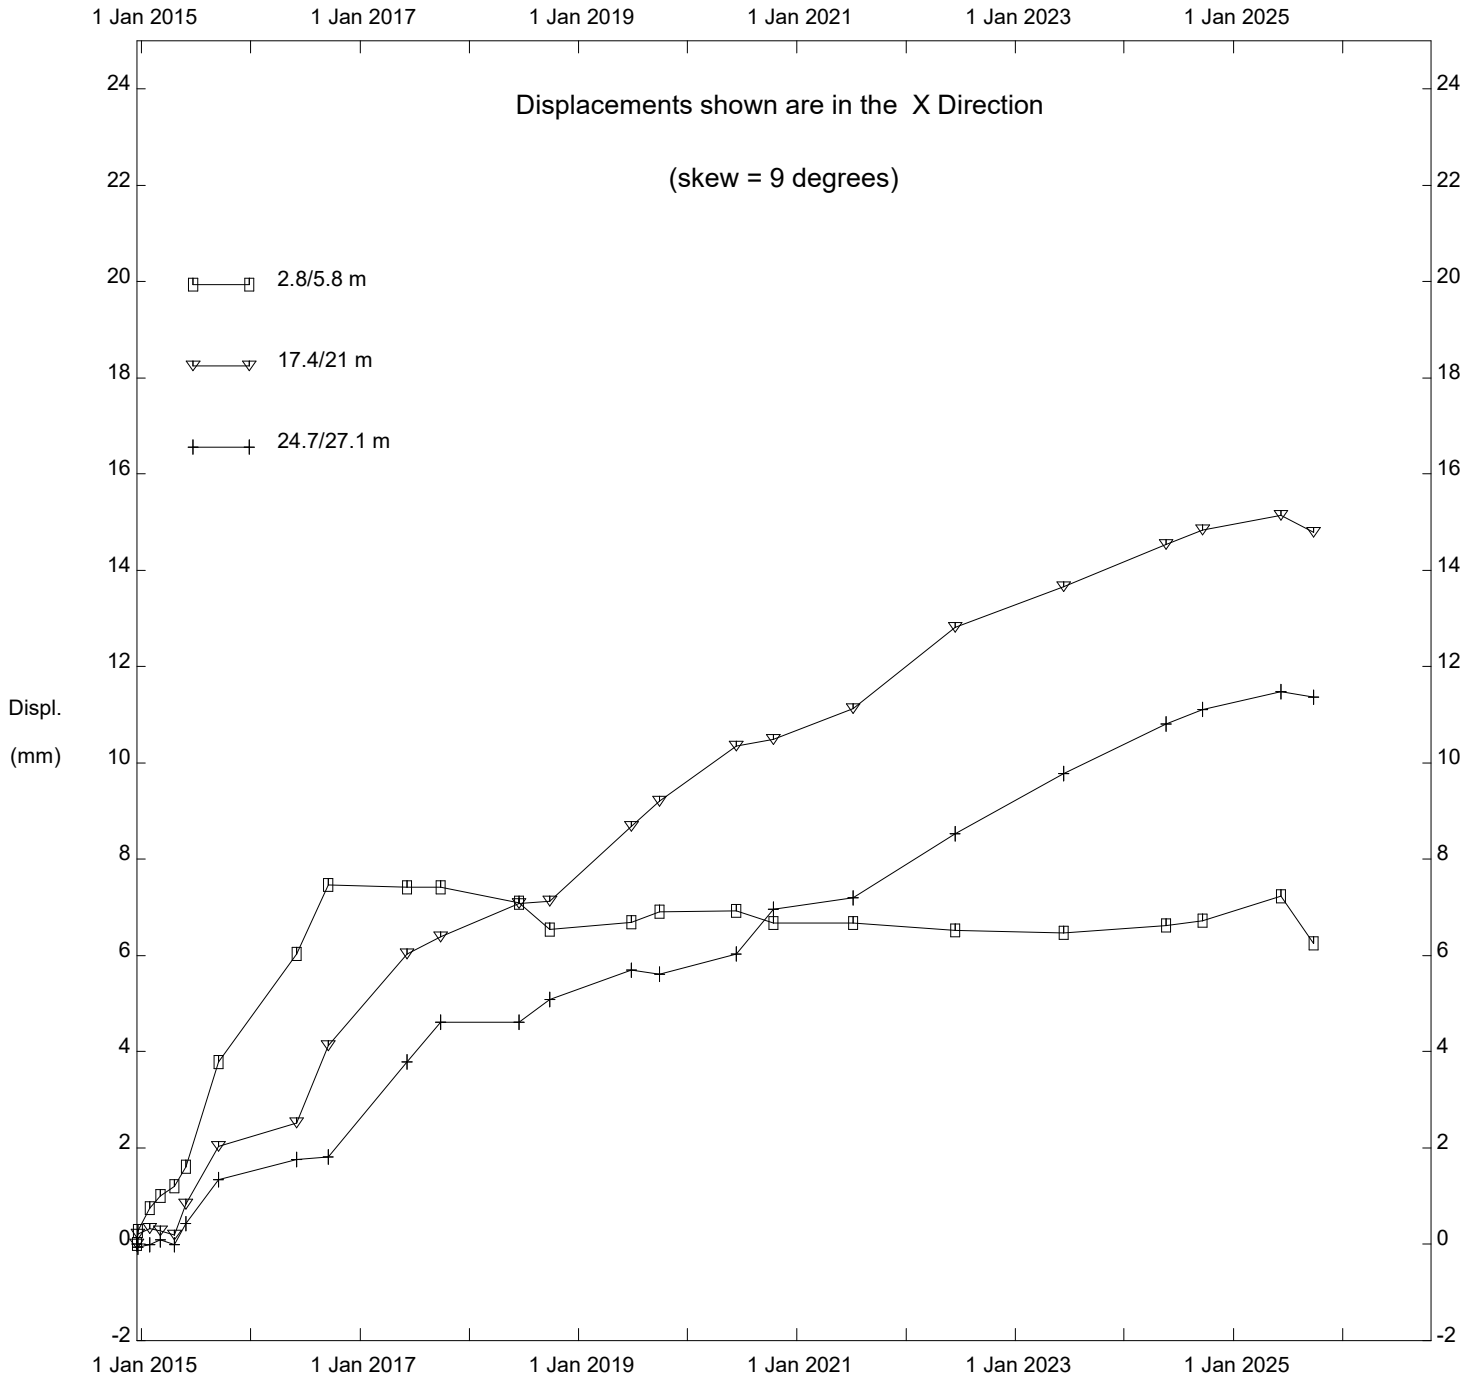
Peace River East Hill PH070, Inclinator SI14-2

| INSTRUMENT # | DATE INITIALIZED | TOTAL CUMULATIVE RESULTANT MOVEMENT AT NOTED DEPTH SINCE INITIAL READING (mm) | MAXIMUM RATE OF MOVEMENT (mm/yr) | CURRENT STATUS | DATE OF PREVIOUS READING | INCREMENTAL MOVEMENT SINCE PREVIOUS READING (mm) | RATE OF MOVEMENT (mm/yr) | CHANGE IN RATE OF MOVEMENT SINCE PREVIOUS READING (mm/yr) |
|---|---|---|---|---|---|--|---|---|
| SI14-2 | December 16, 2014 | 7.2 mm over 2.8 m to 5.8 m depth in 185° direction | 24.7 mm/yr in December 2014 | Operational | June 9, 2025 | No Discernable Movement | N/A | -4.0 |
| | | 15.1 mm over 17.4 m to 21.0 m depth in 185° direction | 18.9 mm/yr in December 2014 | | | No Discernable Movement | N/A | -1.6 |
| | | 11.5 mm over 24.7 m to 27.1 m depth in 185° direction | 4.2 mm/yr in May 2015 | | | No Discernable Movement | N/A | -0.9 |

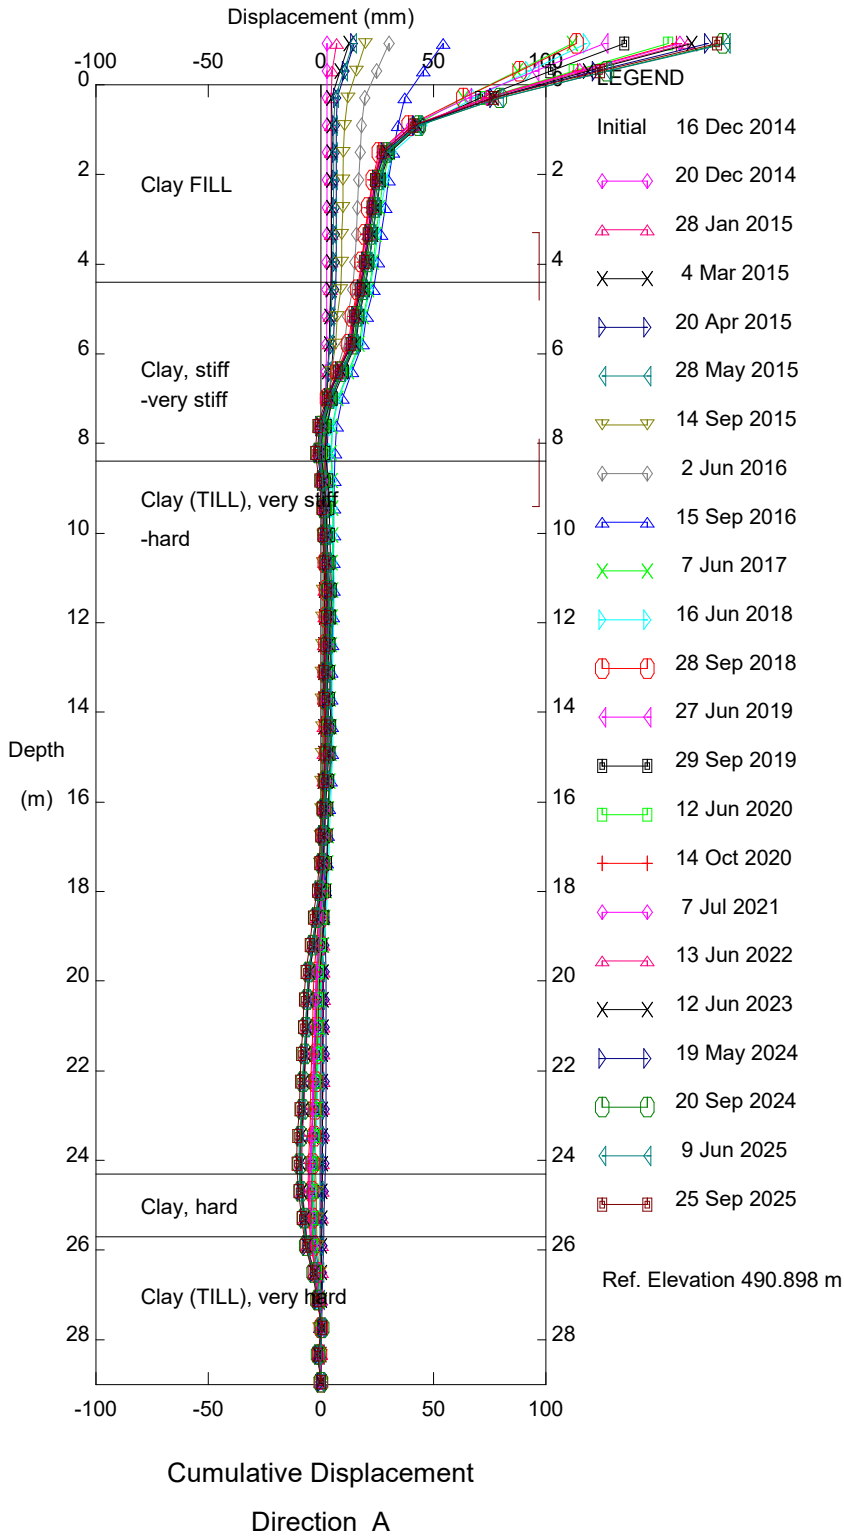
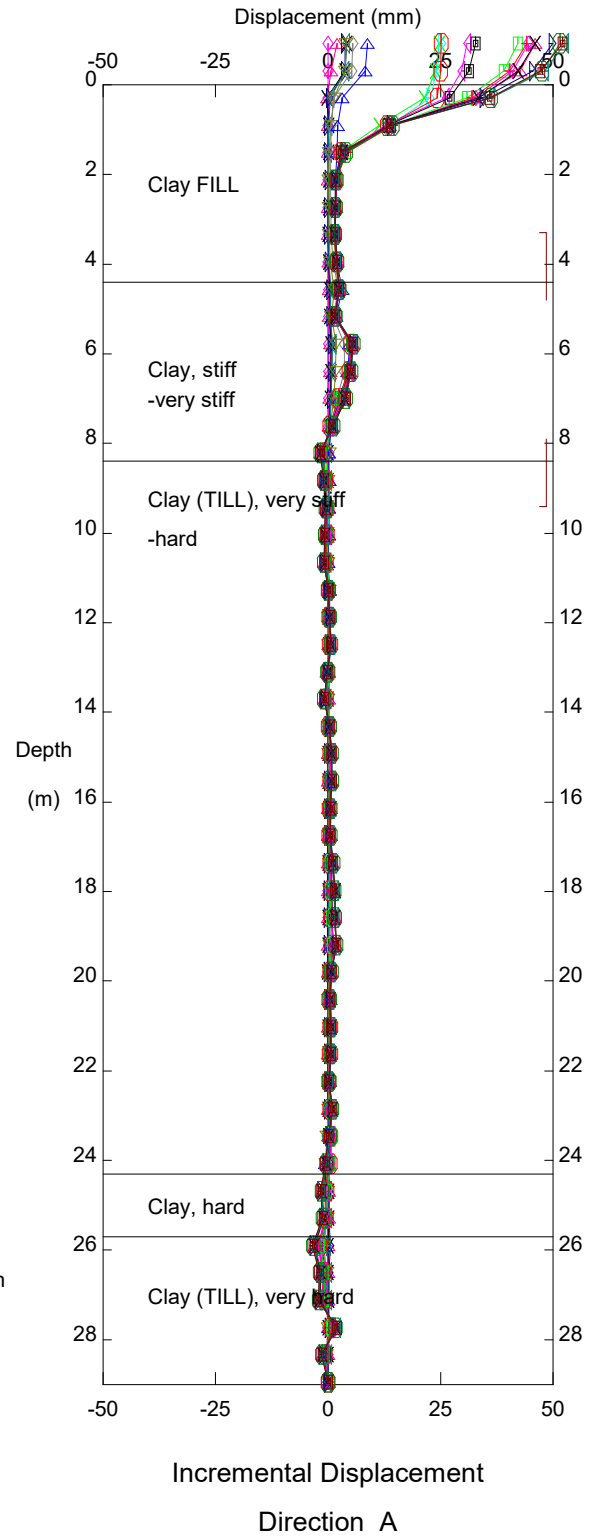
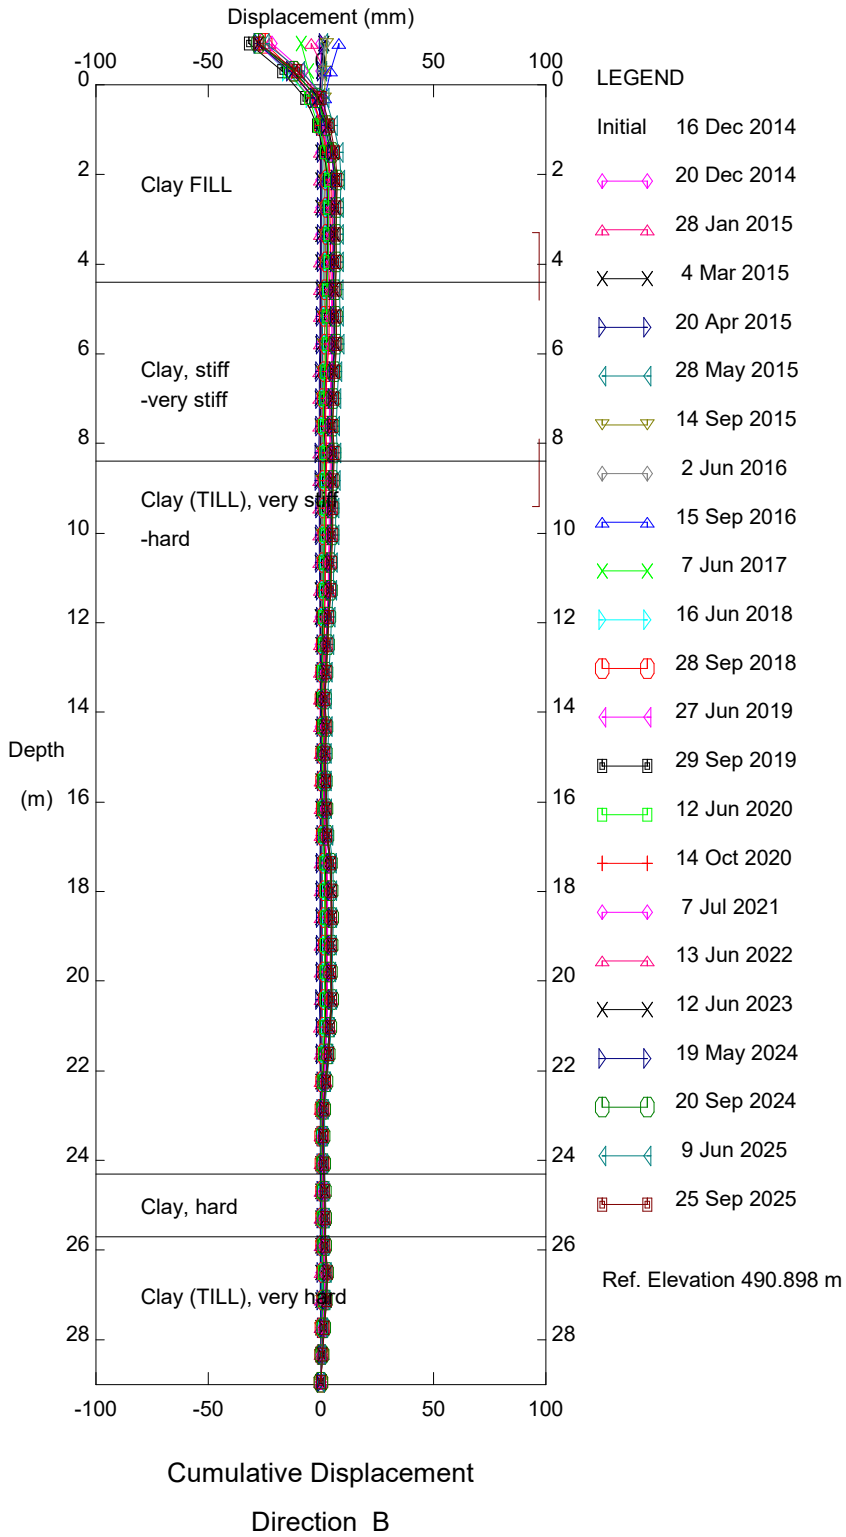
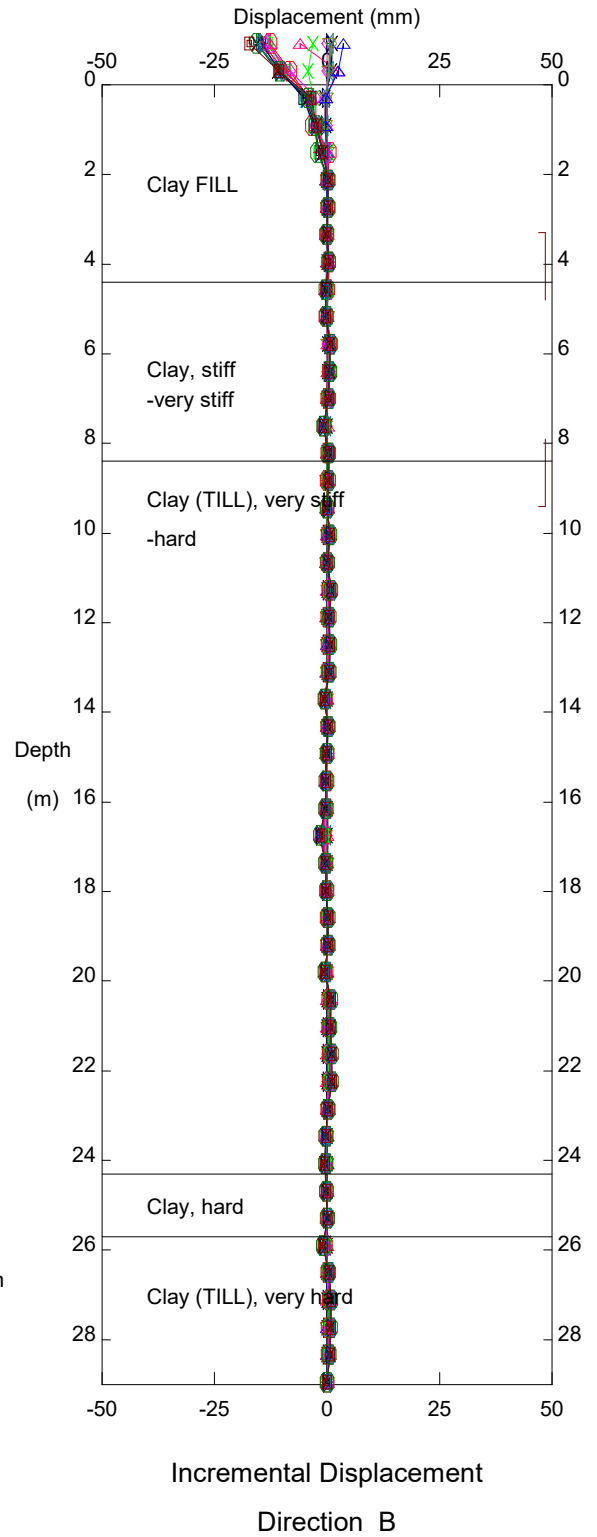
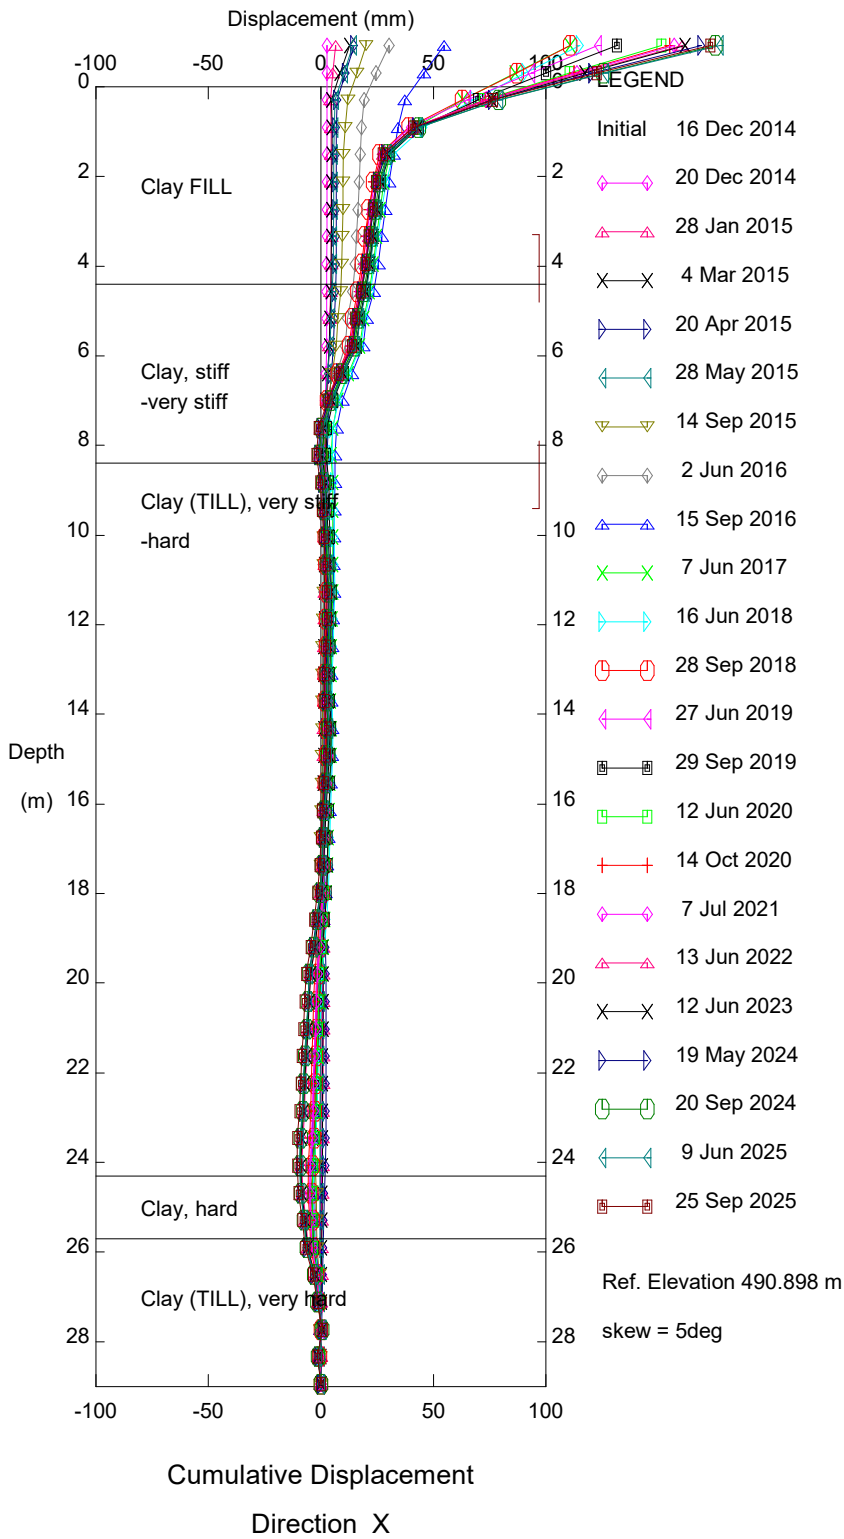
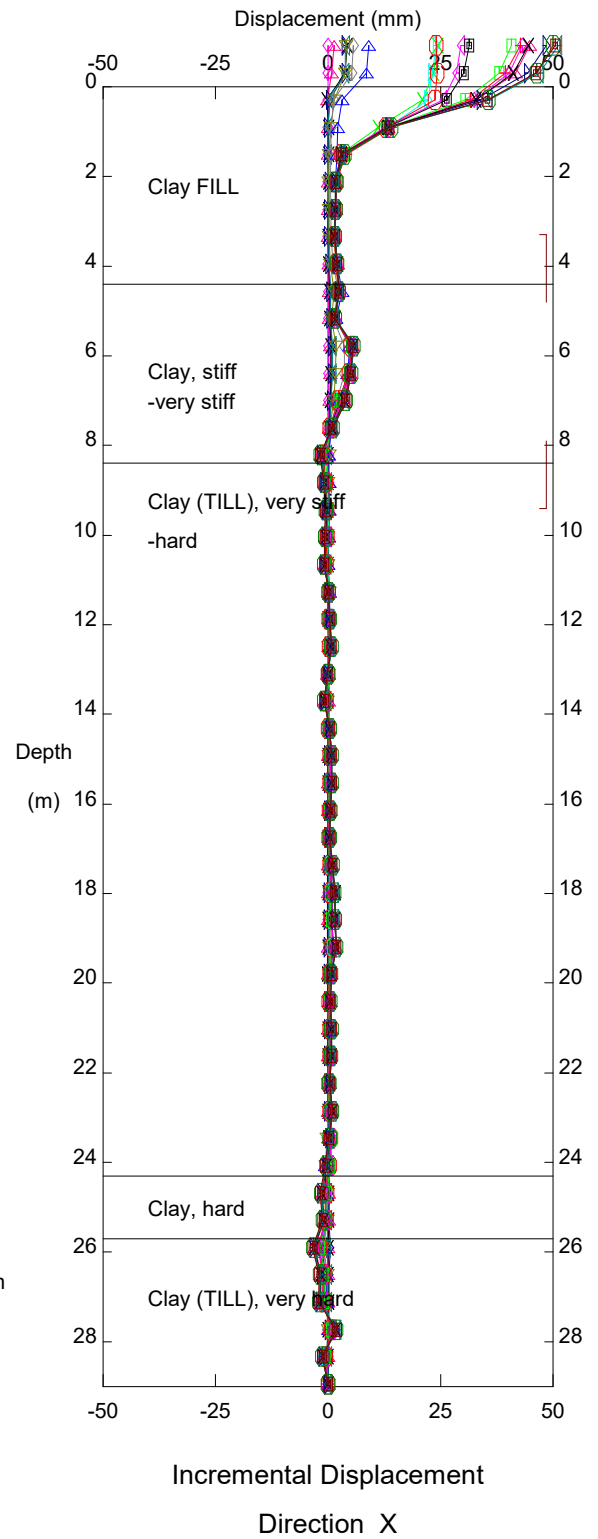
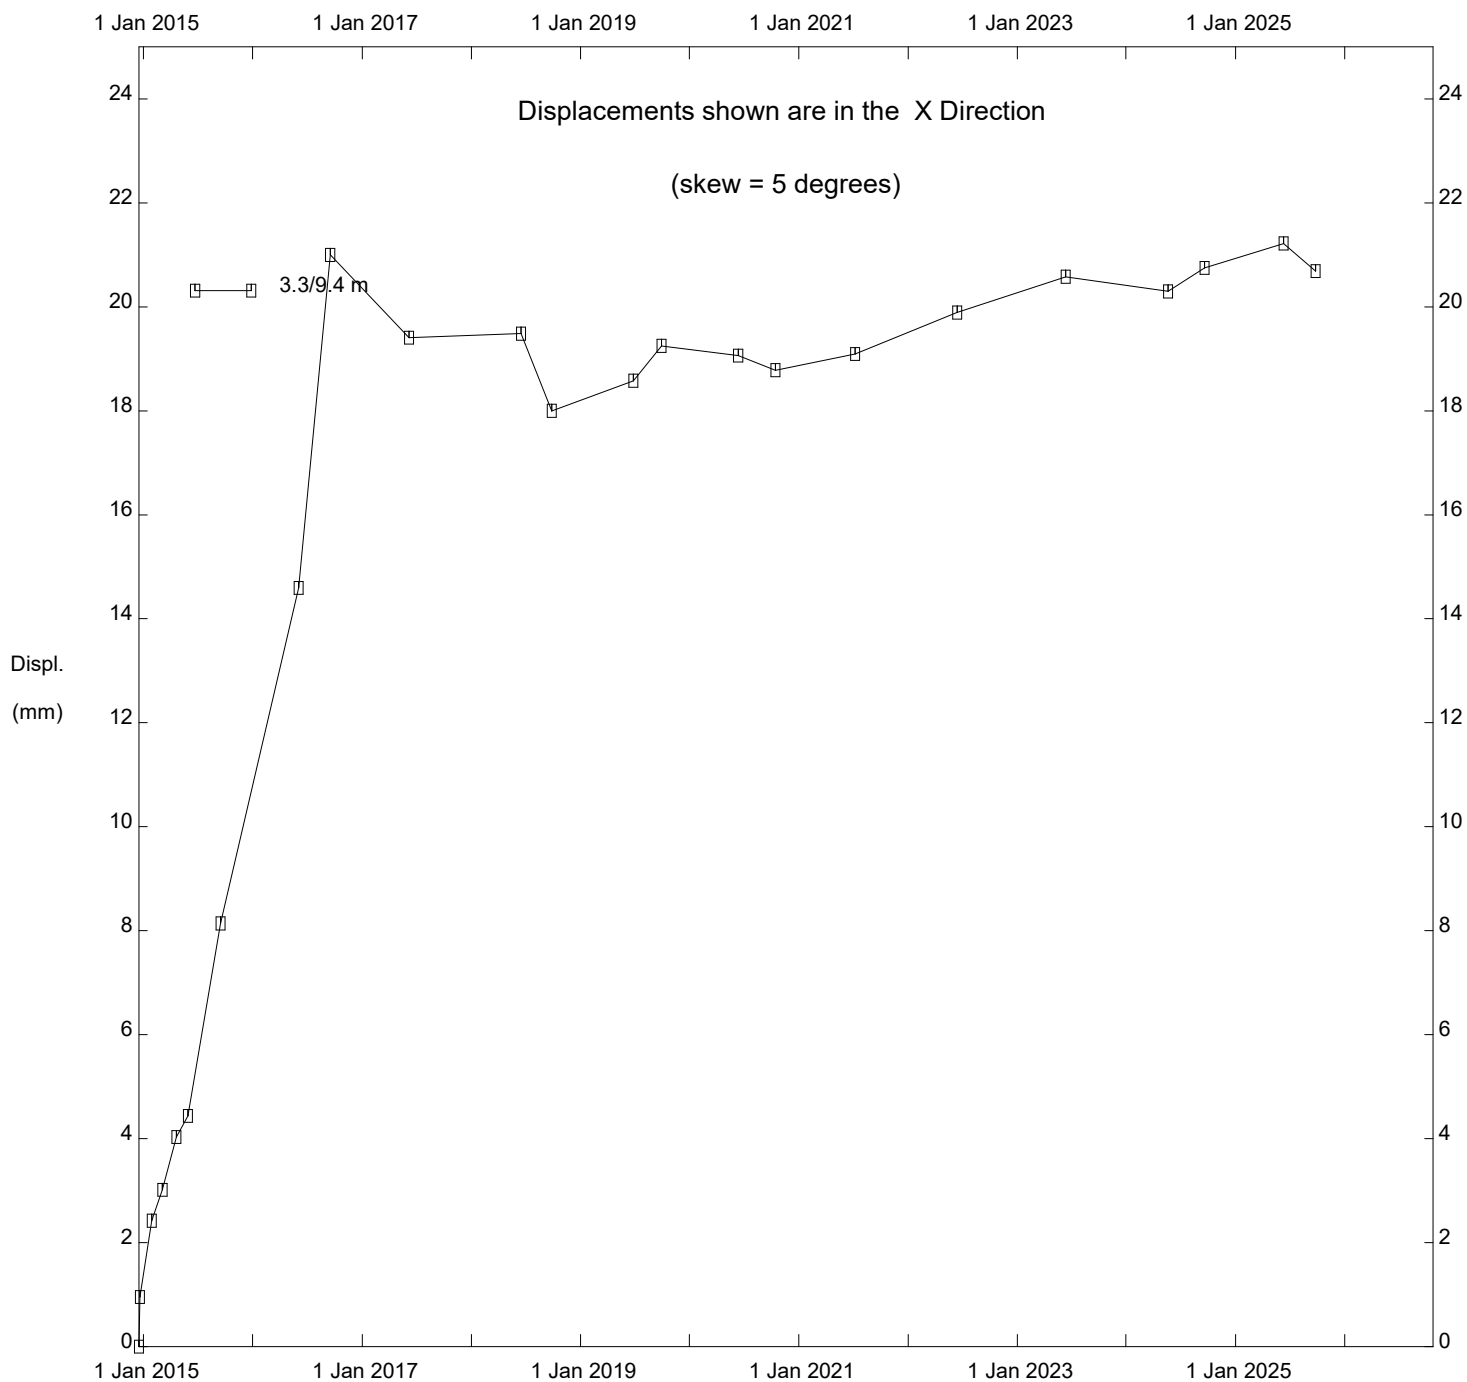
Peace River East Hill PH070, Inclinator SI14-3

Slope inclinometer SI14-3, also located upslope of the new pile wall, showed no discernable movement over 3.3 m to 9.4 m depth since the fall of 2017 readings.

| INSTRUMENT # | DATE INITIALIZED | TOTAL CUMULATIVE RESULTANT MOVEMENT AT NOTED DEPTH SINCE INITIAL READING (mm) | MAXIMUM RATE OF MOVEMENT (mm/yr) | CURRENT STATUS | DATE OF PREVIOUS READING | INCREMENTAL MOVEMENT SINCE PREVIOUS READING (mm) | RATE OF MOVEMENT (mm/yr) | CHANGE IN RATE OF MOVEMENT SINCE PREVIOUS READING (mm/yr) |
|---|---|---|---|---|---|--|---|---|
| SI14-3 | December 16, 2014 | 21.2 mm over 3.3 m to 9.4 m depth in 171° direction | 85.8 mm/yr in December 2014 | Operational | June 9, 2025 | No Discernable Movement | N/A | -2.4 |
