| Site Number | Location | Name | Hwy | km |
| PH070 | HWY 2:60 C1 33.840 | East Hill Retaining Wall Site | 2:60 | Km 33.84 |

| Current Monitoring: | 25-Sep-2025 | Previous Monitoring | 9-June-2025 |

Table PH070-1 Fall 2025 – Hwy 2:60 Peace River East Hill Retaining Wall Site (Km 33.84) Slope Inclinator Instrumentation Reading Summary

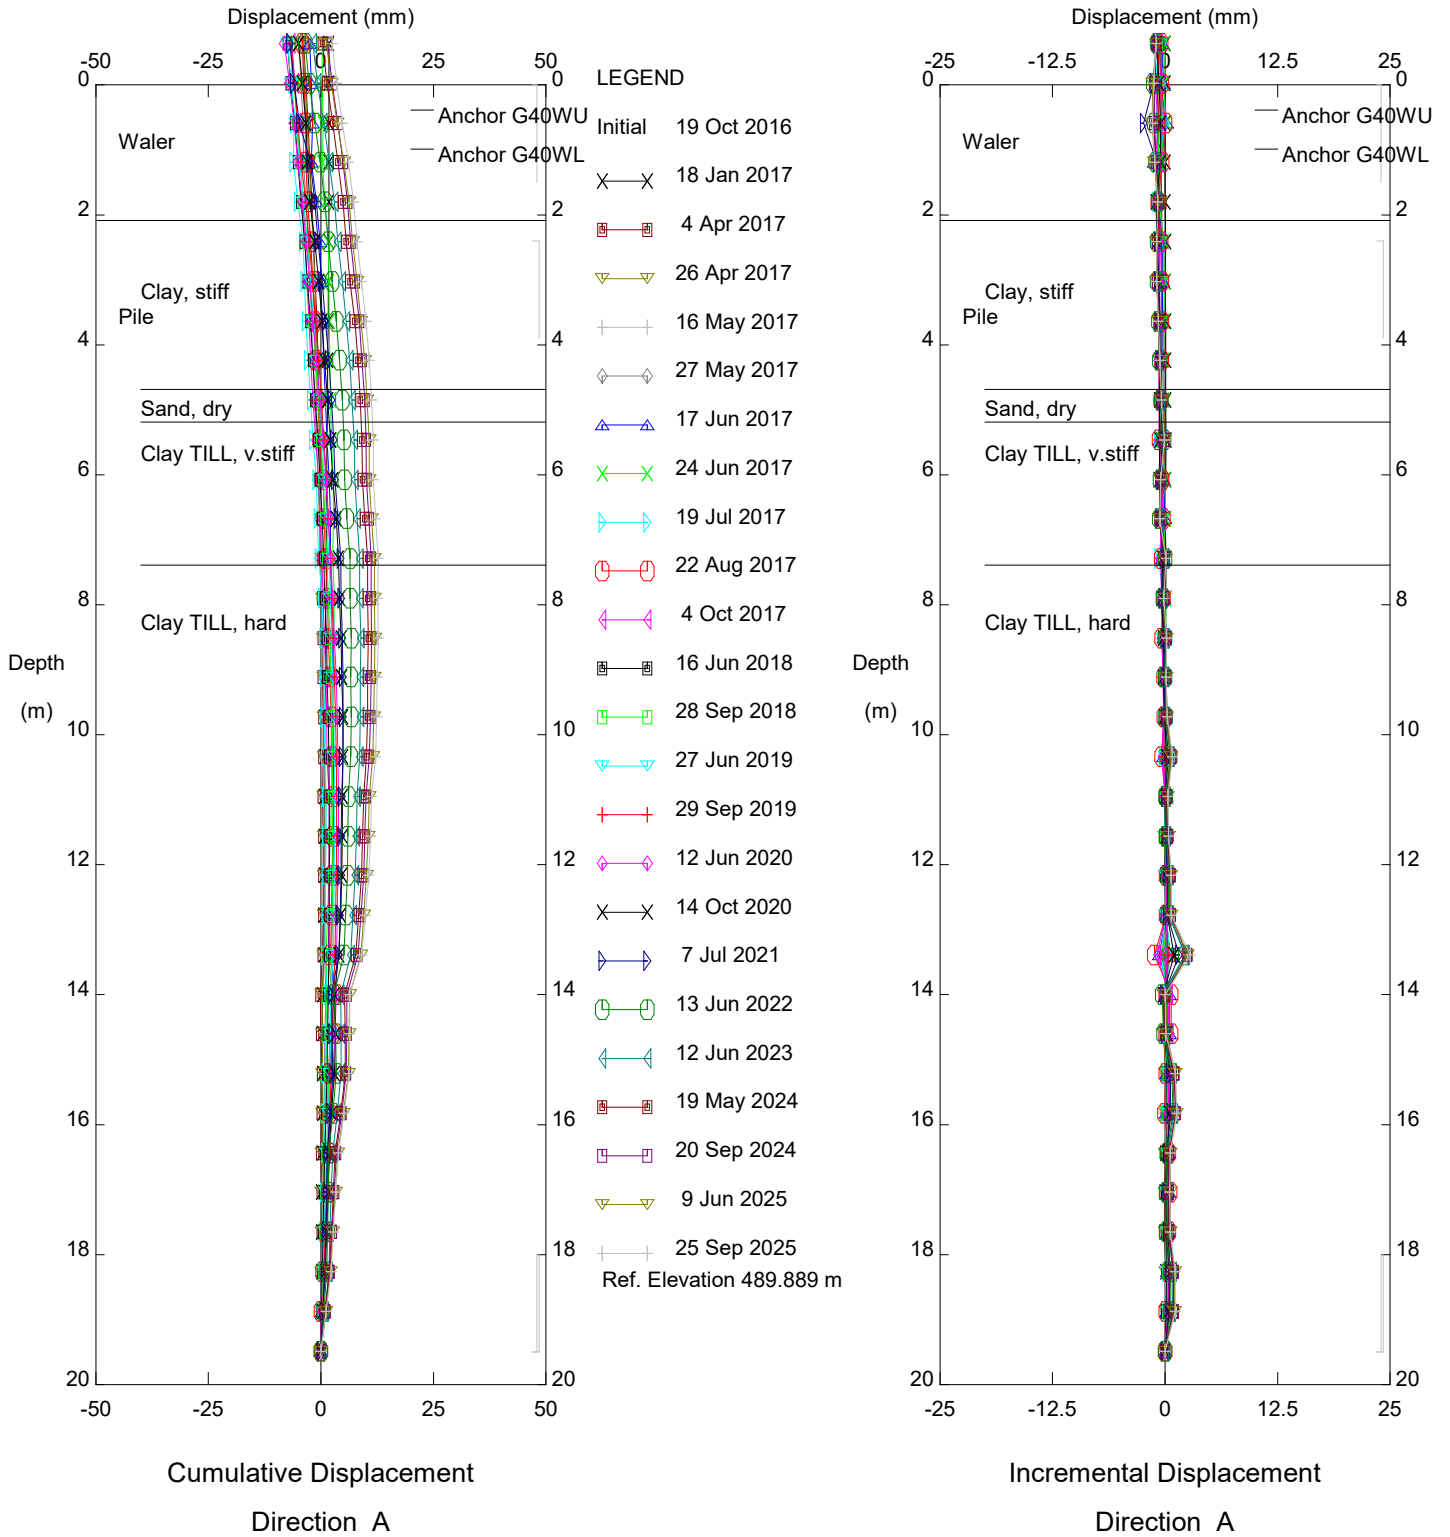
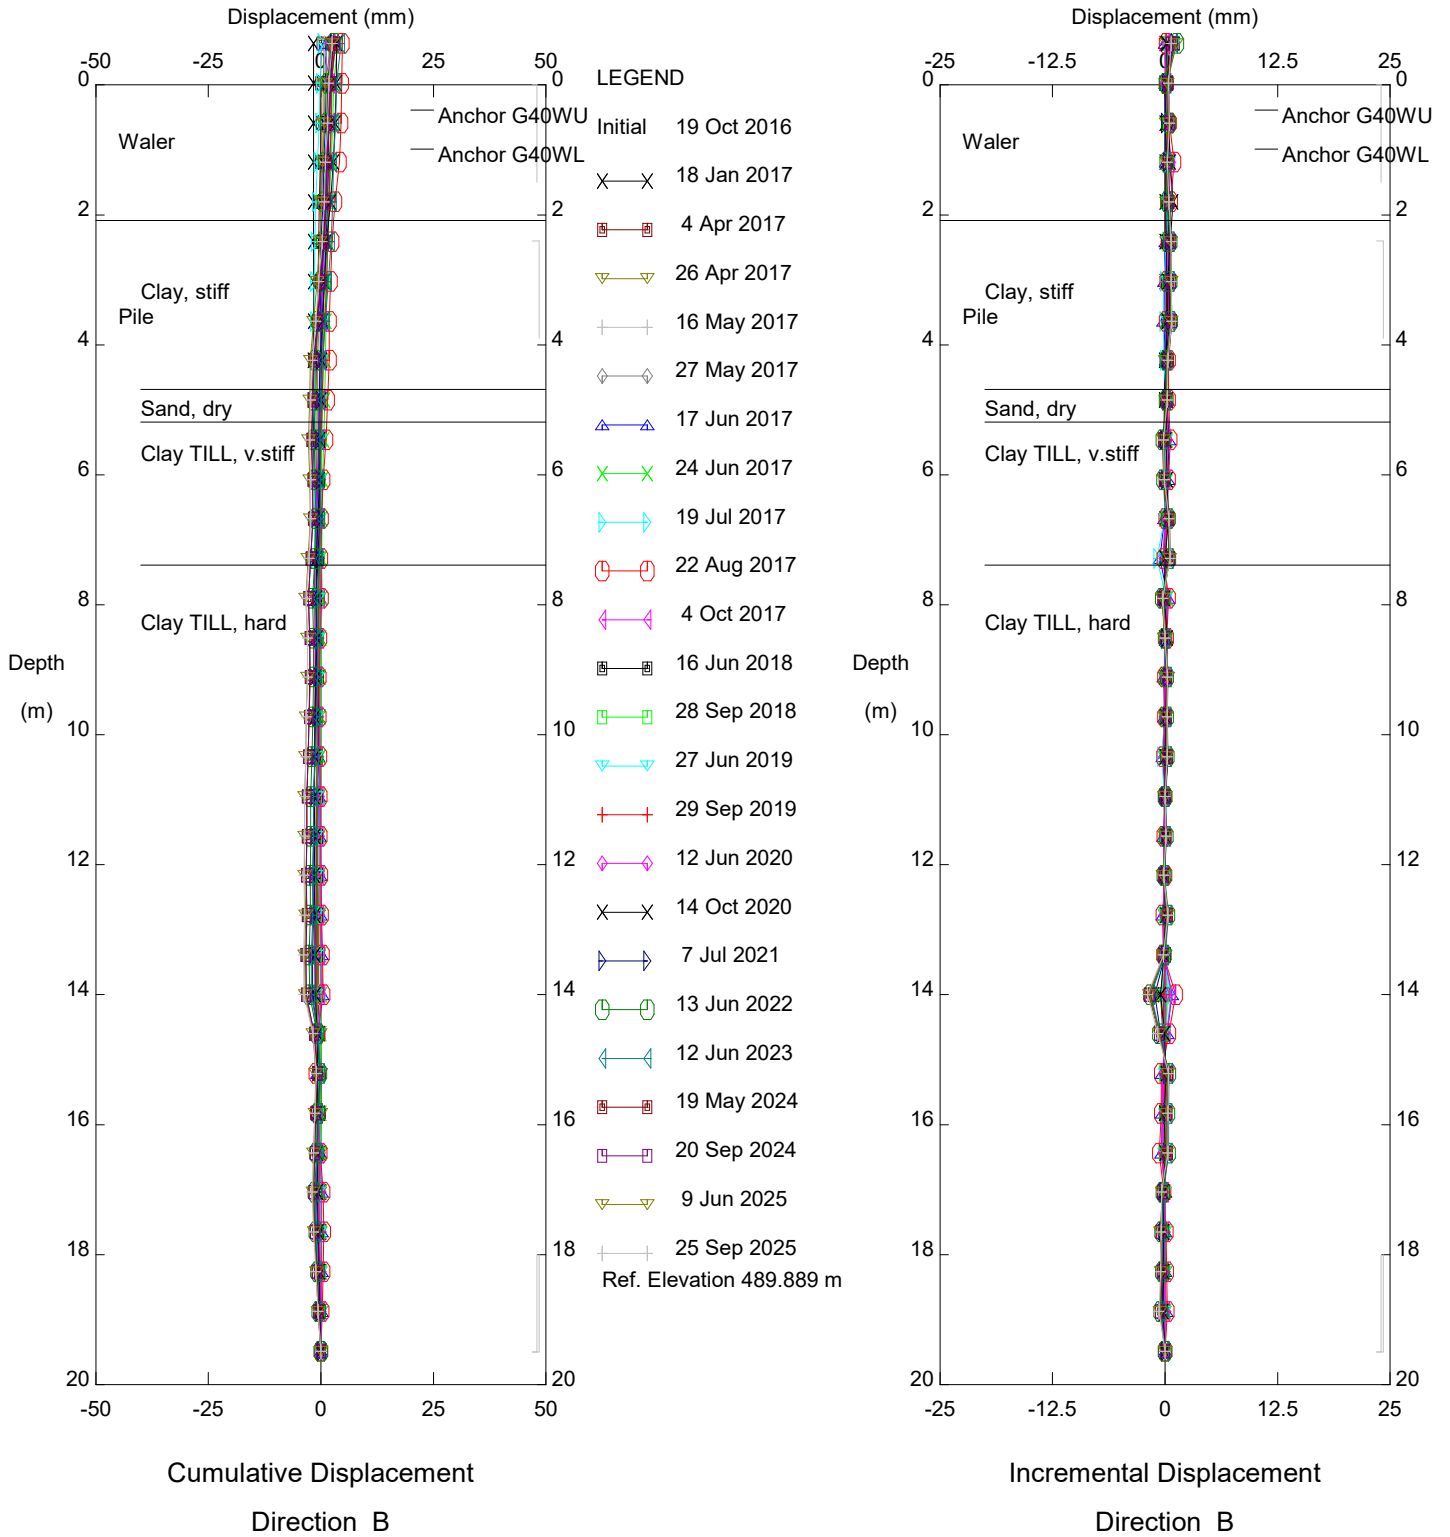
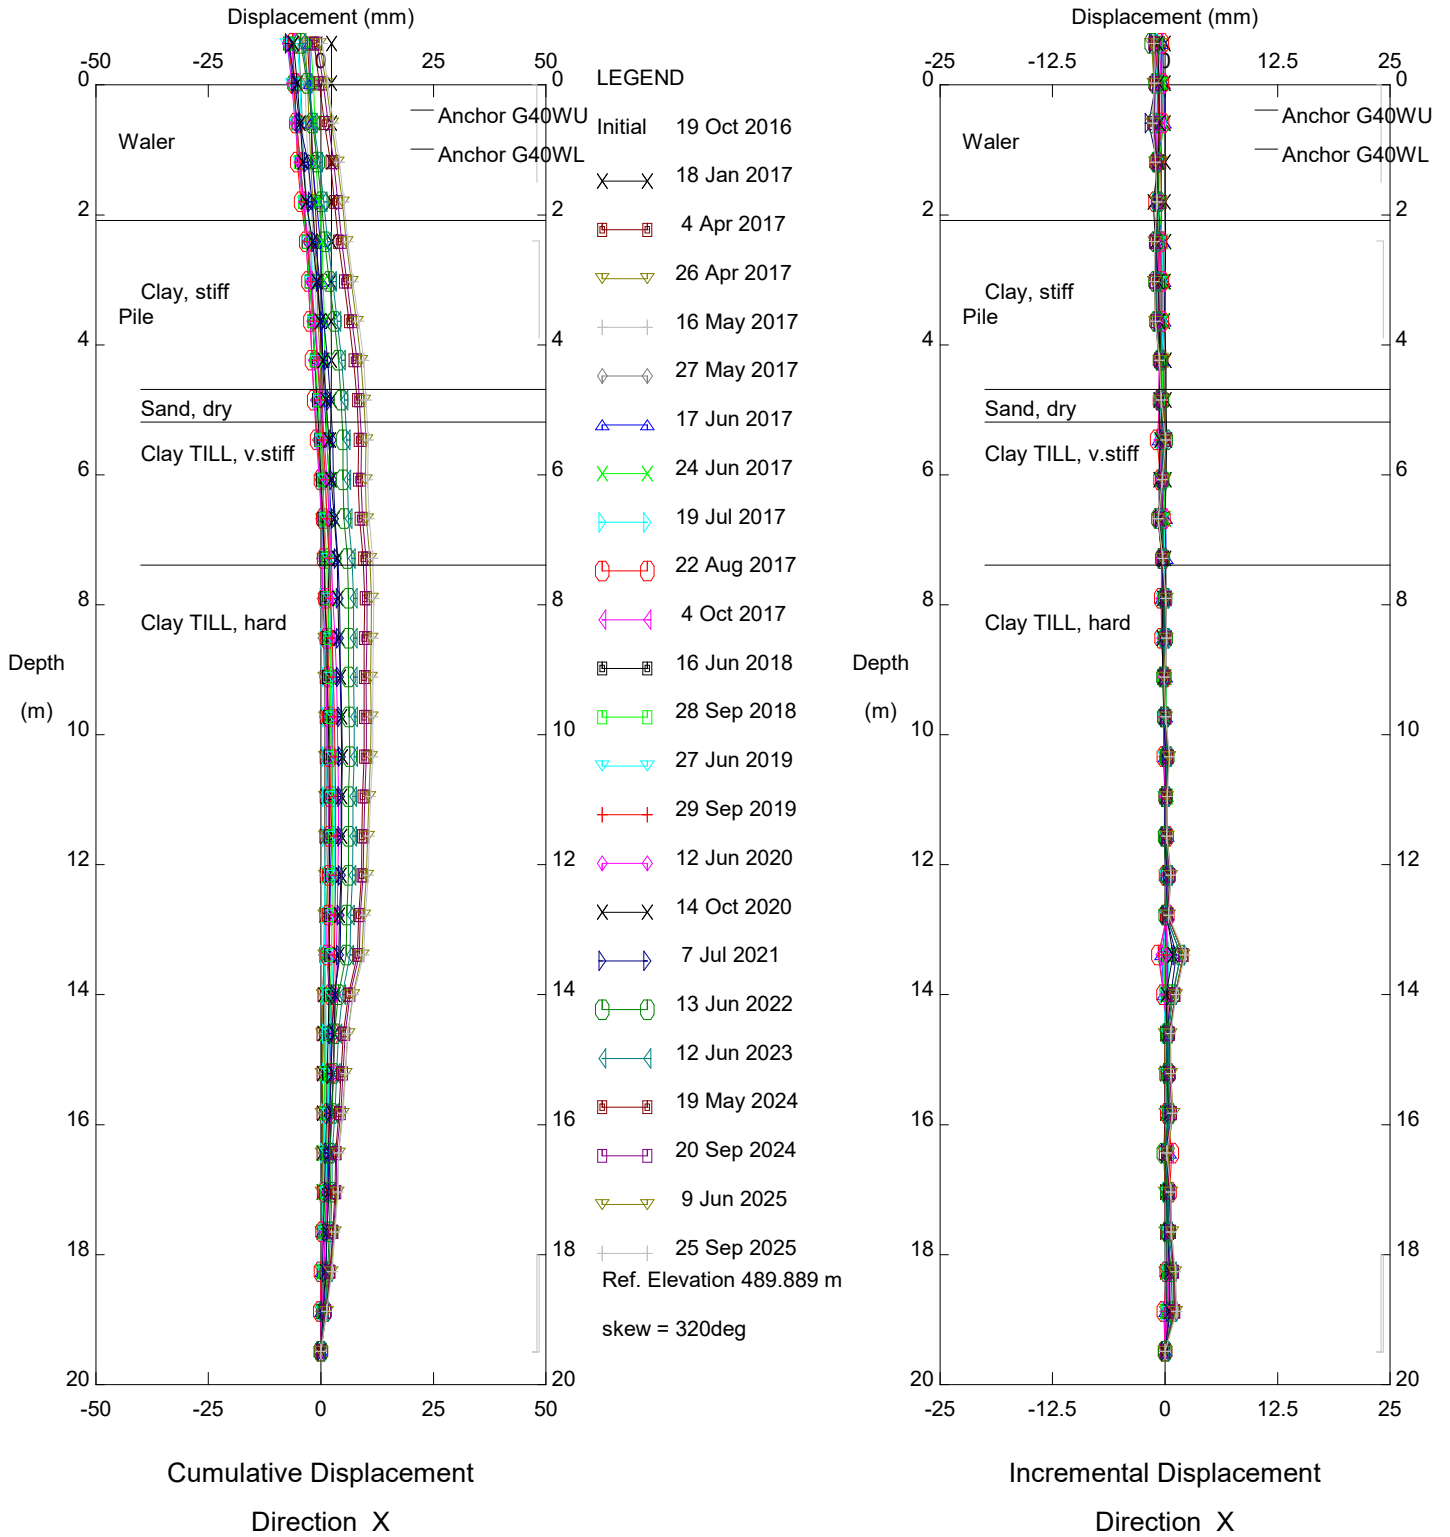
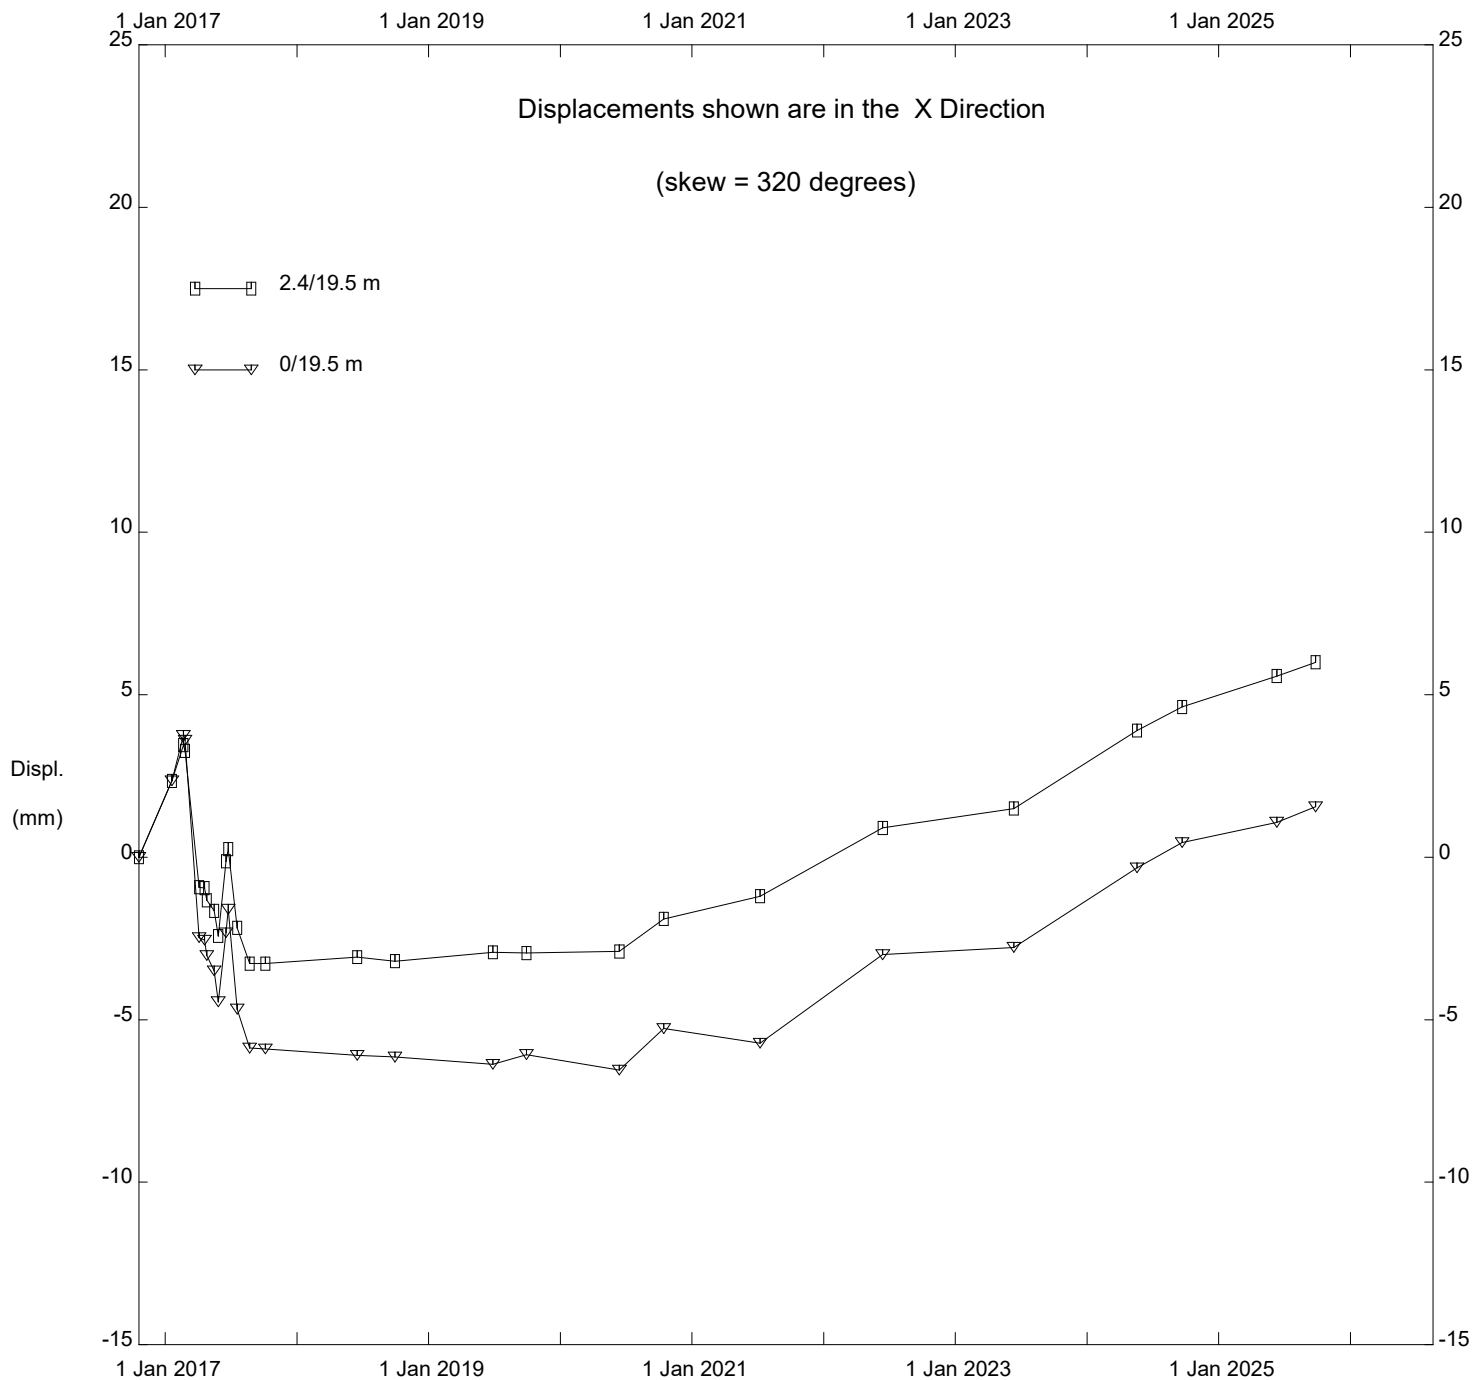
Peace River East Hill PH070, Inclinometer P40

SI-P40, installed in Pile 40, showed a rate of movement of 1.4 mm/yr in the downslope direction over the length of the pile and a rate of movement of 1.5 mm/yr over the combined length of the pile and waler since the spring of 2025 readings. These rates follow a trendline established in the spring of 2020. Pile 40 has shown a total cumulative pile head movement of 6.0 mm in the downslope direction and a total cumulative movement of 1.5 mm in the downslope direction over the combined length of the pile and waler.

| INSTRUMENT # | DATE INITIALIZED | TOTAL CUMULATIVE RESULTANT MOVEMENT AT NOTED DEPTH SINCE INITIAL READING (mm) | MAXIMUM RATE OF MOVEMENT (mm/yr.) | CURRENT STATUS | DATE OF PREVIOUS READING | INCREMENTAL MOVEMENT SINCE PREVIOUS READING (mm) | RATE OF MOVEMENT (mm/yr.) | CHANGE IN RATE OF MOVEMENT SINCE PREVIOUS READING (mm/yr.) |
|---|---|---|---|---|---|--|---|--|
| SI-P40 | October 19, 2016 | 6.0 mm over 2.4 m to 19.5 m depth in 188° direction | -39.8 mm/yr. on April 4, 2017 | Operational | June 9, 2025 | 0.4 | 1.4 | 0.1 |
| | | 1.5 mm over 0 m to 19.5 m depth in 188° direction | -57.3 mm/yr. on April 4, 2017 | | | 0.5 | 1.5 | 0.7 |

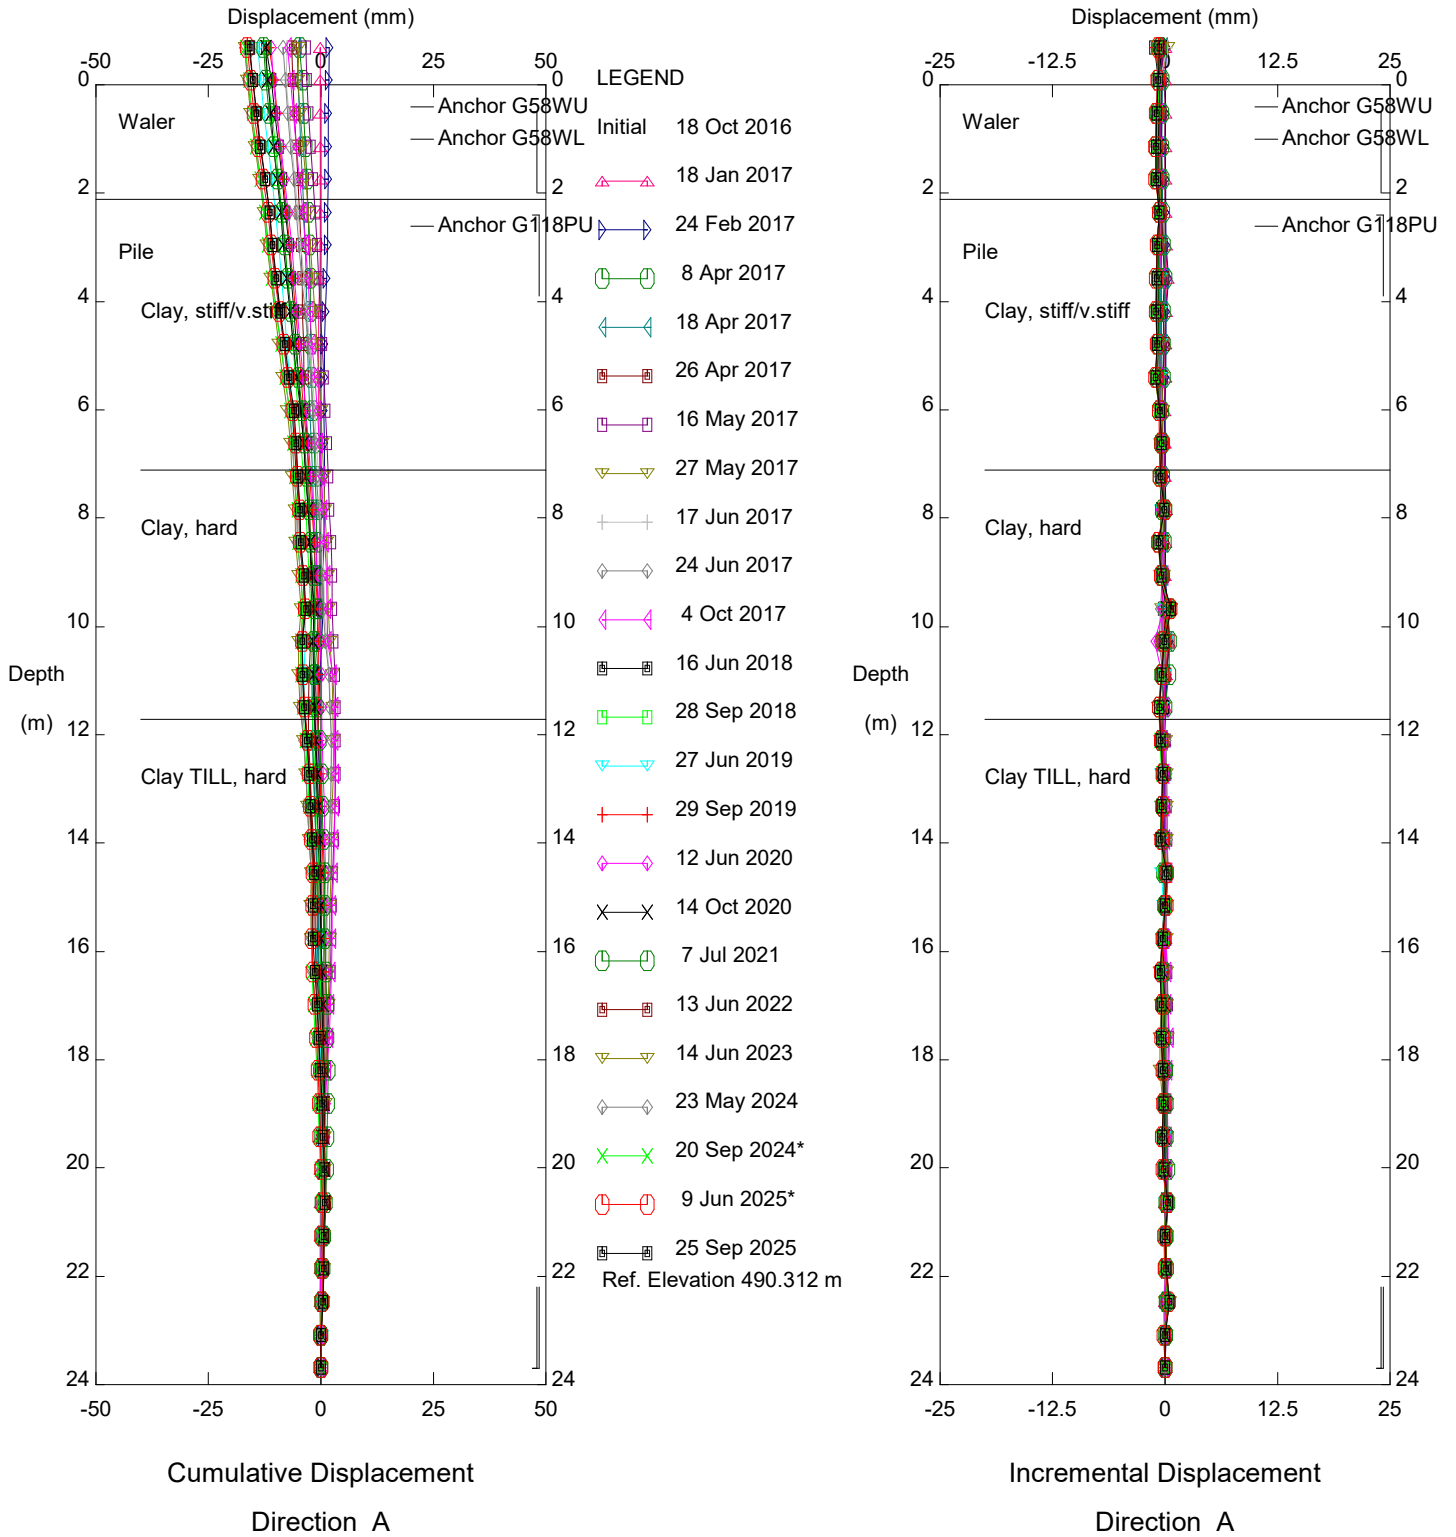
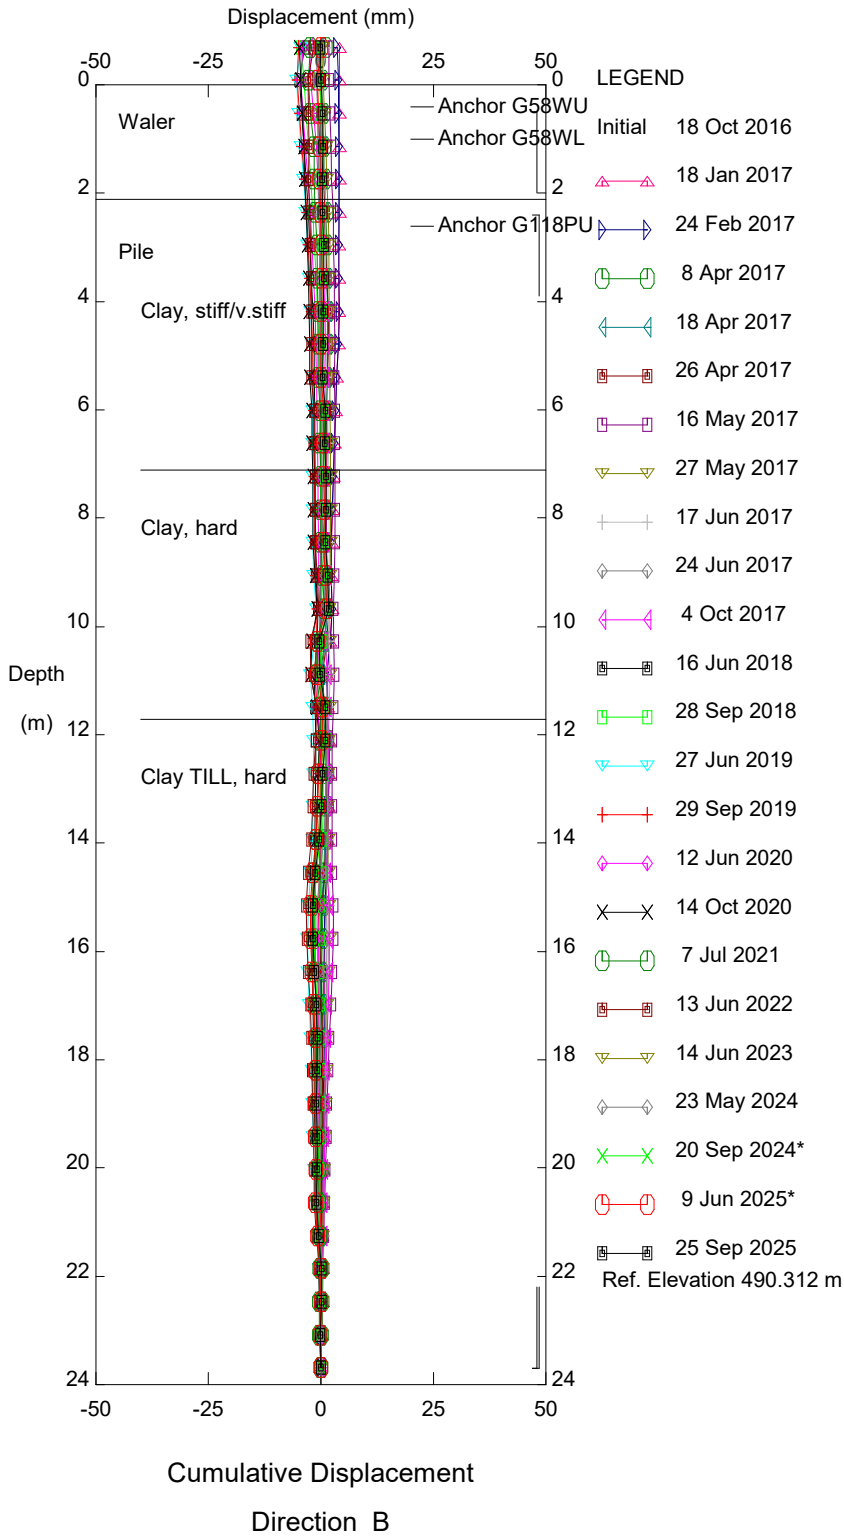
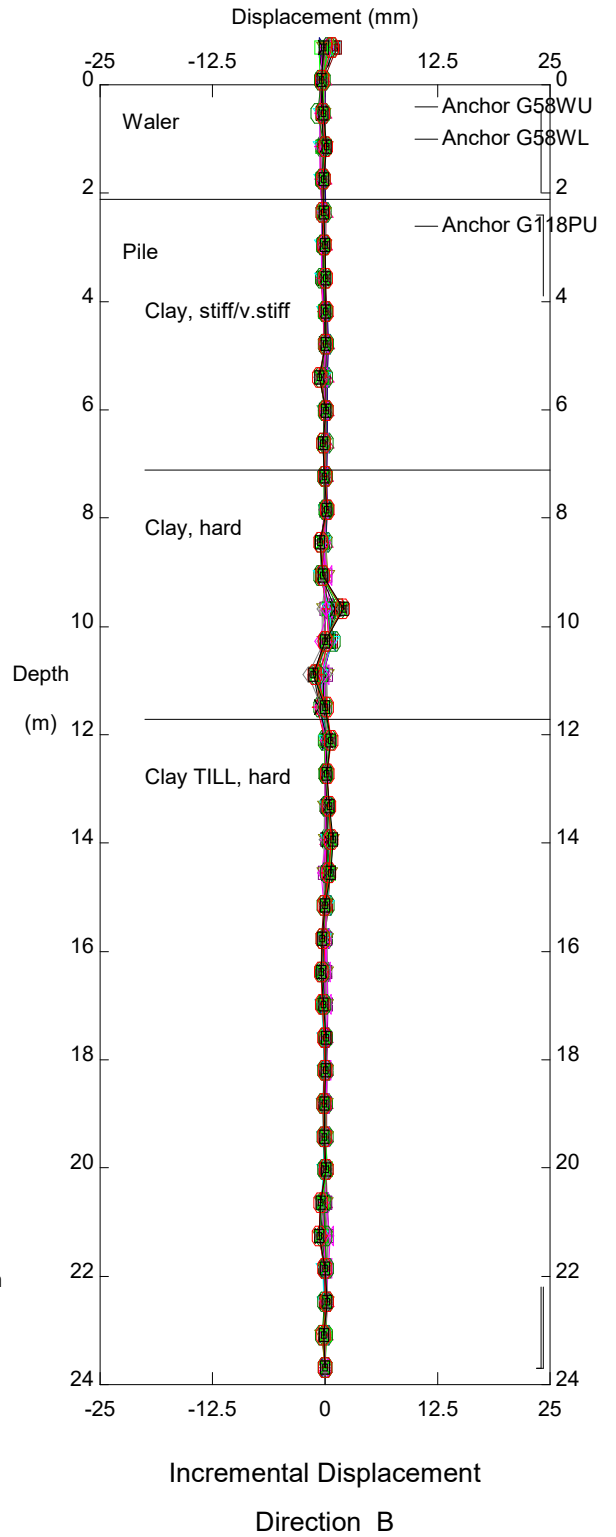
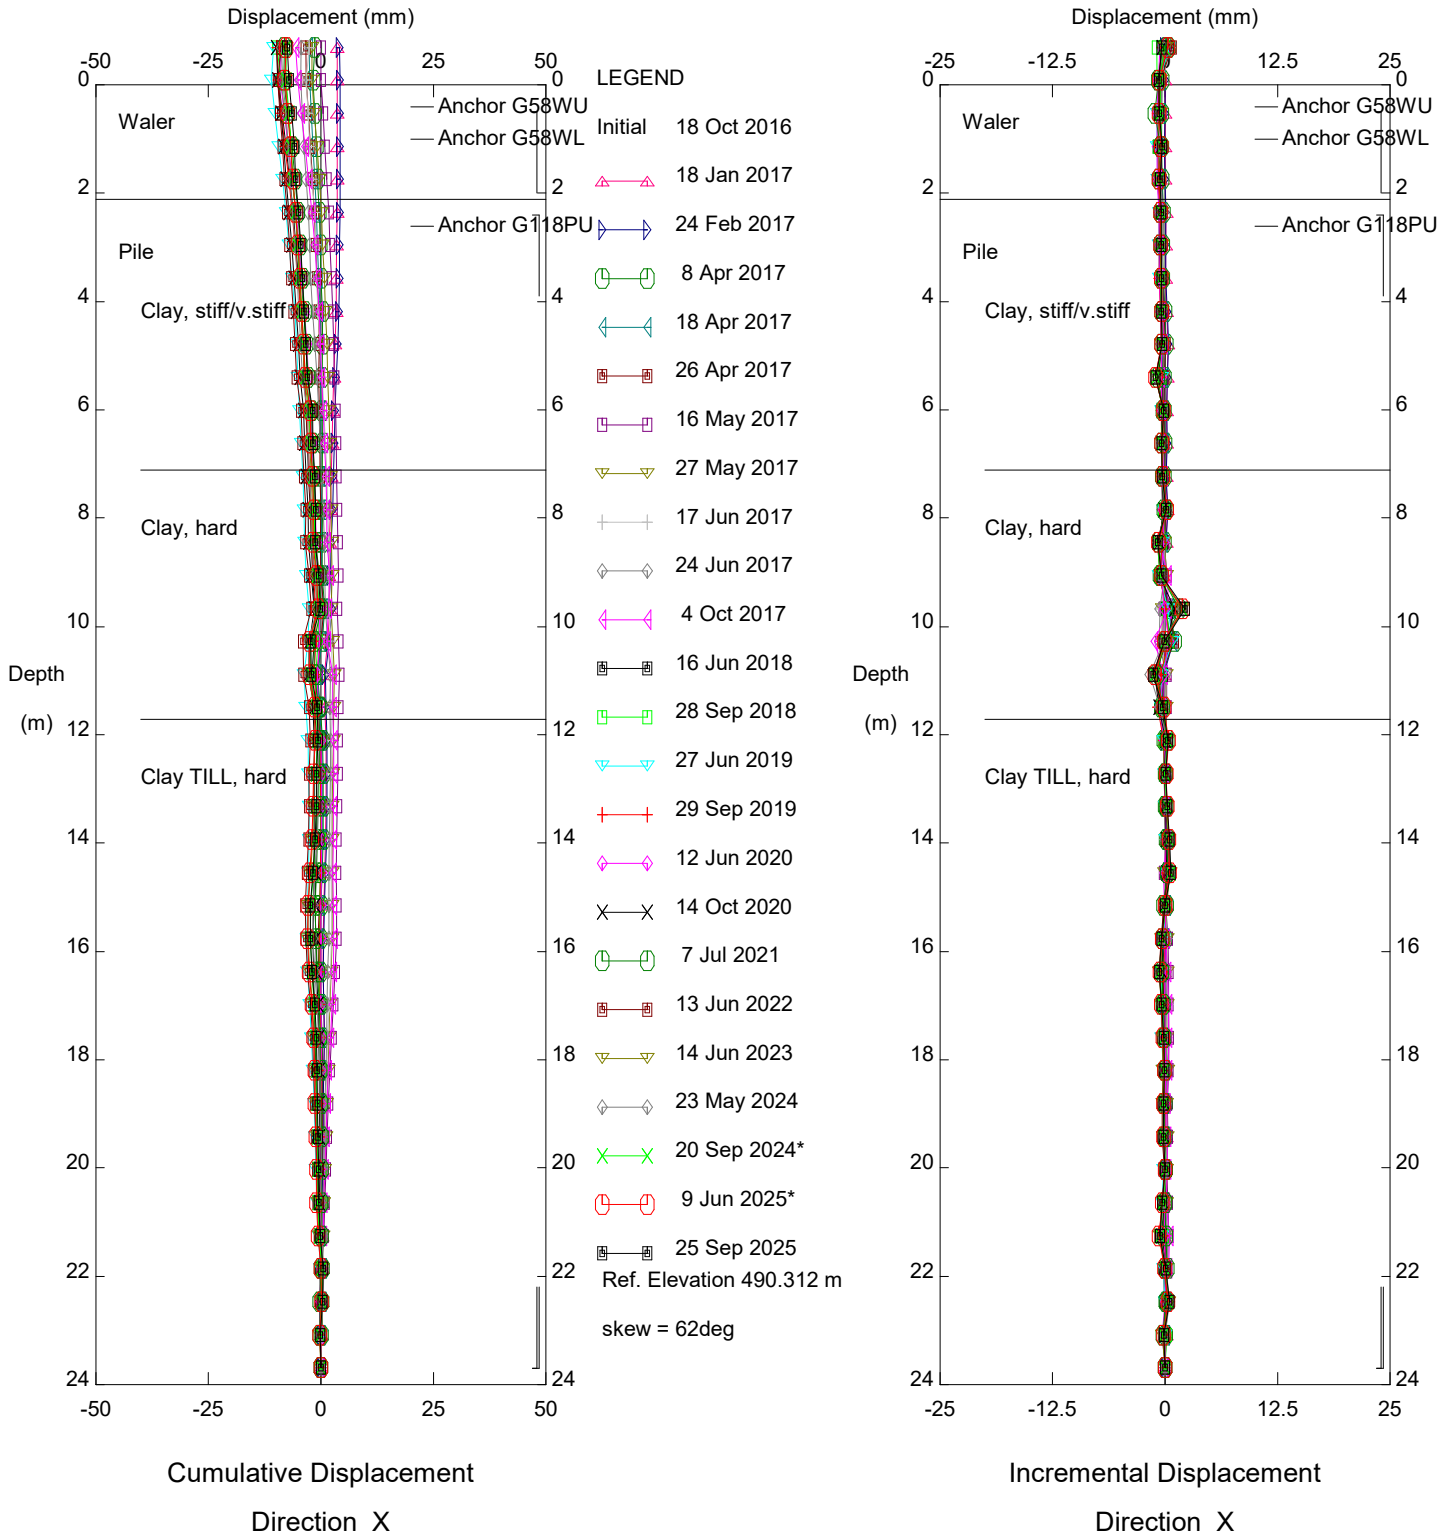
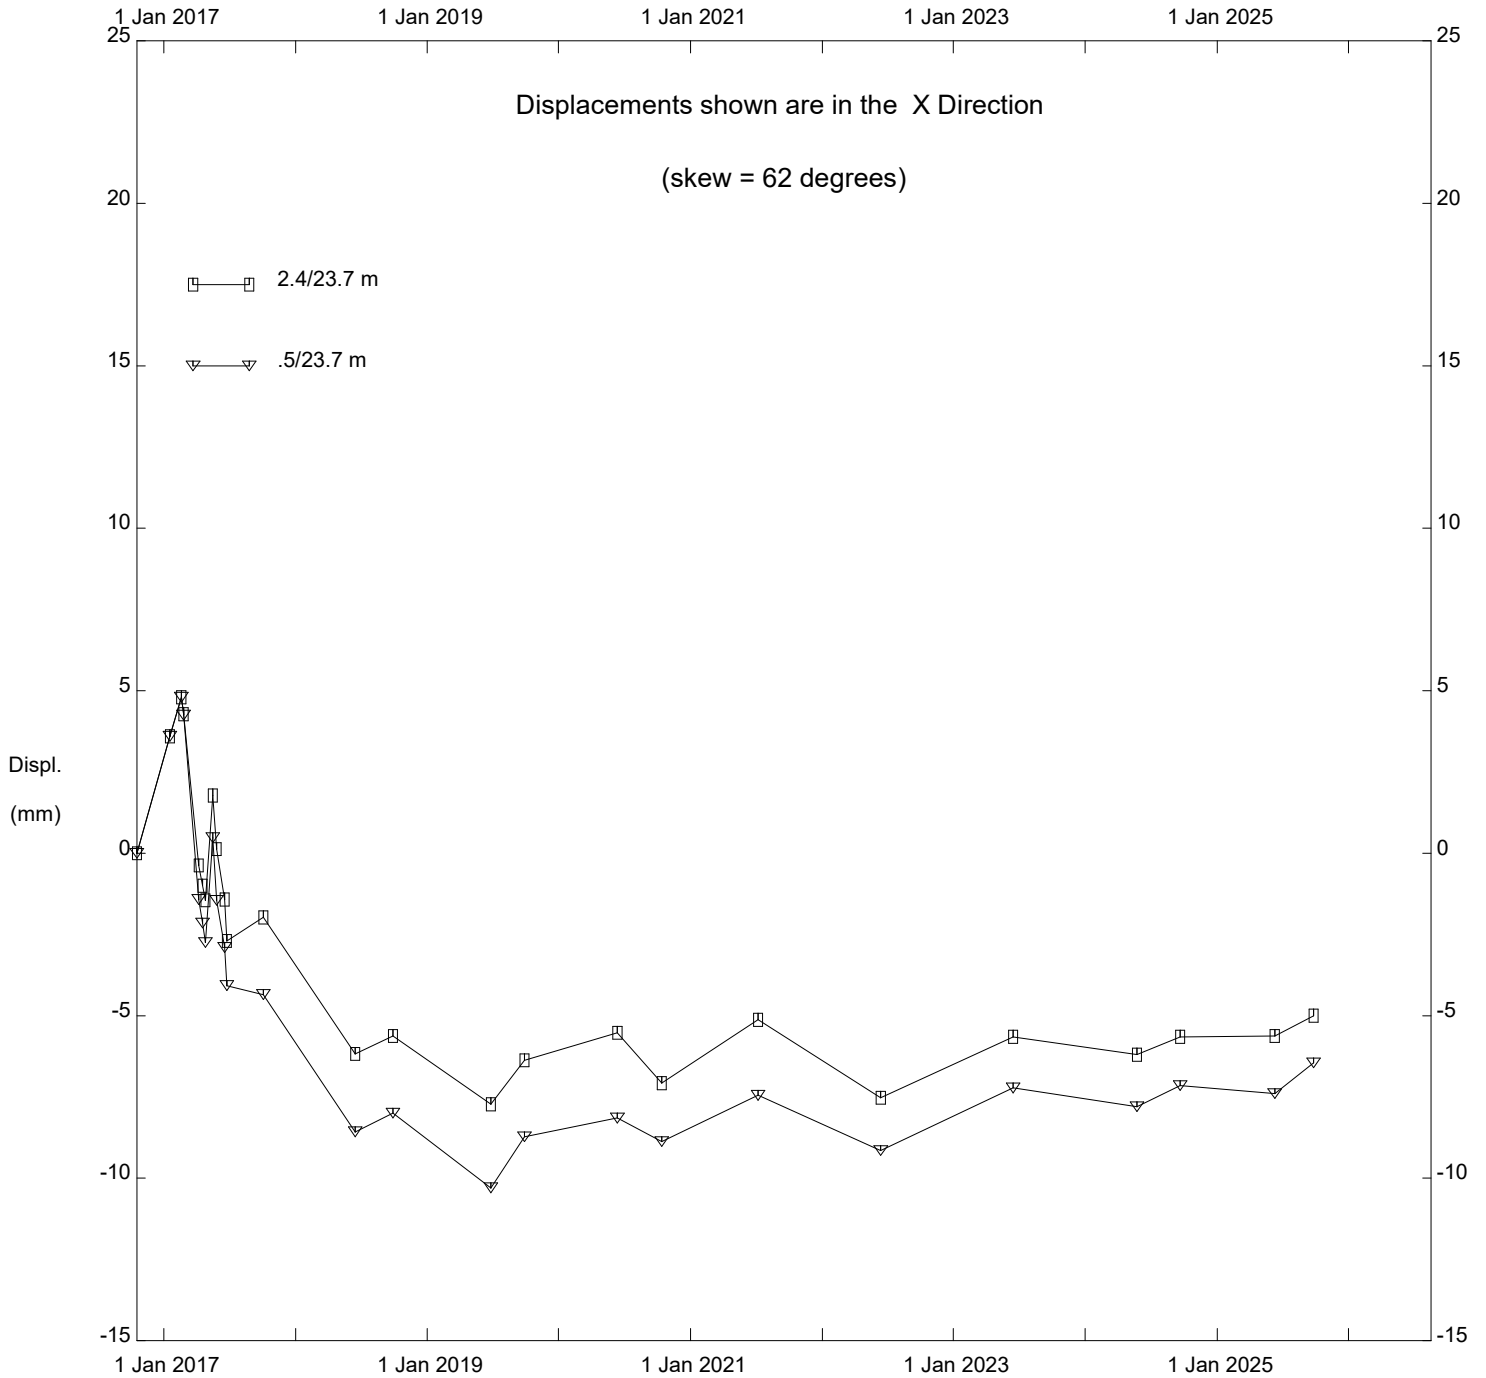
Peace River East Hill PH070, Inclinometer P58

SI-P58, installed in Pile 58, showed a rate of movement of 2.1 mm/yr over the length of the pile and a rate of movement of 3.1 mm/yr over the combined length of the pile and waler since the spring of 2025 readings. The cumulative pile head movement was 5.0 mm in the upslope direction and the cumulative movement at the top of the waler was 6.5 mm in the upslope direction. The cumulative movements have oscillated about approximate these values since the spring of 2018.

| INSTRUMENT # | DATE INITIALIZED | TOTAL CUMULATIVE RESULTANT MOVEMENT AT NOTED DEPTH SINCE INITIAL READING (mm) | MAXIMUM RATE OF MOVEMENT (mm/yr.) | CURRENT STATUS | DATE OF PREVIOUS READING | INCREMENTAL MOVEMENT SINCE PREVIOUS READING (mm) | RATE OF MOVEMENT (mm/yr.) | CHANGE IN RATE OF MOVEMENT SINCE PREVIOUS READING (mm/yr.) |
|---|---|---|---|---|---|--|---|--|
| SI-P58 | October 18, 2016 | -5.0 mm over 2.4 m to 23.7 m depth in 209° direction | -70.8 mm/yr. on June 24, 2017 | Operational | June 9, 2025 | 0.6 | 2.1 | 2.1 |
| | | -6.5 mm over 0.5 m to 23.7 m depth in 209° direction | -65.7 mm/yr. on June 24, 2017 | | | 0.9 | 3.1 | 3.5 |
