| Site Number | Location | Name | Hwy | km |
| PH070 | HWY 2:60 C1 33.840 | East Hill Retaining Wall Site | 2:60 | Km 33.84 |

| Current Monitoring: | 25-Sep-2025 | Previous Monitoring | 9-June-2025 |

Table PH070-1 Fall 2025 – Hwy 2:60 Peace River East Hill Retaining Wall Site (Km 33.84) Slope Inclinator Instrumentation Reading Summary

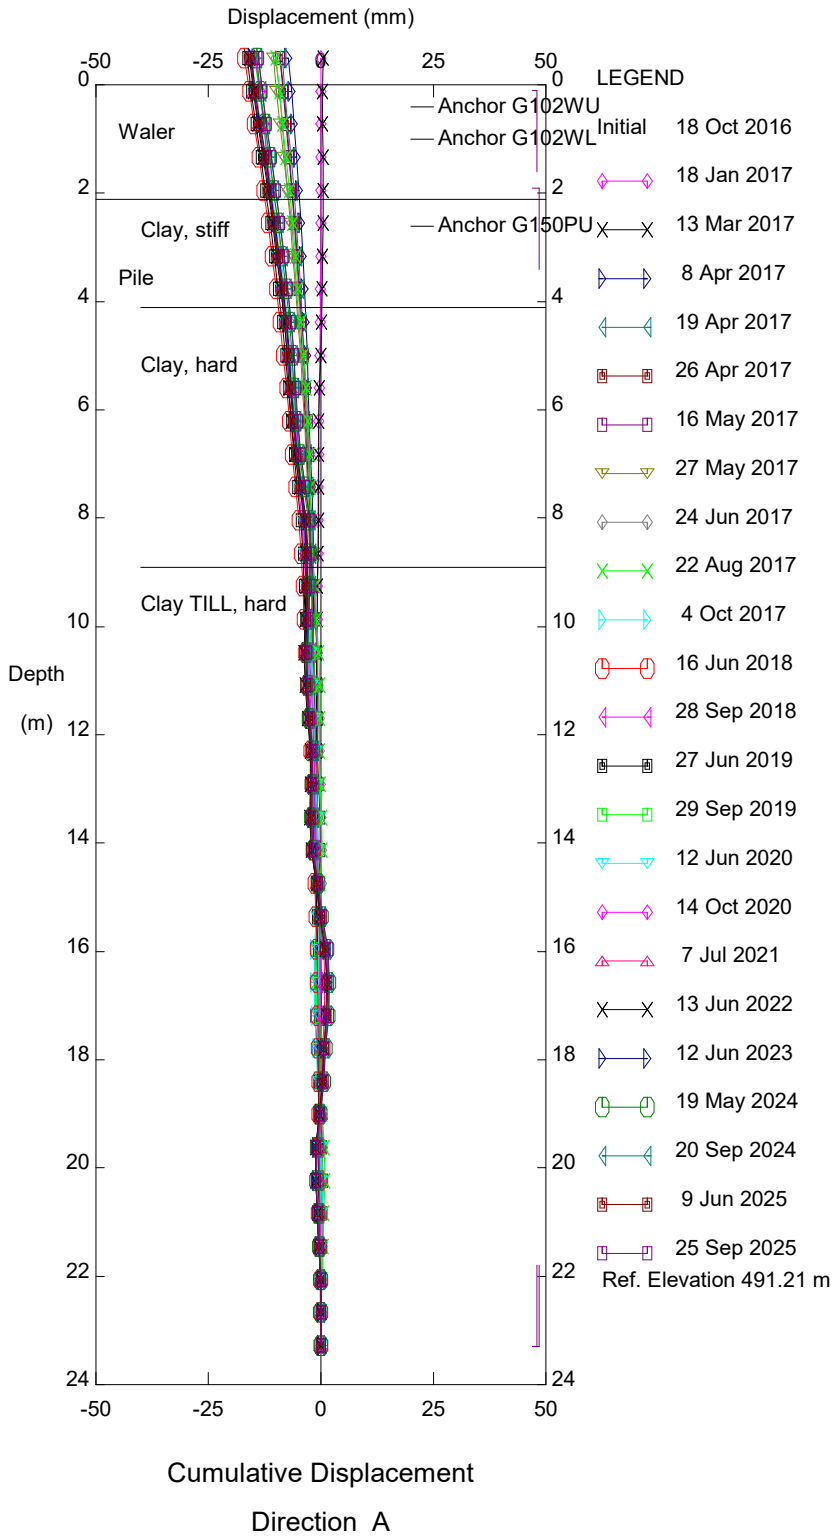
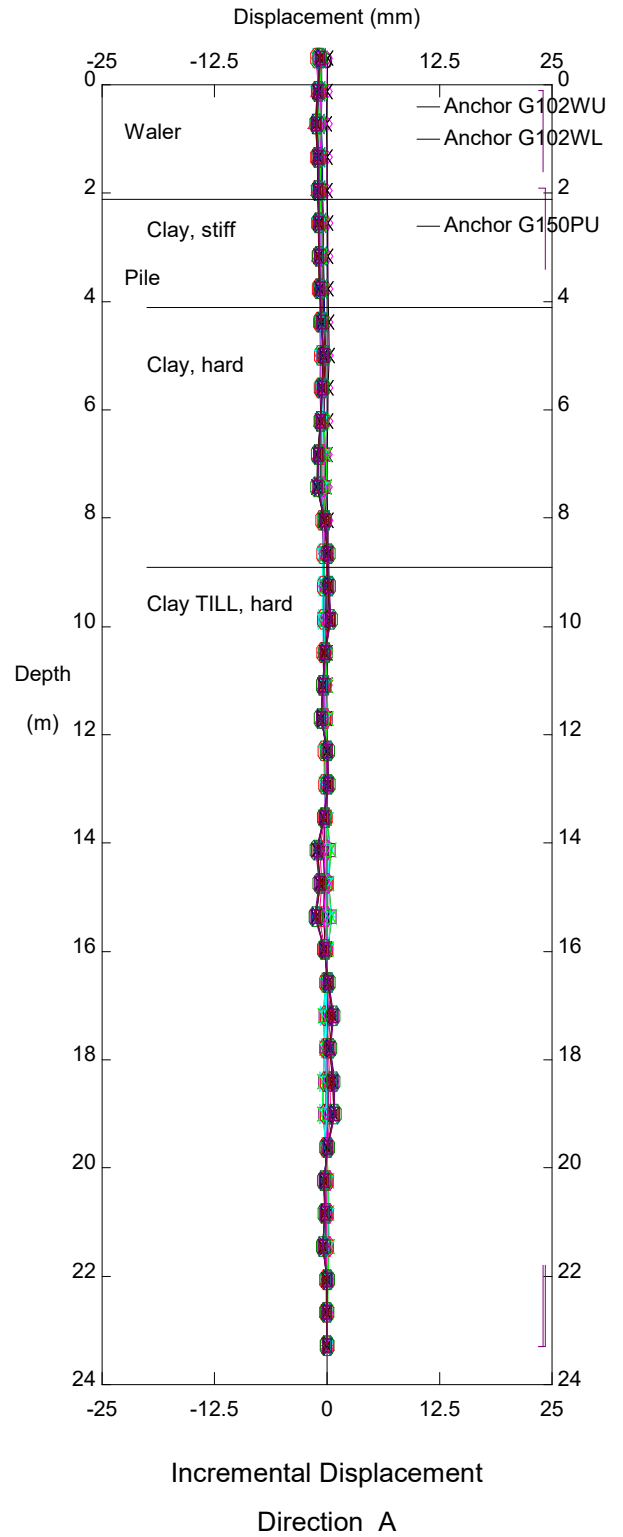
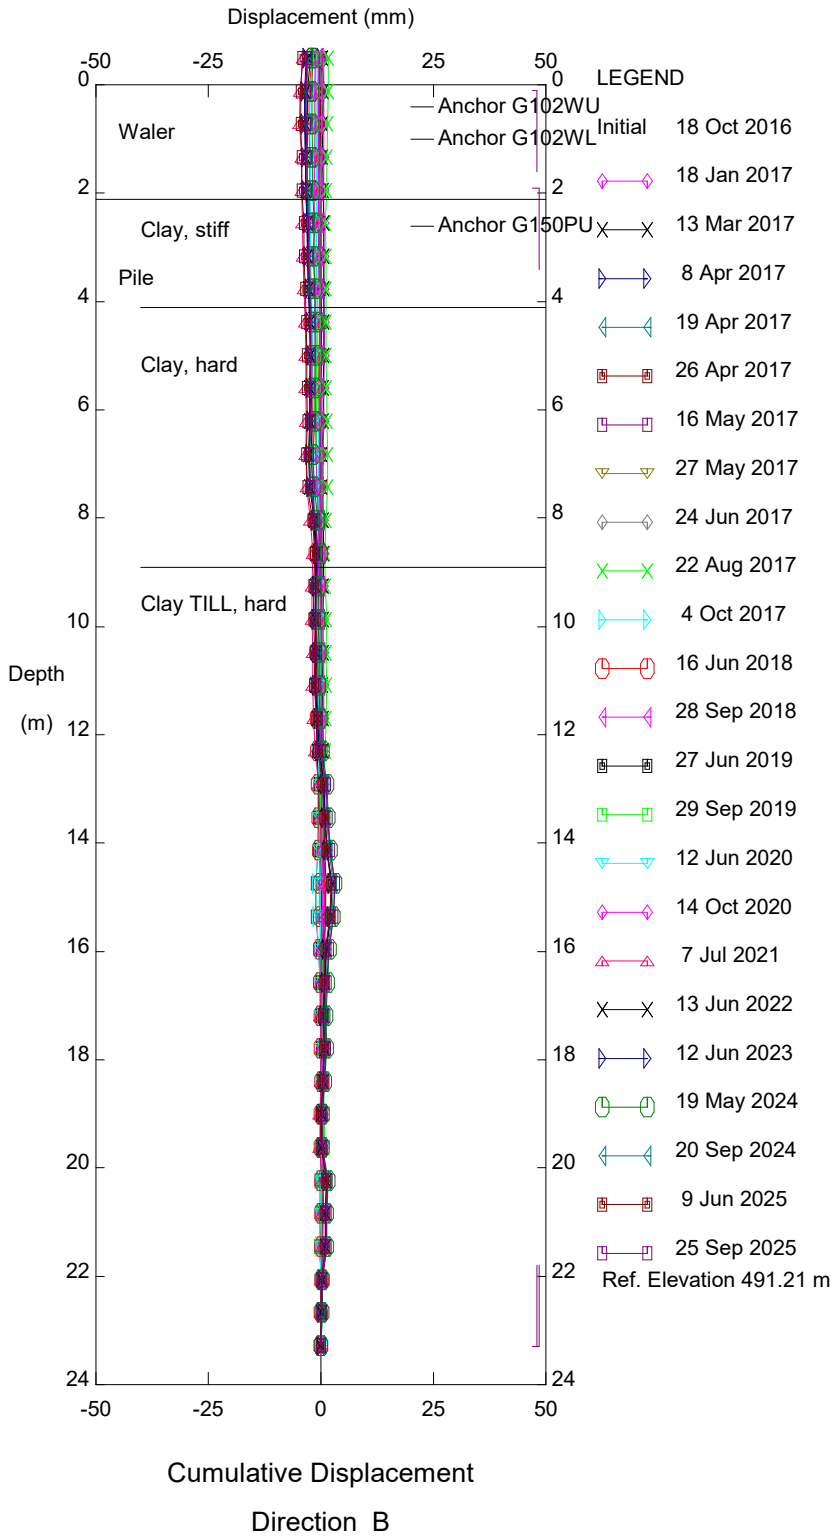
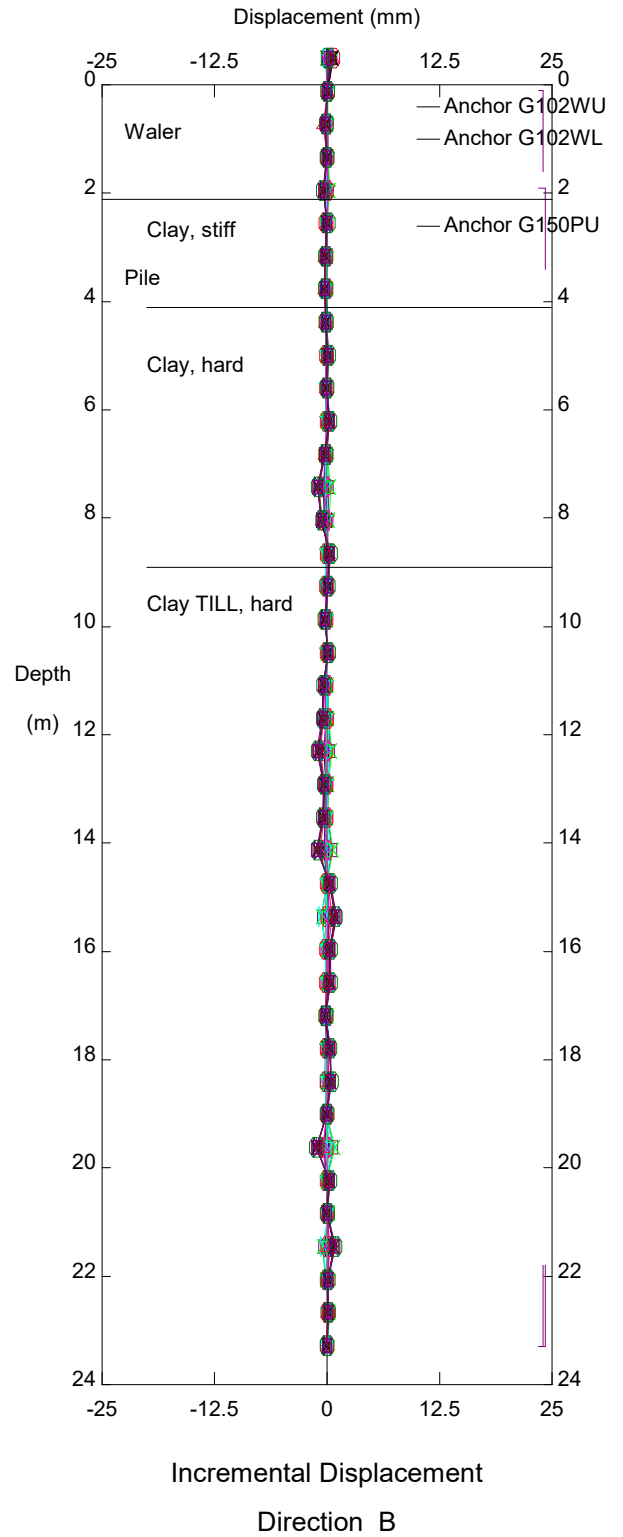
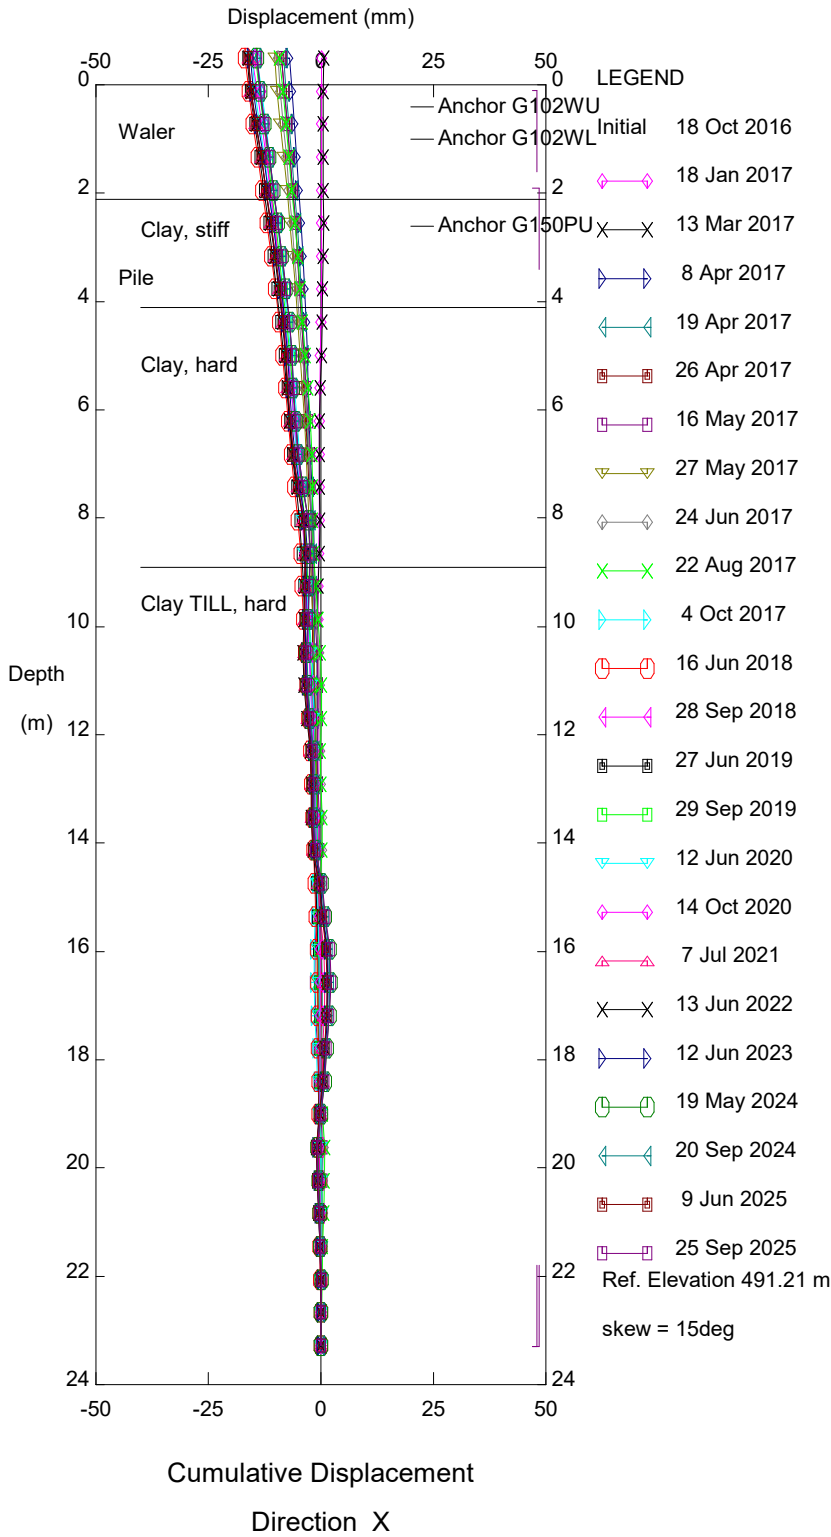
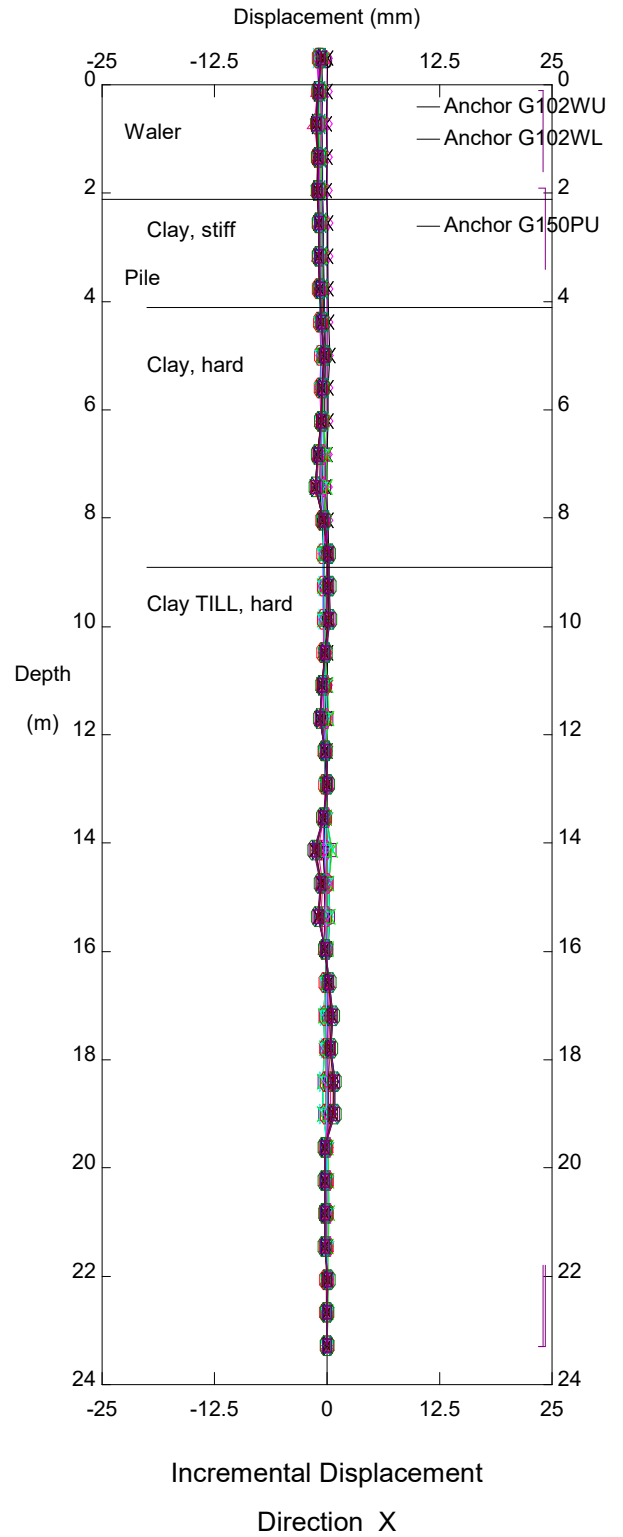
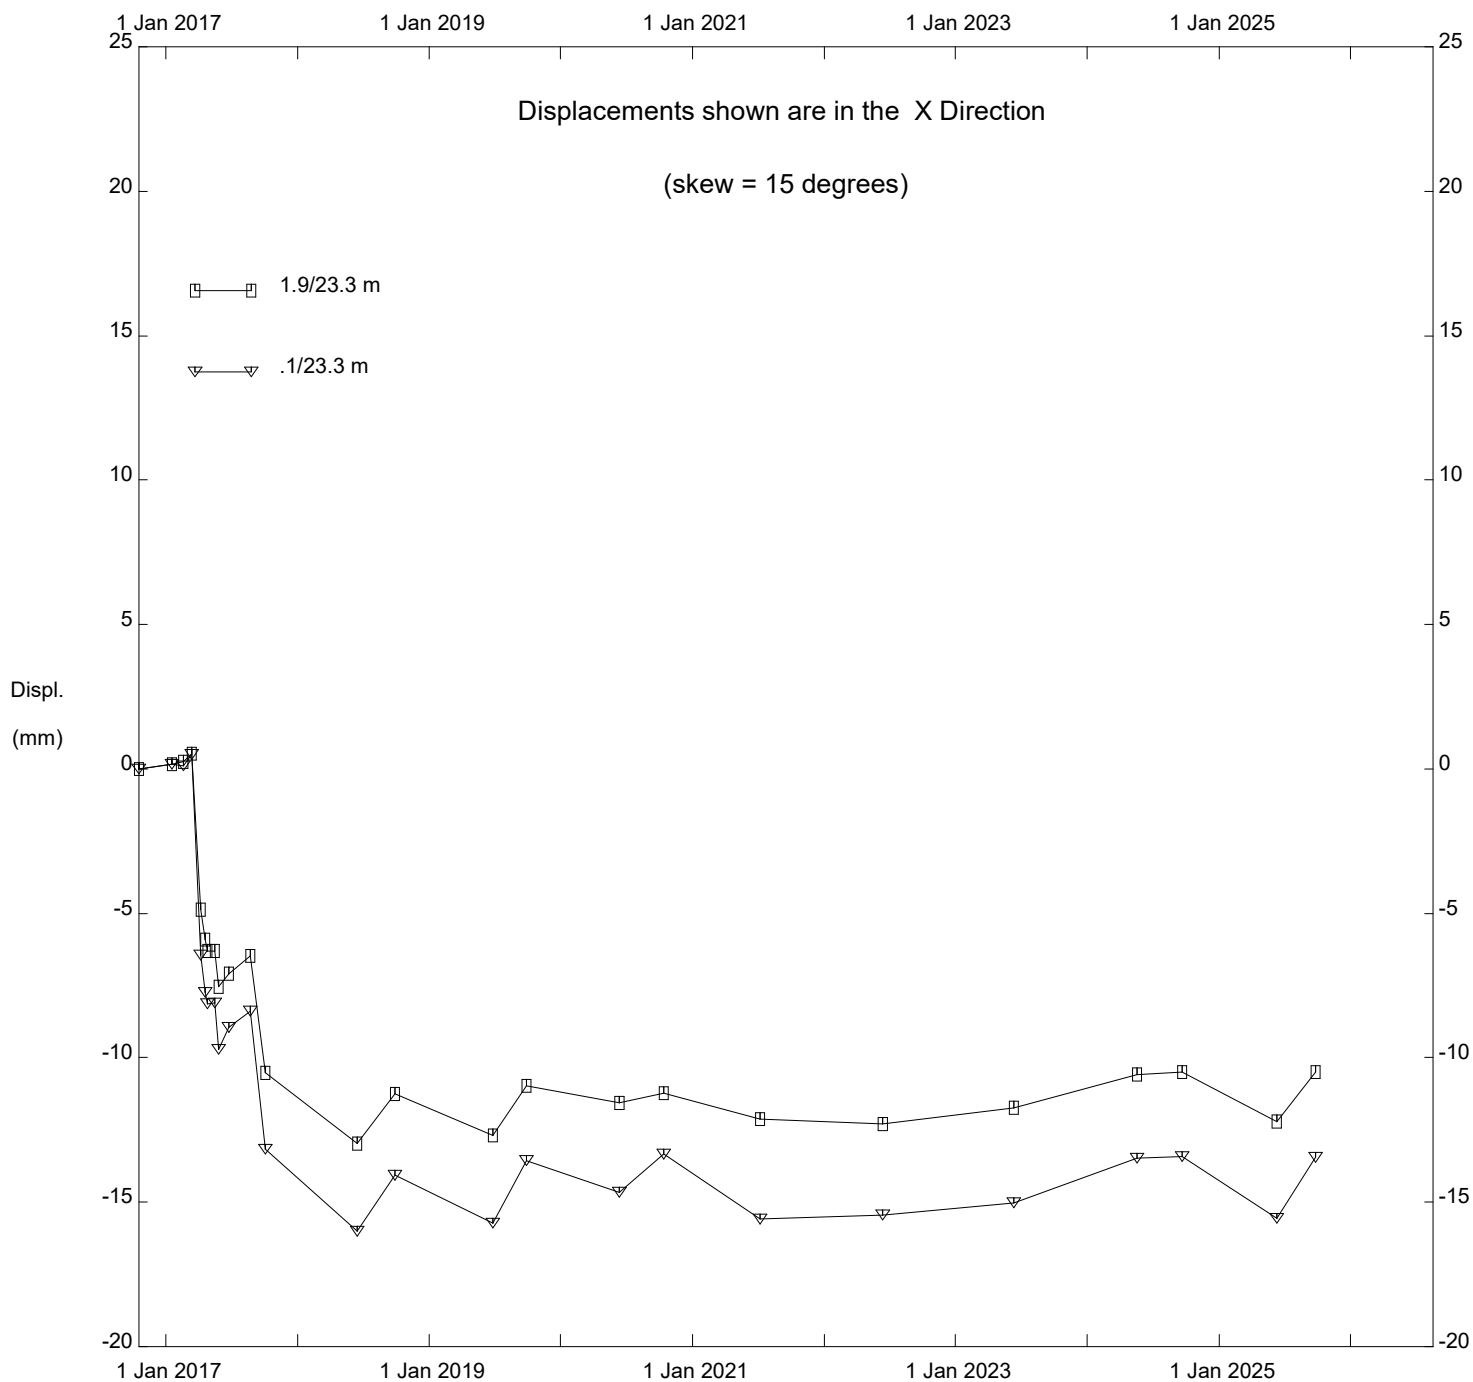
Peace River East Hill PH070, Inclinometer P90

SI-P90, installed in Pile 90, showed a rate of movement of 5.8 mm/yr over the length of the pile and a rate of movement of 7.1 mm/yr over the combined length of the pile and waler since the spring of 2025 readings. Pile 90 has shown a total cumulative pile head movement of 10.5 mm in the upslope direction and a total cumulative movement of 13.4 mm in the upslope direction over the combined length of the pile and waler. The cumulative movements have oscillated about these approximate values since the fall of 2017. SI-P116, installed in Pile 116, showed a rate of movement of 5.0 mm/yr over the length of the pile and a rate of movement of 5.6 mm/yr over the combined length of the pile and waler since the spring of 2025 readings. Pile 116 has shown a total cumulative pile head movement of 9.4 mm in the downslope direction and a total cumulative movement of 9.8 mm in the downslope direction over the combined length of the pile and waler.

| INSTRUMENT # | DATE INITIALIZED | TOTAL CUMULATIVE RESULTANT MOVEMENT AT NOTED DEPTH SINCE INITIAL READING (mm) | MAXIMUM RATE OF MOVEMENT (mm/yr.) | CURRENT STATUS | DATE OF PREVIOUS READING | INCREMENTAL MOVEMENT SINCE PREVIOUS READING (mm) | RATE OF MOVEMENT (mm/yr.) | CHANGE IN RATE OF MOVEMENT SINCE PREVIOUS READING (mm/yr.) |
|---|---|---|---|---|---|--|---|--|
| SI-P90 | October 18, 2016 | -10.5 mm over 1.9 m to 23.3 m depth in 174° direction | -76.0 mm/yr. on April 8, 2017 | Operational | June 9, 2025 | 1.7 | 5.8 | 8.2 |
| | | -13.4 mm over 0.1 m to 23.3 m depth in 174° direction | -97.5 mm/yr. on April 8, 2017 | | | 2.1 | 7.1 | 10.1 |

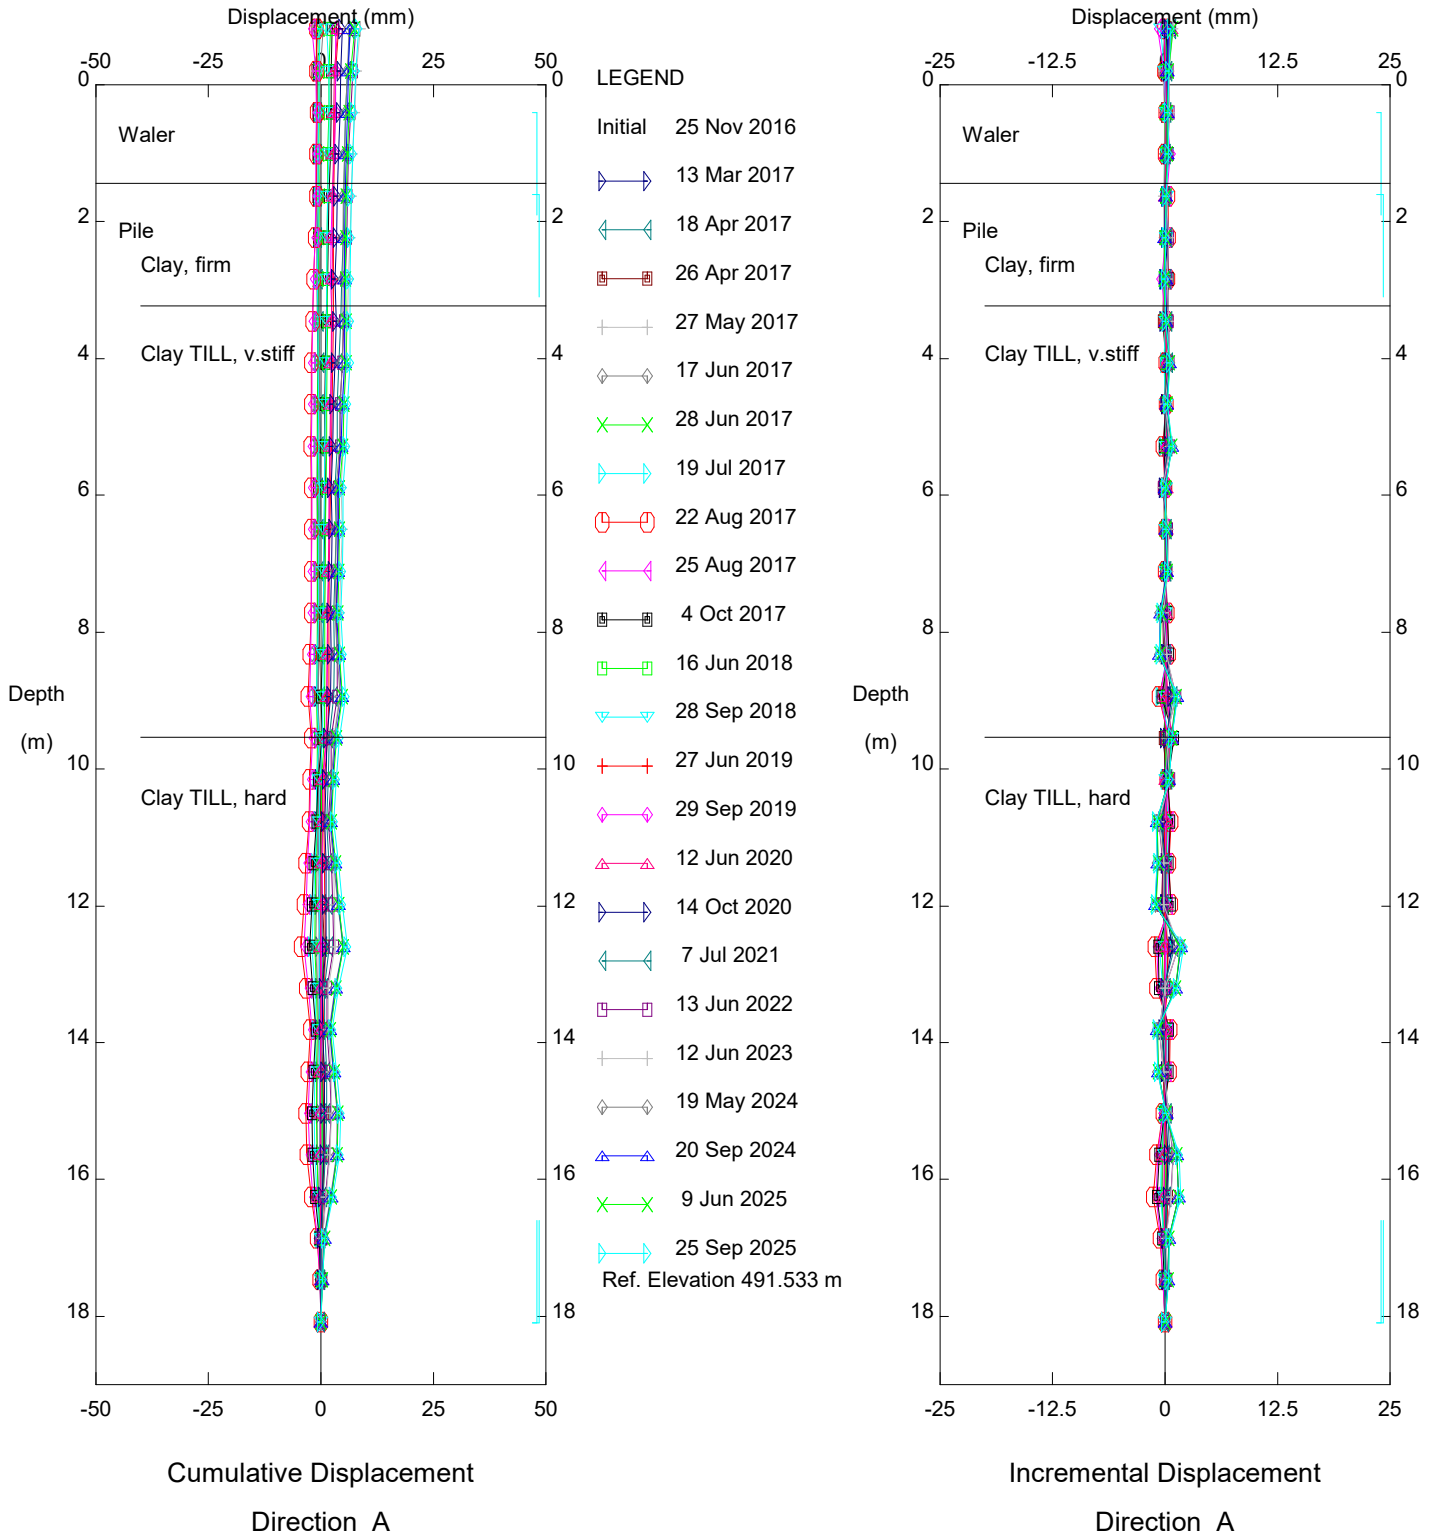
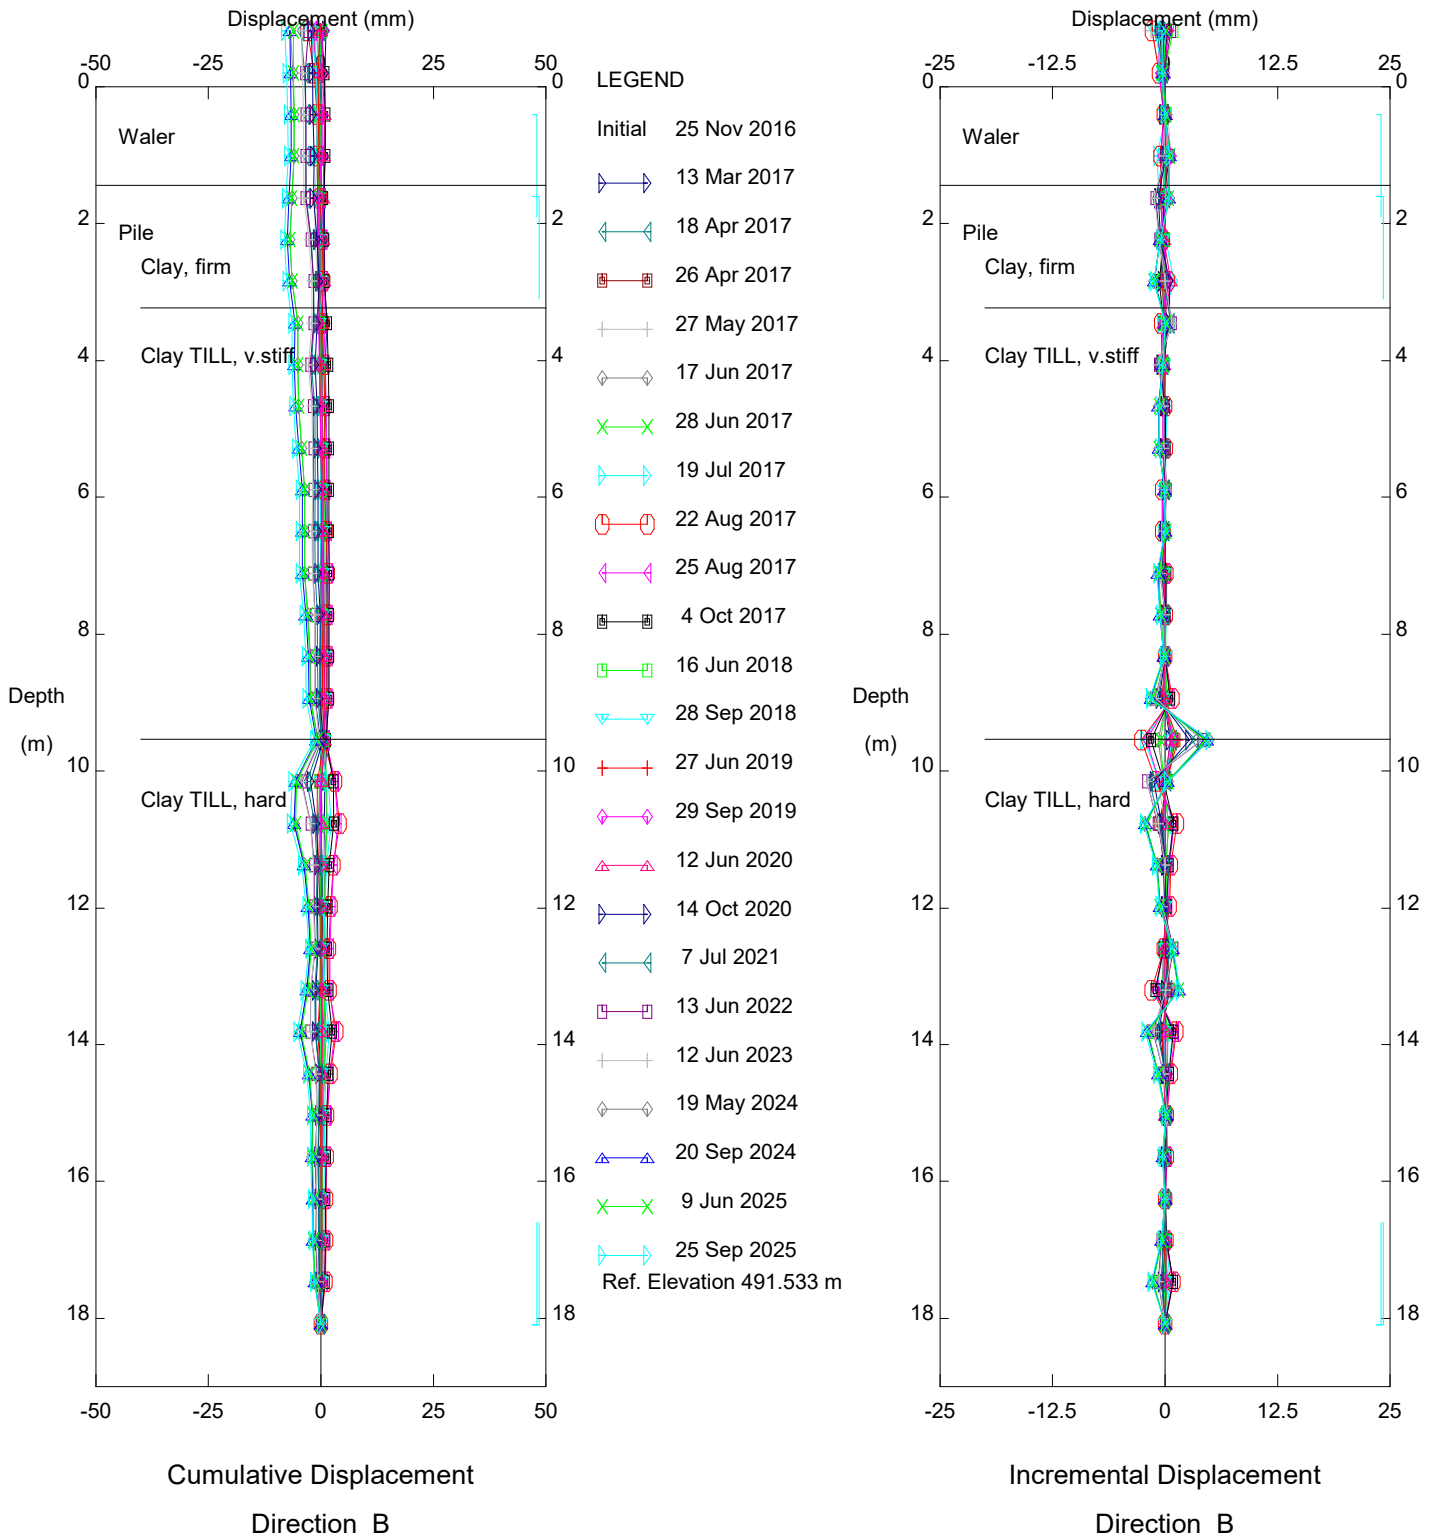
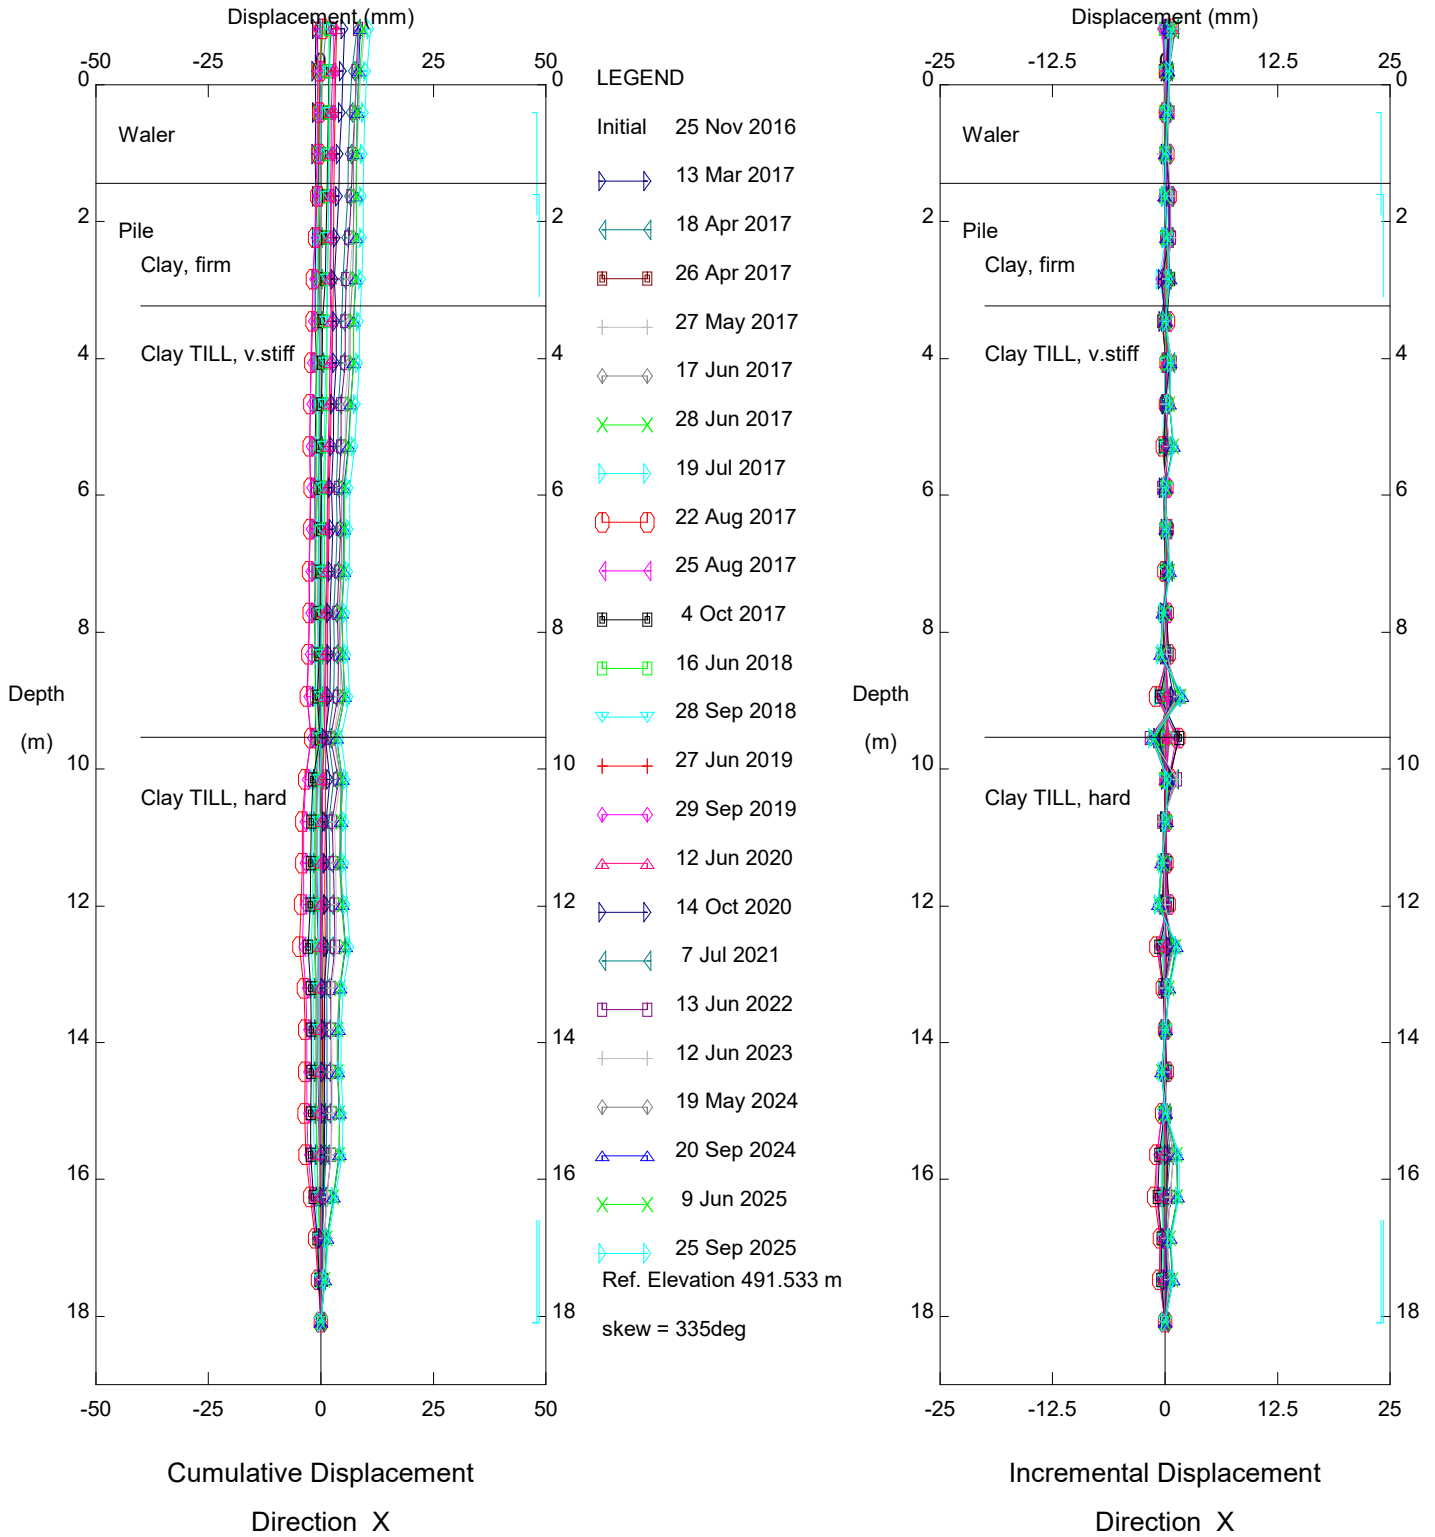
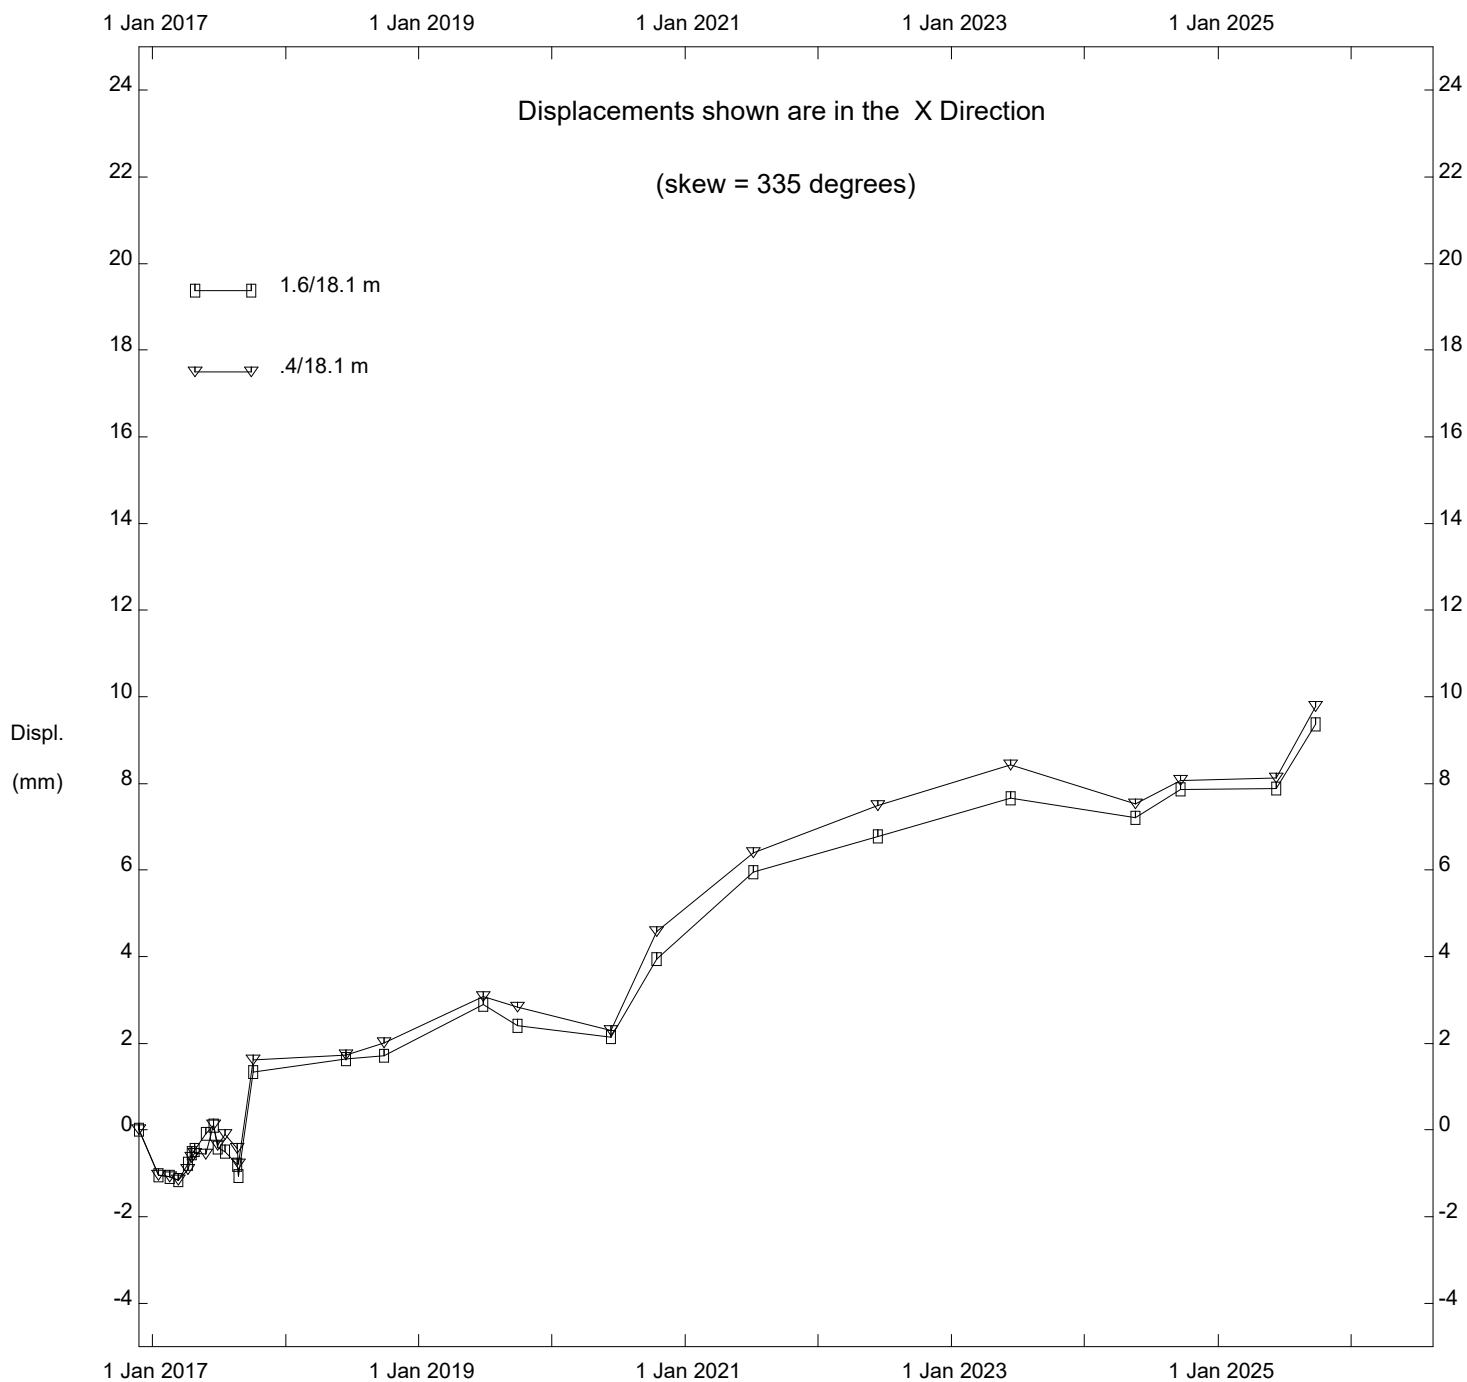
Peace River East Hill PH070, Inclinometer P116

| INSTRUMENT # | DATE INITIALIZED | TOTAL CUMULATIVE RESULTANT MOVEMENT AT NOTED DEPTH SINCE INITIAL READING (mm) | MAXIMUM RATE OF MOVEMENT (mm/yr.) | CURRENT STATUS | DATE OF PREVIOUS READING | INCREMENTAL MOVEMENT SINCE PREVIOUS READING (mm) | RATE OF MOVEMENT (mm/yr.) | CHANGE IN RATE OF MOVEMENT SINCE PREVIOUS READING (mm/yr.) |
|---|---|---|---|---|---|--|---|--|
| SI-P116 | November 25, 2016 | 9.4 mm over 1.6 m to 18.1 m depth in 189° direction | 20.7 mm/yr. on October 4, 2017 | Operational | June 9, 2025 | 1.5 | 5.0 | 5.0 |
| | | 9.8 mm over 0.4 m to 18.1 m depth in 189° direction | 19.6 mm/yr. on October 4, 2017 | | | 1.7 | 5.6 | 5.5 |
