| Site Number | Location | Name | Hwy | km |
| PH070 | HWY 2:60 C1 33.840 | East Hill Retaining Wall Site | 2:60 | Km 33.84 |

| Current Monitoring: | 25-Sep-2025 | Previous Monitoring | 9-June-2025 |

Table PH070-1 Fall 2025 – Hwy 2:60 Peace River East Hill Retaining Wall Site (Km 33.84) Slope Inclinator Instrumentation Reading Summary

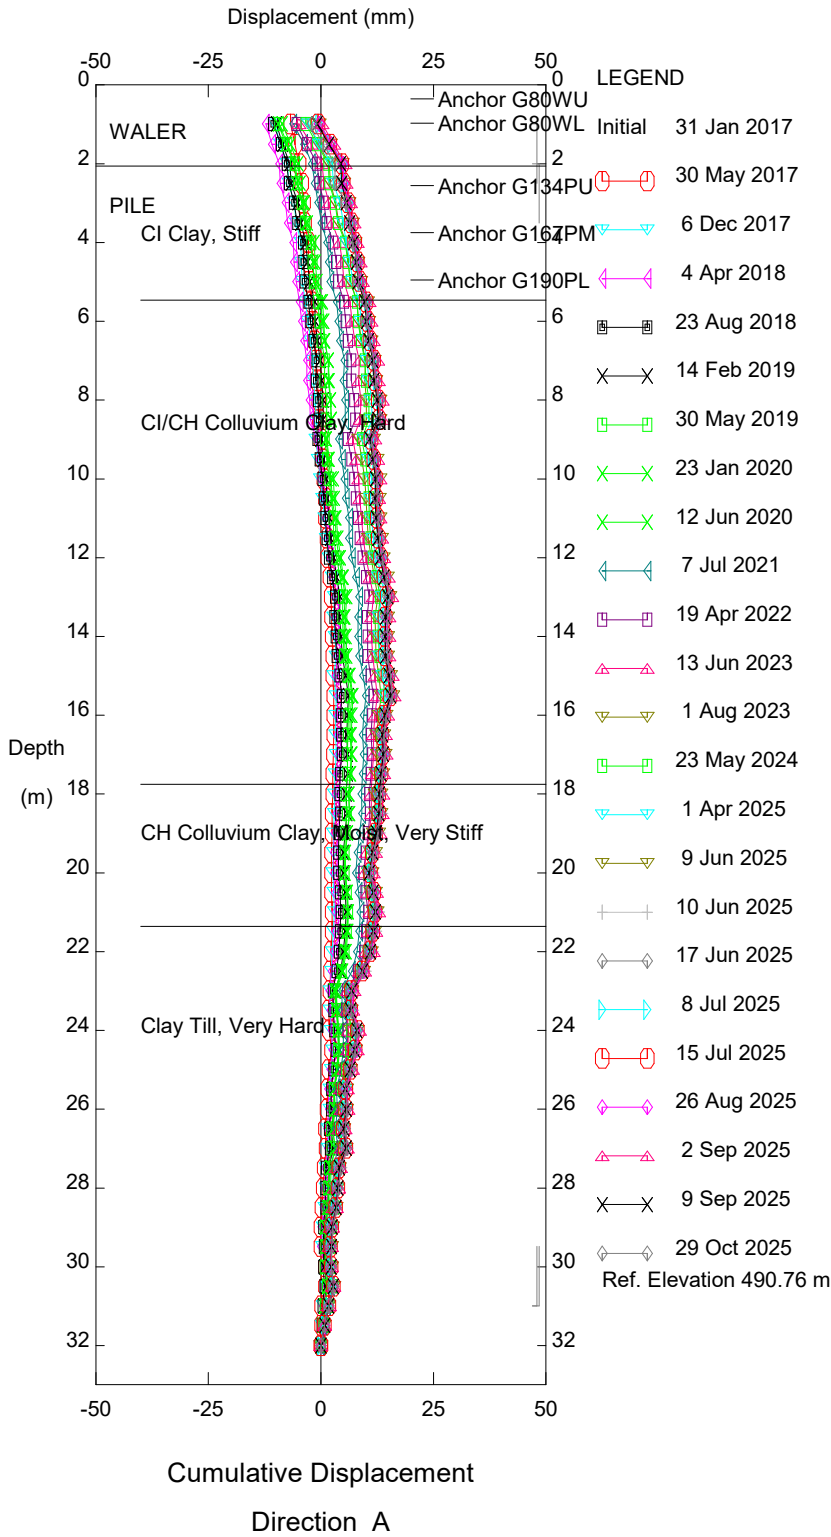
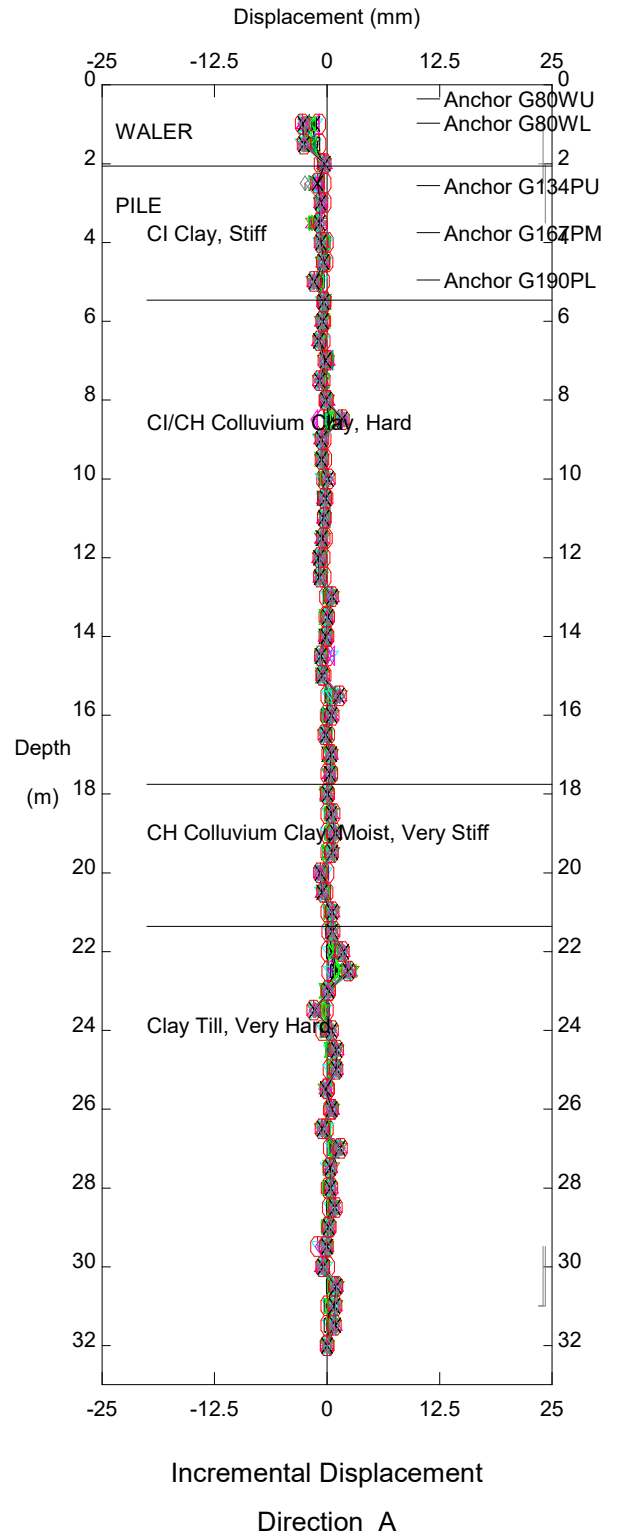
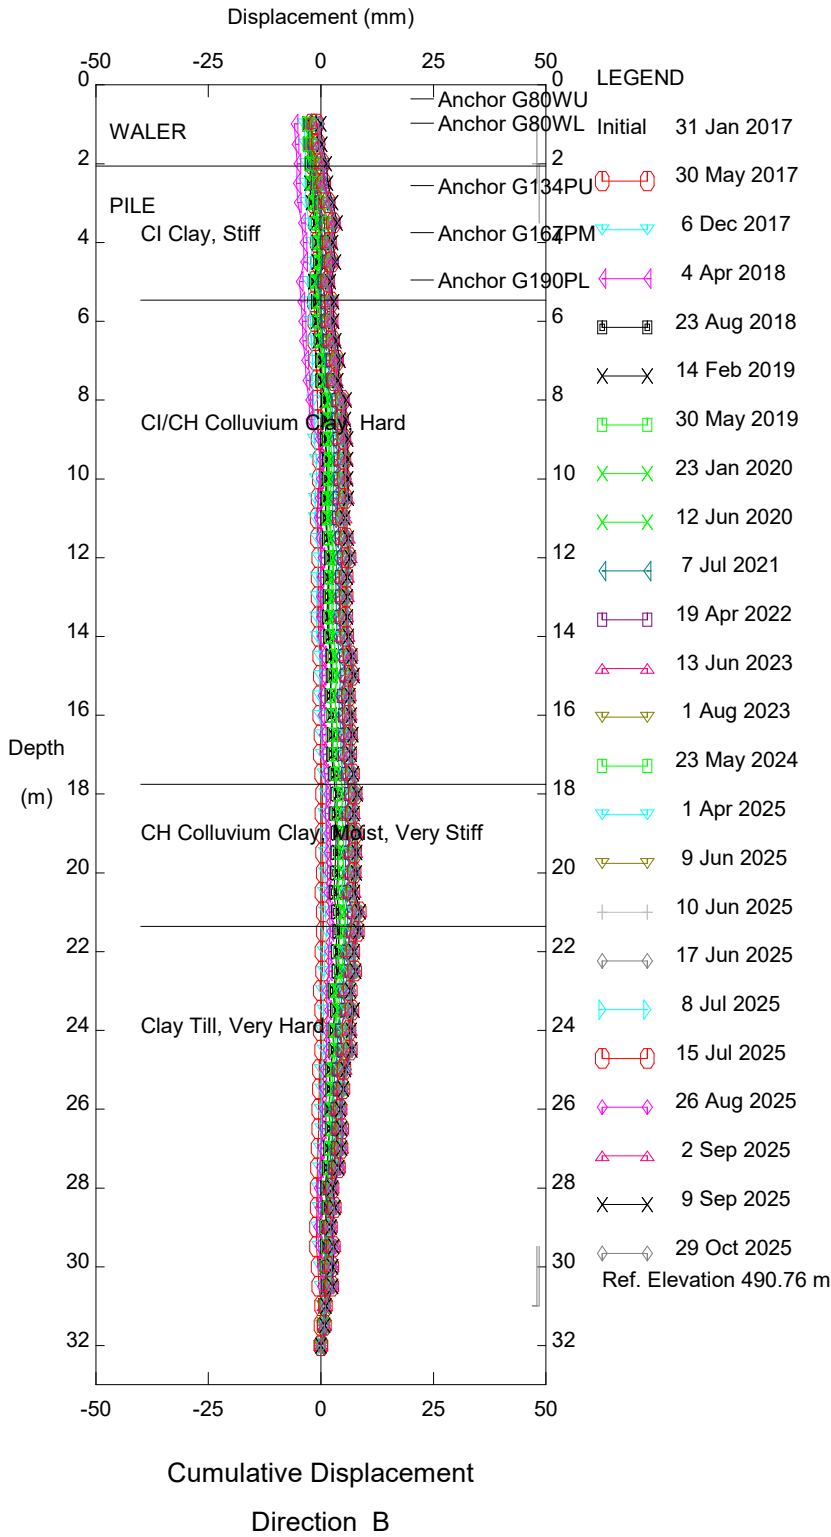
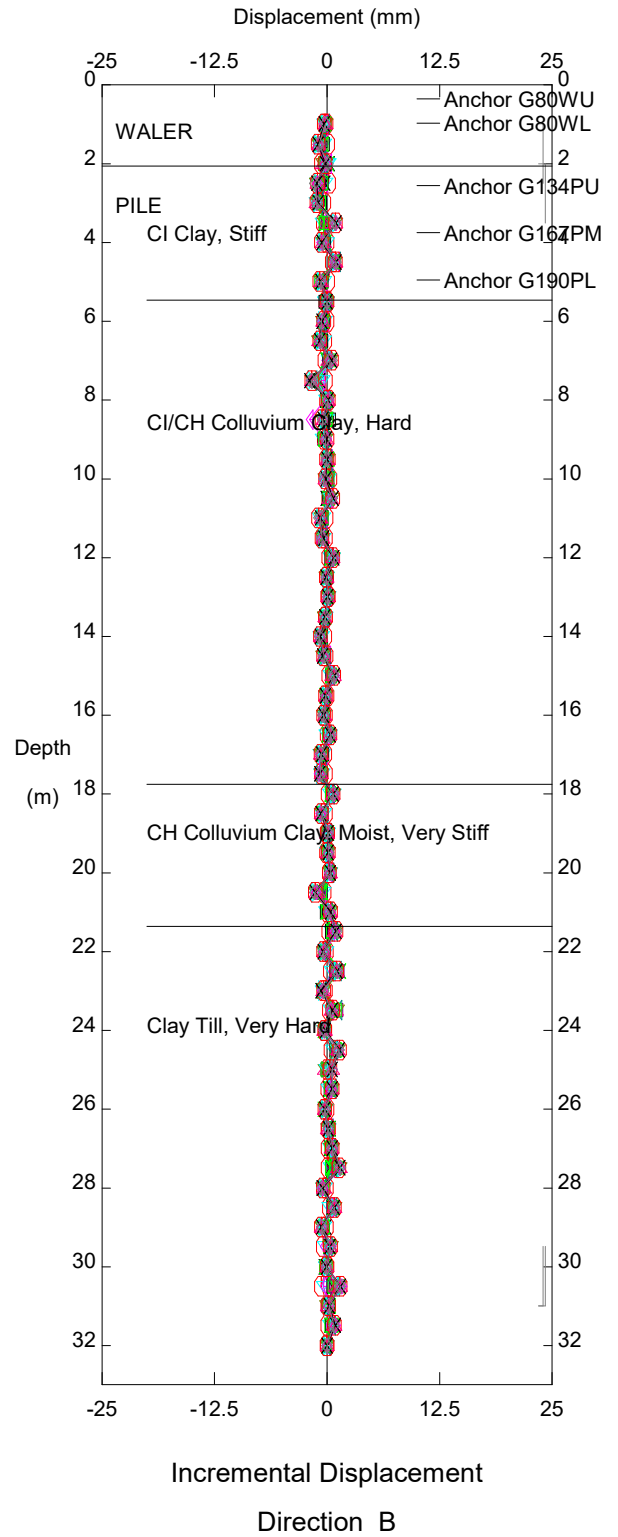
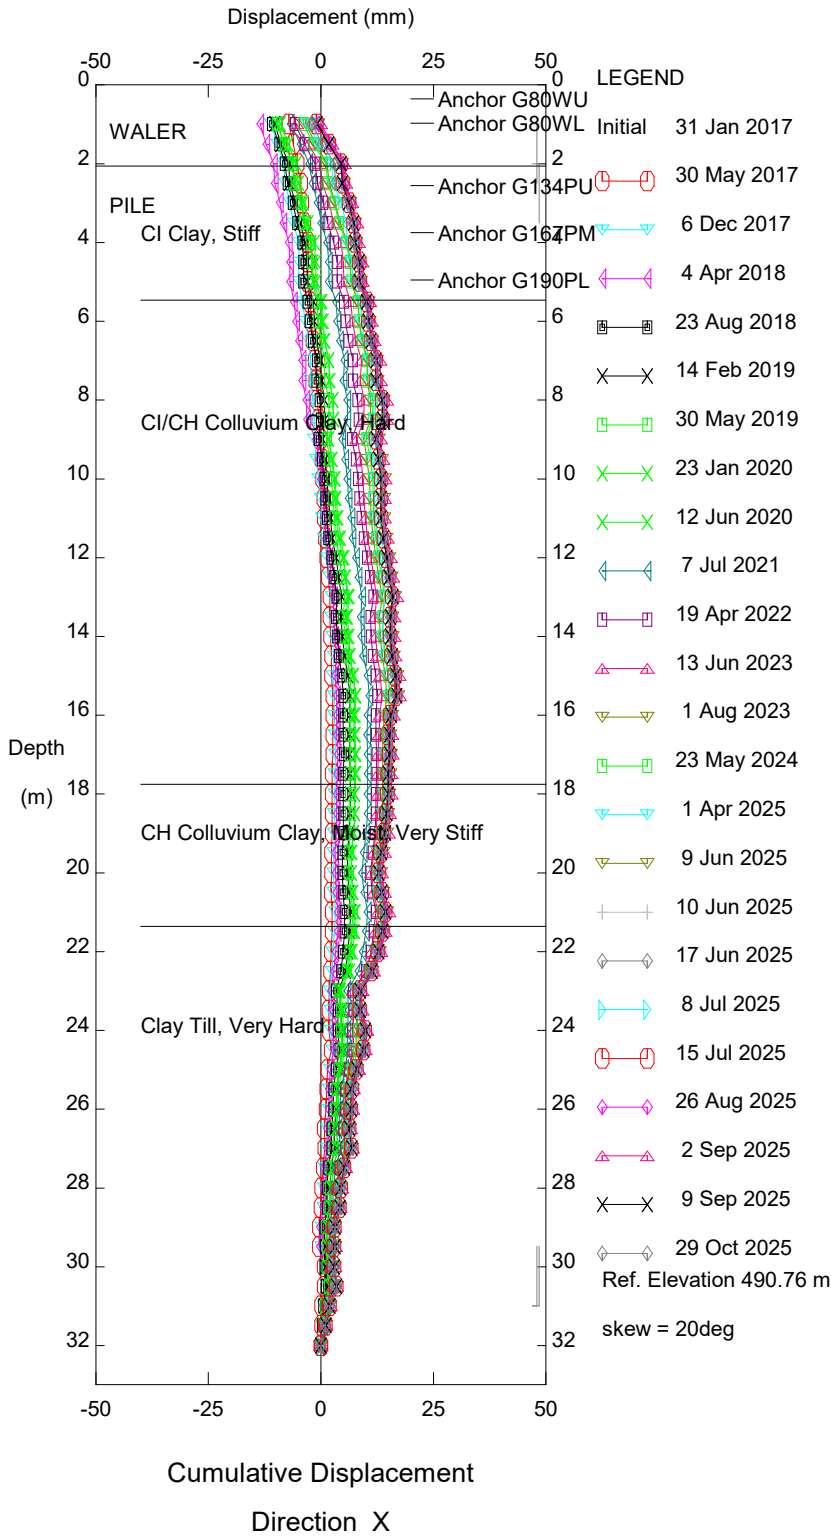
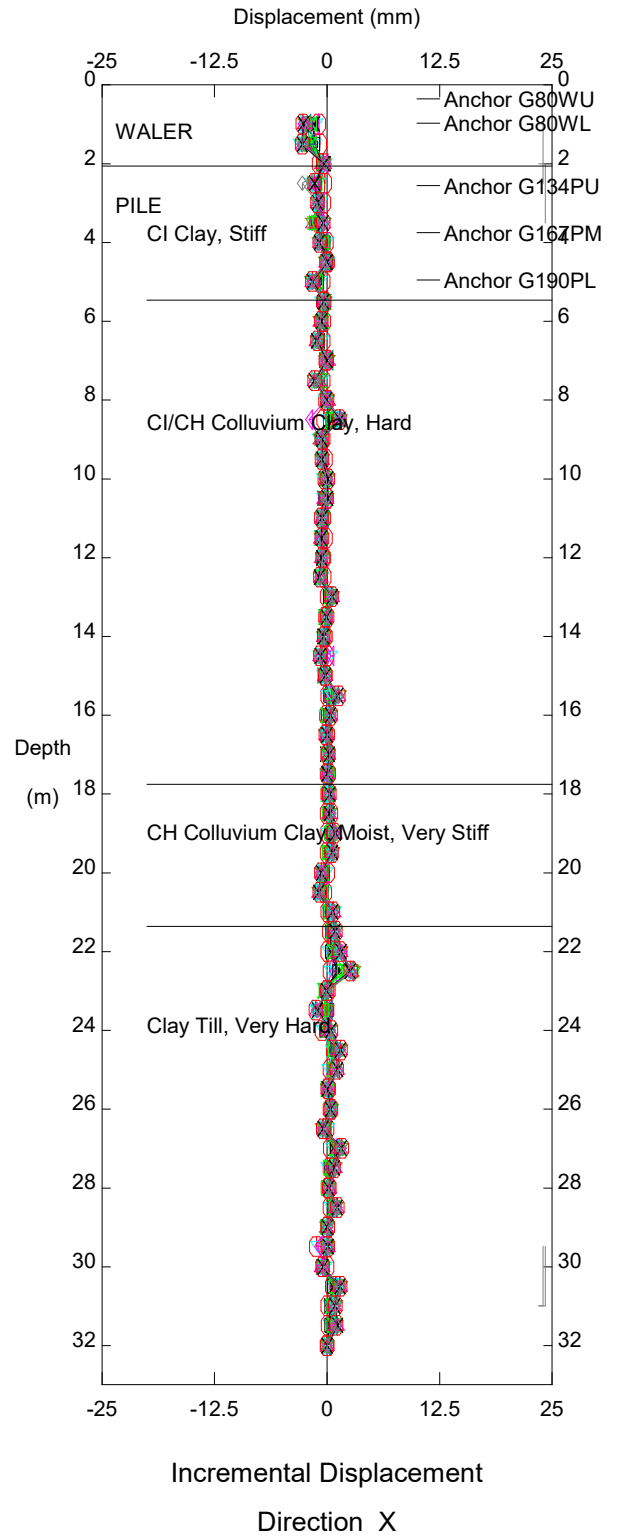
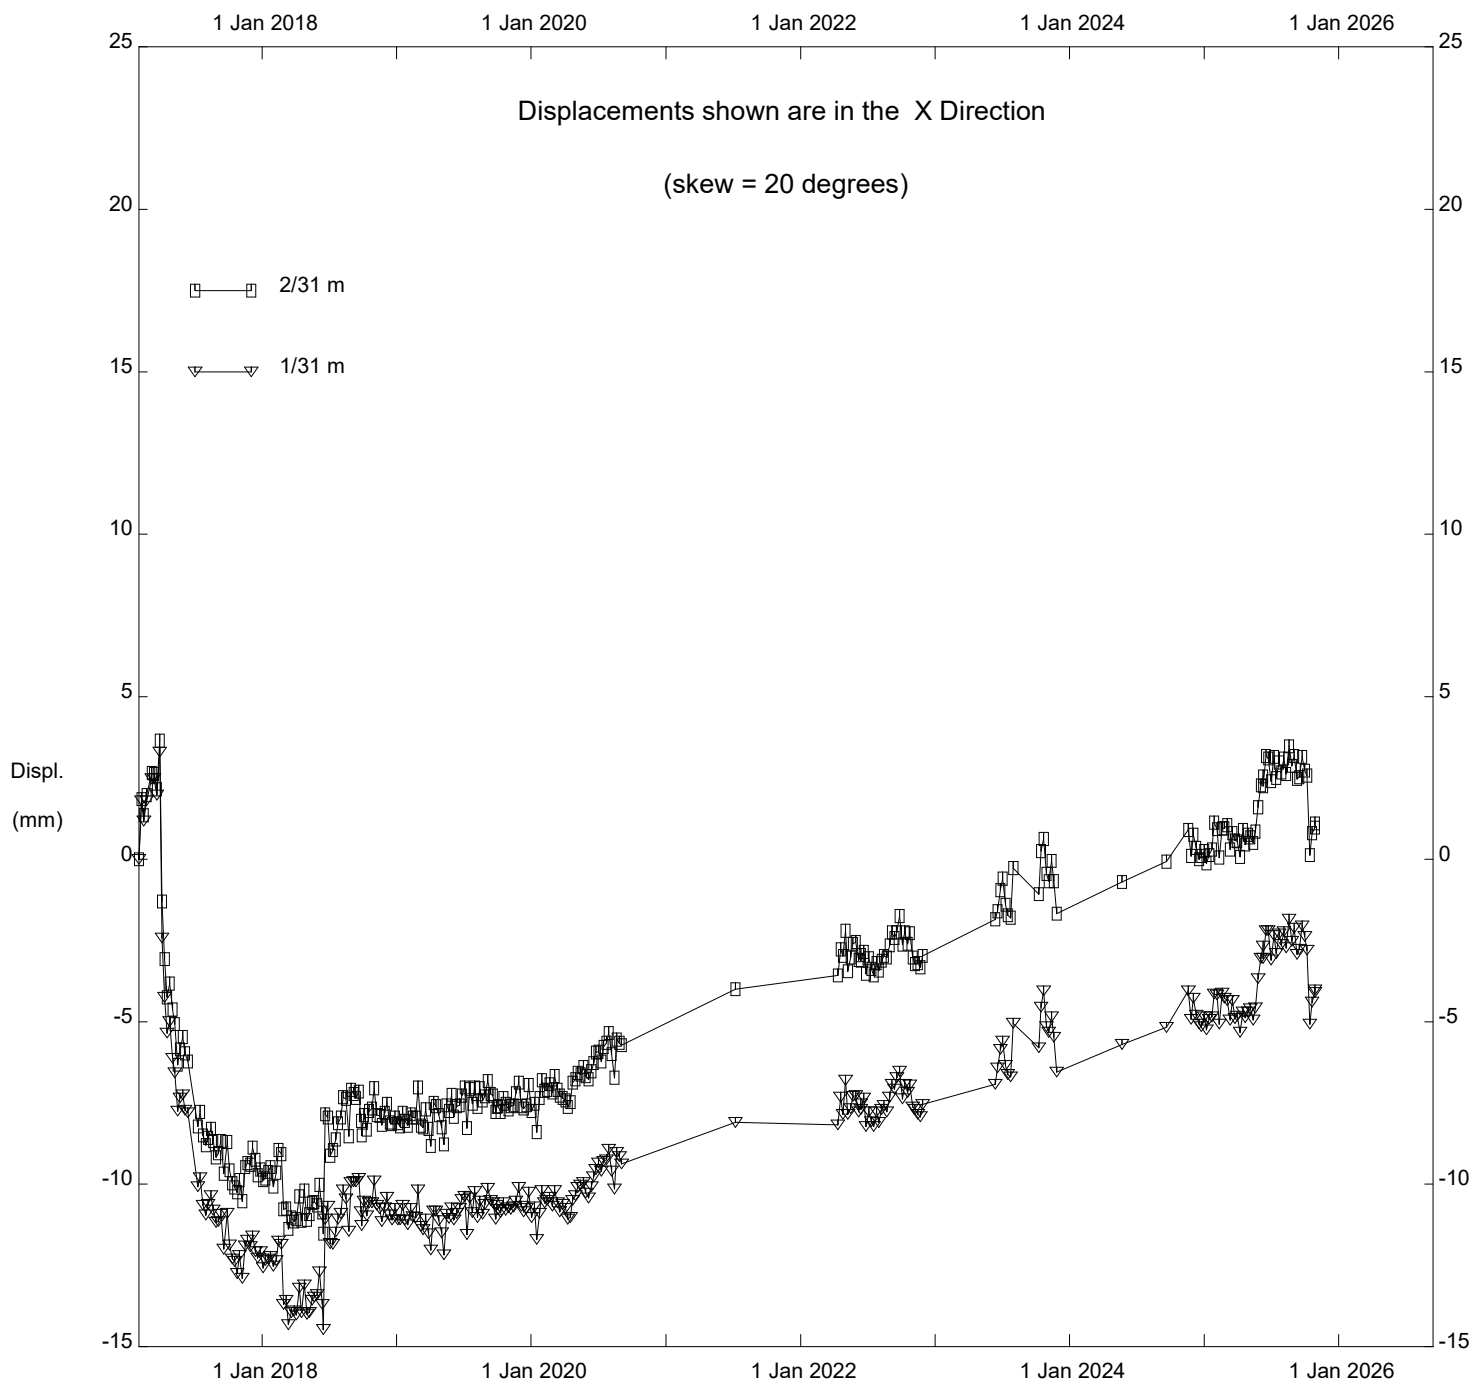
PH070 Hwy 2:60 East Hill, Inclinometer SAA-P74

SAA-P74, installed in pile P74, showed no discernible movement over the length of the pile and over the combined length of the pile and waler in the downslope direction since the spring of 2025 readings. SAA-P74 has shown a total cumulative pile head movement of 1.1 mm in the downslope direction and a total cumulative movement of 4.0 mm in the upslope direction over the combined length of the pile and waler.

| INSTRUMENT # | DATE INITIALIZED | TOTAL CUMULATIVE RESULTANT MOVEMENT AT NOTED DEPTH SINCE INITIAL READING (mm) | CURRENT STATUS | DATE OF PREVIOUS READING* | INCREMENTAL MOVEMENT SINCE PREVIOUS READING (mm) | AVERAGE RATE OF MOVEMENT SINCE PREVIOUS READING (mm/yr.) | CHANGE IN AVERAGE RATE OF MOVEMENT SINCE PREVIOUS READING (mm/yr.) |
|---|---|---|---|---|--|--|--|
| SAA-P74 | January 31, 2017 | 1.1 over 2.0 m to 31.0 m depth in 194° direction | Operational | June 9, 2025 | No Discernable Movement | N/A | -7.4 |
| | | -4.0 over 1.0 m to 31.0 m depth in 194° direction | | | No Discernable Movement | N/A | -6.9 |

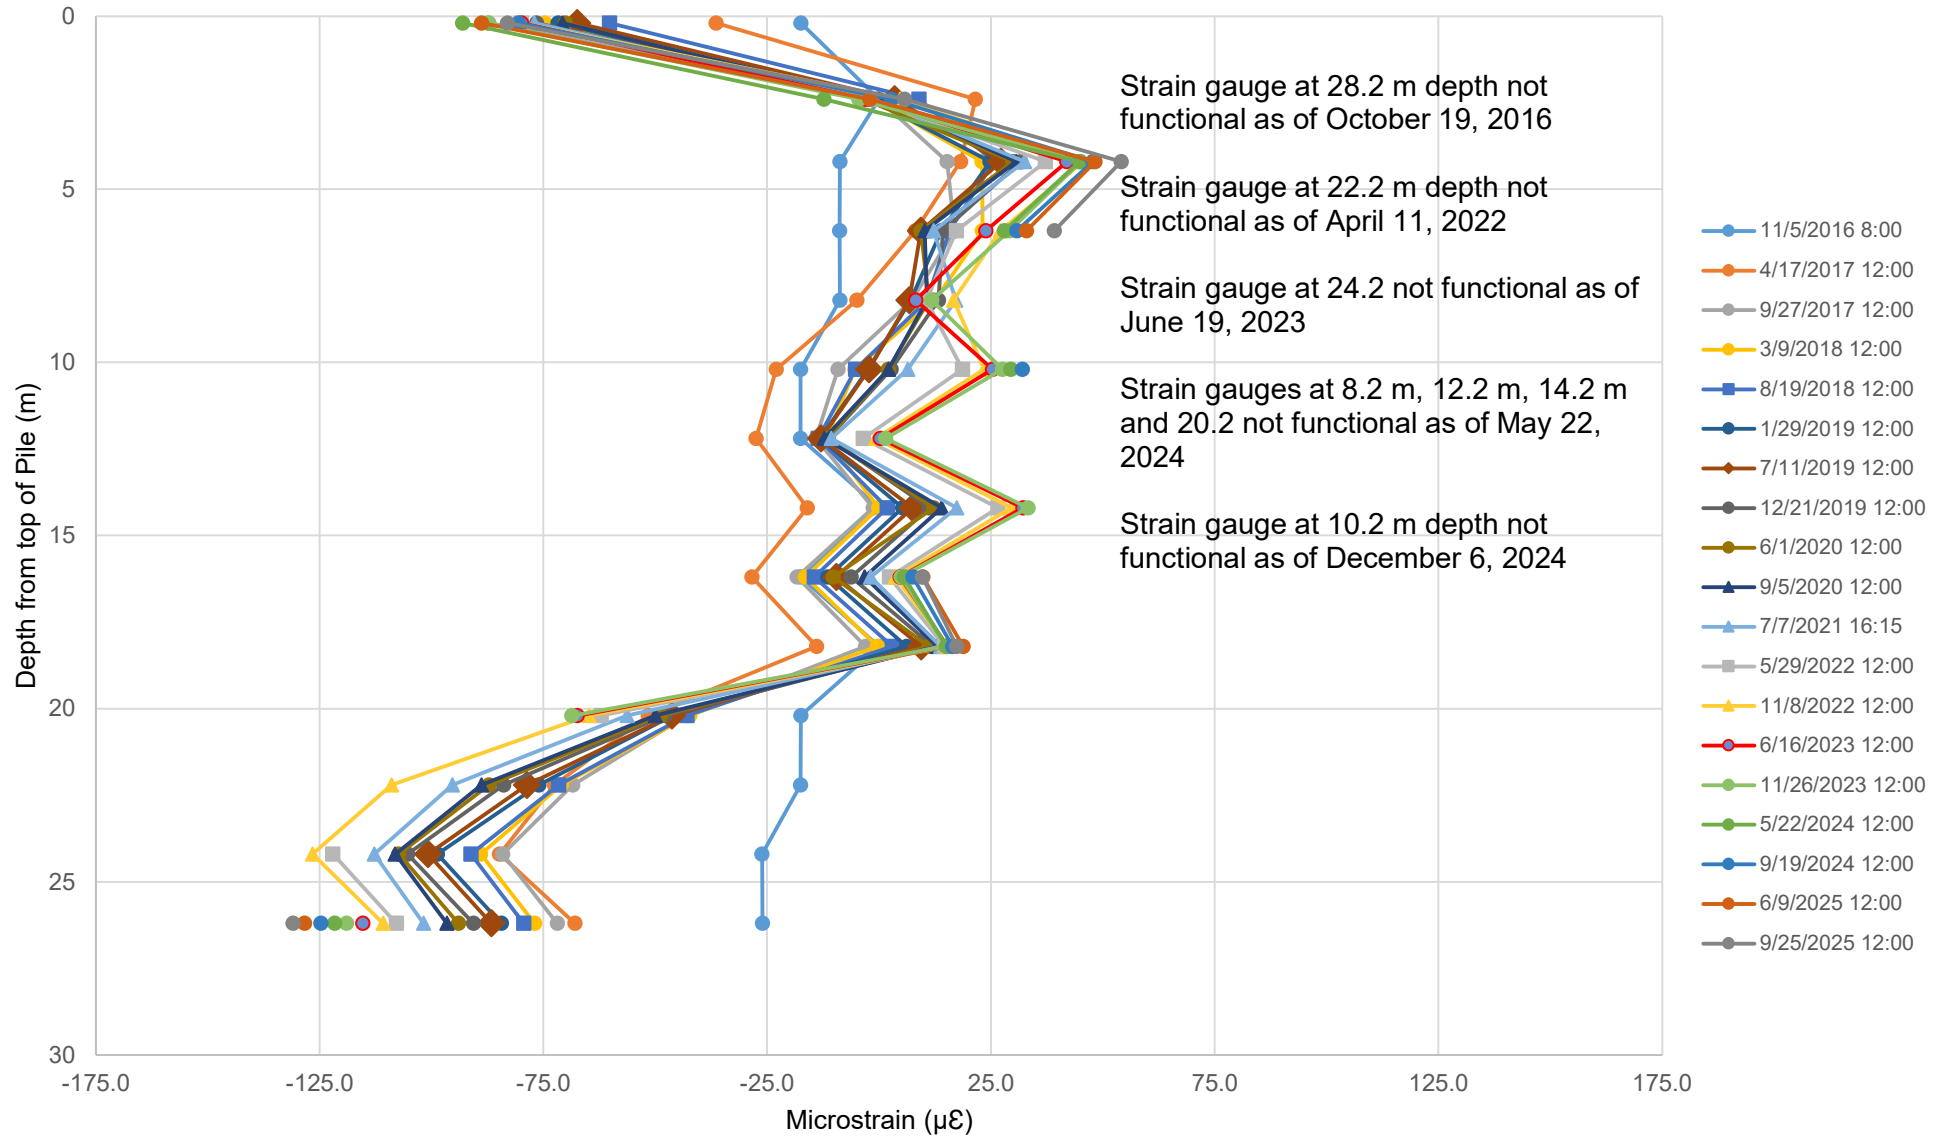
FIGURE PH070-1
HWY 2:60 PEACE RIVER EAST HILL RETAINING WALL SITE (km 33.84)
PILE P74 DOWNSLOPE SIDE STRAIN GAUGE VALUES VS DEPTH

The strain gauges generally showed small increases in negative (compressive) strain on the downslope pile face. On the downslope pile face, the strain gauges generally showed small decreases in negative (compressive) strain. Eight of the strain gauges on the downslope pile face were not functioning during the current readings which limited the assessment of strain trends. The maximum change in microstrain ($\mu\epsilon$) since the previous readings was 13.7 $\mu\epsilon$, measured at 2.4 m depth on the upslope pile face.

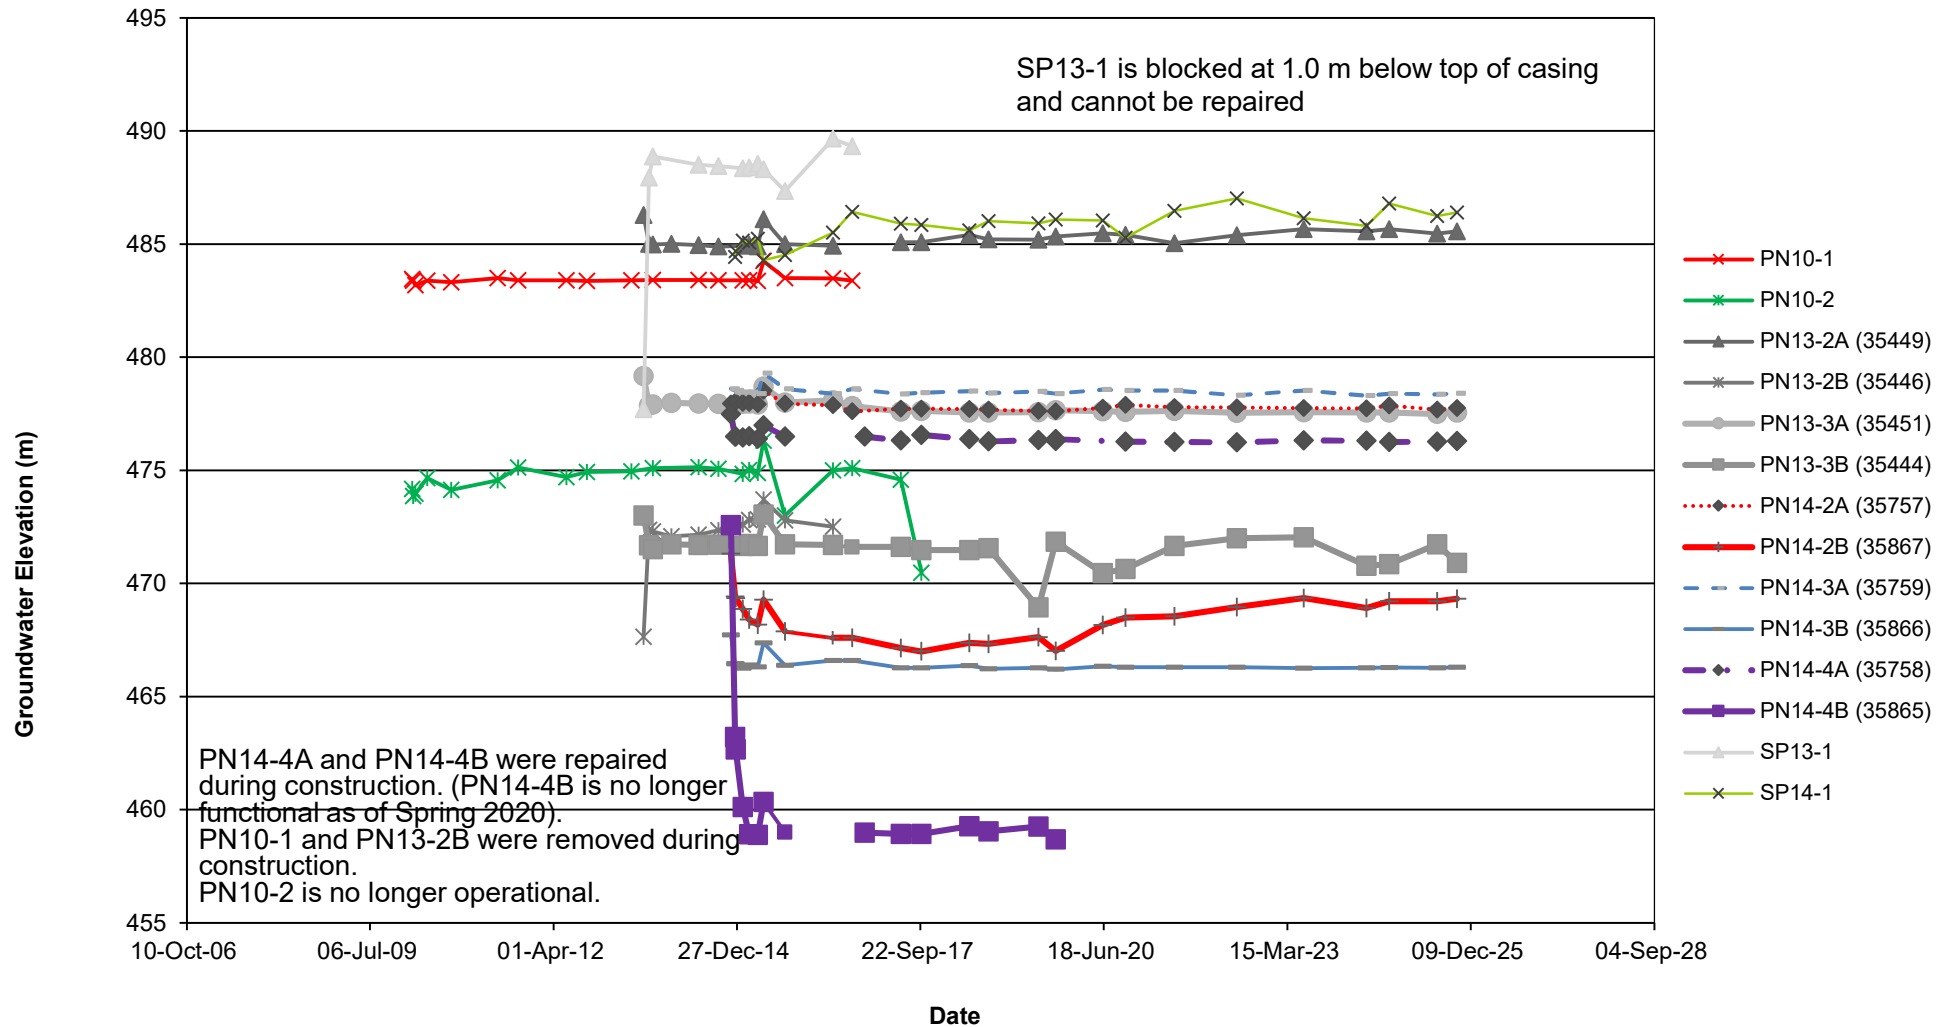
FIGURE PH070-3
HWY 2:60 PEACE RIVER EAST HILL RETAINING WALL SITE (km 33.84)
PIEZOMETRIC ELEVATIONS

Pneumatic piezometers PN13-2A, PN13-3A, PN14-2A, PN14-2B, PN14-3A, PN14-3B, and PN14-4A, showed increases in groundwater level of 0.10 m, 0.06 m, 0.07 m, 0.11 m, 0.04 m, 0.04 m, and 0.04 m, respectively, since the spring of 2025 readings. PN13-3B showed a decrease in groundwater level of 0.83 m since the spring of 2025 readings.

Standpipe piezometer SP14-1 showed an increase in groundwater level of 0.16 m since the spring of 2025 readings.

| | <p>Overall, the piezometers have shown relatively stable groundwater levels for the past several years. These groundwater levels are within historical maximums.</p> <p>LOAD CELLS</p> <p>Load cells G58WU, G80WU, G80WL, G150PU, and G202PL showed decreases in measured load of 1.64 kN, 1.88 kN, 2.59 kN, 0.85 kN, and 2.33 kN, respectively, since the spring of 2025 readings. Load cells G167PM and G190PL showed increases in measured load of 0.02 kN and 2.81 kN, respectively, since the spring of 2025 readings. Load cells G39WL, G40WU, G59WL, G102WU, G102WL, G118PU, G134PU, G182PL, and G188PL could not measure any loads since March to May 2025.</p> <p>It should be noted that channels on the load cell datalogger were functioning inconsistently since December 6, 2024, and only certain time stamps contained useable readings. The reported values represent the most recent functional date for each individual load cell.</p> <p>Wall Section 2: Anchors G39WL and G40WU both show a trend of gradually increasing load and are about 10 kN are above their respective SLS design loads.</p> <p>Wall Section 3A and 3B: Anchor G58WU shows a trend of gradually increasing load and is about 17 kN above the SLS design load. Anchor G150PU did not shown a significant change in load since about 2017 and is below SLS design load. Anchors G59WL, G118PU, G102WU, and G102WL did not register load measurements since the previous reading in March 2025, which were all below the SLS design loads.</p> <p>Wall Section 4: Anchors G167PM and G190PL show a trend of small load increases over time. The loads on these anchors are well below SLS levels. Based on the May 2025 readings the load on G134PU is also well below the design SLS loads Anchor G134PU did not register a load measurement since the previous reading in May 2025, Anchor G80WL shows a relatively stable load and is currently about its SLS design load.</p> <p>Anchors G182PL, G188PL and G202PL were installed as 'stiff anchors' that were left with some slack to allow the piles to deform before the anchors pick up load. Anchor G202PL indicates current load of from 10.04 kN and has not shown significant change in the load since the end of construction. The low load levels at these three anchors suggests that there may still be some slack at the nut in these anchors. Anchors G182PL and G188PL did not register load measurements since the previous reading in March 2025.</p> <p>The load cells on G80WU and G80WL are showing loads that are 57.46 kN and 25.08 kN above SLS design load, respectively. However, these anchors were intentionally locked off at a higher load than the SLS load and the loads have changed very little since they were locked off.</p> |
