ALBERTA TRANSPORTATION AND
ECONOMIC CORRIDORS
GEOHAZARD ASSESSMENT PROGRAM
PEACE REGION (PEACE RIVER DISTRICT)
2025 INSPECTION

Site Number	Location	Name	Hwy	km
PH070	East Hill 33+850 to 34+050	East Hill – Retaining Wall Site	2:60	33.84
Legal Description		UTM Co-ordinates (NAD 83)		
SW27-083-21 W5M		11V E 485363	N 6230677

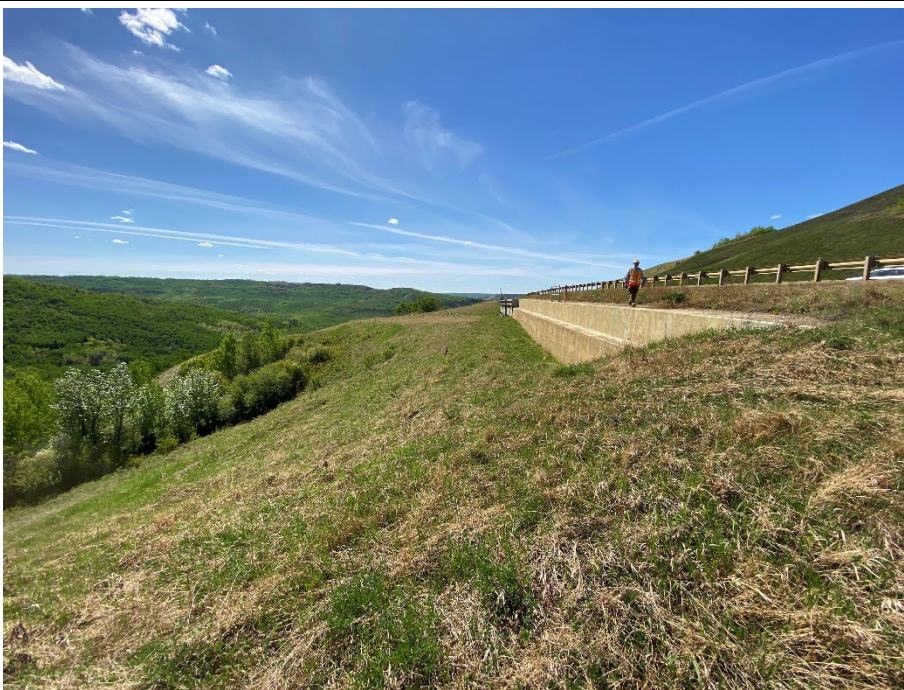
Photo 70-01.
Looking west at concrete pile retaining wall at 33+850. No major visible changes downslope from the wall since 2024.

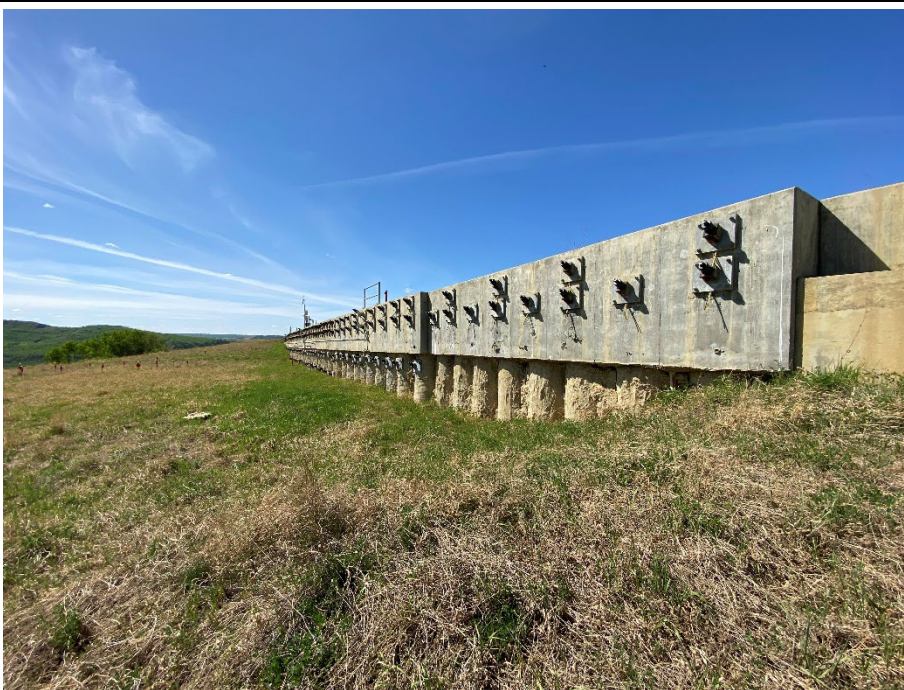
Photo 70-02.
Looking west from the east end of the 2017 concrete pile retaining wall near 33+875.

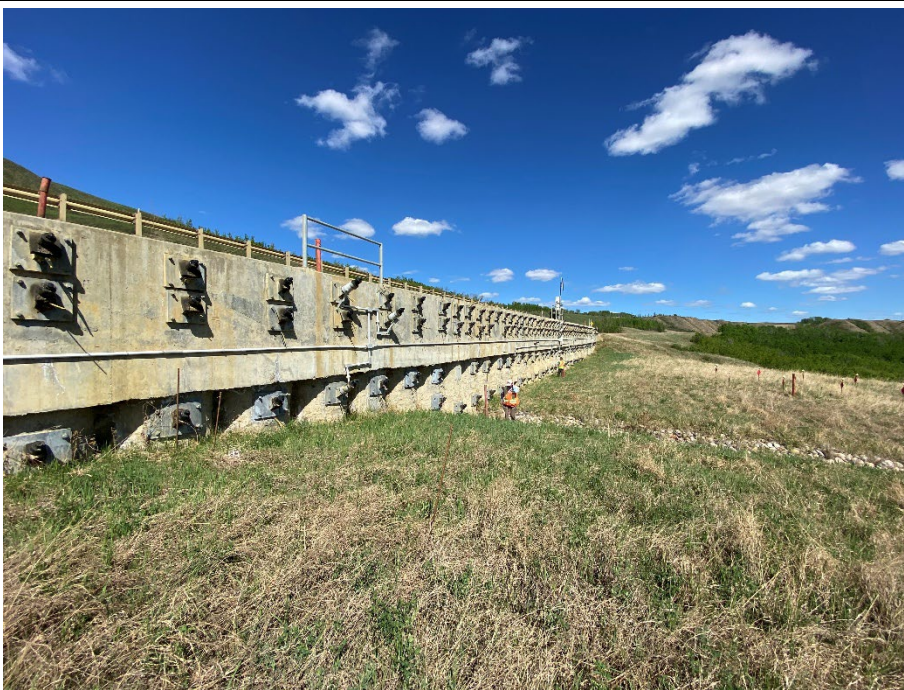
Photo 70-03.
Looking east near the centre of the retaining wall with Class 1 riprap swale located near 33+950. East flank of the 2016 slide is visible in the background. SI13-3 is visible on the right side of the photo. No major changes were visible on the bench below the wall since 2024.

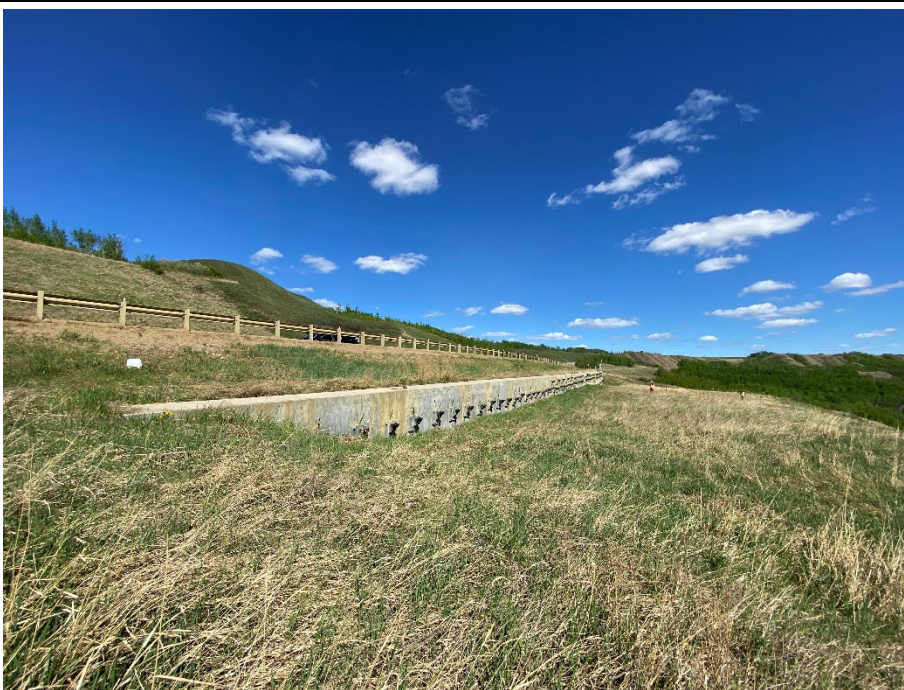
Photo 70-04.
View east from the west end of the 2017 pile wall (34+000) on the downslope side. Similar appearance to the 2024 conditions.

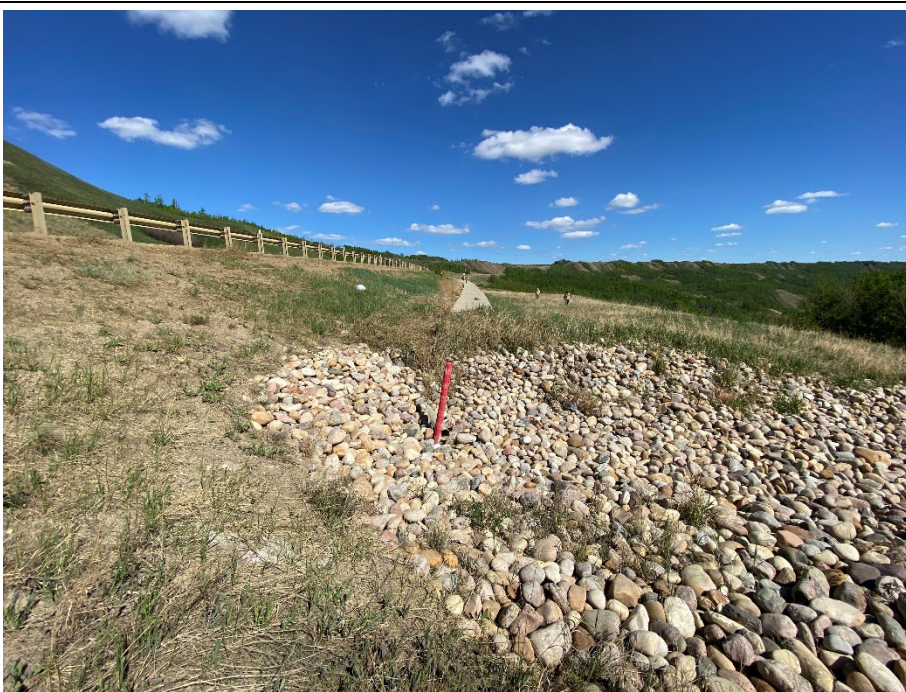
Photo 70-05.

<input type="checkbox"/> Seepage		<input type="checkbox"/>	<input type="checkbox"/>
<input type="checkbox"/> Bridge/Culvert		<input type="checkbox"/>	<input type="checkbox"/>
<input checked="" type="checkbox"/> Other	Drain trough along top of wall was open with minor sediment and debris buildup. Drainage outlet armouring (34+000) was functioning as intended with no visible changes from the 2024 condition. (Photo 70-05)	<input type="checkbox"/>	<input checked="" type="checkbox"/>

View east from west end of pile wall (km 34+015) at armoured drainage outlet for the drain trough along top of wall. Trough drain was open and working as intended with some minor debris and sediment buildup. Overall, no major changes from the 2024 condition.

- The erosion downstream of the drainage outlets should be monitored by regular visual inspection and if the condition significantly worsens, consideration should be given to extending the rock armoring or installing a drainpipe to prevent gully retrogression towards the road and potentially exacerbating landslide movement west of the tied-back pile wall.
- The drain trough along top of pile wall should be cleaned of sediment and debris every Spring.

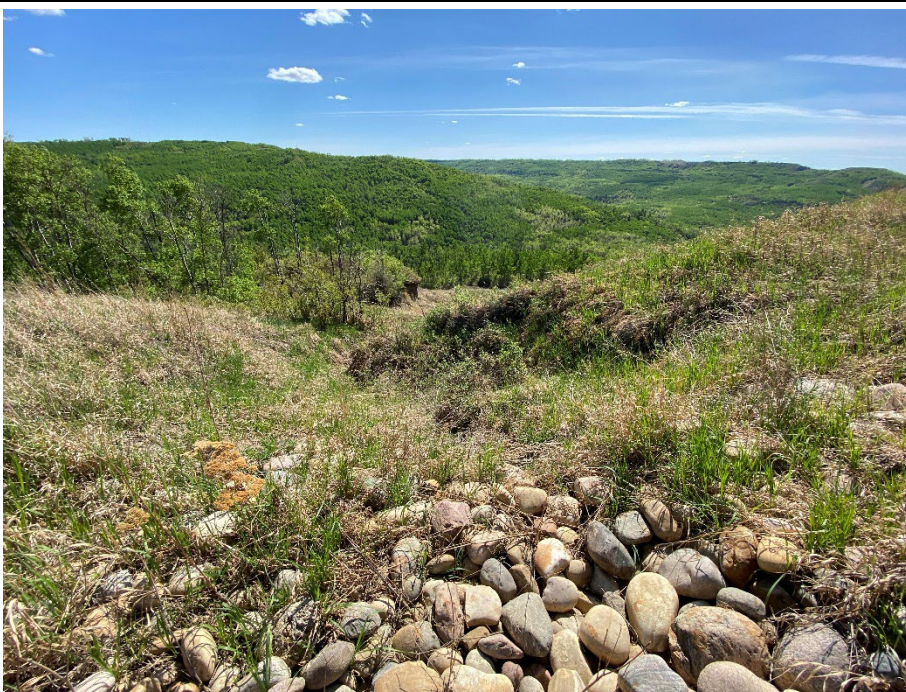
Photo 70-06.

<input checked="" type="checkbox"/> Erosion	<p>Erosion gully at the end of the armored drainage outlet area at the west end of the pile wall was slightly worse but gully sidewalls were well vegetated. (Photo 70-06)</p> <p>No major change to the erosion in the north ditch between 34+000 and 34+100 relative to the 2024 condition.</p>	<input checked="" type="checkbox"/>	<input type="checkbox"/>

Looking south at the top of the erosion gully at the downstream end of the armoured drainage outlet (34+015). Slightly worse but gully sidewalls had good grass growth.

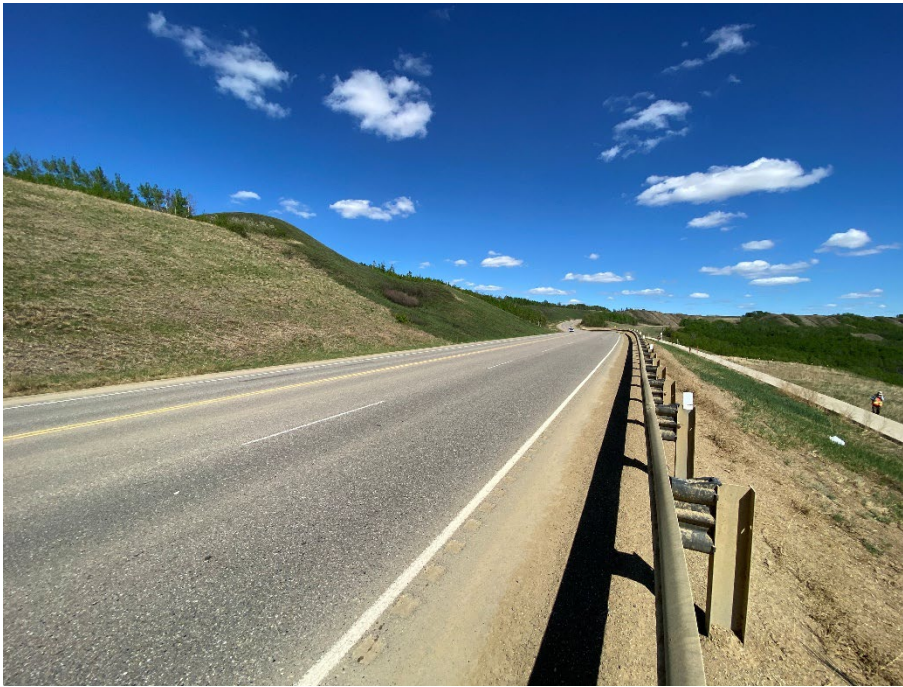
Photo 70-07.
View along highway looking east above pile wall. No pavement disturbance was visible since the Fall 2022 repaving.

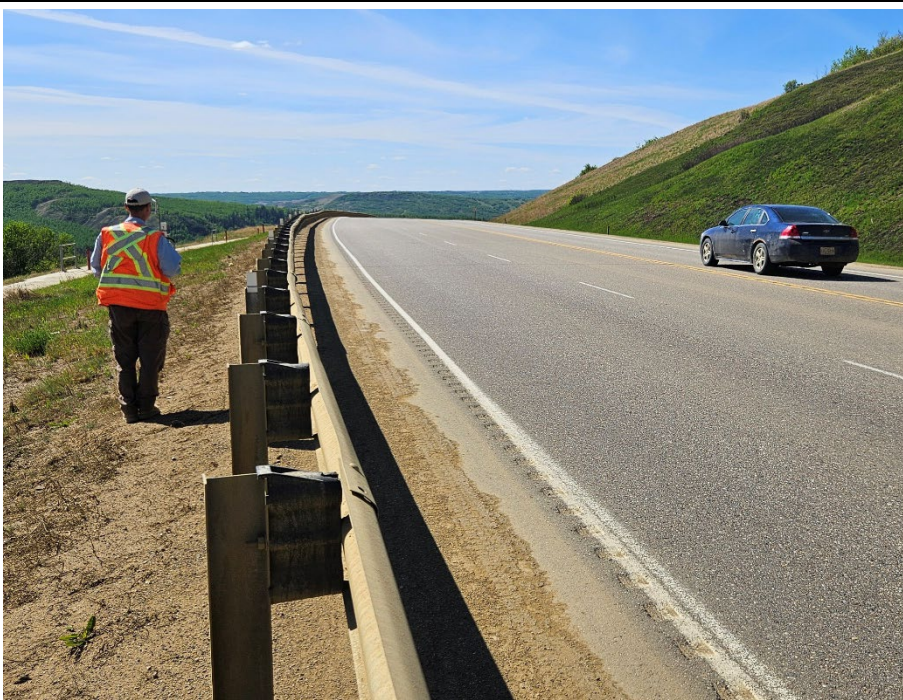
Photo 70-08.
Looking west along highway above pile wall. Visible dip in guardrail (near 33+900) suspected from install and likely not related to slide related settlement that occurred prior to the pile wall. No cracking or other slide related distress was visible in pavement along previous damage extents since the highway was repaved in 2022.

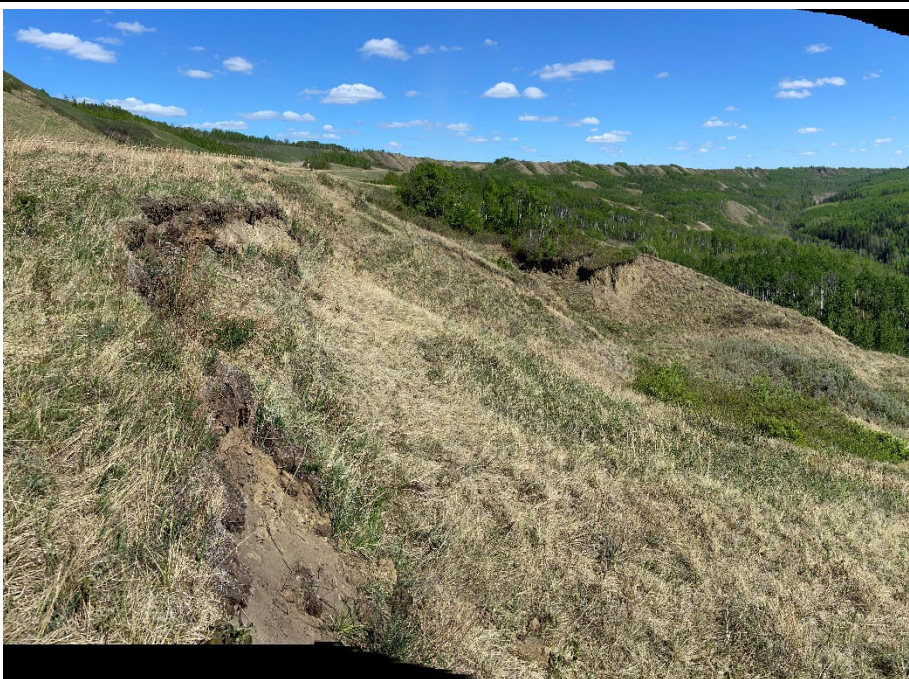
Observations:	Description:	Worsened?	
		Yes	No
<input checked="" type="checkbox"/> Pavement	<p>Minor dip in guardrail and NBL along previously observed extents behind wall in eastbound lane near 33+900 was unchanged from the 2024 condition. Dip at guardrail is suspected to be the installed condition and not due to slide related settlement. Overall pavement section upslope from the wall was in good condition with no distress noted along previous damage extents since being repaved in Fall 2022. (Photos 70-07 and 70-08)</p>	<input type="checkbox"/>	<input checked="" type="checkbox"/>
<input checked="" type="checkbox"/> Slope Movement	<p>The fill slope below the wall and area of previously observed movement has been regraded as part of the pile wall installation work. At the east end of the wall a previously identified scarp/tension crack developing along the extents of the east flank of the previous slide had slightly more visible dropdown (0.4 m) from the 2024 condition. (Photos 70-01 and 70-02)</p> <p>No other visual indicators of slide disturbance were observed downslope of the pile wall. Piles at the west side of the wall that were marked in 2024 with pink paint along the base to monitor future soil drop and had no change. (Photos 70-01 to 70-04)</p> <p>Active slide area developing west and downslope of the pile wall at 34+050 has expanded with more dropdown at the scarp (up to 1.6 m) and extended tension cracks. New tension cracks were forming 0.3 to 1.0 m upslope from the main scarp and further to the southwest. Width of the main slide scarp is now approximately 115 m and has a minimum offset approximately 15 m from the highway at the east end (Photos 70-09 and 70-10)</p>	<input checked="" type="checkbox"/>	<input type="checkbox"/>

The slide developing west of the tied-back wall has developed a very apparent scarp and is expected to considerably worsen over the next 5 years. Due to its current offset from the highway (approximately 15 m at the east end) it is not expected to have an immediate impact to the NBL; however, future retrogression could cause instability that reaches the road shoulder or further if left unmitigated. The progression of this slide area relative to any changes in the rate of creep movements below the west portion of the wall should be made following each annual inspection to determine if the two are related to a single larger slide movement (note two monitoring stakes were installed above the scarp in 2023 with locations marked on Figure PH070-1). Drainage into the disturbed slide terrain below this area is expected to be a factor as the slope loses toe support. Expansion and retrogression of the erosion gully forming downslope from the armored outlet for the pile wall drain trough could cause further destabilization at the east flank of the new slide due to soil loss.

Photo 70-10.
Looking east at main scarp expansion west of the pile wall near 34+100 with increased movement since 2024. Dropdown of the scarp in this area was up to 1.5 m in height. Increased dropdown and lateral expansion along previously observed tension cracks. Minor retrogression towards the highway was measured at the survey stakes. Lower slide terrain has ongoing movement but no major visible changes.

- An investigation program should be considered for the slide at 34+050 if movement rates continue at the observed rates over the last several years. This would likely involve accessing the relatively flat bench between the current scarp and guardrail with tracked drill equipment from the highway approximately 250 m west (end of guardrail section) and drilling two test holes with slope inclinometers. This would allow monitoring for a potential slide surface undermining the highway and provide design input for future remediation if required. Proposed test hole locations have been shown on Figure PH70-1. (\$100k - \$150k)
