Site Number	Location	Name	Hwy	km
PH070	HWY 2:60 C1 33.840	East Hill Retaining Wall Site	2:60	Km 33.84
Legal Description: 4-27-83-21 W5		UTM Co-ordinates		
		11U E 485285	N	6230649

Current Monitoring:	9-June-2025	Previous Monitoring	20-Sep-2024
Instruments Read By:	Mr. Niraj Regmi, G.I.T and Mr. Godfred Etiendem, of Thurber

**ALBERTA TRANSPORTATION AND ECONOMIC CORRIDORS GRMP (CON0022164)
PEACE REGION (PEACE RIVER DISTRICT)
INSTRUMENTATION MONITORING RESULTS**

SPRING 2025

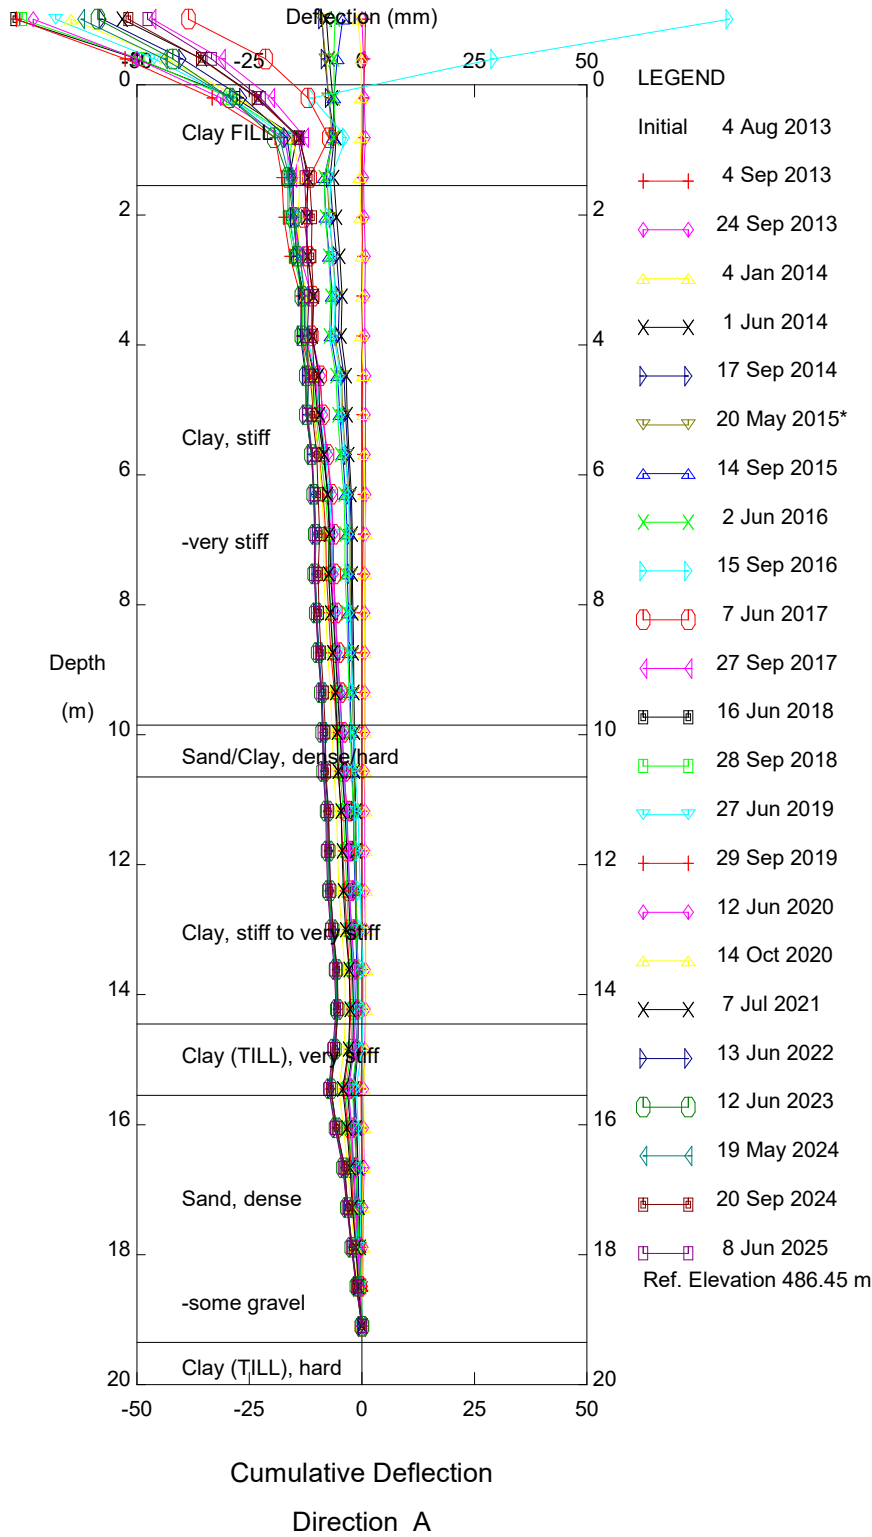
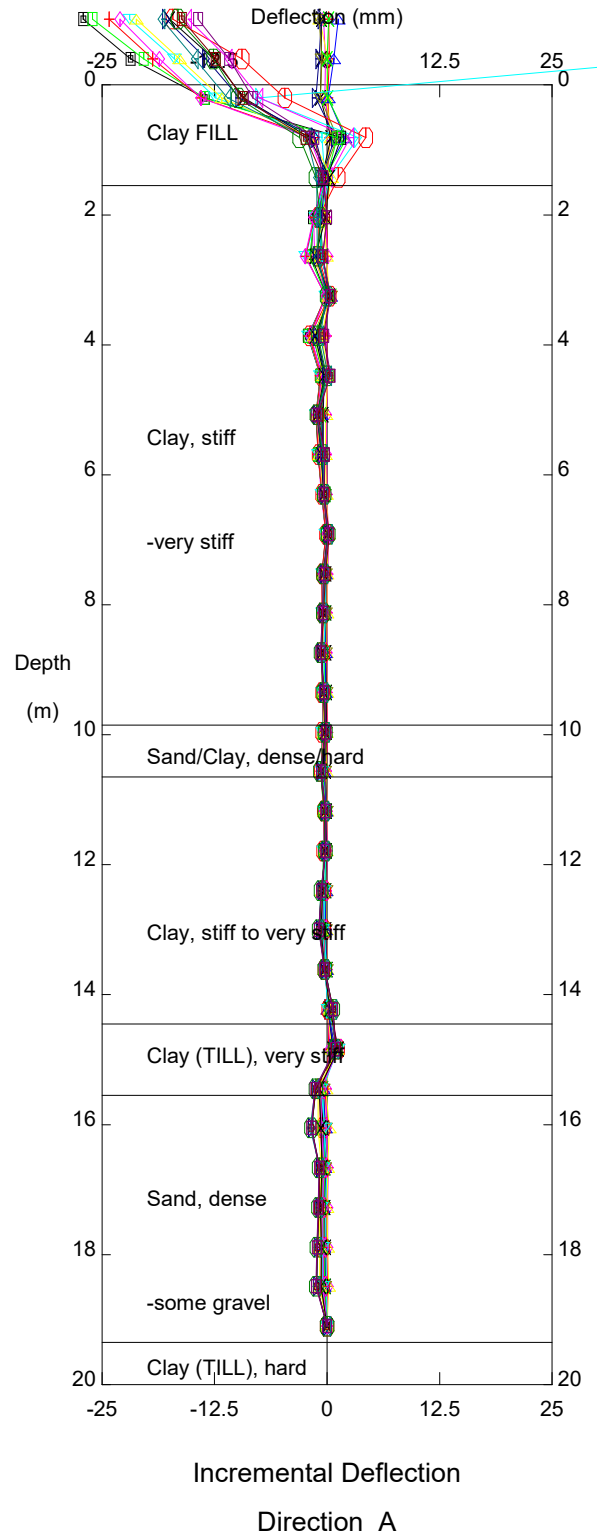
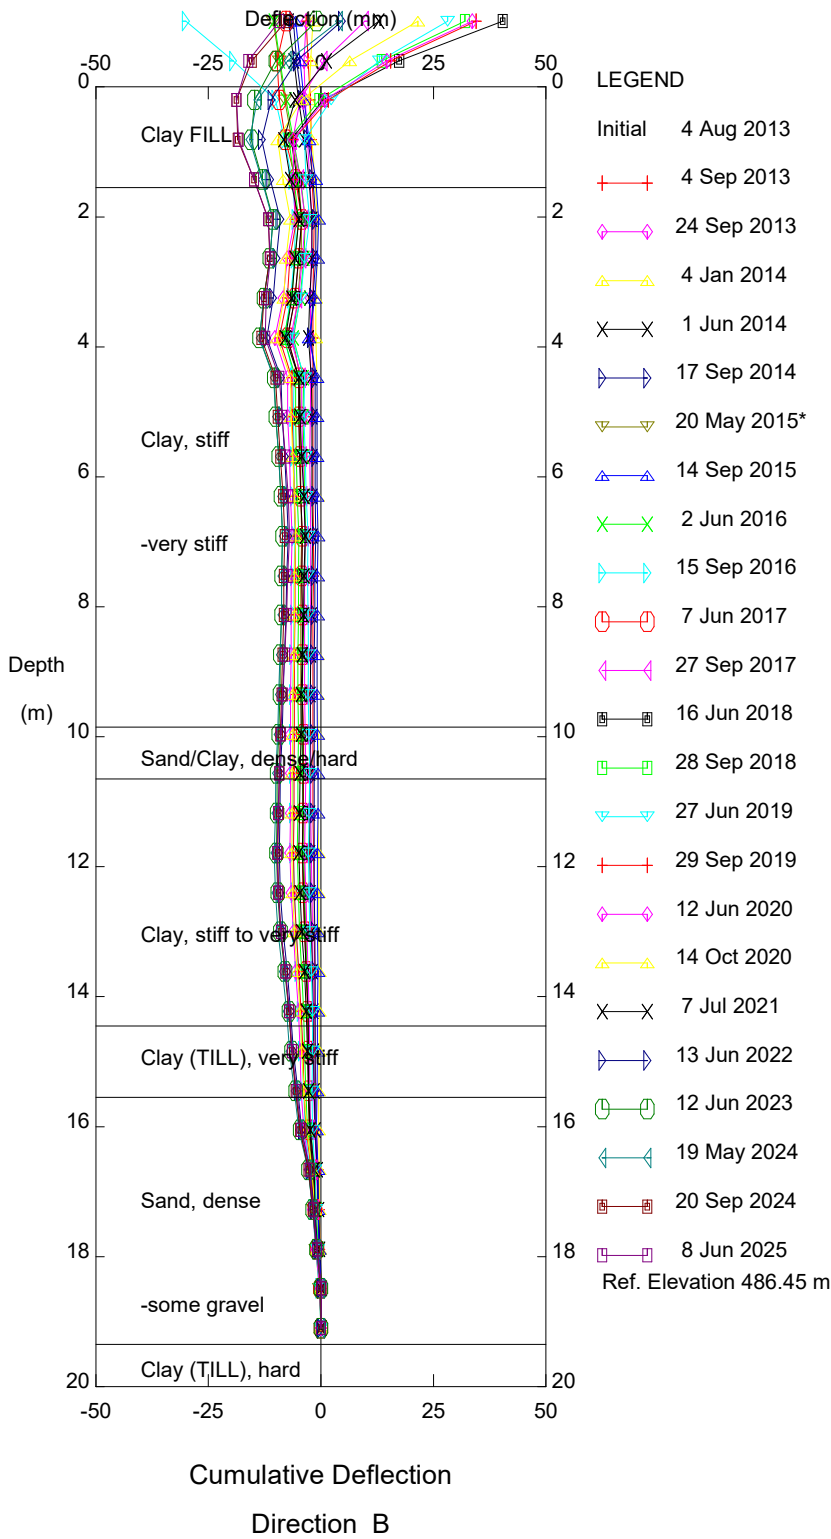
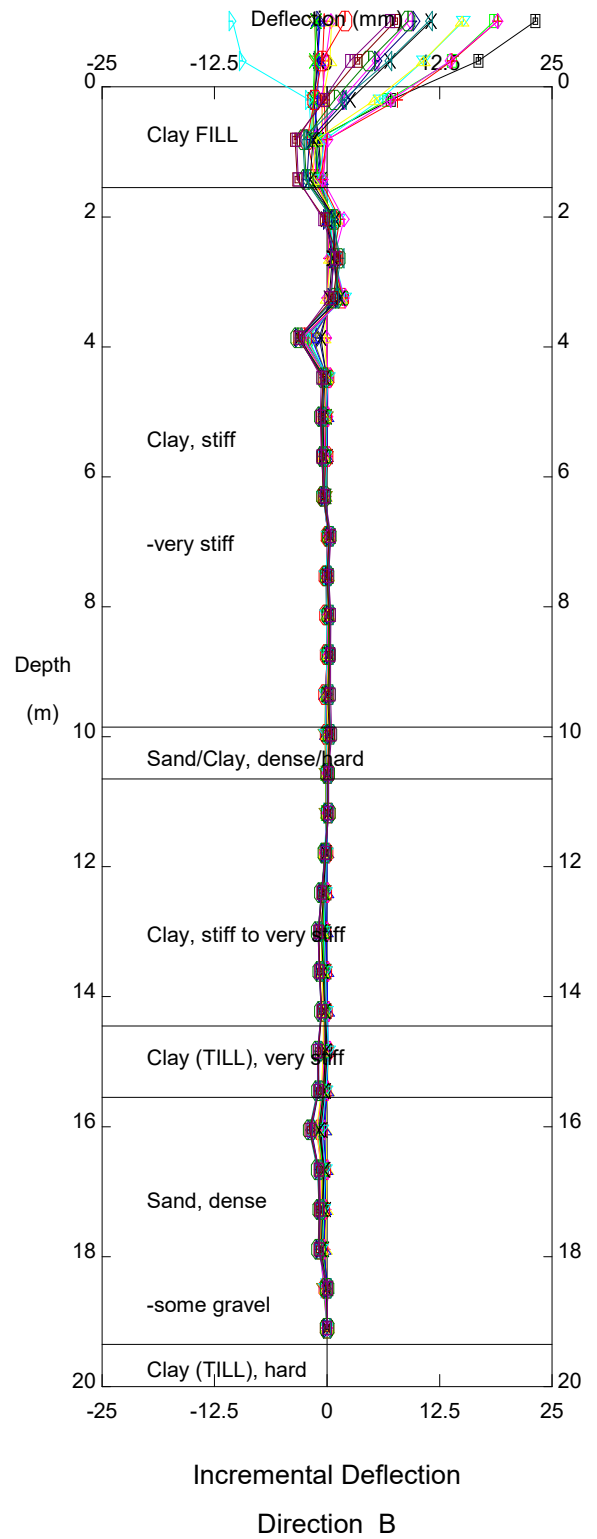
Peace River East Hill PH070, Inclinator SI13-3

Discussion	
Zones of New Movement:	None
Interpretation of Monitoring Results:	SLOPE INDICATORS AND SAA SI13-3, located downslope of the new pile wall, continued to show no discernible movement. Based on the instrument readings and on-site observations, SI13-3 is not installed deep enough to intercept the shear surface of the landslide. Slope inclinometer SI14-2, located upslope of the new pile wall, showed a rate of movement of 0.7 mm/yr over 2.8 m to 5.8 m depth, a rate of movement of 0.4 mm/yr over 17.4 m to 21.0 m depth and a rate of movement of 0.5 mm/yr over 24.7 m to 27.1 m depth since the fall of 2024 readings. These movement rates

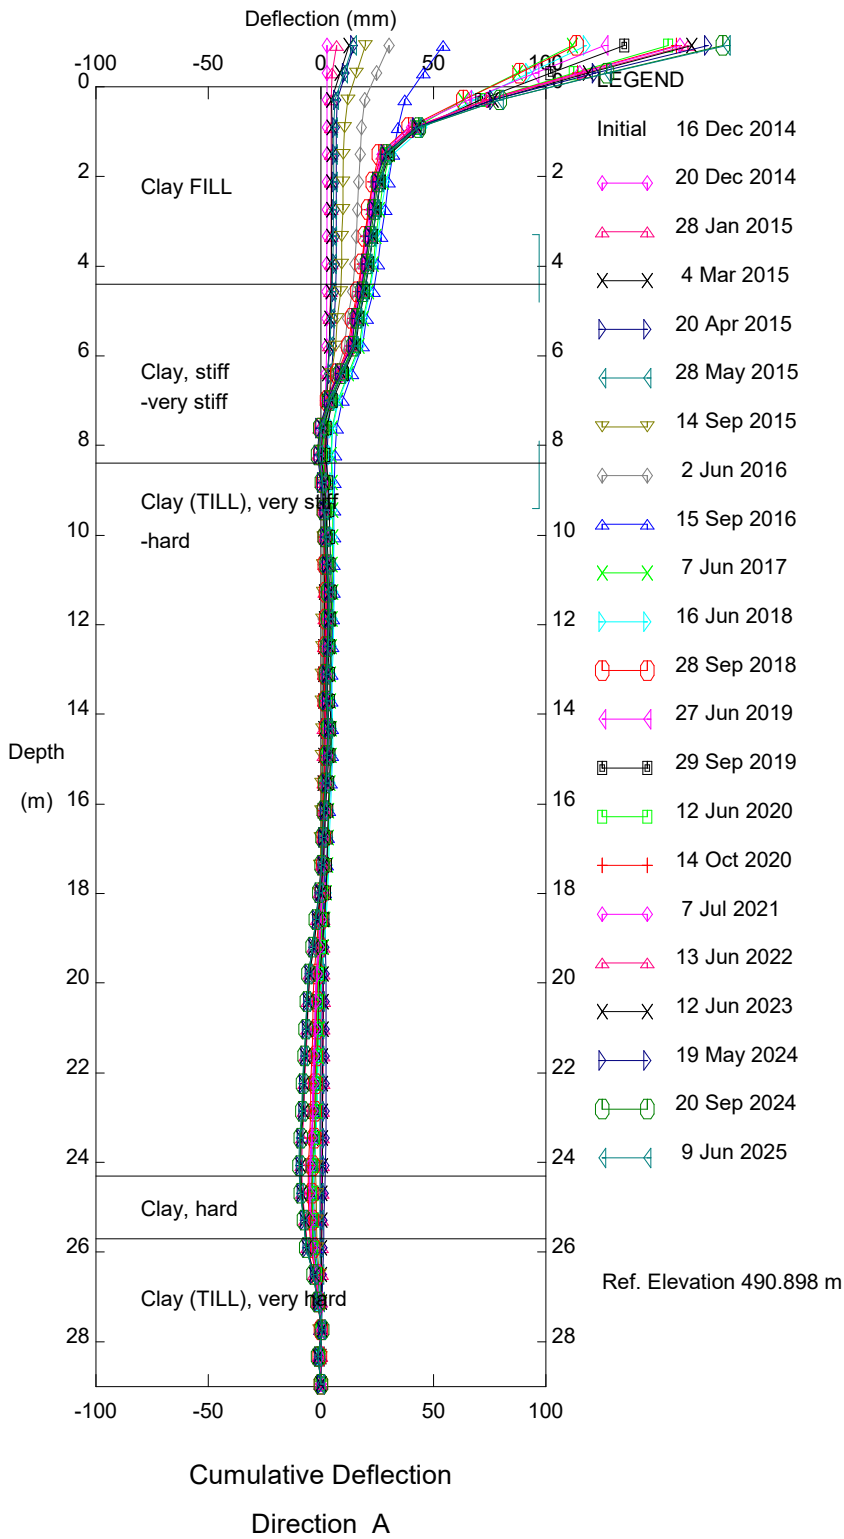
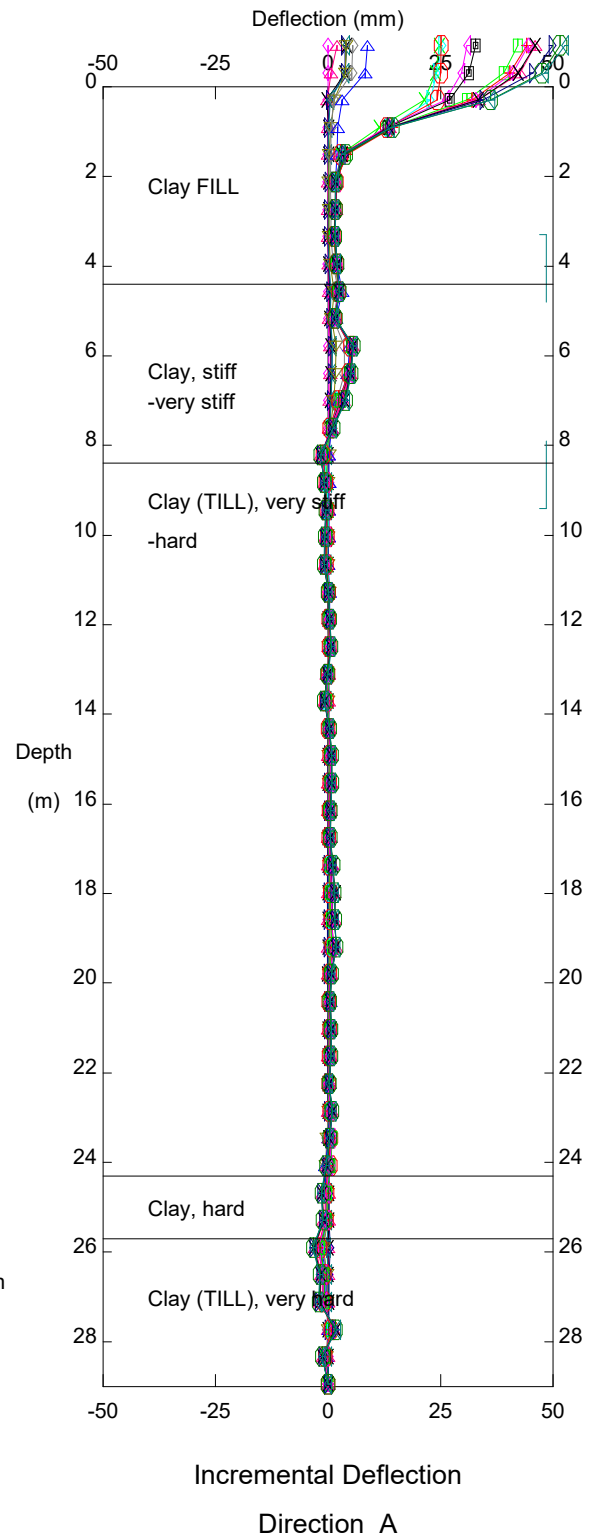
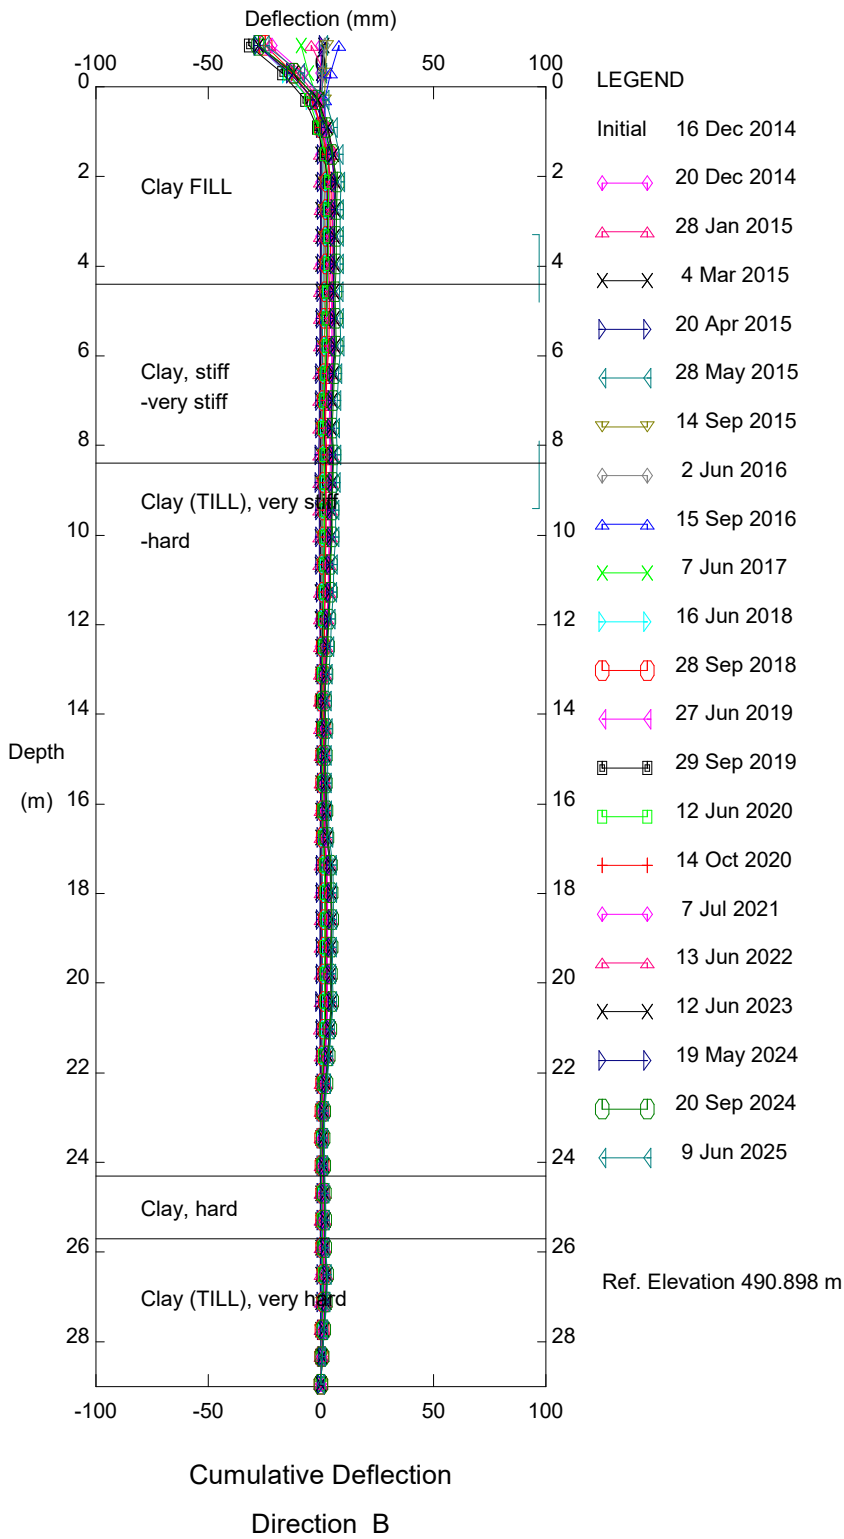
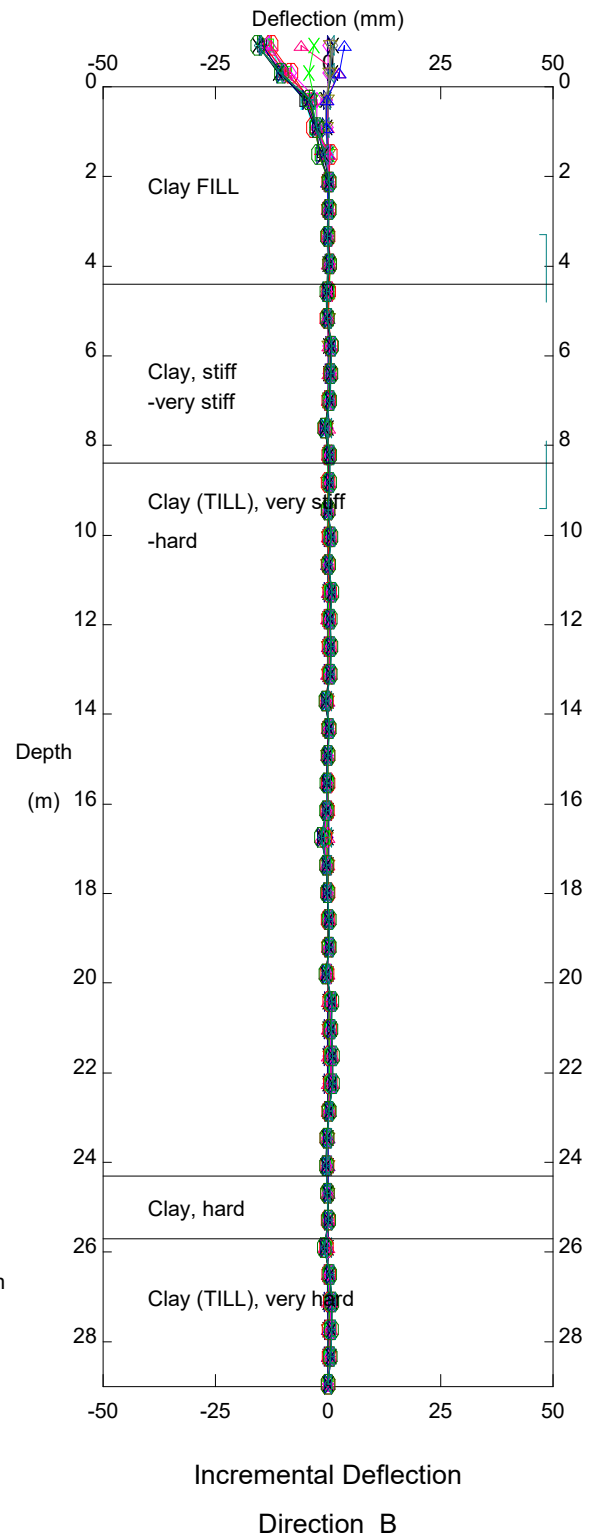
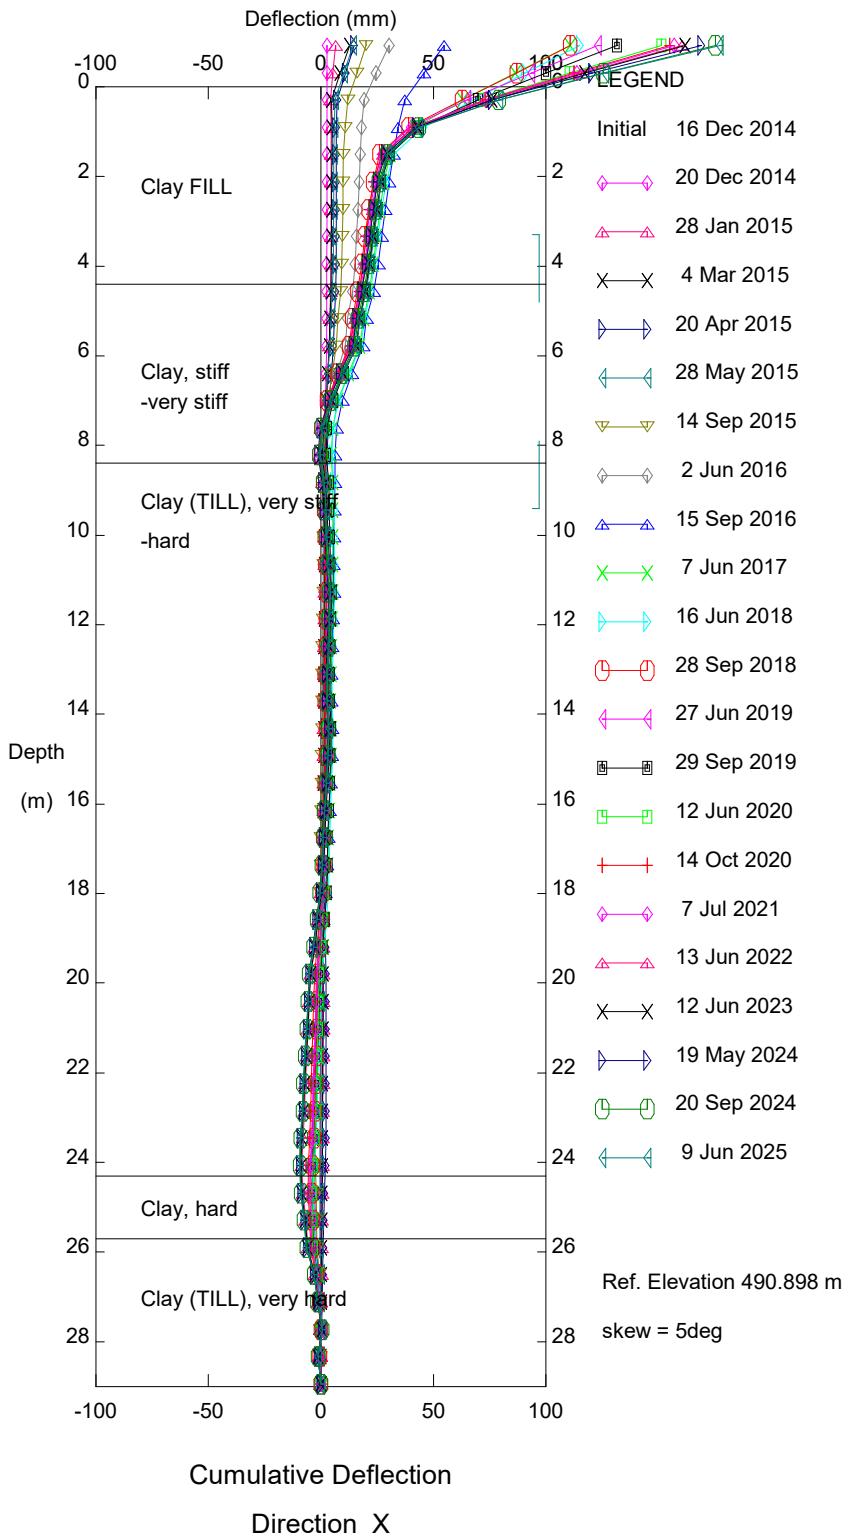
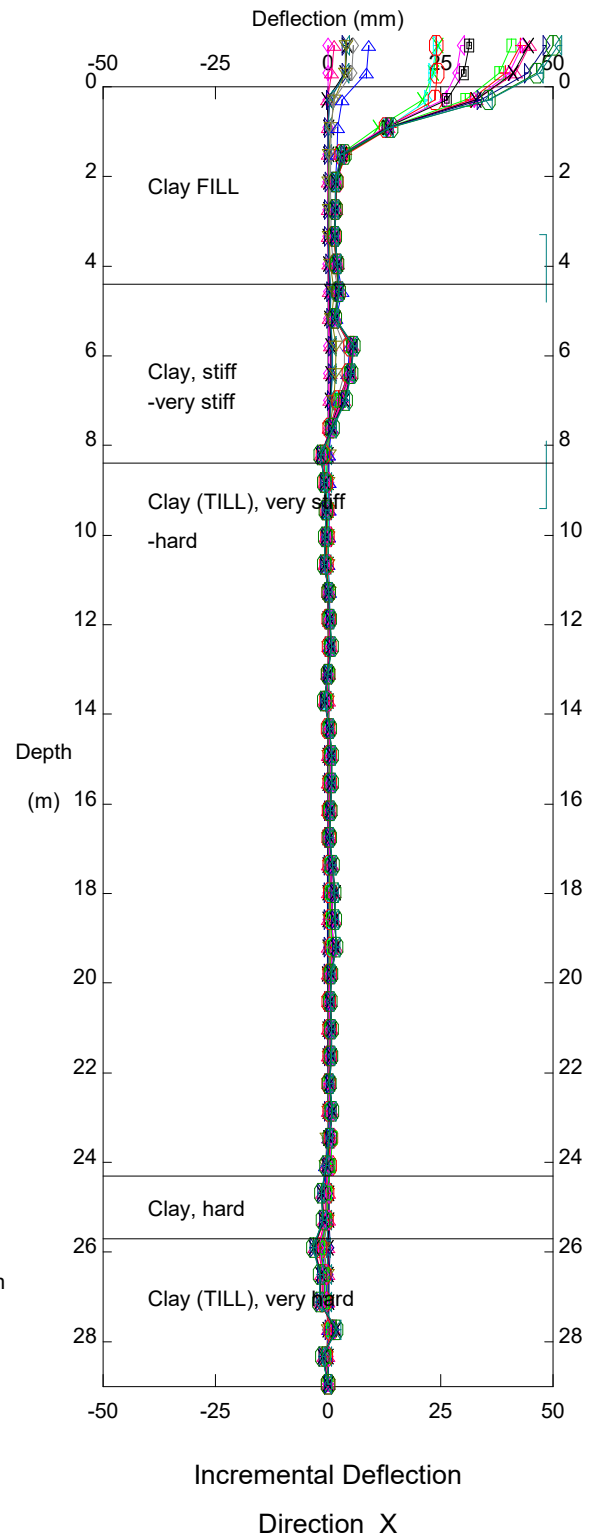
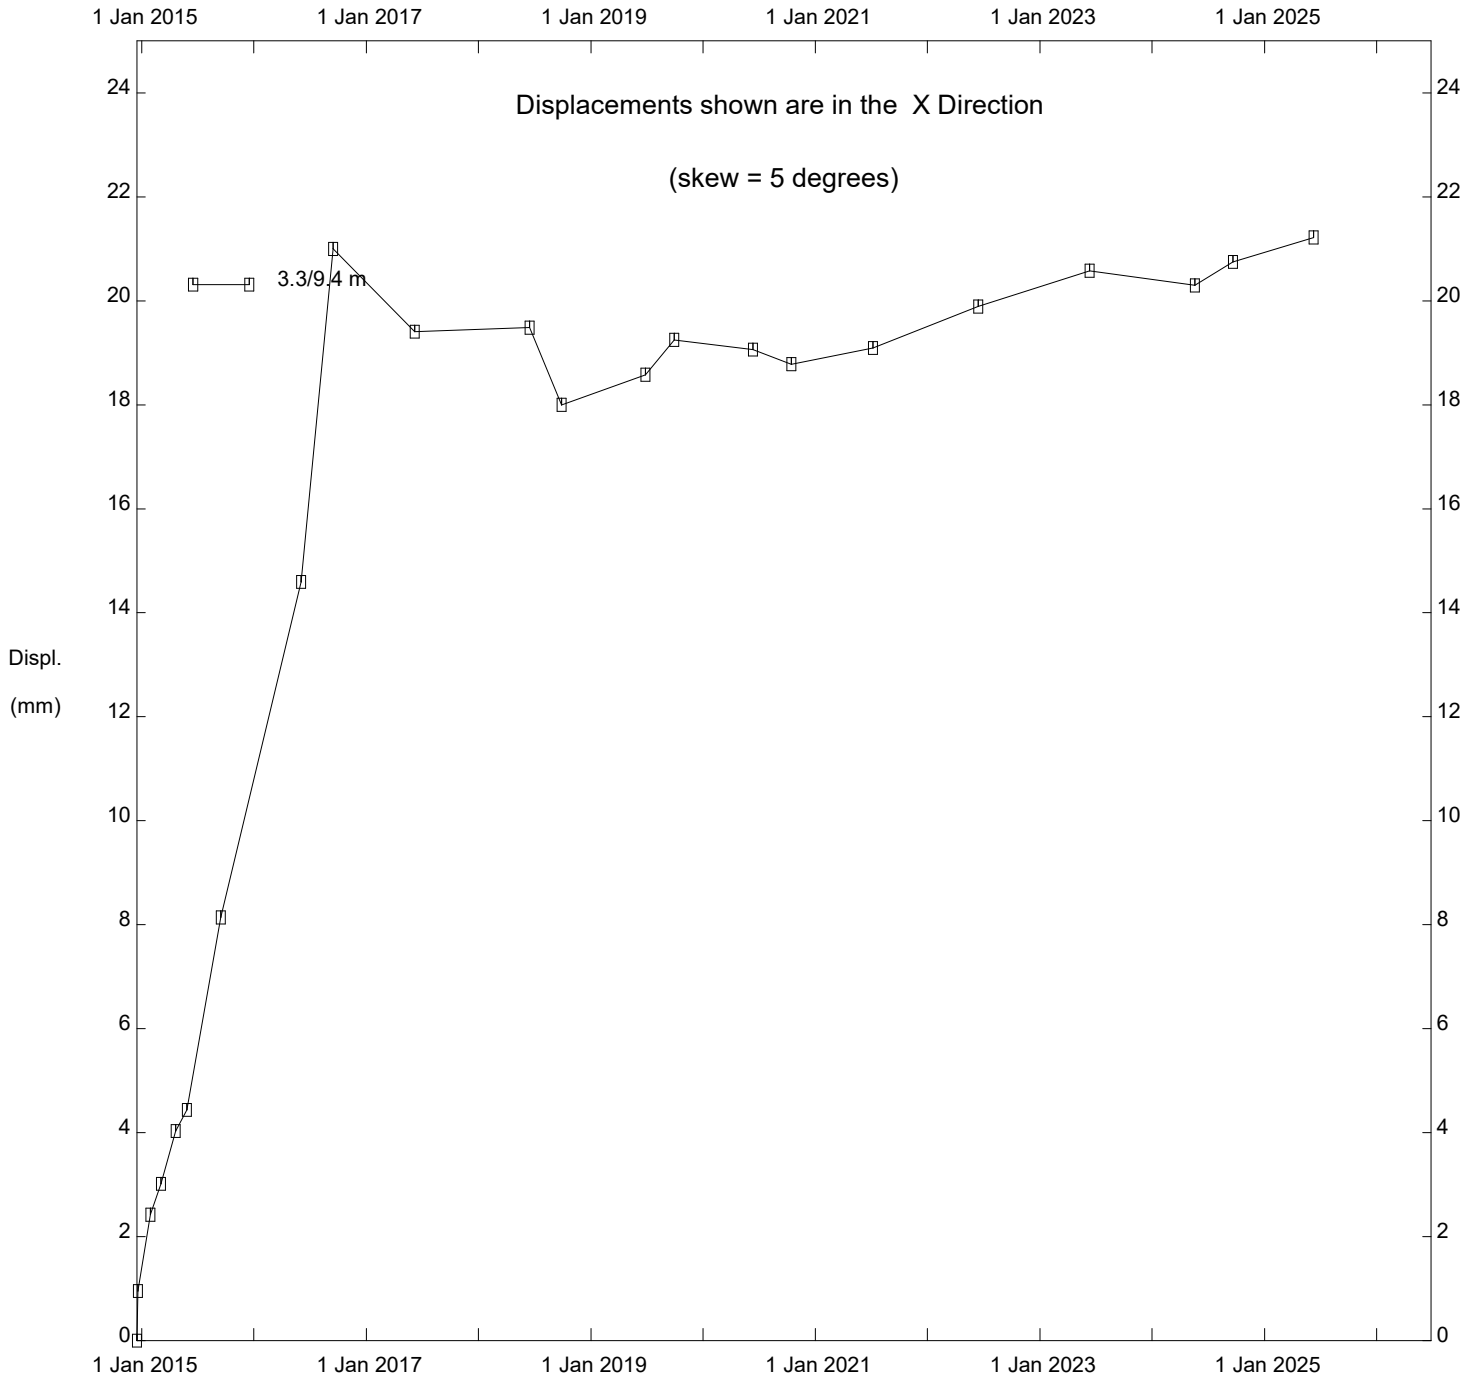
Peace River East Hill PH070, Inclinator SI14-3

have been steady for several years. Slope inclinometer SI14-3, also located upslope of the new pile wall, showed a rate of movement of 0.6 mm/yr over 3.3 m to 9.4 m depth since the fall of 2024 readings. For comparison the average movement rate since fall of 2018 is about 0.4 mm/yr.

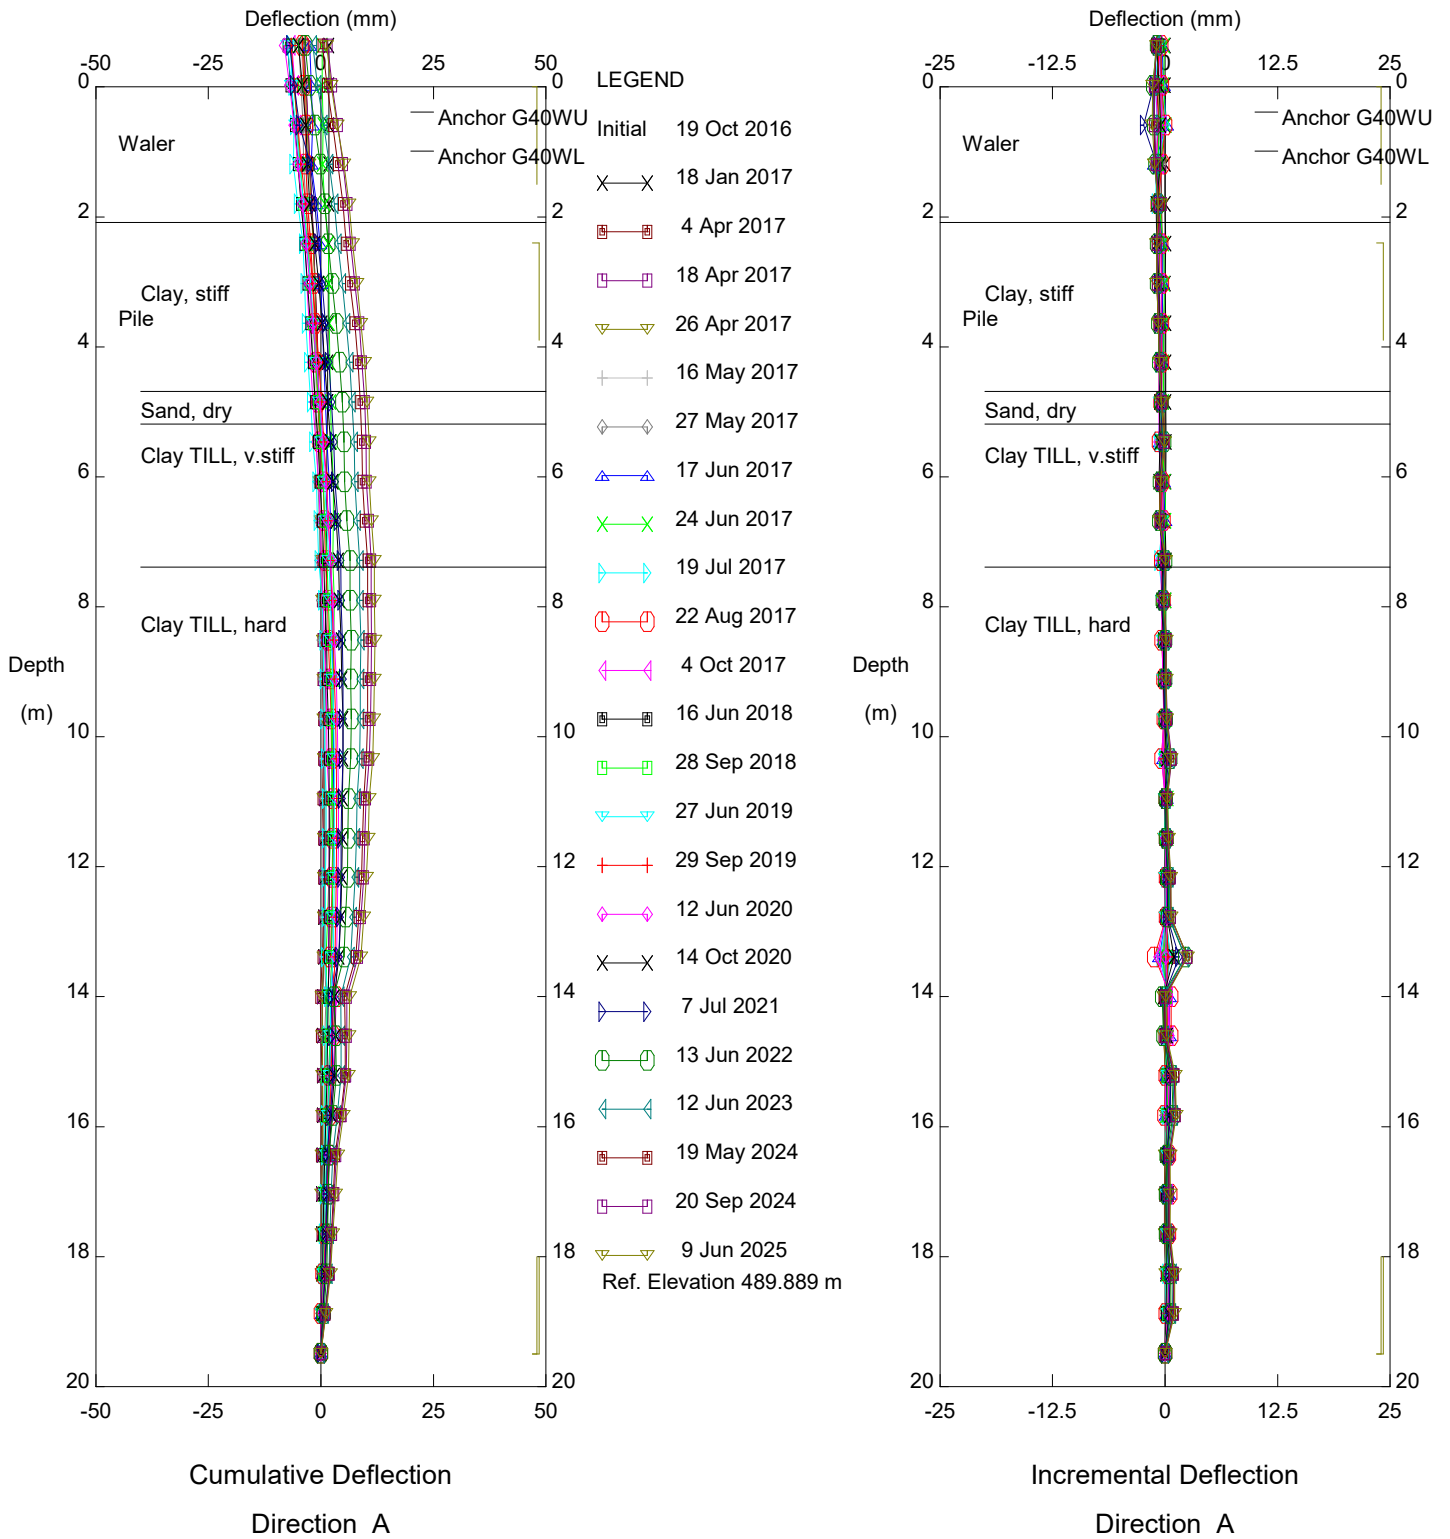
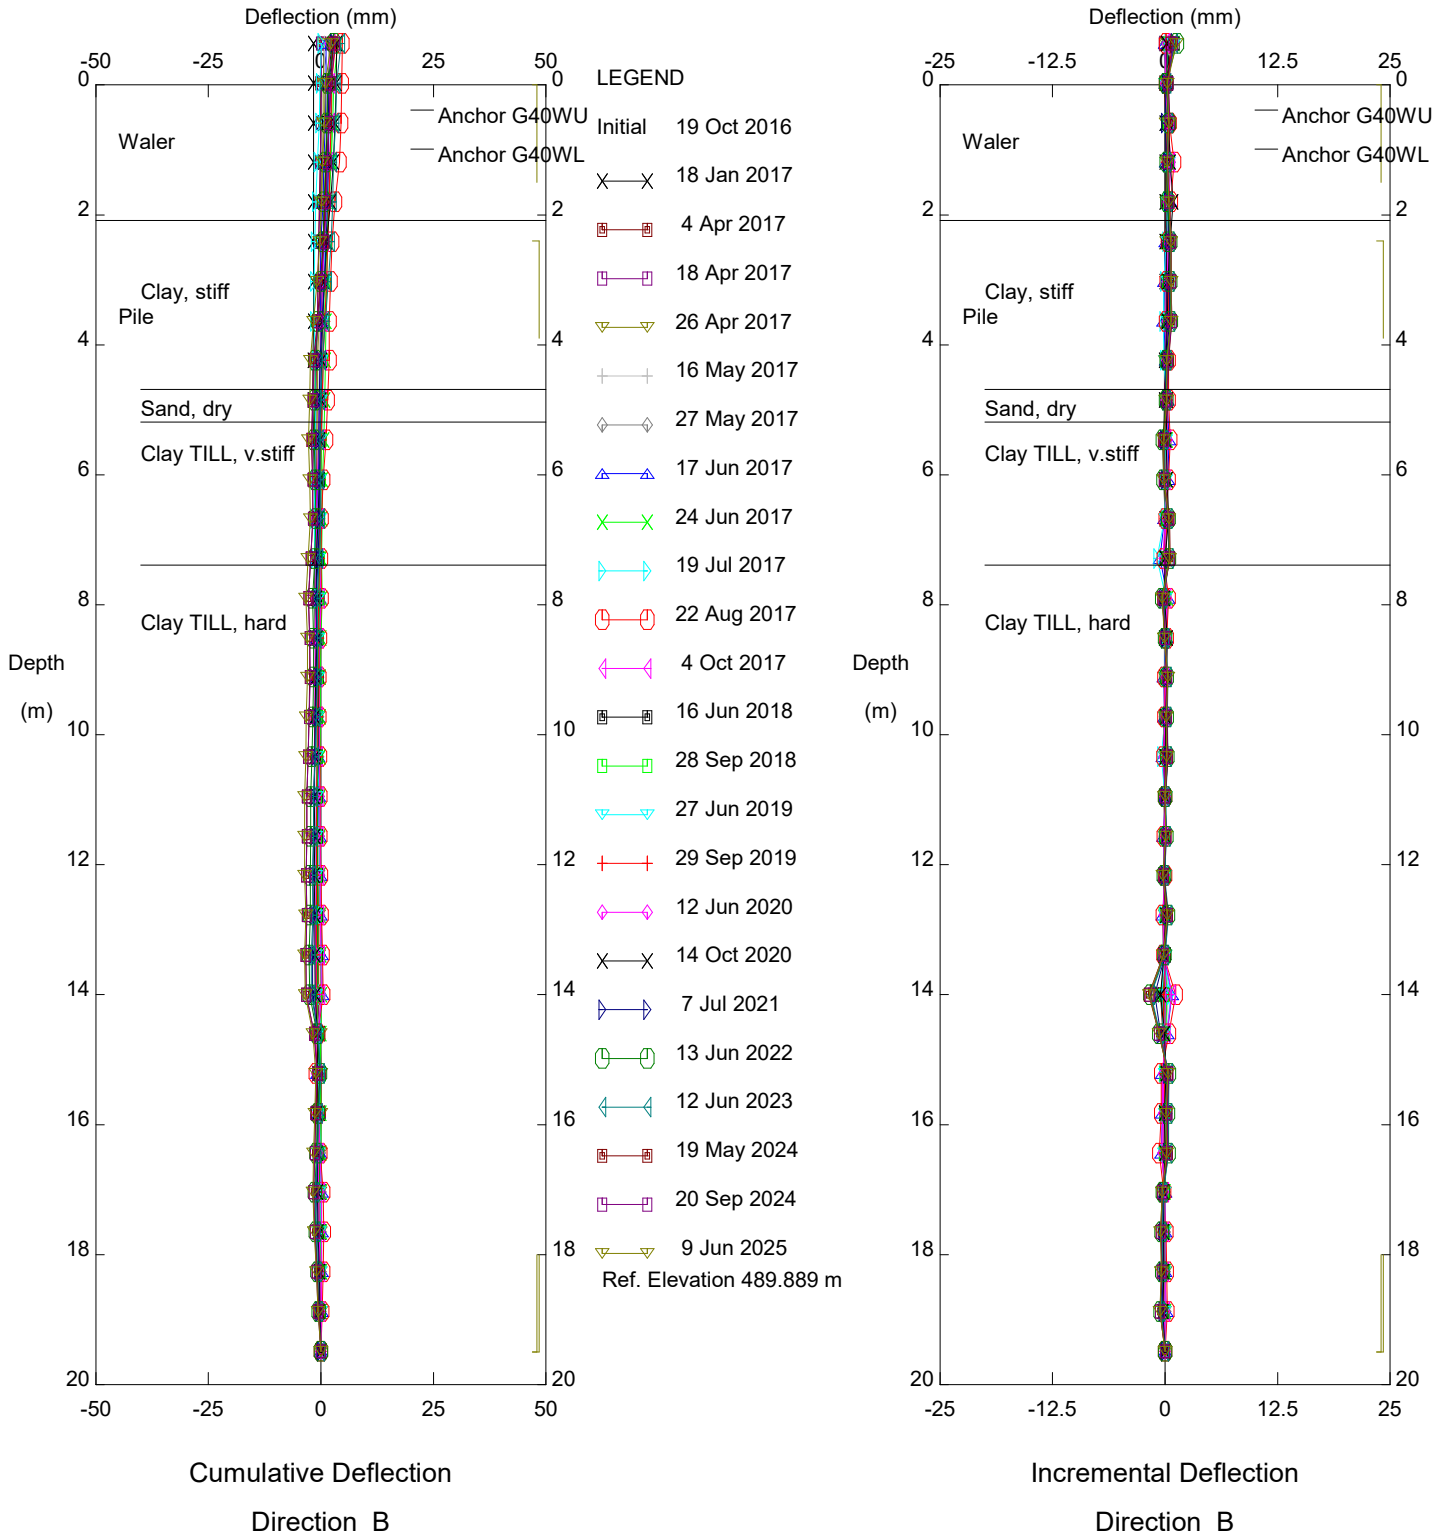
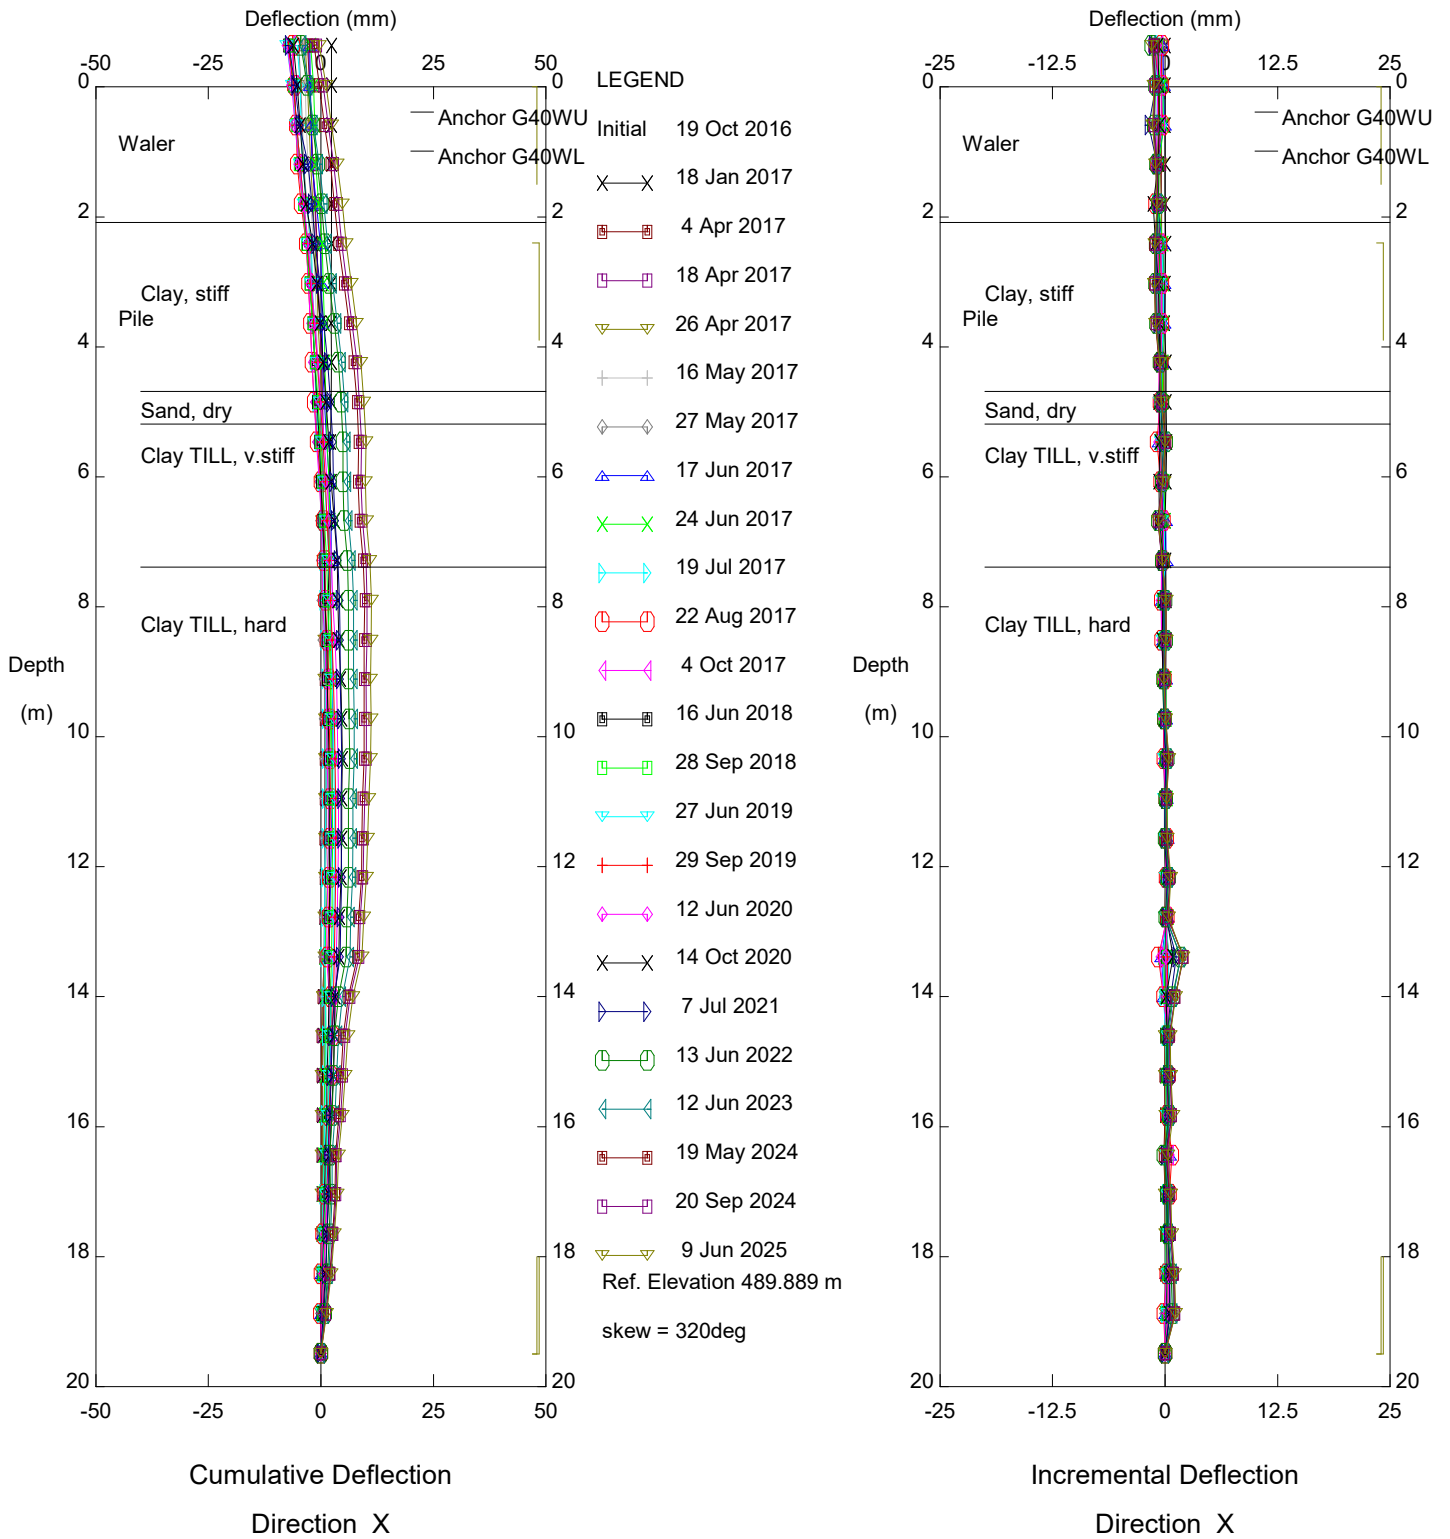
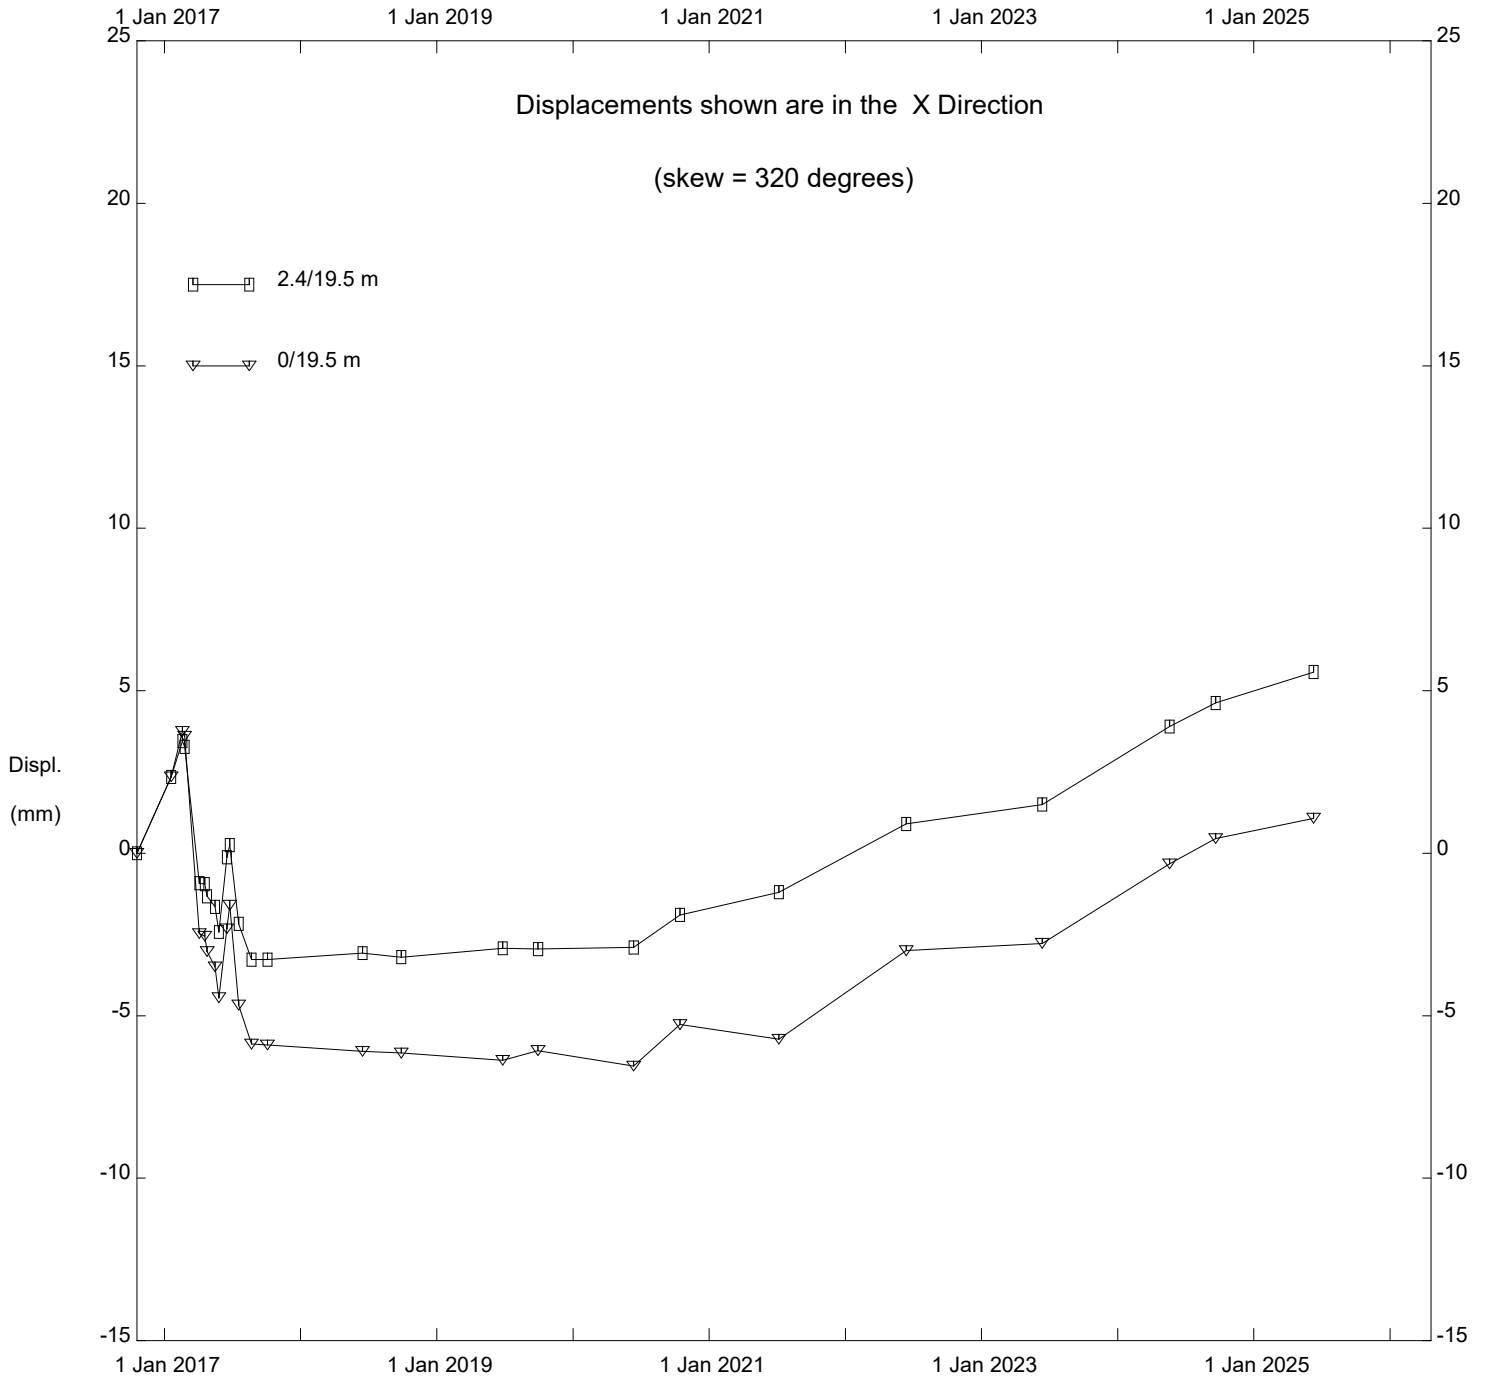
Peace River East Hill PH070, Inclinometer P40

SI-P40, installed in Pile 40, showed a rate of movement of 1.4 mm/yr in the downslope direction over the length of the pile and a rate of movement of 0.9 mm/yr over the combined length of the pile and waler since the fall of 2024 readings. Pile 40 has shown a total cumulative pile head movement of 5.6 mm in the downslope direction and a total cumulative movement of 1.1 mm in the downslope direction over the combined length of the pile and waler.
