Site Number	Location	Name	Hwy	km
PH070	HWY 2:60 C1 33.840	East Hill Retaining Wall Site	2:60	Km 33.84
Legal Description: 4-27-83-21 W5		UTM Co-ordinates		
		11U E 485285	N	6230649

Current Monitoring:	9-June-2025	Previous Monitoring	20-Sep-2024
Instruments Read By:	Mr. Niraj Regmi, G.I.T and Mr. Godfred Etiendem, of Thurber

**ALBERTA TRANSPORTATION AND ECONOMIC CORRIDORS GRMP (CON0022164)
PEACE REGION (PEACE RIVER DISTRICT)
INSTRUMENTATION MONITORING RESULTS**

SPRING 2025

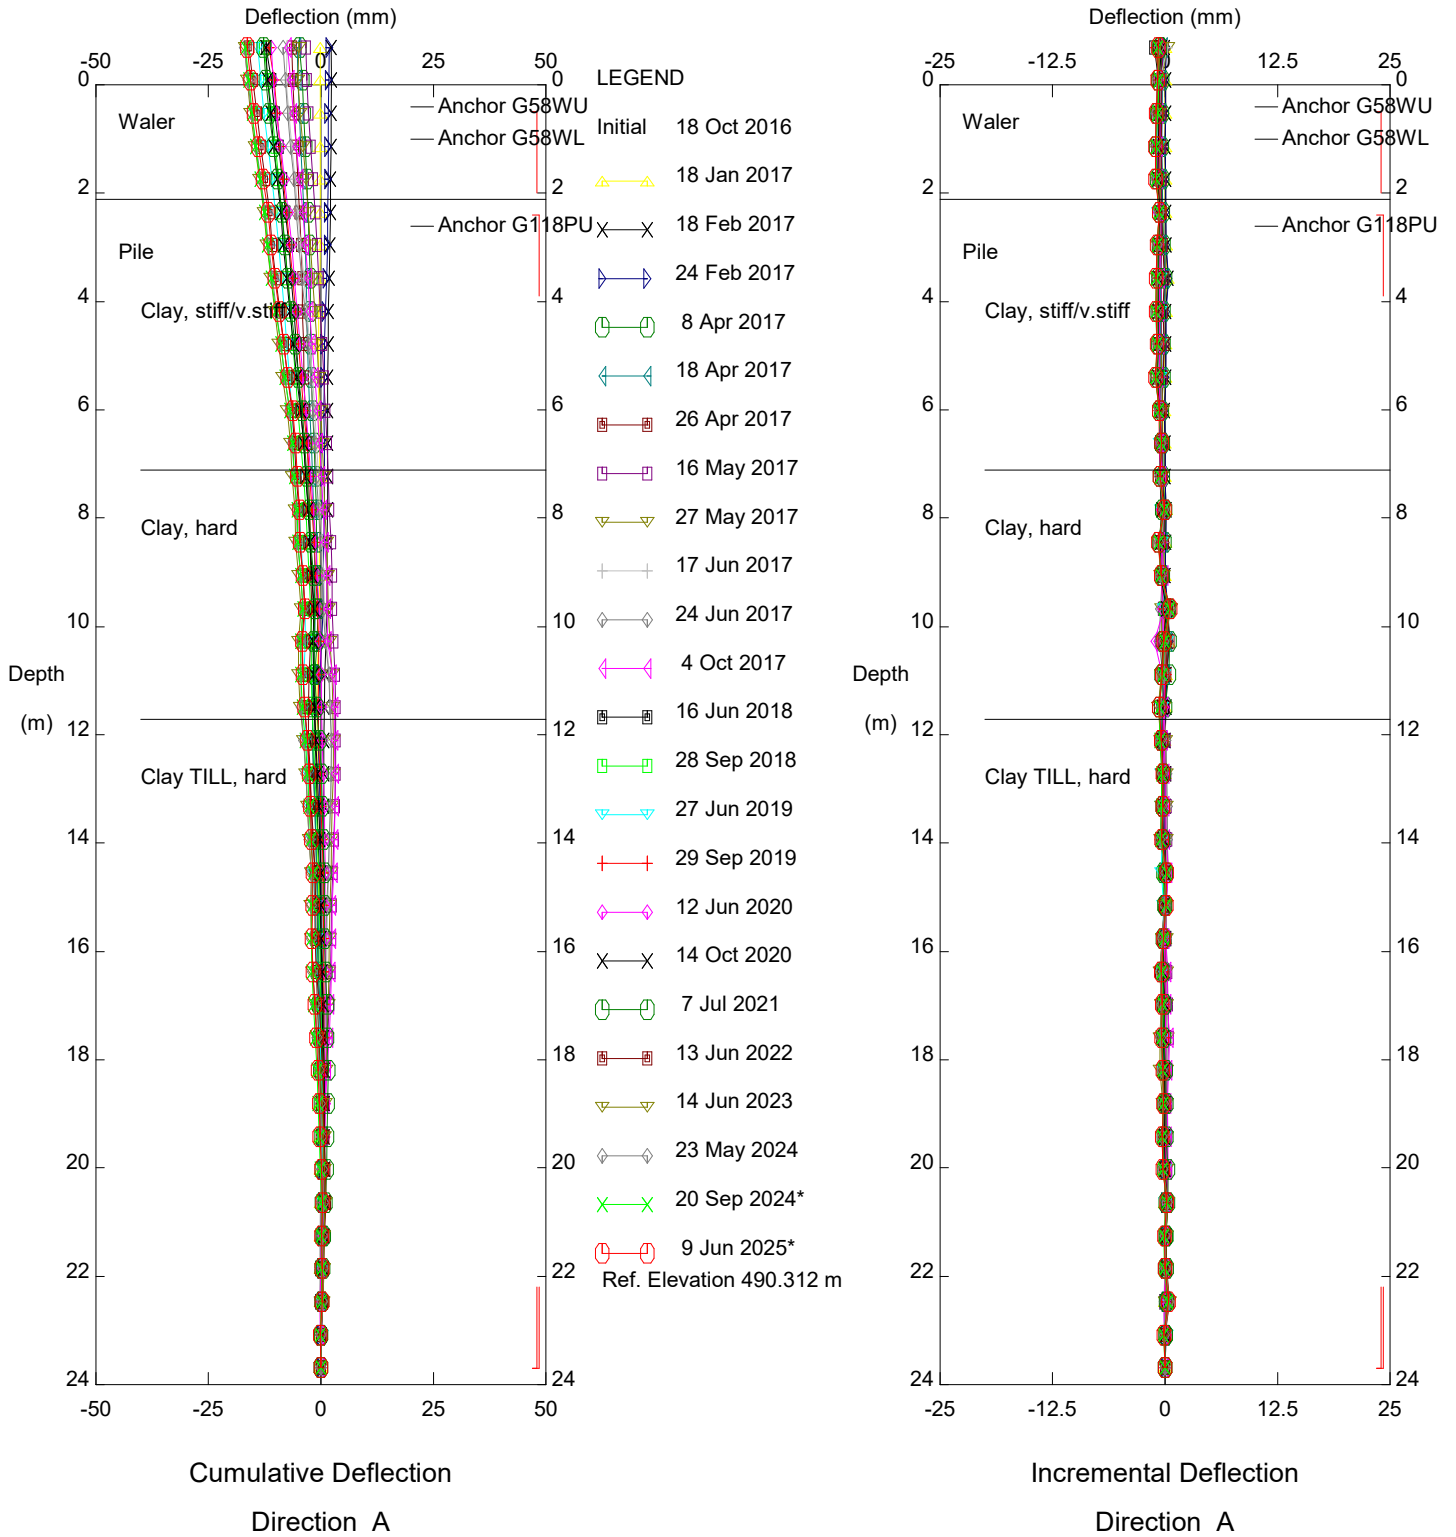
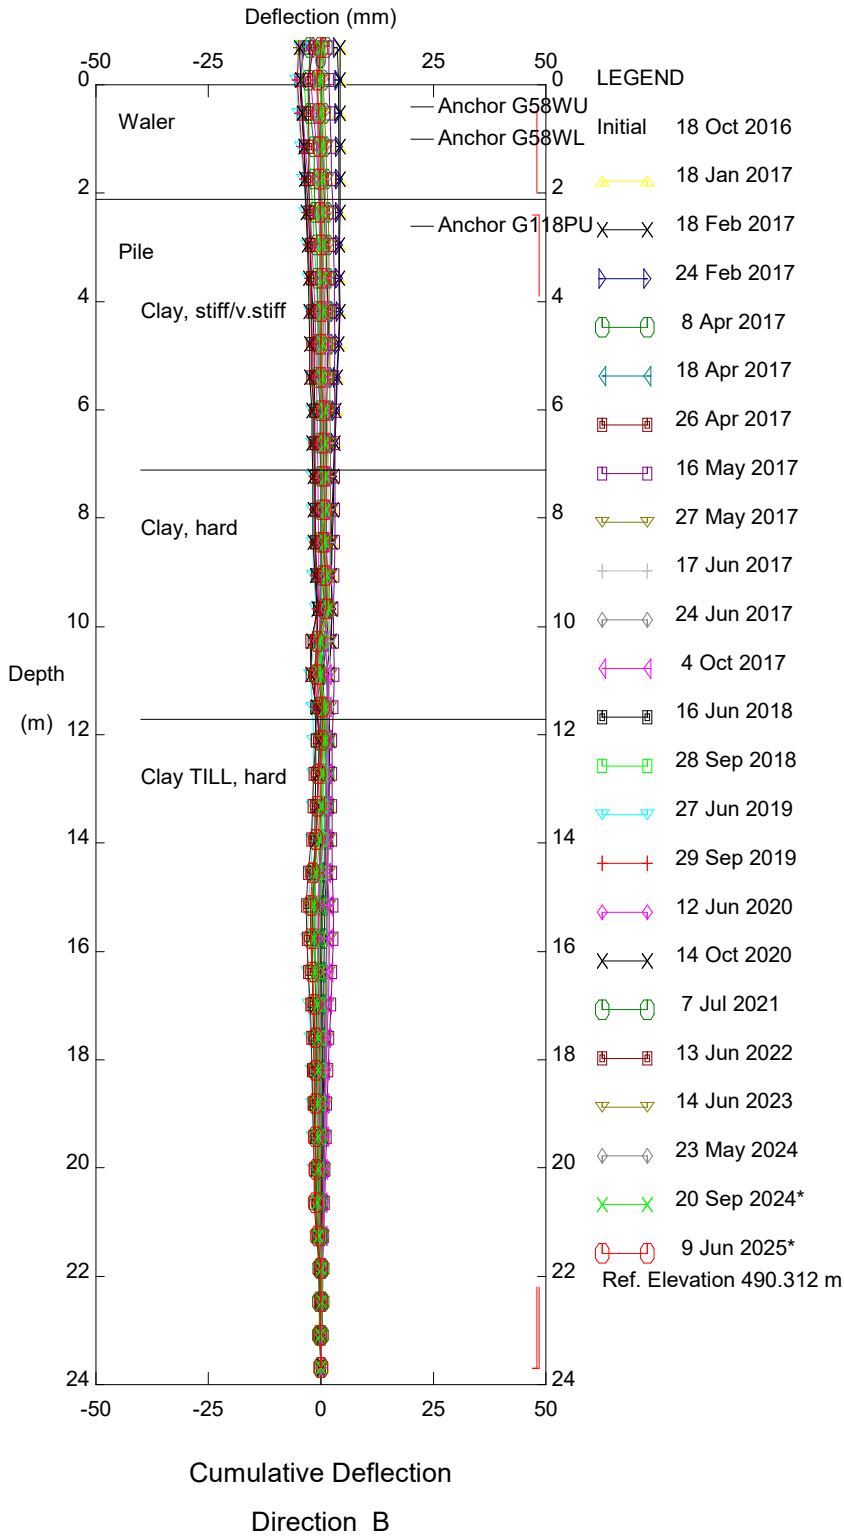
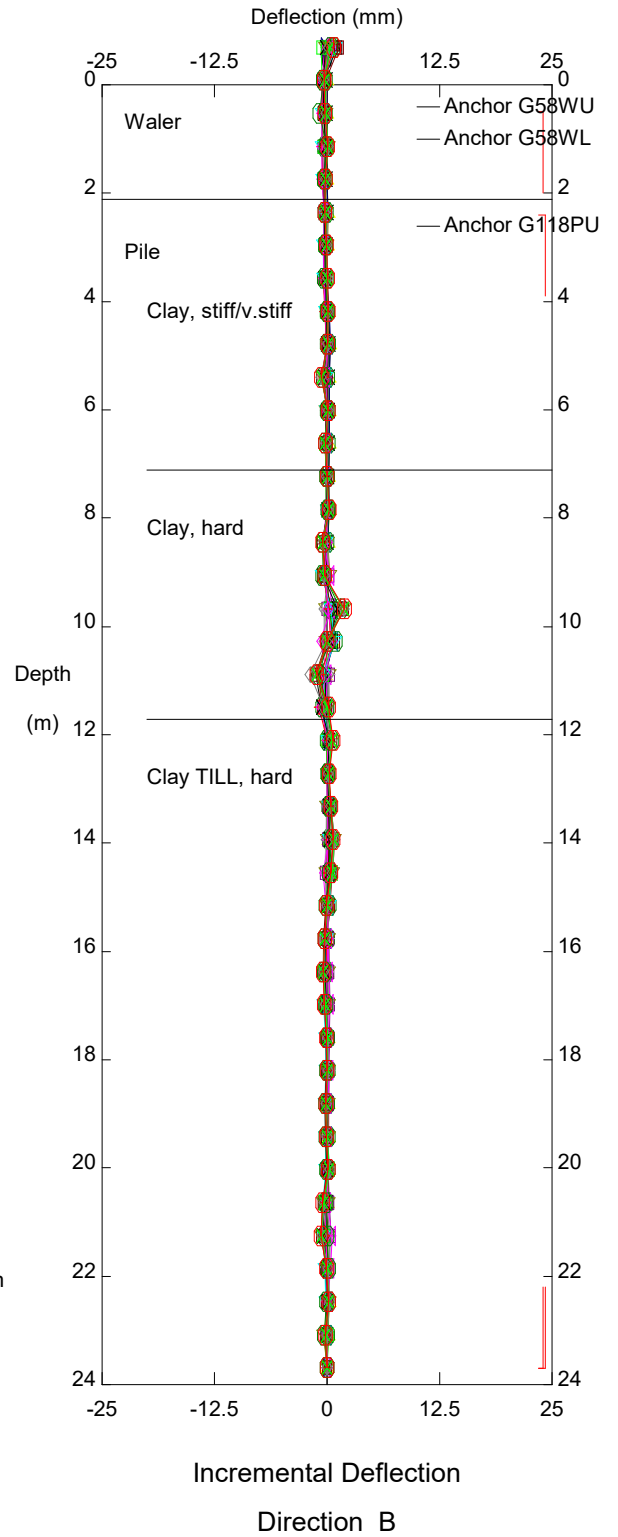
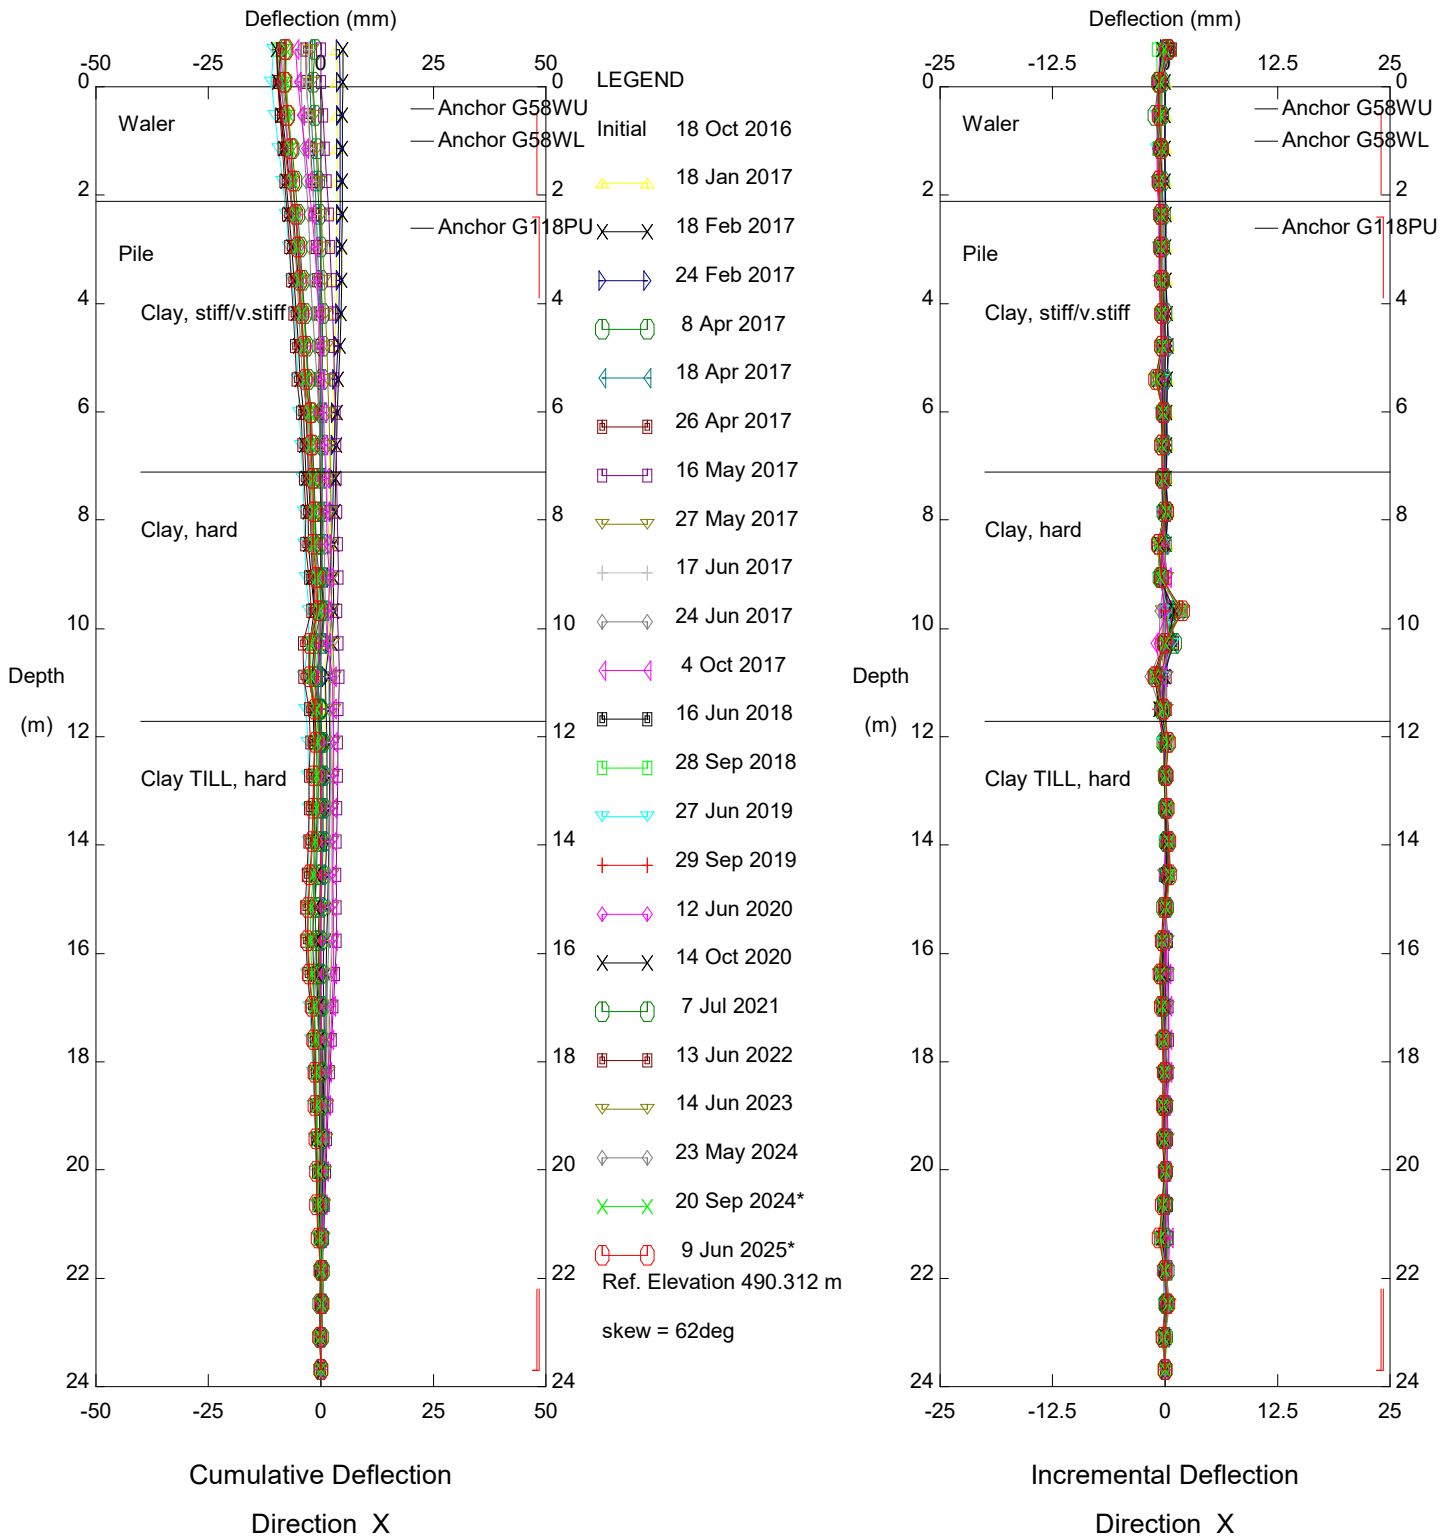
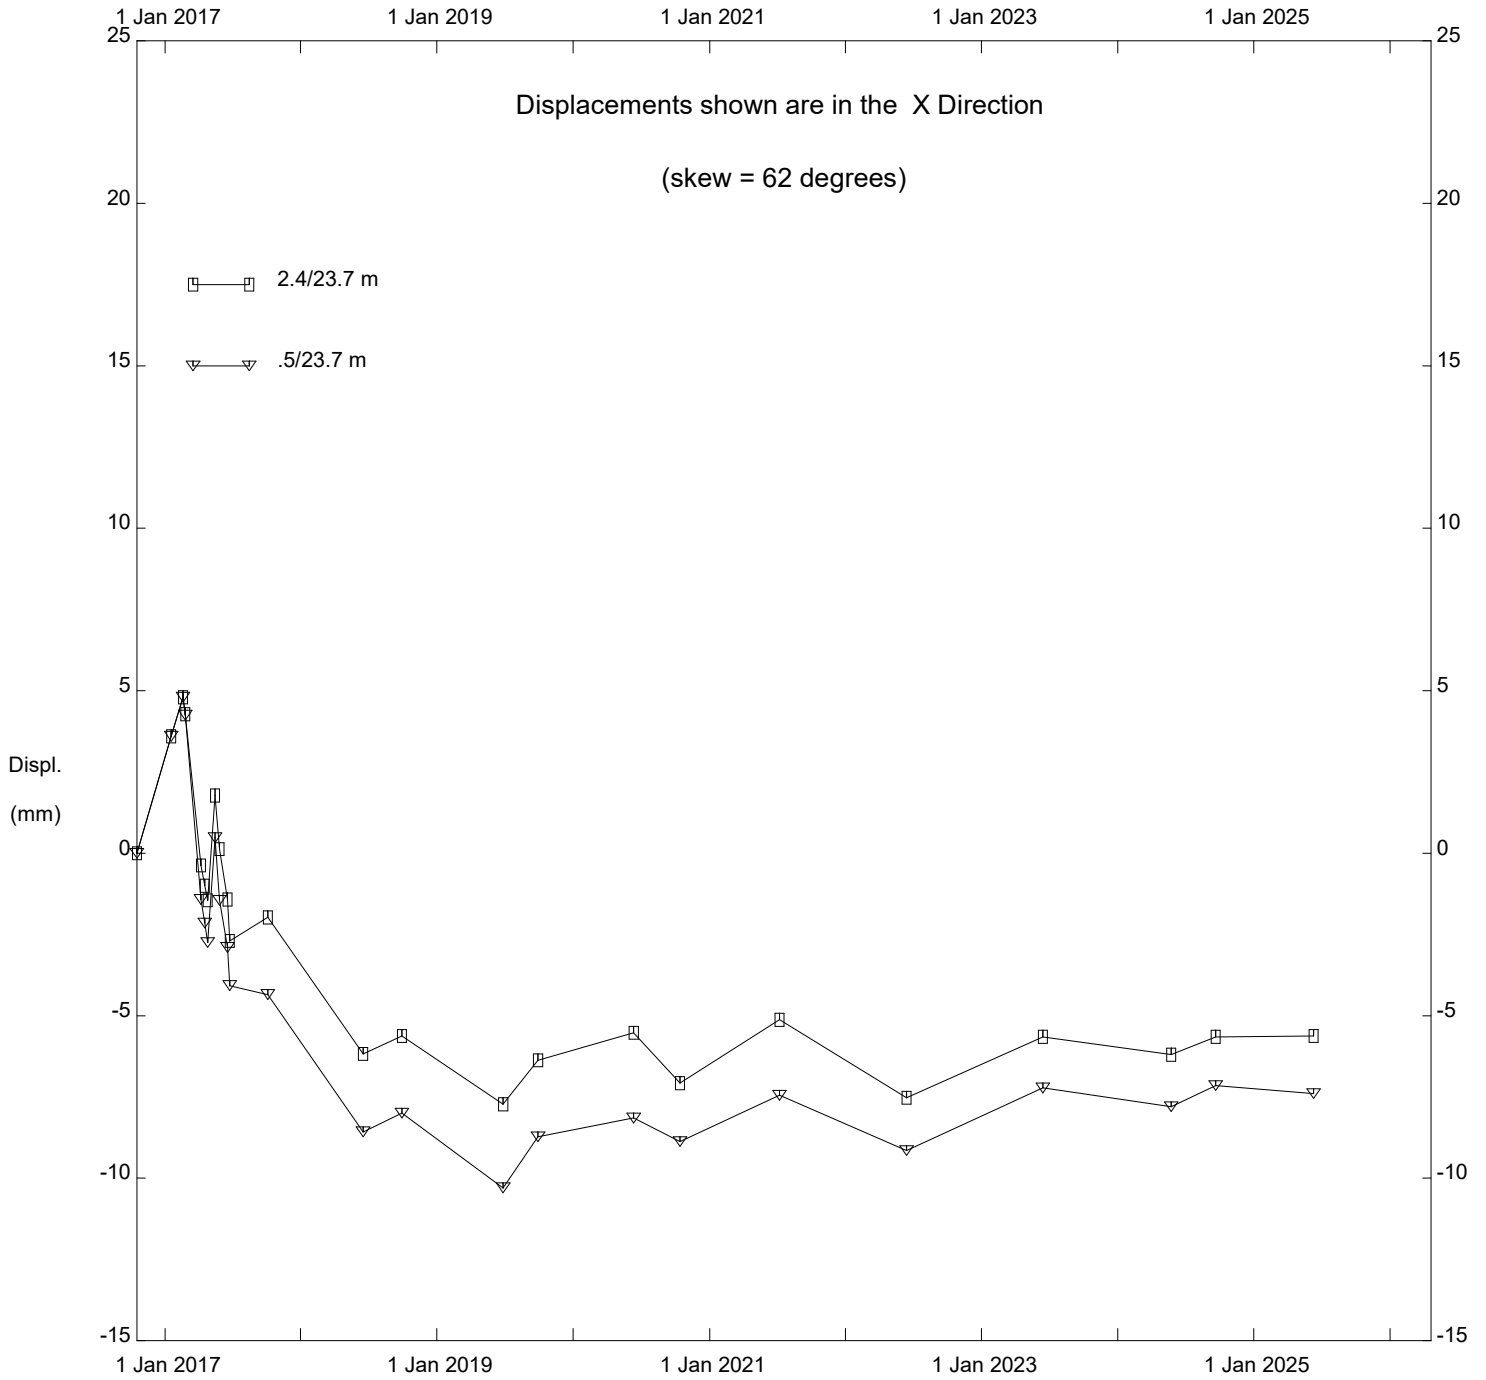
Peace River East Hill PH070, Inclinometer P58

SI-P58, installed in Pile 58, showed a rate of movement of less than 0.1 mm/yr over the length of the pile and no discernible movement over the combined length of the pile and waler since the fall of 2024 readings. The cumulative pile head movement was 5.6 mm in the upslope direction and the cumulative movement at the top of the waler was 7.4 mm in the upslope direction.

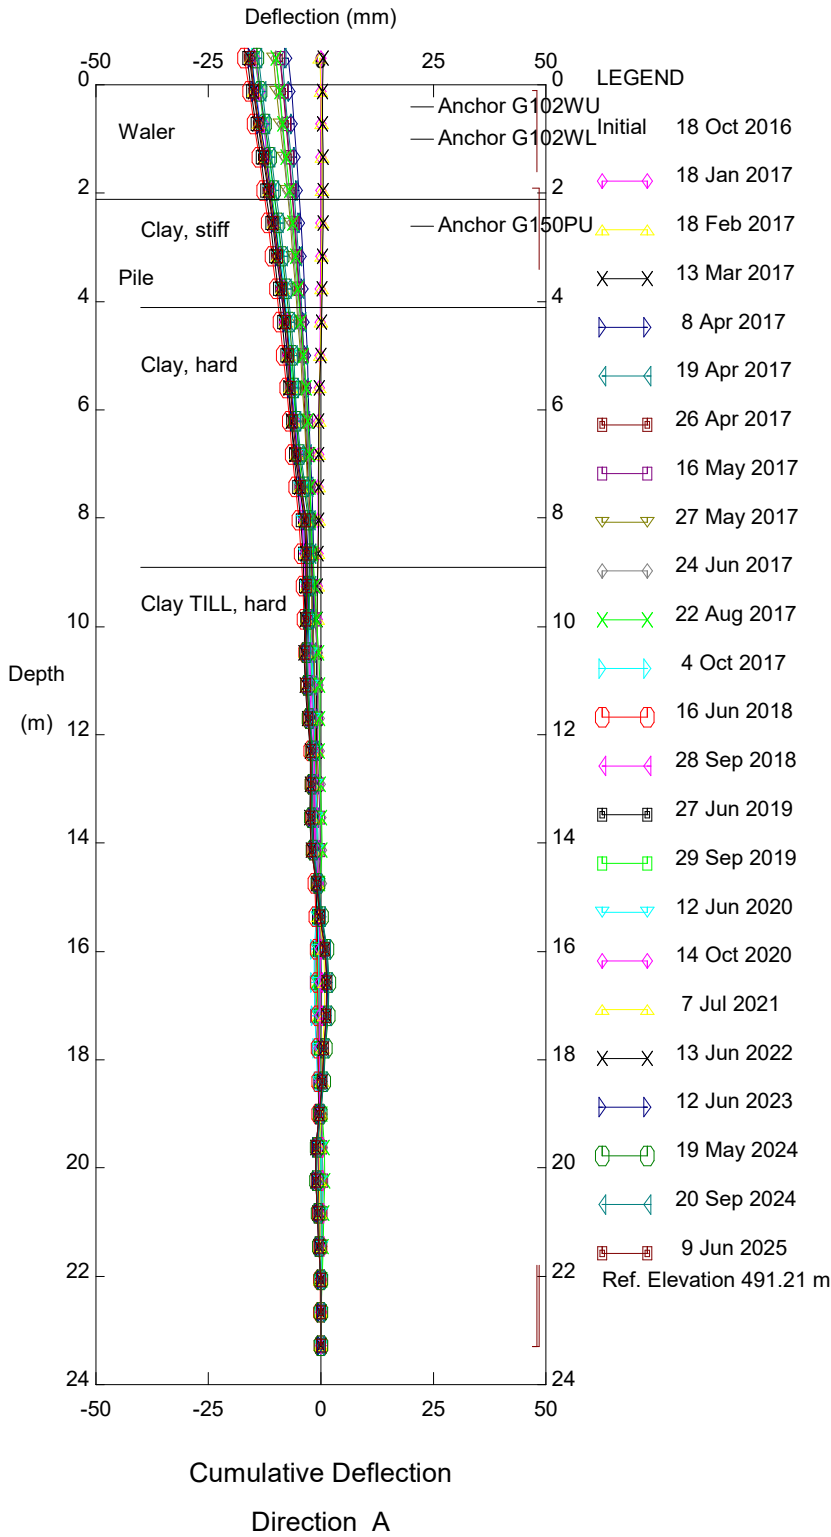
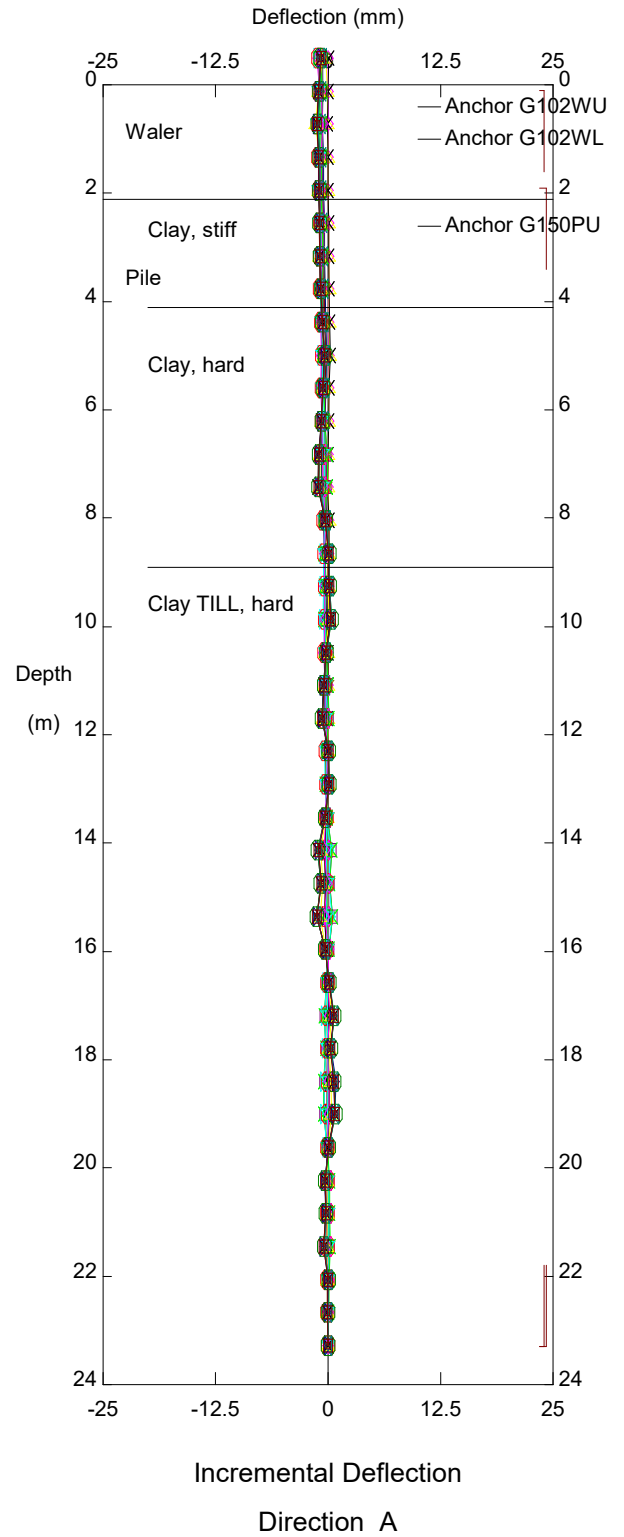
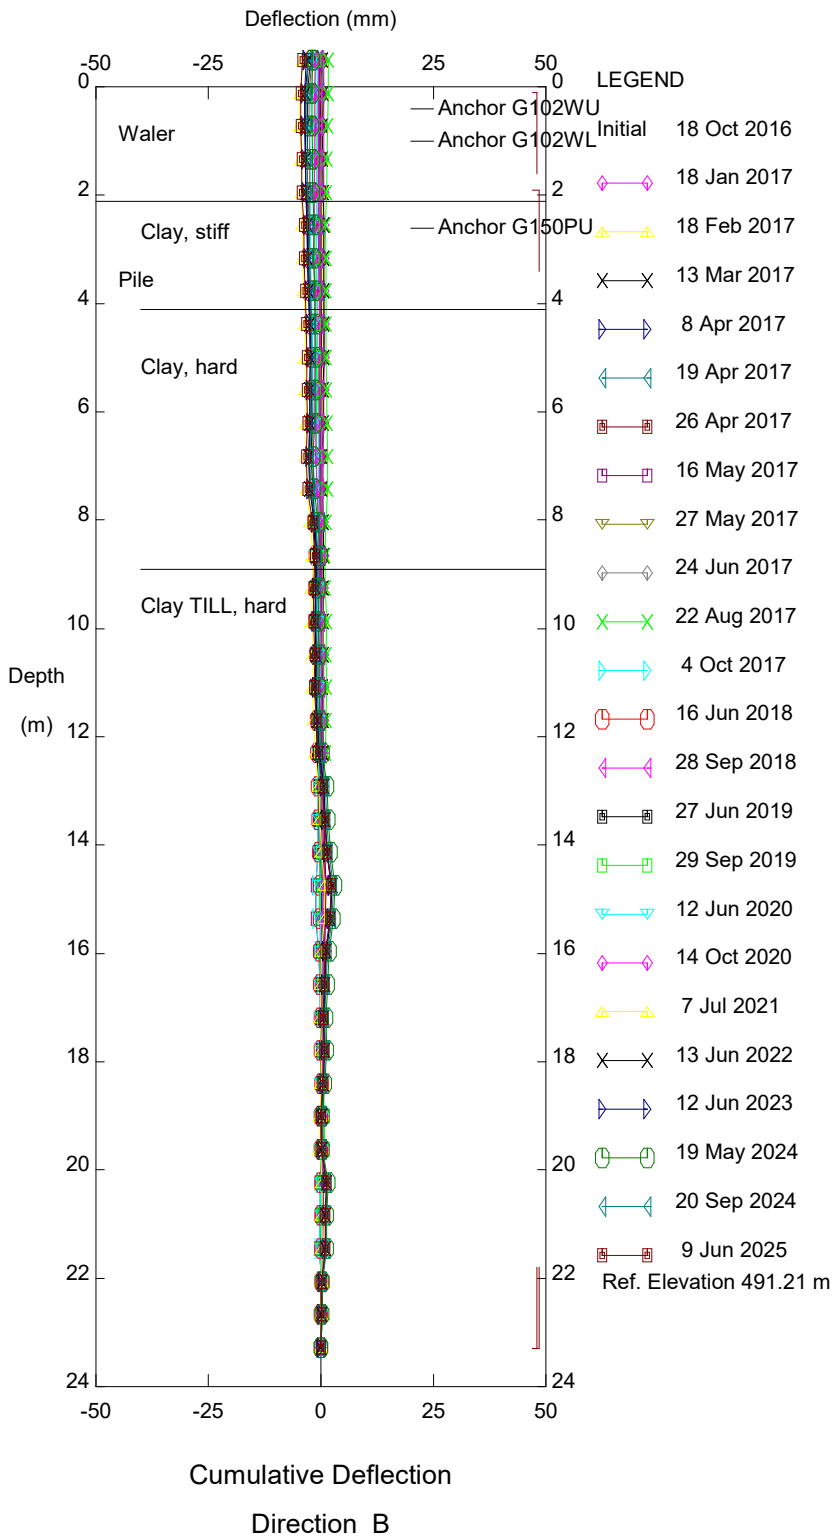
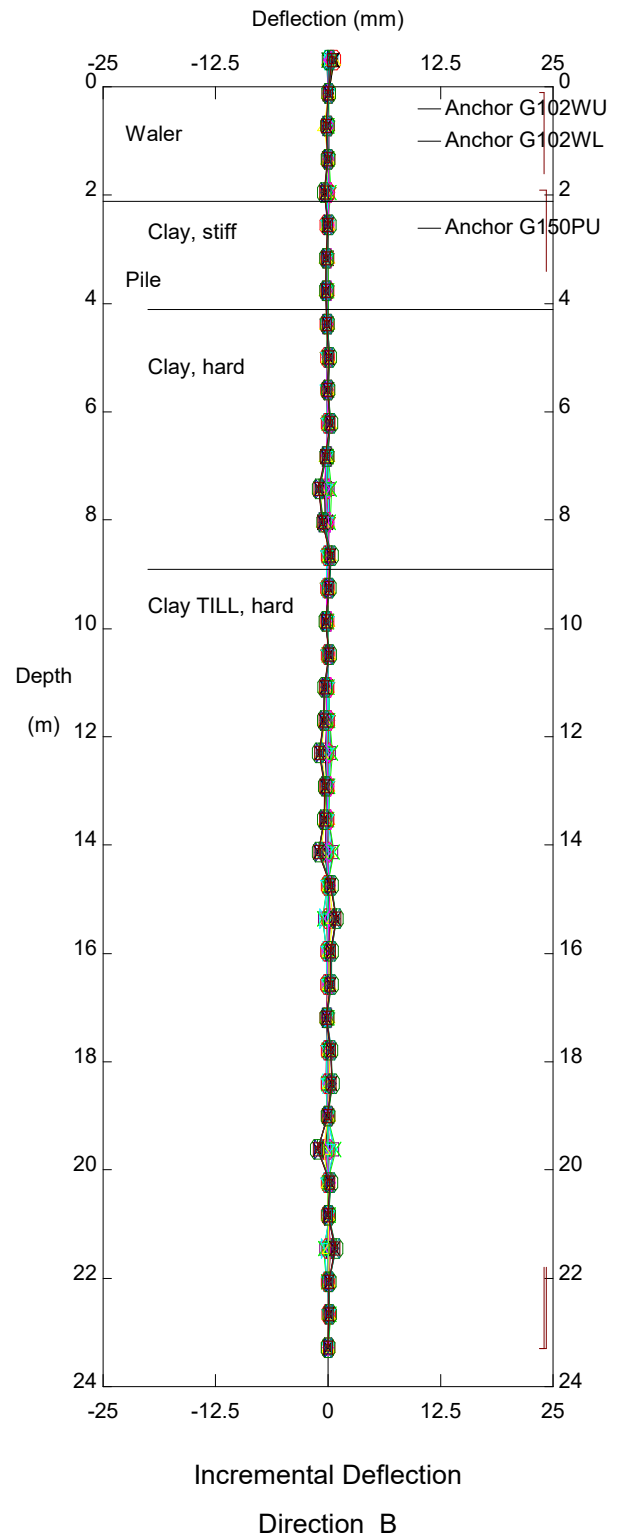
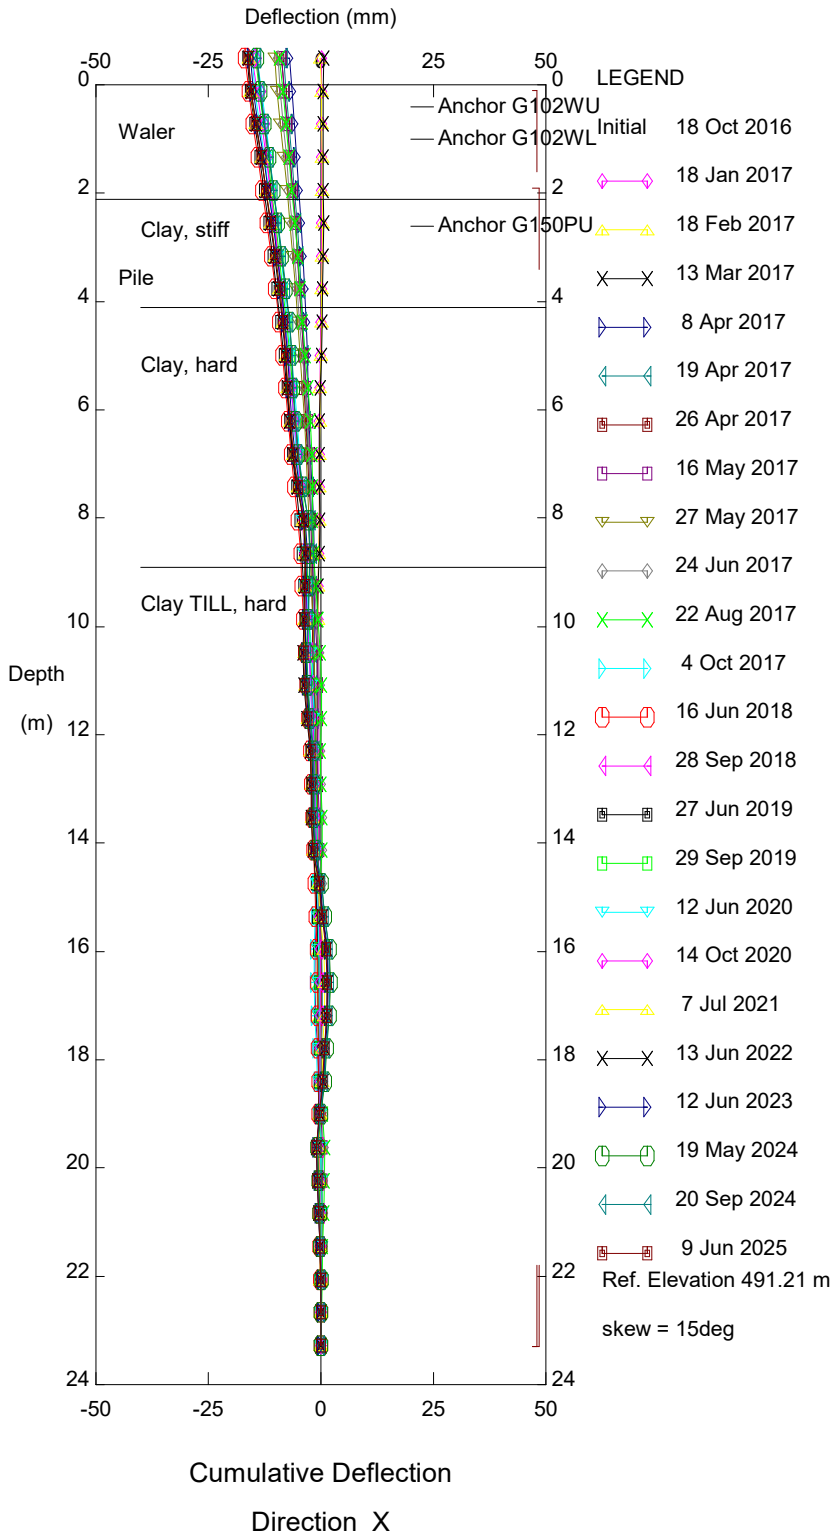
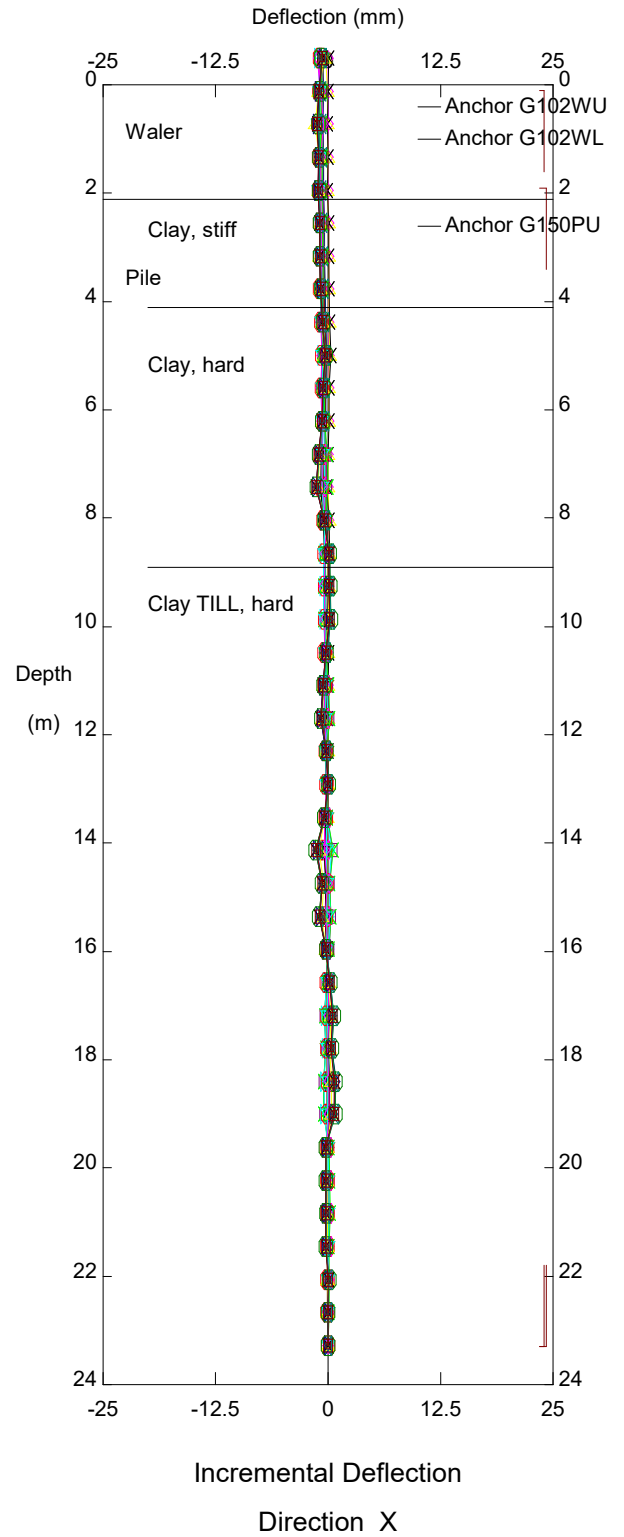
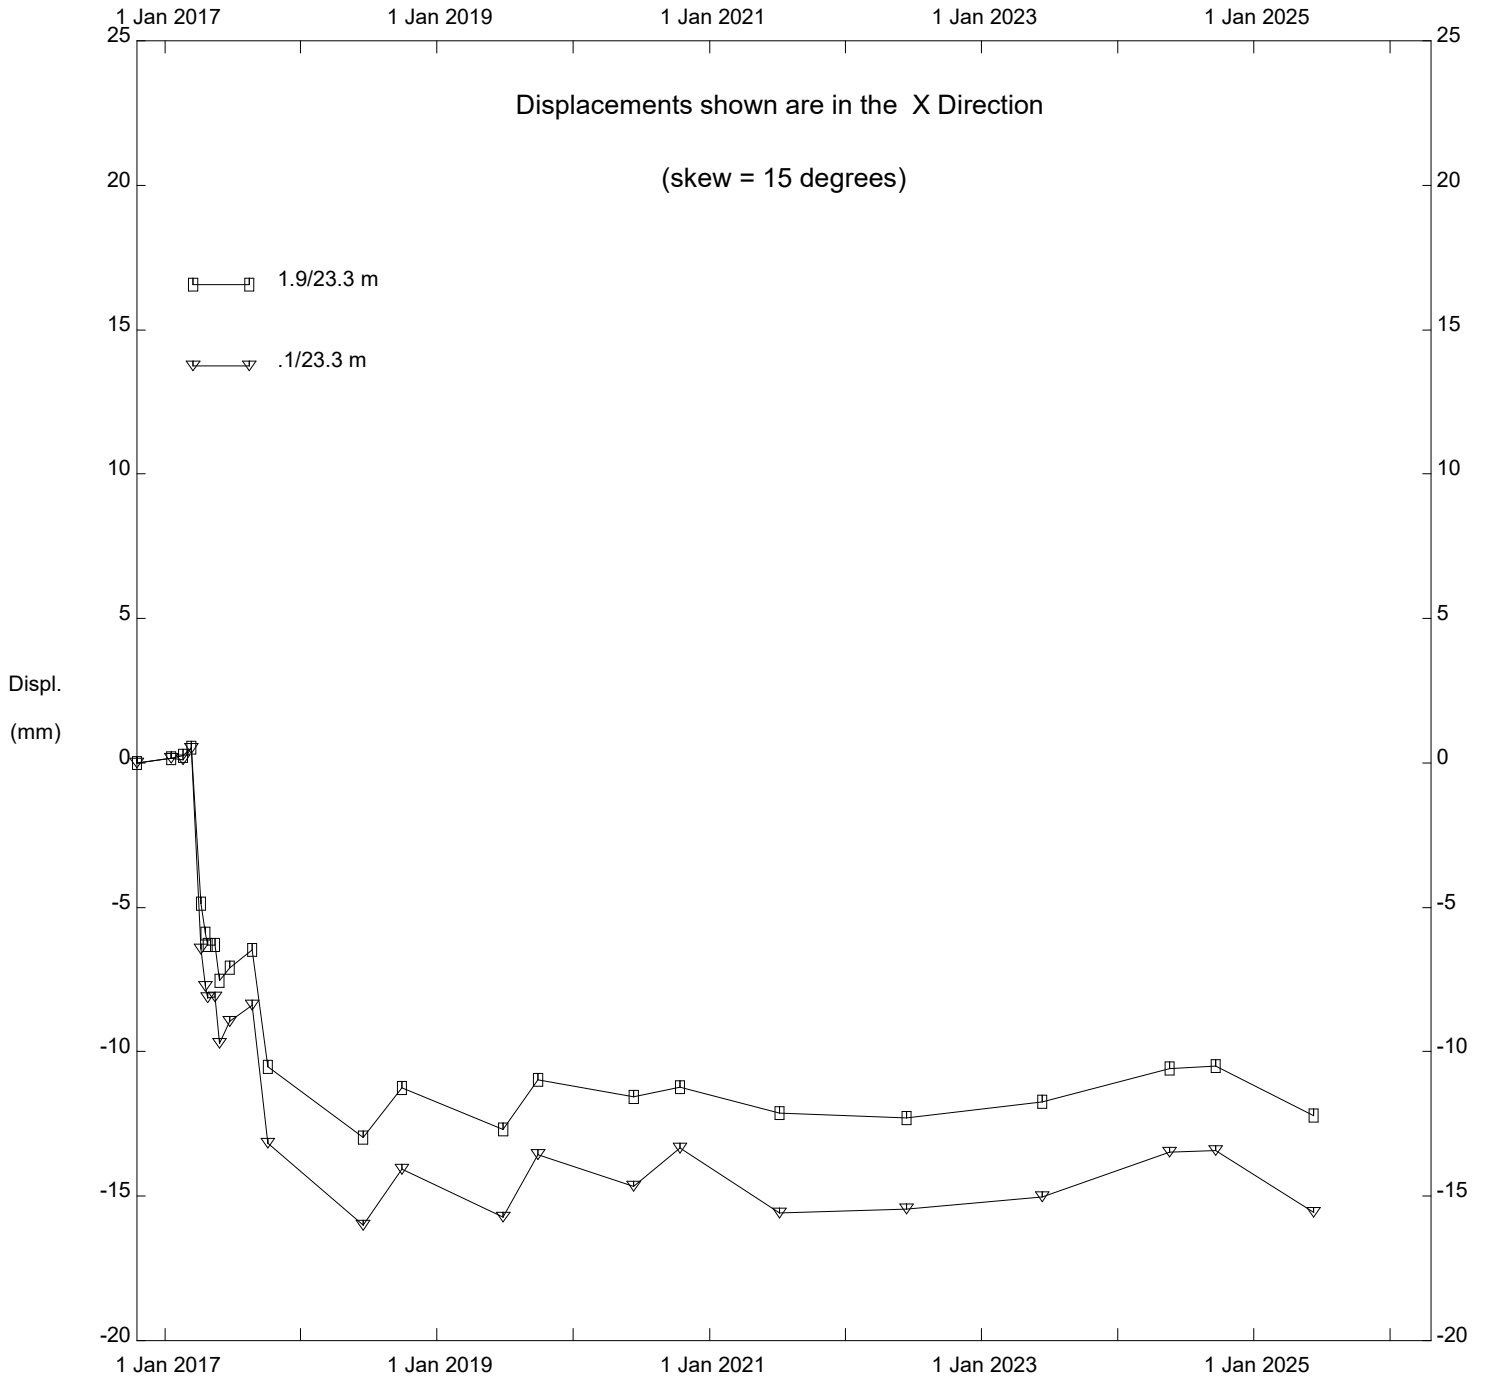
Peace River East Hill PH070, Inclinator P90

SI-P90, installed in Pile 90, showed no discernible movement over both the length of the pile and over the combined length of the pile and waler since the fall of 2024 readings. Pile 90 has shown a total cumulative pile head movement of 12.2 mm in the upslope direction and a total cumulative movement of 15.6 mm in the upslope direction over the combined length of the pile and waler.
