Site Number	Location	Name	Hwy	km
PH070	HWY 2:60 C1 33.840	East Hill Retaining Wall Site	2:60	Km 33.84
Legal Description: 4-27-83-21 W5		UTM Co-ordinates		
		11U E 485285	N	6230649

Current Monitoring:	9-June-2025	Previous Monitoring	20-Sep-2024
Instruments Read By:	Mr. Niraj Regmi, G.I.T and Mr. Godfred Etiendem, of Thurber

**ALBERTA TRANSPORTATION AND ECONOMIC CORRIDORS GRMP (CON0022164)
PEACE REGION (PEACE RIVER DISTRICT)
INSTRUMENTATION MONITORING RESULTS**

SPRING 2025

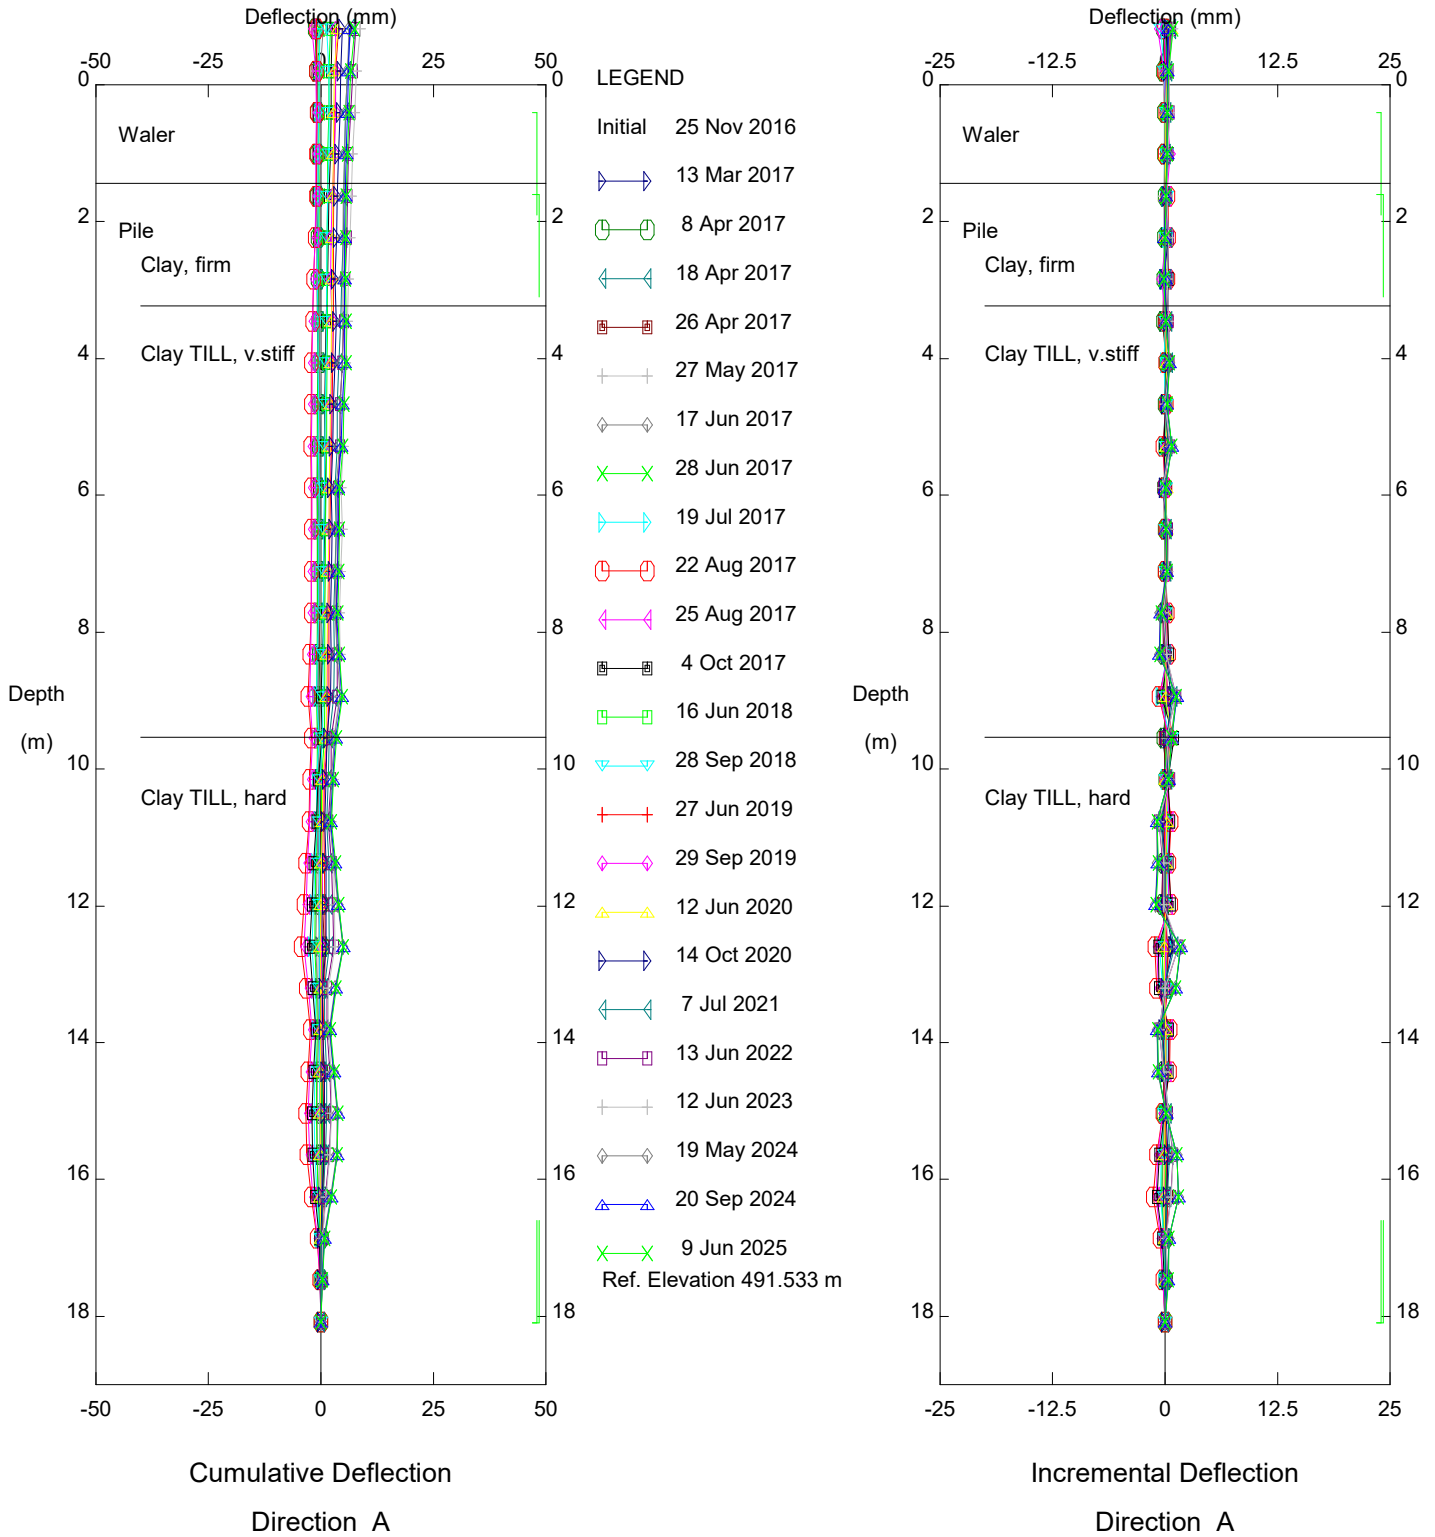
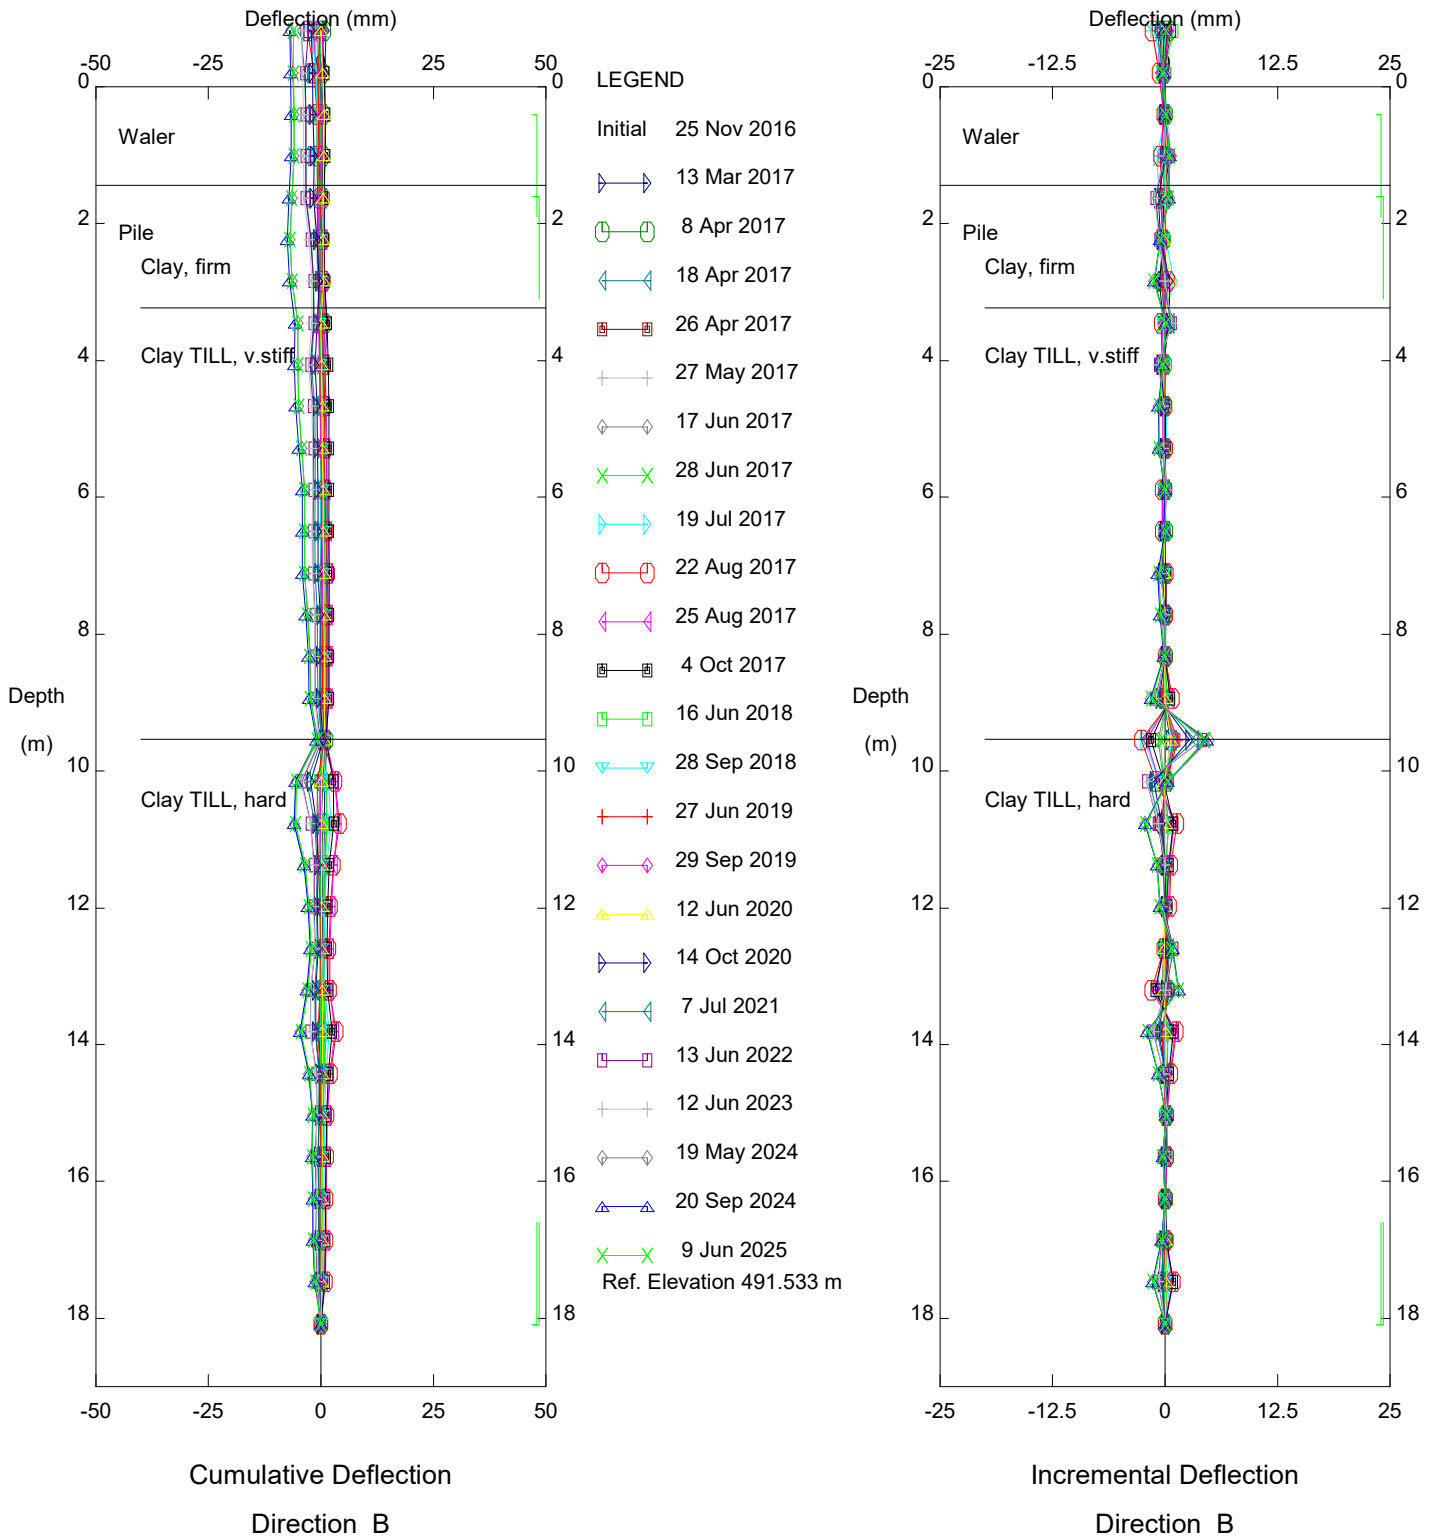
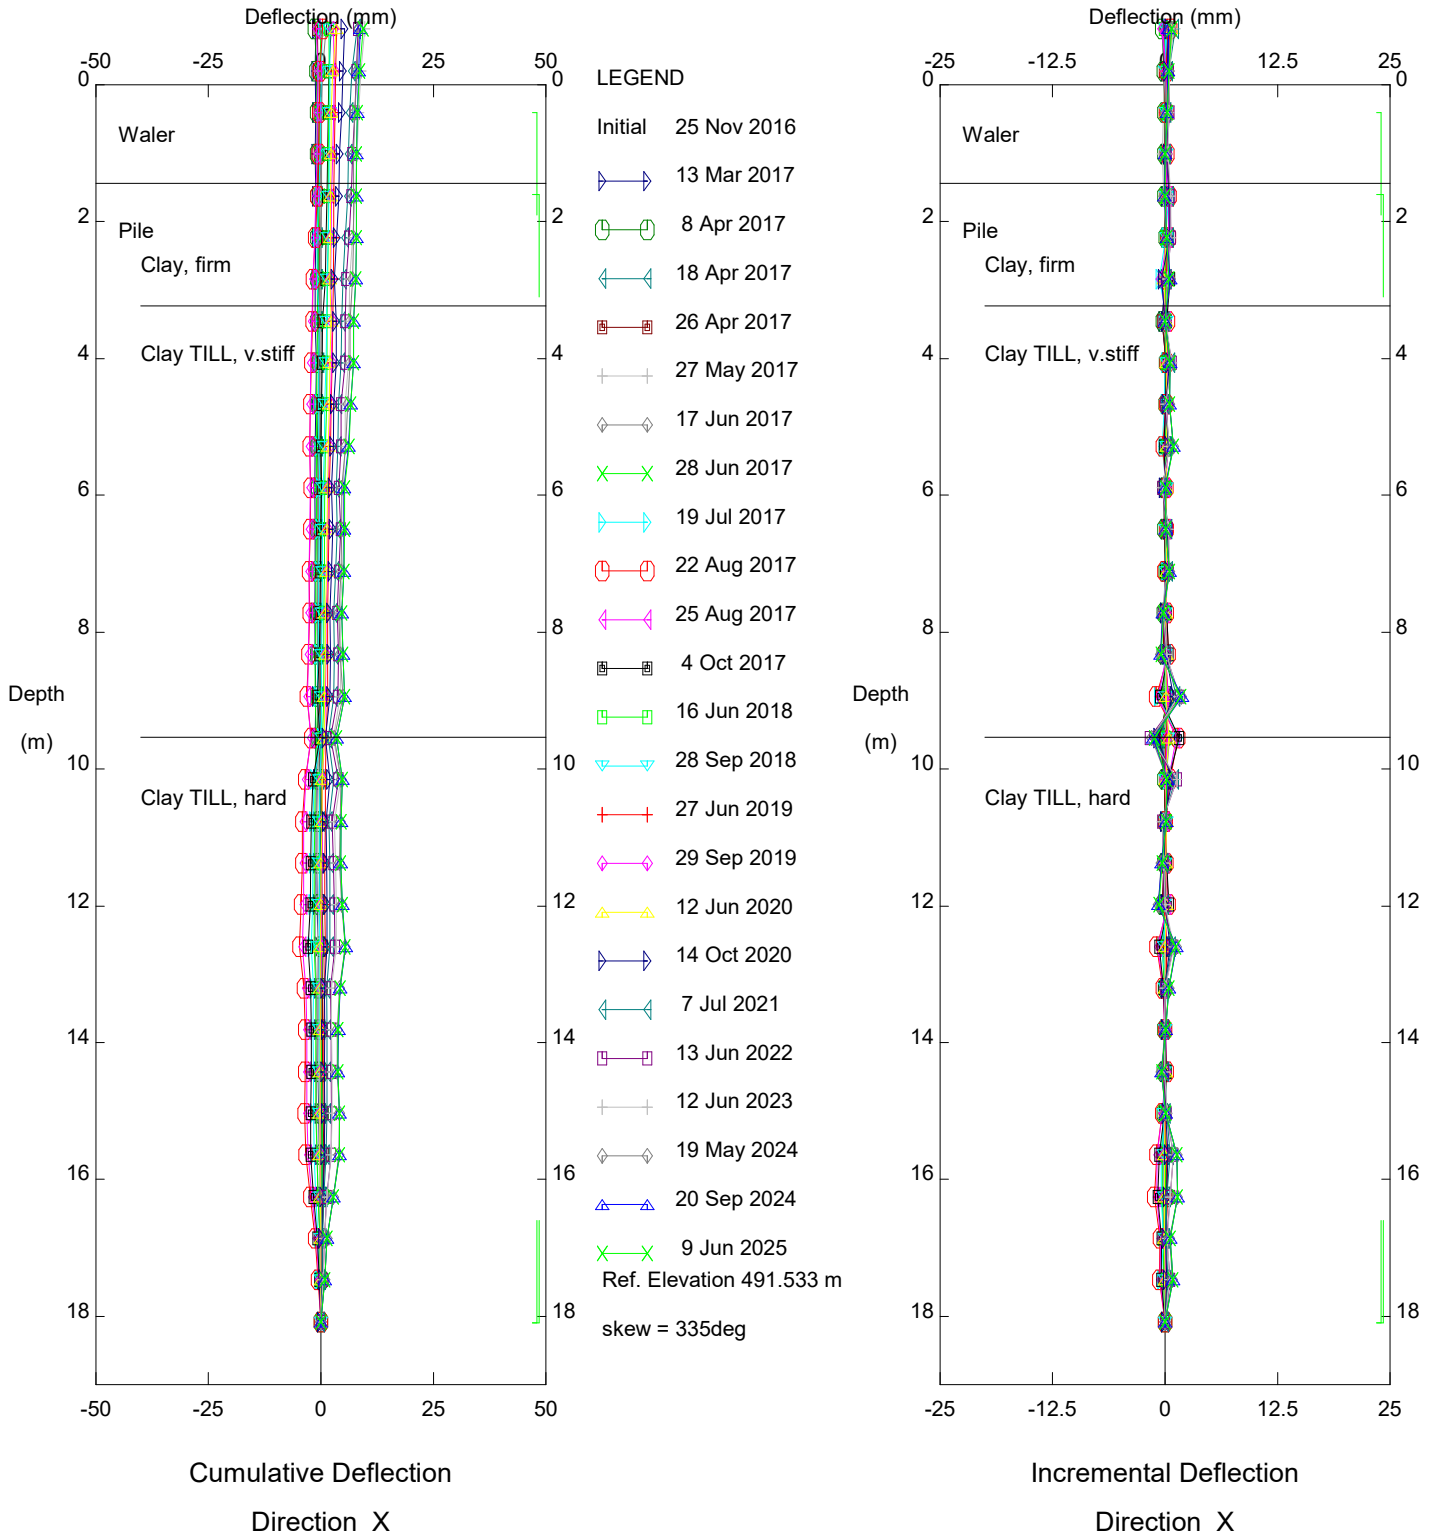
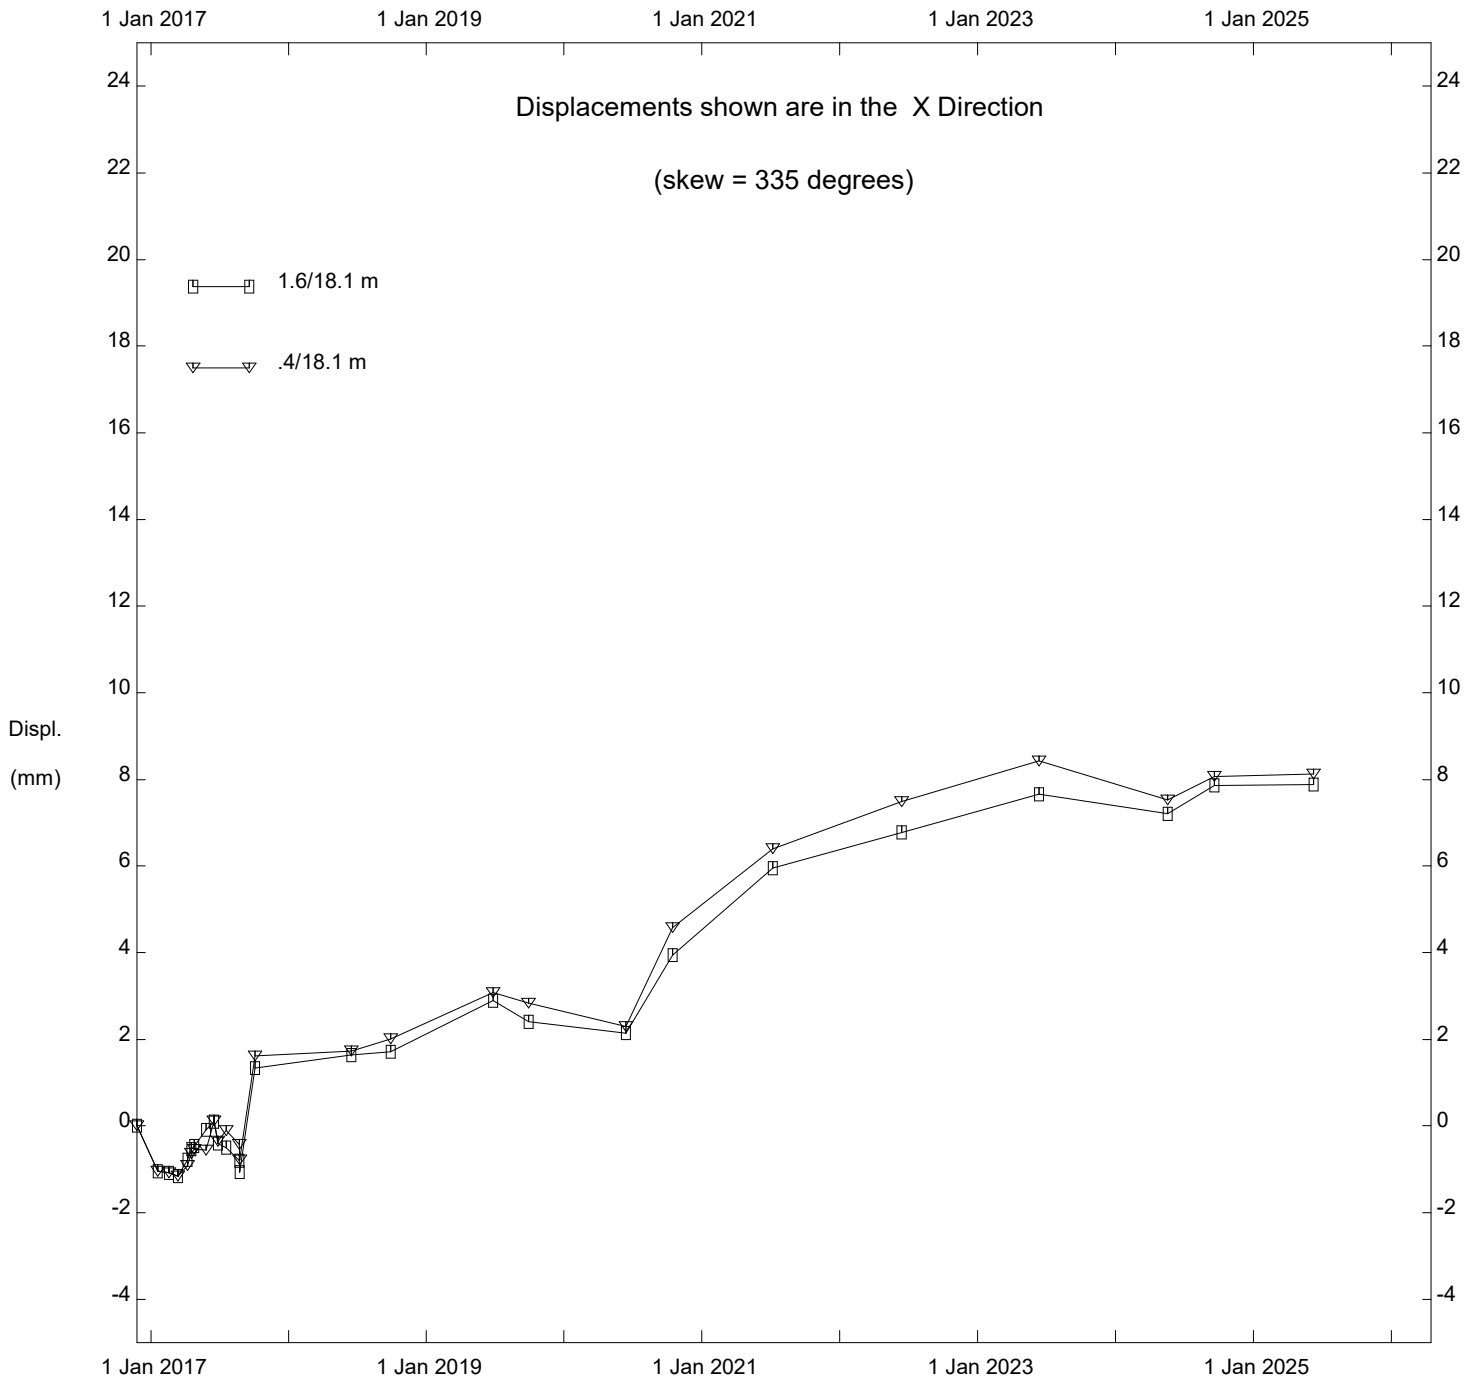
Peace River East Hill PH070, Inclinometer P116

SI-P116, installed in Pile 116, showed a rate of movement of less than 0.1 mm/yr over both the length of the pile and over the combined length of the pile and waler since the fall of 2024 readings. Pile 116 has shown a total cumulative pile head movement of 7.9 mm in the downslope direction and a total cumulative movement of 8.1 mm in the downslope direction over the combined length of the pile and waler.

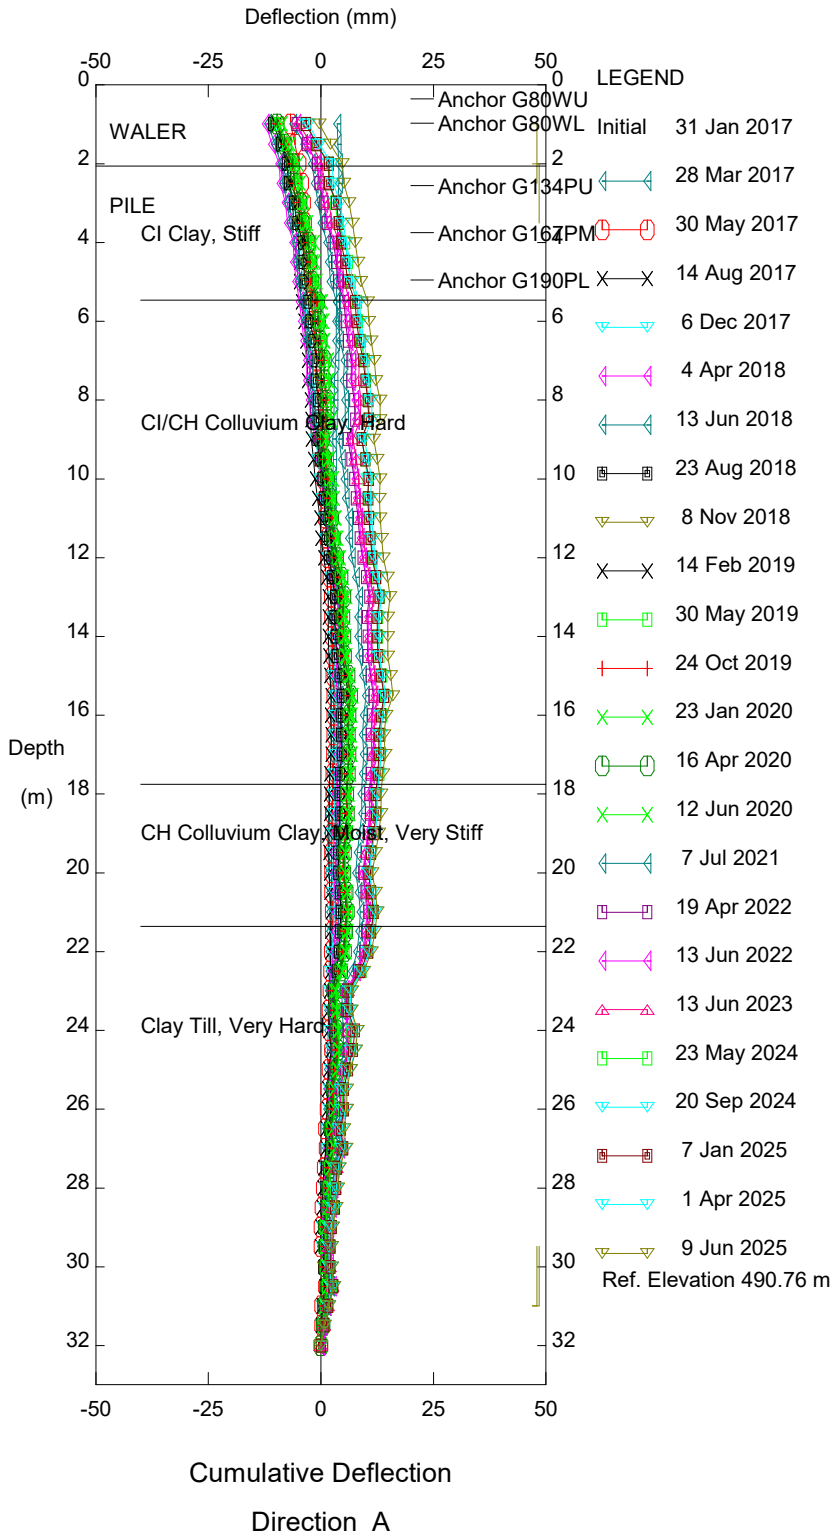
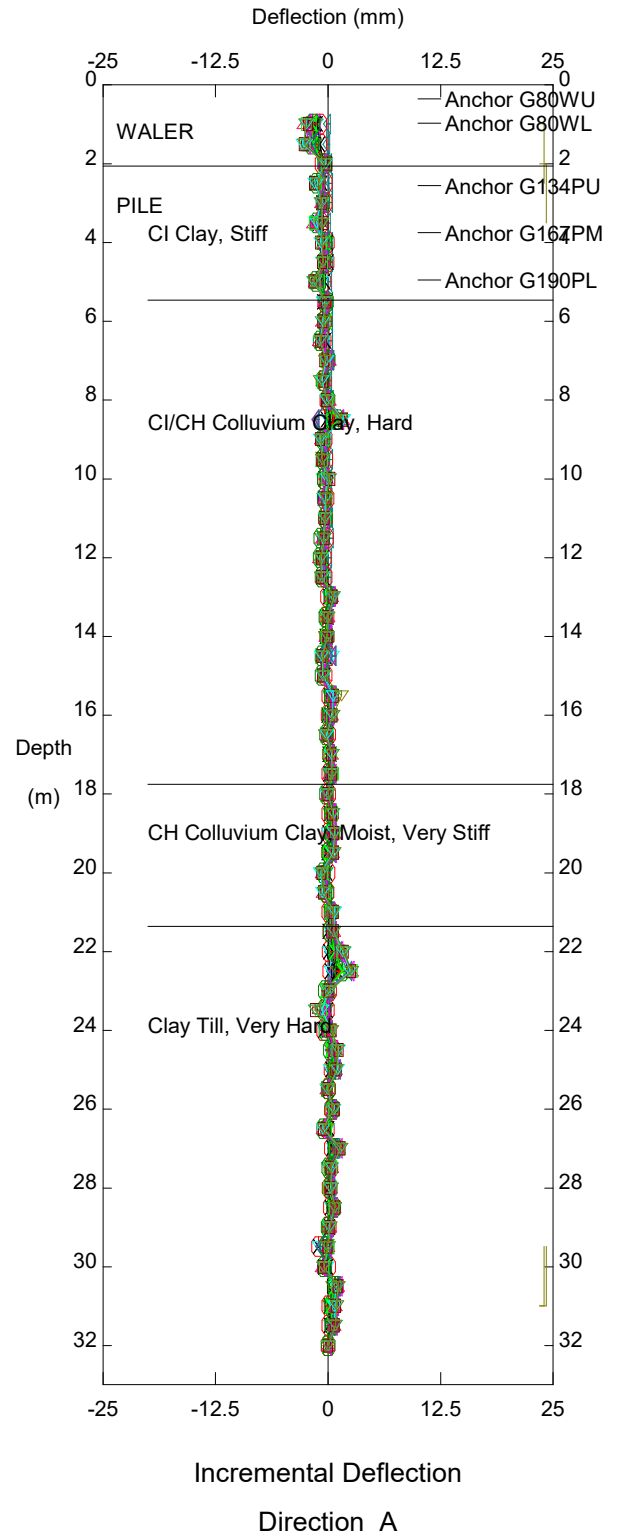
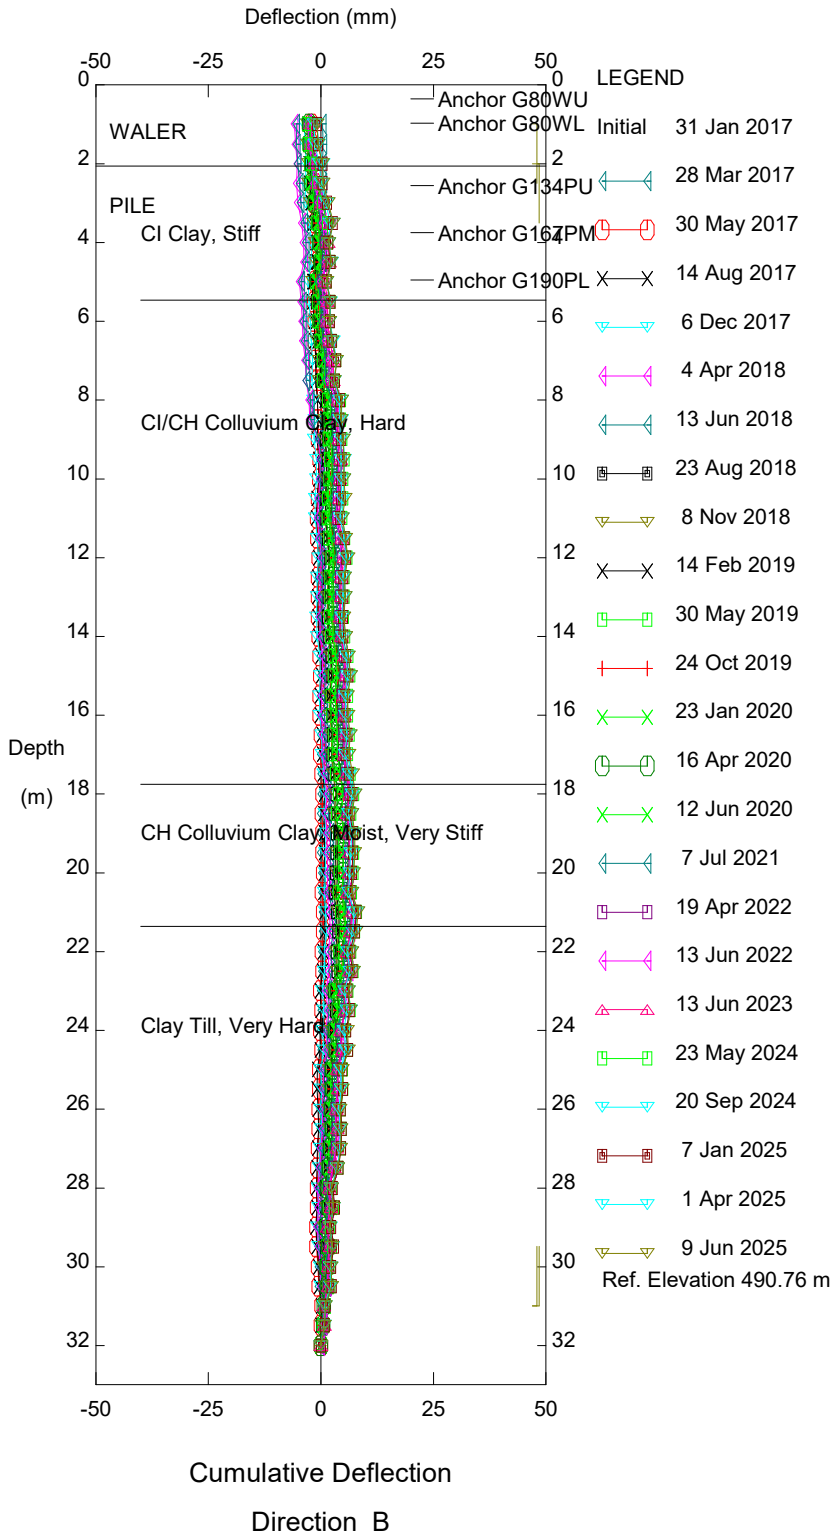
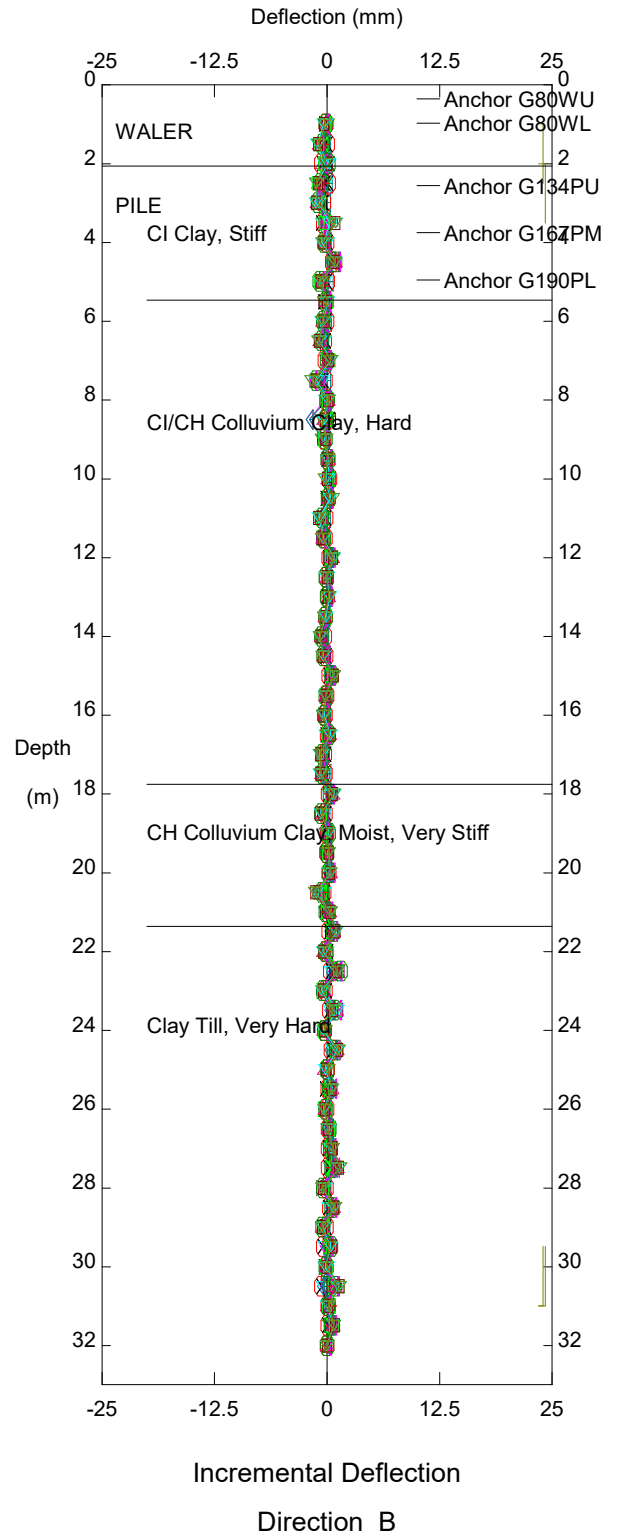
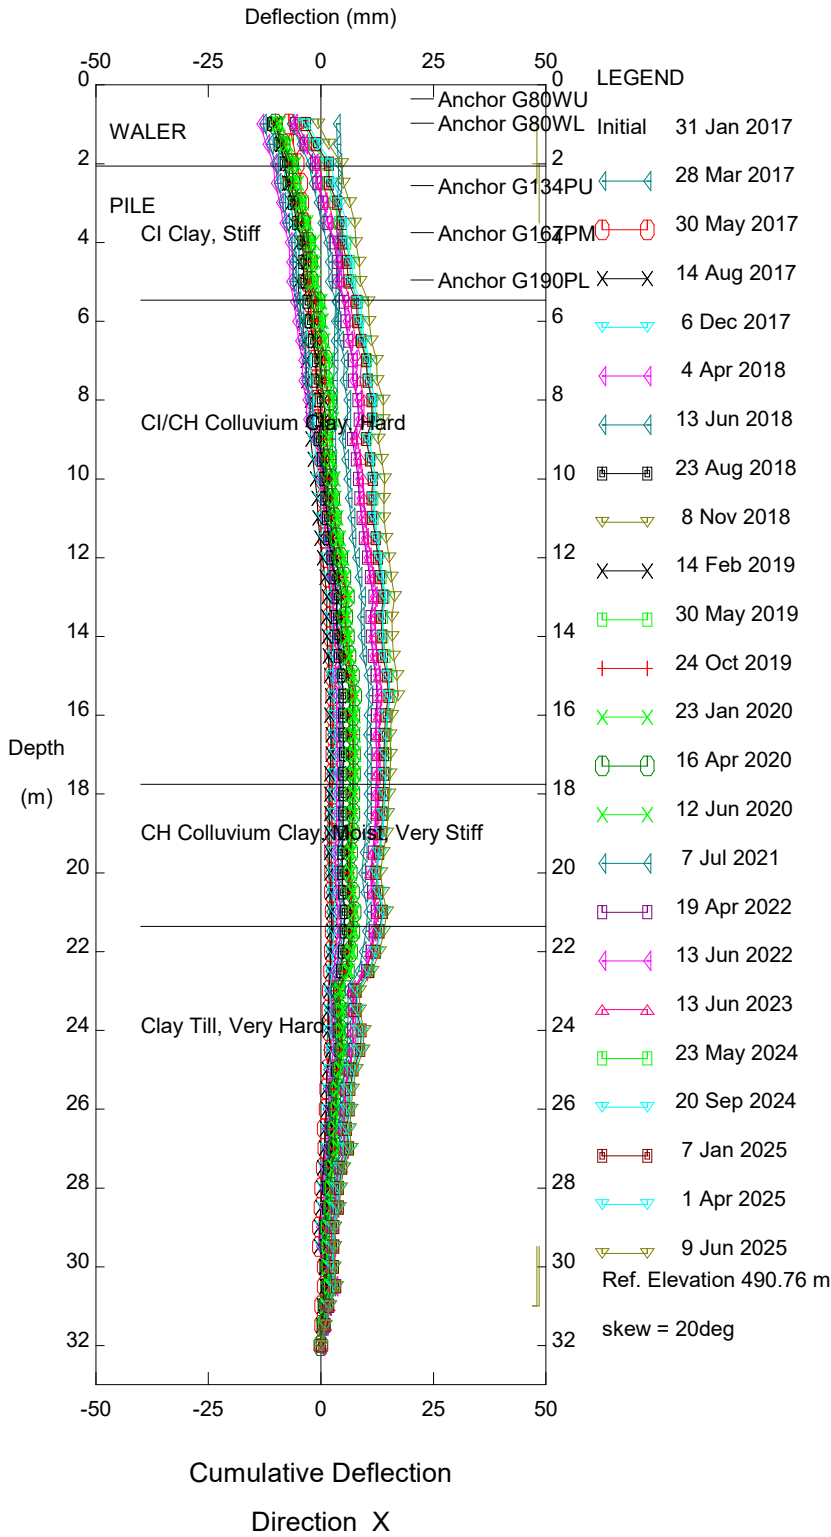
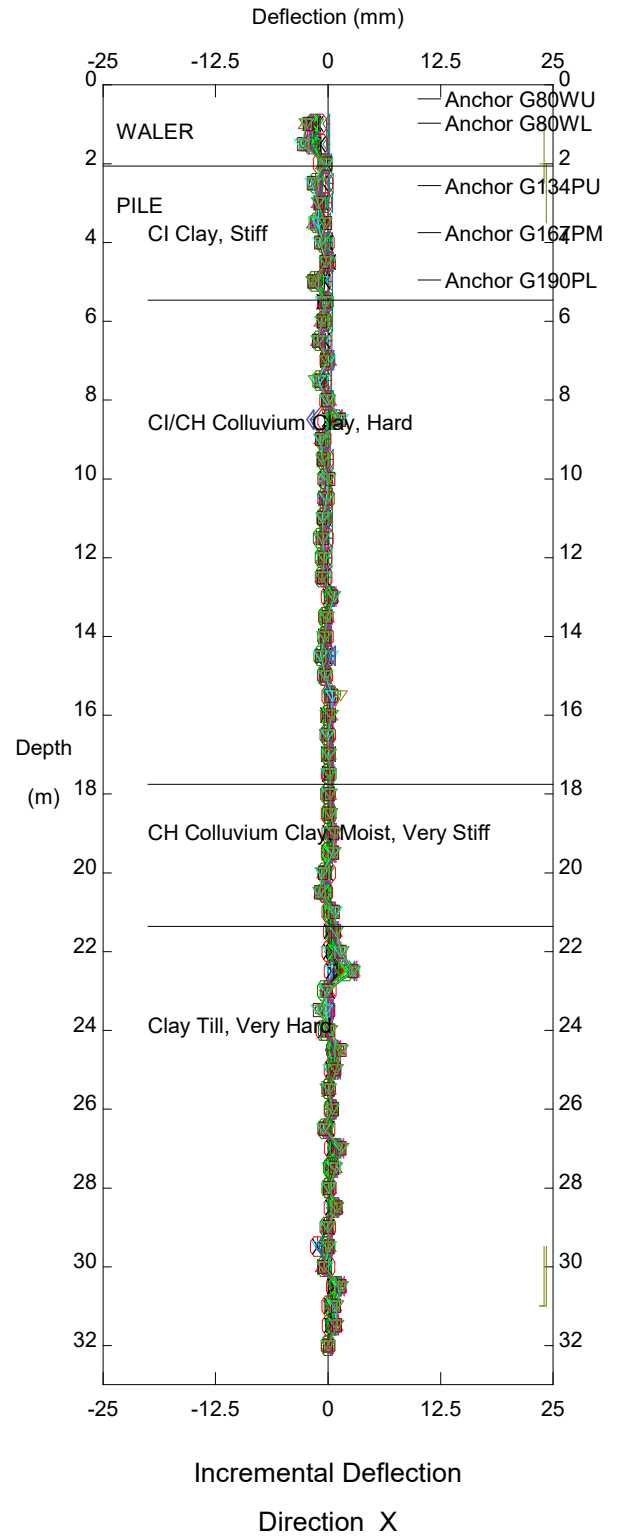
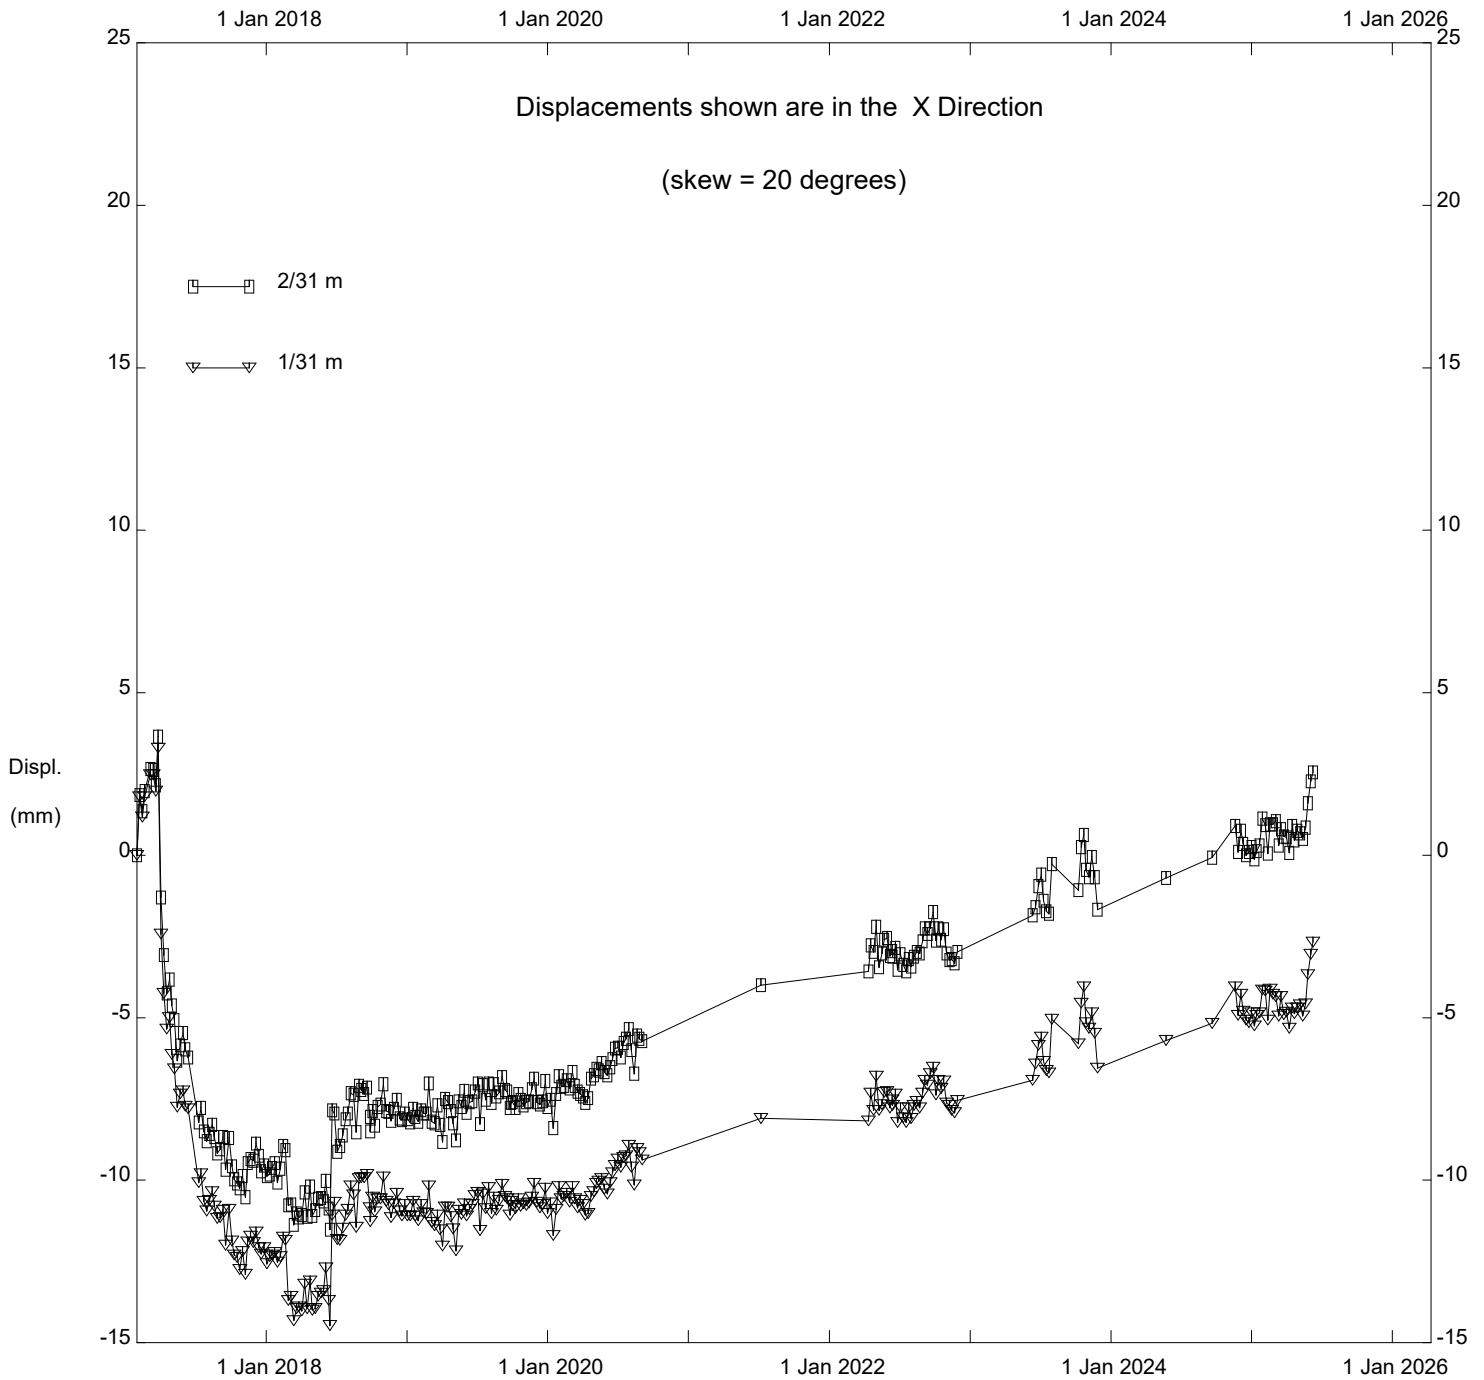
PH070 Hwy 2:60 East Hill, Inclinator SAA-P74

SAA-P74, installed in pile P74, showed an average rate of movement of 3.7 mm/yr in the downslope direction over the length of the pile and an average rate of movement of 3.5 mm/yr over the combined length of the pile and waler in the downslope direction since the fall of 2024 readings. SAAP74 has shown a total cumulative pile head movement of 2.5 mm in the downslope direction and a total cumulative movement of 2.7 mm in the upslope direction over the combined length of the pile and waler.

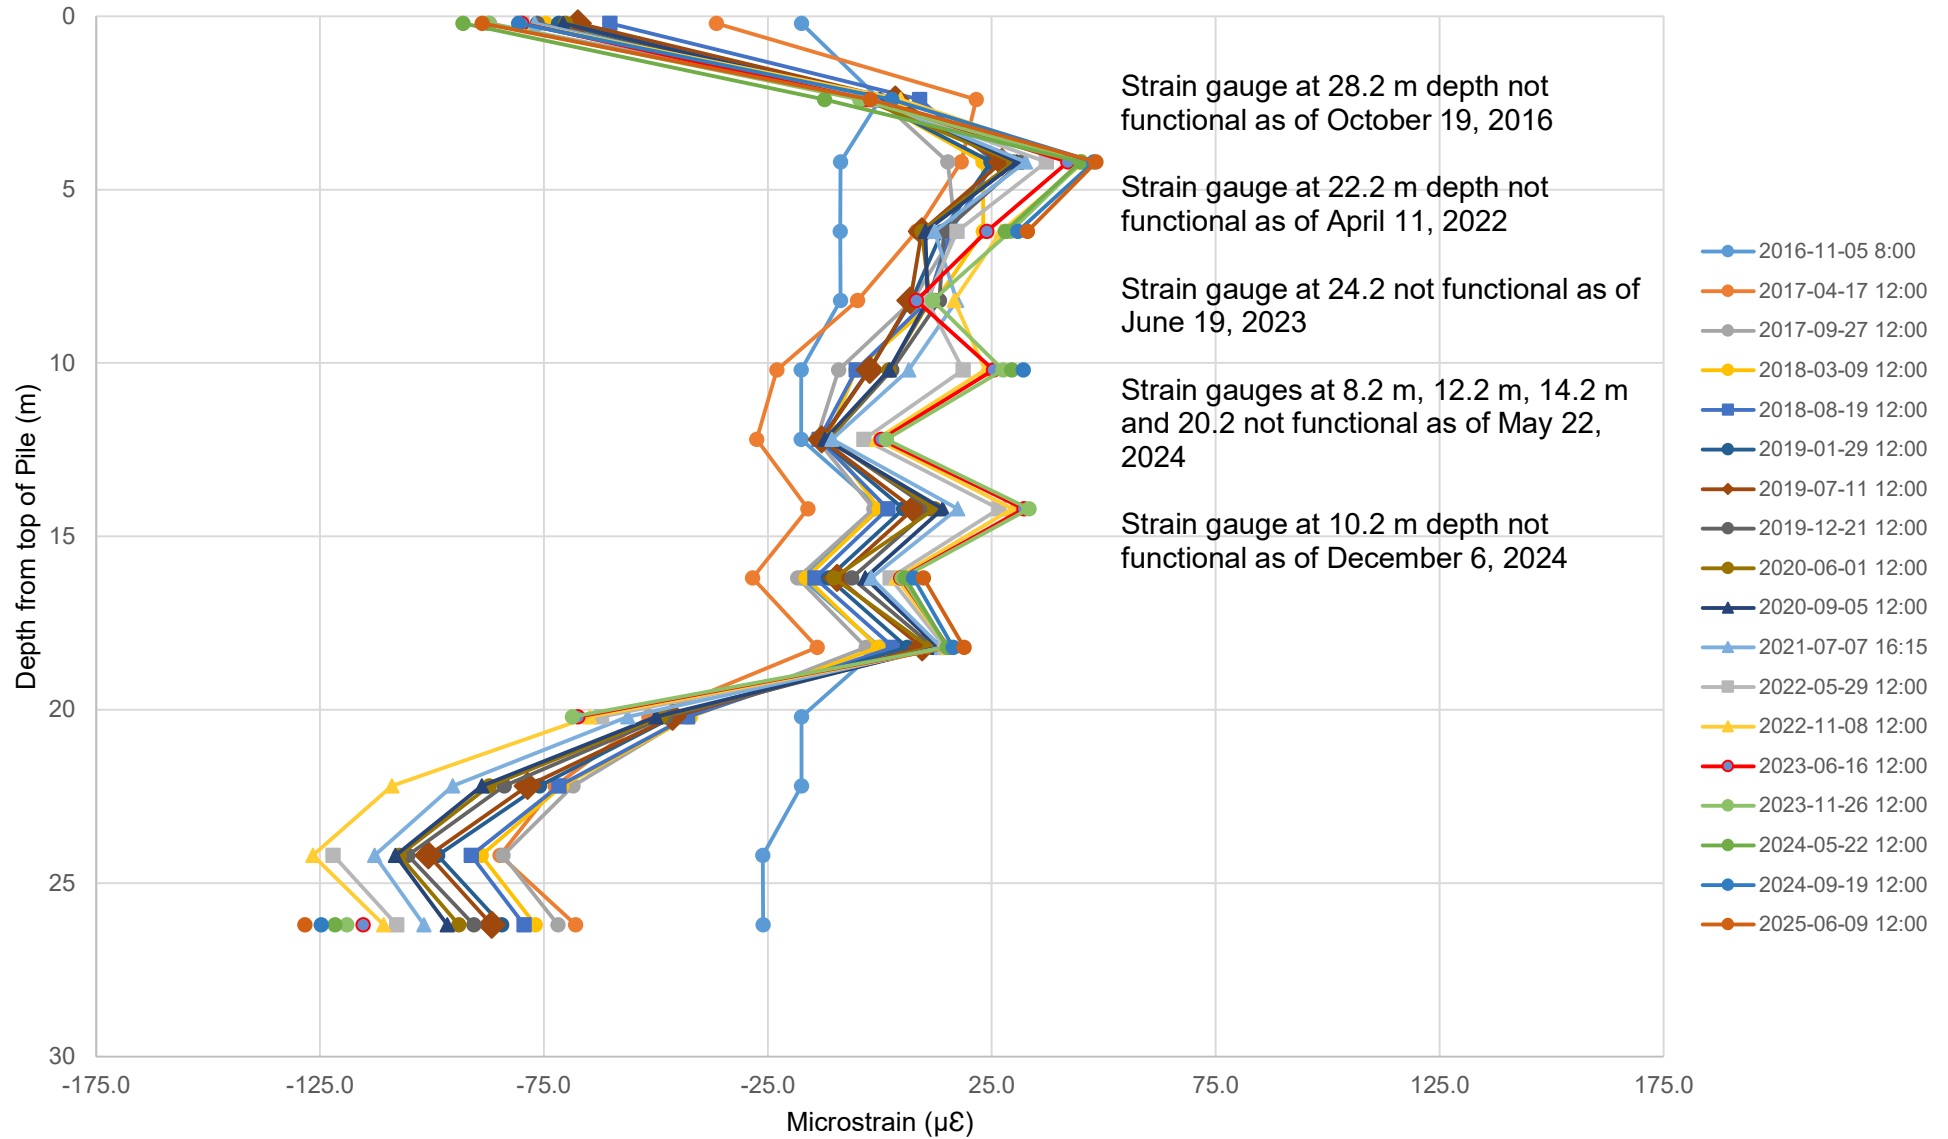
FIGURE PH070-1
HWY 2:60 PEACE RIVER EAST HILL RETAINING WALL SITE (km 33.84)
PILE P74 DOWNSLOPE SIDE STRAIN GAUGE VALUES VS DEPTH

The strain gauges generally showed small increases in negative (compressive) strain on the downslope pile face. On the downslope pile face, the strain gauges generally showed small decreases in negative (compressive) strain. Eight of the strain gauges on the downslope pile face were not functioning during the current readings which made it difficult to observe a trend in the strain. The maximum change in microstrain ($\mu\epsilon$) since the previous readings was 13.7 $\mu\epsilon$, measured at 2.4 m depth on the upslope pile face.

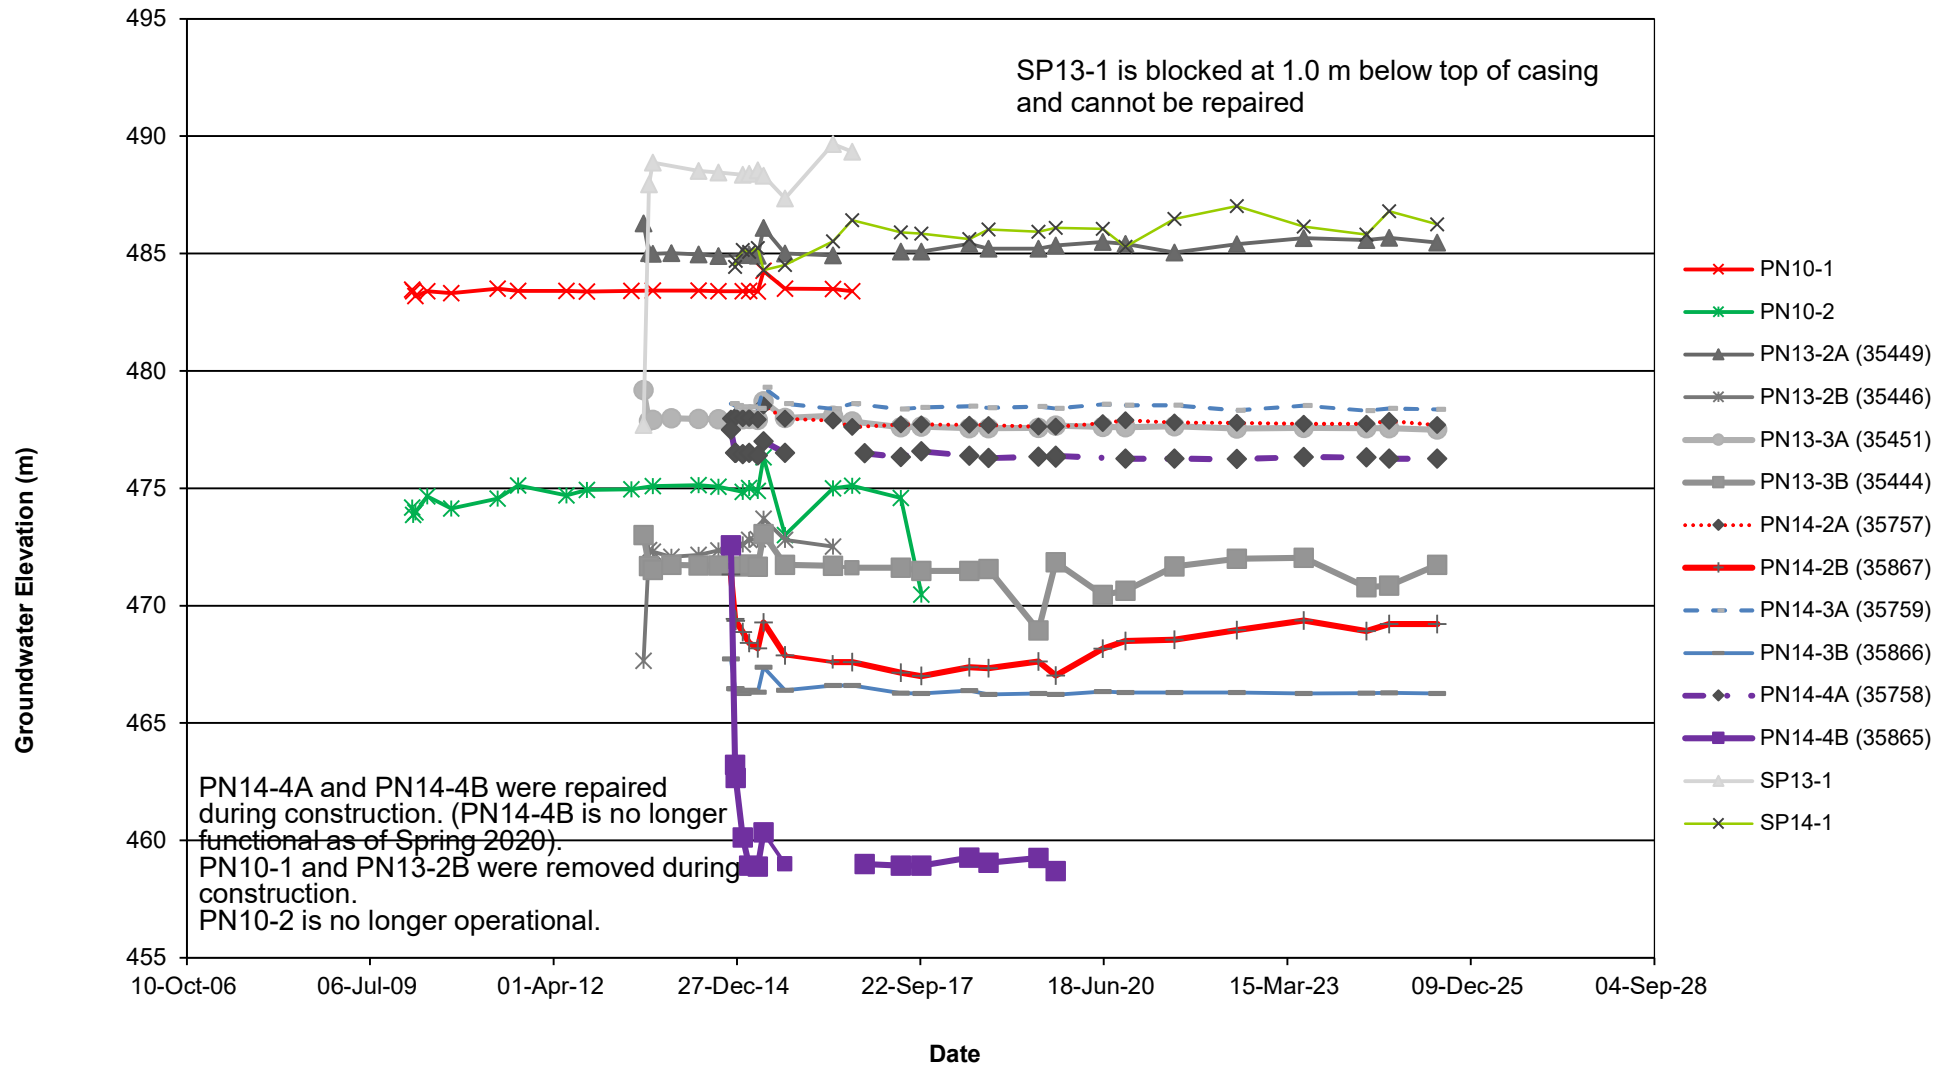
FIGURE PH070-3
HWY 2:60 PEACE RIVER EAST HILL RETAINING WALL SITE (km 33.84)
PIEZOMETRIC ELEVATIONS

Pneumatic piezometers PN13-2A, PN13-3A, PN14-2A, PN14-3A and PN14-3B showed decreases in groundwater level of 0.20 m, 0.05 m, 0.19 m, 0.03 m, and 0.02 m, respectively, since the fall of 2024 readings. PN14-3B and PN14-4A showed increases in groundwater level of 0.89 m and 0.01m, respectively, since the fall of 2024 readings. PN14-2B showed no change in groundwater level.

<p>Overall, the piezometers have shown relatively stable groundwater levels for the past several years. These groundwater levels are within historical maximums.</p> <p>LOAD CELLS</p> <p>The load cells generally showed increases in measured load compared to the fall of 2024 readings, except for in G182PL, G188PL, and G202PL, ranging from an increase of 0.75 kN in anchor G150PU to an increase of 7.19 kN in G40WU. Between the current and fall of 2024 readings, G40WU, G58WU, G59WL, G80WU, G80WL, G134PU, G167PM, G190PL, and G202PL registered their maximum recorded loads. G182PL, G188PL, and G202PL showed decreases in measured load of 1.22 kN, 0.73 kN, and 0.49 kN, respectively.</p> <p>It should be noted that channels on the load cell datalogger were functioning inconsistently since December 6, 2024, and only certain time stamps contained useable readings. Values reported were for the most recent functional date for each individual load cell.</p> <p>Wall Section 2: Anchors G39WL and G40WU currently show a trend of gradually increasing load. G39WL and G40WU are currently 9.7 kN and 11.8 kN, respectively, above their SLS design loads.</p> <p>Wall Section 3A and 3B: Anchor G58WU shows a trend of slowly increasing loads; the current load is currently 21.0 kN above the SLS design load. Anchor G59WL, G118PU, G102WU, G102WL and G150PU have not shown significant changes in load since about 2017 and are all below SLS design loads.</p> <p>Wall Section 4: Anchor G190PL, in the bottom (fifth) row of anchors, shows a trend of increasing load. This is not a concern currently as the design of the wall assumed that the anchors installed through the piles in this wall section will pick up load over time. Anchors G134PU, and G168PM show a trend of small load increases over time. Currently the loads on G134PU and G168PM are well below the design SLS loads. G80WL is currently above its SLS design load by 27.67 kN.</p> <p>Anchors G182PL, G188PL and G202PL were installed as 'stiff anchors' that were left with some slack to allow the piles to deform before the anchors pick up load. These load cells indicate current loads ranging from 12.37 kN to 15.90 kN. These anchors have not shown significant changes in the loads since the end of construction, suggesting that there may still be some slack at the nut in these anchors.</p> <p>The load cells on G80WU and G80WL are showing loads that are 59.34 kN and 27.67 kN above SLS design load, respectively. However, these anchors were intentionally locked off at a higher load than the SLS load during construction, with the expectation that they would slacken over time.</p>
