Site Number	Location	Name	Hwy	km
PH070	HWY 2:60 C1 33.840	East Hill Retaining Wall Site	2:60	Km 33.84
Legal Description: 4-27-83-21 W5		UTM Co-ordinates		
		11U E 485285	N	6230649

Current Monitoring:	9-June-2025	Previous Monitoring	20-Sep-2024
Instruments Read By:	Mr. Niraj Regmi, G.I.T and Mr. Godfred Etiendem, of Thurber

**ALBERTA TRANSPORTATION AND ECONOMIC CORRIDORS GRMP (CON0022164)
PEACE REGION (PEACE RIVER DISTRICT)
INSTRUMENTATION MONITORING RESULTS**

SPRING 2025

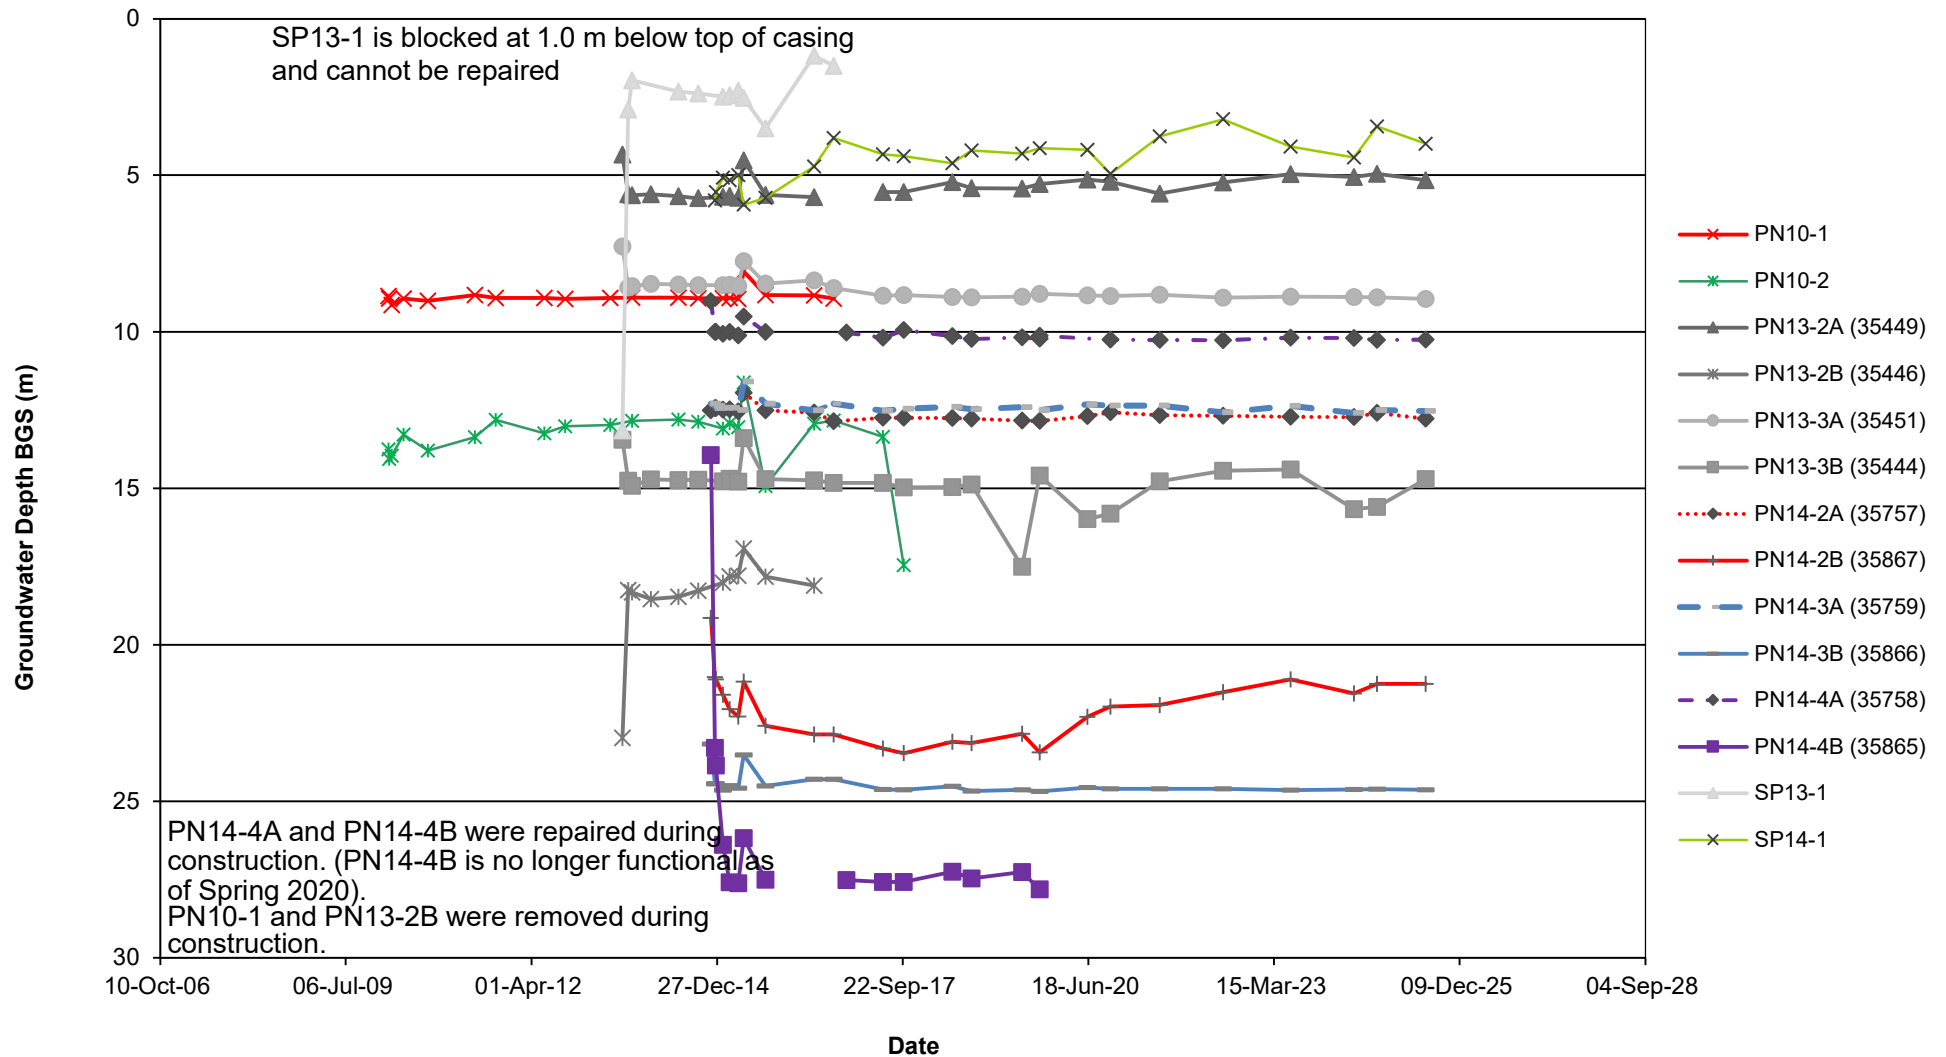
FIGURE PH070-4
HWY 2:60 PEACE RIVER EAST HILL RETAINING WALL SITE (km 33.84)
PIEZOMETRIC DEPTHS

Pneumatic piezometers PN13-2A, PN13-3A, PN14-2A, PN14-3A and PN14-3B showed decreases in groundwater level of 0.20 m, 0.05 m, 0.19 m, 0.03 m, and 0.02 m, respectively, since the fall of 2024 readings. PN14-3B and PN14-4A showed increases in groundwater level of 0.89 m and 0.01m, respectively, since the fall of 2024 readings. PN14-2B showed no change in groundwater level.

<p>Overall, the piezometers have shown relatively stable groundwater levels for the past several years. These groundwater levels are within historical maximums.</p> <p>LOAD CELLS</p> <p>The load cells generally showed increases in measured load compared to the fall of 2024 readings, except for in G182PL, G188PL, and G202PL, ranging from an increase of 0.75 kN in anchor G150PU to an increase of 7.19 kN in G40WU. Between the current and fall of 2024 readings, G40WU, G58WU, G59WL, G80WU, G80WL, G134PU, G167PM, G190PL, and G202PL registered their maximum recorded loads. G182PL, G188PL, and G202PL showed decreases in measured load of 1.22 kN, 0.73 kN, and 0.49 kN, respectively.</p> <p>It should be noted that channels on the load cell datalogger were functioning inconsistently since December 6, 2024, and only certain time stamps contained useable readings. Values reported were for the most recent functional date for each individual load cell.</p> <p>Wall Section 2: Anchors G39WL and G40WU currently show a trend of gradually increasing load. G39WL and G40WU are currently 9.7 kN and 11.8 kN, respectively, above their SLS design loads.</p> <p>Wall Section 3A and 3B: Anchor G58WU shows a trend of slowly increasing loads; the current load is currently 21.0 kN above the SLS design load. Anchor G59WL, G118PU, G102WU, G102WL and G150PU have not shown significant changes in load since about 2017 and are all below SLS design loads.</p> <p>Wall Section 4: Anchor G190PL, in the bottom (fifth) row of anchors, shows a trend of increasing load. This is not a concern currently as the design of the wall assumed that the anchors installed through the piles in this wall section will pick up load over time. Anchors G134PU, and G168PM show a trend of small load increases over time. Currently the loads on G134PU and G168PM are well below the design SLS loads. G80WL is currently above its SLS design load by 27.67 kN.</p> <p>Anchors G182PL, G188PL and G202PL were installed as 'stiff anchors' that were left with some slack to allow the piles to deform before the anchors pick up load. These load cells indicate current loads ranging from 12.37 kN to 15.90 kN. These anchors have not shown significant changes in the loads since the end of construction, suggesting that there may still be some slack at the nut in these anchors.</p> <p>The load cells on G80WU and G80WL are showing loads that are 59.34 kN and 27.67 kN above SLS design load, respectively. However, these anchors were intentionally locked off at a higher load than the SLS load during construction, with the expectation that they would slacken over time.</p>
