ALBERTA TRANSPORTATION AND  
ECONOMIC CORRIDORS GRMP  
PEACE REGION – (PEACE RIVER DISTRICT)  
INSTRUMENTATION MONITORING - FALL 2025

Site Number	Location	Name	Hwy	km
PH009-3	Hwy 684:02 km 30.99, Town of Peace River	Shaftesbury Trail - Shop Slide	684:02	30.9-31.1
			Old 2:02	0.0-0.4
Legal Description:		UTM Co-ordinates		
4-31-83-21 W5		11V    E    480321	N    6232126

<b>Current Monitoring:</b>	26-Sep-2025	<b>Previous Monitoring</b>	8-June-2025
<b>Instruments Read By:</b>	Mr. Niraj Regmi, G.I.T. and Mr. Angelo Castillo, of Thurber

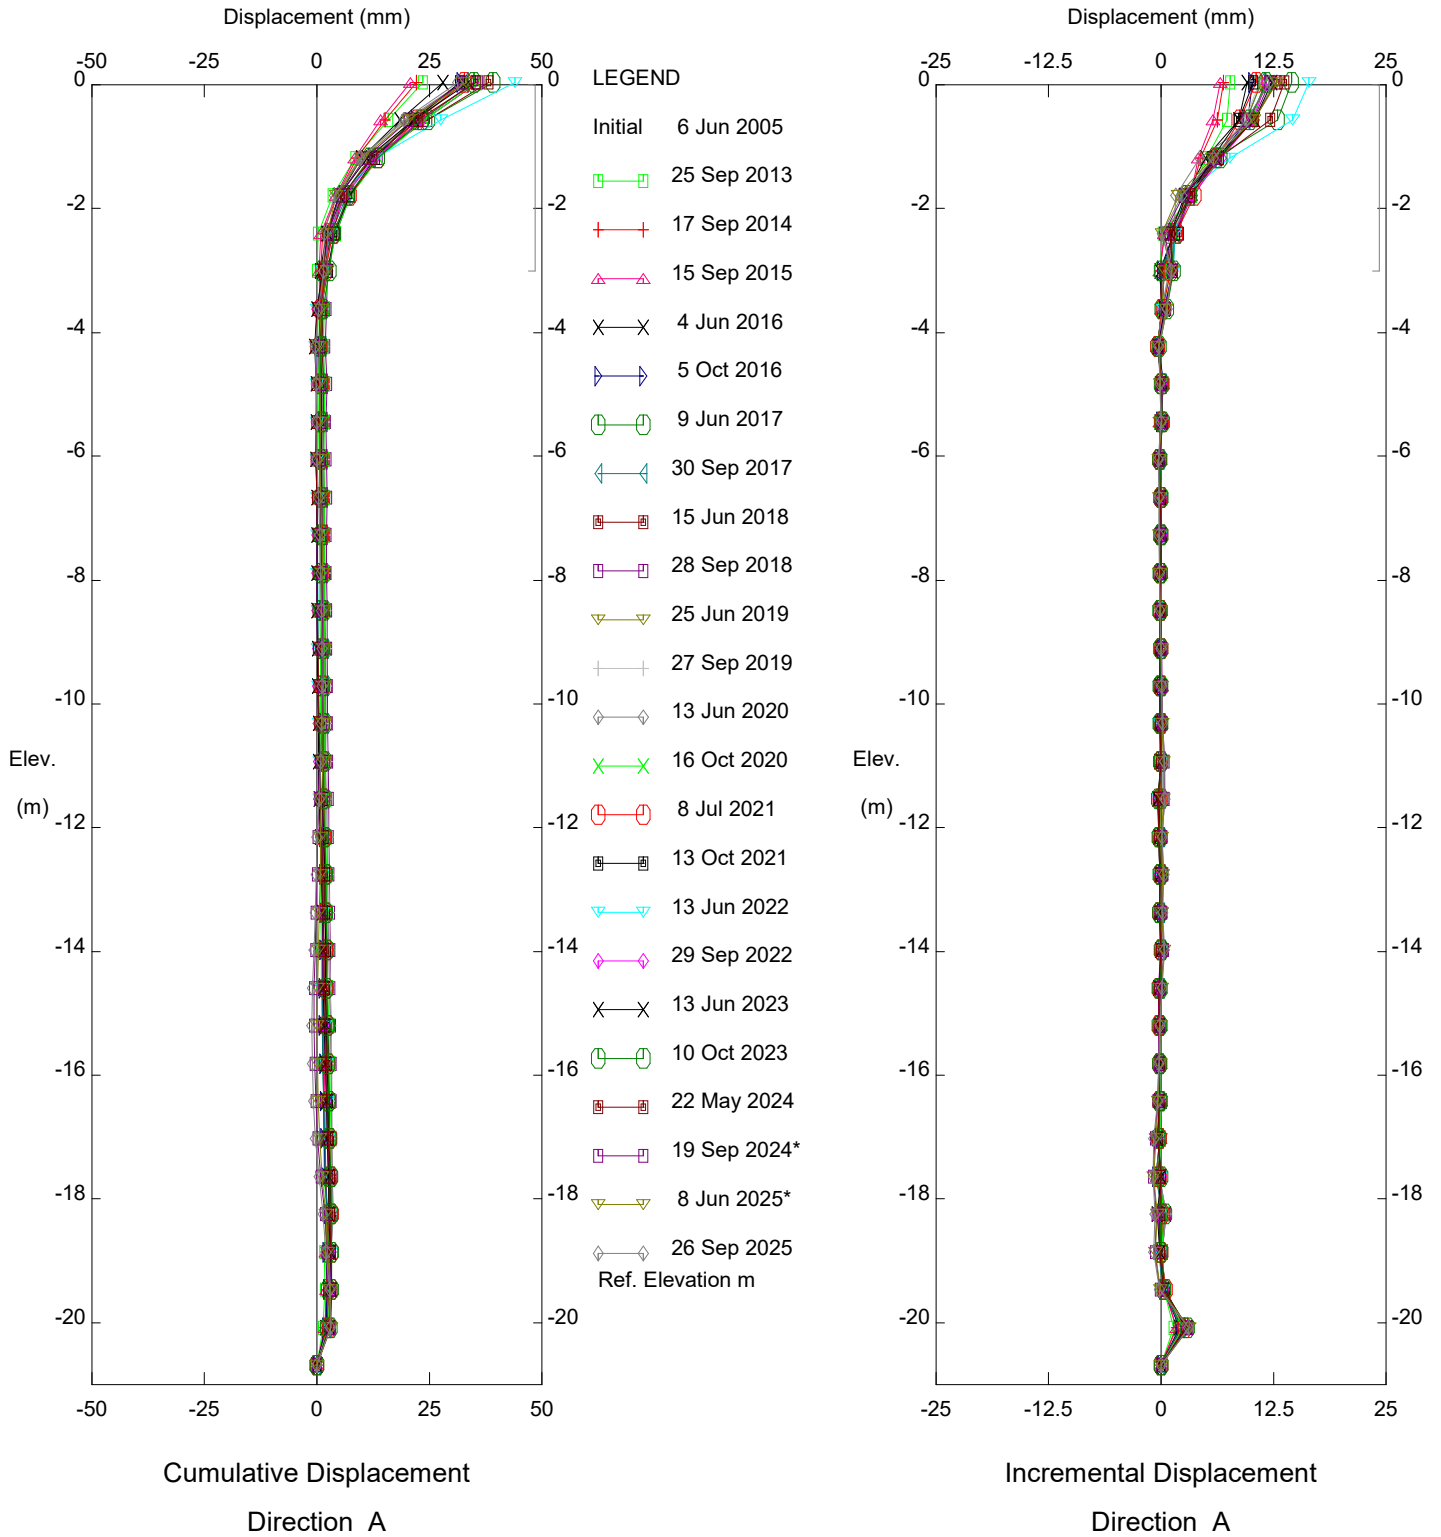
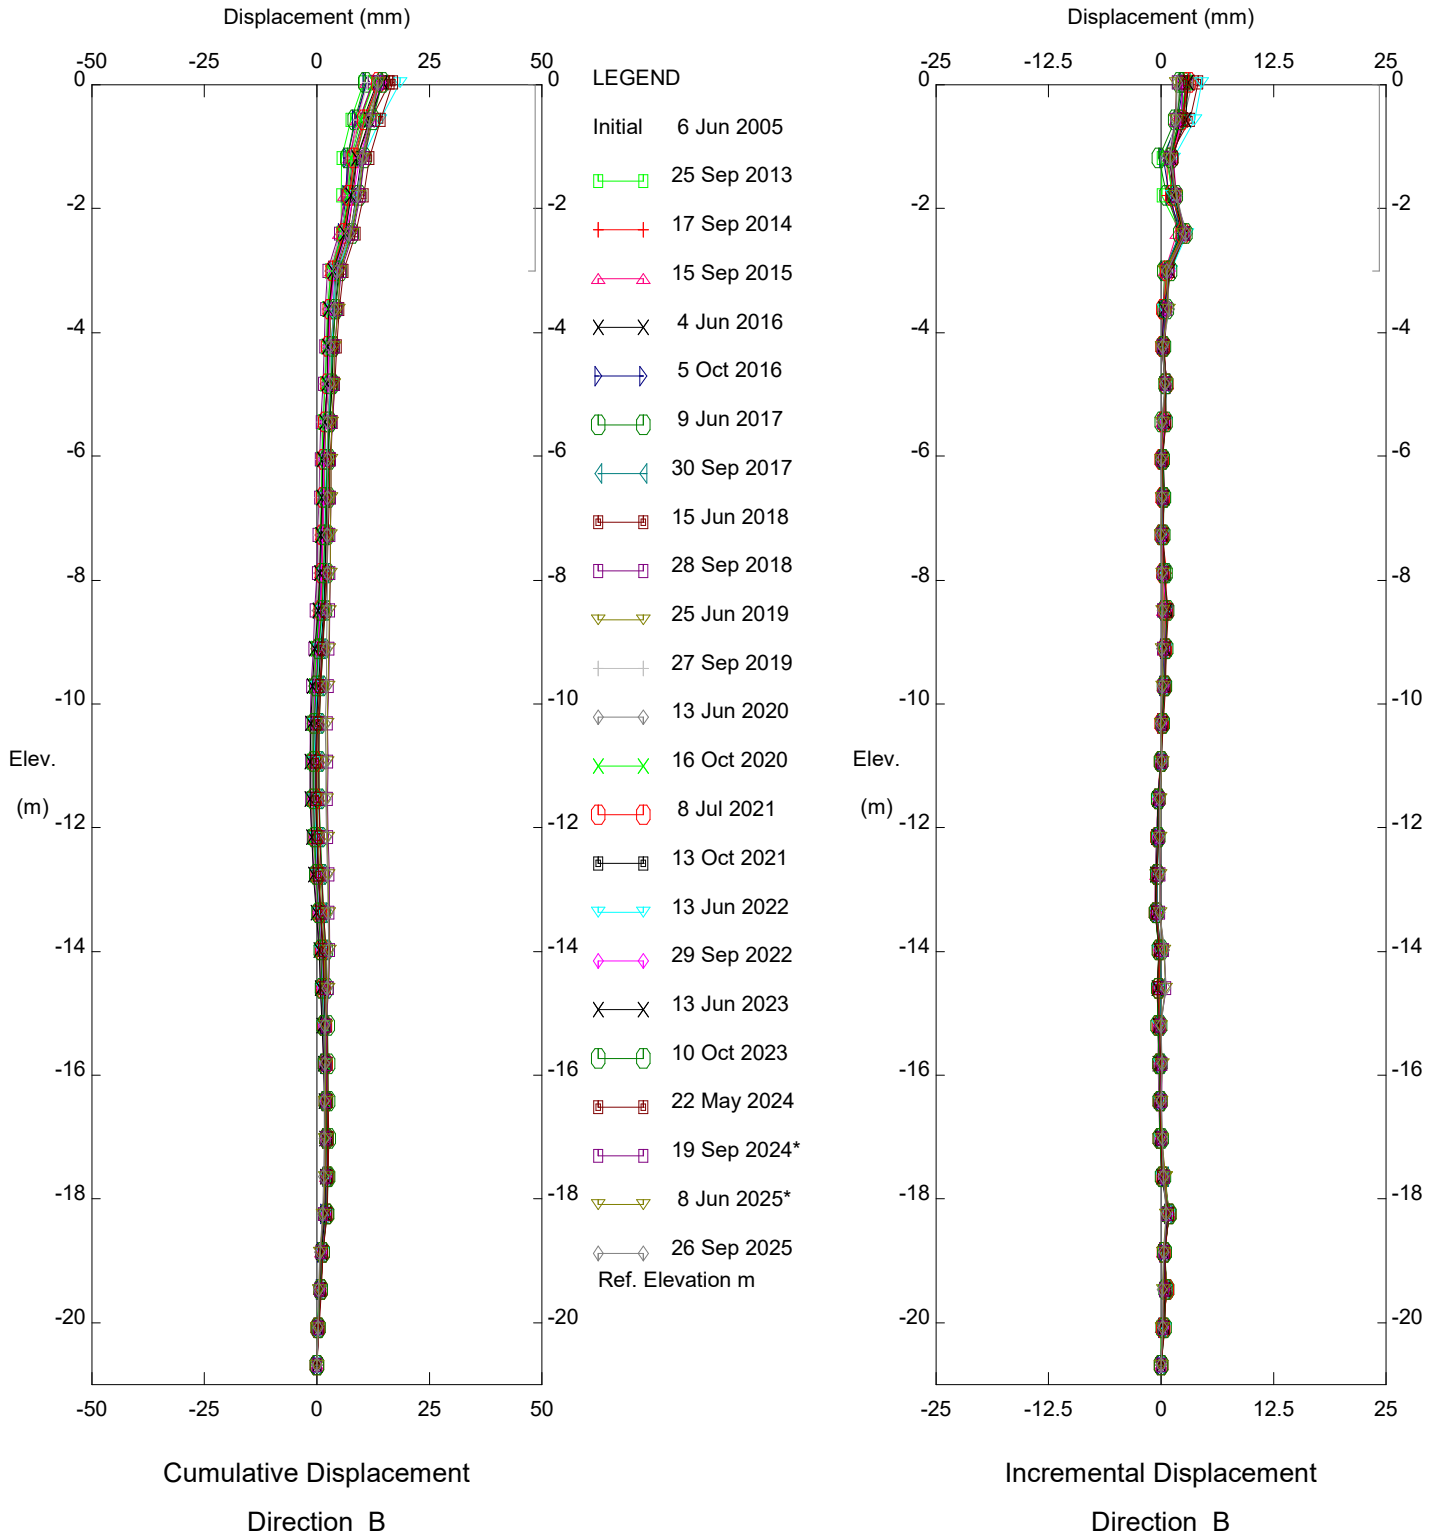
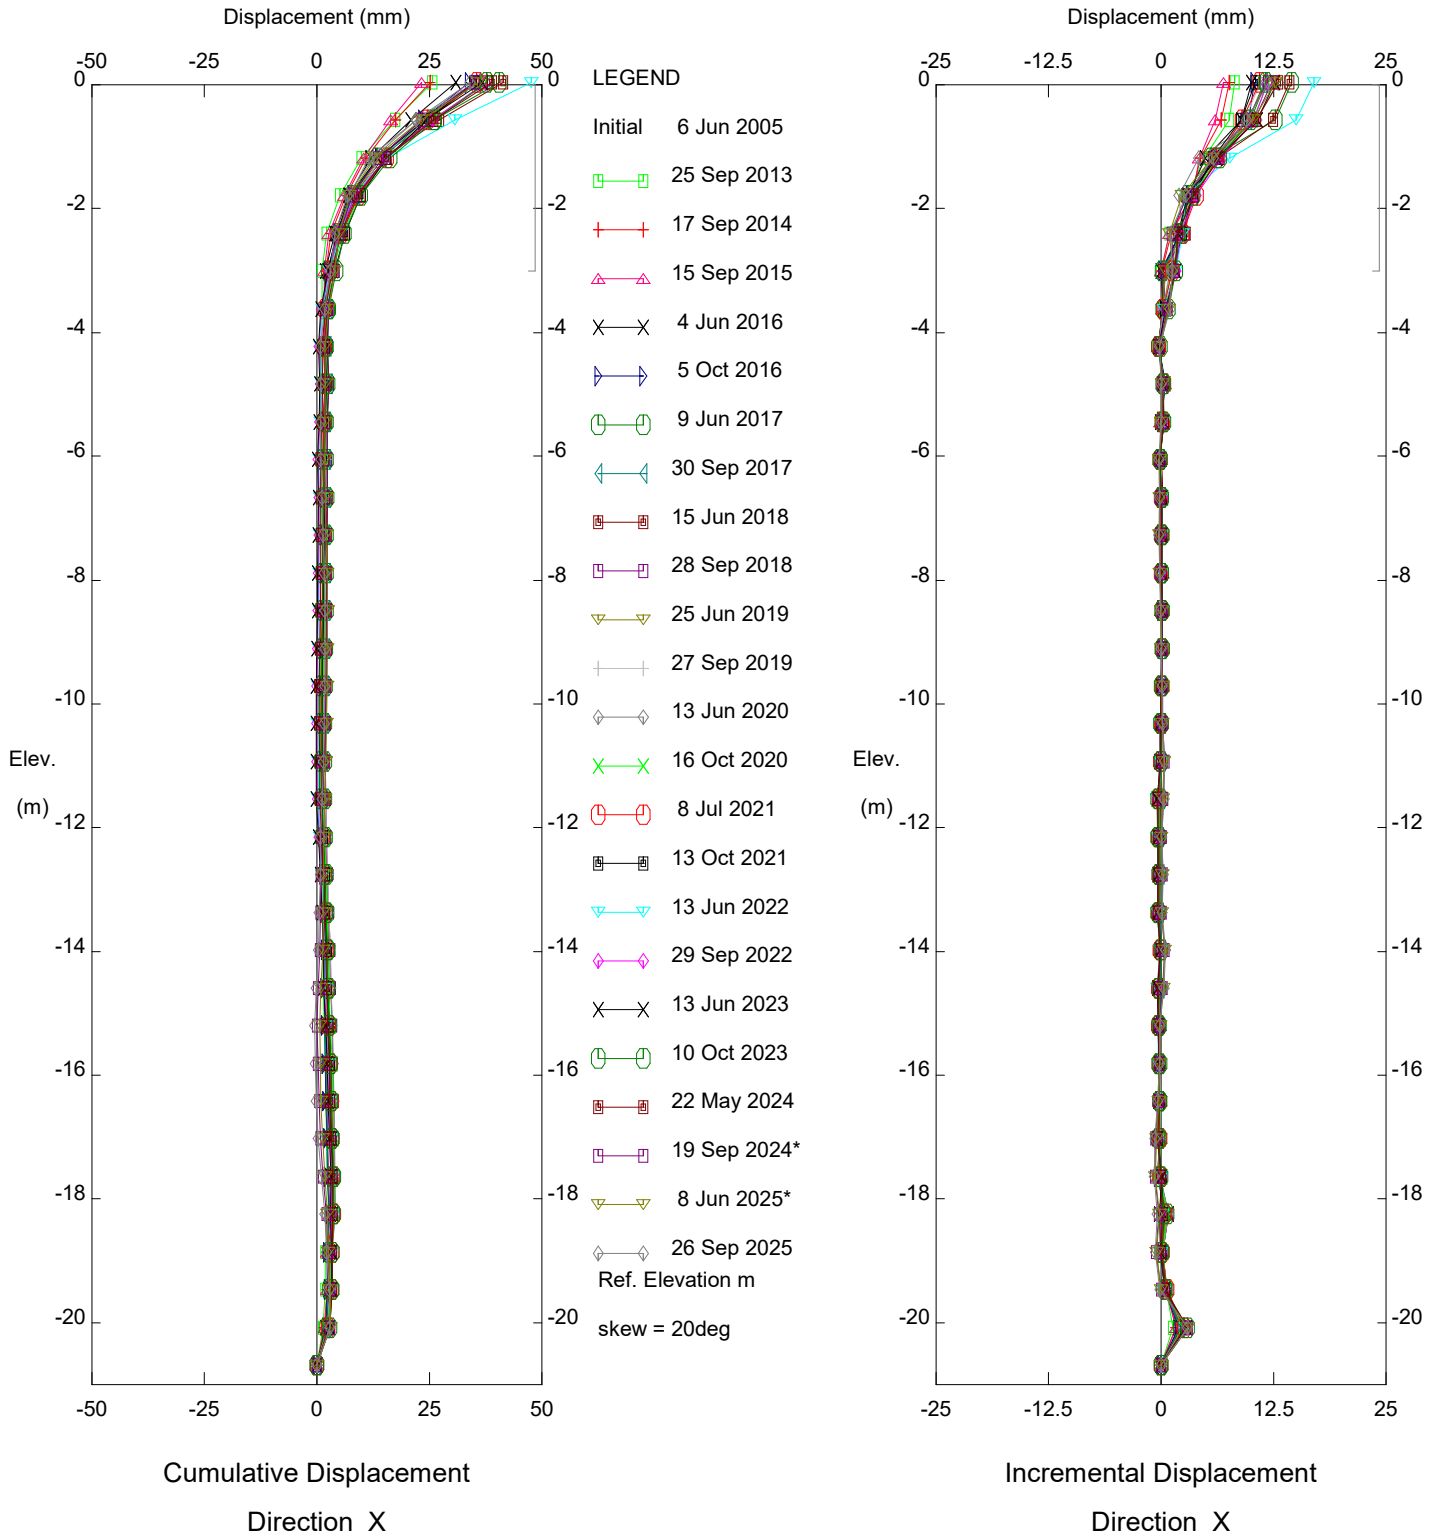
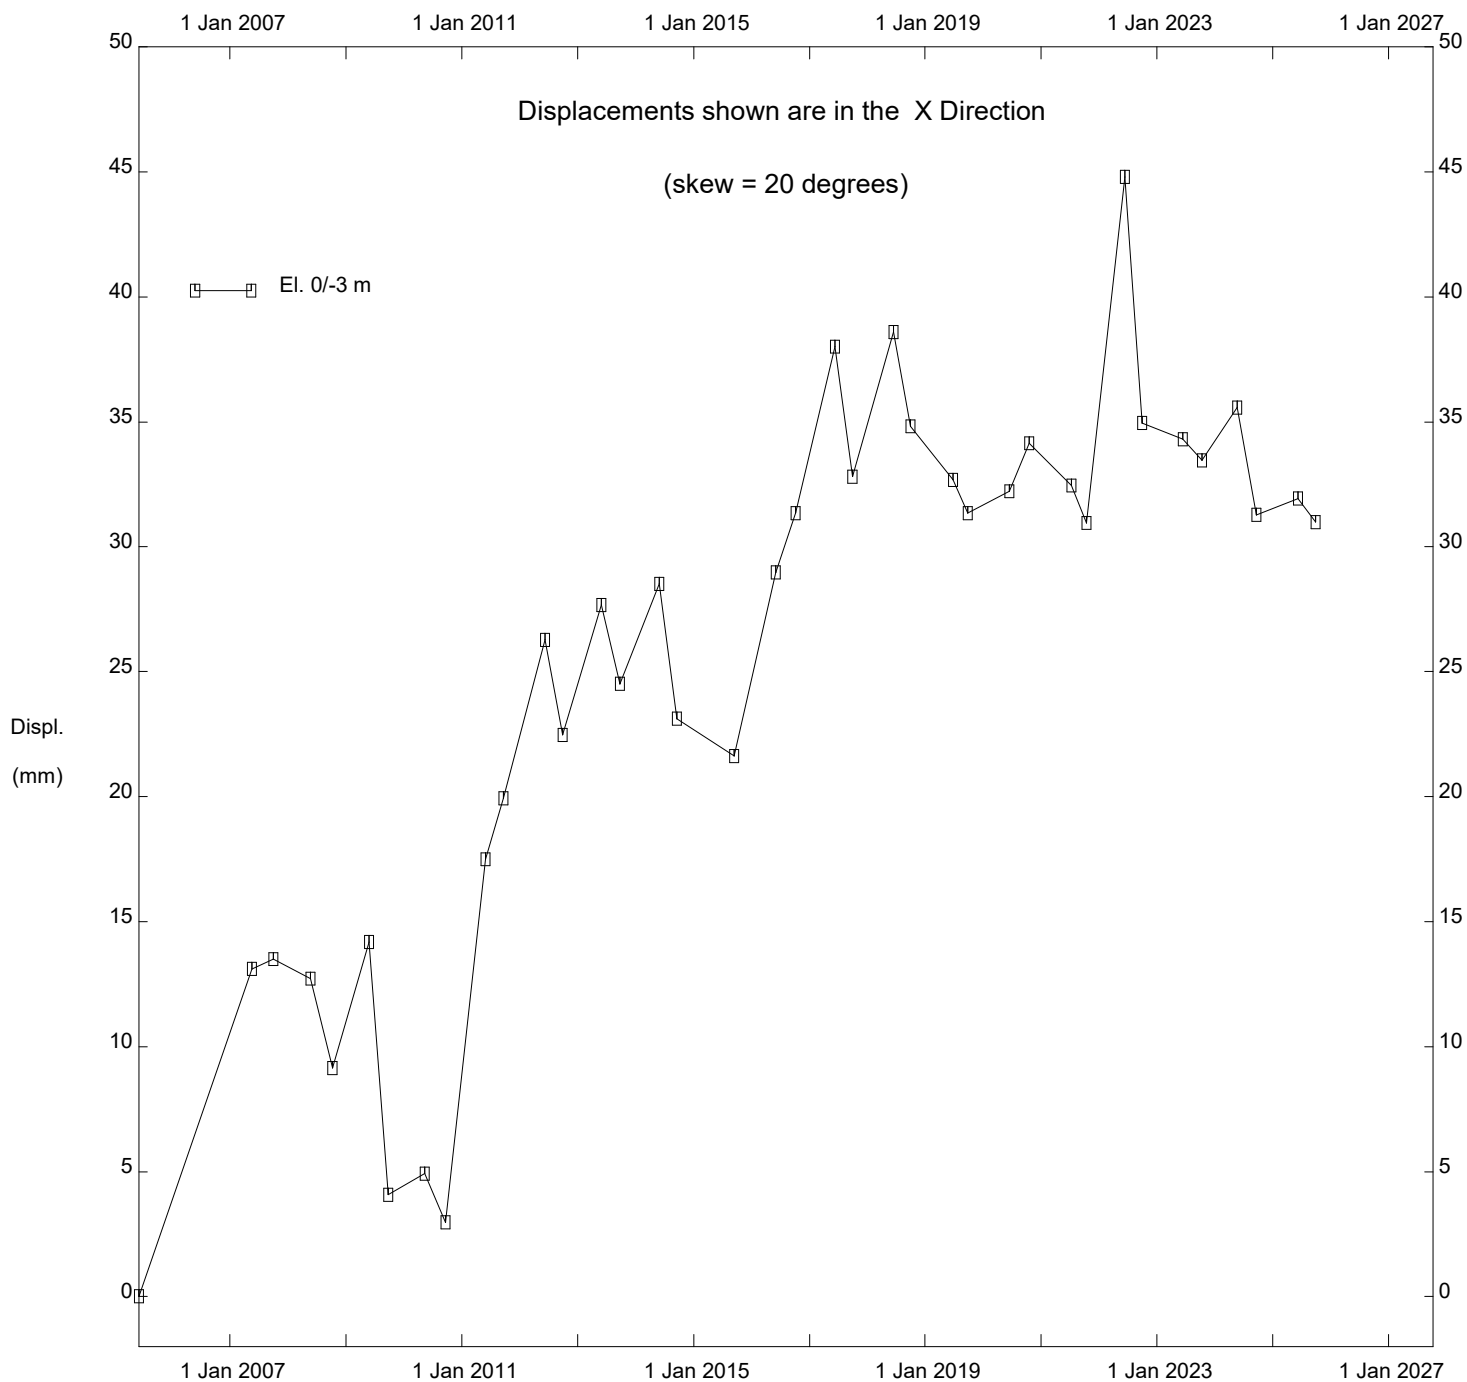
PH009 Old Hwy 2:02 Shop Slide, Inclinometer SI05-1

Discussion	
<b>Zones of New Movement:</b>	None
<b>Interpretation of Monitoring Results:</b>	<p><b>SLOPE INDICATORS</b></p> <p>Slope inclinometer SI05-1 is located upslope of the highway and is not within the main area of movement. It showed no discernable movement over 0.0 m to 3.0 m depth since the spring of 2025 readings. The apparent zone at 20 m has been checked and appears to be an error artifact from an earlier reading.</p> <p>SI09-3 is located east of the rail tracks. It continues to show no discernible movement within the depth of installation, 16.2 m..</p> <p>SI09-4 is located immediately east (downslope) of the newly installed pile wall. It showed a rate of movement of 1.3 mm/yr over 8.6 m to 10.5 m depth and a rate of movement of 0.7 mm/yr over 11.7 m to 13.5 m depth, respectively, since the spring of 2025 readings. These movement zones</p>

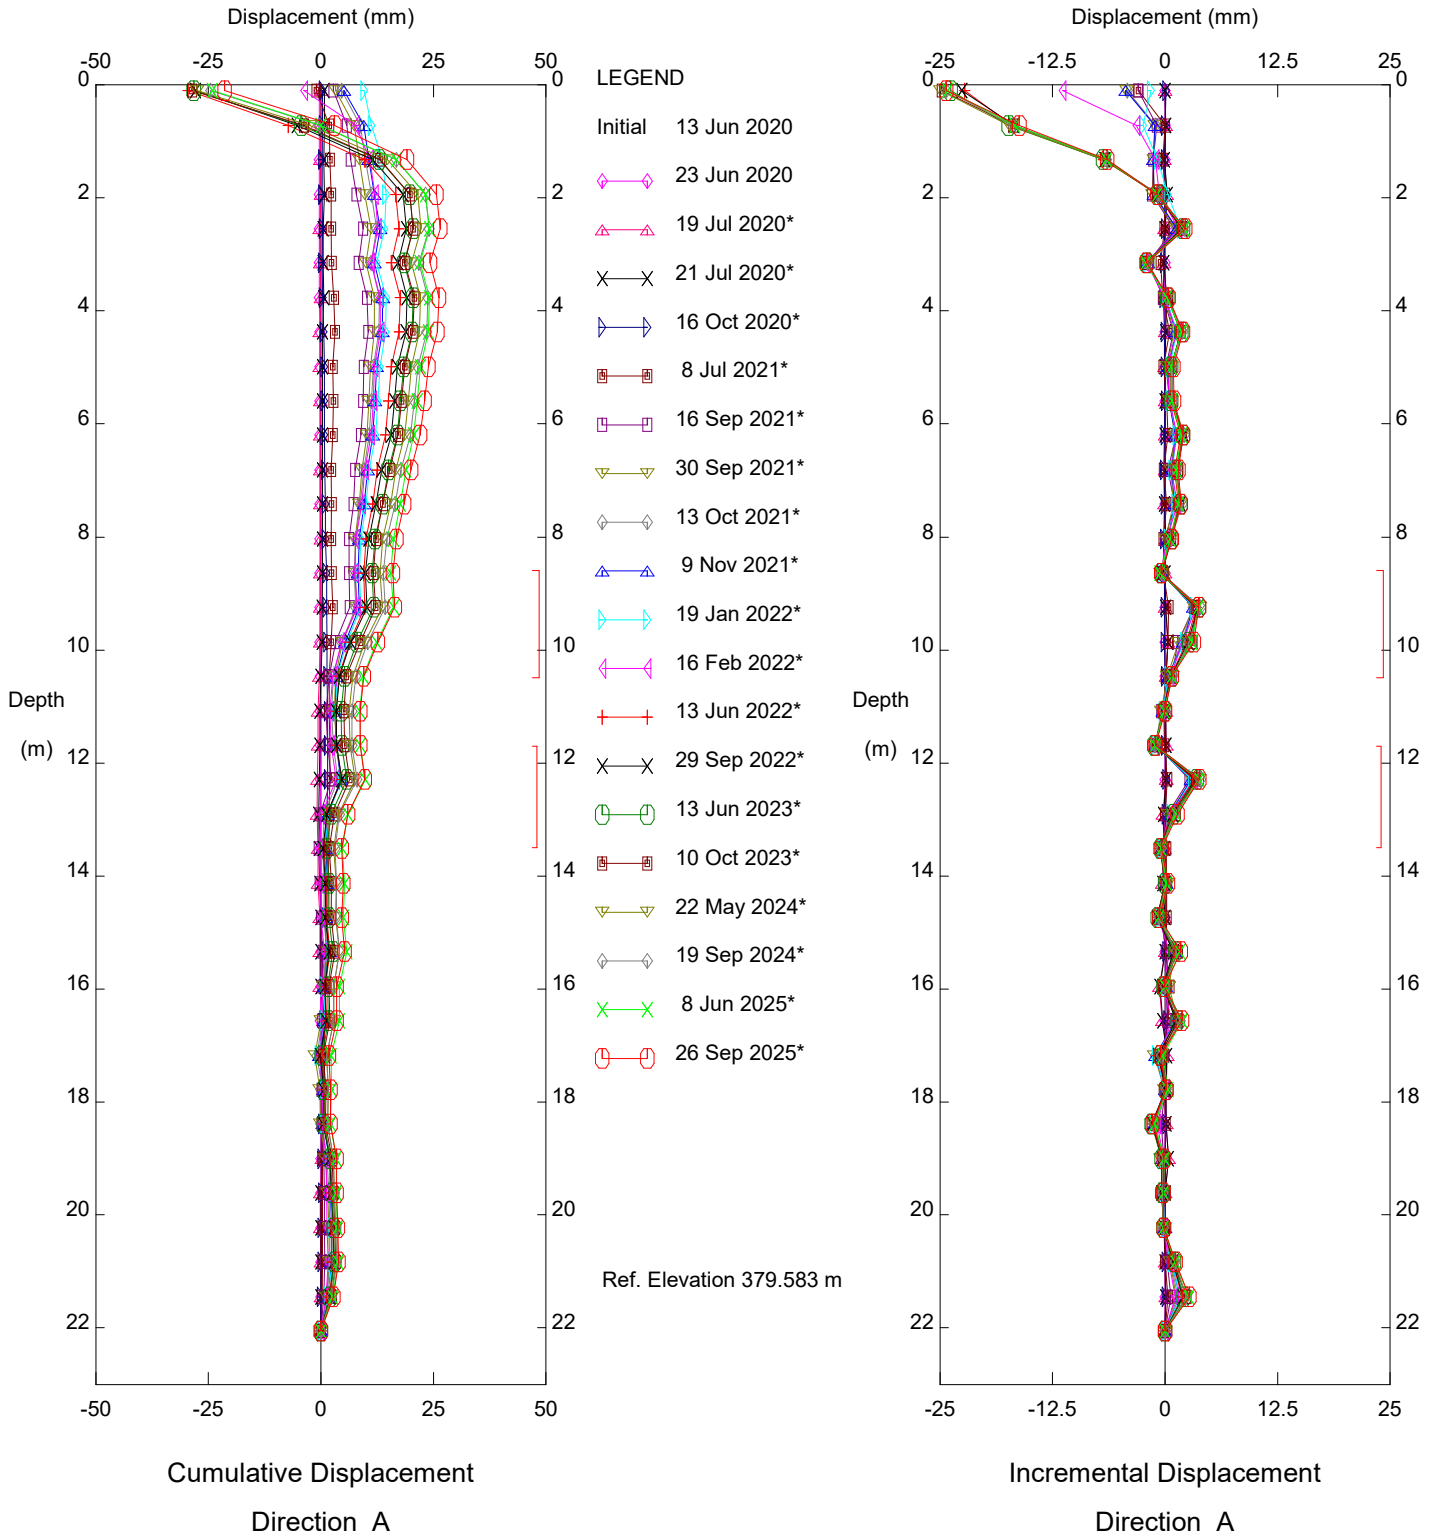
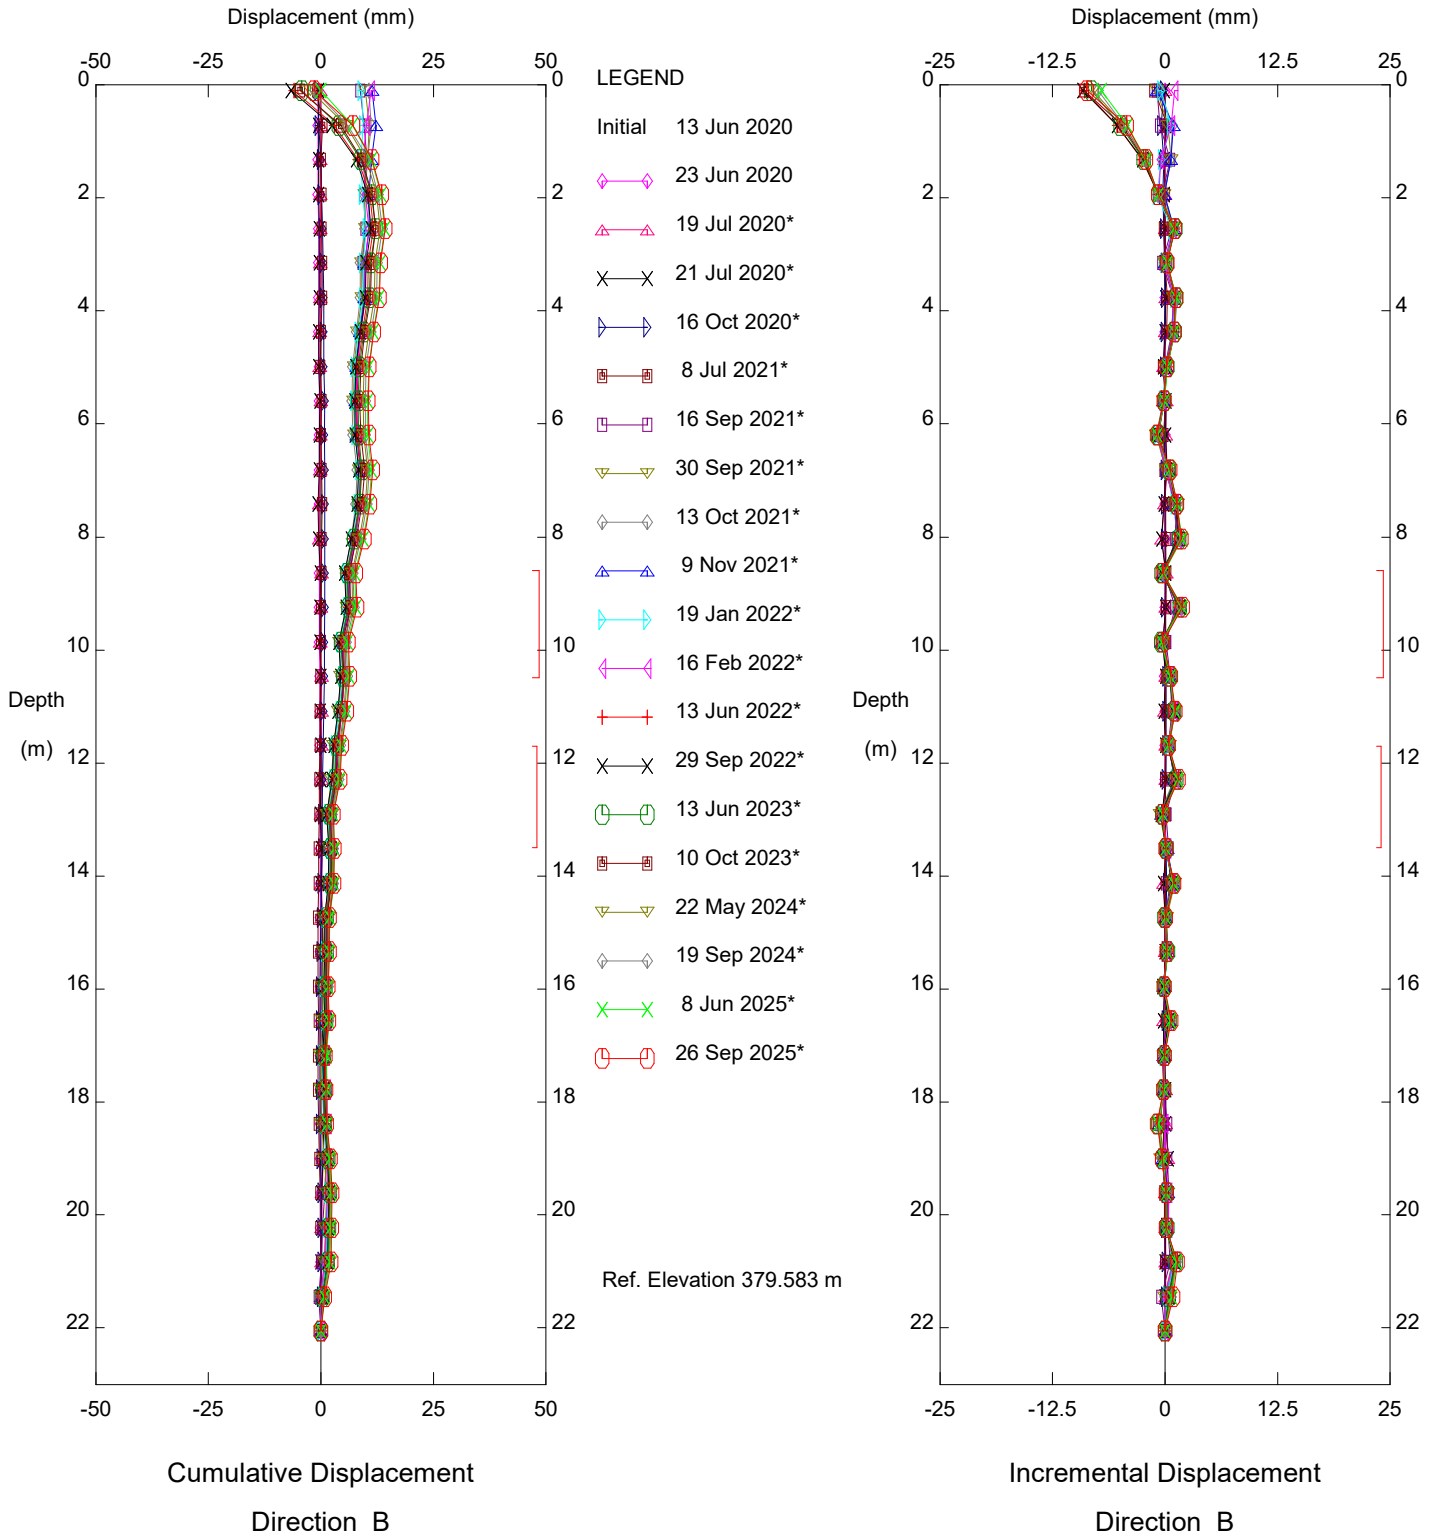
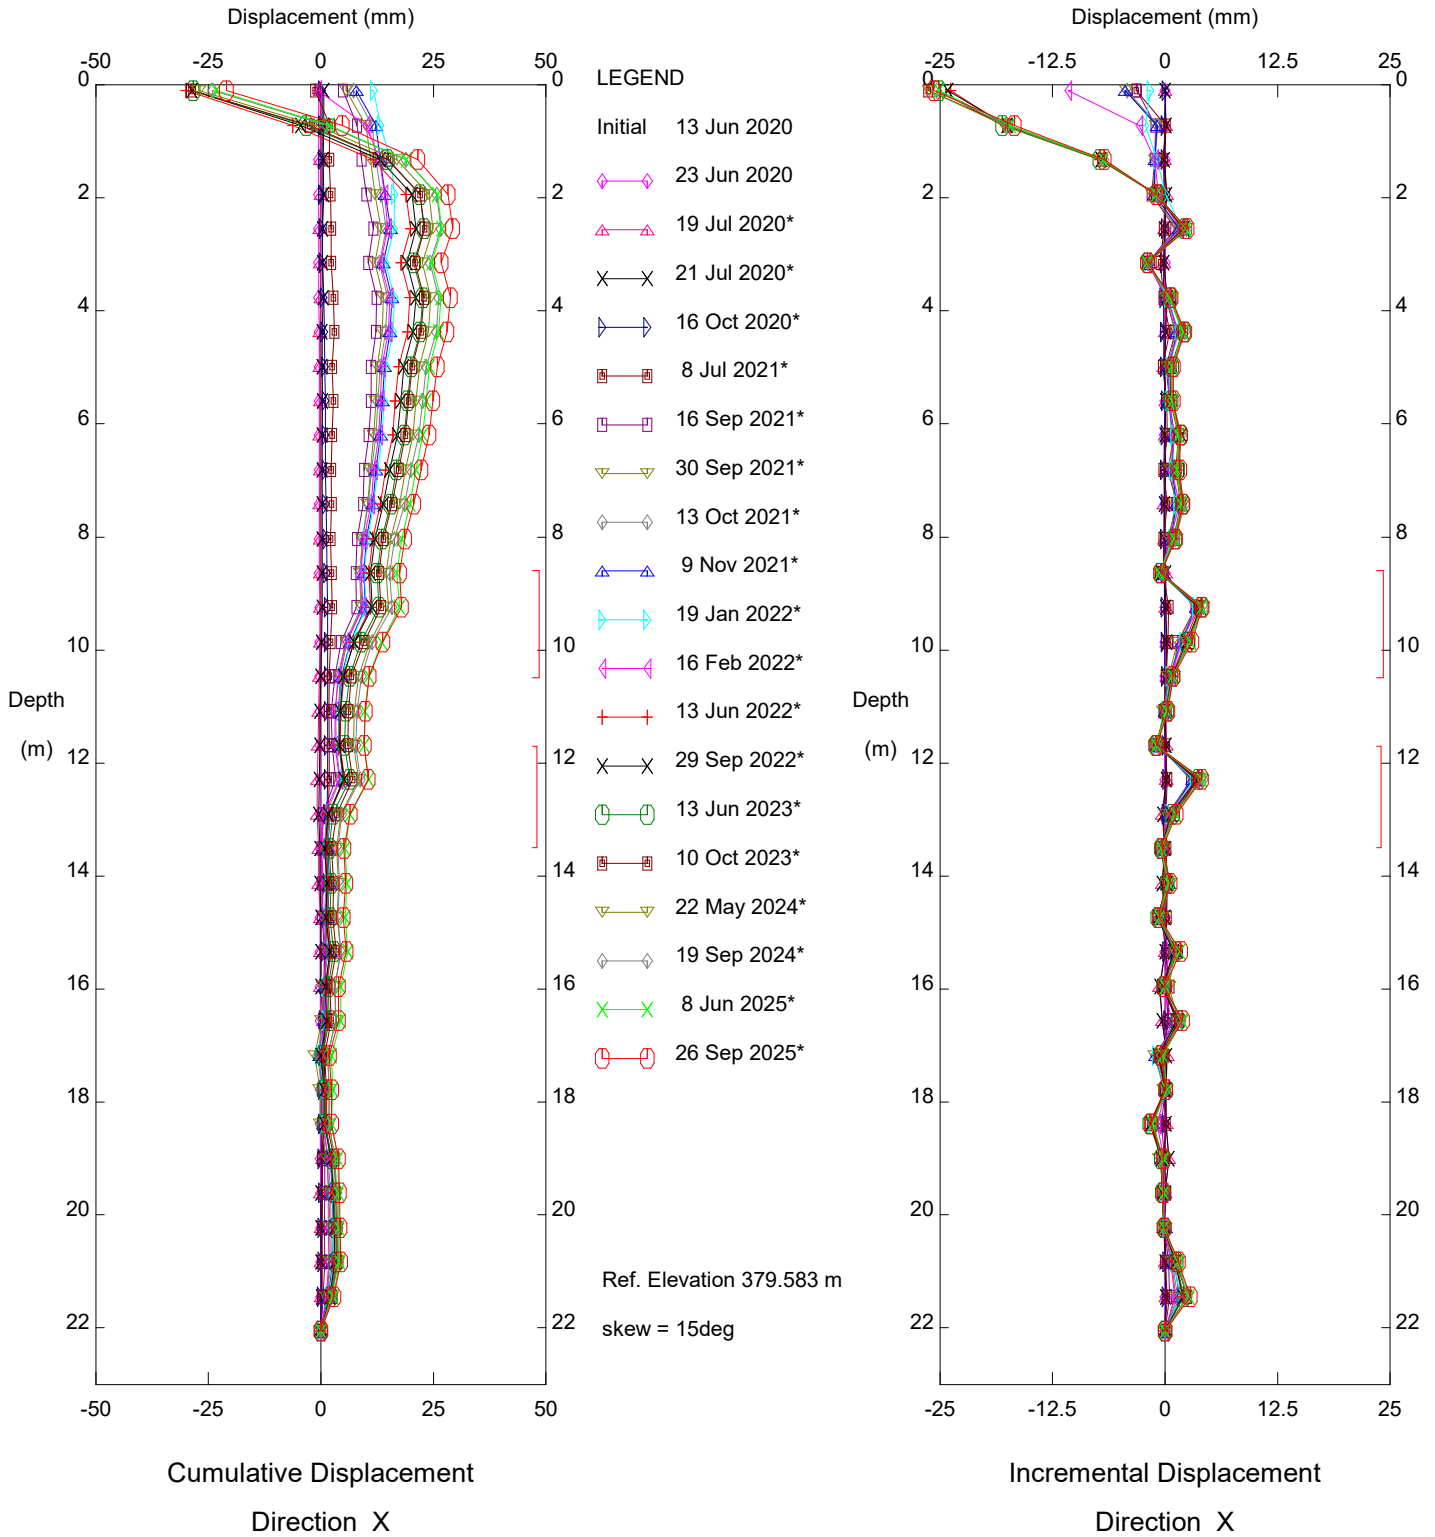
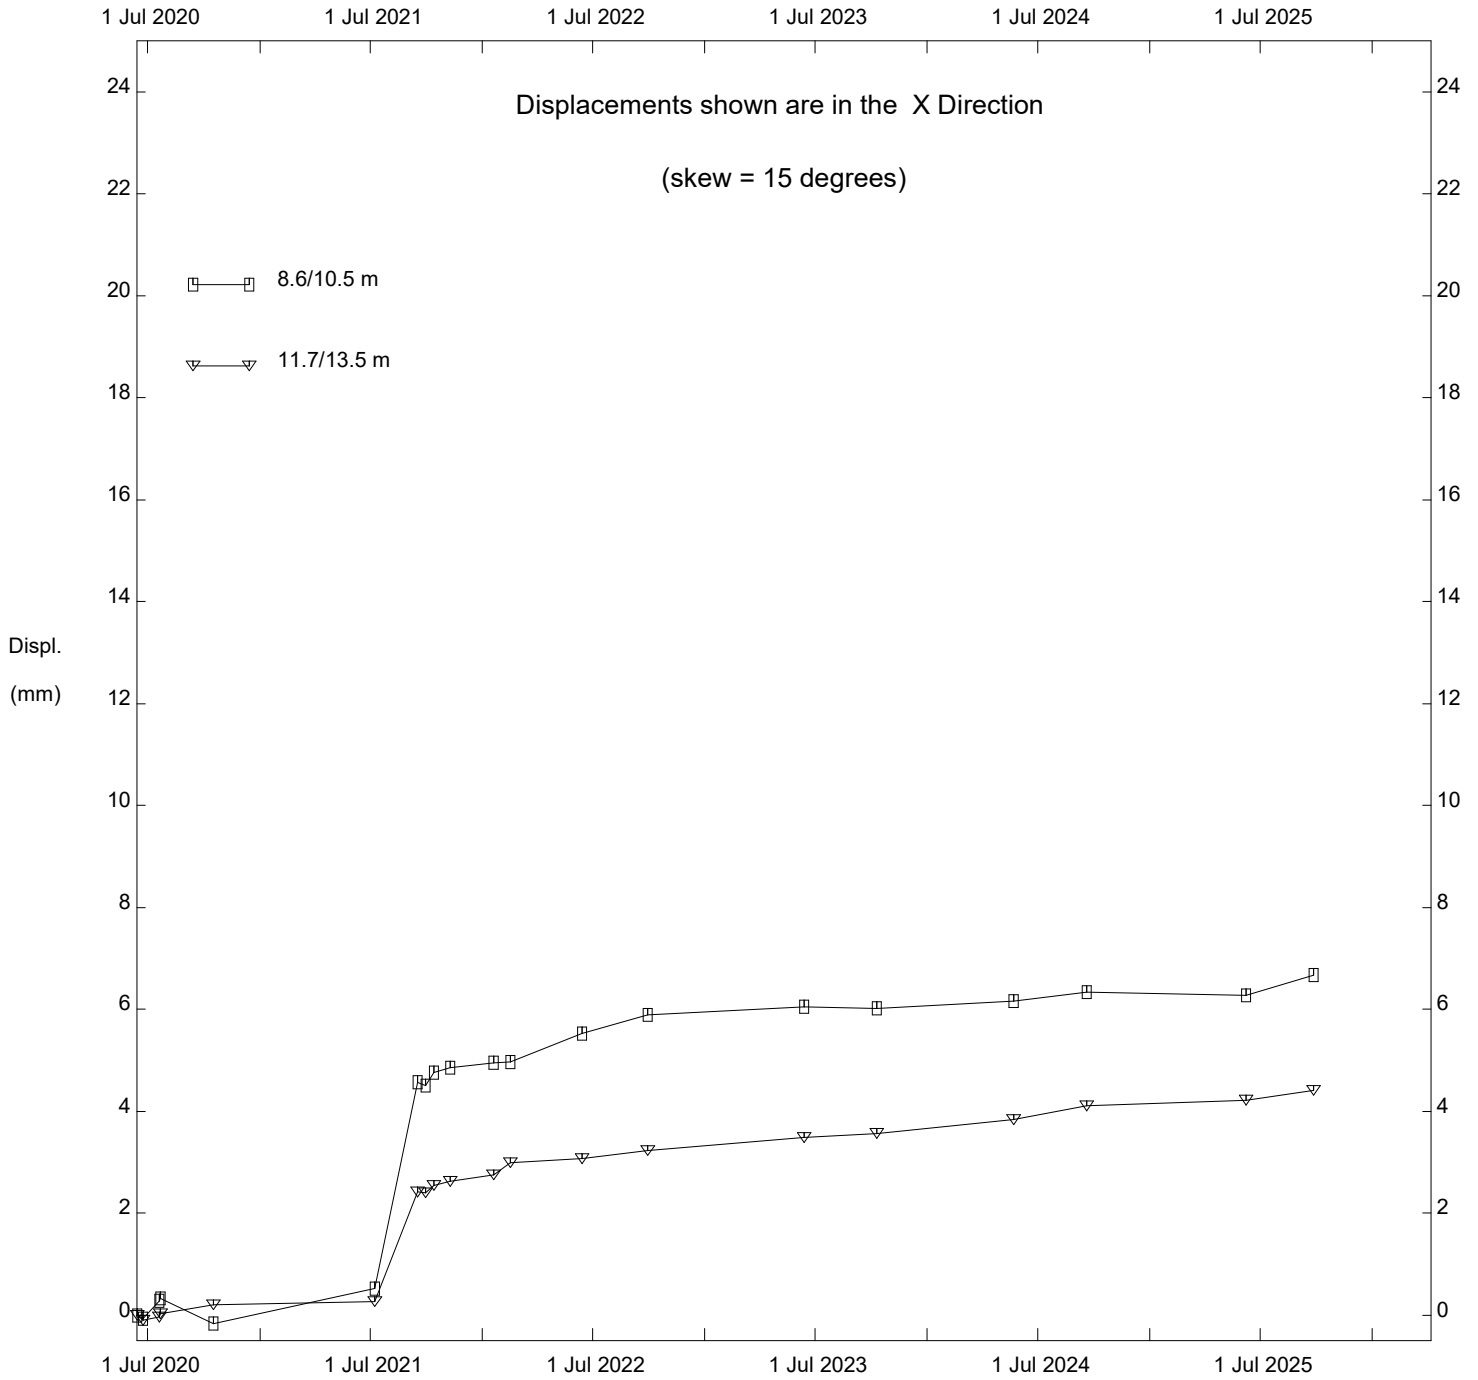
PH009 Old Hwy 2:02 Shop Slide, Inclinometer SI09-4

were first observed in 2021 during construction, and the movement rates had been gradually decreasing. The rates increased in both zones since Spring 2025 but were most pronounced in the upper zone where it increased from 0 mm/yr to 1.3 mm/yr which is the highest since construction was completed. The Spring 2026 readings will be important to understand if this is a trend or an anomaly.
