ALBERTA TRANSPORTATION AND  
ECONOMIC CORRIDORS GRMP  
PEACE REGION – (PEACE RIVER DISTRICT)  
INSTRUMENTATION MONITORING - FALL 2025

Site Number	Location	Name	Hwy	km
PH009-3	Hwy 684:02 km 30.99, Town of Peace River	Shaftesbury Trail - Shop Slide	684:02	30.9-31.1
			Old 2:02	0.0-0.4
Legal Description:		UTM Co-ordinates		
4-31-83-21 W5		11V    E    480321	N    6232126

<b>Current Monitoring:</b>	26-Sep-2025	<b>Previous Monitoring</b>	8-June-2025
<b>Instruments Read By:</b>	Mr. Niraj Regmi, G.I.T. and Mr. Angelo Castillo, of Thurber

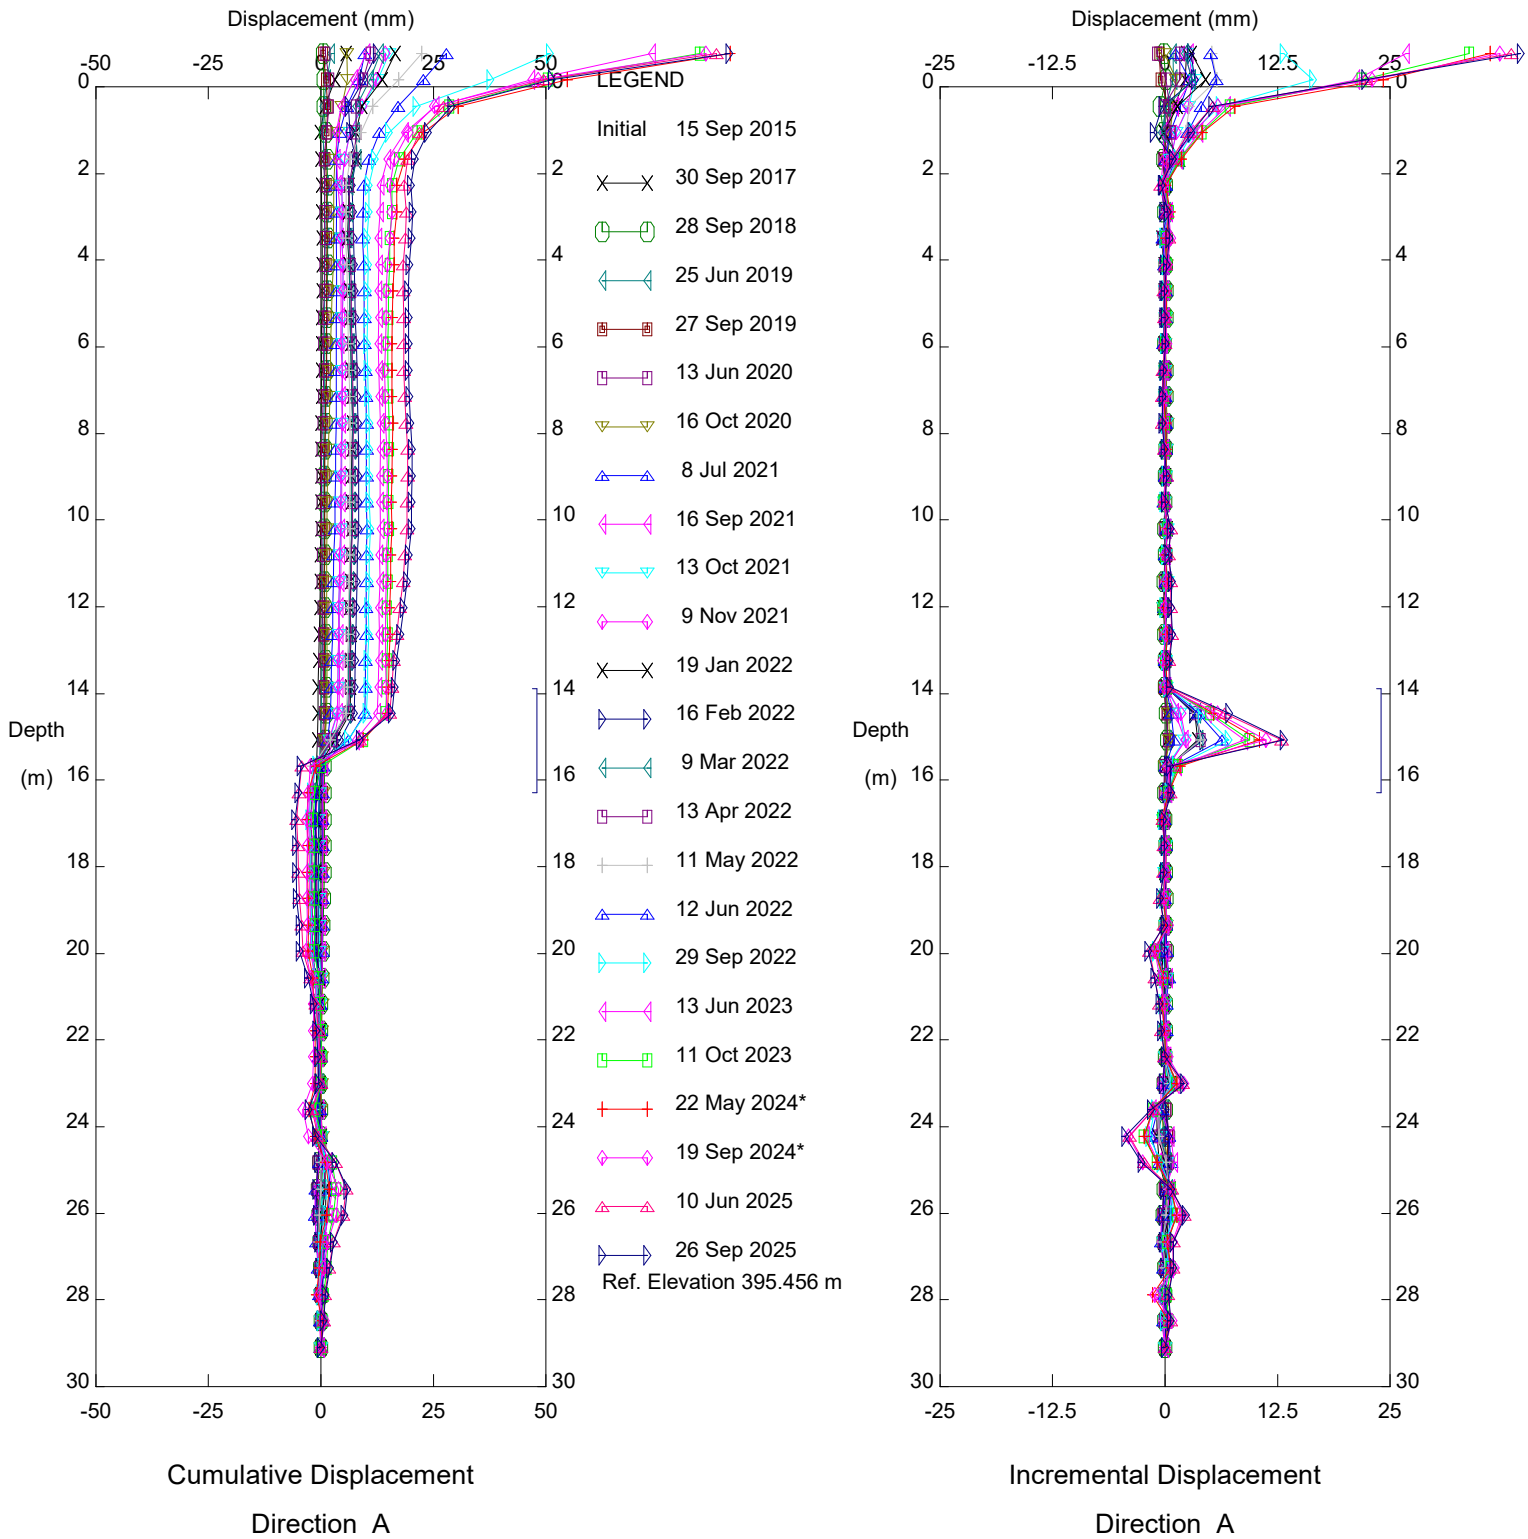
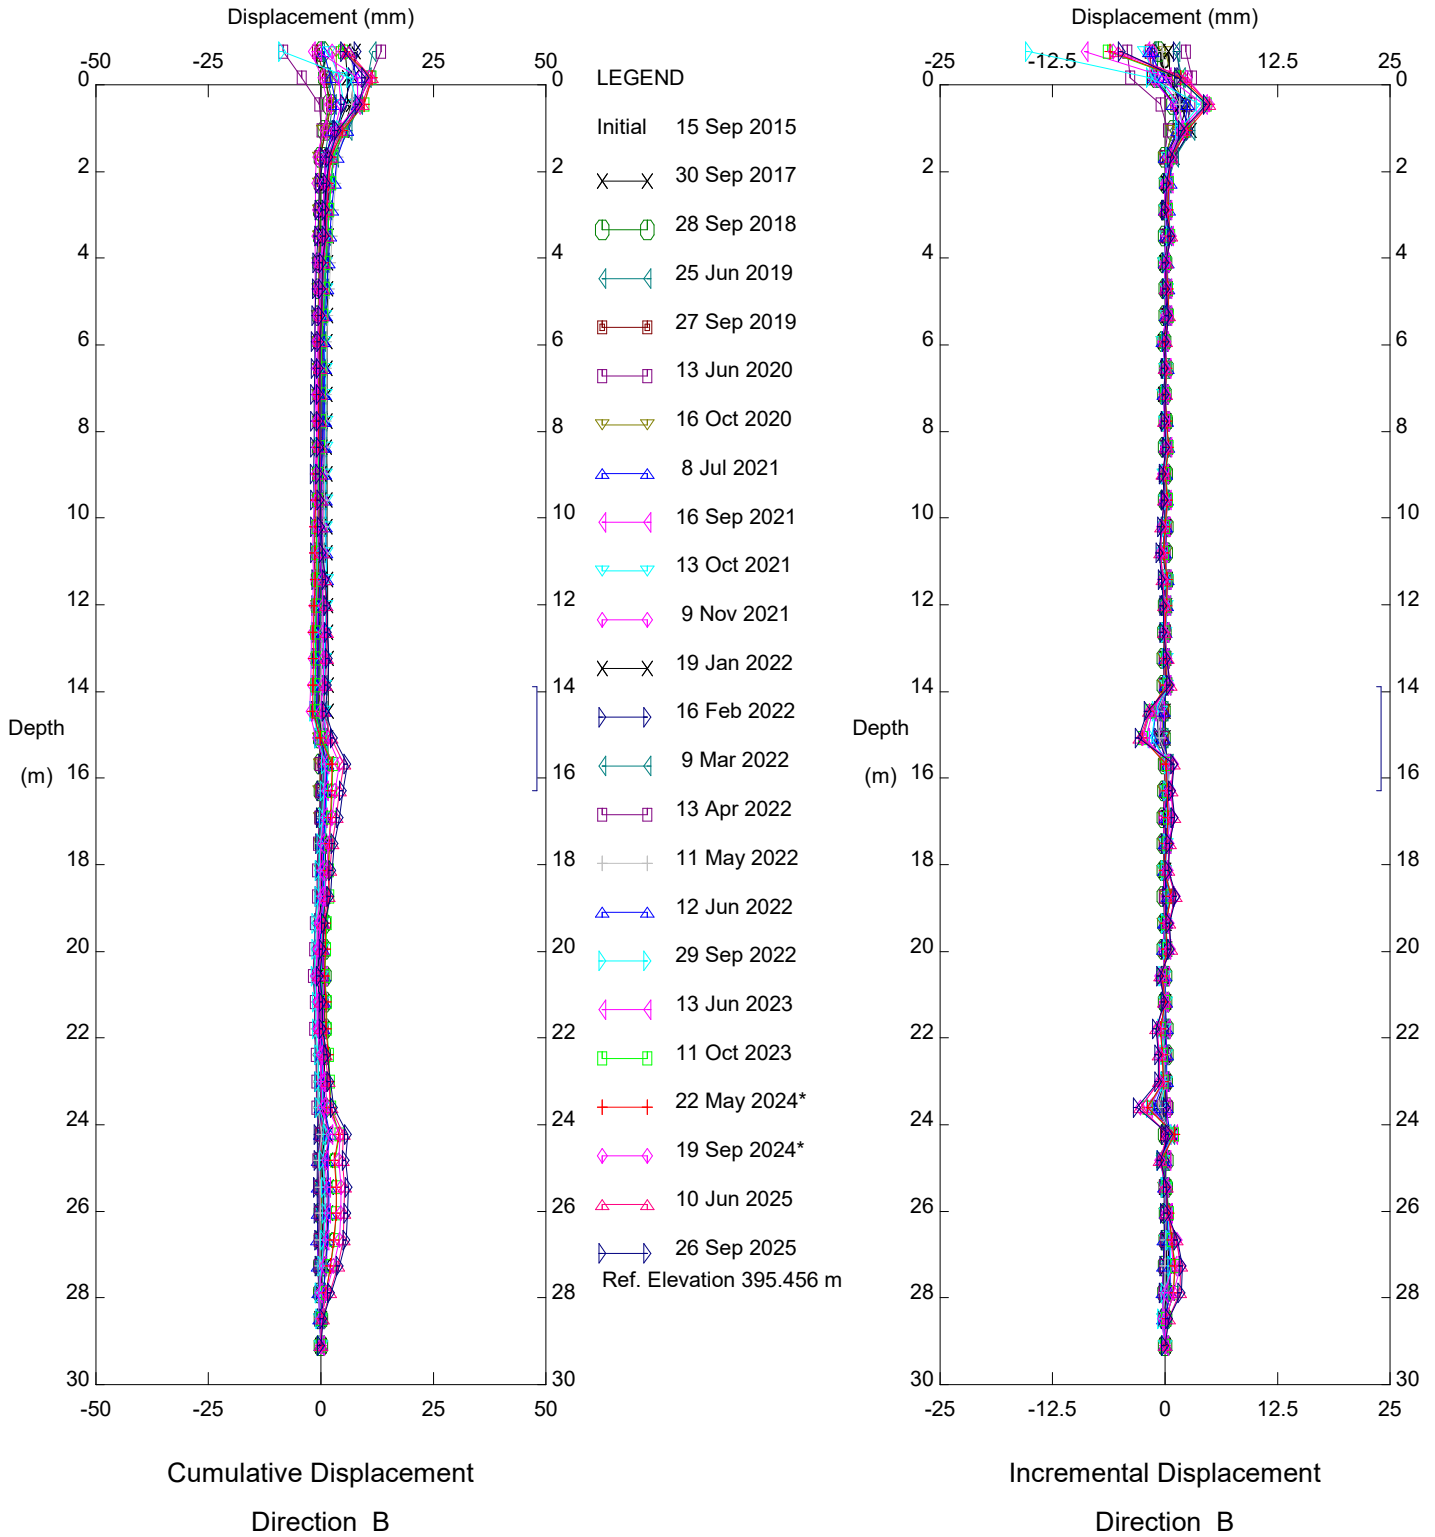
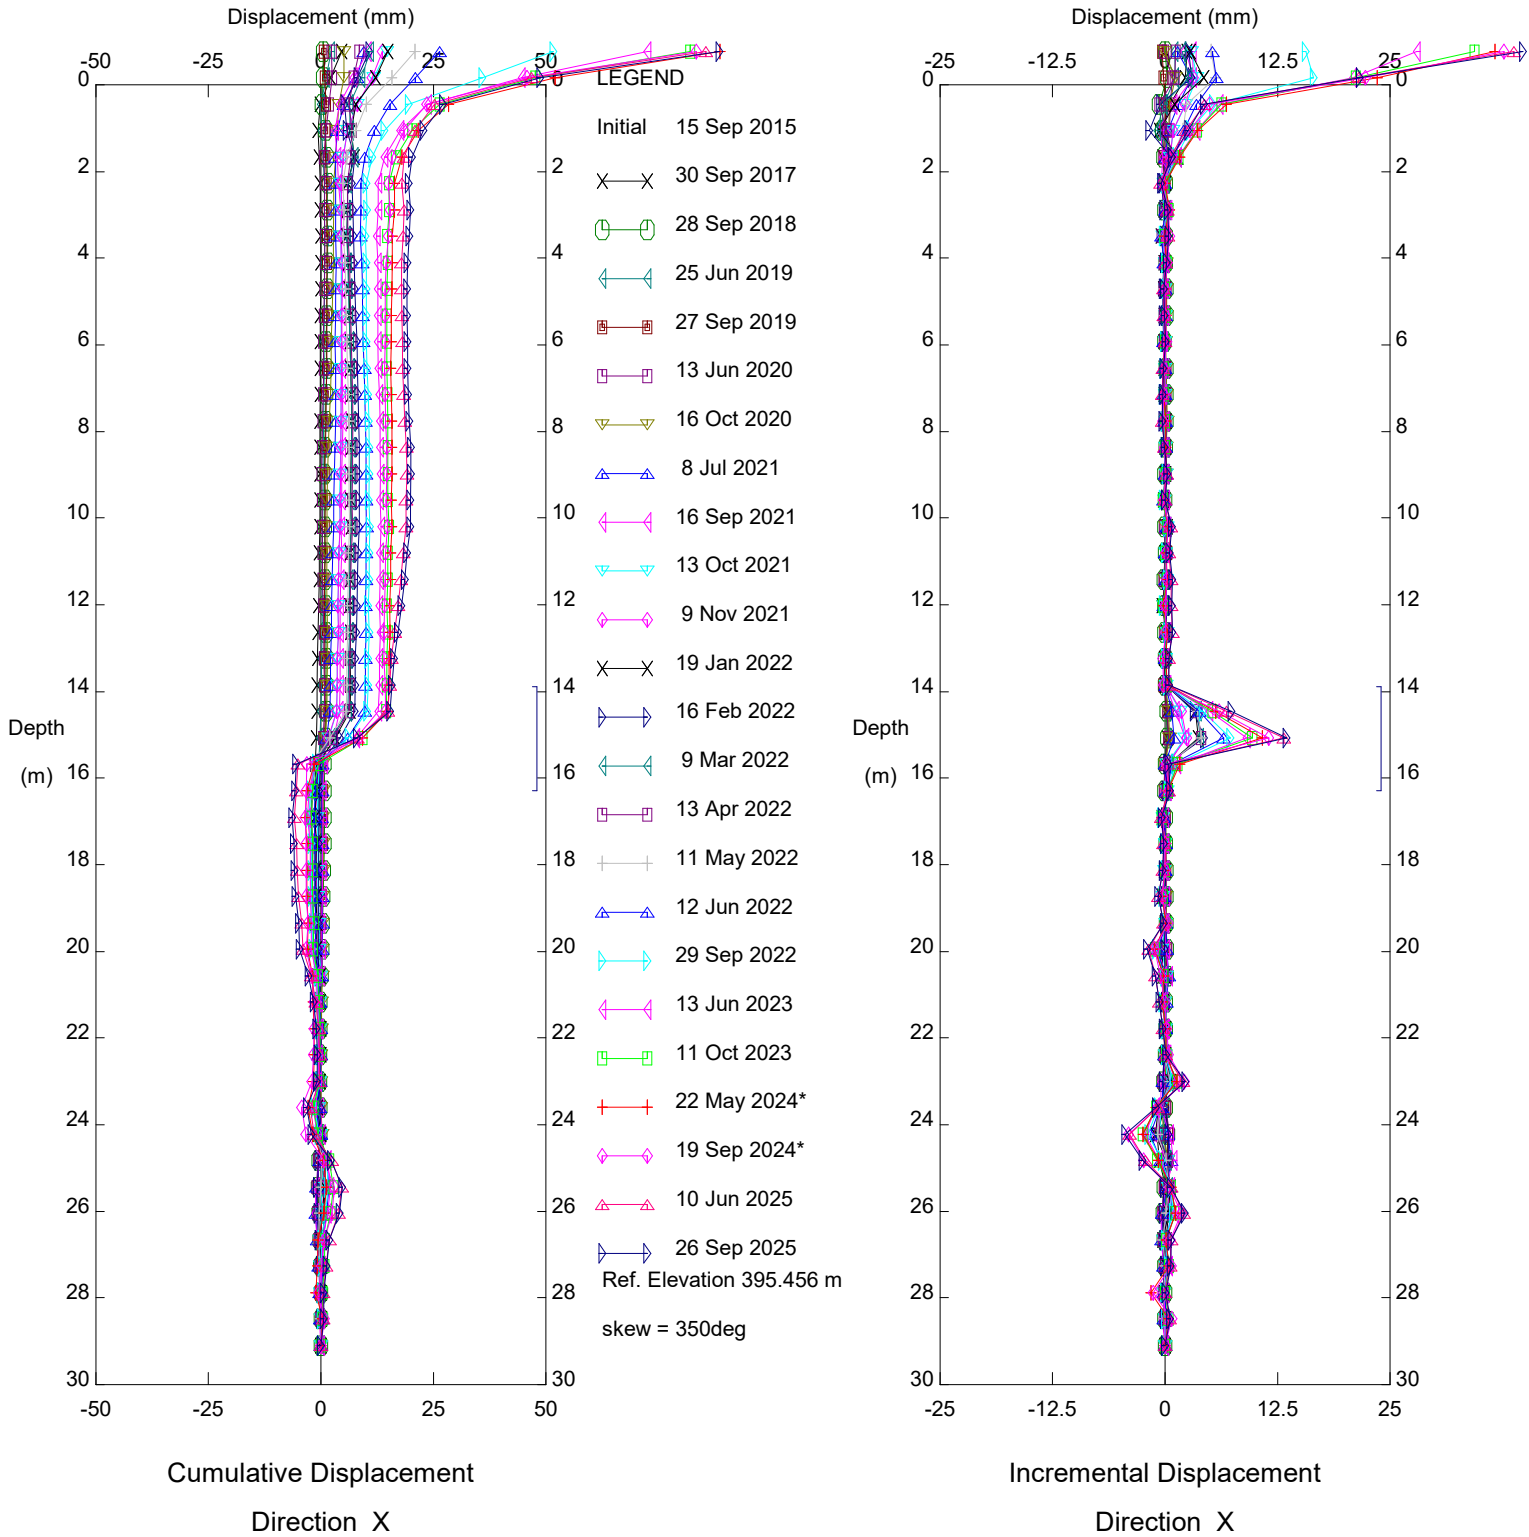
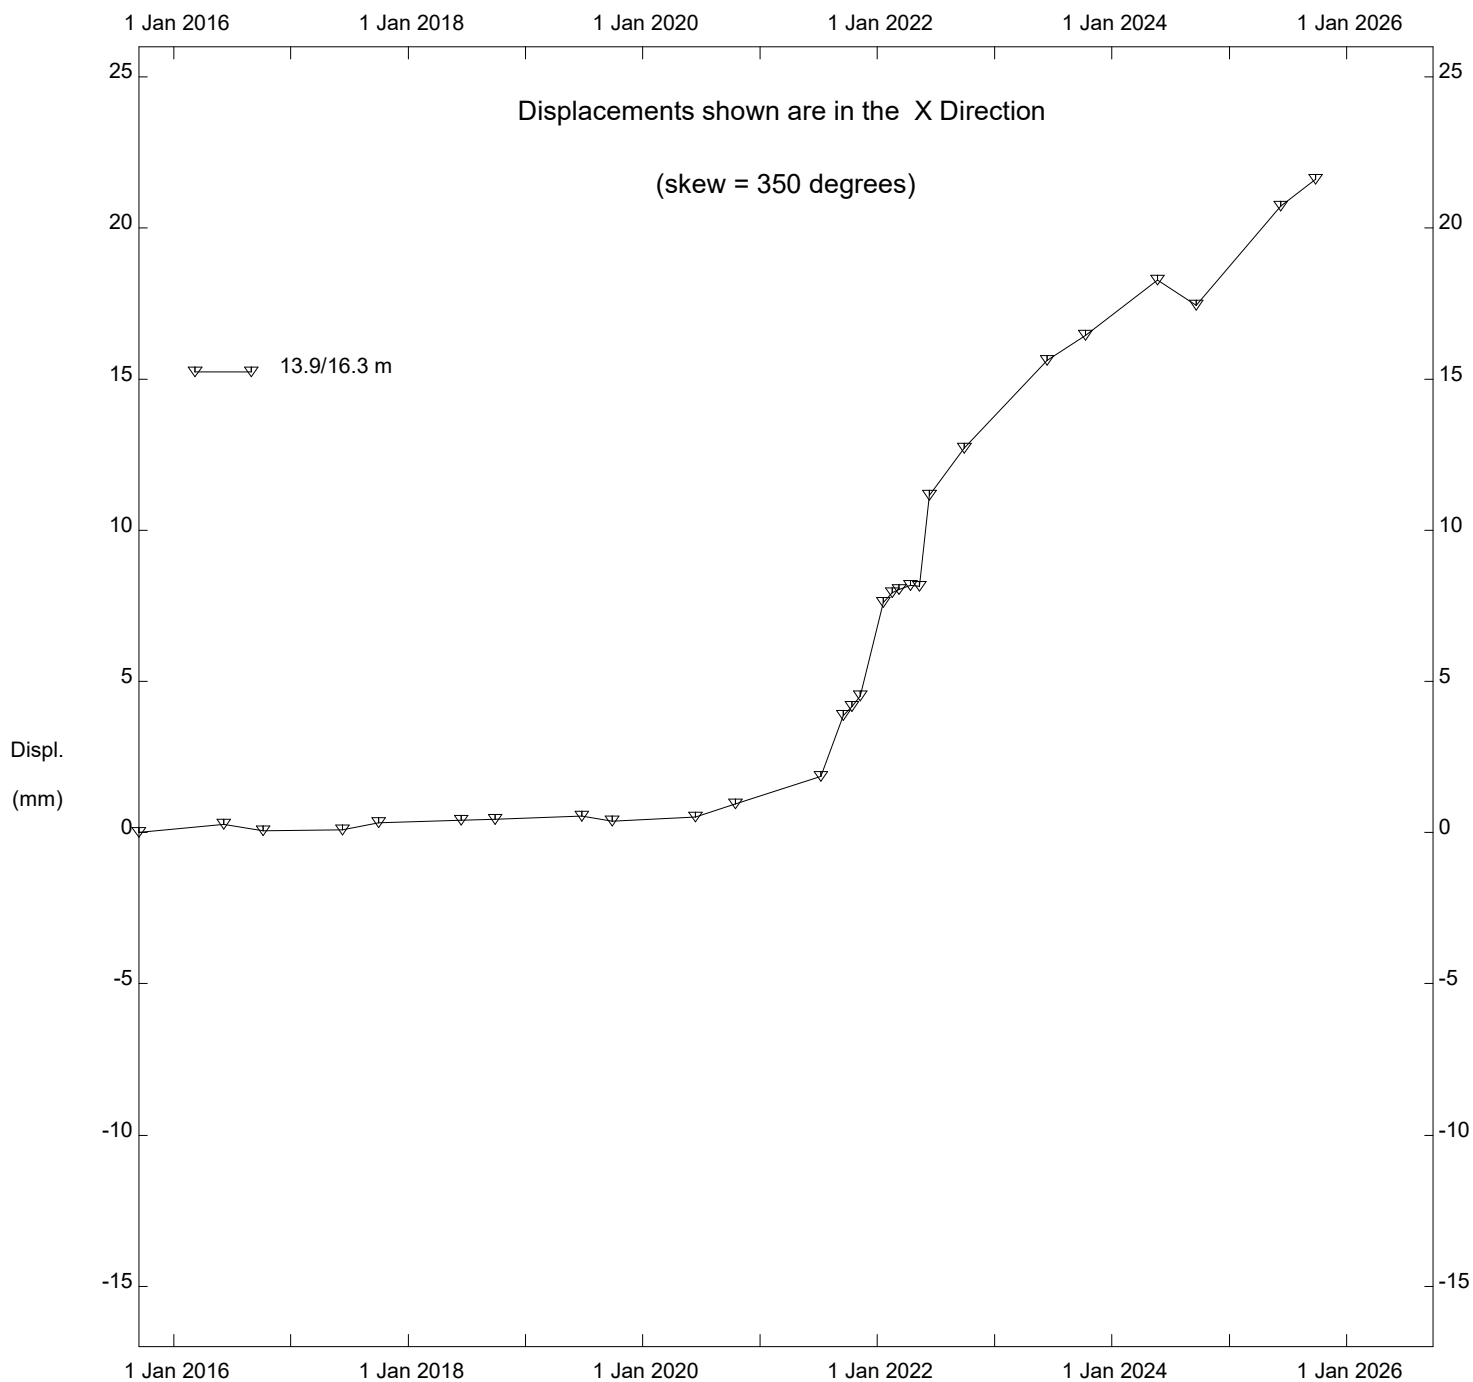
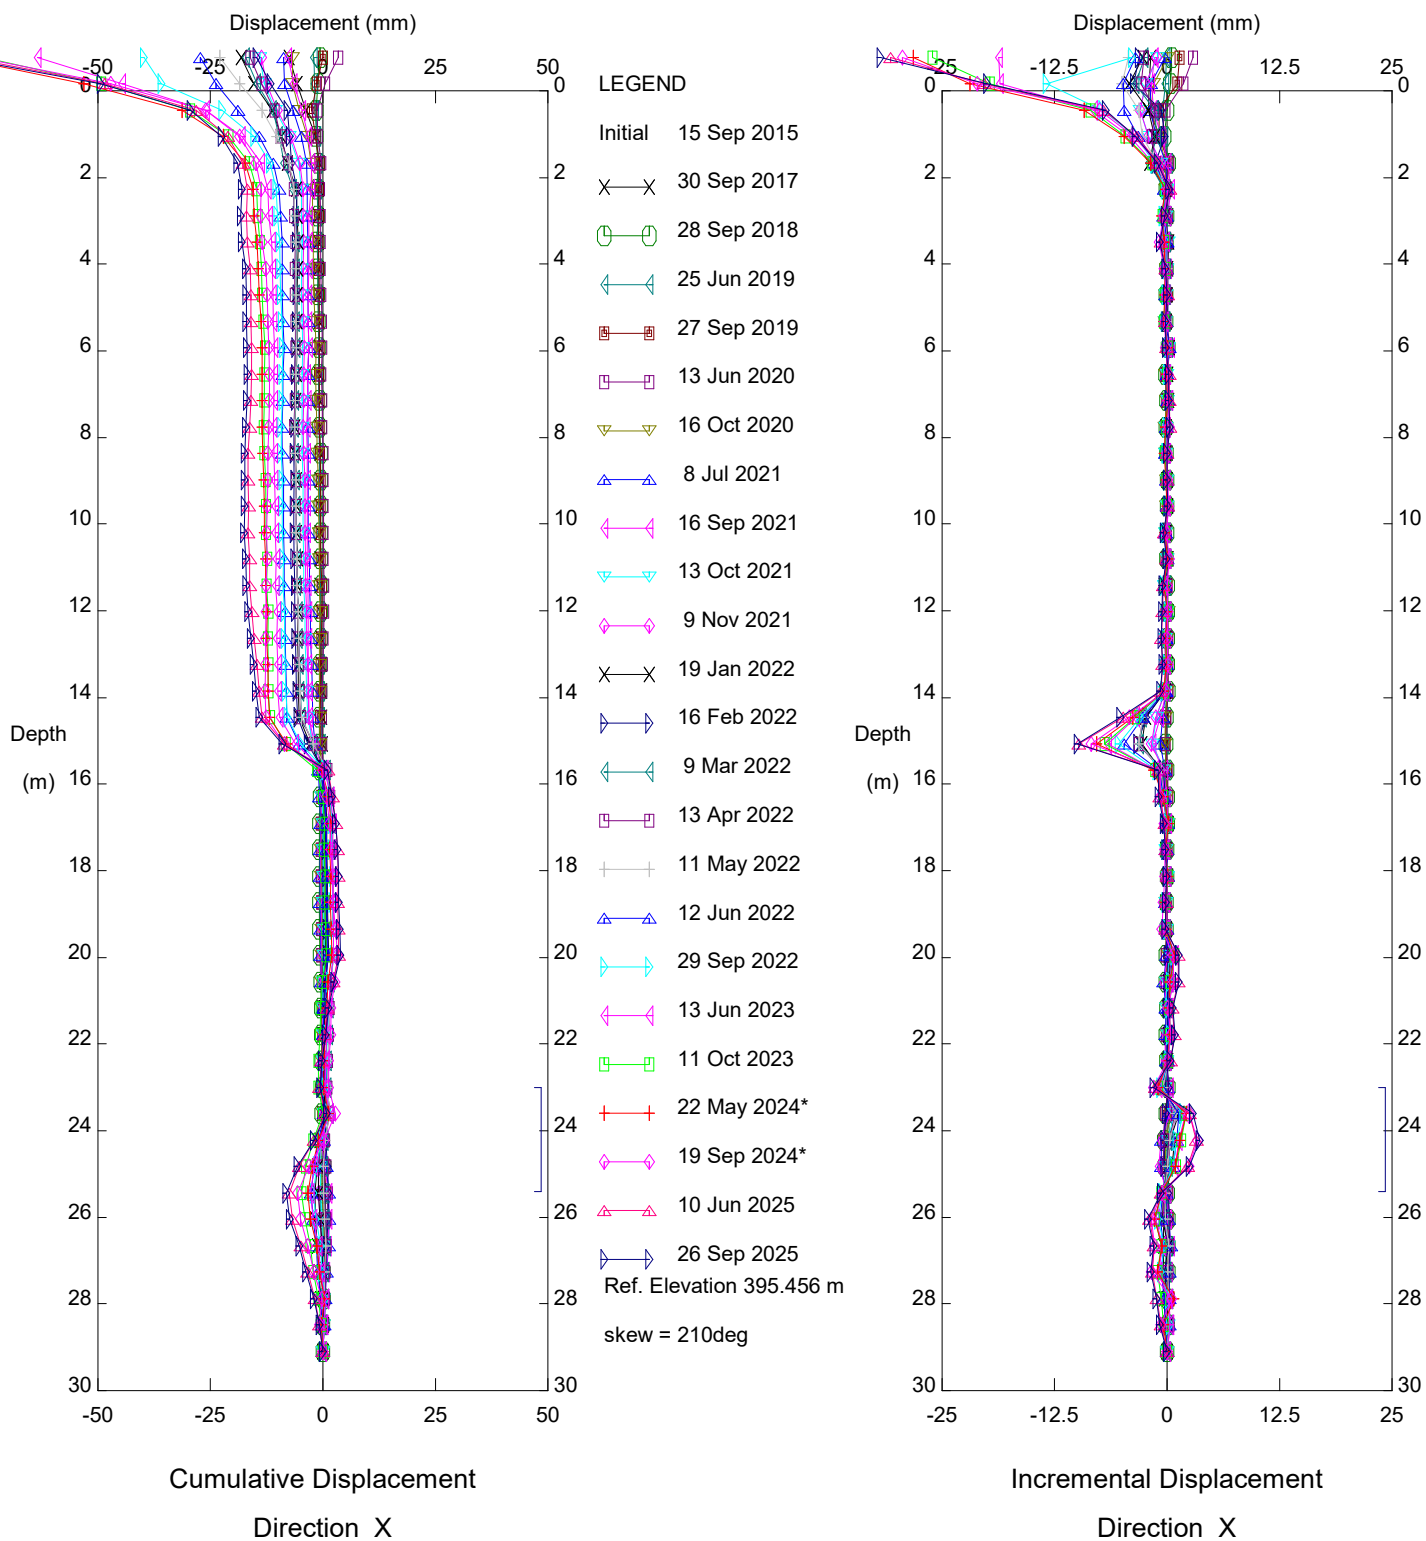
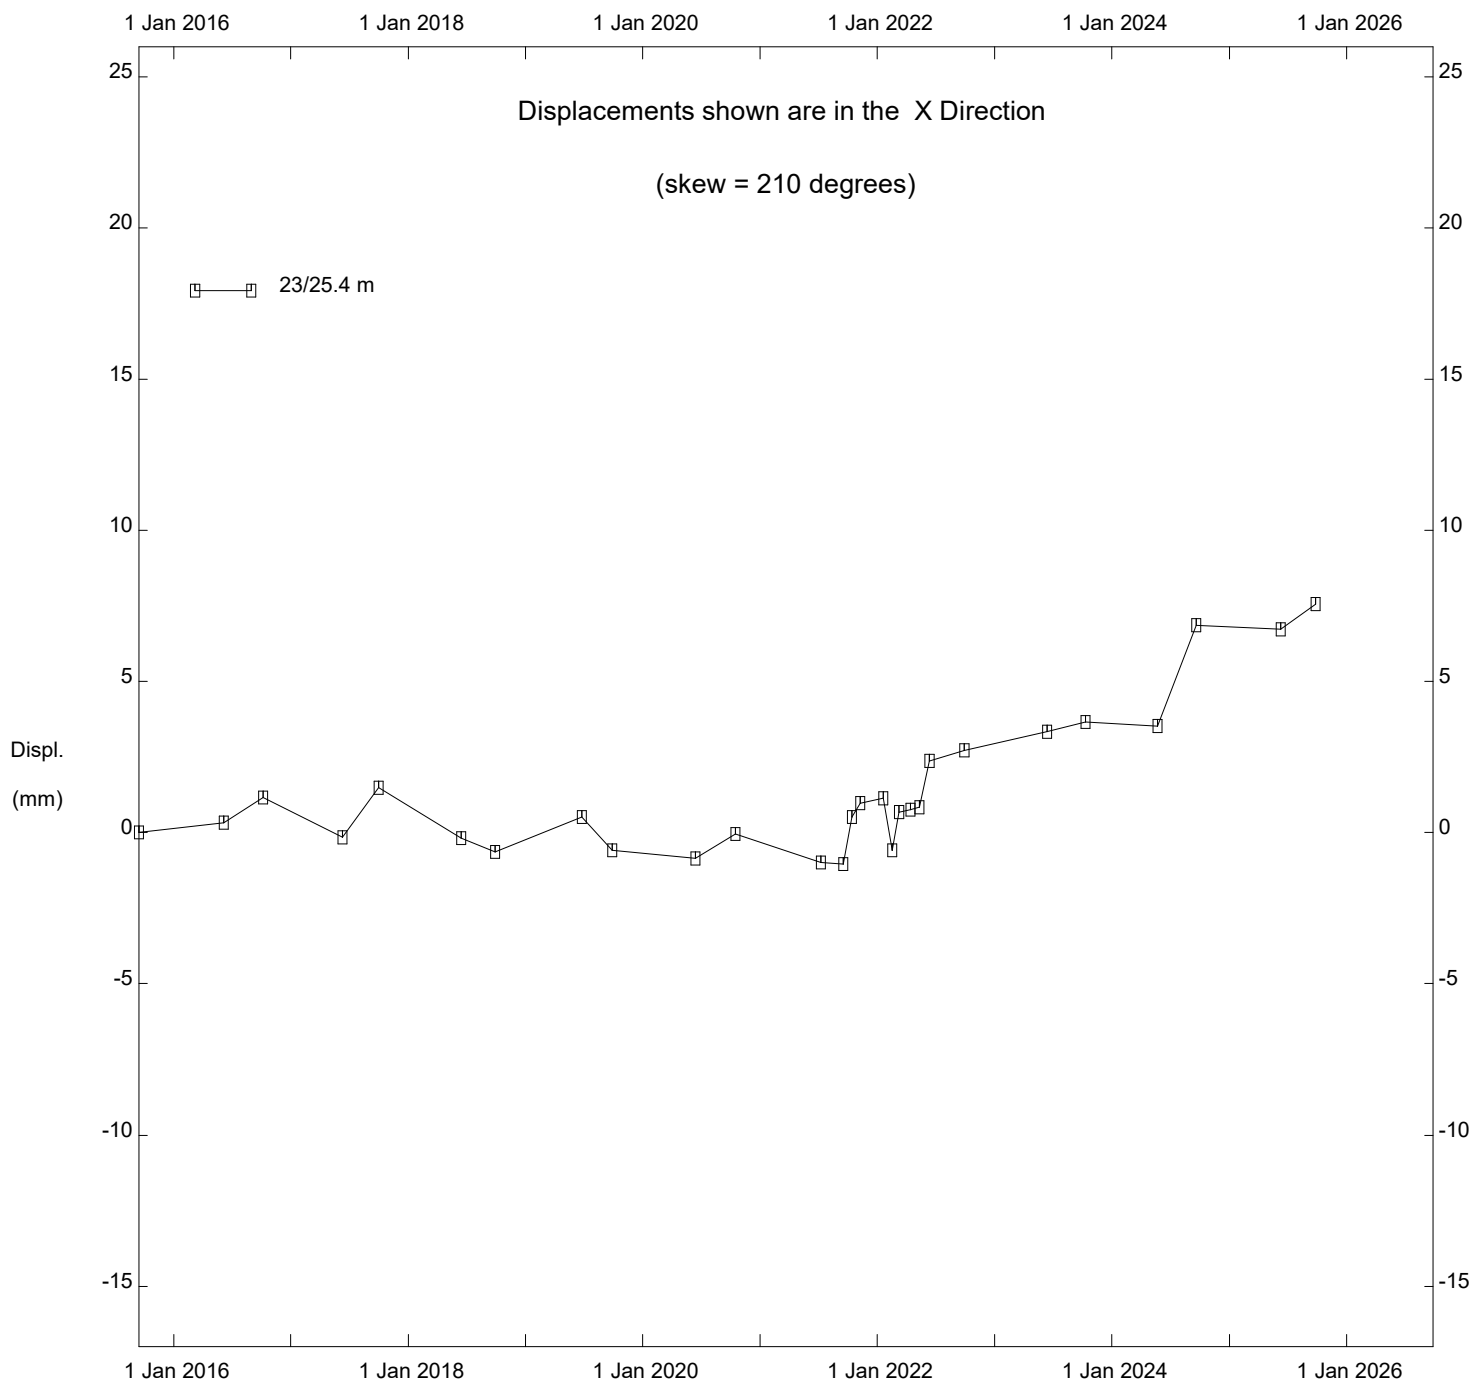
PH009 Old Hwy 2:02 Shop Slide, Inclinometer SI11-01

SI11-01 is located about 7 m north of the north end of the pile wall and measured a movement zone between 13.9 m to 16.3 m depth shortly after construction started with a maximum rate of movement of 34.3 mm/yr occurring in June 14, 2022, near the end of construction. The rate of movement observed over this depth since the spring of 2025 readings was 3.0 mm/yr. The general rate of movement within this zone persists despite the installation of the pile wall and offloading of the slope below. The deeper movement zone first observed during the fall of 2022 readings showed a rate of movement of 2.8 mm/yr over 23.0 m to 25.4 m depth, since the spring of 2025 readings. However, this is in the uphill direction and likely a result of casing settlement and buckling in the hole rather than actual movement.

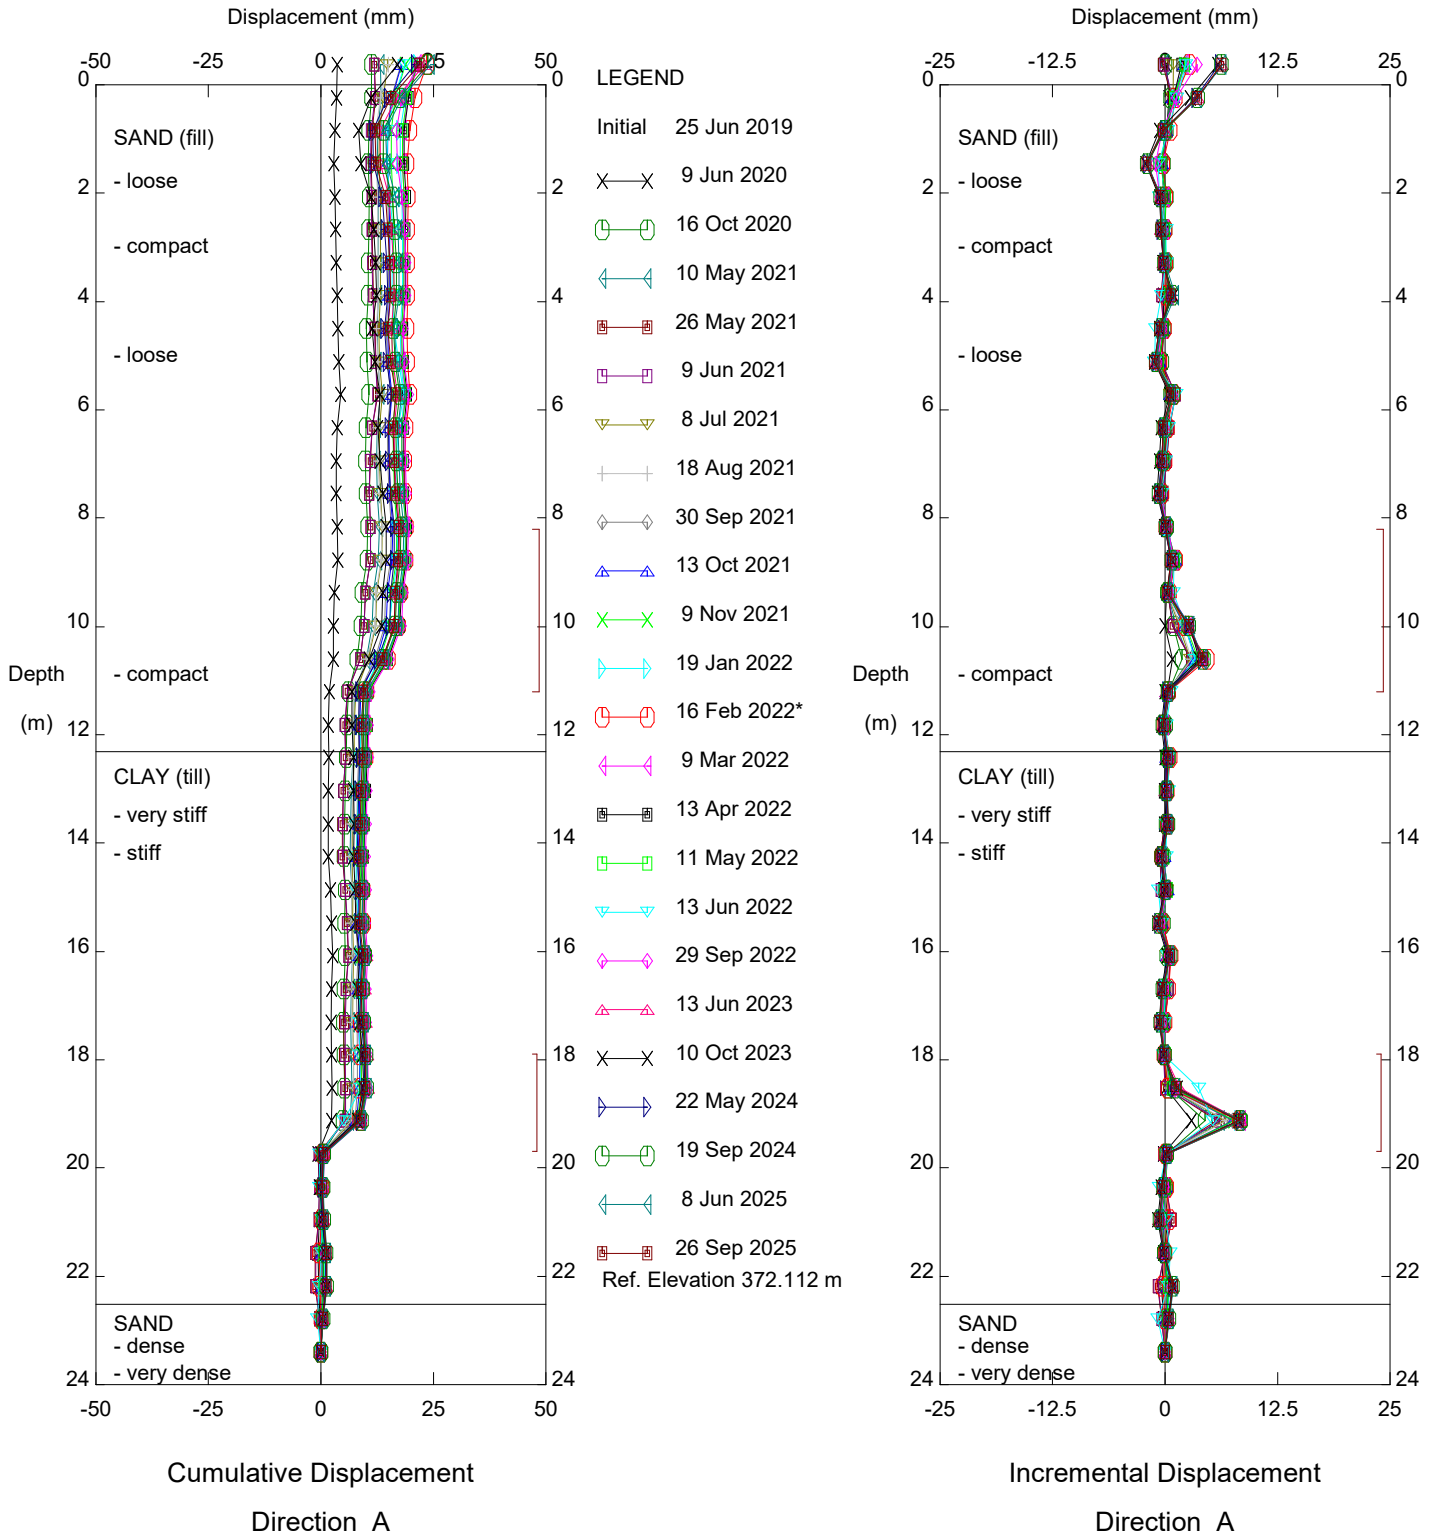
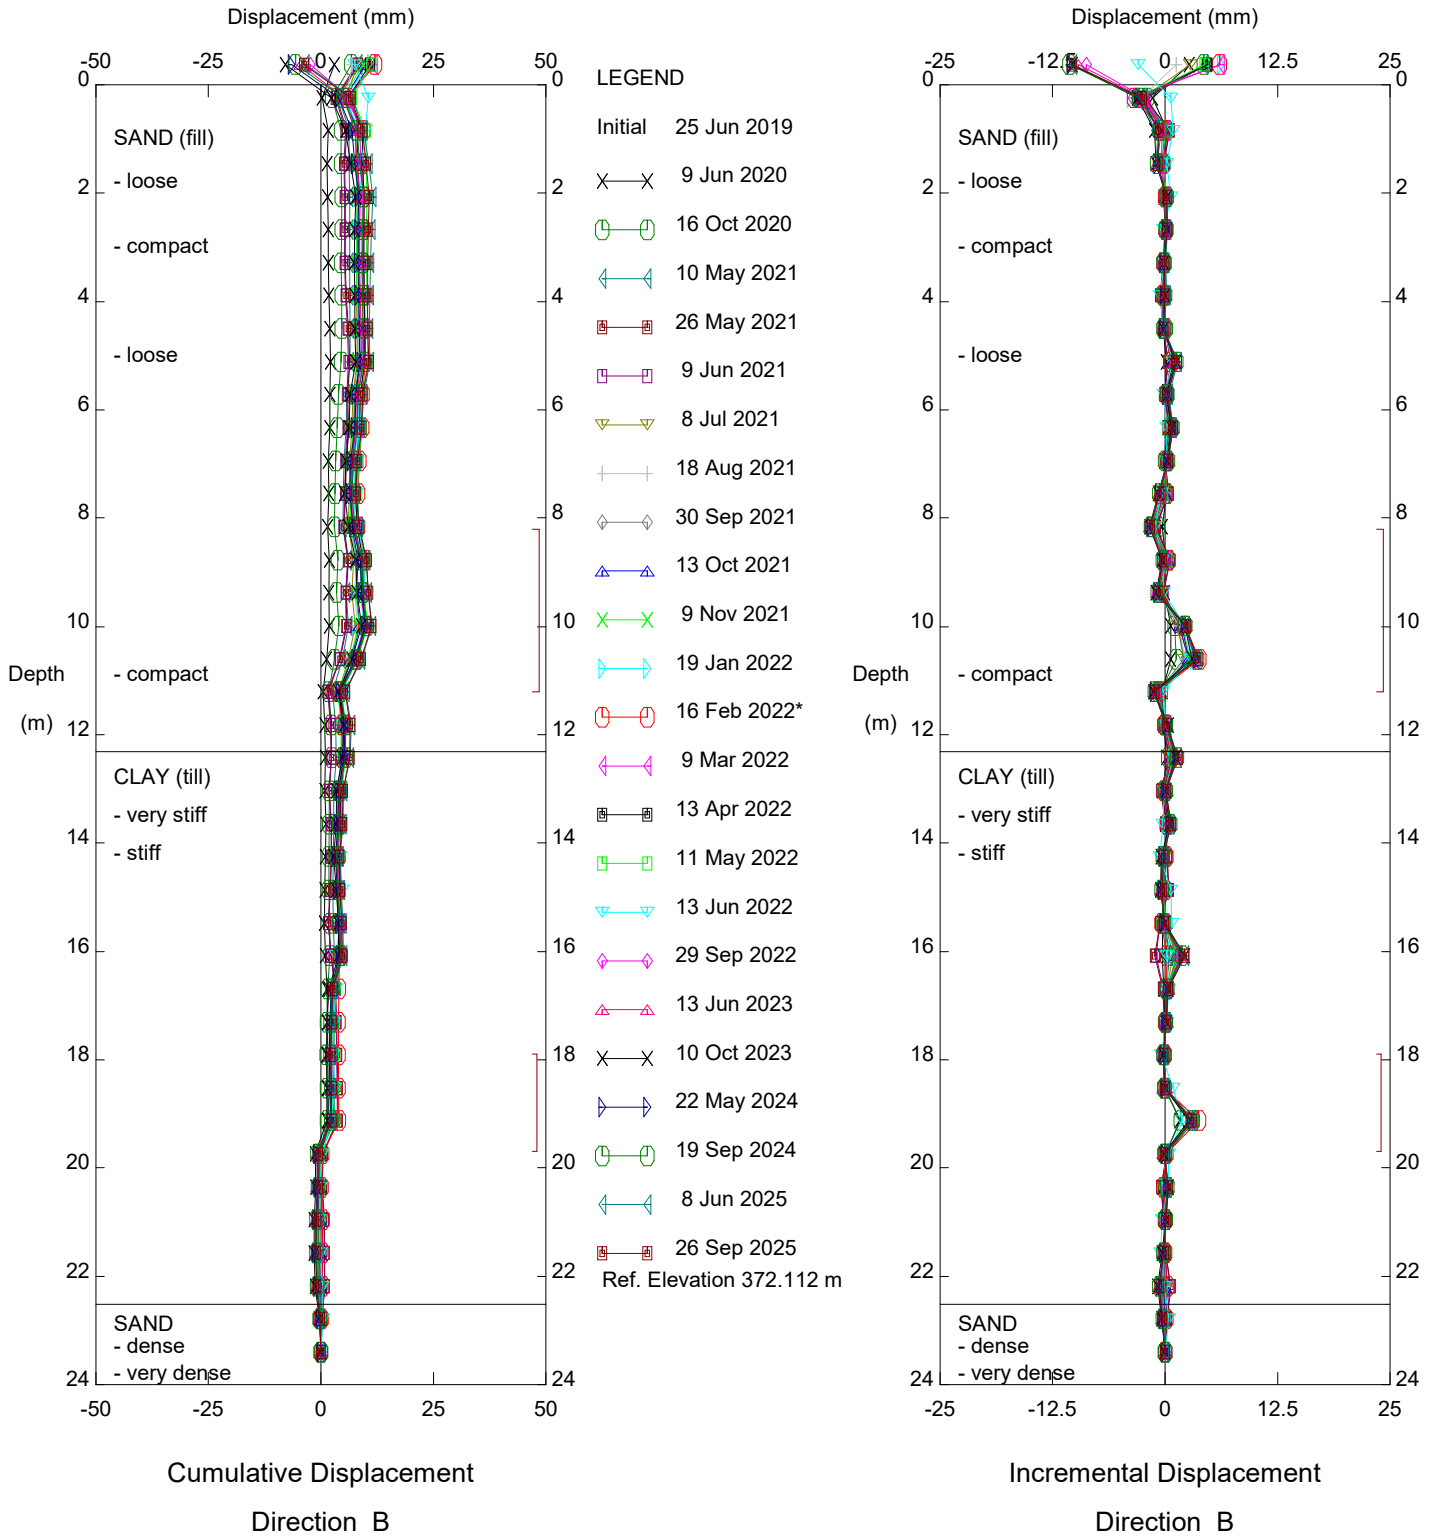
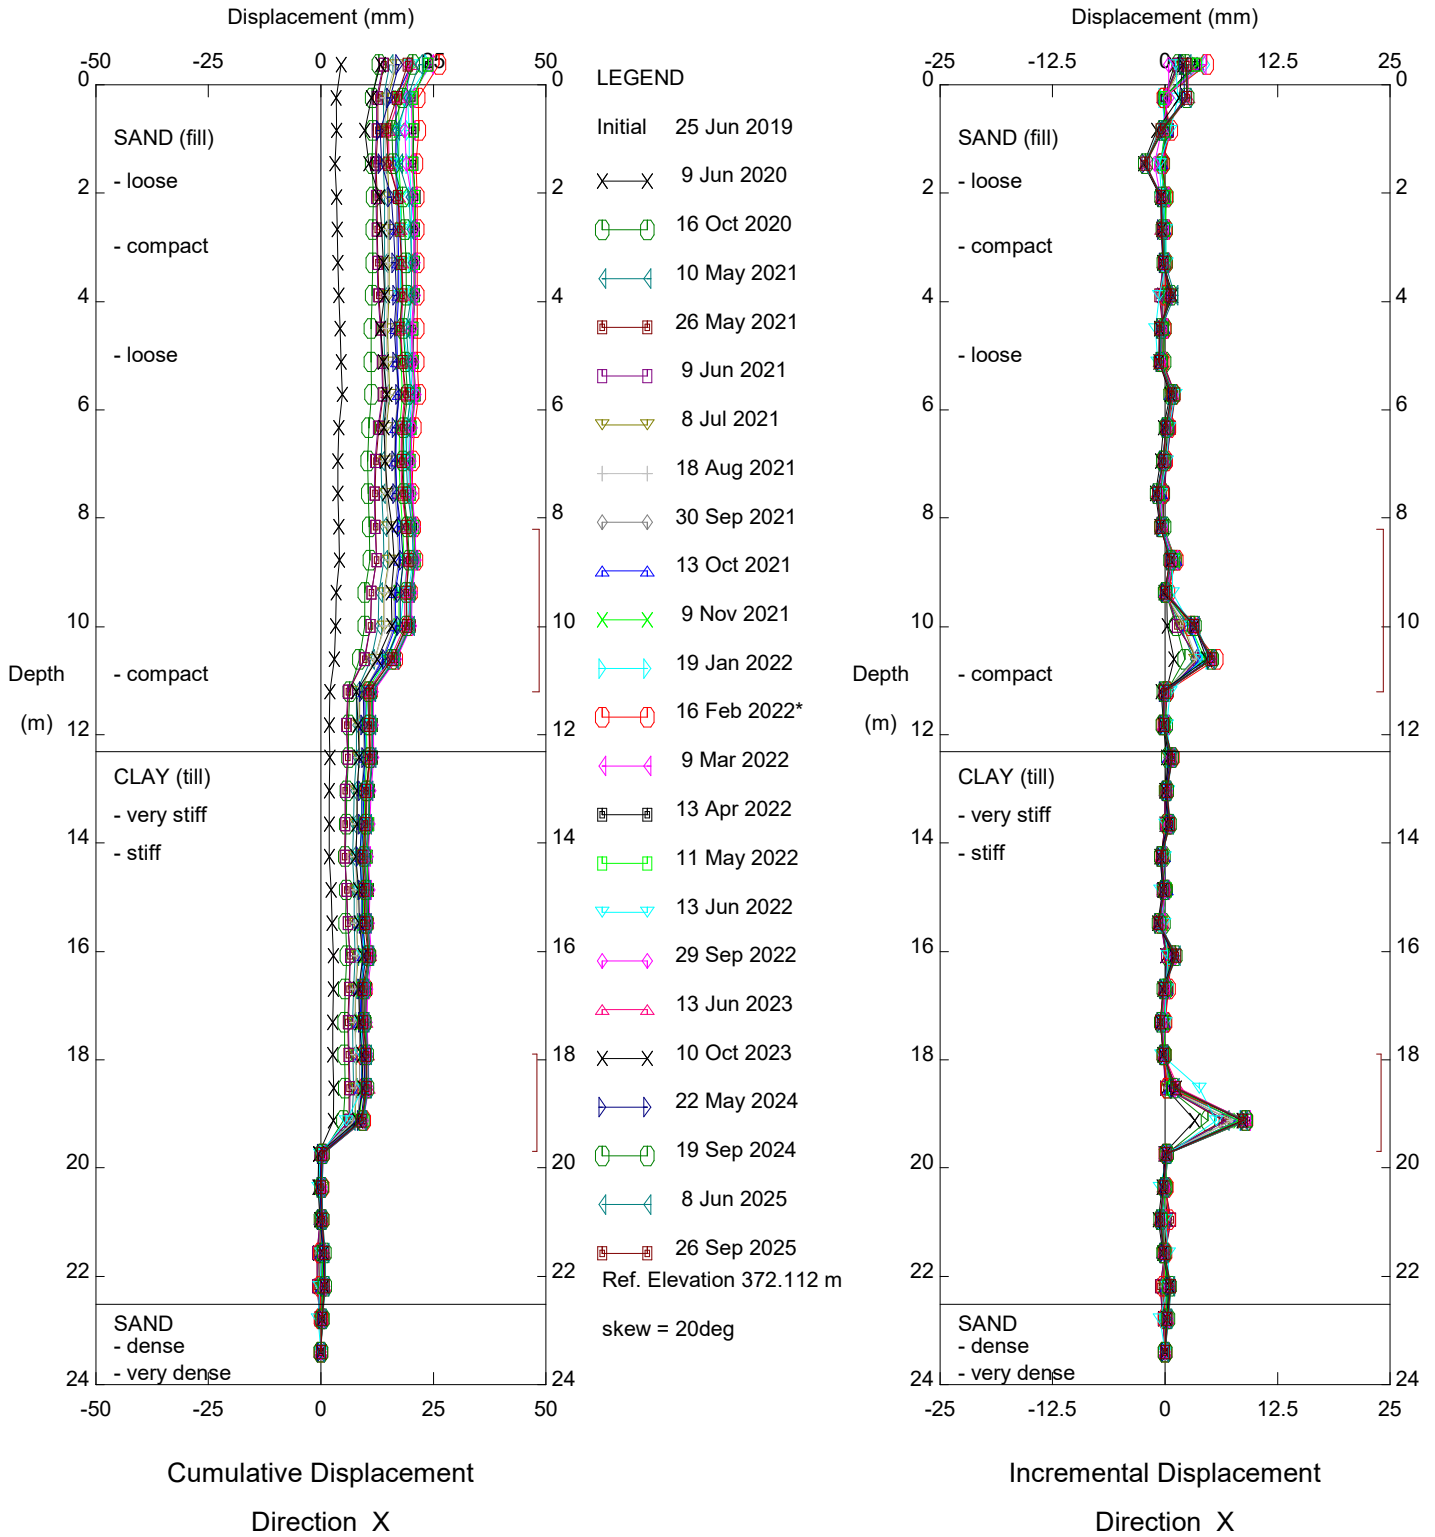
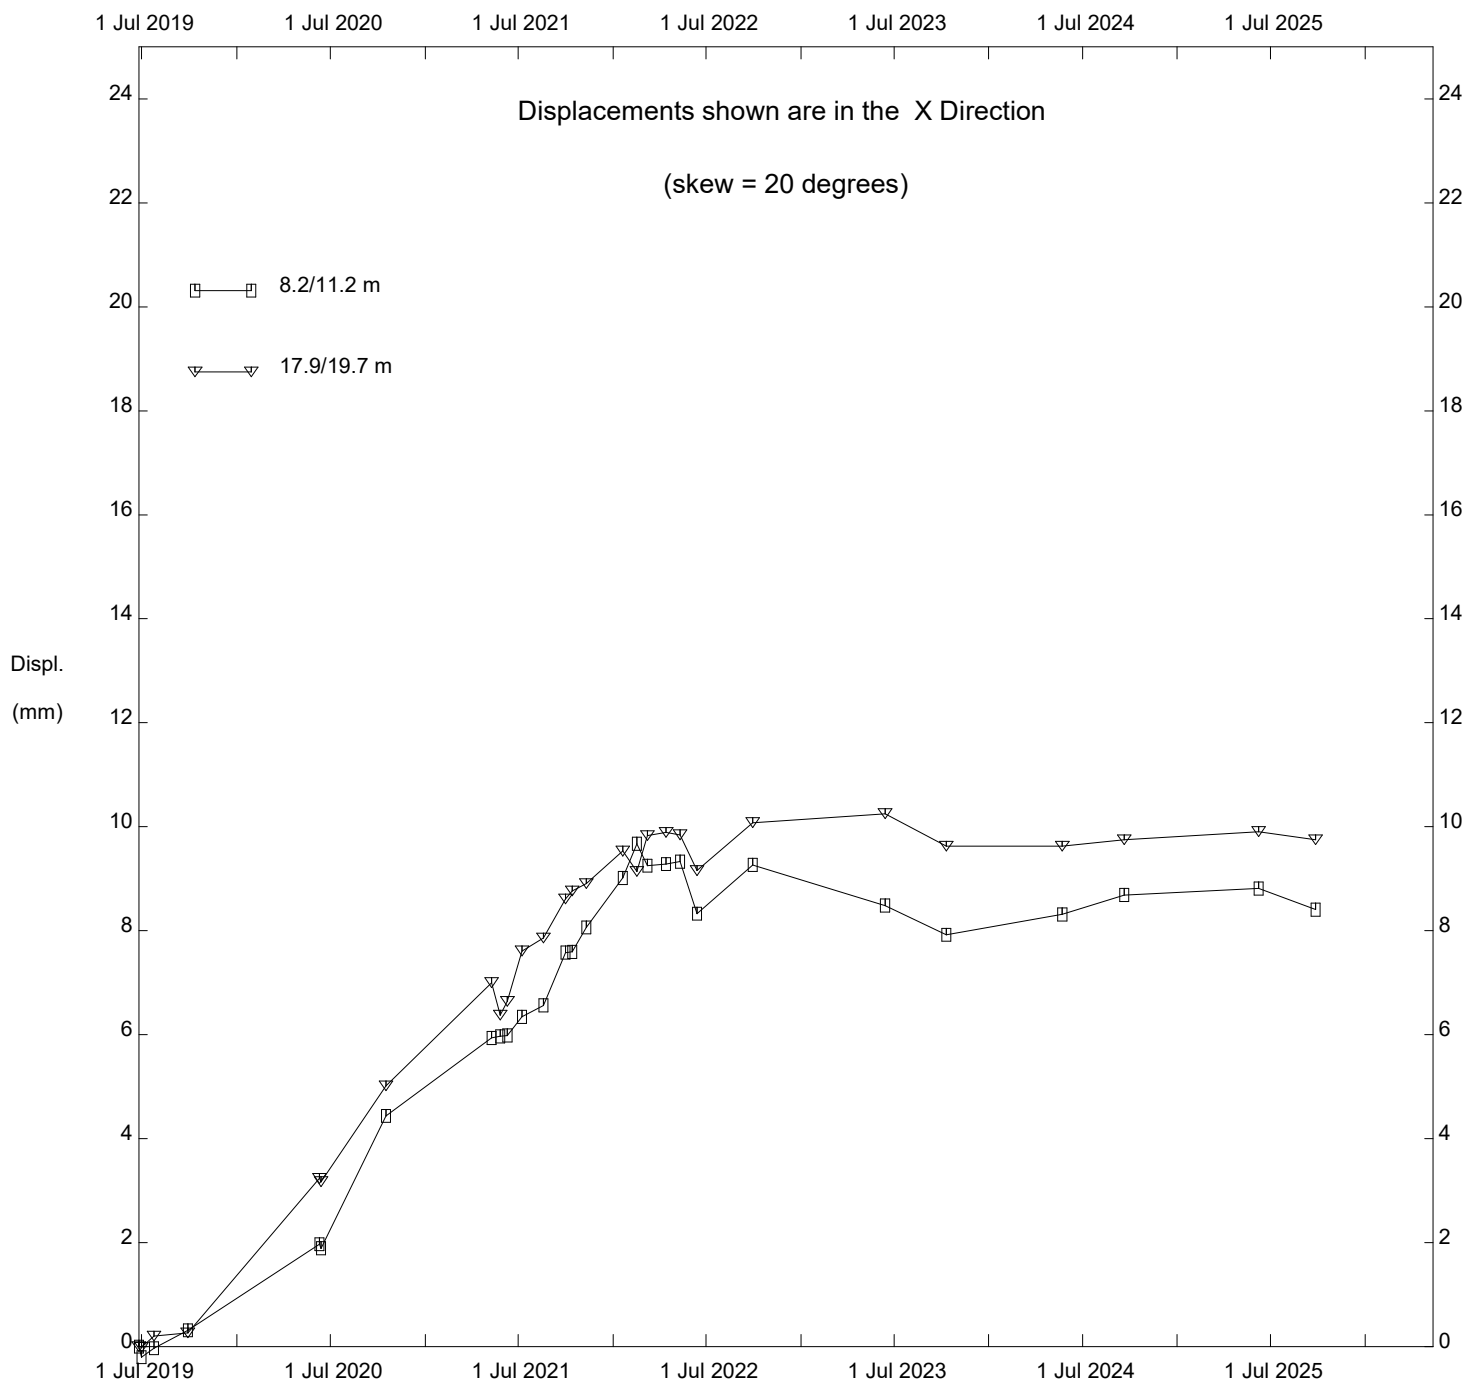
PH009 Old Hwy 2:02 Shop Slide, Inclinator SI19-5

SI19-5 is located in the lower central portion of the slide. It showed no discernable additional movement over 8.2 m to 11.2 m depth and 17.9 m to 19.7 m depth. The overall movement in SI19-5 has slowed significantly since slope offloading and the completion of construction.
