ALBERTA TRANSPORTATION AND  
ECONOMIC CORRIDORS GRMP  
PEACE REGION – (PEACE RIVER DISTRICT)  
INSTRUMENTATION MONITORING - FALL 2025

Site Number	Location	Name	Hwy	km
PH009-3	Hwy 684:02 km 30.99, Town of Peace River	Shaftesbury Trail - Shop Slide	684:02	30.9-31.1
			Old 2:02	0.0-0.4
Legal Description:		UTM Co-ordinates		
4-31-83-21 W5		11V    E    480321	N    6232126

<b>Current Monitoring:</b>	26-Sep-2025	<b>Previous Monitoring</b>	8-June-2025
<b>Instruments Read By:</b>	Mr. Niraj Regmi, G.I.T. and Mr. Angelo Castillo, of Thurber

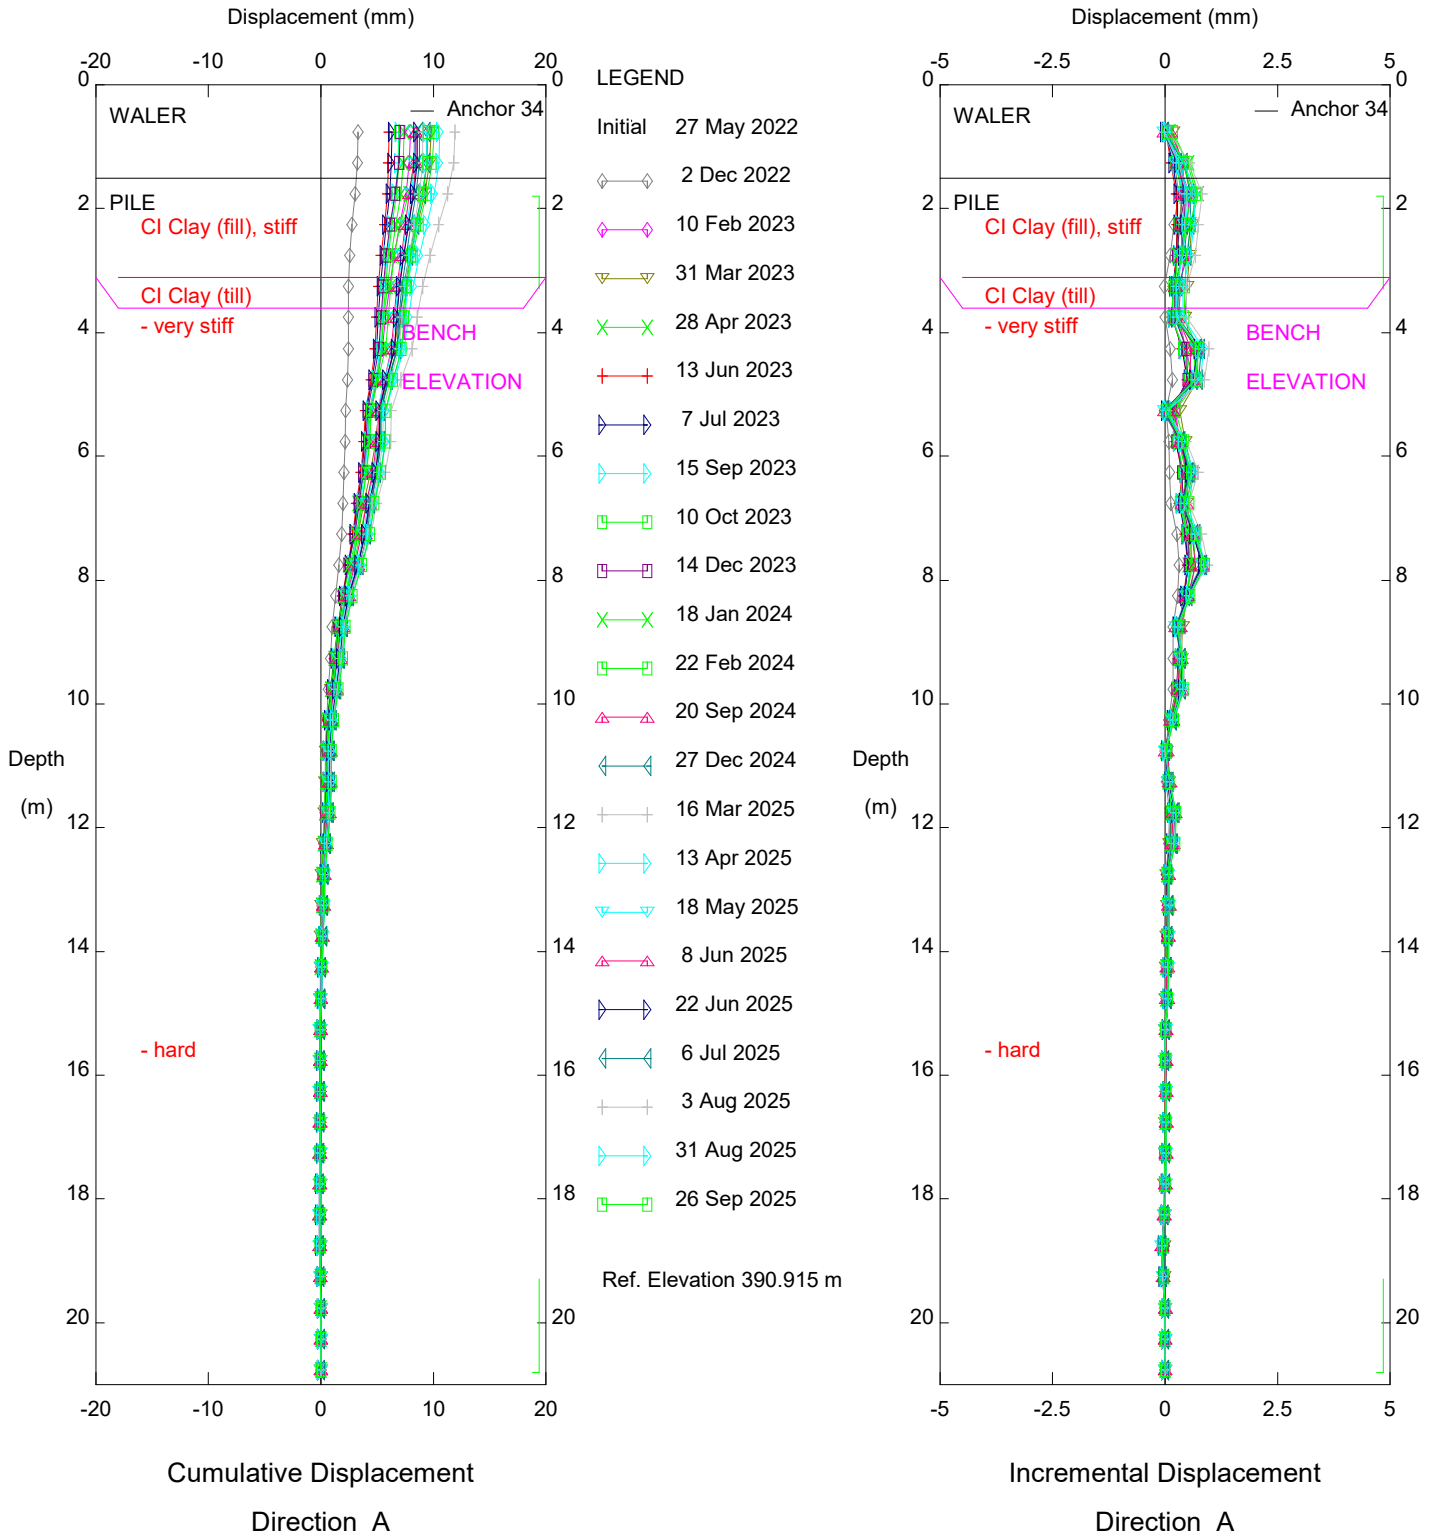
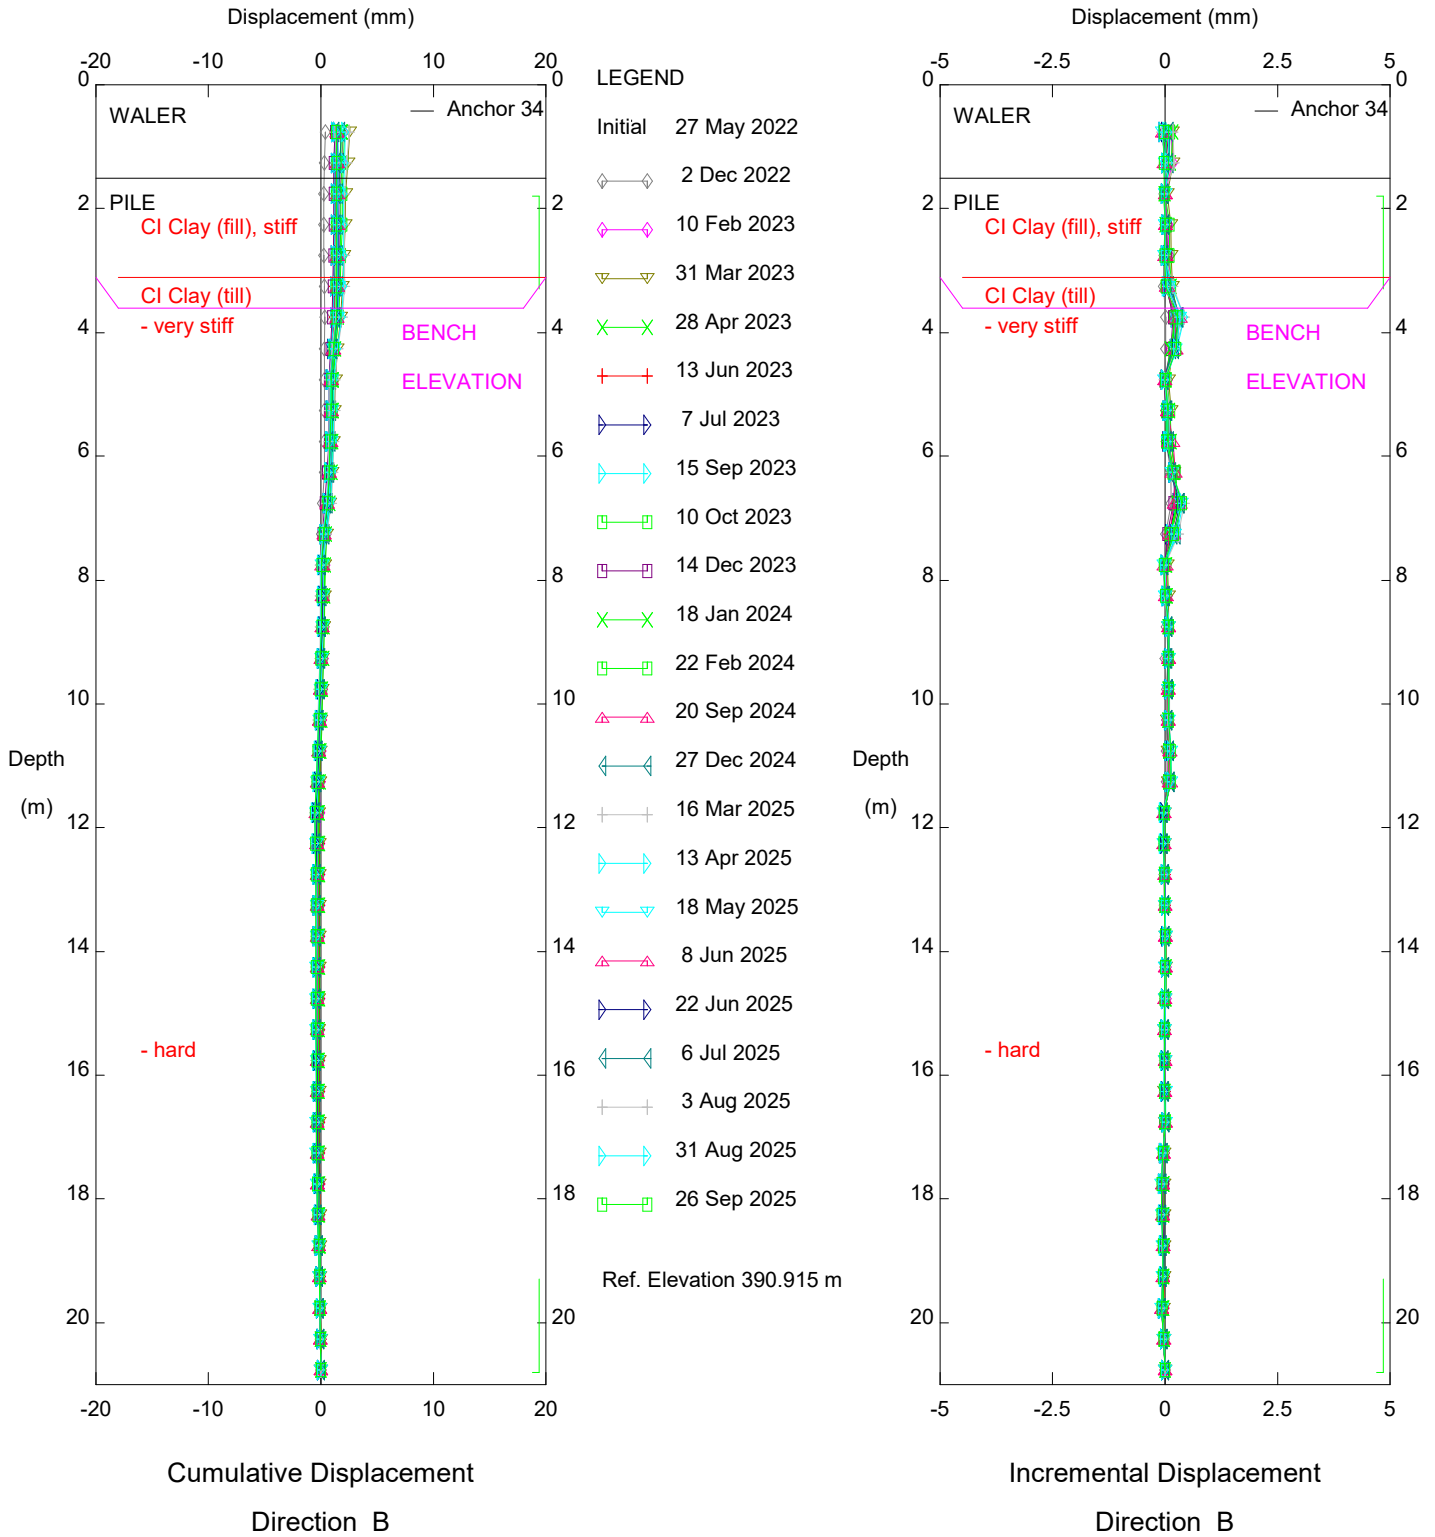
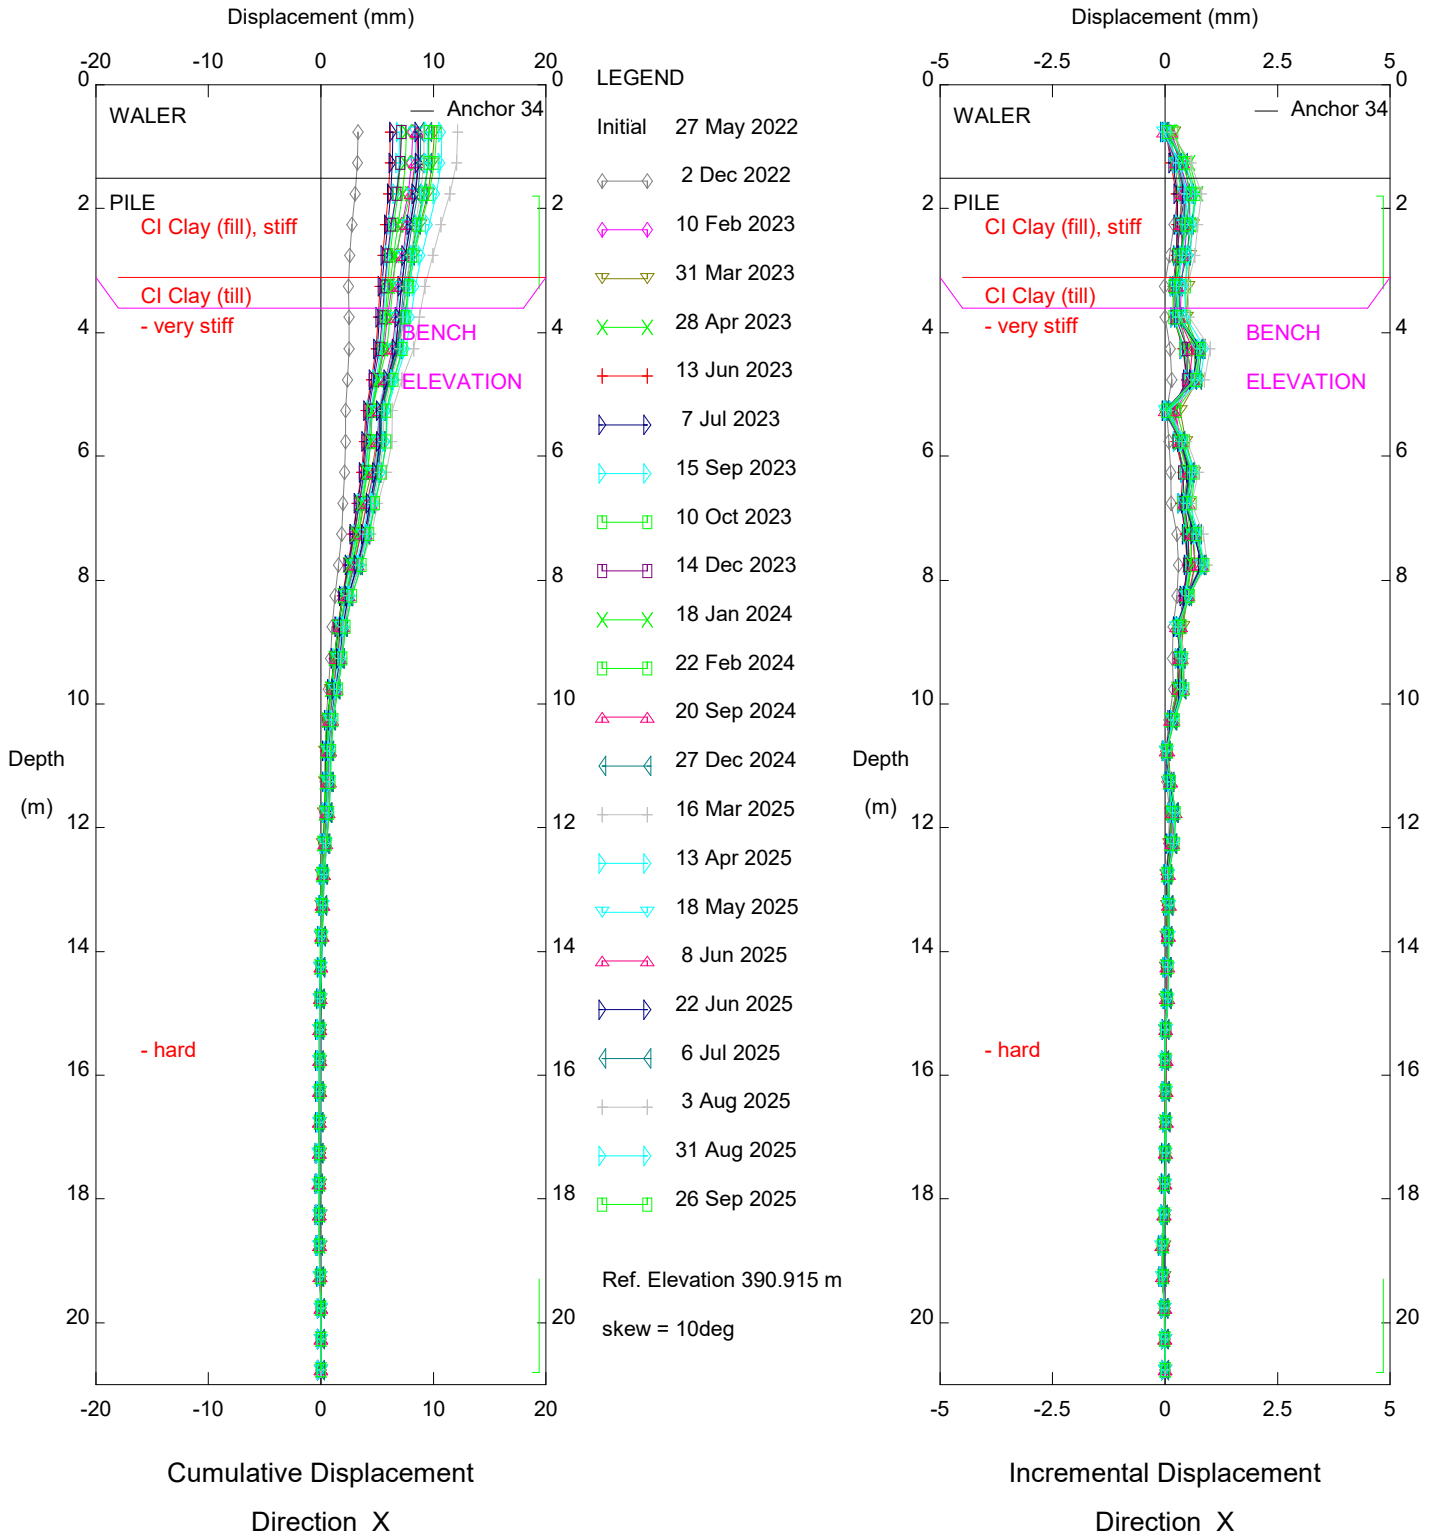
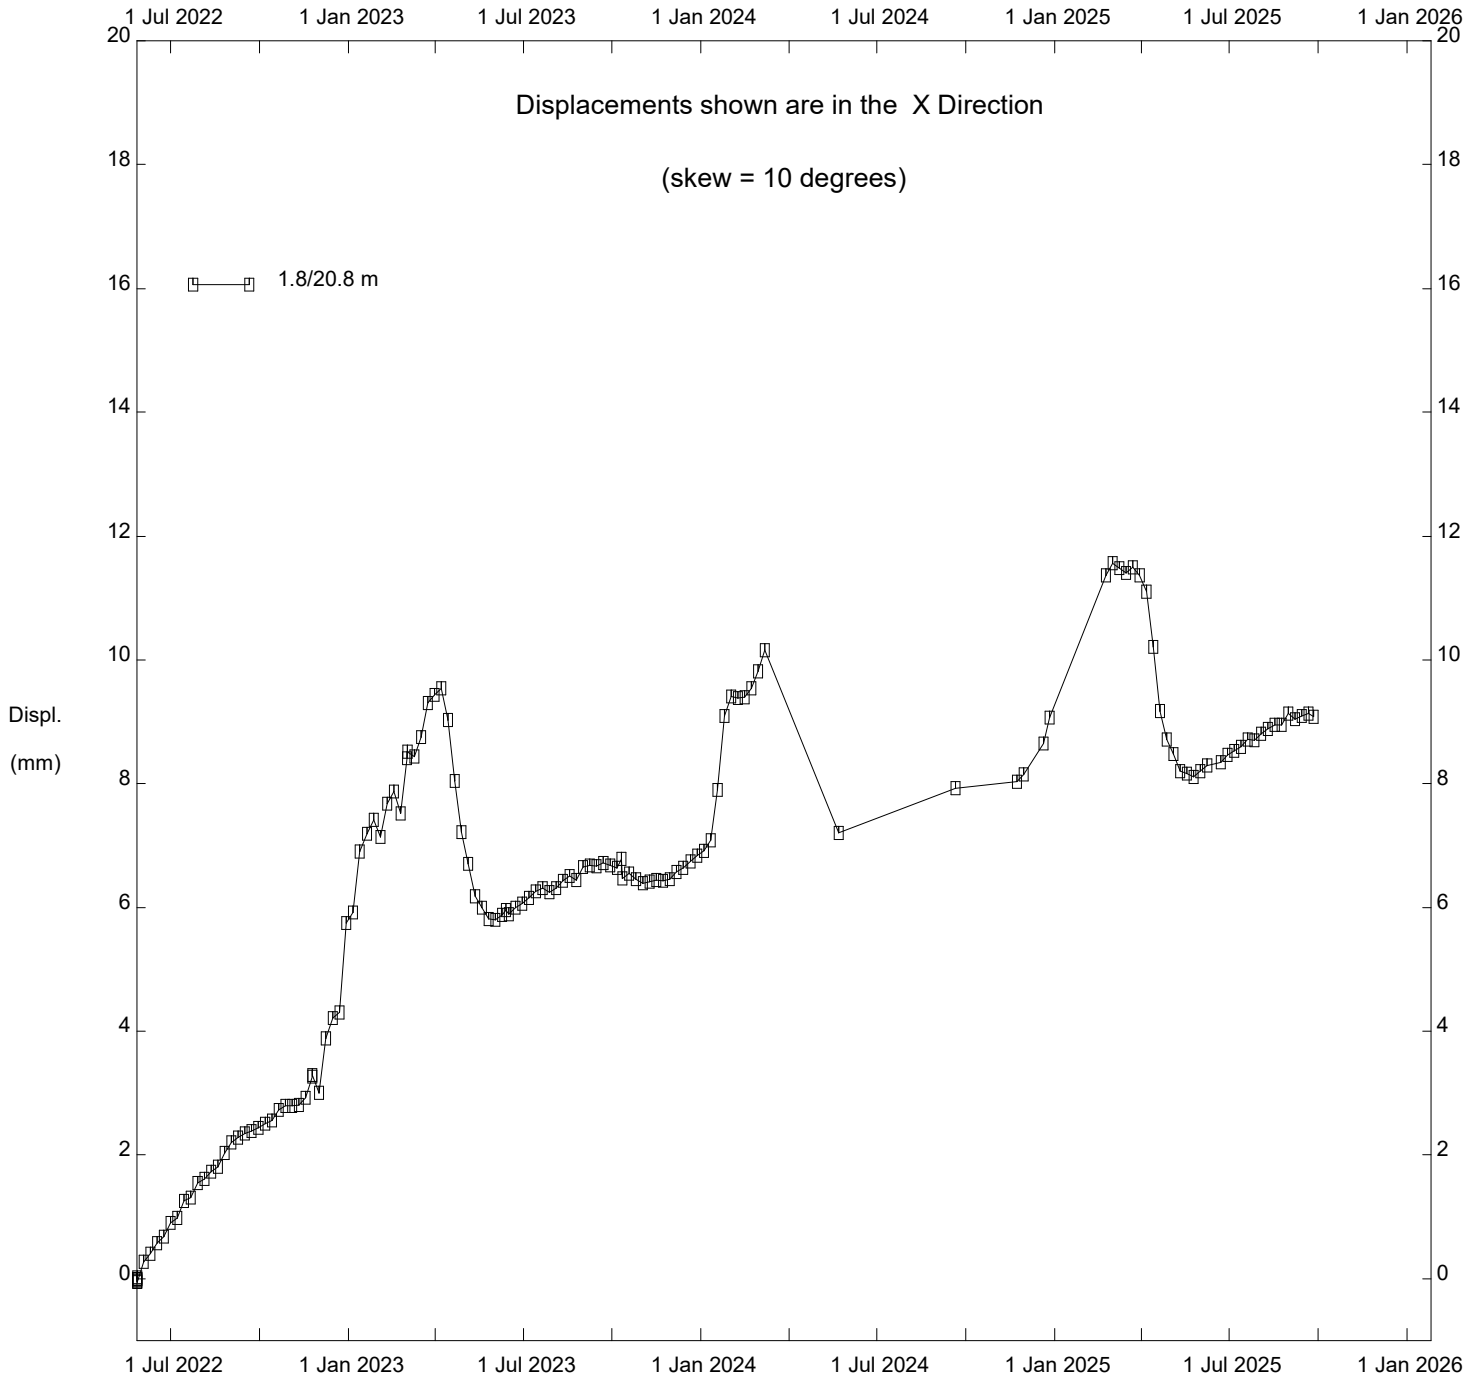
Shop Slide Type 1 Wall Section, Inclinometer SAA-P34

Shape accelerometer arrays (SAA) were installed in three concrete piles. SAA-P34 has shown an average rate of movement of 2.6 mm/yr in the downslope direction since the spring of 2025 readings, with a current pile head deflection of 9.1 mm since datalogger readings began for this instrument on May 27, 2022. The pile deflection appears to be a general tilt of the pile above an inflection point at about 10 m depth. SAA-P34 shows seasonal trends of greater pile deflection through winter months and a relaxation in summer months in response to the seasonal behaviour of anchored pile wall system. The maximum pile head deflection of 12.0 mm was measured in March 2025.

Pile head deflections measured by the SAA are within acceptable design tolerances (below the estimated SLS Design Values, measured since anchor lock-off: 18 mm for SAA-P34, 7 mm for SAA-P77, and 39 mm for SAA-P113). More deflection is noted, as expected, in the cantilever section of the wall (SAA-P113). The additional deflection in SAA-P34 may be due to the deeper amount of cut as compared to the slope below SAA-P77. This will require additional readings and analysis to interpret and will be considered as part of the ongoing development of threshold criteria for this pile wall.

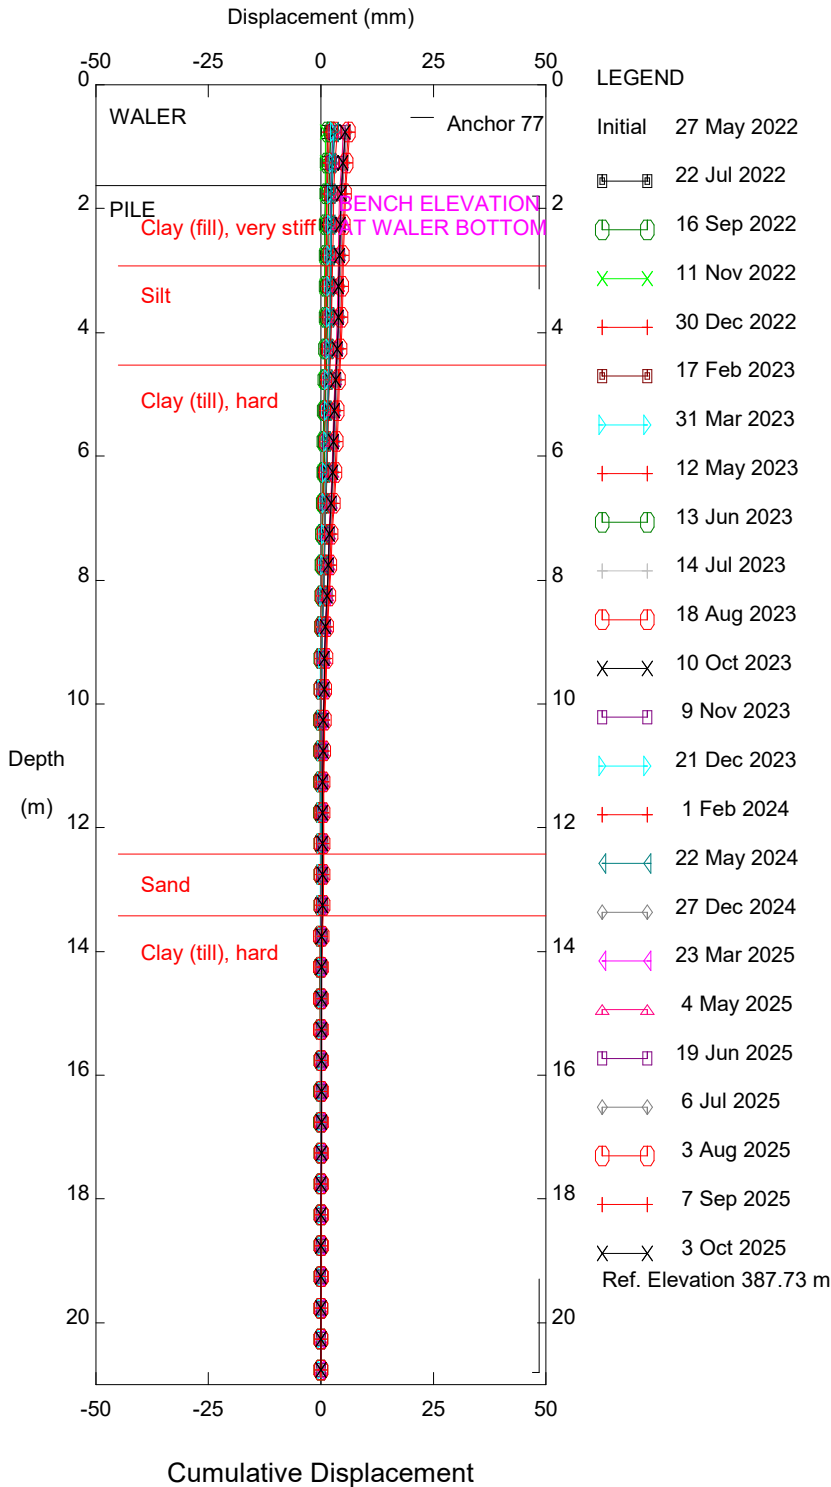
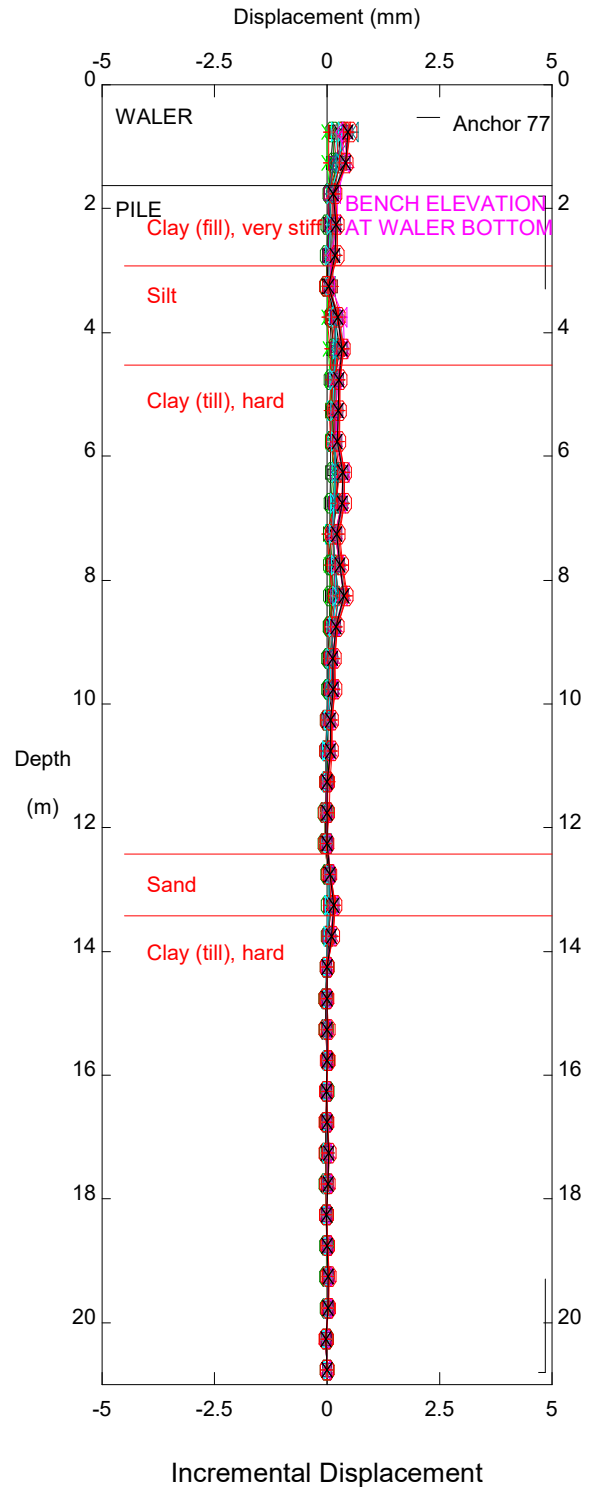
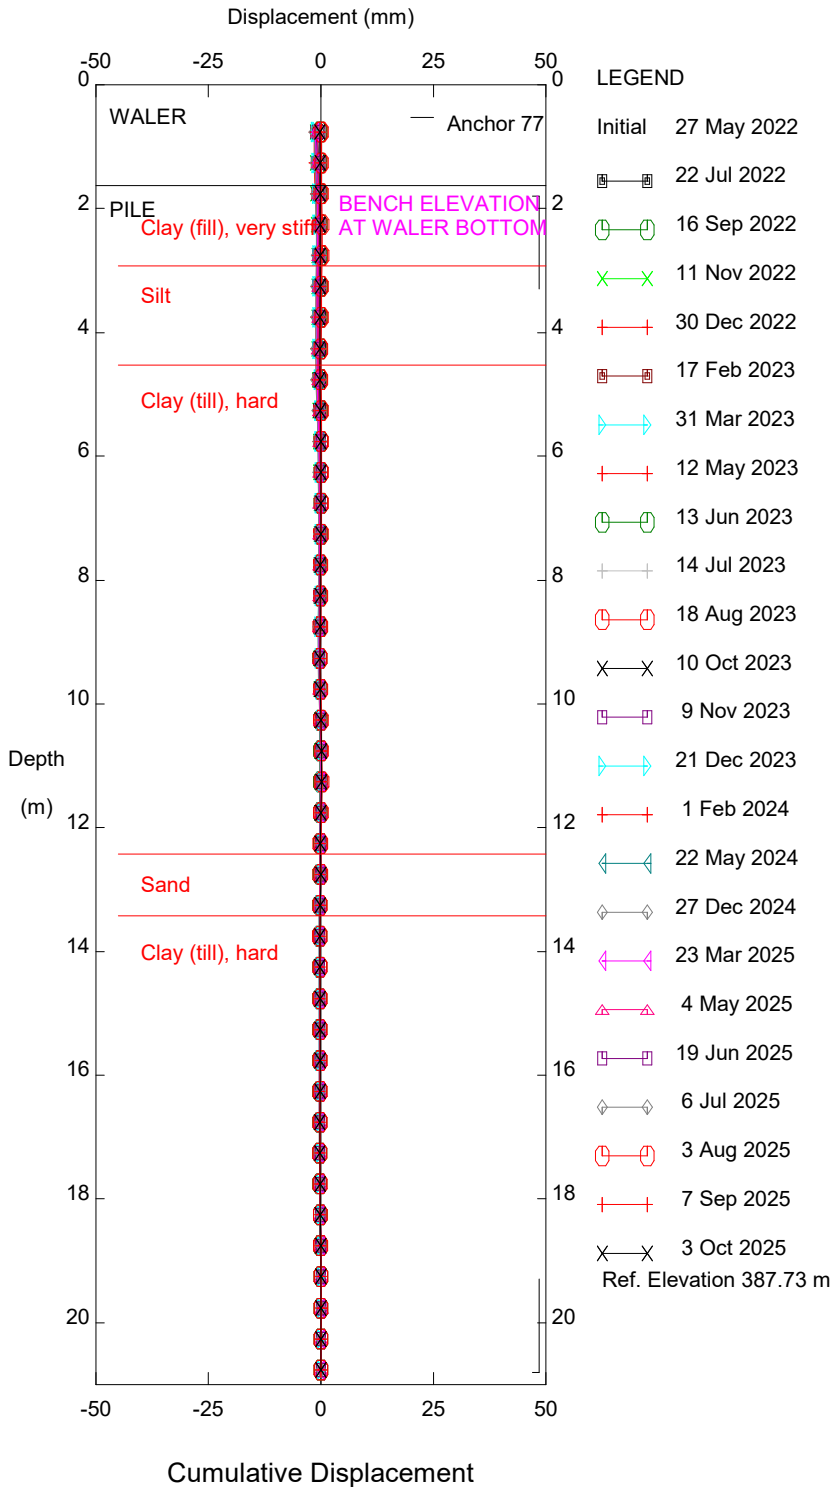
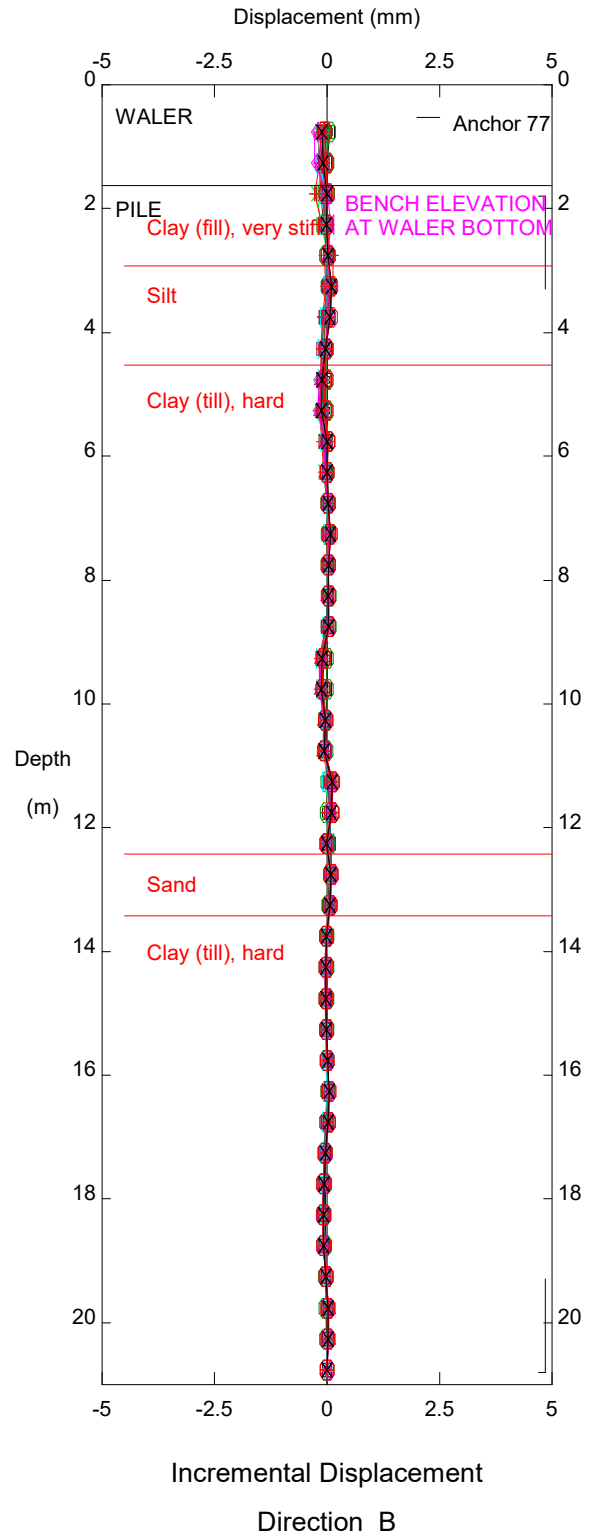
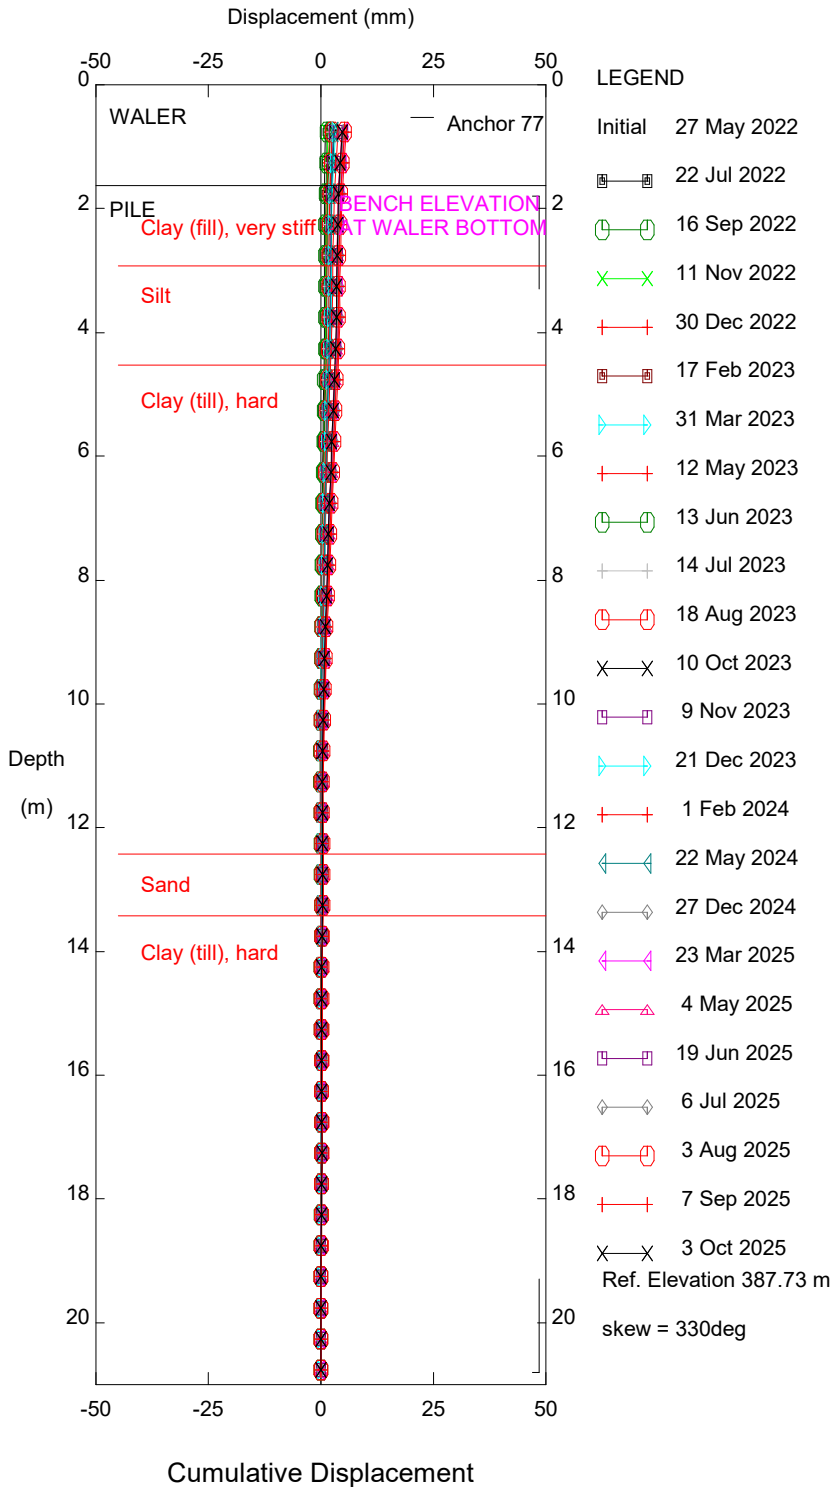
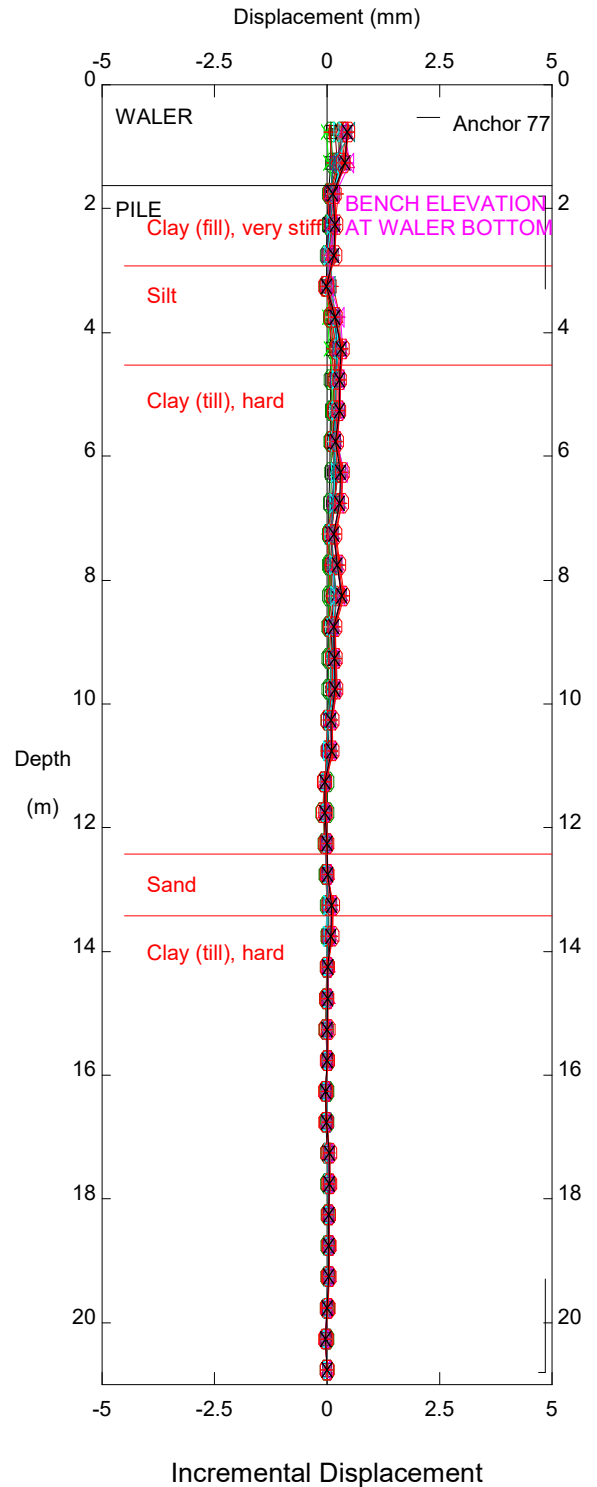
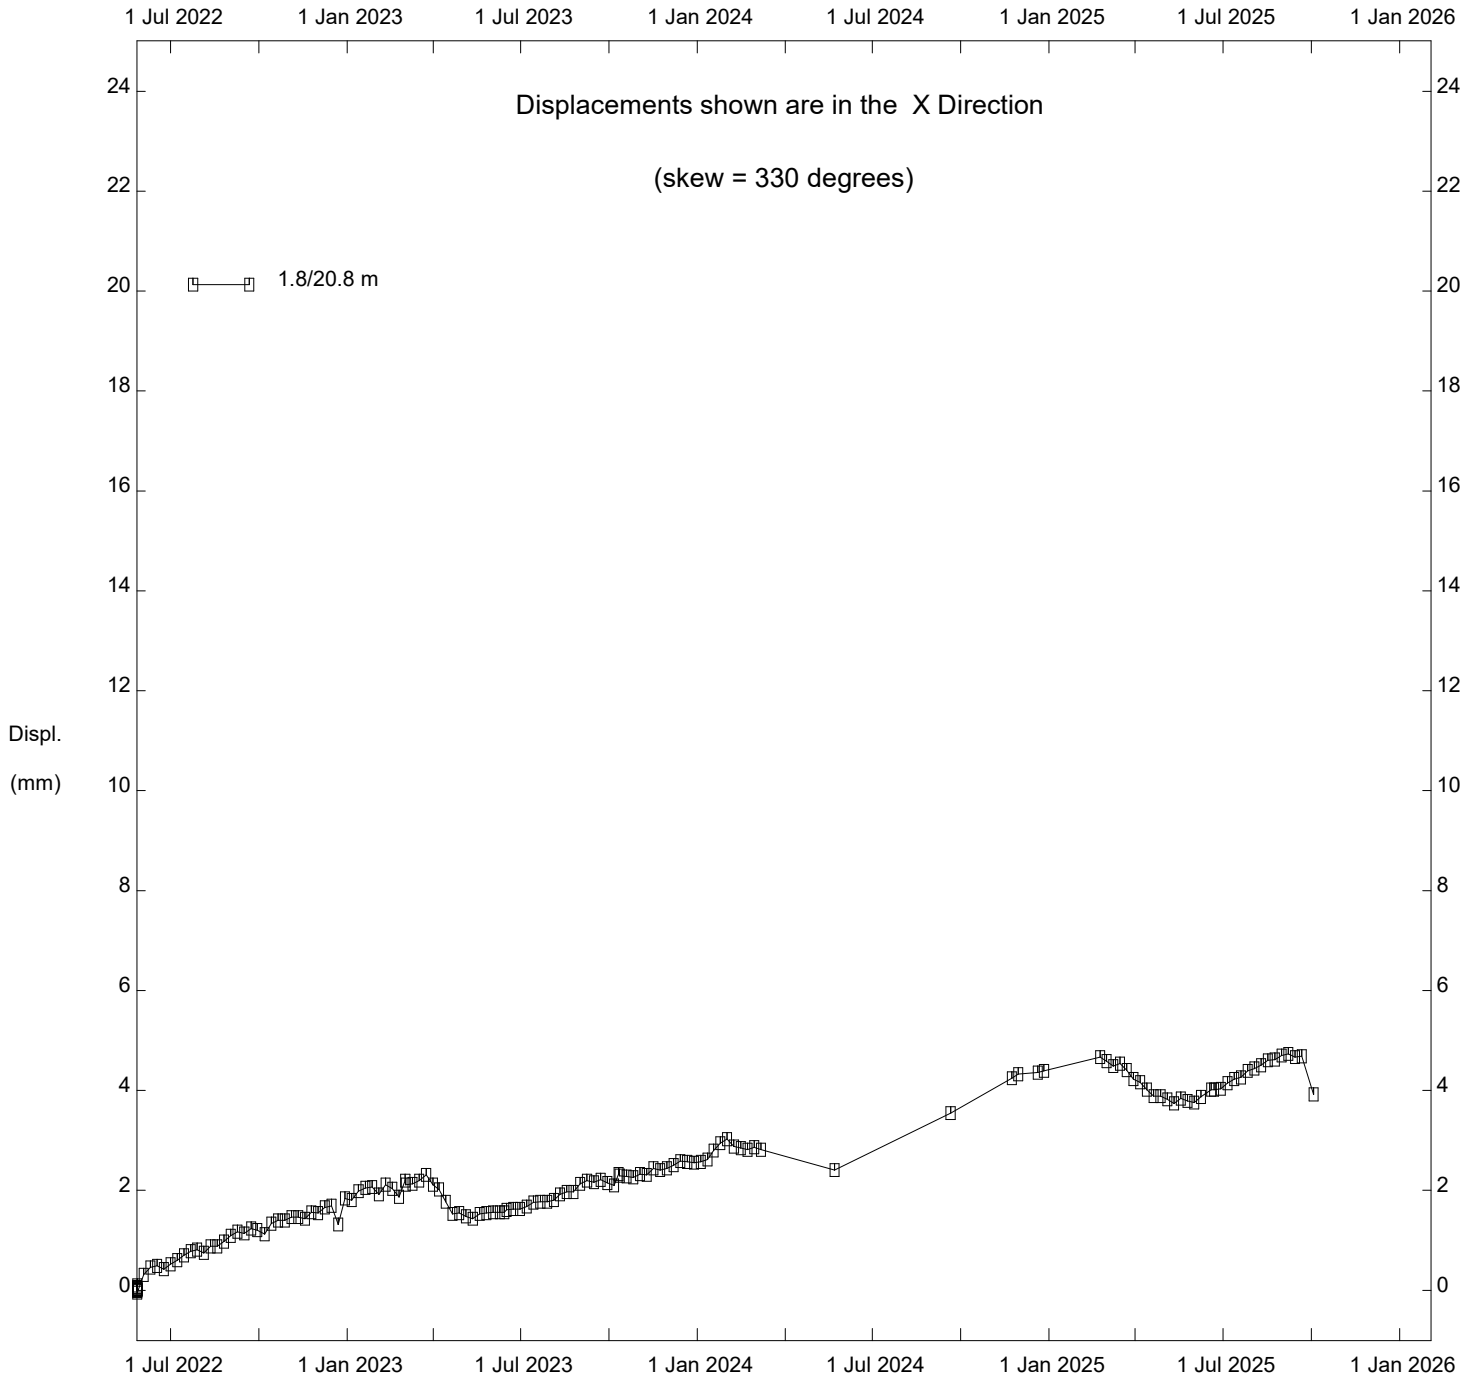
Shop Slide Wall Type 2 Section, Inclinator SAA-P77

SAA-P77 showed a rate of movement of 0.1 mm/yr since the spring of 2025 readings. SAA-P77 has shown a total pile head movement of 4.0 mm since datalogger readings began on May 27, 2022. The maximum pile head deflection of 5.0 mm was measured in March 2025. The pile deflection also appears to be a general tilt of the pile above an inflection point at about 9 m depth. The seasonal movement trend at SAA-P77 is less pronounced compared to SAA-P34, which is due to the lower cantilever height of the wall at this location (roughly 3 m compared to 6 m to 7 m at P34) which restrains the pile movement.
