ALBERTA TRANSPORTATION AND  
ECONOMIC CORRIDORS GRMP  
PEACE REGION – (PEACE RIVER DISTRICT)  
INSTRUMENTATION MONITORING - FALL 2025

Site Number	Location	Name	Hwy	km
PH009-3	Hwy 684:02 km 30.99, Town of Peace River	Shaftesbury Trail - Shop Slide	684:02	30.9-31.1
			Old 2:02	0.0-0.4
Legal Description:		UTM Co-ordinates		
4-31-83-21 W5		11V    E    480321	N    6232126

<b>Current Monitoring:</b>	26-Sep-2025	<b>Previous Monitoring</b>	8-June-2025
<b>Instruments Read By:</b>	Mr. Niraj Regmi, G.I.T. and Mr. Angelo Castillo, of Thurber

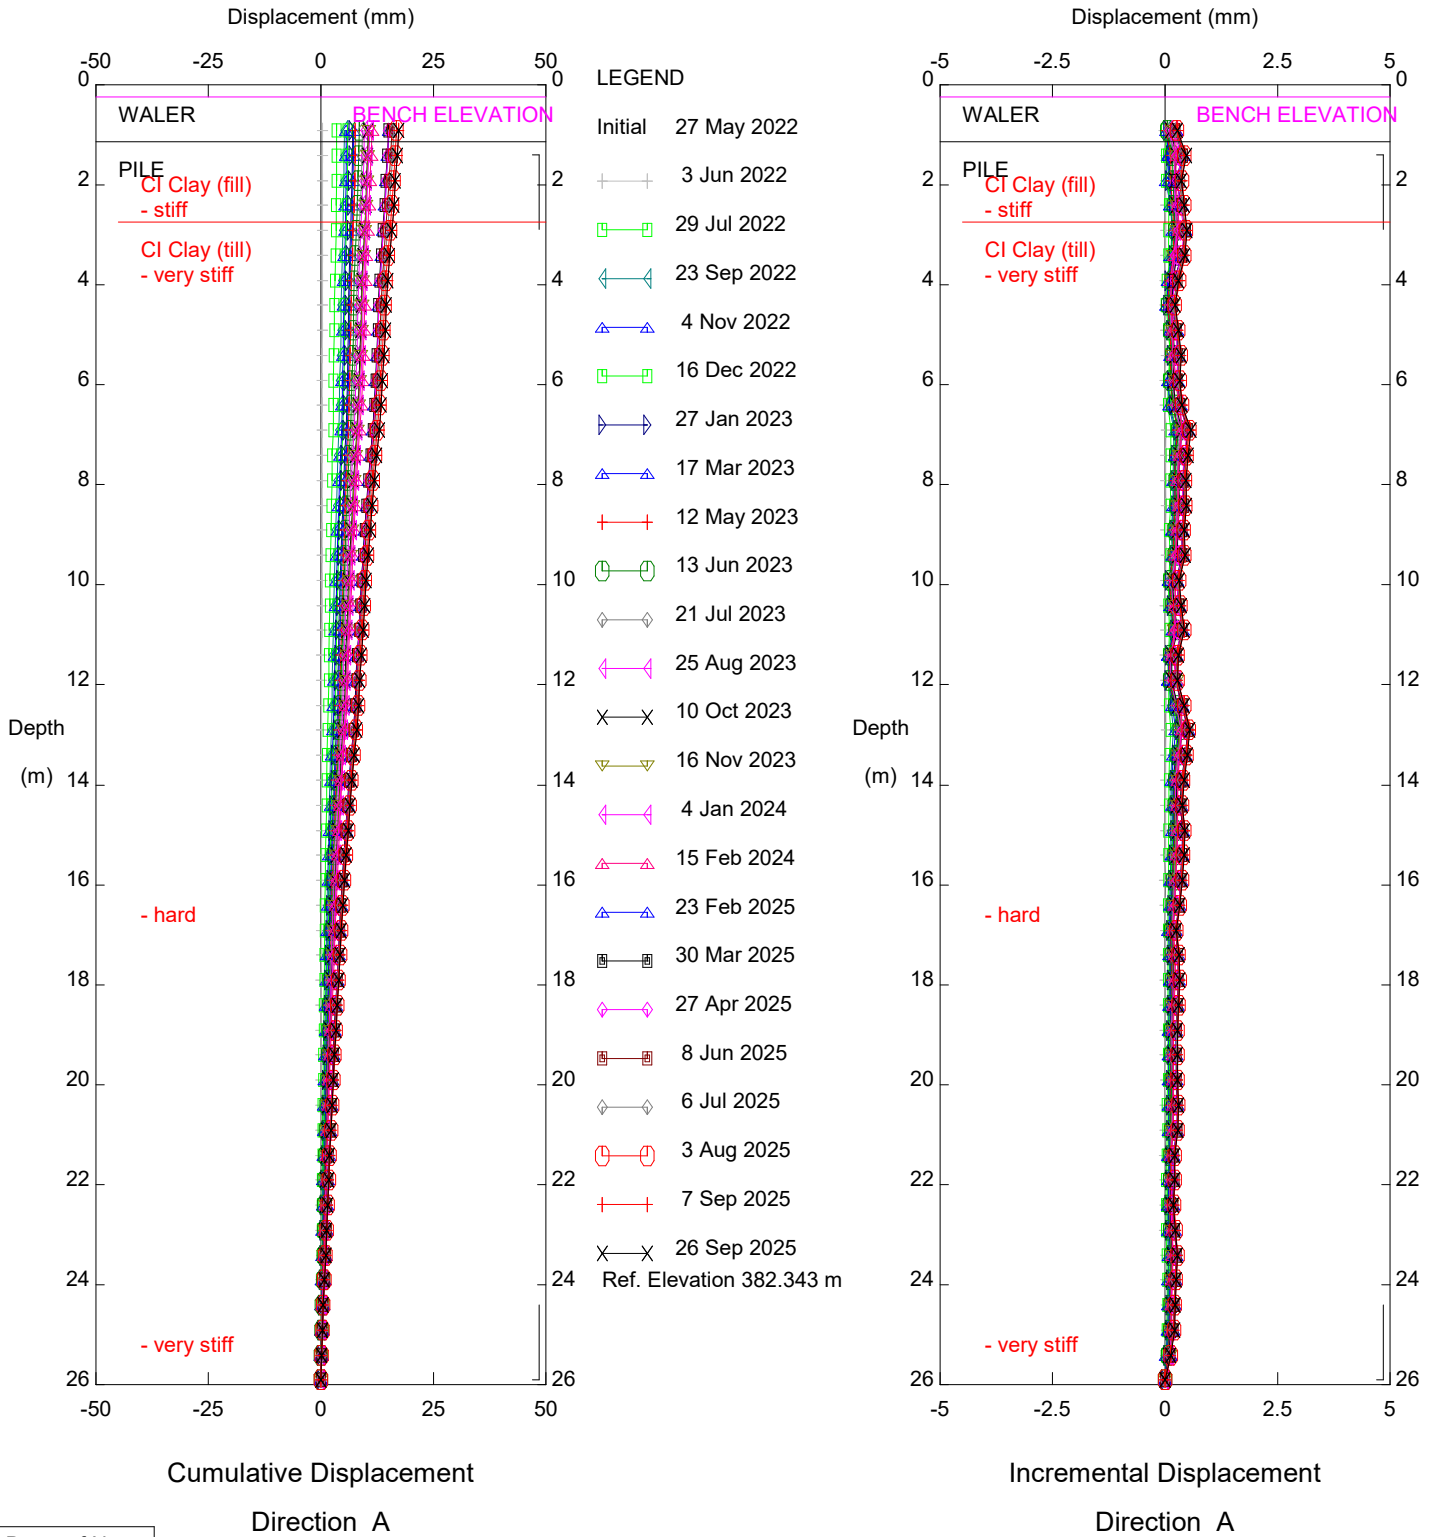
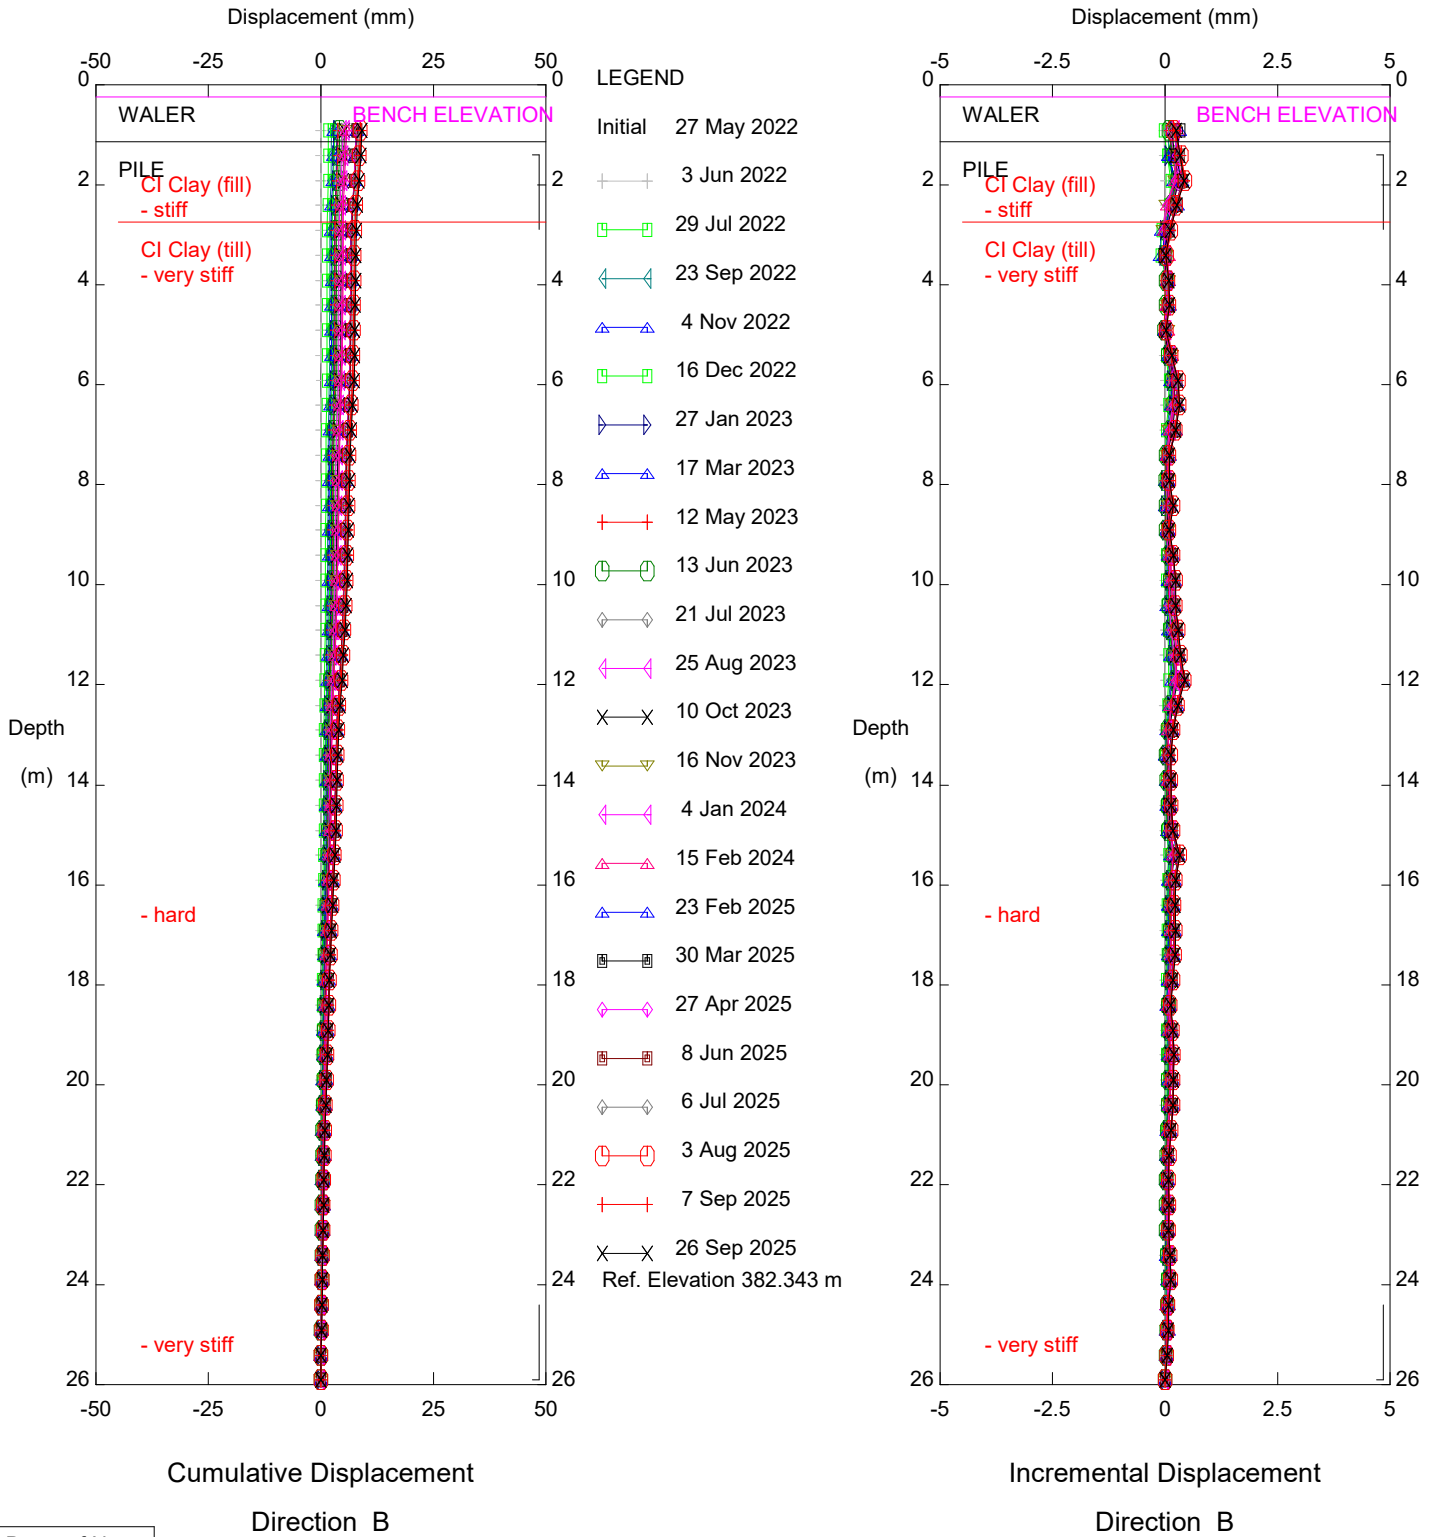
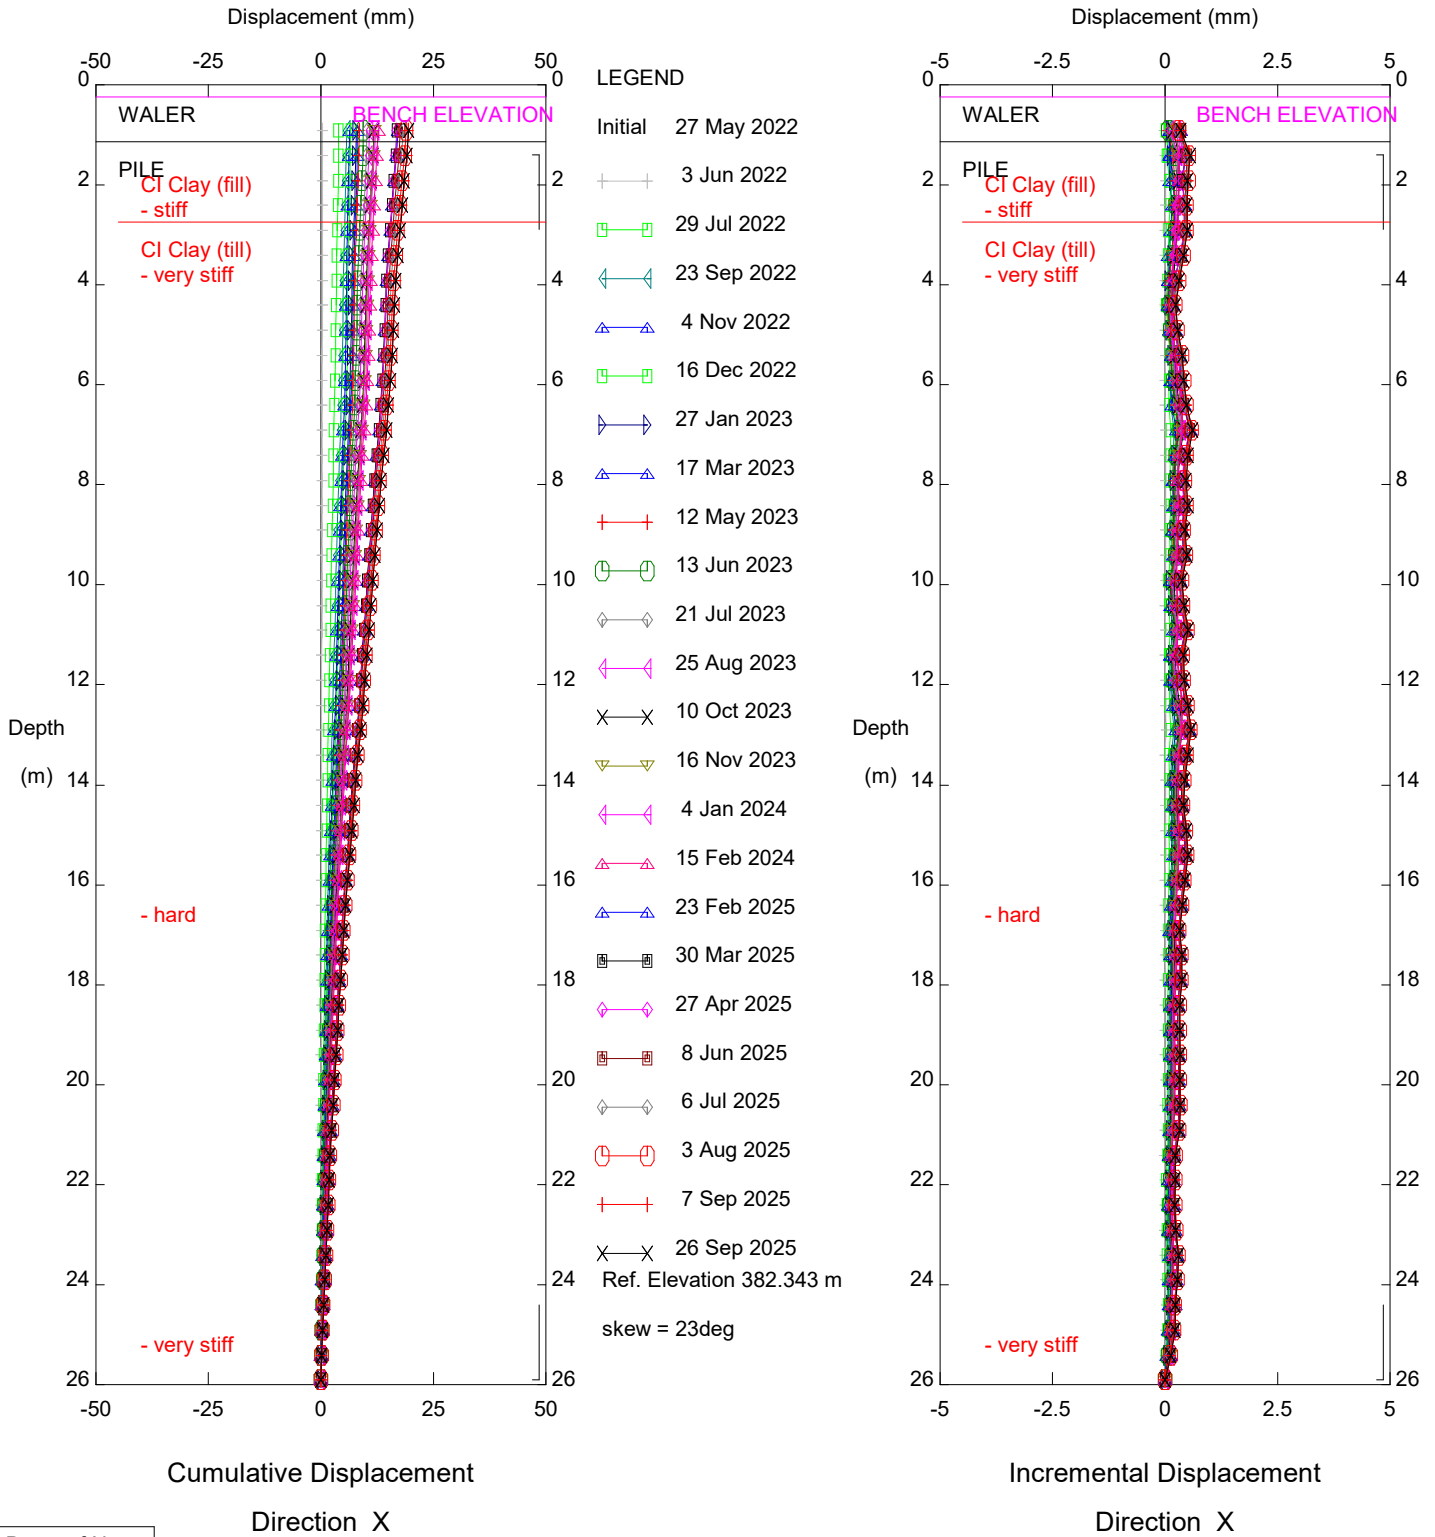
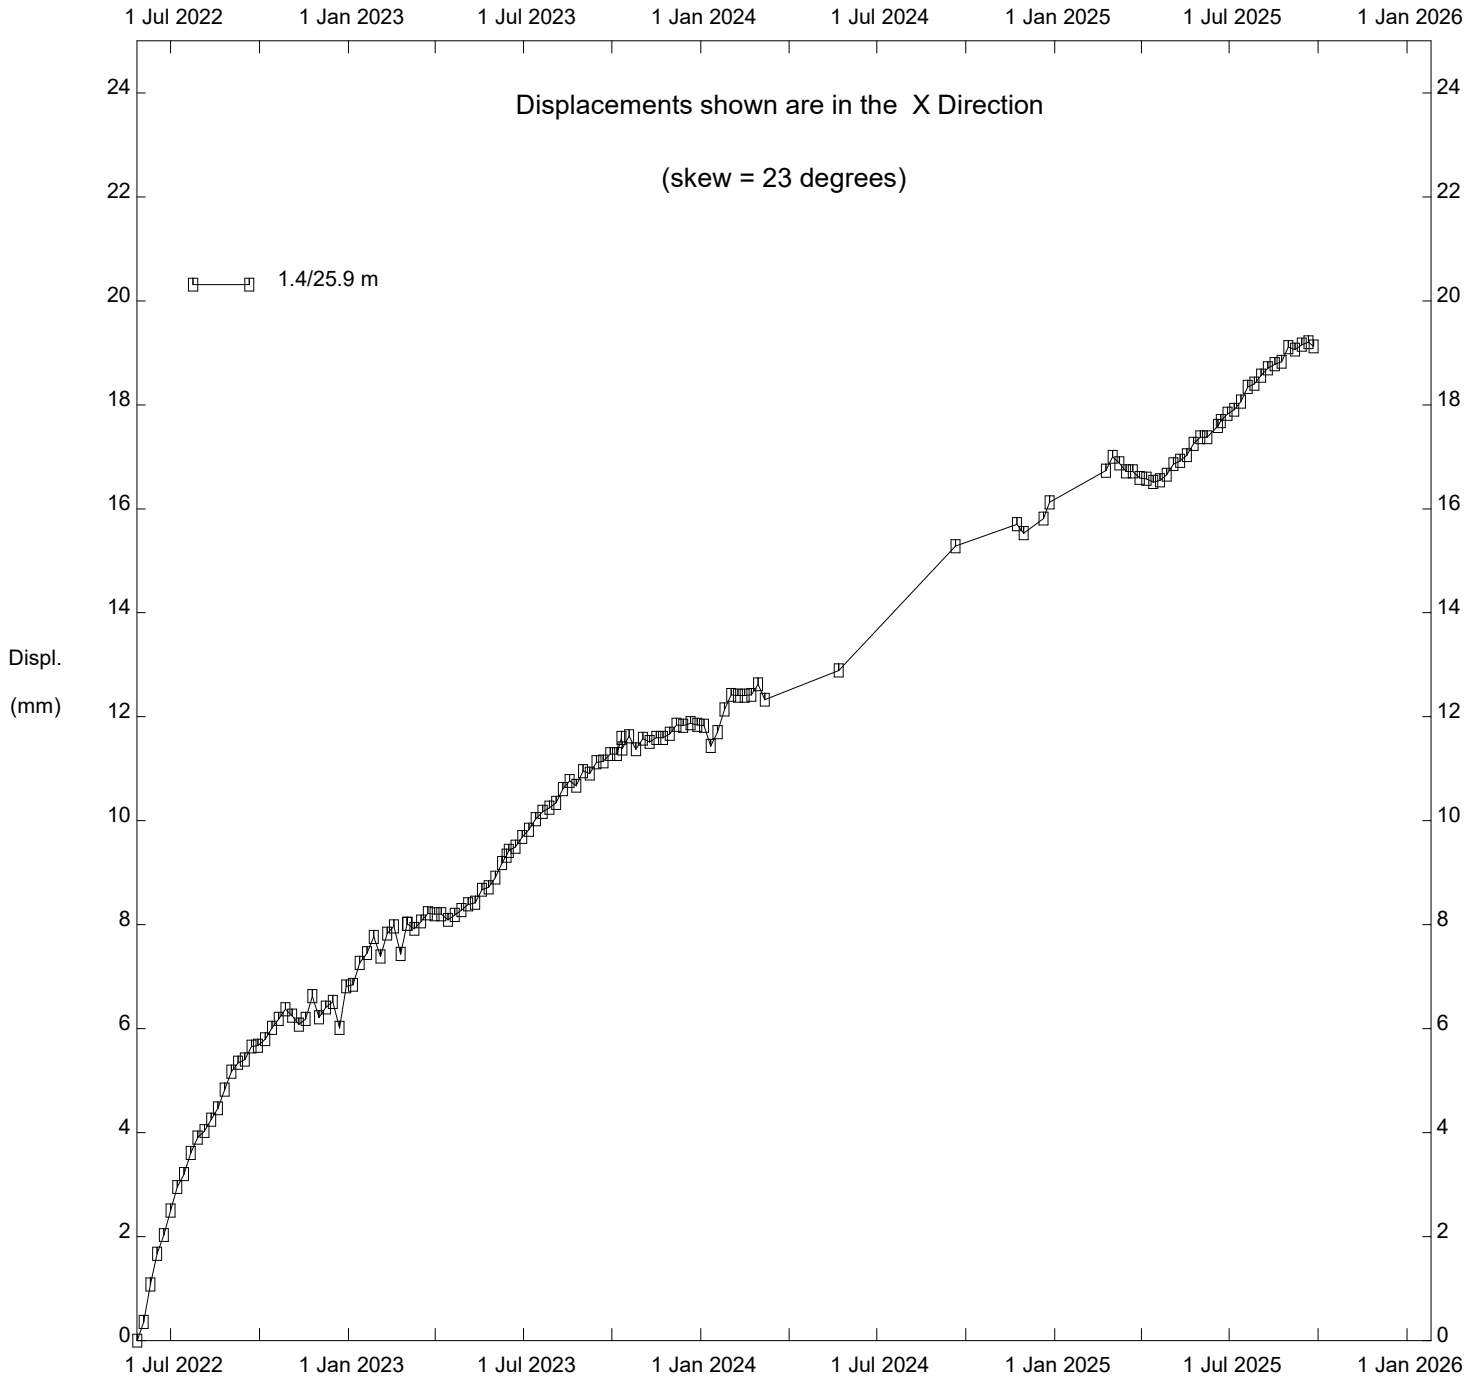
Shop Slide Wall Type 3, Inclinometer SAA-P113

SAA-P113 has shown an average rate of movement of 5.8 mm/yr in the downslope direction since the spring of 2025 readings, with a total pile head deflection of 19.1 mm since datalogger readings began on May 27, 2022. The larger deflection measured in SAA-P113 can be attributed to the fact that the pile wall at this location is cantilevered rather than tied-back like the other portions of the wall. The movement rate measured in the instrument has increased since the spring of 2025 readings by 2.9 mm/yr. The pile deflection appears to be a general tilt of the pile above an inflection point at about 20 m depth. SAA-P113 does less distinct seasonal movement trends as SAA-P34 or SAA-P77 since there are no anchors in this portion of the wall.

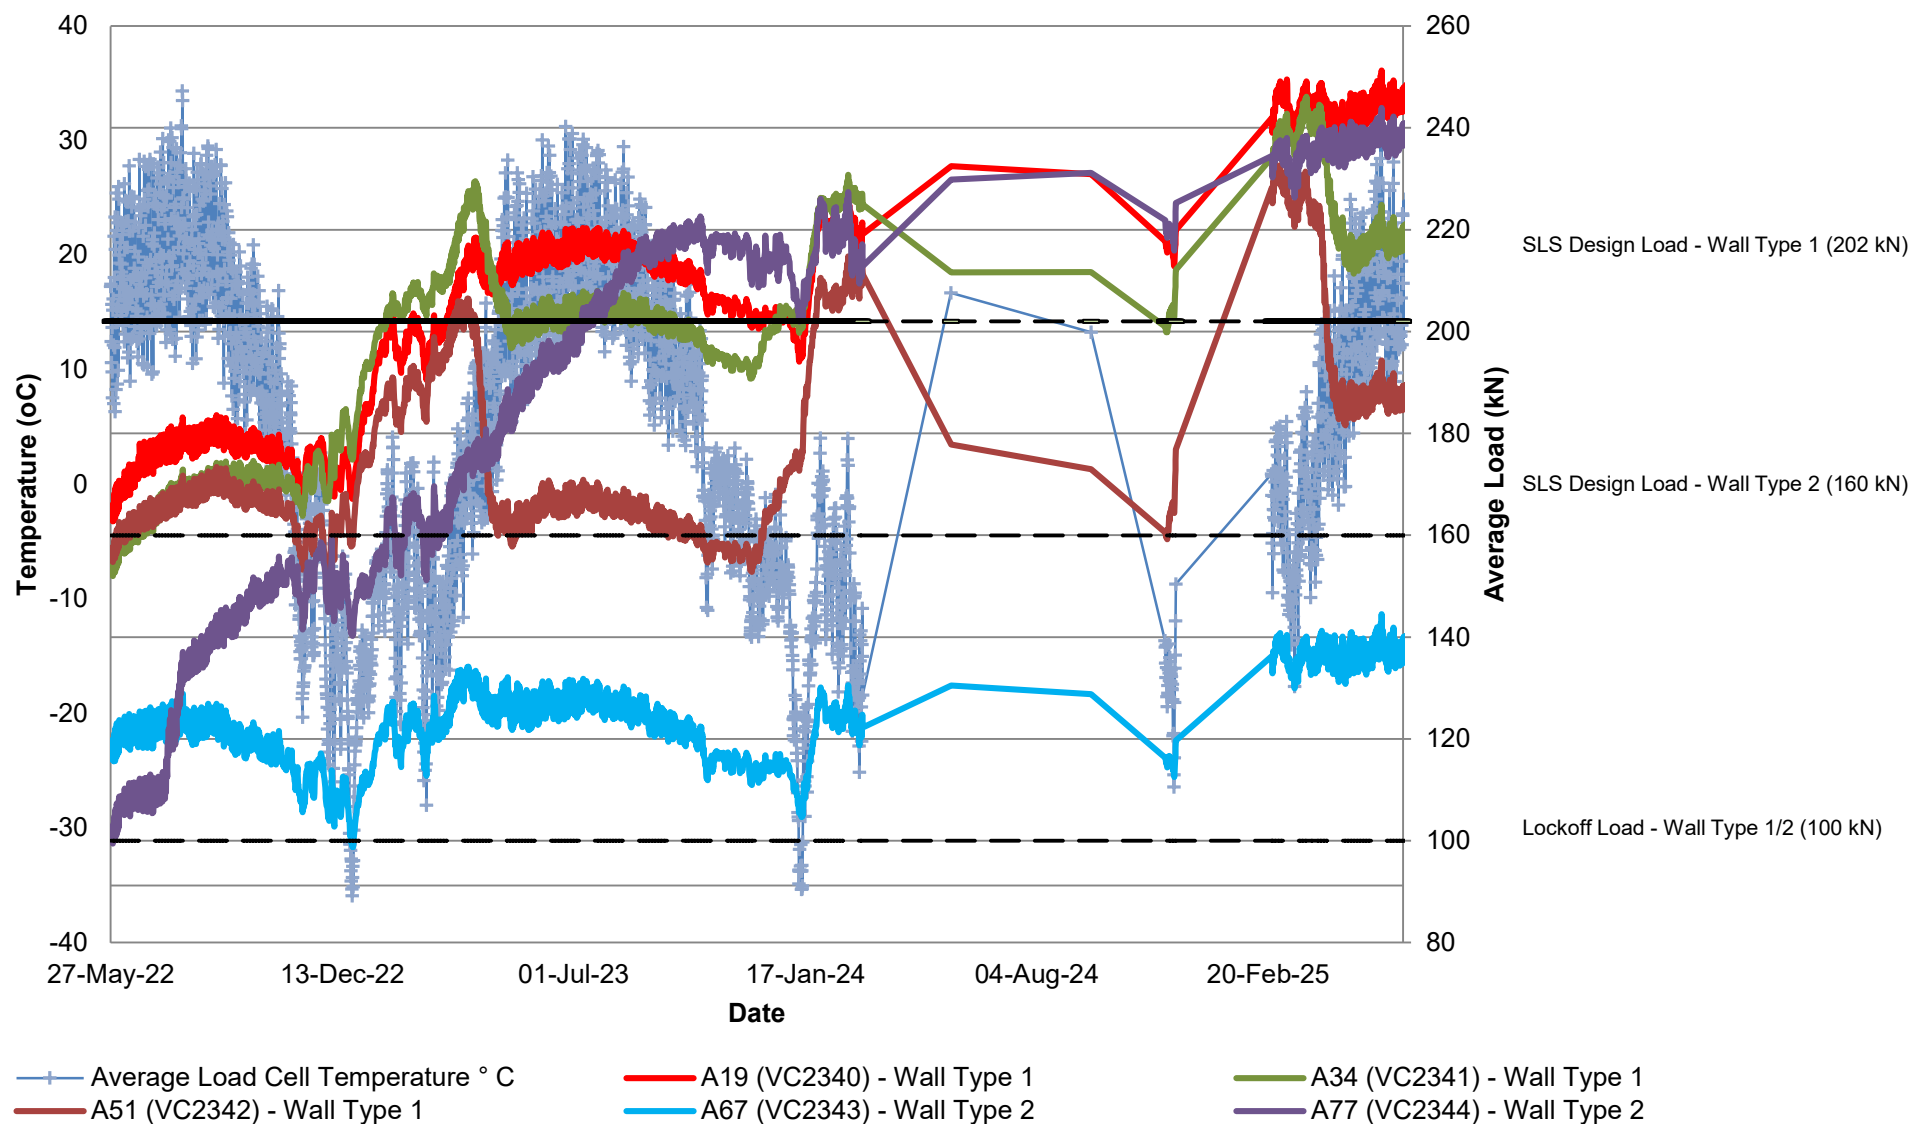
**FIGURE PH009-10  
OLD HWY 2:02 SHOP SLIDE LOAD CELL READINGS**

The load cell readings are summarized in Table PH009-4. The anchors showed decreases in measured load ranging from a decrease of 5.86 kN in Anchor A34 (Load Cell VC2341) to a decrease of 13.25 kN in Anchor A51 (Load Cell VC2340), compared to the spring of 2025 readings.

The load cells generally show a pattern of highest loads in the winter months, in response to seasonal frost pressures acting on the back of the wall, before relaxing slightly into the spring and summer months. Anchors A67 (Load Cell VC2343) and A77 (Load Cell VC2344) continue to show an overall trend of increasing load with a smaller post-winter relaxation than the other anchors. Overall, the anchor loads have risen significantly since they were locked off, and Anchors A19, A34, and A77 are currently above their SLS design loads but have not exceeded the 270 kN load that would require remedial measures. The load cells will need to be closely monitored to see if the increased movement trend continues. The load cell readings are plotted on Figure PH009-10 in Appendix A.

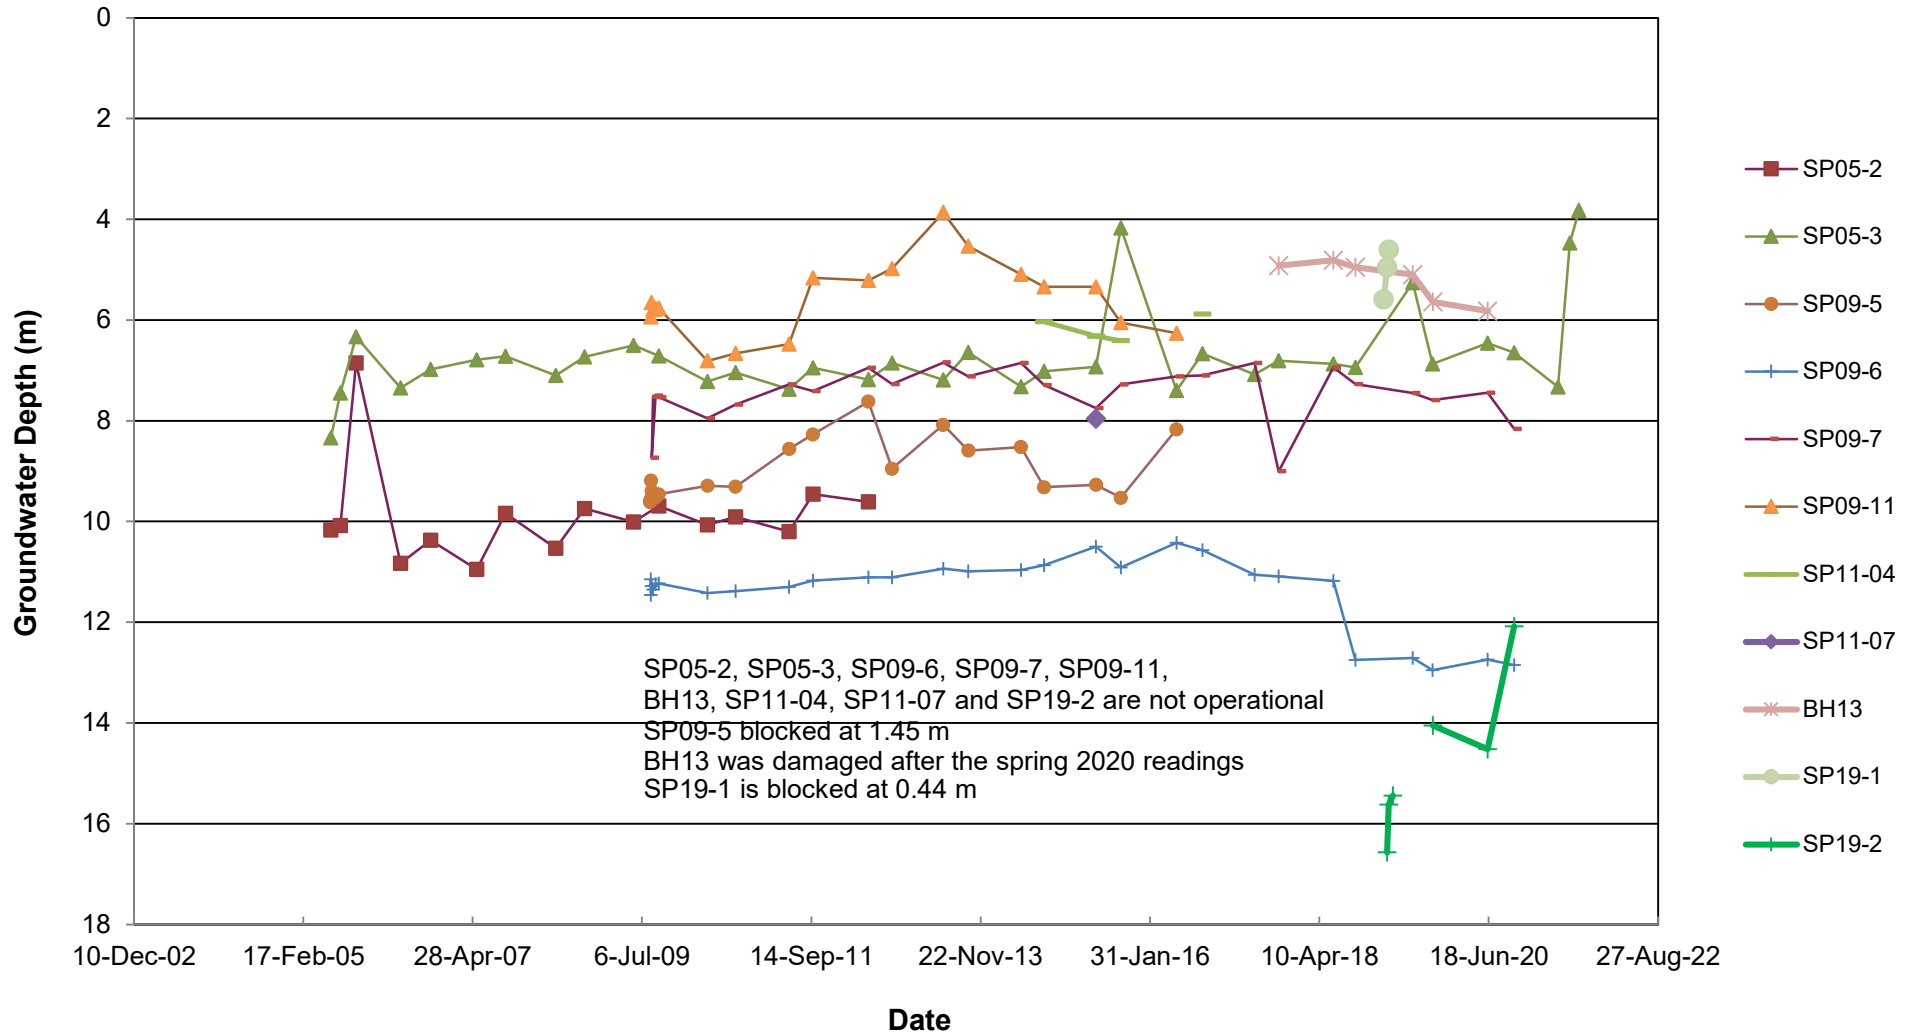
**FIGURE PH009-12  
HISTORICAL STANDPIPE PIEZOMETER READINGS:  
SHOP SLIDE**

Standpipe piezometers SP05-1, SP05-4, and SP05-5 showed decreases in groundwater level of 0.10 m, 1.09 m, and 0.95 m respectively, since the spring of 2025 readings. Standpipe piezometer SP09-10 and SP13-3 showed increases in groundwater level of 0.52 m and 1.06 m respectively, since the spring of 2025 readings. SP11-06, SP09-8, and SP09-9 continued to be dry (SP09-8 and SP09-9 have been dry since installation). The water levels measured in the standpipes have not demonstrated a trend. The results of the standpipe piezometers are summarized in Table PH009-5, and are plotted in Figure PH009-11 in Appendix A. Historical standpipe piezometer readings are presented in Figure PH009-12.

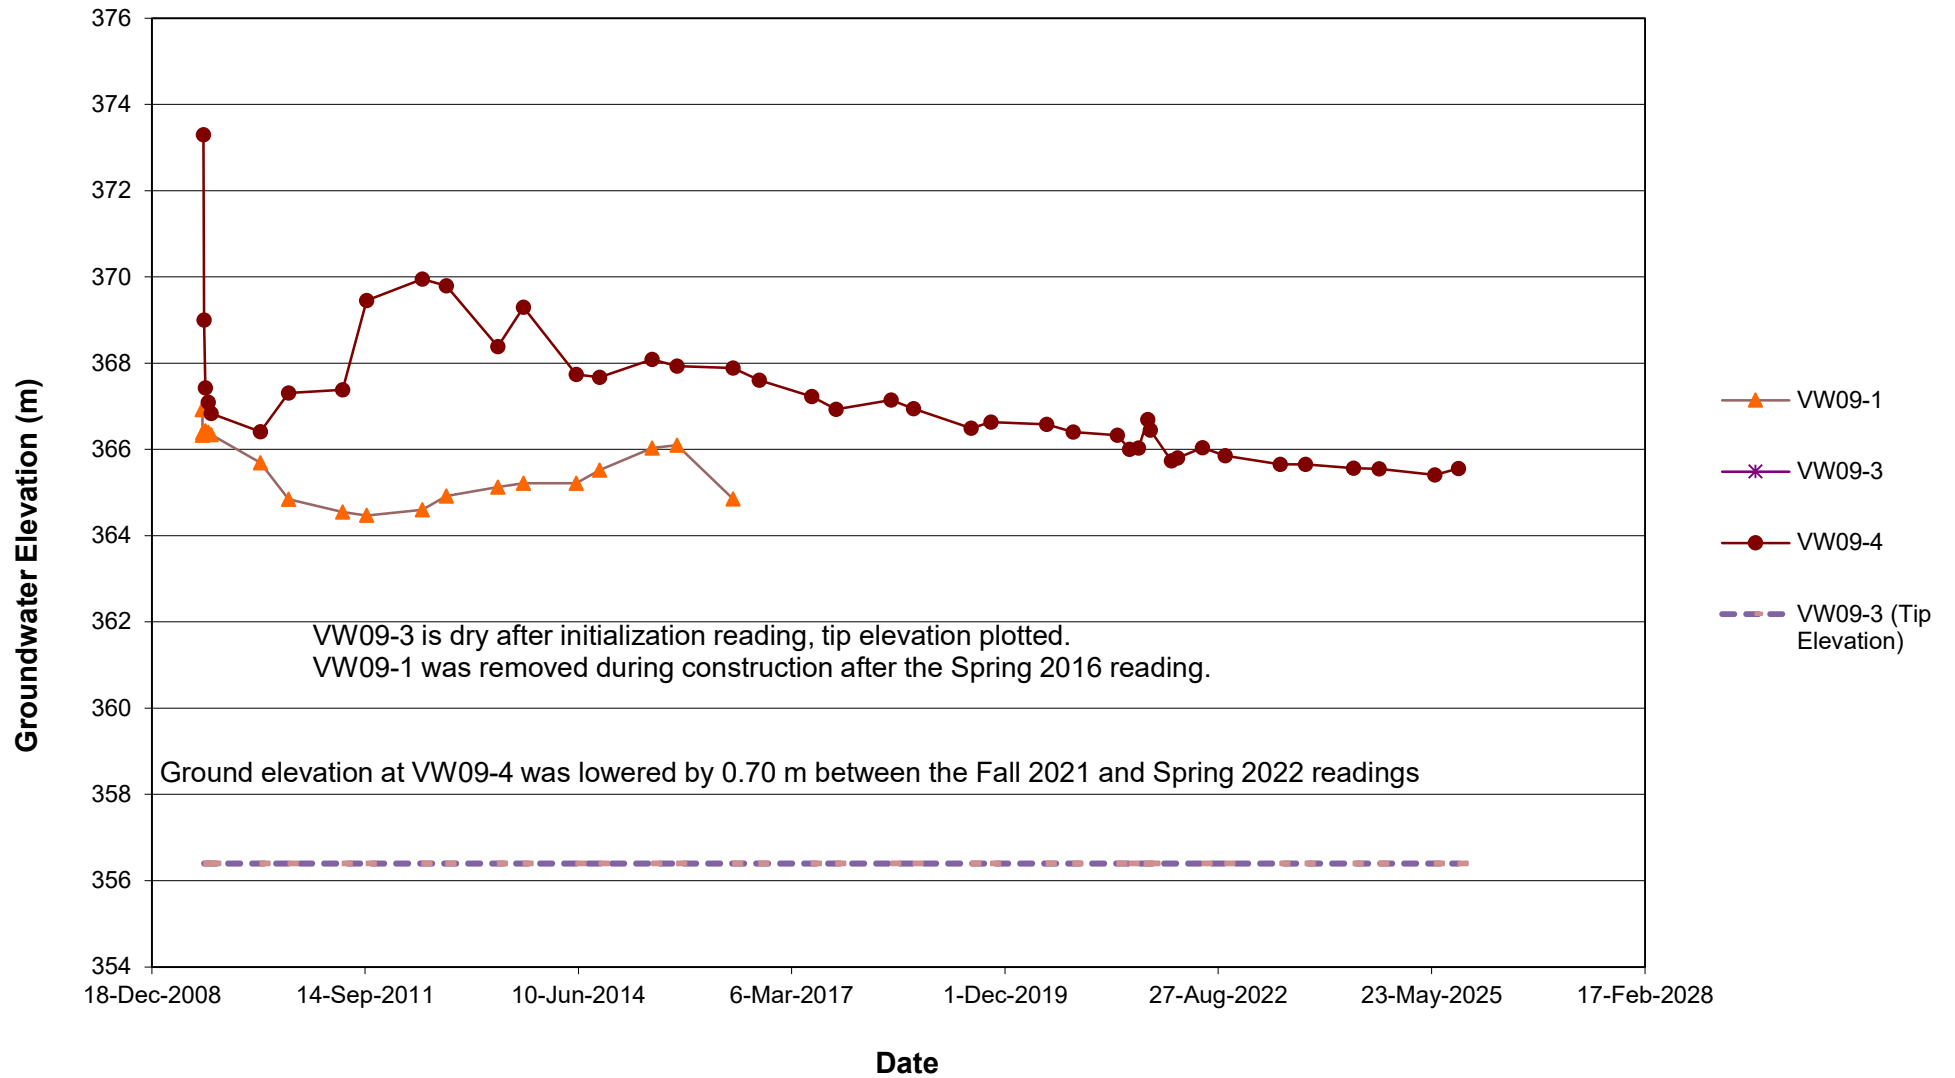
FIGURE PH009-13  
VIBRATING WIRE PIEZOMETER DATA  
SHOP SLIDE

<p>VW09-4 showed an increase in ground water level of 0.15 m since the spring of 2025 readings; over the long term the groundwater level has dropped 4.4 m since 2012. VW09-3 has been dry since August 2009. The vibrating wire piezometer results are summarized in Table PH009-6, and are plotted in Figure PH009-13 in Appendix A.</p> <p>Pneumatic piezometer PN15-5A showed a decrease in groundwater level of 0.01 m since the previous reading in spring of 2025. PN19-5B showed an increase in groundwater level of 0.09 m since the spring of 2025 readings and has had a slight increasing trend overall, rising about 1 m since installation (February 2019). Pneumatic piezometer results are summarized in Table PH009-7, and are plotted in Figure PH009-14 in Appendix A.</p>
<b>Future Work:</b>	<p>The instruments should be read again in the spring of 2026. The movement rate in SI11-01 should be monitored carefully as it is beyond the north extent of the wall and slope unloading. The movement rates at SI09-4 should also be reviewed following the next set of readings to confirm if a pattern is developing.</p> <p>The instruments at the pile wall, particularly for the load cells, will need to be frequently monitored to see if the loads increase. At present, the loads, strain, and deflections are within acceptable limits based on the modeling done during detailed design of the wall.</p>
