December 17, 2013
EG10030

**Re: Peace River (Swan Hills) Region Geohazard Assessment
Hwy 33:12 SH1A
Call-Out Report**

During the annual site inspections, AT staff reported an area of pavement cracking and distortion along Highway 33:12. The site is approximately 9.8 km north of Swan Hills, Alberta and 450 m northeast (along the highway) of the Swan Hills Retaining Wall site (Site SH1).

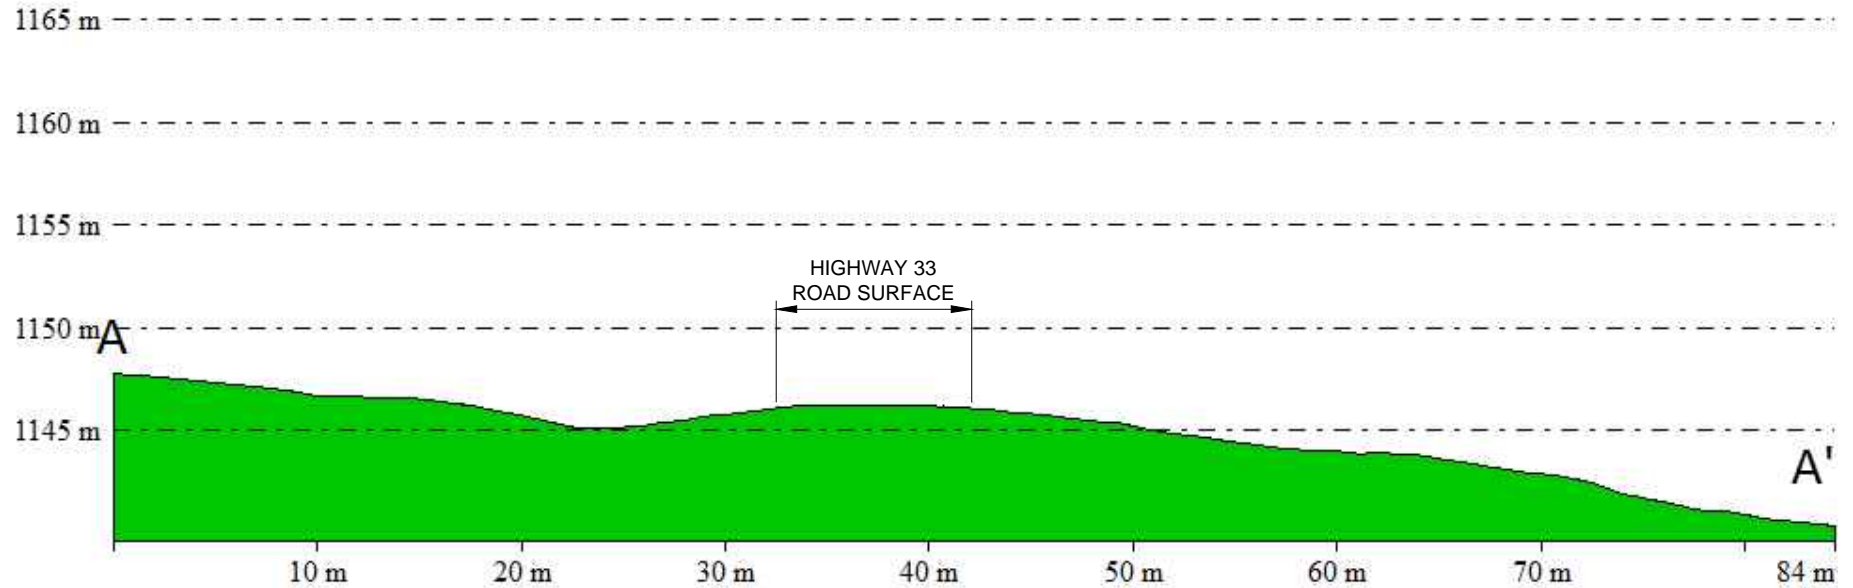
DATUM: -	TITLE: SH1A HWY 33:12 CROSS-SECTION A-A'	REV. No.: A
	PROJECTION: -		FIGURE No.: FIGURE 2
	SCALE: N.T.S.

This section of Highway 33 is aligned approximately northeast/southwest. The highway embankment traverses across and down the slope of a gully/draw at an approximate 4% grade. In the area of the pavement distress, the west side of the road embankment ranges from approximately 1 m to 1.5 m high and the east side of the road embankment ranges from approximately 2 to 3 m high.

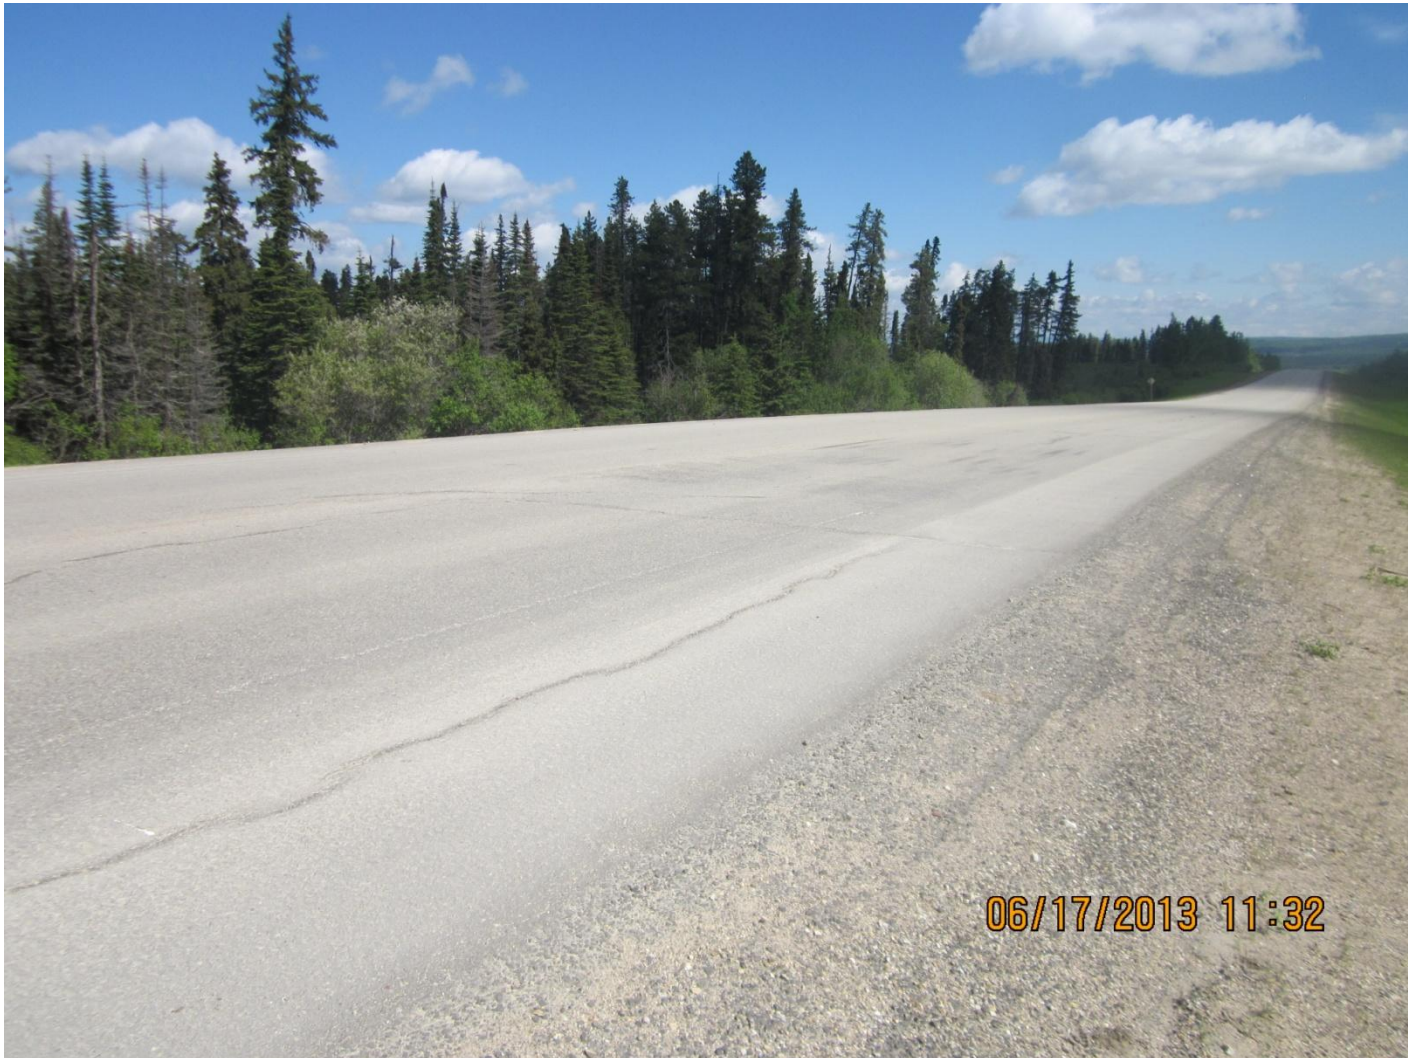
The pavement distress consisted of moderate to severe pavement cracking over an approximate 30 m stretch of the highway. In addition, on the south west side of the site, the pavement cracking was accompanied by moderate pavement distortion over an approximate 10 m stretch of the highway.

Photo 1: Looking north. Note pavement cracking and distortion.

Short term repairs of the road surface including routing and sealing of cracks and milling and patching of pavement distortion should be carried out. Annual inspection of the site should be continued to determine if on-going pavement distress is occurring. If on going pavement distress was observed, this would indicate that alternative or additional mitigative measures may be necessary. Based on a preliminary assessment, surface and or subsurface drainage improvements may be required to address impeded water west of the road.

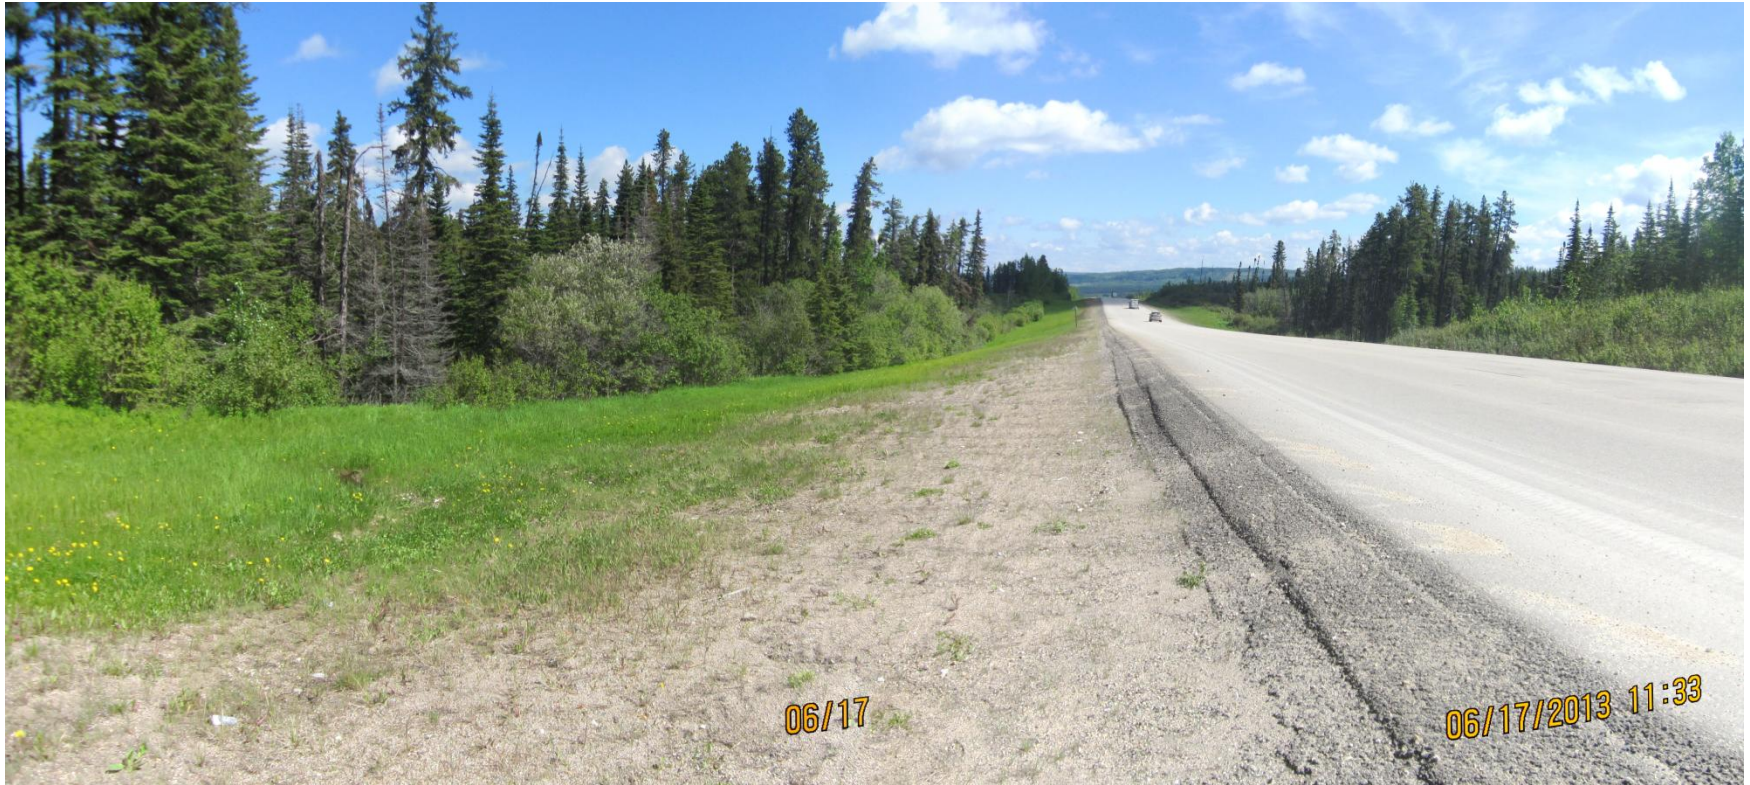
Photo 2: Looking north east along downslope side of highway embankment.

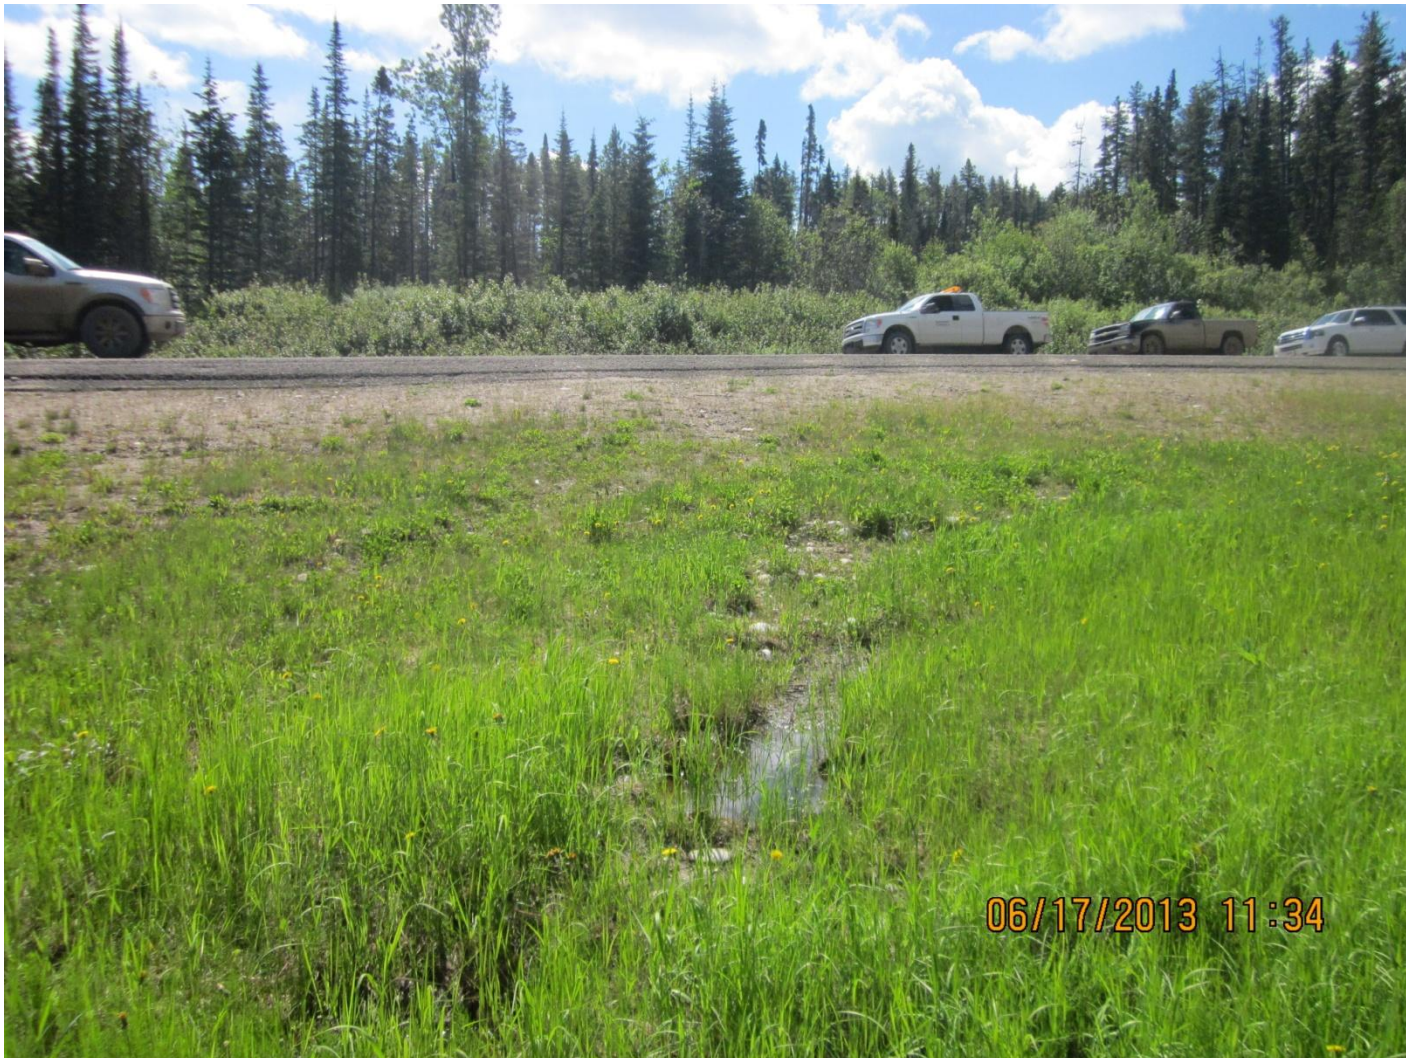
Through examination of lidar imagery, there are some subtle features upslope of the site that may be representative of relic landslide terrain. However, it is noted that the area has been heavily eroded and no distinctly active landslide features are apparent in the lidar imagery. Although it is possible that the pavement distress is related to a larger area of landslide activity, it is considered more likely that the pavement distress is related to poor drainage and associated subgrade softening and/or residual affects of differential frost heave. The areas to the south and west of the site drain surface water to the west roadway ditch. The roadway ditch then conveys water along the ditch to a culvert at the base of the gully/draw at an oblique angle to the natural fall of the slope. Further, surface water was observed in the downslope ditch adjacent to the distressed pavement area. Thus it is possible that, at the site, surface water penetrates the embankment fills as it attempts to follow the natural fall of the slope.

Photo 3: Looking south. Wet area of downslope ditch
