**ALBERTA TRANSPORTATION
GEOHAZARD ASSESSMENT PROGRAM
PEACE REGION – SWAN HILLS
2020 INSPECTION**

Site Number	Location	Name	Hwy	km
SH001-1 SH001A	North of Swan Hills	Swan Hills Retaining Wall	33:12	9.33-9.75 10.00-10.05
Legal Description		UTM Co-ordinates		
SE/NE05-67-09-W5M		11U E 607,545	N	6,070,516

**SH001-1: HWY 33:12
2020 SITE INSPECTION PLAN**

**SH001A-1: HWY 33:12
2020 SITE INSPECTION PLAN**

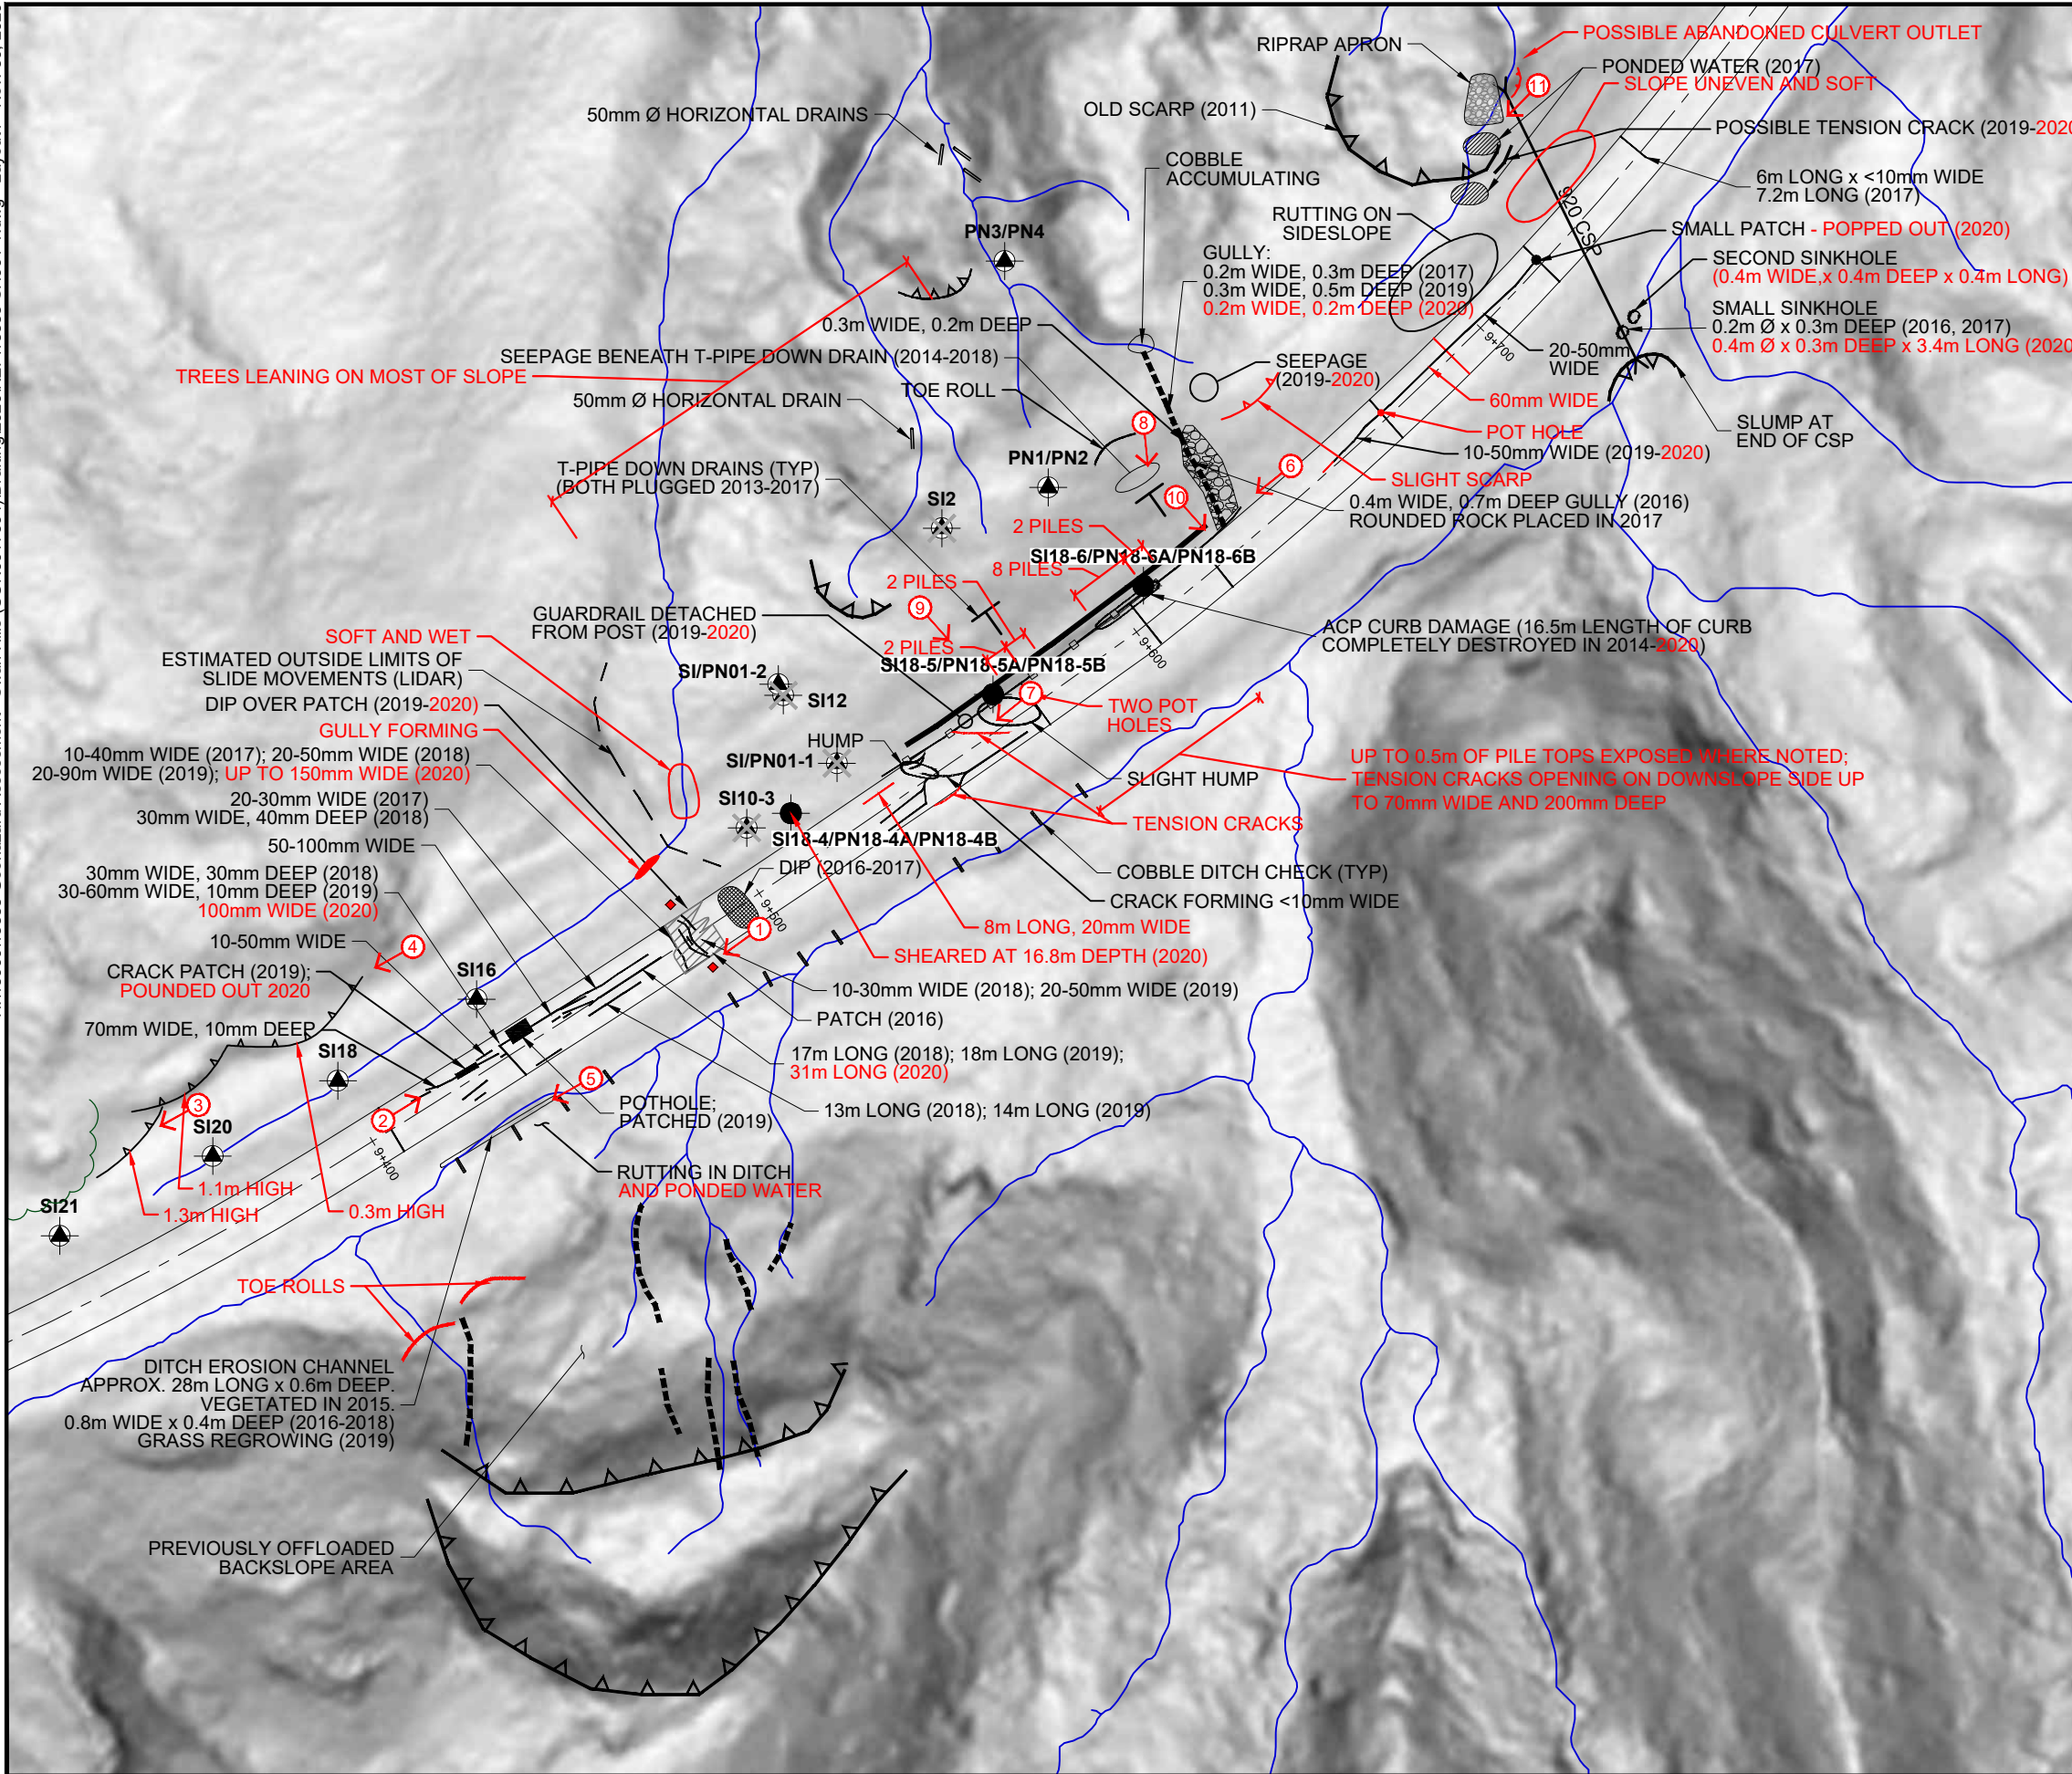
DWG No. 13355-SH001-1

Primary Site Issue:	<p>SH001-1: Highway embankment placed over creek/gully obstructing seepage and mobilizing slide with creep movements at about 18 m to 20 m depth below the roadway. Pavement distress occurring behind and to the south of the floating pile wall.</p> <p>SH001A: Developing rotational landslide causing vertical displacement of highway surface.</p>
Dimensions:	<p>SH001-1: The pile wall is ~81 m in length. Pavement distress encompasses approximately 270 m of highway.</p> <p>SH001A: 50 m of highway affected by soft subgrade and slope movements.</p>
Date of Remediation:	<p><u>1970:</u> Highway reconstructed about 30 m from original alignment which was buried by backslope failure.</p> <p><u>1979:</u> 9 – 50mm dia. slotted steel horizontal subdrains installed 3 m to 7.5 m below the roadway. Subdrain at 3 m depth installed in backslope ditch draining to four culverts.</p> <p><u>1982:</u> Backslope drains no longer functioning; 5 horizontal PVC drains installed from toe of north-facing embankment slope with lengths between 61 m and 73 m.</p> <p><u>1989:</u> Floating concrete pile wall 81 m long installed to depths of 6 m to 12 m below roadway surface. The 82 piles were 760 mm diameter installed at 1 m centre-to-centre spacing.</p> <p><u>1991:</u> Two rows of tie-back anchors install 1 m and 3 m below top of piles at 30° into clay shale at a length of 7.5 m.</p> <p><u>1995, 1996:</u> Backslope offloading undertaken.</p> <p><u>2010:</u> ACP curb installed directing surface water into two “T” drains; sideslopes regraded and tops of piles covered with gravel; guardrail installed.</p>

Observations:	Description	Worsened?
<input checked="" type="checkbox"/> Pavement Distress	SH001-1: Cracking present over much of the length; dip south of the wall appeared Spring 2016 and second in 2019. Slight hump near west end of guardrail appeared in 2018 and second in 2019. Tension cracking continues to increase. Lack of maintenance leading to surficial deterioration (potholes). SH001A: dips have formed at both ends of patch and hump appeared in 2019; crack pattern is widening and becoming braided.	<input checked="" type="checkbox"/>
<input checked="" type="checkbox"/> Slope Movement	SH001-1: Ongoing creep movement causing cracking and settling of highway surface at south end of pile wall. Slope may be pulling away from pile wall. SI south of wall sheared off in 2 years. SH001A: pavements cracks have developed into scarp pattern and are widening with vertical deformation.	<input checked="" type="checkbox"/>

<input checked="" type="checkbox"/> Erosion	SH001-1: Some erosion noted on sideslope between and below piles. Deeper channels at west end of wall were infilled but are reforming Erosion in east ditch south of wall starting to revegetate; new gully forming in west ditch.	<input checked="" type="checkbox"/>
<input checked="" type="checkbox"/> Seepage	SH001-1: Seepage observed in backslope area and wet zones noted below the pile wall. SH001A: Steady flow observed in east tree line and ditch.	<input type="checkbox"/>
<input checked="" type="checkbox"/> Bridge/Culvert Distress	SH001-1: T-Drains outlets have been plugged with debris (partially accumulated since last cleaning) and one inlet is slightly damaged. Two sinkholes near the inlet of the culvert north of the pile wall are slowly growing and there are slumps near the outlet. SH001A: No apparent distress at culvert 130 m north of site.	<input checked="" type="checkbox"/>

SH001-1: Consideration should be given to placing additional horizontal drainage measures to further reduce groundwater levels in the highway embankment particularly to the southwest of the wall. This might also be accomplished with a subdrain or relief wells to the south of the highway. Consideration could also be given to extending the pile wall further southwest should ongoing maintenance become difficult and/or expensive.

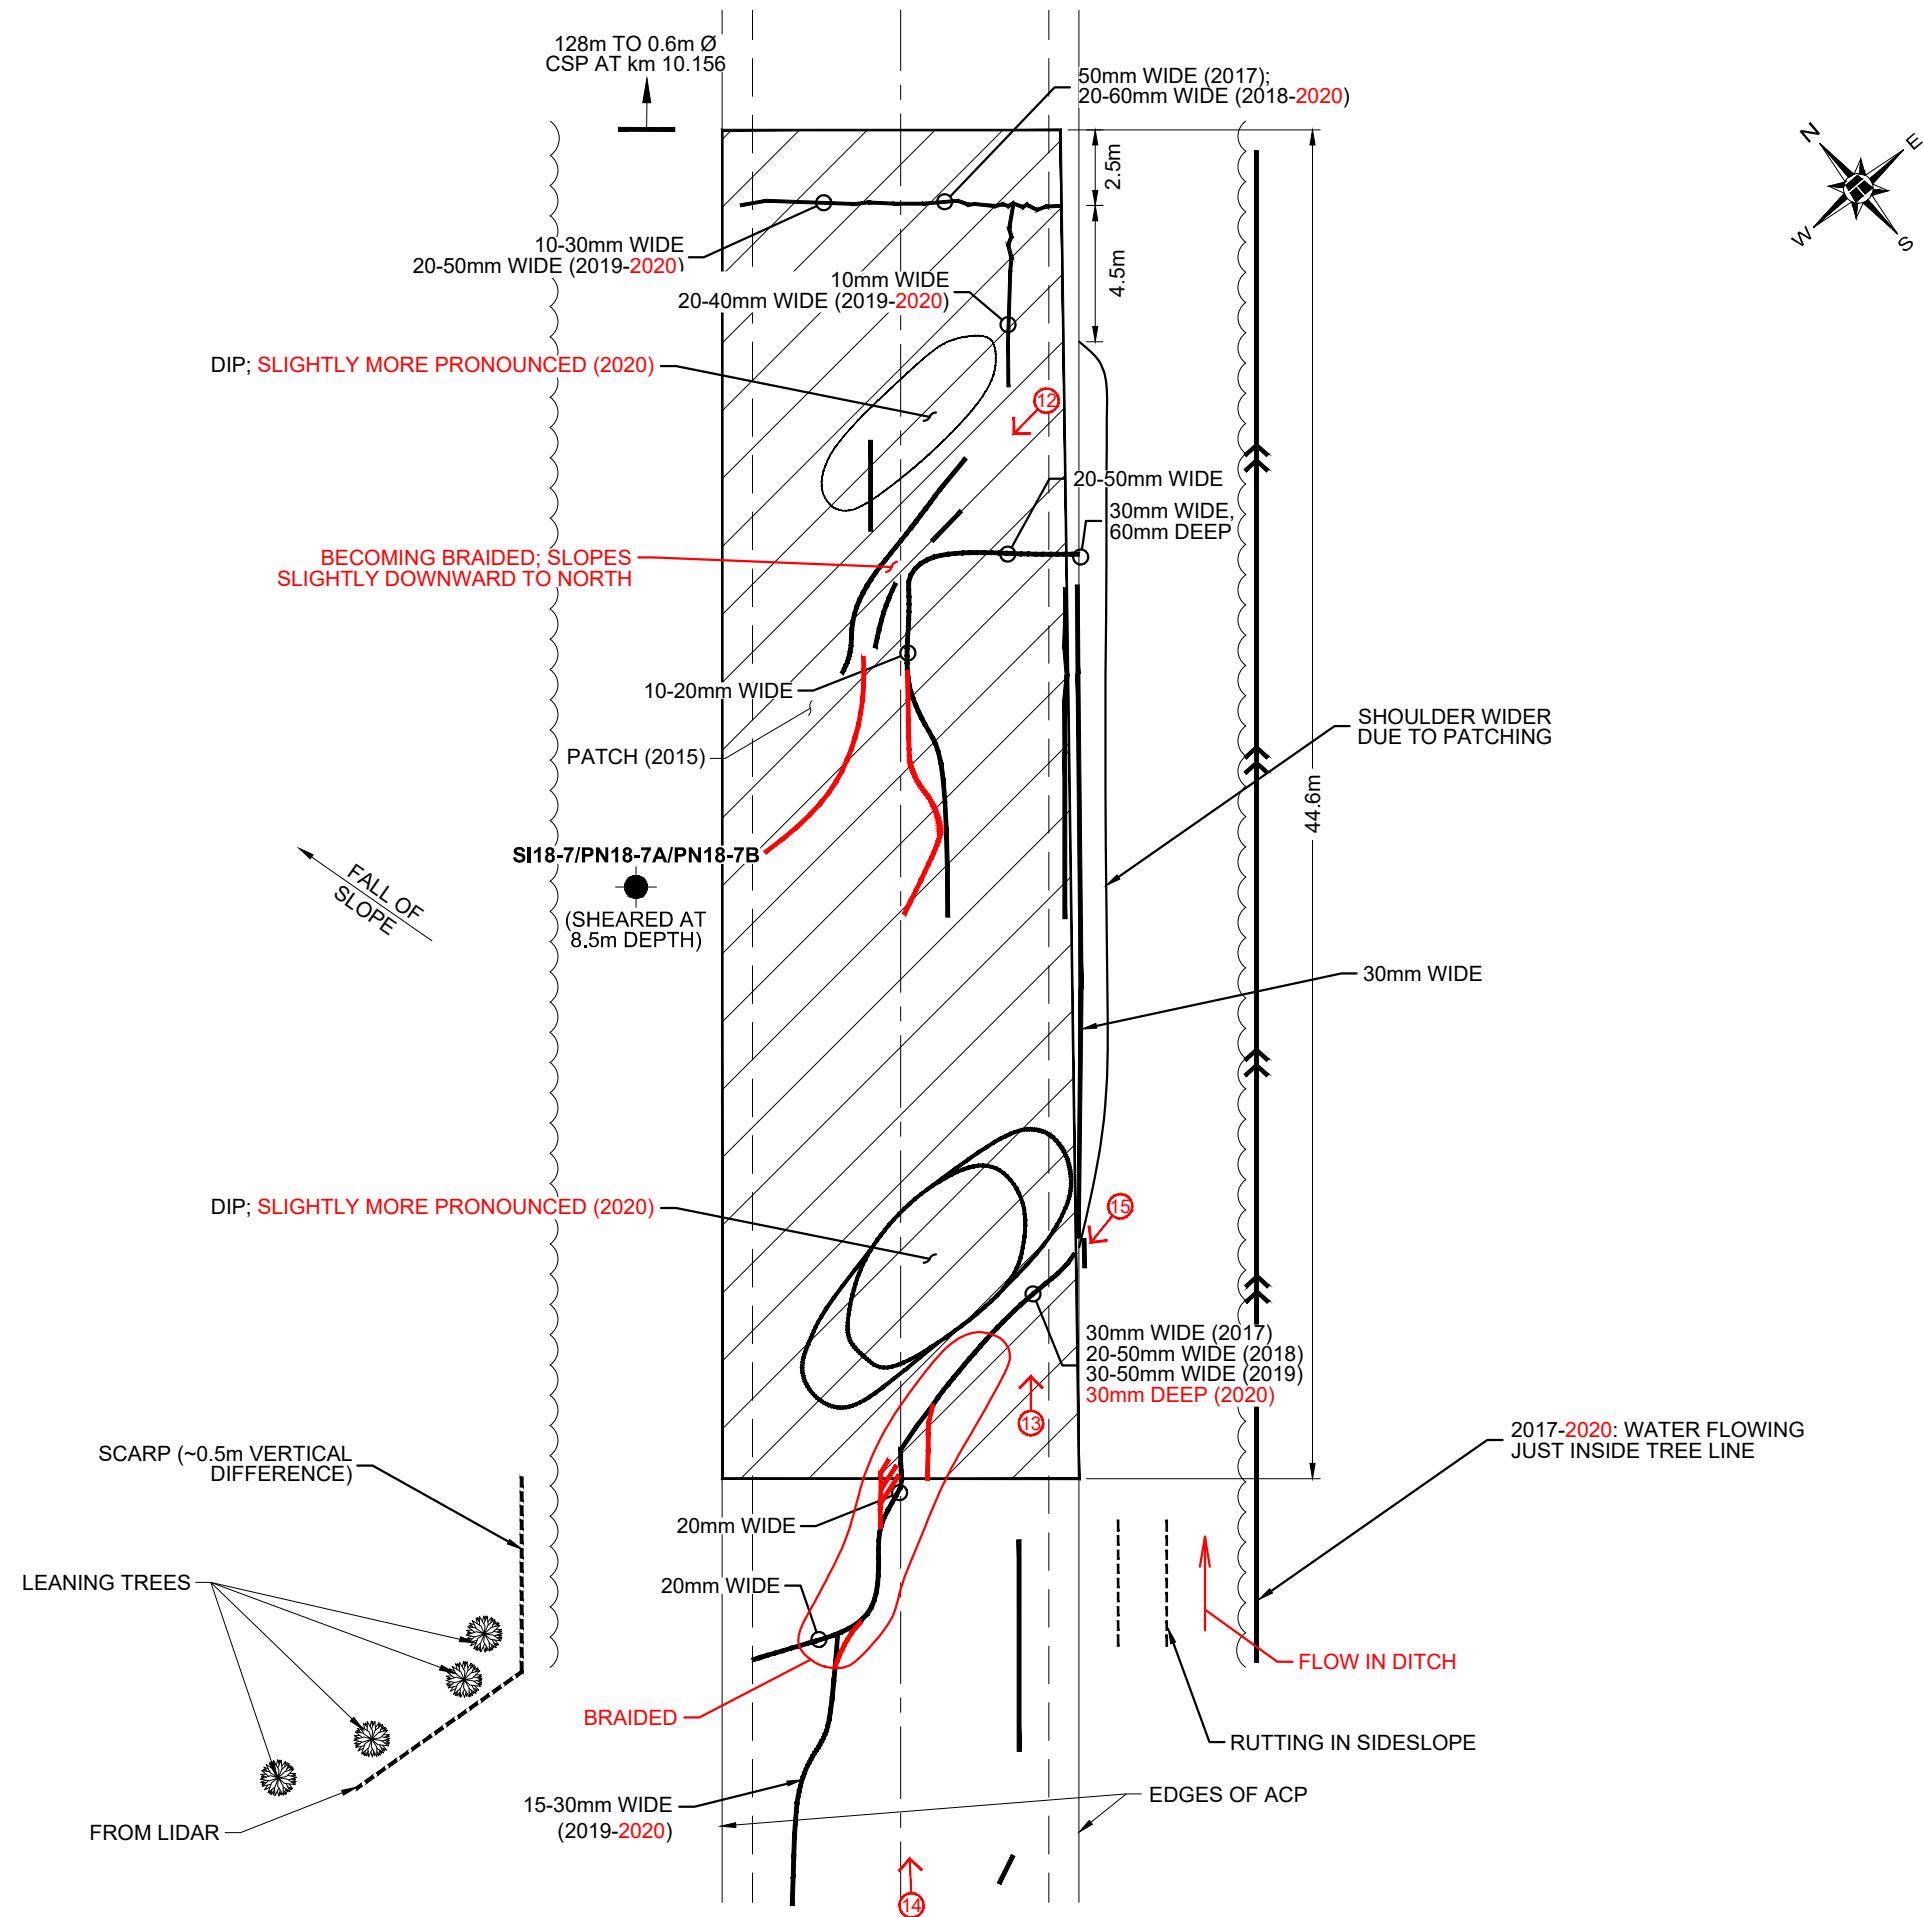
DWG No. 13355-SH001A-1

There is about 20 m of relief from the highway surface to the downslope creek but over a distance of about 190 m which is relatively flat (6°); however, remolded shale is expected to have a low friction angle.

SH001A: An inexpensive option would be to install a subdrain in the upslope ditch to see if intercepting some of the groundwater might reduce the rate of movement. Although this is unlikely to remediate the site, it might extend the time before a full intervention is necessary.

SH001A: With confirmed movement at this site, it is recommended that a preliminary engineering assessment be undertaken to determine potential mechanisms and develop alternates for stabilizing this location. A LiDAR review should be included to try to better define the possible limits of the landslide.

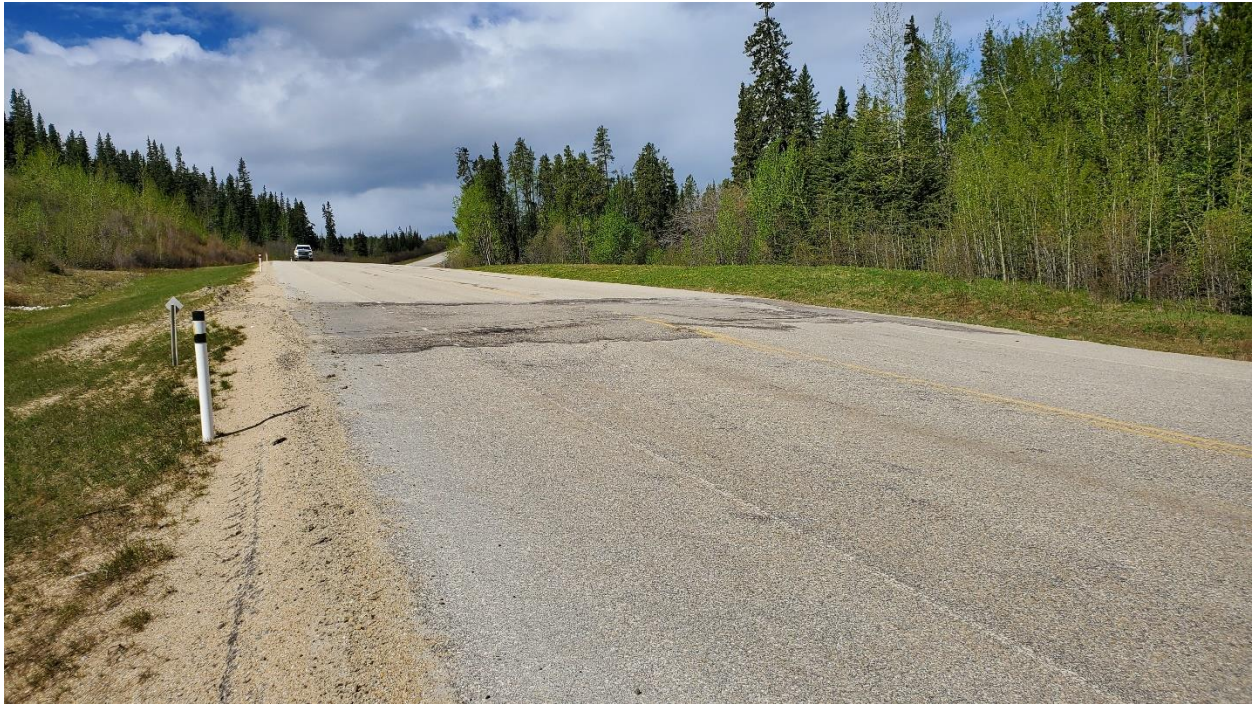
Photo 1 – Looking southwest at patch over cracks forming at the southwest end of the wall.

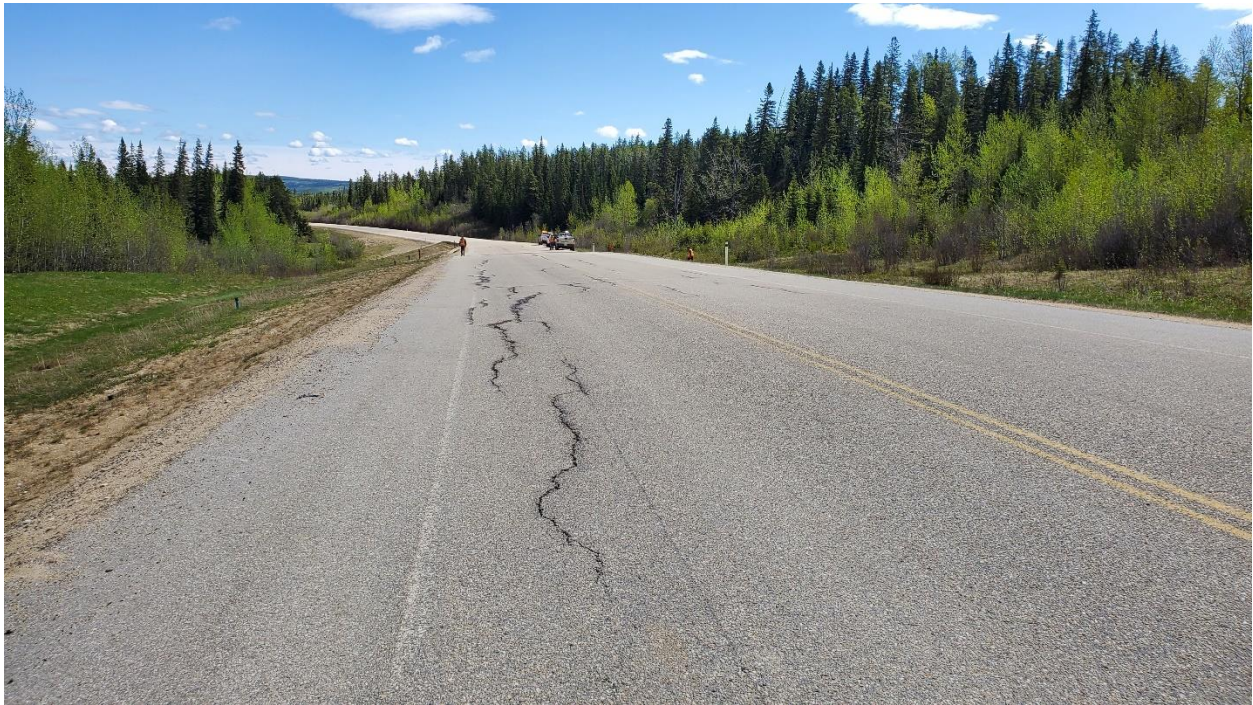
Photo 2 – Looking north at cracking in highway surface immediately south of the pile wall.

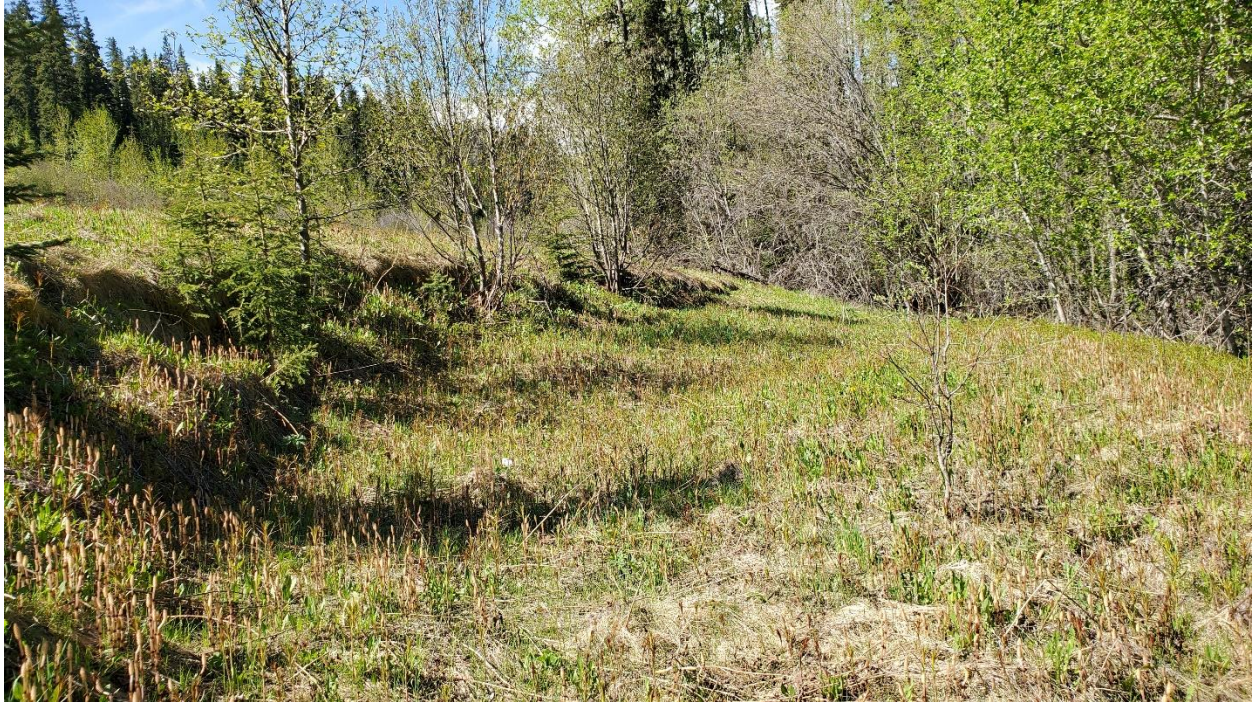
Photo 3: Looking southwest at scarp on slope below highway between SI20 and SI21.

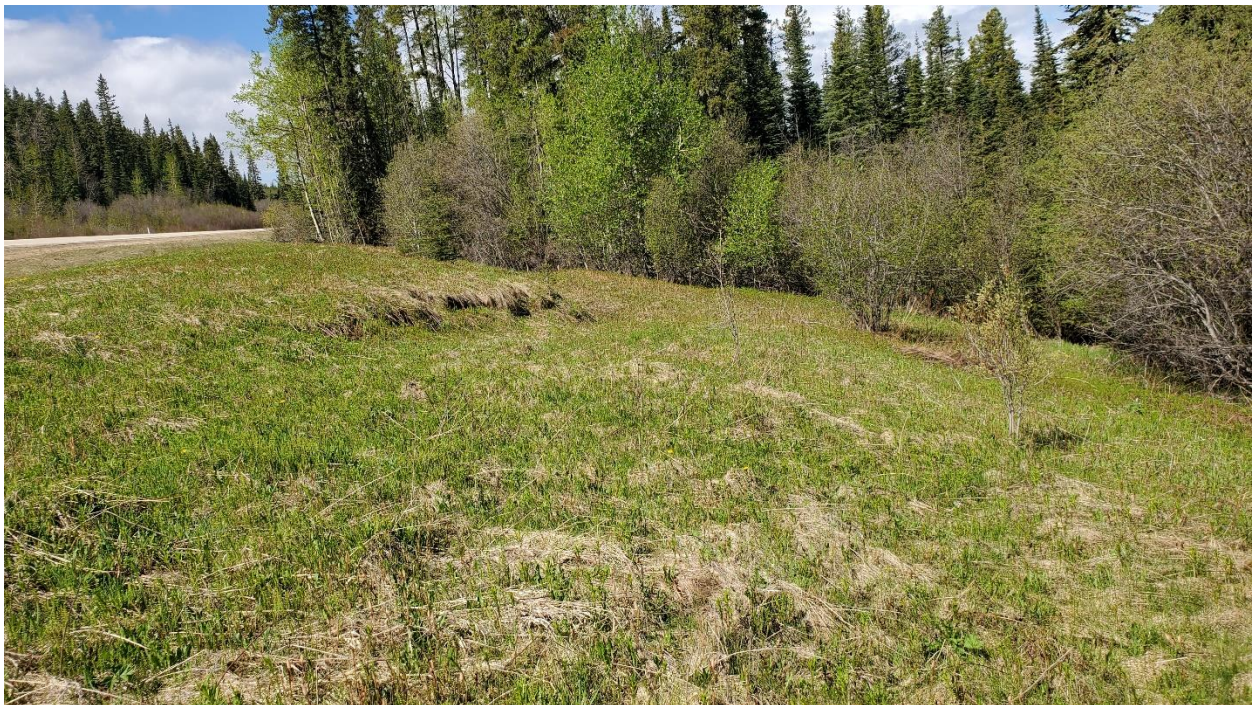
Photo 4: Looking southwest at scarp below highway near SI18.

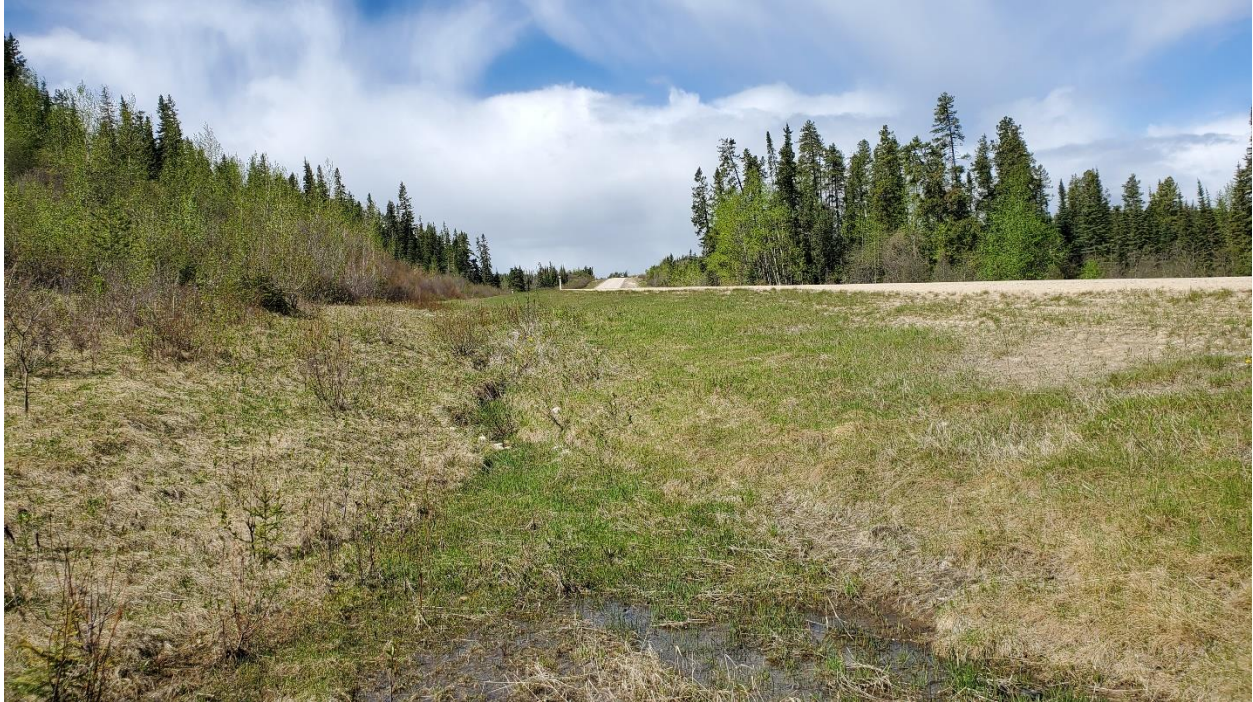
Photo 5 – Looking south at erosion in east ditch.

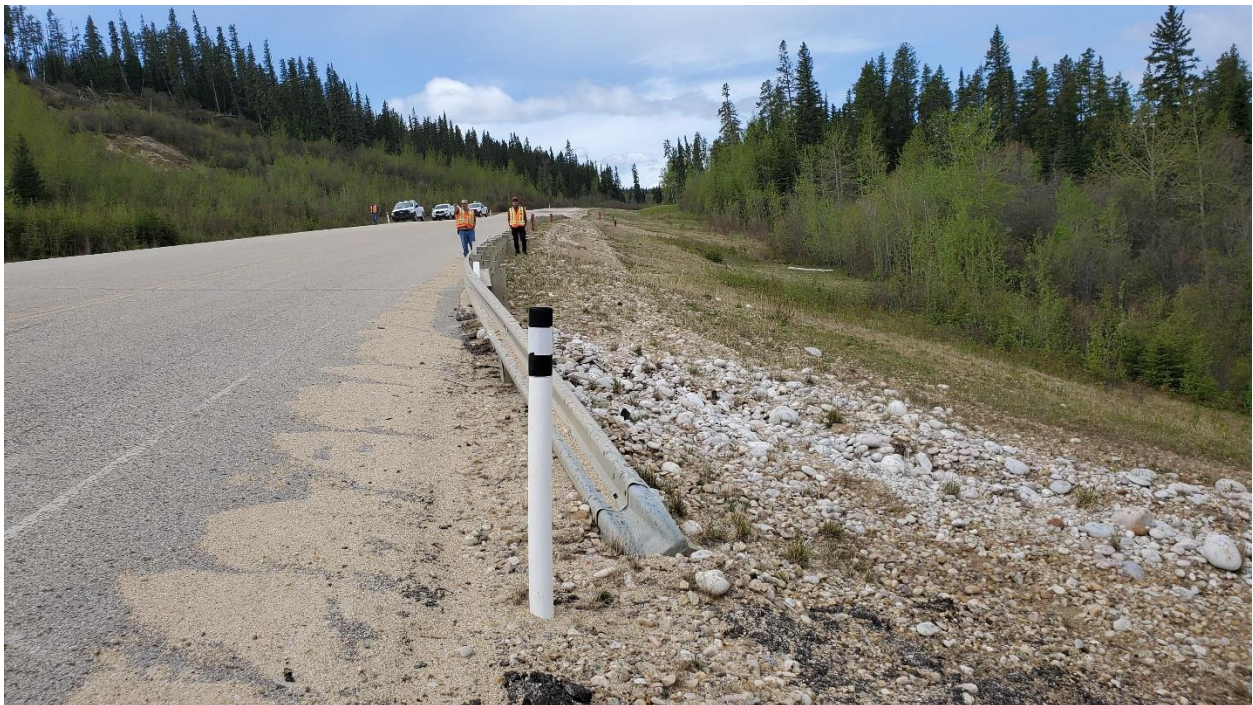
Photo 6 – Looking south at cobbles placed in gully at north end of guardrail.

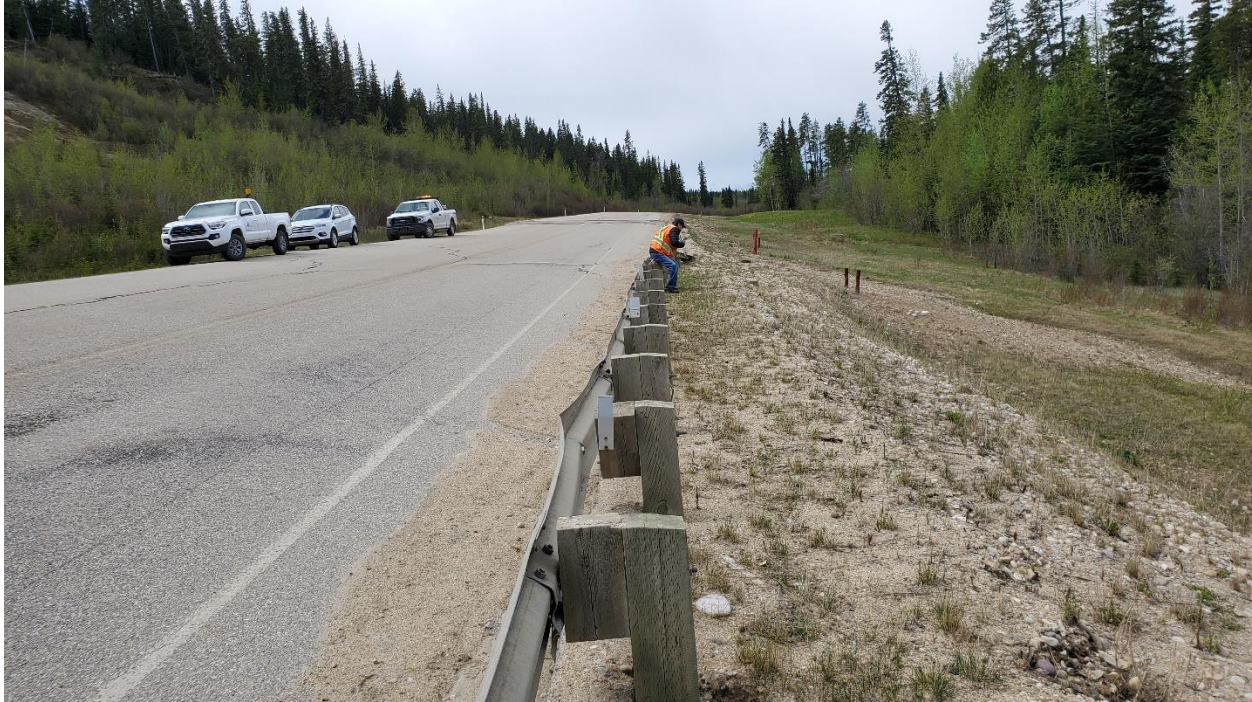
Photo 7 – Looking southwest at cracked curb at south end of guardrail.

- Road maintenance should continue as necessary to maintain the roadway surface and may consist of milling, patching, and crack sealing of the ACP.
- Re-establish the asphalt curb and clean the T-drains (this should be a periodic maintenance item).
- Re-grade, and augment with additional granular material if necessary, the sideslope below the pile wall as was partially undertaken since the 2016 inspection.

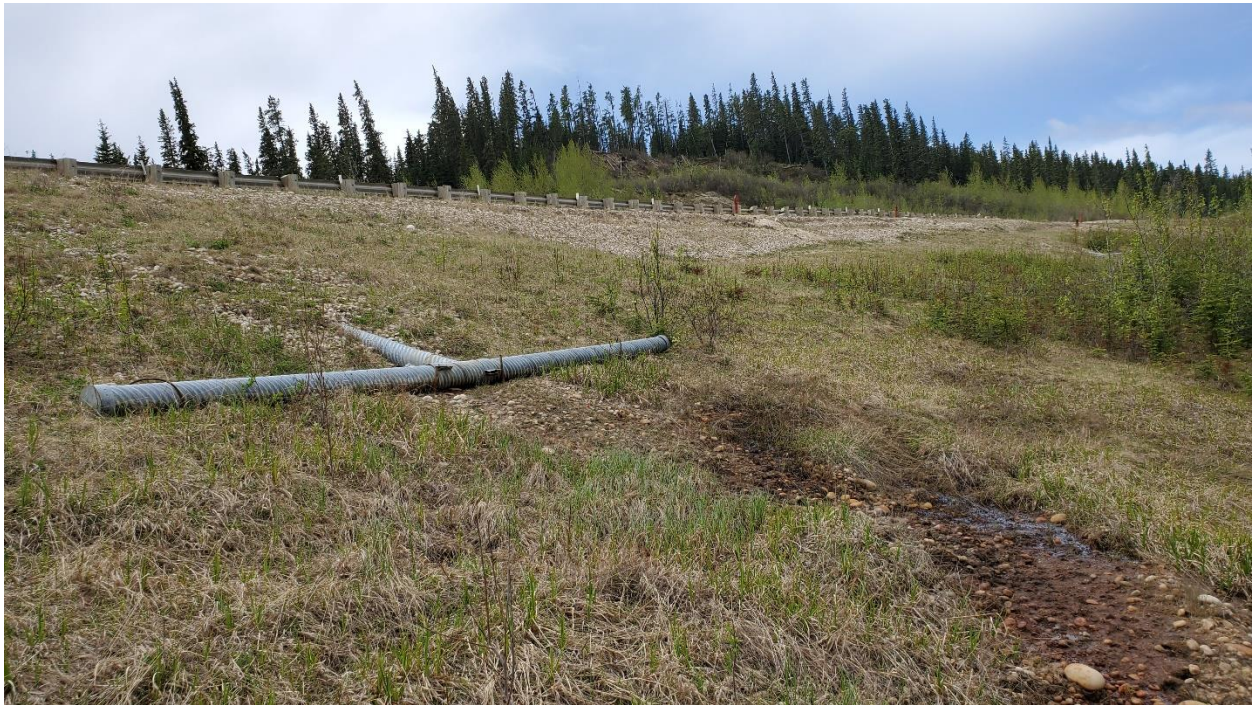
Photo 8 – Seepage out of slope below north-most T-drain.

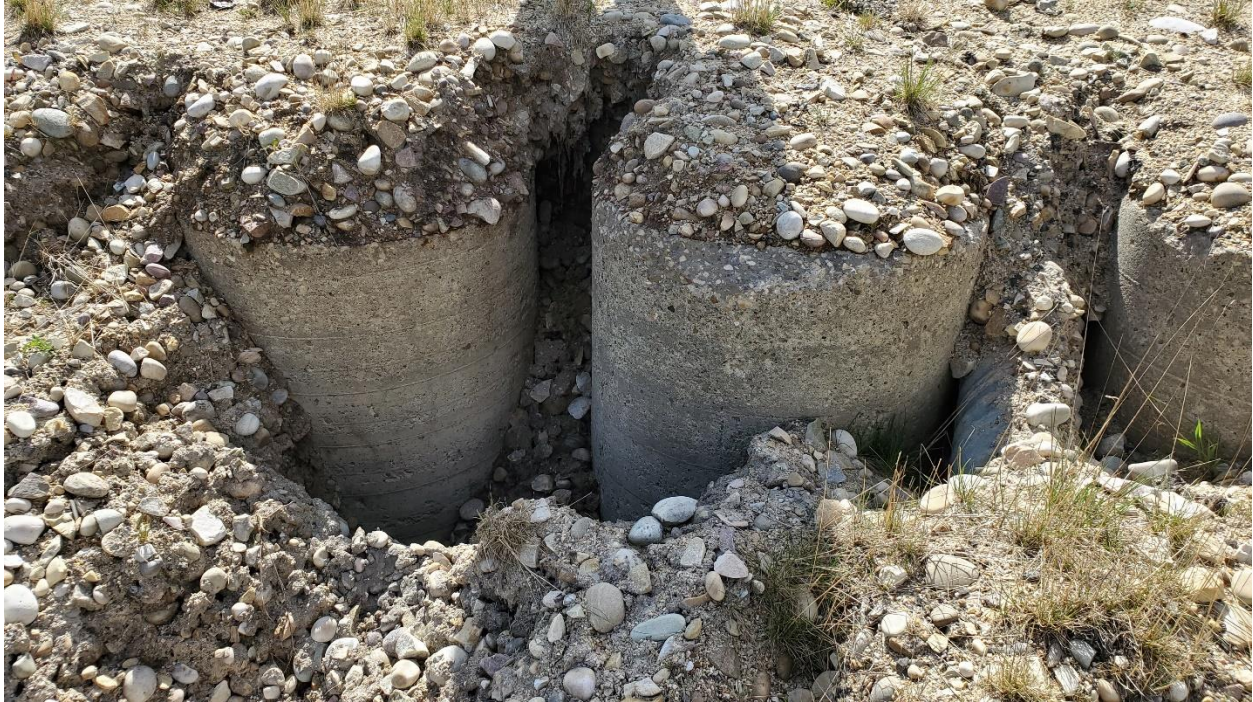
Photo 9: Erosion and/or movement away from the piles around the southwest down drain.

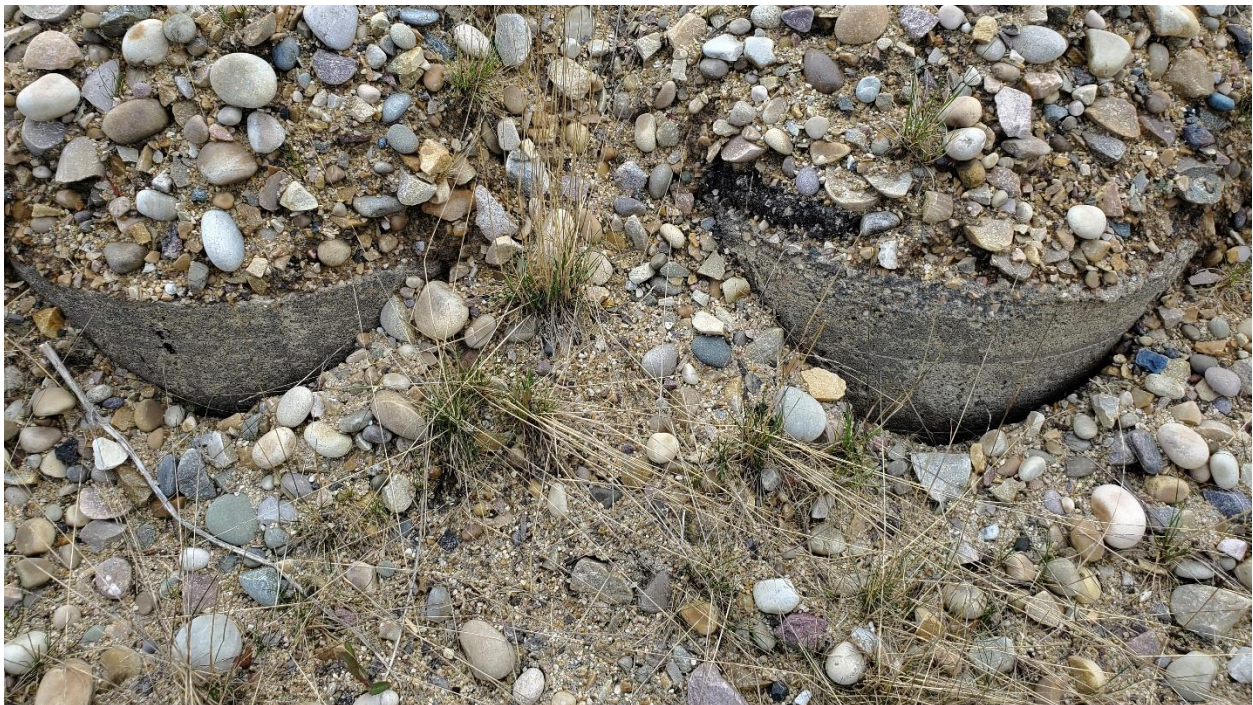
Photo 10: Soil pulling away from the downslope side of piles near the northwest down drain.

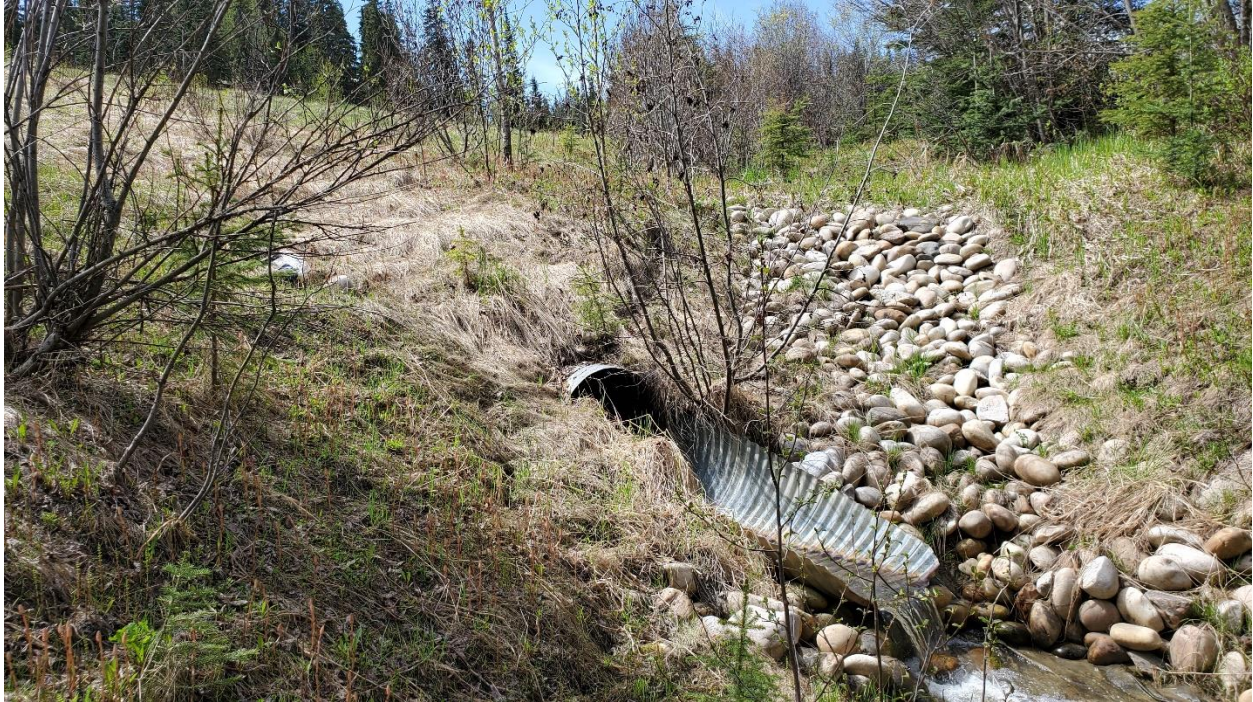
Photo 11 – 920 mm dia. centreline culvert outlet.

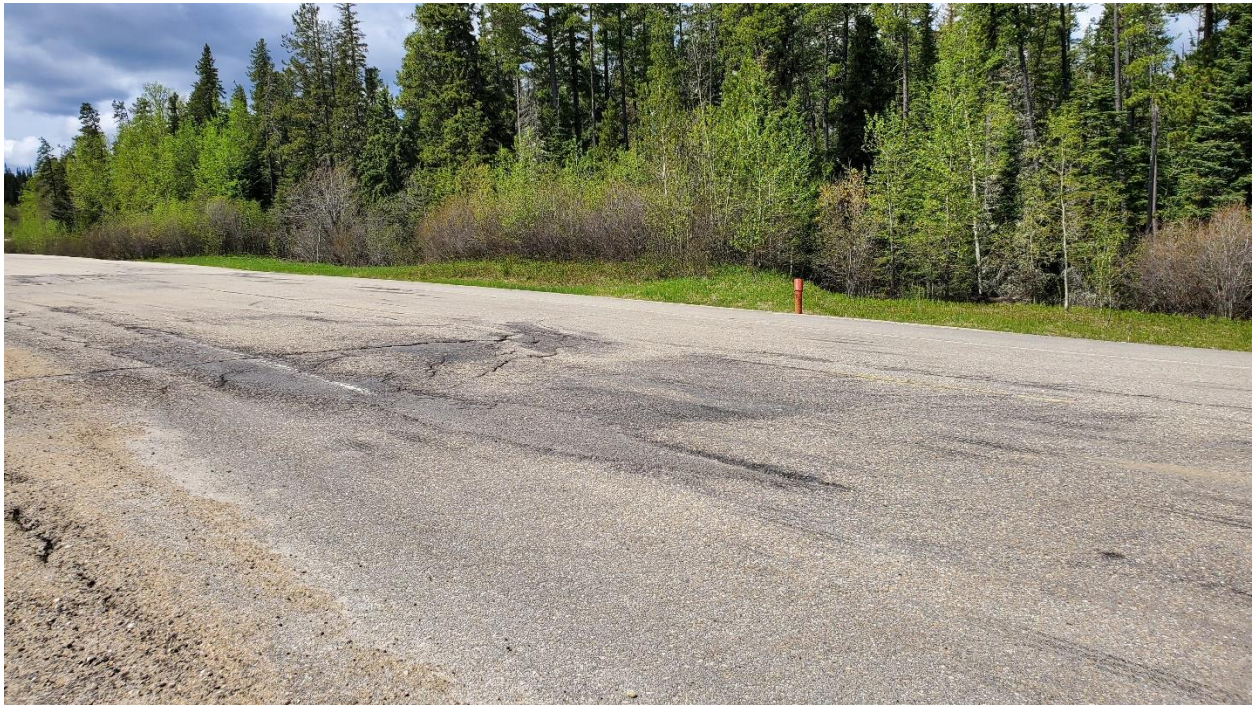
Photo 12 – Crack pattern at SH001A site.

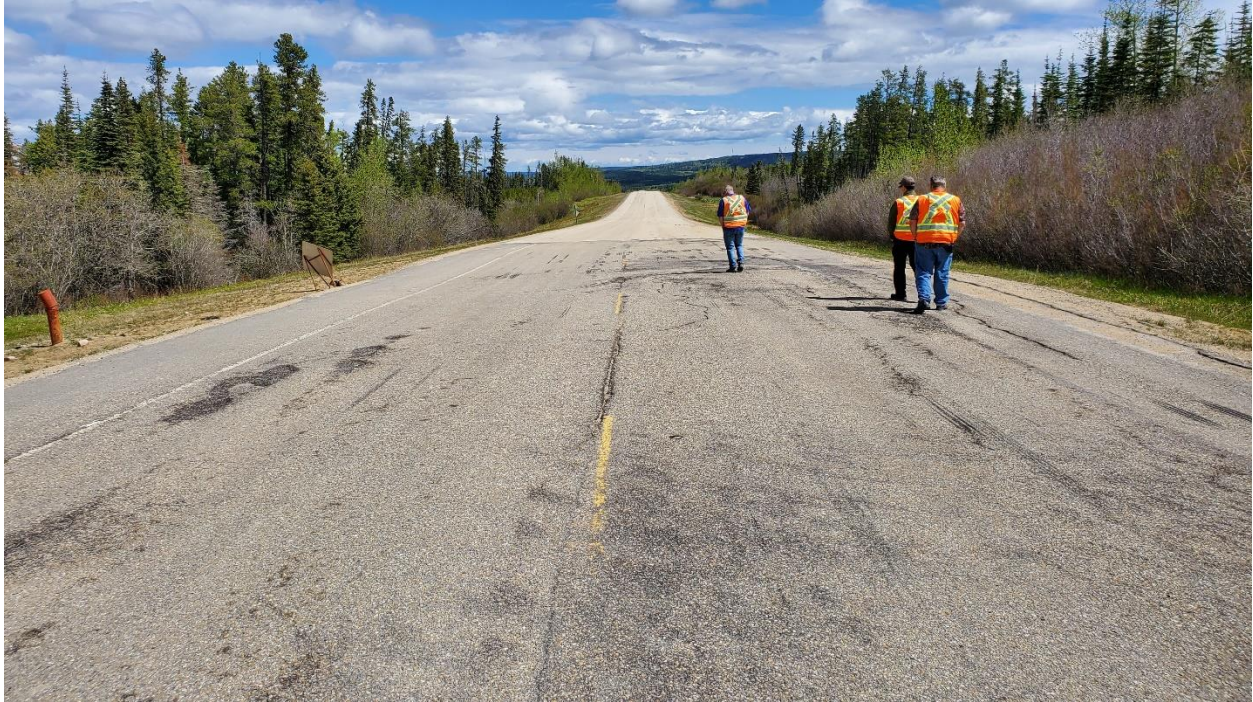
Photo 13 - Looking northeast at second crack with slight pavement dip just beyond at SH001A site.

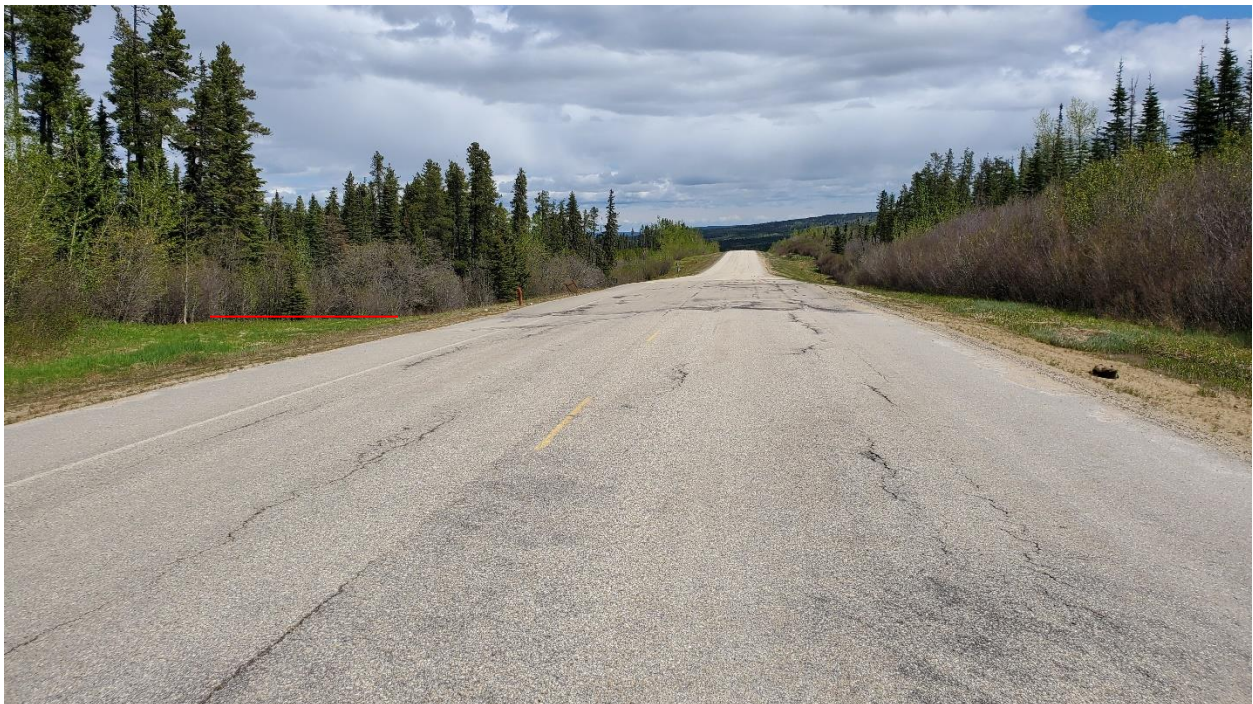
Photo 14 - Looking northeast at roadway crack and scarp (red line) at tree line at SH001A site.

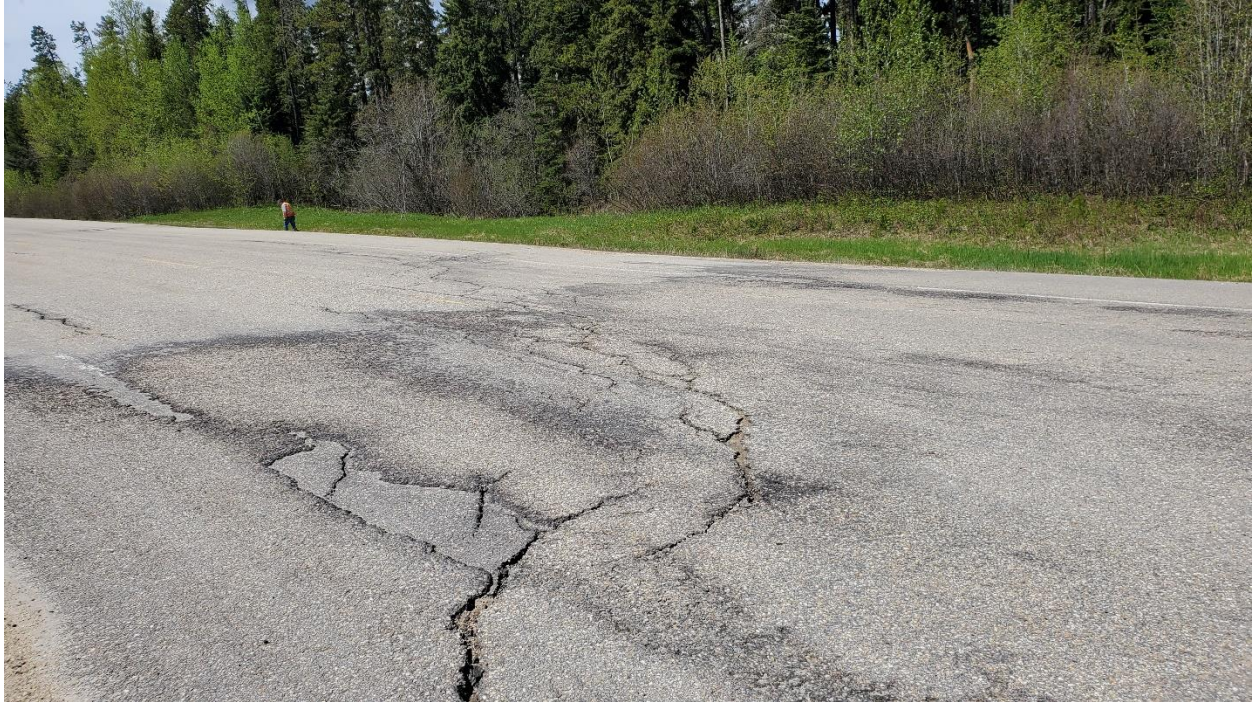
Photo 15 - Looking west at cracks at south end of patch at SH001A site.
