**ALBERTA TRANSPORTATION  
GEOHAZARD ASSESSMENT PROGRAM  
PEACE REGION – SWAN HILLS  
2022 INSPECTION**

Site Number	Location	Name	Hwy	km
SH001-1 SH001A-1	North of Swan Hills	Swan Hills Retaining Wall	33:12	9.33-9.75 10.00-10.05
Legal Description		UTM Co-ordinates		
SE/NE05-67-09-W5M		11U E 607,545	N	6,070,516

SH001-1: HWY 33:12  
2022 SITE INSPECTION PLAN

**SH001A-1: HWY 33:12  
2022 SITE INSPECTION PLAN**

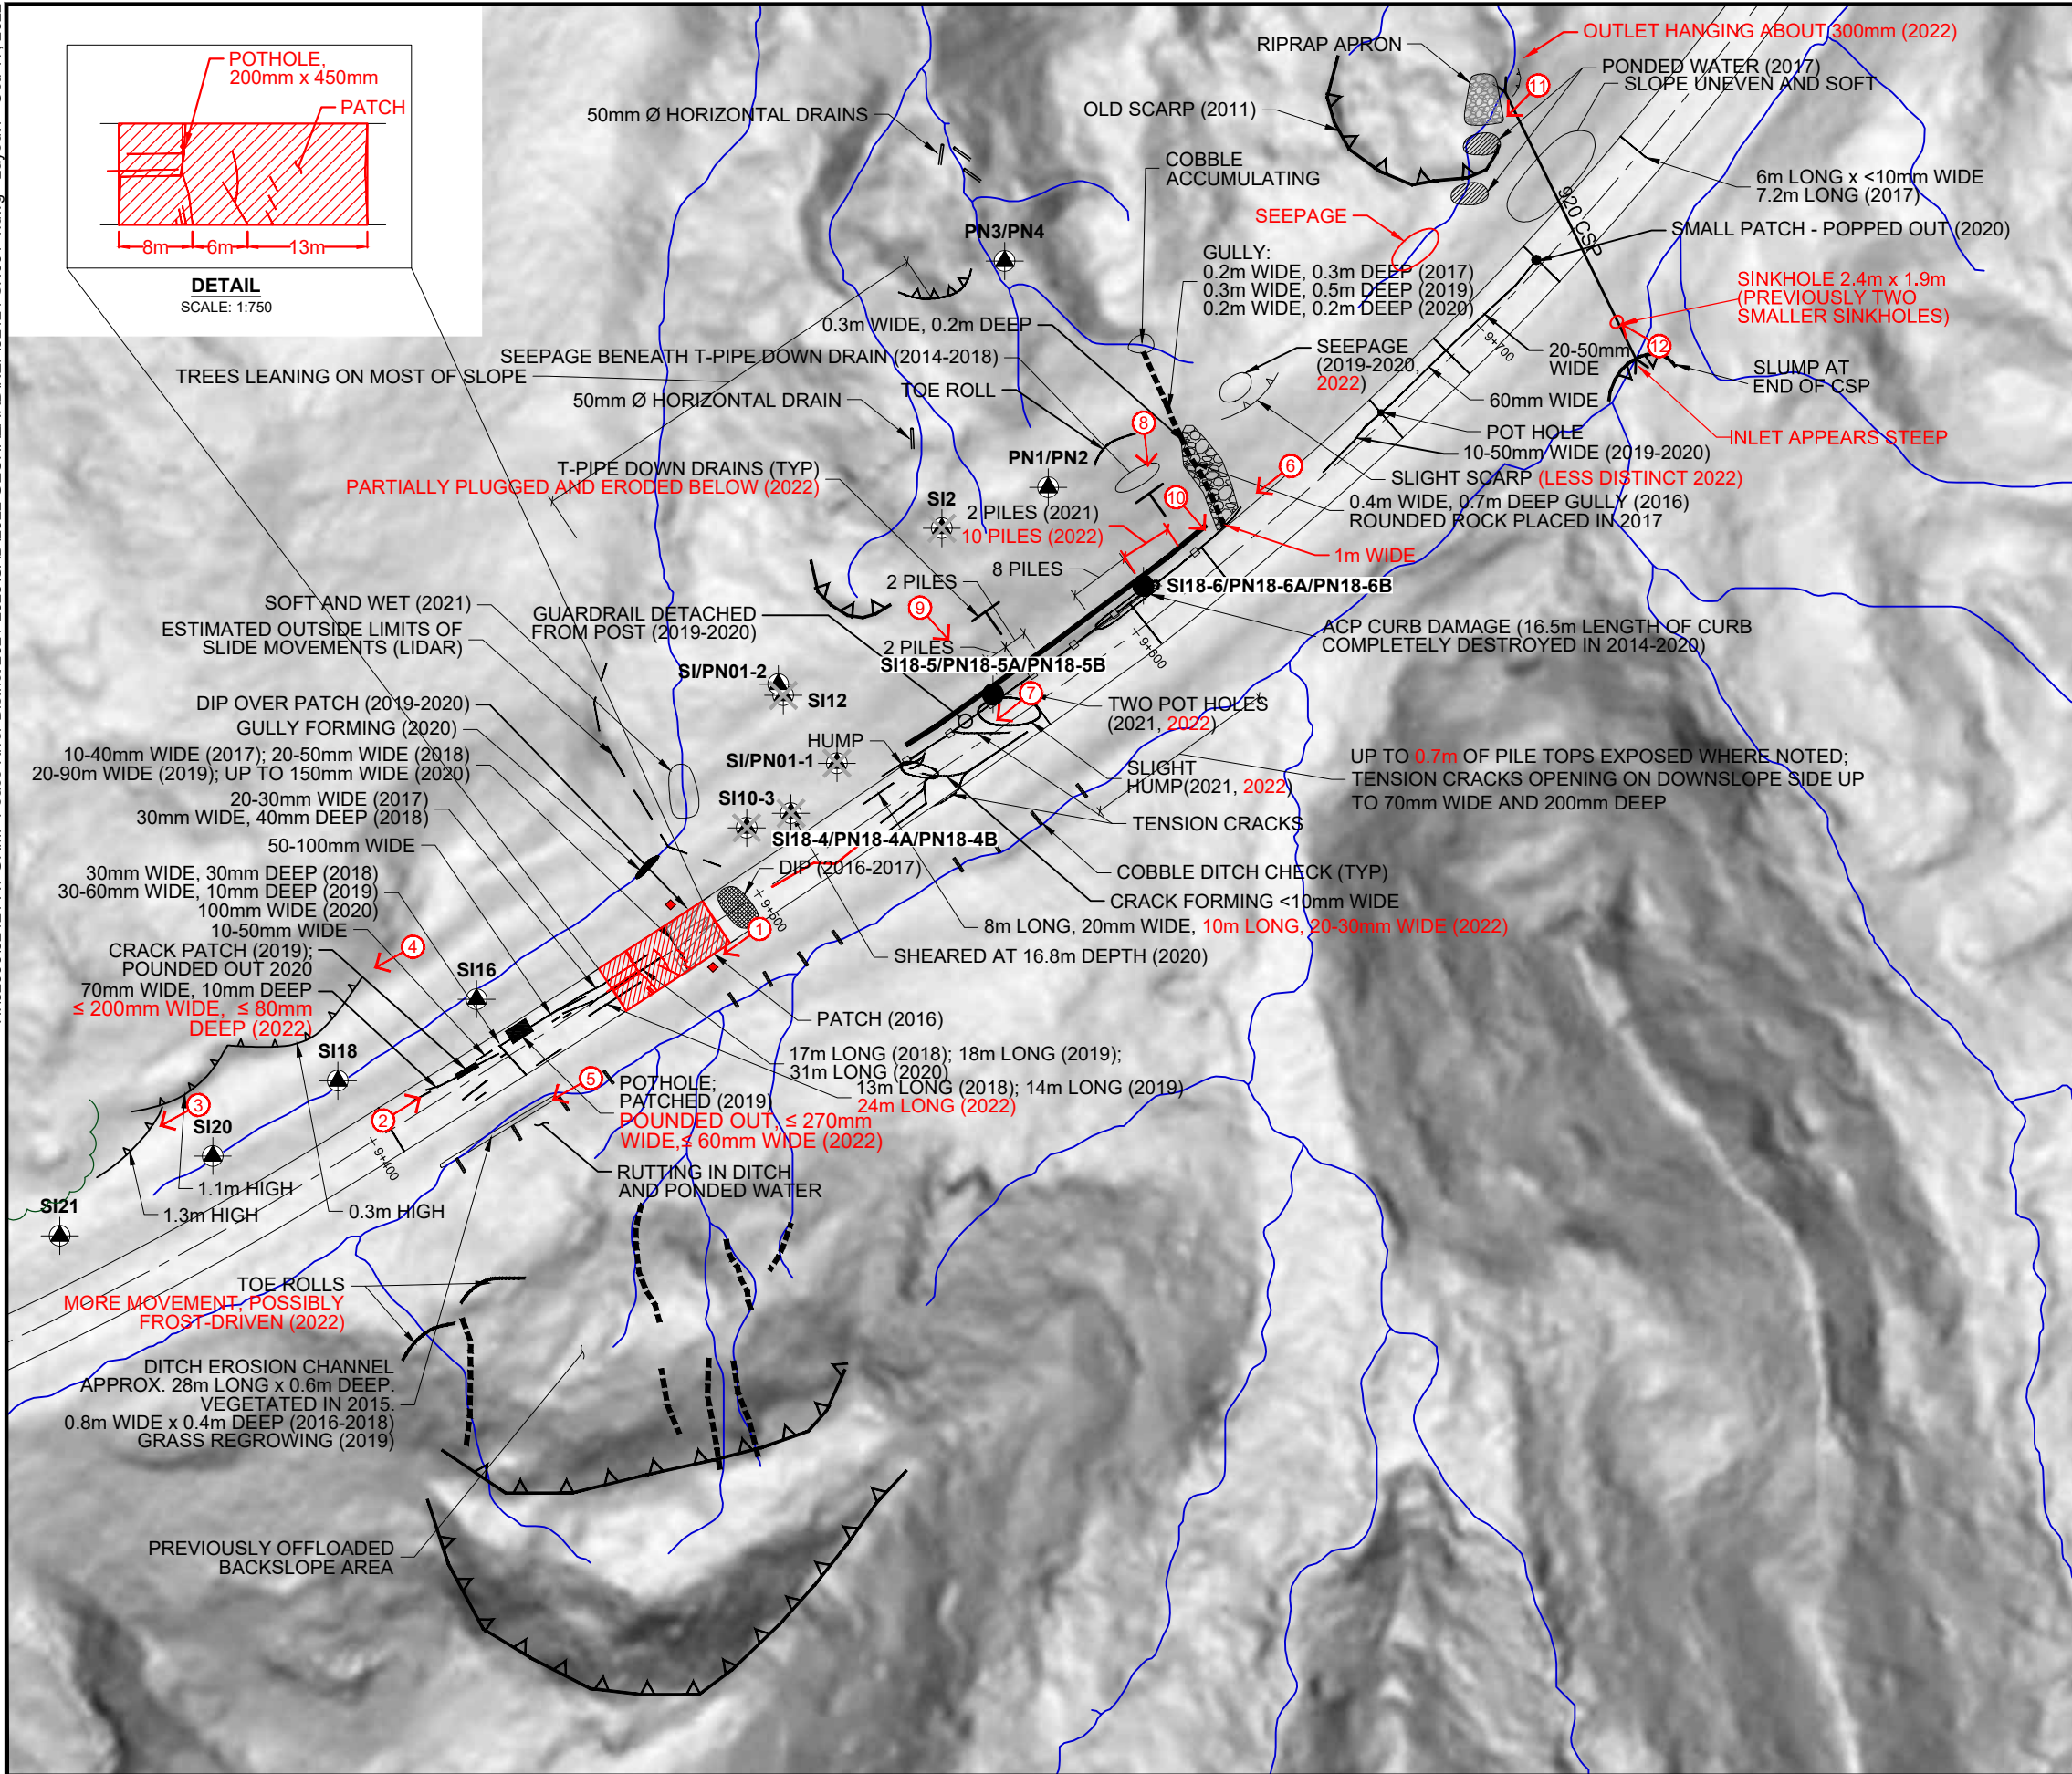
DWG No. 32121-SH001-1

<b>Primary Site Issue:</b>	SH001-1: Highway embankment placed over creek/gully obstructing seepage and mobilizing slide with creep movements at about 18 m to 20 m depth below the roadway. Pavement distress occurring behind and to the south of the floating pile wall. SH001A: Rotational landslide causing vertical displacement of highway surface.
<b>Dimensions:</b>	SH001-1: The pile wall is ~81 m in length. Pavement distress encompasses approximately 270 m of highway. SH001A-1: 50 m of highway affected by soft subgrade and slope movements.
<b>Date of Remediation:</b>	<p><b>Site SH001-1:</b>  <u>1970:</u> Highway reconstructed about 30 m from original alignment which was buried by backslope failure.  <u>1979:</u> 9 – 50mm dia. slotted steel horizontal subdrains installed 3 m to 7.5 m below the roadway. Subdrain at 3 m depth installed in backslope ditch draining to four culverts.  <u>1982:</u> Backslope drains no longer functioning; 5 horizontal PVC drains installed from toe of north-facing embankment slope with lengths between 61 m and 73 m.  <u>1989:</u> Floating concrete pile wall 81 m long installed to depths of 6 m to 12 m below roadway surface. The 82 piles were 760 mm diameter installed at 1 m centre-to-centre spacing.  <u>1991:</u> Two rows of tie-back anchors install 1 m and 3 m below top of piles at 30° into clay shale at a length of 7.5 m.  <u>1995, 1996:</u> Backslope offloading undertaken.  <u>2010:</u> ACP curb installed directing surface water into two “T” drains; sideslopes regraded and tops of piles covered with gravel; guardrail installed.</p> <p><b>Site SH001A-1:</b>            No remediation was done other than patching.</p>

SH001-1: Consideration should be given to placing additional horizontal drainage measures to further reduce groundwater levels in the highway embankment particularly to the southwest of the wall. This might also be accomplished with a subdrain or relief wells to the south of the highway. Consideration could also be given to extending the pile wall further southwest should ongoing maintenance become difficult and/or expensive.

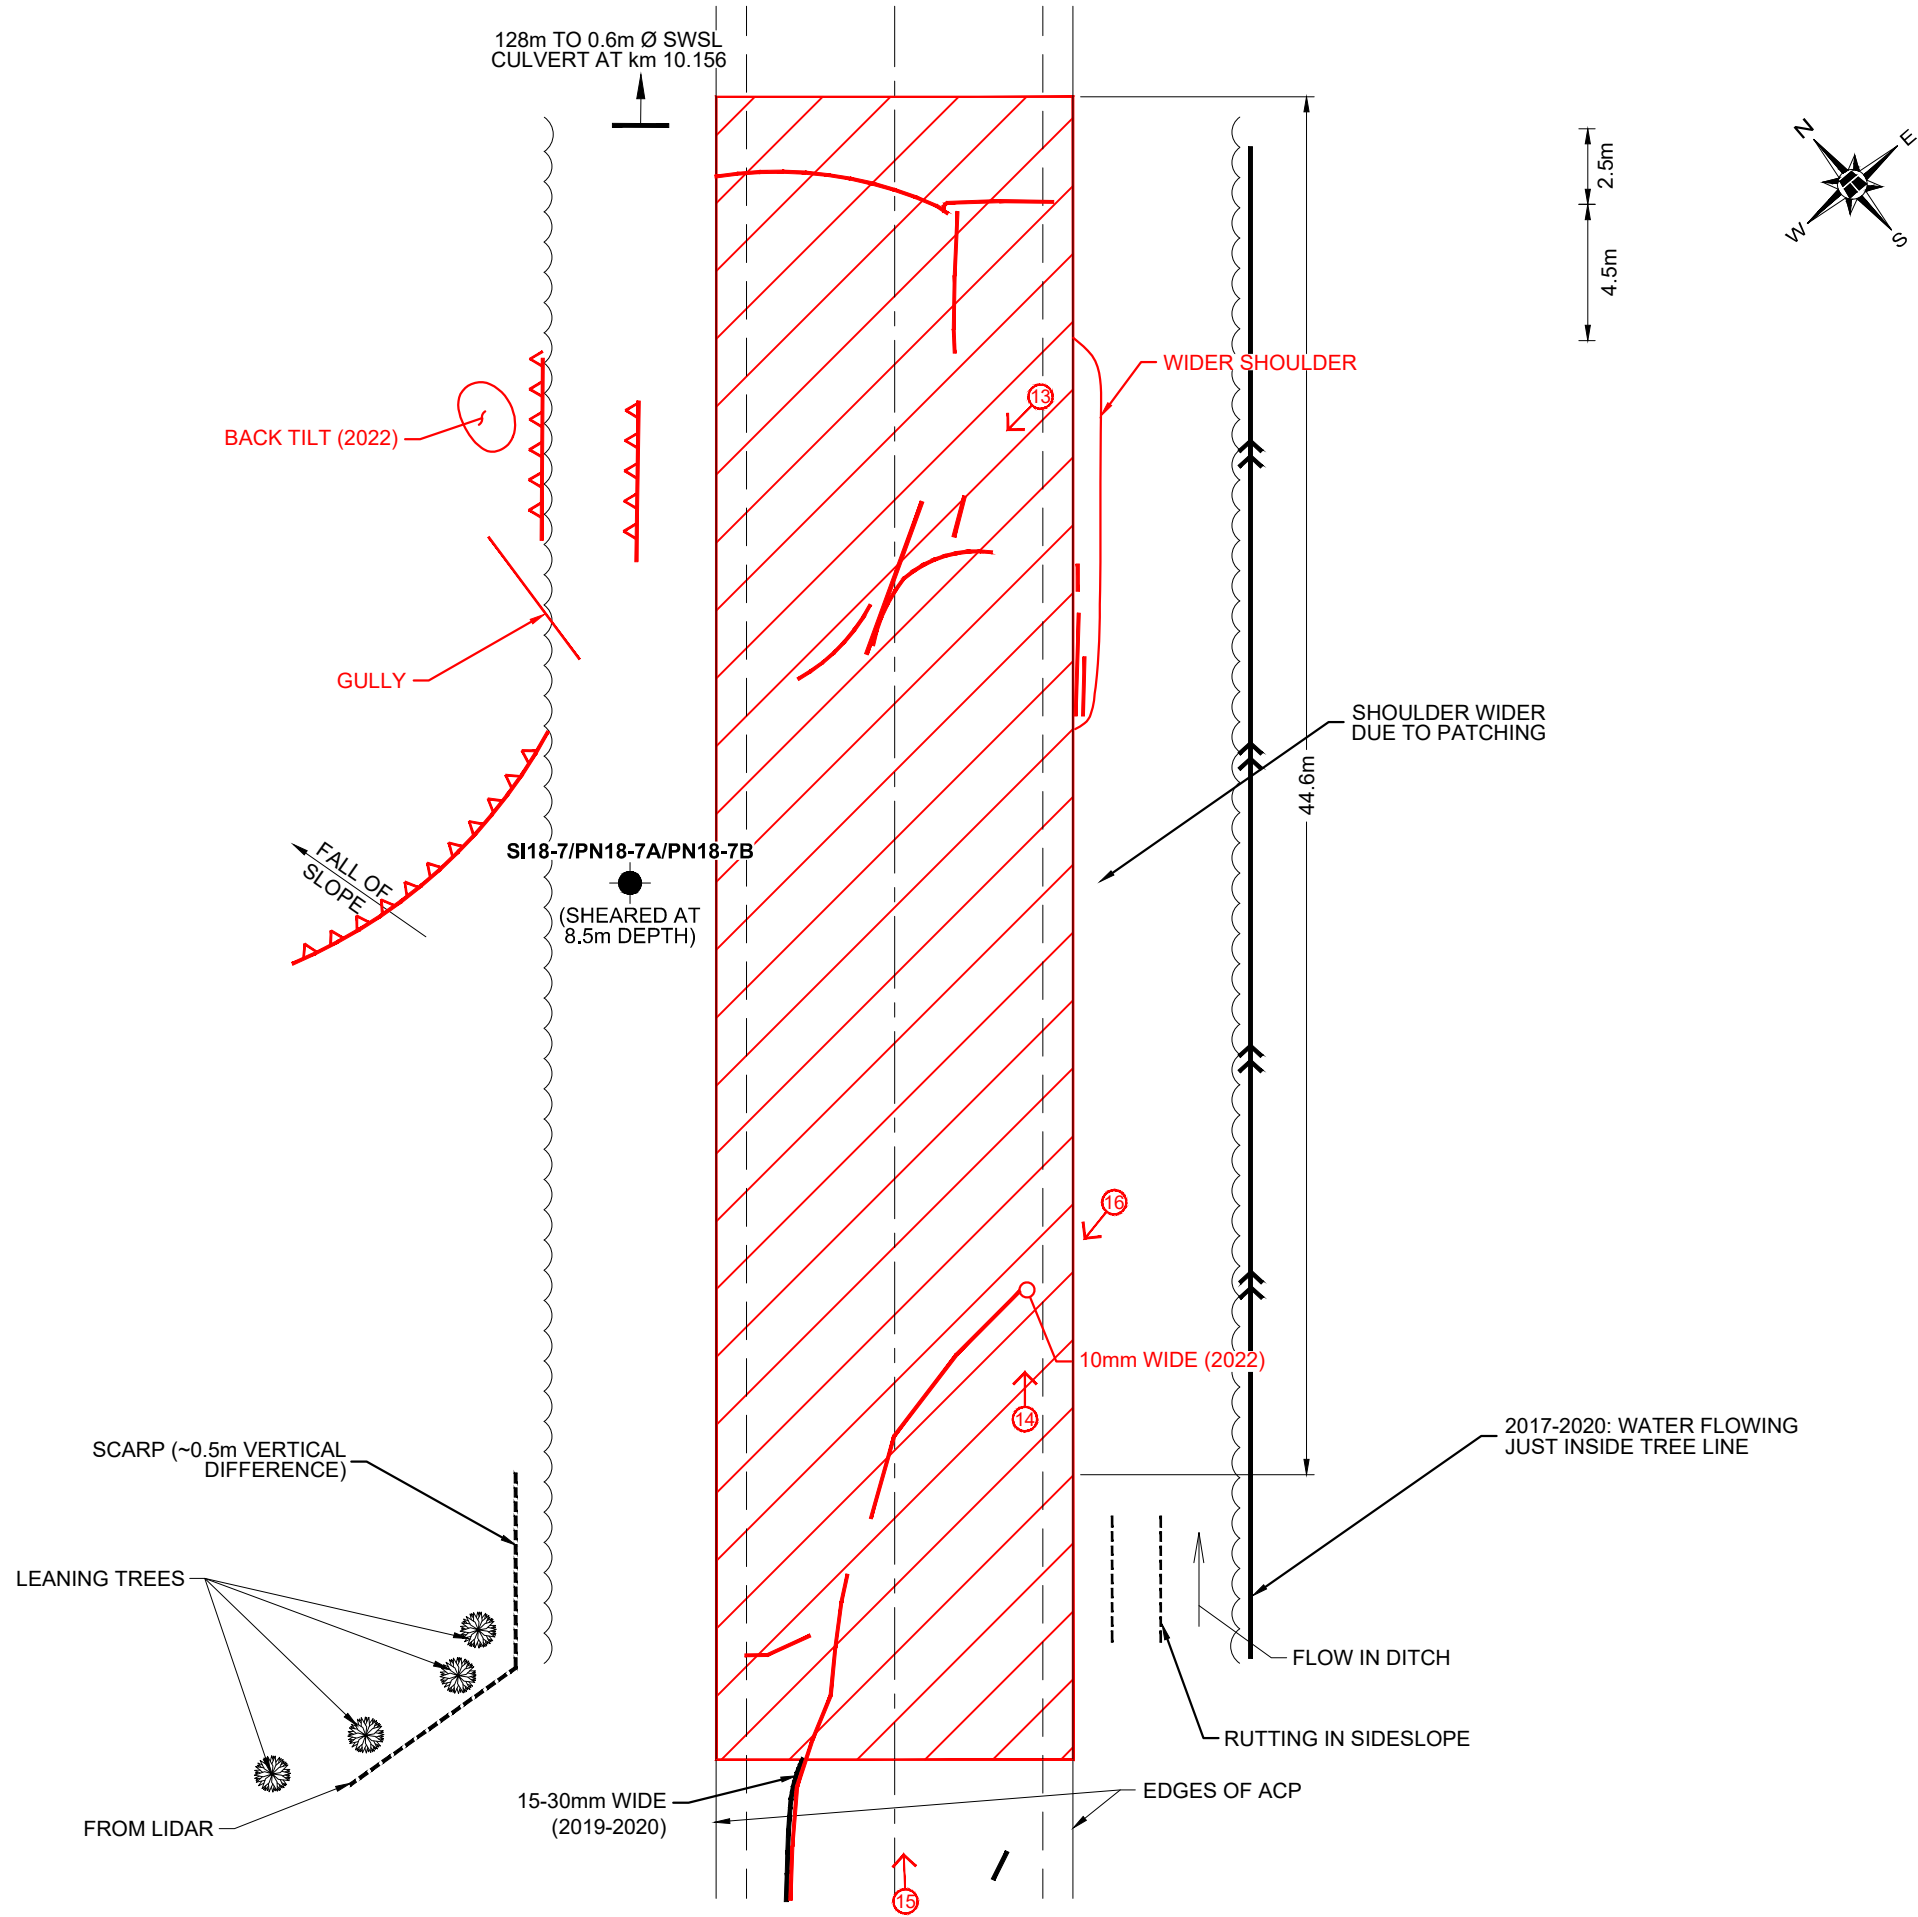
DWG No. 32121-SH001A-1

modified groundwater flow regime. Like at SH001-1, the highway was patched in 2022 but the cracks and potholes are starting to surface through the patch. The soil stratigraphy observed in SH18-7 consists of gravel and clay fill overlying native clay over a thin zone of clay till. The site is underlain by clay shale with sandstone layers. The movement zone appears to be at the contact between the clay till and clay shale. The high groundwater level measured in the clay till layer, which became artesian in Spring 2019, might be a trigger for the slide movements. The Spring 2022 readings still indicate flowing artesian groundwater conditions. The mechanism for the landslide occurring at this site has not yet been identified. There is about 20 m of relief from the highway surface to the downslope creek but over a distance of about 190 m which is relatively flat (6°); however, remolded shale is expected to have a low friction angle.

SH001A-1: With confirmed movement at this site, it is recommended that a preliminary engineering assessment be undertaken to determine potential mechanisms and develop alternates for stabilizing this location. A LiDAR review should be included to try to better define the possible limits of the landslide.

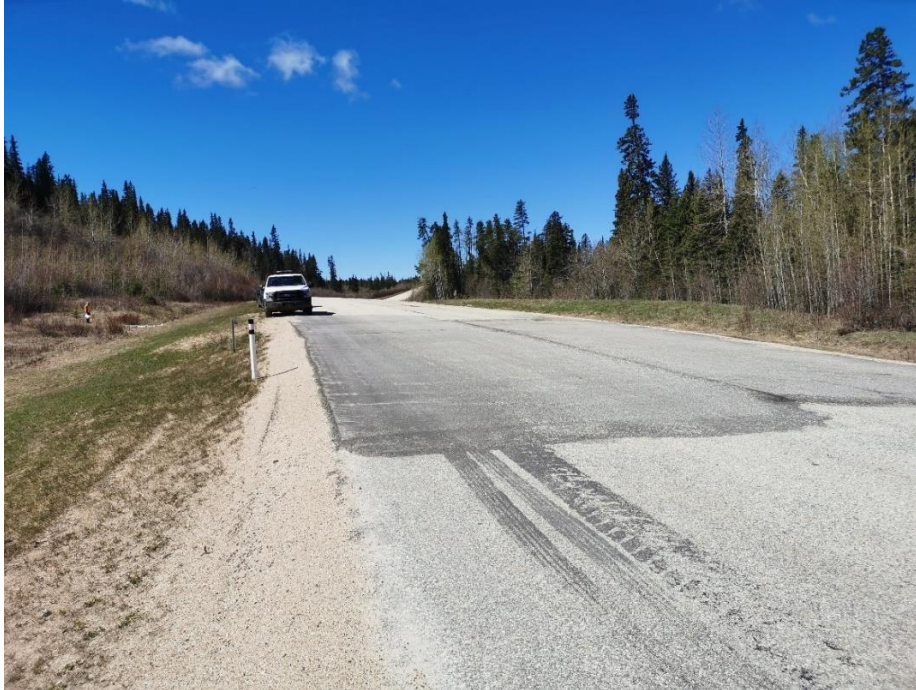
Photo 1, SH001-1 – Looking southwest at patch over cracks forming at the southwest end of the wall .

- Road maintenance should continue as necessary to maintain the roadway surface and may consist of milling, patching, and crack sealing of the ACP.
- Re-establish the asphalt curb and clean the T-drains (this should be a periodic maintenance item).
- Re-grade, and augment with additional granular material, if necessary, the sideslope below the pile wall as was partially undertaken since the 2016 inspection.

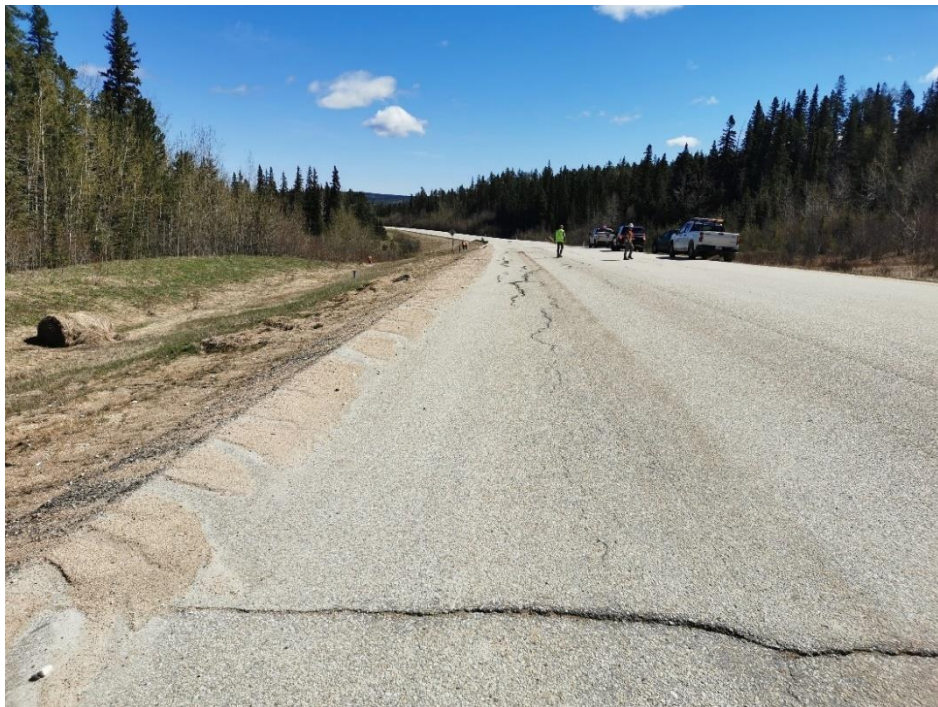
Photo 2, SH001-1 – Looking north at cracking in highway surface immediately south of the pile wall.

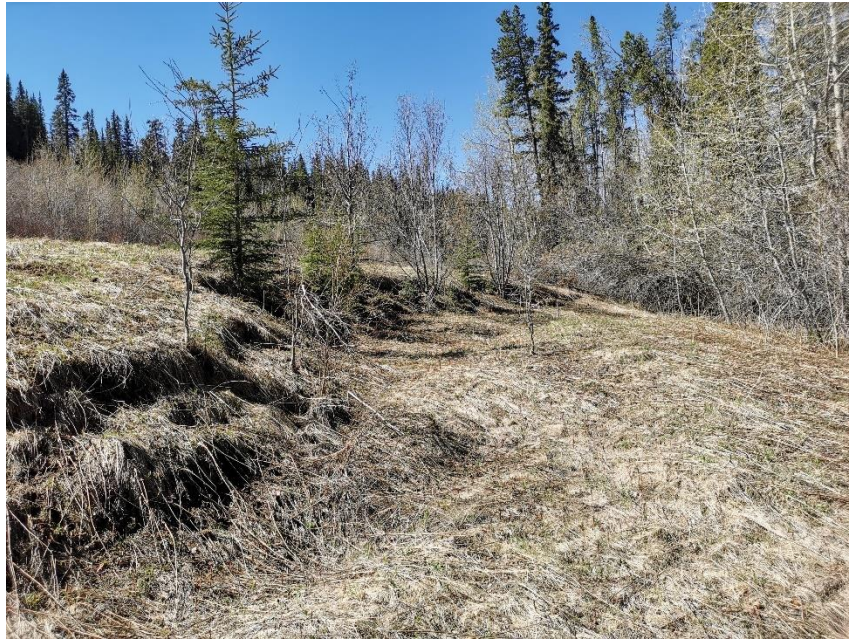
Photo 3, SH001-1 – Looking southwest at scarp on slope below highway between SI20 and SI21.

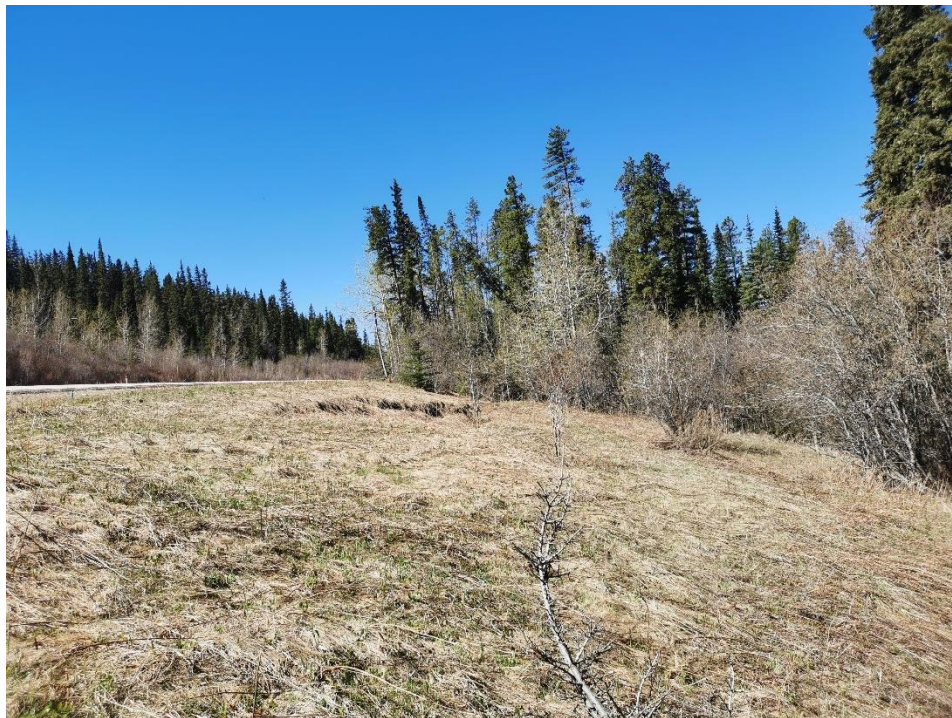
Photo 4, SH001-1 – Looking southwest at scarp below highway near SI18.

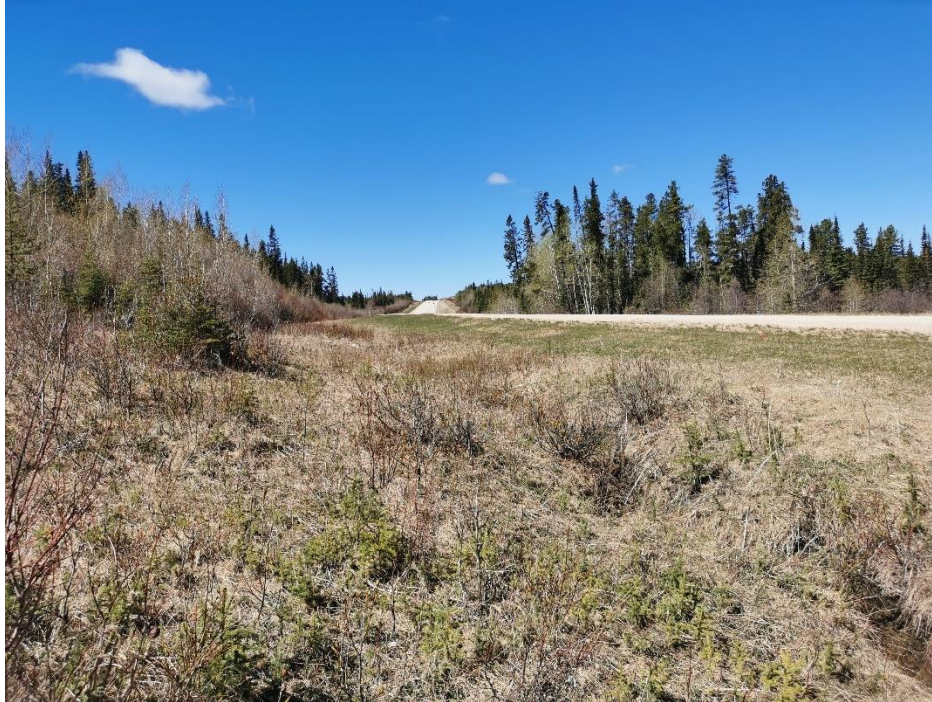
<input checked="" type="checkbox"/> Erosion	<p>SH001-1: Some erosion noted on sideslope between and below piles. Deeper channels at west end of wall were infilled but are reforming  Erosion in east ditch south of wall starting to revegetate; new gully forming in west ditch.</p>	<input checked="" type="checkbox"/>
<input checked="" type="checkbox"/> Seepage	<p>SH001-1: Seepage observed in backslope area and wet zones noted below the pile wall.  SH001A-1: Steady flow observed in east tree line and ditch.</p>	<input type="checkbox"/>
<input checked="" type="checkbox"/> Bridge/Culvert Distress	<p>SH001-1: T-Drains outlets have been plugged with debris (partially accumulated since last cleaning) and one inlet is slightly damaged.  Two sinkholes near the inlet of the culvert north of the pile wall have joined to form a single and larger sinkhole and there are slumps near the outlet.  SH001A-1: No apparent distress at culvert 130 m north of site.</p>	<input checked="" type="checkbox"/>

Photo 5, SH001-1 – Looking south at erosion in east ditch.

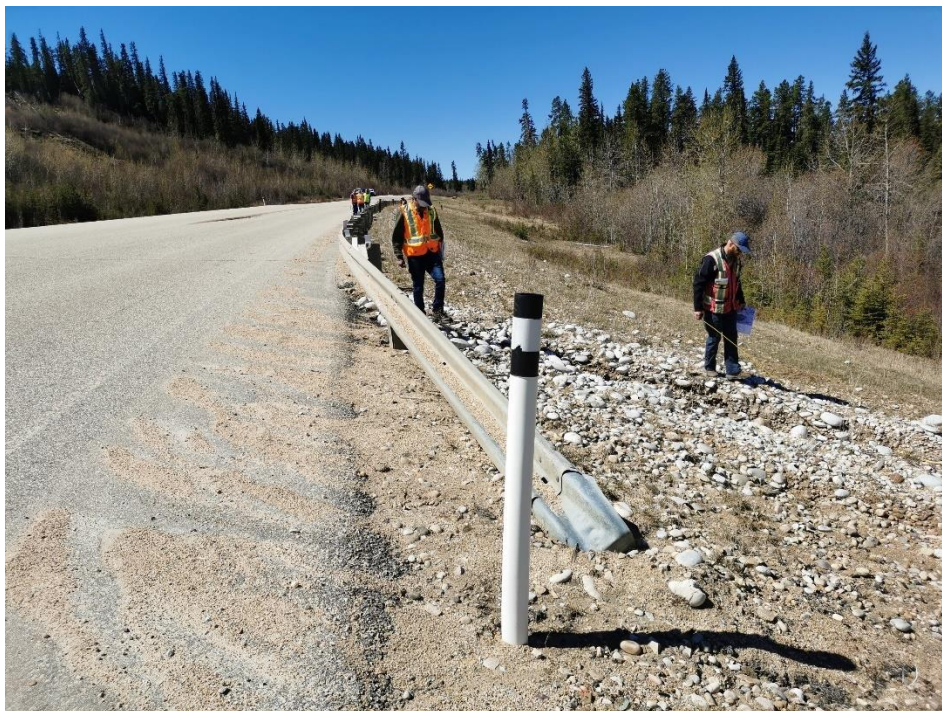
Photo 6, SH001-1 – Looking south at cobbles placed in gully at north end of guardrail.

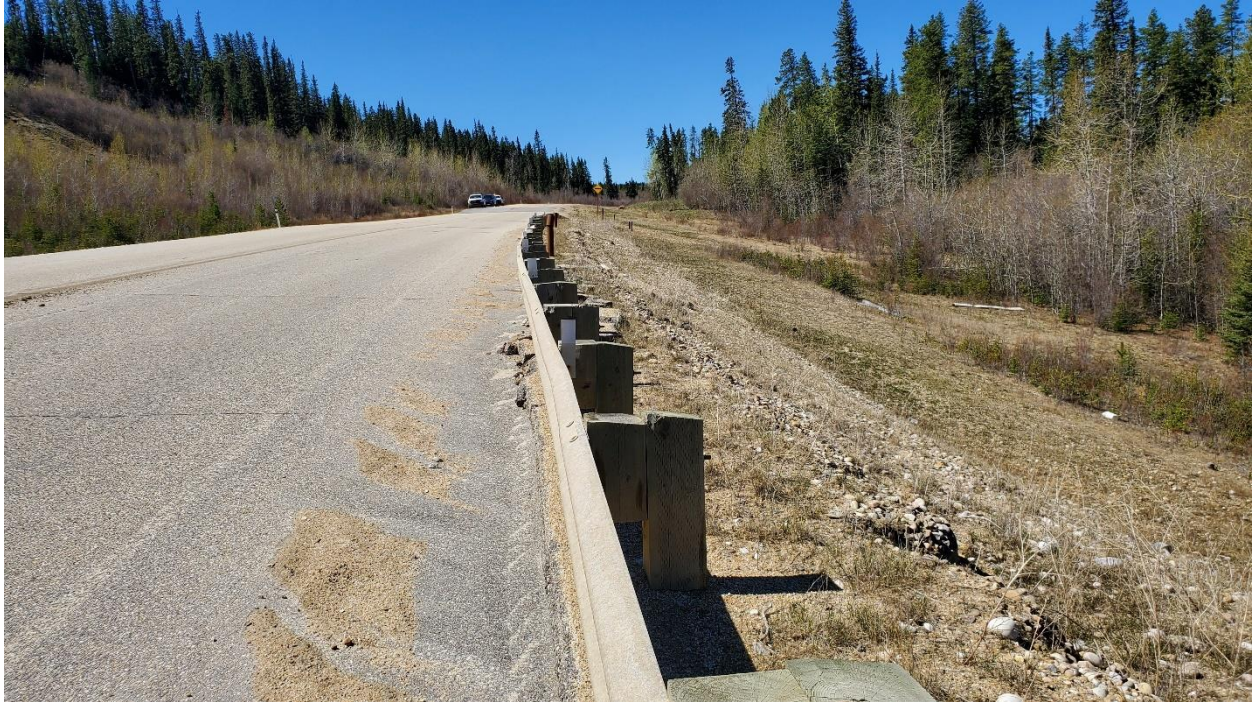
Photo 7, SH001-1 – Looking southwest at cracked curb at south end of guardrail.

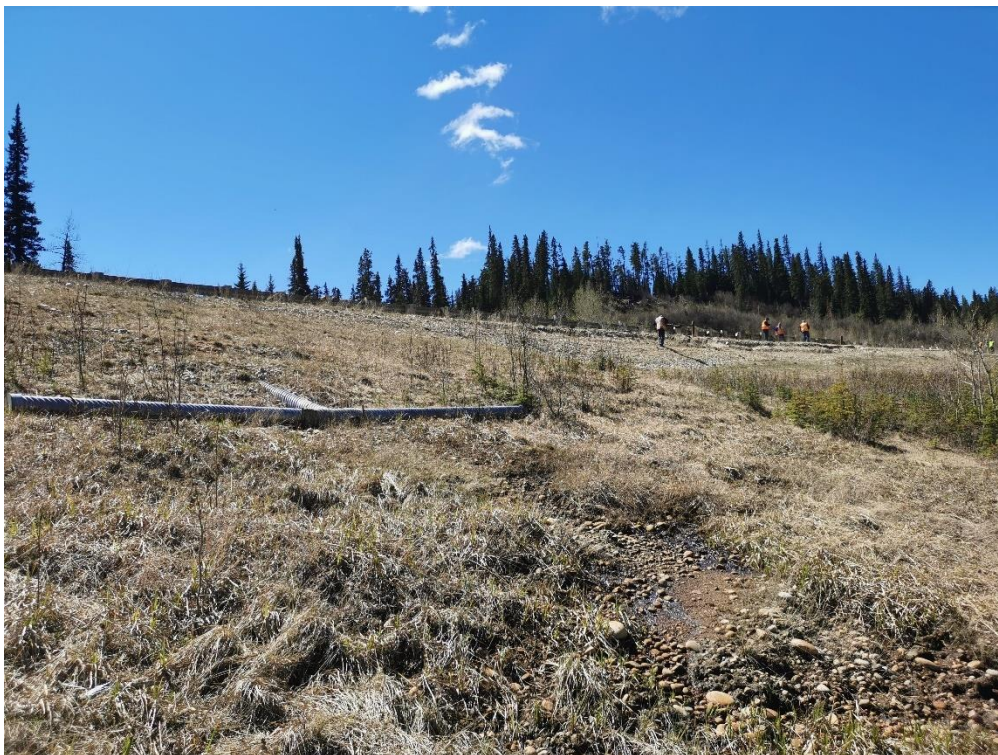
Photo 8, SH001-1 – Seepage out of slope below north-most T-drain.

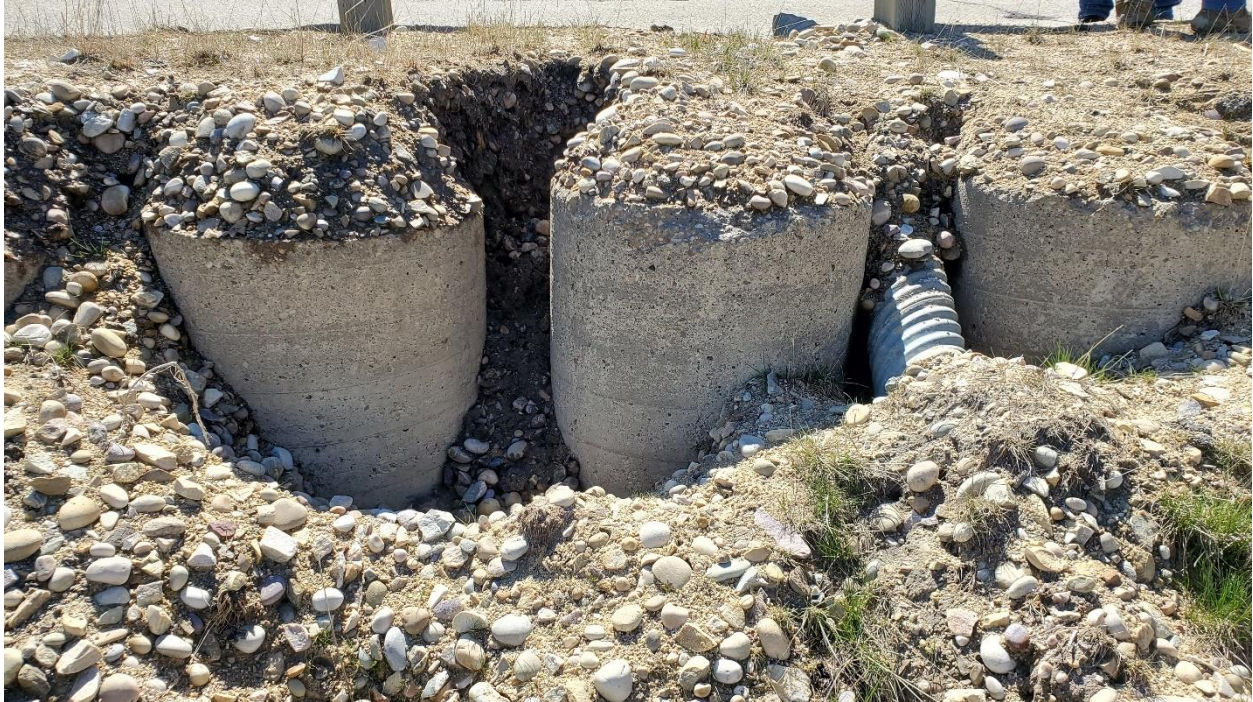
Photo 9, SH001-1 – Erosion and/or movement away from the piles around the southwest down drain.

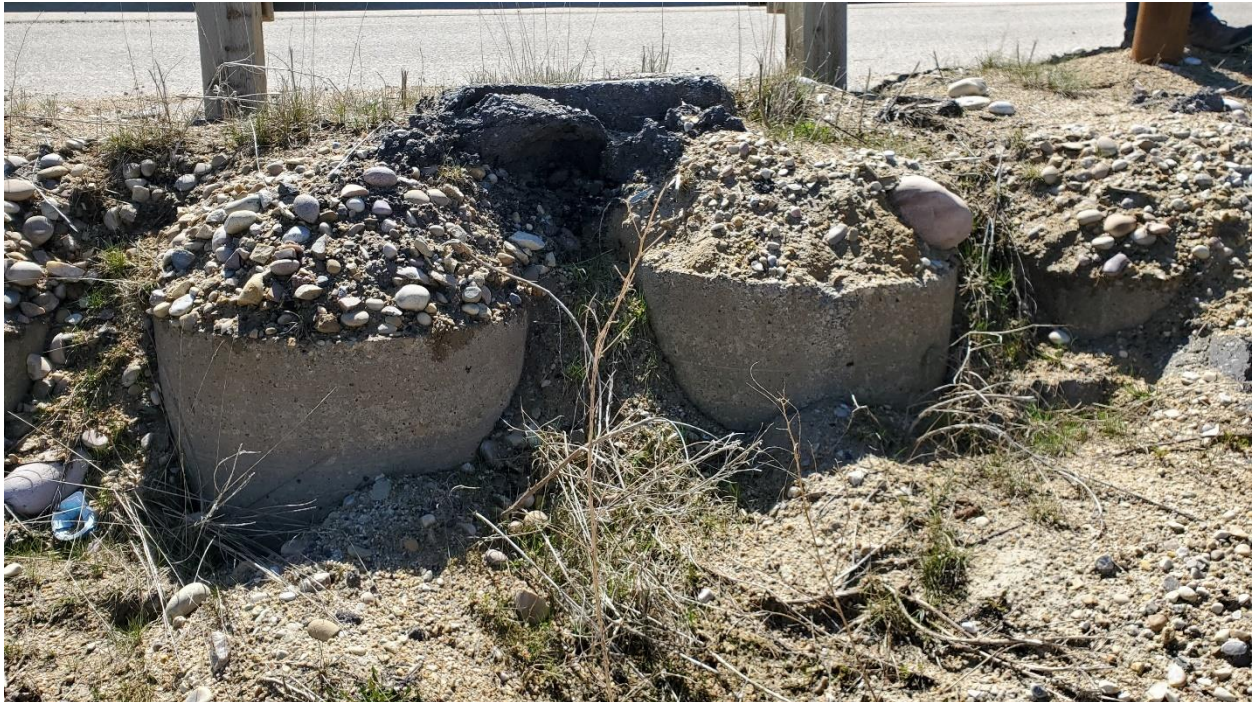
Photo 10, SH001-1 – Soil pulling away from the downslope side of piles near the northwest down drain.

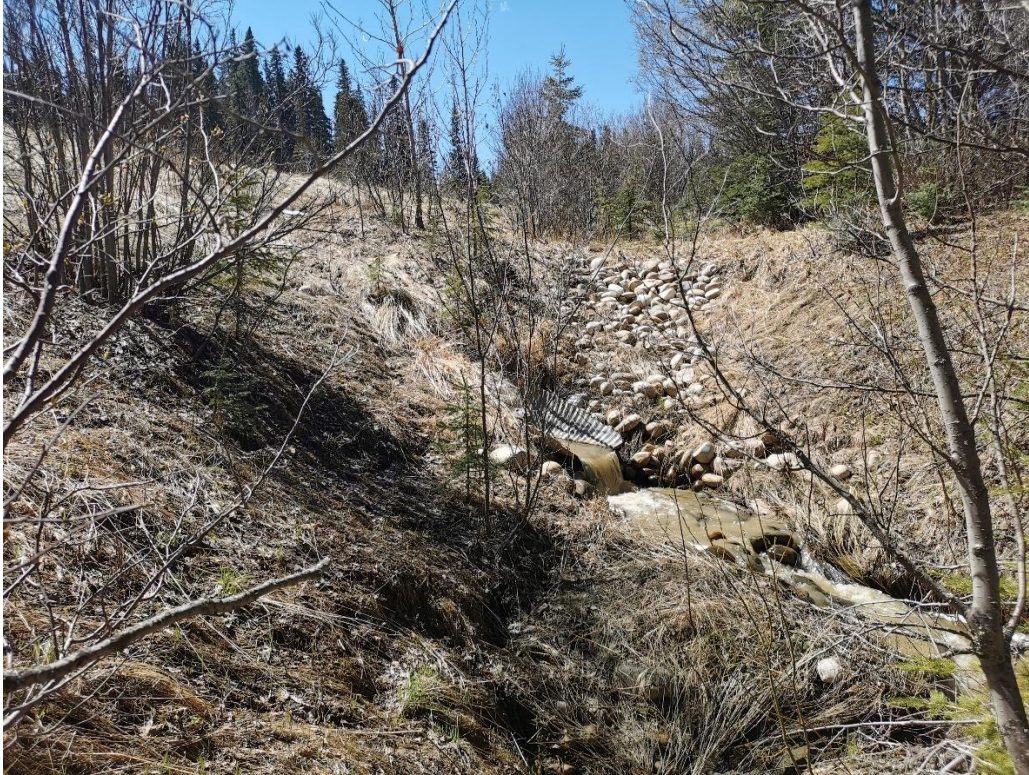
Photo 11, SH001-1 – 920 mm dia. centreline culvert outlet.

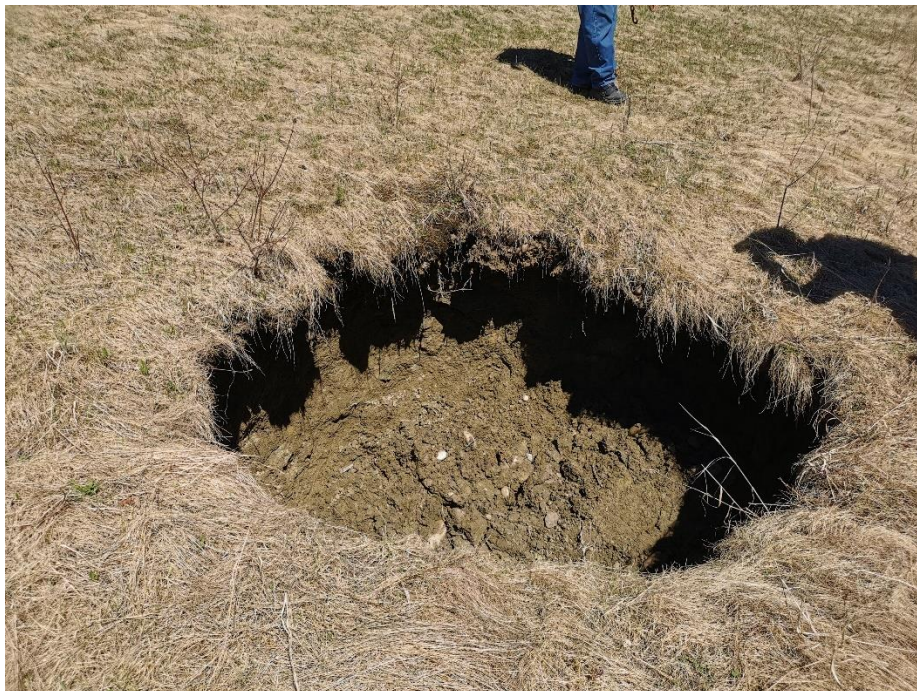
Photo 12, SH001-1 – Two sinkholes at culvert inlet have combined to form a larger sinkhole.

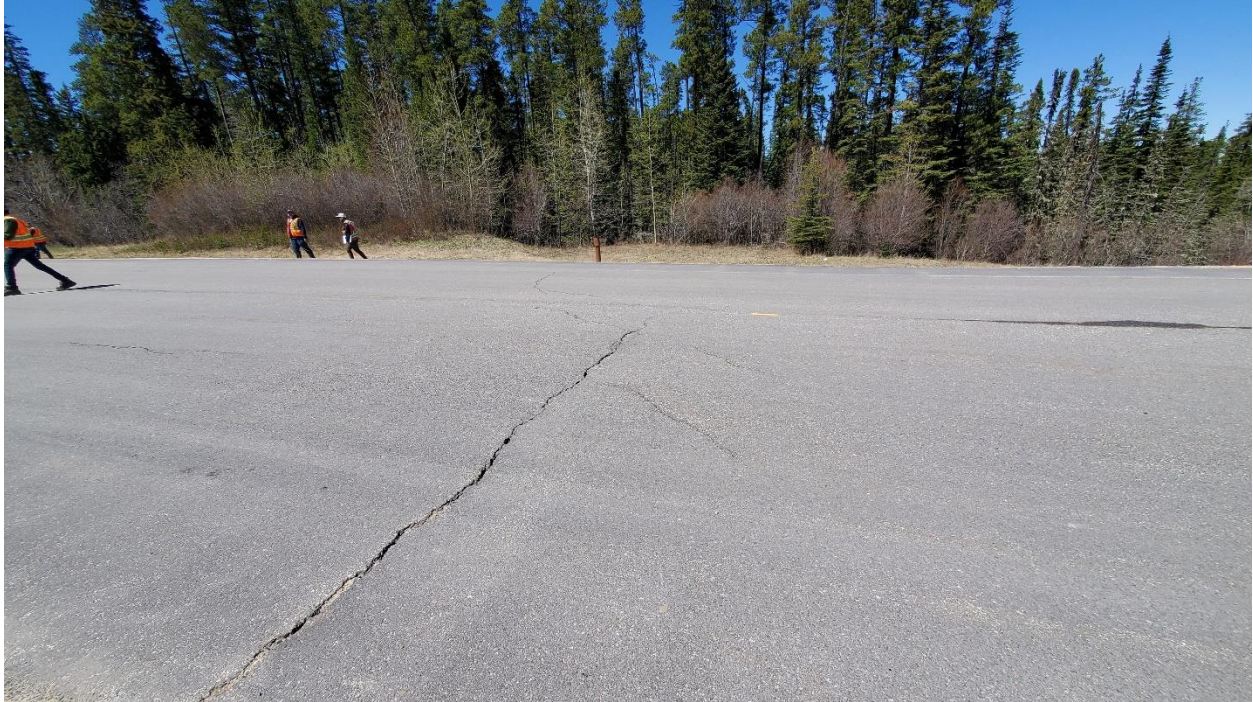
Photo 13, SH001A-1 – Crack pattern at the north end of the Site.

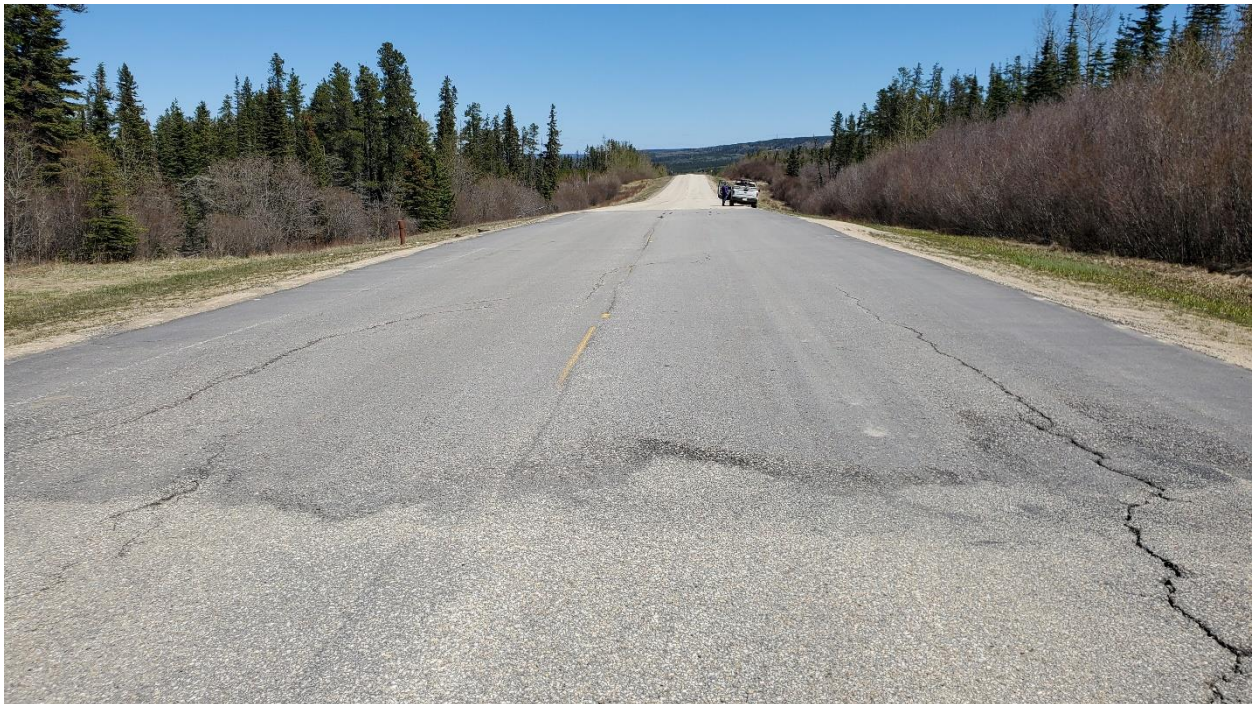
Photo 14, SH001A-1 - Looking northeast from the south end of the patch.

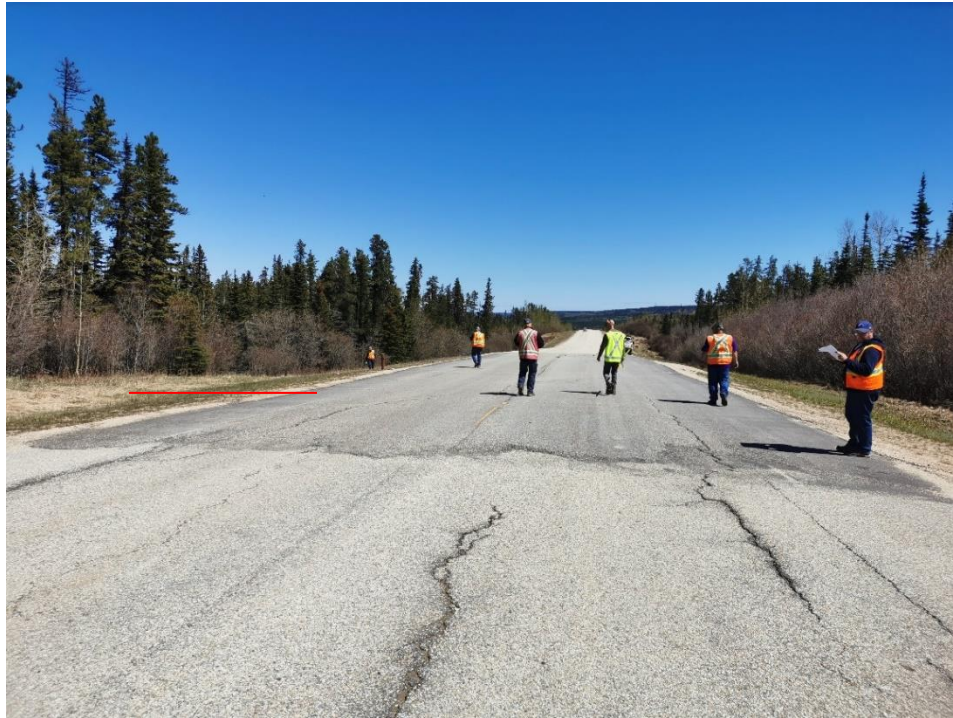
Photo 15, SH001A-1 – Looking northeast at roadway crack and scarp (red line) at tree line.

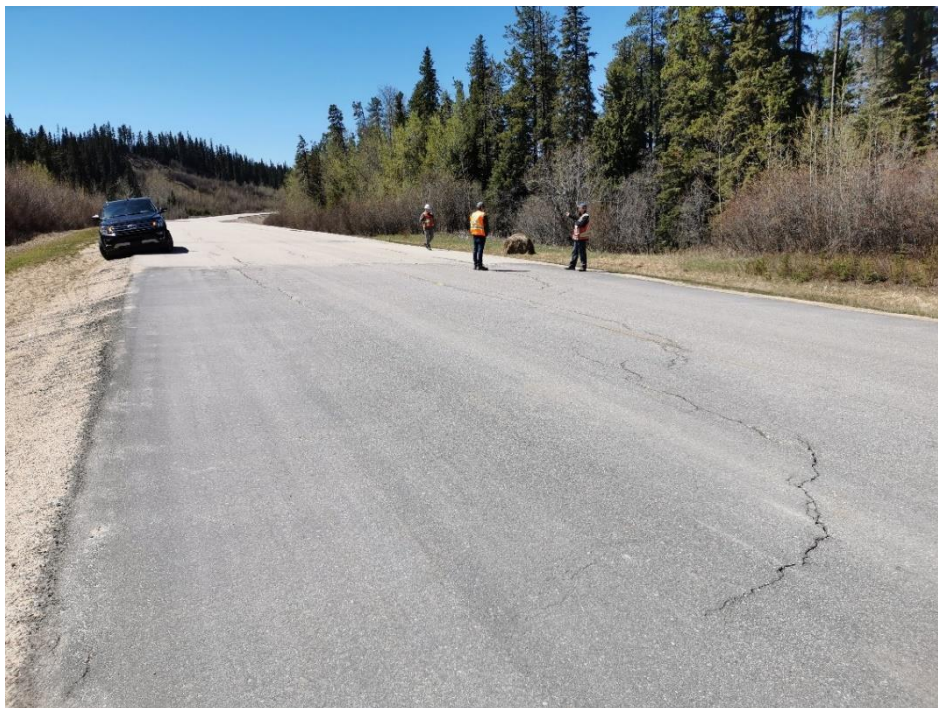
Photo 16, SH001A-1 - Looking west at cracks at south end of patch.
