July 26, 2022

**ALBERTA TRANSPORTATION GRMP (CON0022164)
PEACE REGION (PEACE RIVER DISTRICT)
INSTRUMENTATION MONITORING RESULTS – SPRING 2022**

SITE SH001/SH001A: HWY 33:12 (SWAN HILLS RETAINING WALL)

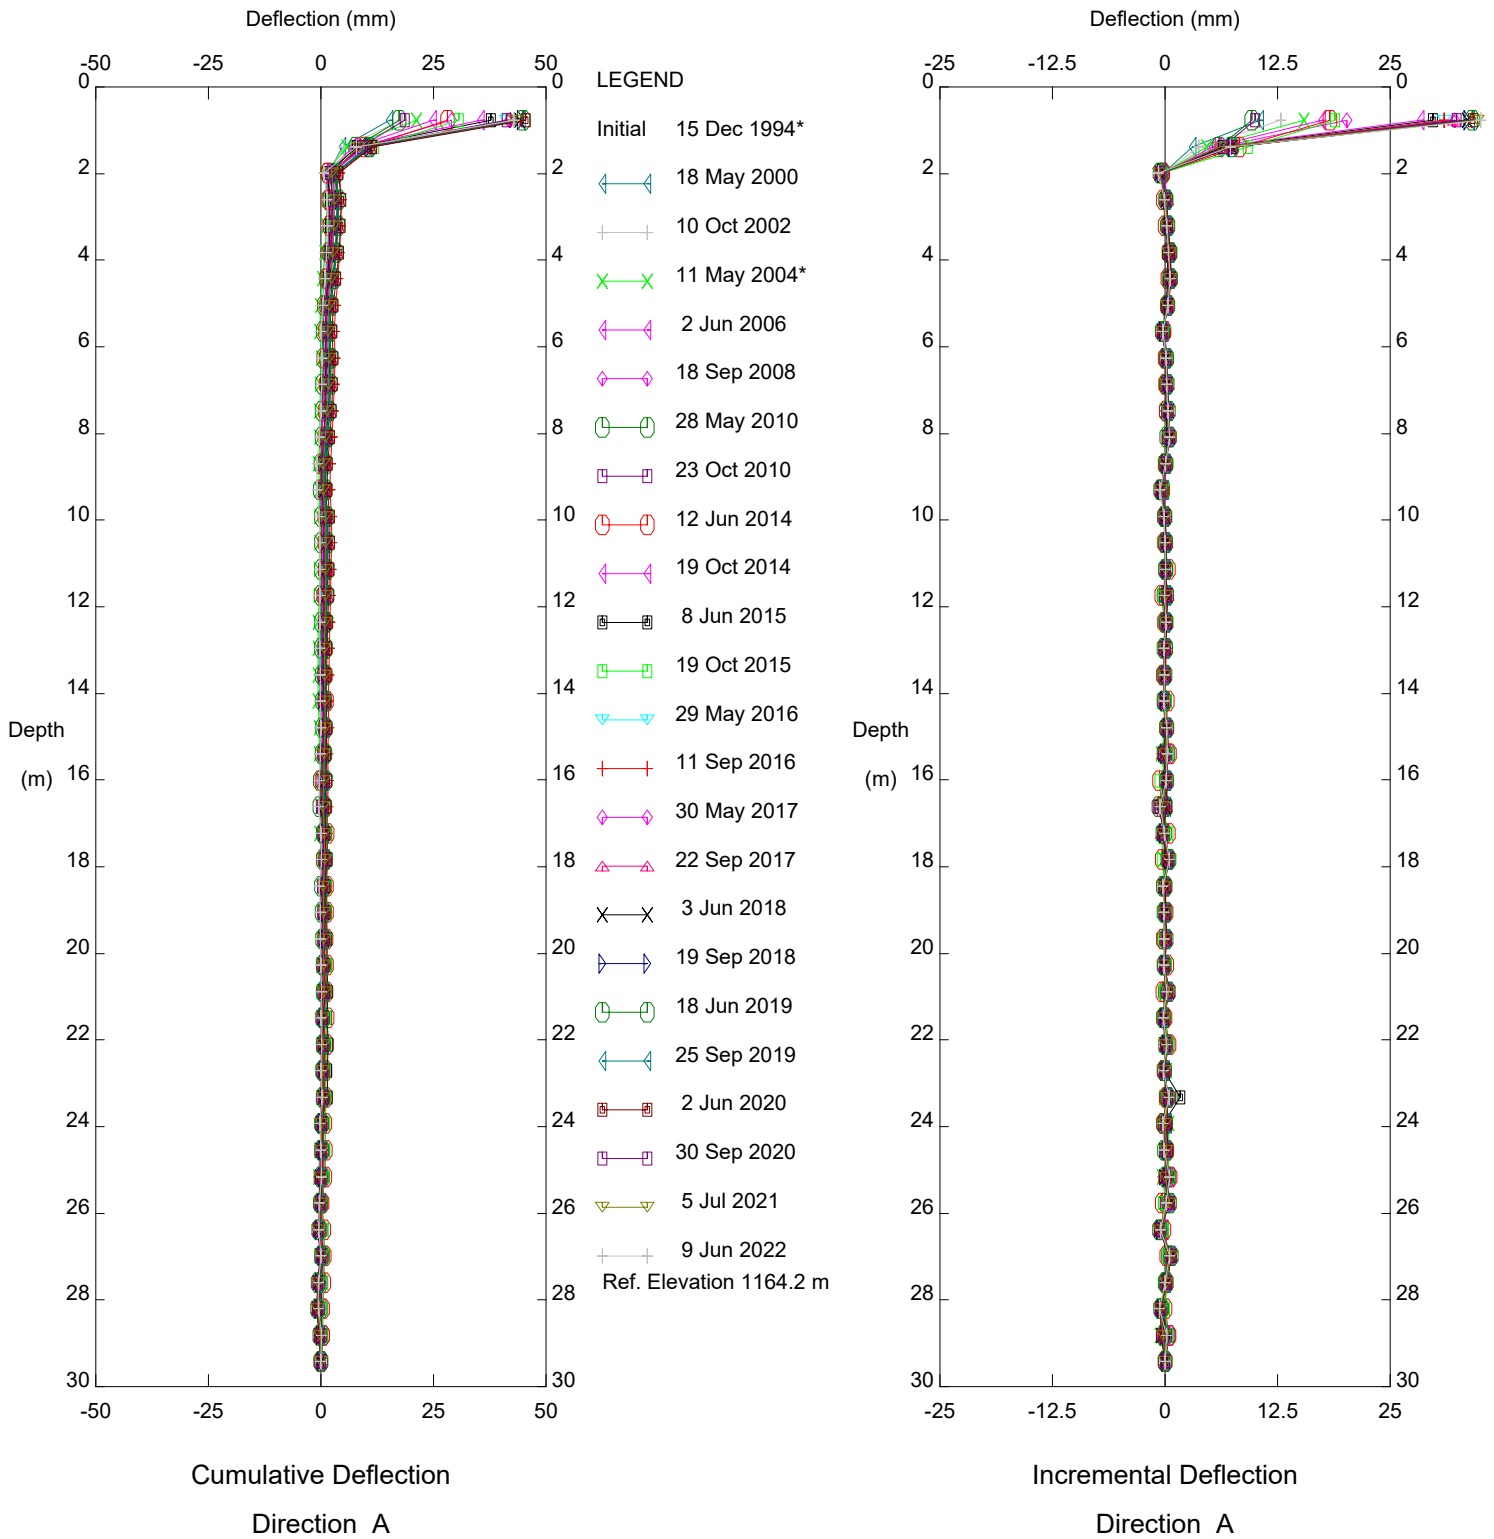
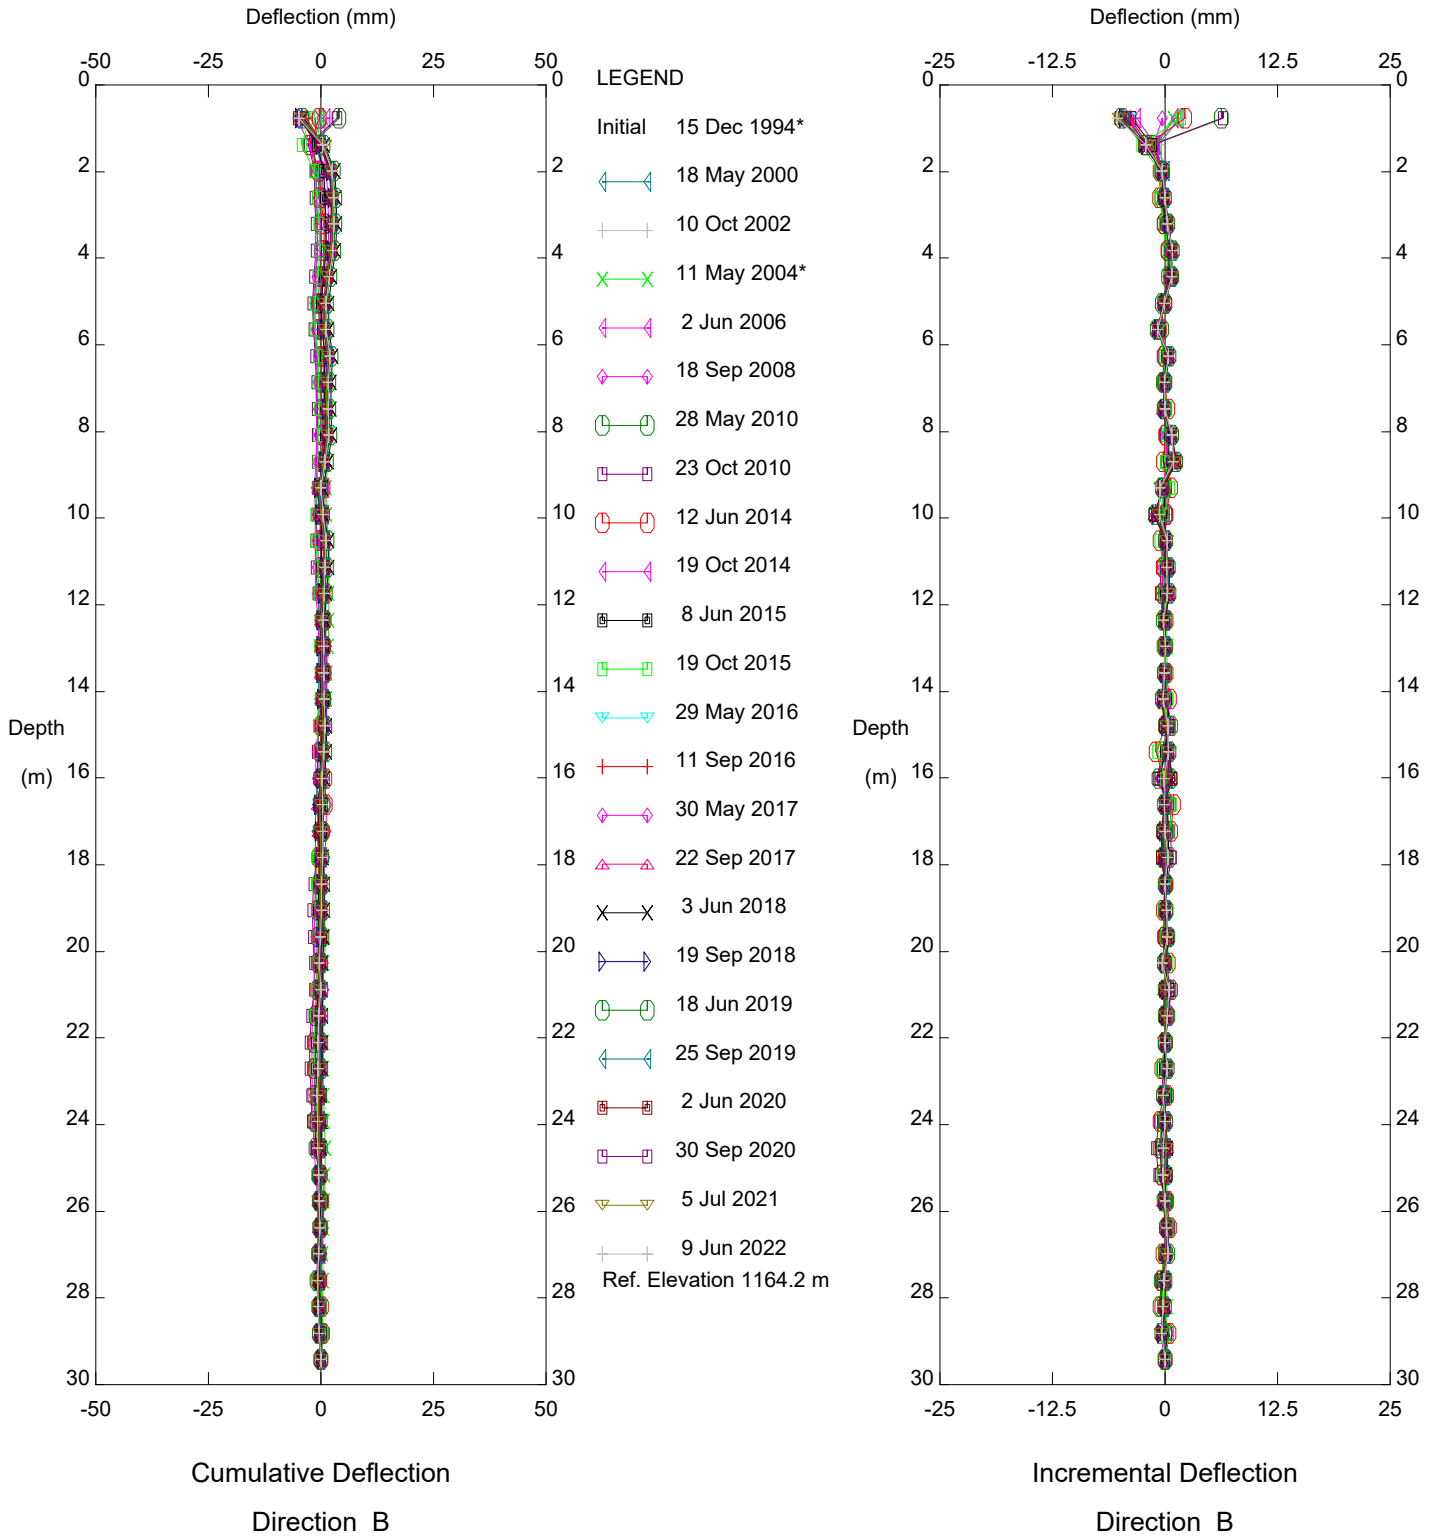
SH001 - Swan Hills Retaining Wall, Inclinometer SI 16

Slope inclinometers SI-16, SI-18 and SI-20 continued to show no discernible movement.

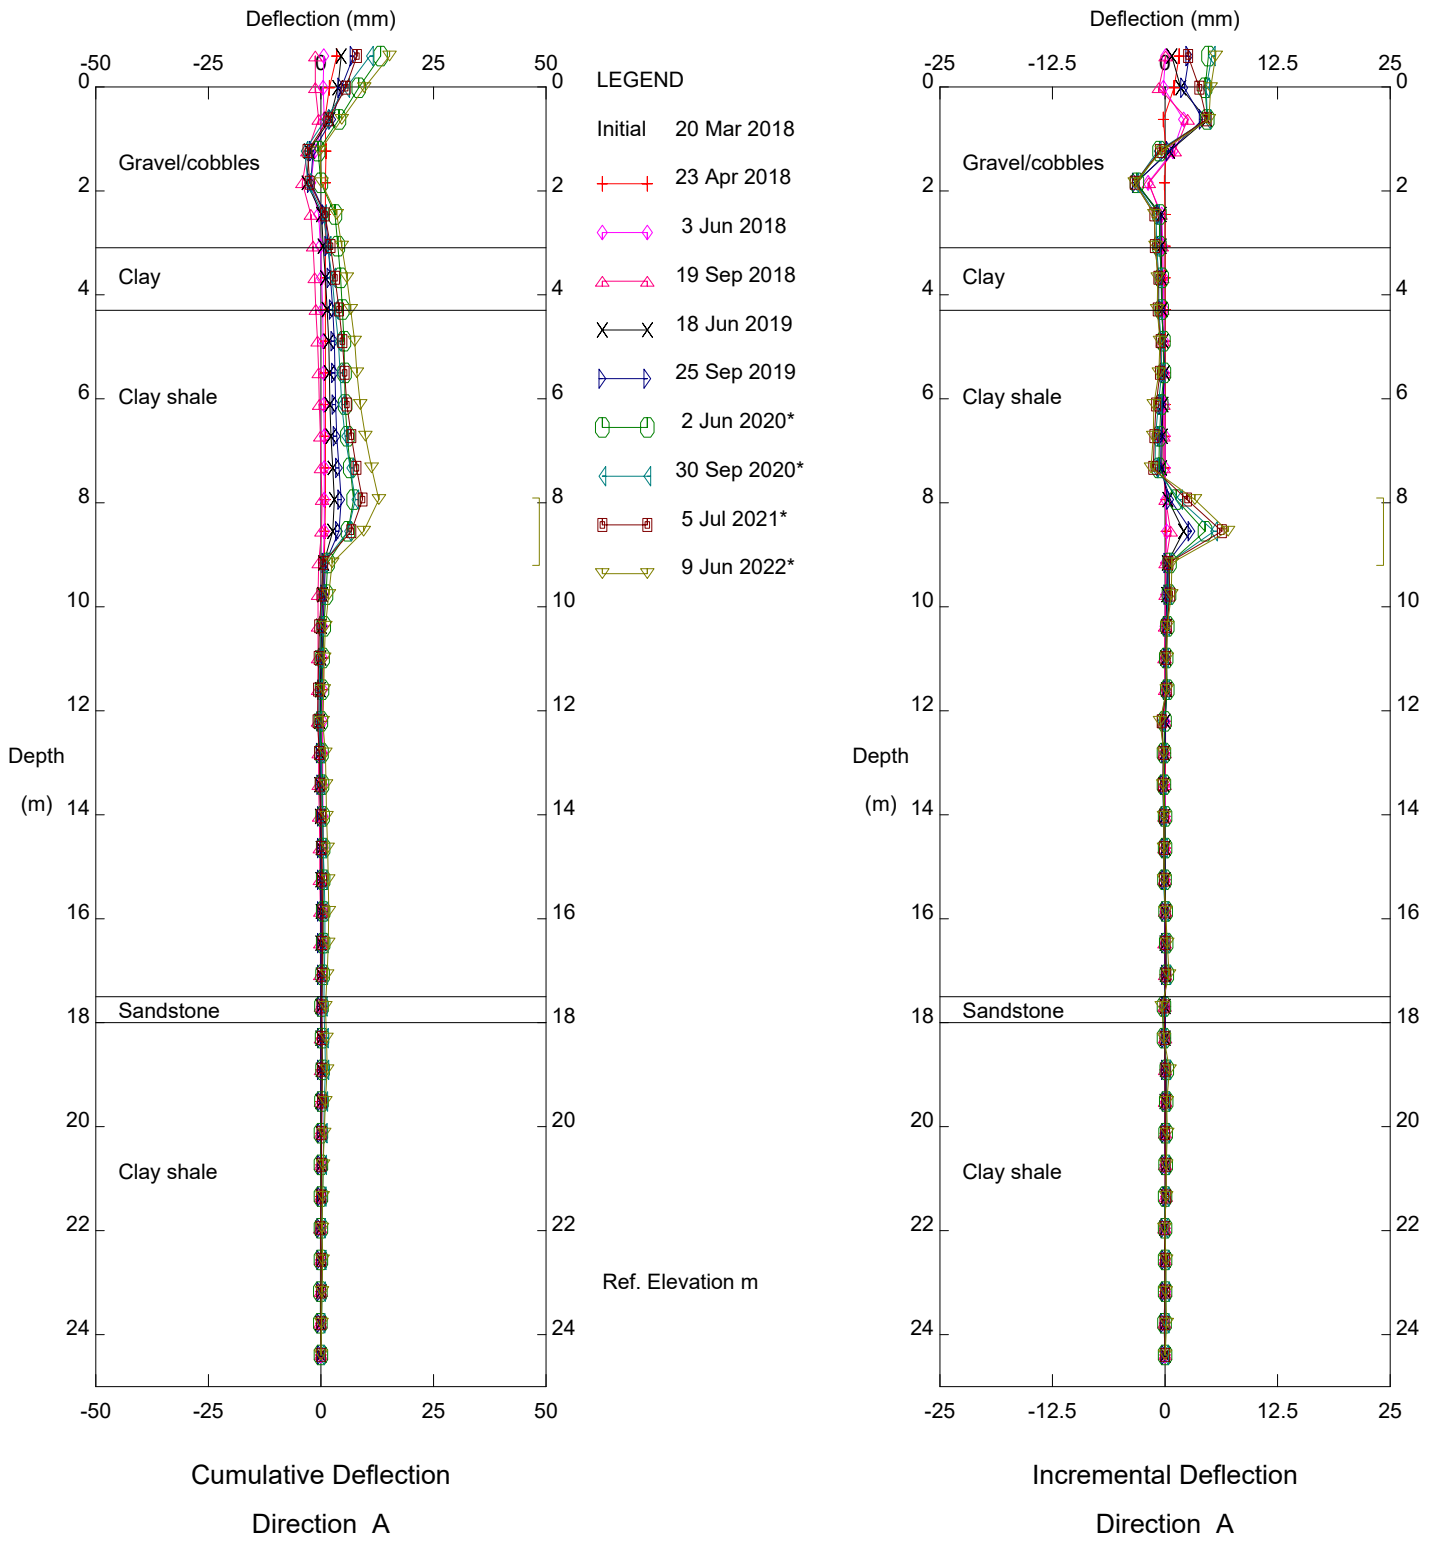
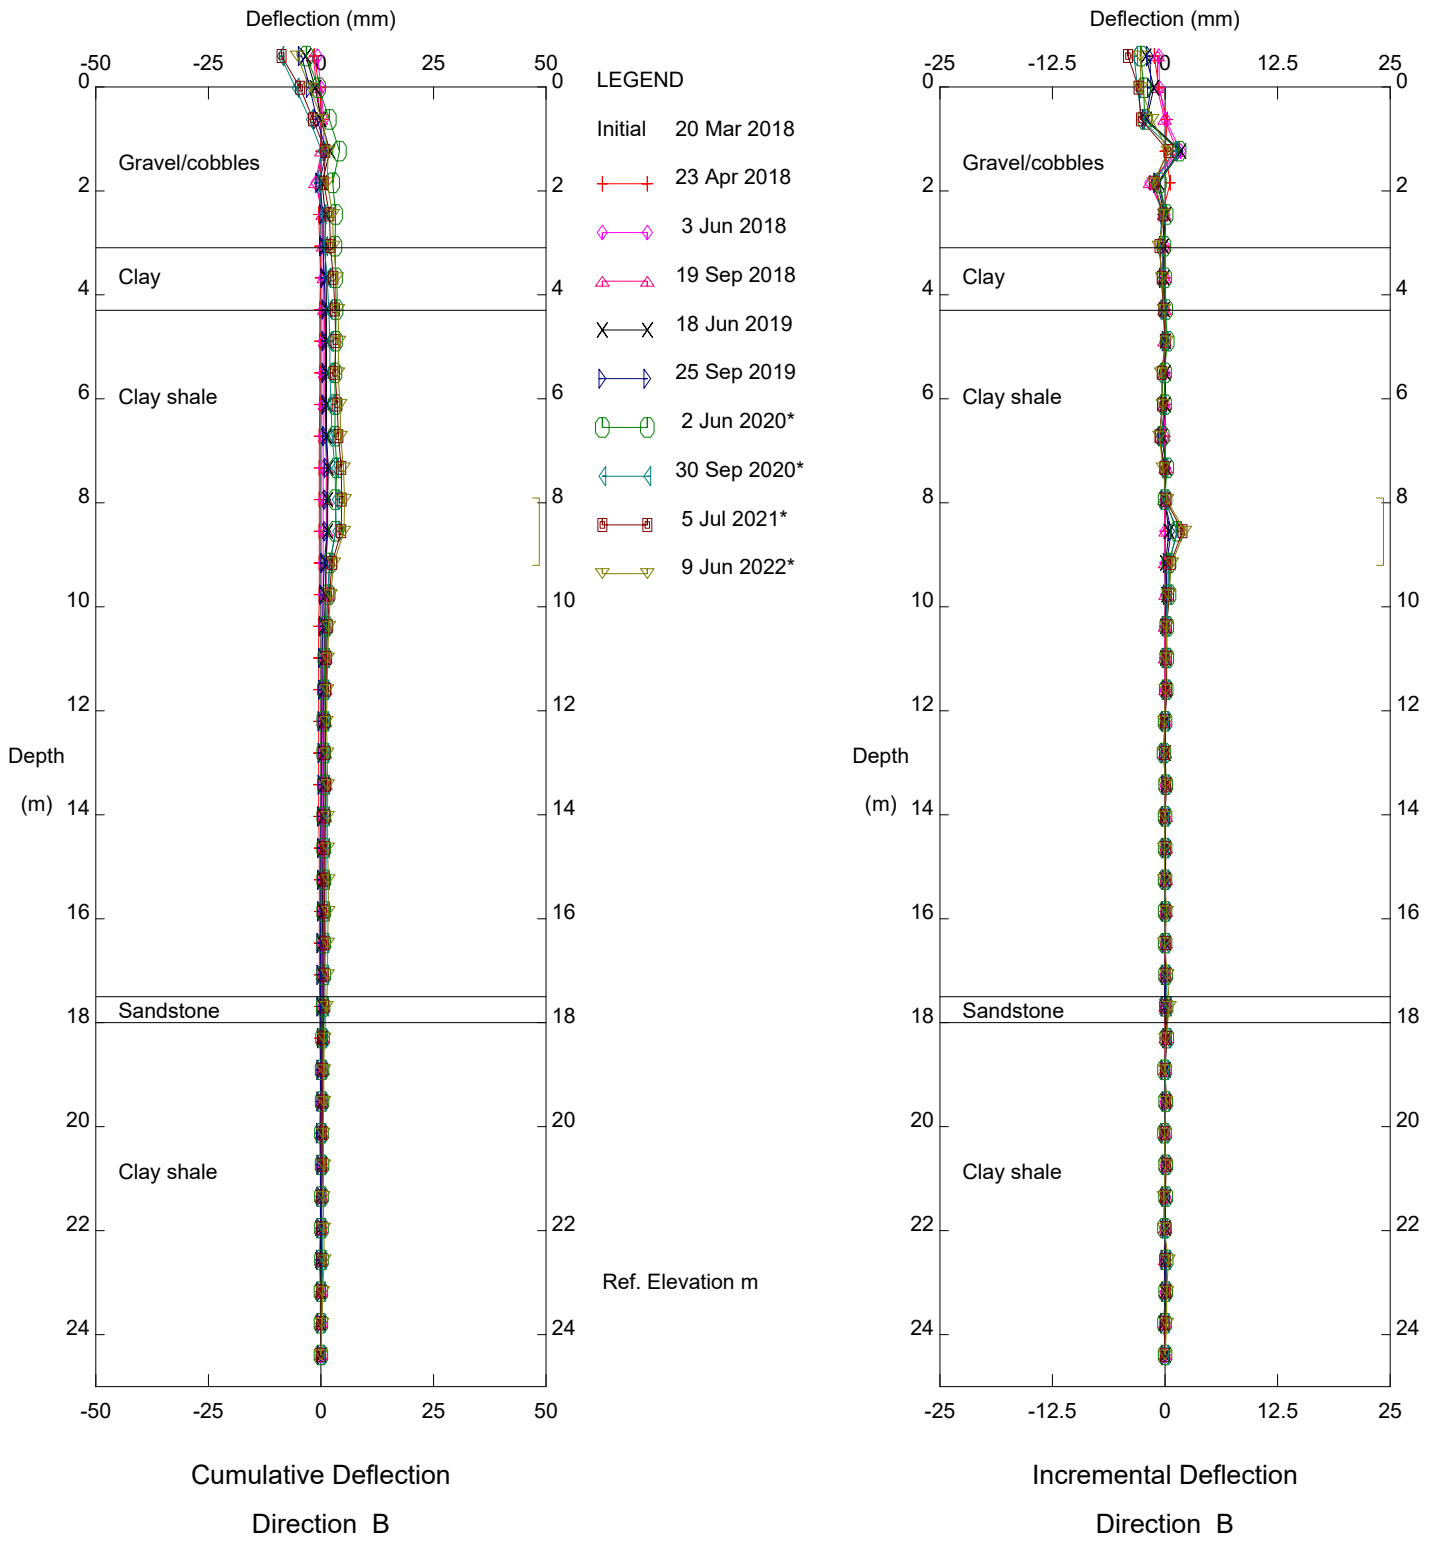
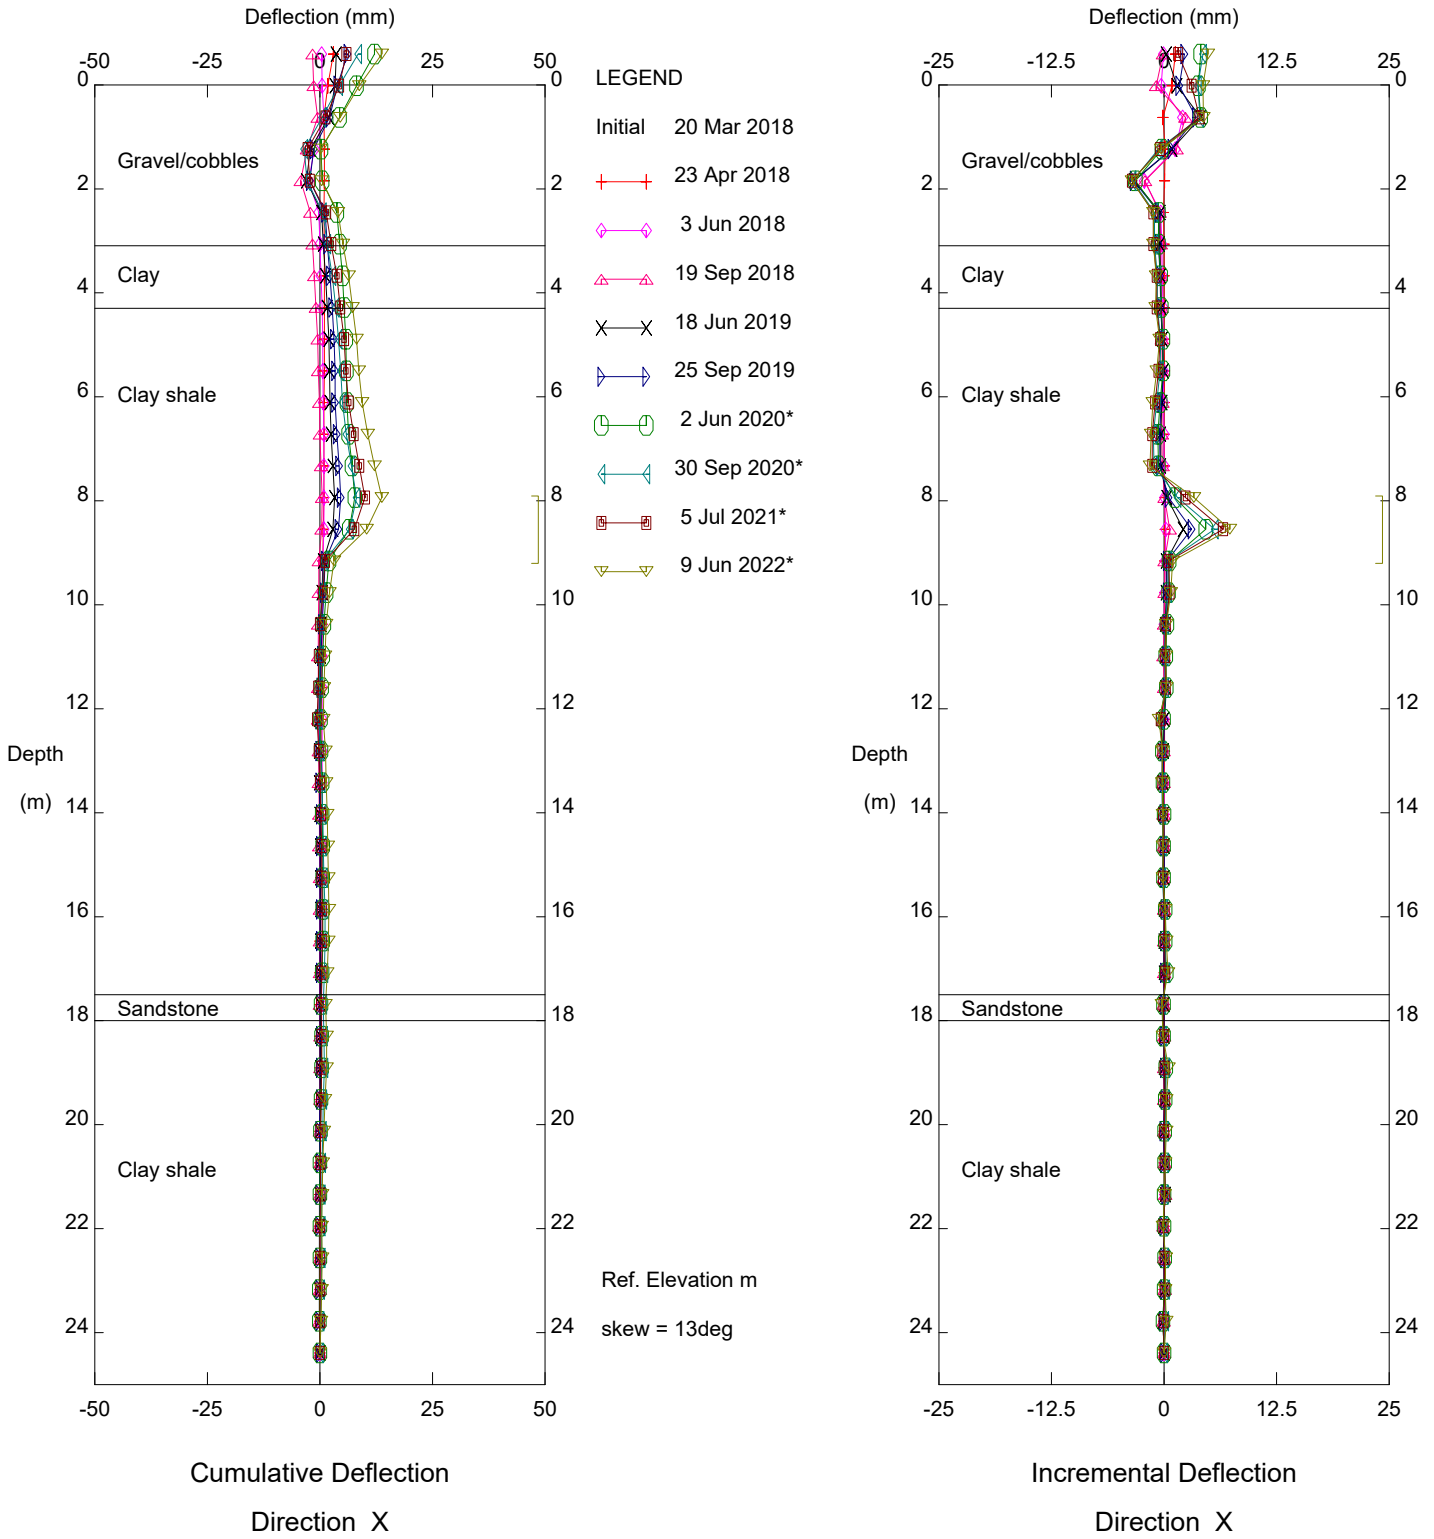
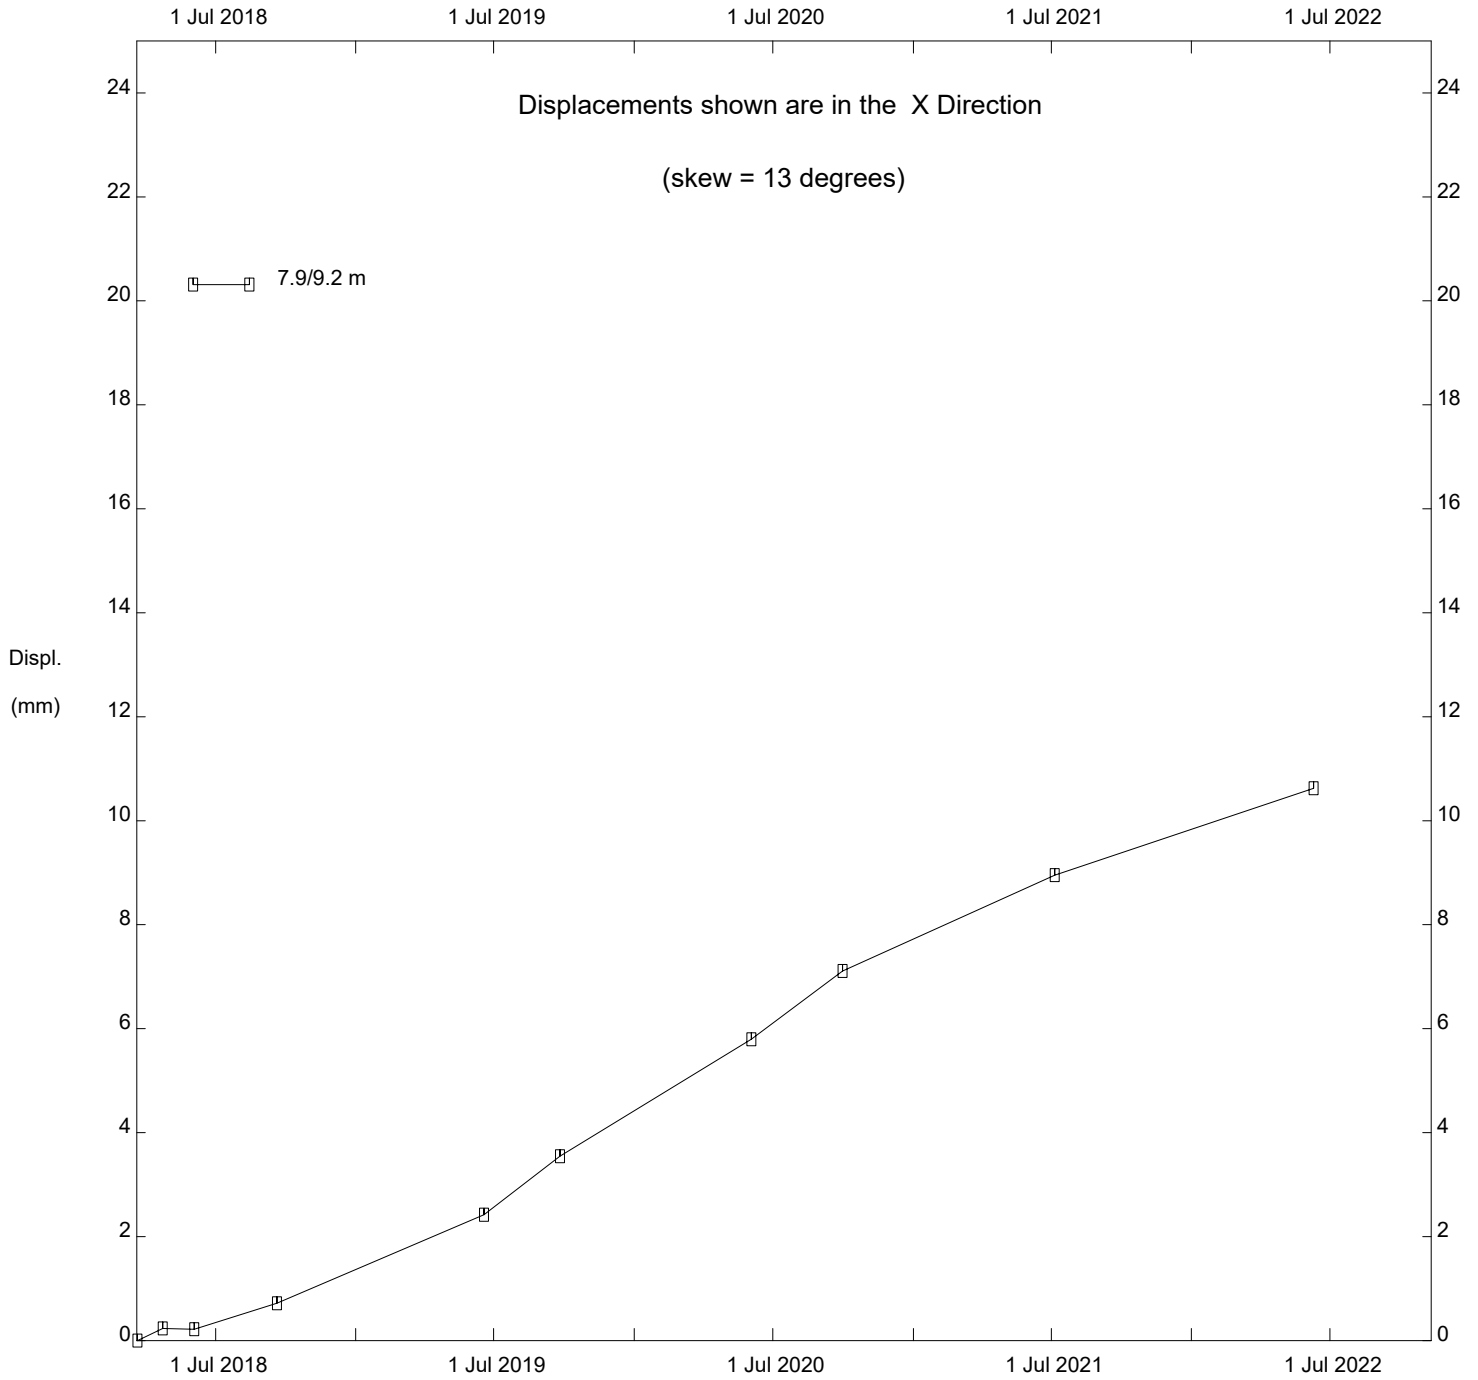
SH001 Retaining Wall, Inclinometer SI18-5

SI18-5, installed behind the retaining wall, showed a rate of movement of 1.8 mm/yr over 7.9 m to 9.2 m depth since the spring of 2021 readings. The rate of movement in SI18-5 is similar to movement rates shown during previous readings cycles as the overall rate (since initialization) was 2.5 mm/year.

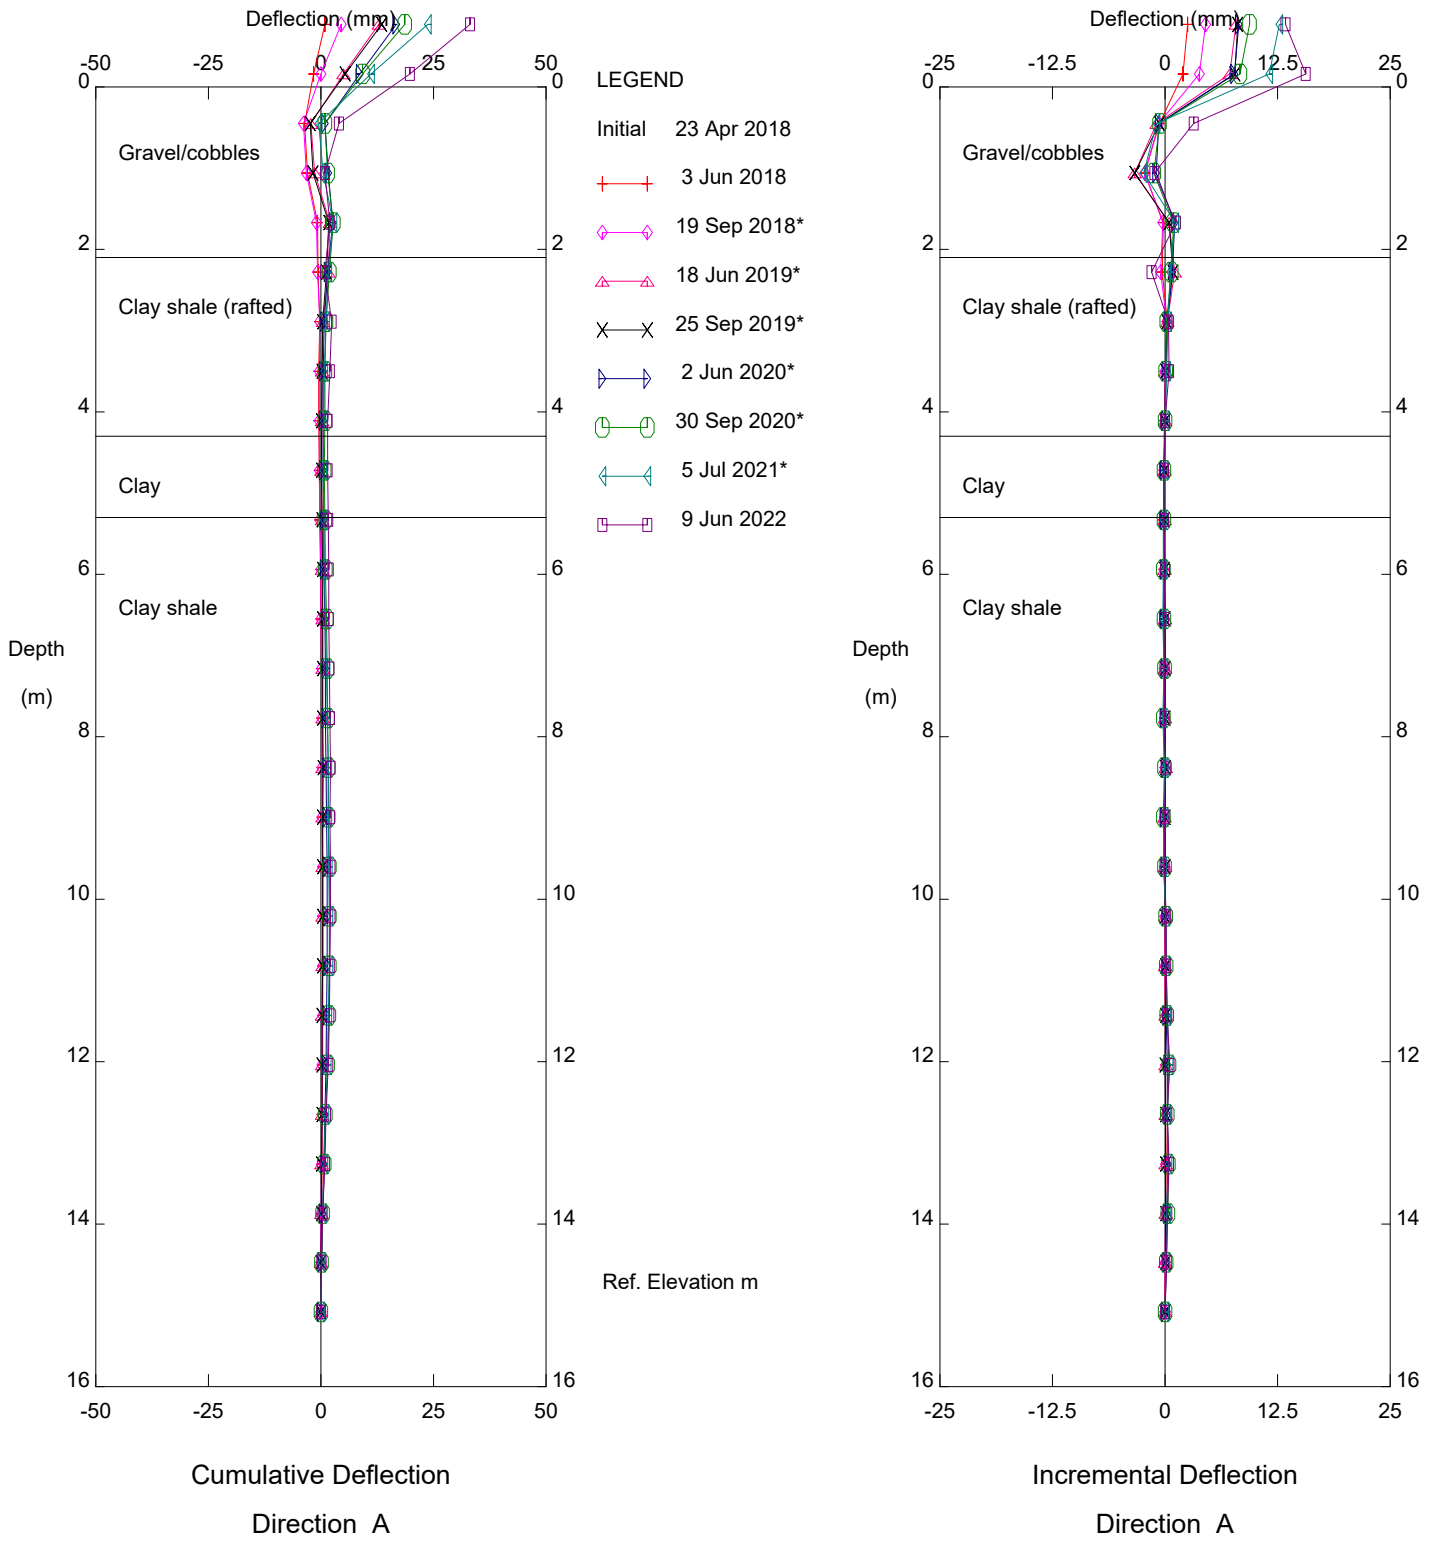
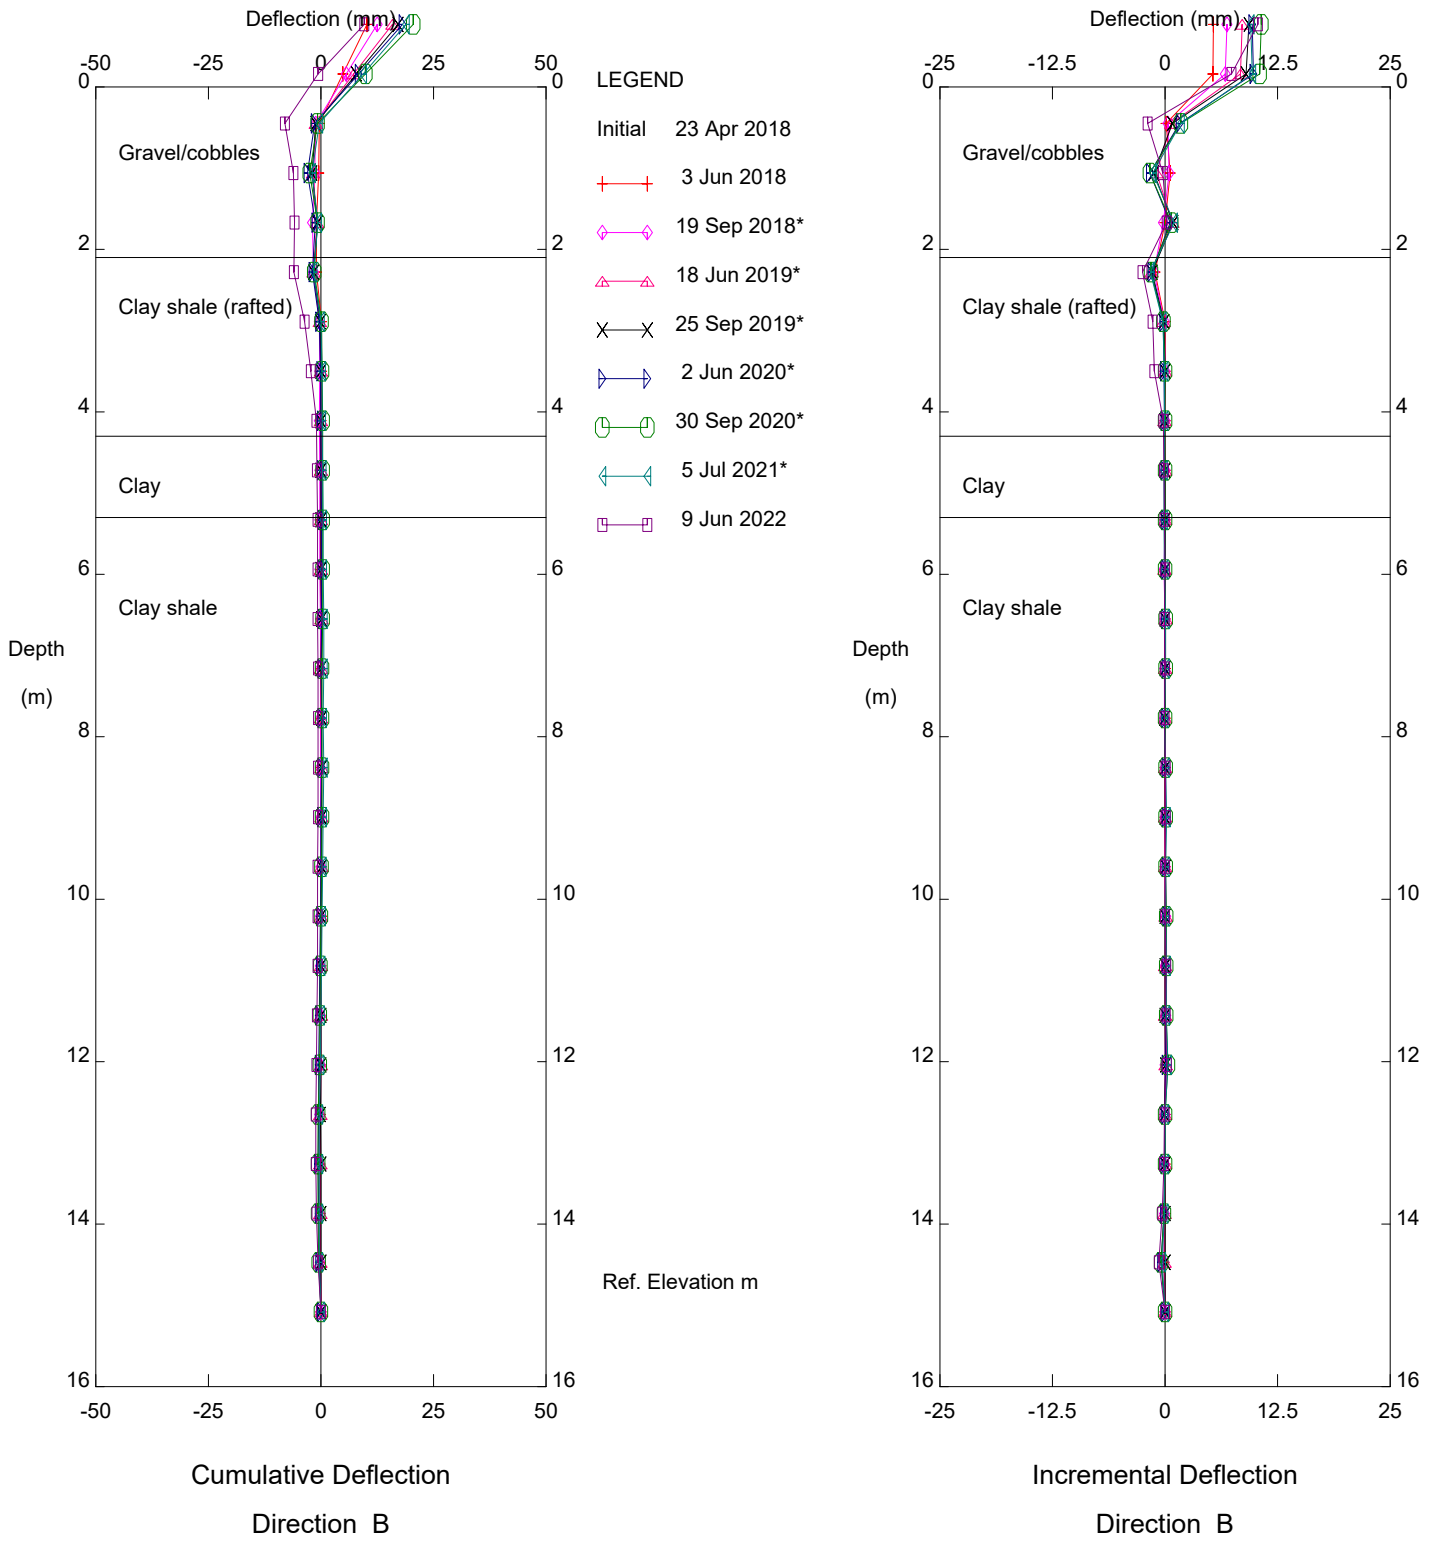
SH001 Retaining Wall, Inclinometer SI18-6

SI18-6, also installed behind the retaining wall, has shown no discernible movement since installation other than some scatter in the upper 2 m.

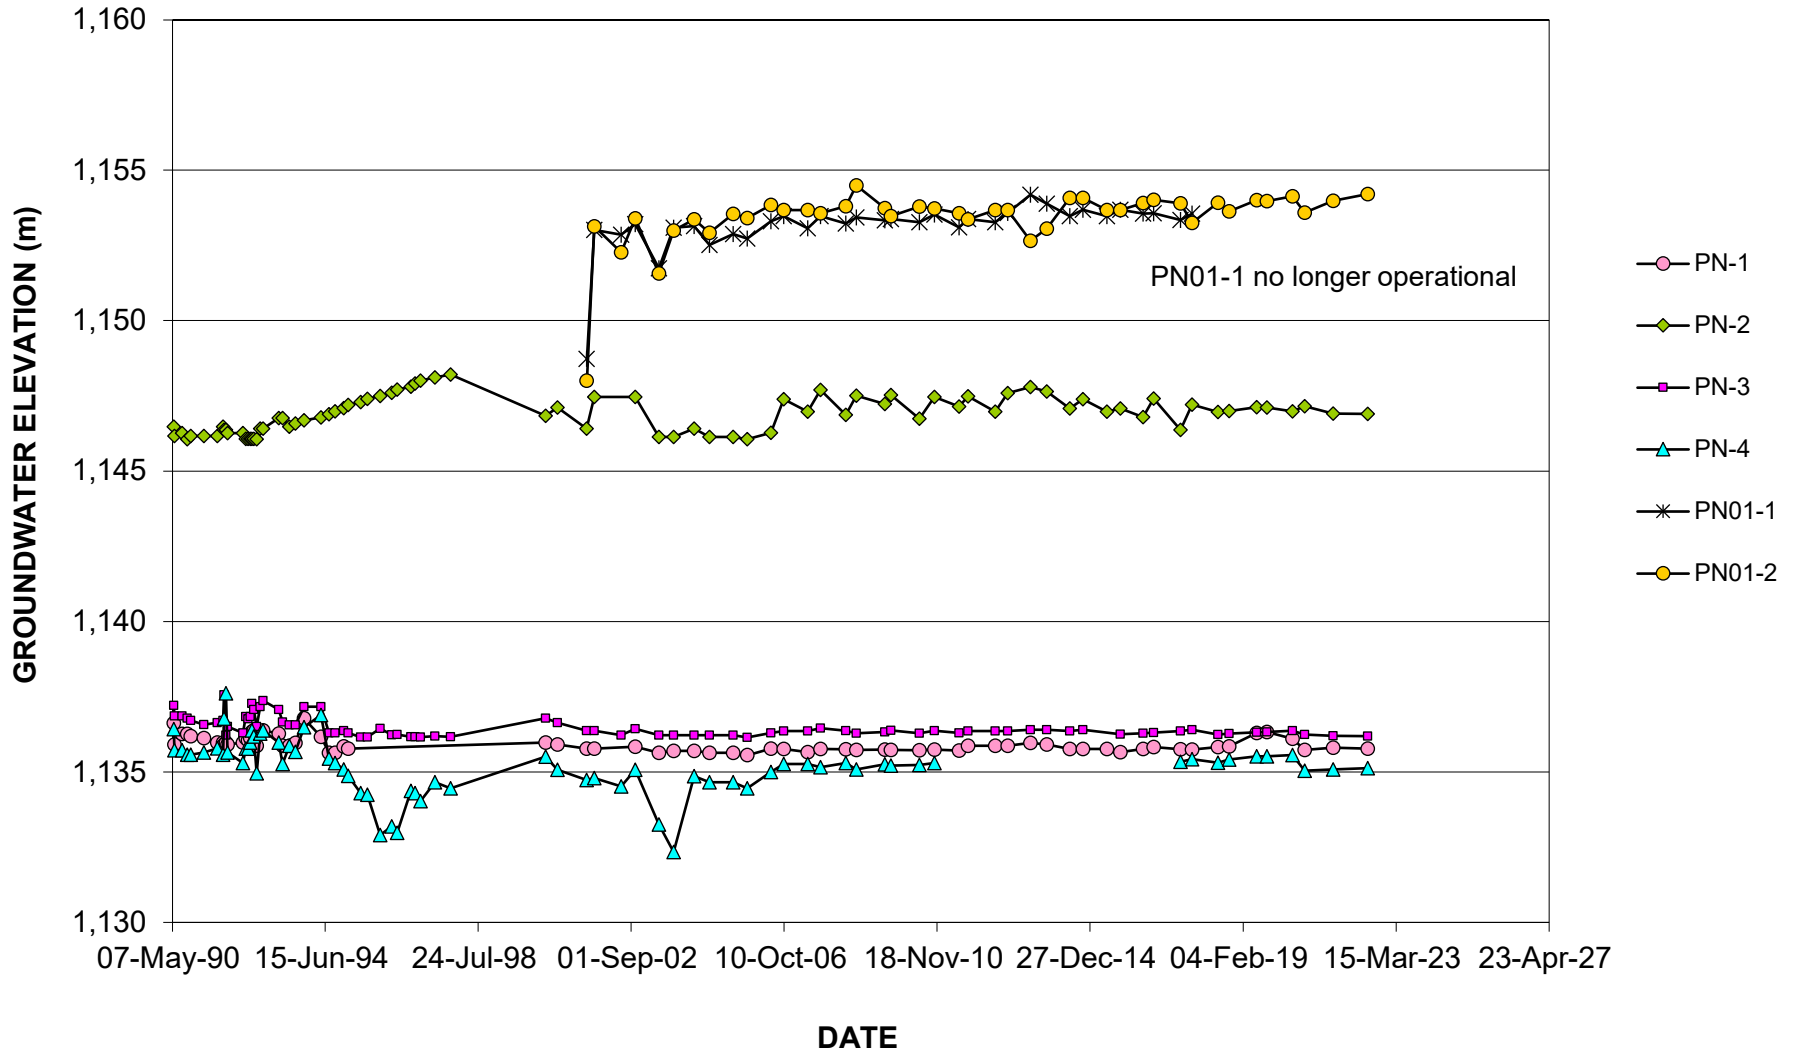
**FIGURE SH001-1
PNEUMATIC PIEZOMETER ELEVATIONS FOR
HWY 33:12 (SWAN HILLS RETAINING WALL - PRE-2018 INSTRUMENTS)**

Pneumatic piezometers PN-1, PN-2, and PN-3 showed decreases in groundwater level of 0.03 m, 0.01 m, and 0.01 m, respectively, since the spring of 2021 readings. PN-4, and PN01-2 showed increases in groundwater level of 0.04 m and 0.22 m, respectively, since the spring of 2021 readings. There does not appear to be a clear trend at these instruments; however, the water levels are all within their respective historical ranges.

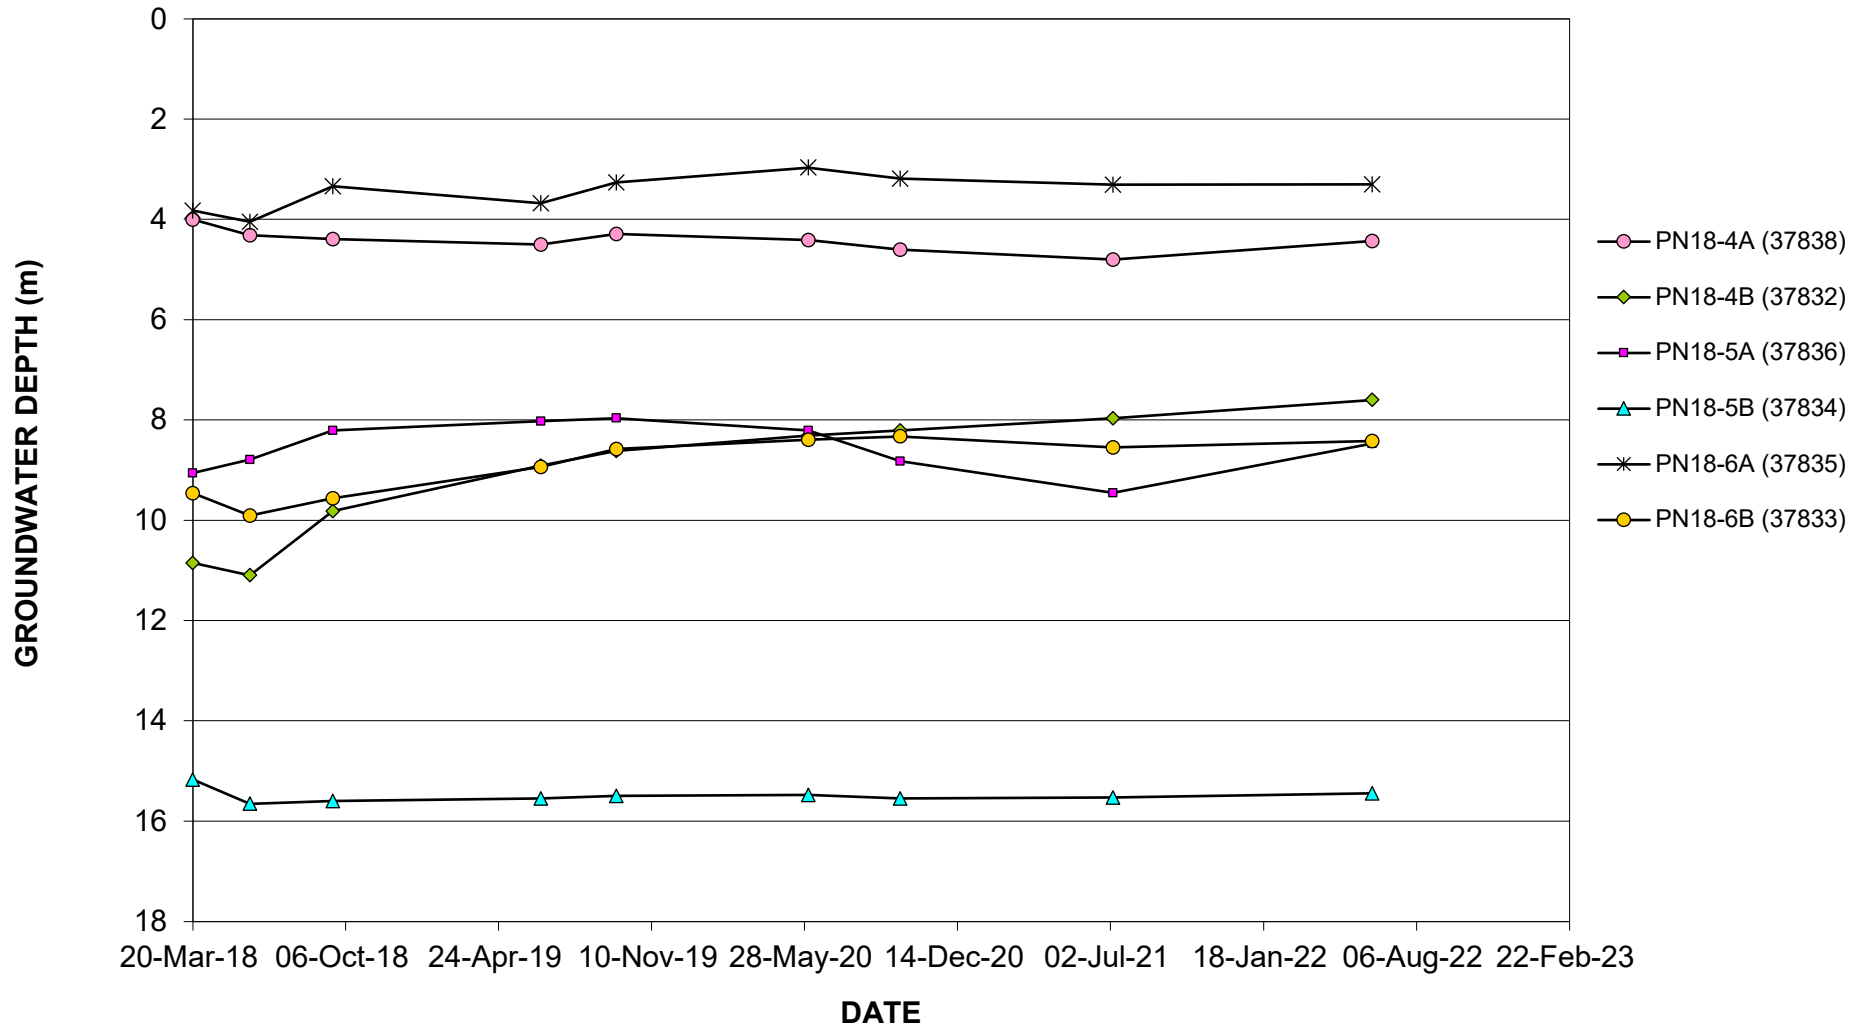
**FIGURE SH001-3
PNEUMATIC PIEZOMETER DEPTHS FOR
HWY 33:12 (SWAN HILLS RETAINING WALL - 2018 INSTRUMENTS)**

Pneumatic piezometers PN18-4A, PN18-4B, PN18-5A, PN18-5B, PN18-6A, and PN18-6B showed increases in groundwater level of 0.37 m, 0.36 m, 0.98 m, 0.08 m, 0.01 m, and 0.13 m, respectively, since the spring of 2021 readings. Other than PN18-4B where the water level has been trending upward and the current level is the highest recorded in the instrument since initialization, there is no apparent trend to the water levels, and all are within their respective historical ranges.
