July 26, 2022

**ALBERTA TRANSPORTATION GRMP (CON0022164)
PEACE REGION (PEACE RIVER DISTRICT)
INSTRUMENTATION MONITORING RESULTS – SPRING 2022**

SITE SH001/SH001A: HWY 33:12 (SWAN HILLS RETAINING WALL)

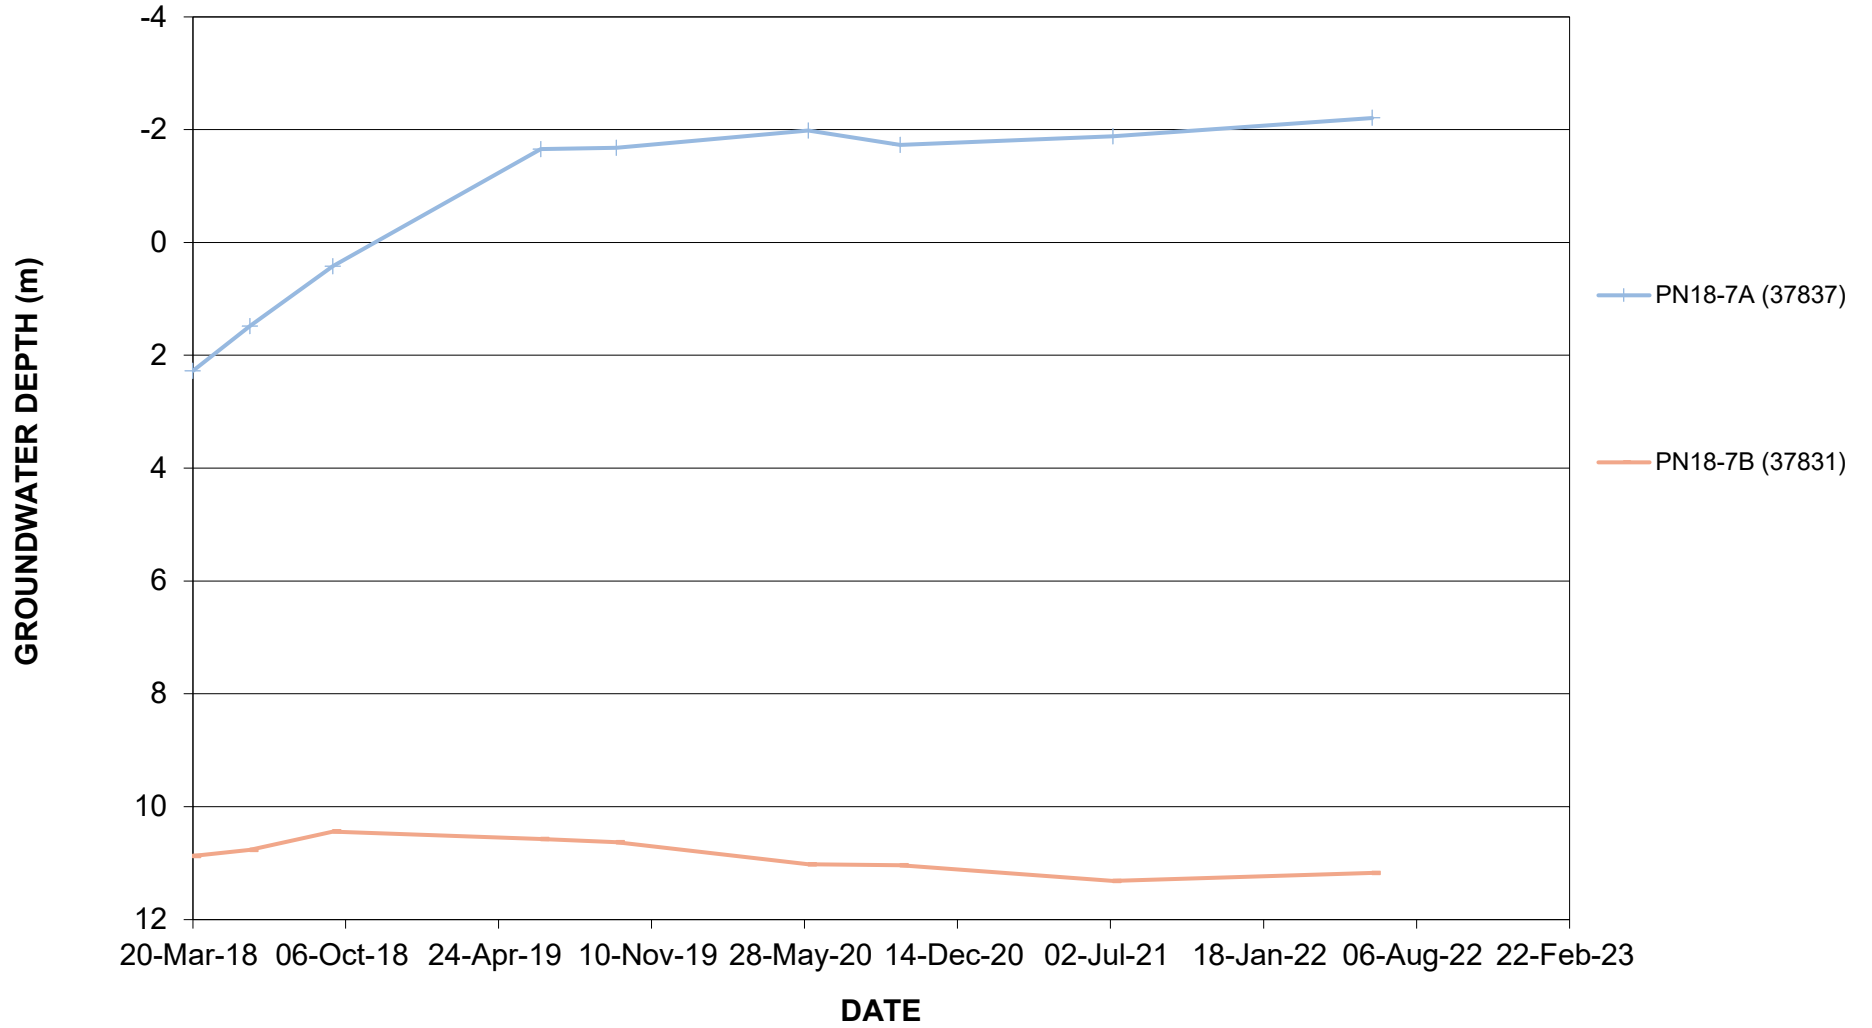
**FIGURE SH001-4
PNEUMATIC PIEZOMETER DEPTHS FOR
HWY 33:12 (SWAN HILLS SITE 1A - 2018 INSTRUMENTS)**

Pneumatic piezometer PN18-7A, located west of the pavement distress at site SH001A, showed an increase in groundwater level of 0.33 m since the spring of 2021 readings. PN18-7A currently shows an above-ground (flowing artesian) groundwater level of 2.21 m, which is the highest water level since the instrument was initialized. This instrument has been showing artesian pressures since the spring of 2019 (about one year after installation). PN18-7B, also at the SH001A site, showed an increase in groundwater level of 0.15 m compared to the spring of 2021 readings.
