ALBERTA TRANSPORTATION AND  
ECONOMIC CORRIDORS GRMP  
PEACE REGION – (PEACE RIVER DISTRICT)  
INSTRUMENTATION MONITORING - SPRING 2025

Site Number	Location	Name	Hwy	km
SH001	HWY 33:12 C1 9.432	Swan Hills Retaining Wall	33:12	Km 9.4
SH001A	HWY 33:12 C1 10.00			Km 10.0
<b>Legal Description:</b>		<b>UTM Co-ordinates</b>		
7-5-67-9 W5		11U E 607430	N	6070455

<b>Current Monitoring:</b>	20-June-2025	<b>Previous Monitoring</b>	16-May-2024
<b>Instruments Read By:</b>	Mr. Niraj Regmi, G.I.T., and Mr. Godfred Etiendem, Thurber

**SITE SH001/SH001A: HWY 33:12 (SWAN HILLS RETAINING WALL)**

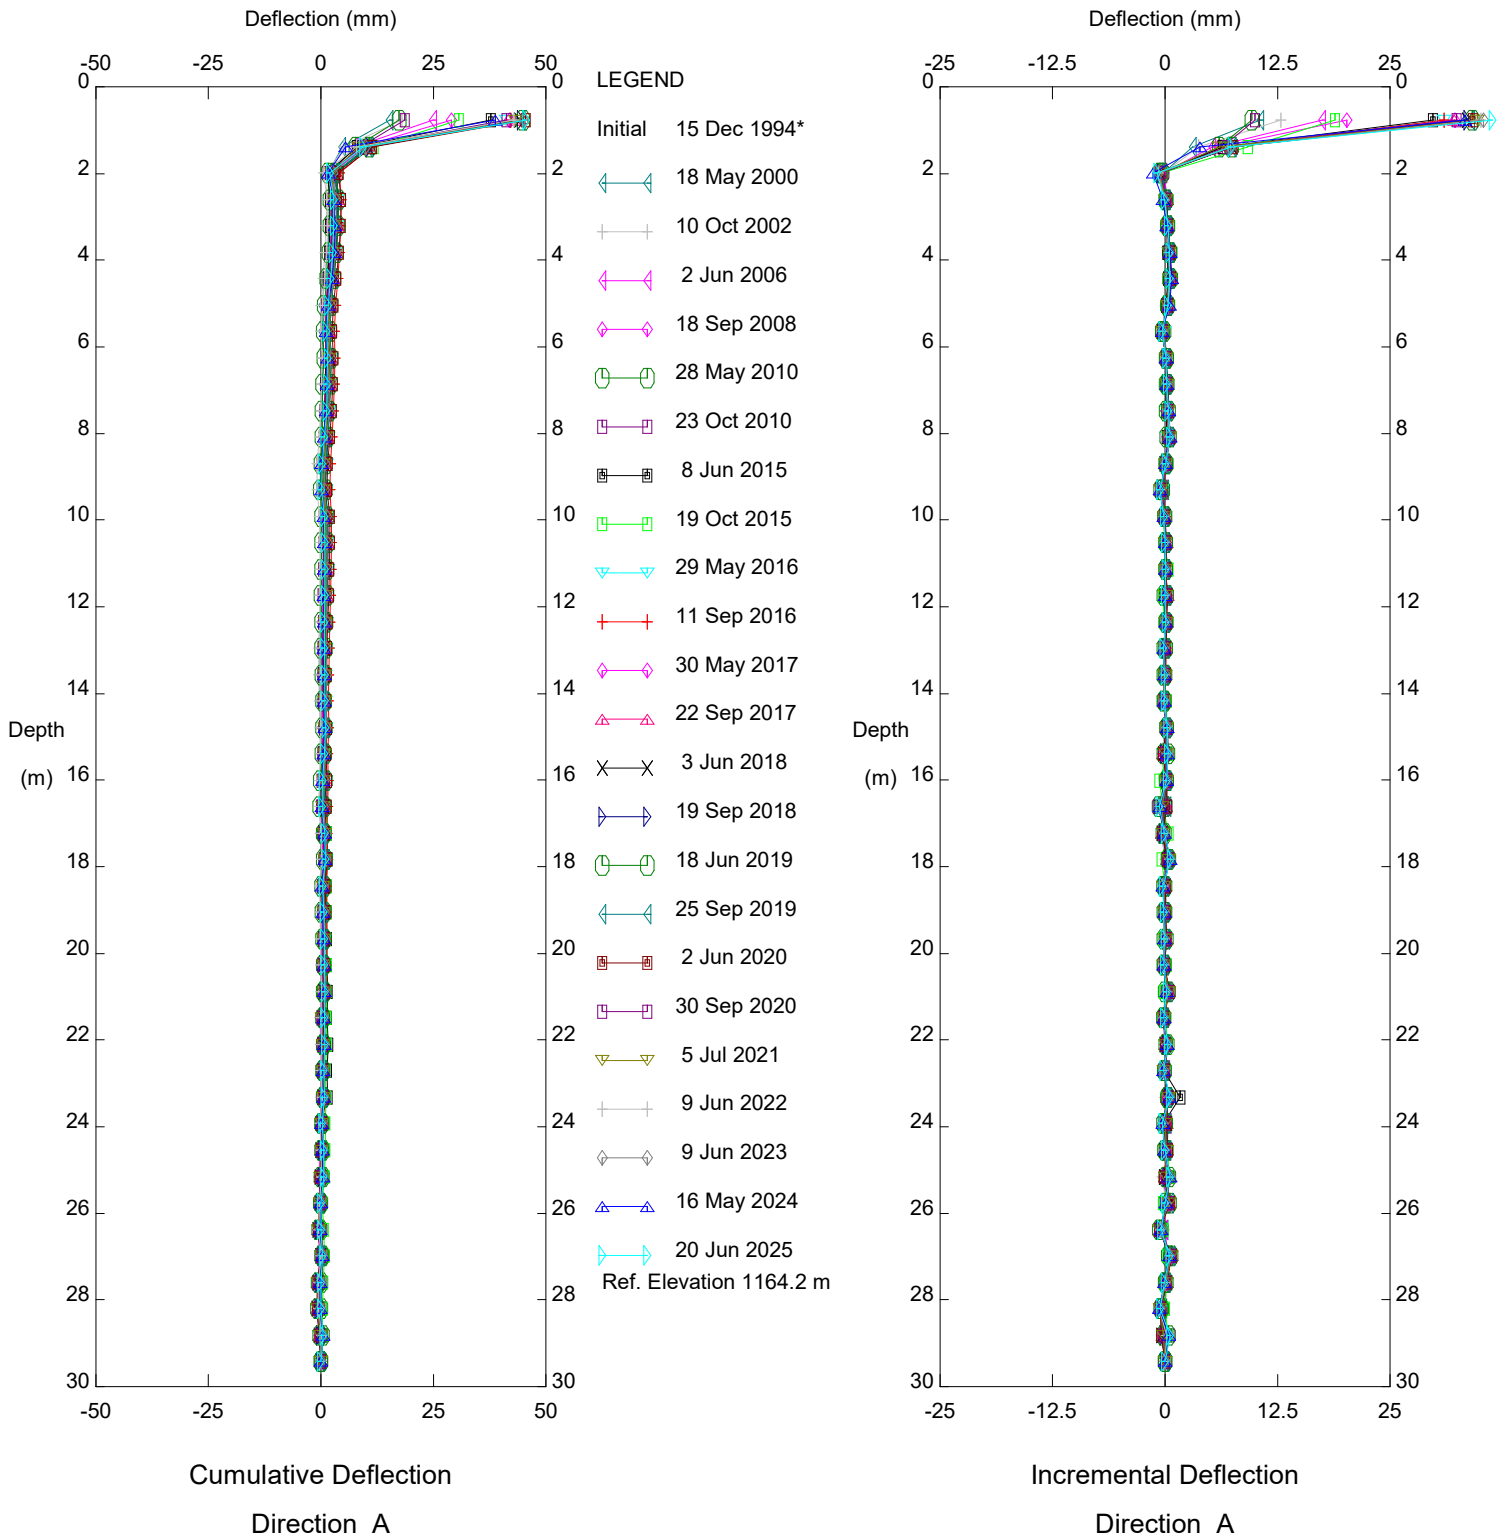
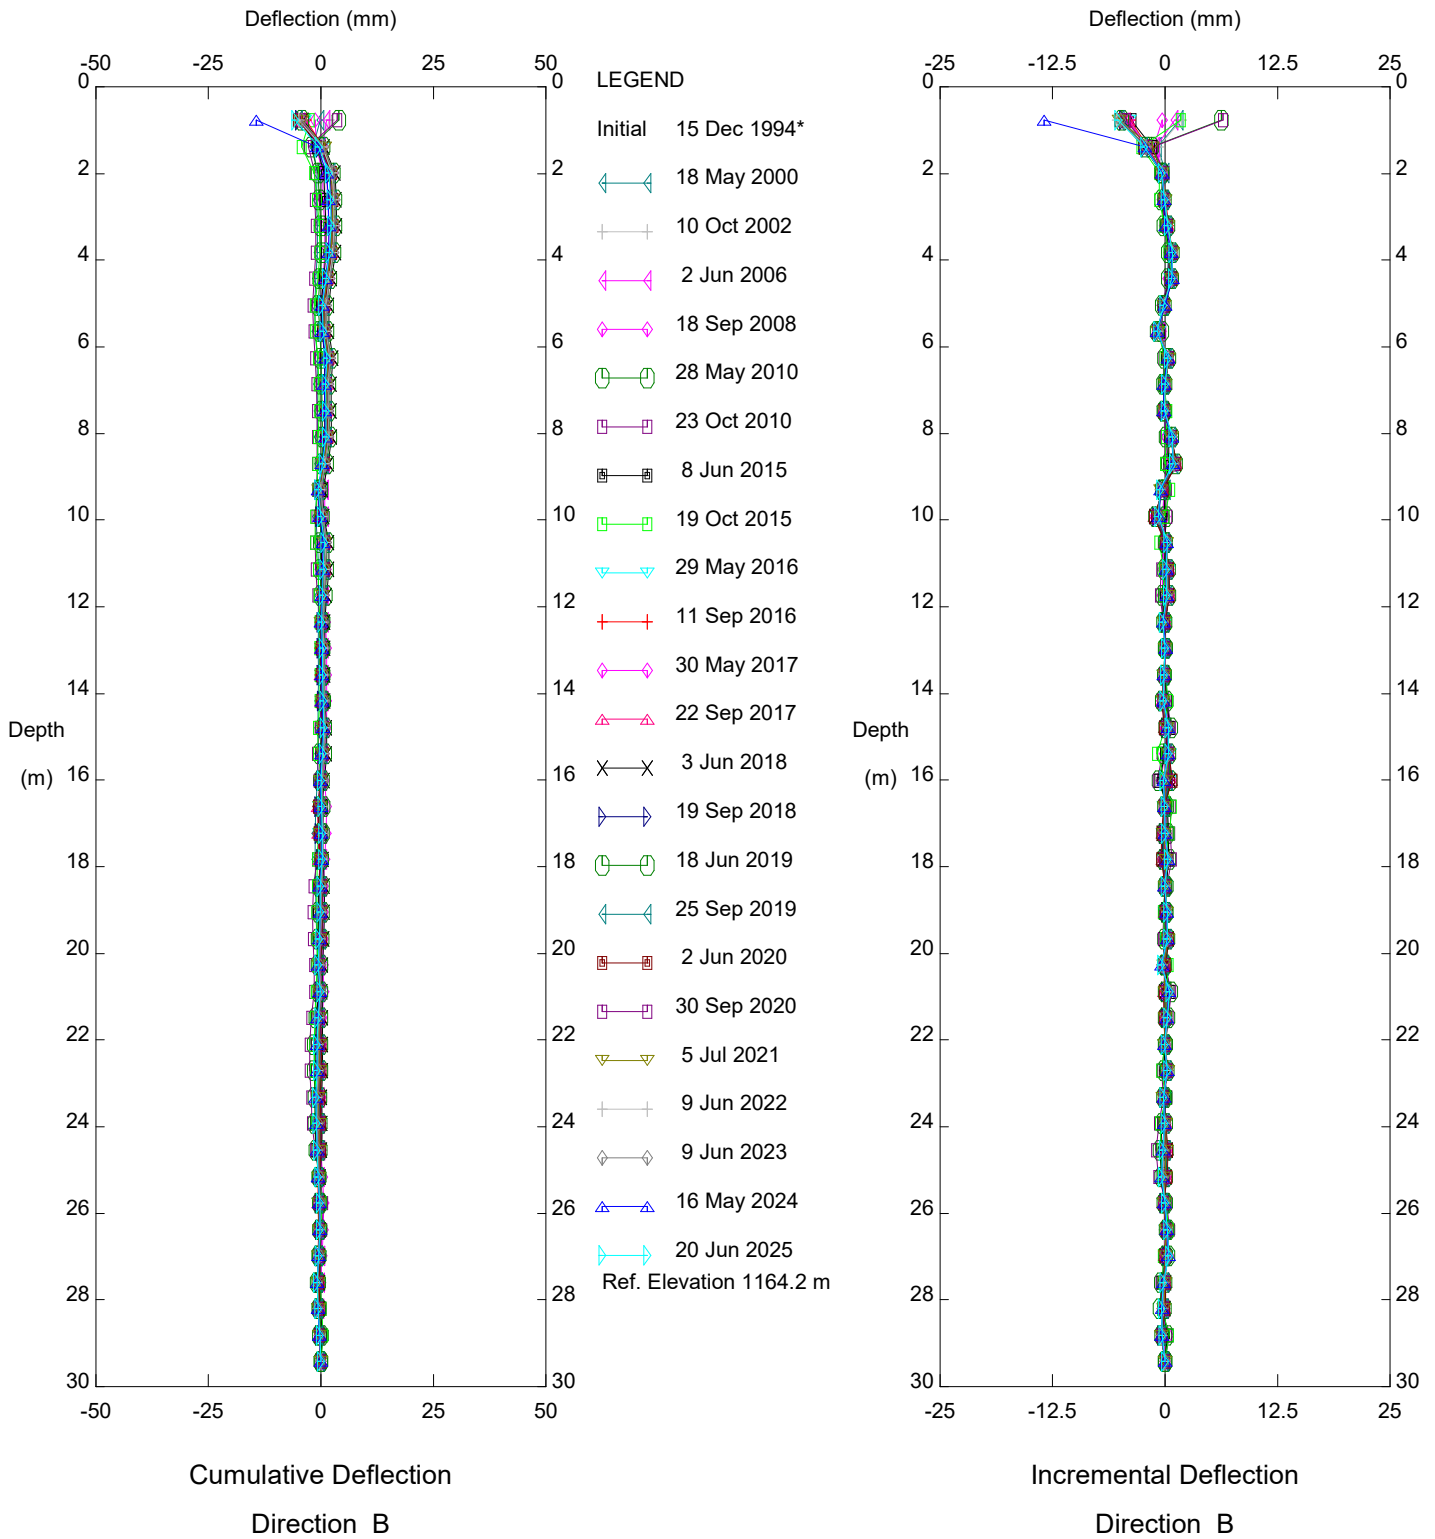
SH001 - Swan Hills Retaining Wall, Inclinometer SI 16

Discussion	
<b>Zones of New Movement:</b>	None
<b>Interpretation of Monitoring Results:</b>	<p>Slope inclinometers SI-16 and SI-20 are located about 120 m southwest of the pile wall, outside of the main slide area. SI-16 and SI-20 do not show discernible movement patterns.</p> <p>SI18-5 and SI18-6 are both installed between the highway and the pile wall. SI18-5 showed a rate of movement of 1.7 mm/yr over 7.9 m to 9.2 m depth since the spring of 2024 readings. This movement rate is within clay shale and is slightly below the long-term movement rate (since initialization) of 2.6 mm/yr (18.5 mm over the past 7 years). SI18-6 shows no discernible movement since installation other than some scatter in the upper 2 m.</p> <p>North of the pile wall, pneumatic piezometers PN-1 and PN-4 showed increases in groundwater level of 0.07 m since the spring of 2024 readings. PN01-2 showed a decrease in groundwater level of 1.09 m since the spring of 2024 readings. These instruments have shown overall stable groundwater levels for the past several reading cycles, and all of them show current groundwater levels within the historical levels in the instruments.</p>

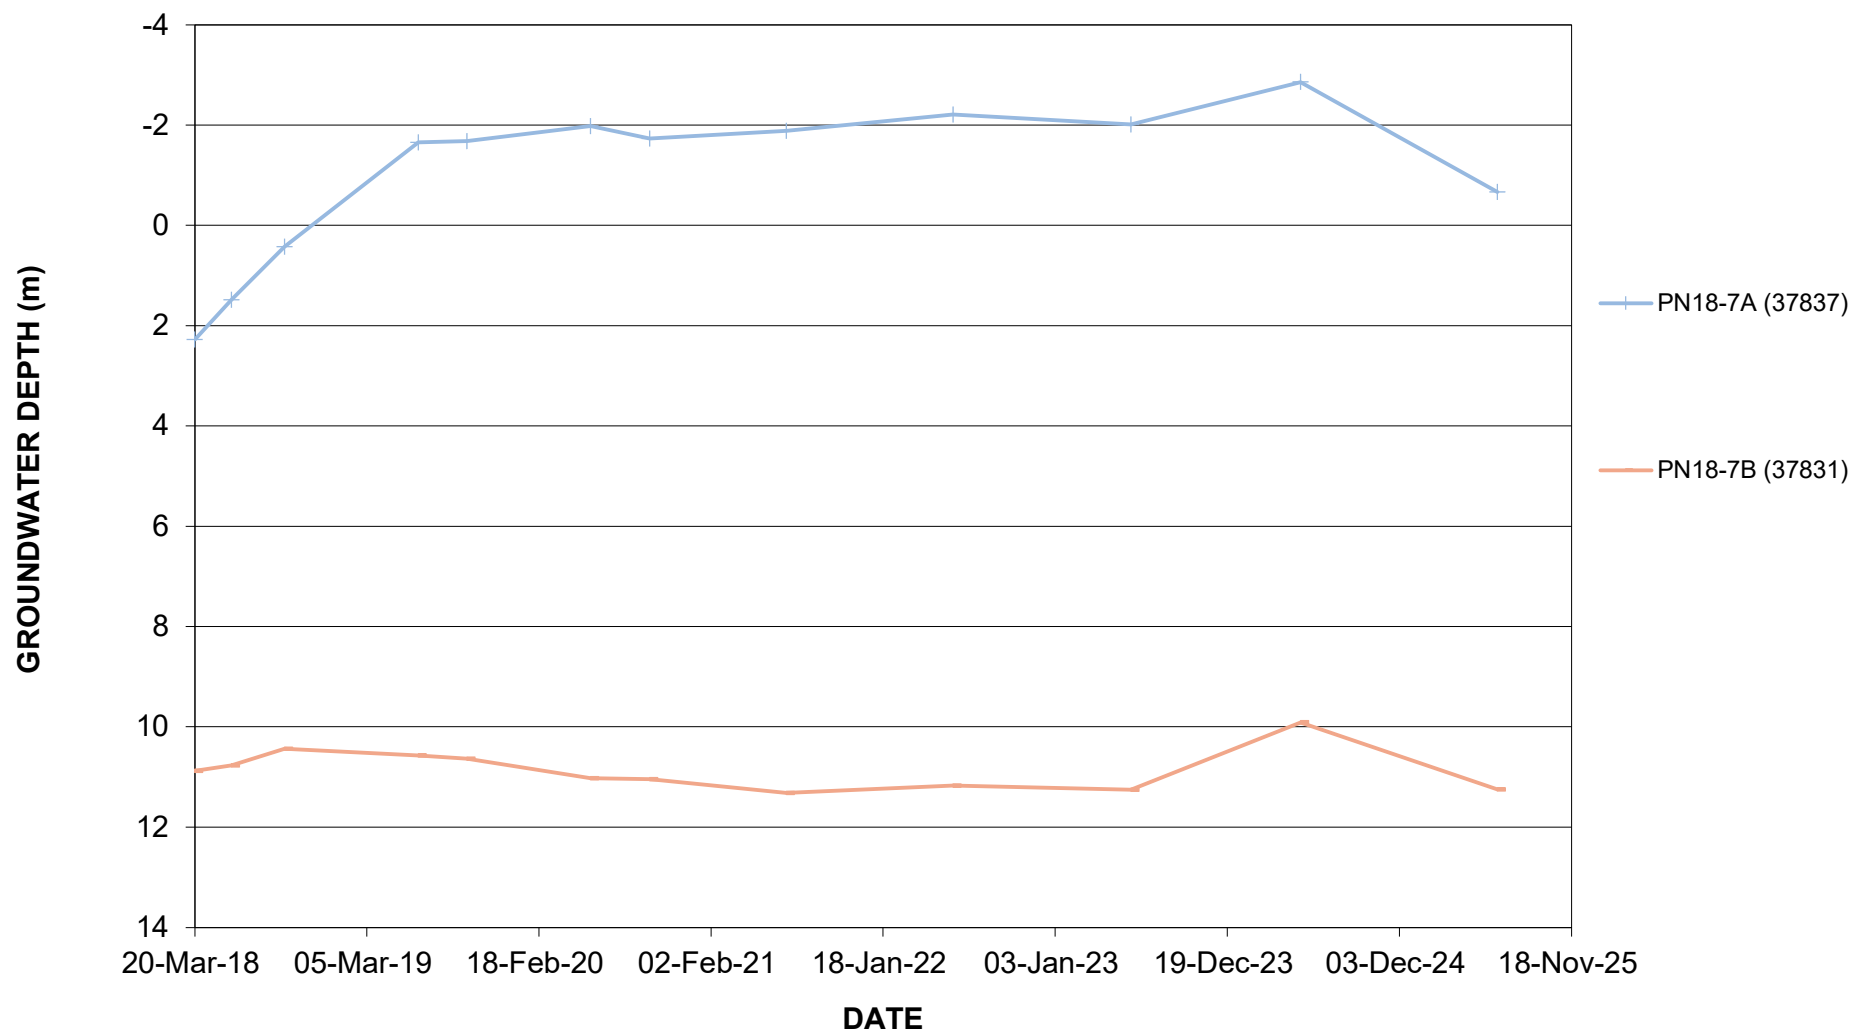
**FIGURE SH001-4  
PNEUMATIC PIEZOMETER DEPTHS FOR  
HWY 33:12 (SWAN HILLS SITE 1A - 2018 INSTRUMENTS)**

<p>Immediately south of the pile wall, pneumatic piezometer PN18-4A showed an increase in groundwater level of 0.97 m since the spring of 2024 reading. PN18-4B, PN18-5A, PN18-5B, PN18-6A and PN18-6B showed decreases in groundwater level of 1.23 m, 3.42 m, 4.94 m, 1.18 m, and 1.69 m, respectively, since the spring of 2024 readings. Overall, the groundwater levels in these instruments returned to readings within the historical ranges for the instruments.</p> <p>At SH001A, pneumatic piezometers PN18-7A and PN18-7B showed decreases in groundwater level of 2.19 m and 1.34 m, respectively, since the spring of 2024 readings. PN18-7A currently shows flowing artesian conditions with an above-ground groundwater level of 0.67 m. This instrument has shown artesian pressures since the spring of 2019 (about one year after installation). The groundwater level in both instruments are within historical ranges.</p> <p>Tables SH001-2 and SH001-3 summarize the pneumatic piezometer readings. The pneumatic piezometer results are plotted on Figures SH001-1, SH001-2, SH001-3, and SH001-4 in Appendix A.</p>

<b>Future Work:</b>	The instruments should be read again in the spring of 2026.
<b>Instrumentation Repairs:</b>	We recommend that repairs to slope indicator SI-18 be undertaken during the spring 2026 readings.
<b>Additional Comments:</b>	The groundwater levels at SH001A are very high. The site should be inspected for signs of seepage and increased slope deformation and pavement cracking.
