**ALBERTA TRANSPORTATION
GEOHAZARD ASSESSMENT PROGRAM
PEACE REGION – SWAN HILLS
2020 INSPECTION**

Site Number	Location	Name	Hwy	km
SH006-1	North of Swan Hills	Klumph Creek	33:14	18.1-18.6
Legal Description		UTM Co-ordinates		
NE28/SE33-70-9-W5M		11U E 608,502	N 6,107,107

Date	PF	CF	Total
Previous Inspection:	10-Jun-2019	10	4	40
Current Inspection:	1-Jun-2020	10	4	40
Road AADT:	670		Year:	2020
Inspected By:	Rocky Wang, TRANS Ed Szmata, TRANS Rodney Johnston, TRANS Ken Froese, Thurber			
Report Attachments:	<input checked="" type="checkbox"/> Photographs <input checked="" type="checkbox"/> Plans <input type="checkbox"/> Maintenance Items

SH006-1: KLUMPH CREEK SLIDE ON HWY 33:14
2020 SITE INSPECTION PLAN

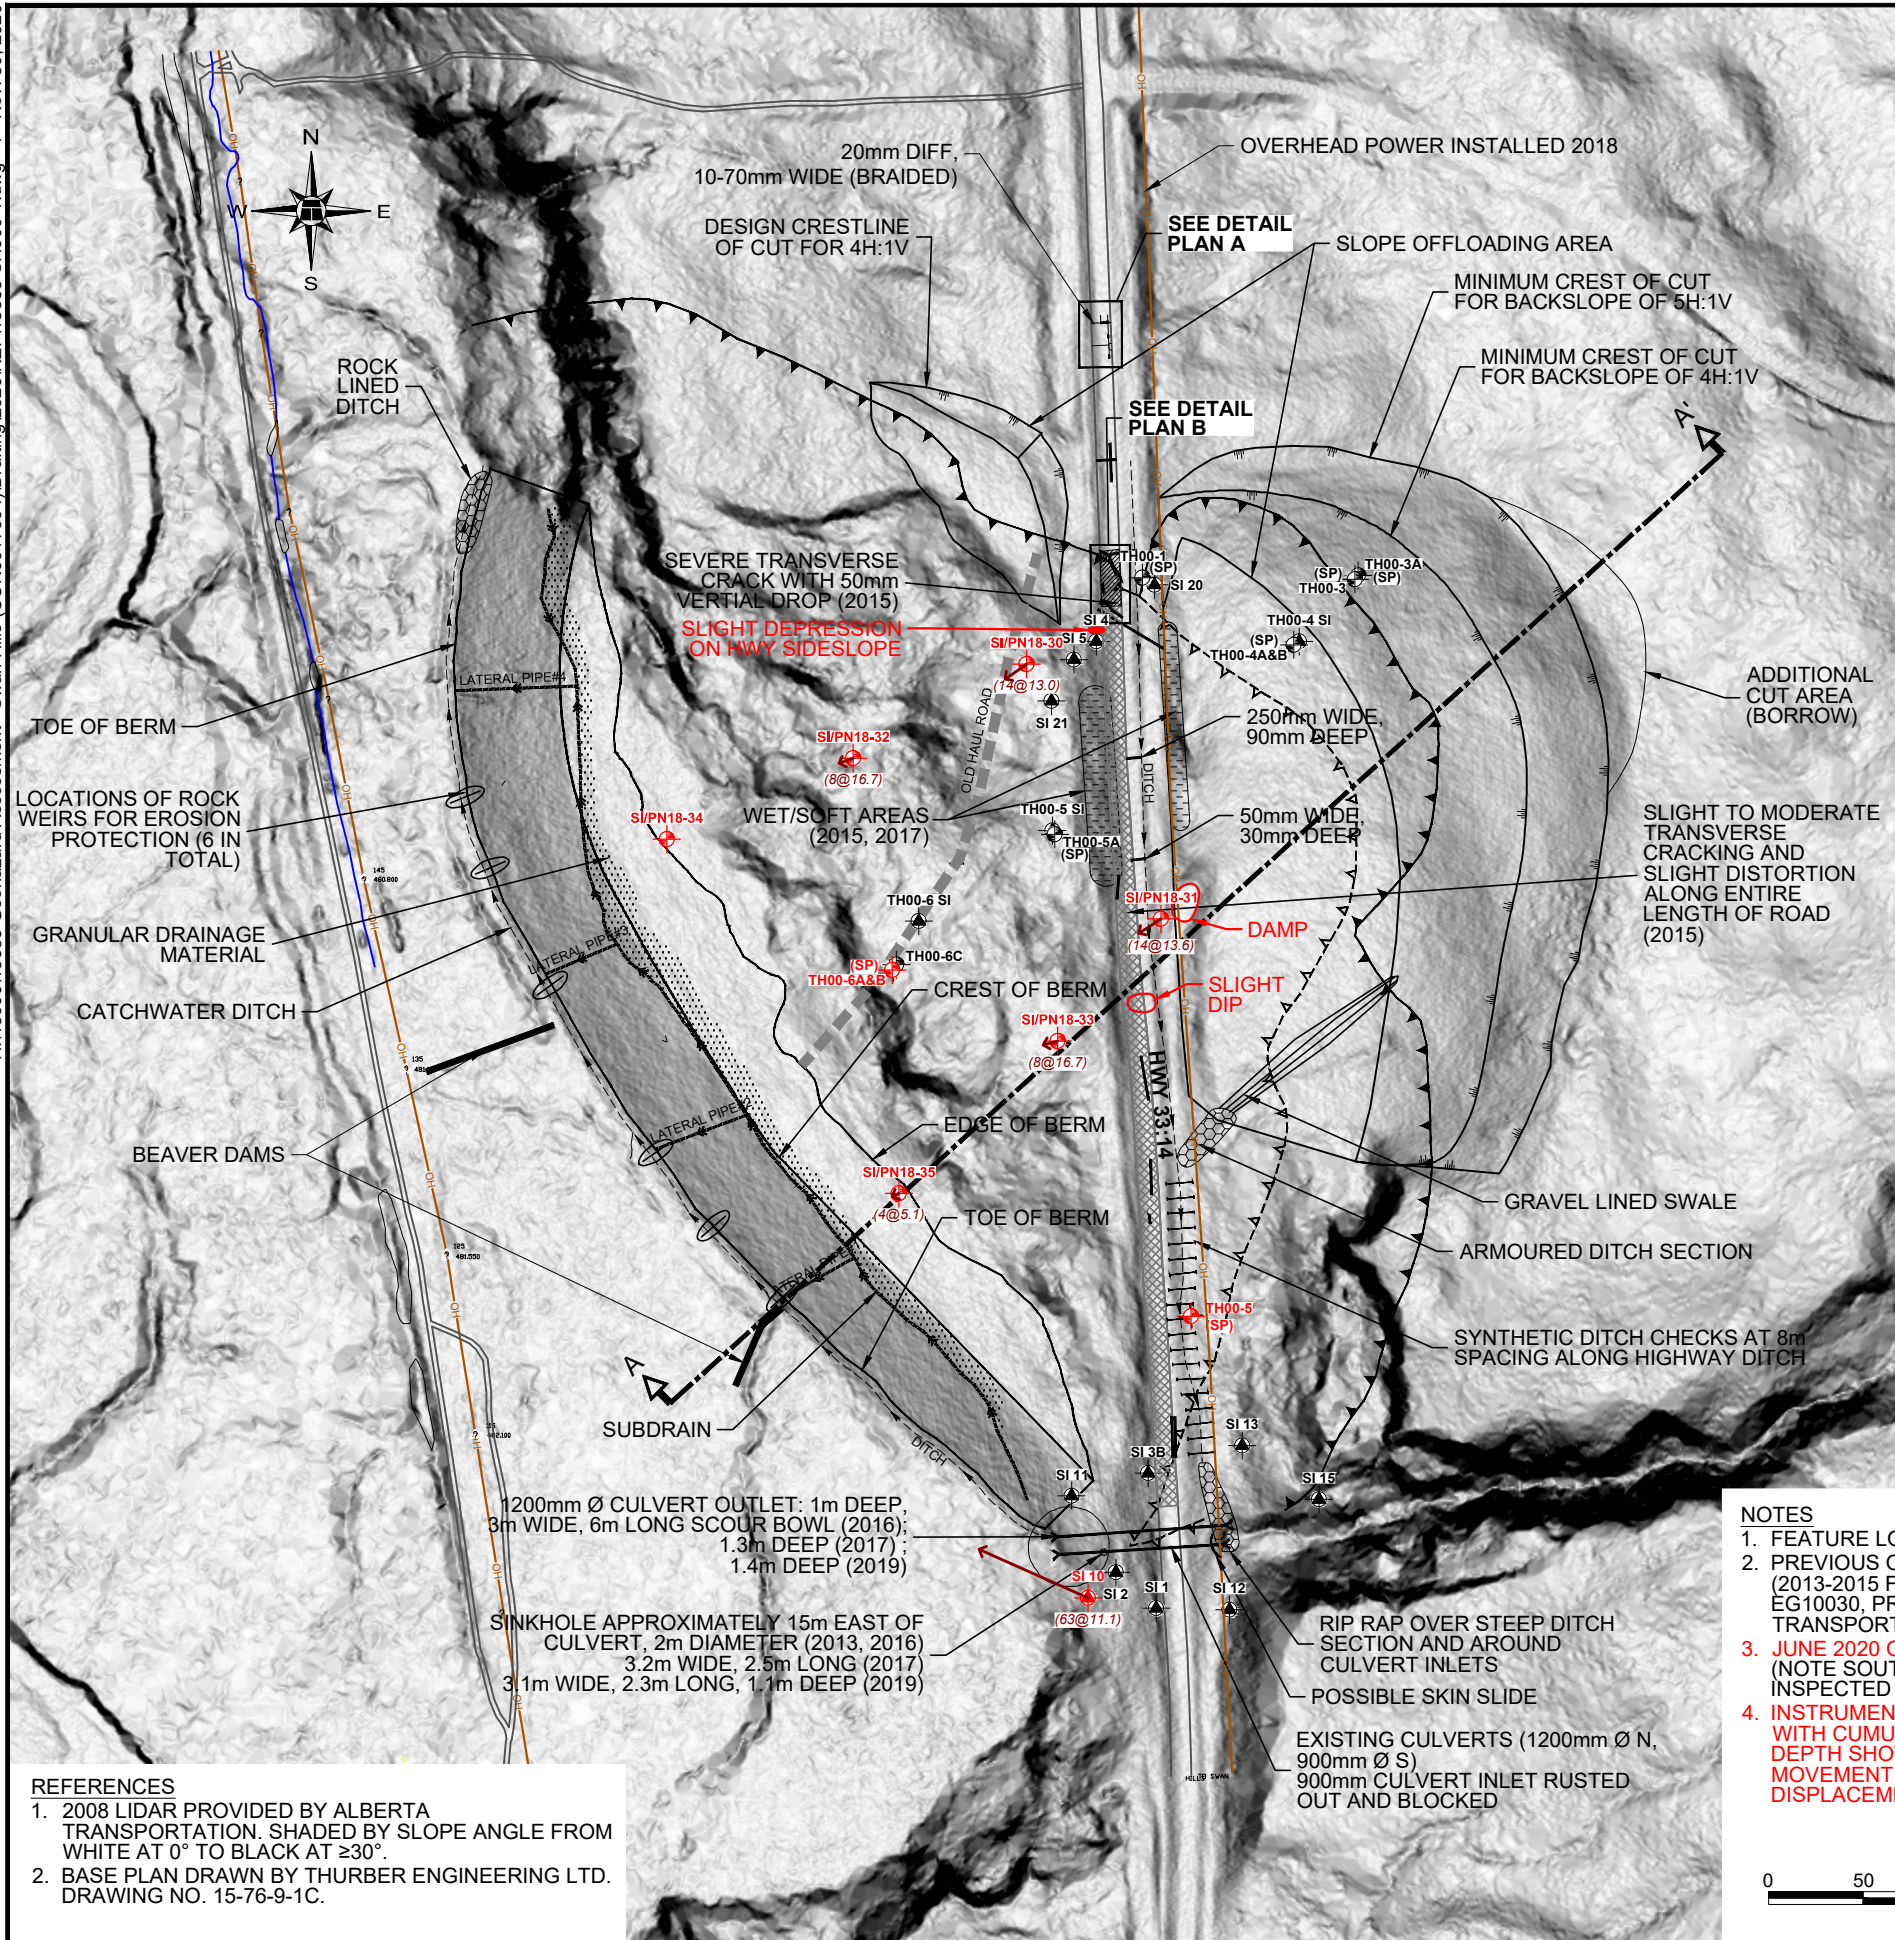
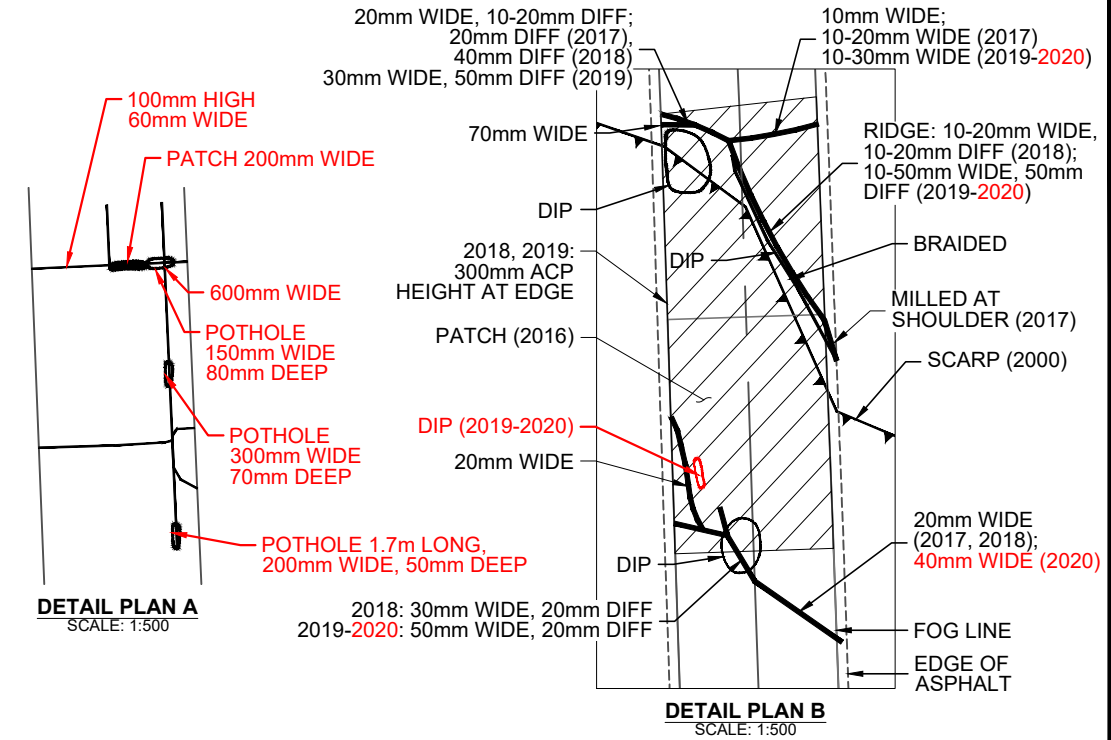
Observations:	Description	Worsened?
<input checked="" type="checkbox"/> Pavement Distress	Crack pattern at north end of site has reflected through patch. Deterioration of driving surface observed over most of the highway length.	<input checked="" type="checkbox"/>
<input checked="" type="checkbox"/> Slope Movement	Ongoing movement observed in instruments and confirmed by pavement distress; possible skin slide observed near culvert inlets in 2019.	<input checked="" type="checkbox"/>
<input checked="" type="checkbox"/> Erosion	Erosion at outlet of north culvert riprap apron noted in 2014 deepened in 2017 and again in 2019.	<input checked="" type="checkbox"/>
<input checked="" type="checkbox"/> Seepage	Soft/wet areas sometimes observed along ditches in north half of site.	<input type="checkbox"/>
<input checked="" type="checkbox"/> Bridge/Culvert Distress	Sinkhole (3 m by 2 m) observed in 2013 has not changed in size.	<input type="checkbox"/>

<input type="checkbox"/> Other		<input type="checkbox"/>
Instrumentation (as of Fall 2020):		
SI10	Ongoing movement at 10.5 m depth with a current rate of about 5.9 mm/year compared to the average rate (since 2013) of about 2.2 mm/year with cumulative movement of 62 mm. The rate of movement has noticeably accelerated in the last year.	
SI18-30 to -35	Two deeper movements zones have been identified in SI18-30 (14 m depth) and SI18-31 (13.3 m depth) with cumulative movements of 14 mm and 14 mm, respectively, which is an increase of 9 mm and 8 mm since Fall 2019. Previous tentative movement zones identified in SI18-32 at 15.5 m depth and SI18-33 at 16.7 m depth have resolved into active zones with cumulative movements of 8 mm. After some initial movement, the near-surface movement zone at SI18-35 has not developed further; the potential movement zone at 5.4 m depth appears to be resolving with 4 mm of cumulative movement. No movement pattern has been apparent yet at SI18-34.

Recommendations:		
<p>Short-term road maintenance (patching and milling to provide a safe, smooth surface) should continue as required and the annual GeoHazard inspection and twice-annual instrumentation readings should continue as scheduled.</p> <p>The recommended instrumentation was installed in early 2018 and are starting to reveal ongoing creep movement patterns. Given the large size of the landslide and slow movements, periodic patching of the asphalt at each flank appears to be the current most cost-effective method of dealing with the landslide movements. However, continued monitoring of the site (visual and instrumentation) is recommended to manage the risks.</p>

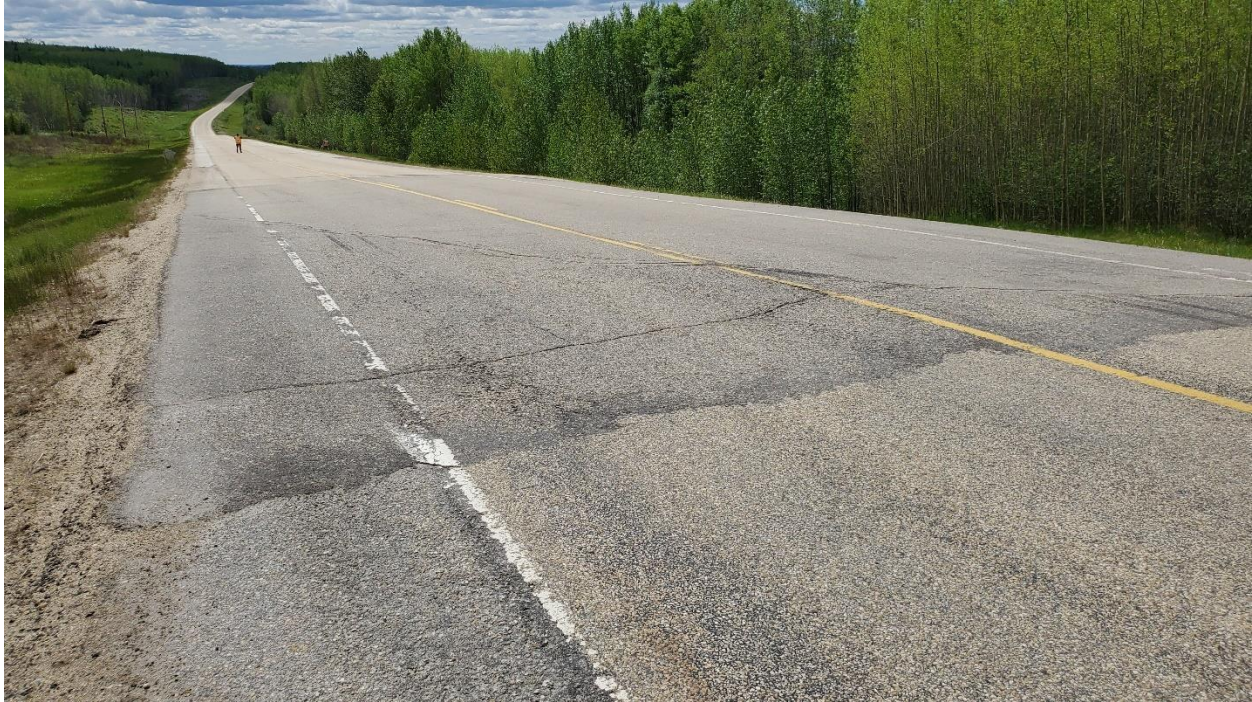
Photo 1 – Looking south from east shoulder at main scarp crack and patch at north end of site.

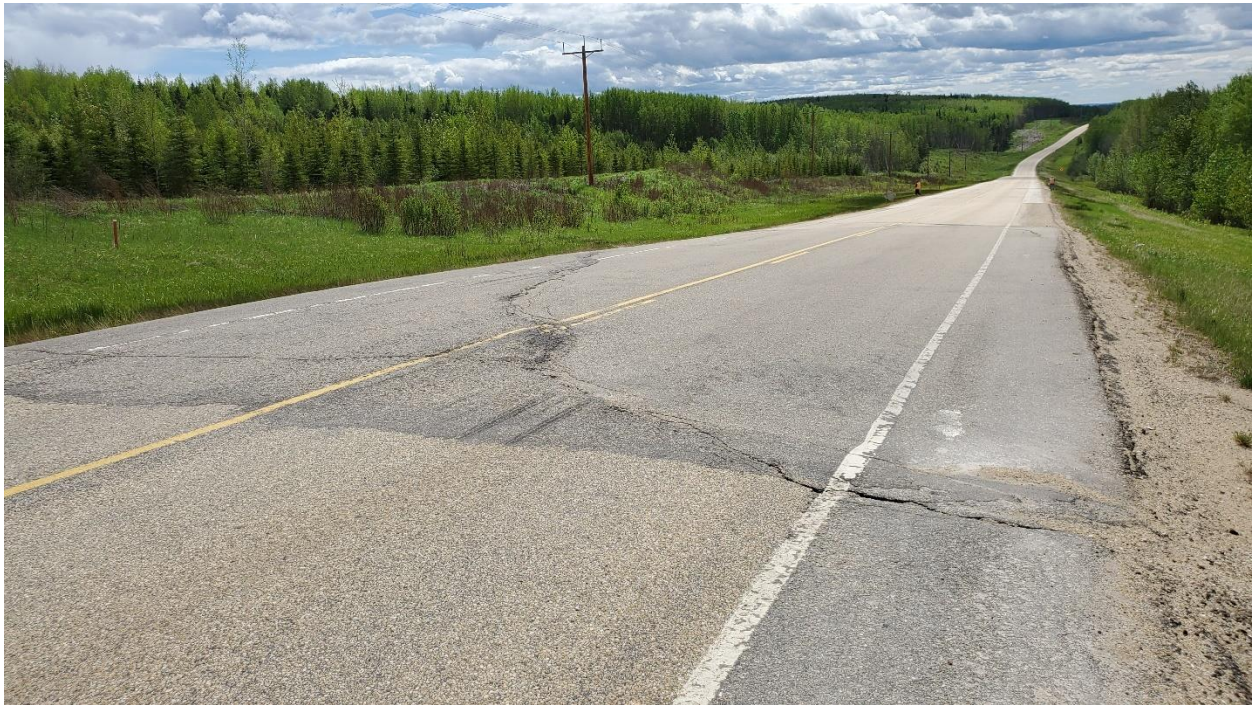
Photo 2 – Looking south from west shoulder at main scarp crack and patch at north end of site.
Note powerline installed on east side of highway since 2017 visit.

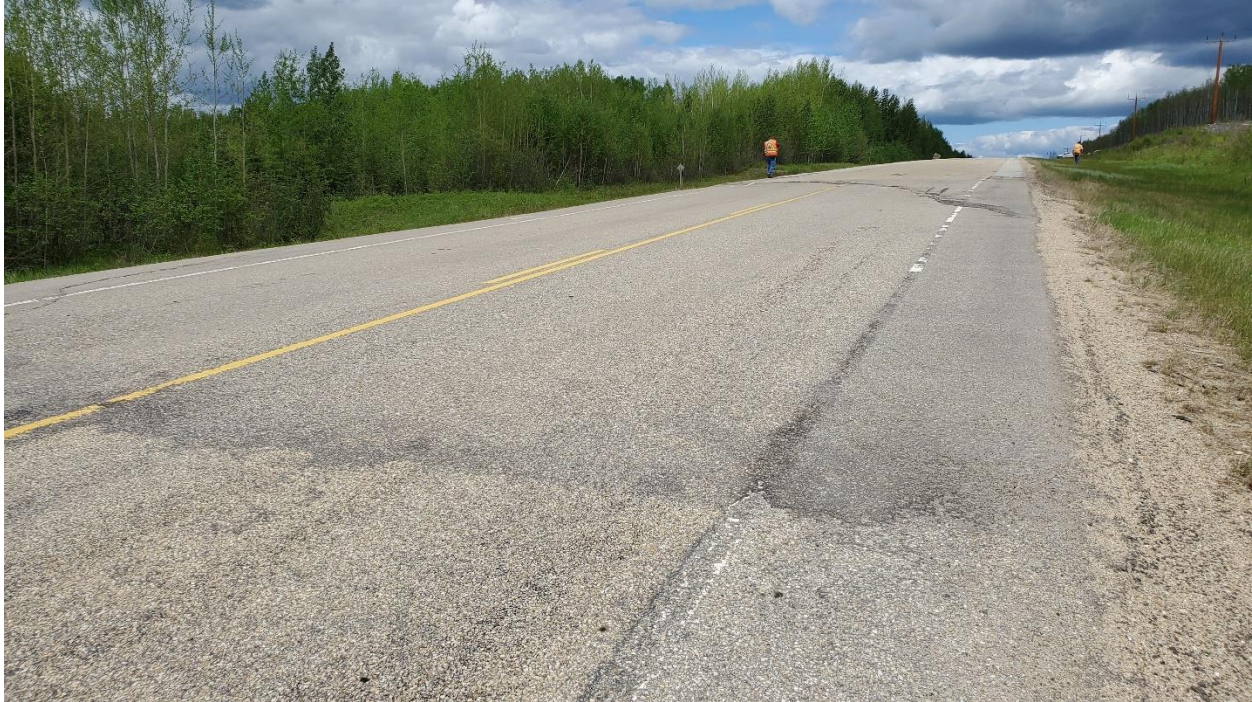
Photo 3: Looking north at hump over main scrap crack at north end of the site.

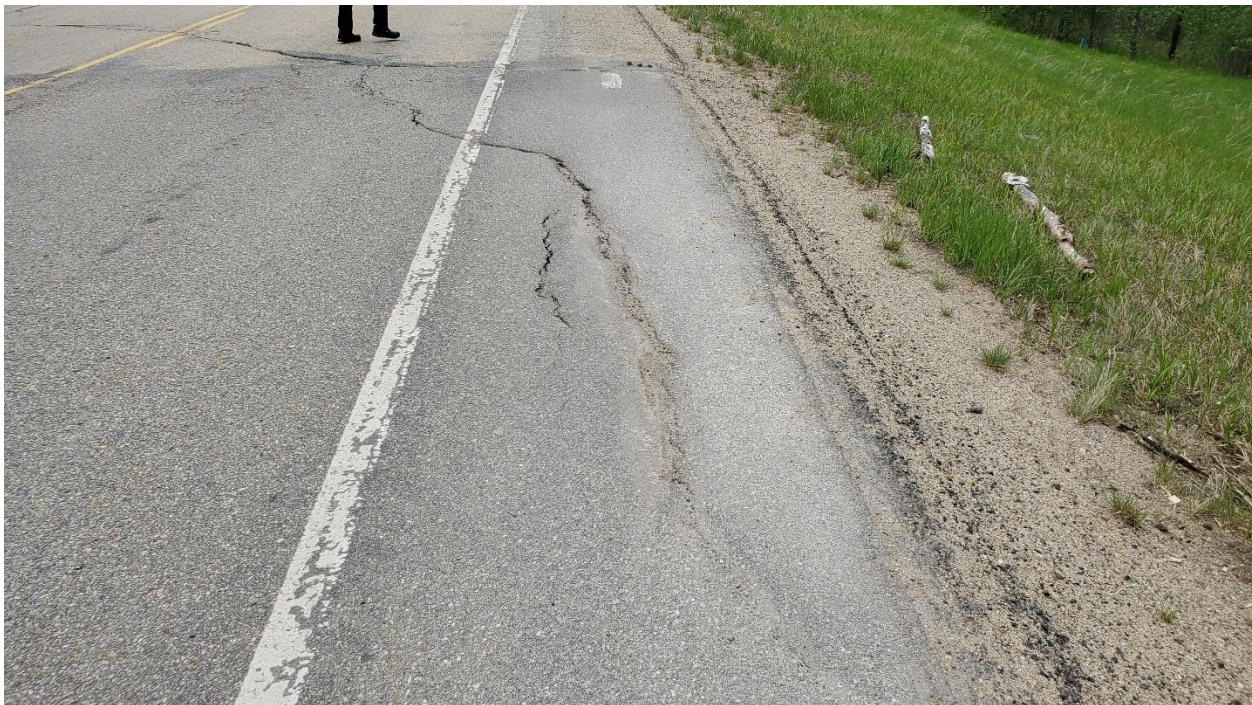
Photo 4: Looking south at crack at south end of patch at north end of the site.

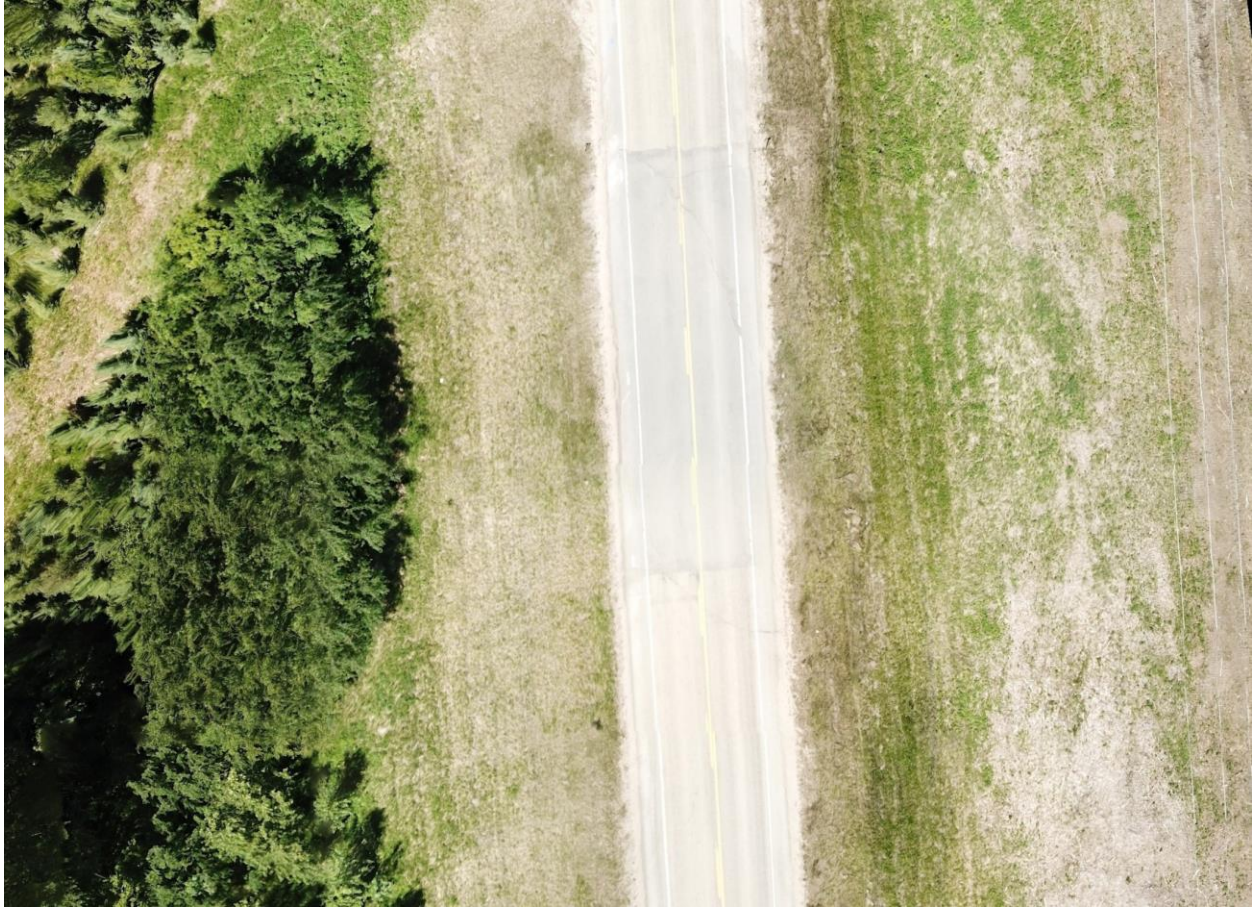
2018 UAV Image of patch section at north end of slide with drill access road to the west and new powerline on the east.
