**ALBERTA TRANSPORTATION  
GEOHAZARD ASSESSMENT PROGRAM  
PEACE REGION (PEACE RIVER DISTRICT)  
2022 INSPECTION**

| Site Number | Location | Name | Hwy | km |
|---|---|---|---|---|
| SH006-1 | North of Swan Hills | Klumph Creek | 33:14 | 18.1-18.6 |

| | Date | PF | CF | Total |
|---|--|---|--|---|
| <b>Current Inspection:</b> | 30-May-2022 | 10 | 4 | 40 |

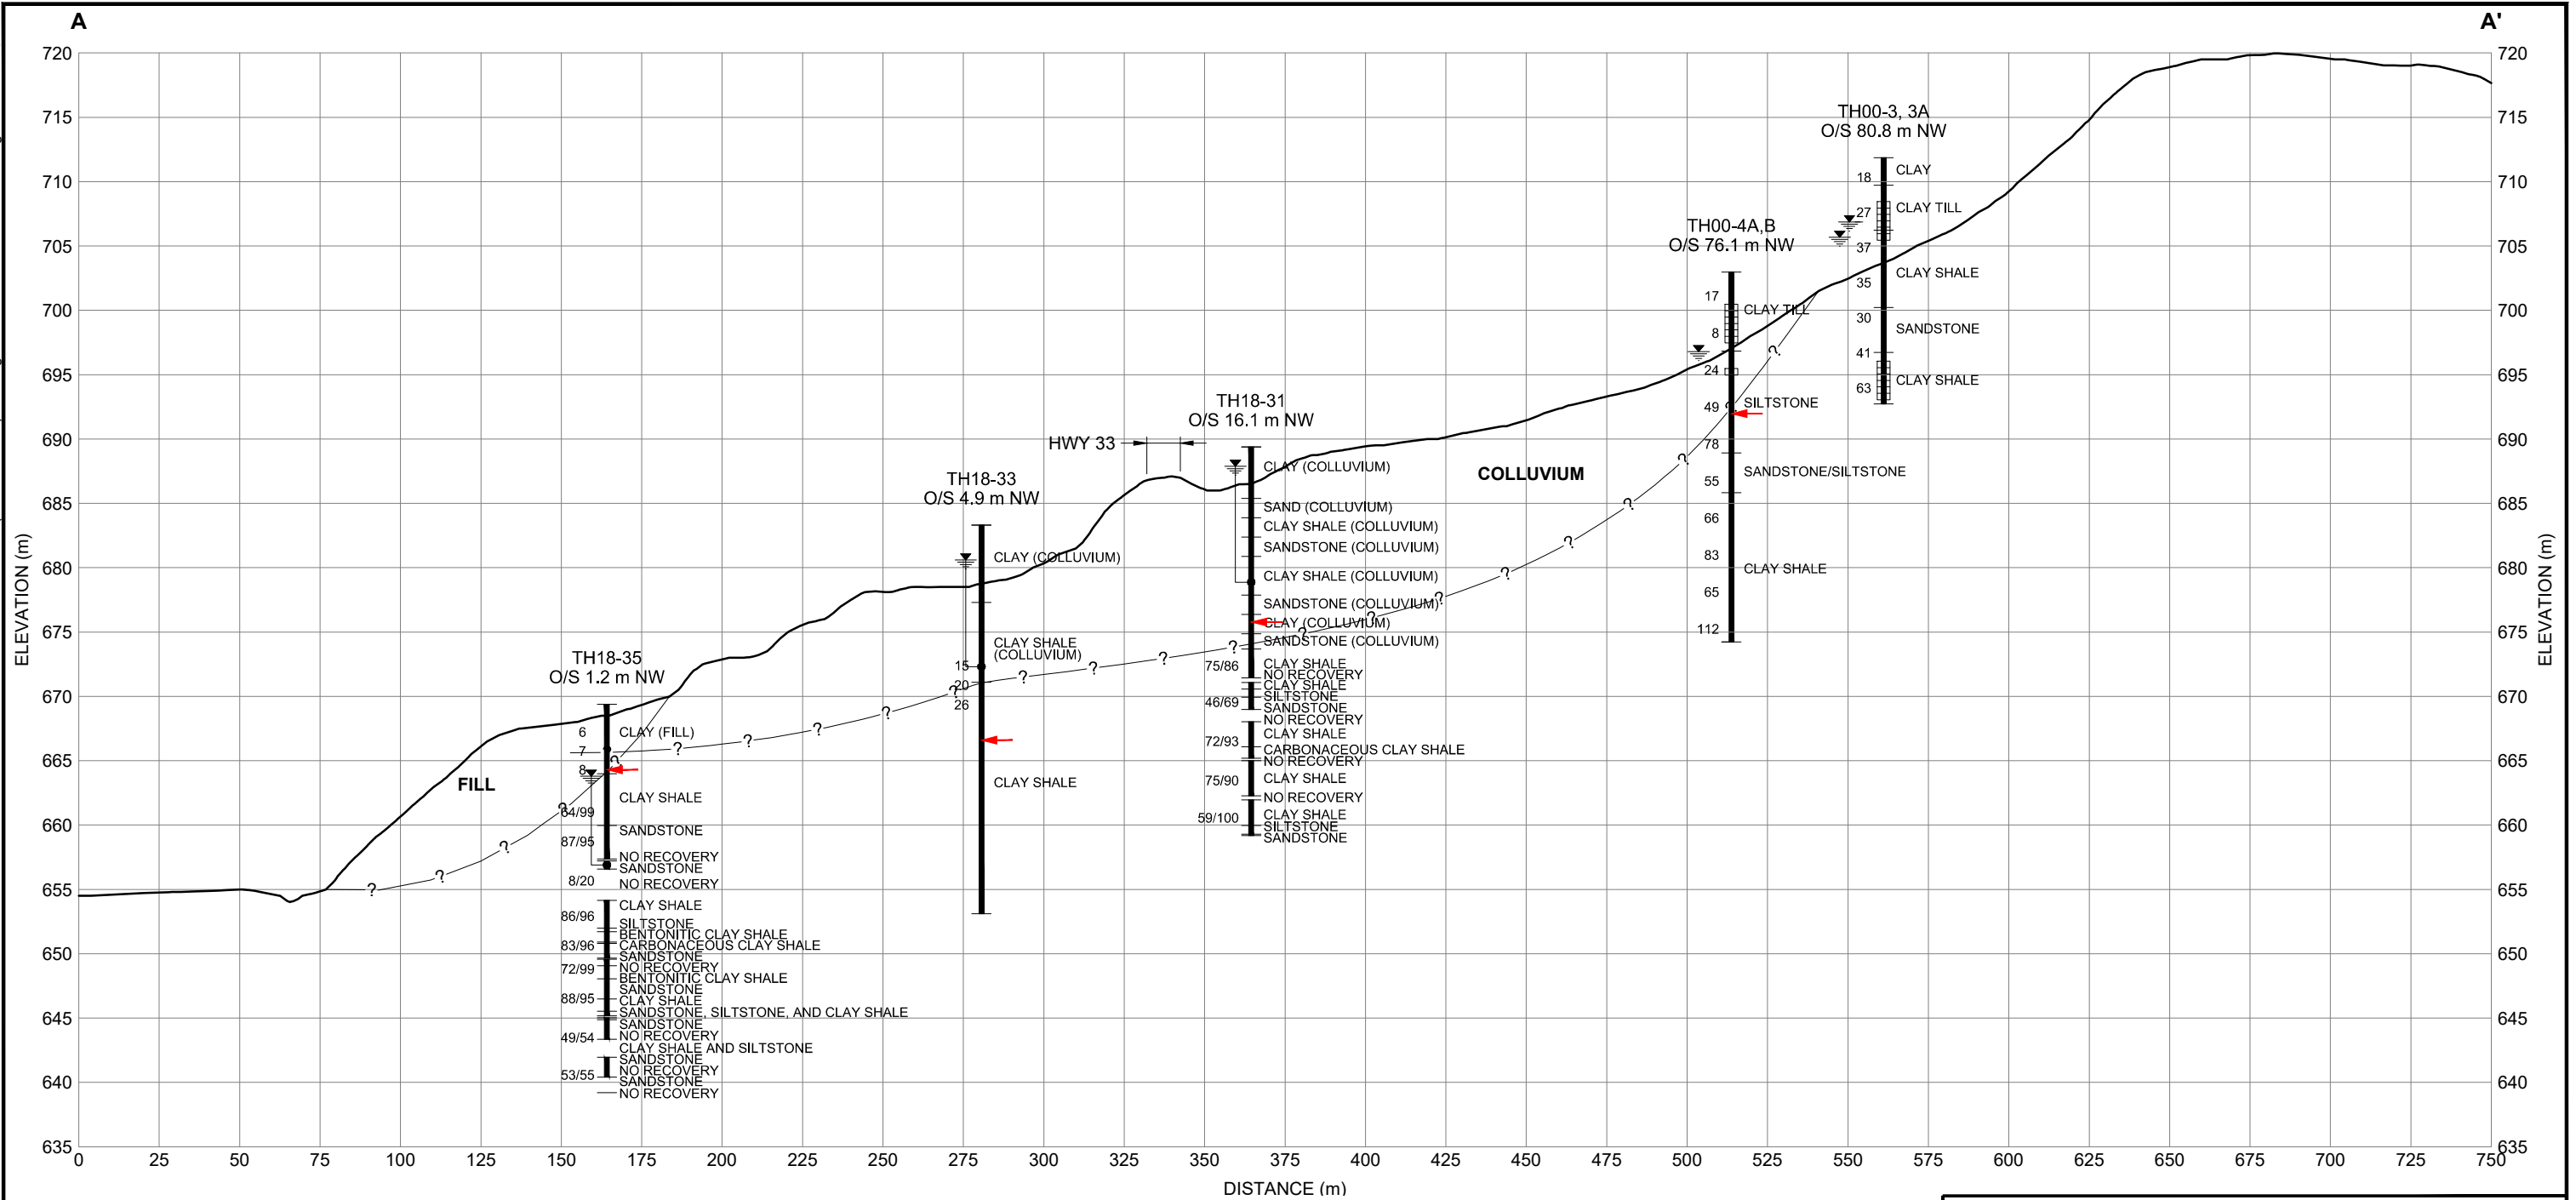
DWG No. 13355-SH006-1-2

**SH006-1: KLUMPH CREEK SLIDE ON HWY 33:14  
CROSS - SECTION A - A'**

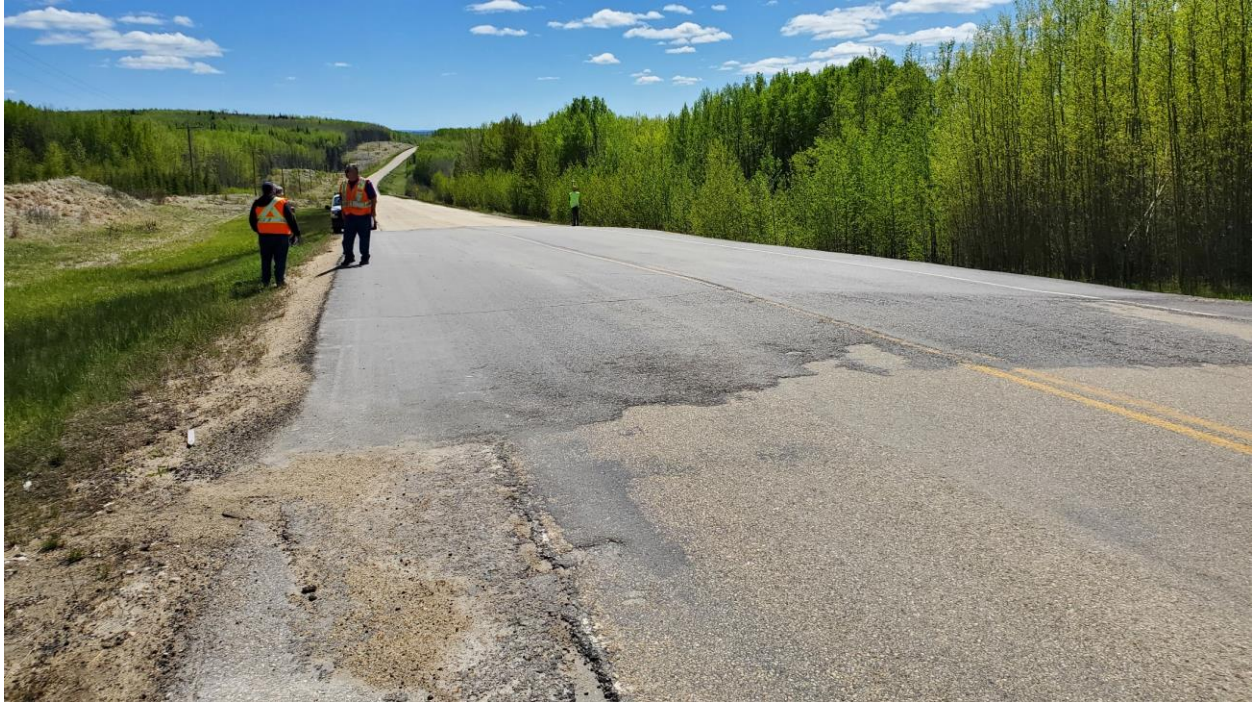
| Observations: | Description | Worsened? |
|---|--|---|
| <input checked="" type="checkbox"/> Pavement Distress | Crack pattern at north end of site has reflected through patch. Deterioration of driving surface observed over most of the highway length. | <input checked="" type="checkbox"/> |

Photo 1 – Looking south from east shoulder at main scarp crack and patch at north end of site.

| <b>Instrumentation (Spring 2022):</b> | |
|--|---|
| <ul style="list-style-type: none"> <li>▪ Short-term road maintenance (patching and milling to provide a safe, smooth surface) should continue as required.</li> <li>▪</li> </ul> | |

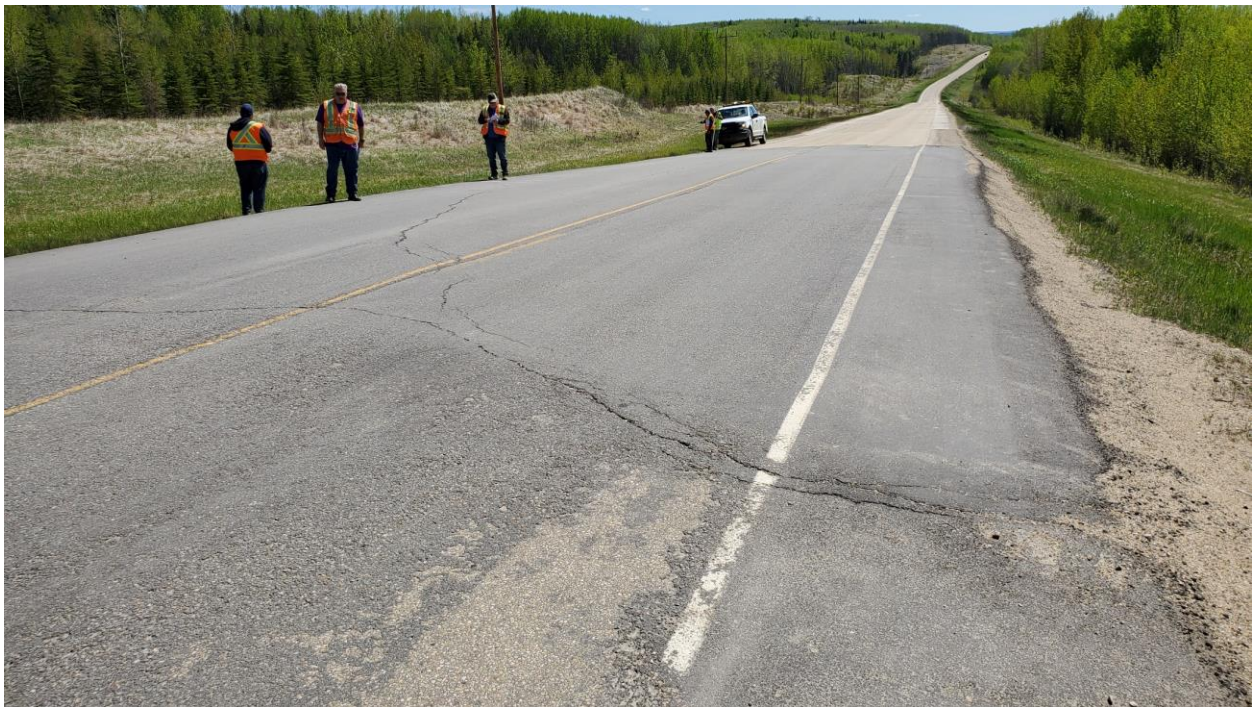
Photo 2 – Looking south from west shoulder at main scarp crack and patch at north end of site. Note powerline installed on east side of highway since 2017 visit.

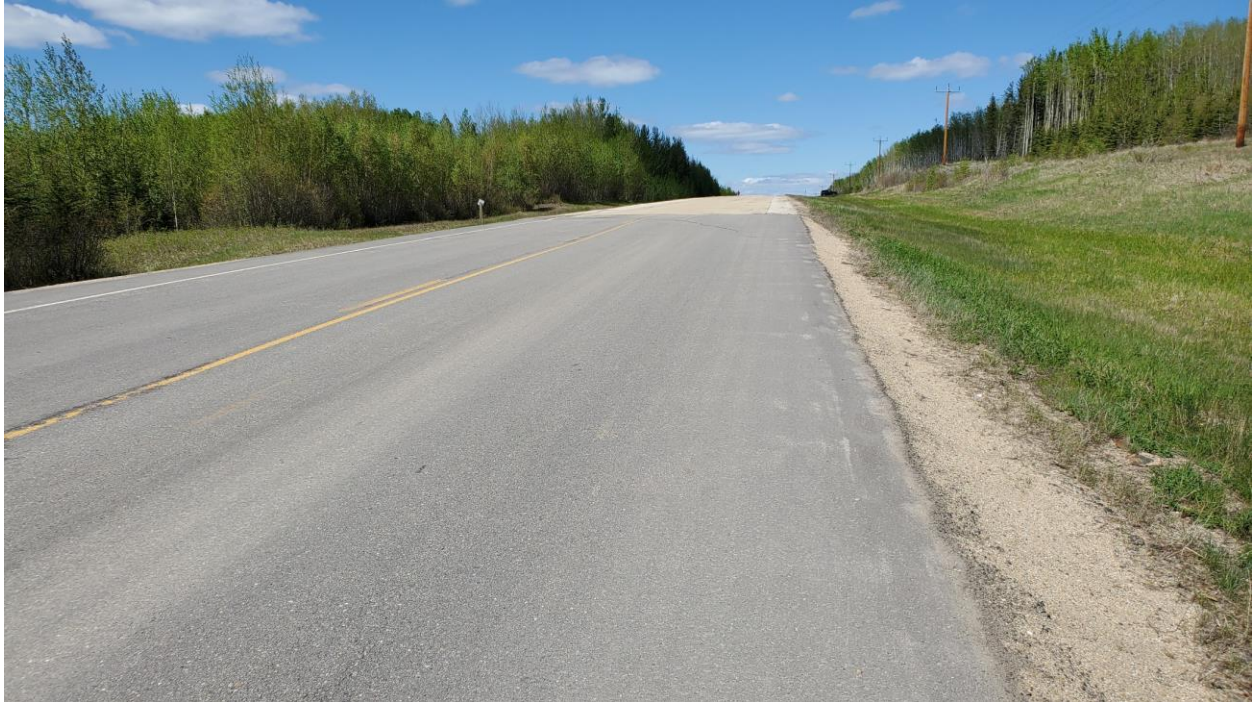
Photo 3: Looking north at hump over main scrap crack at north end of the site.

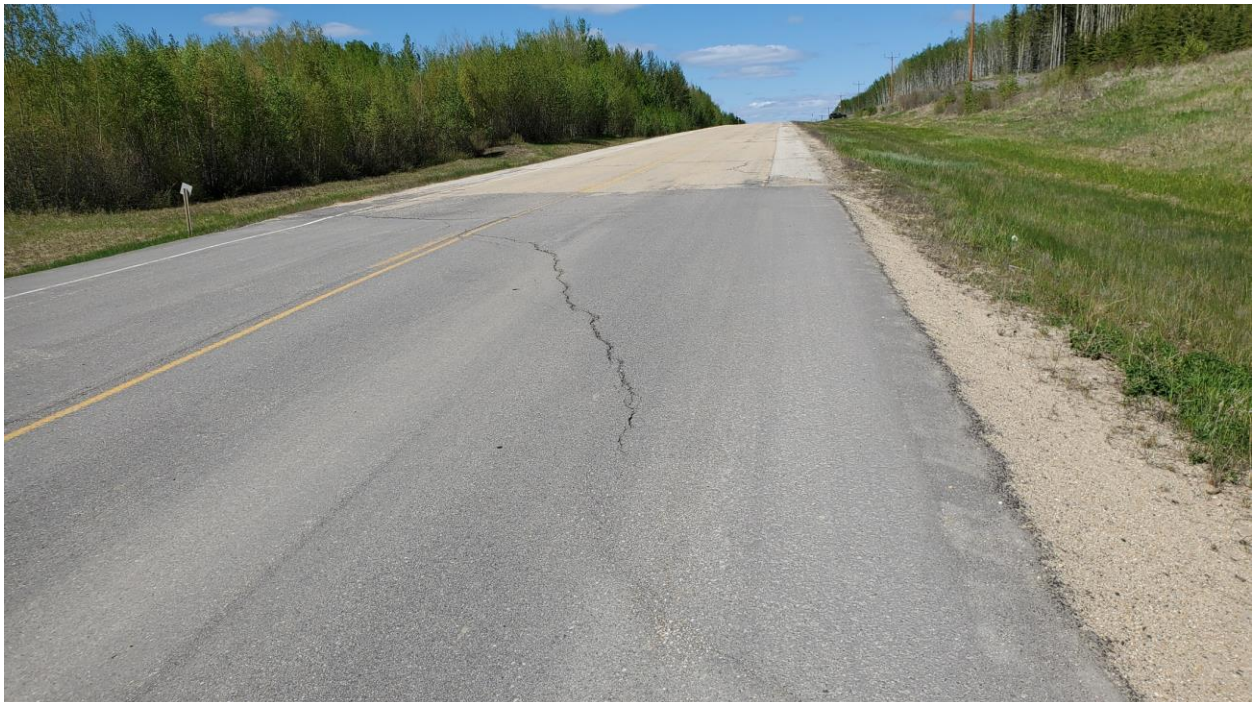
Photo 4: Looking south at crack at south end of patch at north end of the site.
