**ALBERTA TRANSPORTATION  
GEOHAZARD ASSESSMENT PROGRAM  
PEACE REGION – HIGH LEVEL  
2020 INSPECTION**

Site Number	Location	Name	Hwy	km
PH044-1 (A) PH044-2 (B)	North of Manning, AB	Meikle River Slides A and B	35:08	26.14 25.82
Legal Description		UTM Co-ordinates		
Slide A: SW7-94-22-W5M		11U E 467,665	N	6,333,024
Slide B: SW7-94-22-W5M		11U E 467,800	N	6,332,742

<b>Primary Site Issue:</b>	Sideslope slumping of high embankment into oxbow of the Meikle River.	
<b>Dimensions:</b>	Slide A: 34 m length of highway, 18 m high embankment Slide B: 65 m length of highway, 24 m high embankment	
<b>Date of Remediation:</b>	1993, Slide B: Pile wall installed	
<b>Maintenance:</b>	2008: spray-patch of cracks. 2016: Overlay and chip seal of Highway 35 including these sites. High tension steel cable barrier (HTSC) installed. 2019: HTSC replaced with W-Beam guardrail	
<b>Observations (Slide A):</b>	<b>Description</b>	<b>Worsened?</b>
<input checked="" type="checkbox"/> Pavement Distress	Cracks on pavement are not related to slide. Dip same as 2016.	<input type="checkbox"/>
<input checked="" type="checkbox"/> Slope Movement	Continued retrogressive movement. The backscarp is 5.8 m from the highway;

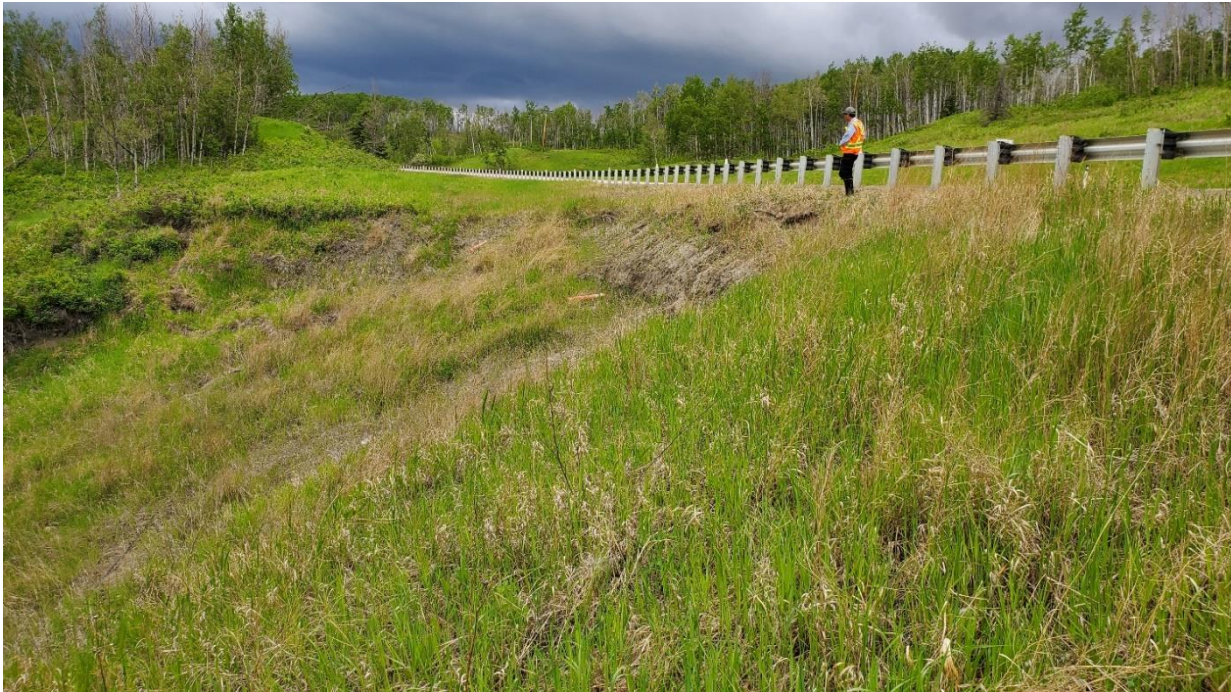
Photo 1 – Slide B: Backscarp and highway, looking north.

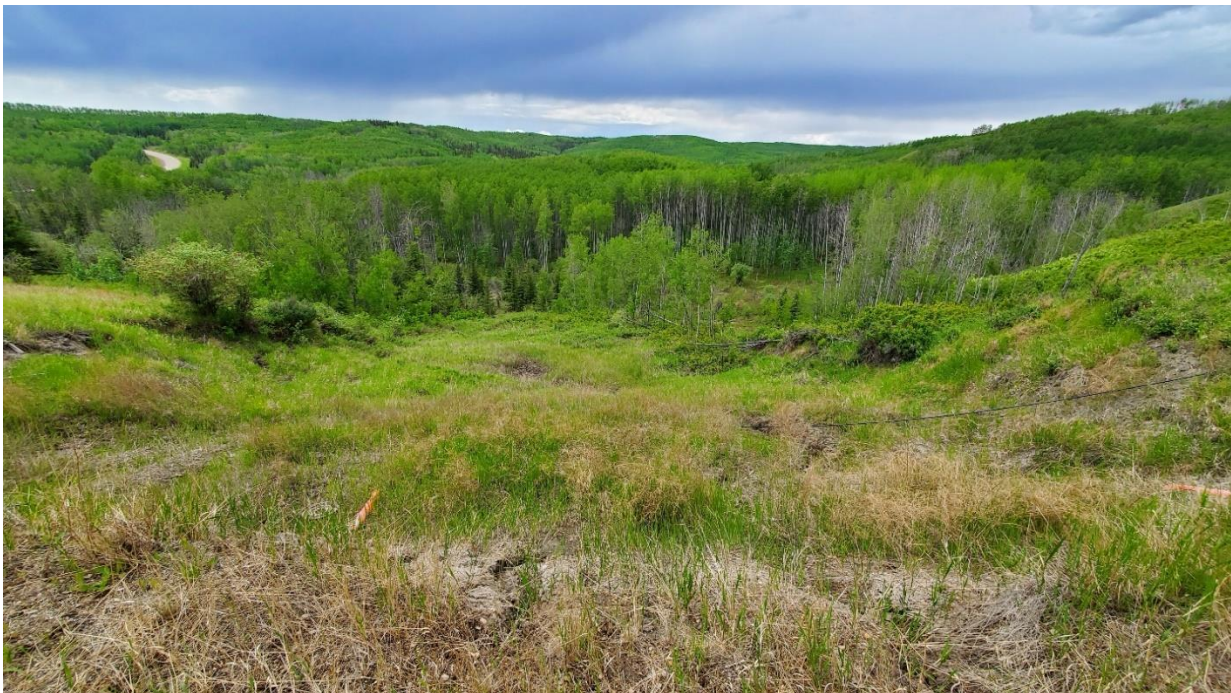
Photo 2 – Slide B: View of slope failure and slide block, looking southwest.

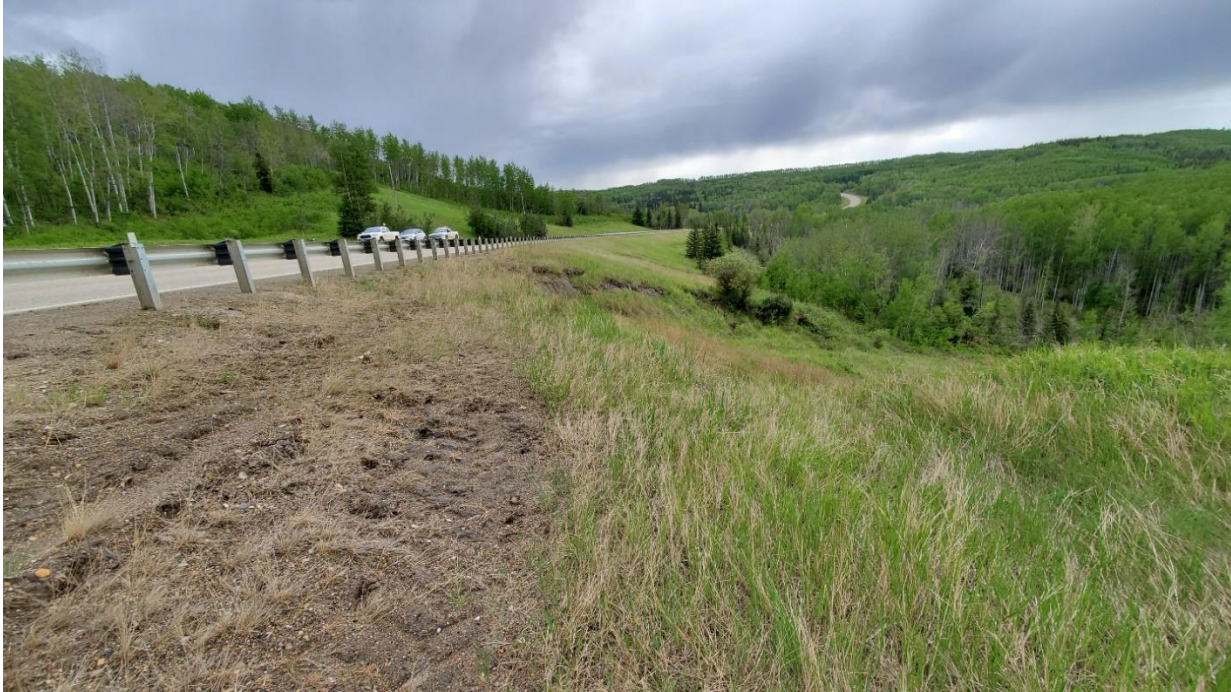
Photo 3 – Slide B: Backscarp and highway, looking south.

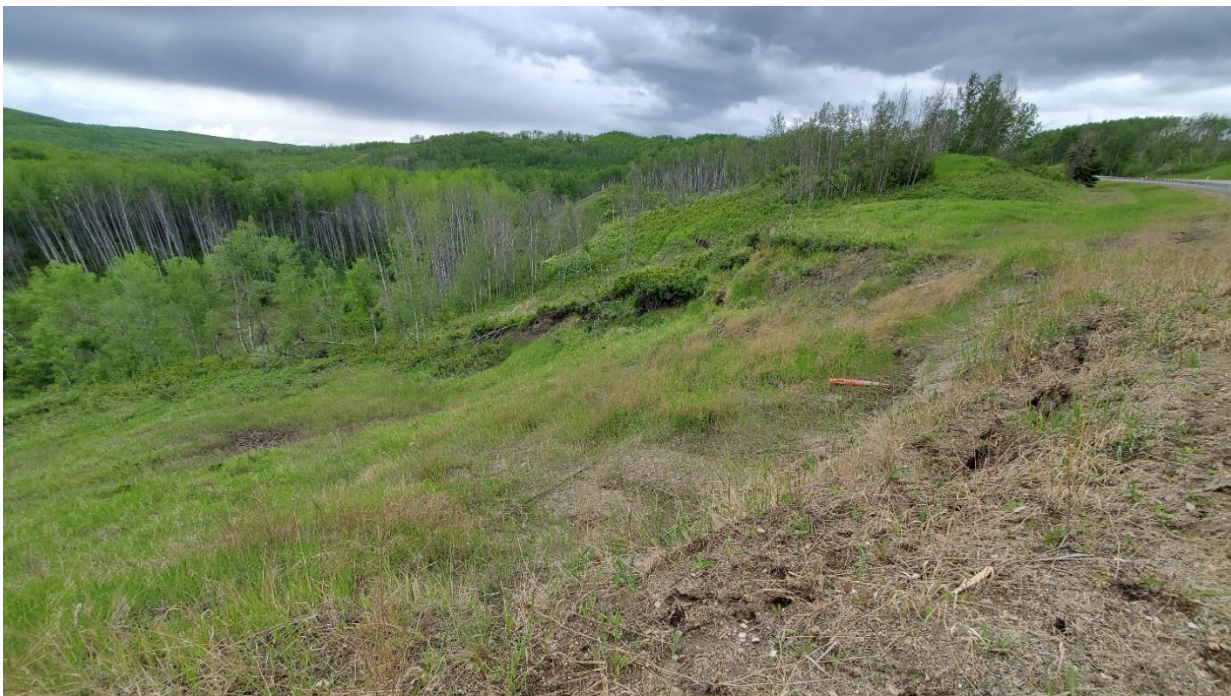
Photo 4 – Slide B: View of backscarp looking north.

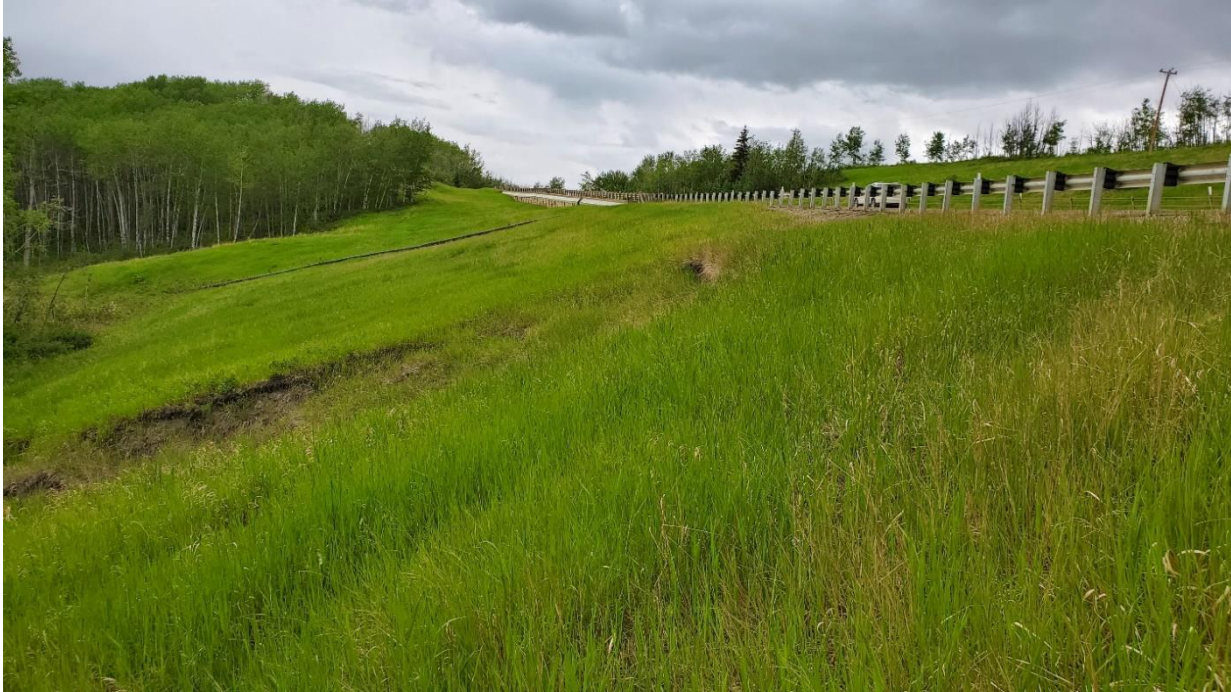
Photo 5 – Slide A: Increased retrogression movement, looking north.

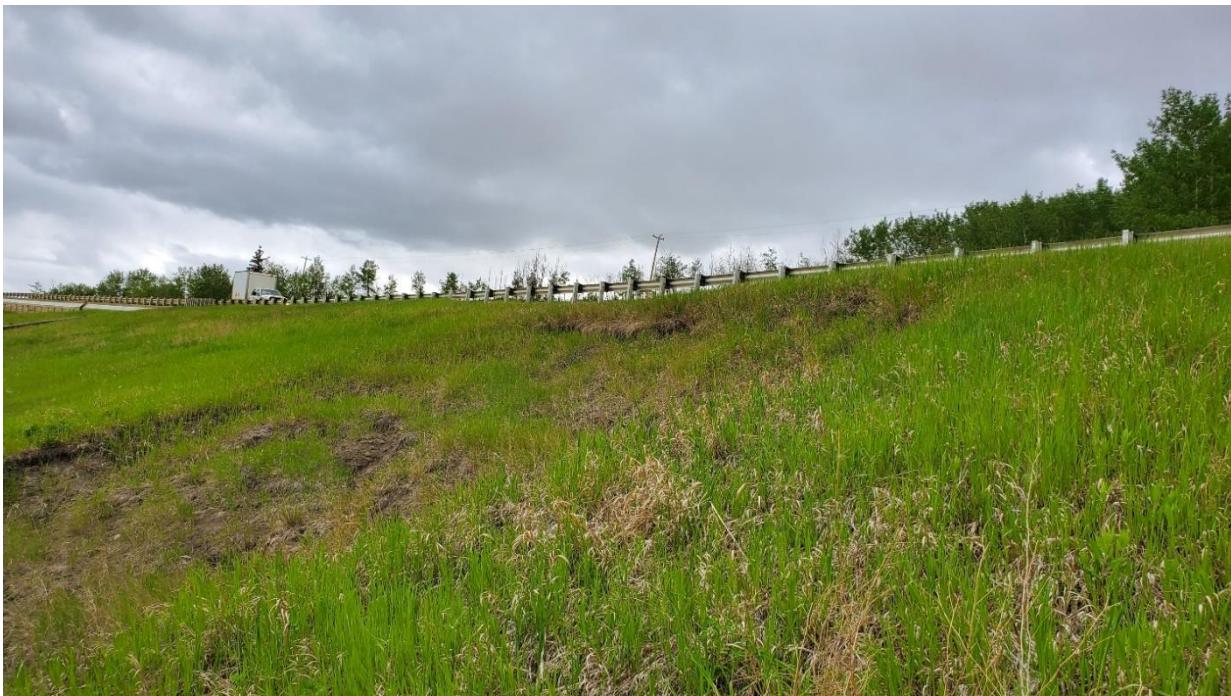
Photo 6 – Slide A: Embankment sideslope, looking northeast.

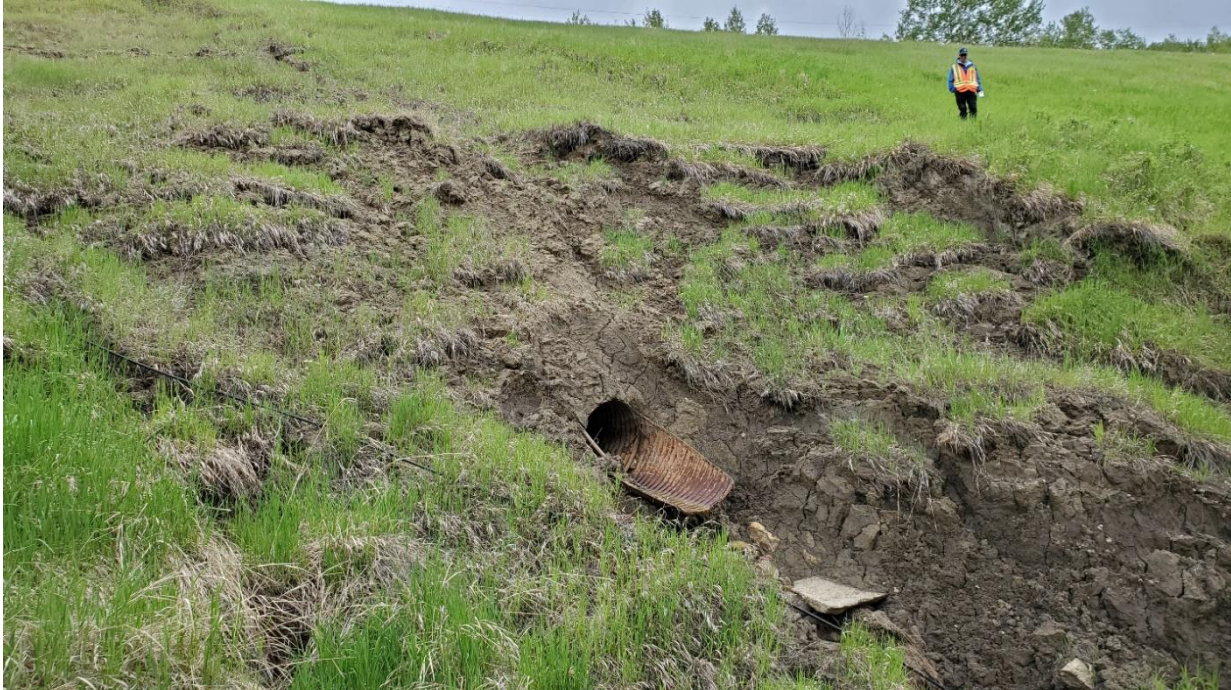
Photo 7 – Slide A: Slope movement near the toe of the slope, looking east. Culvert outlet became buried in 2017 and exposed again in 2019 (deteriorated significantly since 2015).

- Slide A: Consideration should be given to lining the culvert and welding a downpipe to the outlet to direct culvert flow to the bottom of the slope into a dissipation bowl. This could reduce some of the driving force on the slide and minimize issues that may arise from the reduced culvert flow due to the covered outlet.
- Slide B: Drainage water should be prevented from running on to the slide area. An asphalt curb could be used to direct surface runoff away from the slide which will also reduce the ravelling of the embankment between the highway and pile wall.

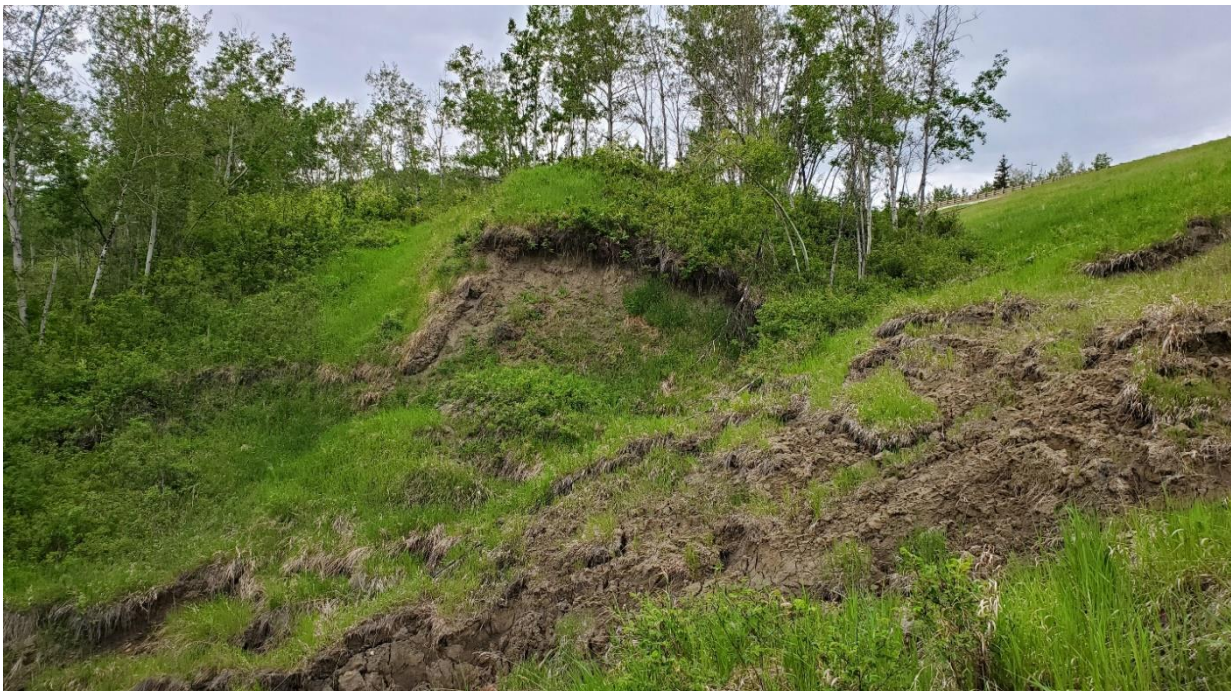
Photo 8 – Slide A: Downslope view, looking west. Over-steepened exposed slope face is more vegetated than in 2015. A former grass-covered access route is located on the left side of the small hill in the center of the photo.

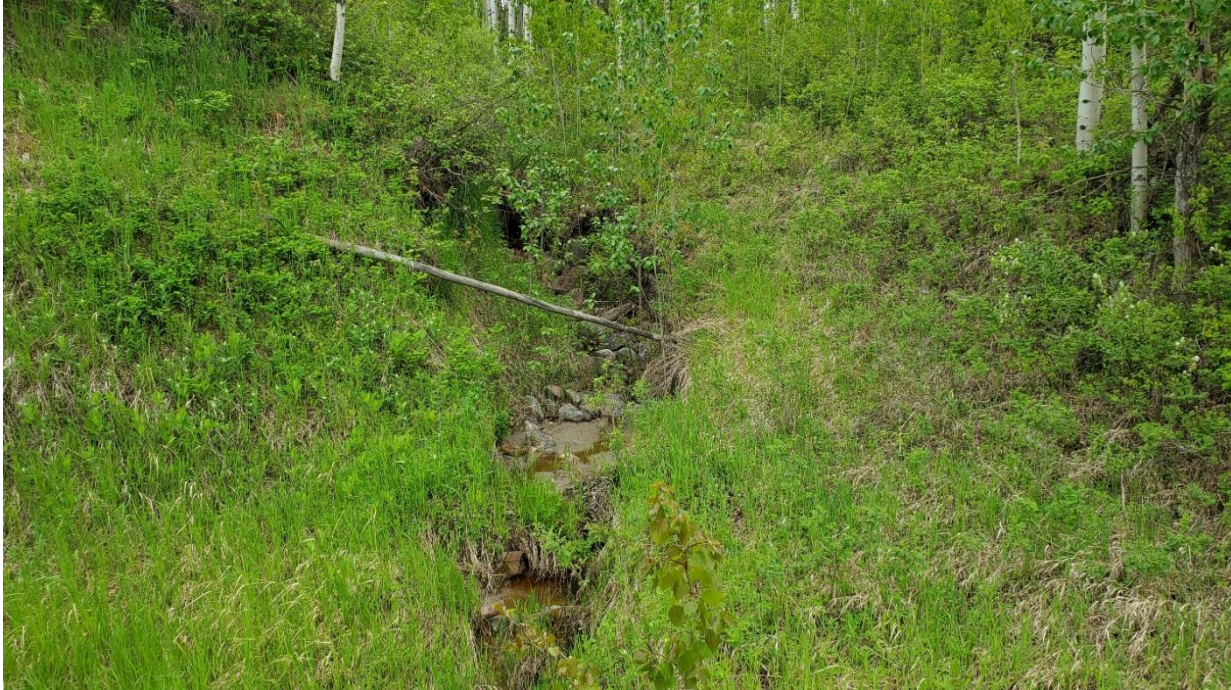
Photo 9 – Slide A: Erosion gully outside culvert inlet, looking northeast.

- Slide A: the slide material (predominantly clay till) could be removed, and the slope reconstructed at a flatter angle with well-compacted, moisture-conditioned clay benched into the intact fill slope. The culvert should be replaced or repaired following excavation of the slumped material and extended to a flatter area downslope where a dissipation bowl should be constructed. Extending the outlet may allow sufficient room for a small toe berm so the slope could be flattened somewhat. In addition, the area surrounding the culvert inlet should be regraded and protected with a high-flow soil covering.

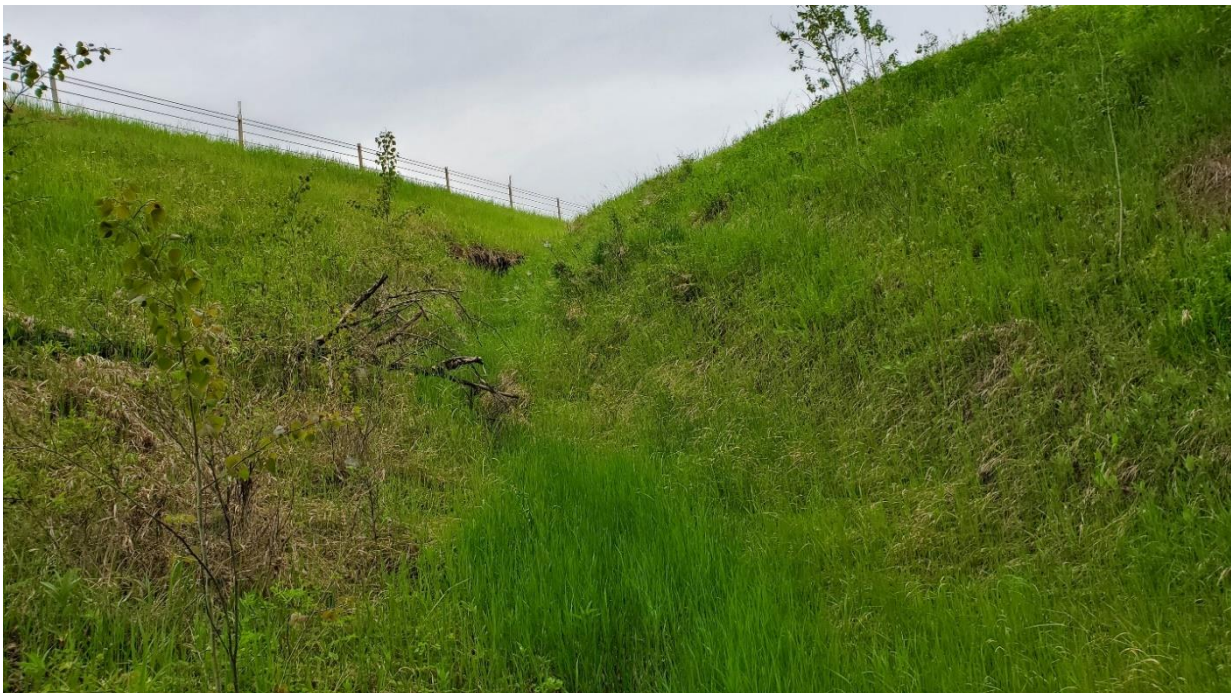
Photo 10 – Slide A: Erosion gully in sideslope draining towards culvert inlet, looking north.
