**ALBERTA TRANSPORTATION  
GEOHAZARD ASSESSMENT  
PEACE REGION (PEACE RIVER DISTRICT)  
2022 INSPECTION**

Site Number	Location	Name	Hwy	km
PH044-1 (A) PH044-2 (B)	North of Manning, AB	Meikle River Slides A and B	35:08	26.14 25.82
Legal Description		UTM Co-ordinates		
Slide A: SW7-94-22-W5M		11U E 467,665	N	6,333,024

<b>Primary Site Issue:</b>	Sideslope slumping of high embankment into oxbow of the Meikle River.	
<b>Dimensions:</b>	Slide A: 34 m length of highway, 18 m high embankment Slide B: 65 m length of highway, 24 m high embankment	
<b>Date of Remediation:</b>	1993, Slide B: Pile wall installed	
<b>Maintenance:</b>	2008: spray-patch of cracks. 2016: Overlay and chip seal of Highway 35 including these sites. High tension steel cable barrier (HTSC) installed. 2019: HTSC replaced with W-Beam guardrail	
<b>Observations (Slide A):</b>	<b>Description</b>	<b>Worsened?</b>
<input checked="" type="checkbox"/> Pavement Distress	No distress observed since overlay in 2016.	<input type="checkbox"/>
<input checked="" type="checkbox"/> Slope Movement	Continued retrogressive movement. The backscarp is 5.8 m from the highway; the landslide mass continues to expand, move, and break up.	<input

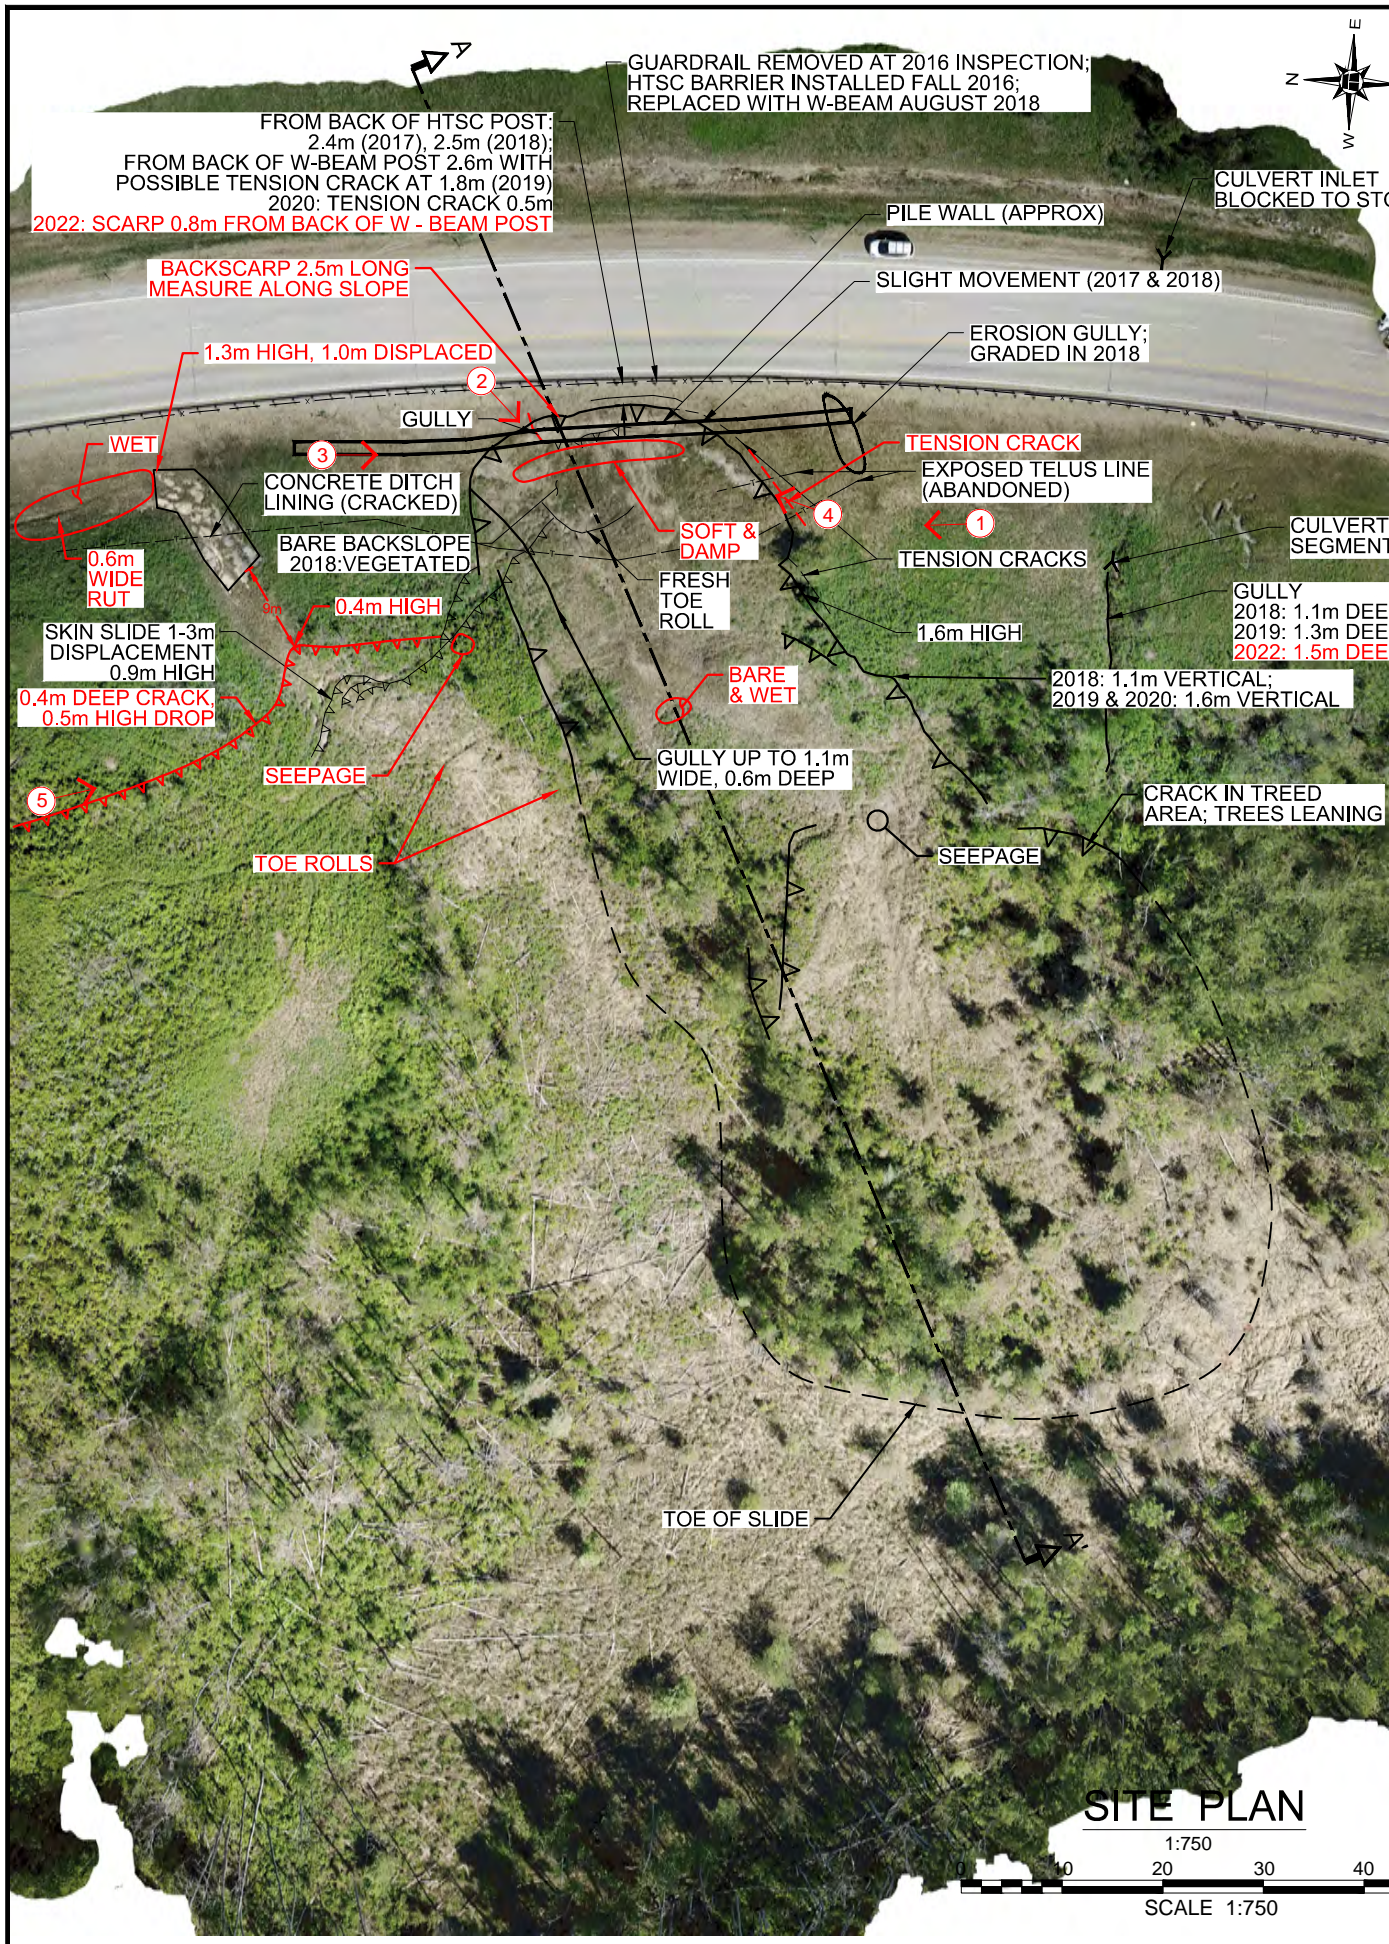
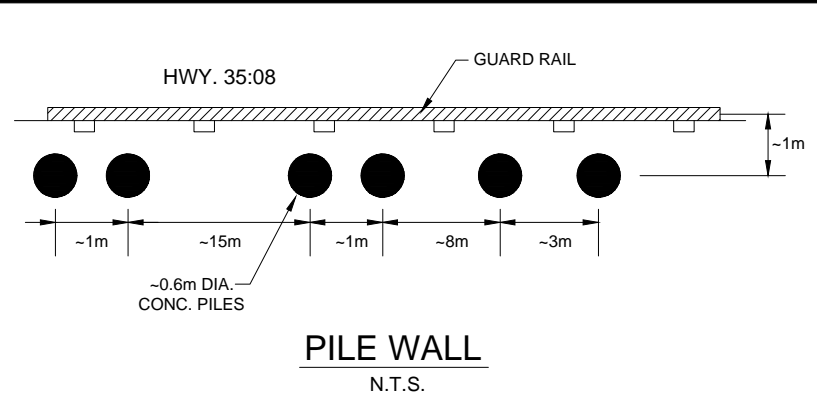
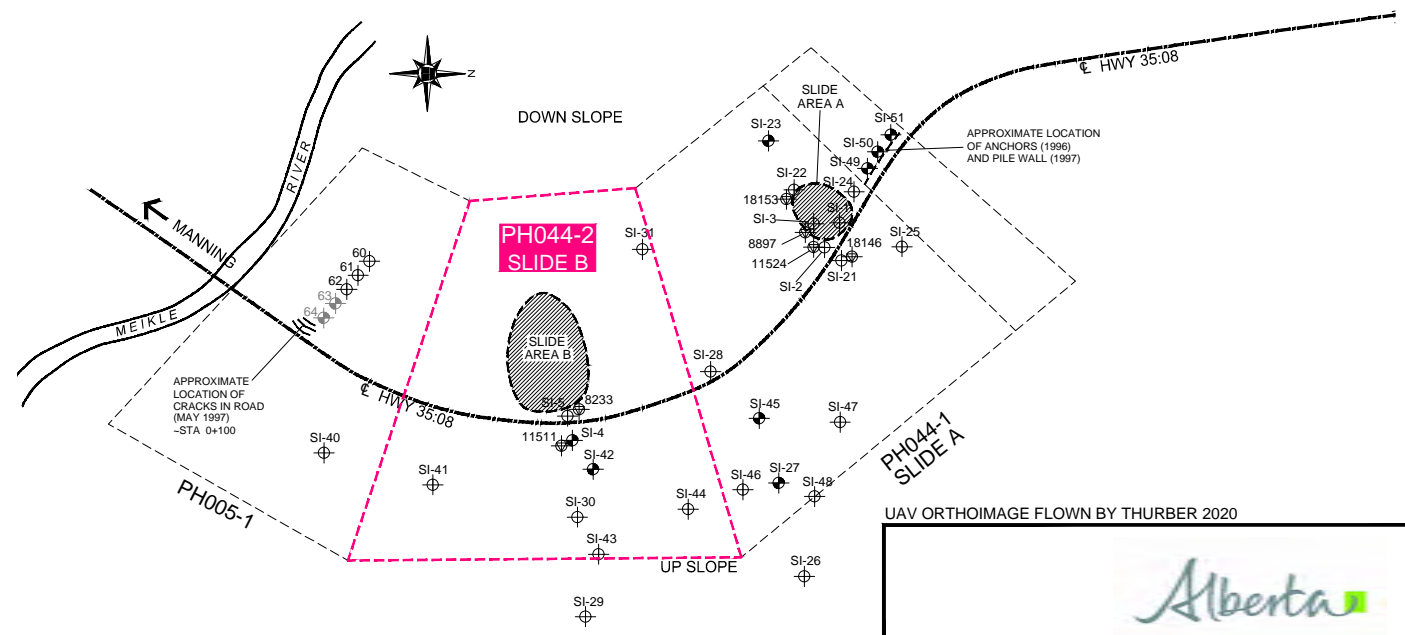
DWG No. 32121-PH044-2-1

<b>SLIDE B</b> (km 25.82 was STATION 0+500): - See Drawing 13351-PH044-2-1		
<p>The landslide movement consists of a rotational landslide located downslope of the pile wall. Although the wall appears to be protecting the highway, there is increasing raveling and eroding of the slope adjacent to the highway. After being relatively stable for the previous few years, the new movement observed in 2020 continued to deteriorate in 2022: tension cracks are forming near the headscarp, an intermediate scarp formed in the main scarp, and the skin landslide extension to the north has extended further.</p>

It is believed that the landslide has occurred due to a gradual loss of cohesion of the clay embankment fill due to surface weathering. Ongoing slope movement could eventually reduce the support to the back of the pile wall and result in distress to the wall and highway.

- Slide A: alternatively, a pile wall could be constructed at the shoulder to protect the highway similar to the approach taken at Slide B.
- Slide B: Consideration could be given to excavating and replacing the landslide material below the wall and reconstructing the slope at a flatter angle with well-compacted, moisture-conditioned clay benched into the intact fill. Soil nailing could be considered as an alternative to stabilize the upper portion of the landslide.

- Slide B: The concrete ditch liner at the north end of the landslide is cracked and could be repaired with fillcrete, which would prolong the useful life or replaced. Consideration should be given to installing a half-culvert to convey the water to the toe of the slope rather than spilling onto the fresh movement area.

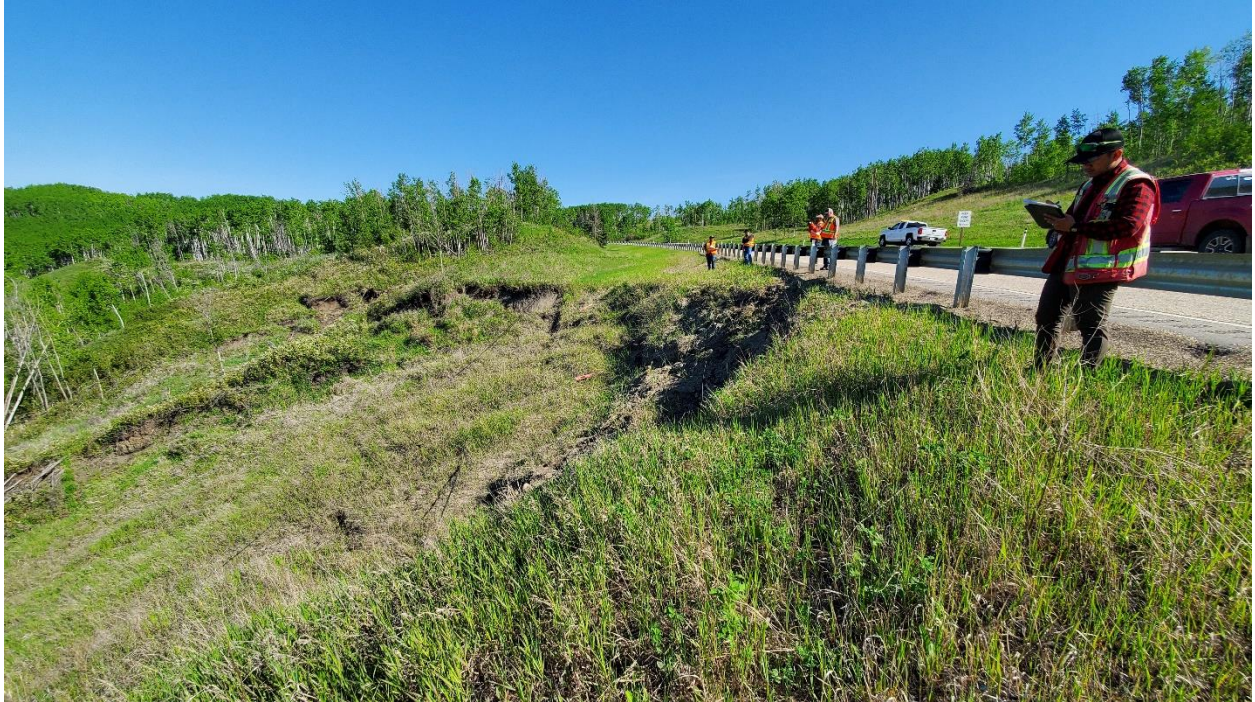
Photo 1 – Slide B: Backscarp and highway, looking north.

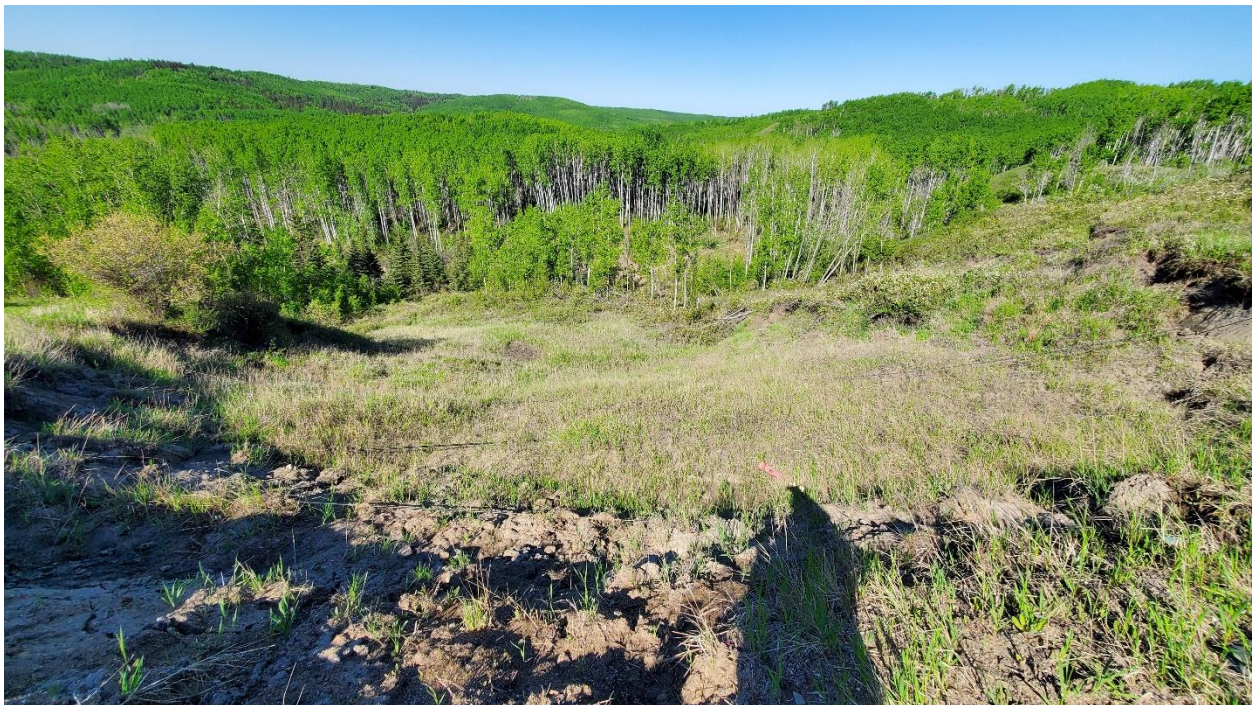
Photo 2 – Slide B: View of slope failure and landslide block, looking southwest.

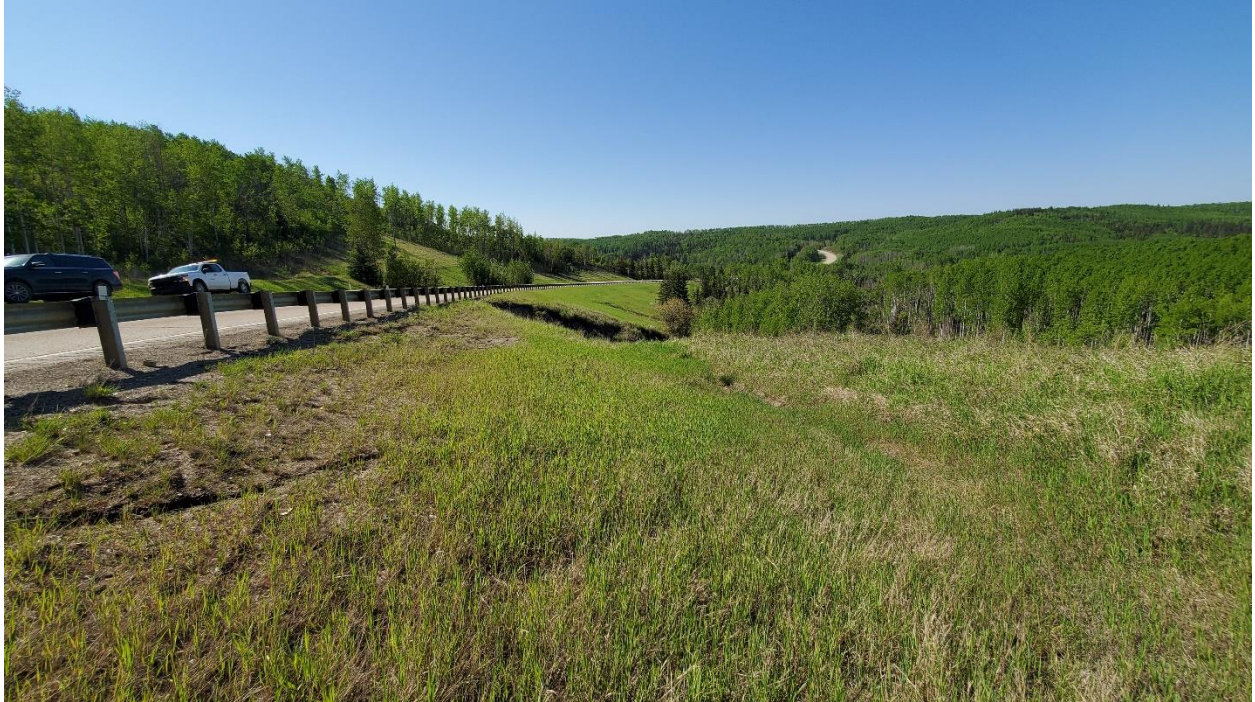
Photo 3 – Slide B: Backscarp and highway, looking south.

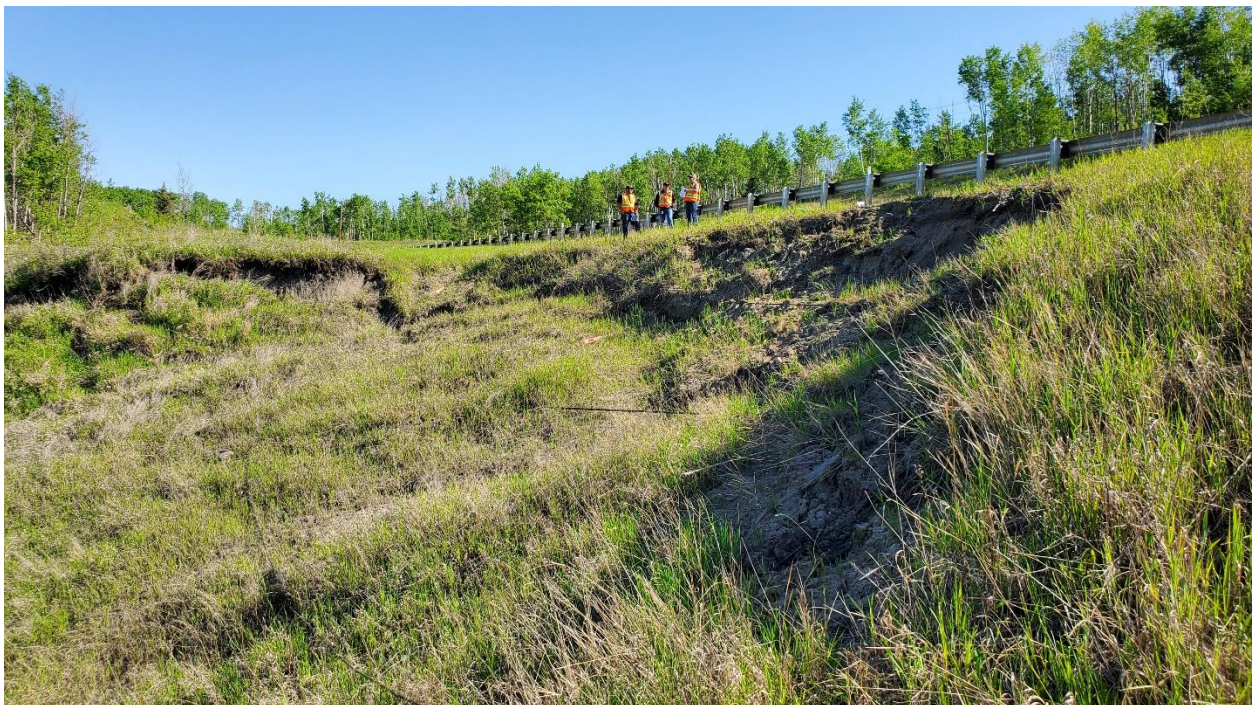
Photo 4 – Slide B: View of backscarp looking north.

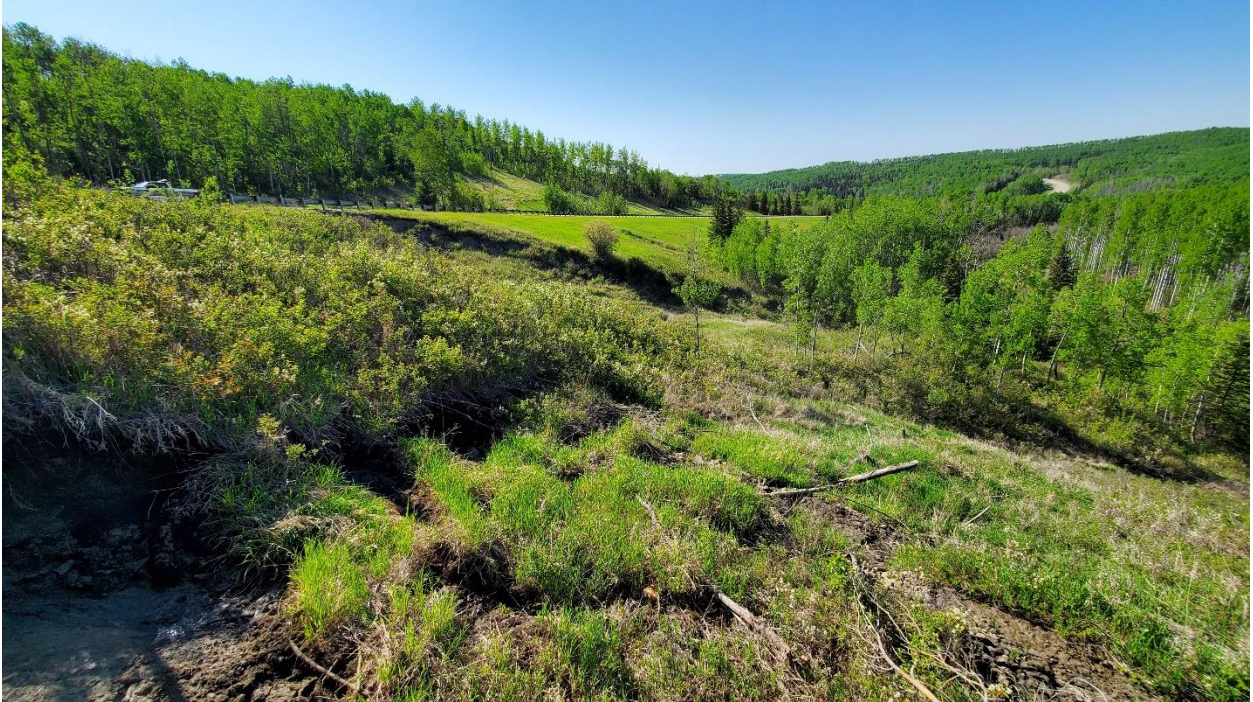
Photo 5 – Slide B: Looking south at the developing extension on the north side of the landslide.

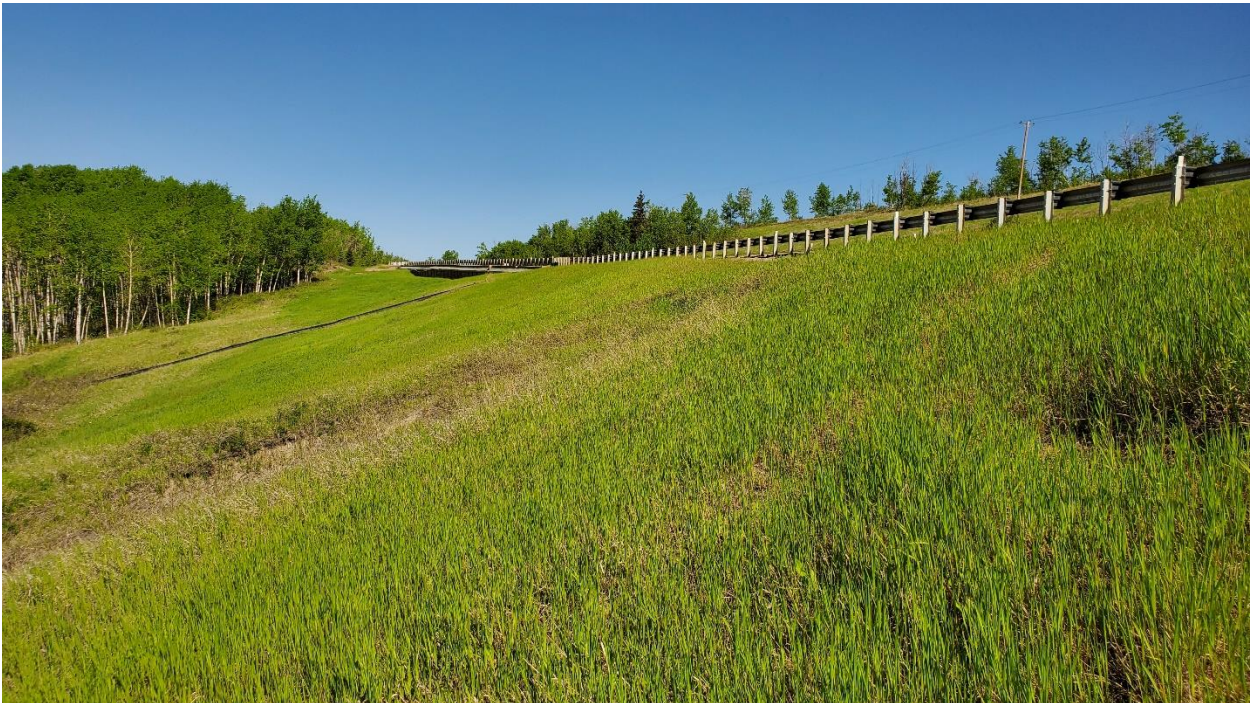
Photo 6 – Slide A: Embankment sideslope, looking north.

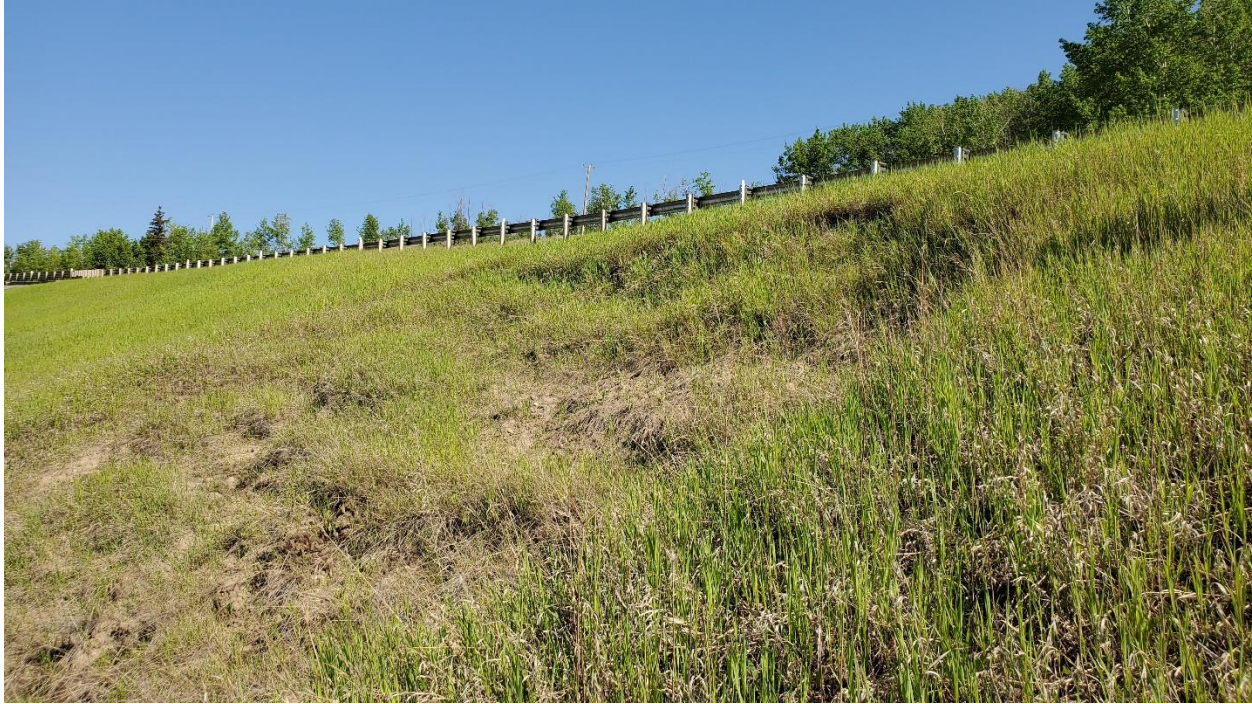
Photo 7 – Slide A: Embankment sideslope, looking northeast.

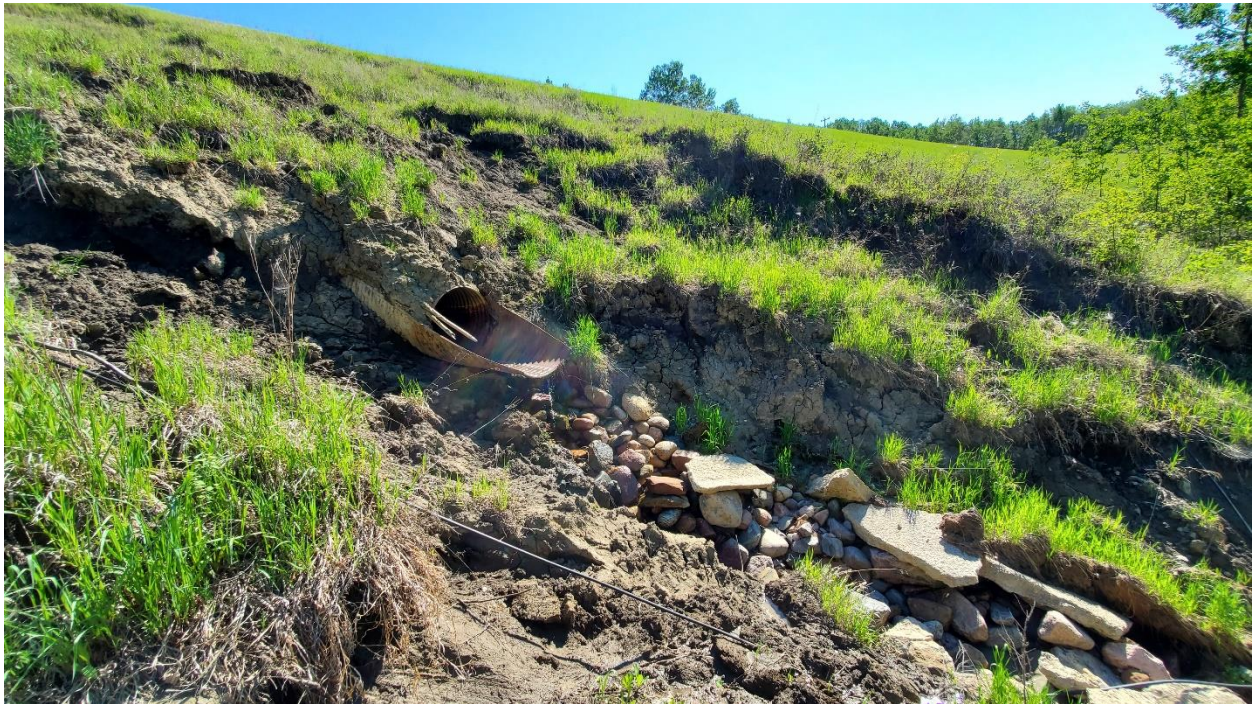
Photo 8 – Slide A: Slope movement near the toe of the slope, looking east. Recent movement has occurred below and to the left of the culvert outlet.

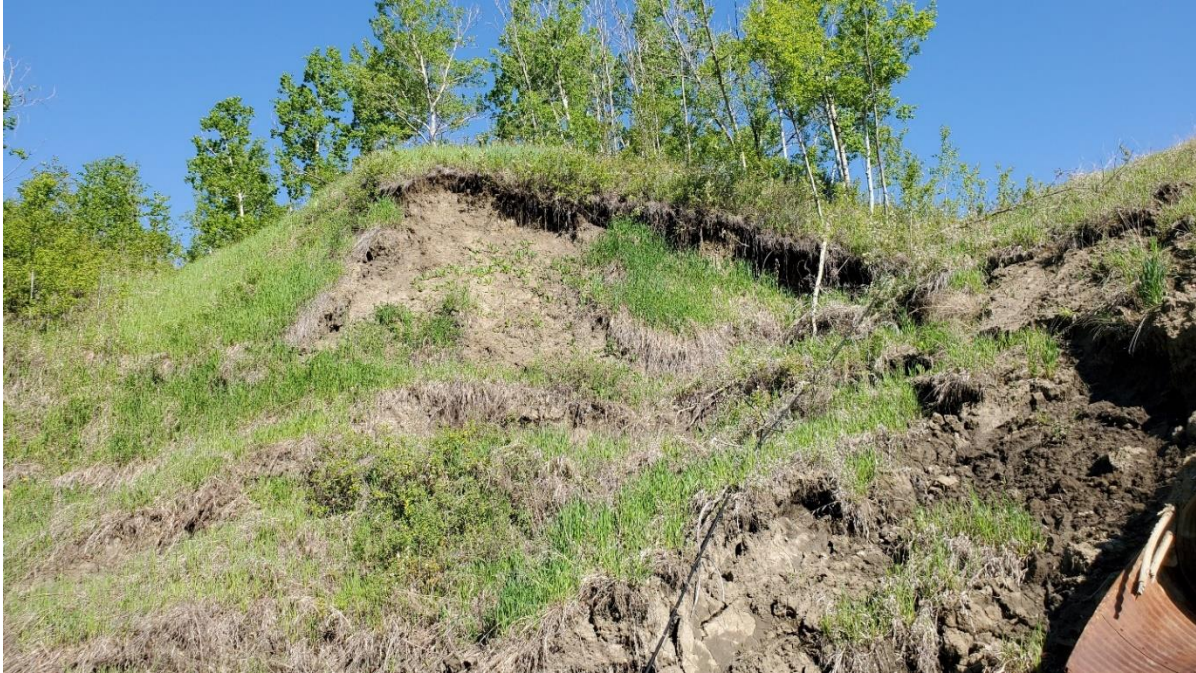
Photo 9 – Slide A: Downslope view, looking west. Some vegetation has slumped off the face on the left hand side. A former grass-covered access route is located on the left side of the small hill in the center of the photo.

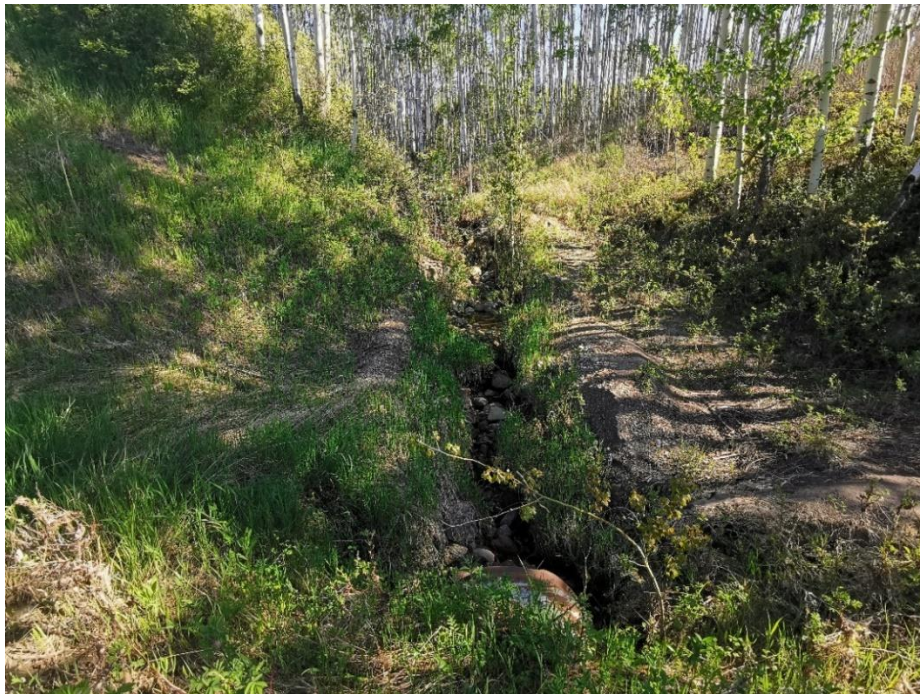
Photo 10 – Slide A: Erosion gully outside culvert inlet, looking northeast. Note fresh silt deposit on the right-hand side.

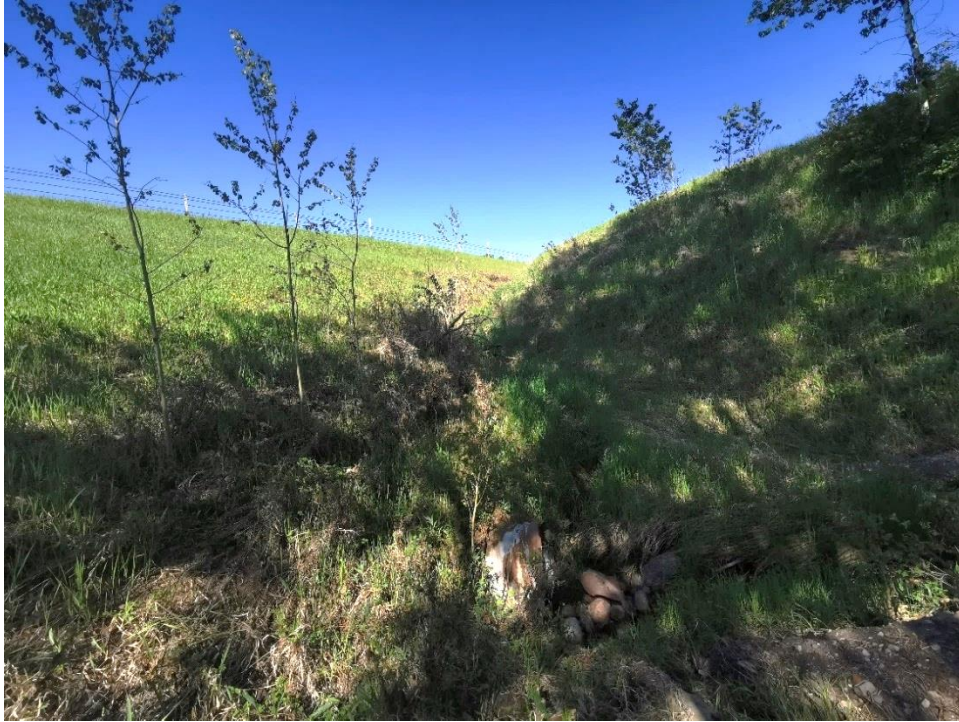
Photo 11 – Slide A: Erosion gully in sideslope draining towards culvert inlet, looking north.

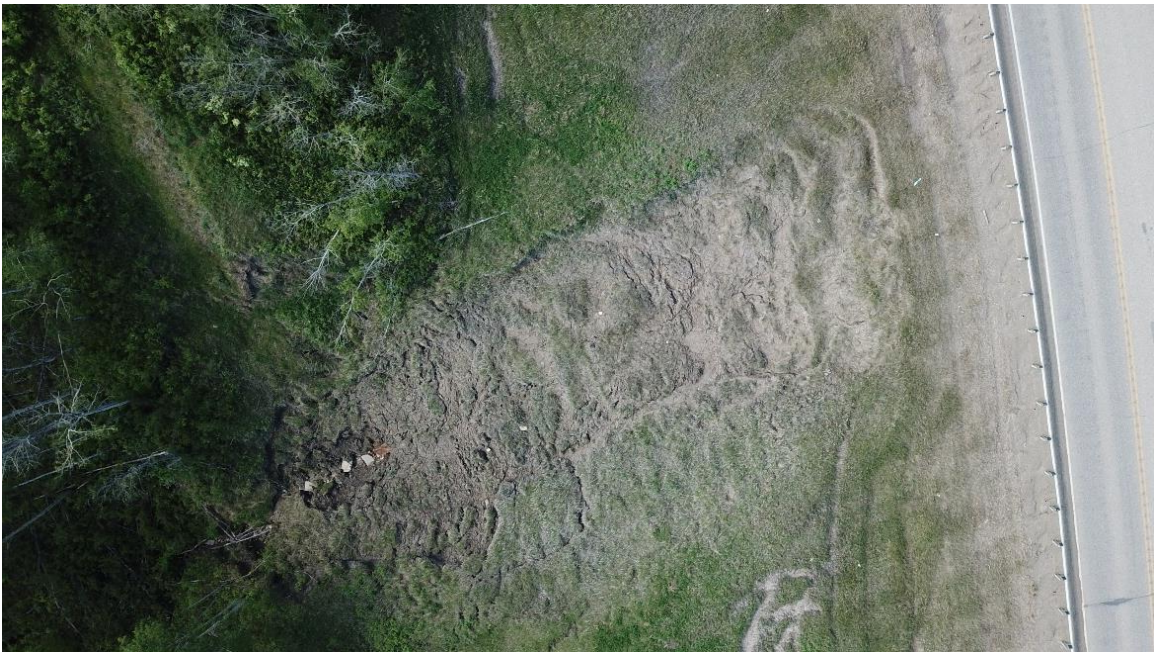
Slide A: 2020 UAV photo of landslide.

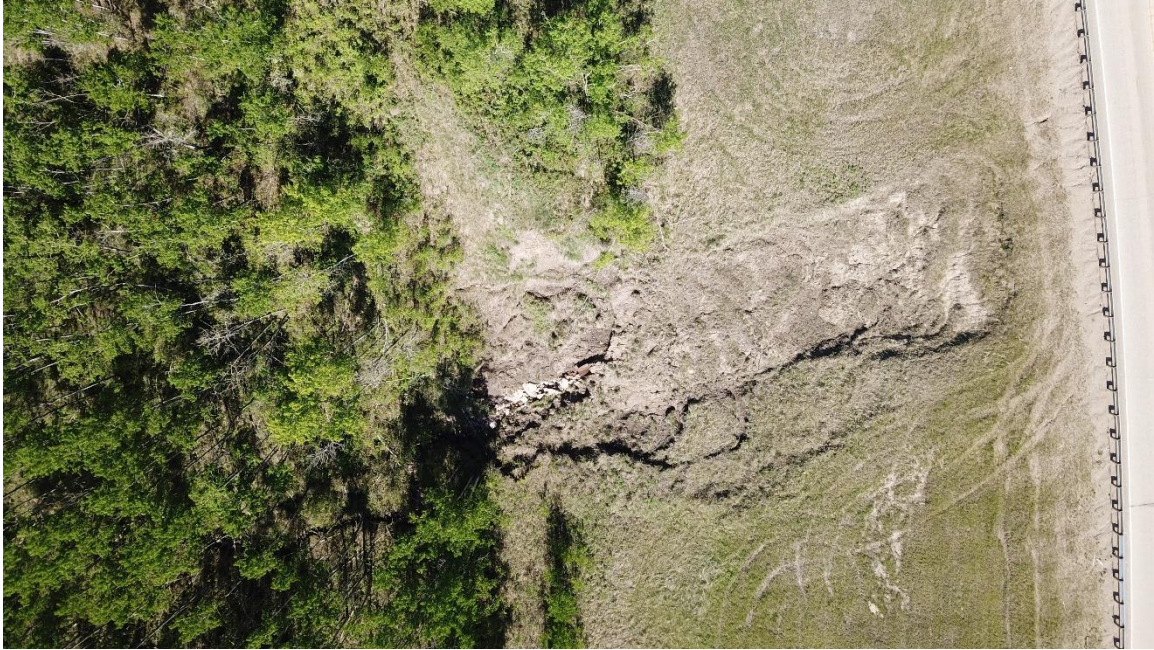
Slide A: 2022 UAV photo of landslide.
