**ALBERTA TRANSPORTATION AND
ECONOMIC CORRIDORS
GEOHAZARD ASSESSMENT PROGRAM
PEACE REGION (PEACE RIVER DISTRICT)
2024 INSPECTION**

Site Number	Location	Name	Hwy	km
PH044-1 (A) PH044-2 (B)	North of Manning, AB	Meikle River Slides A and B	35:08	26.14 25.82
Legal Description		UTM Co-ordinates		
Slide A: SW7-94-22-W5M		11 E 467,665	N	6,333,024

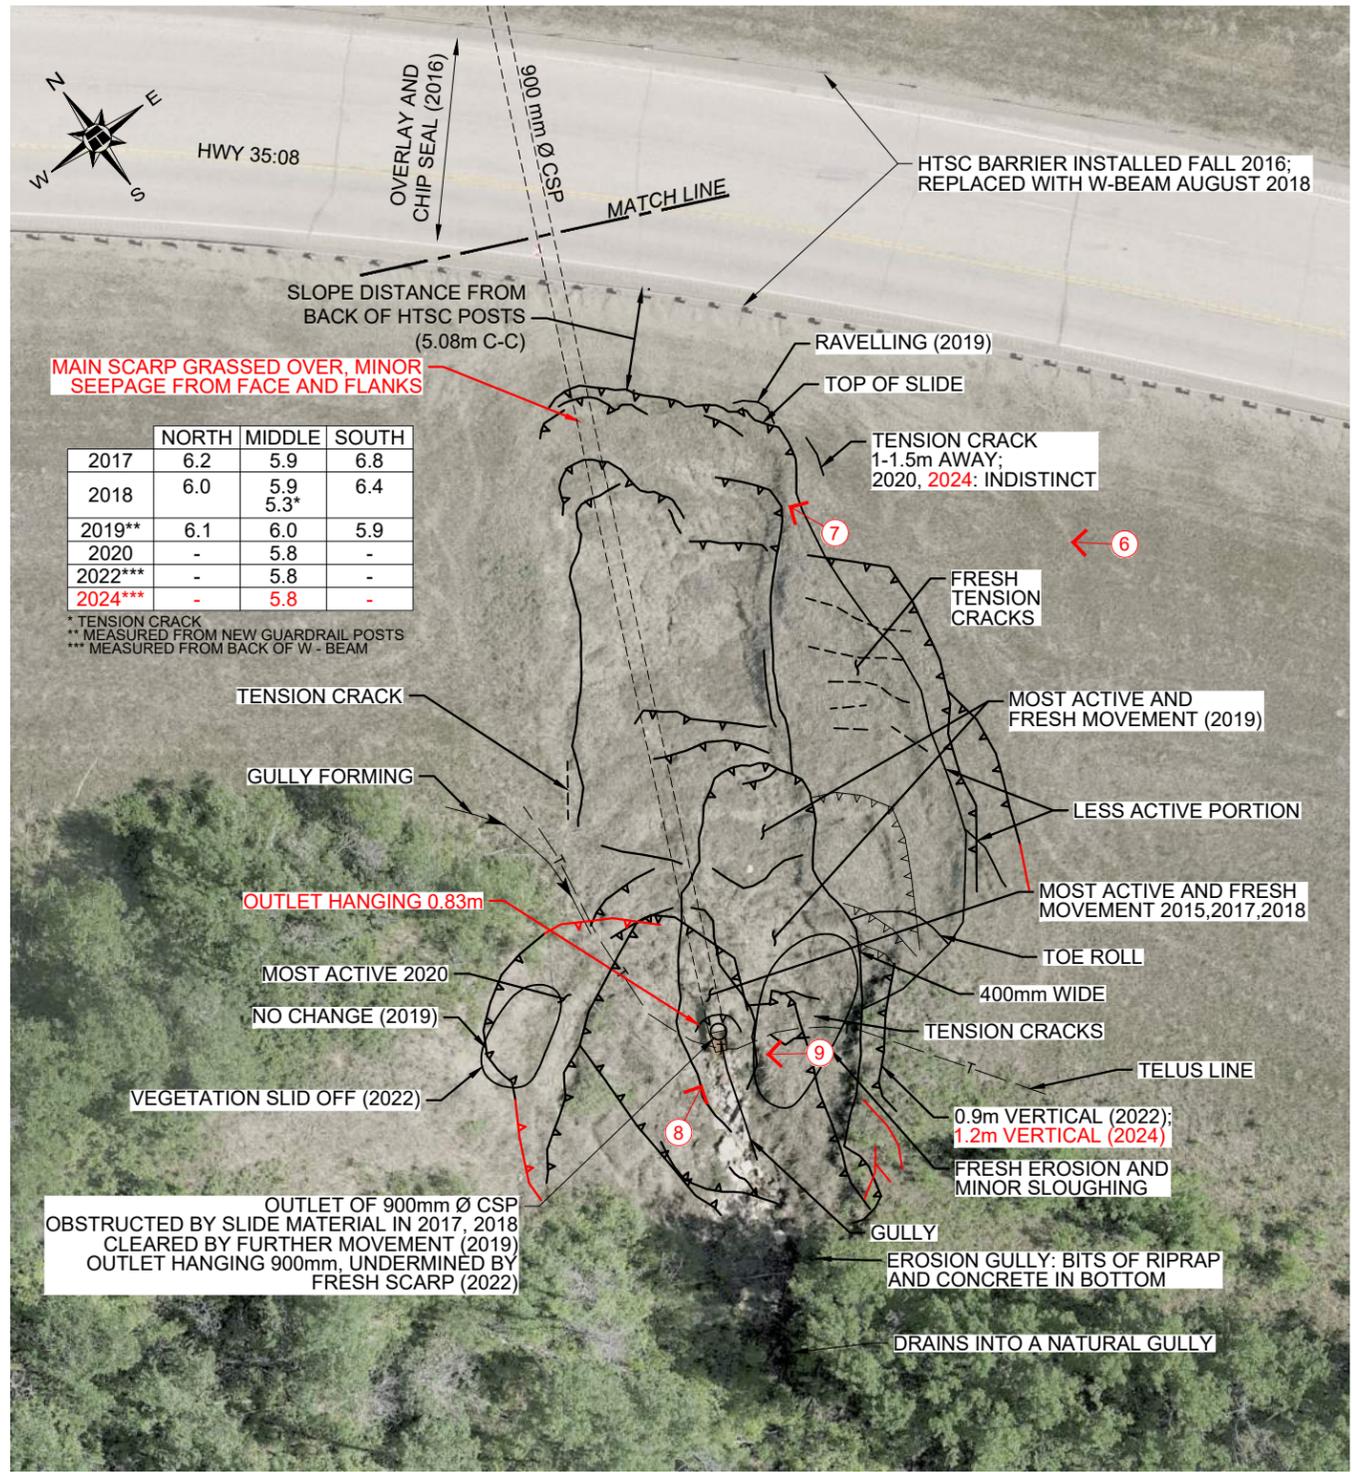
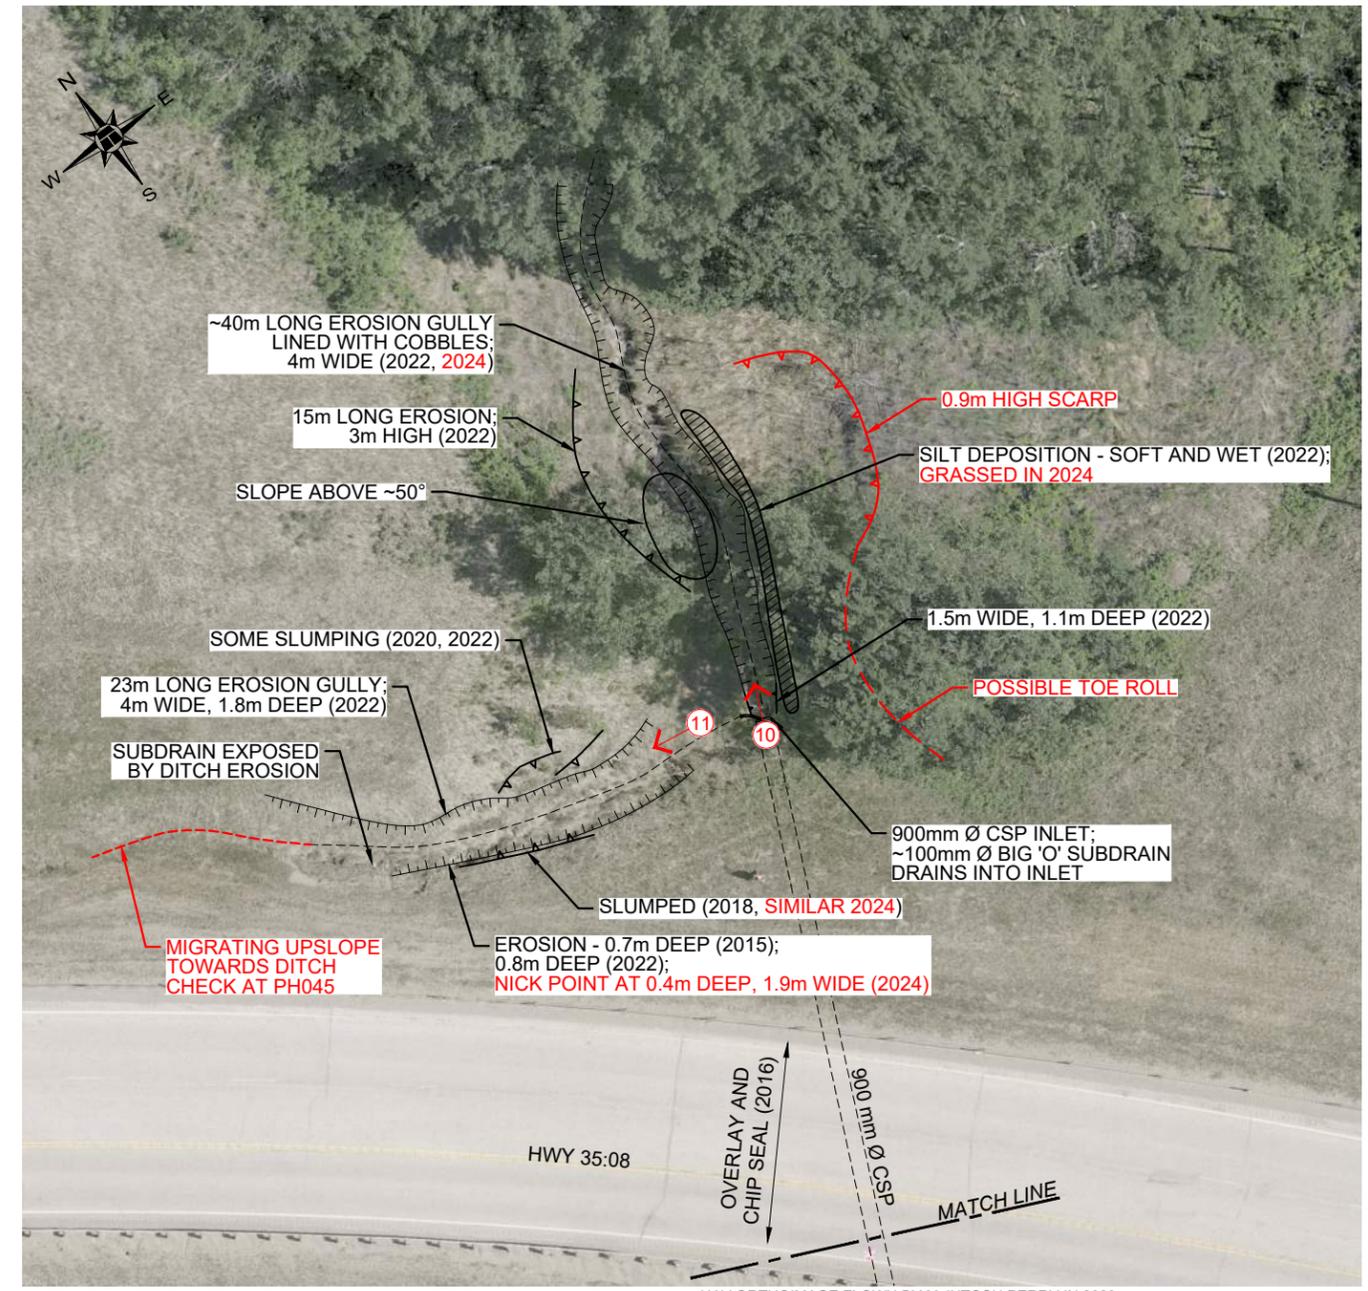
DWG No. 32121-PH044-1-1

SLIDE A (km 26.14, was STATION 0+650) – See Drawing 32121-PH044-1-1:

The landslide movement consists of a rotational landslide with two blocks occurring on an 18 m high embankment inclined at an overall angle of 18°. The headscarp has ravelled in the past and has been relatively stable since 2019. However, the lower slope continues to be active with an extension of a tension crack observed on the east side, large extensions of the active scarp on the west side and continued movement below the hanging culvert outlet. The pavement surface does not appear to be currently affected by the movements at Slide A. It is believed that the landslide has occurred due to a gradual loss of cohesion of the clay embankment fill due to surface weathering (similar at Slide B). The crest of the landslide has retrogressed about 1.7 m since 2009 and evidence of seepage (salt staining) was previously noted in the backscarp about 1 m below the crest. Measurements of the offset between the guardrail and the slide crest indicate the crest has not regressed toward the road since 2020, and remains about 5.8 m. There is a significant erosion channel developing below the culvert outlet which is causing continued slumping at the toe of the slope which has regressed upslope and above the culvert.

A silt deposit noted in 2022 on the southeast side of the upslope culvert outlet is now grassed over. In 2024, a scarp and toe roll were noted on the east side of this gully. The gully in the upslope ditch appears to be migrating westward towards the ditch check at PH045.

- Slide A: Consideration should be given to lining the culvert and welding a downpipe to the outlet to direct culvert flow to the bottom of the slope into a dissipation bowl. This could reduce some of the driving force on the landslide and minimize issues that may arise from the reduced culvert flow due to the covered outlet. An inspection of the culvert should be undertaken to confirm that it is intact.

- Slide A: The upslope ditch erosion should be mitigated to reduce the risk of slumping of the highway sideslope. This could be done by reshaping the ditch which may require importing material and lining the reshaped ditch with erosion protection such as a TRM or Class 1M riprap. The ditch flow could be further improved by discharging into a proper riprap apron and directed into the culvert inlet. A similar treatment could be used for the gully north of the inlet but there is less risk to the highway and the heavy vegetation and steeper slopes would make it more difficult to repair.

- Slide A
 - The landslide material (predominantly clay till) could be removed, and the slope reconstructed at a flatter angle with well-compacted, moisture-conditioned clay benched into the intact fill slope. The culvert should be replaced or repaired following excavation of the slumped material and extended to a flatter area downslope where a dissipation bowl should be constructed. Extending the outlet may allow sufficient room for a small toe berm so the slope could be flattened somewhat. In addition, the area surrounding the culvert inlet should be regraded and protected with a high-flow soil covering.

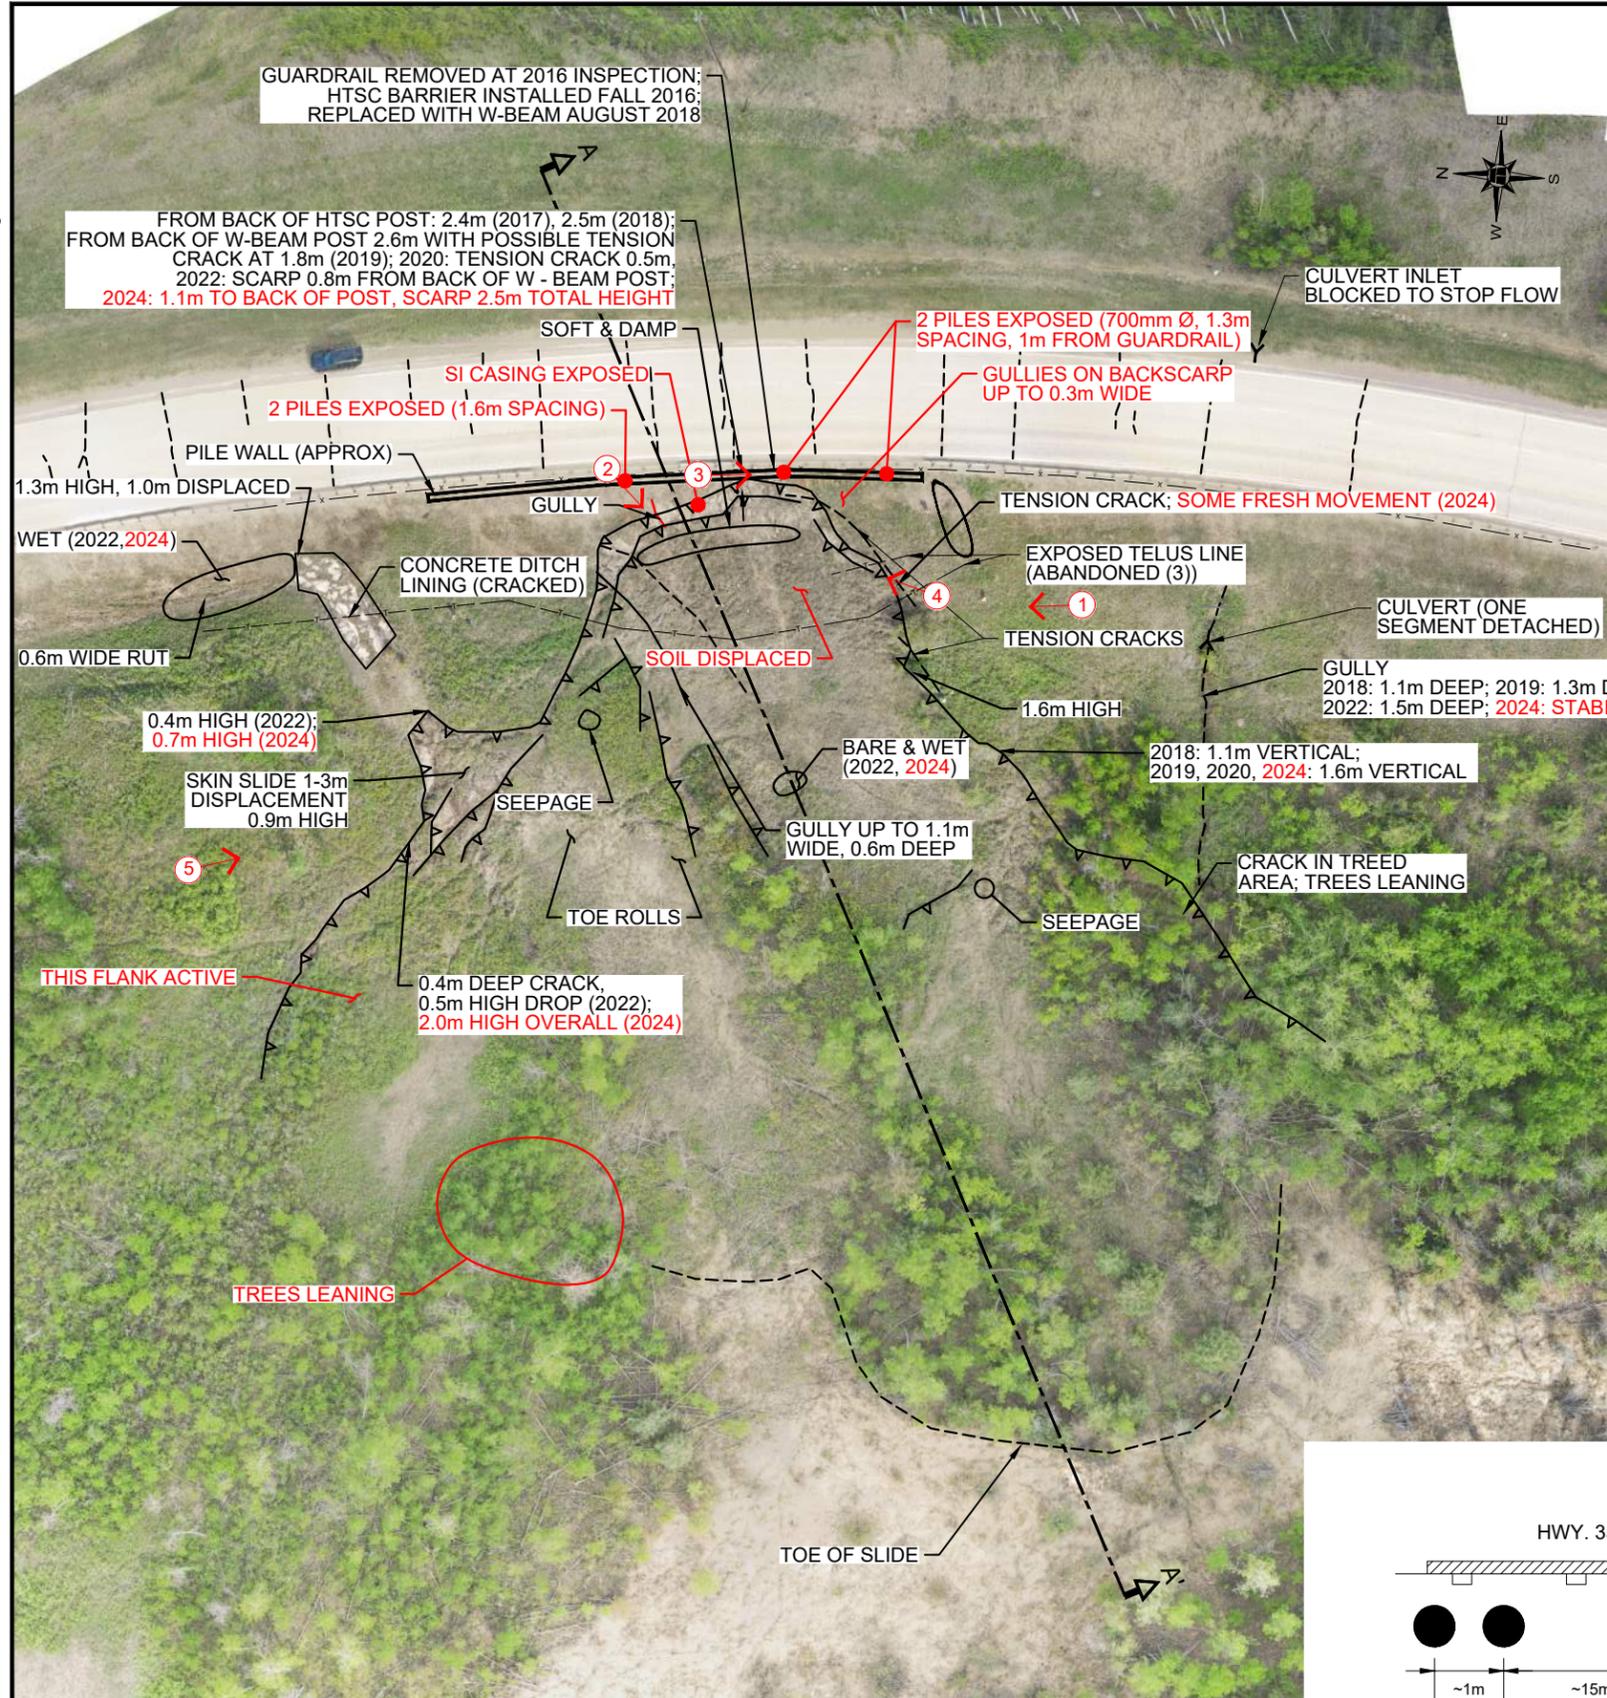
DWG No. 32121-PH044-2-1

SLIDE B (km 25.82 was STATION 0+500) - See Drawing 13351-PH044-2-1:

The landslide movement consists of a rotational landslide located downslope of the pile wall. Although the wall appears to be protecting the highway, there is increasing raveling and eroding of the slope adjacent to the highway. After being relatively stable for the previous few years, the new movement observed in 2020 continued to deteriorate in 2022: tension cracks are forming near the headscarp, an intermediate scarp formed in the main scarp, and the skin landslide extension to the north has extended further. Although it does not appear to have expanded further in 2024, there were indications that it was sliding further downslope such as leaning trees near the toe of the valley.

Downcutting in the gully below the abandoned culvert south of the landslide, which resulted in a segment of the culvert becoming detached, has not yet stabilized despite that the inlet was blocked off in 2016 but as 2024, vegetation has begun to grow and further downcutting appears to have stopped.

It is believed that the landslide has occurred due to a gradual loss of cohesion of the clay embankment fill due to surface weathering. Ongoing slope movement could eventually reduce the support to the back of the pile wall and result in distress to the wall and highway. Ravelling in 2024 has exposed some of the pile tops. File review undertaken during preliminary engineering work at the PH045 pile wall further upslope encountered details of the piles installed at this PH044 Slide B site which were reported to consist of 30 m-long span of 16 x 24 inch-dia. concrete piles installed at 2 m center-to-center spacing to a depth of 12 m reinforced with 9 M25 bars in a 20 inch-dia. cage. This wall was installed in 1993 at the same time a subdrain was installed in the upslope ditch over a length of about 70 m running about 70 m northwest from the culvert at the southeast end of the site. The subdrain consisted of 100 mm-dia. plastic pipe installed up to 4 m deep with a 1 m clay cap at the top of the trench.

- Slide B: Drainage water should be prevented from running onto the landslide area. An asphalt curb could be used to direct surface runoff away from the landslide, which will also reduce the ravelling of the embankment between the highway and pile wall.

- Alternatively, a pile wall could be constructed at the shoulder to protect the highway similar to the approach taken at Slide B.
- Slide B
 - Consideration could be given to excavating and replacing the landslide material below the wall and reconstructing the slope at a flatter angle with well-compacted, moisture-conditioned clay benched into the intact fill. Soil nailing could be considered as an alternative to stabilize the upper portion of the landslide.

- The concrete ditch liner at the north end of the landslide is cracked and could be repaired with fillcrete, which would prolong the useful life or replaced. Consideration should be given to installing a half-culvert to convey the water to the toe of the slope rather than spilling onto the fresh movement area.

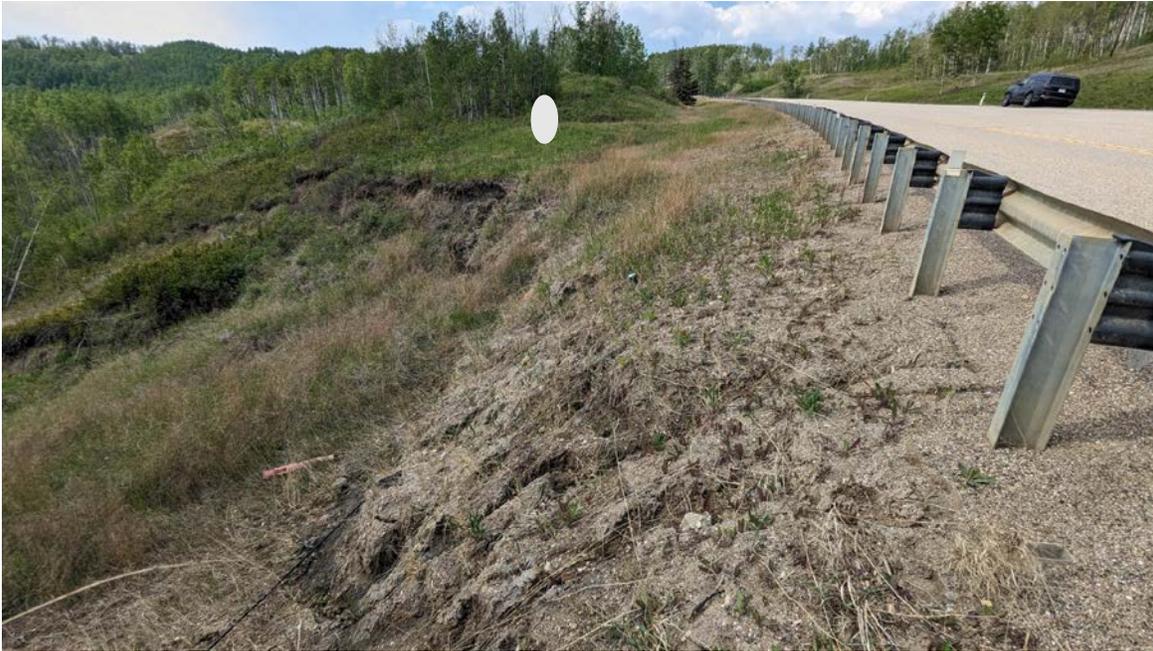
Photo 1 – Slide B: Backscarp and highway, looking north.

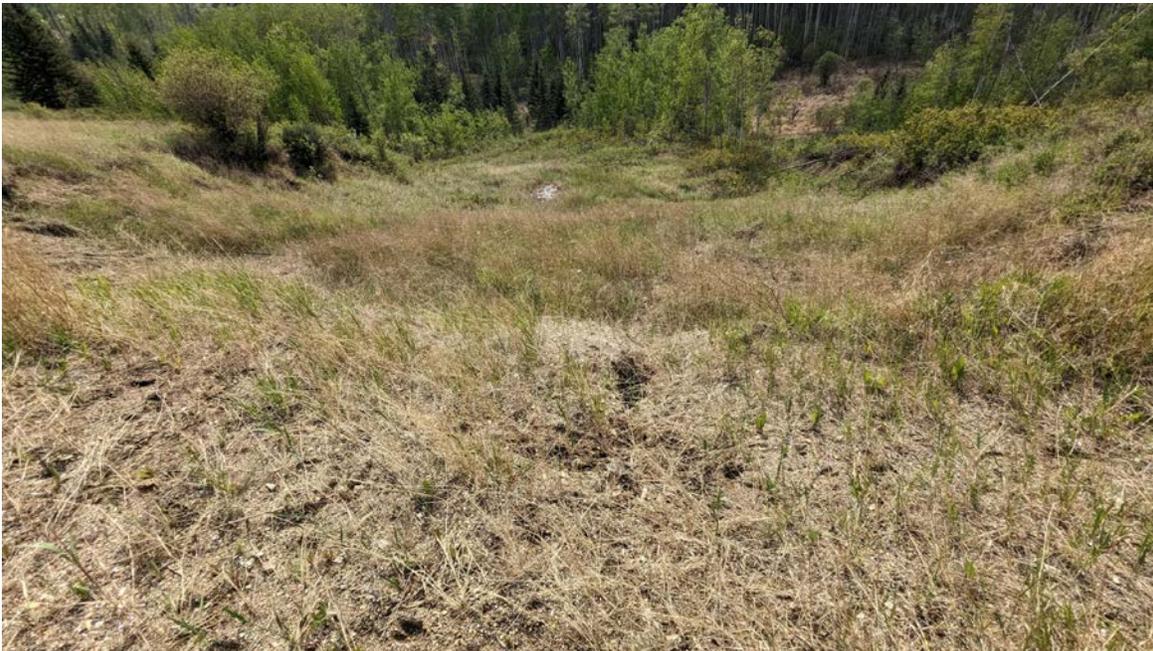
Photo 2 – Slide B: View of slope failure and landslide block, looking southwest.

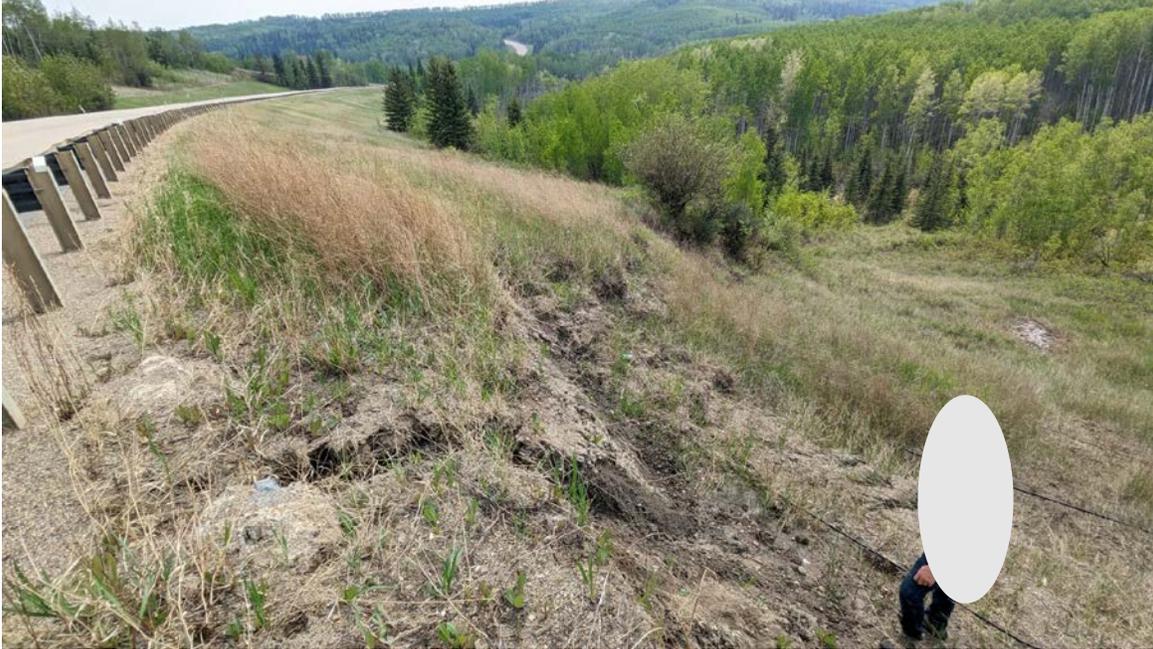
Photo 3 – Slide B: Looking south at the south half of the backscarp including two recently-exposed piles in the foreground near the guardrail.

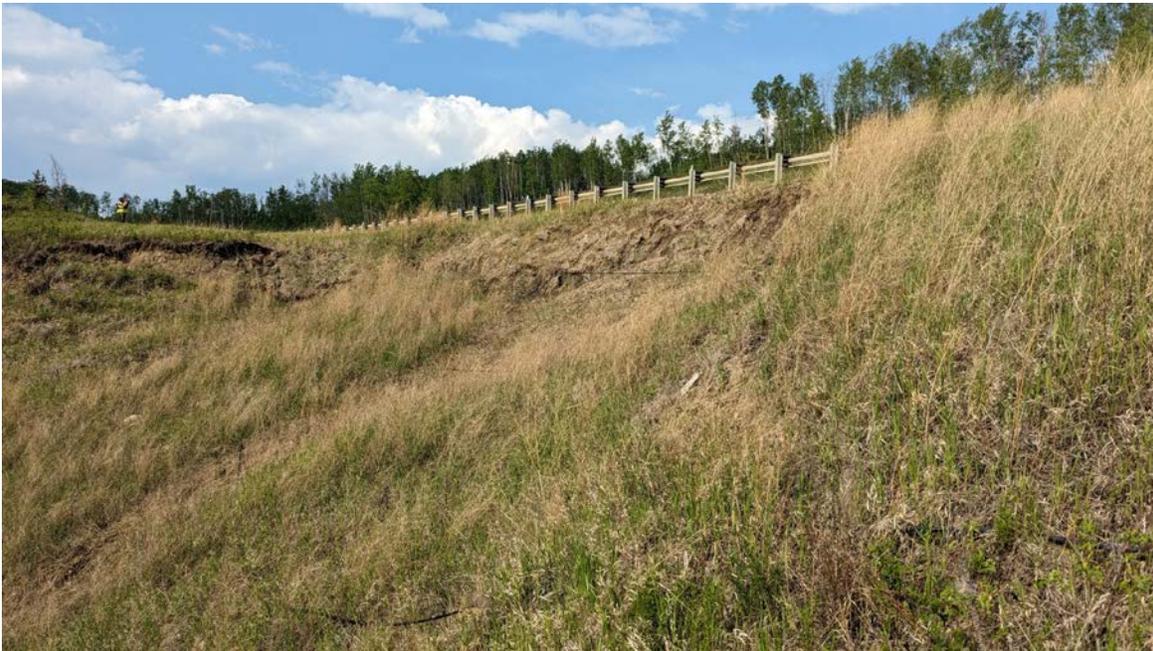
Photo 4 – Slide B: View of backscarp looking north.

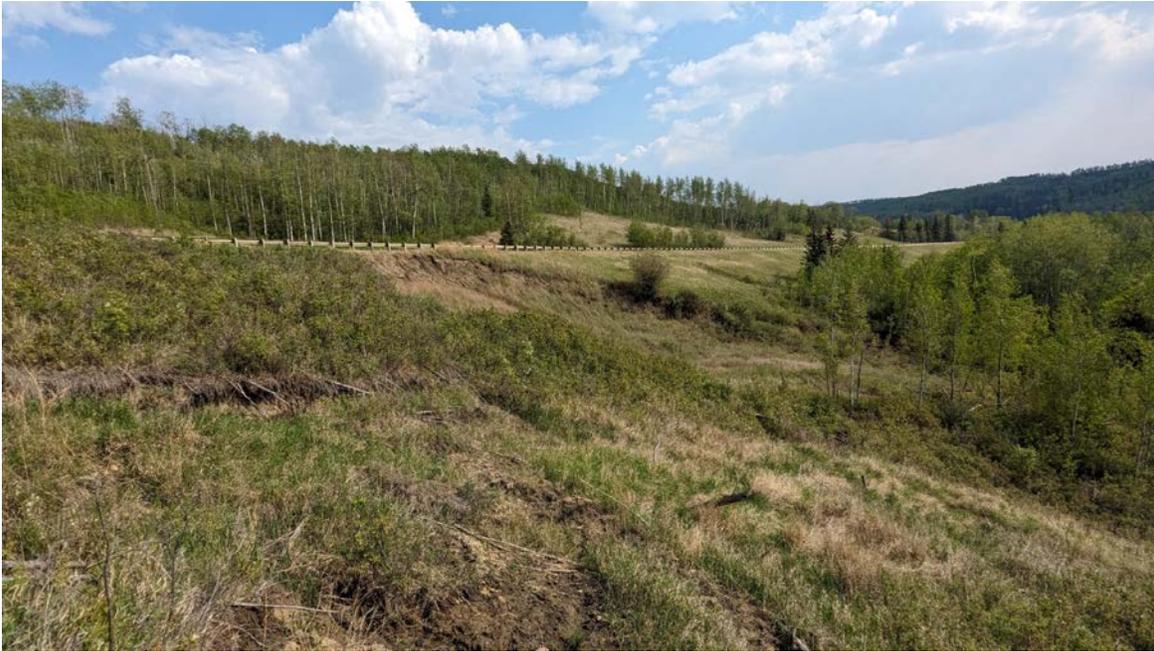
Photo 5 – Slide B: Looking south at the developing extension on the north side of the landslide.

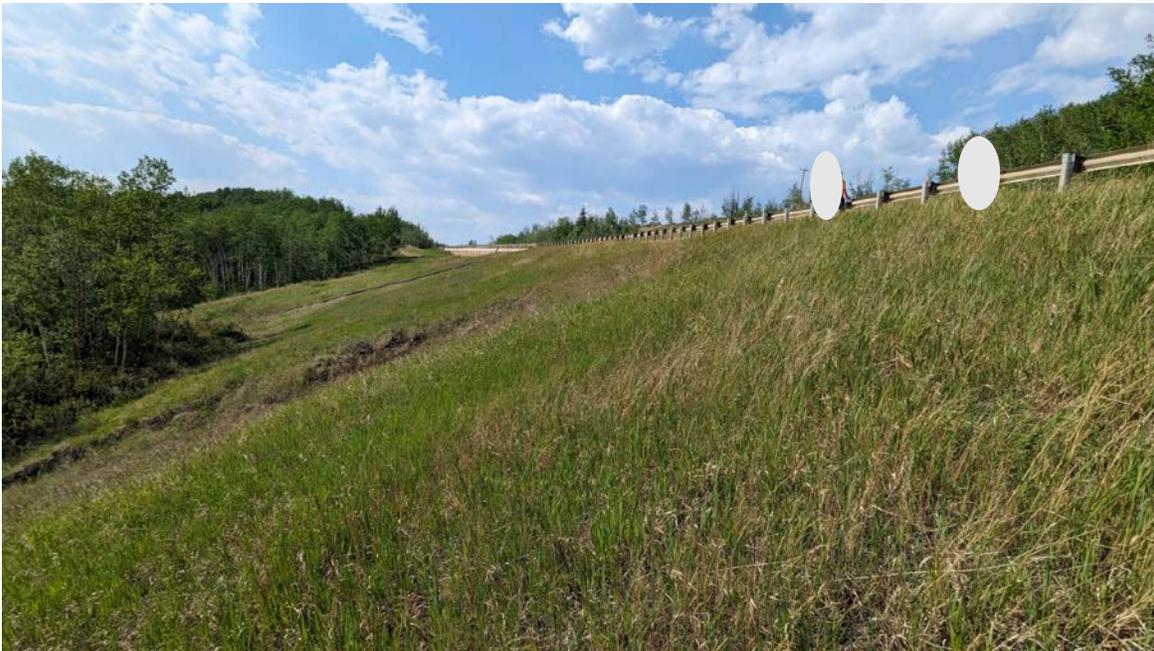
Photo 6 – Slide A: Looking northwest at the embankment sideslope.

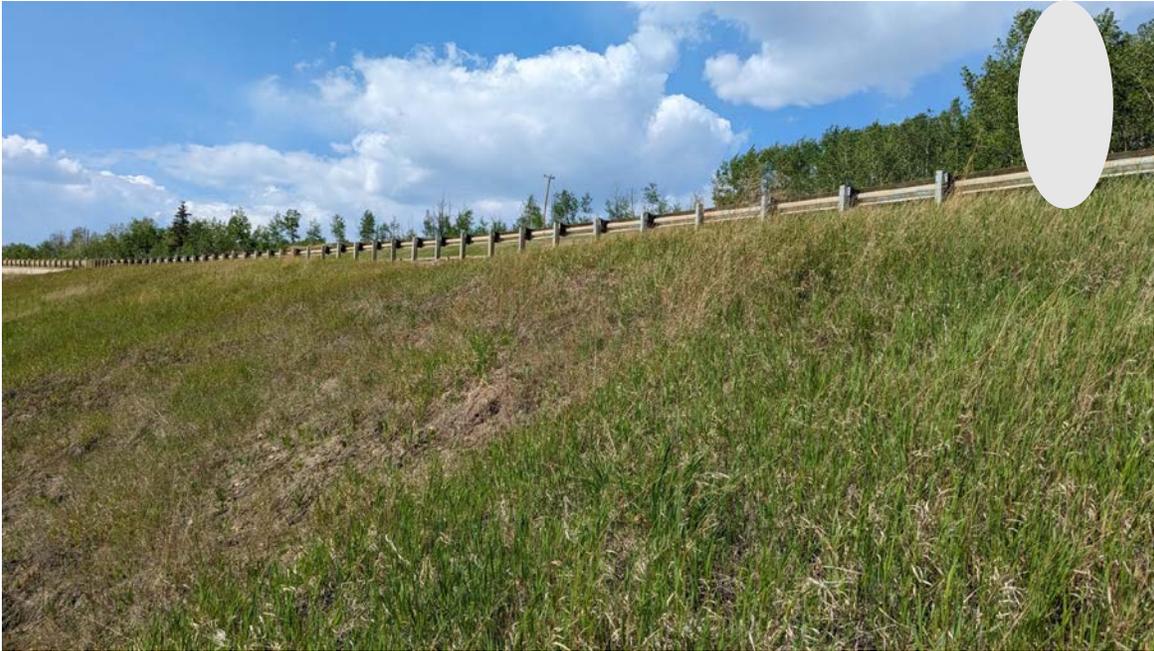
Photo 7 – Slide A: Looking north at the embankment sideslope.

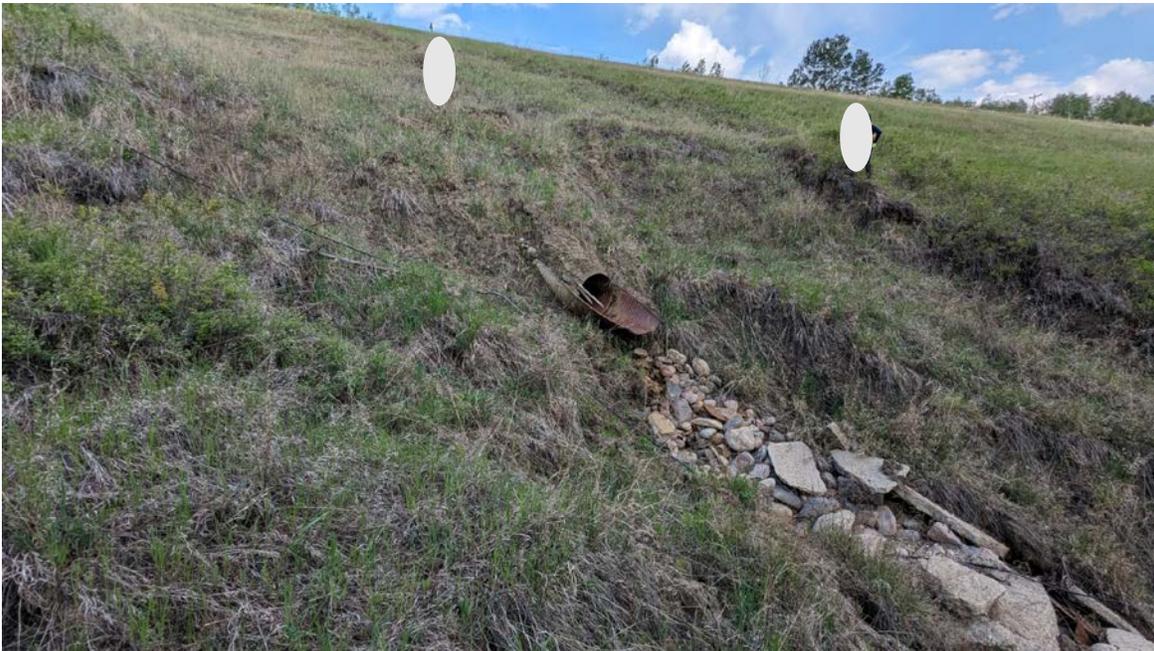
Photo 8 – Slide A: Looking east at the toe of the embankment.

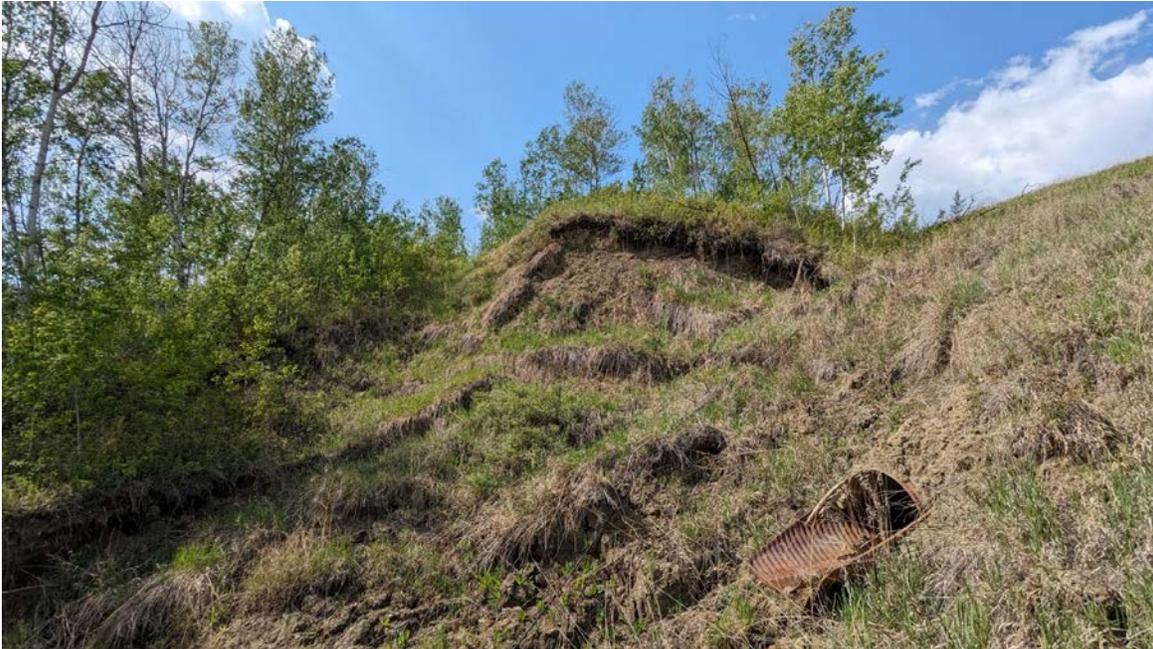
Photo 9 – Slide A: Looking northwest across hanging culvert outlet and knoll beyond where some vegetation has slumped off the face.

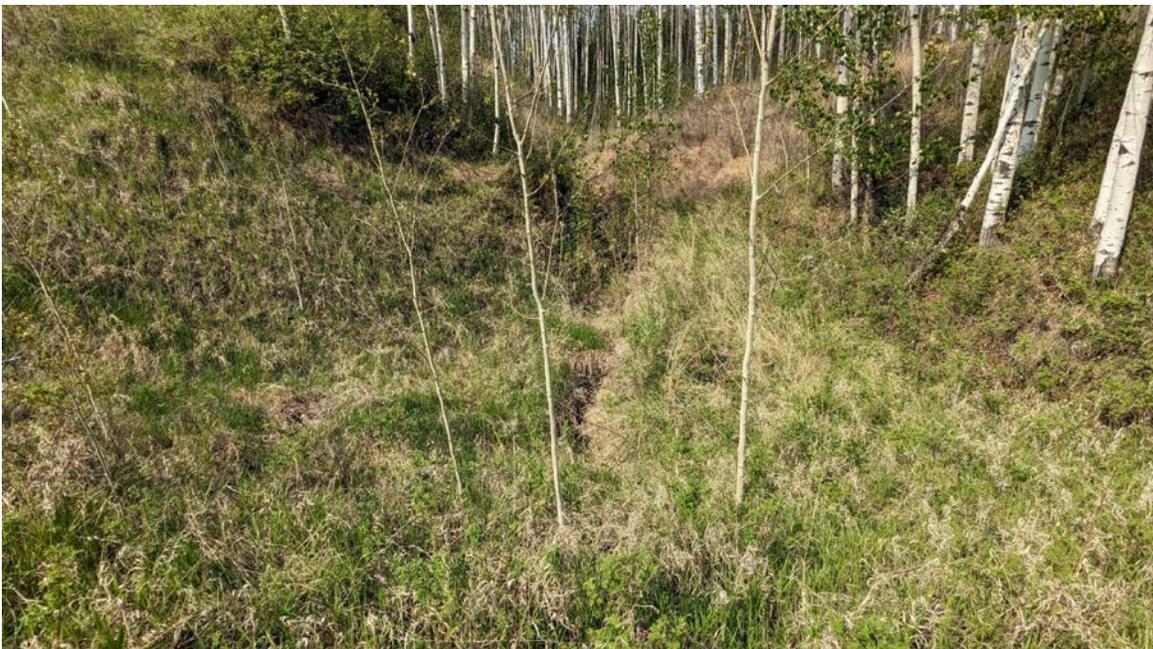
Photo 10 – Slide A: Looking northeast at erosion gully north of the culvert inlet. Note fresh silt deposit in 2022 on the right-hand side has become grassed.

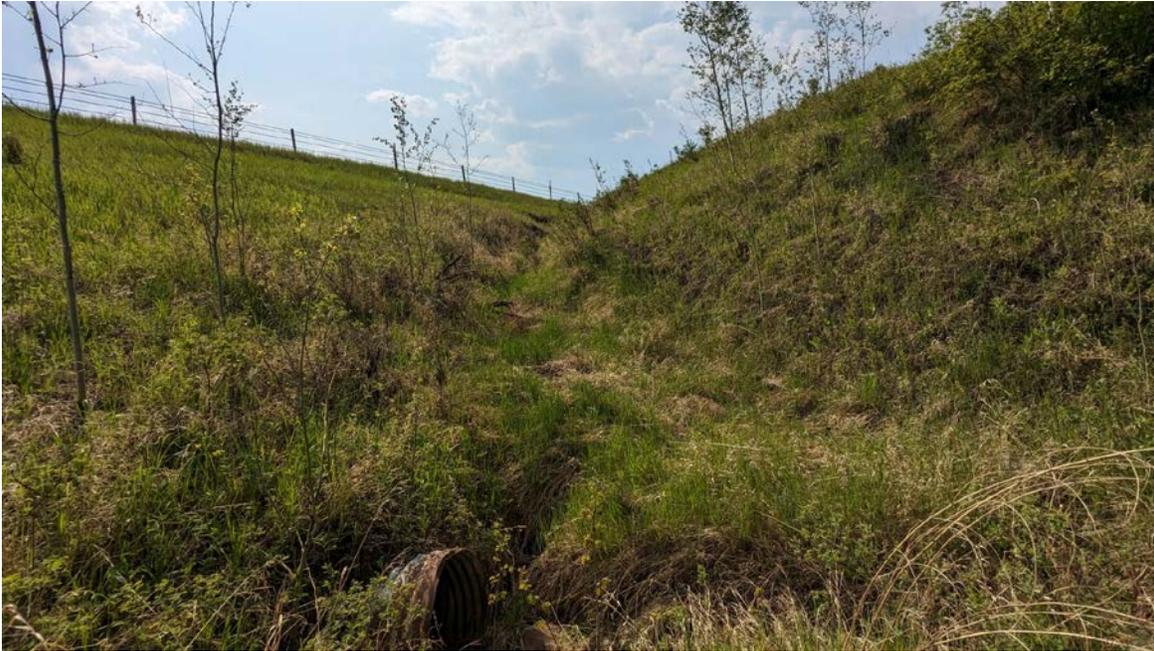
Photo 11 – Slide A: Looking north at an erosion gully in sideslope draining towards culvert inlet.
