Site Number	Location	Name	Hwy	km
PH044	HWY 35:08 C1 25.97	Meikle River Upper Slope Slides	35:08	Km 26.1 (Slide A) Km 25.8 (Slide B)
<b>Legal Description:</b>		<b>UTM Co-ordinates</b>		
6-7-94-22 W5		11U	E 467856.90 N	6332922.84

<b>Current Monitoring:</b>	24-May-2024	<b>Previous Monitoring</b>	18-Jun-2023
<b>Instruments Read By:</b>	Mr. Niraj Regmi, G.I.T., and Mr. Nixson Mationg, Thurber

**ALBERTA TRANSPORTATION AND ECONOMIC CORRIDORS GRMP (CON0022164)  
PEACE REGION (PEACE RIVER DISTRICT)  
INSTRUMENTATION MONITORING RESULTS**

**SPRING 2024**

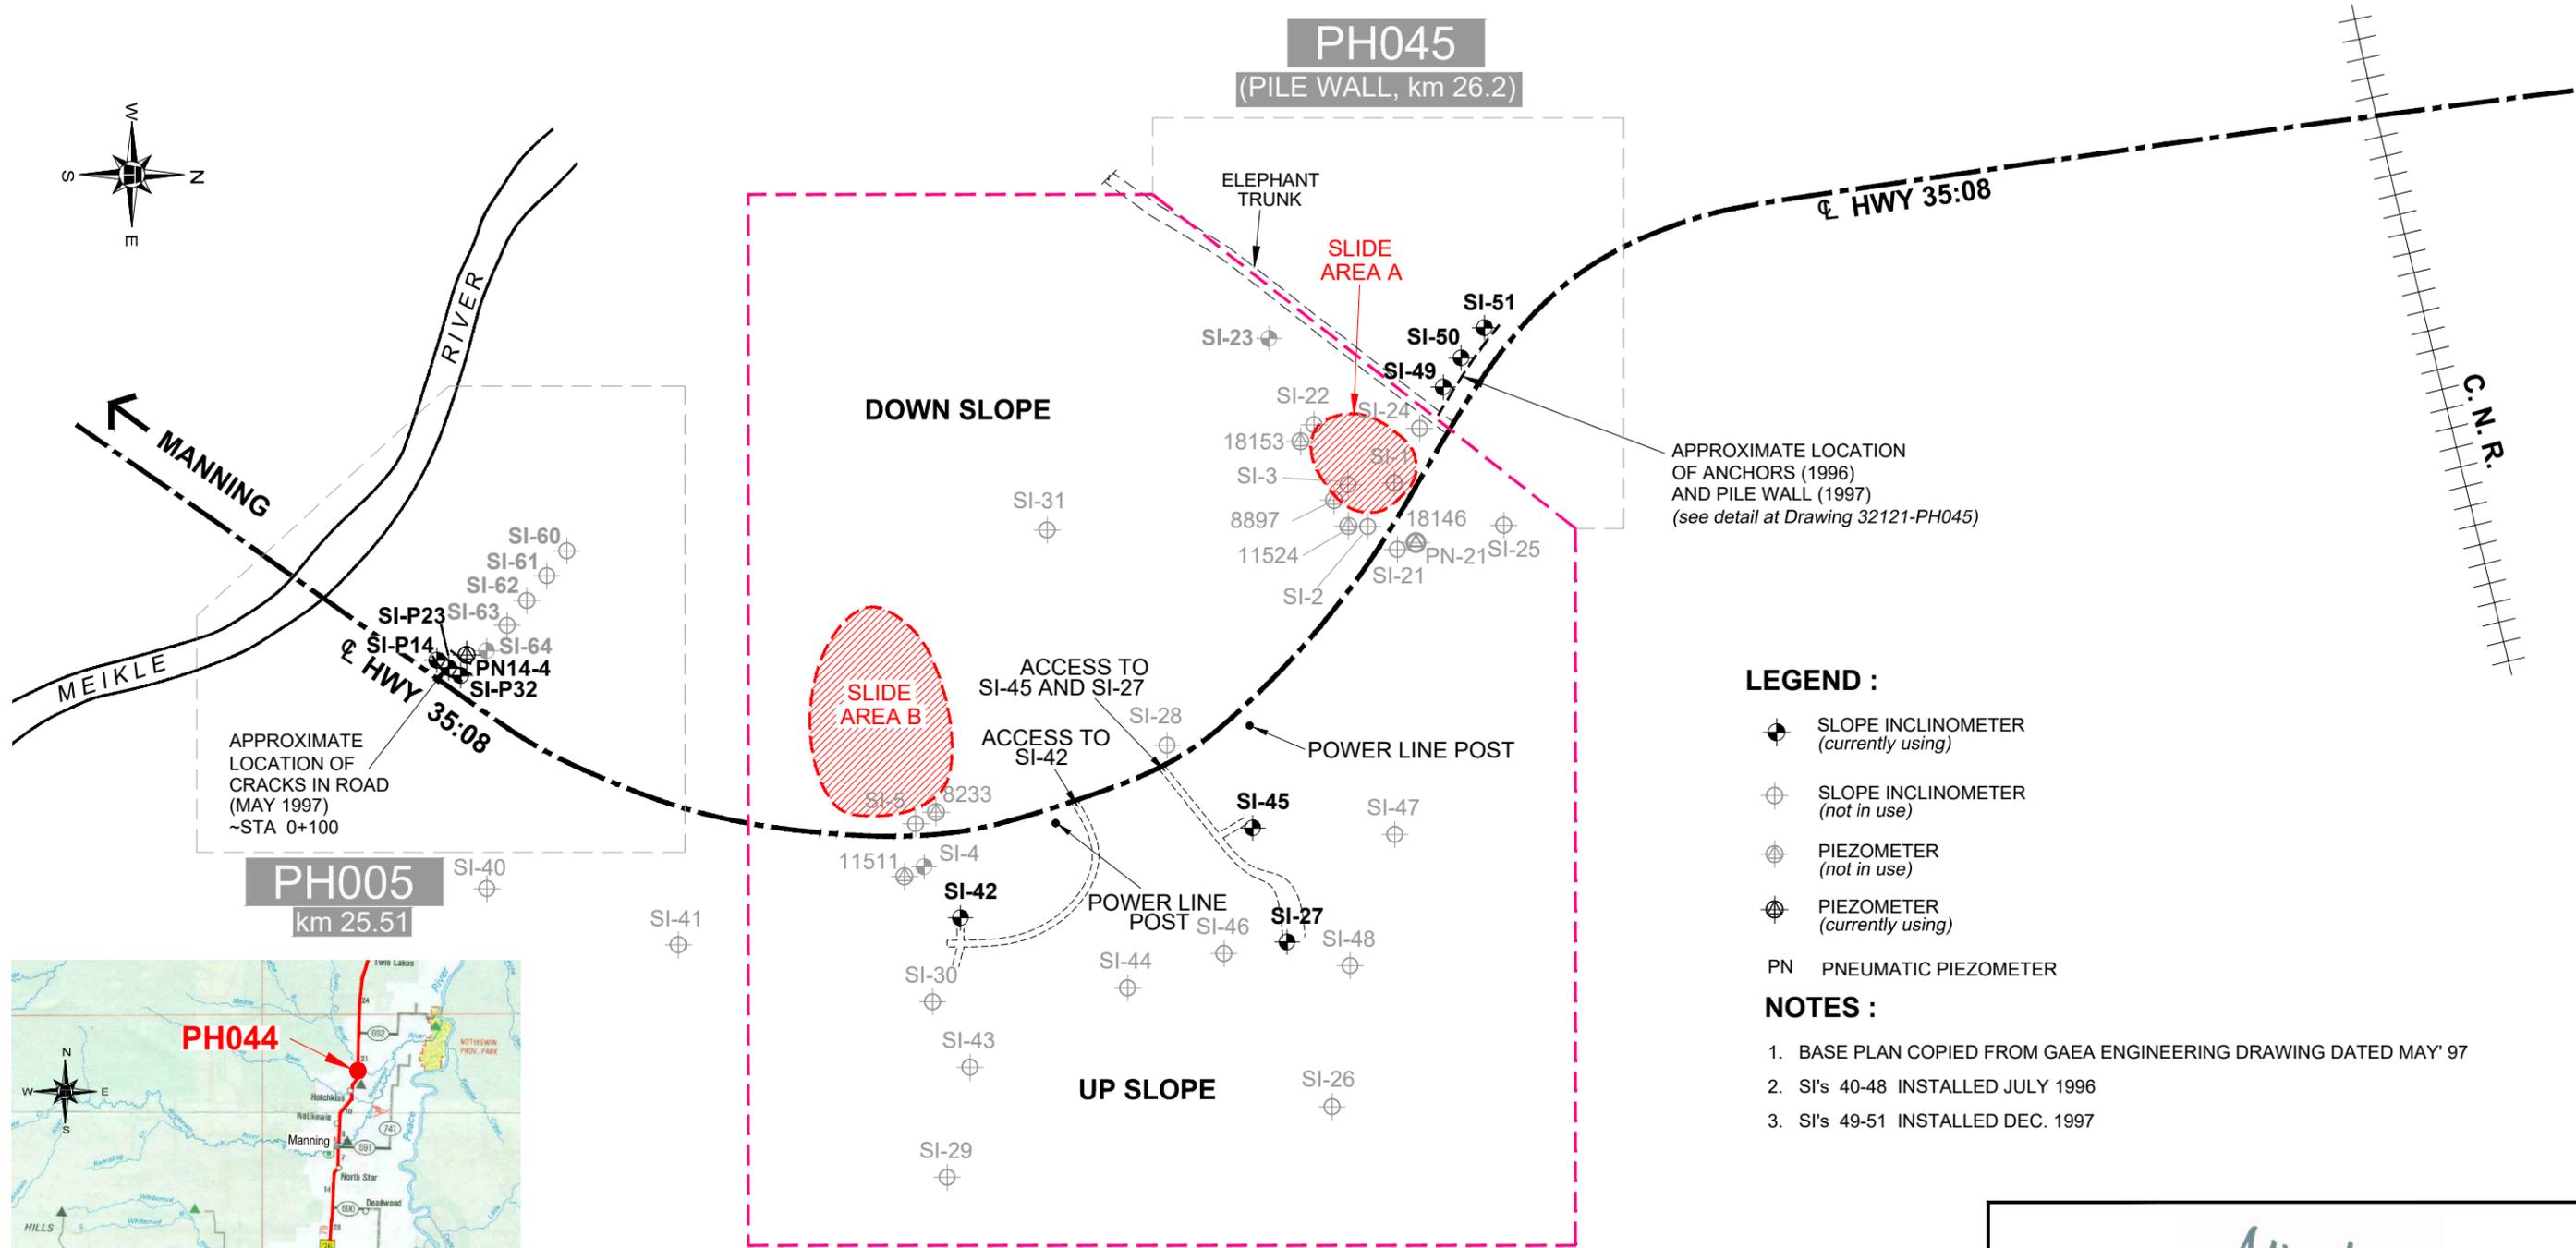
Drawing 32121-PH044 in Appendix A provides a sketch of the approximate locations of the monitoring instrumentation for this site.

APPROXIMATE LOCATION OF CRACKS IN ROAD (MAY 1997) ~STA 0+100

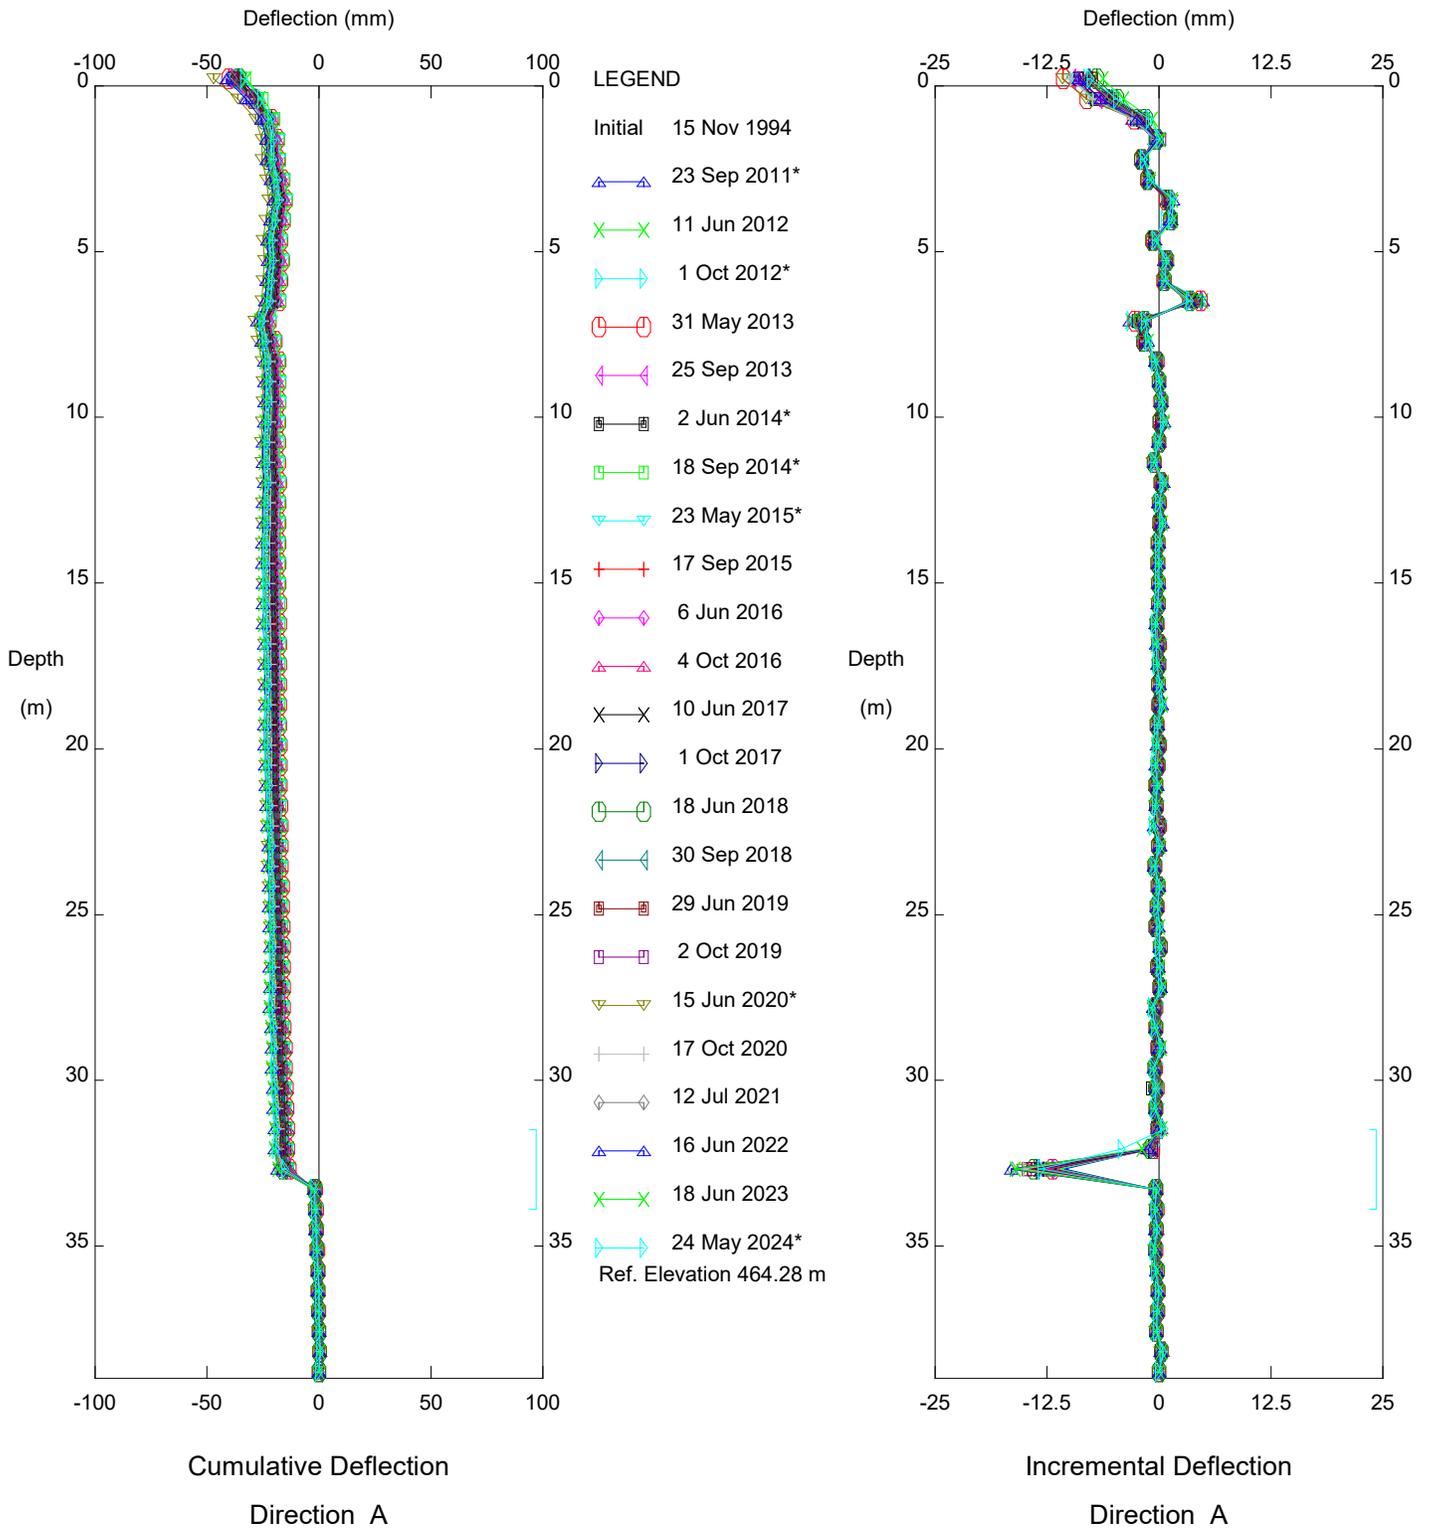
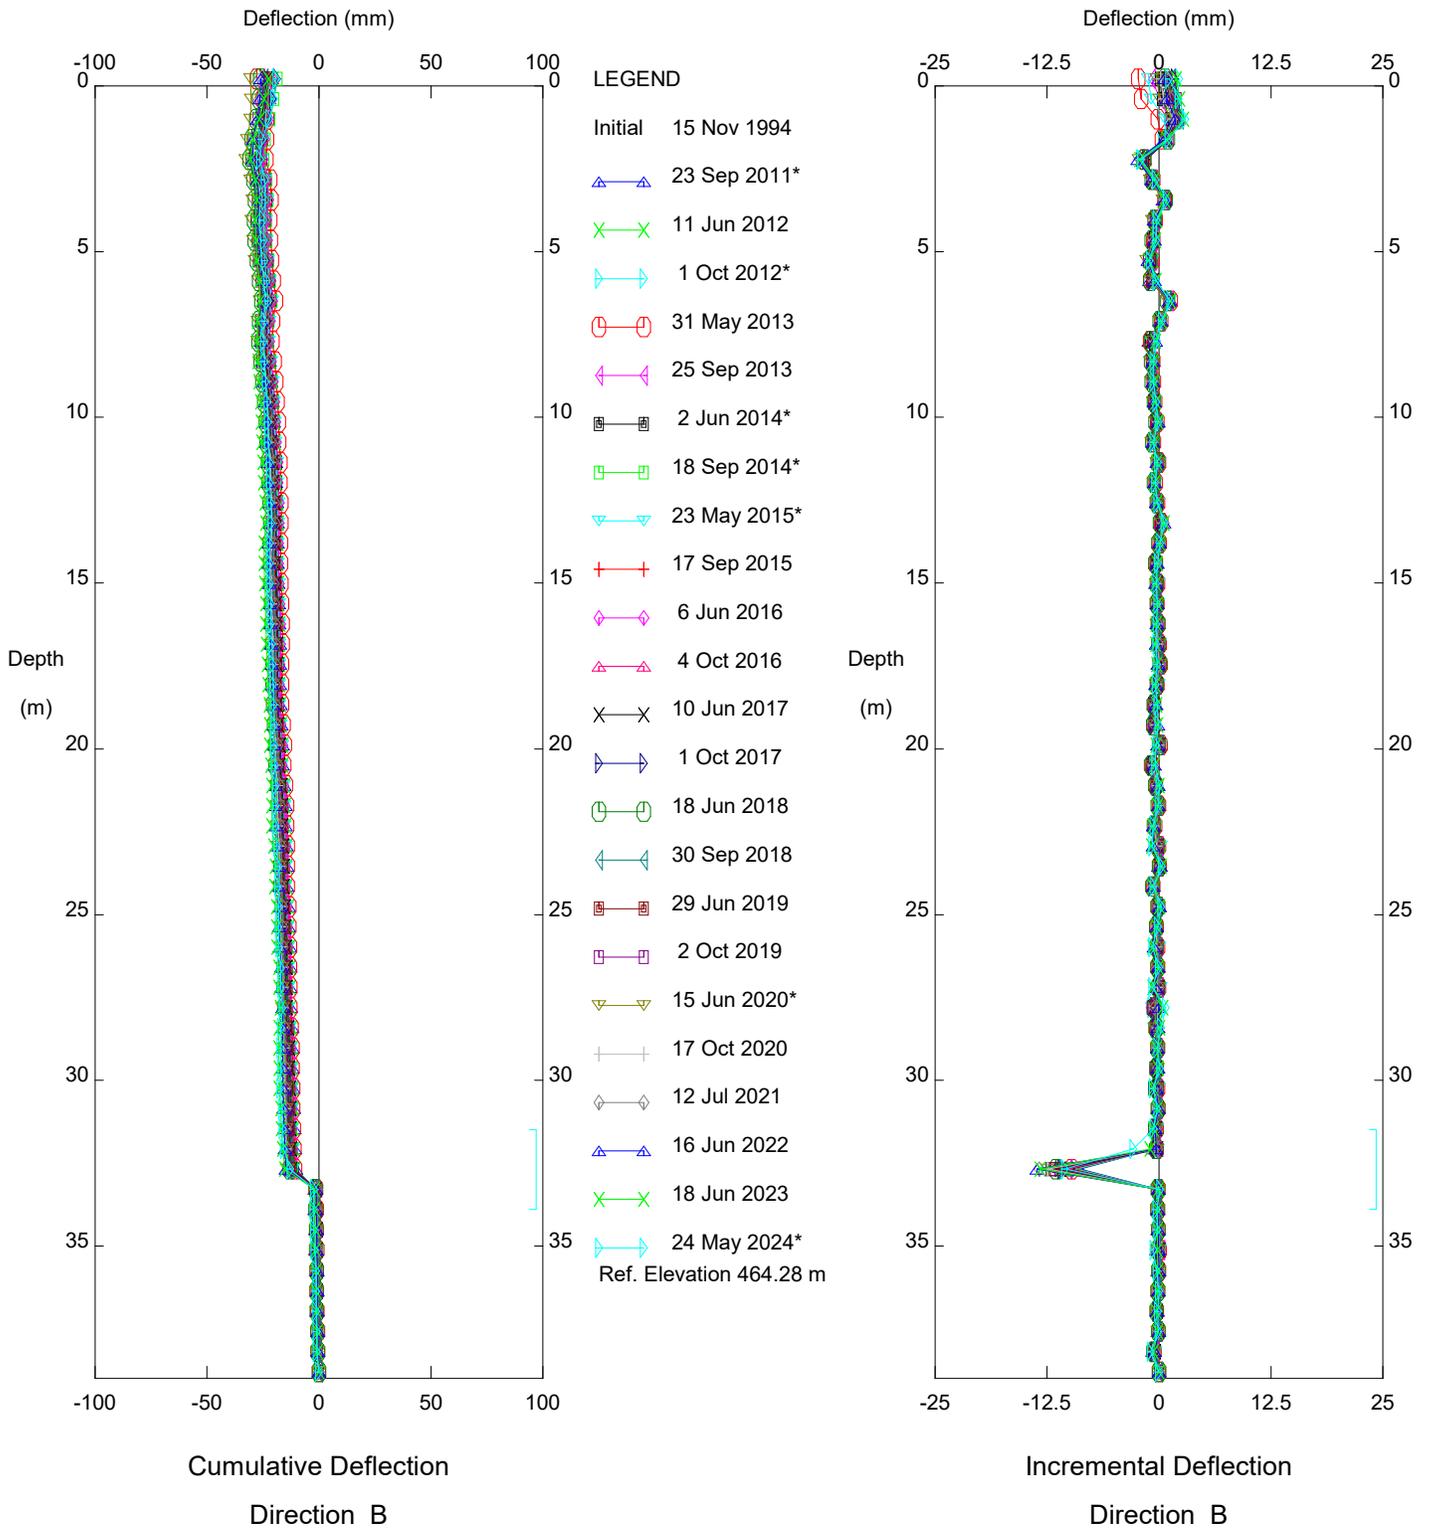
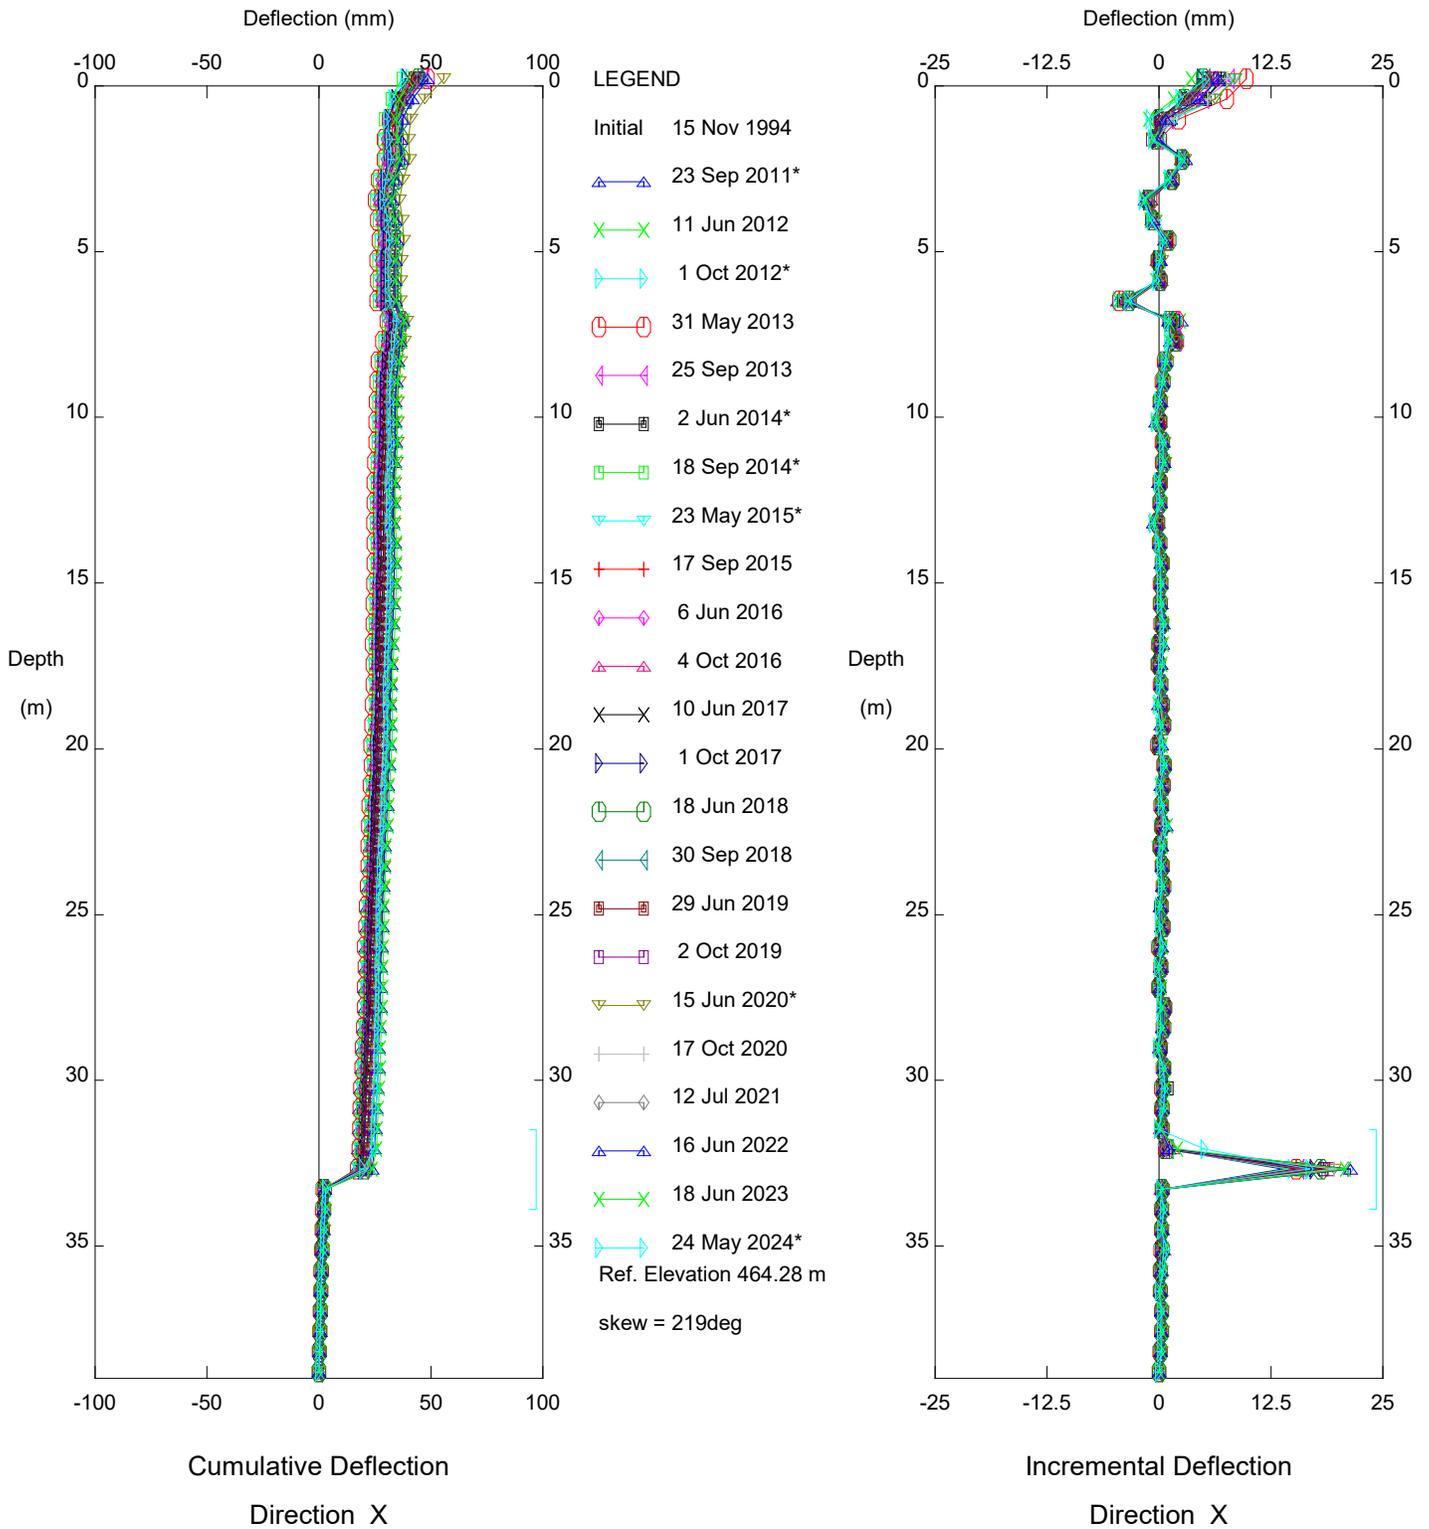
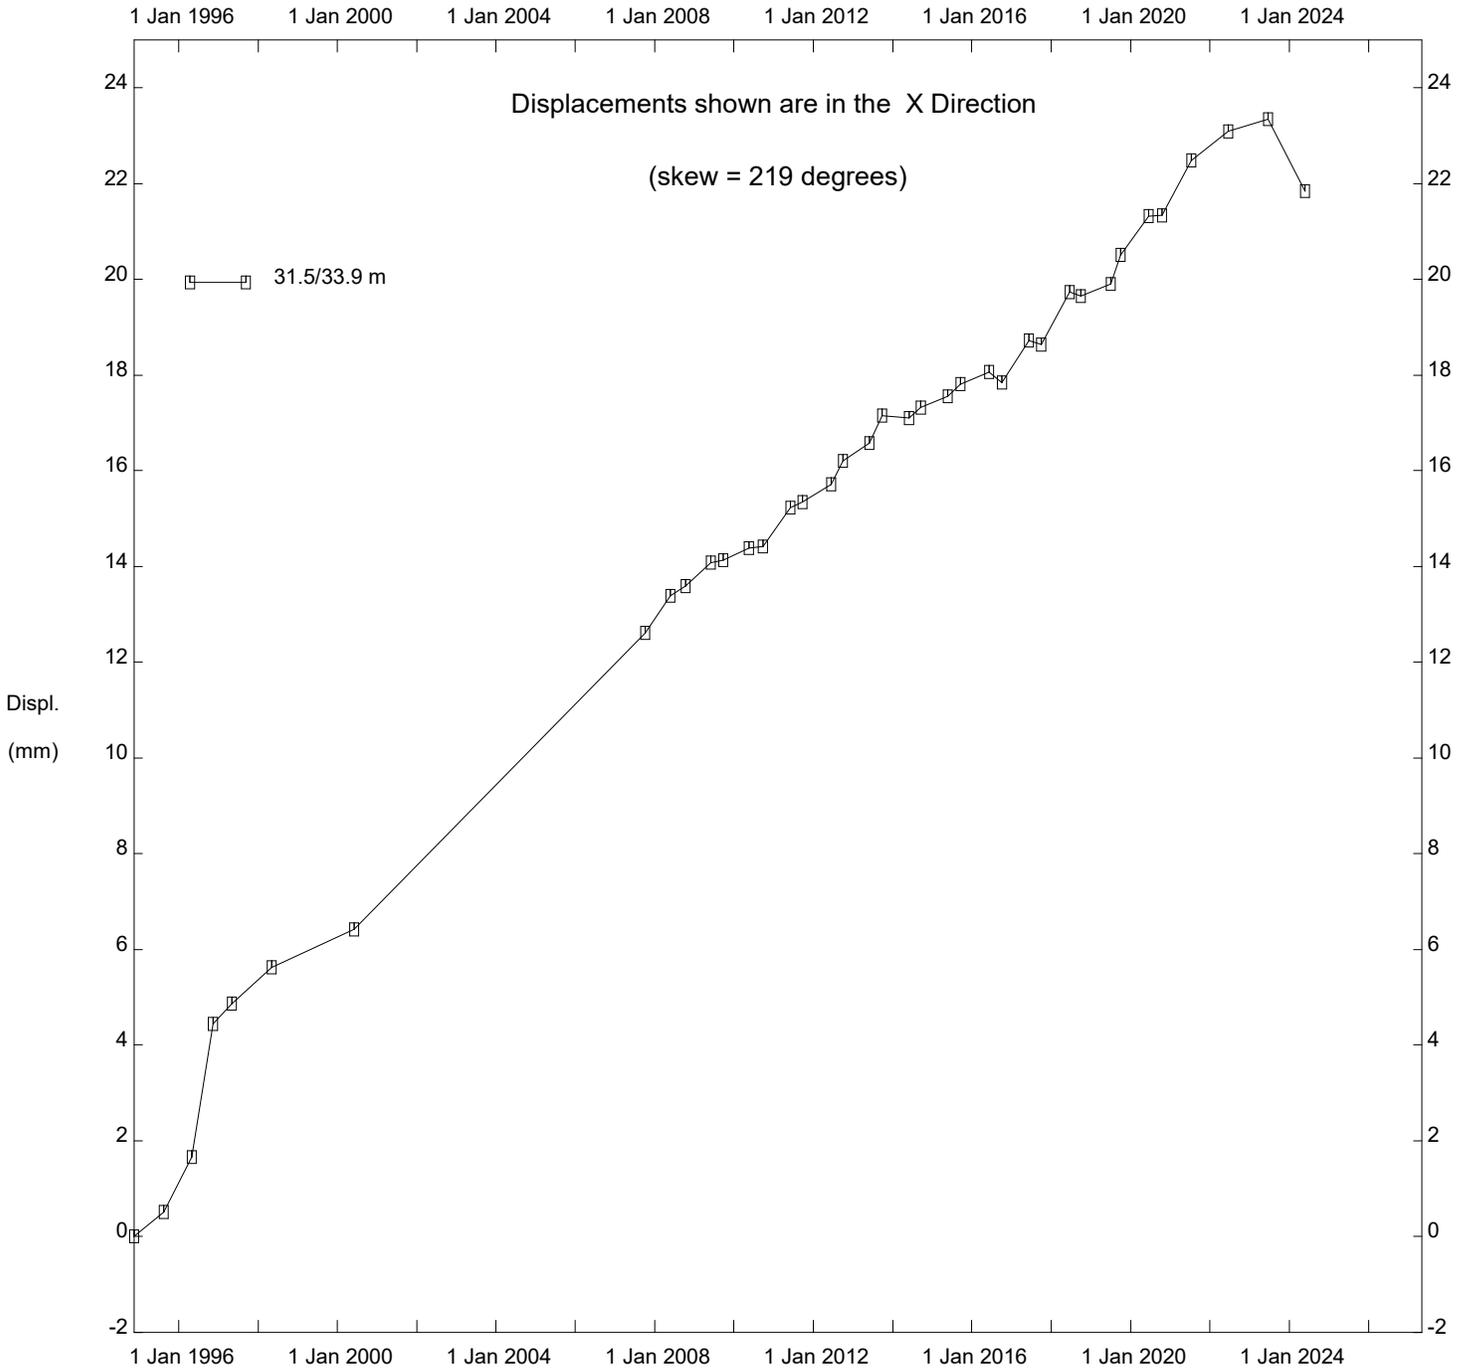
HWY 35:08 (PH044), Inclinometer SI-27

Discussion	
<b>Zones of New Movement:</b>	None
<b>Interpretation of Monitoring Results:</b>	<p>All three SIs at this site are located upslope, east of the highway. Overall, the SIs showed slower rates of movement compared to the past several readings cycles.</p> <p>Slope inclinometer SI-27 has a distinct shear zone at about 33 m depth along which a slow movement rate of about 0.7 mm/yr has persisted since about 1998. An unusual upslope movement trend was measured since the Spring 2023 readings. Additional readings will be required to confirm if this is a change in the movement pattern or an anomalous reading.</p> <p>Slope inclinometer SI-42 has registered barely discernable movements at about 37 m depth since installation.</p> <p>Slope inclinometer SI-45 a rate of movement of 0.1 mm/yr over 36.6 m to 37.8 m depth since the spring of 2023 readings. SI-45 has shown an overall rate of movement 0.5 mm/yr since initialization.</p> <p>The location of instrumentation at this site is inadequate to assess the stability of the slides at this site.</p>

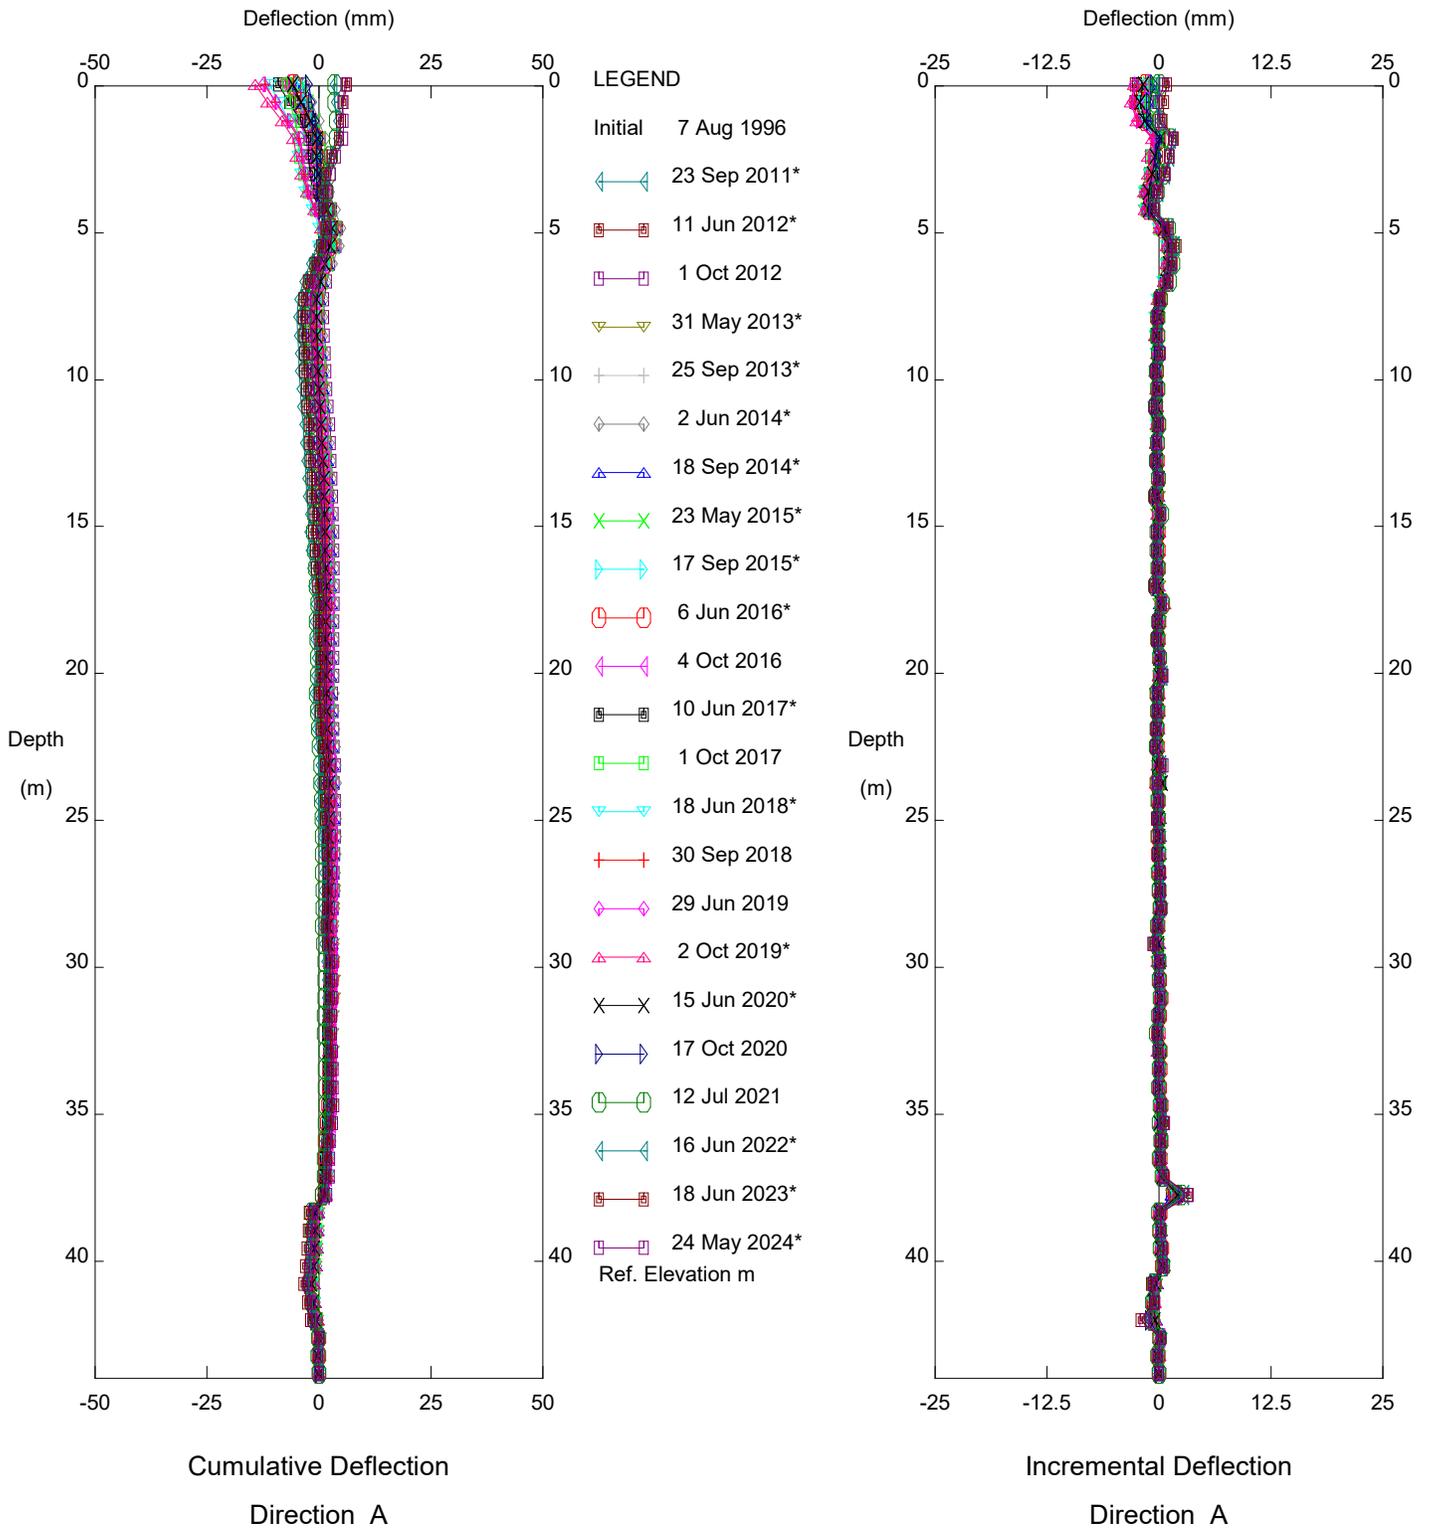
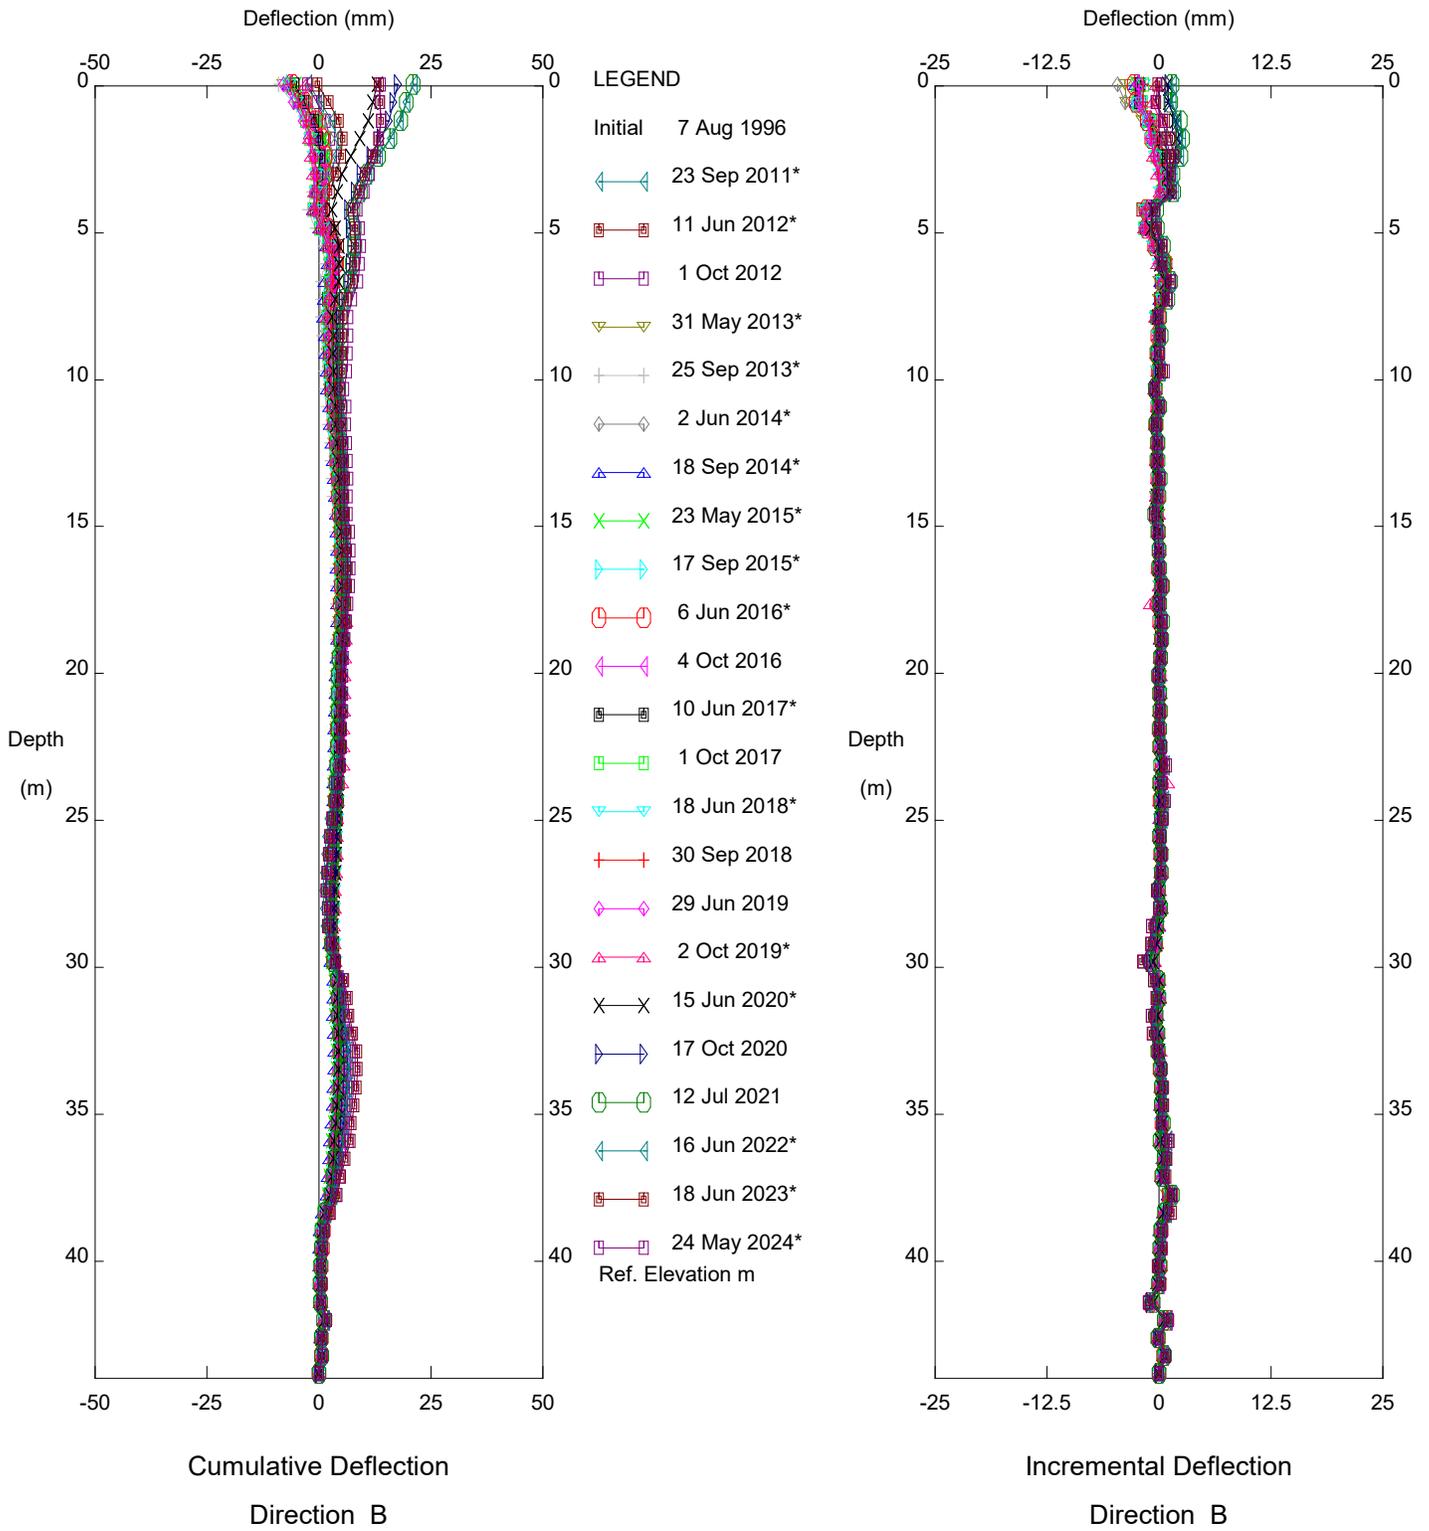
HWY 35:08 (PH044), Inclinometer SI-42

18.2 mm between 27.4 m and 29.3 m depth in 246° direction	8.6 in October 2012			N/A	N/A	N/A
SI-27	Nov. 15, 1994	21.8 mm between 31.5 m to 33.9 m depth in 232° direction	5.2 Between April and Nov. 1996	Operational	June 18, 2023	No discernible movement	N/A	-1.9
SI-42	Aug. 7, 1996	No discernible movement pattern	N/A	Operational	June 18, 2023	N/A	N/A	N/A
SI-45	Aug. 7, 1996	14.9 mm between 36.6 m to 37.8 m depth in 206° direction	1.9 in October 2020	Operational	June 18, 2023	0.1	0.1	0.2
