Site Number	Location	Name	Hwy	km
PH044	HWY 35:08 C1 25.97	Meikle River Upper Slope Slides	35:08	Km 26.1 (Slide A) Km 25.8 (Slide B)
<b>Legal Description:</b>		<b>UTM Co-ordinates</b>		
6-7-94-22 W5		11U	E 467856.90 N	6332922.84

<b>Current Monitoring:</b>	24-May-2024	<b>Previous Monitoring</b>	18-Jun-2023
<b>Instruments Read By:</b>	Mr. Niraj Regmi, G.I.T., and Mr. Nixson Mationg, Thurber

**ALBERTA TRANSPORTATION AND ECONOMIC CORRIDORS GRMP (CON0022164)  
PEACE REGION (PEACE RIVER DISTRICT)  
INSTRUMENTATION MONITORING RESULTS**

**SPRING 2024**

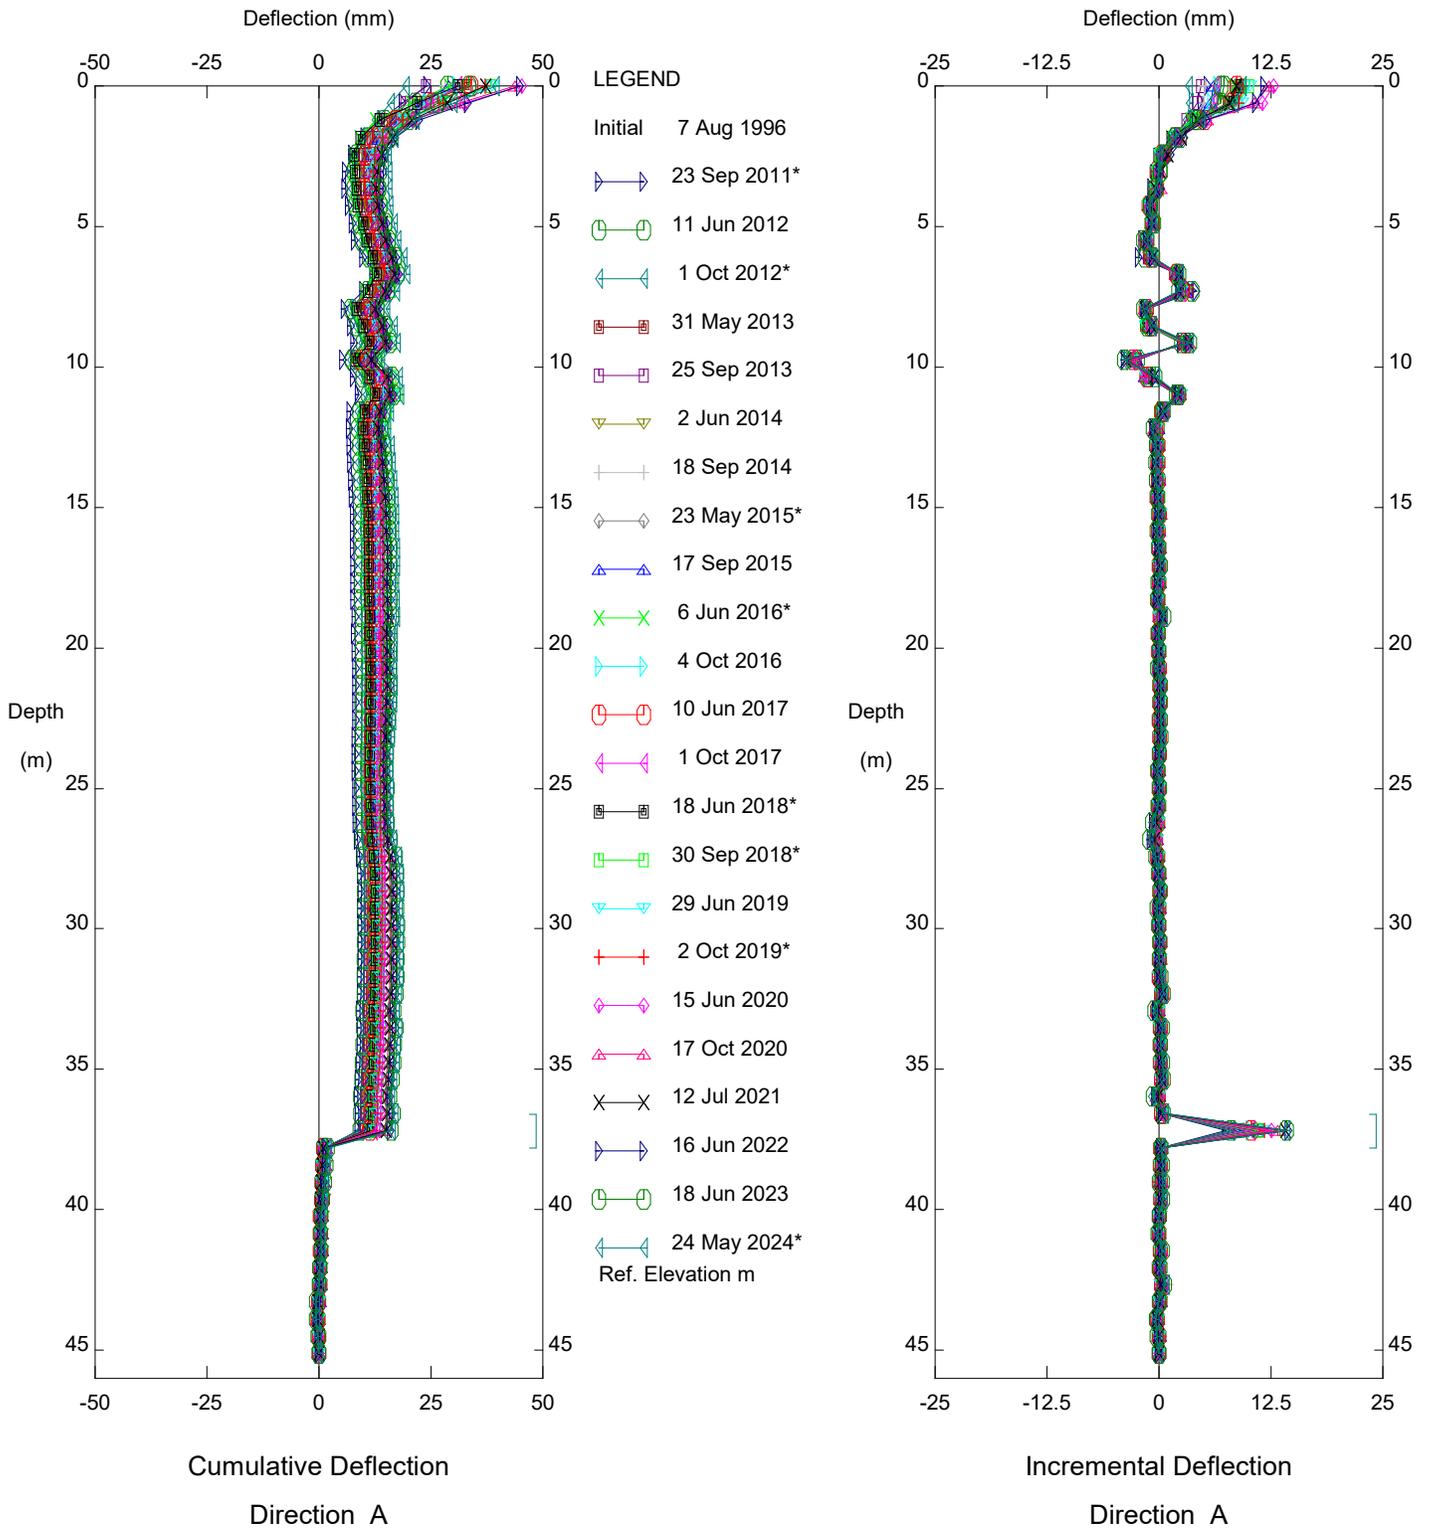
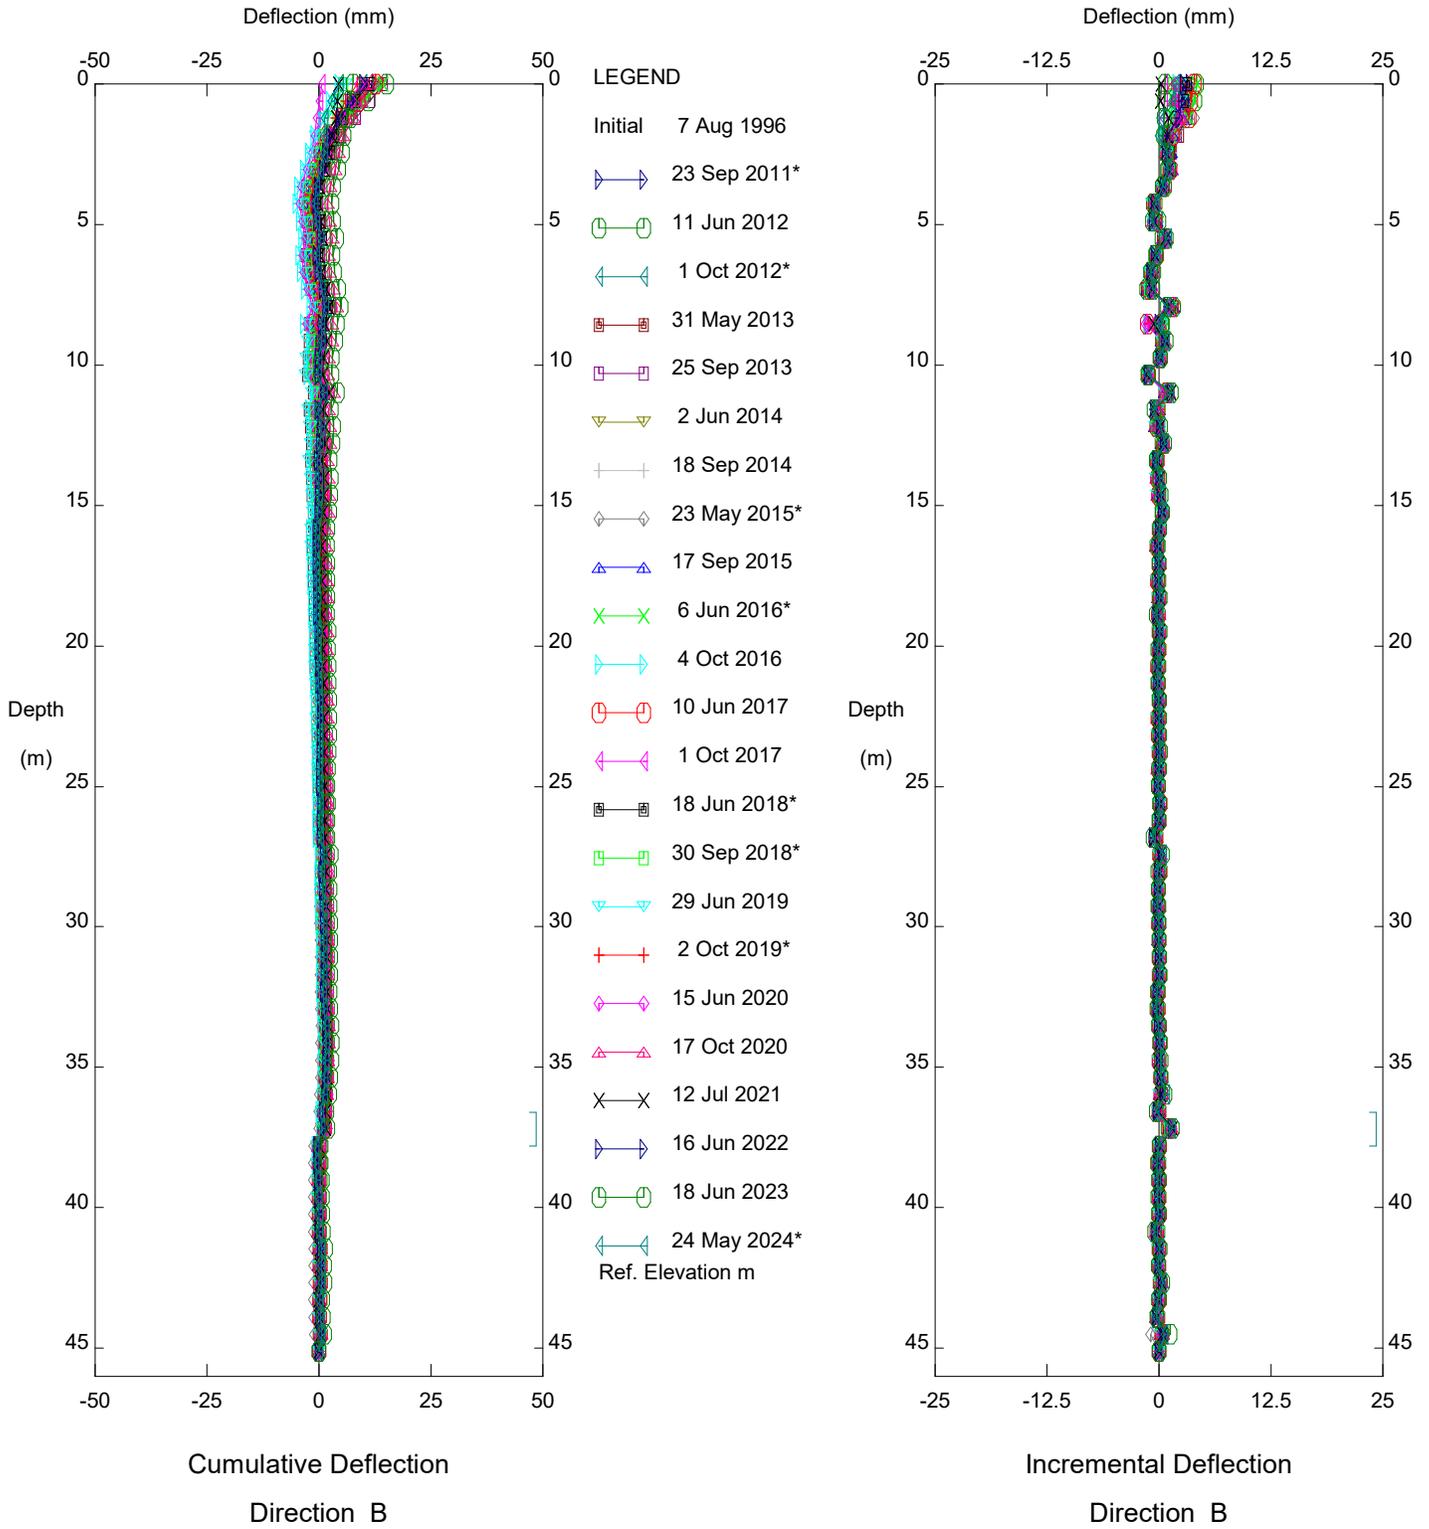
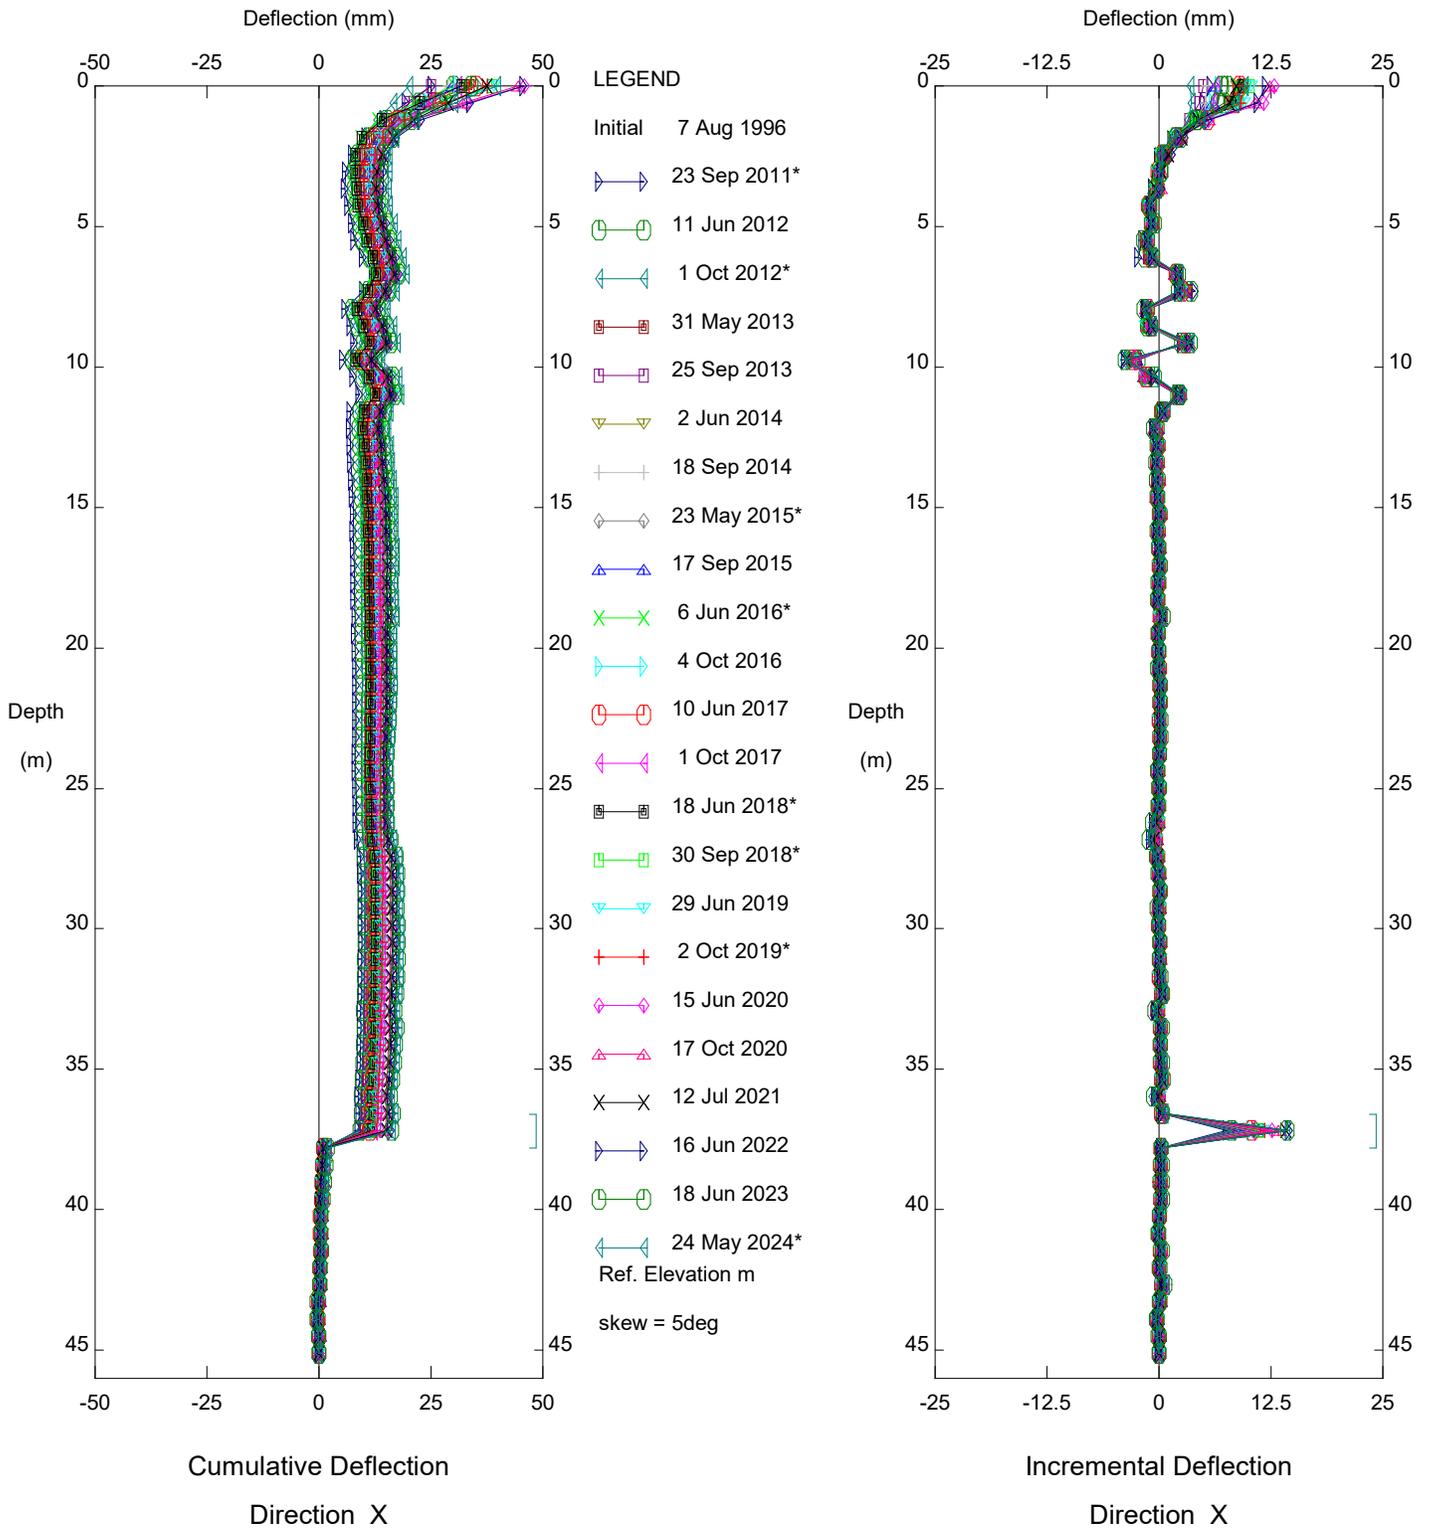
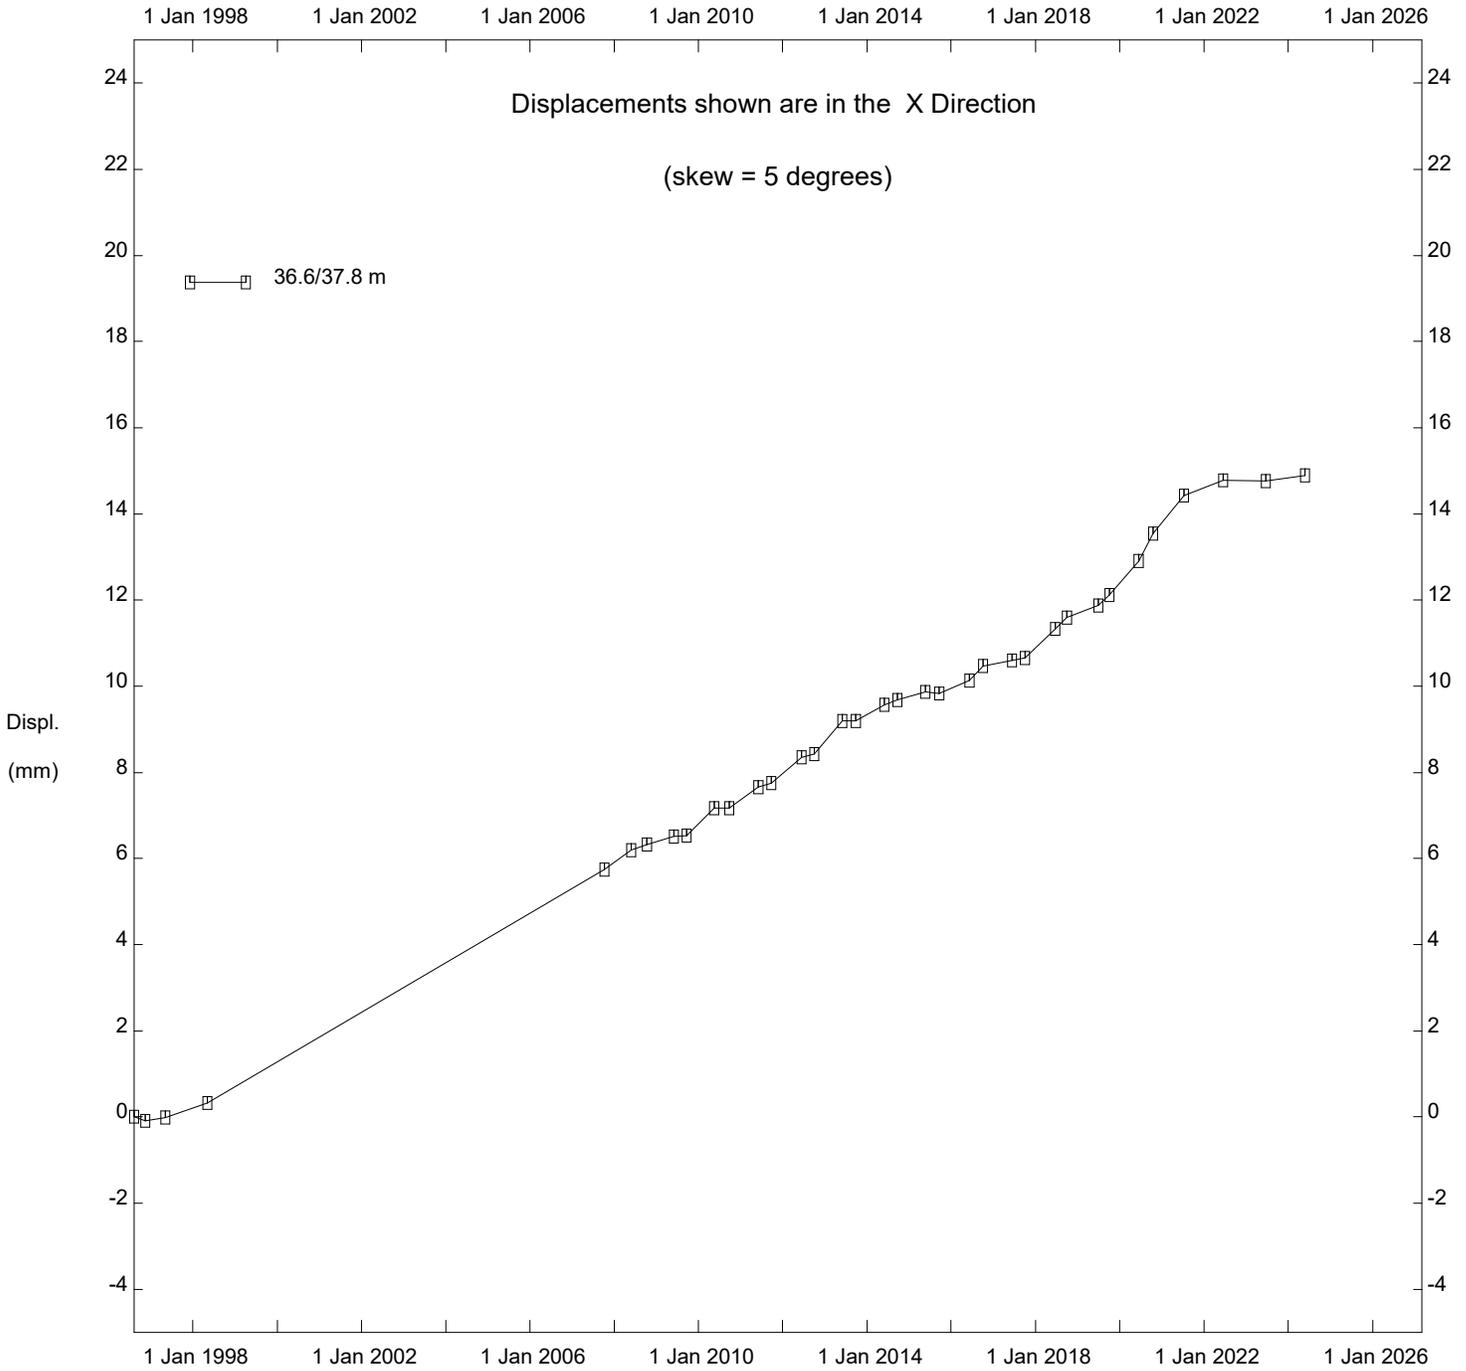
HWY 35:08 (PH044), Inclinometer SI-45

18.2 mm between 27.4 m and 29.3 m depth in 246° direction	8.6 in October 2012			N/A	N/A	N/A
SI-27	Nov. 15, 1994	21.8 mm between 31.5 m to 33.9 m depth in 232° direction	5.2 Between April and Nov. 1996	Operational	June 18, 2023	No discernible movement	N/A	-1.9
SI-42	Aug. 7, 1996	No discernible movement pattern	N/A	Operational	June 18, 2023	N/A	N/A	N/A
SI-45	Aug. 7, 1996	14.9 mm between 36.6 m to 37.8 m depth in 206° direction	1.9 in October 2020	Operational	June 18, 2023	0.1	0.1	0.2
