GEOHAZARD ASSESSMENT PROGRAM

PEACE RIVER / HIGH LEVEL AREA

2011 CALLOUT INSPECTION

Site Number	Location	Name	Hwy	km
PH45	North of Manning, AB	Meikle River (Pile Wall)	35:08	Approx. 27.5
Legal Description		UTM Co-ordinates		
SW1/4 7-94-22-5		11V N 6333081	E 467581

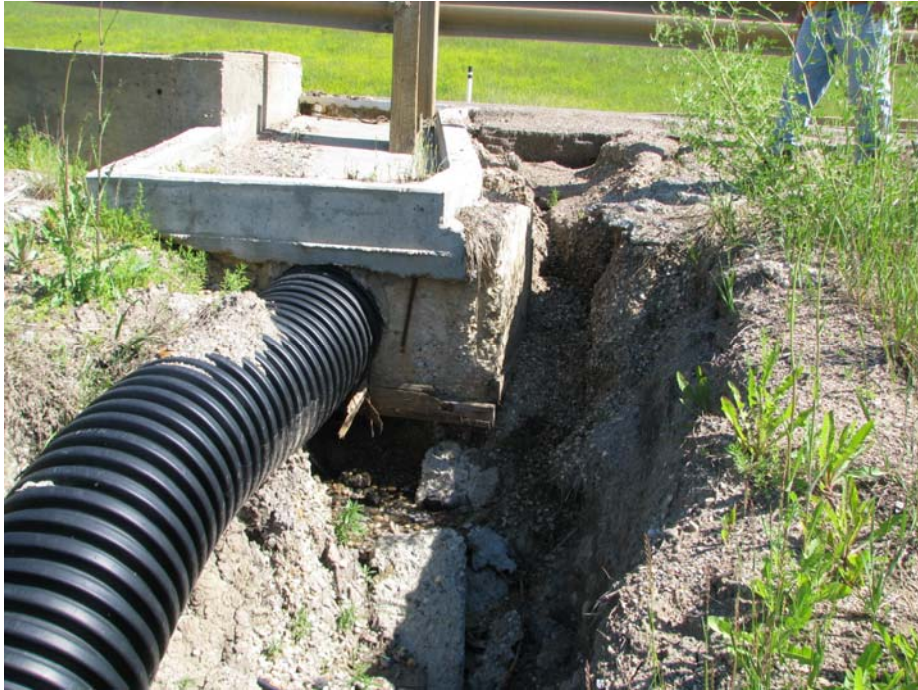
- Three voids appeared along the wall during the recent heavy rainfall.
- The void at the north side is encroaching into the roadway.
- The continued movement of the slope has resulted in the development and worsened the voids along the cap beam, which allows roadway surface runoff to seep down along the inside face of the wall and erode the granular fill beneath the pavement and cap beam, leading to the development of the sinkholes.
- Voids ranging from 150 mm to 650 mm were recorded underneath the cap beam as a result of recent rains.
- The erosion hole around the down drain pipe has worsened.
- Settlement under the drainage concrete apron has also worsened, and the apron is tilting and cracking. The drainage grate is plugged with sand.

Photo 1 – View of pile wall looking northwest, showing the drainage inlet (Plugged with Sand).

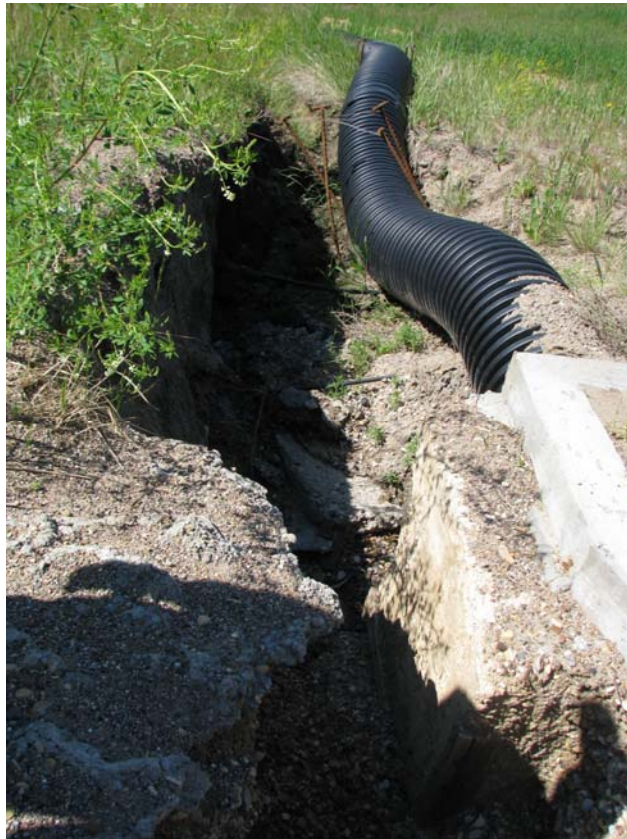
Photo 2 – Downslope view of drainage pipe, showing erosion around it.

As the erosion underneath the drainage pipe is encroaching the highway, consideration should be given in backfilling the erosion hole around the drain pipe. The drain pipe should be removed to allow the erosion gullies in the slope to be filled with compacted clay fill and then re-installed with the drain depressed more relative to the road than in its current location. The slope repair should be top soiled and seeded and low flow soil covering should be placed over the repaired slope to reduce the potential of future surface erosion. The sand plugging the grate should be removed and the grate cleaned to promote drainage. The cracks in concrete apron should be repaired. The voids underneath the concrete apron should be filled with fillcrete. The ballpark cost for this work is \$35,000.

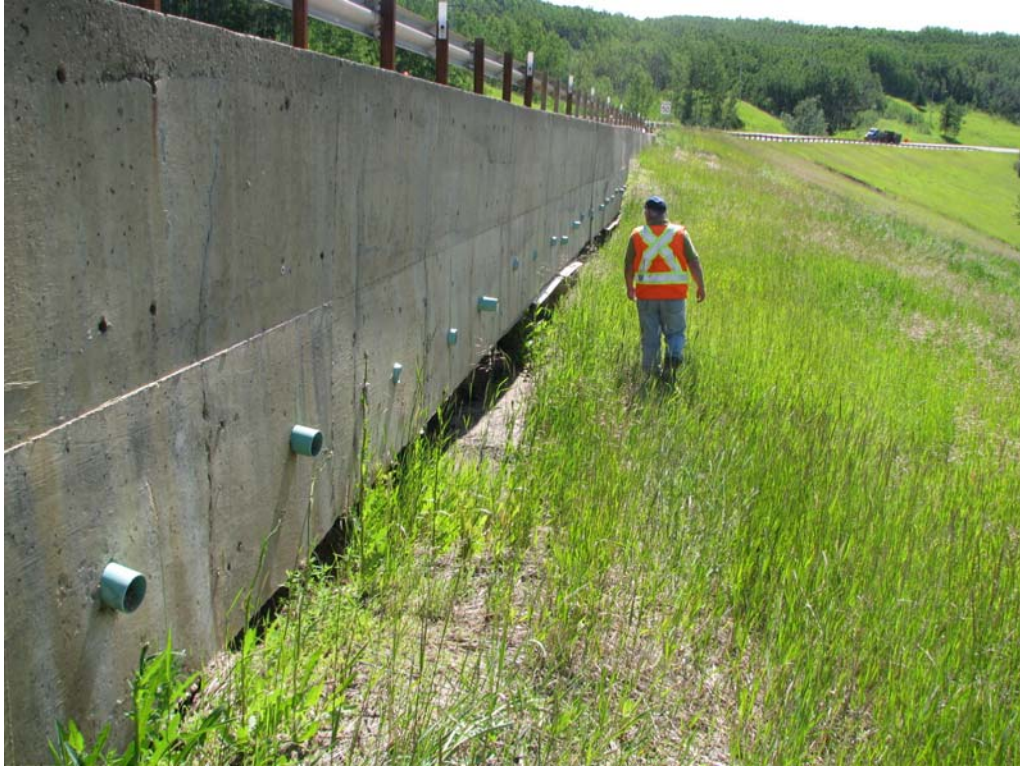
Photo 3 – Voids Underneath Cap Beam, Looking Southeast

In the short term, the void underneath the pile cap should be backfilled. A more robust plan was discussed on site which should be applied to the length of the pile wall and consists of the following:

- The loose material and debris underneath the pile cap should be removed and a flat ground surface should be provided below the pile cap, which should extend from the piles edge towards the outside, slightly beyond the pile cap.

- Permanent formwork consisting of treated timber planks constrained laterally by H-Piles pushed into the ground should be placed vertically, extending slightly above the bottom of the pile cap. Non-woven geotextile should be placed over the ground surface under the void and pulled up and stapled to the inside of the timber formwork.

- Extend 100 mm diameter PVC pipes through the timber lagging to promote drainage through the cap beam.
- A highly fluid mix of fillcrete can be poured through the gap left between the face of the pile cap and the formwork.

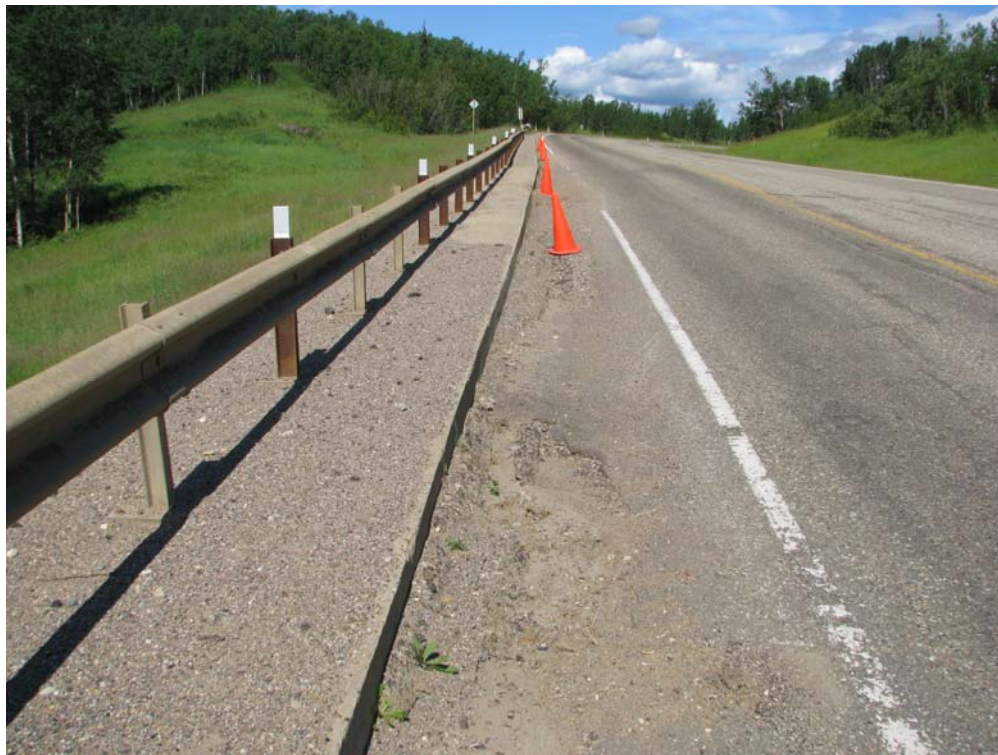
Photo 4 – Developed Piping holes in front of pile wall, looking northwest.

- After the void underneath the pile cap has been backfilled, the sinkholes in front of the pile wall may be over excavated and backfilled, using again a highly fluid mix of fillcrete.

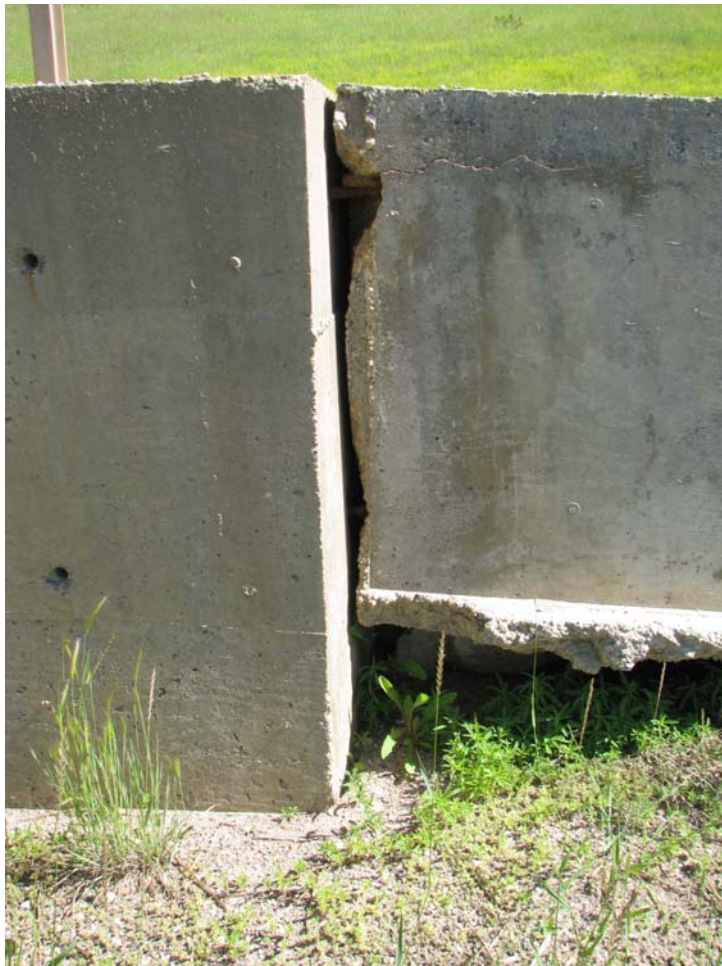
Photo 5 – Concrete joint Worsened.

Fix the joint at the concrete wall using quick set grout.

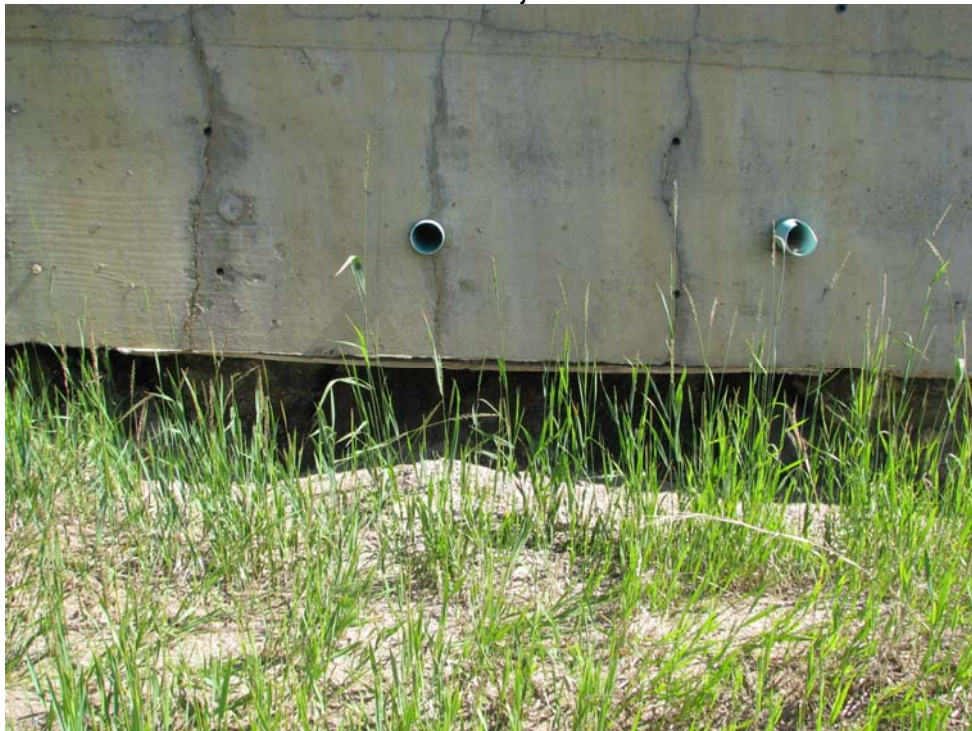
Photo 6 – Void underneath the pile cap showing sand washed out from the front of the pile cap.

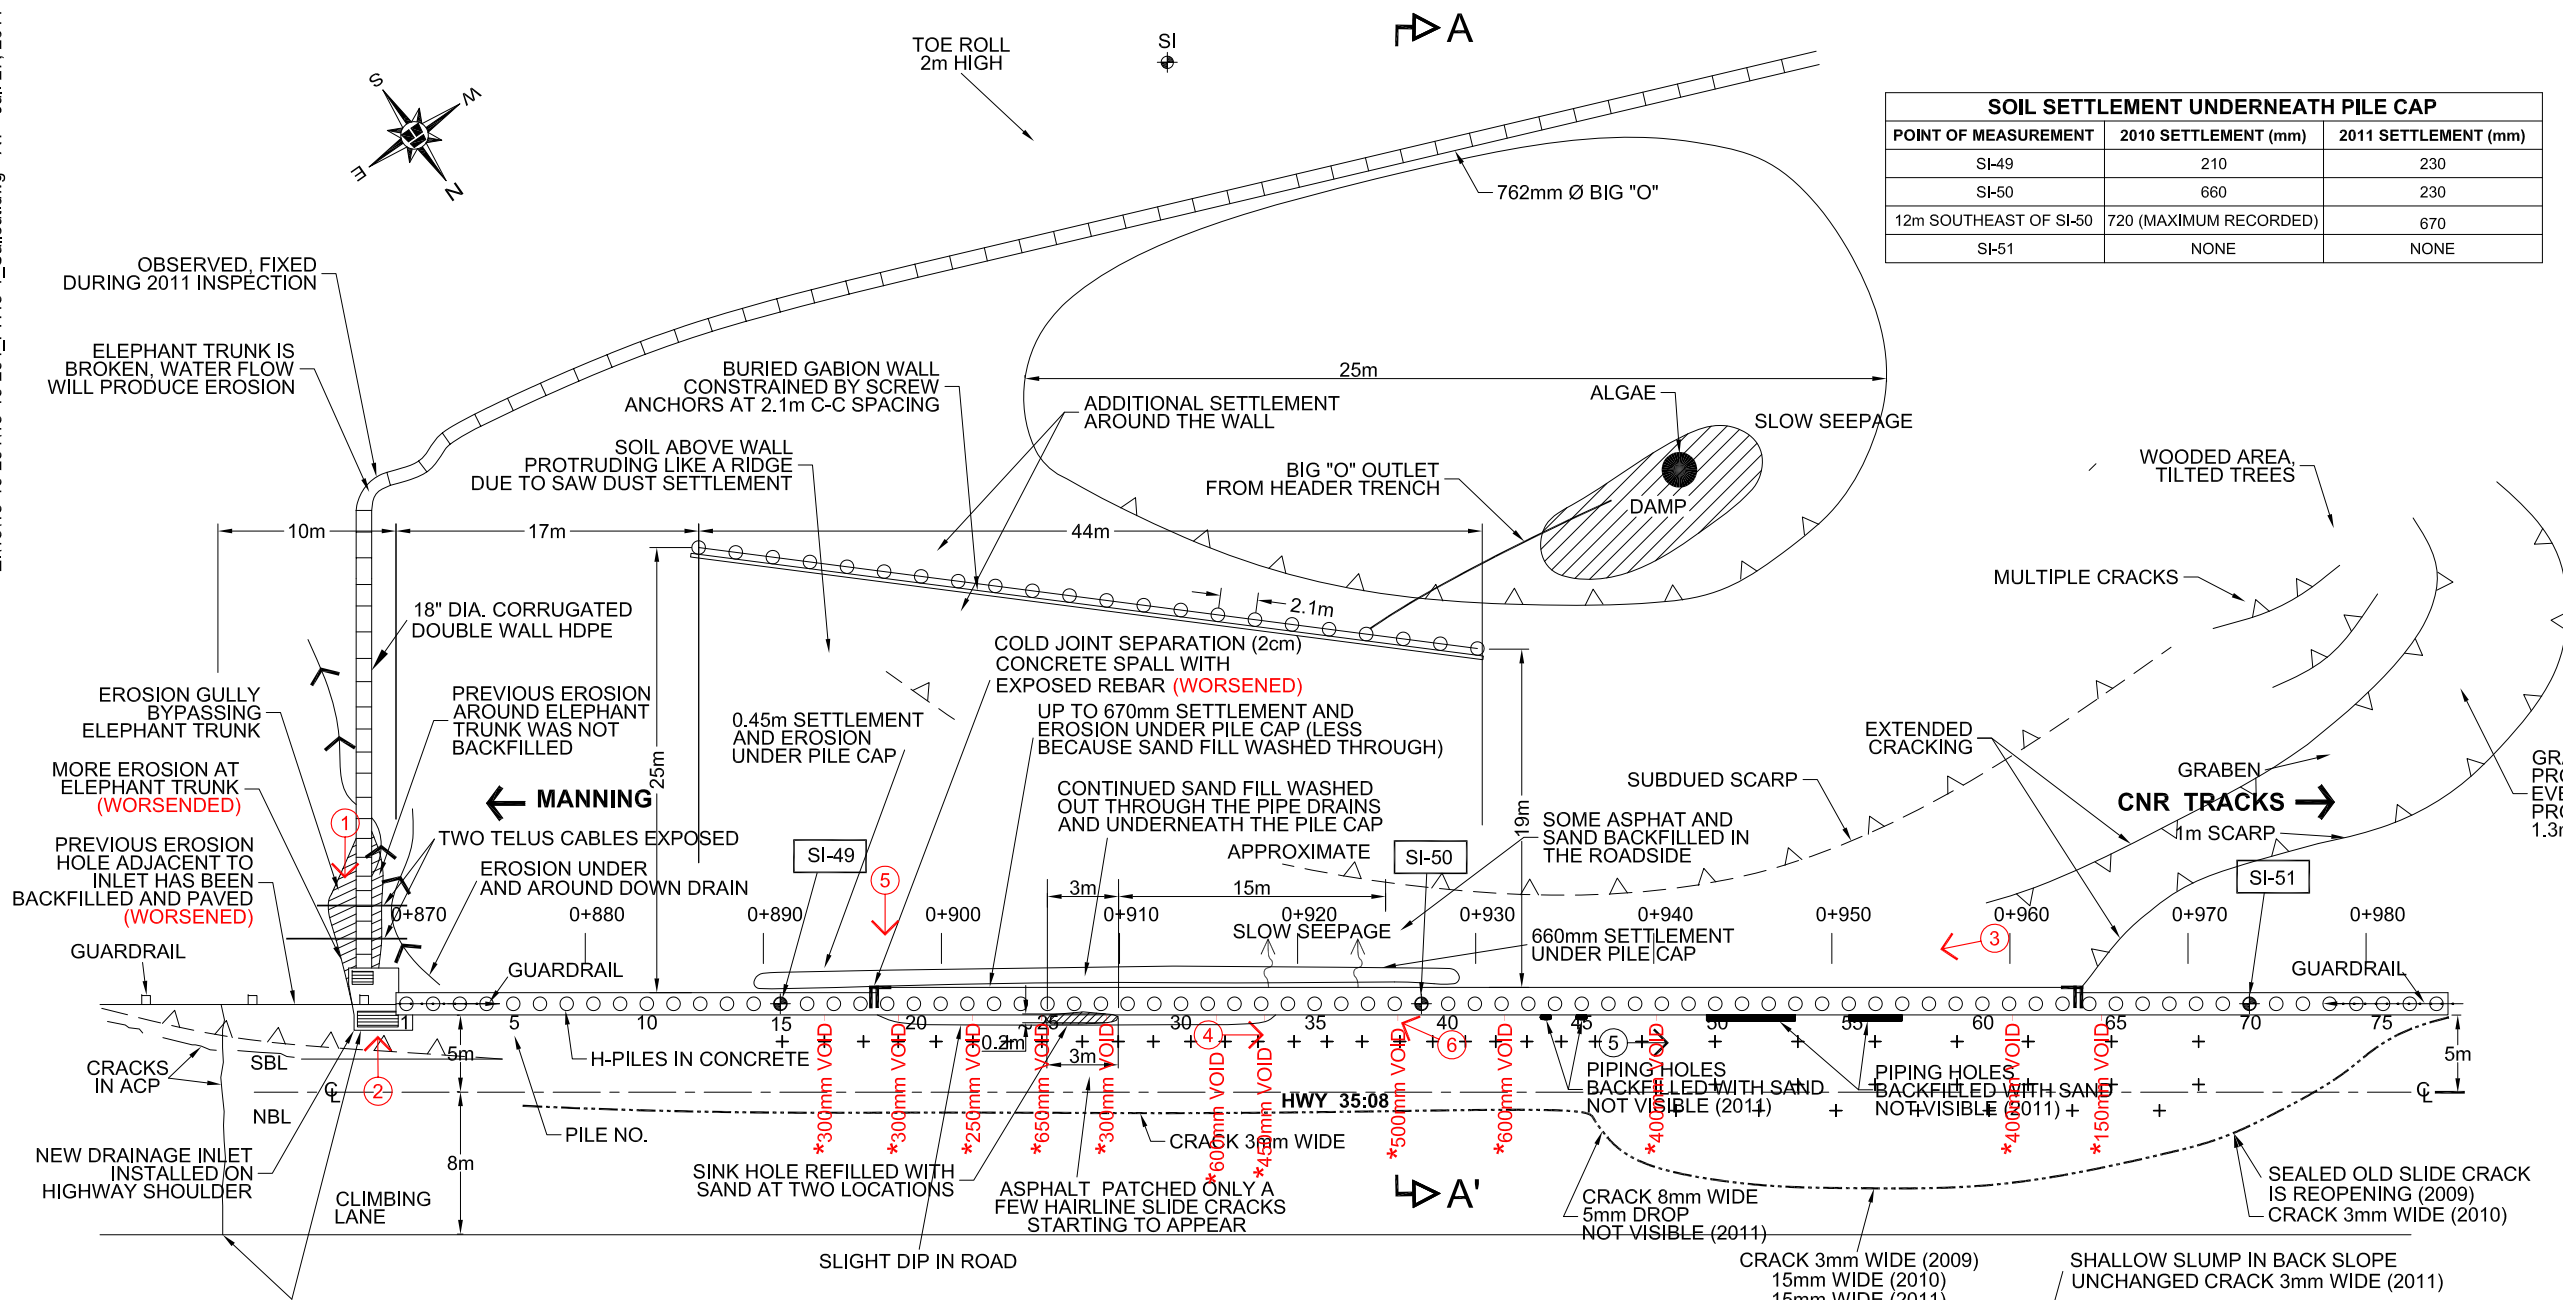
Z:\1515-16-264\15-16-264_PH45-1_Callout.dwg - AT - Jul. 27, 2011

SOIL SETTLEMENT UNDERNEATH PILE CAP		
POINT OF MEASUREMENT	2010 SETTLEMENT (mm)	2011 SETTLEMENT (mm)
SI-49	210	230
SI-50	660	230
12m SOUTHEAST OF SI-50	720 (MAXIMUM RECORDED)	670
SI-51	NONE	NONE
