**ALBERTA TRANSPORTATION
GEOHAZARD ASSESSMENT PROGRAM
PEACE REGION – HIGH LEVEL
2017 INSPECTION**

Site Number	Location	Name	Hwy	km
PH045-1	North of Manning, AB	Meikle River (Pile Wall)	35:08	26.2
Legal Description		UTM Co-ordinates		
SW7-94-22-W5M		11U E 467,581	N	6,333,081

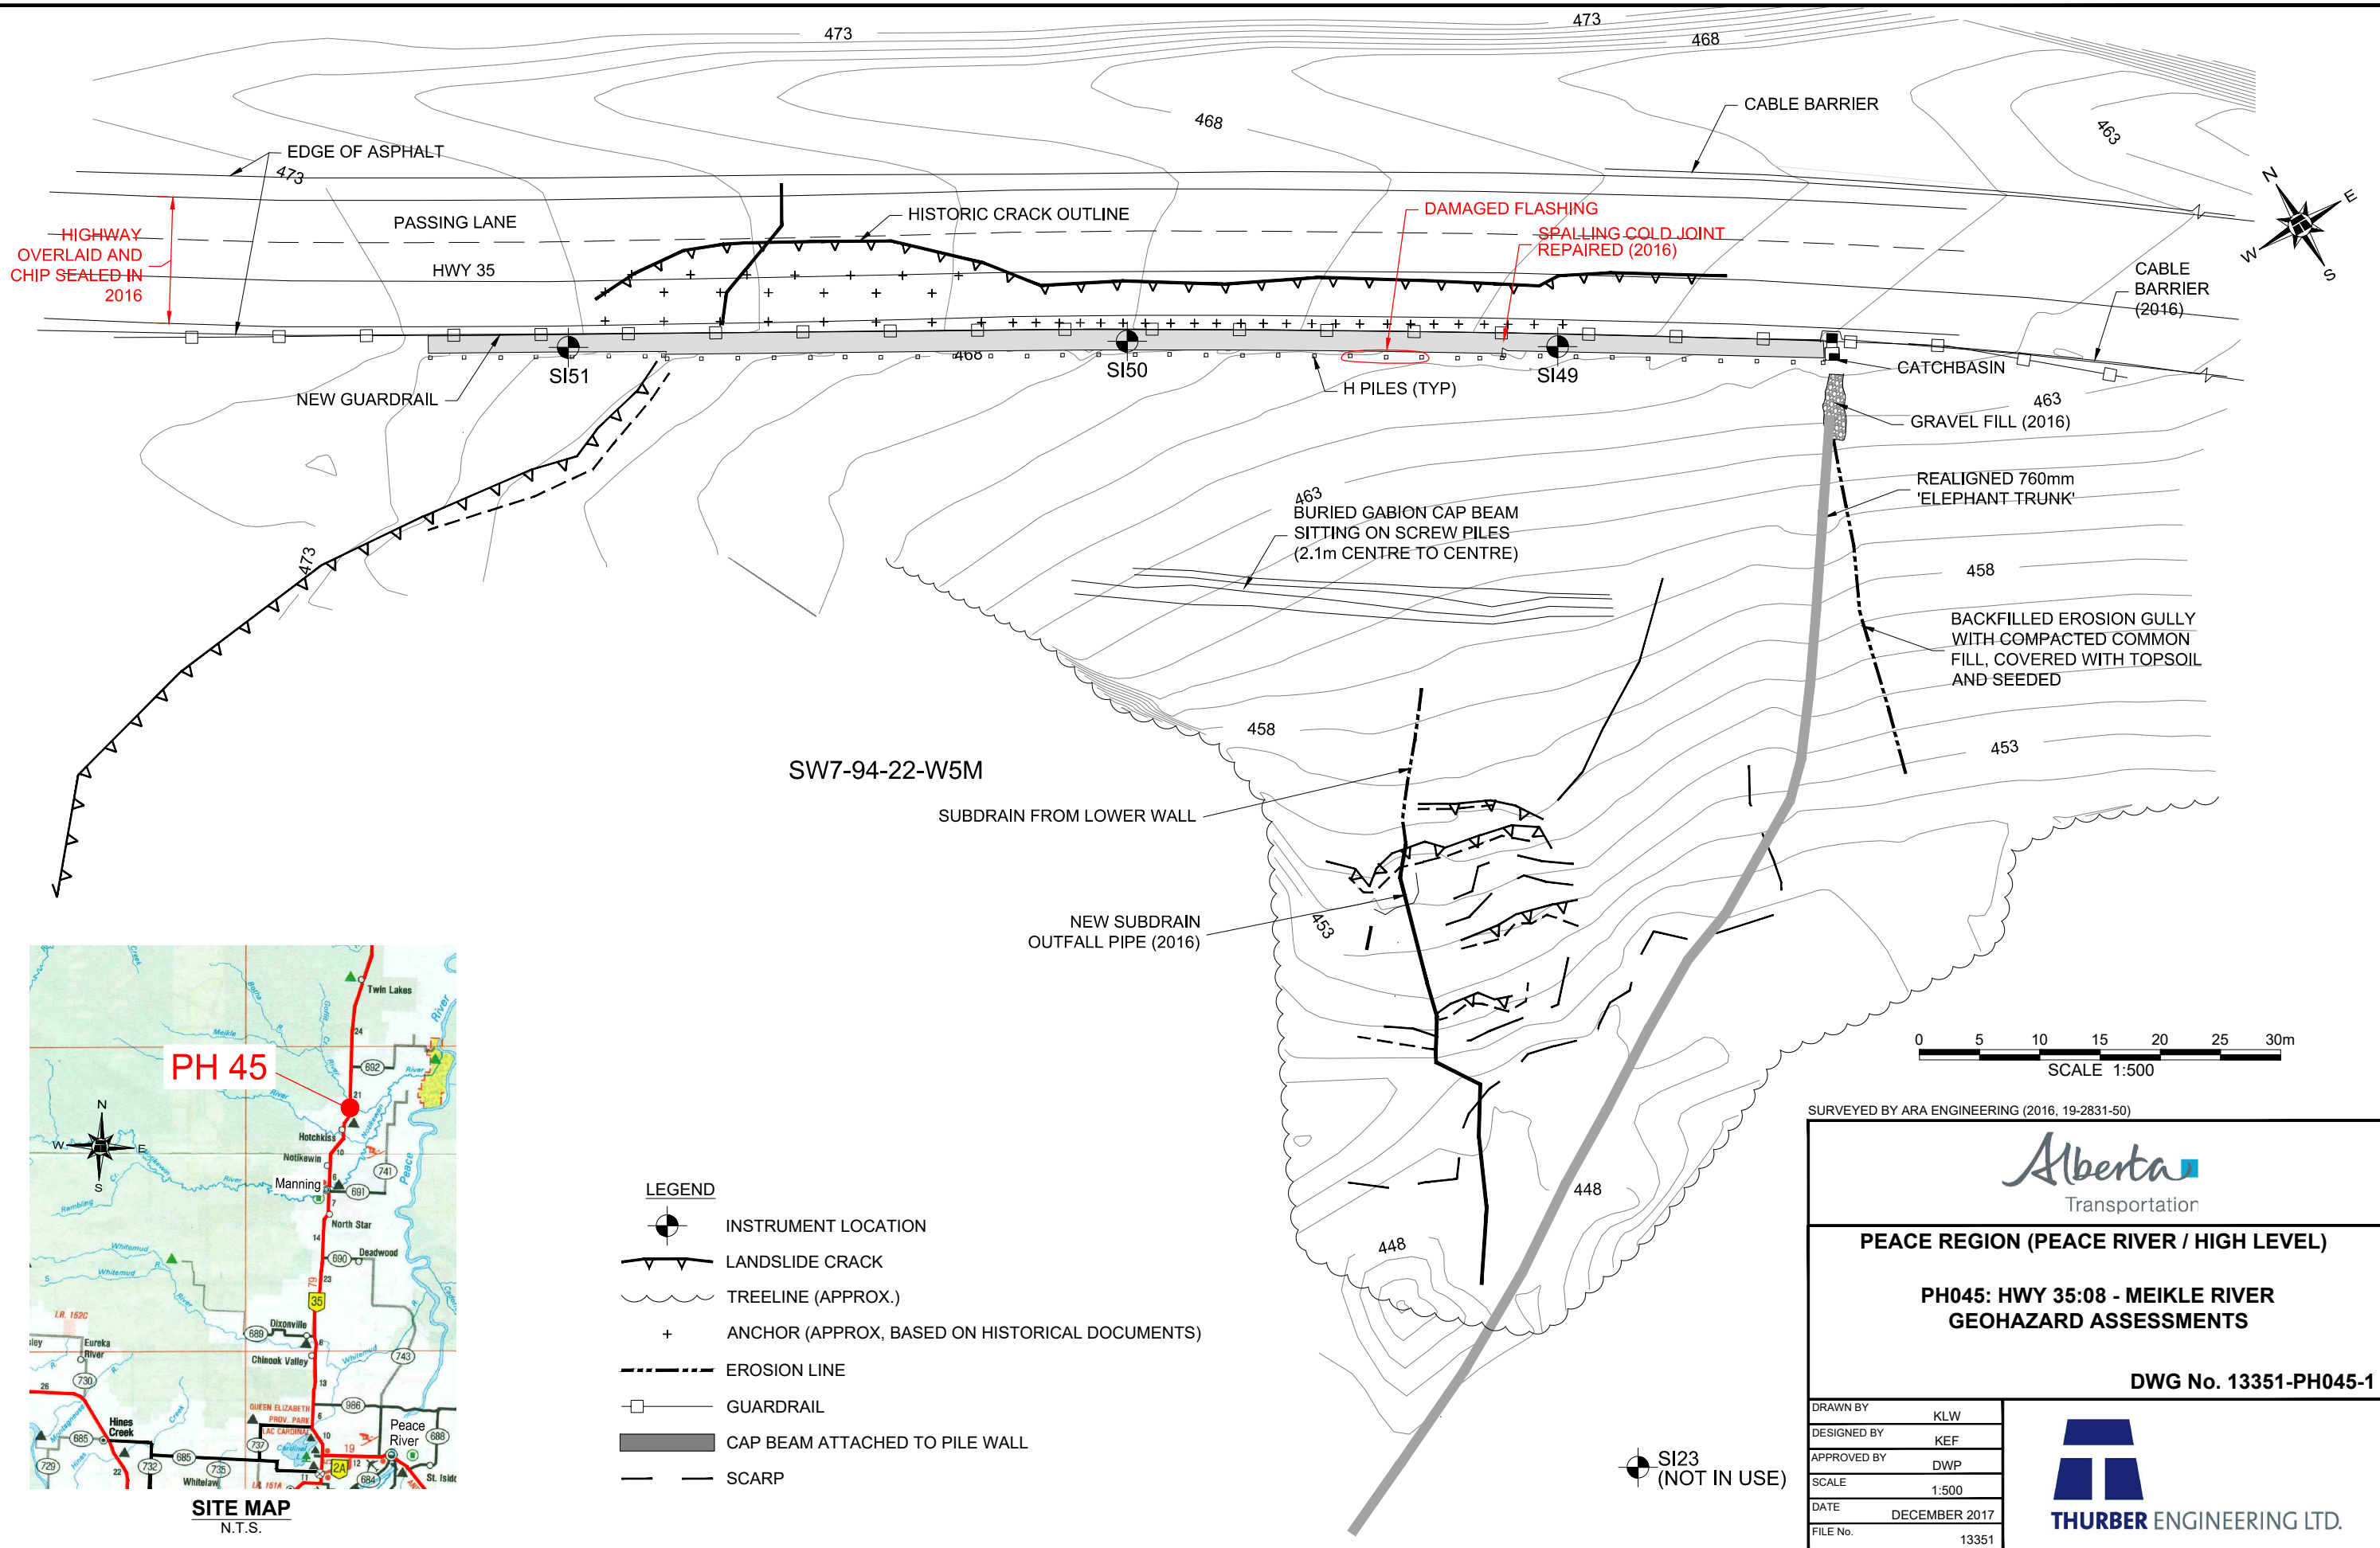
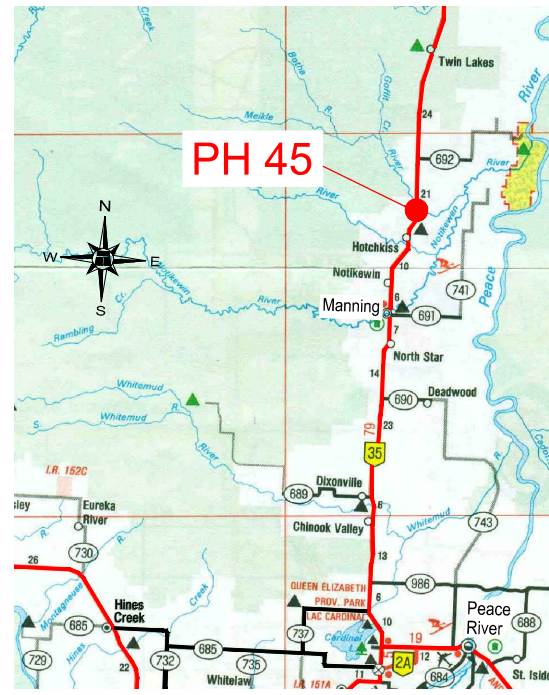
- It is suggested that the annual GeoHazard inspections be carried out at least one more year and that bi-annual instrumentation readings should continue as scheduled.

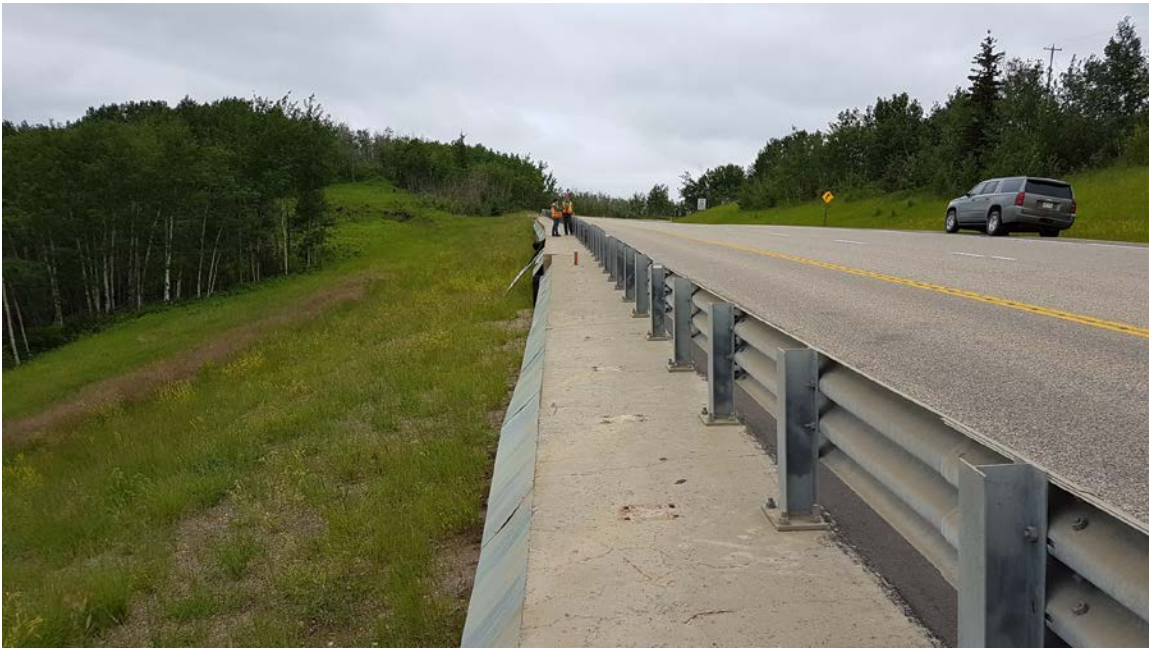
Photo 4 – Looking northwest at repaired and overlaid asphalt surface. Note new bridge rail installed along the top of the cap beam and damaged flashing at about the center of the wall.

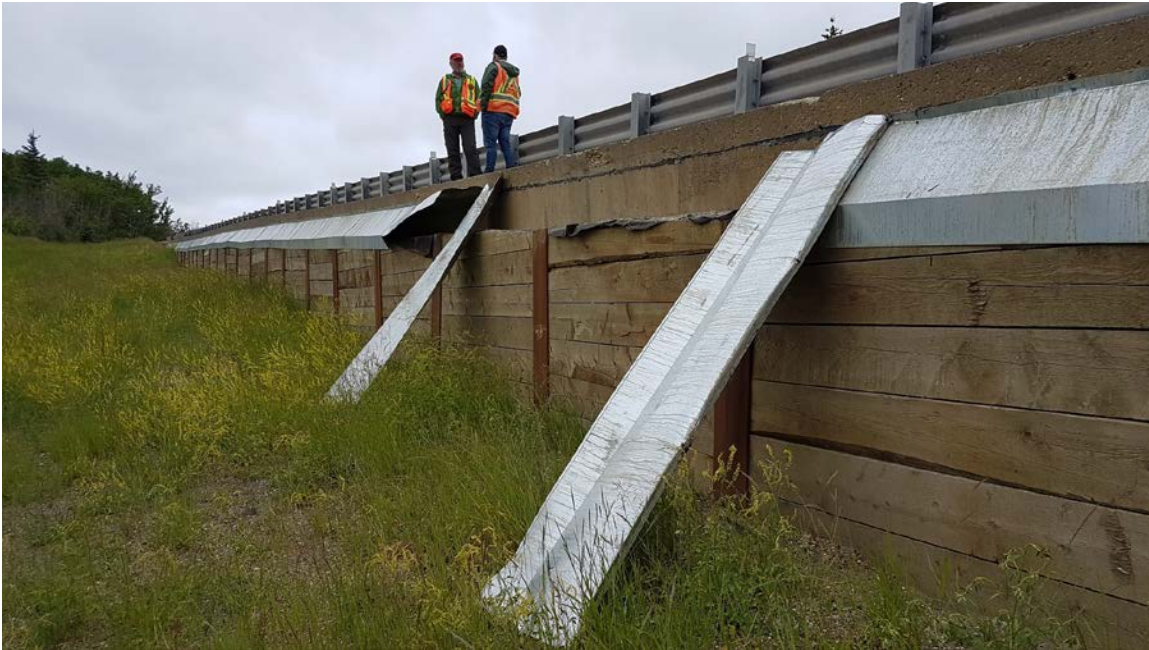
Photo 5 – Looking northwest at main section of damaged flashing.

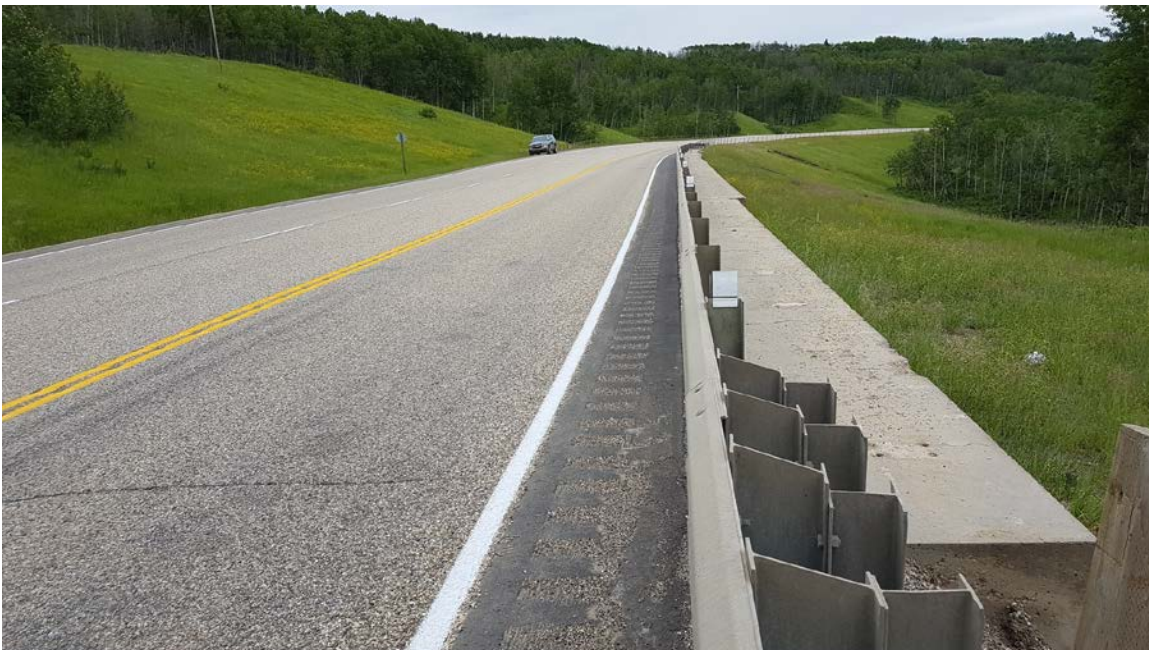
Photo 6 – Looking southeast at repaired and overlaid asphalt surface. Note new bridge rail installed along the top of the cap beam.

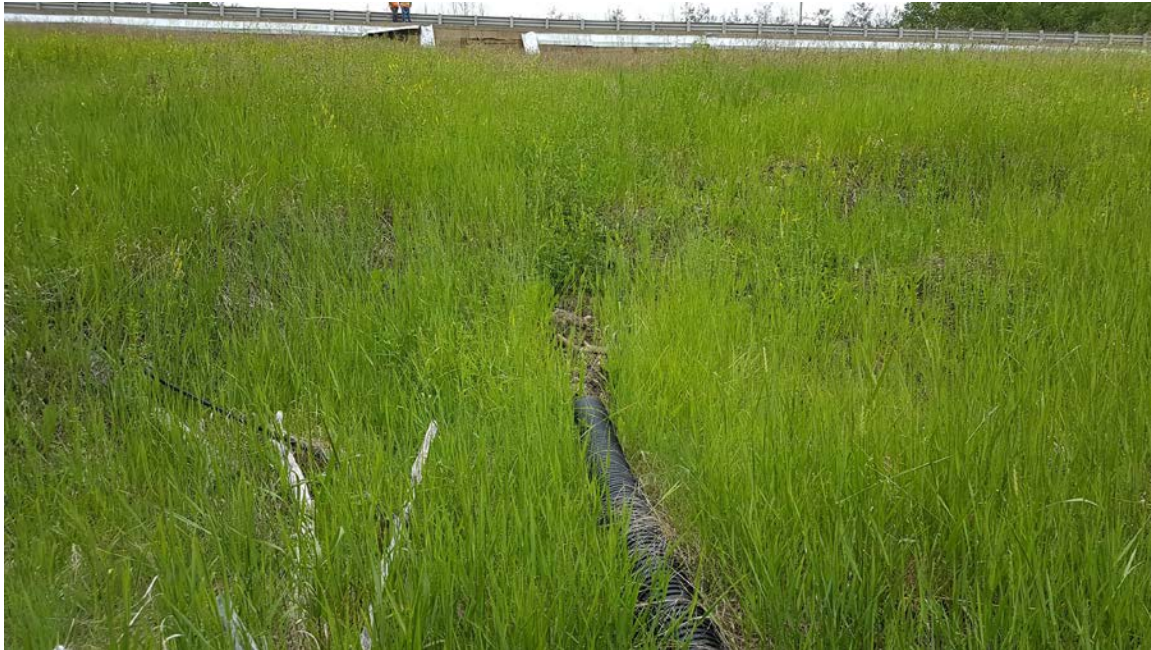
Photo 7 – Looking northeast at subdrain in the lower part of the slope that was located and extended during 2016 construction.
