**ALBERTA TRANSPORTATION
GEOHAZARD ASSESSMENT
PEACE REGION (PEACE RIVER DISTRICT)
2022 INSPECTION**

Site Number	Location	Name	Hwy	km
PH045-1	North of Manning, AB	Meikle River (Pile Wall)	35:08	26.2
Legal Description		UTM Co-ordinates		
SW7-94-22-W5M		11U E 467,581	N	6,333,081

**PH045: HWY 35:08 - MEIKLE RIVER
 GEOHAZARD ASSESSMENTS**

DWG No. 32121-PH045-1

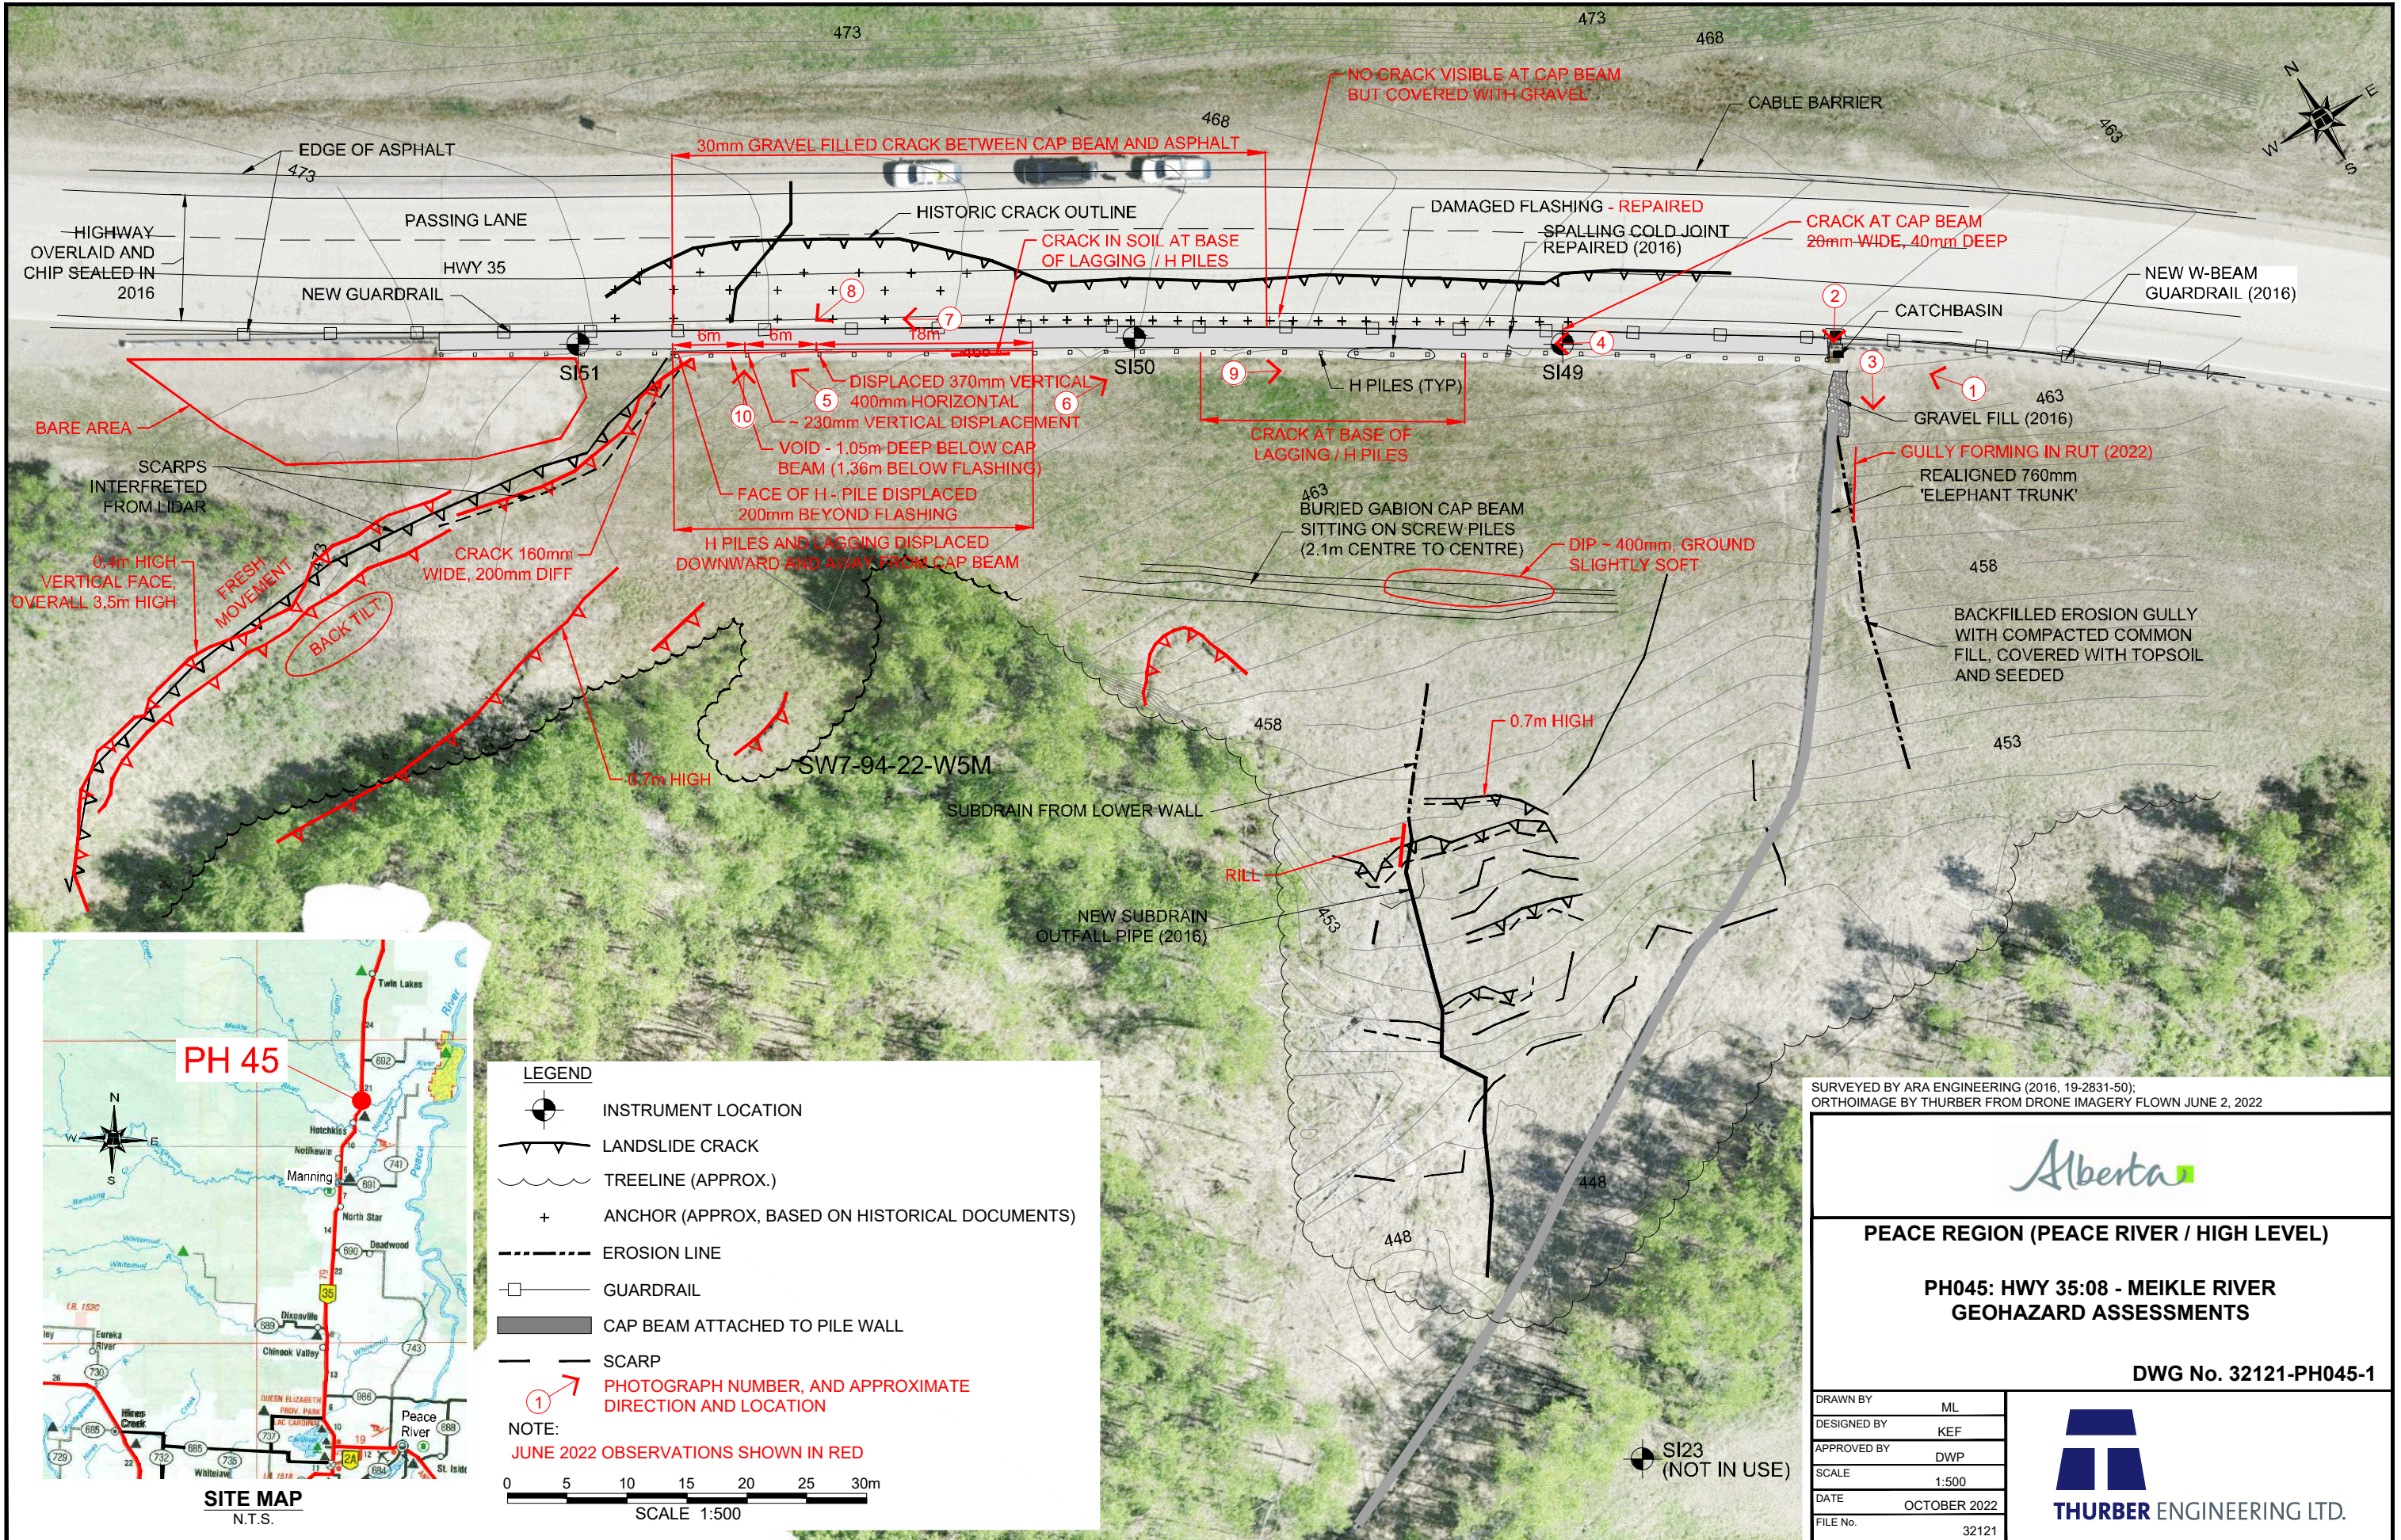
NOTE:
 JUNE 2022 OBSERVATIONS SHOWN IN RED

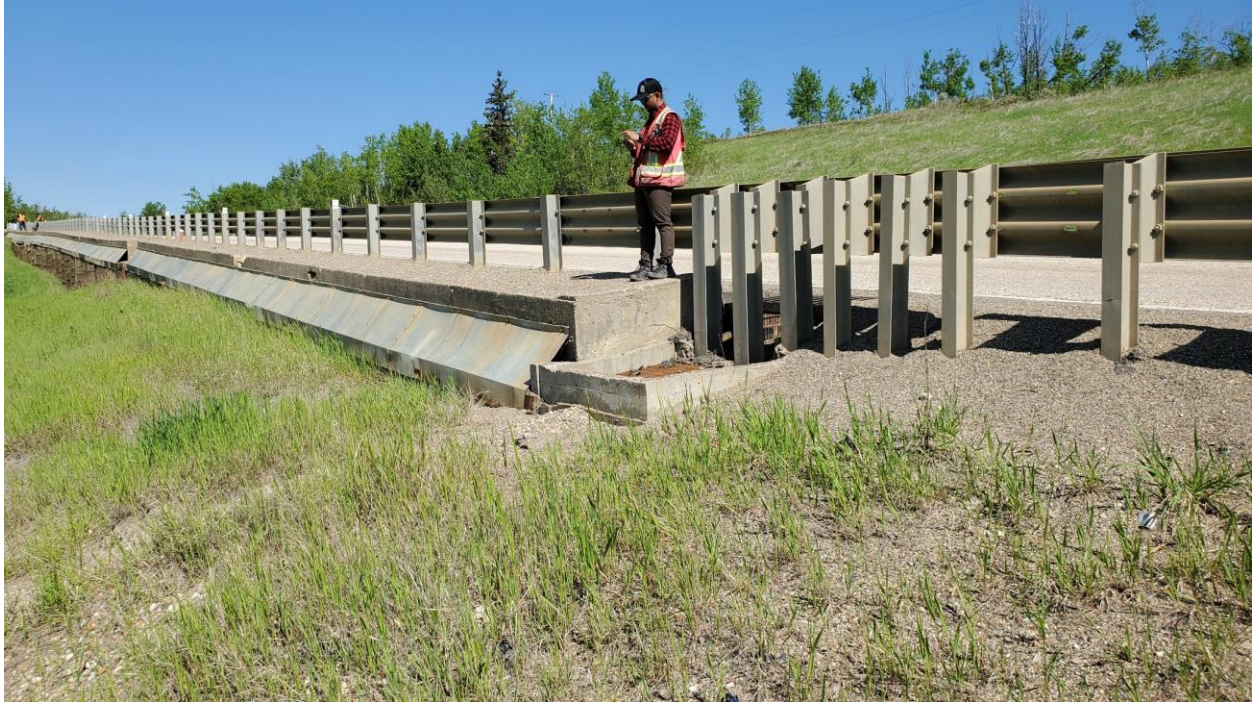
Photo 1 – Looking northwest at the catch basin and pile wall.

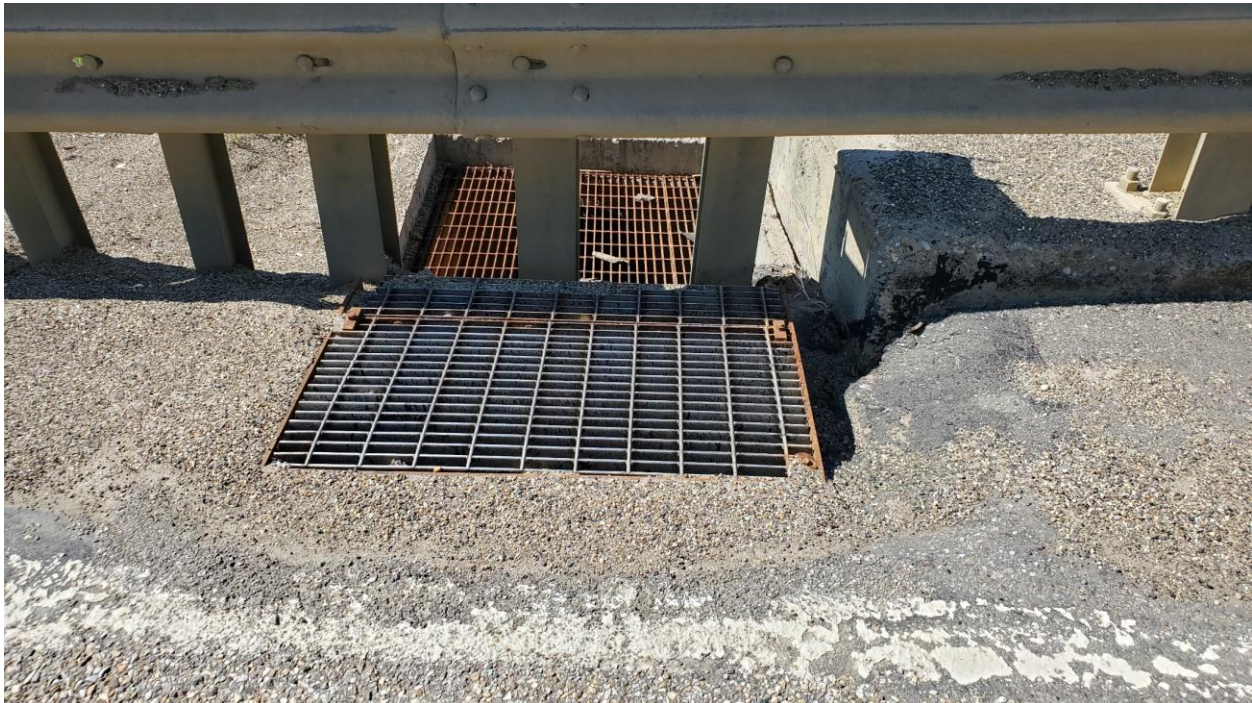
Photo 2 – Catch basin inlet at the south end of the wall leading to the elephant trunk downpipe.

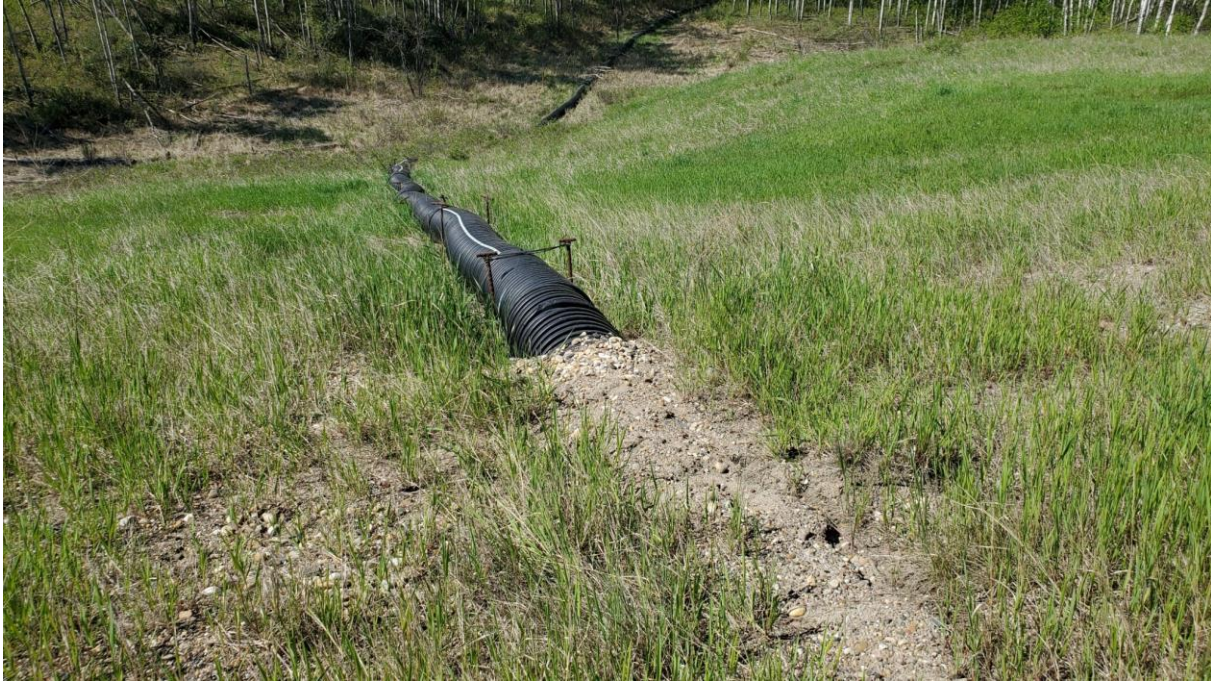
Photo 3 – Looking downslope at “elephant trunk” drain pipe. There is some erosion forming in mower ruts on the left (south) side of the drain pipe.

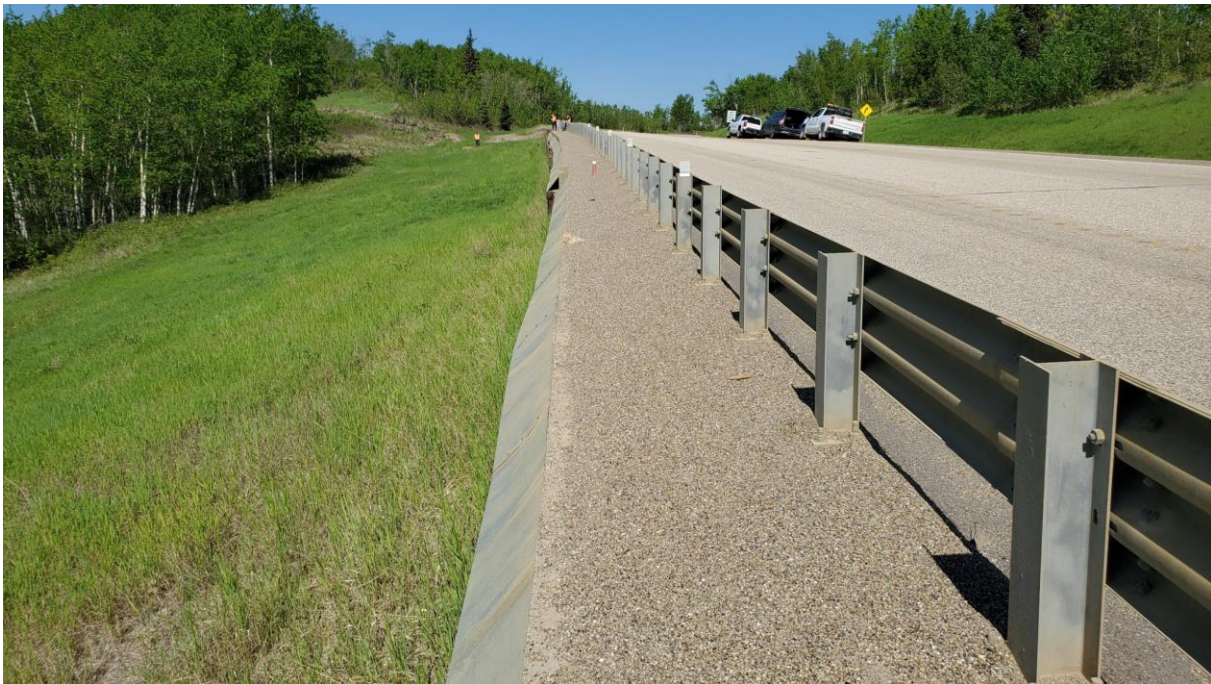
Photo 4 – Looking northwest at repaired and overlaid asphalt surface. A new bridge rail was installed during construction and damaged flashing at about the center of the wall noted previously has been repaired.

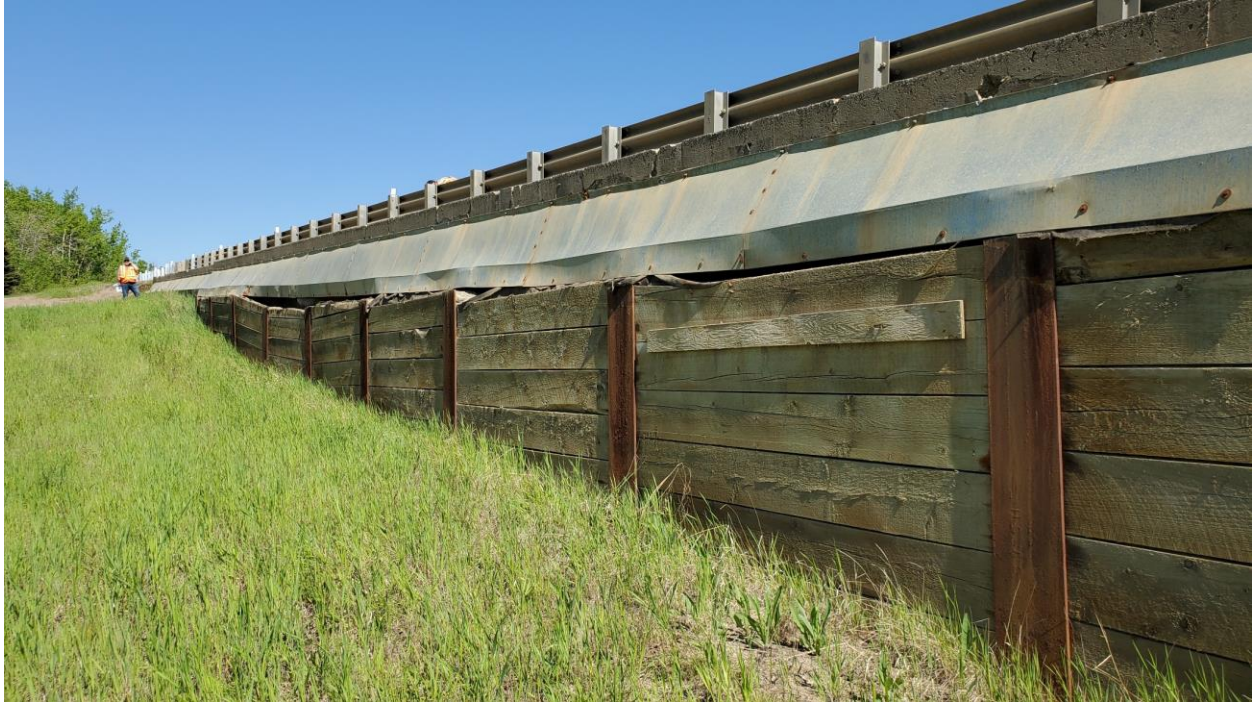
Photo 5 – Looking north at the displaced H-pile and timber lagging wall near the scarp at the north end of the wall.

- As this landslide has become active again, it is recommended that a geotechnical investigation and analysis of pile-soil interaction be undertaken in the near-future so that a tie-back system can be designed. It is anticipated that additional stabilization measures will be required at this site.

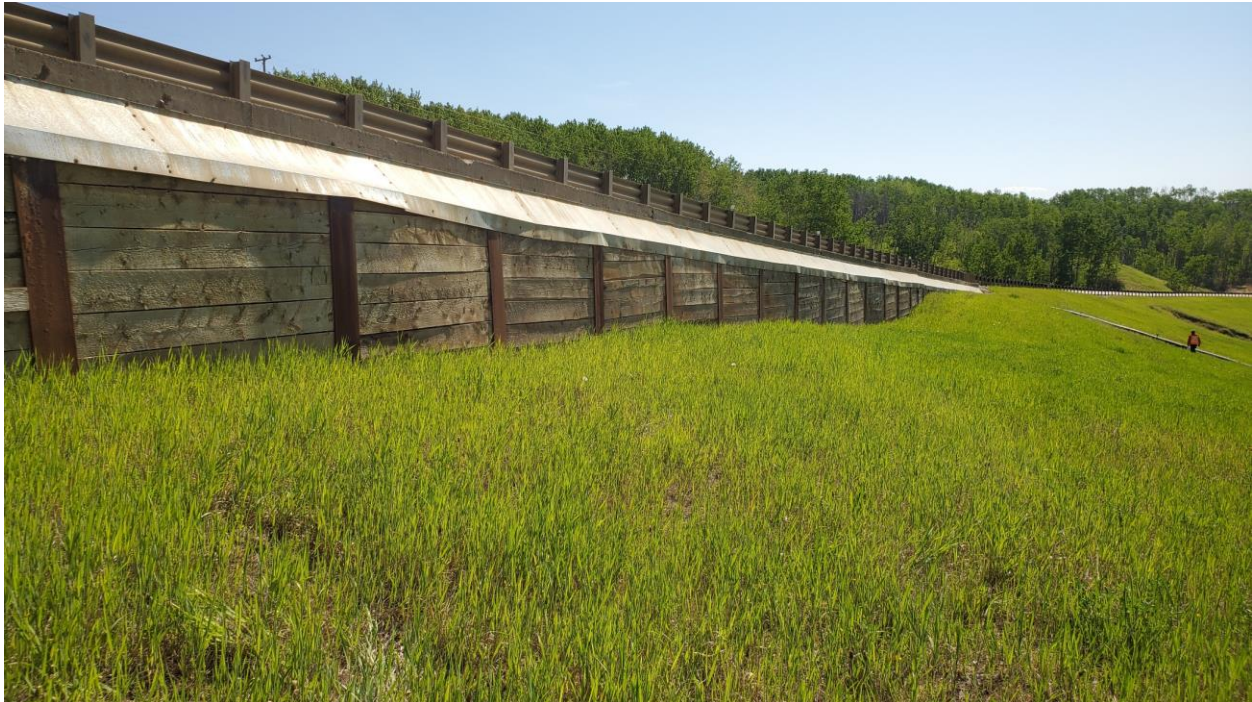
Photo 6 – Looking east at the end of the displaced section of lagging and beyond to (as yet) undisturbed lagging.

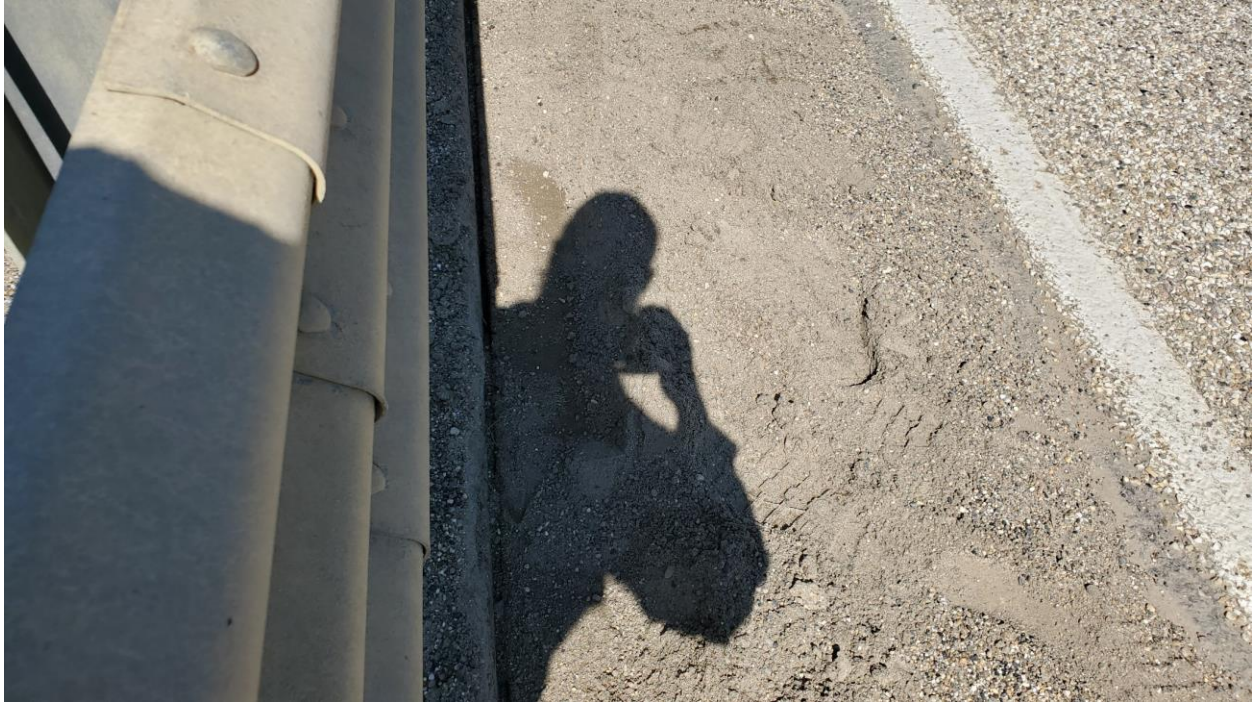
Photo 7 – Looking at the crack that is opening up again between the cap beam and asphalt.

- Routine crack sealing between the asphalt and the cap beam to limit infiltration of runoff.

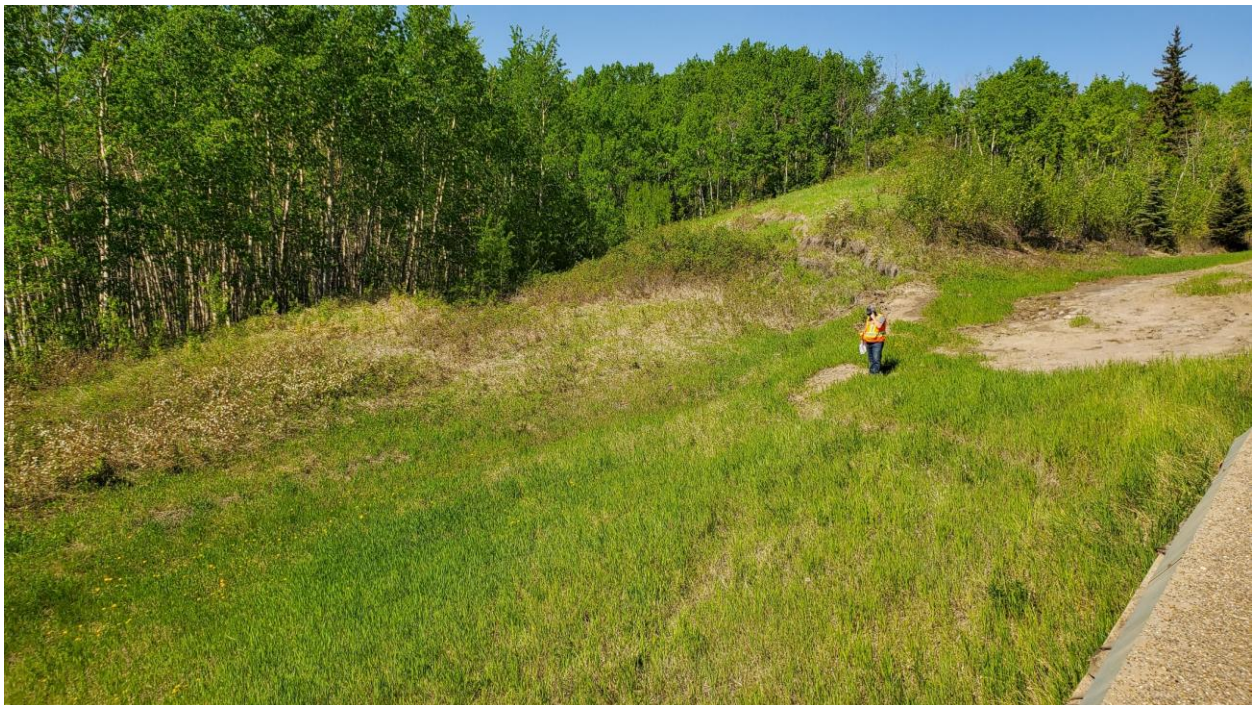
Photo 8 – Looking west at graben block northwest of the wall, which appears to have become re-activated.

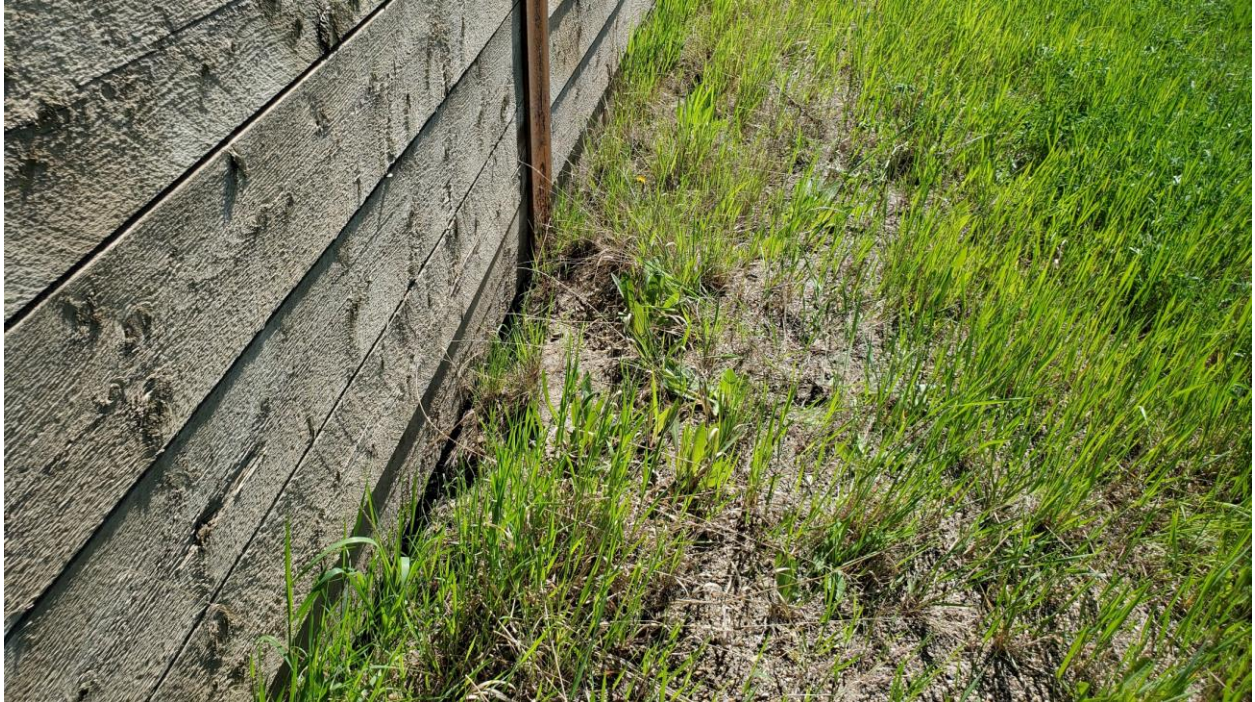
Photo 9 – The crack forming below the lagging wall at the south end where the soil is starting to pull away.

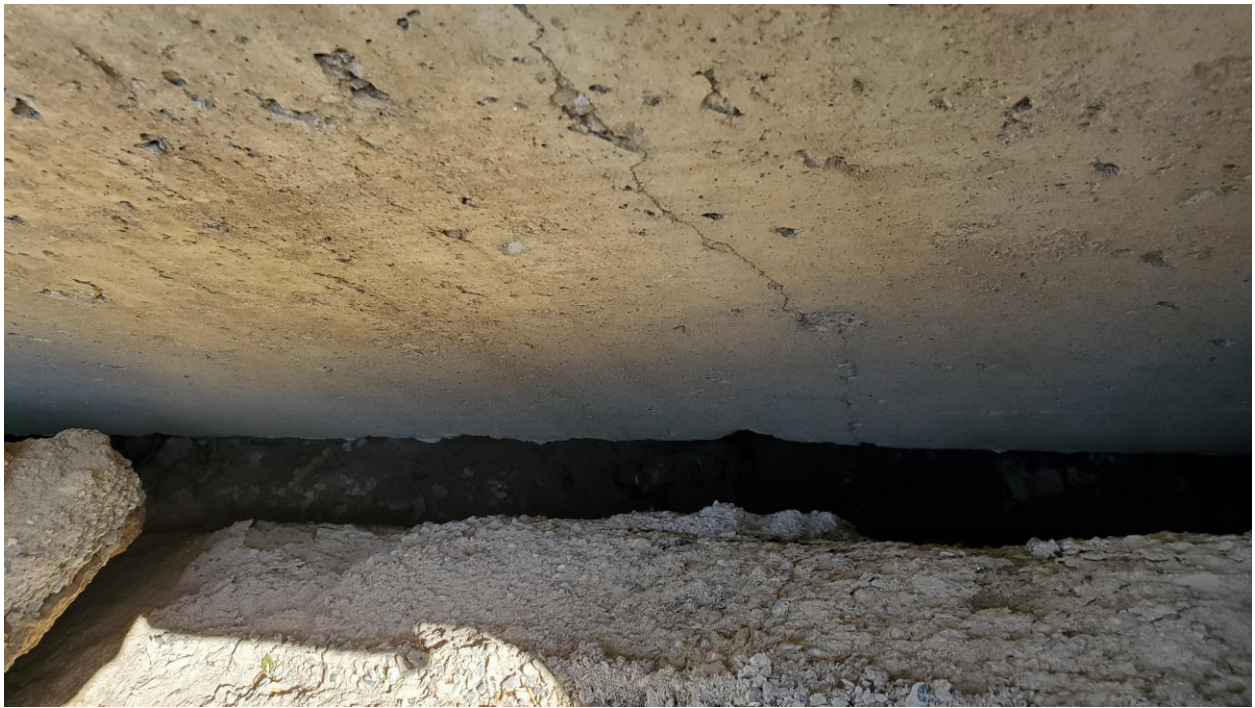
The site is subjected to ongoing creep movements of the slope had led to the formation of voids behind the pile wall and cap beam and subsequent loss of material from below the highway and cap

Photo 10 – The void forming in front of and behind the cap beam as the lagging wall and grout backfill is displaced by slope movement.
