July 26, 2022

**ALBERTA TRANSPORTATION GRMP (CON0022164)
PEACE REGION (PEACE RIVER DISTRICT)
INSTRUMENTATION MONITORING RESULTS – SPRING 2022**

SITE PH045: HWY 35:08, MEIKLE RIVER (km 26.2 PILE WALL)

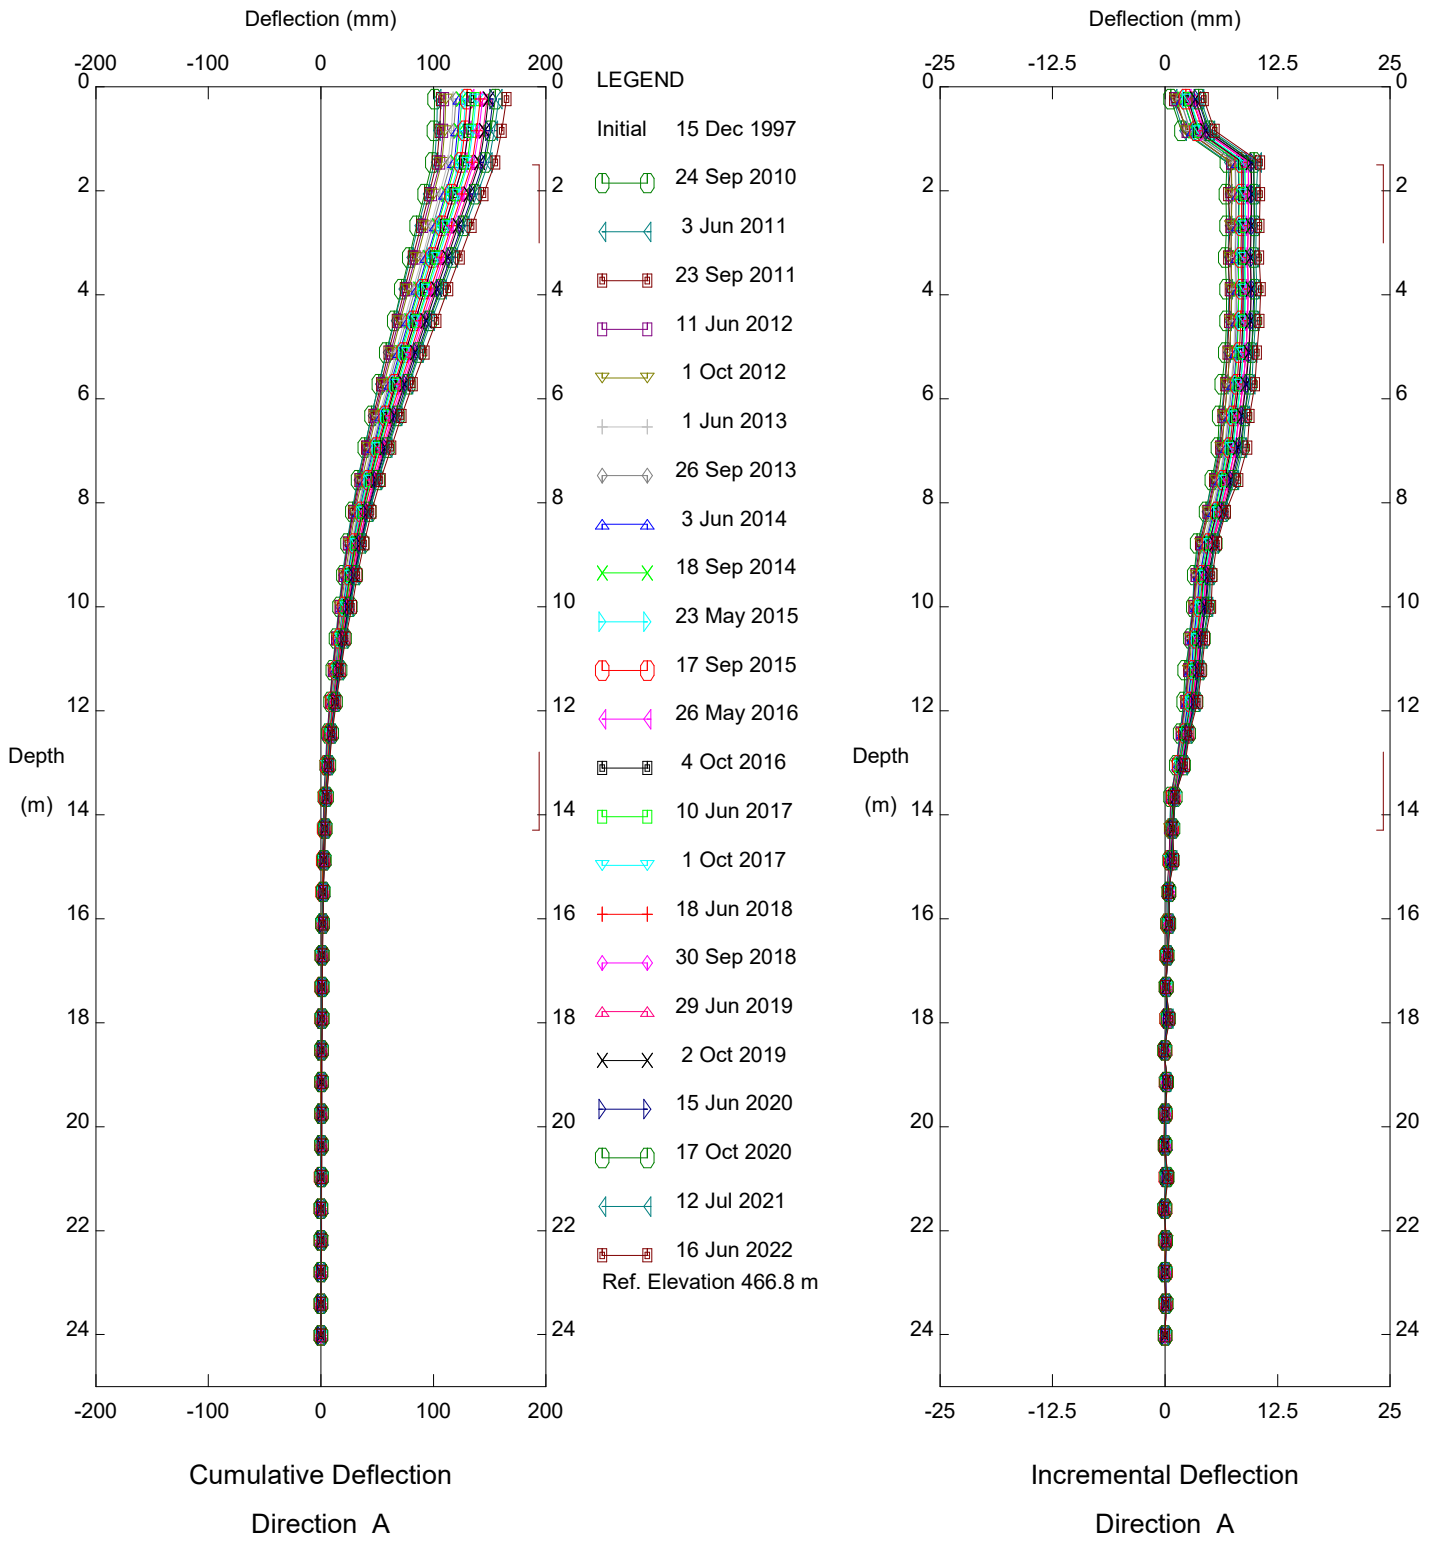
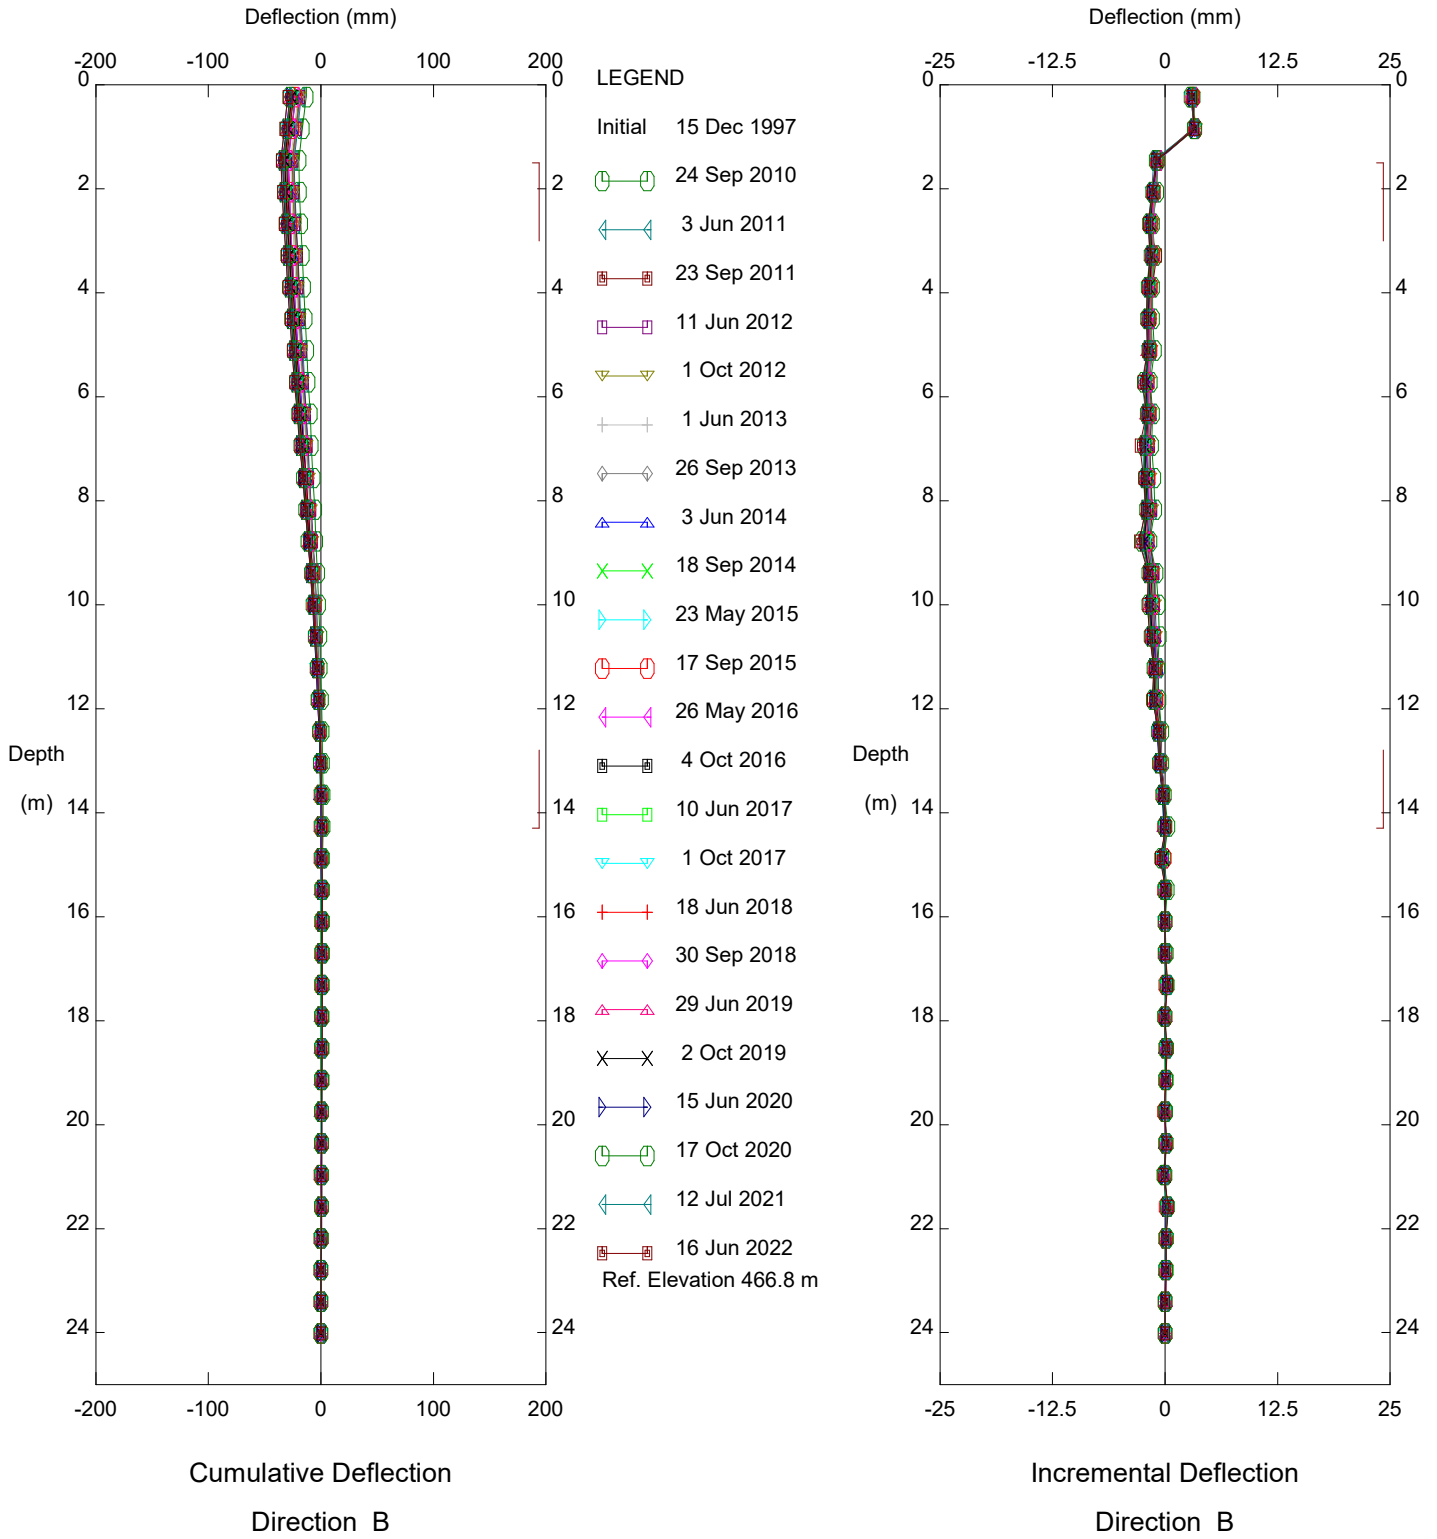
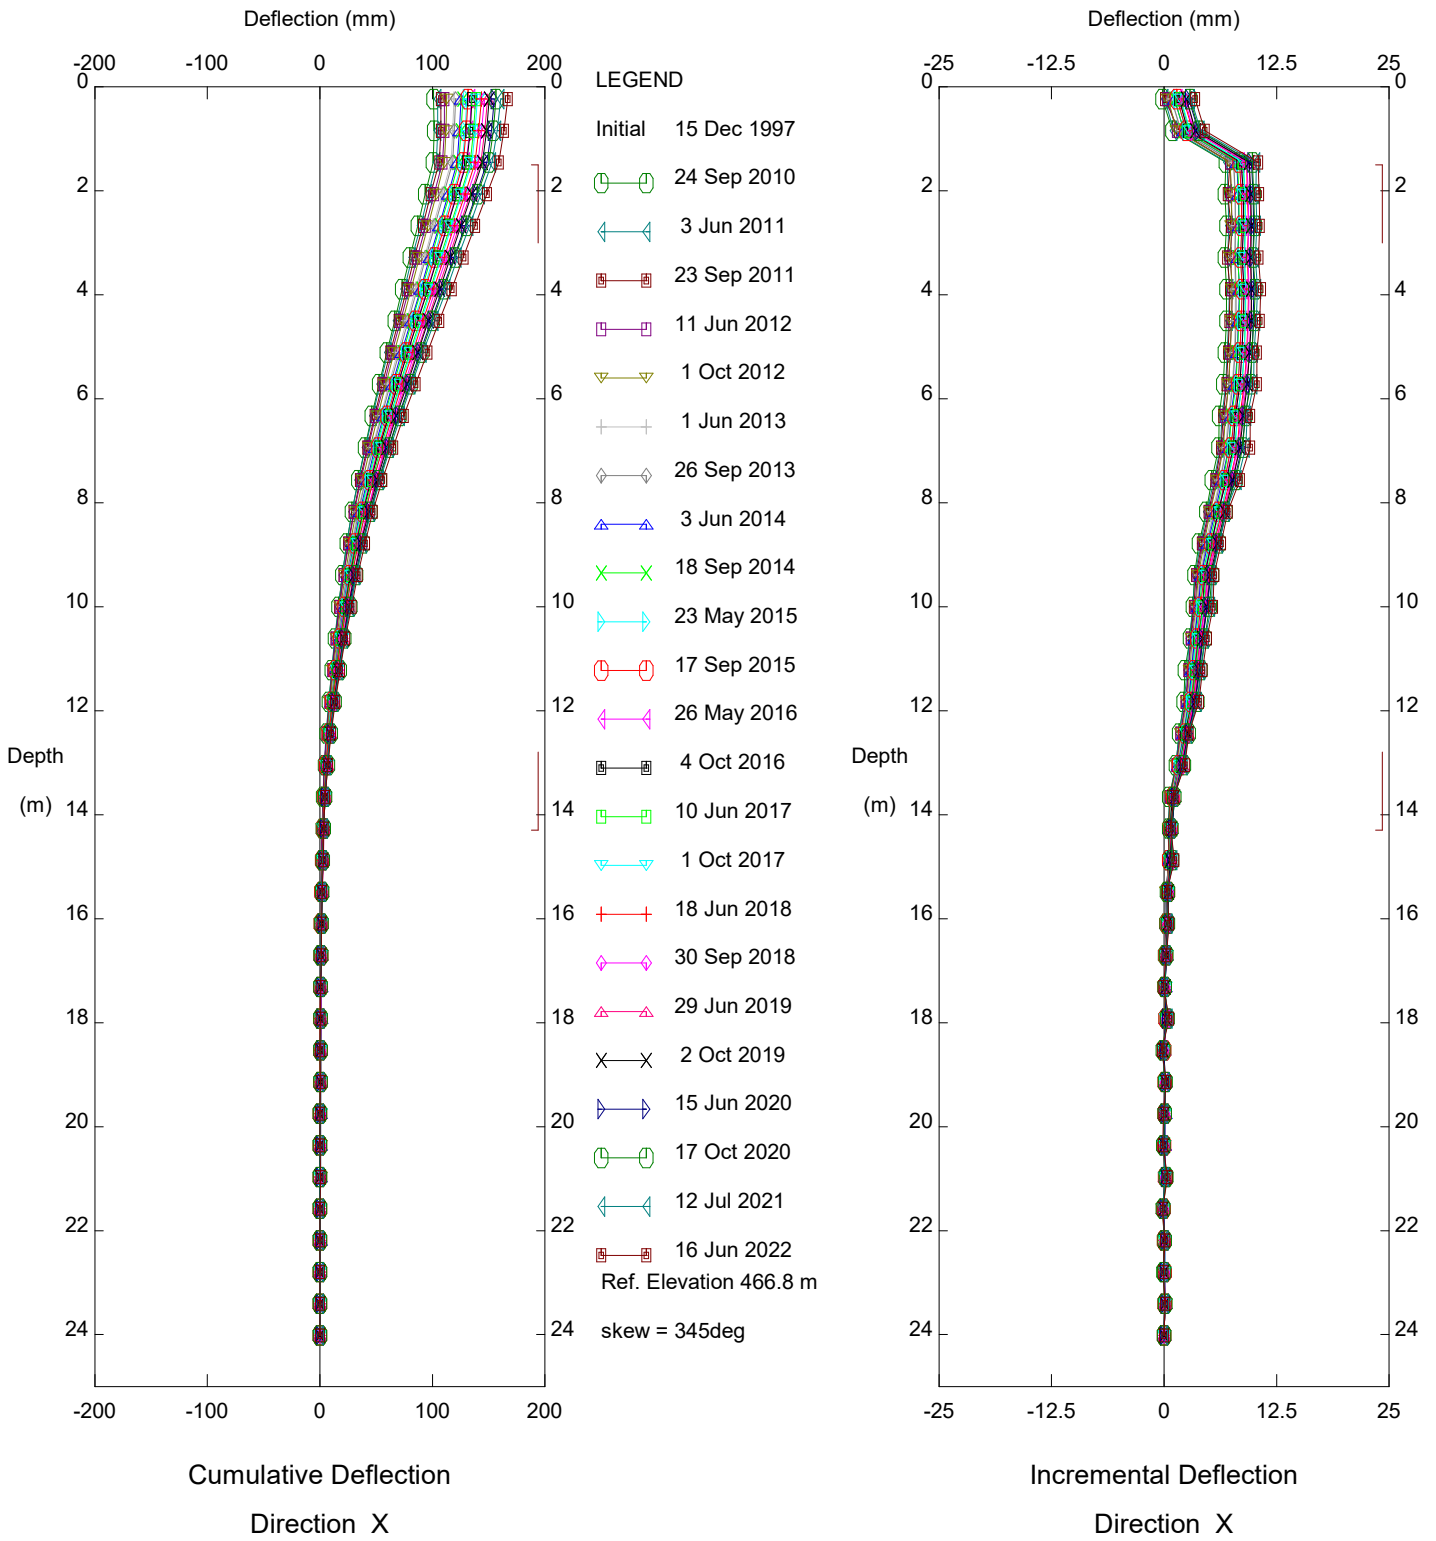
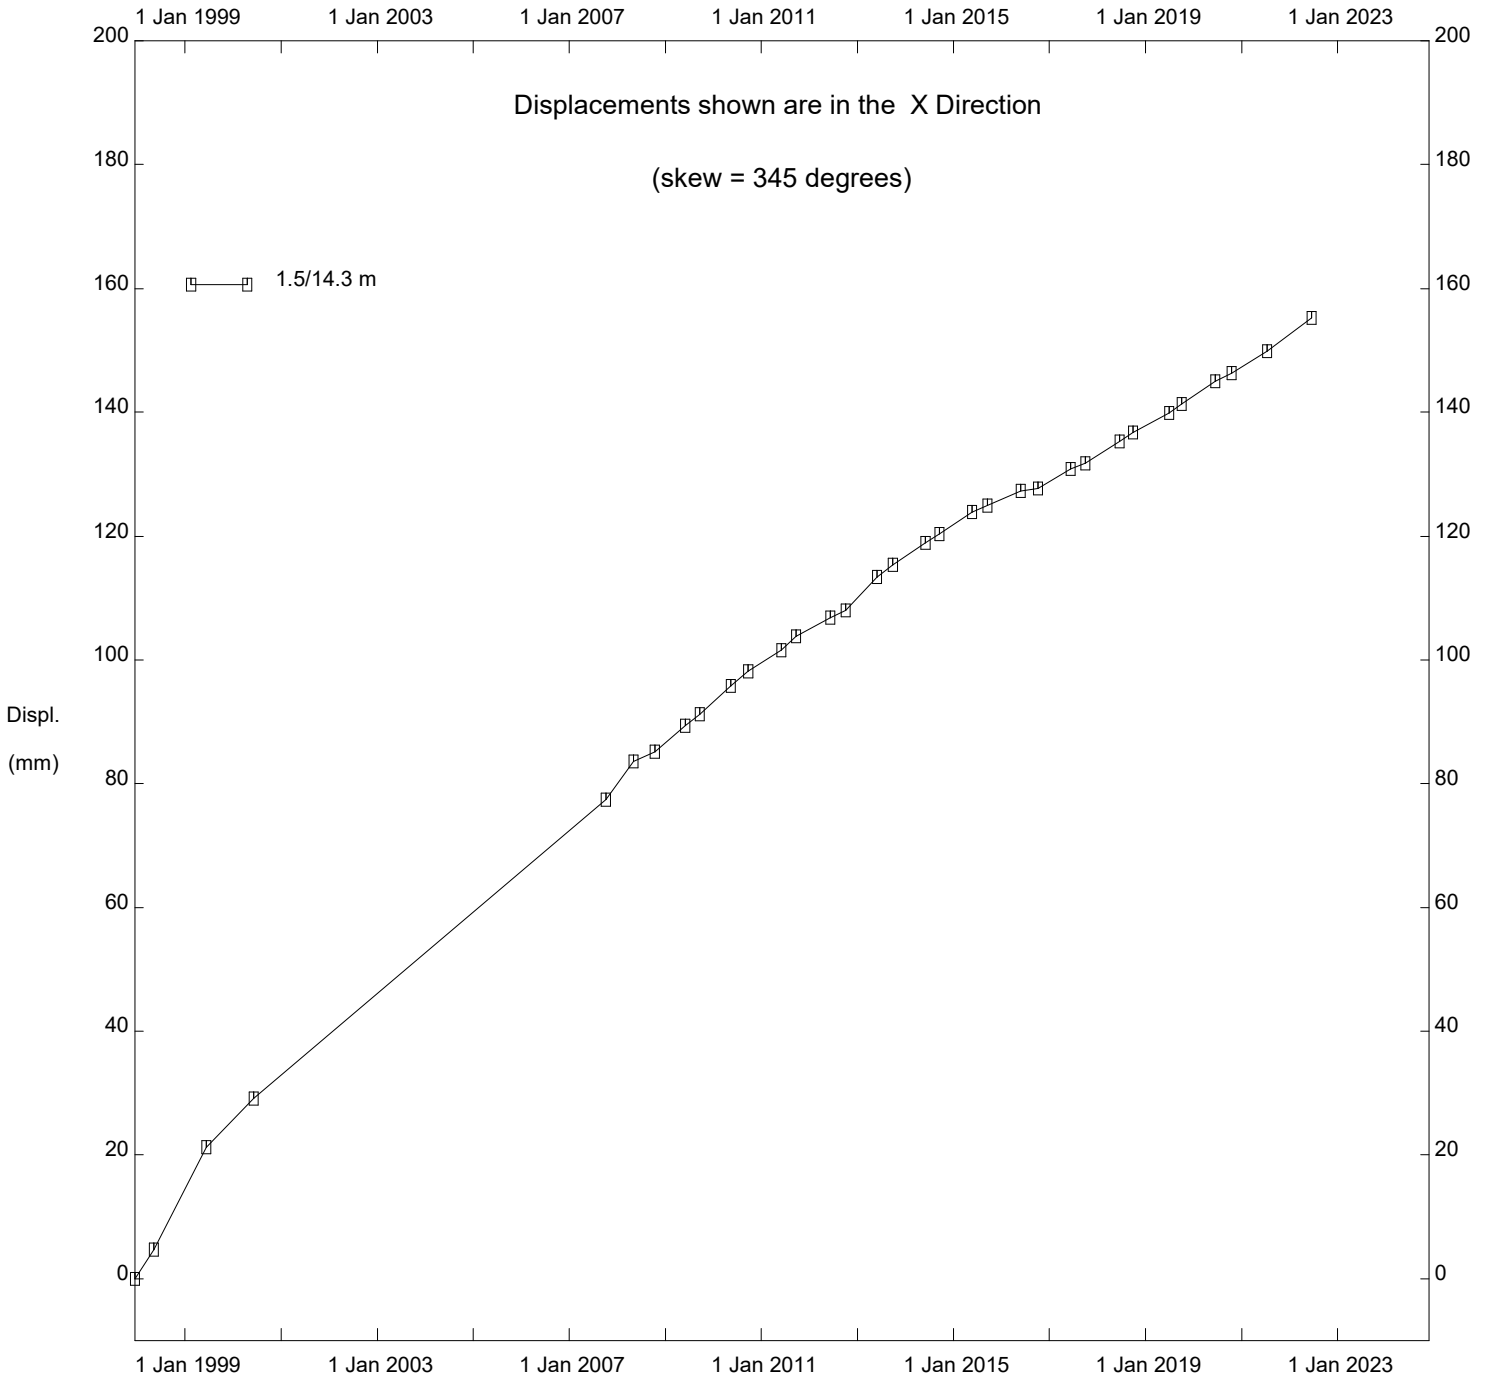
HWY 35:08 (PH045), Inclinometer SI-49

Since the spring of 2021 readings, slope inclinometer SI-49 showed a rate of movement of 5.7 mm/yr over 1.5 m to 14.3 m depth with a total cumulative deflection to date of 155.3 mm. Although this rate is slightly slower than overall rate (since initialization) of 6.3 mm/year, the trend has been steady. SI-50 showed a rate of movement of 4.4 mm/yr over 1.7 m to 13.9 m depth since the spring of 2021 readings with a total cumulative movement to date of 160.0 mm. This rate is slower than the overall rate of 6.5 mm/year but there are indications that the movement rate has accelerated slightly since Spring 2020. SI-51 showed a rate of movement of 2.8 mm/yr since the spring of 2021 readings with a total cumulative movement to date of 73.3 mm. The rate of movement had been negative over the last two cycles which has also happened in the past. The trend in this inclinometer appears to be inconsistent.

Overall, the movement pattern at SI-49 appears to have been unaffected by the repairs undertaken in 2016. SI-50 showed a marked reduction in movement rate and SI-51 is somewhat inconclusive due to the irregular movement trends.

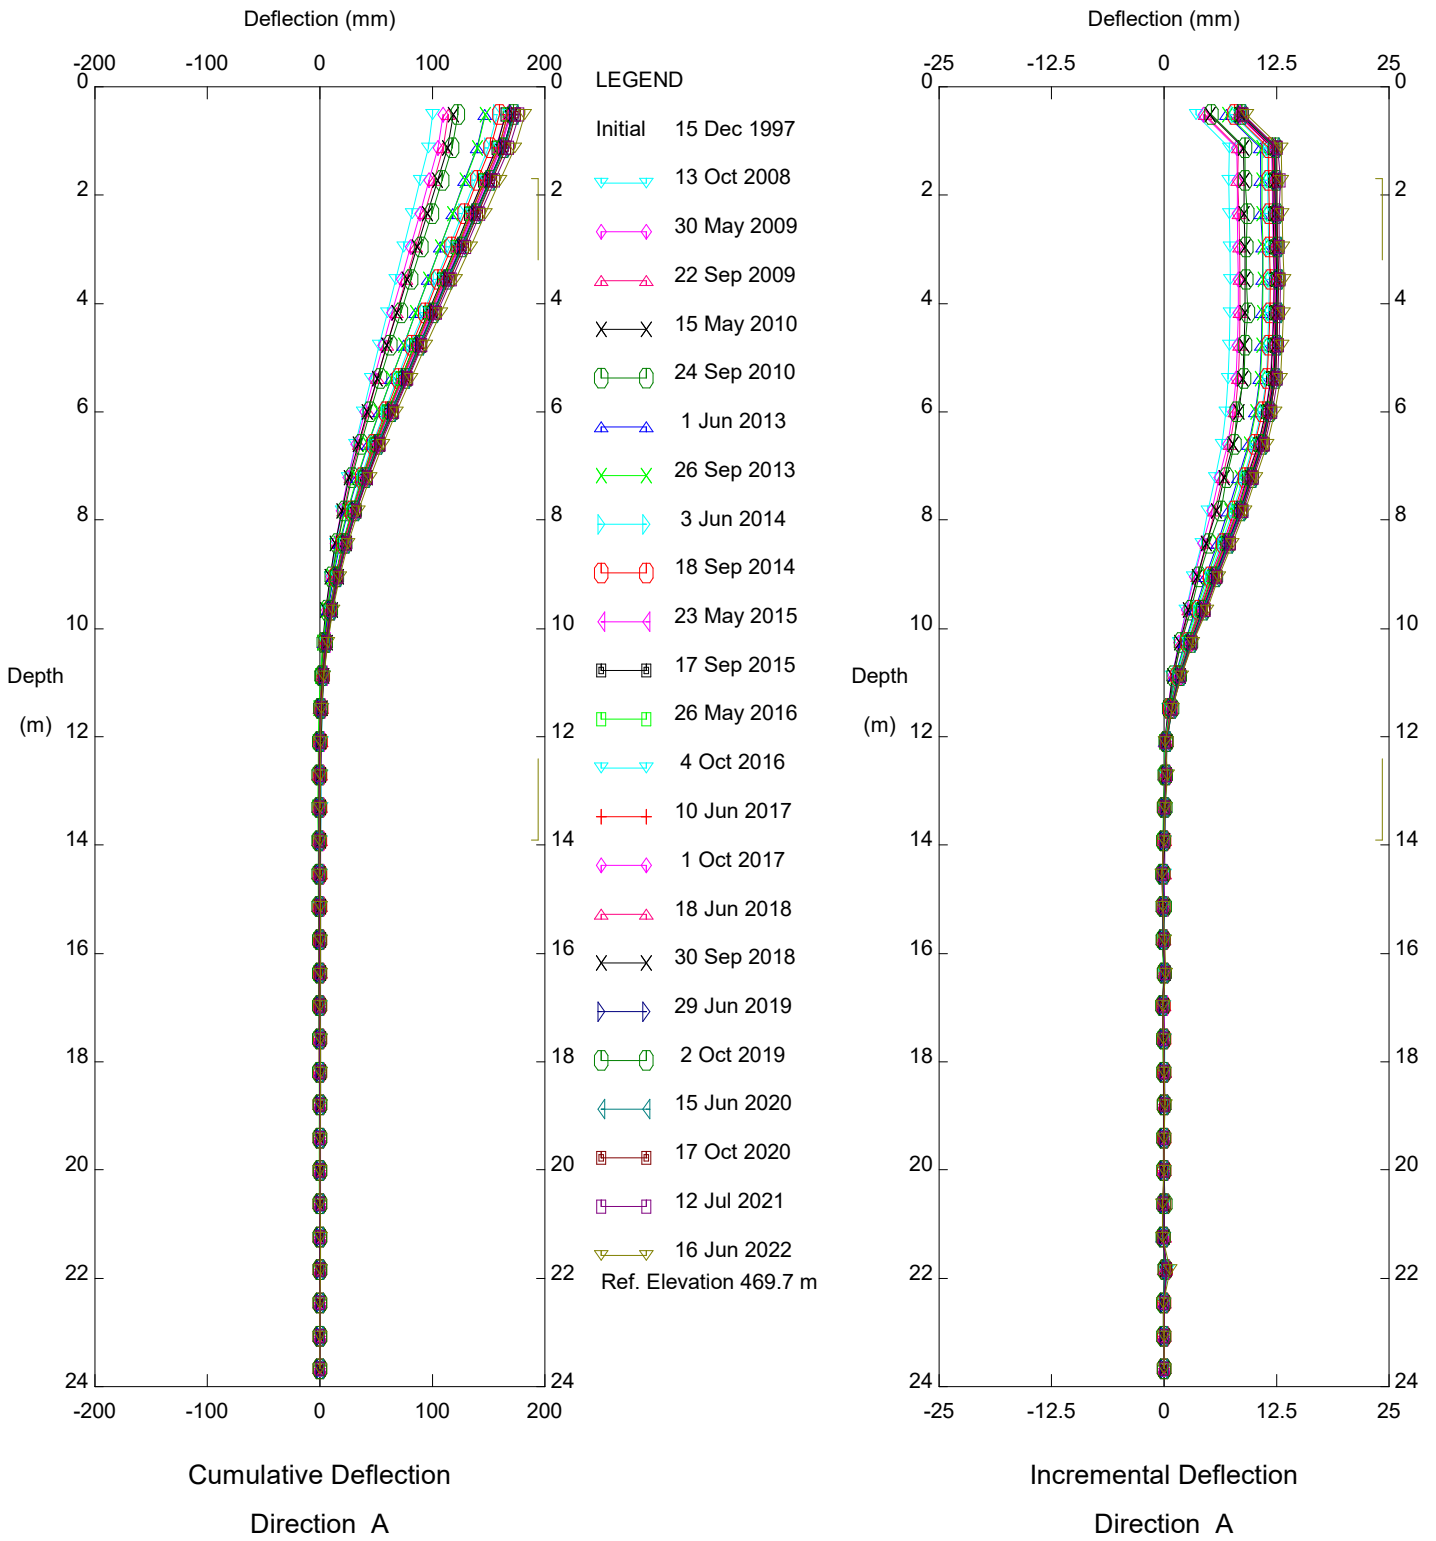
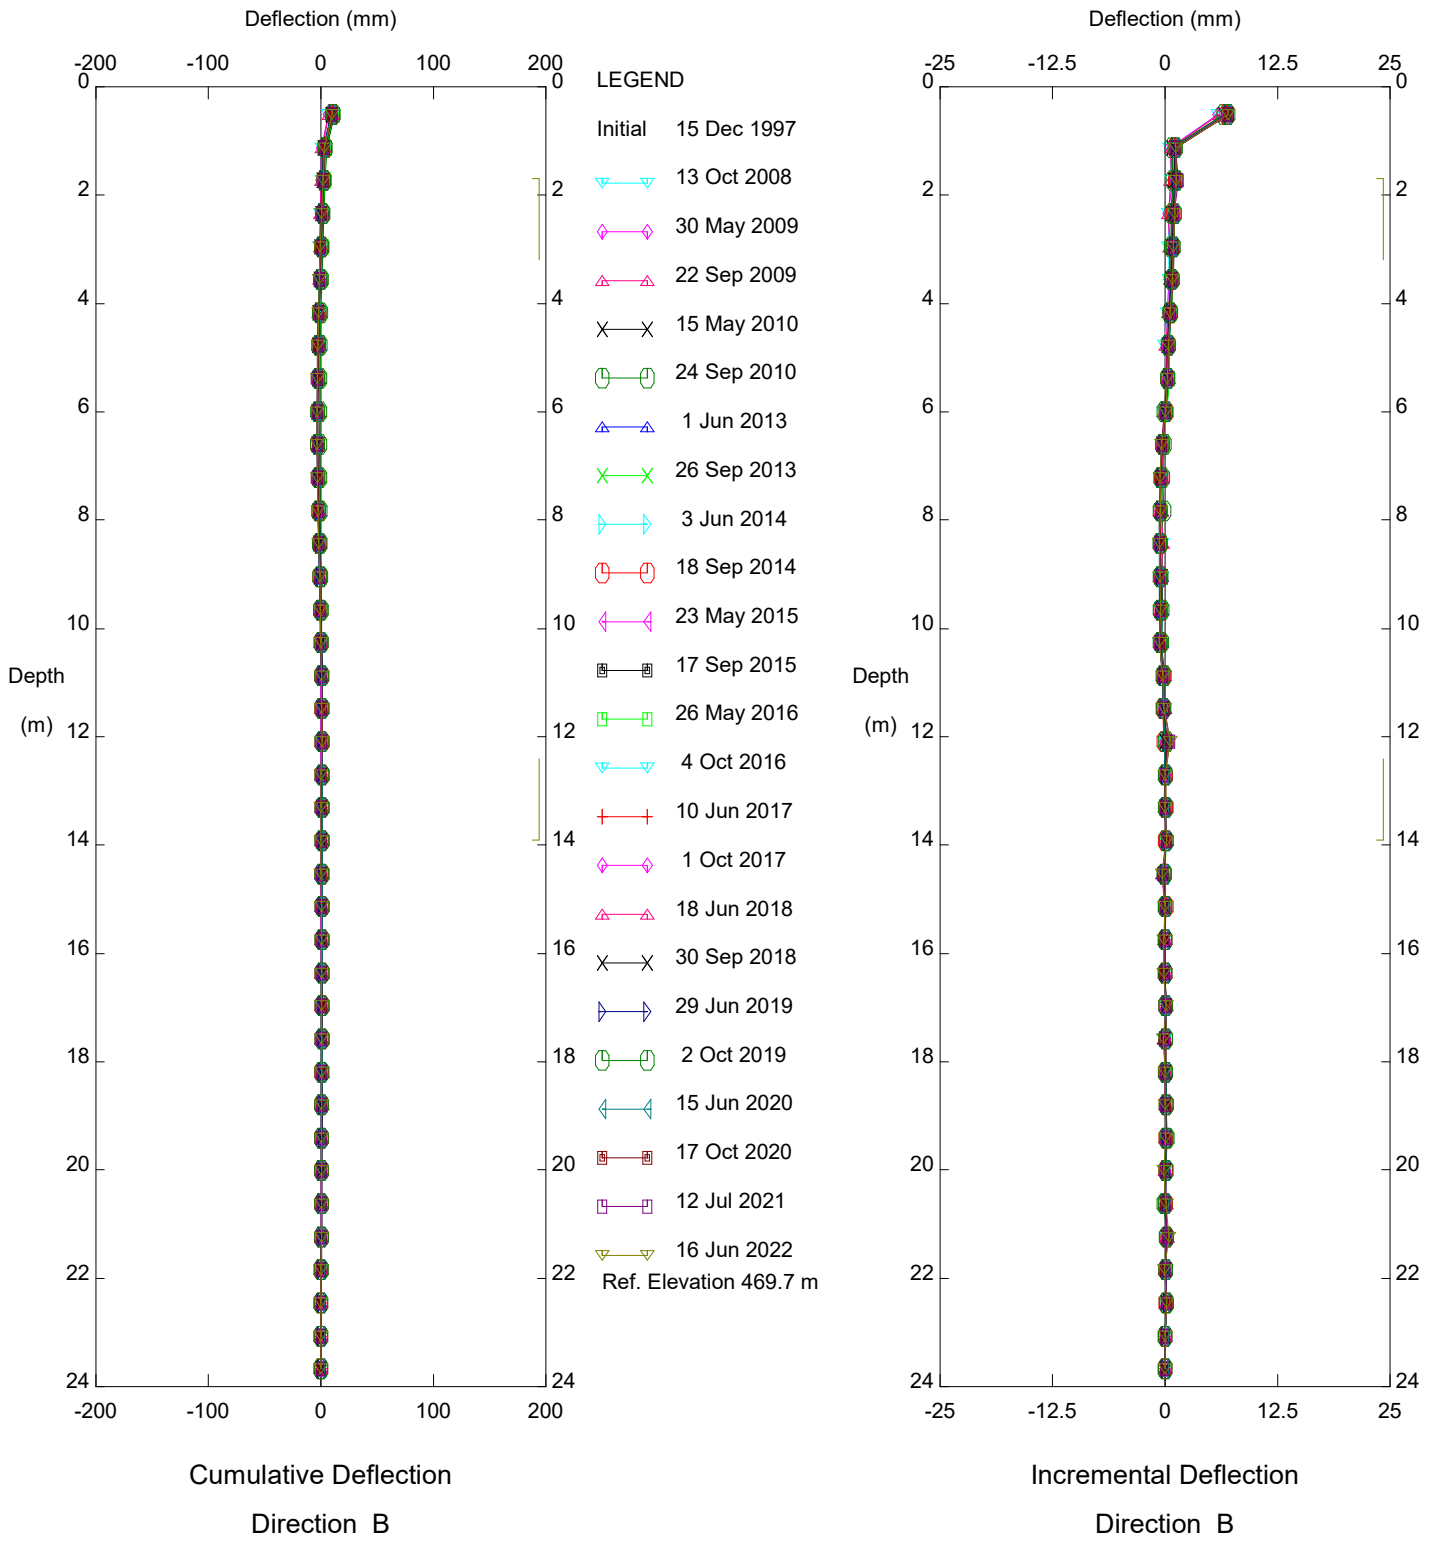
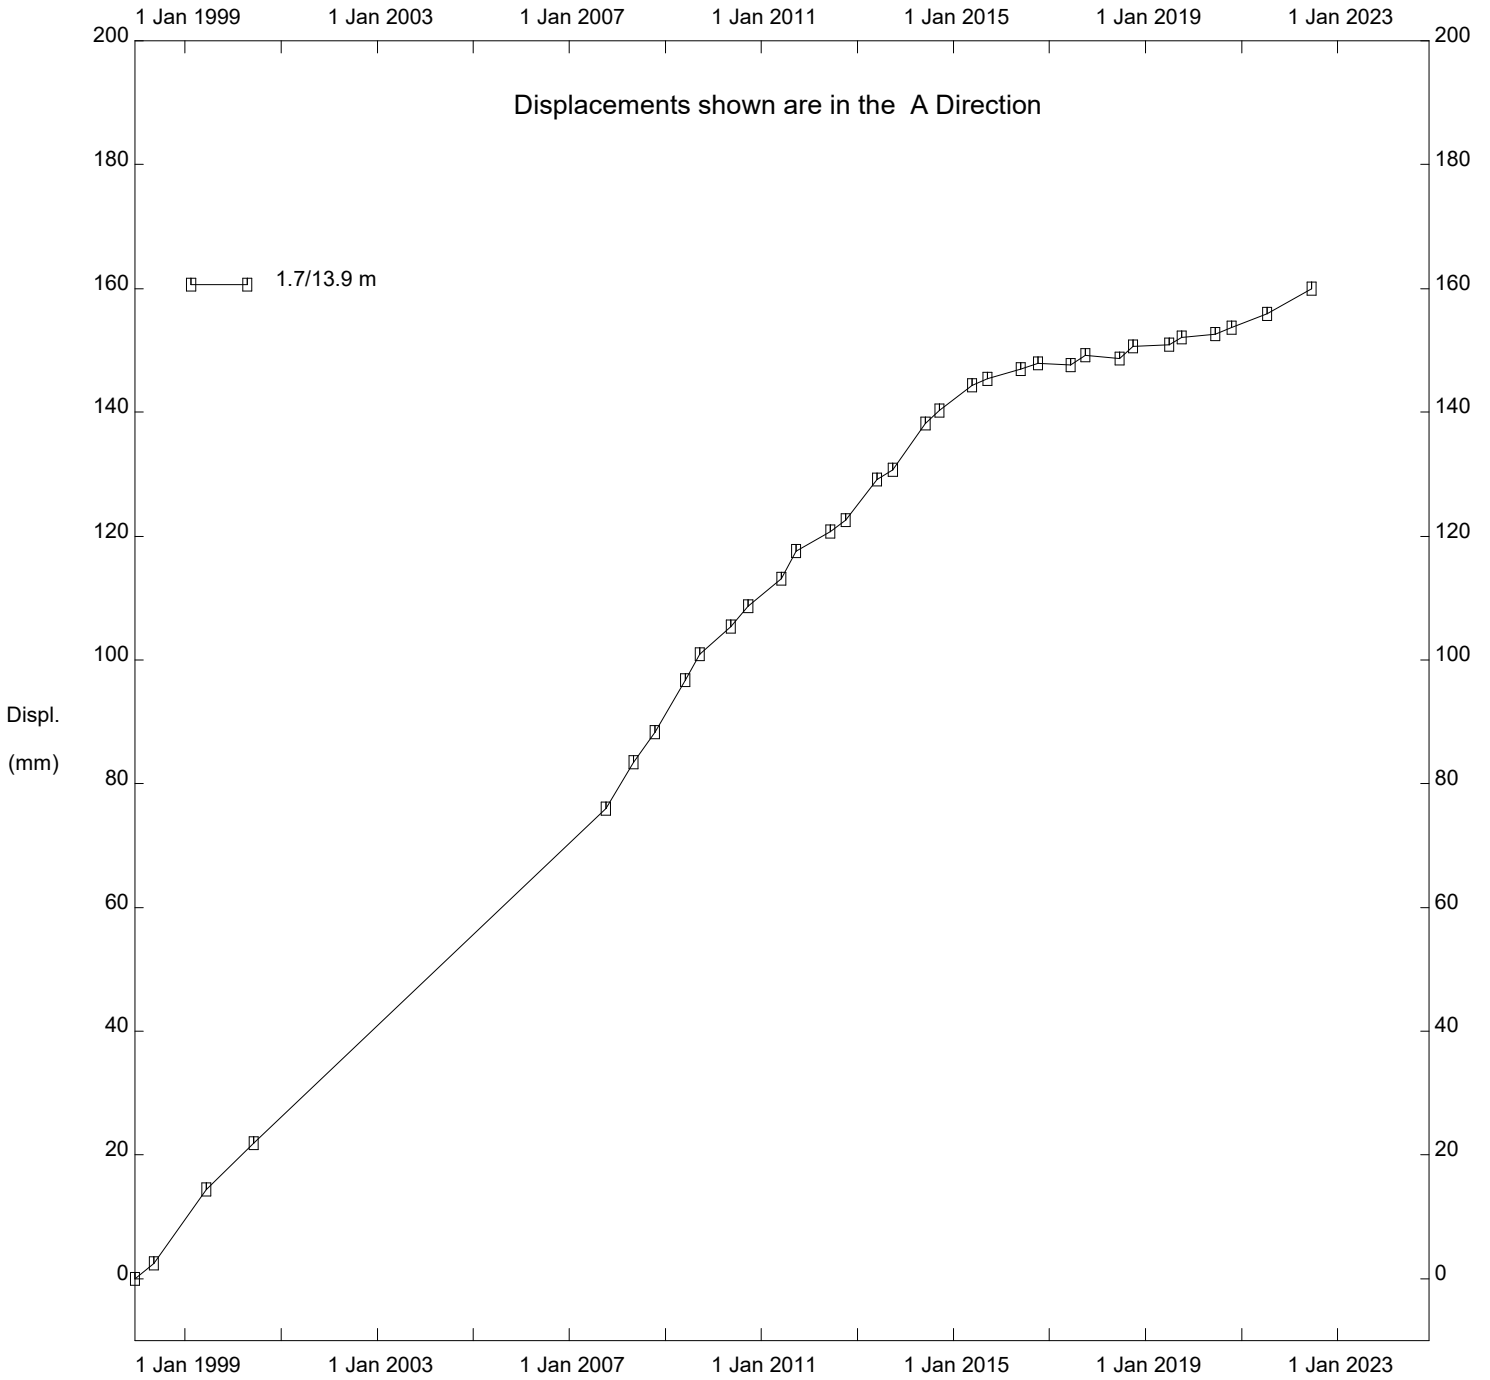
HWY 35:08 (PH045), Inclinometer SI-50

* SI-51 probe comes to surface not in grooves, may be damaged at 2 feet depth. Top of casing damaged
** SI-50 - top of SI slightly damaged
