July 26, 2022

**ALBERTA TRANSPORTATION GRMP (CON0022164)
PEACE REGION (PEACE RIVER DISTRICT)
INSTRUMENTATION MONITORING RESULTS – SPRING 2022**

SITE PH045: HWY 35:08, MEIKLE RIVER (km 26.2 PILE WALL)

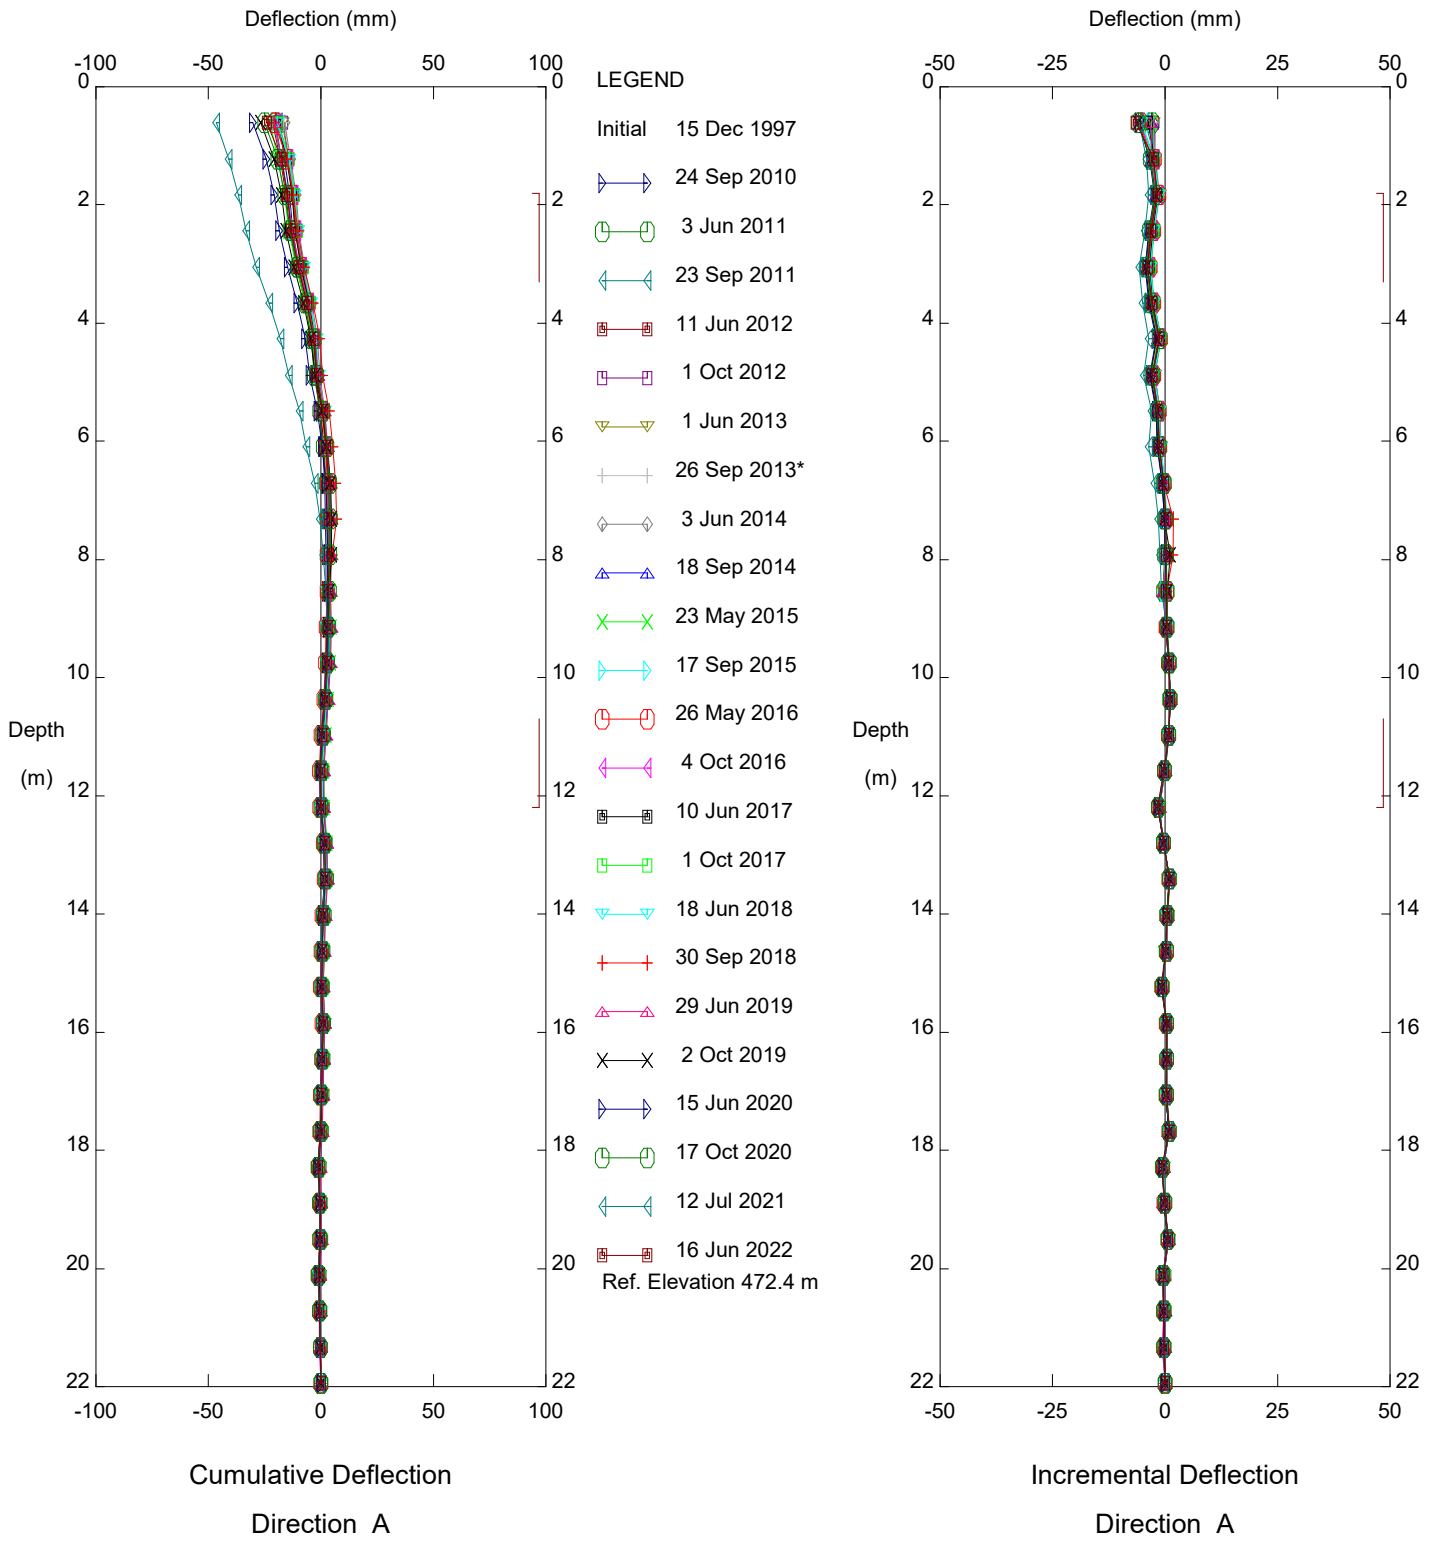
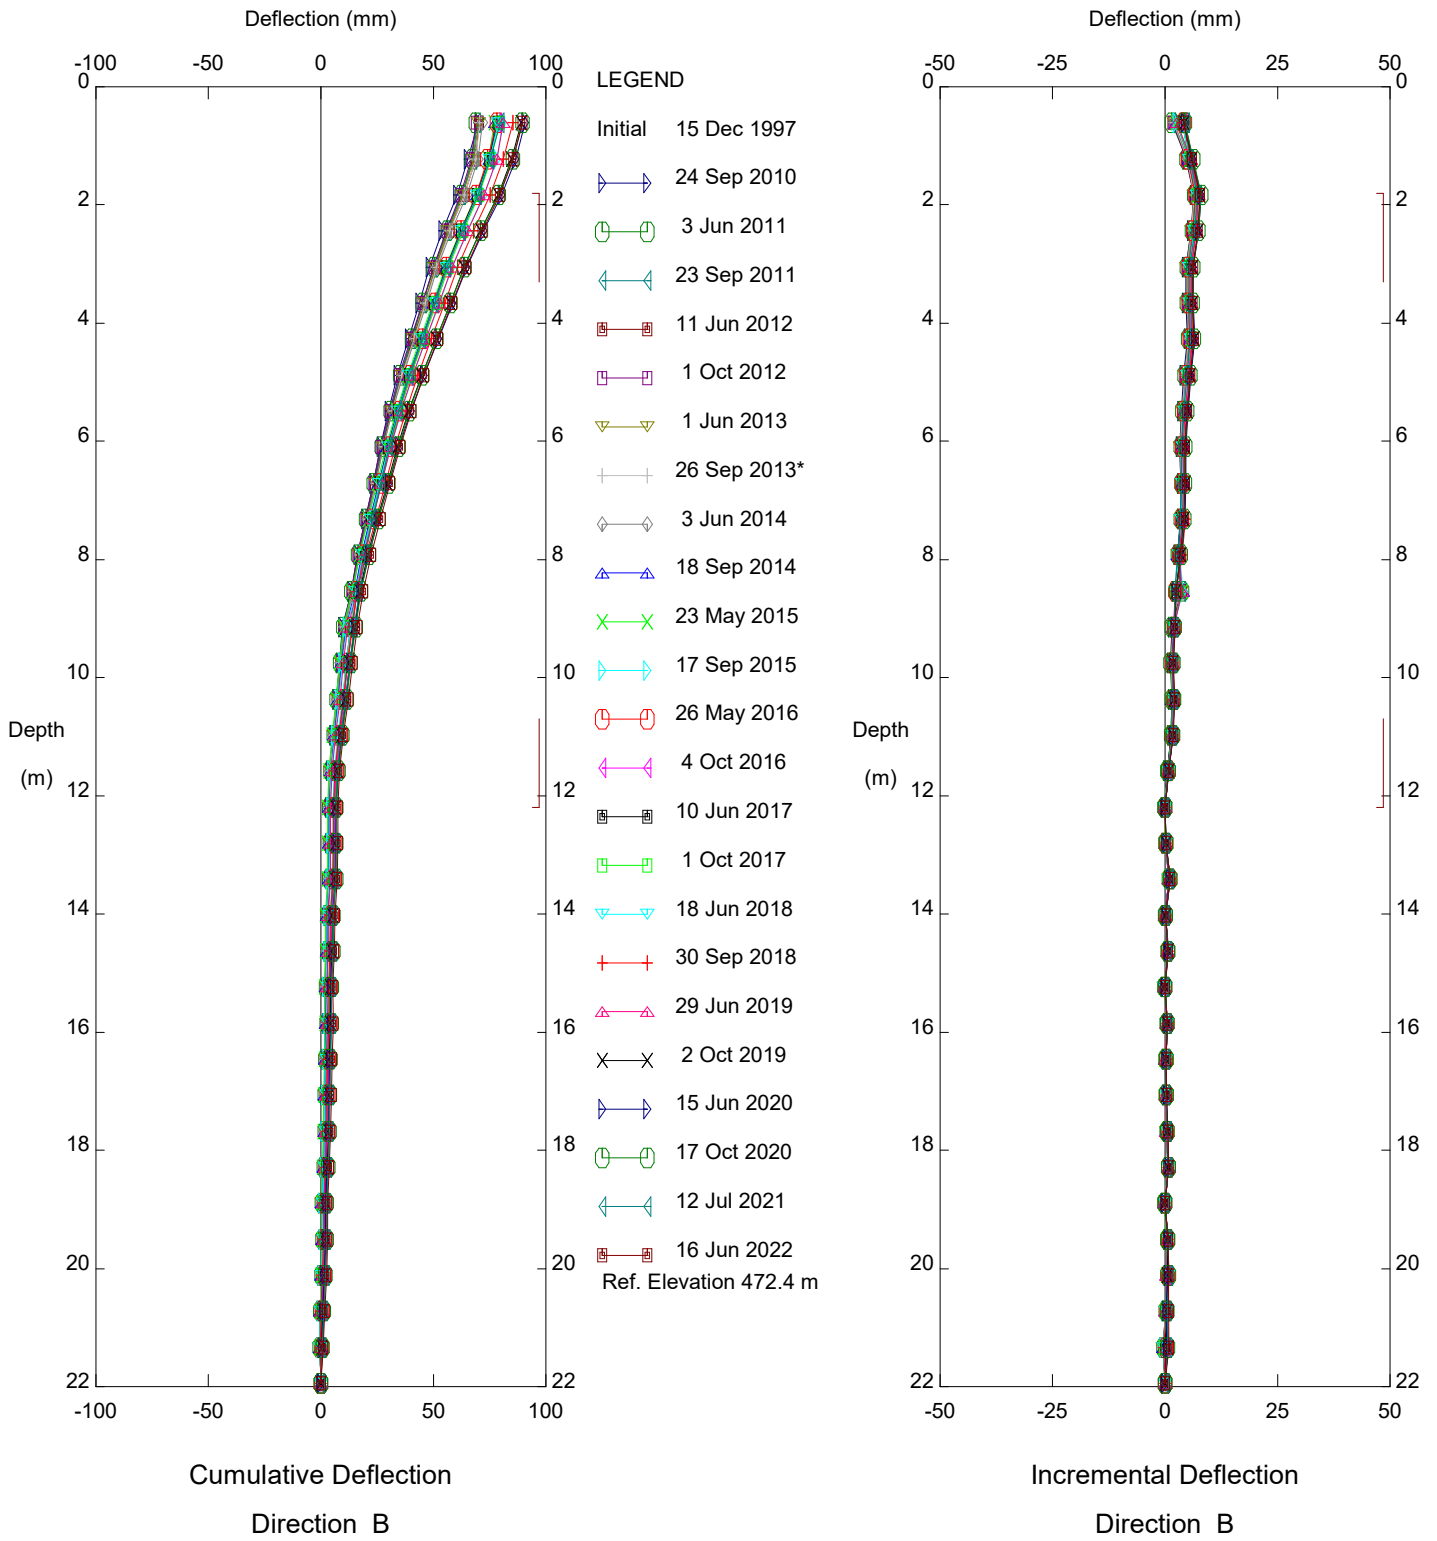
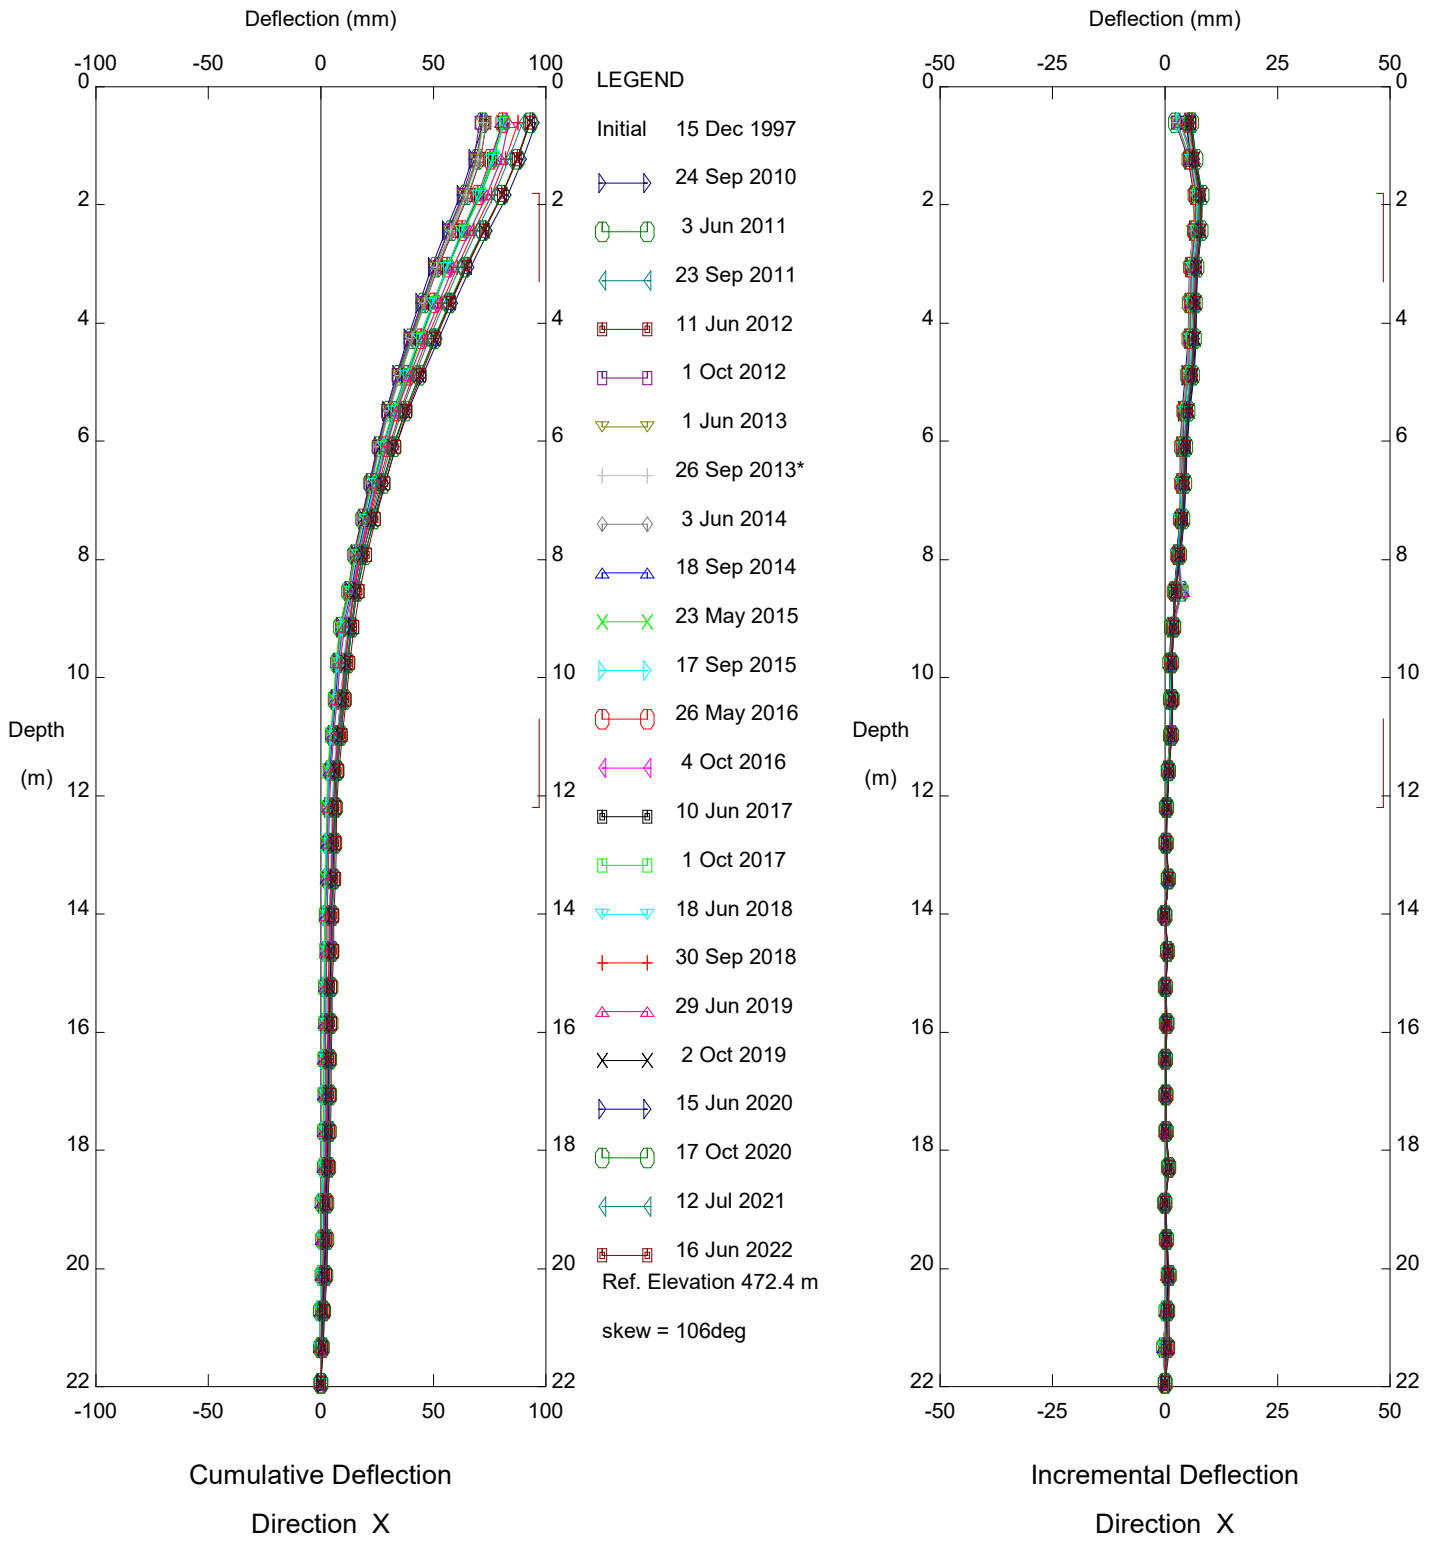
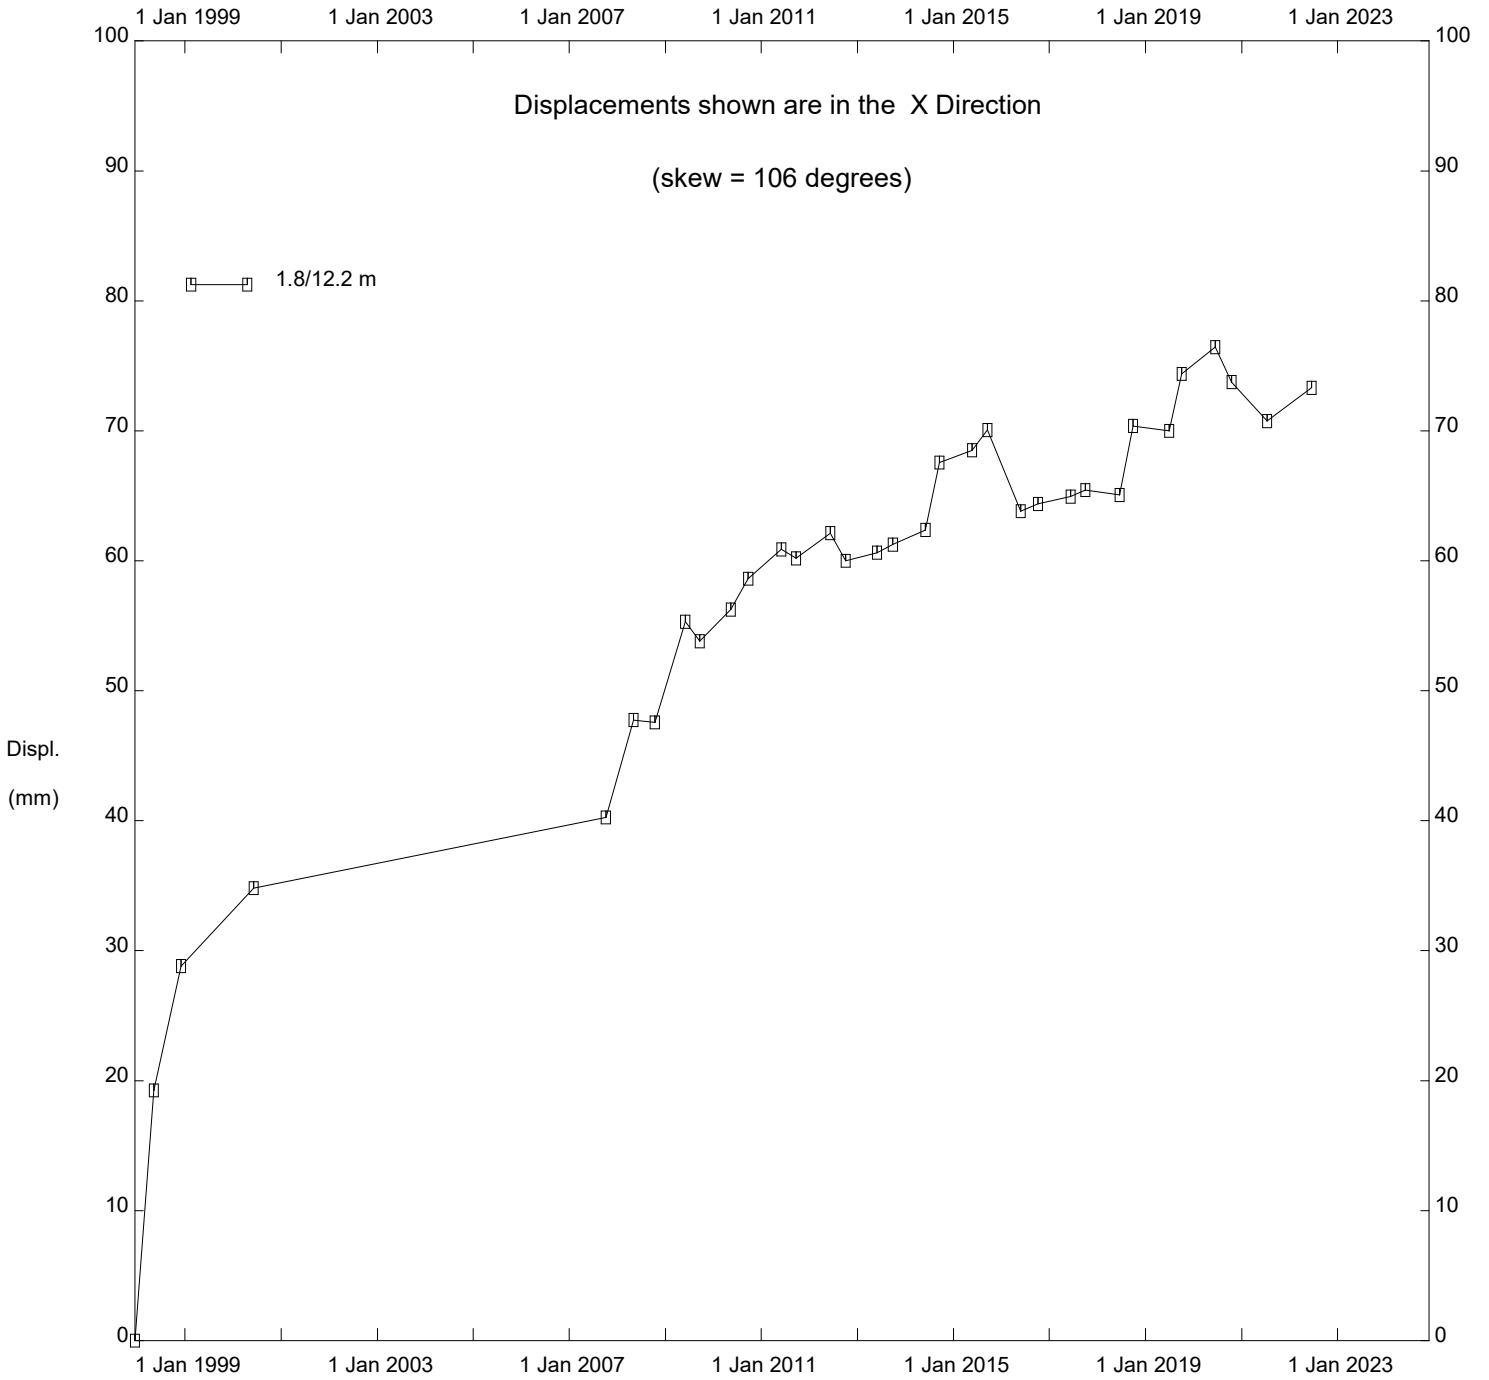
HWY 35:08 (PH045), Inclinometer SI-51

Since the spring of 2021 readings, slope inclinometer SI-49 showed a rate of movement of 5.7 mm/yr over 1.5 m to 14.3 m depth with a total cumulative deflection to date of 155.3 mm. Although this rate is slightly slower than overall rate (since initialization) of 6.3 mm/year, the trend has been steady. SI-50 showed a rate of movement of 4.4 mm/yr over 1.7 m to 13.9 m depth since the spring of 2021 readings with a total cumulative movement to date of 160.0 mm. This rate is slower than the overall rate of 6.5 mm/year but there are indications that the movement rate has accelerated slightly since Spring 2020. SI-51 showed a rate of movement of 2.8 mm/yr since the spring of 2021 readings with a total cumulative movement to date of 73.3 mm. The rate of movement had been negative over the last two cycles which has also happened in the past. The trend in this inclinometer appears to be inconsistent.

Overall, the movement pattern at SI-49 appears to have been unaffected by the repairs undertaken in 2016. SI-50 showed a marked reduction in movement rate and SI-51 is somewhat inconclusive due to the irregular movement trends.

* SI-51 probe comes to surface not in grooves, may be damaged at 2 feet depth. Top of casing damaged
** SI-50 - top of SI slightly damaged
