**GEOHAZARD ASSESSMENT PROGRAM**

**PEACE RIVER / HIGH LEVEL AREA**

**2011 CALL OUT INSPECTION**

Site Number	Location	Name	Hwy	km
PH5	North of Manning, AB	Meikle River (0+100)	35:08	Approx. 28
Legal Description		UTM Co-ordinates		
SW 7-94-22-5		11V N 6333992	E 467077

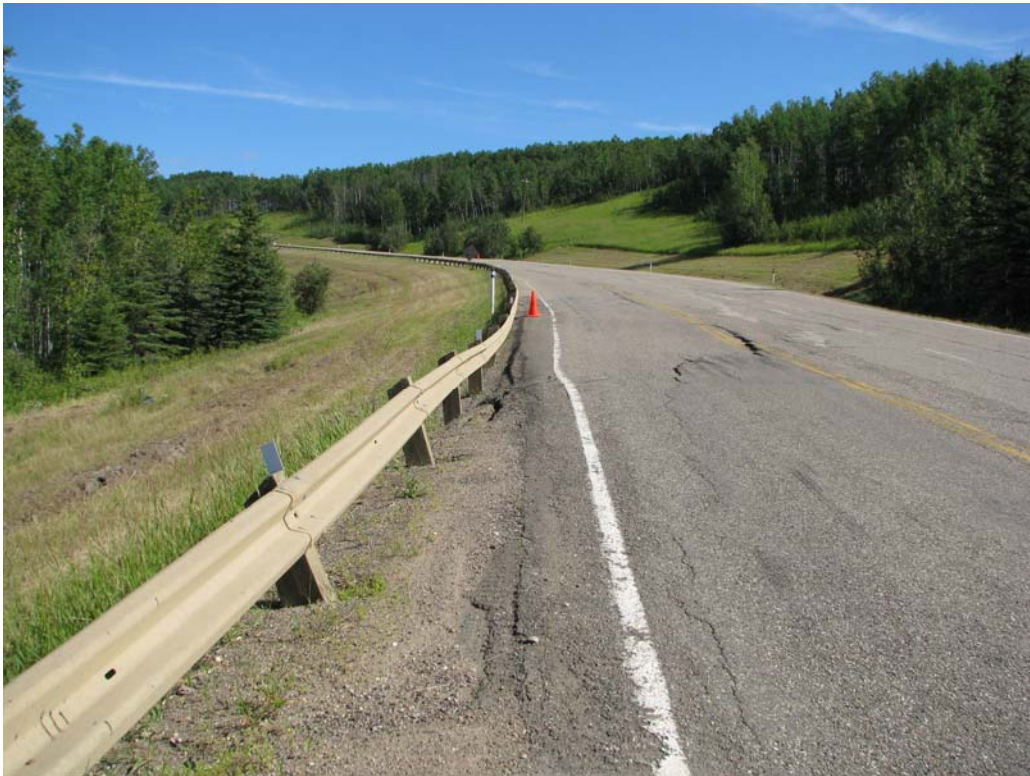
Fresh cracks of up to 70 mm deep and 50 mm wide appeared at the asphalt patch as a result of heavy precipitation on July 27, 2011. The 200 mm deflection in the guard rail and increased cracking indicates that the rate of movement increased.

Photo 1 - View of asphalt patch and cracks on Highway 35:08, looking northeast.

- Pavement patching is required immediately to maintain a smooth even road surface for traffic safety.
- Groundwater appears to be a contributing factor to the slide movements. It may be possible to install subdrains in the upslope ditch and/or French drains or drill subhorizontal drains in the sideslope to try to intercept groundwater flowing in silt and sand layers in the clay. Some surface grading could also be completed as a maintenance item to smooth out the drill access benches and reduce ponding of water on the slope.

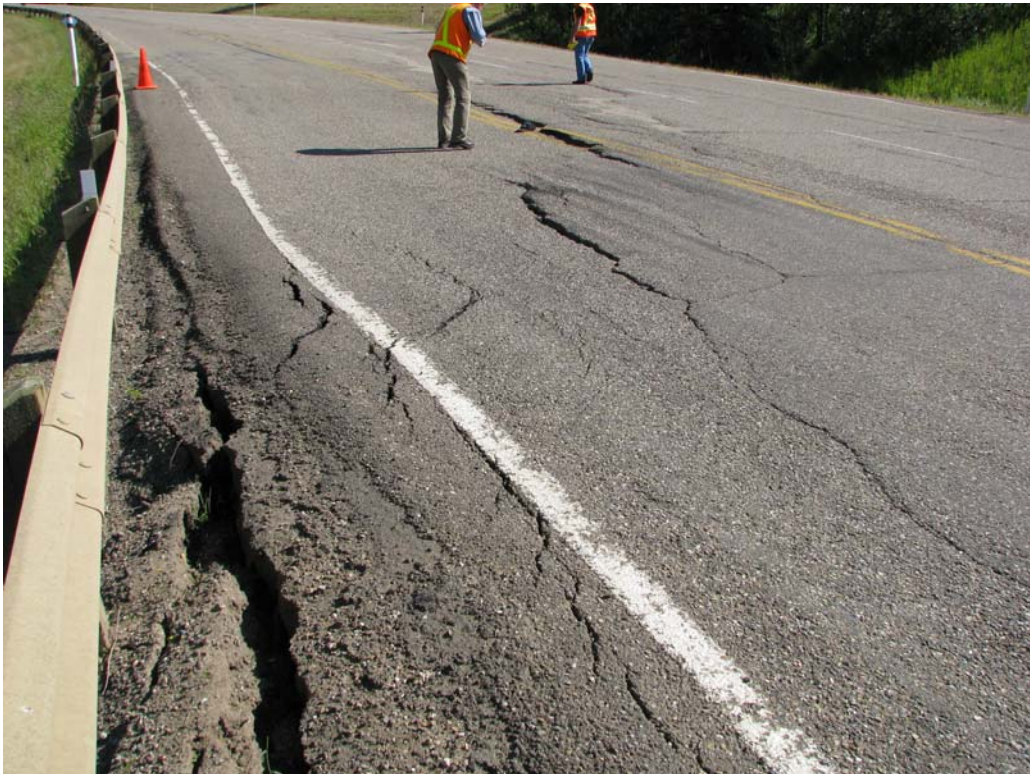
Photo 2 – Fresh Pavement cracks through ACP patch and near guard rail looking northeast.

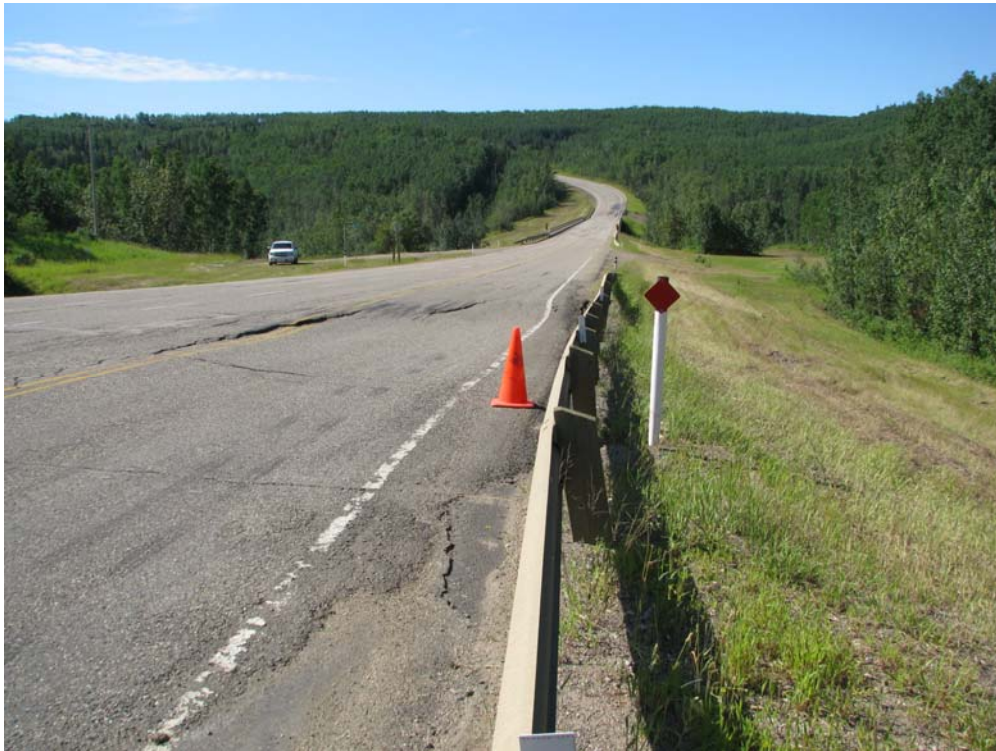
Photo 3 – Fresh Cracks beyond and along the ACP patch, looking southwest

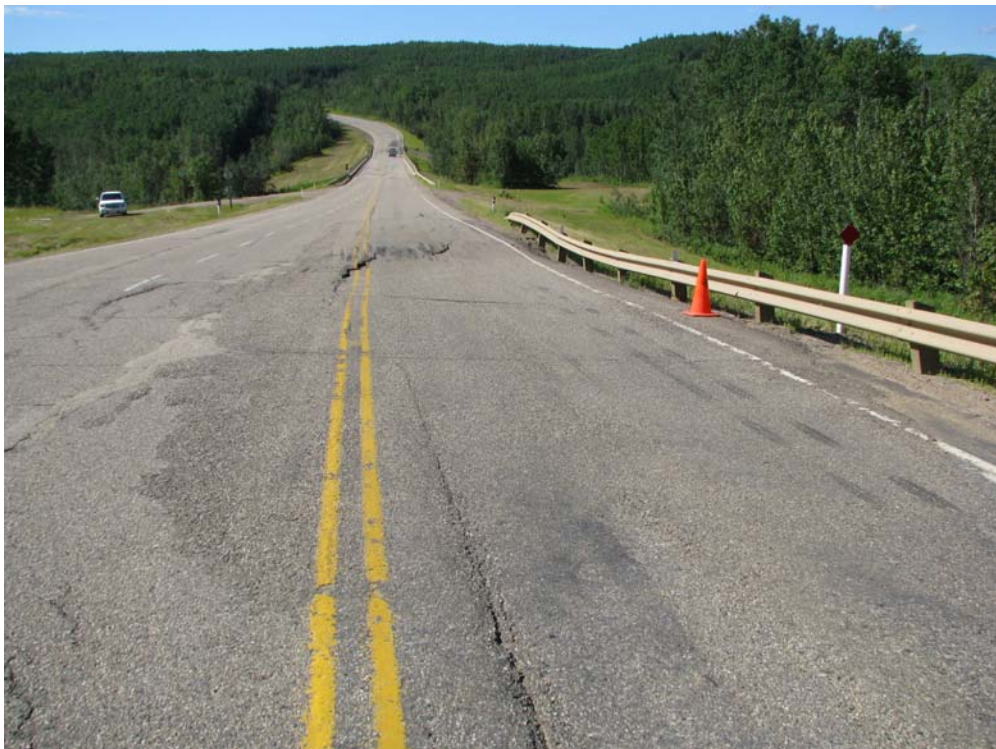
Photo 4 – Additional cracking along the ACP patch, looking southwest.

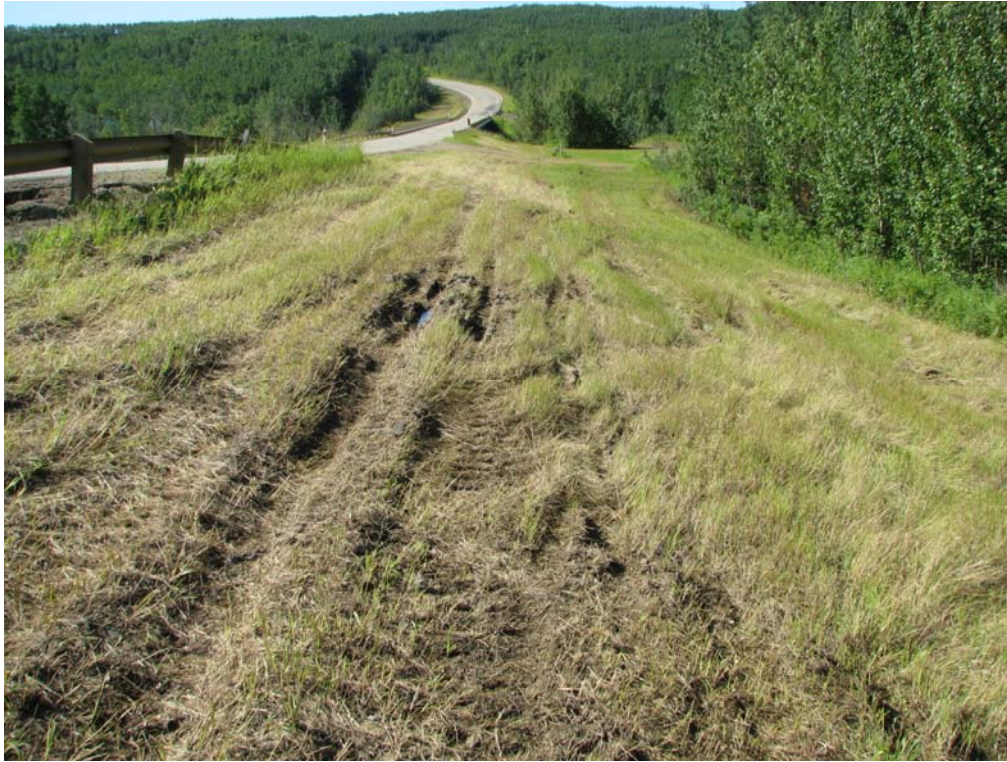
Photo 5 – Wet area at the back cut of access bench, looking southwest.

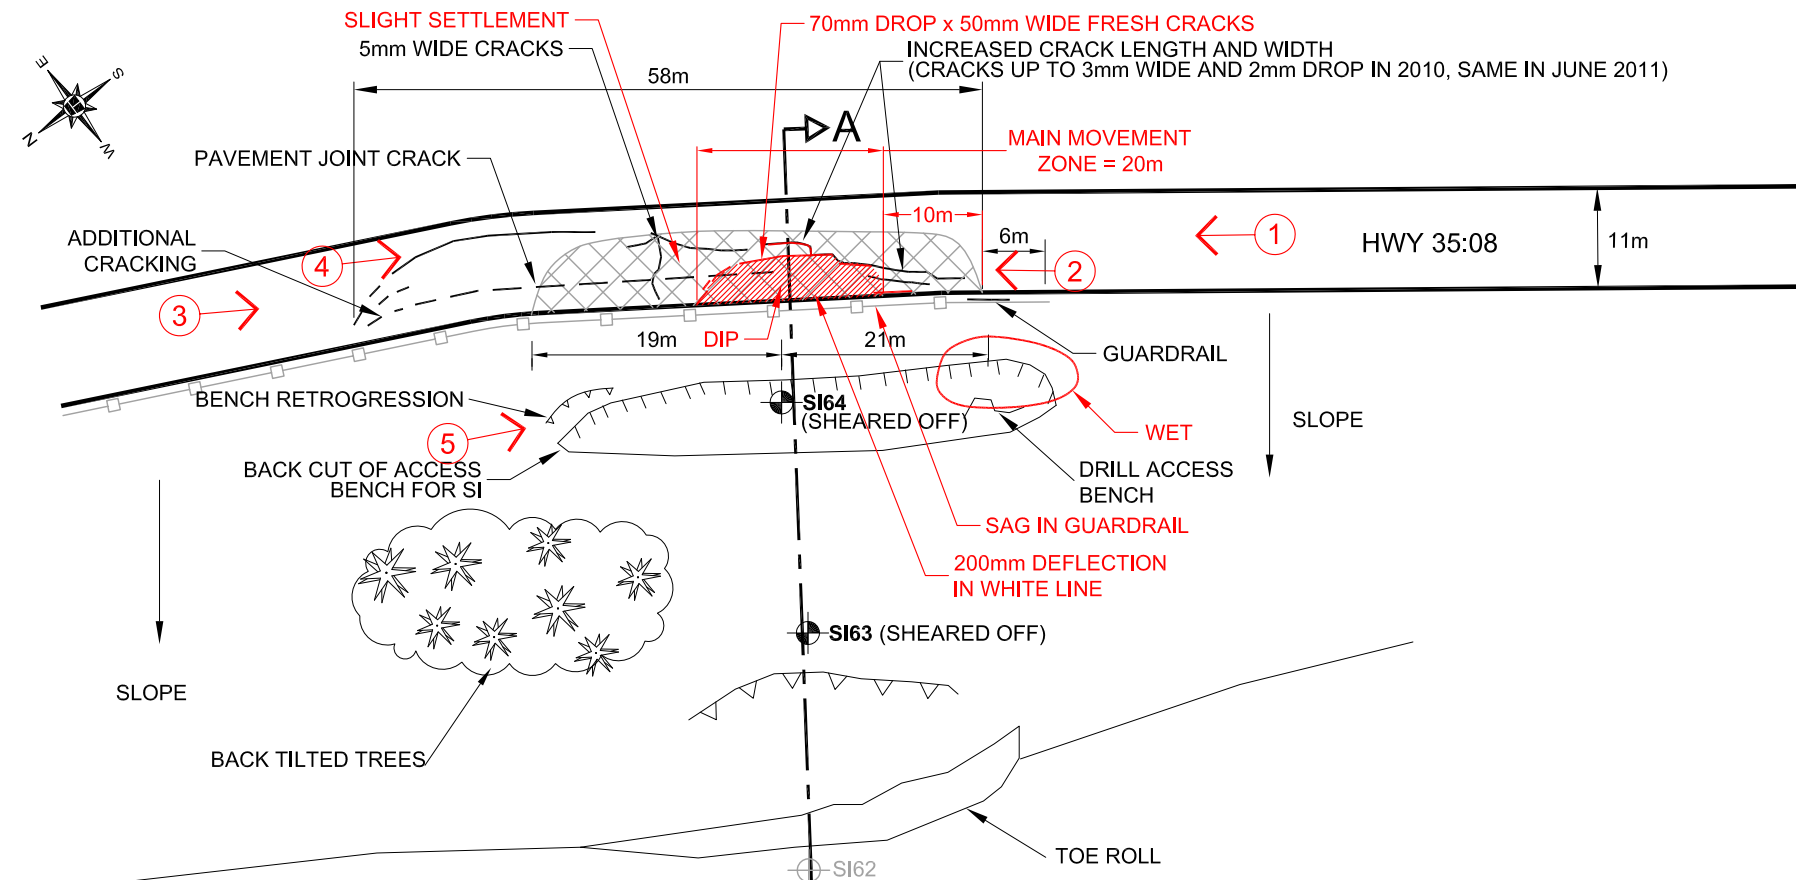
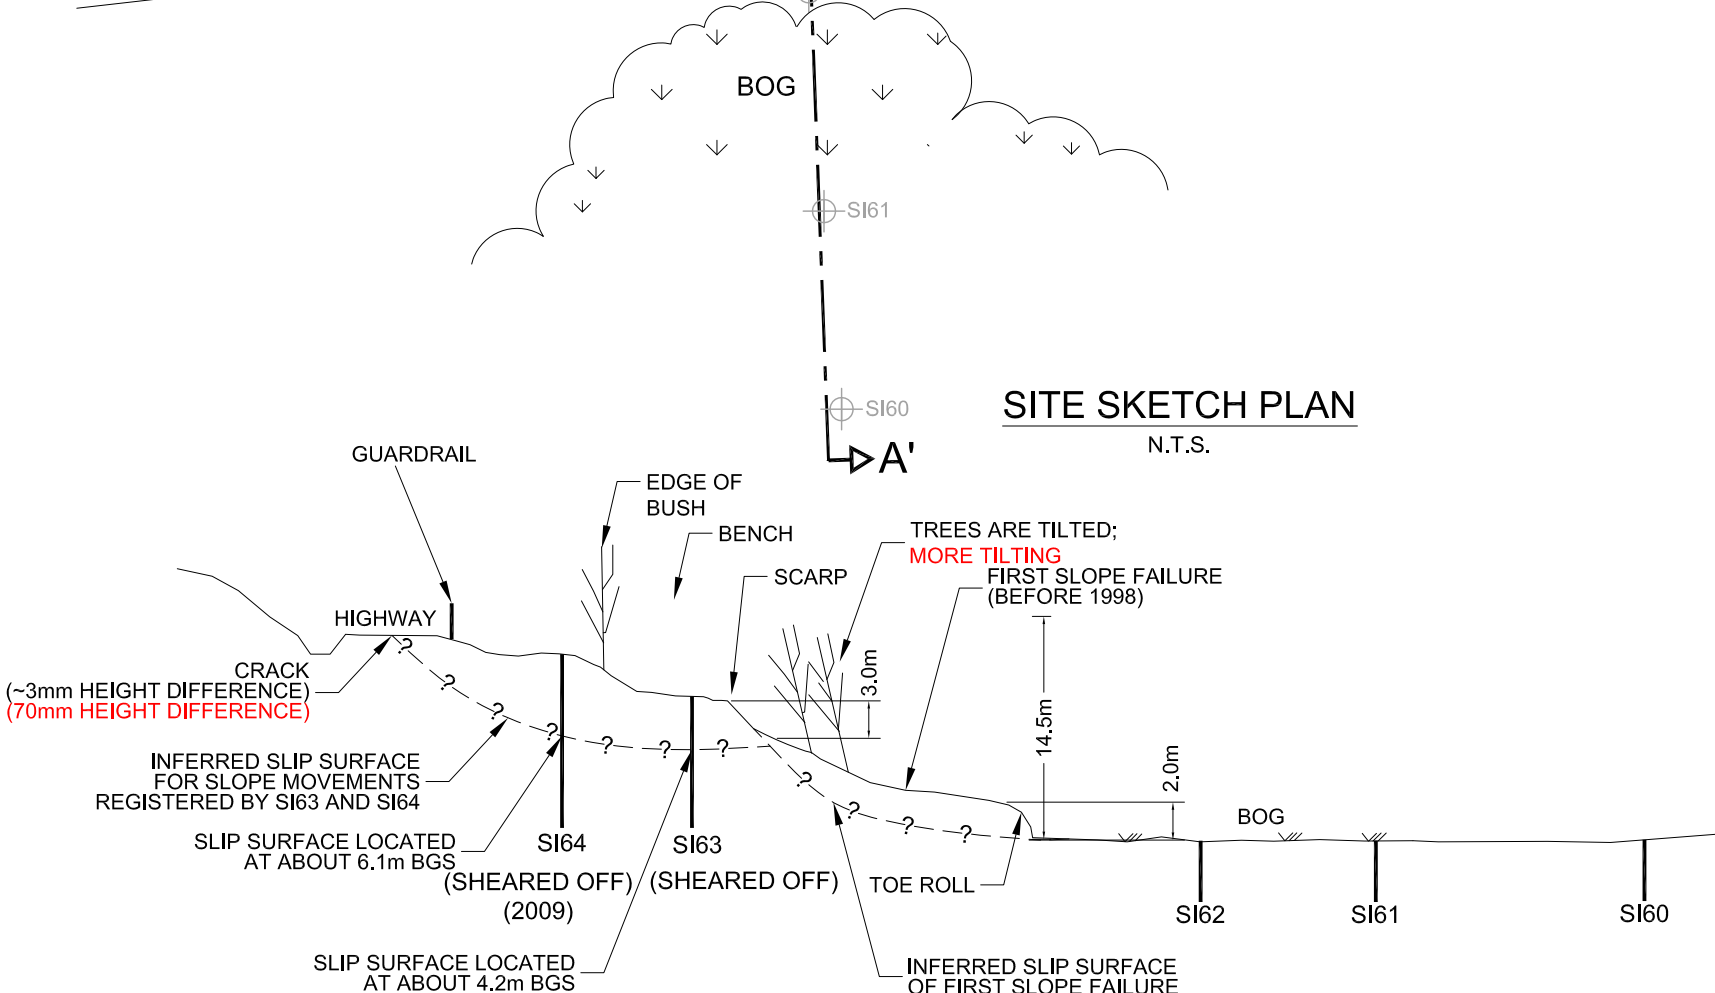
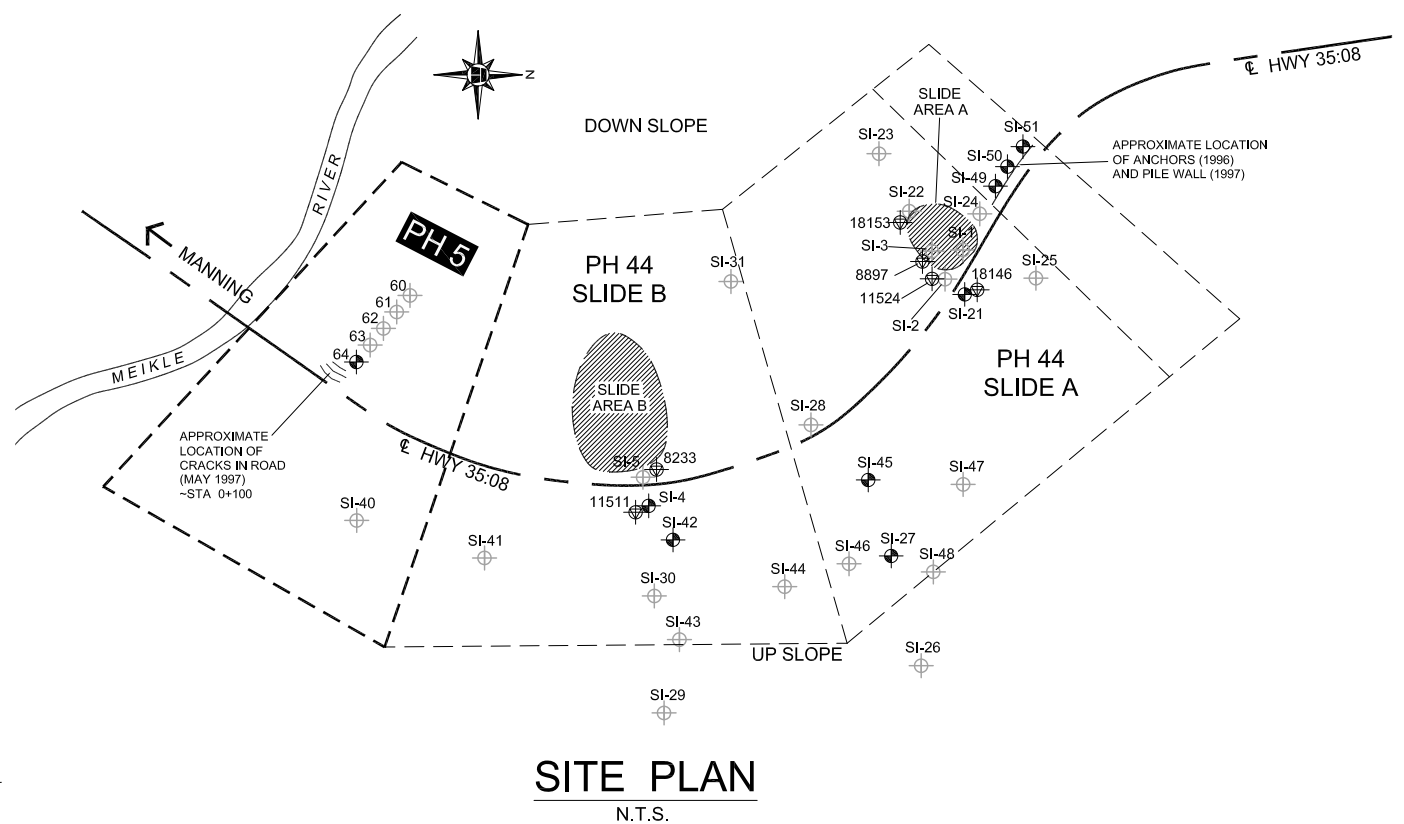
**FIGURE PH5-CALLOUT SITE PLAN**  
PH5 : HWY 35:08 - MEIKLE RIVER STA 0+100  
PEACE REGION (PEACE RIVER / HIGH LEVEL) GEOHAZARD ASSESSMENTS

**Assessment (Refer to Figure PH5-1):**  
 A slope failure occurred prior to 1998 further downslope, which left a backscarp about 3 m in height. Continued slide movements have occurred in the area behind the backscarp. The movements have extended into the highway pavement.

- It is recommended to install a driven steel pile wall along the shoulder of the highway for a longitudinal length of about 60 m. The inferred slip surface is expected to be 2.5 to 3 m deep. Based on the similar projects the wall could cost in the order of \$400 - \$500 thousand dollars.
