**ALBERTA TRANSPORTATION
GEOHAZARD ASSESSMENT PROGRAM
PEACE REGION – HIGH LEVEL
2016 INSPECTION**

Site Number	Location	Name	Hwy	km
PH005-1	North of Manning, AB	Meikle River (km 25.21)	35:08	25.51
Legal Description		UTM Co-ordinates		
SW7-94-22-W5M		11U E 467,717	N	6,332,466

**PH005-1: HWY 35:08 (km 25.5) - MEIKLE RIVER SLIDE
GEOHAZARD ASSESSMENTS**

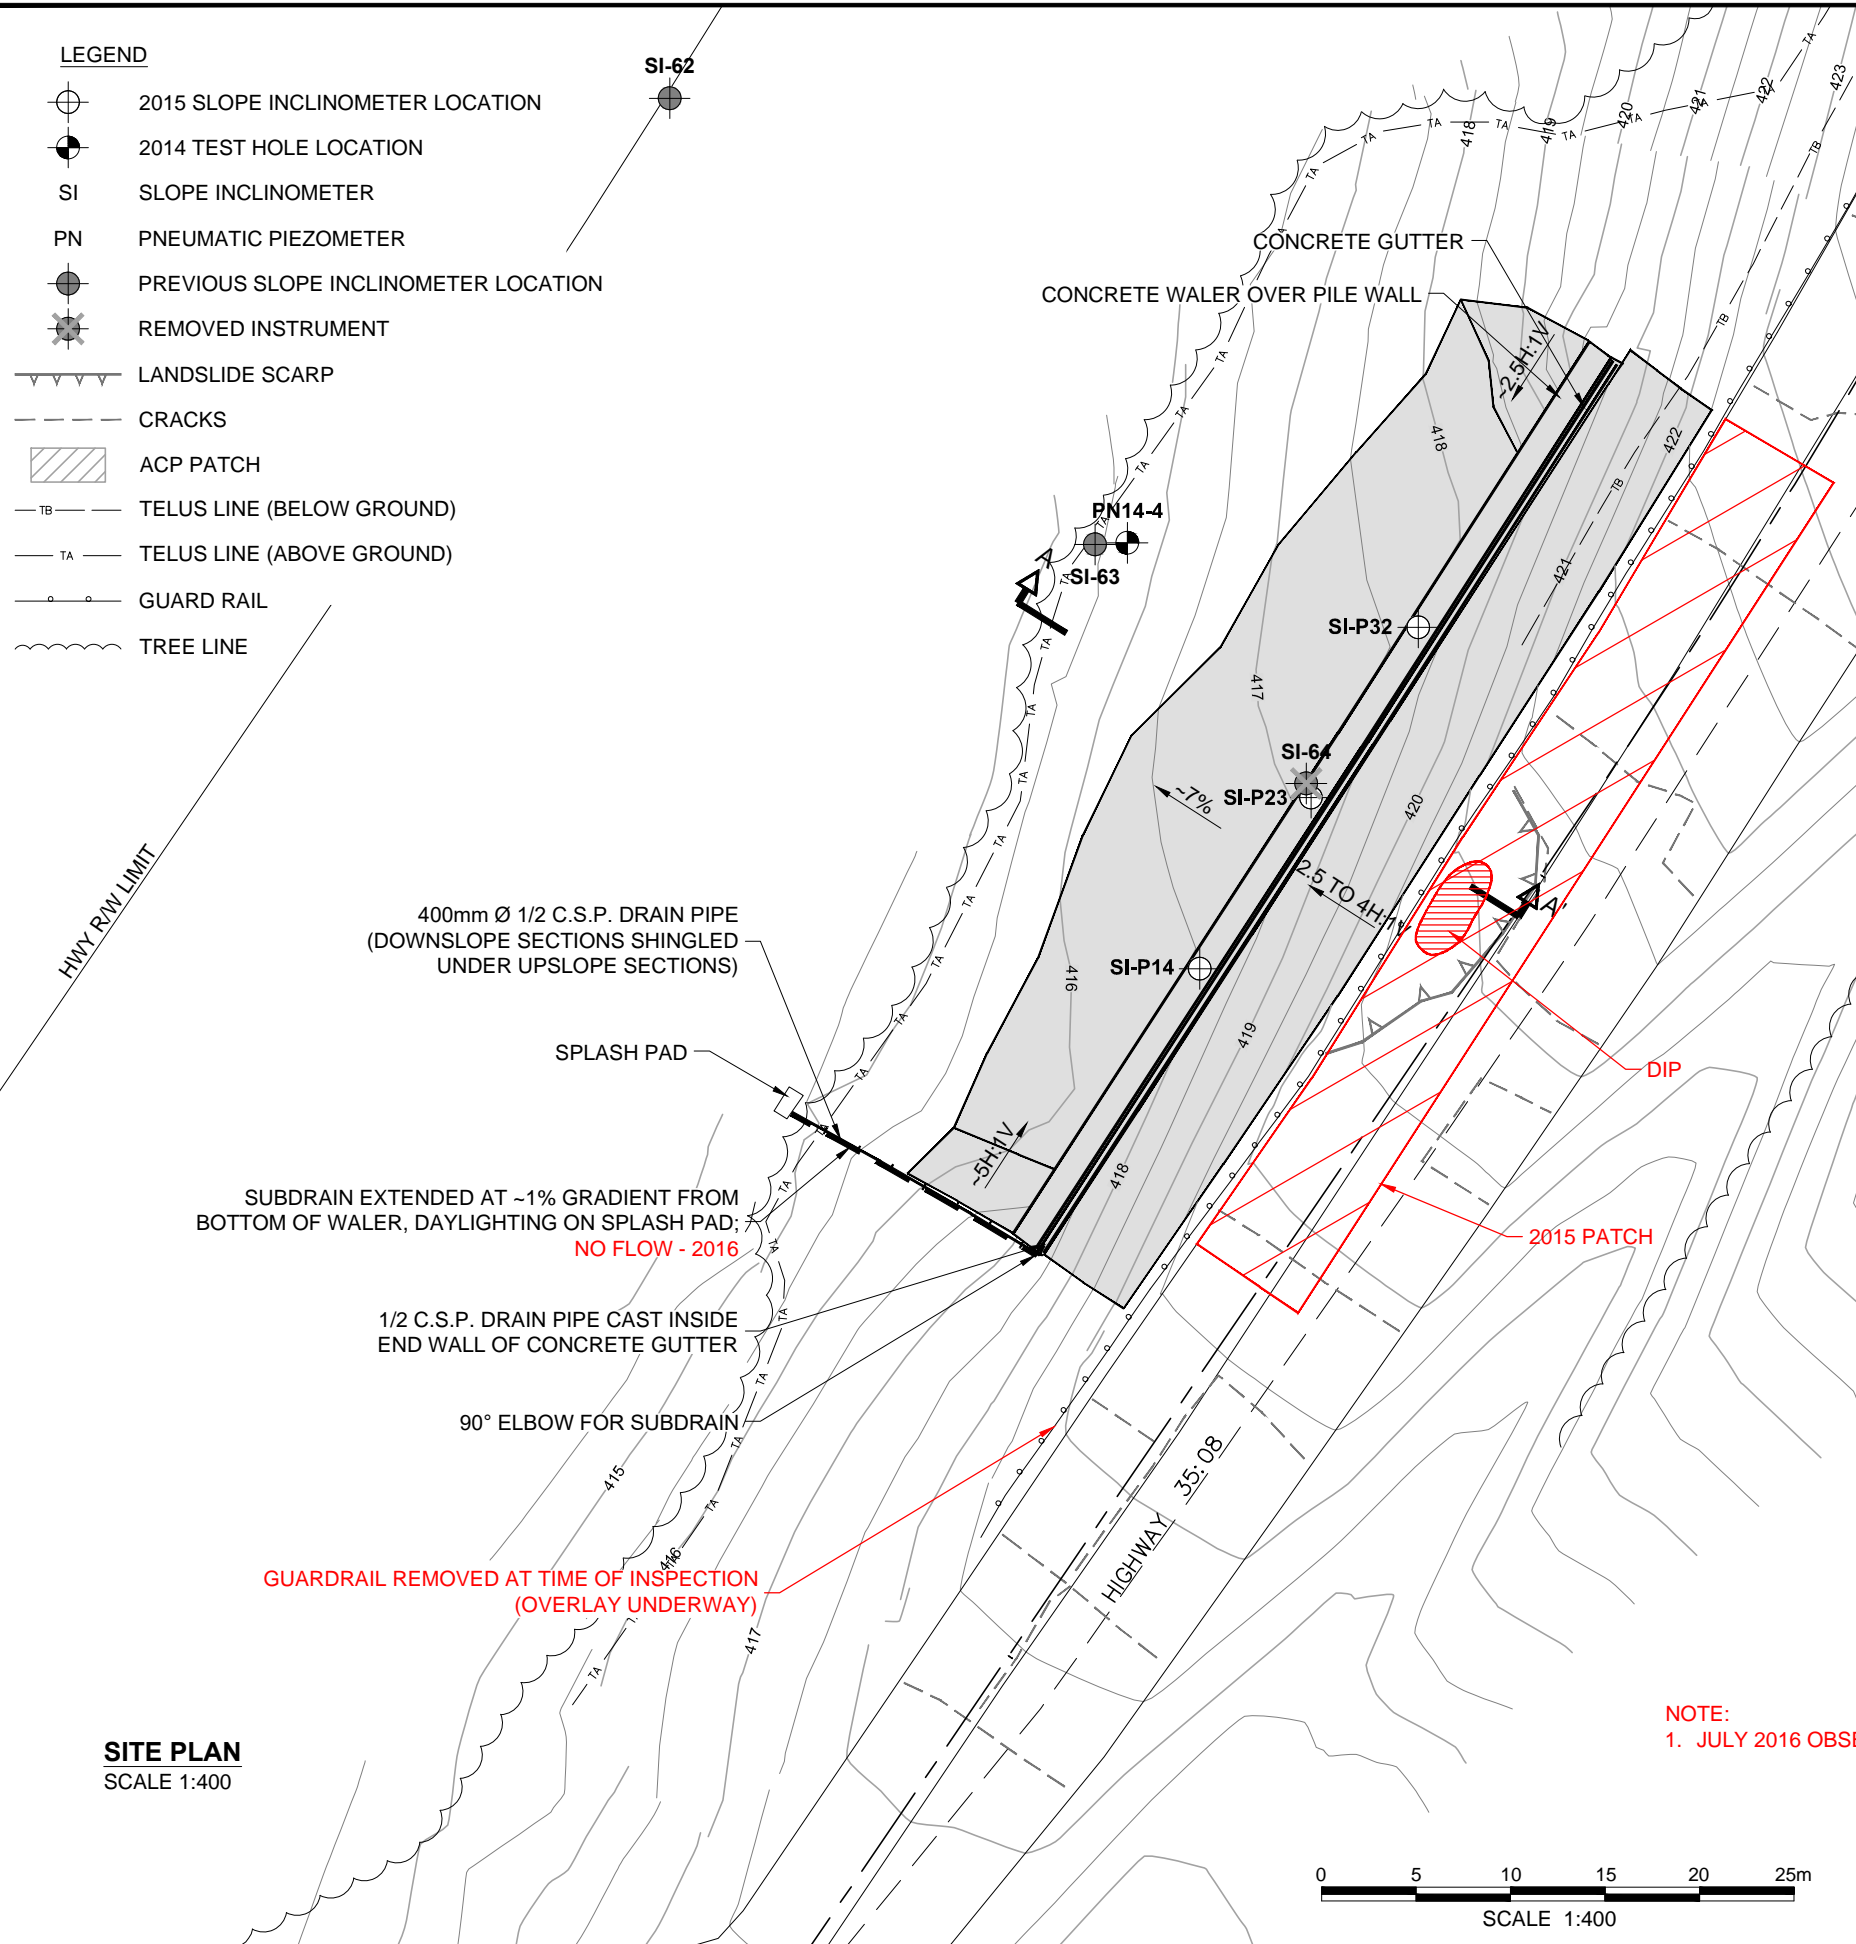
SITE PLAN
SCALE 1:400

SUBDRAIN EXTENDED AT ~1% GRADIENT FROM
BOTTOM OF WALER, DAYLIGHTING ON SPLASH PAD;
NO FLOW - 2016

**GUARDRAIL REMOVED AT TIME OF INSPECTION
(OVERLAY UNDERWAY)**

- As noted earlier, there are plans to place an ACP overlay on the highway through this site.
- Measures should be implemented to protect traffic from the sharp drop off at the new wall if the new guardrail has not been installed yet as part of the overlay contract.

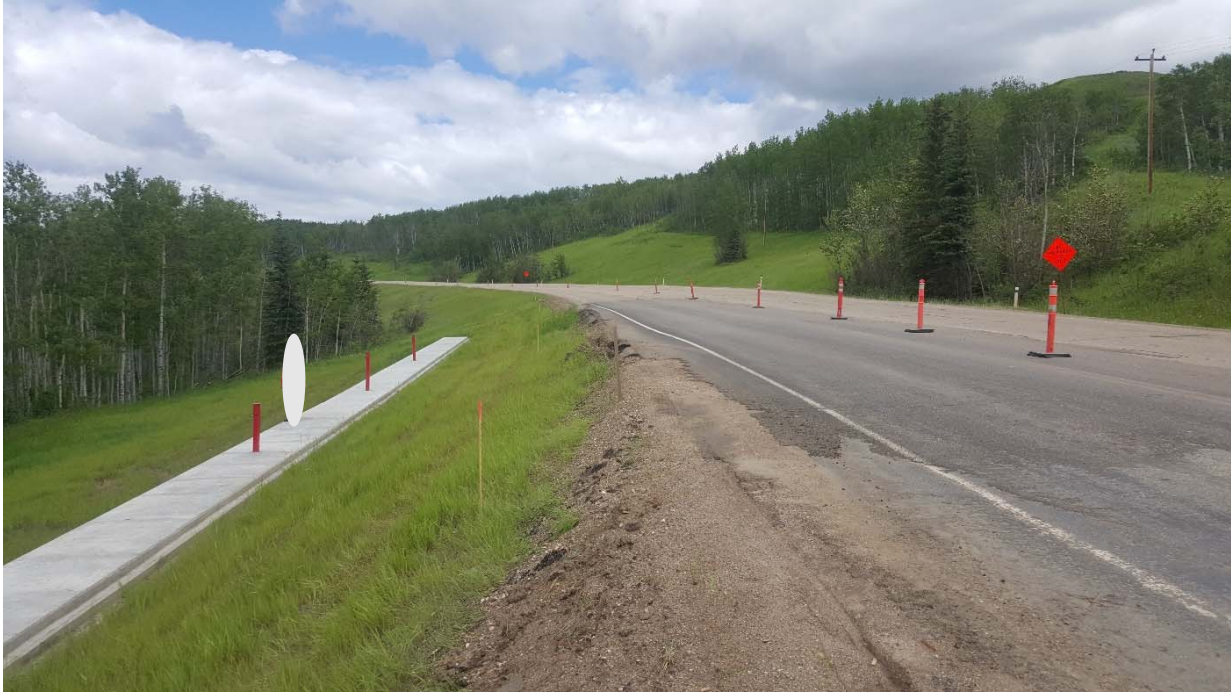
Photo 1 – Looking north along rebuilt slope with pile wall. Guardrail was removed as part of the milling and overlay contract underway on Highway 35.

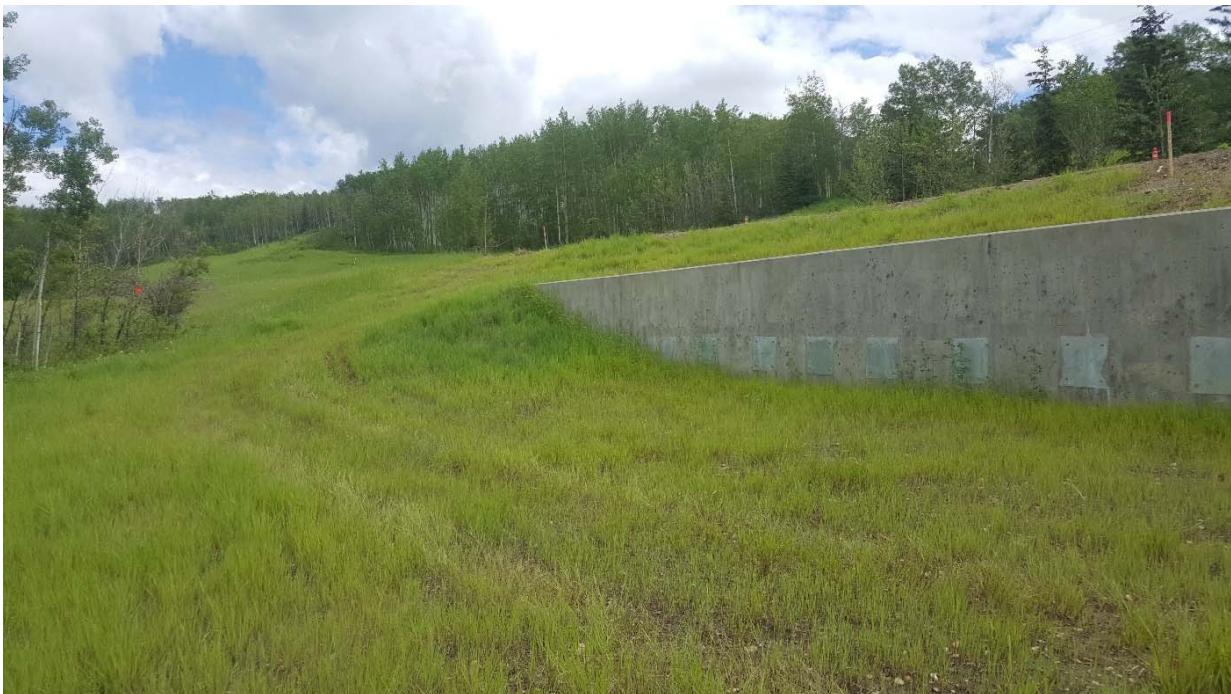
Photo 2 – Looking northeast at north end of the pile wall. Note the plates along the bottom of the water covering the sleeves for future tie-back installation, if required.

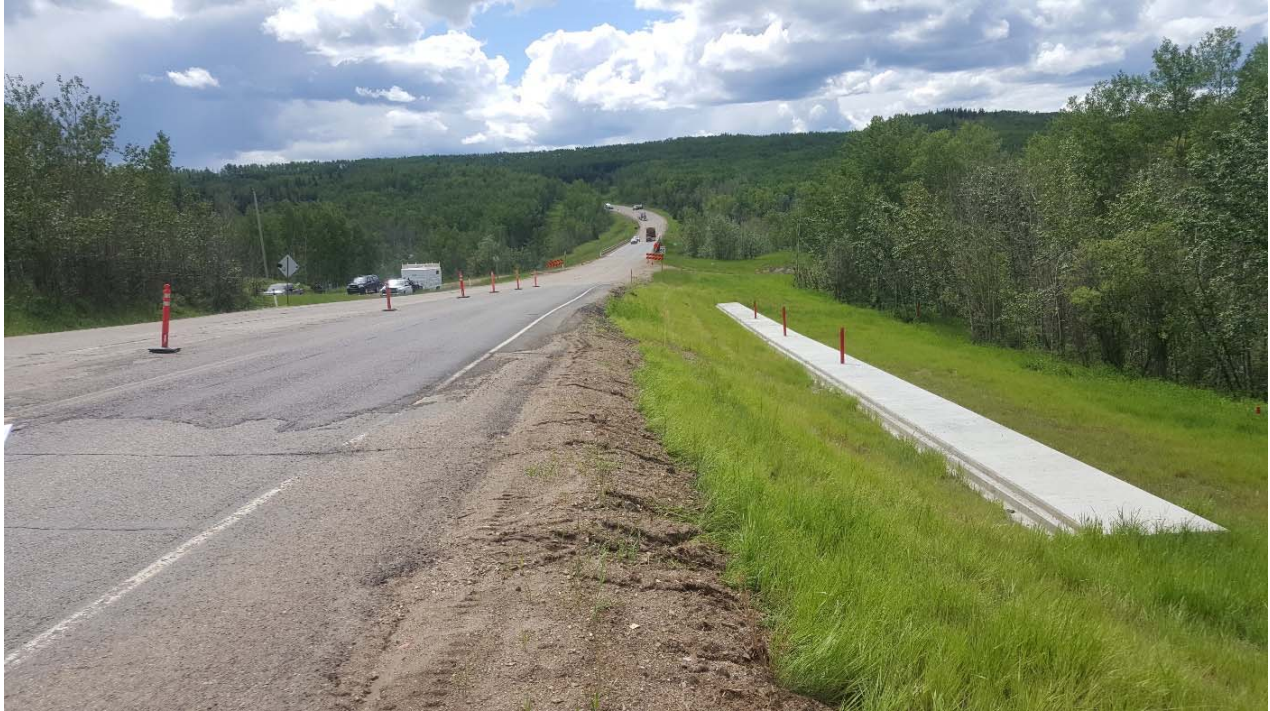
Photo 3 – Looking south along pile wall.

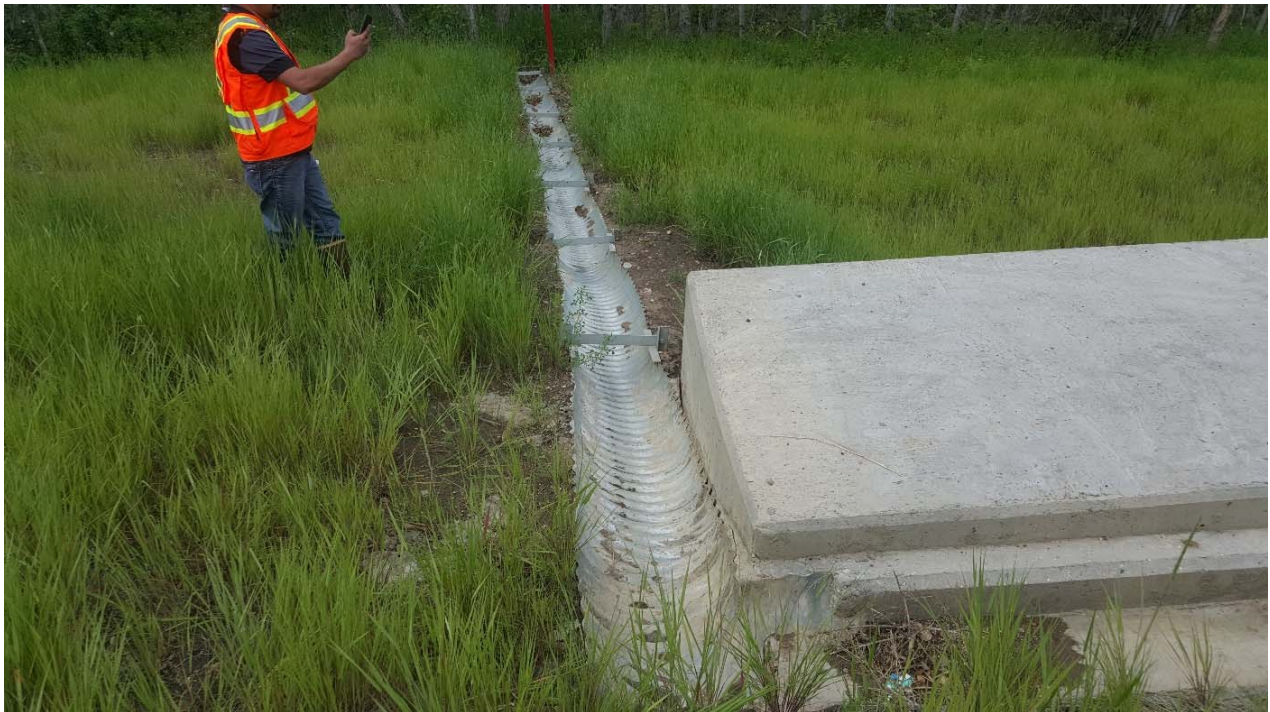
Photo 4 – Looking west along half-culvert down drain at the south end of the water.
