**ALBERTA TRANSPORTATION  
GEOHAZARD ASSESSMENT PROGRAM  
PEACE REGION – HIGH LEVEL  
2017 INSPECTION**

Site Number	Location	Name	Hwy	km
PH005-1	North of Manning, AB	Meikle River (km 25.21)	35:08	25.51
Legal Description		UTM Co-ordinates		
SW7-94-22-W5M		11U E 467,717	N	6,332,466

**PH005-1: HWY 35:08 (km 25.5) - MEIKLE RIVER SLIDE GEOHAZARD ASSESSMENTS**

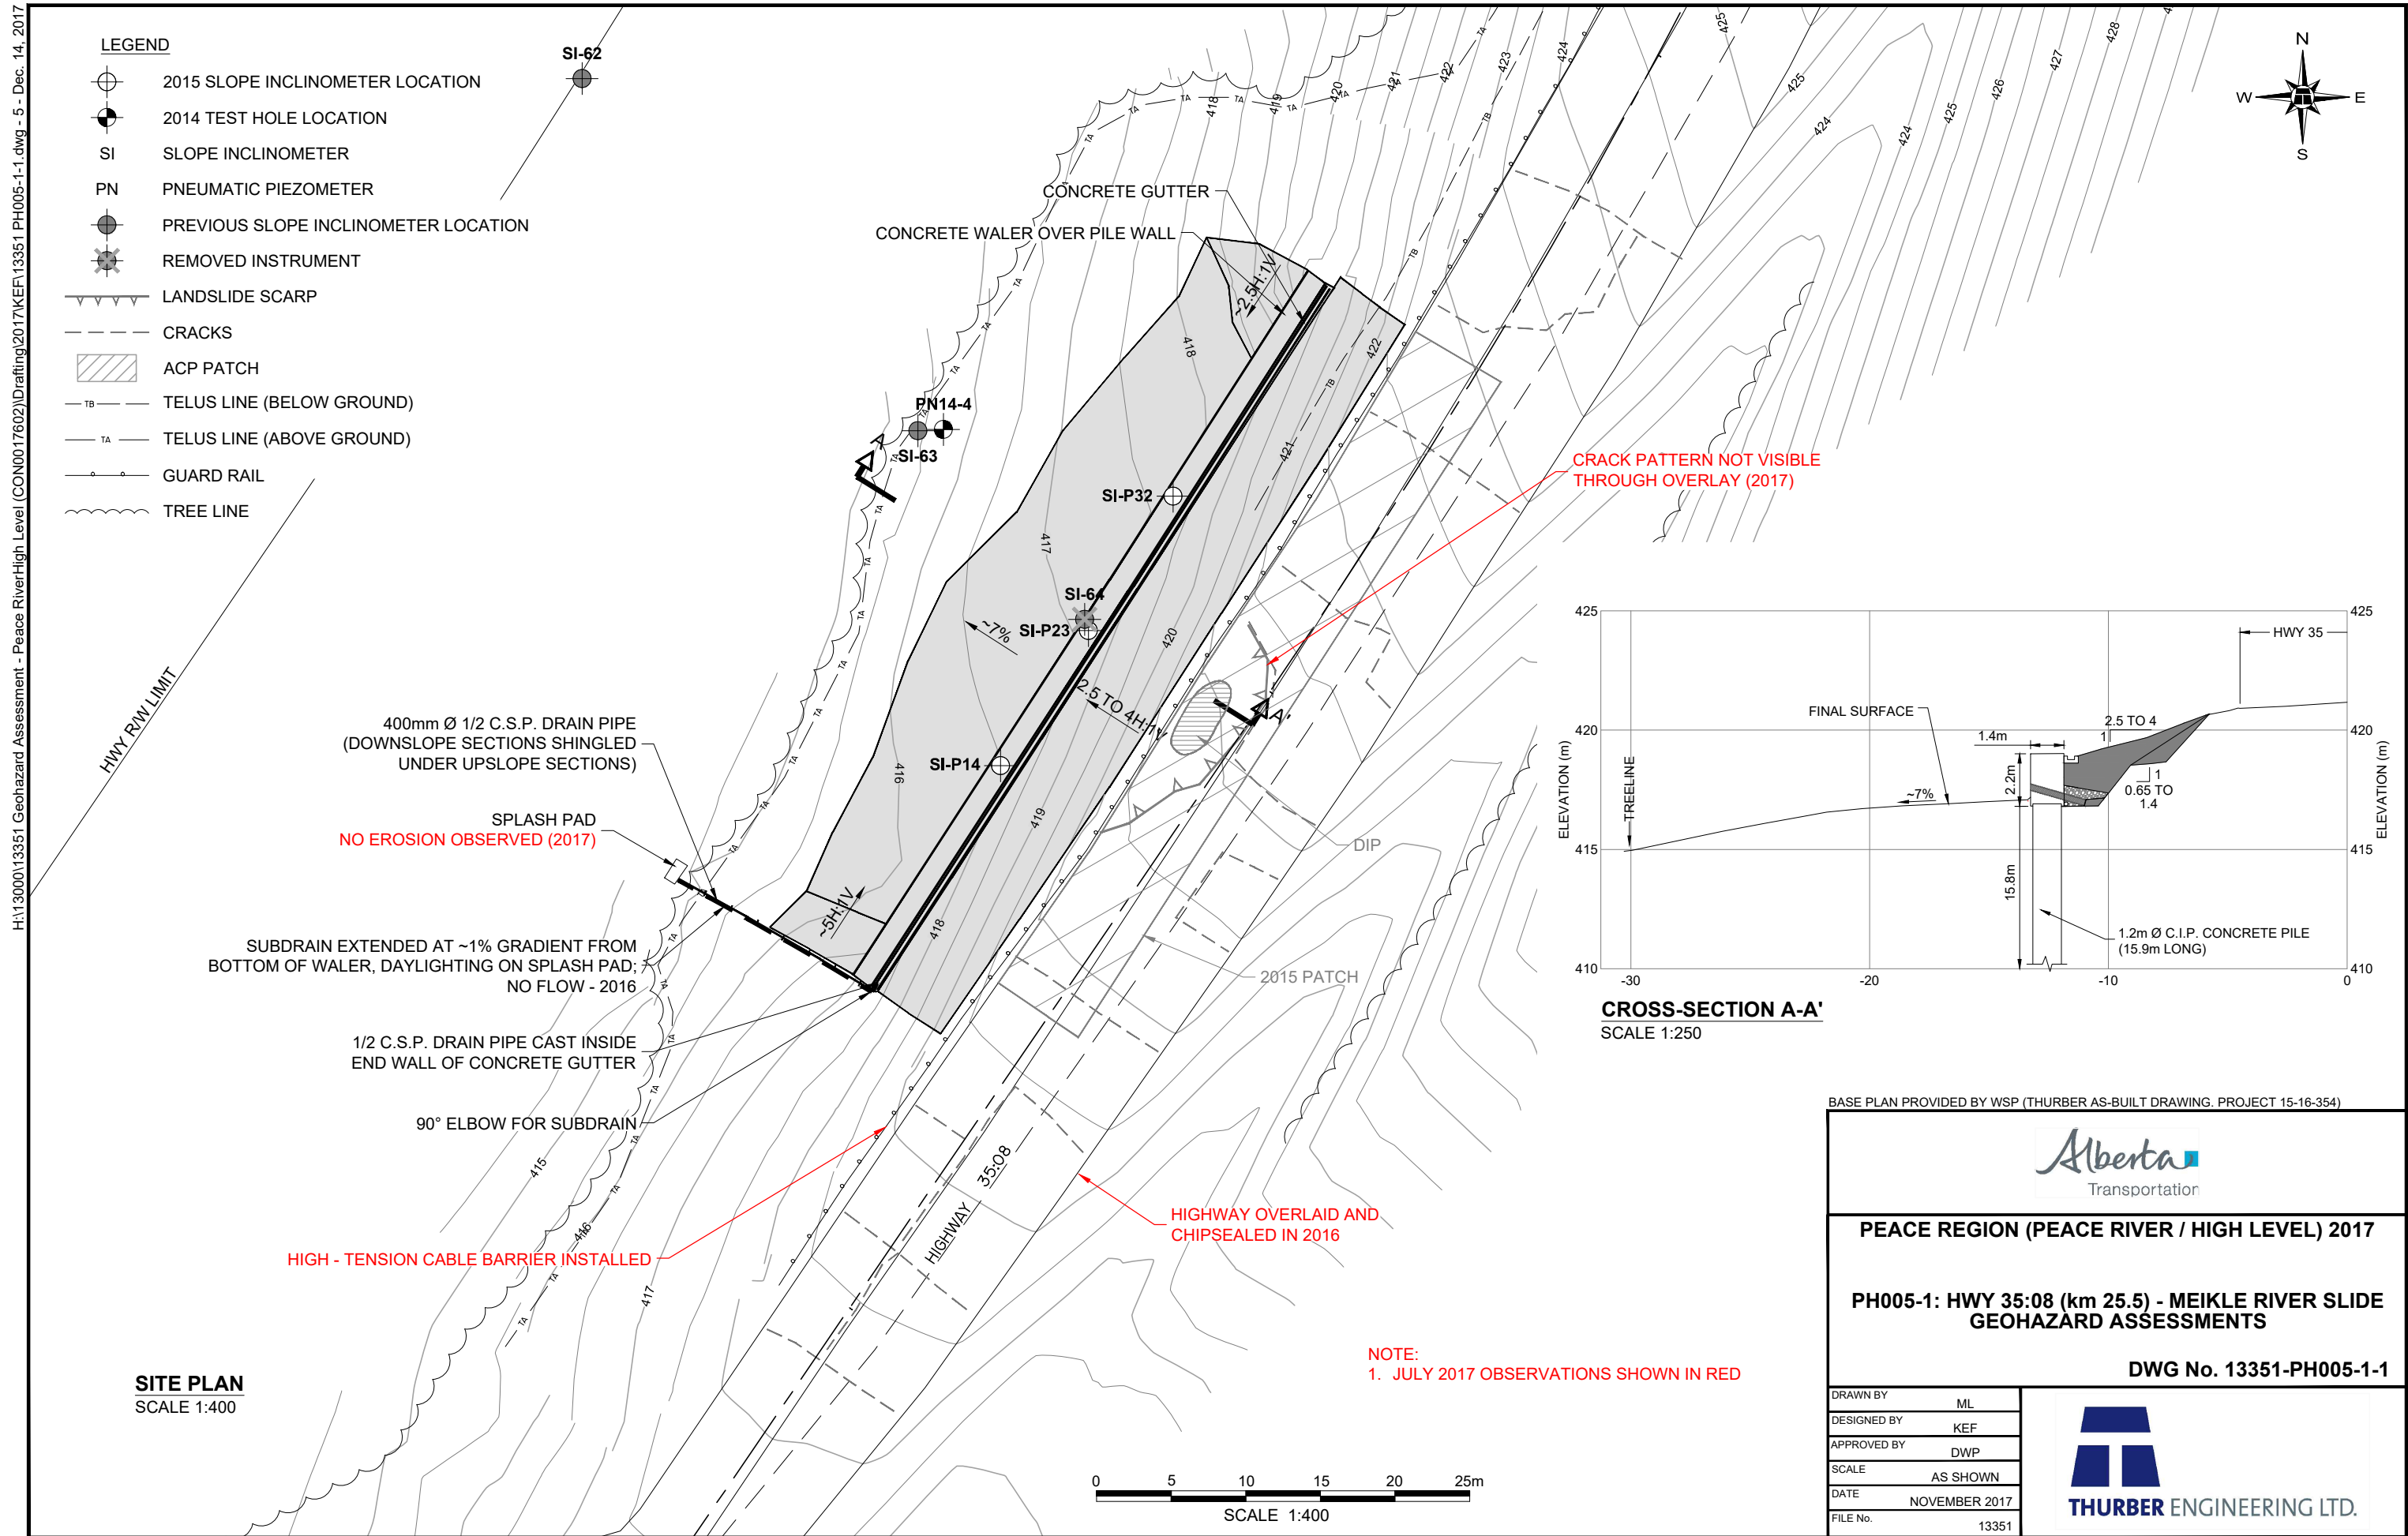
**SITE PLAN**  
SCALE 1:400

CRACK PATTERN NOT VISIBLE THROUGH OVERLAY (2017)

SPLASH PAD  
NO EROSION OBSERVED (2017)

SUBDRAIN EXTENDED AT ~1% GRADIENT FROM BOTTOM OF WALER, DAYLIGHTING ON SPLASH PAD; NO FLOW - 2016

HIGH - TENSION CABLE BARRIER INSTALLED

HIGHWAY OVERLAID AND CHIPSEALED IN 2016

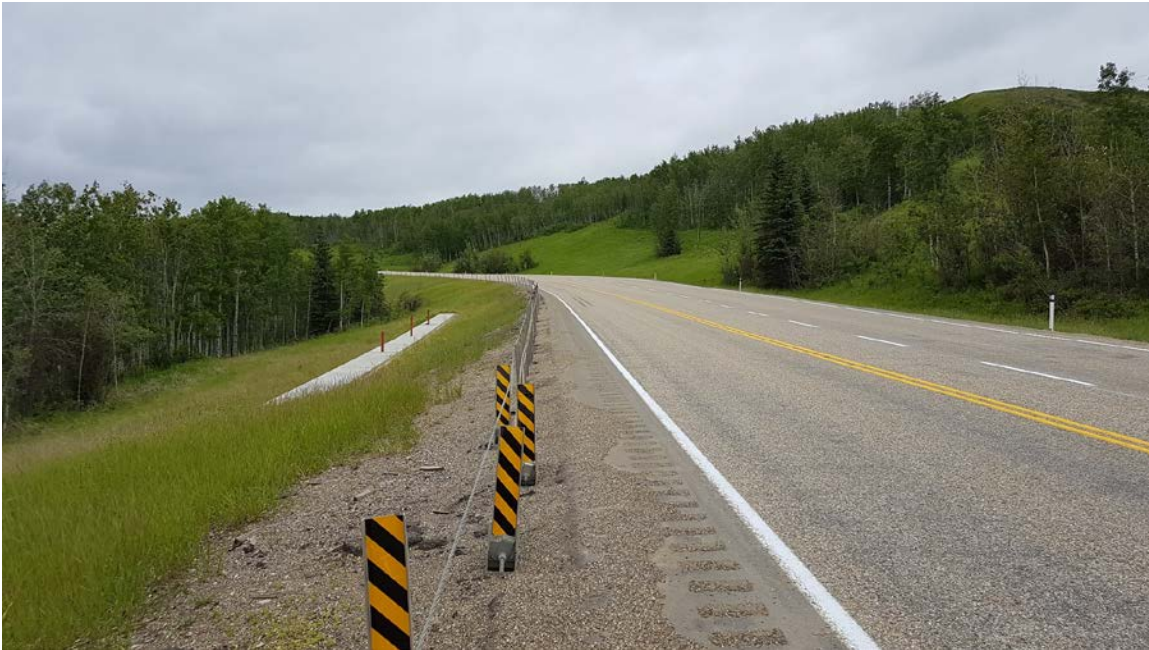
Photo 1 – Looking north along rebuilt slope with pile wall. Guardrail was removed as part of the milling and overlay on Highway 35 and replaced with a high-tension cable barrier.

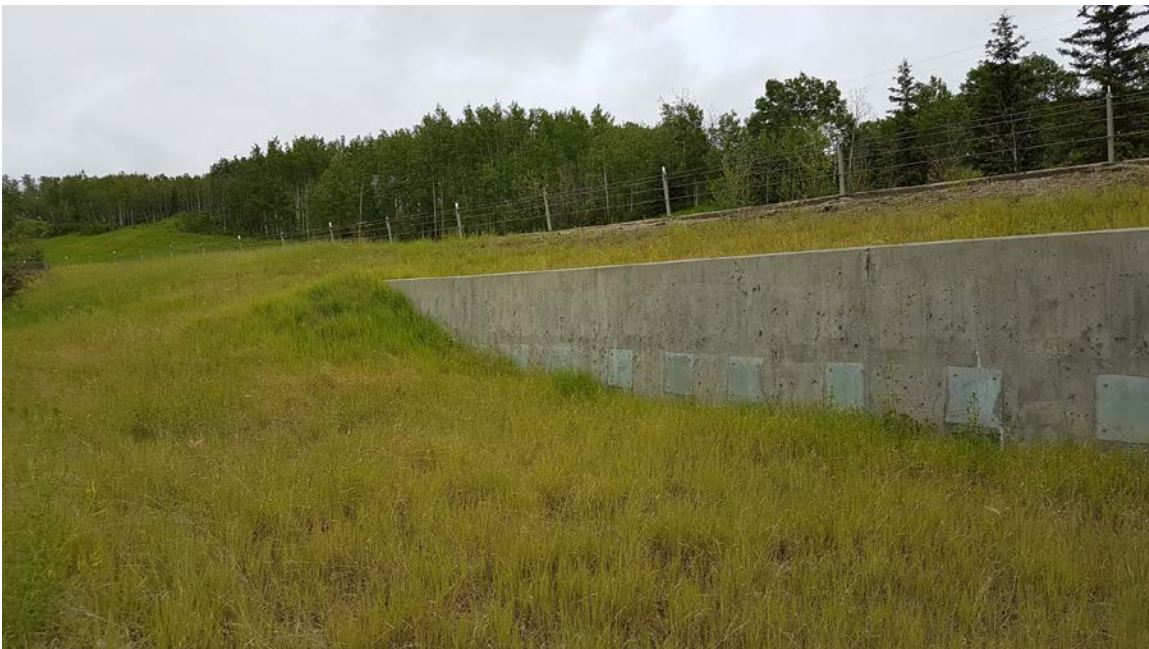
Photo 2 – Looking northeast at north end of the pile wall. Note the plates along the bottom of the wall covering the sleeves for future tie-back installation, if required.

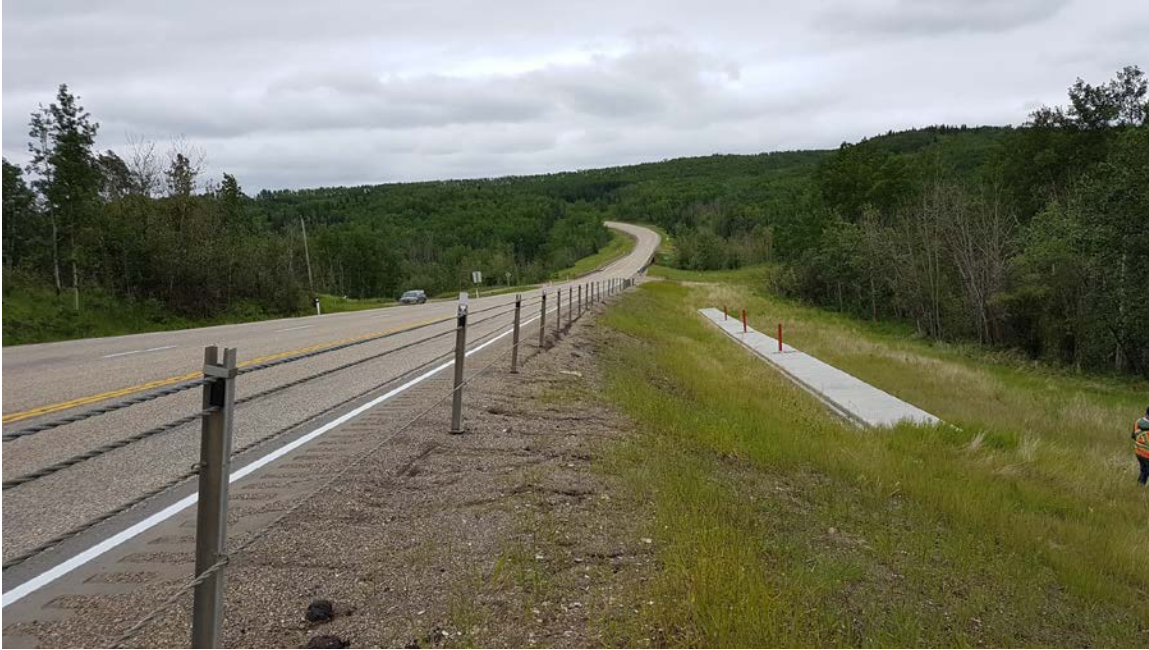
Photo 3 – Looking south along pile wall.

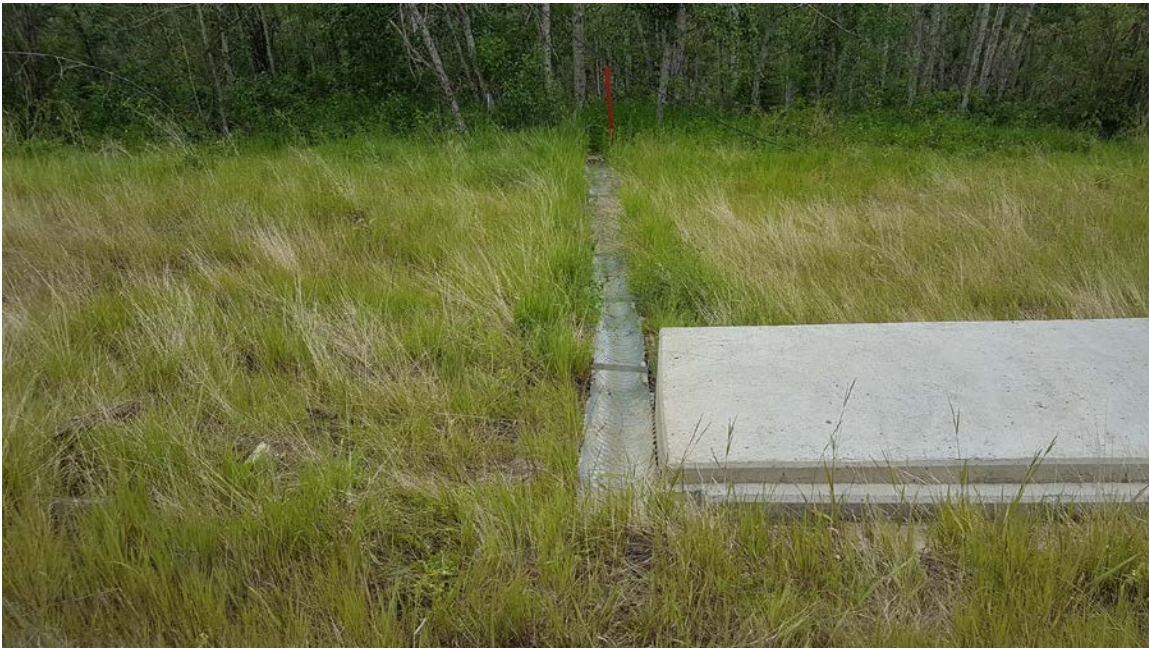
Photo 4 – Looking west along half-culvert down drain at the south end of the wall.
