**ALBERTA TRANSPORTATION
GEOHAZARD ASSESSMENT PROGRAM
PEACE REGION – SWAN HILLS
2020 INSPECTION**

Site Number	Location	Name	Hwy	km
SH008-1	2 km E of Watino Bridge	Watino East Hill	49:08	18.80-19.05
Legal Description		UTM Co-ordinates		
NE26-77-24-W5M		11U E 462,307	N	6,173,153

**SH008-1: HWY 49:08 WATINO EAST HILL SMOKY RIVER
2020 SITE INSPECTION PLAN**

DWG No. 13355-SH008-1

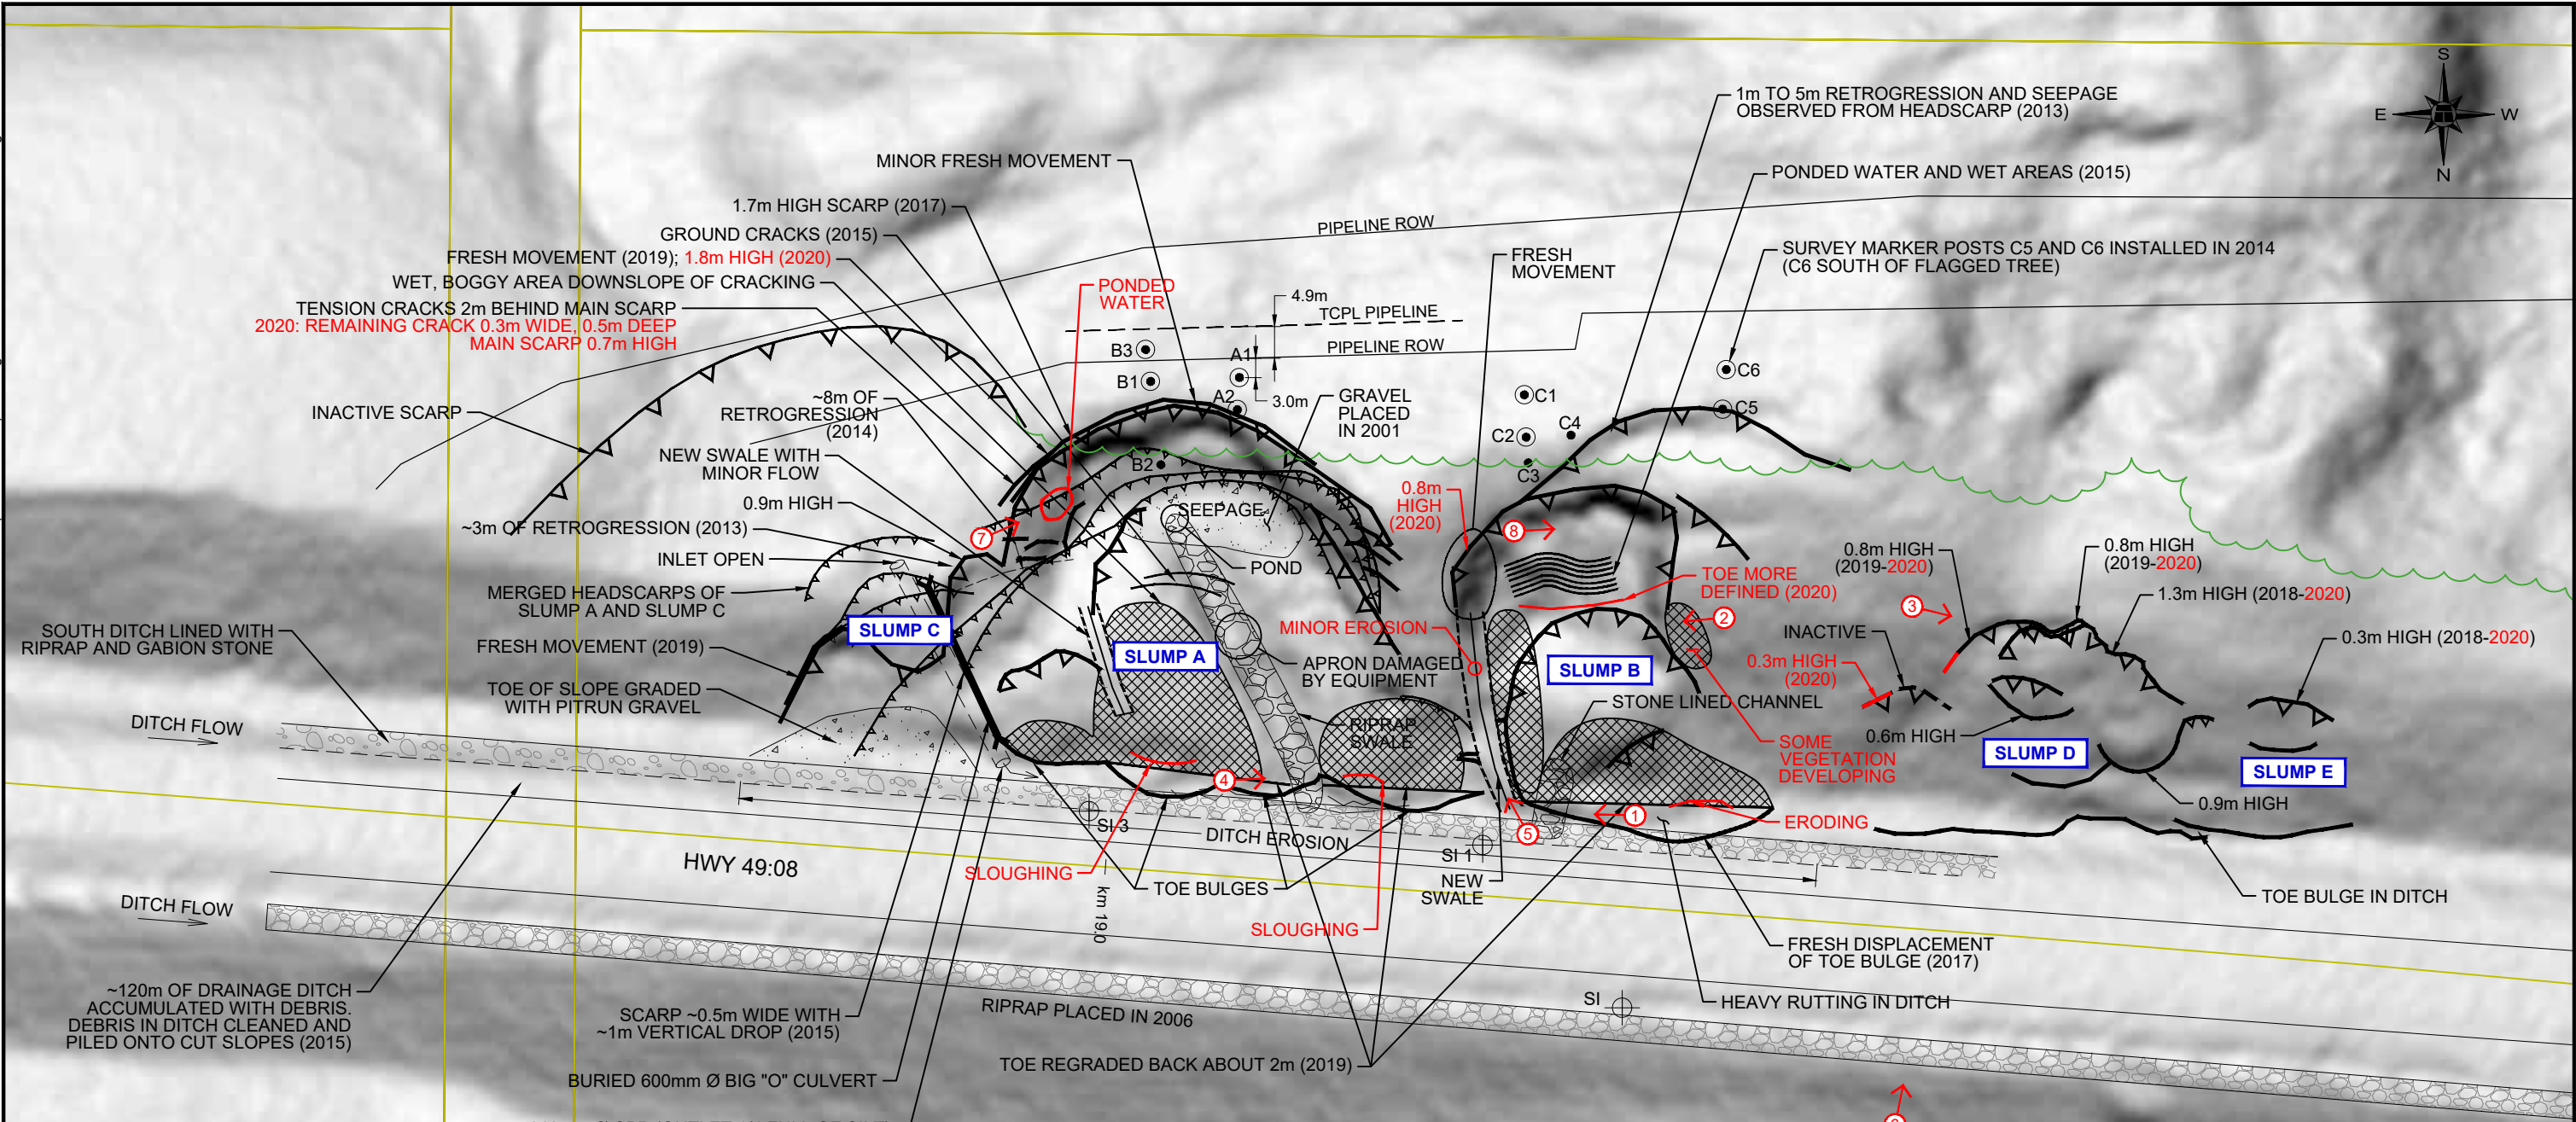
The uppermost scarp of Slump A did not appear to have regressed since 2016; however, signs of fresh vertical movement were observed in 2017 and 2018. Further movement was observed in 2019 including a new tension crack about 2 m further upslope on the east flank of the slump and minor regression at line B. The tension crack had widened as of 2020 and some material had fallen in the slide. In 2017, one of the pins in line B was removed from the slide mass and placed 5 m further back of pin B1. The encroachment into the ditch had increased in 2017 and 2018; regrading in 2019 has pushed the toe further back into the slope. Slump B appears relatively unchanged since 2018 although a mid-slope toe appeared more defined. The slumps further west (D and E) appeared to be relatively unchanged since 2016 although additional cracks were mapped in 2018 (they may have been present before but not recorded) and toe rolls heights were measured in 2019. Seepage is accumulating at the tops of some of the slump blocks which will further reduce the strength of the slumped material and lead to further movement. With the continued seepage and the continued removal of material from the ditch (whether eroded by water or excavated to maintain ditch flow), the slumps will likely retrogress as toe support is lost. The rate of regression of the top of the slumps is difficult to estimate and it is recommended that a remediation option be developed along with a minimum horizontal offset to the pipelines that would trigger its construction.

An underground utility locate was undertaken in 2018 to identify the locations of the pipelines at the top of the slope. The TransCanada pipeline (TCPL) was closest at an offset 3.9 m south of Pin A1 and 0.1 m south of Pin B3. The East Peace Gas Co-op natural gas line is located further south of the TCPL line.

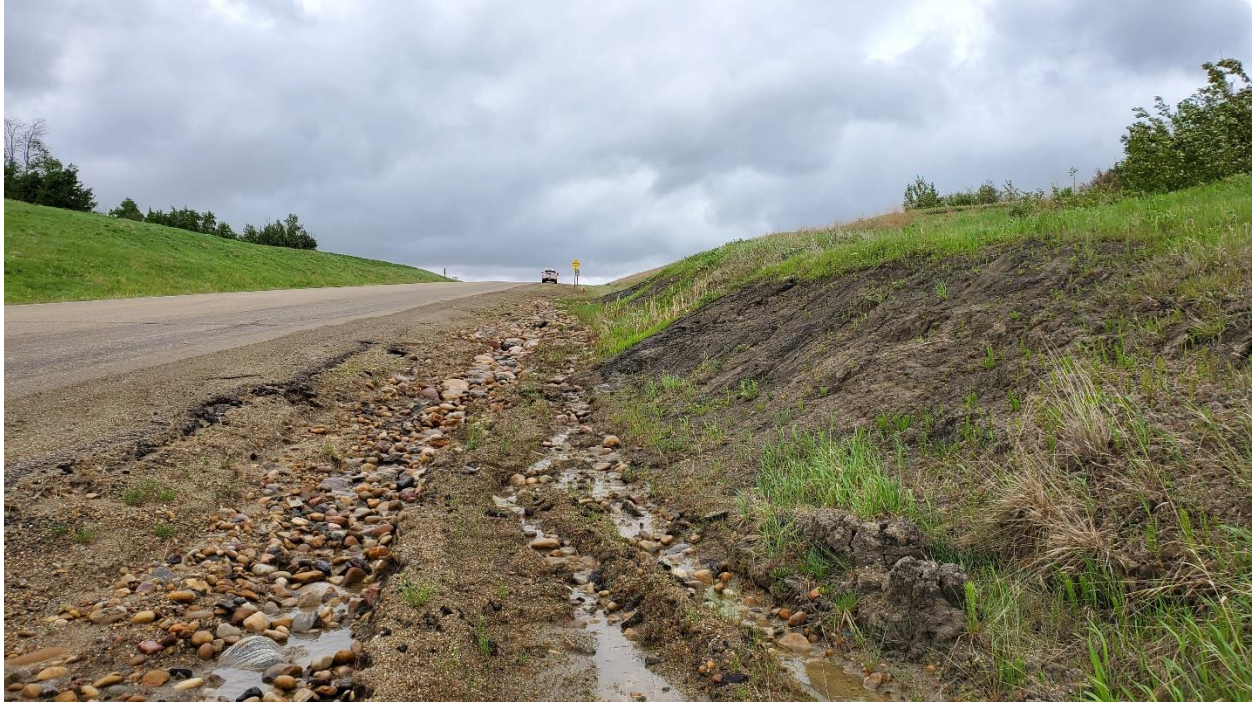
In the spring of 2019, the maintenance contractor excavated the toe rolls to improve ditch drainage. The material was wasted higher up on the slopes. The contractor also added two swales on the slope to assist with drainage from the sag ponds further up the slope. The grading work obscured some of the slide features and may also contribute to local instability at the toe due to the overall steepening of the lower portion of the backslope. However, it solved the ditch drainage issue. In 2020, there was deterioration of the toe of this regrading with some sloughing and erosion observed. The upper portions of the fill are starting to revegetate.

Photo 1 – Looking east at toes of Slumps B and A which were excavated in 2019 to improve ditch flow with the material placed back onto the slide masses.

- Remove material from the ditch when required to maintain flow but do not place the excavated material back onto the slide mass as it will load the slide. Augment the ditch bottom rip-rap to minimize downcutting and erosion of the recently-graded faces of the slide toe rolls. Excavated material from the regrading in the spring of 2019 should be removed to reduce the potential for local instability.
- Establish a line of communication with the pipeline owners to determine risk tolerance and minimum setback distance.

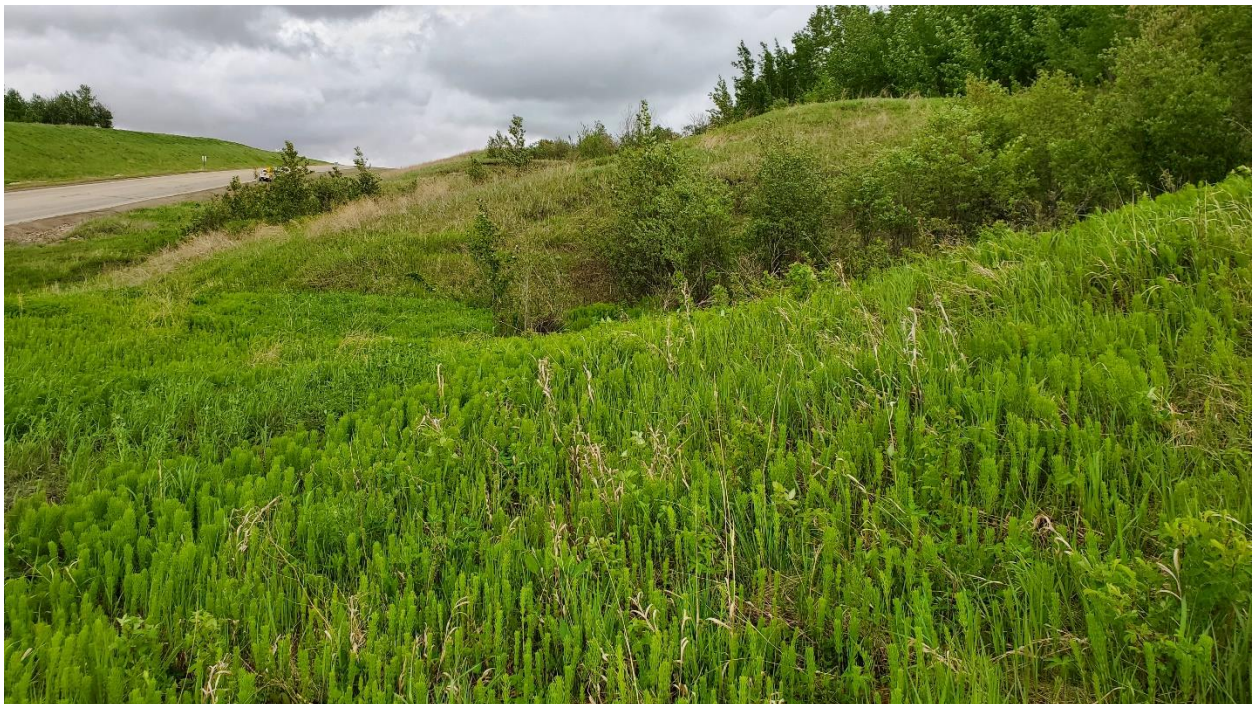
Photo 2 – Looking southeast at the top of Slump B. Disturbances from 2019 regrading becoming vegetated.

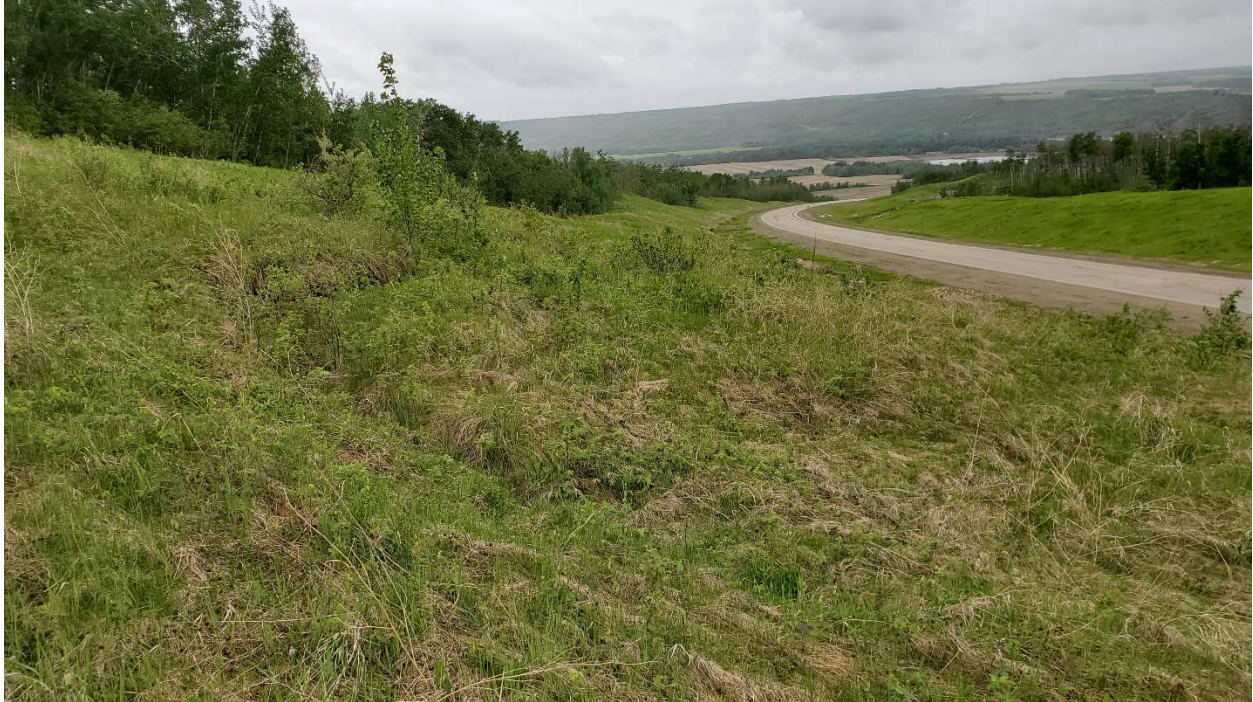
Photo 3 – Looking west at crest of Slump D

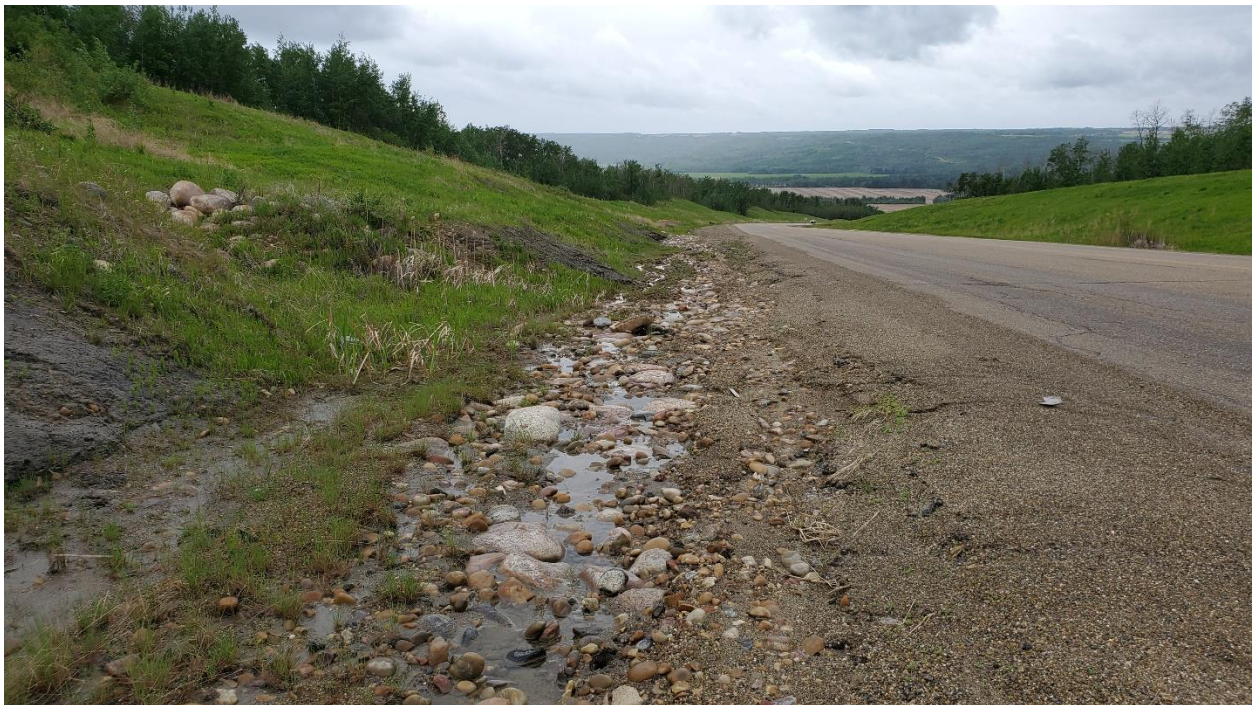
Photo 4 – Looking west at the toe of Slump B.

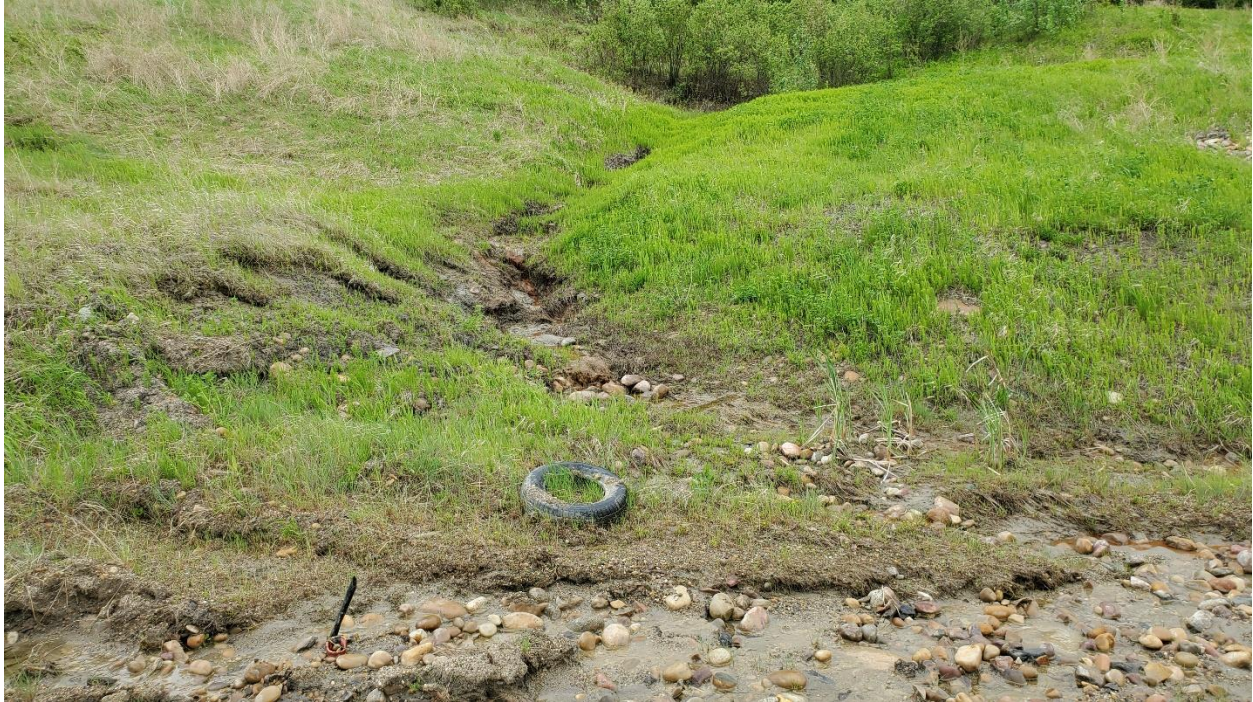
Photo 5: Recent grading (2019) of lower portion of the slope at toe of Slump B becoming vegetated.

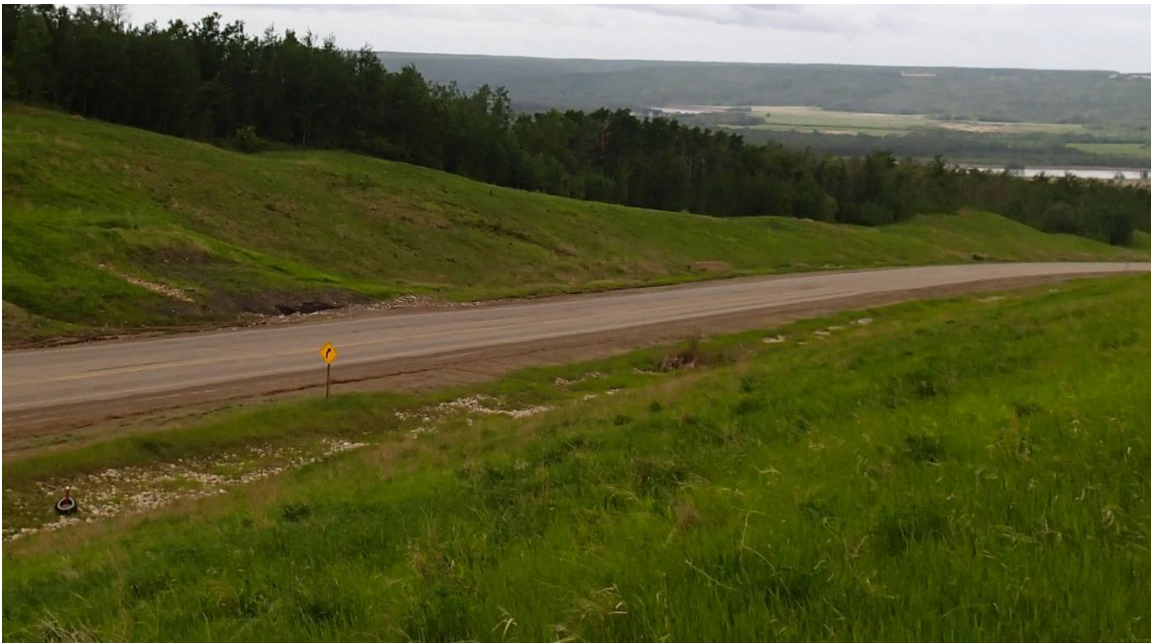
Photo 6: Looking southwest at Slump D (by R. Wang, TRANS).

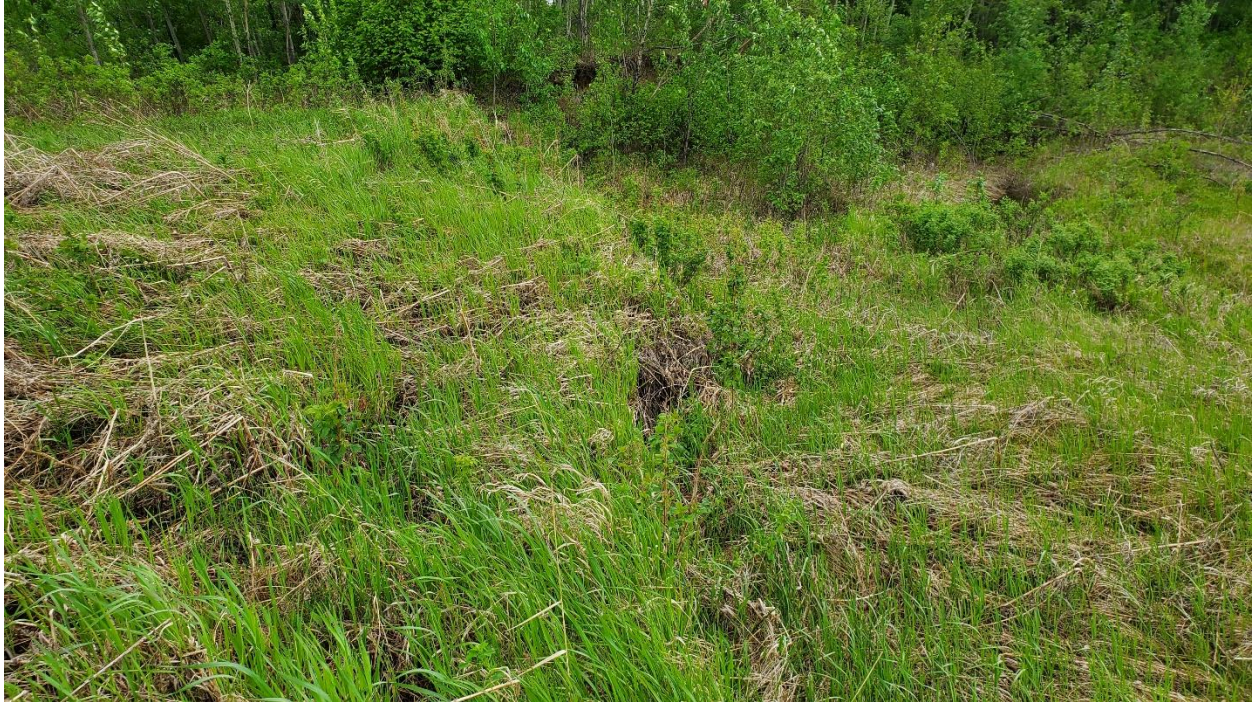
Photo 7: Looking south at recent movement on the east flank of Slump A.

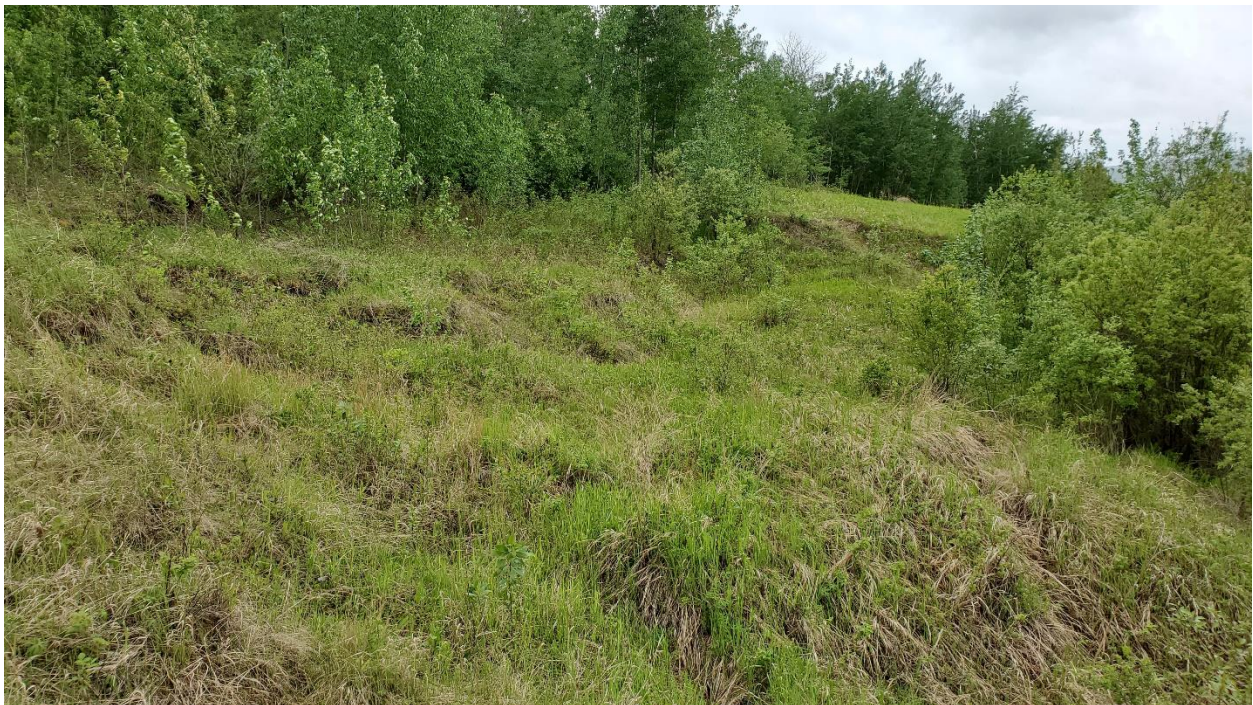
Photo 8: Looking west at top of Slump B.
