**ALBERTA TRANSPORTATION  
GEOHAZARD ASSESSMENT PROGRAM  
PEACE REGION (PEACE RIVER DISTRICT)  
2021 INSPECTION**

<b>Site Number</b>	<b>Location</b>	<b>Name</b>	<b>Hwy</b>	<b>km</b>
SH008-1	2 km E of Watino Bridge	Watino East Hill	49:08	18.80-19.05
<b>Legal Description</b>		<b>UTM Co-ordinates</b>		
NE26-77-24-W5M		11U E 462,307	N	6,173,153

**SH008-1: HWY 49:08 WATINO EAST HILL SMOKY RIVER  
2021 SITE INSPECTION PLAN**

**DWG No. 32121-SH008-1**

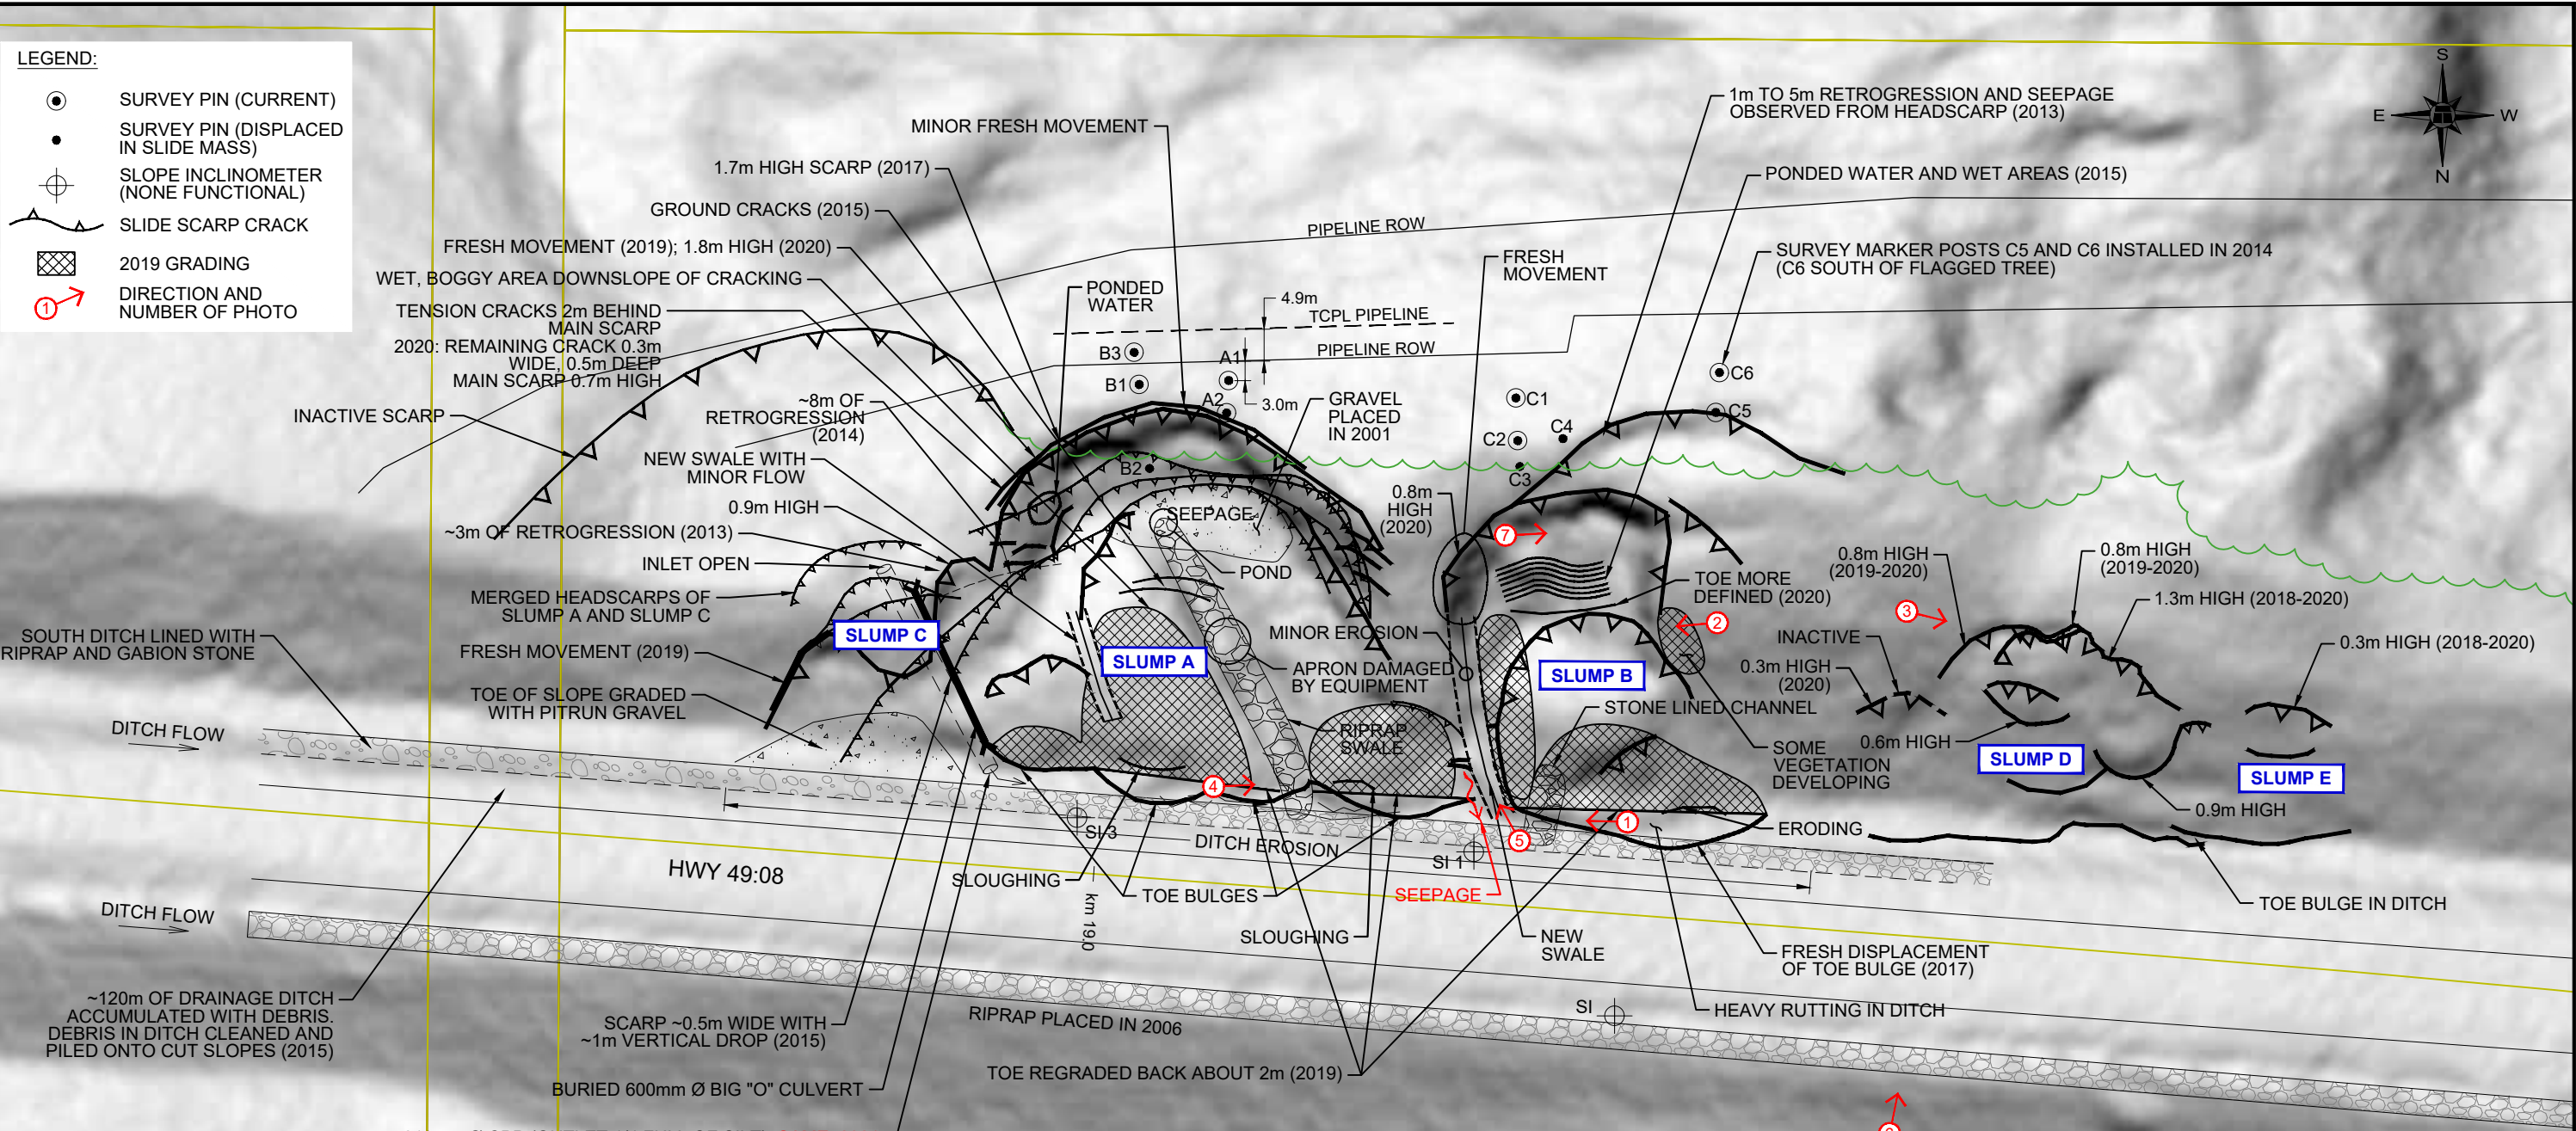
MARKER	MARKER DISTANCES (m)									SCARP HEIGHT (m)				
	2021	2020	2019	2018	2017	2016	2015	2014	2013	2021	2020	2019	2018	2017
B1 - B2				4.9	-	-	-	-	5.7					
B2 - SCARP				-	-	-	-	-	5.2					
B1 - SCARP	3.2	3.2	3.2	3.3	3.3	3.3	3.4	3.4	-	1.6****	1.6****	1.7	1.9	1.9
B1 - B3* **					5.0	-	-	-	-					
A1 - A2***				5.0	5.4	5.4	6.6	6.6	5.4					
A2 - SCARP	0.8	0.8	0.8	0.8	0.9	0.9	1.2	1.2	2.1	1.3	1.3	1.3	1.3	1.3
C1 - C2				7.8	7.8	7.8	7.8	7.8	7.9					
C2 - C3				-	-	-	-	-	5.1					
C2 - SCARP		2.1	2.1	2.1	2.2	2.2	2.3	2.3	2.3	0.6****	1.1	1.0	0.7	
C3 - SCARP	0.5													
C5 - C6				2.0	2.0	2.0	2.0	2.0	-					
C5 - SCARP		5.7	5.7	5.9	5.9	5.9	5.9	6.0	-	1.0	0.7	0.4	0.3

\*B2 REBAR PIN SALVAGED AND INSTALLED 5m BEHIND B1 AND RENAMED B3  
 \*\*B3 LOCATED 0.1m NORTH OF TCPL PIPELINE  
 \*\*\*A1 LOCATED 3.9m NORTH OF TCPL PIPELINE  
 \*\*\*\* SCARP HAS RAVELLED SO LESS VERTICAL

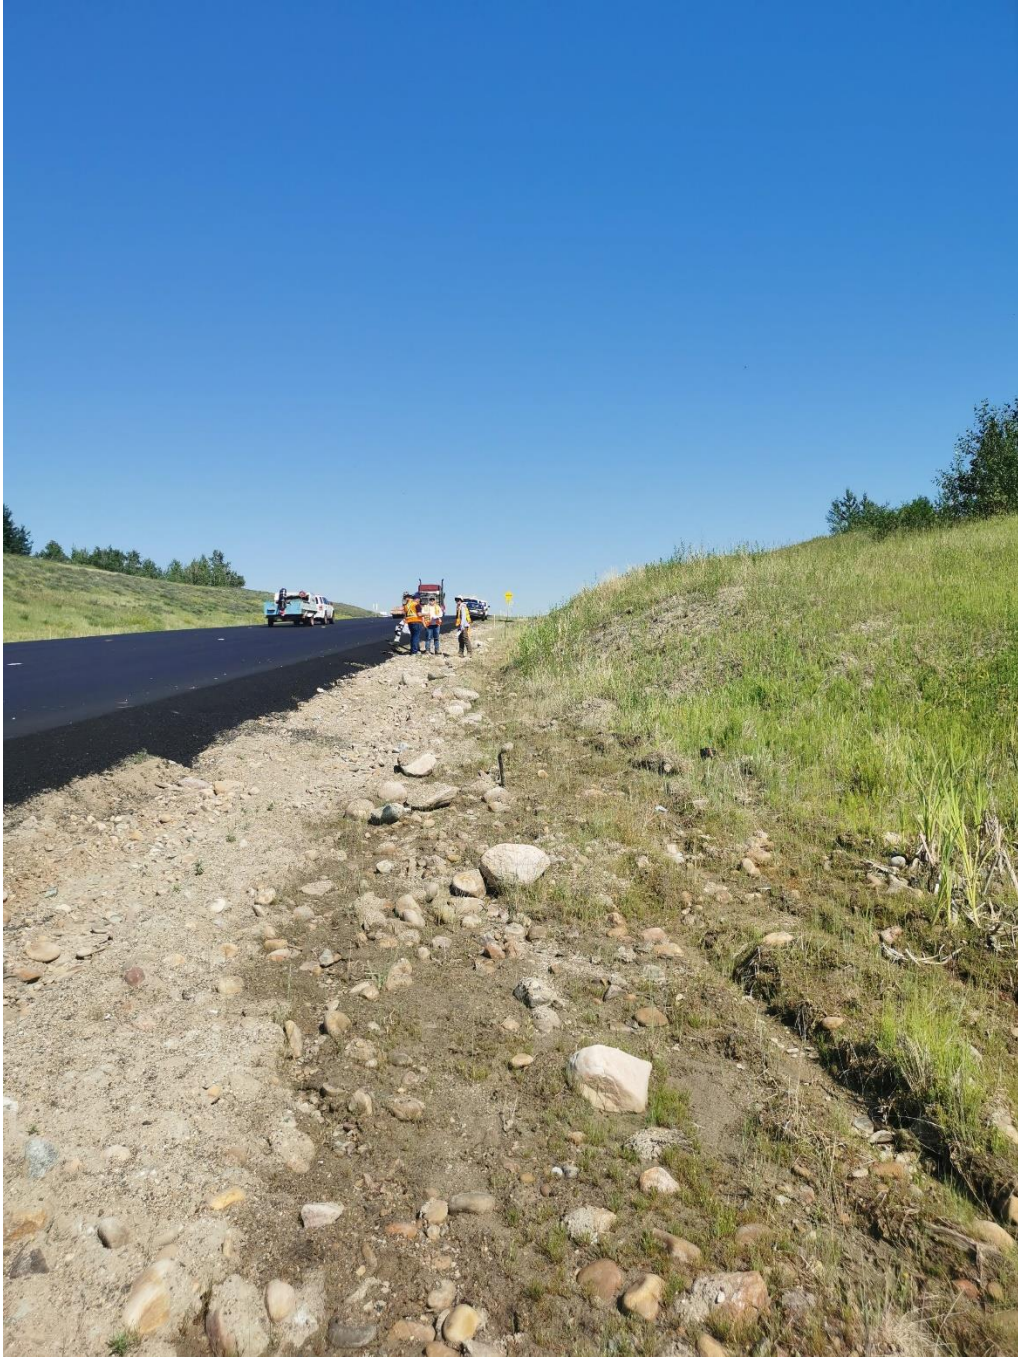
In the spring of 2019, the maintenance contractor excavated the toe rolls to improve ditch drainage. The material was wasted higher up on the slopes. The contractor also added two swales on the slope to assist with drainage from the sag ponds further up the slope. The grading work obscured some of the slide features and may also contribute to local instability at the toe due to the overall steepening of the lower portion of the backslope. However, it solved the ditch drainage issue. In 2020, there was deterioration of the toe of this regrading with some sloughing and erosion observed, however the site hadn't gotten worse in 2021. The upper portions of the fill are starting to revegetate.

Photo 1 – Looking east at toes of Slumps B and A which were excavated in 2019 to improve ditch flow with the material placed back onto the slide masses.

- Remove material from the ditch when required to maintain flow but do not place the excavated material back onto the slide mass as it will load the slide. Augment the ditch bottom rip-rap to minimize downcutting and erosion of the recently-graded faces of the slide toe rolls.
- Establish a line of communication with the pipeline owners to determine risk tolerance and minimum setback distance.

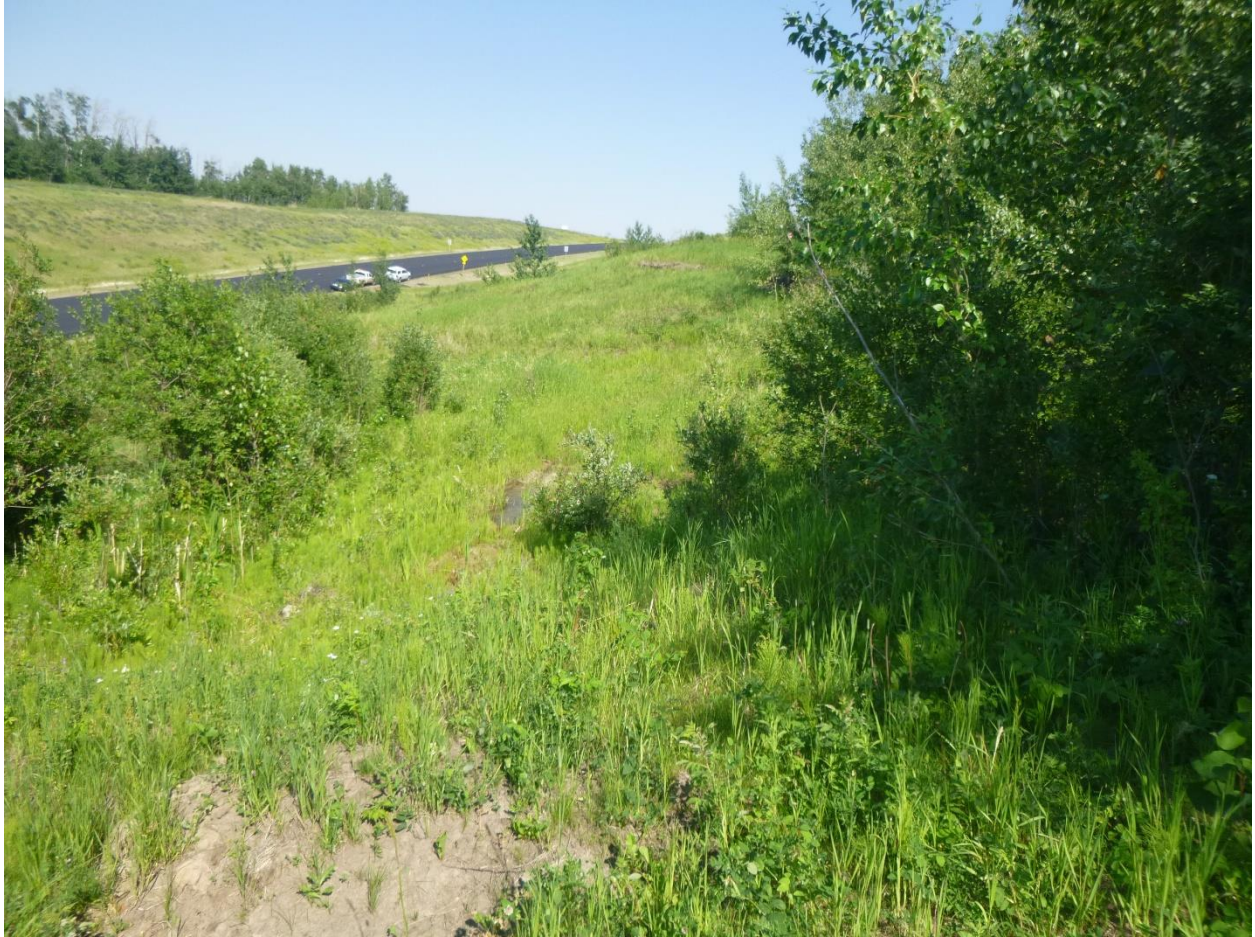
Photo 2 – Looking southeast at the top of Slump B. Disturbances from 2019 regrading becoming vegetated.

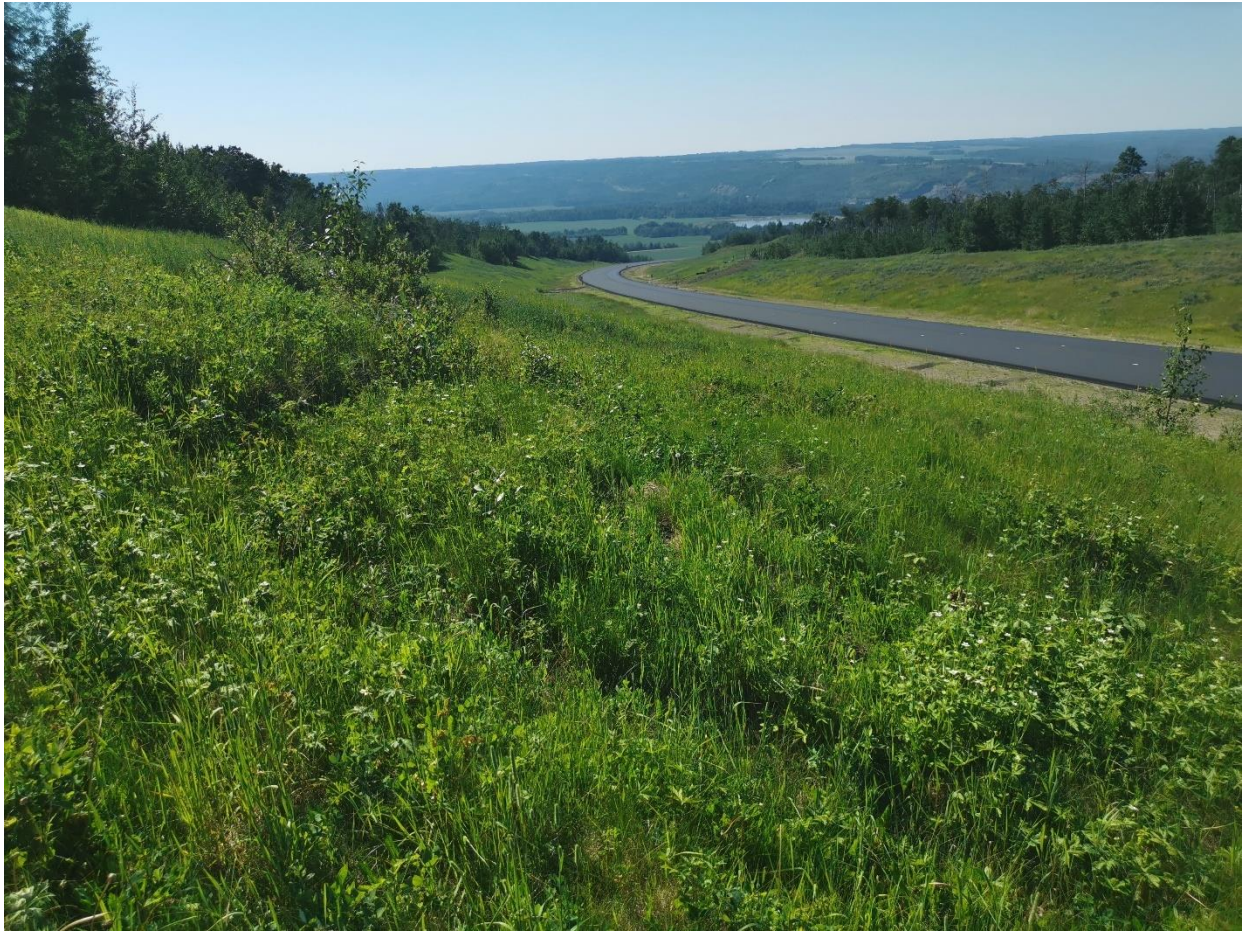
Photo 3 – Looking west at crest of Slump D

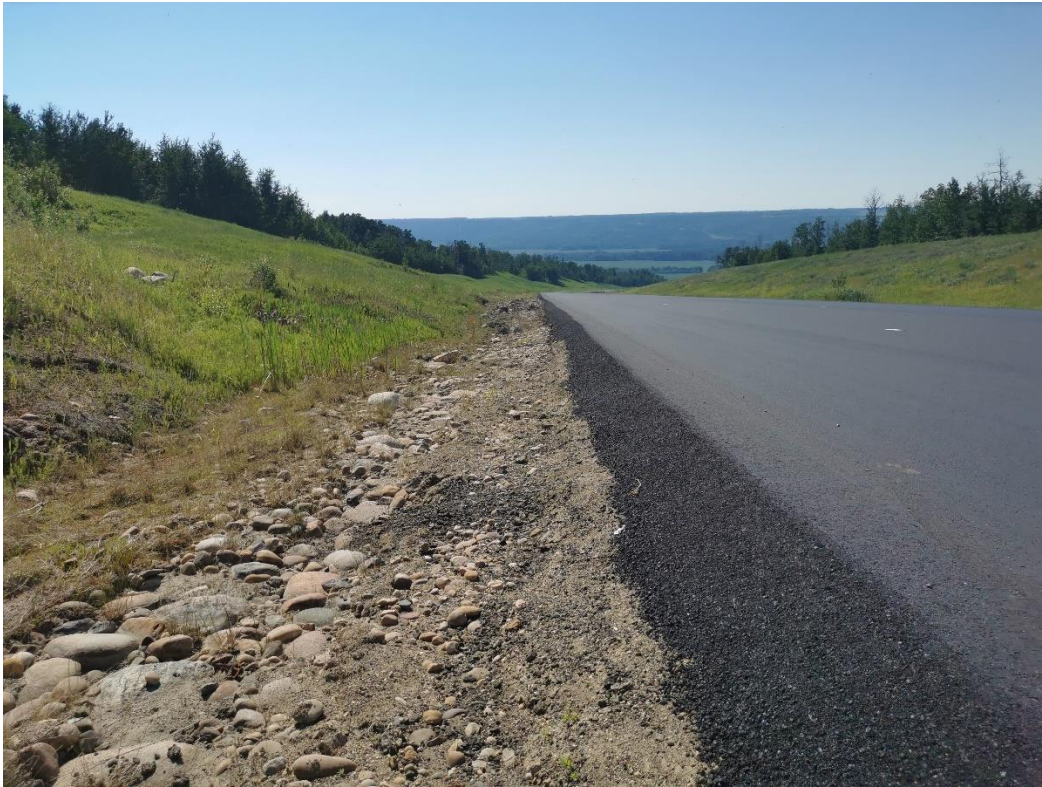
Photo 4 – Looking west at the toe of Slump B.

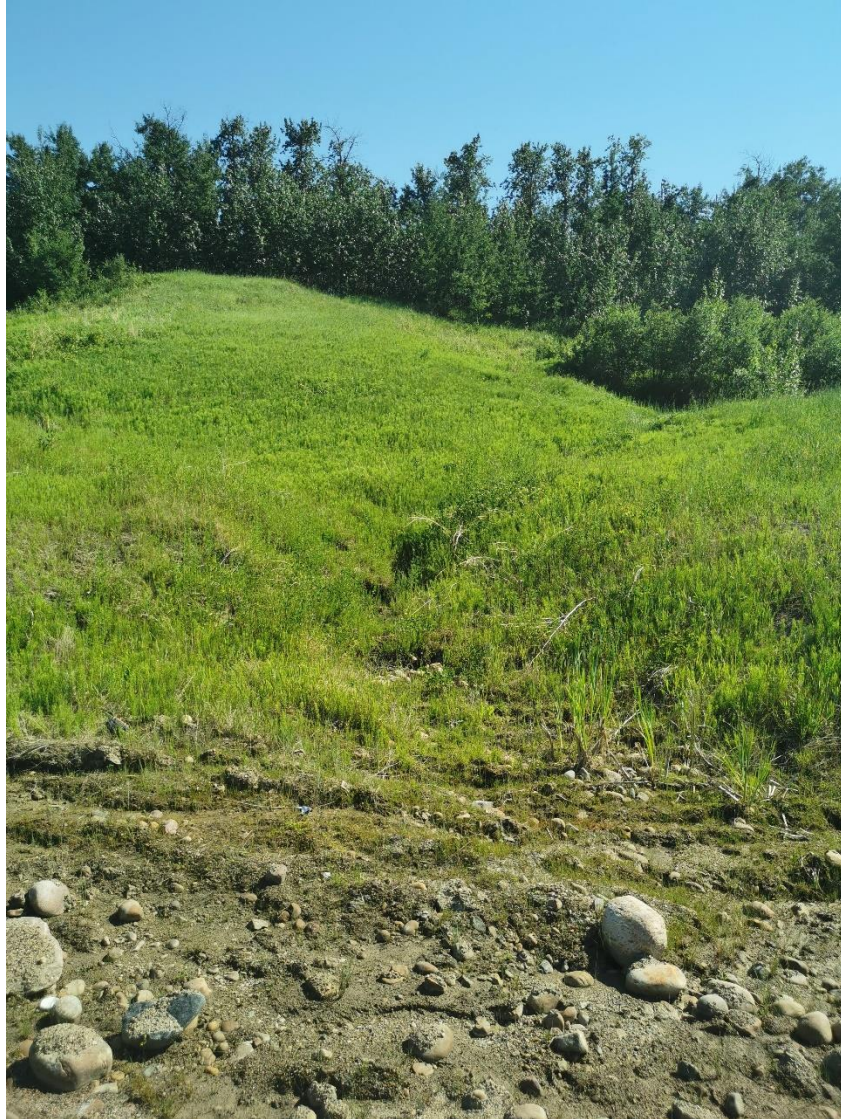
Photo 5: Recent grading (2019) of lower portion of the slope at toe of Slump B becoming vegetated.

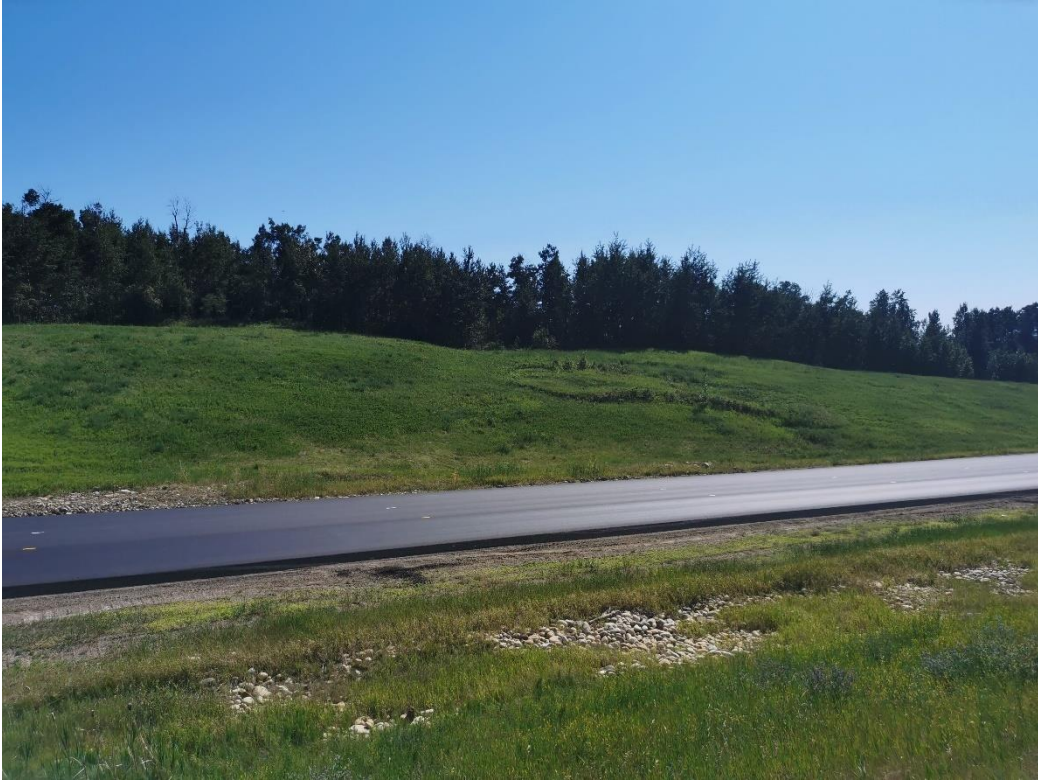
Photo 6: Looking southwest at Slump D.

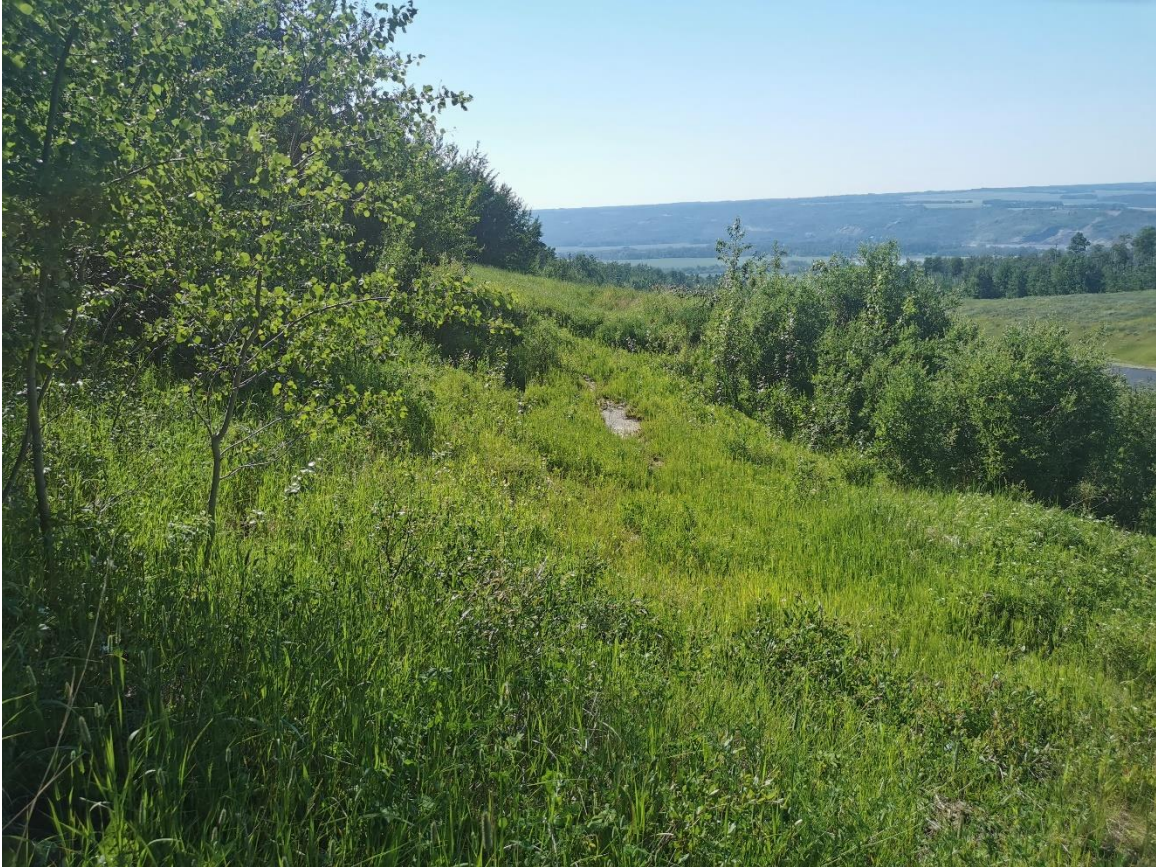
Photo 7: Looking west at top of Slump B.
