**ALBERTA TRANSPORTATION AND
ECONOMIC CORRIDORS
GEOHAZARD RISK MANAGEMENT PROGRAM
PEACE REGION (PEACE RIVER DISTRICT)
2025 INSPECTION**

Site Number	Location	Name	Hwy	km
SH008-1	2 km E of Watino Bridge	Watino East Hill	49:08	18.80-19.05
Legal Description		UTM Co-ordinates		
NE26-77-24-W5M		11U E 462,307	N	6,173,153

SH008-1: HWY 49:08 WATINO EAST HILL SMOKY RIVER
2025 SITE INSPECTION PLAN

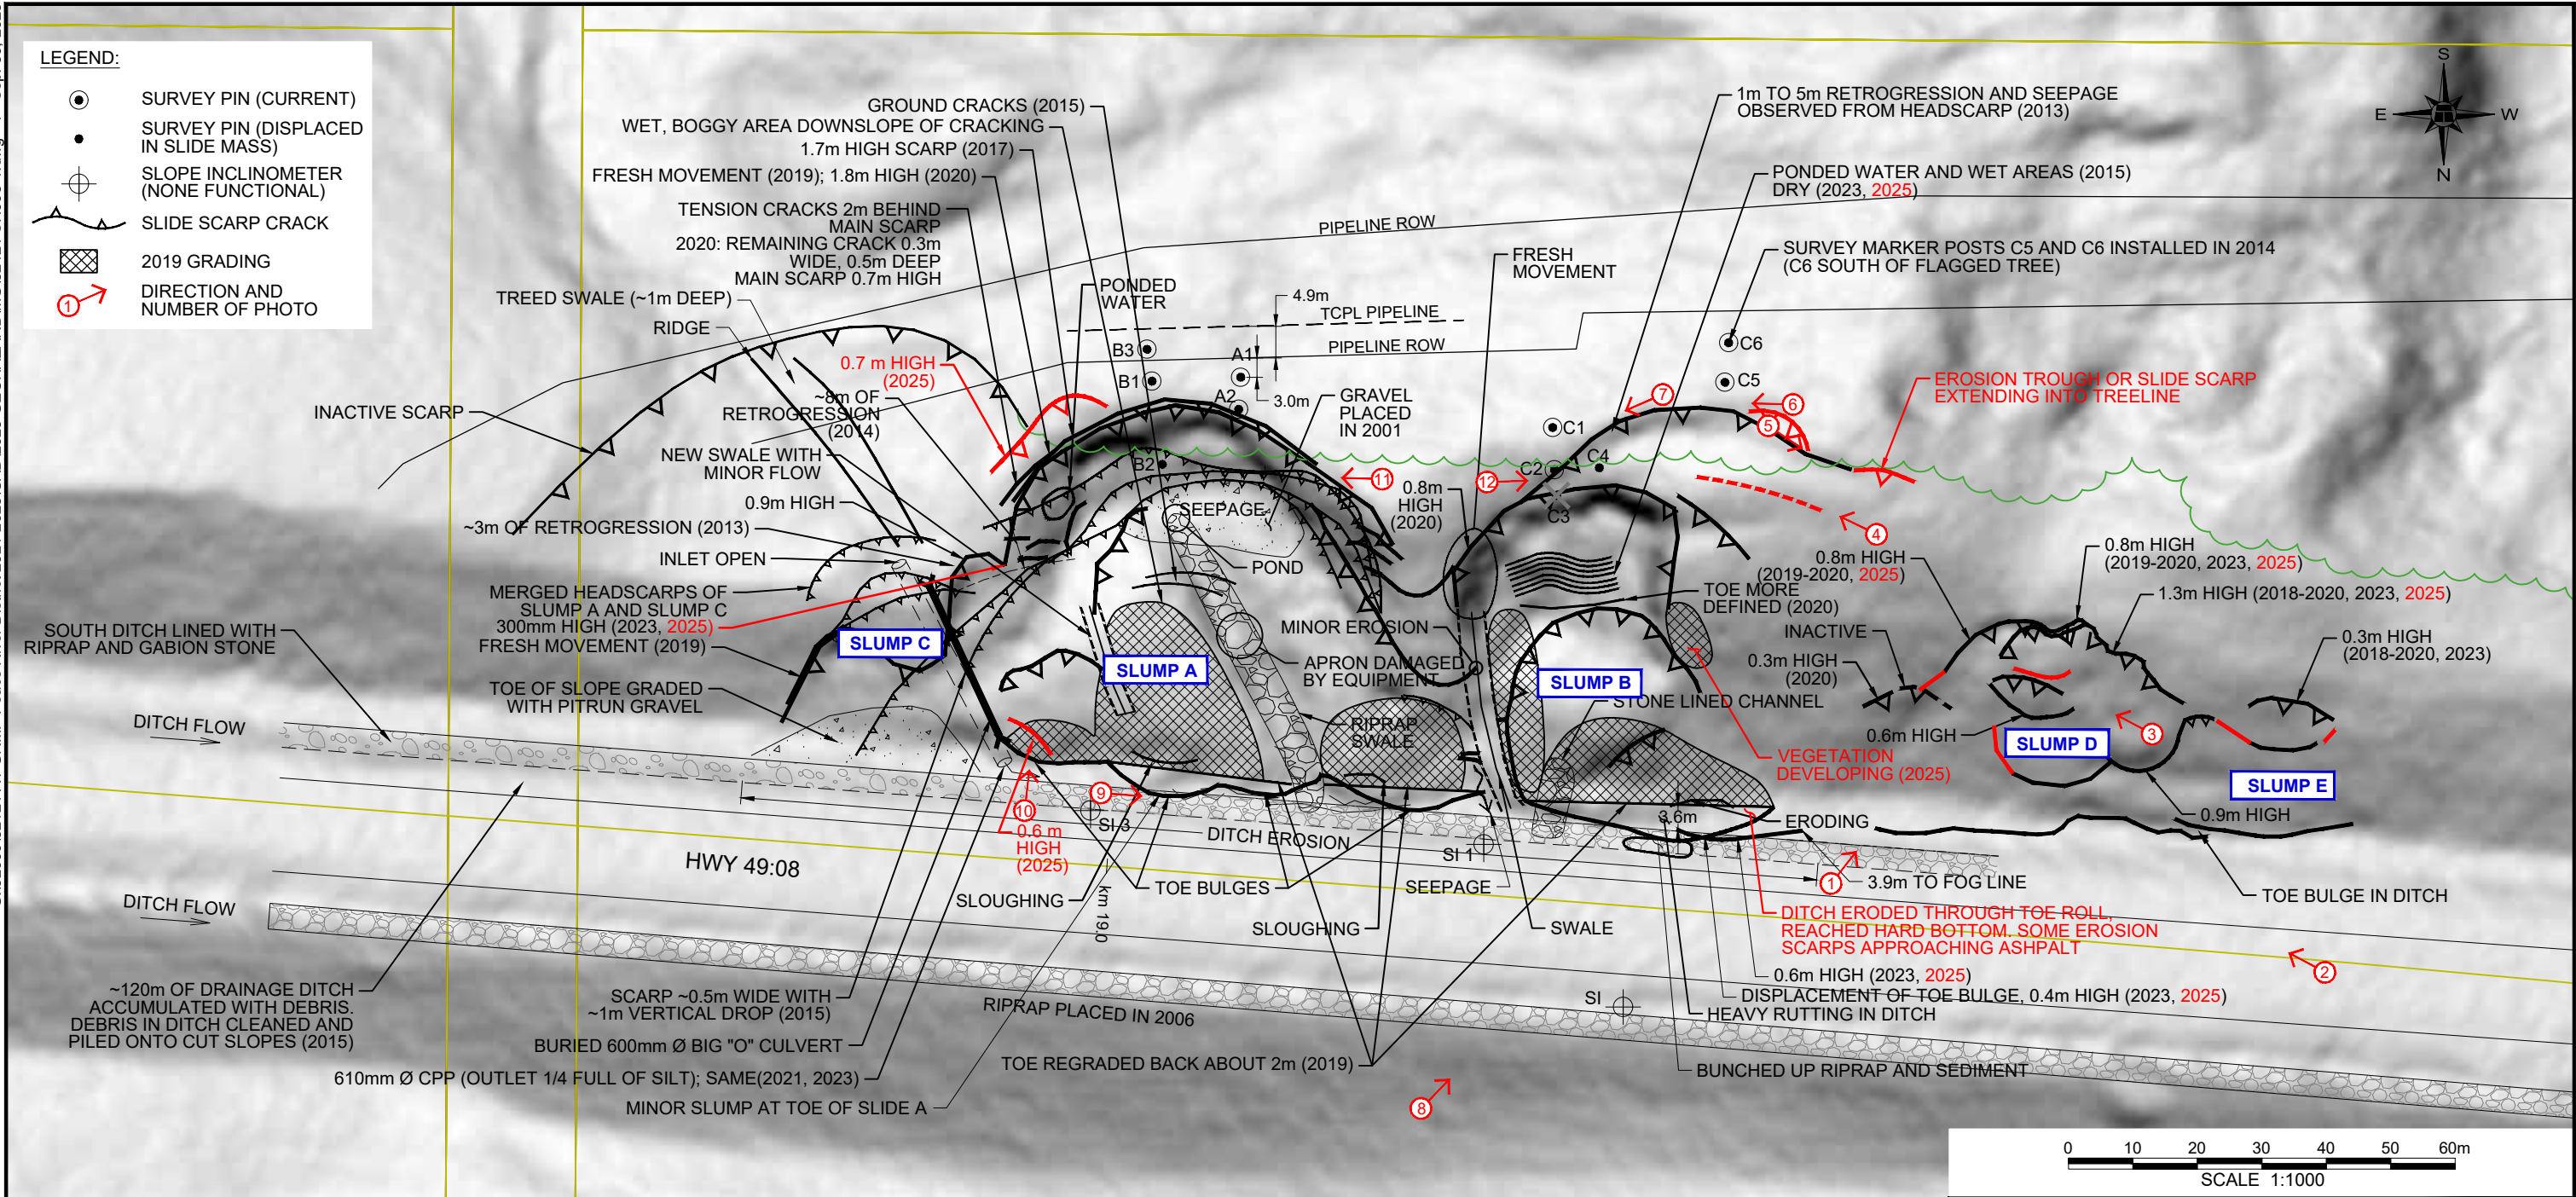
DWG No. 32121-SH008-1

MARKER DISTANCES (m)											SCARP HEIGHT (m)						
MARKER	TYPE	2025	2023	2021	2020	2019	2018	2017	2016	2015	2014	2013	2025	2023	2021	2020	2019	2018	2017
B1 - B2							4.9	-	-	-	-	5.7							
B2 - SCARP							-	-	-	-	-	5.2							
B1 - SCARP	REBAR	2.8	3.2	3.2	3.2	3.2	3.3	3.3	3.3	3.4	3.4	-	0.9m VERTICAL 1.6m OVERALL	0.7m VERTICAL 1.6m OVERALL	1.6****	1.6****	1.7	1.9	1.9
B1 - B3* **	REBAR							5.0	-	-	-	-							
A1 - A2***		5.5	5.5				5.0	5.4	5.4	6.6	6.6	5.4							
A2 - SCARP		0.7	0.8	0.8	0.8	0.8	0.8	0.9	0.9	1.2	1.2	2.1	0.8m VERTICAL 1.3m OVERALL	0.6m VERTICAL 1.3m OVERALL	1.3	1.3	1.3	1.3	1.3
C1 - C2	REBAR	8.1	8.1				7.8	7.8	7.8	7.8	7.8	7.9							
C2 - C3	REBAR						-	-	-	-	-	5.1							
C2 - SCARP		0.5	0.5	0.5	2.1	2.1	2.1	2.2	2.2	2.3	2.3	2.3				0.6****	1.1	1.0	0.7
C5 - C6	SURVEY MARKER	2.0	2.0				2.0	2.0	2.0	2.0	2.0	-							
C5 - SCARP	SURVEY MARKER	5.7	5.7		5.7	5.7	5.9	5.9	5.9	5.9	6.0	-		0.8		1.0	0.7	0.4	0.3

*B2 REBAR PIN SALVAGED AND INSTALLED 5m BEHIND B1 AND RENAMED B3
**B3 LOCATED 0.1m NORTH OF TCPL PIPELINE
***A1 LOCATED 3.9m NORTH OF TCPL PIPELINE
**** SCARP HAS RAVELLED SO LESS VERTICAL

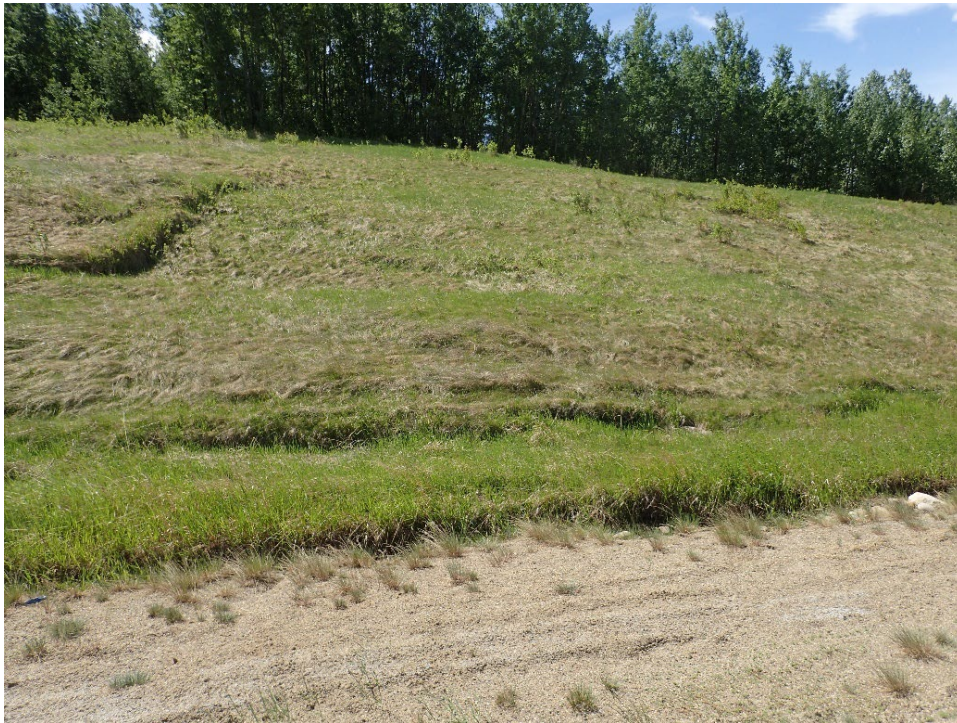
Photo 1 – Looking southwest at Slump D where extensions of scarps were observed due to continued creep movement.

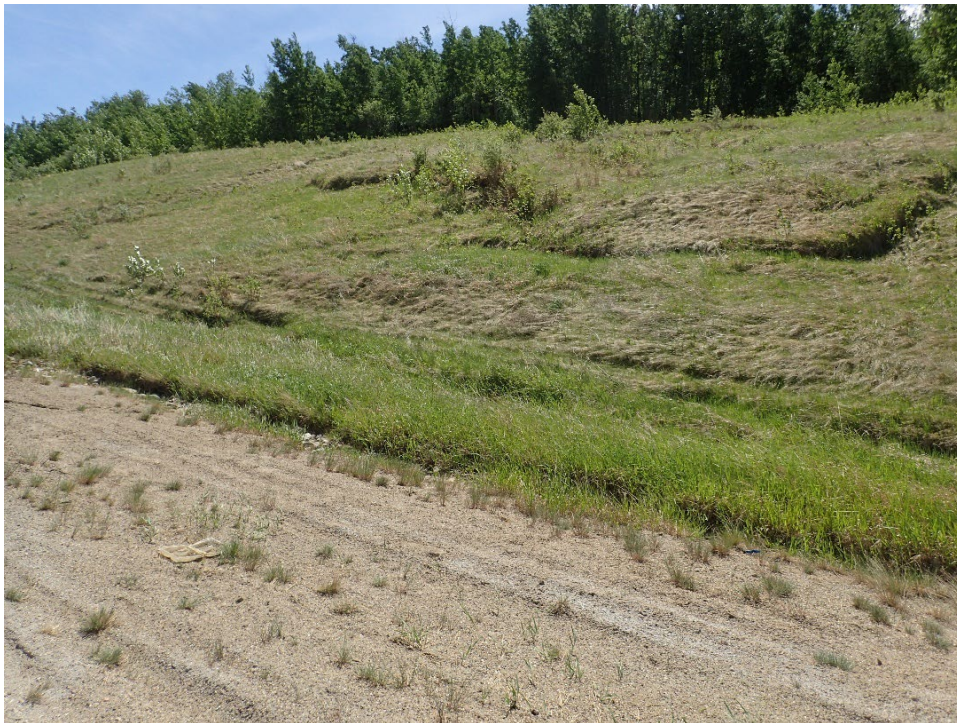
Photo 2 – Looking southeast toe bulges of Slumps D and E. No significant changes since 2023 inspection.

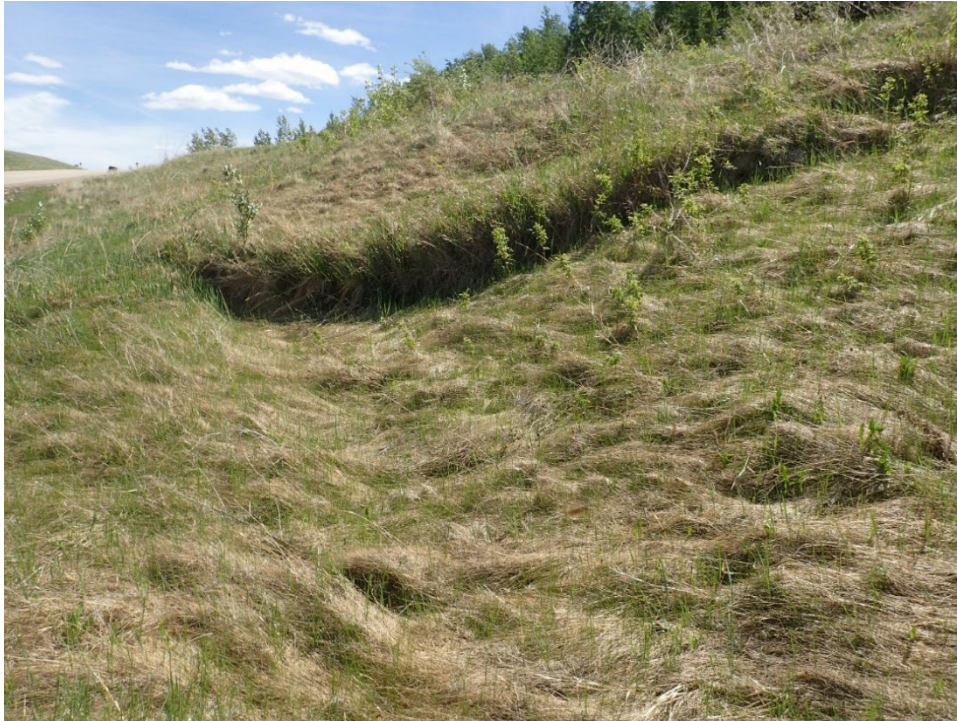
Photo 3 – Looking east at intermediate scarp within Slump D that has vegetation present.

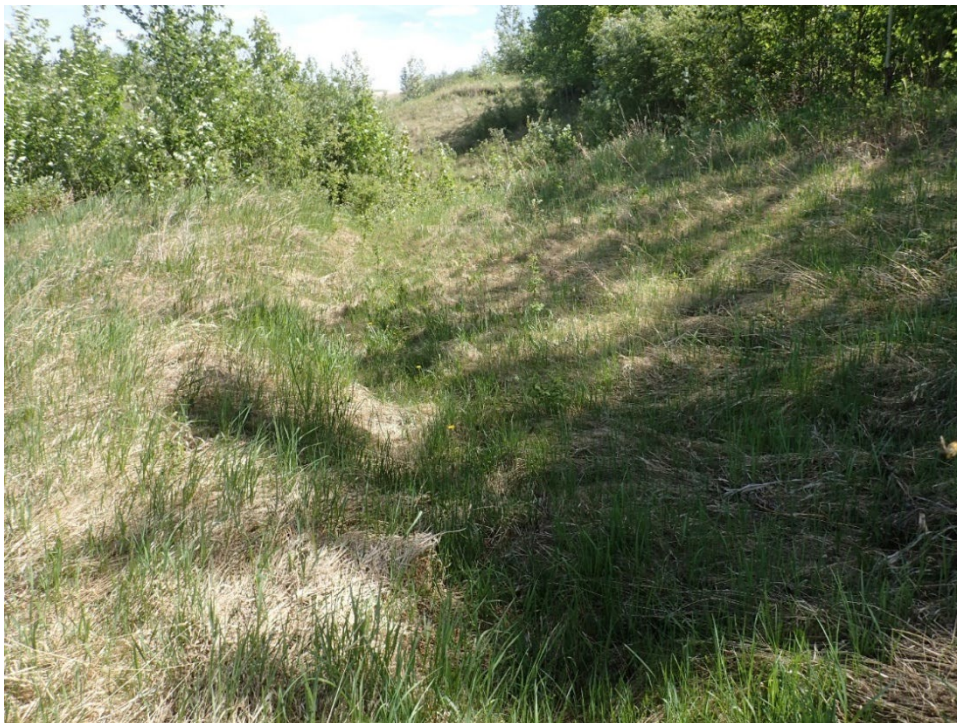
Photo 4 – Looking east at possible intermediate scarp within Slump B and downslope of treeline.

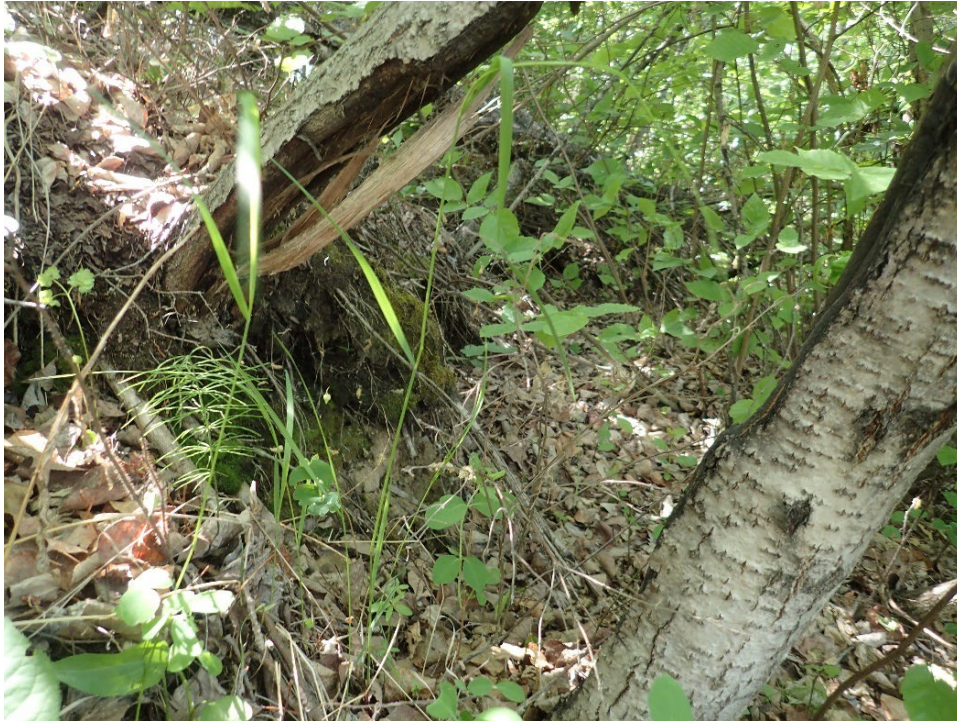
Photo 5: Looking west at headscarp of Slump B extending into treeline.

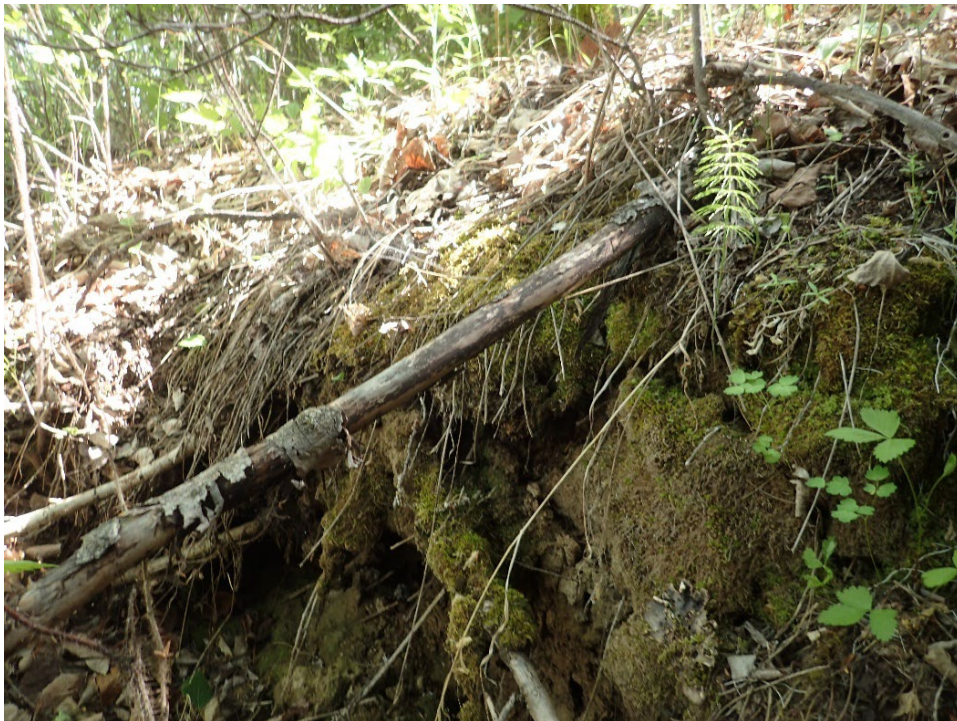
Photo 6: Looking east at headscarp retrogressing upslope.

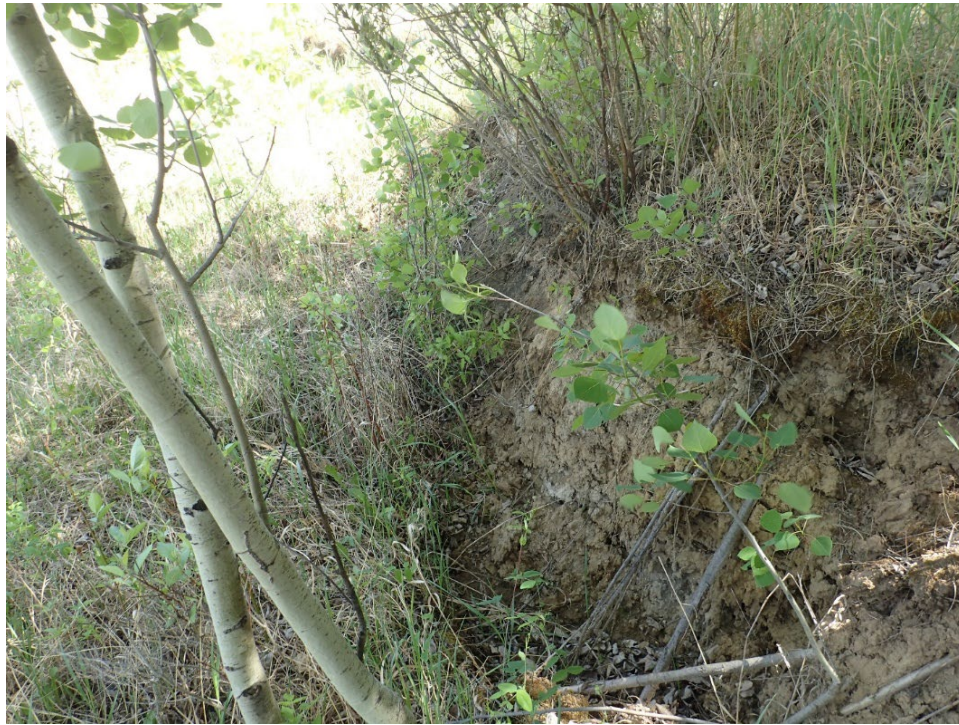
Photo 7: Looking east at headscarp of Slump B.

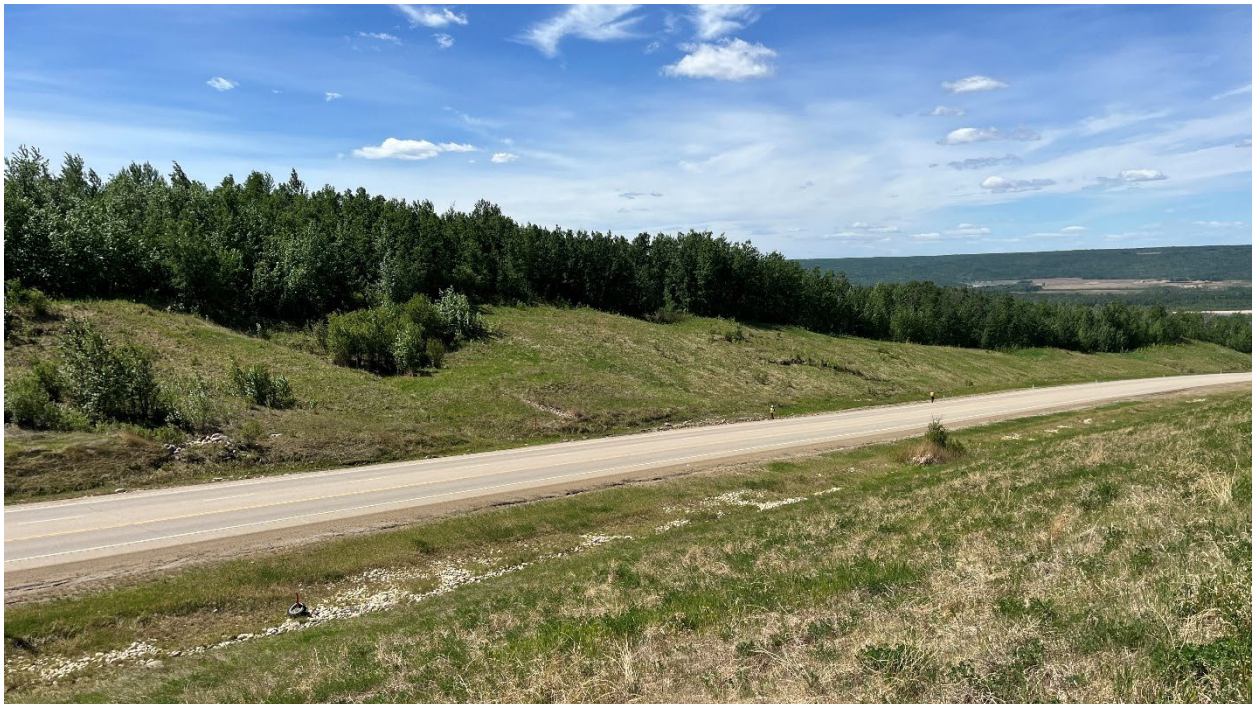
Photo 8 – Looking southwest at Slumps B, D and E from backslope across the highway.

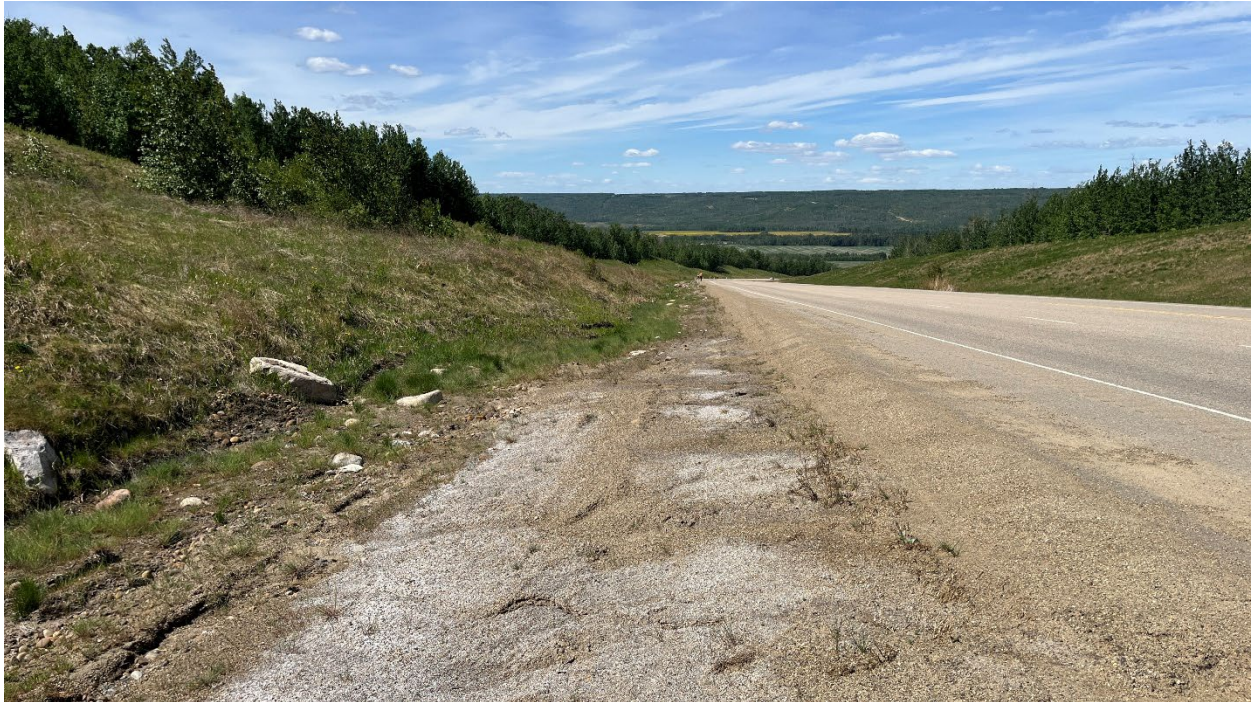
Photo 9 – Looking west at the toe of Slump A.

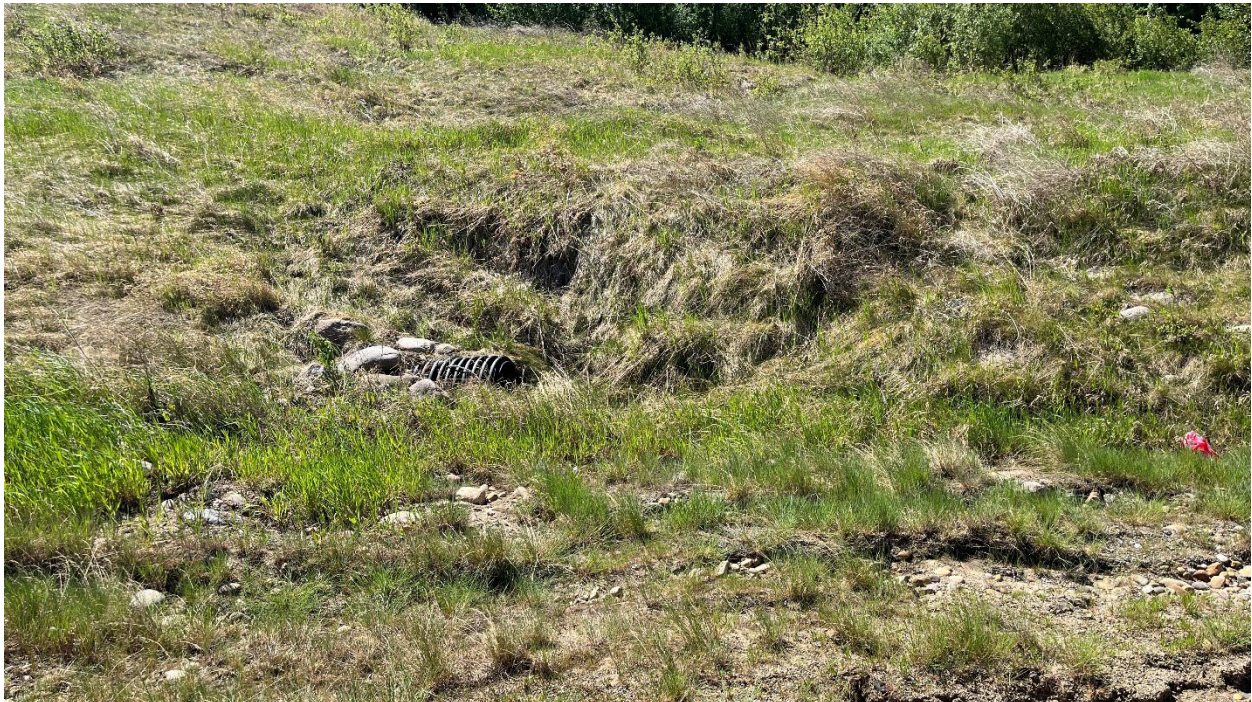
Photo 10: Lower south at culvert outlet with observed slumps upslope.

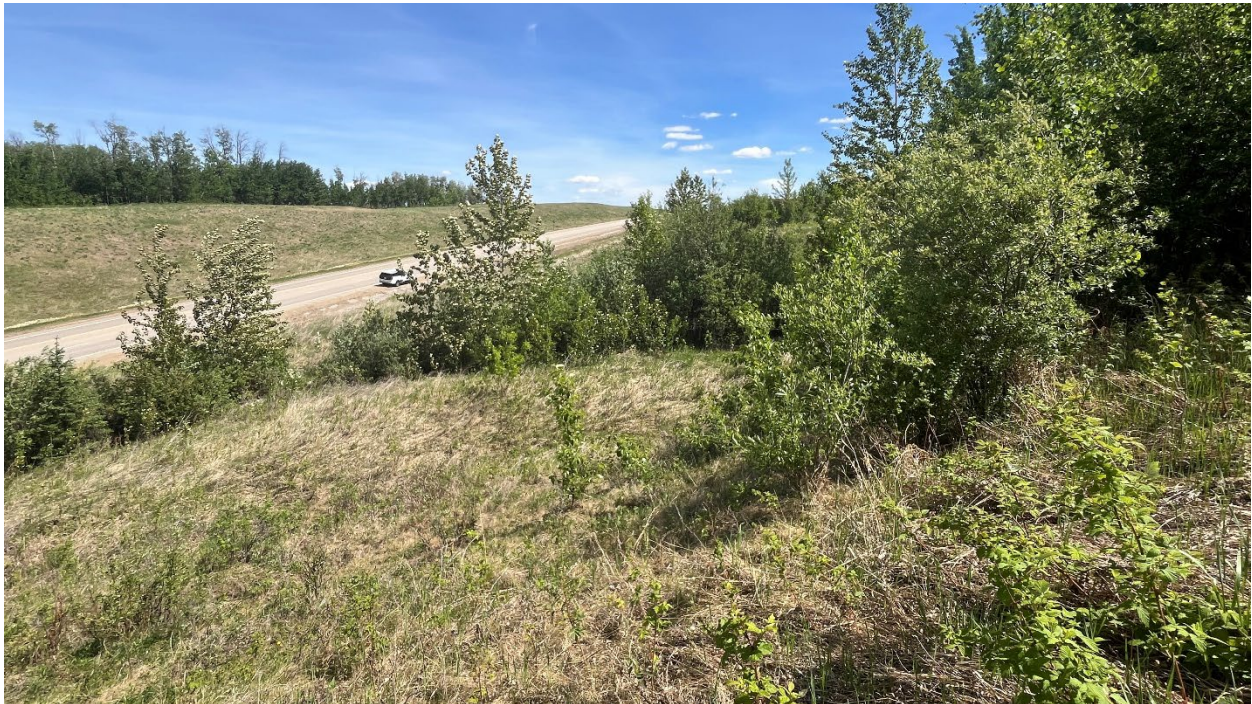
Photo 11: Looking east at top of Slump A.

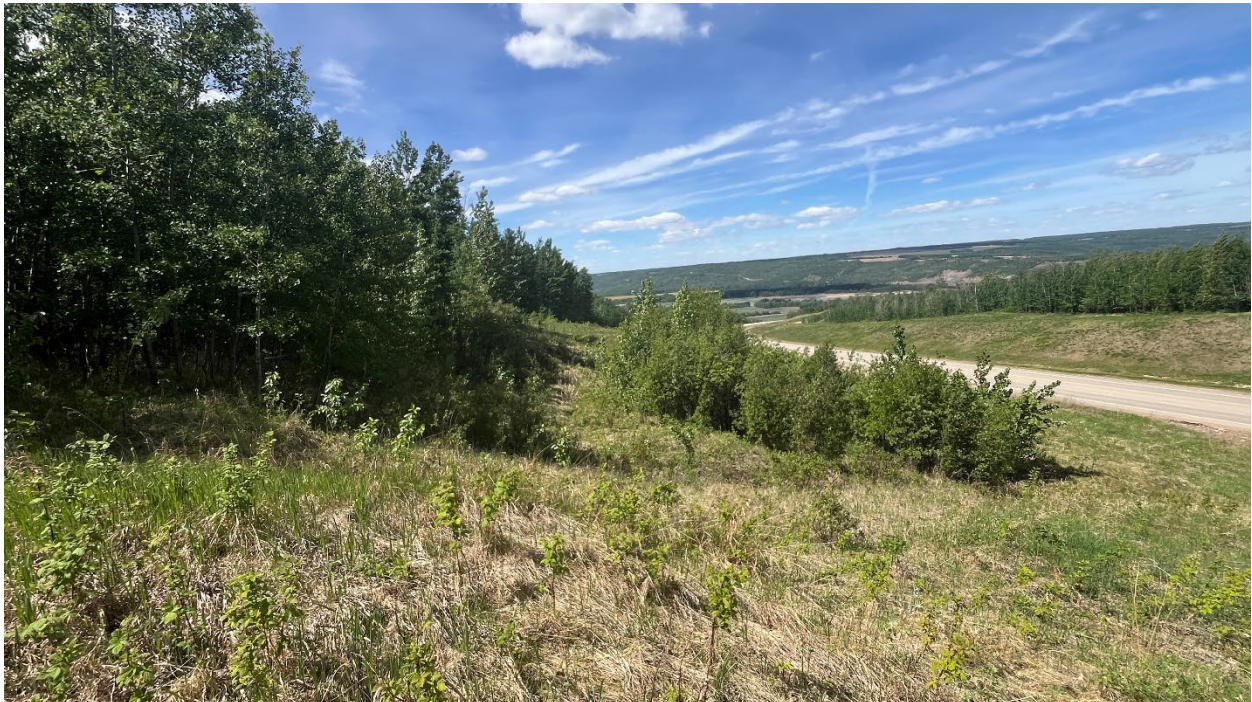
Photo 12: Looking west at the top of Slump B.
