**ALBERTA TRANSPORTATION
GEOHAZARD ASSESSMENT PROGRAM
PEACE REGION (PEACE RIVER DISTRICT)
2022 INSPECTION**

THURBER ENGINEERING LTD.

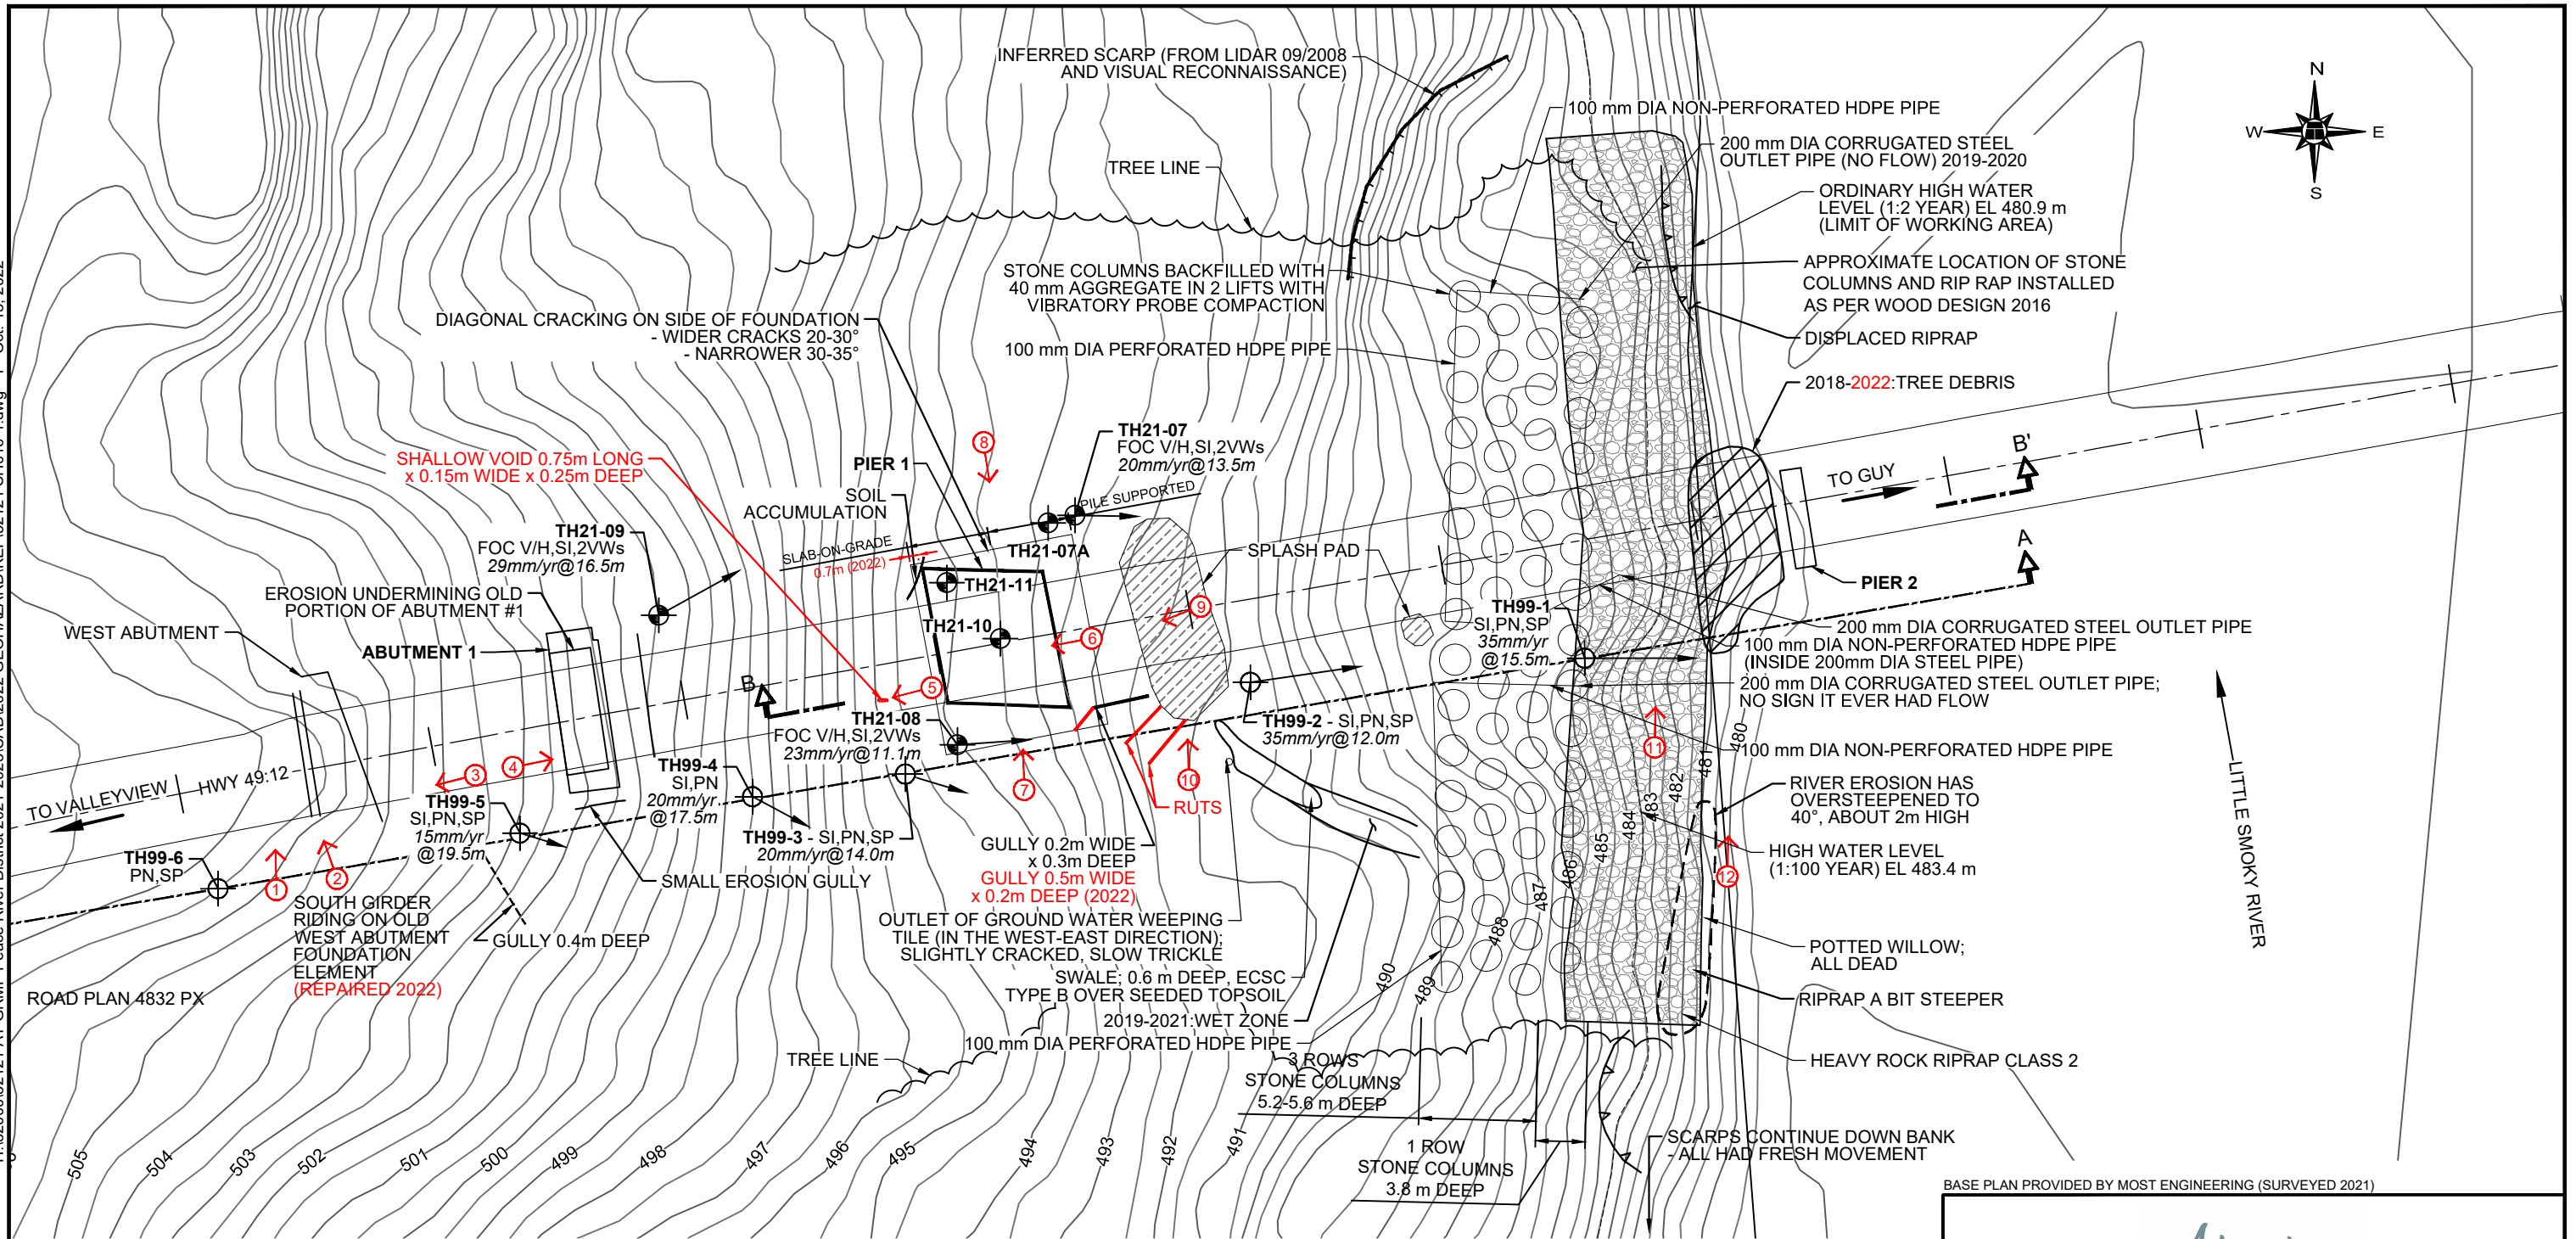
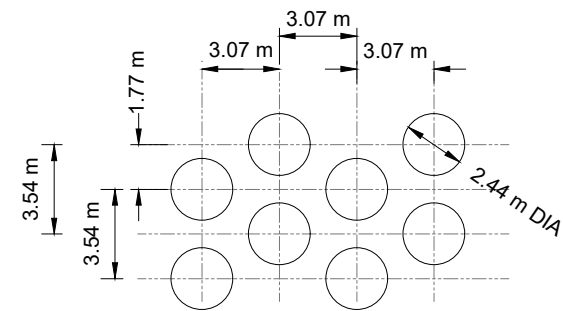
TYPICAL DETAIL OF STONE COLUMN SPACING
SCALE 1:300

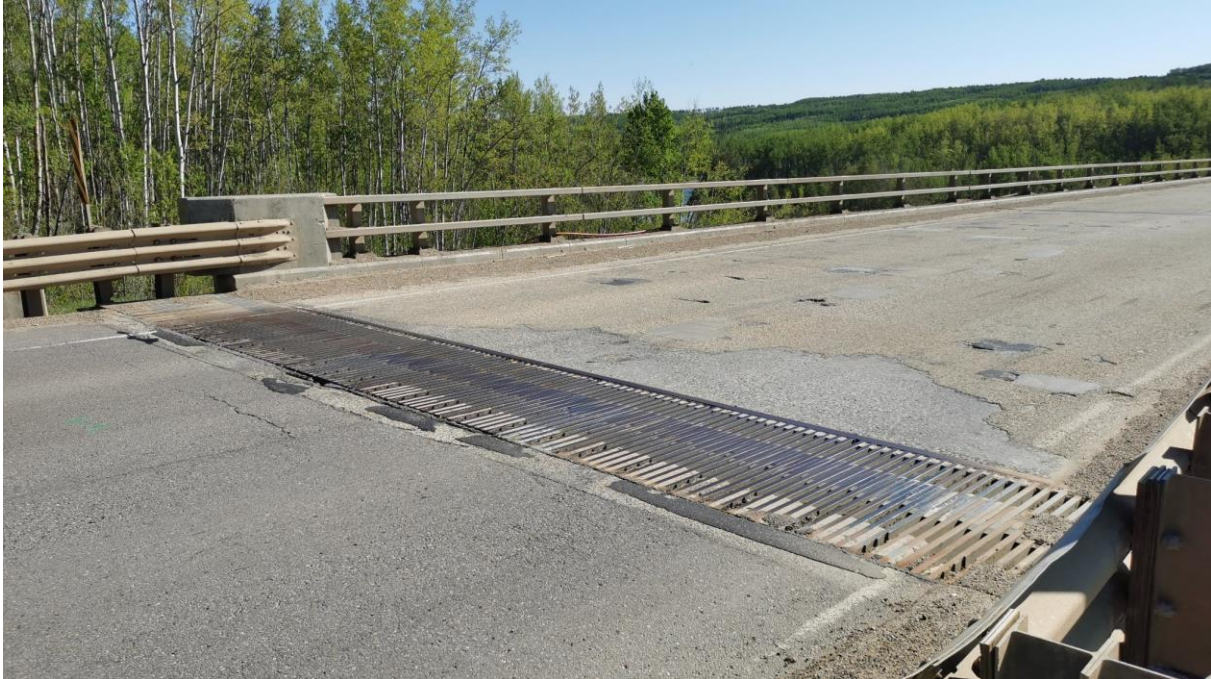
Photo 1 – Looking southeast at crack pattern forming at the west abutment expansion joint. This was overlaid or patched since 2020.

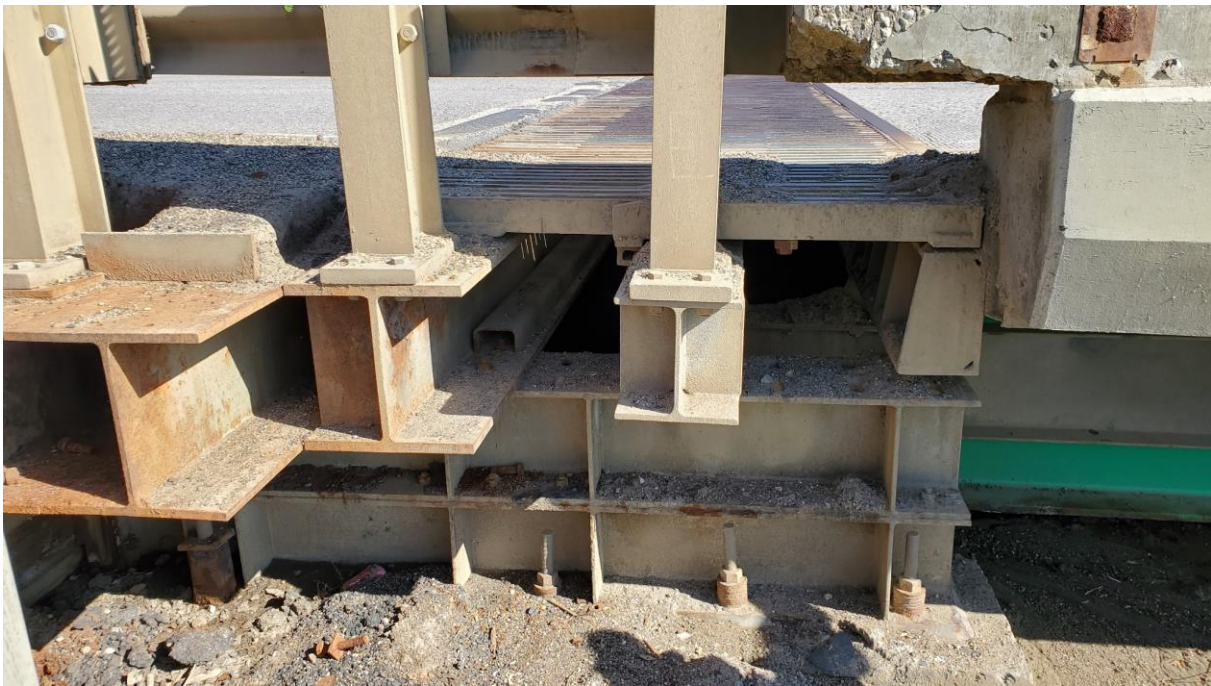
Photo 2 – Looking north at west bridge abutment. Distance between angle iron and concrete of bridge deck was 2.42 m (2.60 m in 2020, 2.69 m in 2019, 2.72 m in 2018, 2.82 m in 2017). The two I-beams at the edge of the wingwall are the remainder of the 5 installed in 2000.

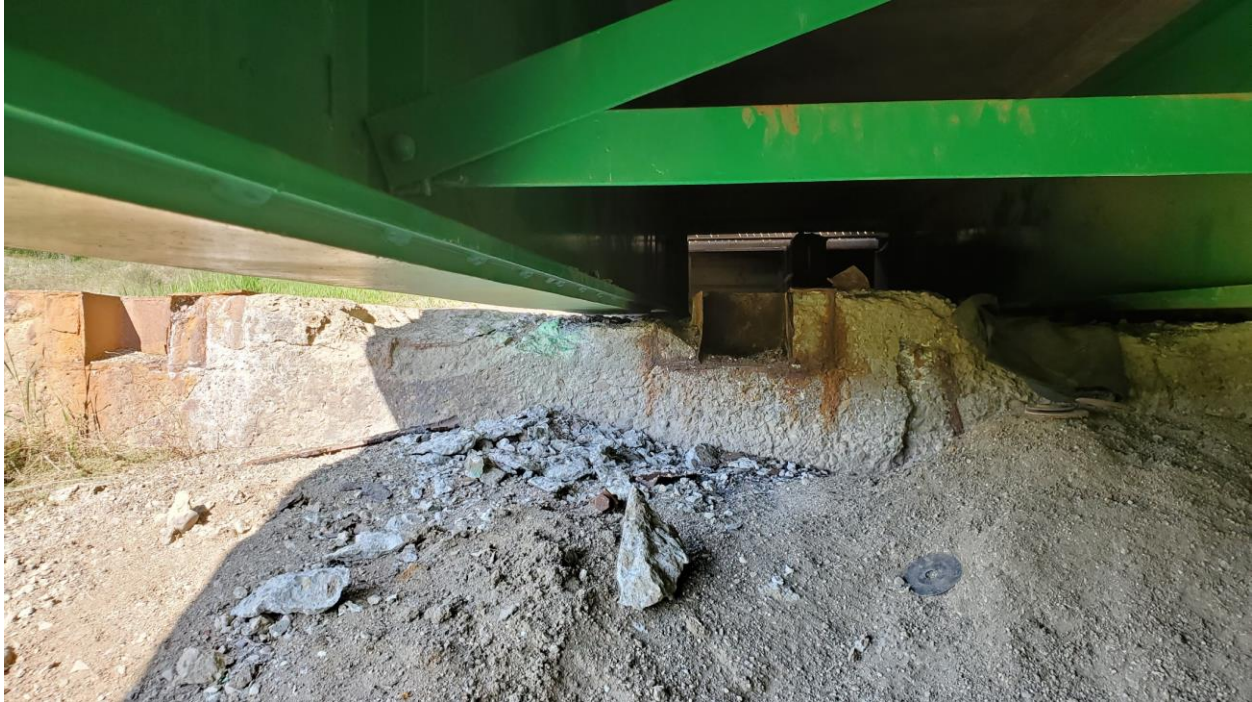
Photo 3 – Looking towards the West Abutment where portions of the old foundation concrete was removed to allow movement of the girders between the West Abutment and Abutment 1.

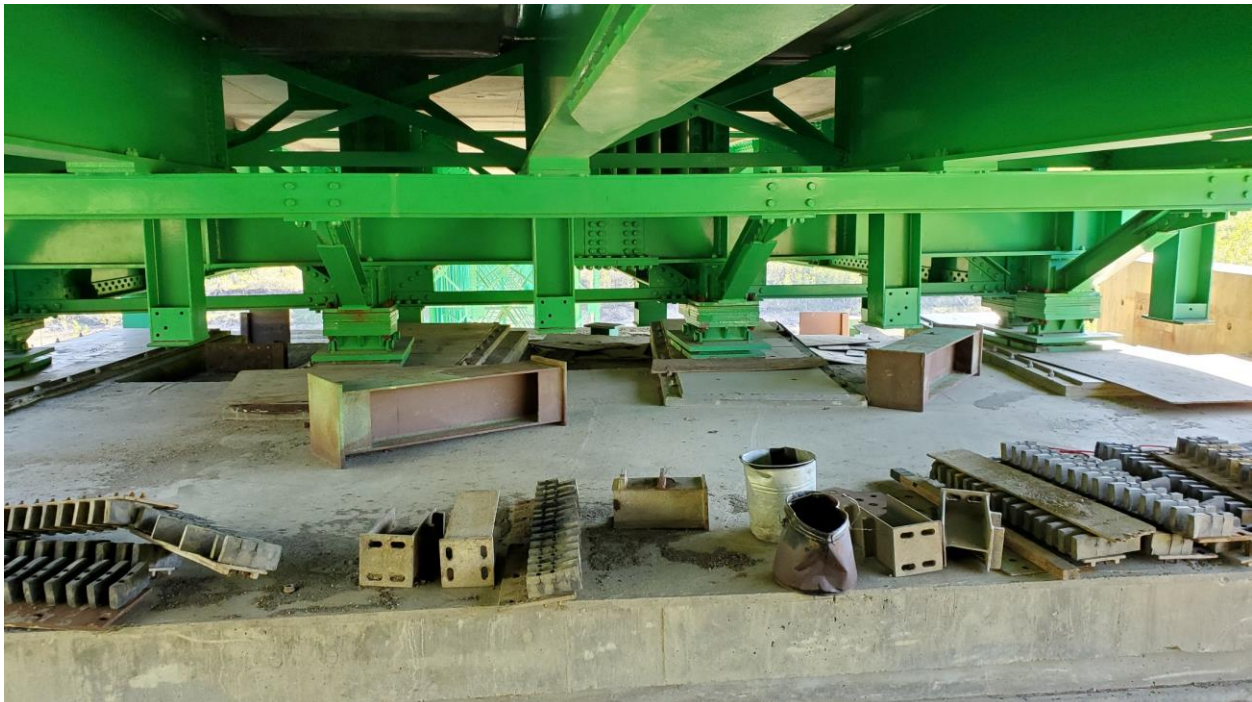
Photo 4: Sliding configuration at Abutment 1. Movement at right-most (south) bearing plate in June 2020 was 35 mm since May 14, 2020, and 121 mm since June 10, 2019.

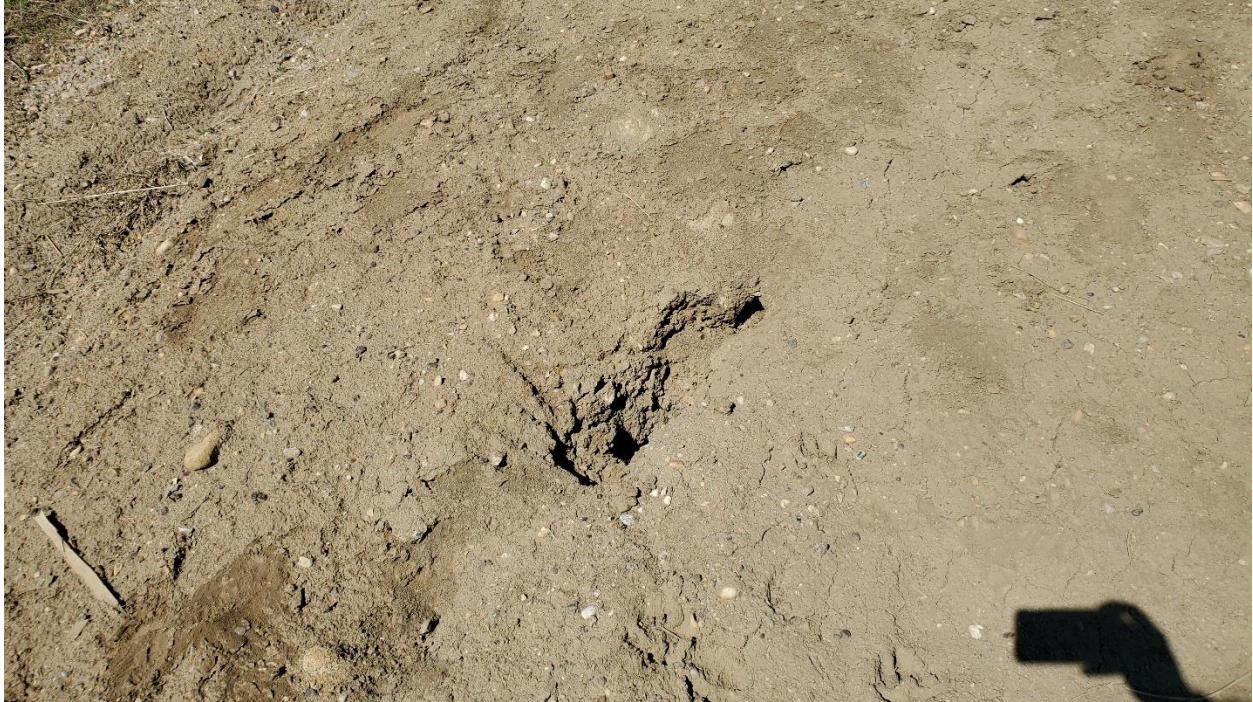
Photo 5: Shallow voids on headslope below Abutment 1. The voids, now combined, showed up in 2021 and the cause is unknown.

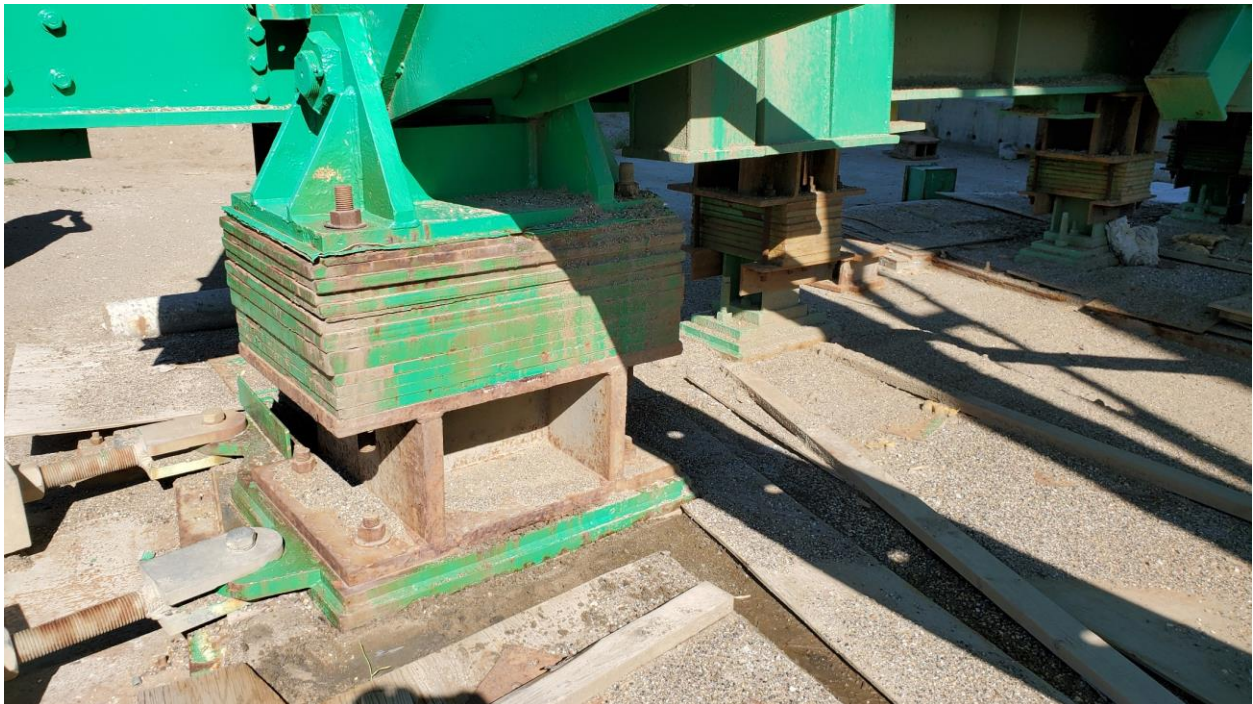
Photo 6 – Shims (increased to 0.84 m from 0.755 m) under rocker bearings at Pier 1: remained 0.84 m at the south bearing plate (left-most) and 0.76 m at the north bearing plate (right-most).

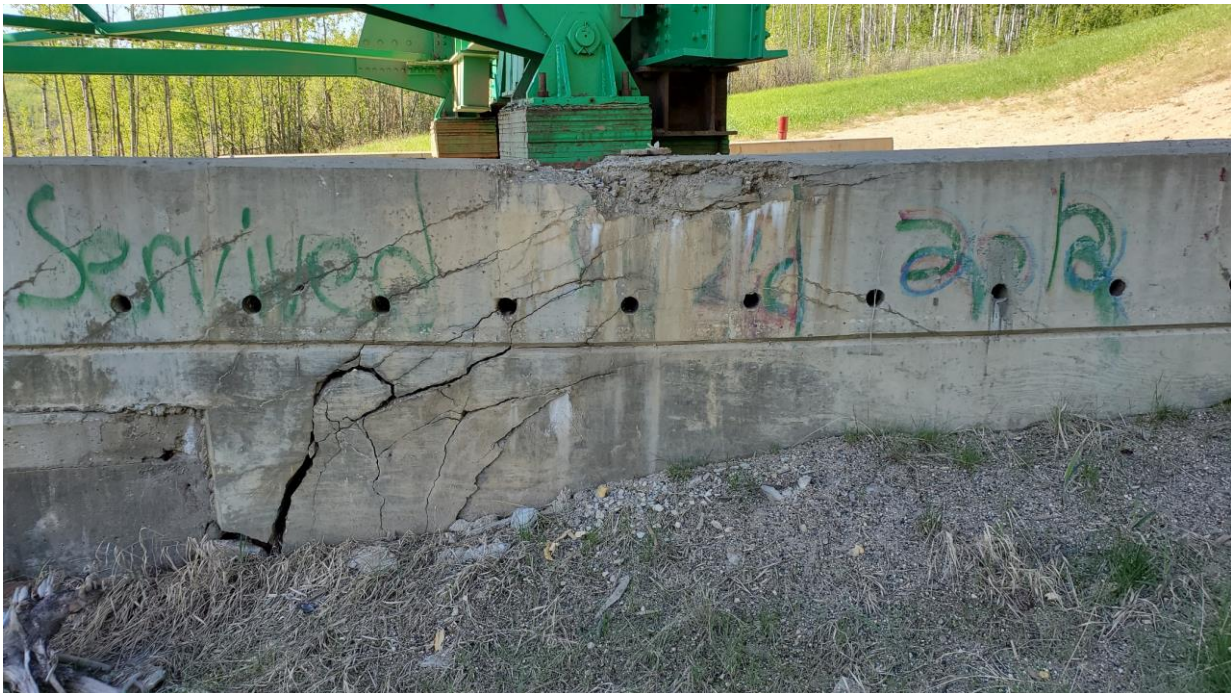
Photo 8 – Looking south at Pier 1 wingwall at arc-shaped compression crack pattern in foundation. Left-hand portion of foundation is pile supported; right-hand is on-grade. Crack at the base is 40 mm in width.

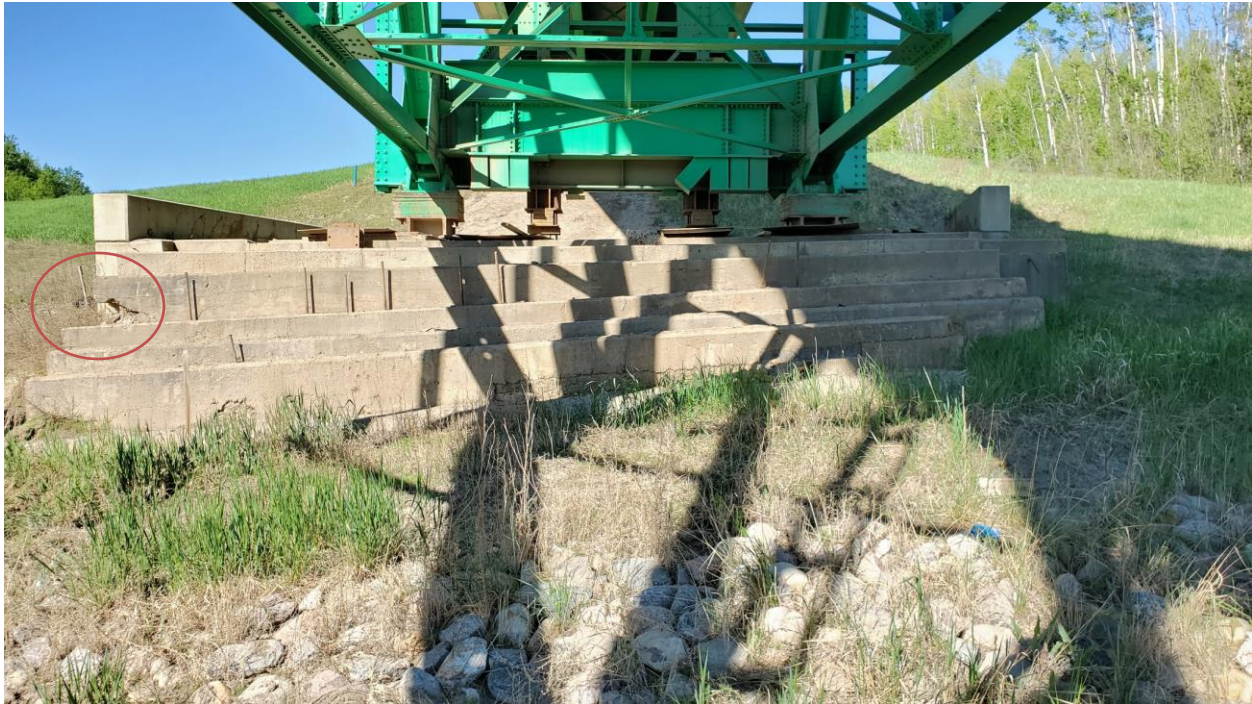
Photo 9 – Looking west at Pier 1 foundation which is tilted downward to the south. The angle from horizontal was 4° at the top and 7° at the bottom stage. Concrete is starting to crack and spall in circled area.

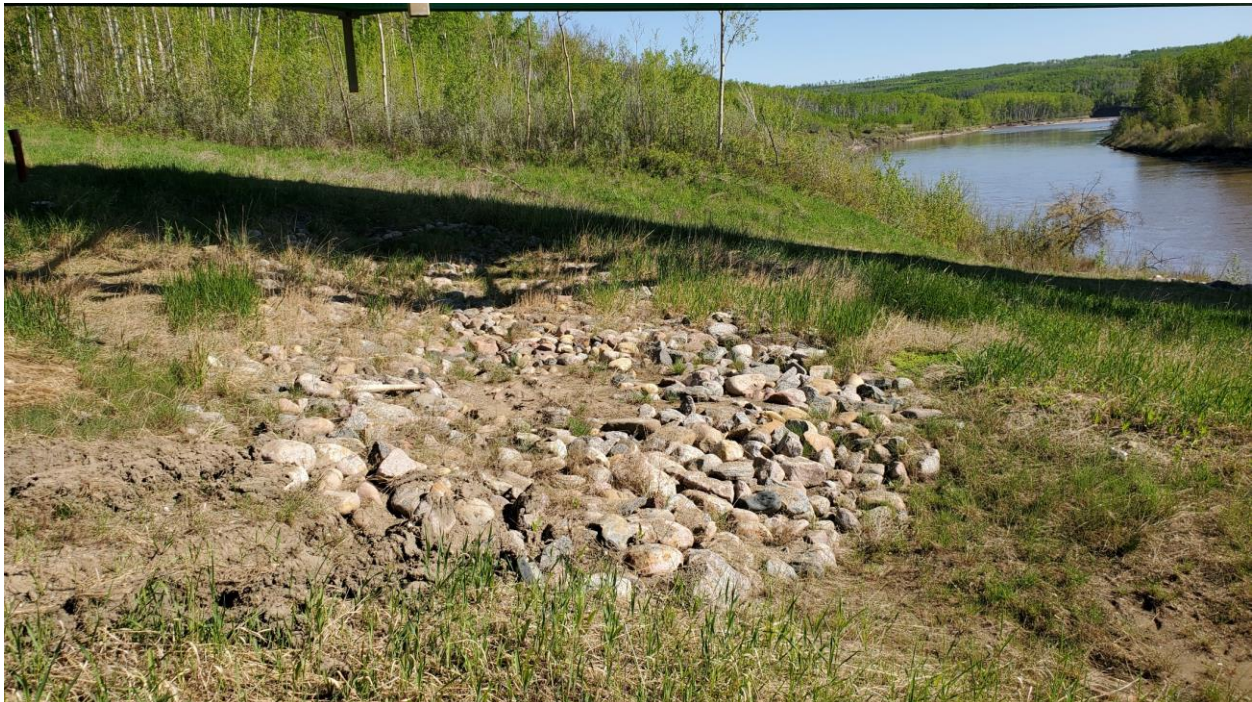
Photo 10 – Looking north at previous scarp of local slump below Pier 1.
