**ALBERTA TRANSPORTATION  
GEOHAZARD ASSESSMENT PROGRAM  
PEACE REGION (PEACE RIVER DISTRICT)  
2021 INSPECTION**

**THURBER ENGINEERING LTD.**

<b>Site Number</b>	<b>Location</b>	<b>Name</b>	<b>Hwy</b>	<b>km</b>
SH003-1	North of Little Smoky River	Little Smoky River (North)	49:12	0.4-0.8
<b>Legal Description</b>		<b>UTM Co-ordinates</b>		
NW34-74-21-W5M		11U E 490,730	N 6,145,966

**SH003-1: HWY 49:12  
2021 SITE INSPECTION PLAN**

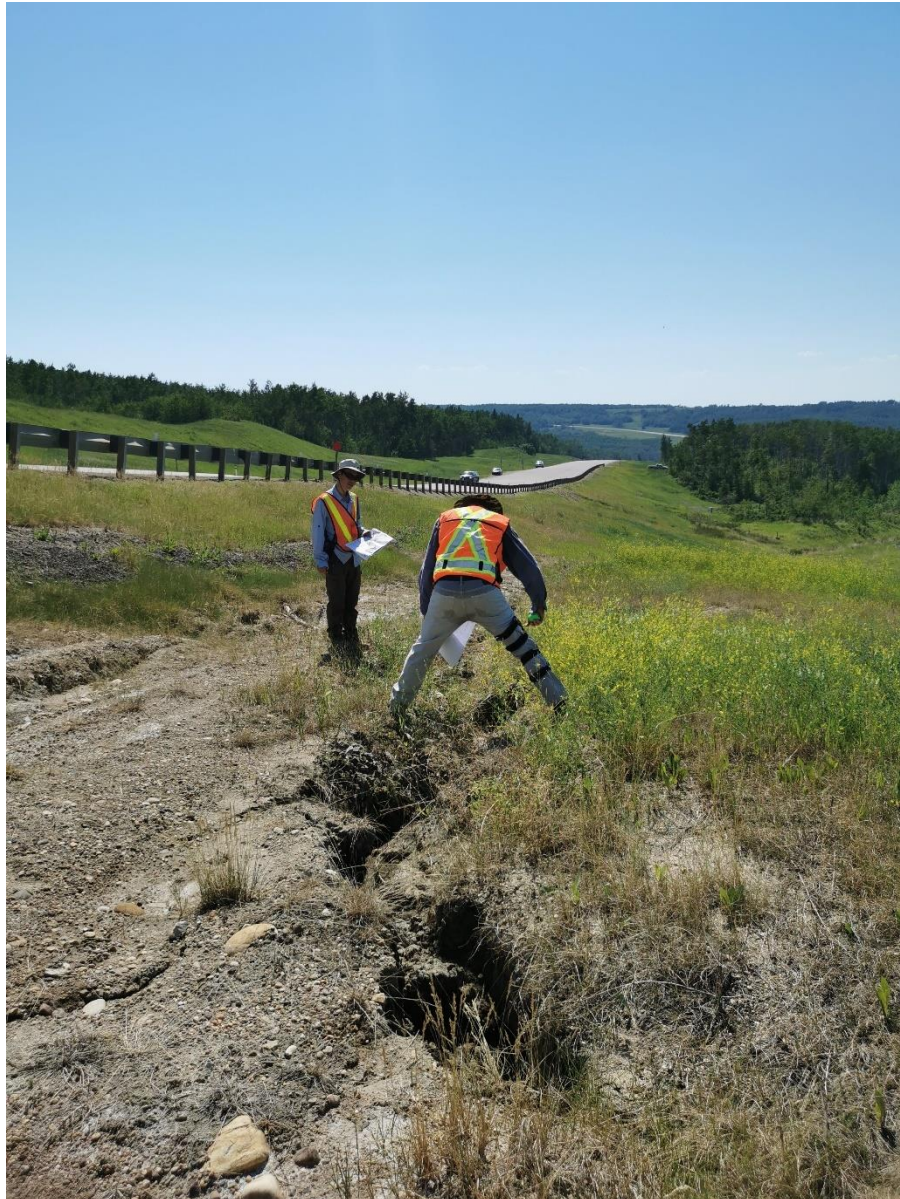
Photo 2 – Looking southeast along erosion gully near Sta. 0+550. Note windrow of milled materials on sideslope of highway.

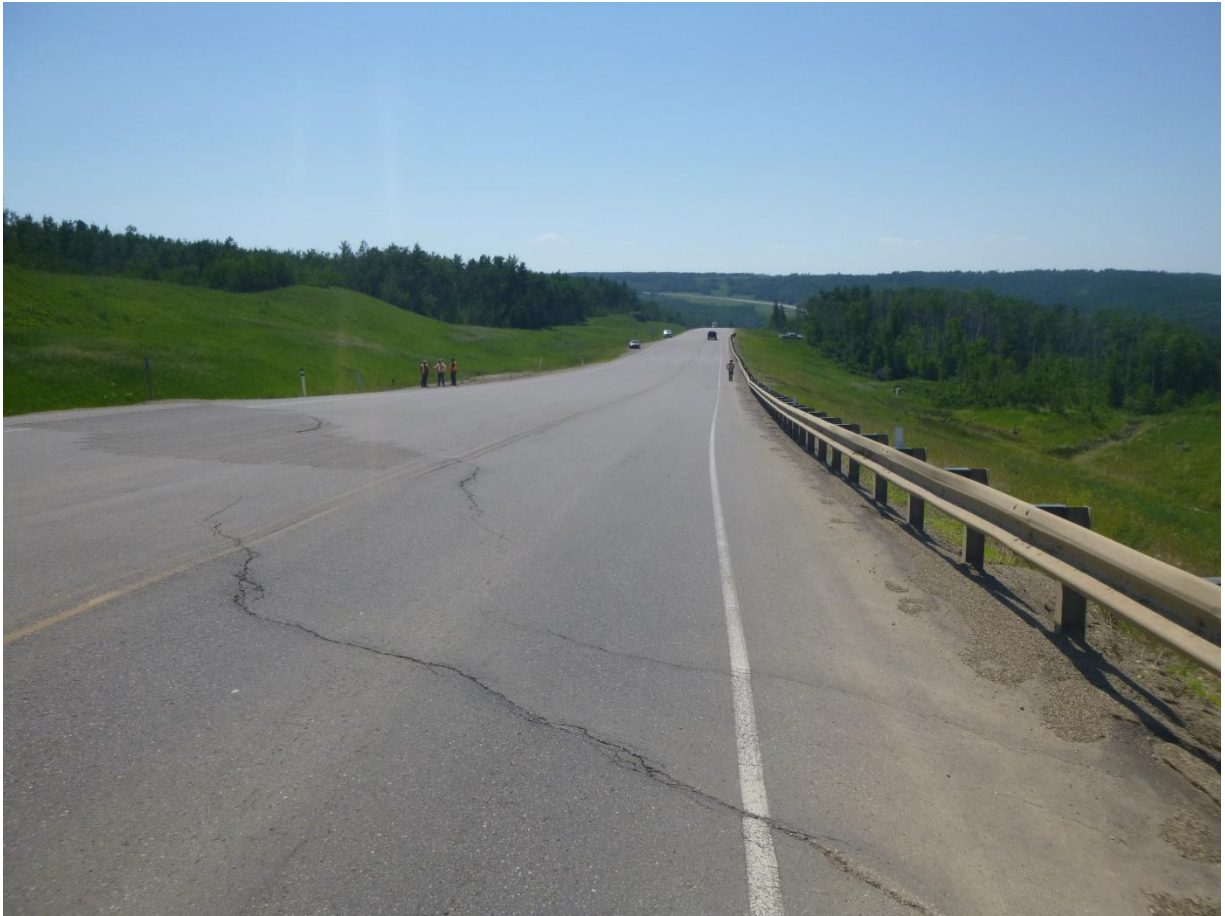
Photo 3 – Looking southwest over the main sag (graben) area extending from Sta. 0+600 to 0+800.

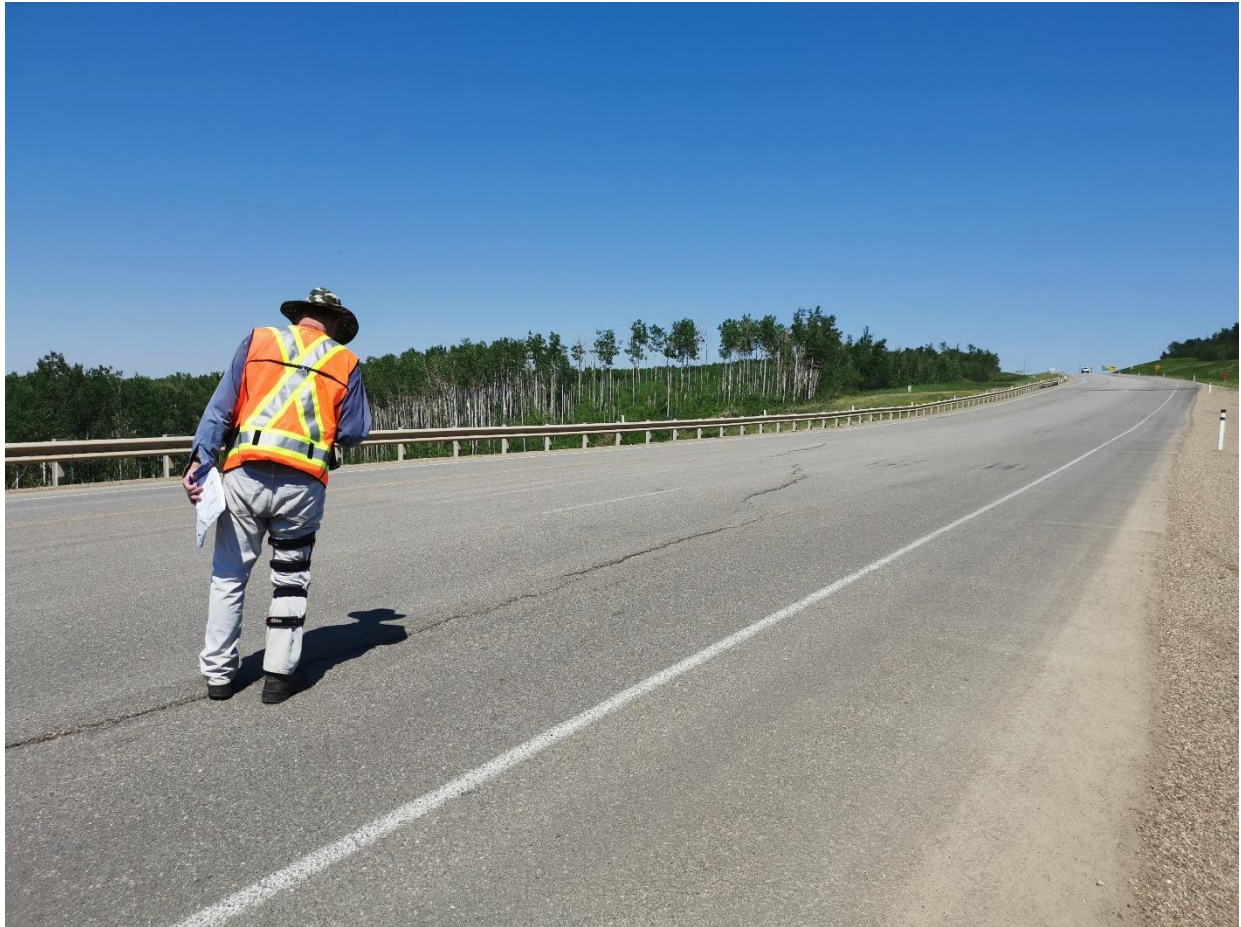
Photo 4 – Looking northeast at fresh cracks which are part of the main graben block movement between Sta. 0+600 and 0+800.

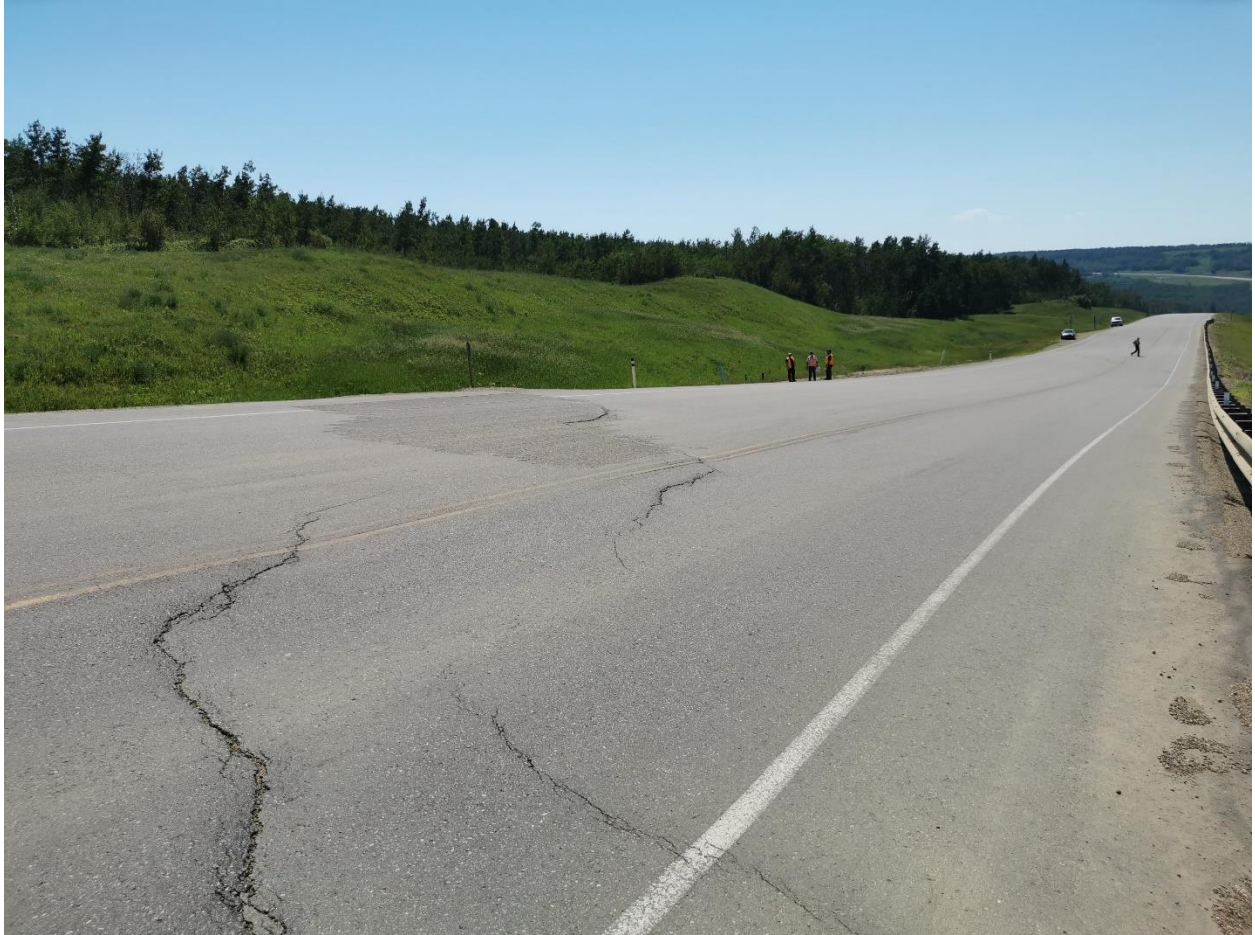
Photo 5 – Looking south at cracks at northeast end of main graben block at Sta. 0+600.

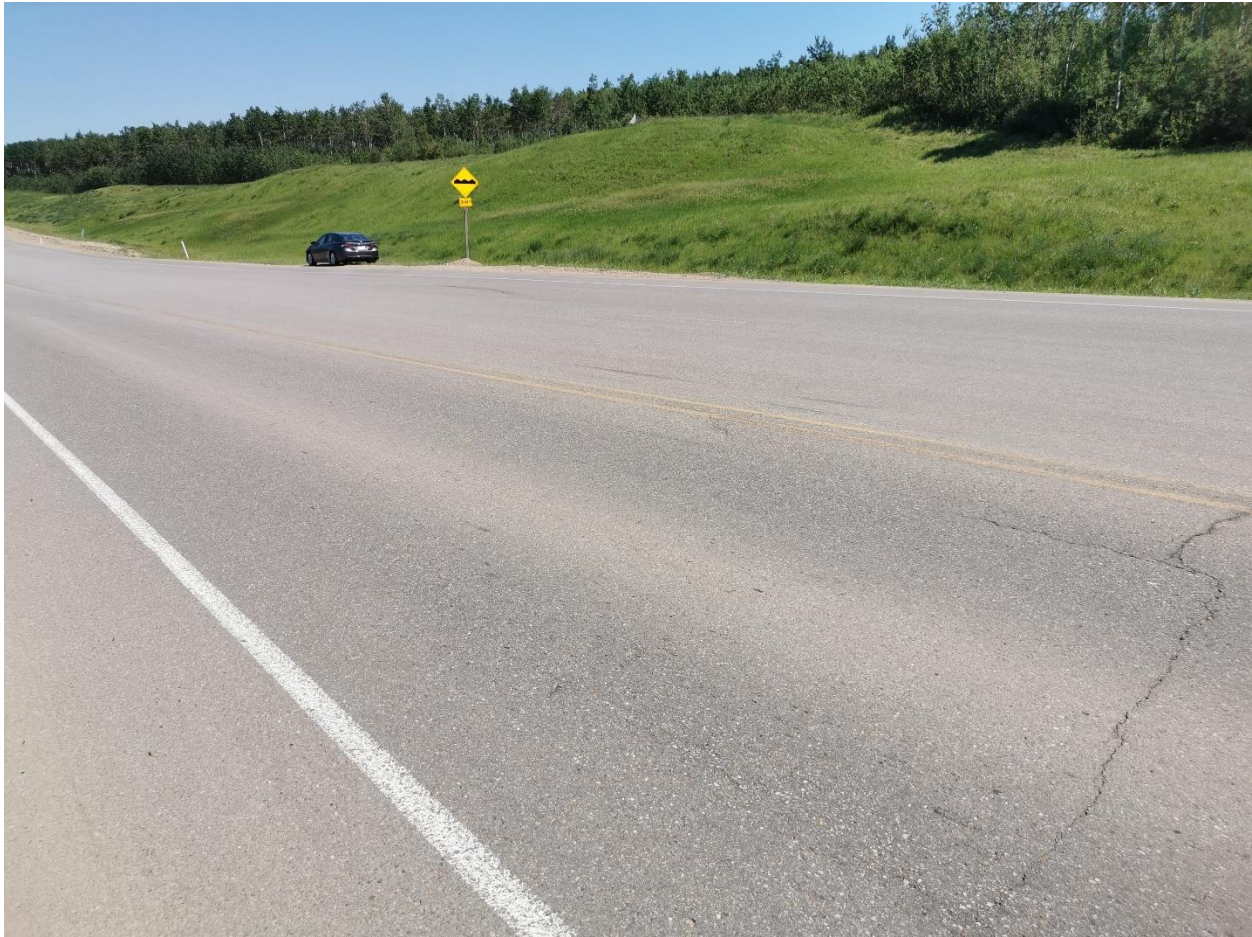
Photo 6 – Looking east where previous cracks were paved over on the southwest end around Sta. 0+800.

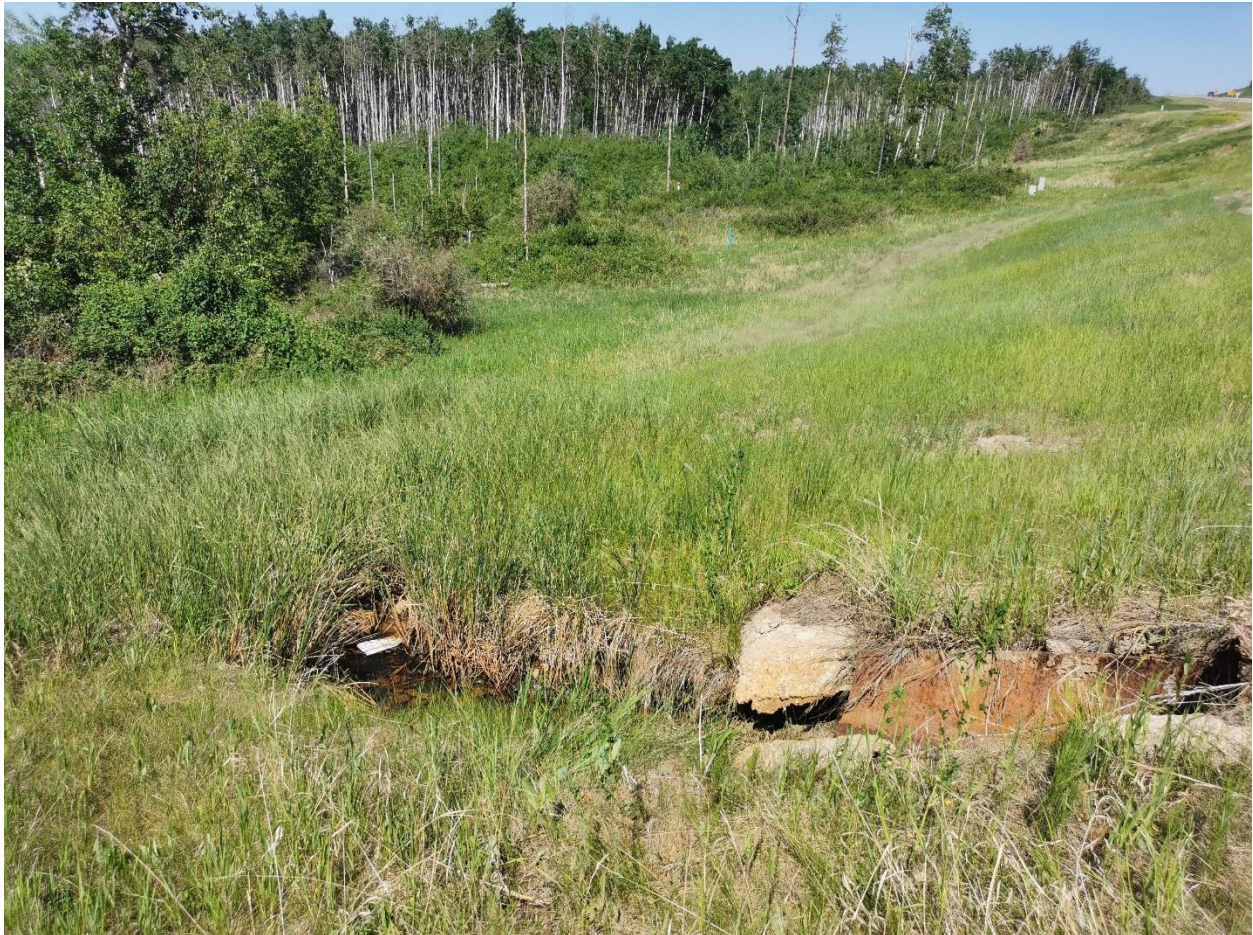
<input checked="" type="checkbox"/> Bridge/Culvert Distress	Erosion bowl forming at outlet of culvert at 0+800 Slumping obstructing culvert inlet at Sta. 0+460	<input checked="" type="checkbox"/>
<input type="checkbox"/> Other		<input type="checkbox"/>
<b>Instrumentation (as of Spring 2021):</b>		
SI96-4, SI96-5, SI96-6	No discernable movement pattern (SI's may be too shallow)	
SI31a	Sheared at 22.5 m; readings have continued above this depth and after resetting from Spring 2017. No discernable movement observed.	
PZ01-1, PZ01-3, VW07-1, VW07-1A	Water levels at PZ01-1 and PZ01-3 generally stable over last decade with very slight decreasing trend over last few years with levels at 540 m and 515 m elevation, respectively. VW07-1 has been essentially stable since Fall 2016 at 14.3 m below ground; VW07-1A has slight increasing trend over the last three years at is currently at 18.2 m below ground.

Photo 7 – Developing erosion bowl at outlet of culvert at about Sta. 0+800.

- The erosion gully at the Sta. 0+460 culvert inlet is deteriorating and may affect the highway within a few years. Consideration should be given to regrading of this section of ditch and lining with erosion control measures (Class 1M riprap or concrete block blanket like Flexamat).
- The erosion bowl that has recently formed at the culvert outlet at about Sta. 0+800 should be repaired before it increases in size. This could consist of backfilling the bowl with pitrun gravel and adding riprap (there does not appear to have been riprap put around the outlet when the culvert was installed).
