**ALBERTA TRANSPORTATION
GEOHAZARD ASSESSMENT PROGRAM
PEACE REGION (PEACE RIVER DISTRICT)
2022 INSPECTION**

Site Number	Location	Name	Hwy	km
SH003-1	North of Little Smoky River	Little Smoky River (North)	49:12	0.4-0.8
Legal Description		UTM Co-ordinates		
NW34-74-21-W5M		11U E 490,730		N 6,145,966

**SH003-1: HWY 49:12
2022 SITE INSPECTION PLAN**

DWG No. 32121-SH003-1-1

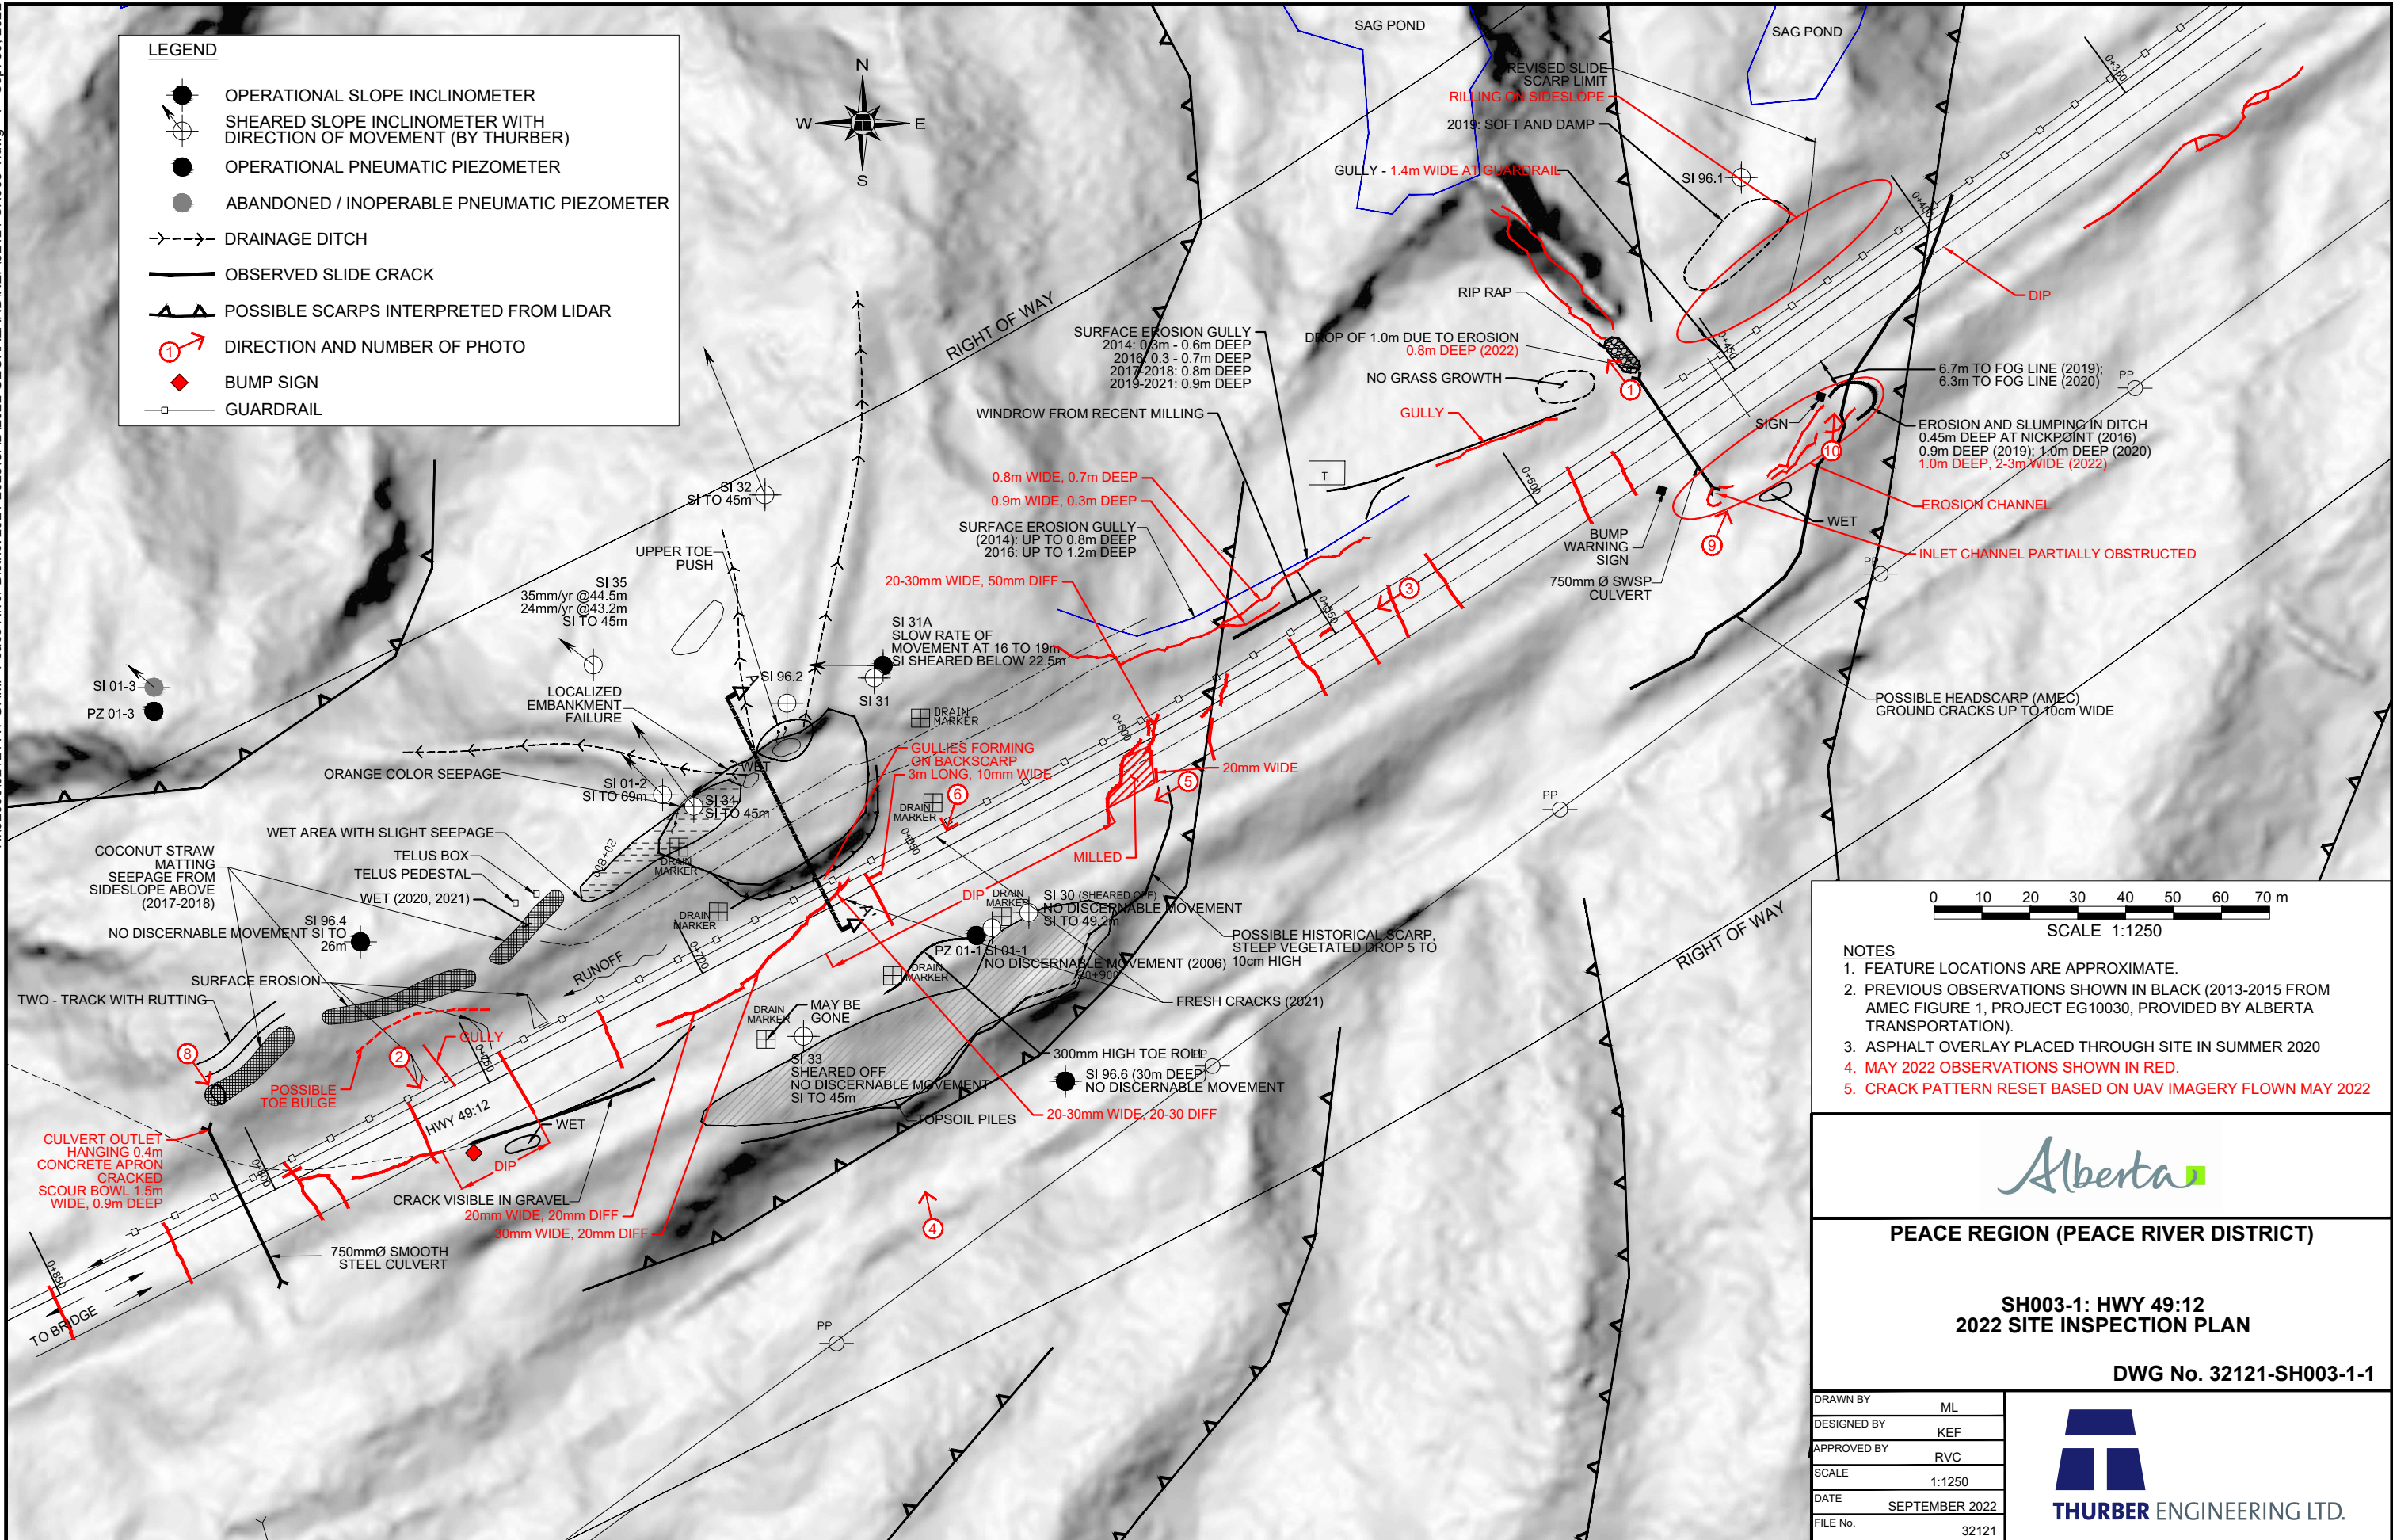
Primary Site Issue:	Highway (aligned SW-NE) traverses WNW-oriented deep-seated (about 55 m), retrogressive landslide with ongoing creep movement over the entire valley slope due partly to erosion at toe by the Little Smoky River.	
Dimensions:	400 m length of highway affected by several intersecting scarps resulting in uneven riding surface. There is also a localized embankment failure on the north slope and erosion issues at specific locations. Approx. 1.5 km of the highway crosses this unstable east valley slope.	
Date of Remediation:	1990's: Draining and regrading of a sag pond adjacent to the highway. 2003: Slope flattening of the local instability failure. Fall 2020: Pavement overlay and guardrail replacement	
Maintenance:	2016: Grader-laid patch (350 t) 2018: \$90,000 of milling on SH003 and SH004 Fall 2019: Milling both sides of valley for about 172,000 m ³ Spring 2022: Milling	
Observations:	Description	Worsened?

<input checked="" type="checkbox"/> Pavement Distress	Cracking and uneven roadway surface requires ongoing patching and milling.	<input checked="" type="checkbox"/>
<input checked="" type="checkbox"/> Slope Movement	Overall slope movement continues and the localize failure at Sta. 0+640 to 0+680 continues to ravel.	<input type="checkbox"/>
<input checked="" type="checkbox"/> Erosion	Gully at 0+460 culvert inlet continues to down cut and now encroaching toward highway. Surface erosion gully between Sta. 0+500 to 0+640 became somewhat deeper.	<input checked="" type="checkbox"/>
<input checked="" type="checkbox"/> Seepage	Seepage observed at a few locations adjacent to the localized failure.	<input type="checkbox"/>
<input checked="" type="checkbox"/> Bridge/Culvert Distress	Erosion bowl forming at outlet of culvert at 0+800 Slumping obstructing culvert inlet at Sta. 0+460	<input checked="" type="checkbox"/>

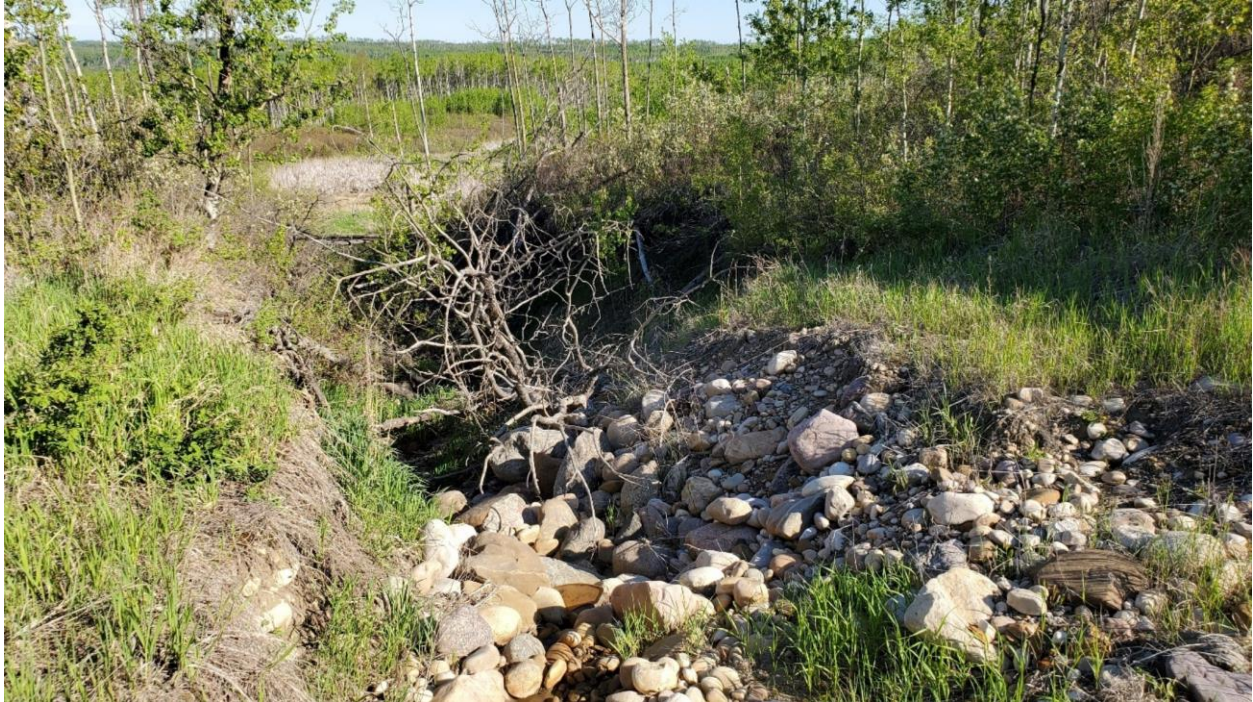
Photo 1 – Erosion gully at outlet of culvert at about Sta. 0+450.

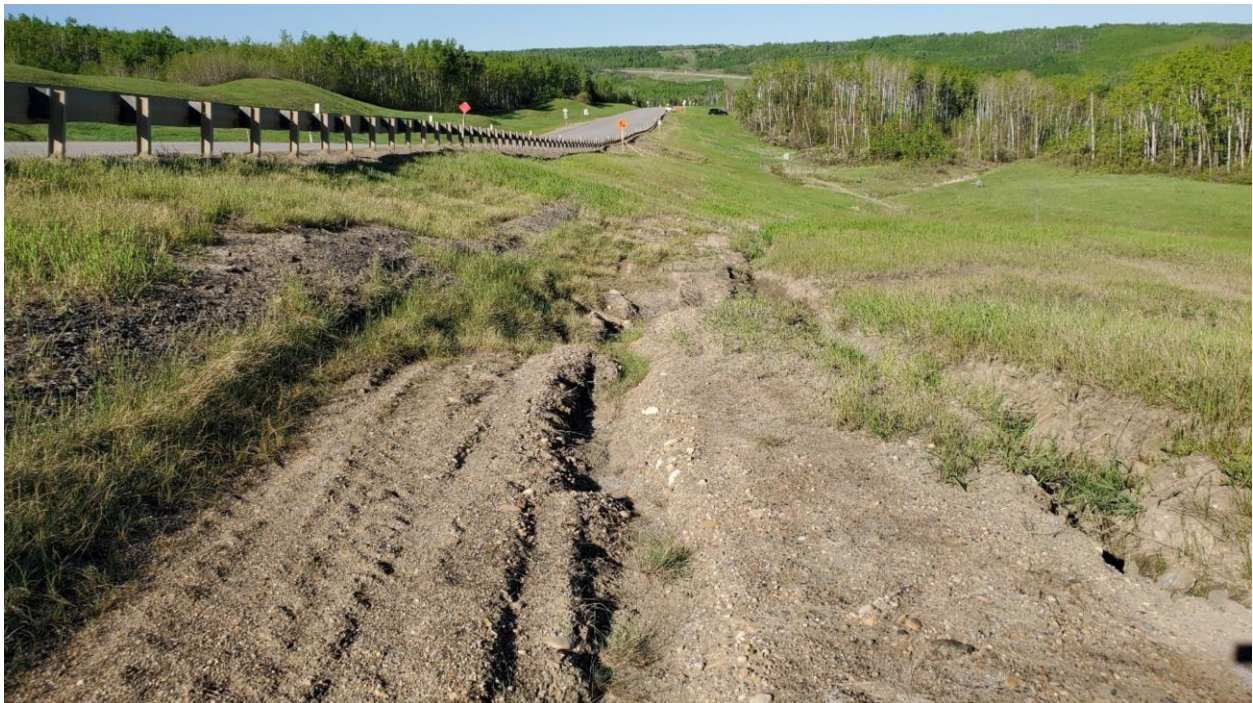
Photo 2 – Looking southeast along erosion gully near Sta. 0+550.

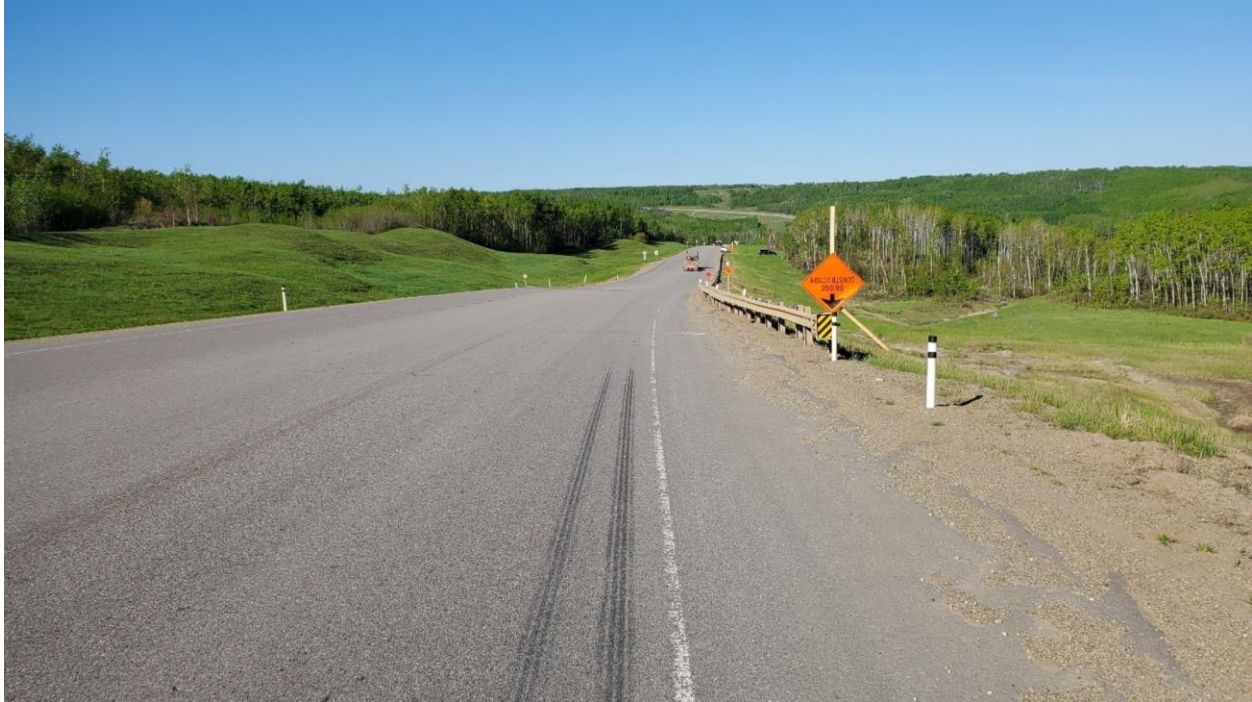
Photo 3 – Looking southwest over the main sag (graben) area extending from Sta. 0+600 to 0+800.

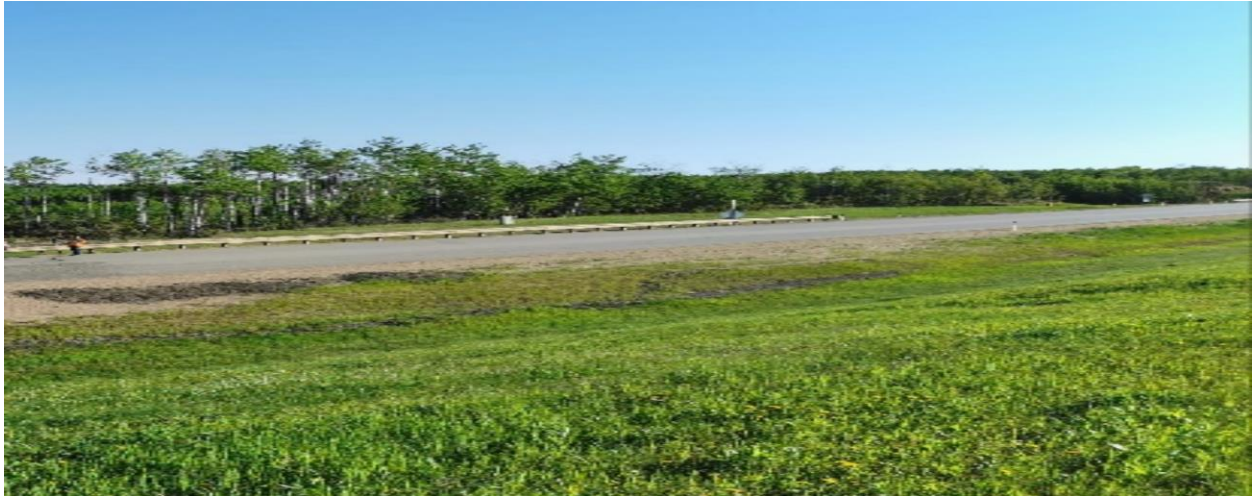
Photo 4 – Looking north at the main graben at about Sta. 0+600 where dips in the highway surface are starting to become re-established.

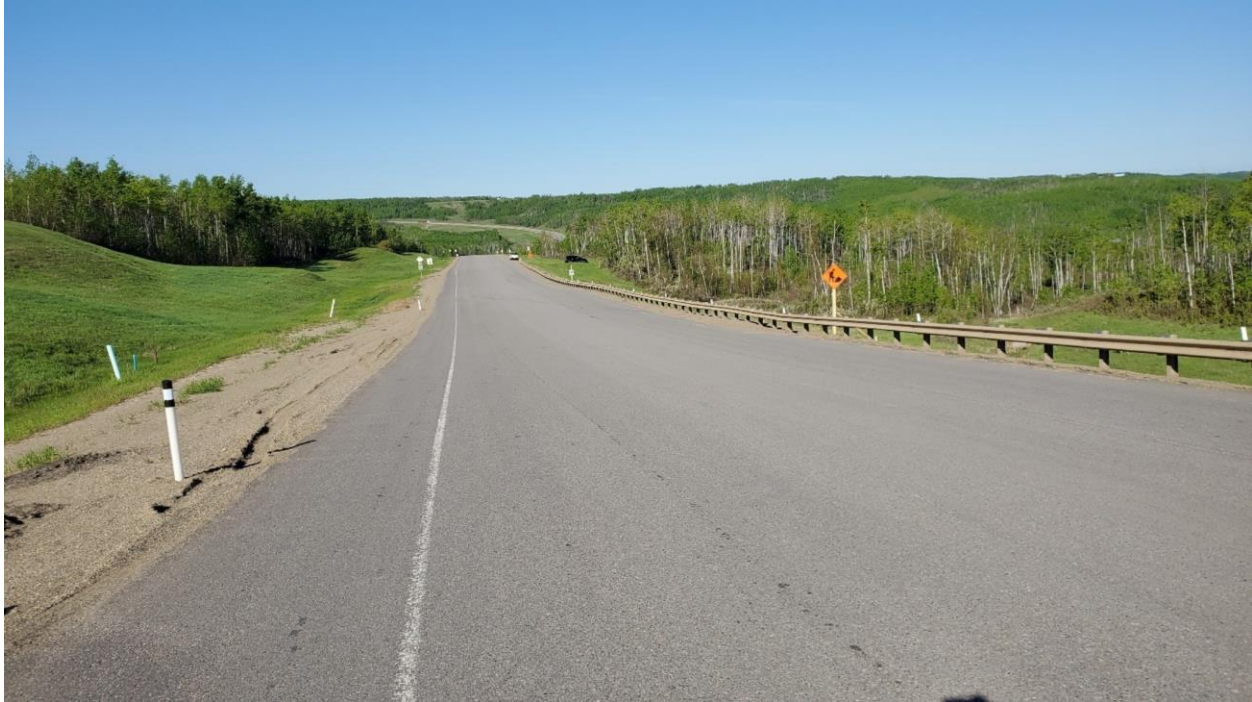
Photo 5 – Looking southwest an area of frequent patching in the main graben block movement between Sta. 0+600 and 0+800.

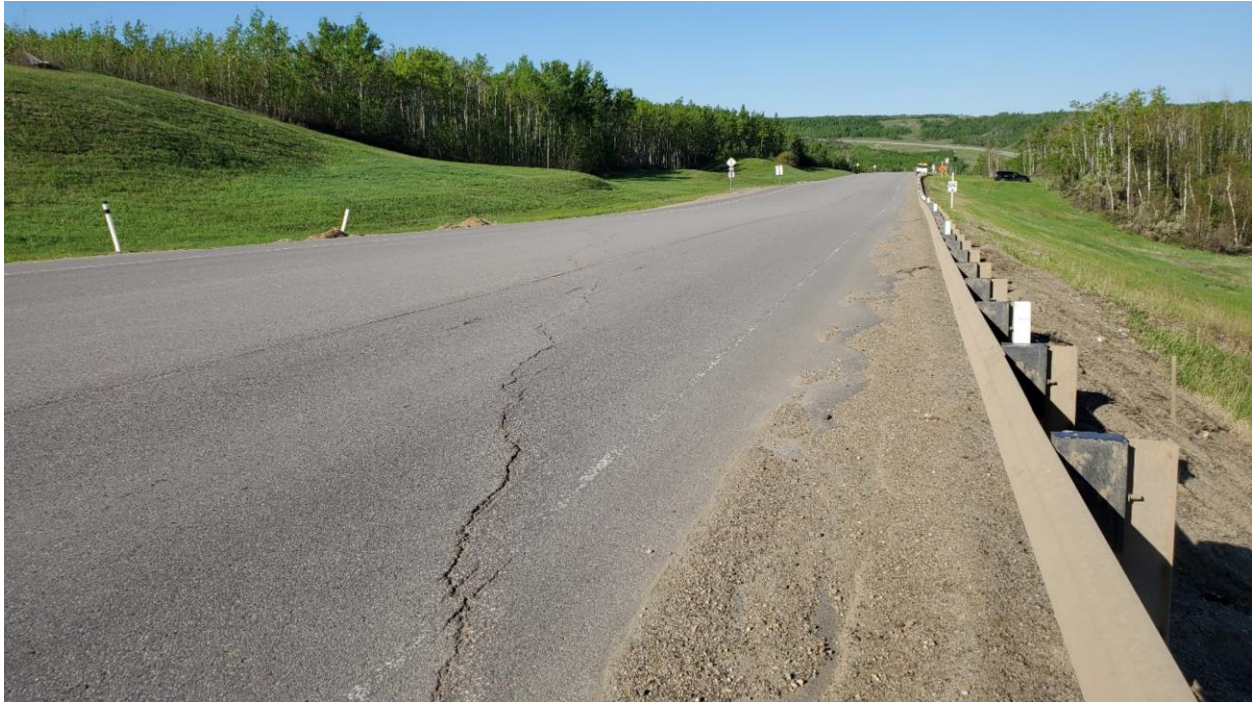
Photo 6 – Looking south at cracks at northeast end of main graben block at Sta. 0+600.

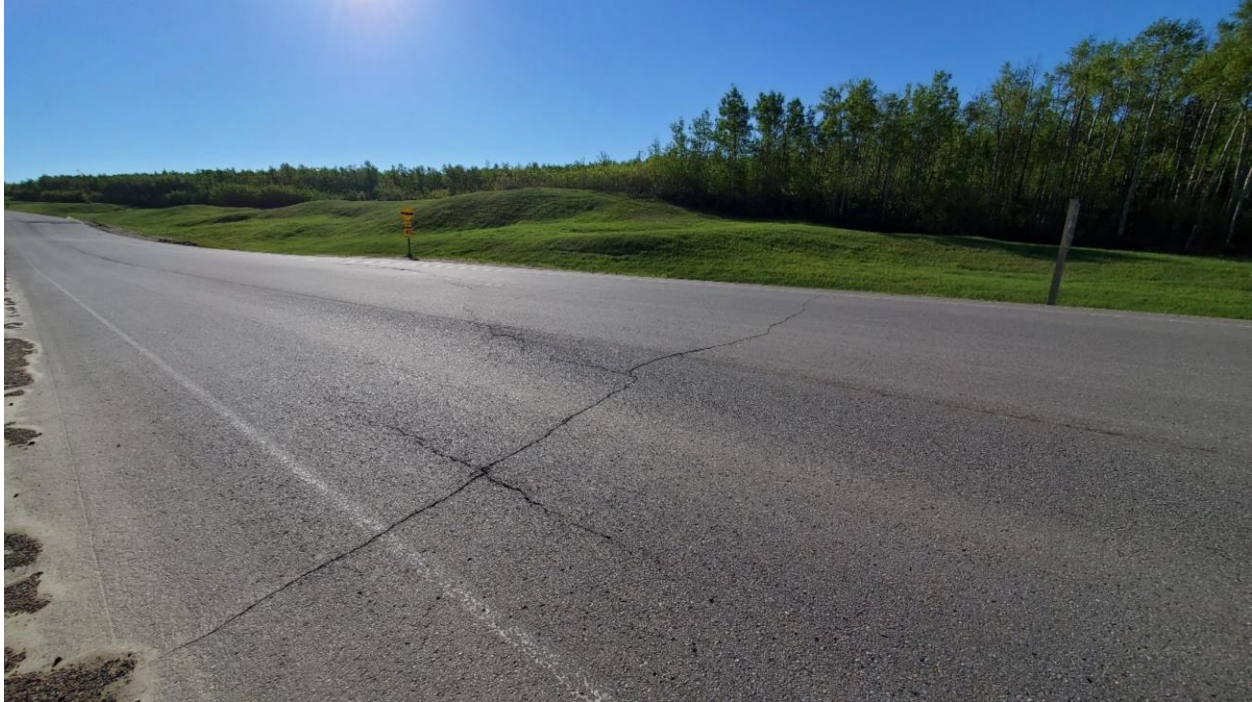
Photo 7 – Looking east at the cracks on the southwest end of the main graben.

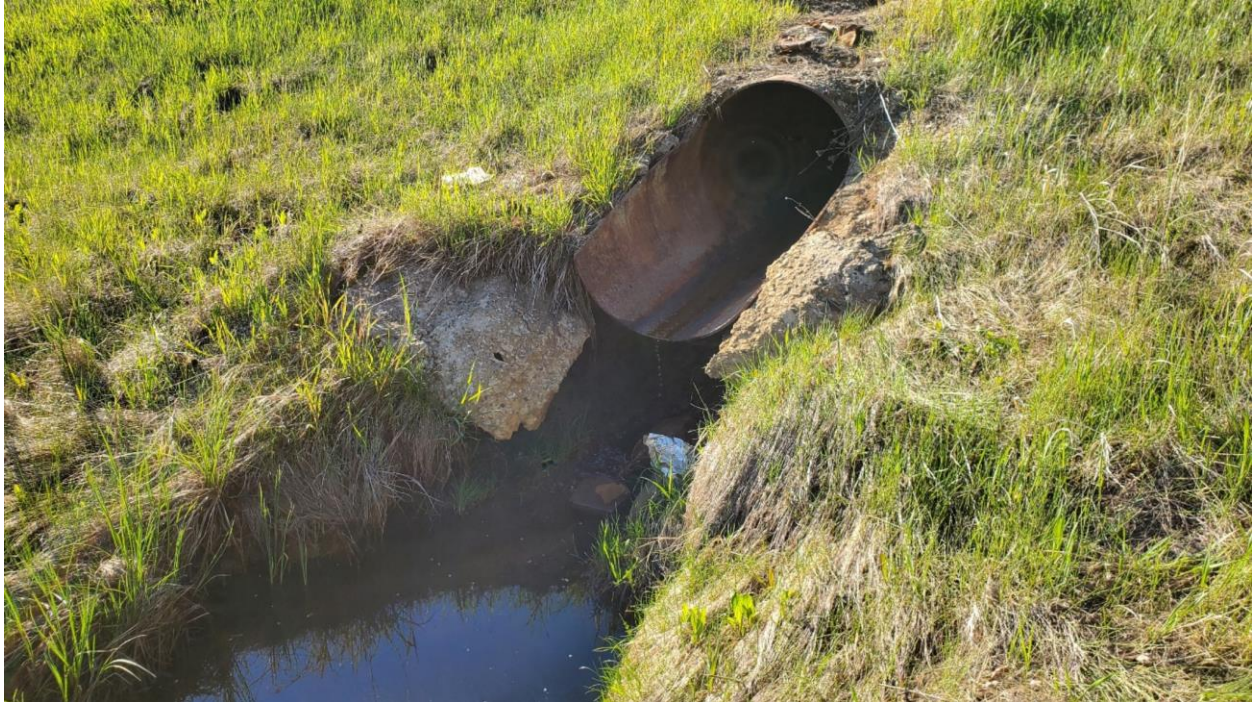
Photo 8 – Developing erosion bowl at outlet of culvert at about Sta. 0+800.

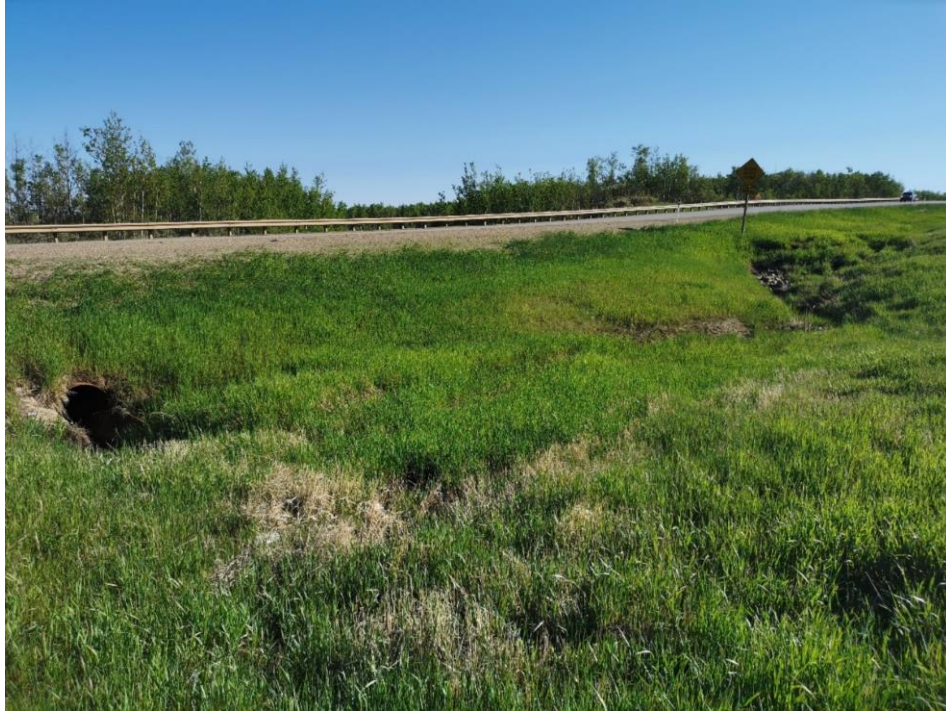
Photo 9: Erosion at the culvert inlet (left side) and scour bowl (right side) at Sta. 0+430 is starting to encroach towards the highway.

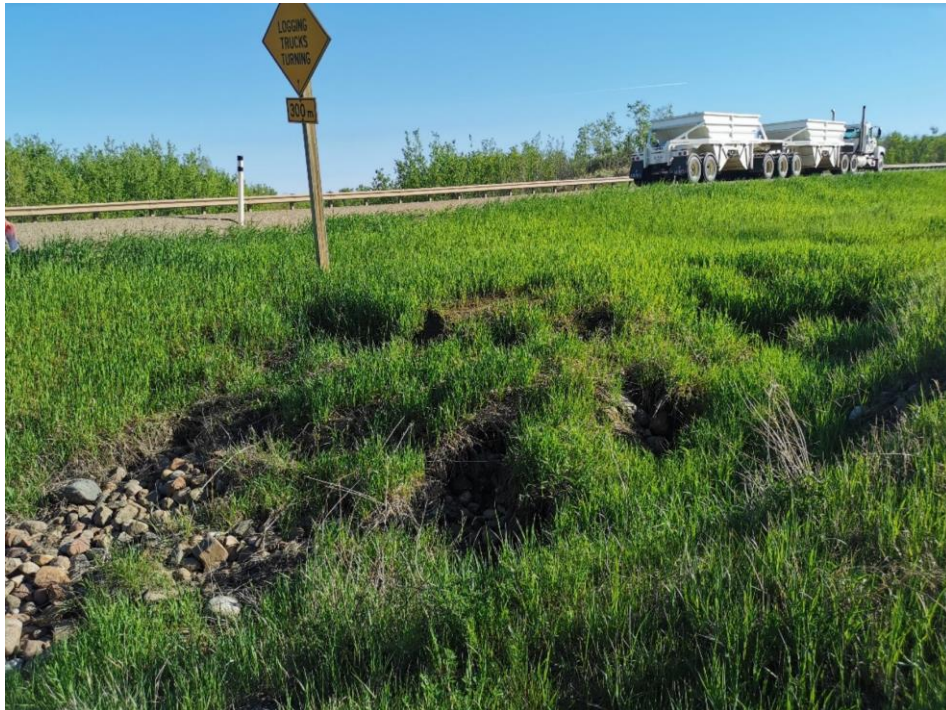
Photo 10: Scour bowl forming close to the edge of the highway at Sta 0+430.
