ALBERTA TRANSPORTATION AND
ECONOMIC CORRIDORS
GEOHAZARD RISK MANAGEMENT PROGRAM
PEACE REGION (PEACE RIVER DISTRICT)
2025 INSPECTION

Site Number	Location	Name	Hwy	km
SH003-1	North of Little Smoky River	Little Smoky River (North of Bridge)	49:12	0.4-0.8
Legal Description		UTM Co-ordinates		
NW34-74-21-W5M		11 E 490,730	N 6,145,966

Date	PF	CF	Total
Previous Inspection:	3-Jun-2024	13	6	78
Current Inspection:	26-May-2025	13	6	78
Road AADT:	1460		Year:	2024
Inspected By:	Kristen Tappenden, TEC Mark Gallego, Thurber Roger Skirrow, Thurber			
Report Attachments:	<input checked="" type="checkbox"/> Photographs	<input checked="" type="checkbox"/> Plans	<input type="checkbox"/> Maintenance Items

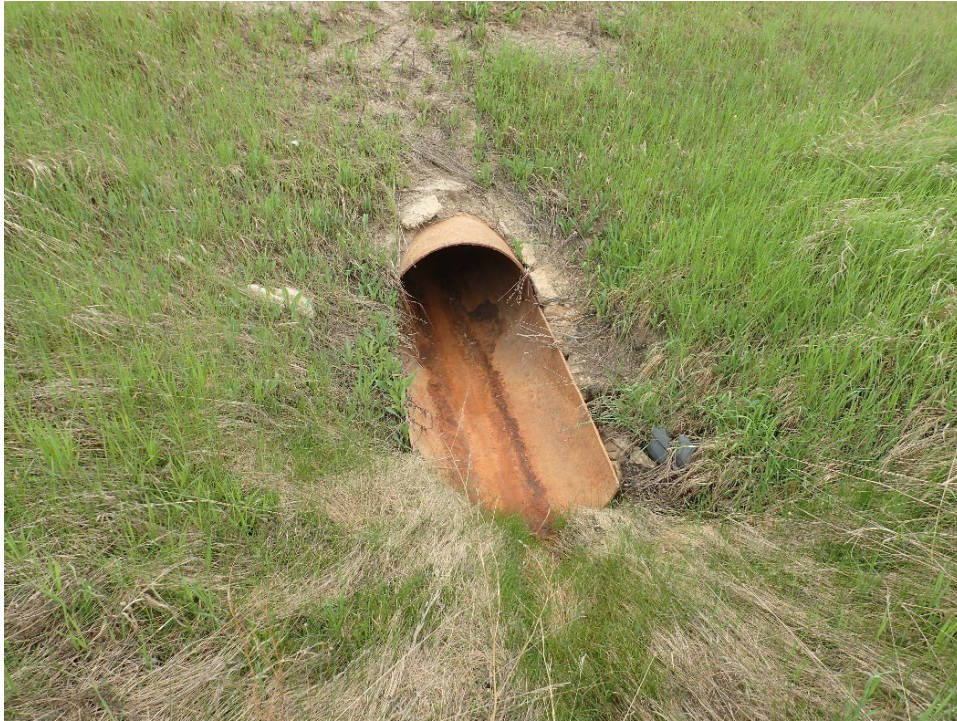
Photo 1 – Inlet of the 750 mm diameter culvert at about Sta. 0+810.

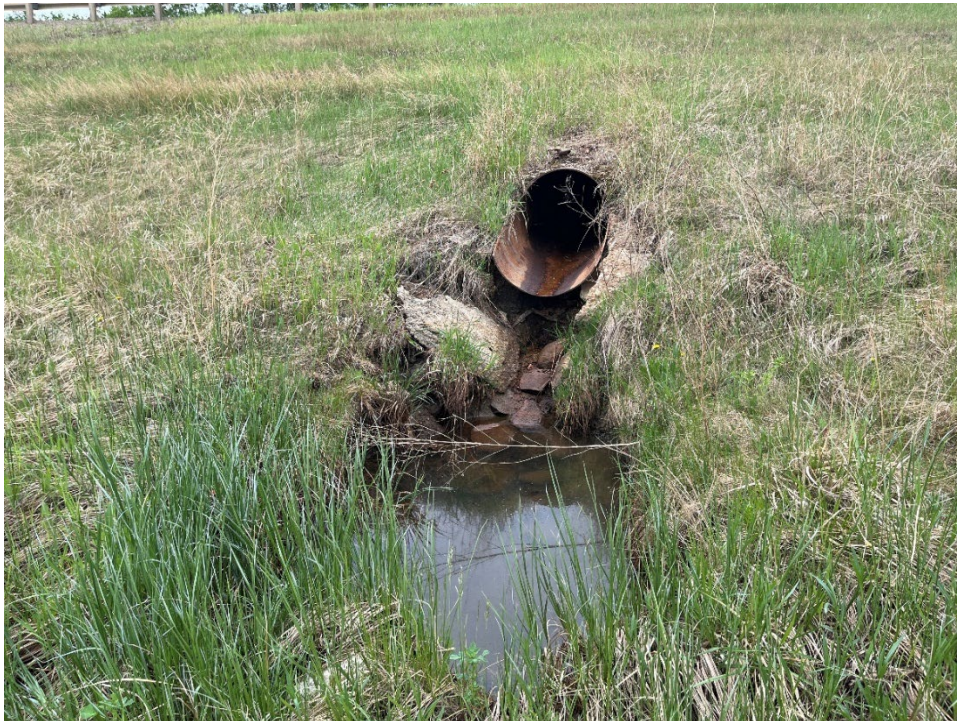
<input checked="" type="checkbox"/> Bridge/Culvert	Erosion bowl forming at outlet of culvert at 0+810 Slumping obstructing culvert inlet at Sta. 0+460	<input type="checkbox"/>
<input type="checkbox"/> Other		<input type="checkbox"/>

Photo 2 – Erosion bowl at outlet of the 750 mm diameter culvert at about Sta. 0+810.

Recommendations:	
Short-term:	
<ul style="list-style-type: none">▪ Road maintenance consisting of milling and patching should continue as necessary (once or twice annually) to maintain the roadway surface in a safe condition. Crack sealing of the ACP should be done to limit infiltration of rain fall and snow melt into the extensive crack network.▪ The gully in the north ditch from about Sta. 0+500 to 0+550 could be repaired with minor excavation and placement of pitrun gravel. Consideration could be given to placing topsoil and seed that is secured with an erosion control blanket.▪ The erosion gully at the Sta. 0+460 culvert inlet is deteriorating and may affect the highway within a few years. Consideration should be given to regrading this section of the ditch and lining with erosion control measures (Class 1M riprap or comparable protection).▪ The erosion bowl that has formed at the culvert outlet at about Sta. 0+810 could be repaired before it increases significantly in size. This could consist of backfilling the bowl with pitrun gravel and adding riprap as per TEC culvert outlet protection specifications.

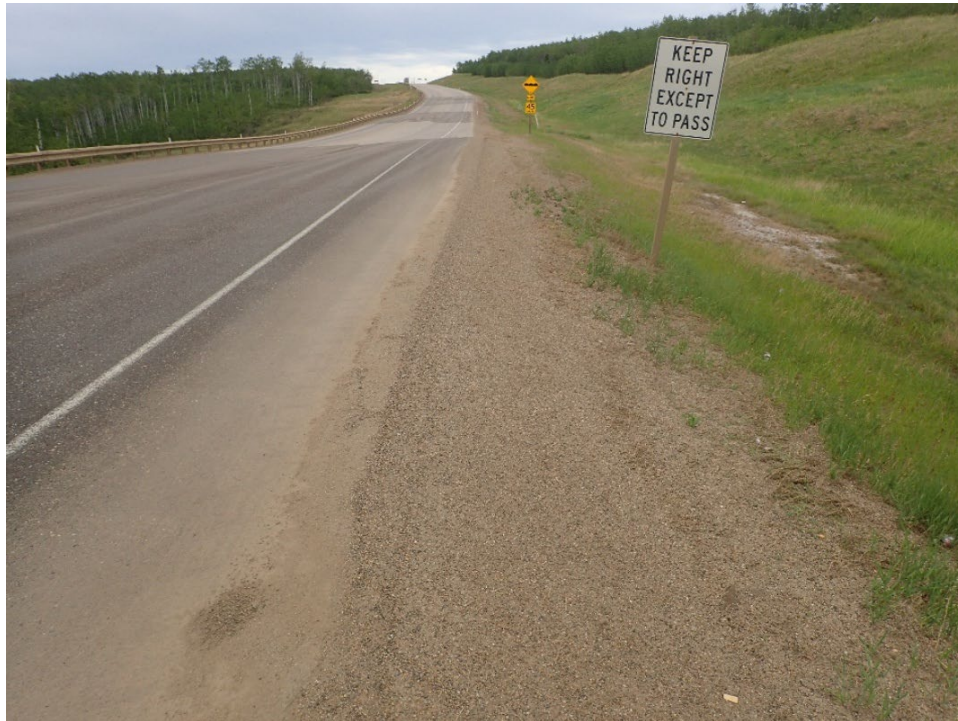
Photo 3 – Looking east where the main scarps cross the highway at three locations.

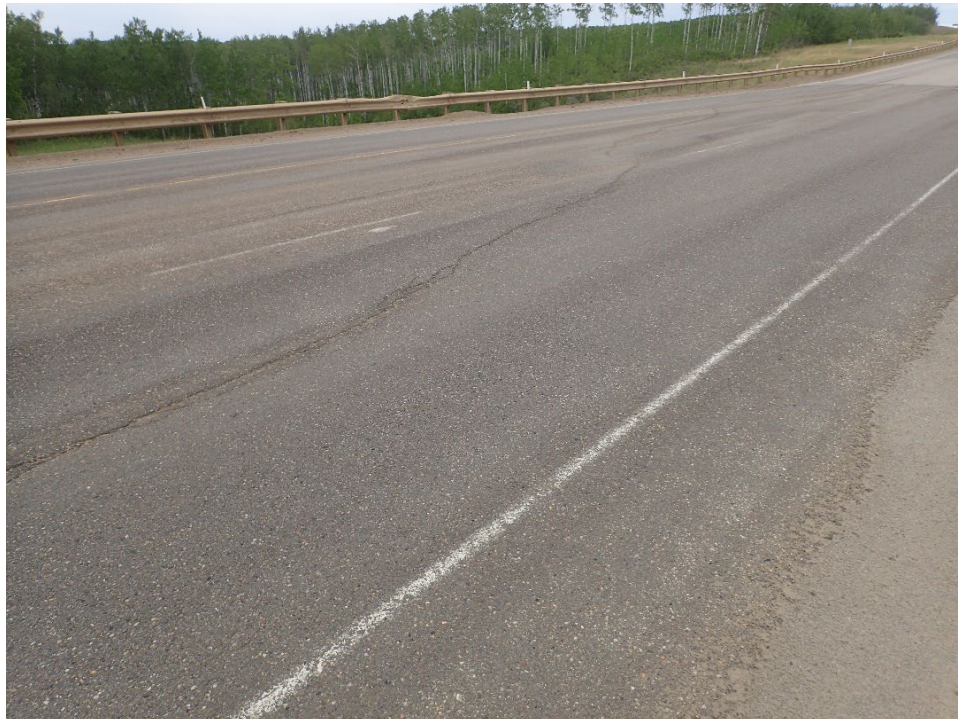
Photo 4 – Looking east at area of frequent patching at Sta. 0+700.

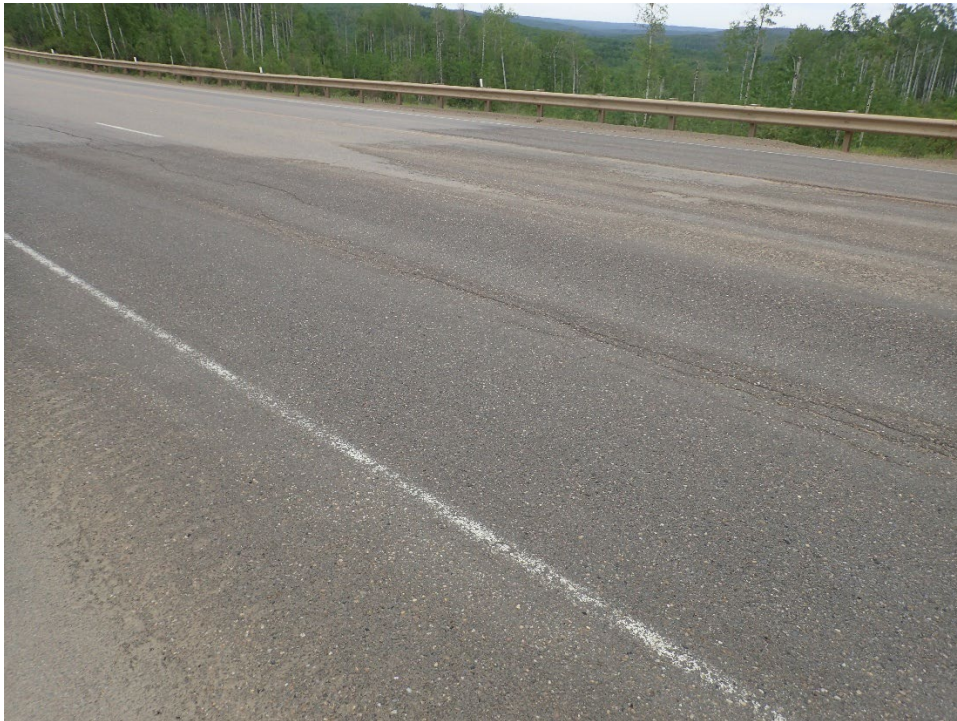
Photo 5 – Looking northwest at area of frequent patching at Sta. 0+700.

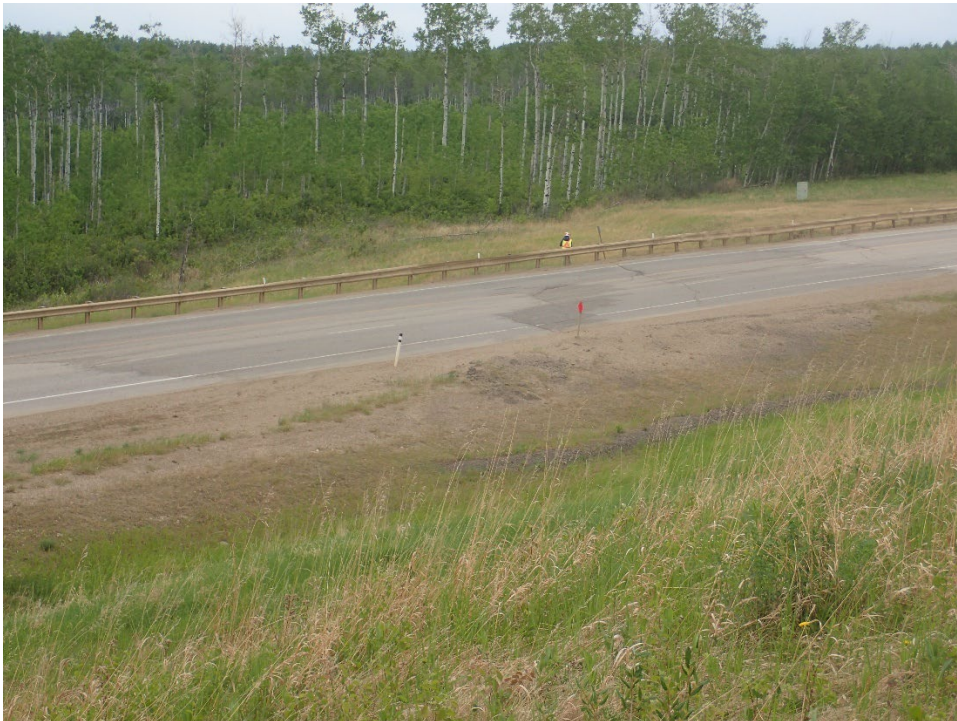
Photo 6 – Looking northeast at where main scarp crack crosses highway at Sta. 0+600.

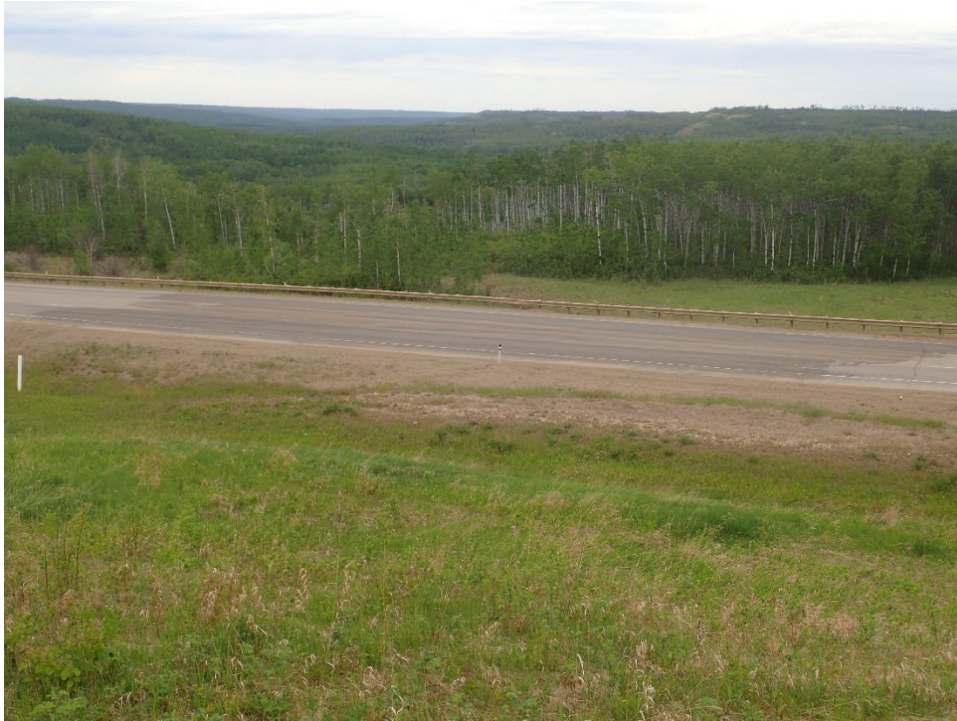
Photo 7 – Looking north at where main scarp crack crosses highway at Sta. 0+700.

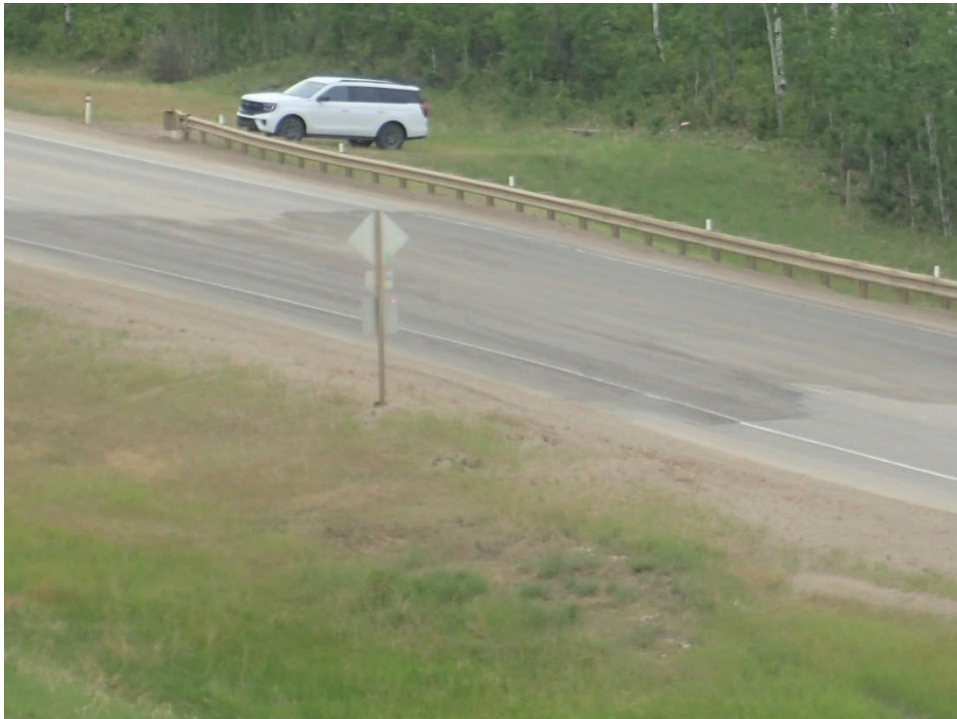
Photo 8 – Looking northwest at where main scarp crack crosses highway at Sta. 0+780.

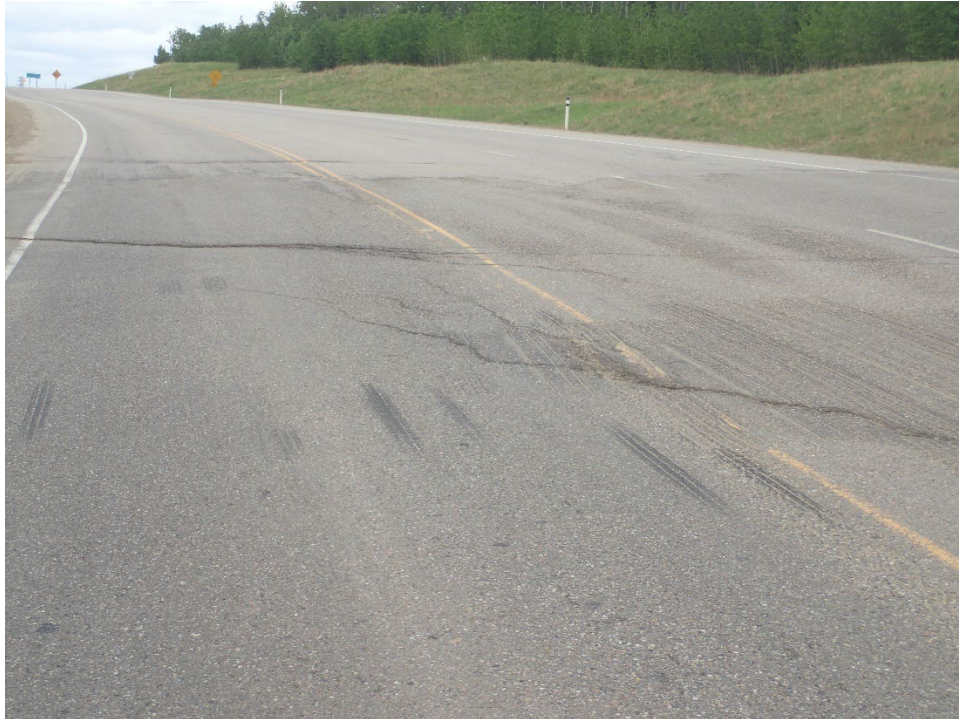
Photo 9 – Looking southeast at cracks that were milled at Sta. 0+600.

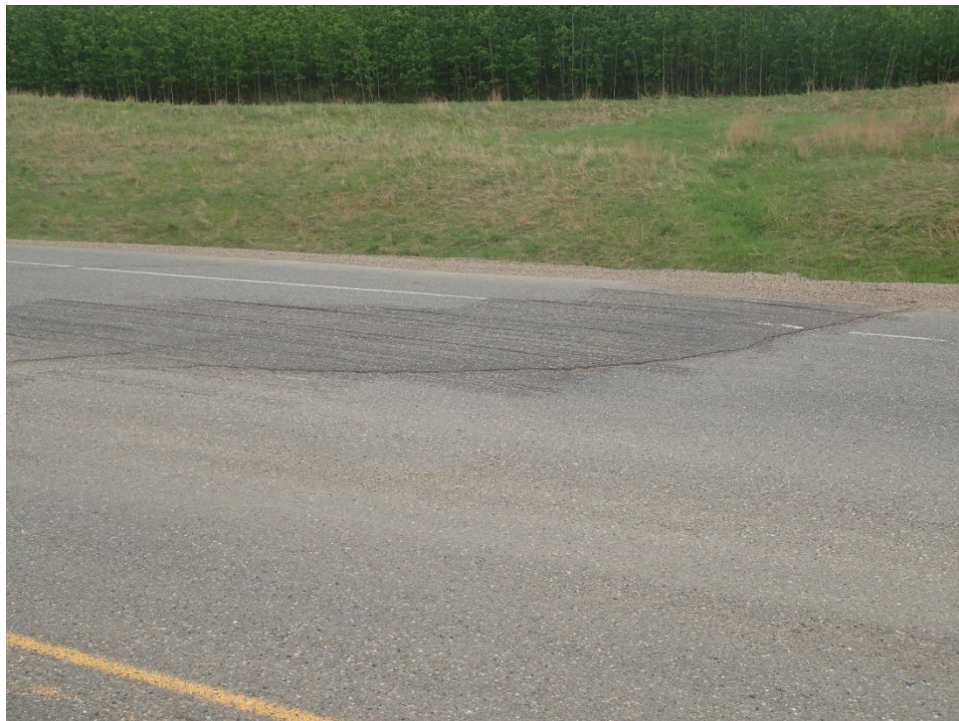
Photo 10 – Looking south at cracks that were milled at Sta. 0+600.

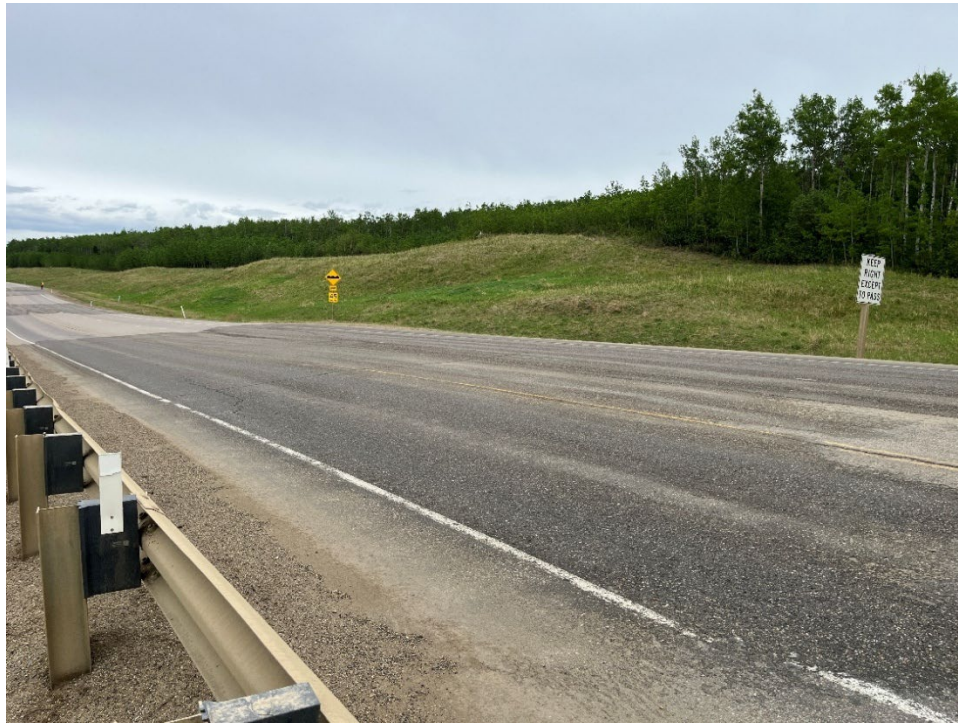
Photo 11 – Looking southeast at the cracks on the west side of main scarp block at Sta. 0+770.

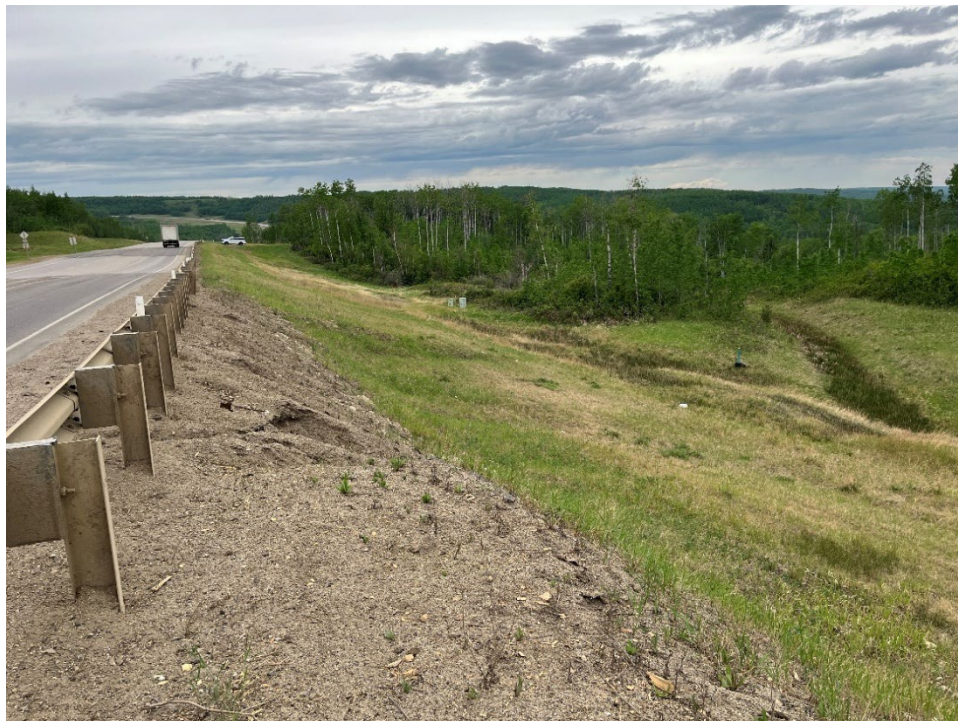
Photo 12 – Erosion rills by the guardrail and ravelling of the north side slope backscarp between Sta. 0+650 and 0+700.

The localized embankment failure could be repaired using clay or pitrun backfill and regraded to match the surrounding slope. Alternatively, consideration could be given to using a geogrid-reinforced backfill to reduce the amount of fill. This approach has the advantage of reducing the driving force on the slide block.

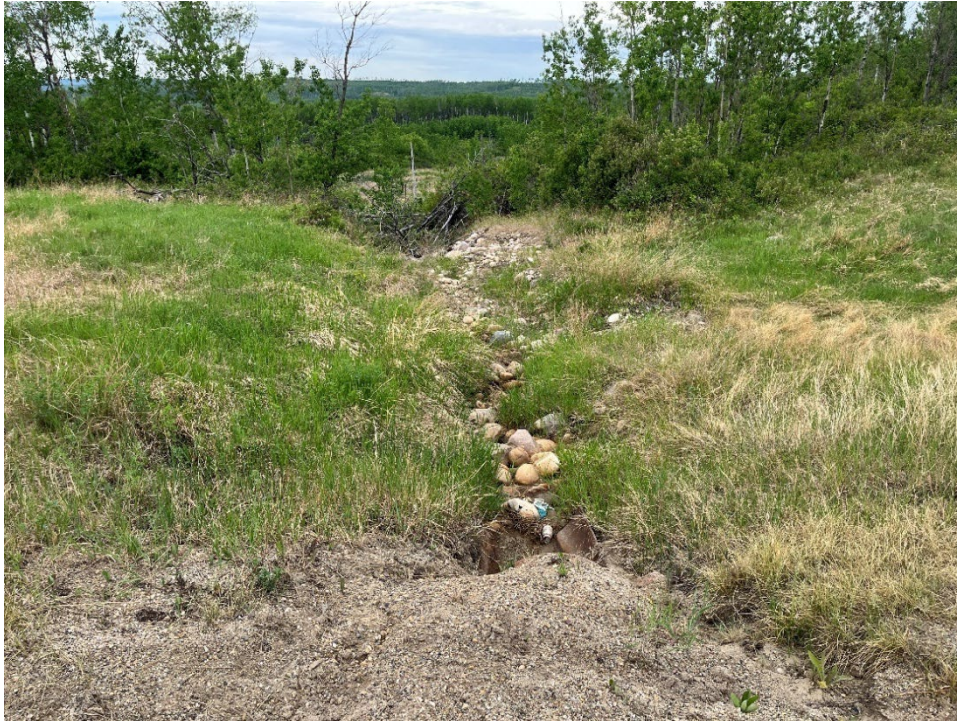
Photo 13 – Erosion gully at outlet of culvert at about Sta. 0+470.

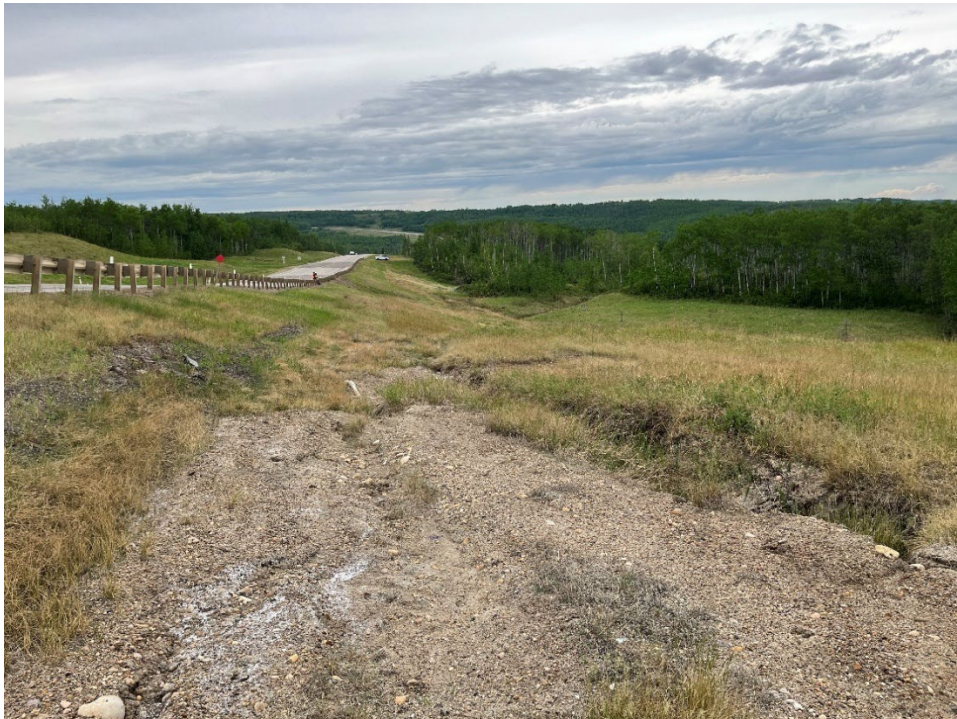
Photo 14 – Looking southwest along erosion gully near Sta. 0+550.

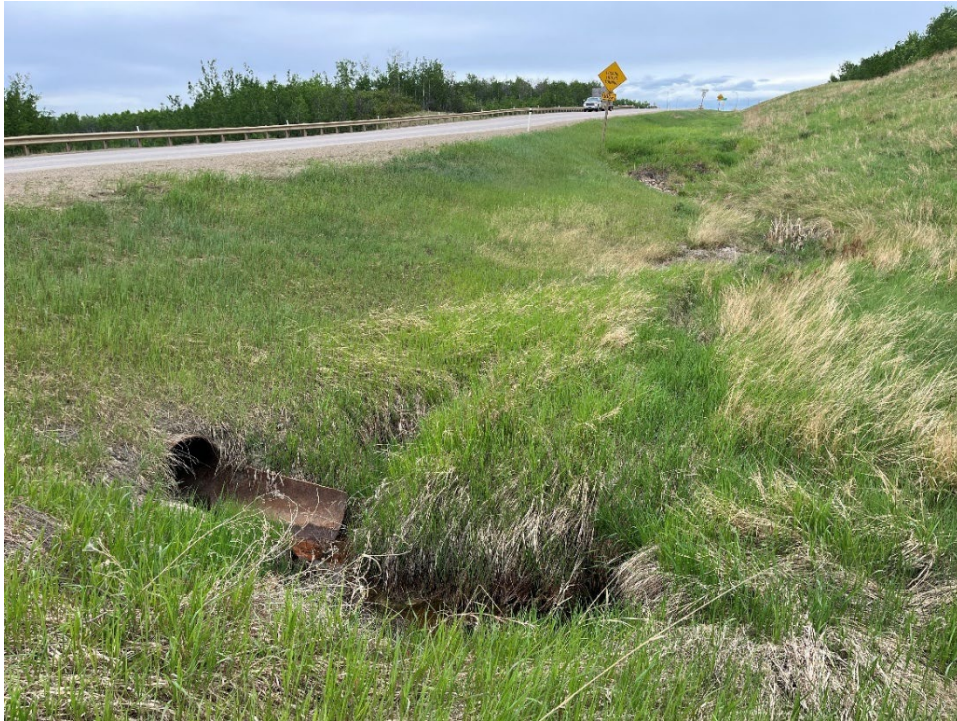
Photo 15 – Erosion at the culvert inlet (foreground). Scour bowl (background) at Sta. 0+430 is encroaching towards the highway.
