**ALBERTA TRANSPORTATION
GEOHAZARD ASSESSMENT PROGRAM
PEACE REGION (PEACE RIVER DISTRICT)
2021 INSPECTION**

Site Number	Location	Name	Hwy	km
SH004-1	South of Little Smoky River	Little Smoky River (South of Bridge)	49:12	2.3-2.6
Legal Description		UTM Co-ordinates		
W33-074-21-W5M		11U E 489,224	N 6,145,128

**SH004-1: HWY 49:12 LITTLE SMOKY RIVER
SOUTH OF BRIDGE
2021 SITE INSPECTION PLAN**

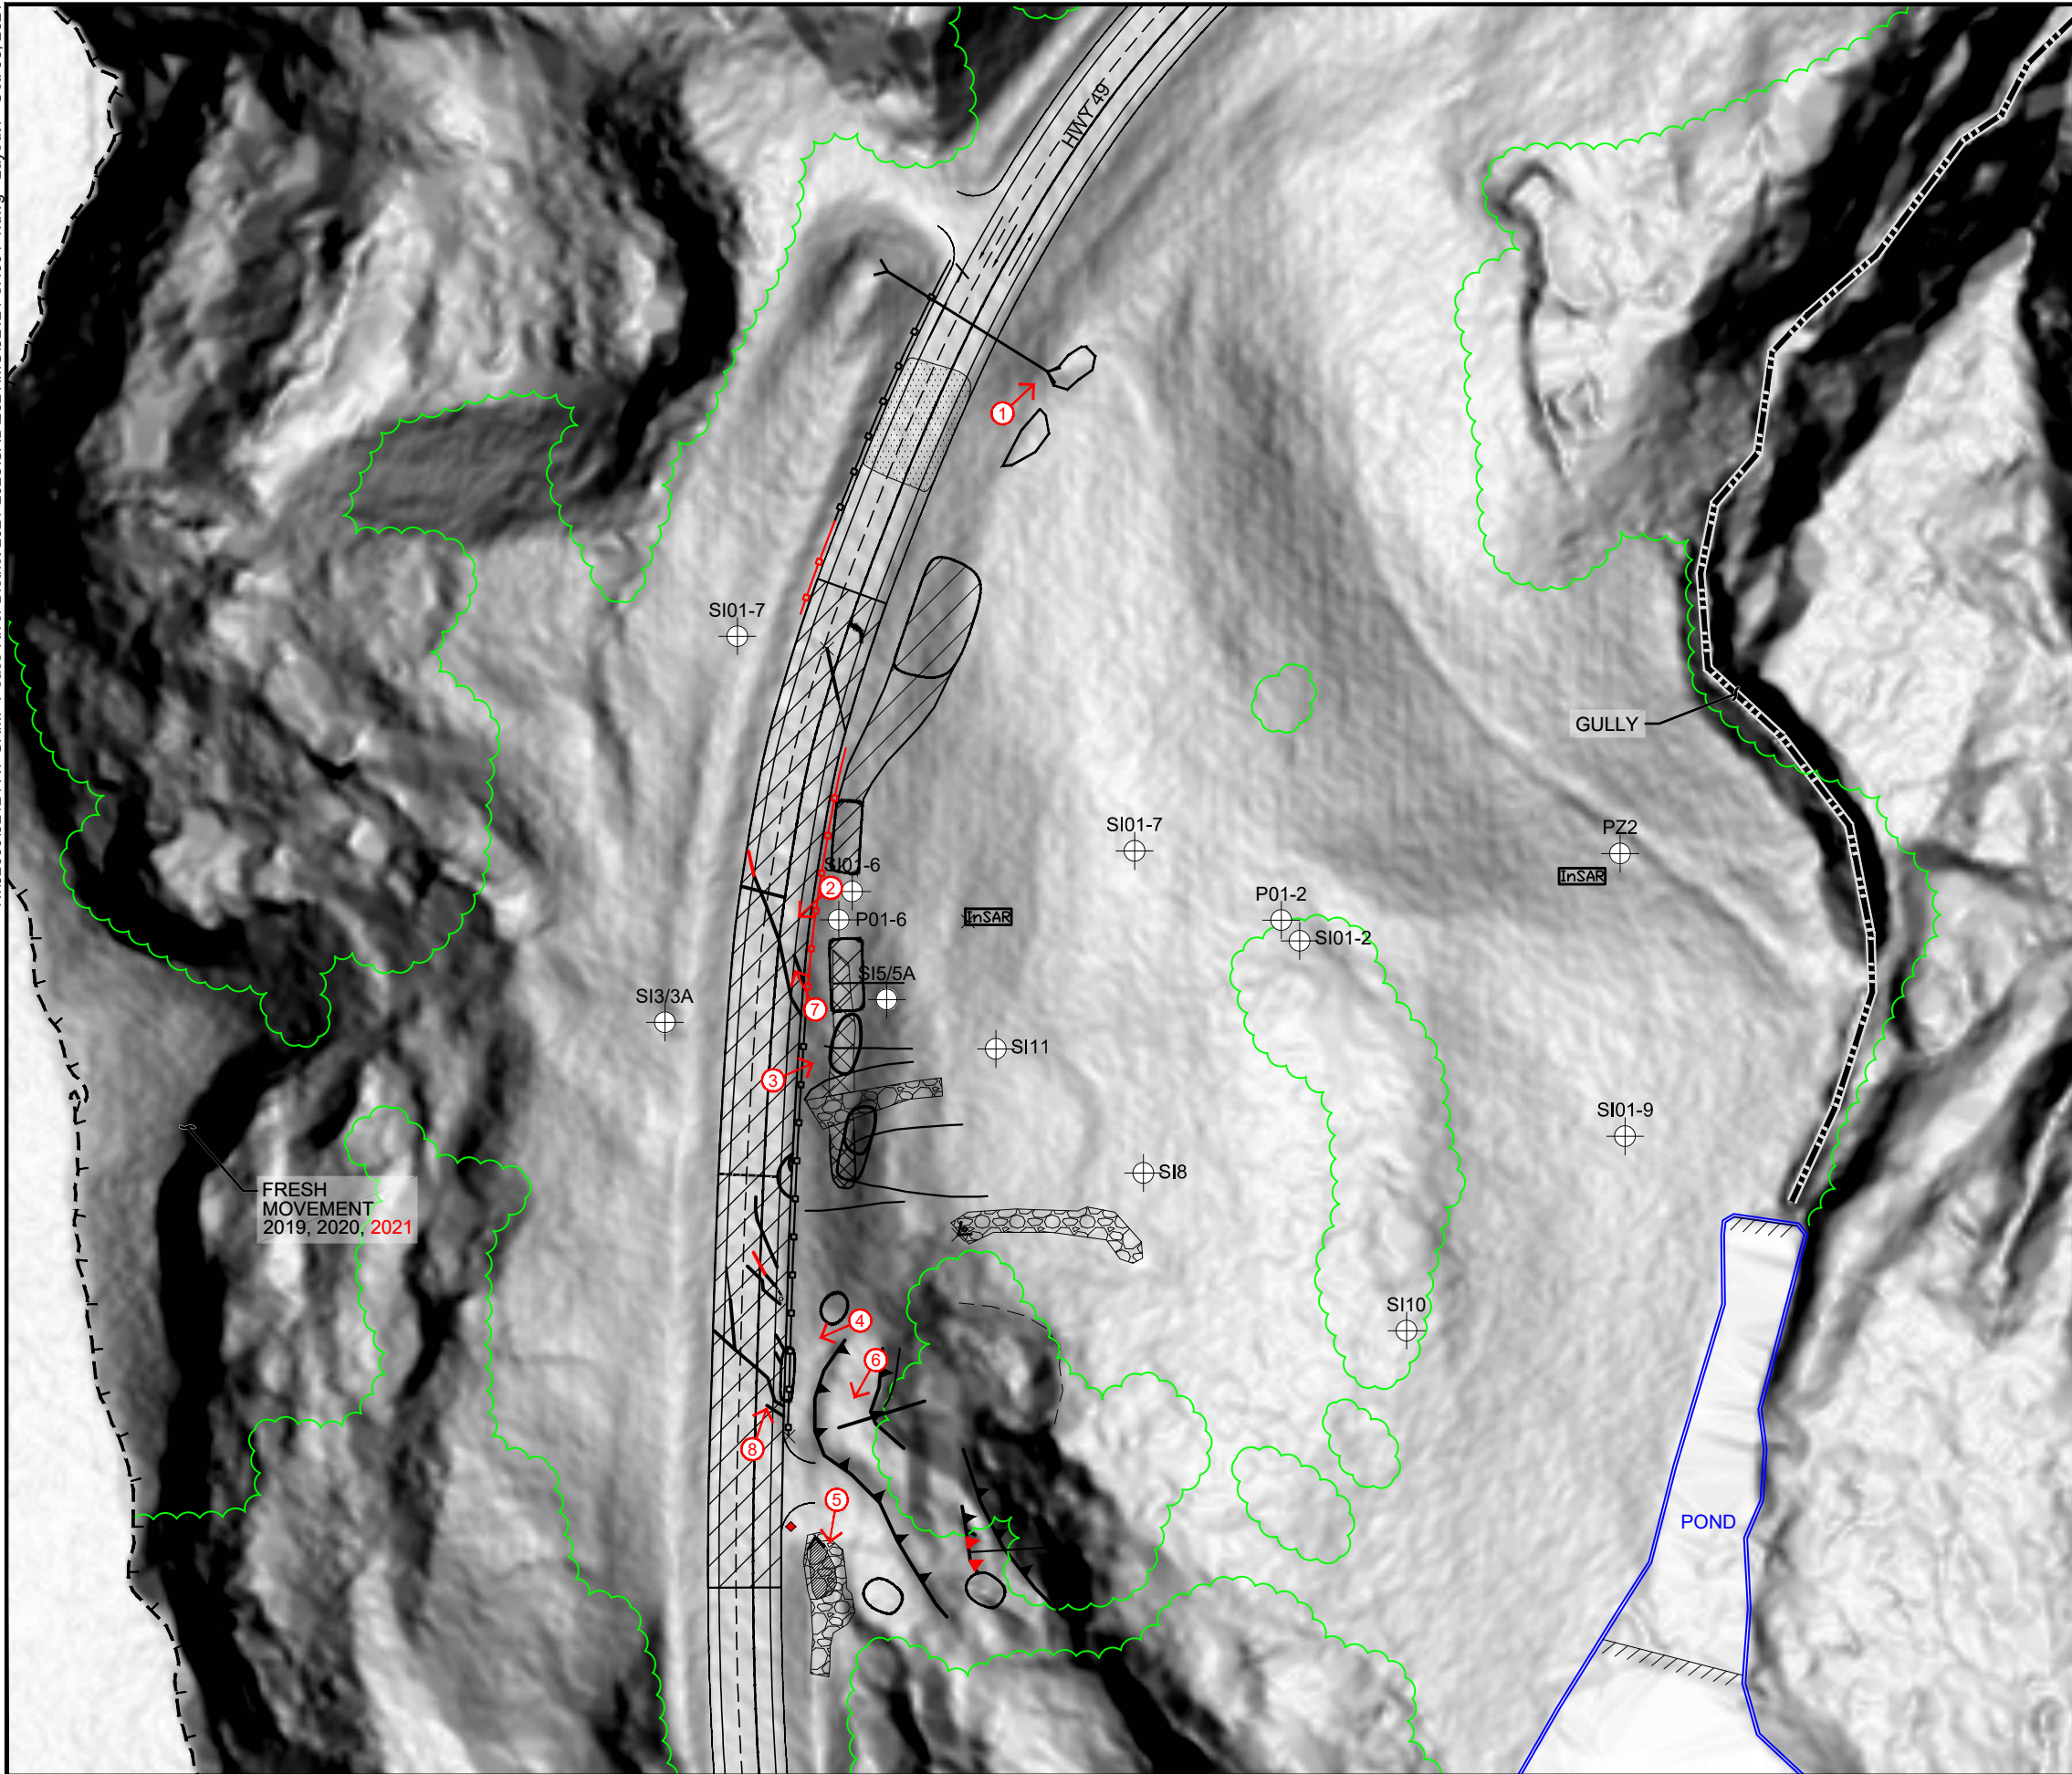
DWG No. 32121-SH004-1-1

1. FEATURE LOCATIONS ARE APPROXIMATE.
2. PREVIOUS OBSERVATIONS SHOWN IN BLACK (2013-2015 FROM AMEC FIGURE 1, PROJECT EG10030, PROVIDED BY ALBERTA TRANSPORTATION).
3. JUNE 2021 OBSERVATIONS SHOWN IN RED.
4. 2018 AND 2019 MILLING EXPOSED CRACKS PREVIOUSLY COVERED BY PATCHING. MILLING MATERIAL SPREAD ON SIDESLOPES.

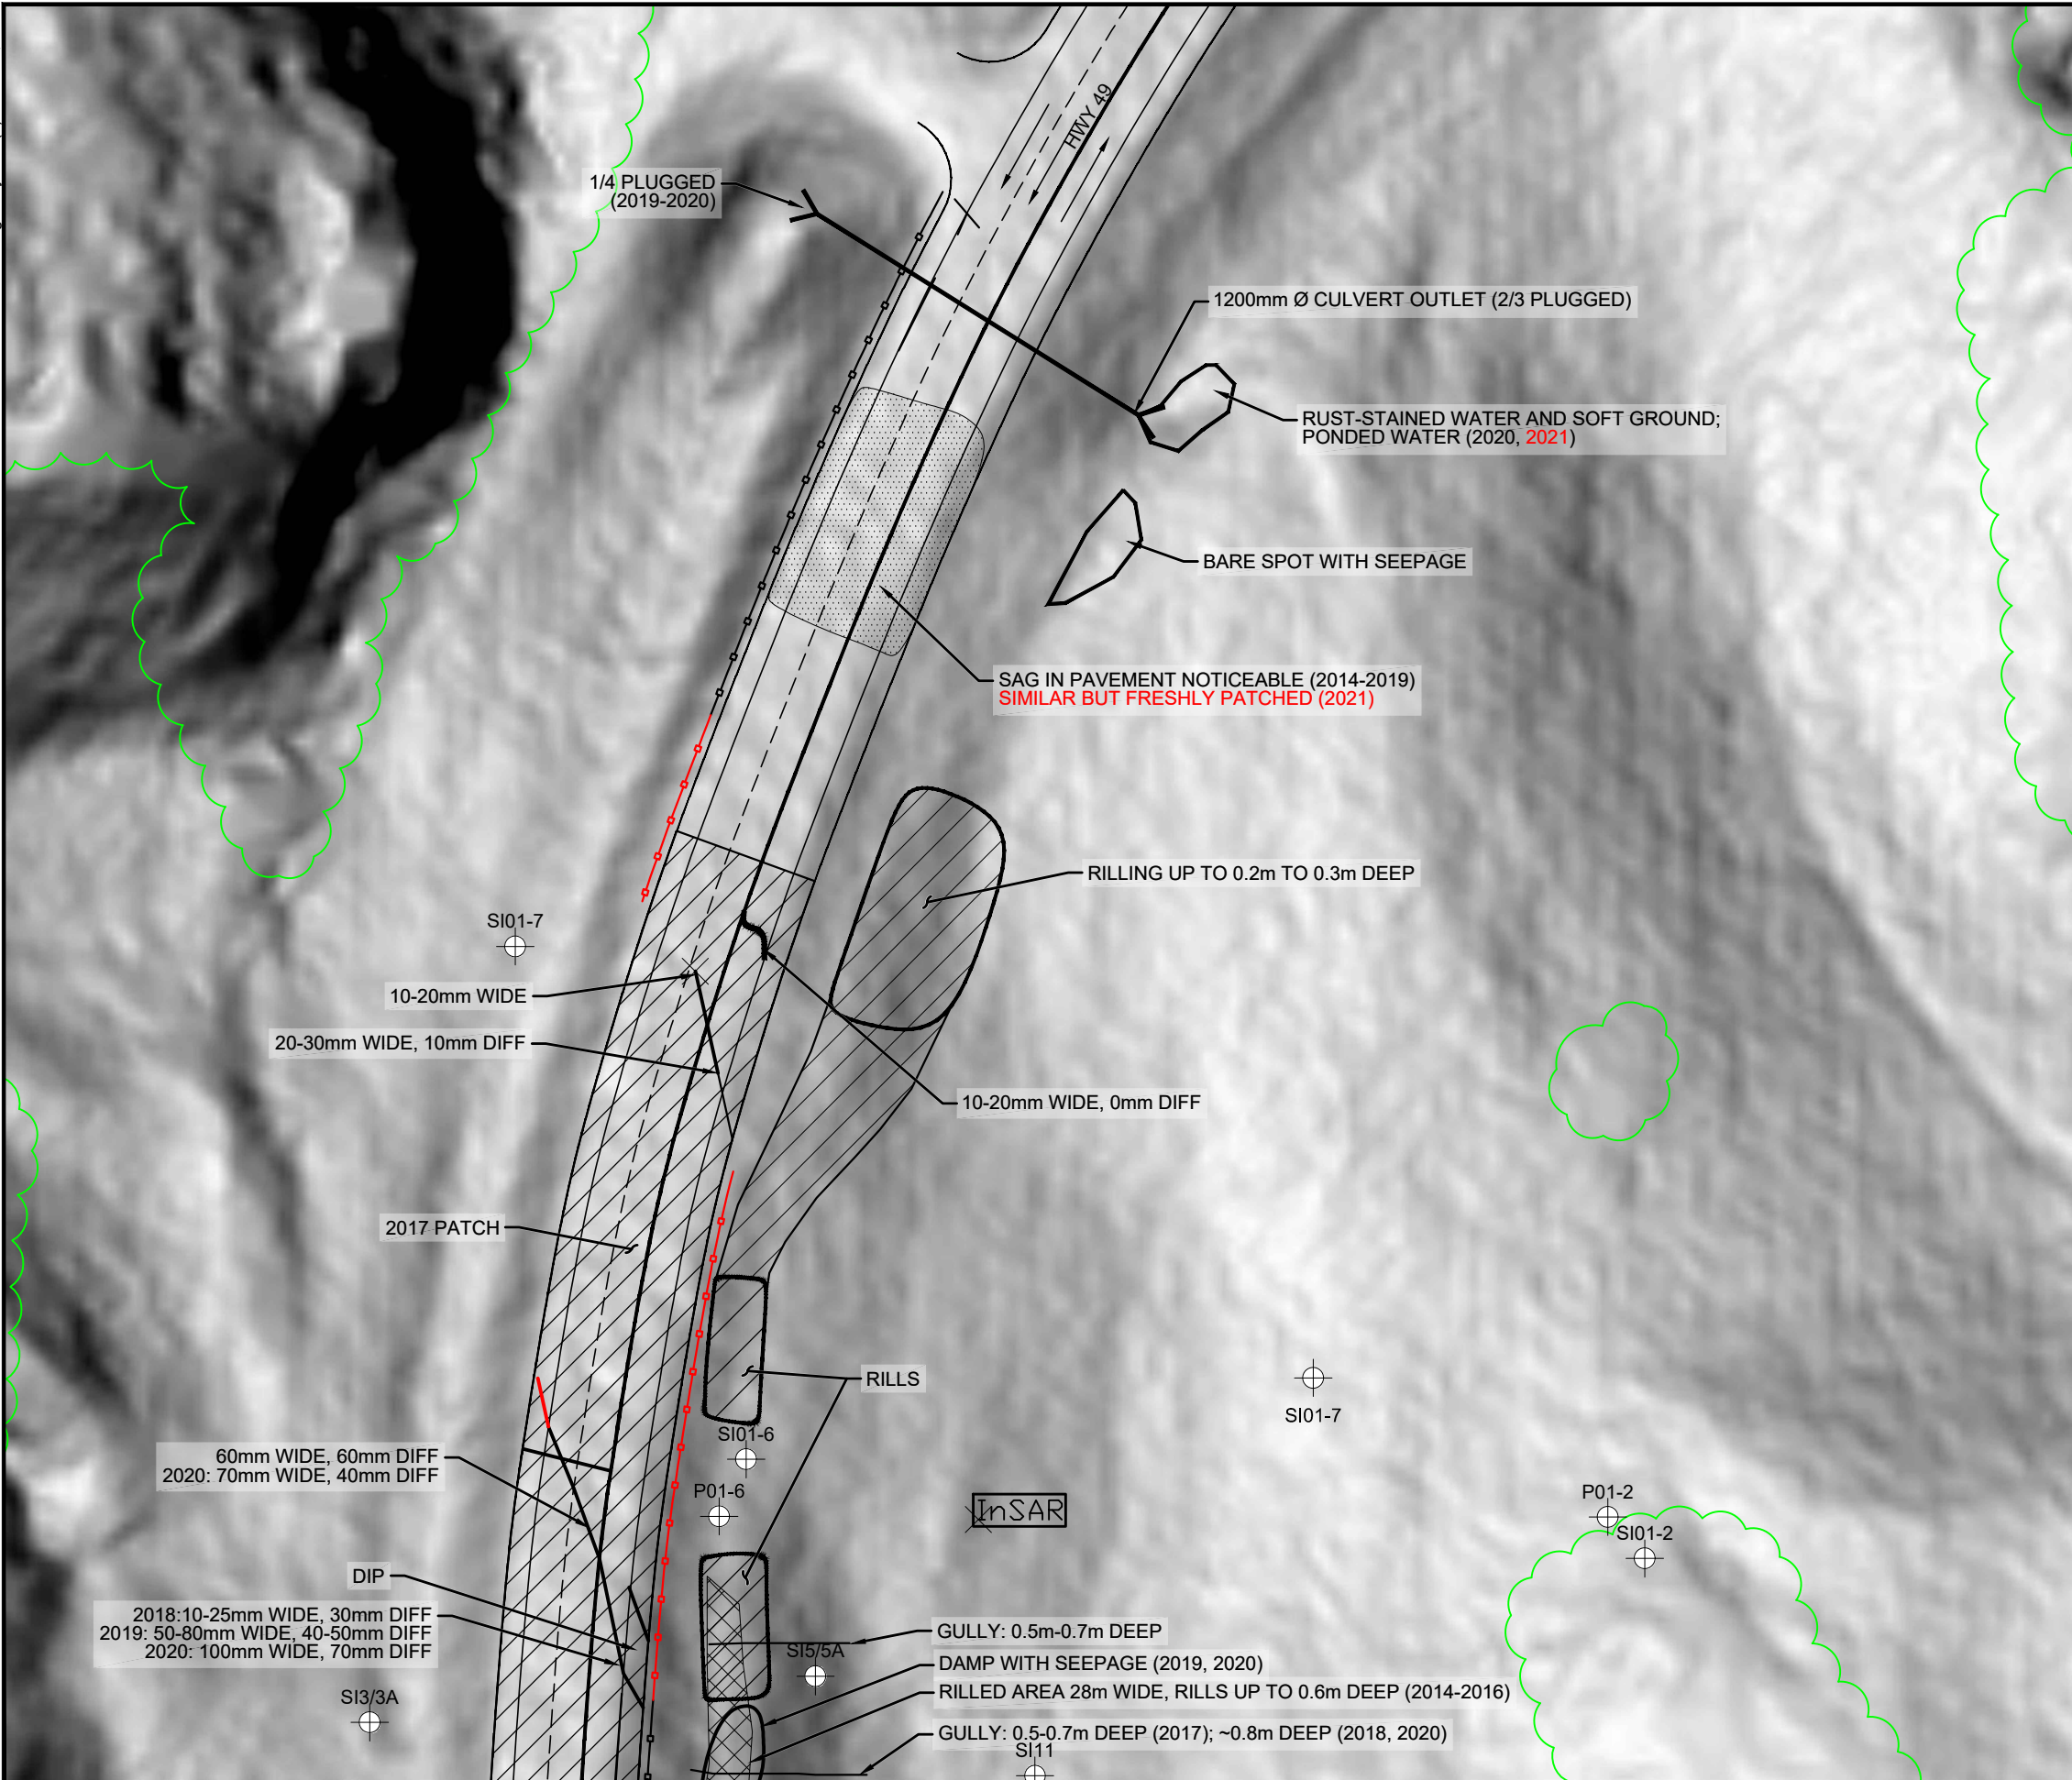
DWG No. 32121-SH004-1-2

1. FEATURE LOCATIONS ARE APPROXIMATE.
2. PREVIOUS OBSERVATIONS SHOWN IN BLACK (2013-2015 FROM AMEC FIGURE 1, PROJECT EG10030, PROVIDED BY ALBERTA TRANSPORTATION).
3. JUNE 2021 OBSERVATIONS SHOWN IN RED.
4. 2018 AND 2019 MILLING EXPOSED CRACKS PREVIOUSLY COVERED BY PATCHING. MILLING MATERIAL SPREAD ON SIDESLOPES.

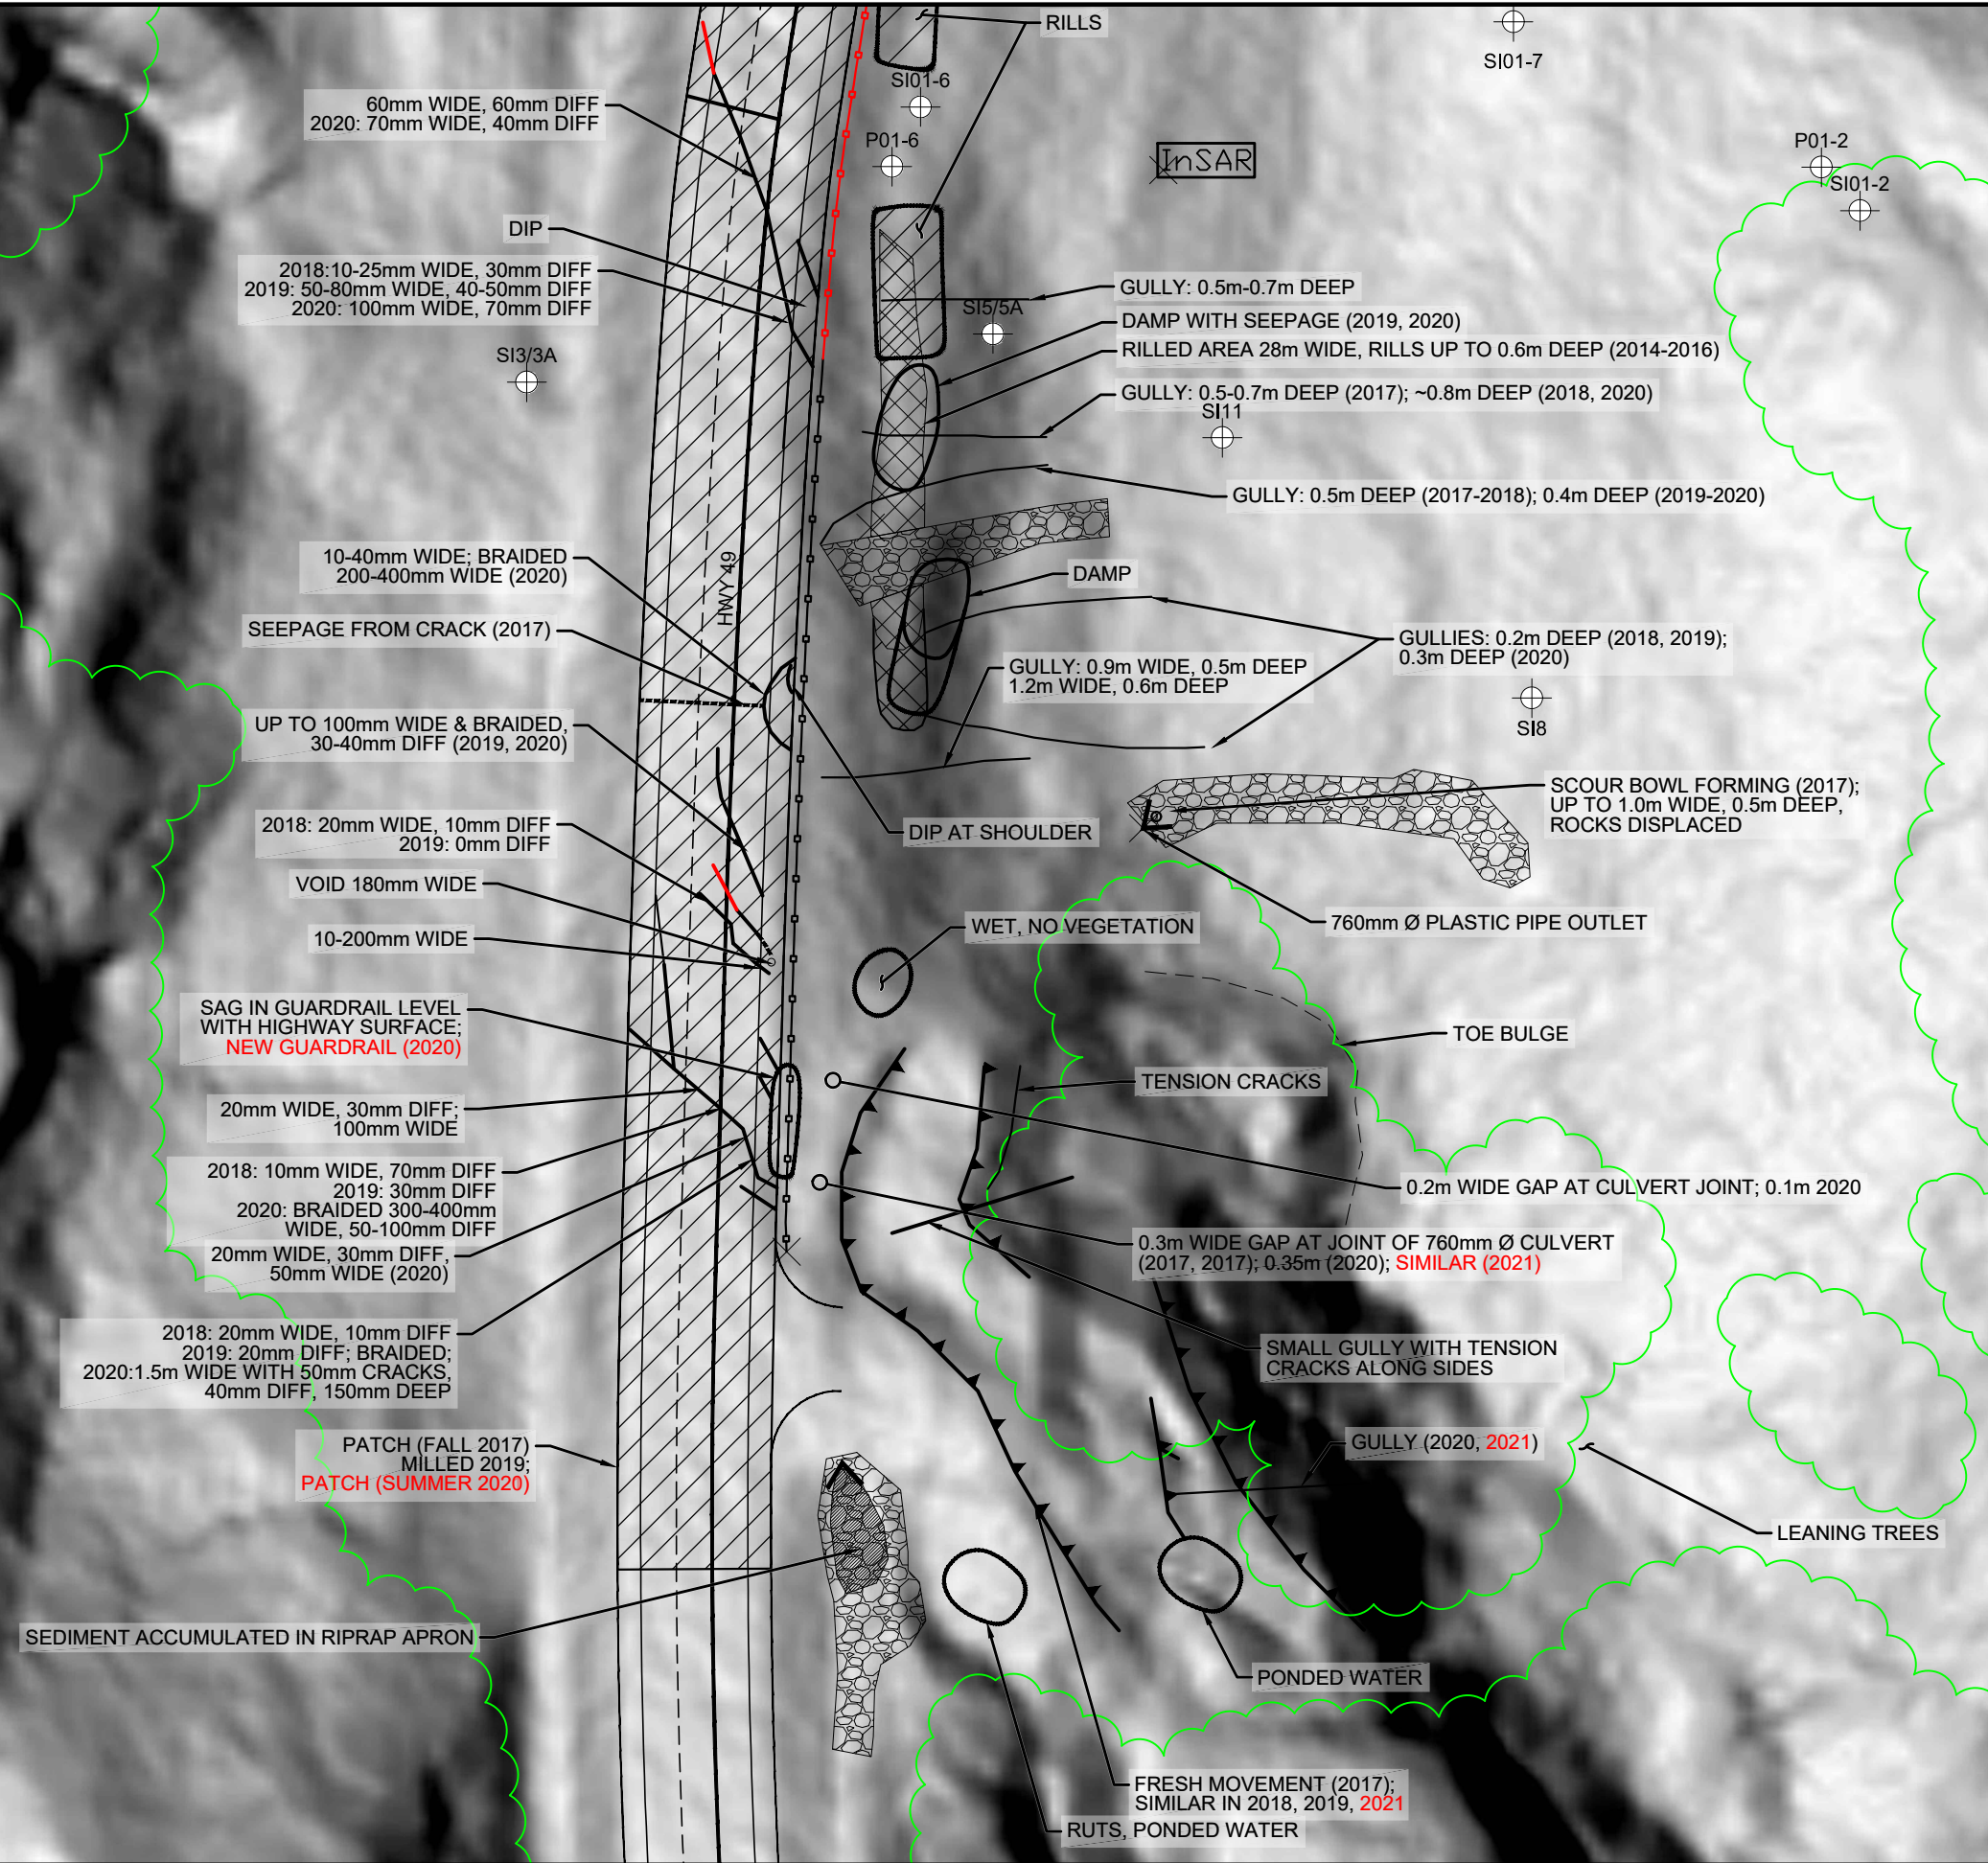
DWG No. 32121-SH004-1-3

1. FEATURE LOCATIONS ARE APPROXIMATE.
2. PREVIOUS OBSERVATIONS SHOWN IN BLACK (2013-2015 FROM AMEC FIGURE 1, PROJECT EG10030, PROVIDED BY ALBERTA TRANSPORTATION).
3. JUNE 2021 OBSERVATIONS SHOWN IN RED.
4. 2018 AND 2019 MILLING EXPOSED CRACKS PREVIOUSLY COVERED BY PATCHING. MILLING MATERIAL SPREAD ON SIDESLOPES.

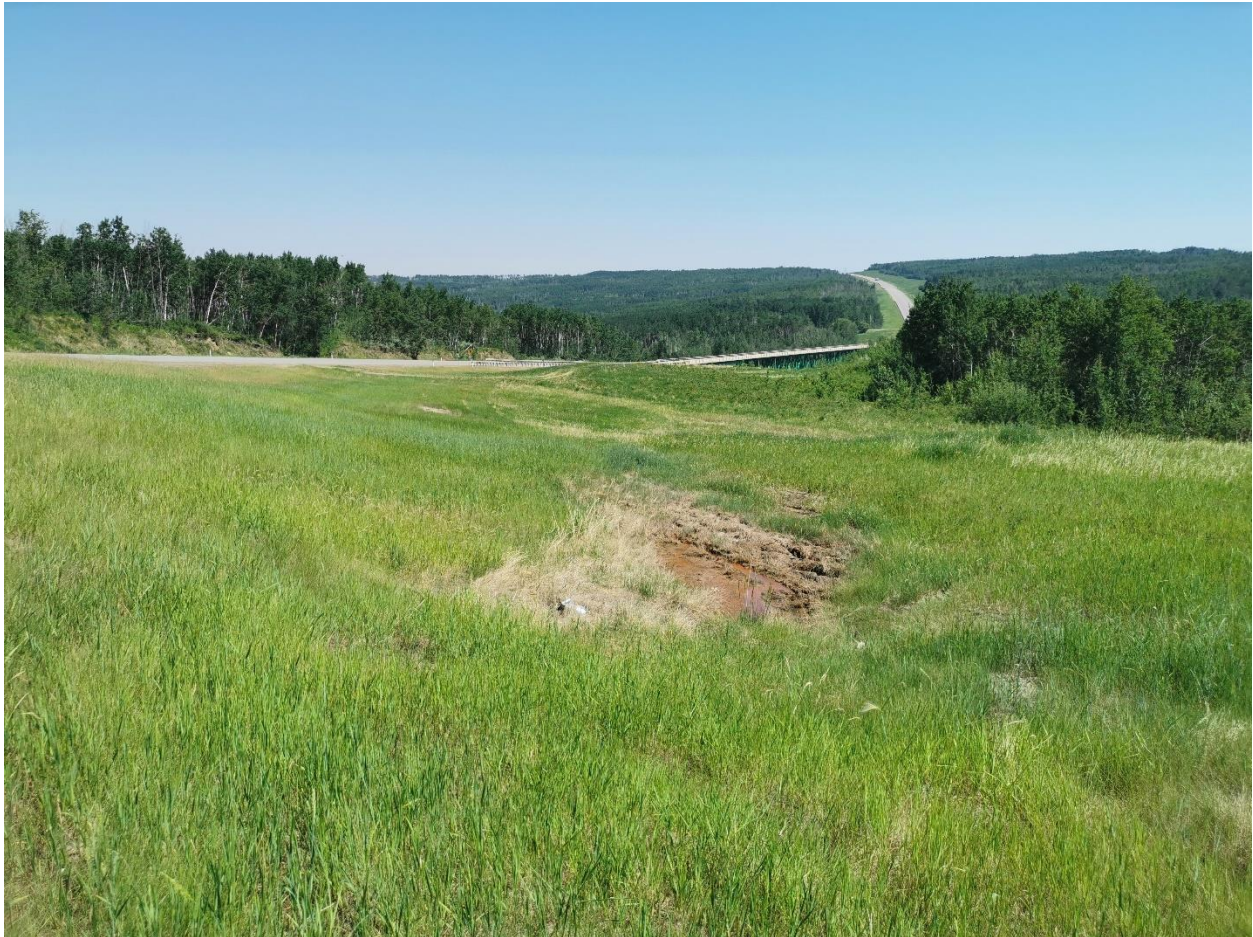
Observations:	Description	Worsened?
<input checked="" type="checkbox"/> Pavement Distress	Cracking and uneven roadway surface requires ongoing patching and milling especially at the landslide scarp cracks and the south end of the bridge.	<input checked="" type="checkbox"/>
<input type="checkbox"/> Slope Movement	Overall slope movement continues resulting in cracks at scarps and sags in the graben blocks.	<input checked="" type="checkbox"/>
<input checked="" type="checkbox"/> Erosion	Riling between riprap channel and beyond P01-6. Lesser riling near north end of patch.	<input type="checkbox"/>
<input checked="" type="checkbox"/> Seepage	Evidence of seepage observed at culvert outlet at north end of site.	<input type="checkbox"/>

Photo 1 – Looking north at seepage on downslope side of highway at the north end of the site.

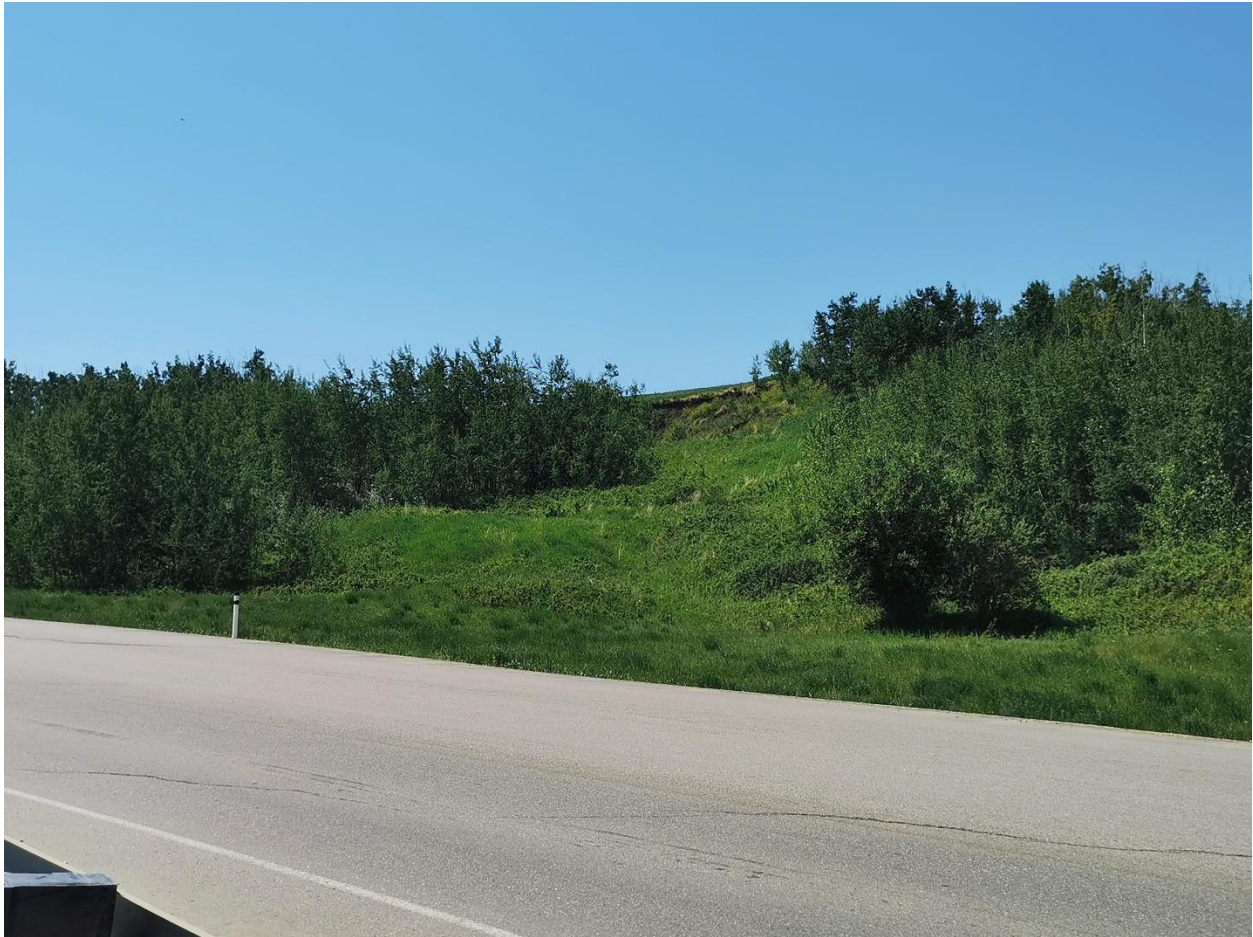
Photo 2 – Looking southwest at slide movement in the backslope above the highway.

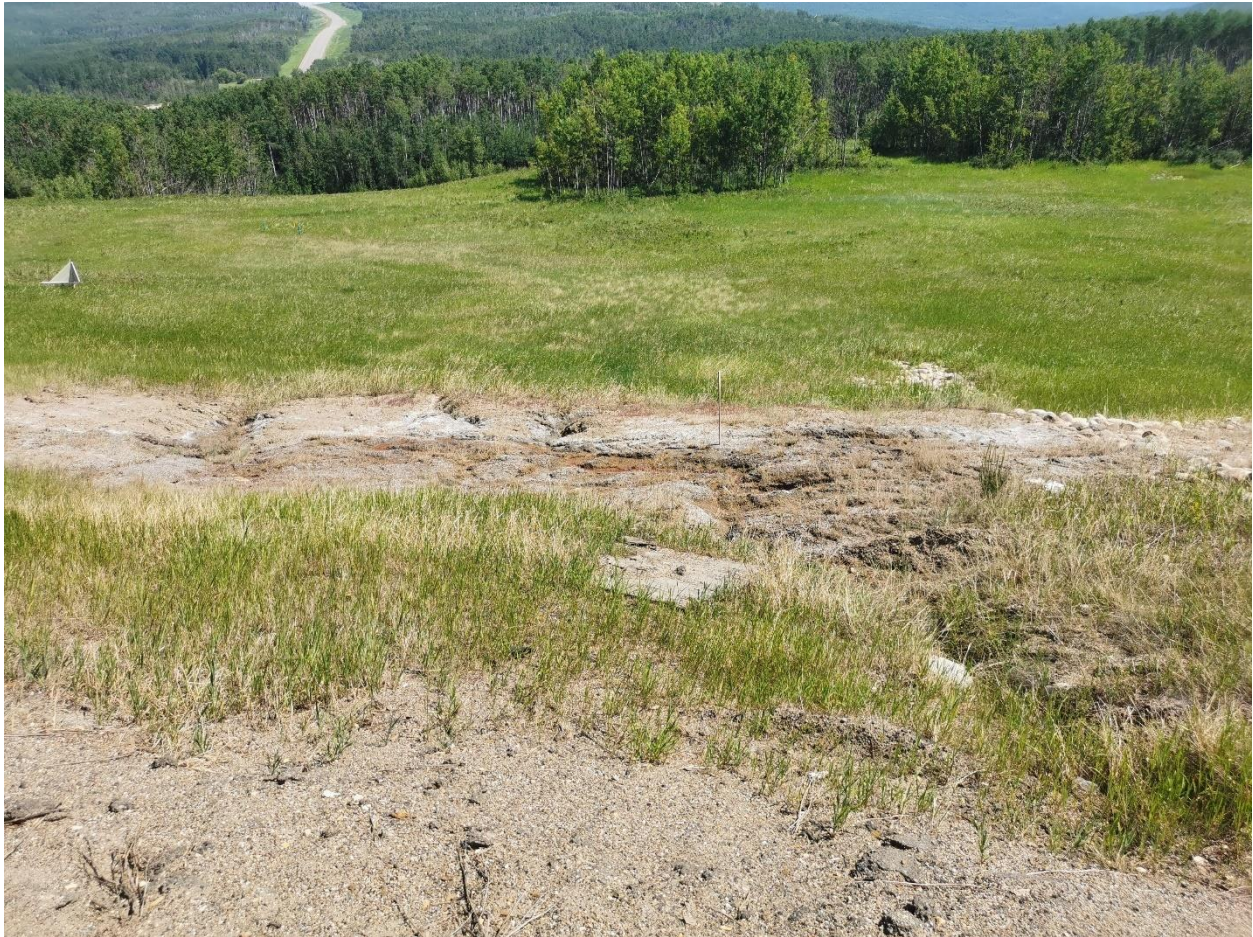
Photo 3 – Looking northeast at rilling on either side of riprap apron.

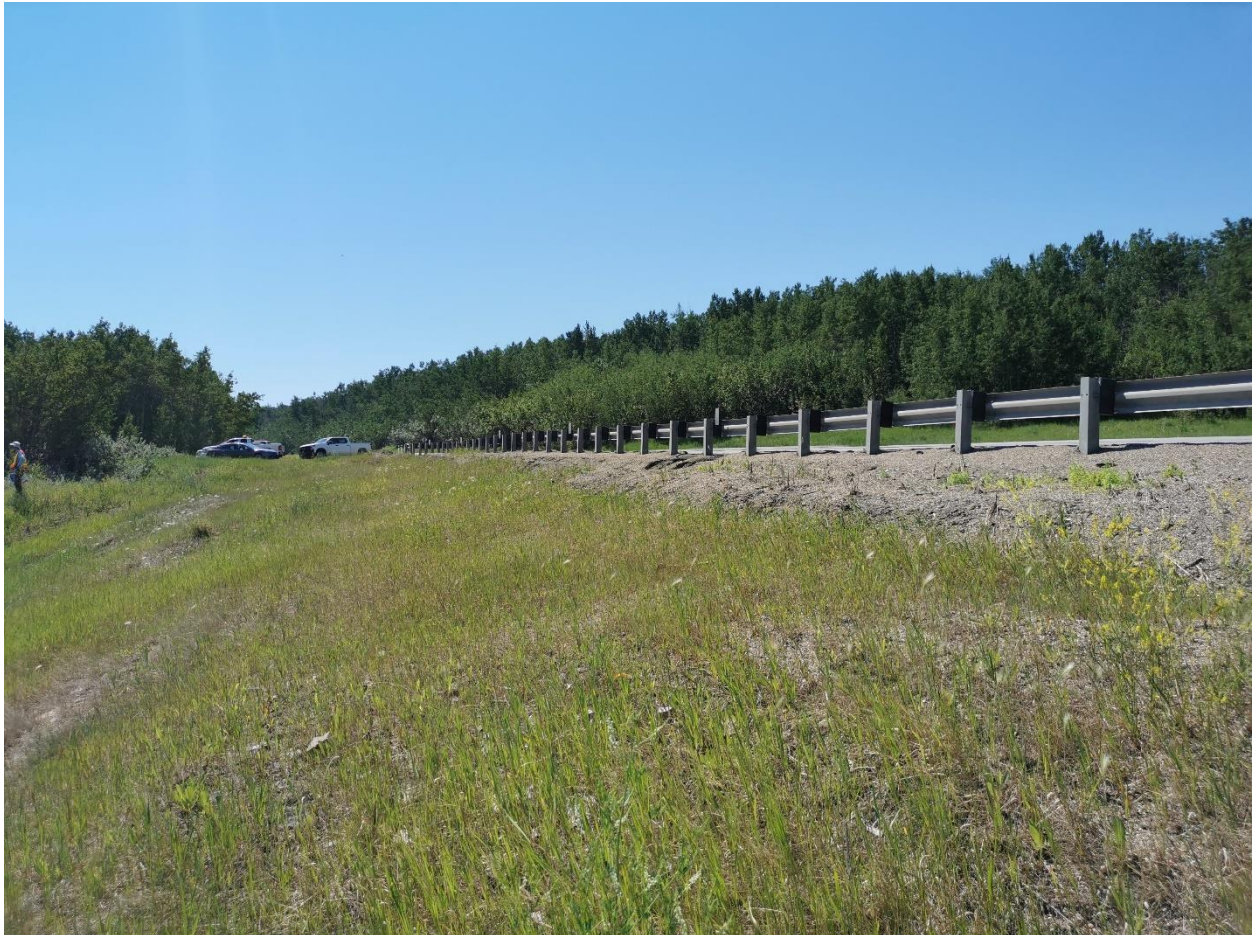
Photo 4 – Looking southwest at guardrail at south end of site.

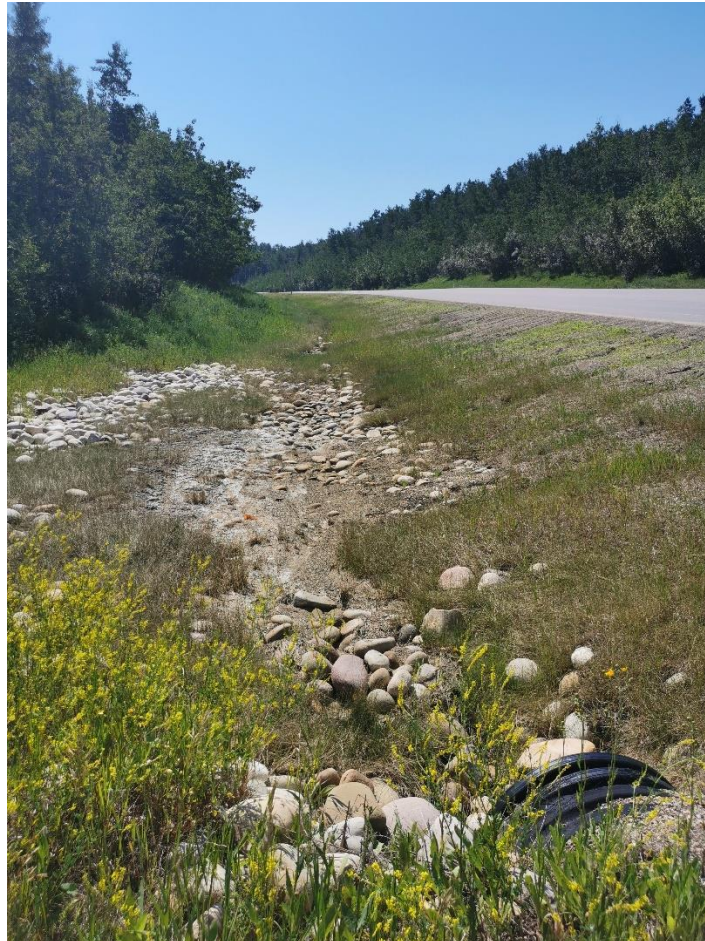
Photo 5 – Looking south along downslope ditch at sedimentation at inlet of 760 mm plastic culvert.

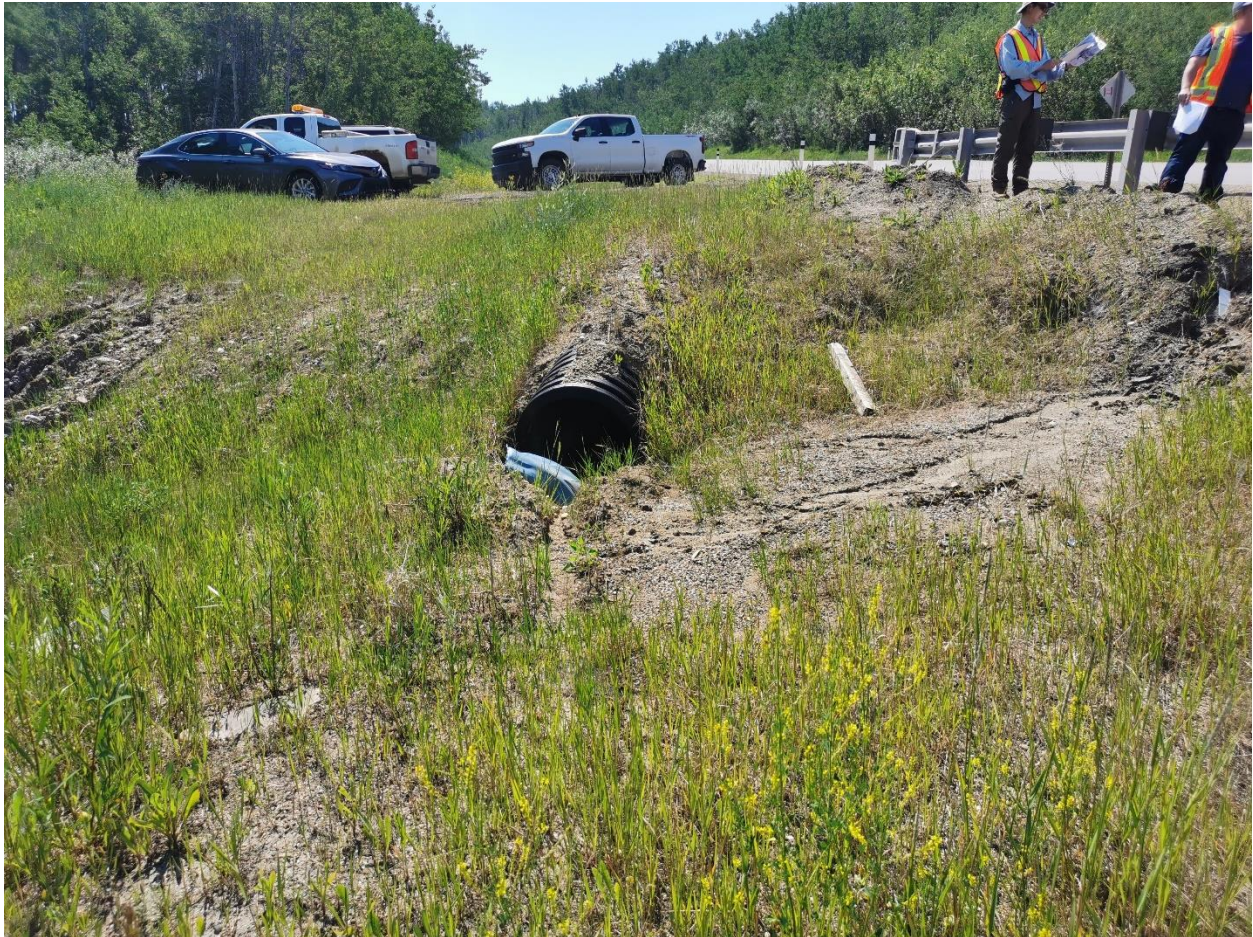
<input checked="" type="checkbox"/> Bridge/Culvert Distress	Separation of plastic culvert was 0.6 m wide in 2016 and decreased to 0.3 m in 2017 and 2018.	<input type="checkbox"/>
<input type="checkbox"/> Other		<input type="checkbox"/>
Instrumentation (as of Spring 2020):		
VW07-2, VW07-2A, VW07-3, VW07-3A	Relatively stable with a slight increasing trend at VW07-3, VW07 3A over the last four years.	
Destroyed/Lost	VW07-2B and -3B (damaged Fall 2014); SI4A, SI01-6, SI01-7, SI01-2, SI07-3B, SI01-9, SI07-2B, PZ01-6, PZ01-2 (discontinued)	
Assessment:		
<p>The overall valley slope is moving as several separate slide blocks resulting in numerous scarps, sag ponds, and differential movement zones and the highway is intersected at several locations by these features resulting in an uneven highway surface. The driving mechanism appears to be toe erosion by the Little Smoky River although stability analyses undertaken by others indicate that a high ground water table may also be contributing. Based on GPS survey of the InSAR points conducted by Alberta Geological Survey (AGS Open Report 2013-14), this portion of the highway is located on landslide blocks moving relatively slower (5 mm to 40 mm per year) as compared to the north side (SH003) or the bridge site (SH016). Drawing 32121-SH004-1-1 shows some of the local slide features that have been interpreted from the 2008 LiDAR imagery. Regrading of the slopes at this site has obscured the scarps of the larger slide blocks that are likely present beneath the highway alignment.</p> <p>The ongoing movement of the valley slope results in continued deformation of the highway surface that requires frequent patching and required an overlay in the summer of 2020 to maintain the smoothness of the highway.</p> <p>The riling in the bare area on the downslope side of the highway to the north of the riprap apron appears to in a state similar to the previous inspection. These rill and gully areas should be repaired to prevent further degradation. There is a second area of riling toward the north which is not quite as deep also appears to be in a state similar to the previous inspection.</p> <p>There is a break in the plastic culvert that handles downslope ditch flow from the south that was about 0.6 m wide in 2016 and only 0.3 m in 2017 which may indicate some lateral shifting of the pipe. There is a small sinkhole below the break. Similar conditions were observed in 2018, 2019 and 2021. A second gap at a culvert joint was observed in 2019 about 10 m further north.</p>

Photo 6 – Looking south at 760 mm culvert joint separation.

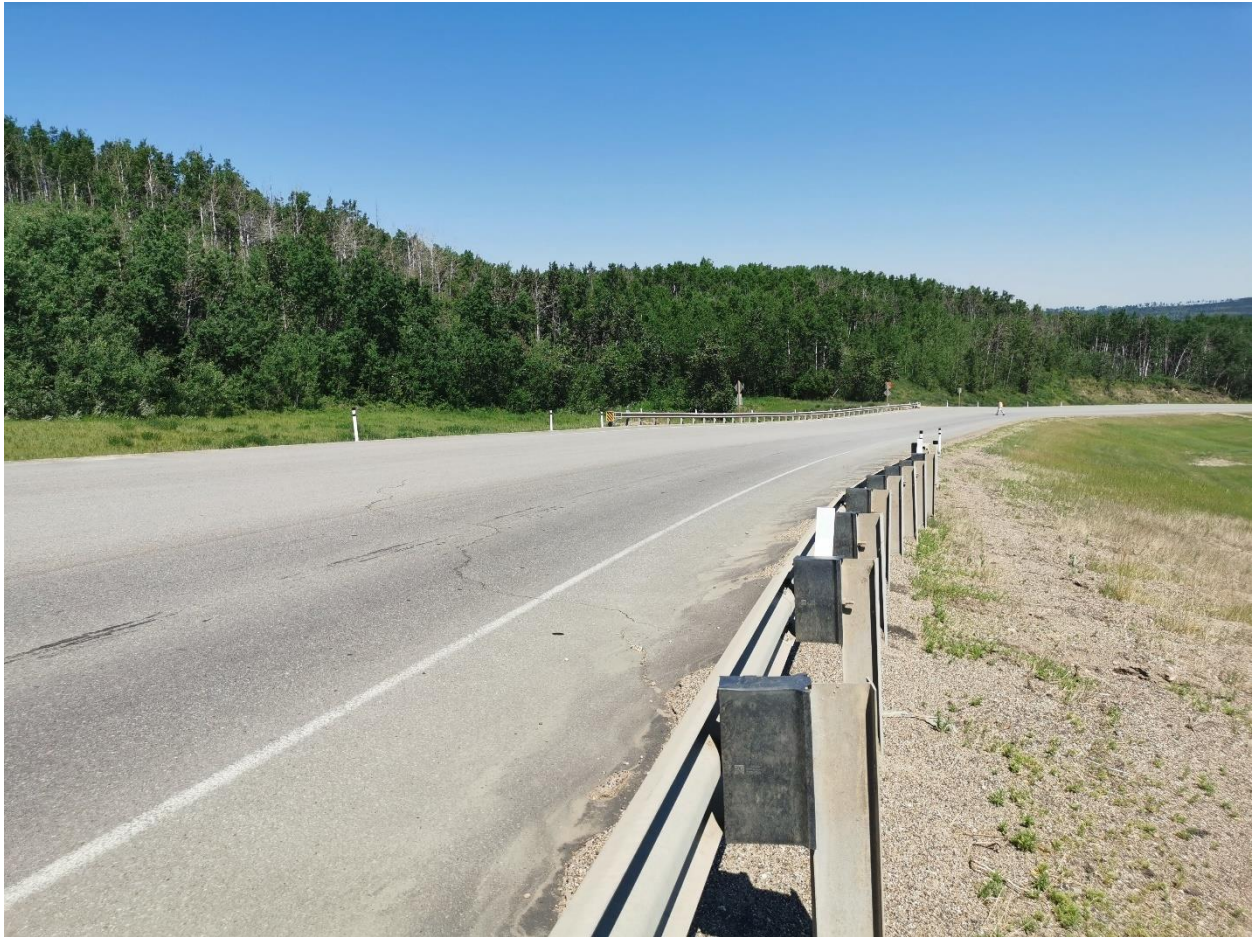
Photo 7 – Looking north at crack adjacent to the north end of the downslope guardrail.

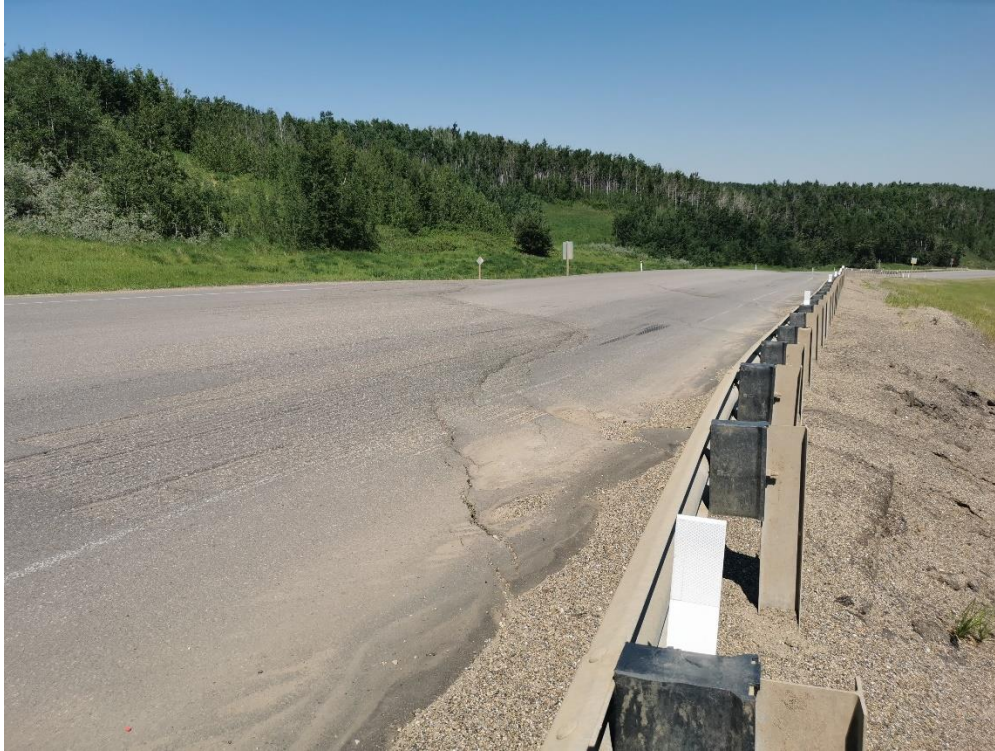
Photo 8 – Overlay and guardrail added in Fall 2020; cracking and differential becoming re-established through the ACP overlay.

Recommendations:		
<p>Short-term:</p> <ul style="list-style-type: none"> ▪ Road maintenance should continue as necessary to maintain an even, safe roadway surface and may consist of milling, patching, and crack sealing of the pavement. An asphalt overlay was placed through the site in Summer 2020, but rapid slide movements have already cracked and distorted it. ▪ The bare areas on the downslope side of the highway to the north of the riprap apron have the potential to deteriorate further. This area should be regraded and covered with topsoil and seed secured with an erosion control blanket or seed-impregnated compost blanket. The second riling area near the north end of the site could be repaired at the same time with the same methodology. ▪ The break in the culvert should be excavated and repaired to limit infiltration into the slope which could potentially result in slope movement or significant erosion. <p>Long-Term:</p> <p>The two alternatives for this location are: to realign the highway either using the existing bridge crossing or constructing a new one on more stable ground; or to control river erosion at the toe of the slope such that remedial measures above will have a longer effectiveness. It is understood that AMEC prepared a report under the High Water Related Mitigation Works program providing recommendations for erosion control at the toe and drainage measures on the slope for the sag</p>
