**ALBERTA TRANSPORTATION
GEOHAZARD ASSESSMENT PROGRAM
PEACE REGION (PEACE RIVER DISTRICT)
2022 INSPECTION**

Site Number	Location	Name	Hwy	km
SH004-1	South of Little Smoky River	Little Smoky River (South of Bridge)	49:12	2.3-2.6
Legal Description		UTM Co-ordinates		
W33-074-21-W5M		11U E 489,224	N 6,145,128

**SH004-1: HWY 49:12 LITTLE SMOKY RIVER
SOUTH OF BRIDGE
2022 SITE INSPECTION PLAN - OVERALL**

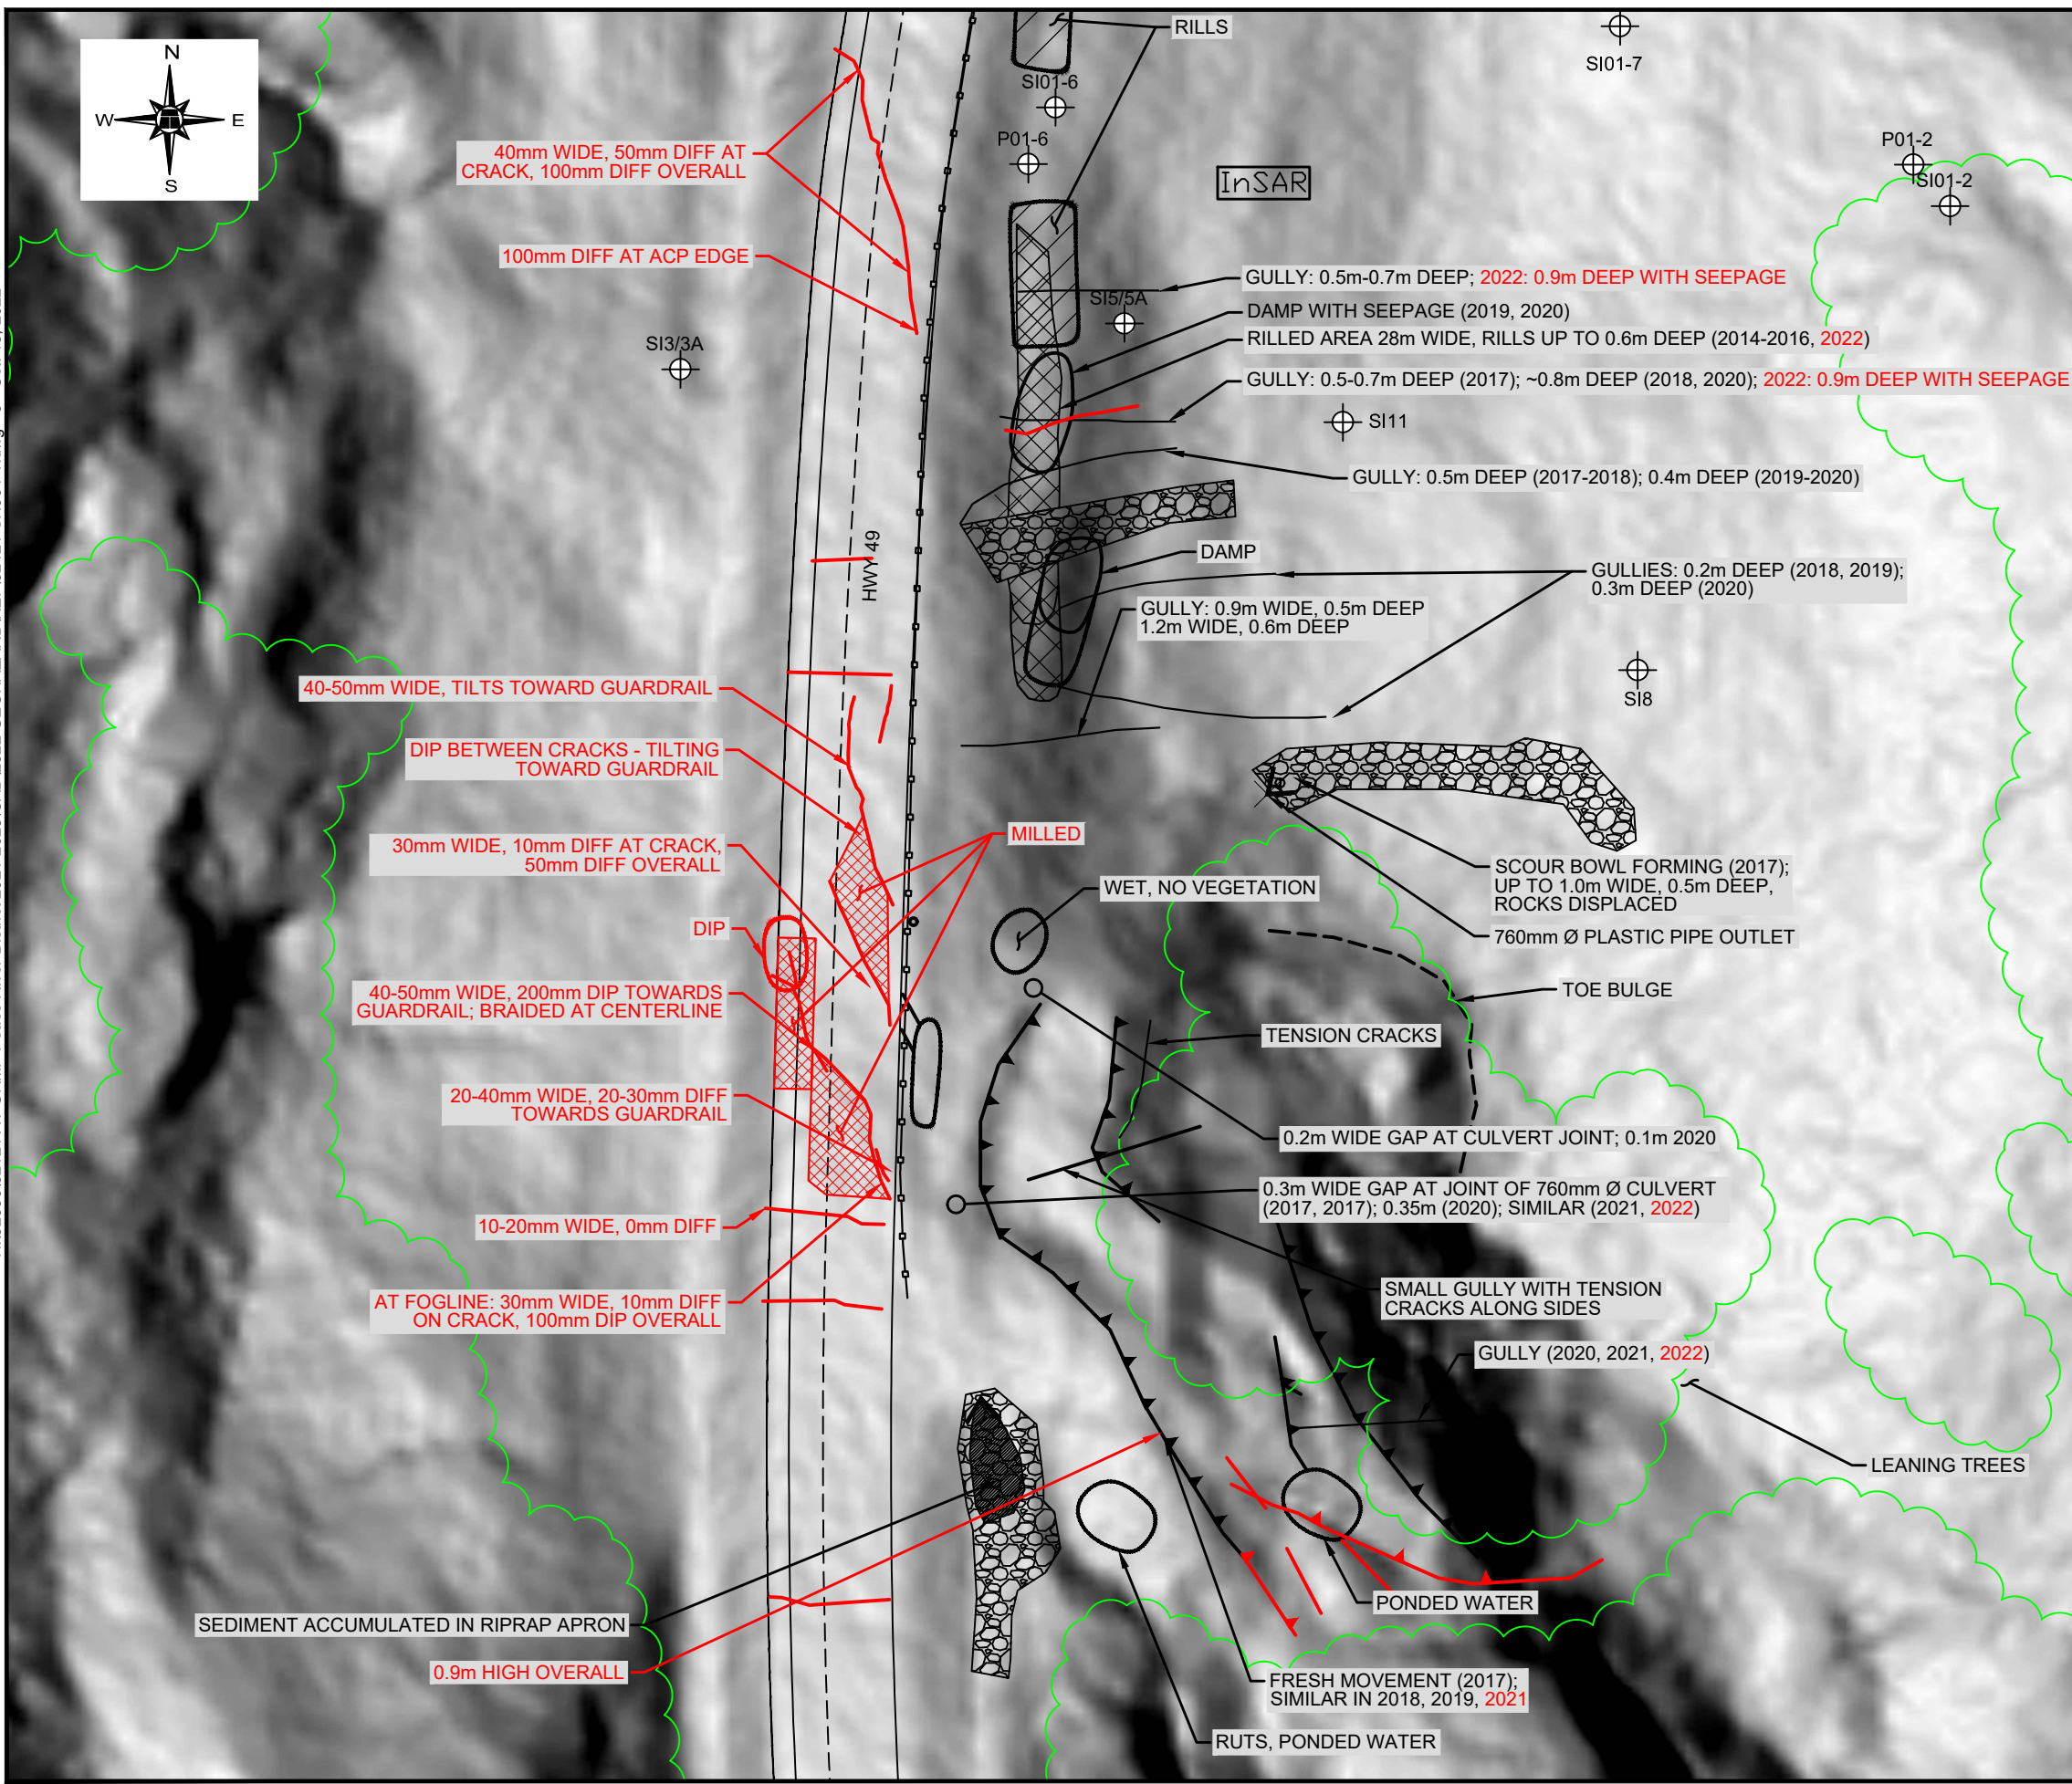
DWG No. 32121-SH004-1-3

**SH004-1: HWY 49:12 LITTLE SMOKY RIVER
SOUTH OF BRIDGE
2022 SITE INSPECTION PLAN - SOUTH PORTION**

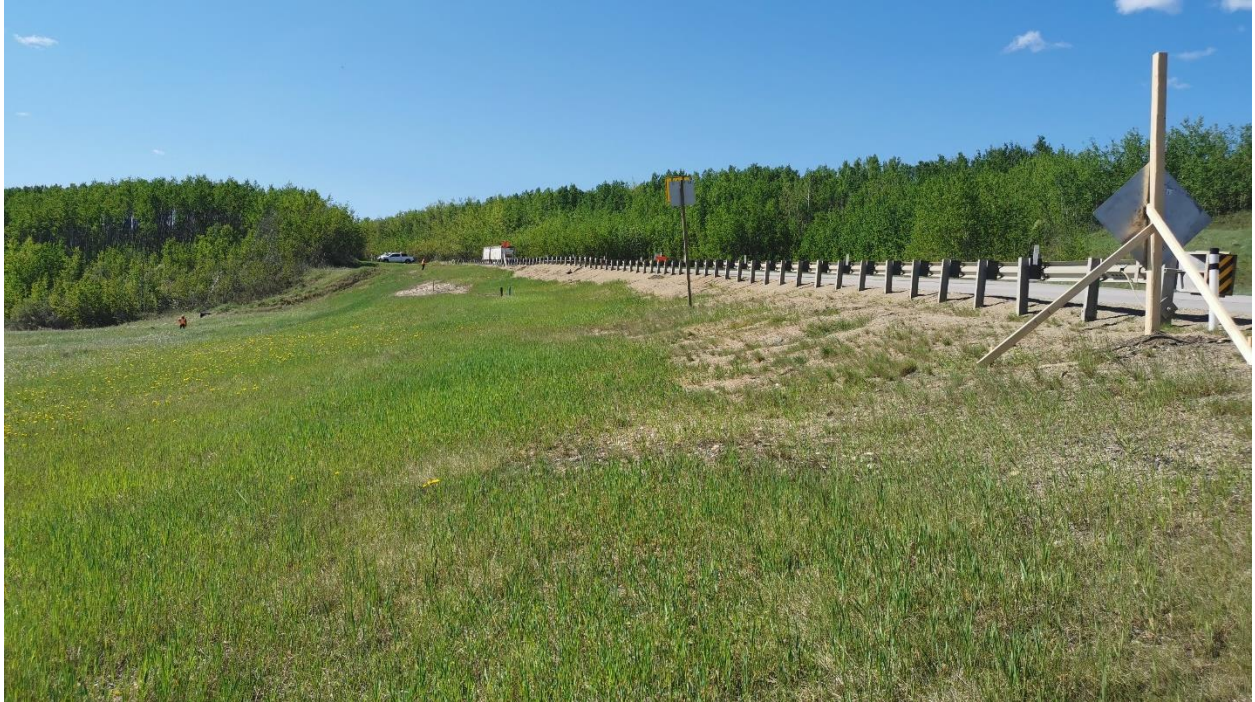
Photo 1 – Looking south at downslope side of highway at the north end of the site.

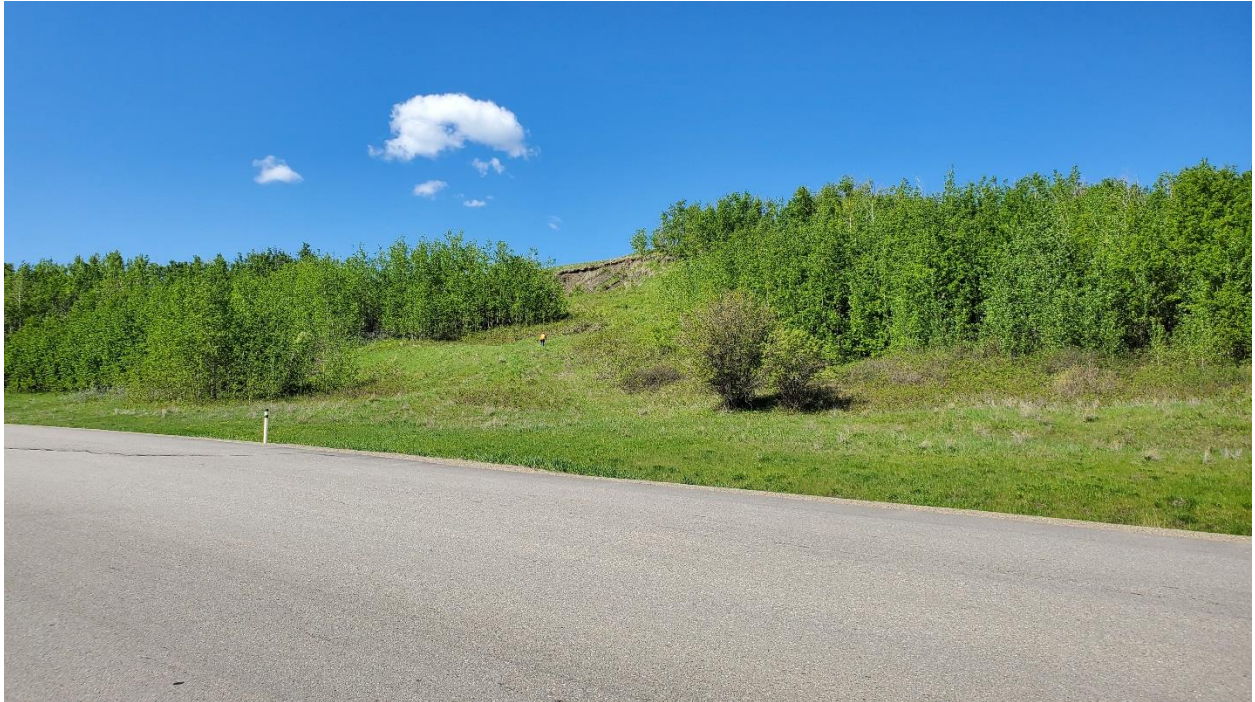
Photo 2 – Looking southwest slide movement in the backslope above the highway.

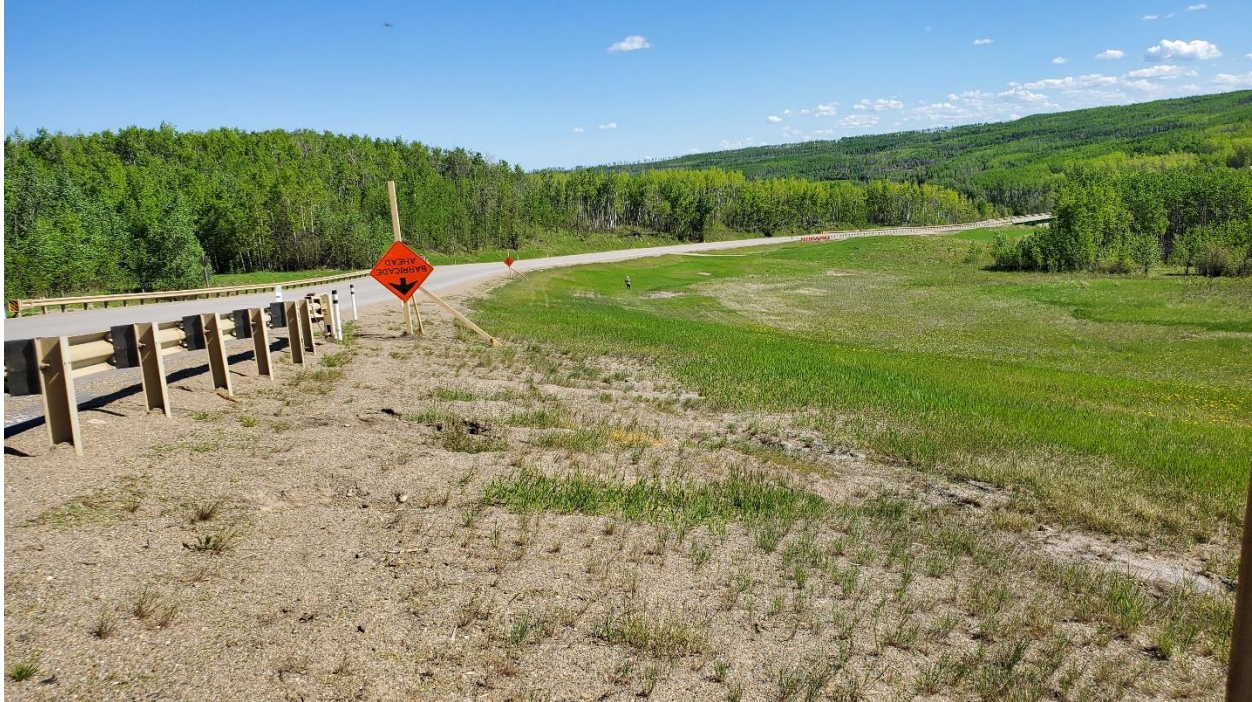
Photo 3 – Looking northeast at rilling below the guardrail.

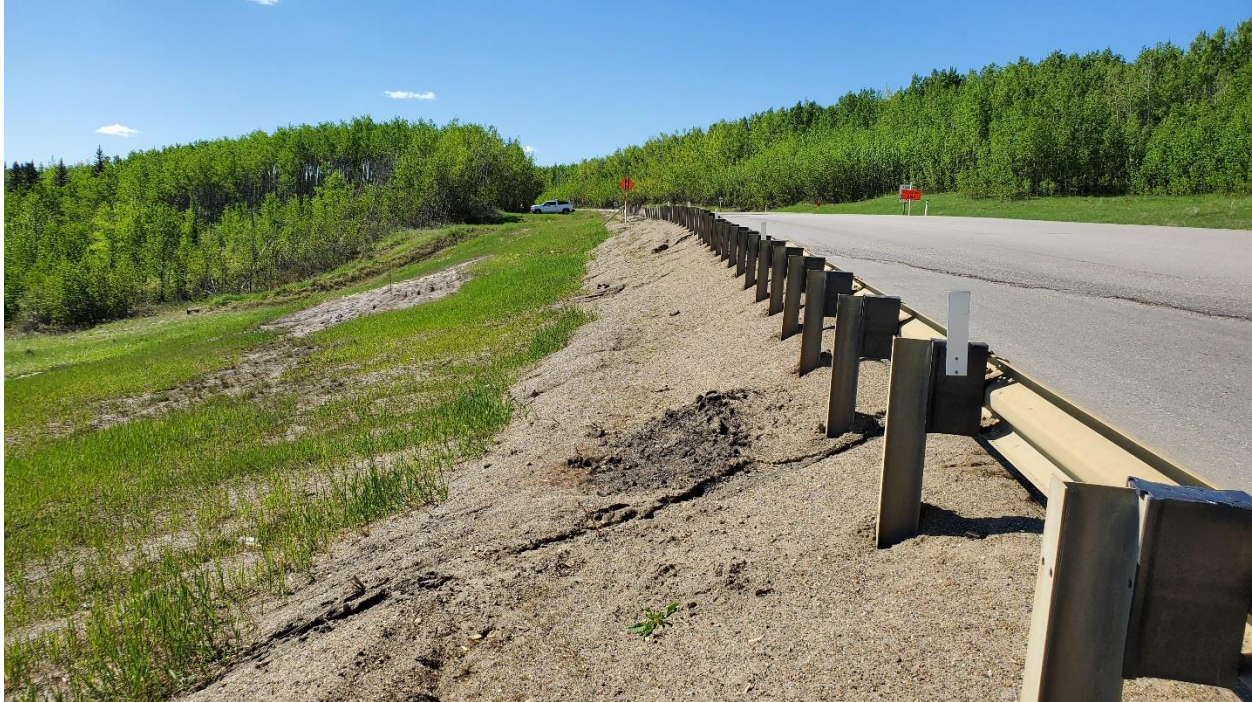
Photo 4 – Looking southwest at guardrail at south end of site. There was a significant sag at this location before the work in 2020.

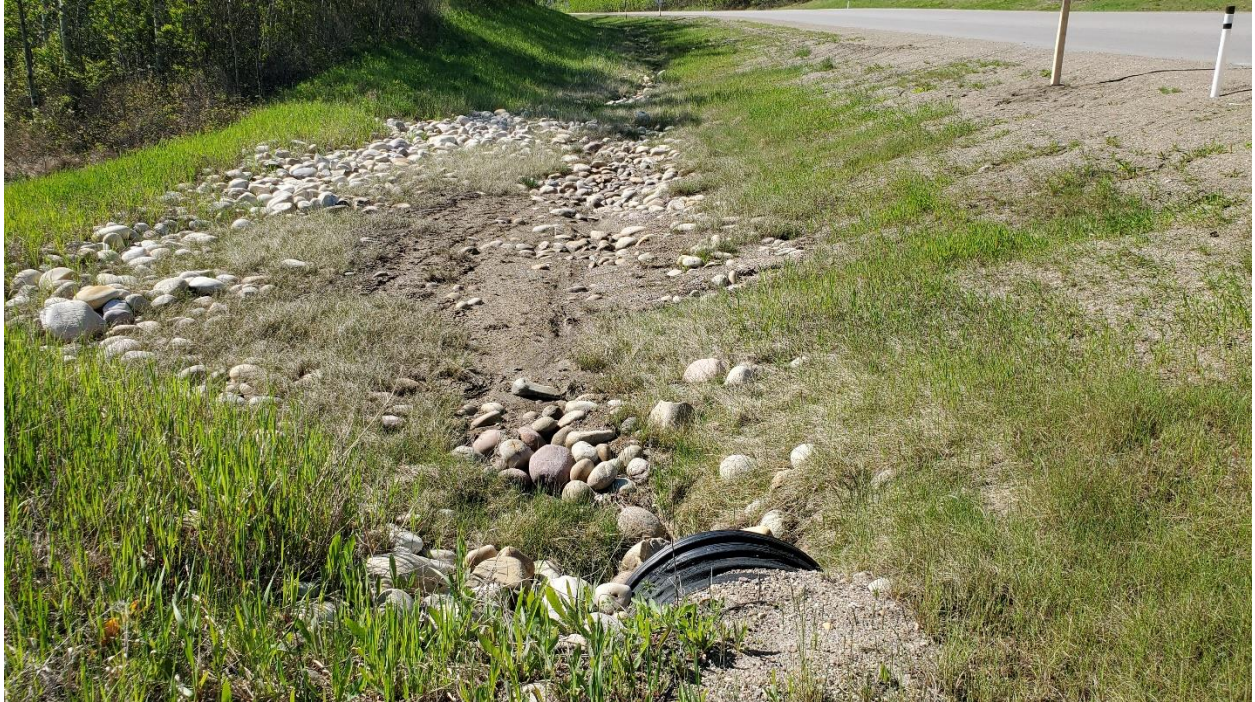
Photo 5 – Looking south along downslope ditch at sedimentation at inlet of 760 mm plastic culvert.

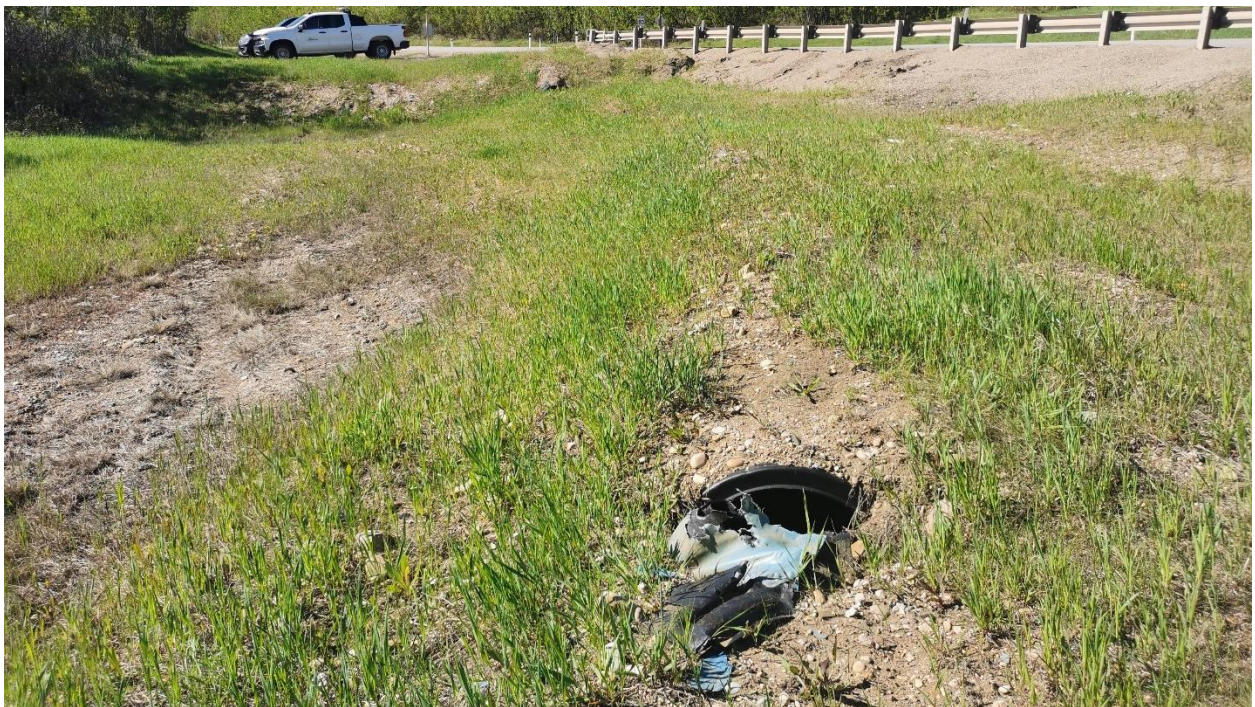
Photo 6 – Looking at 760 mm culvert joint separation.

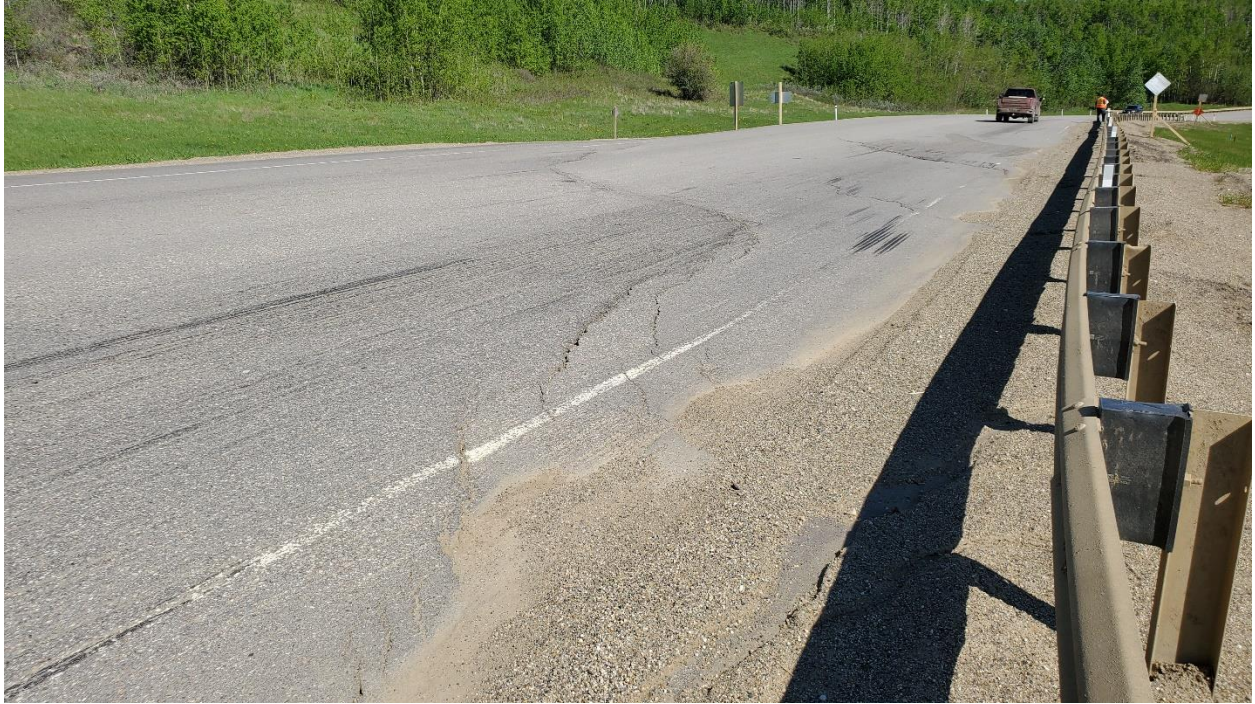
Photo 7 – Looking north at crack just north of the downslope guardrail.

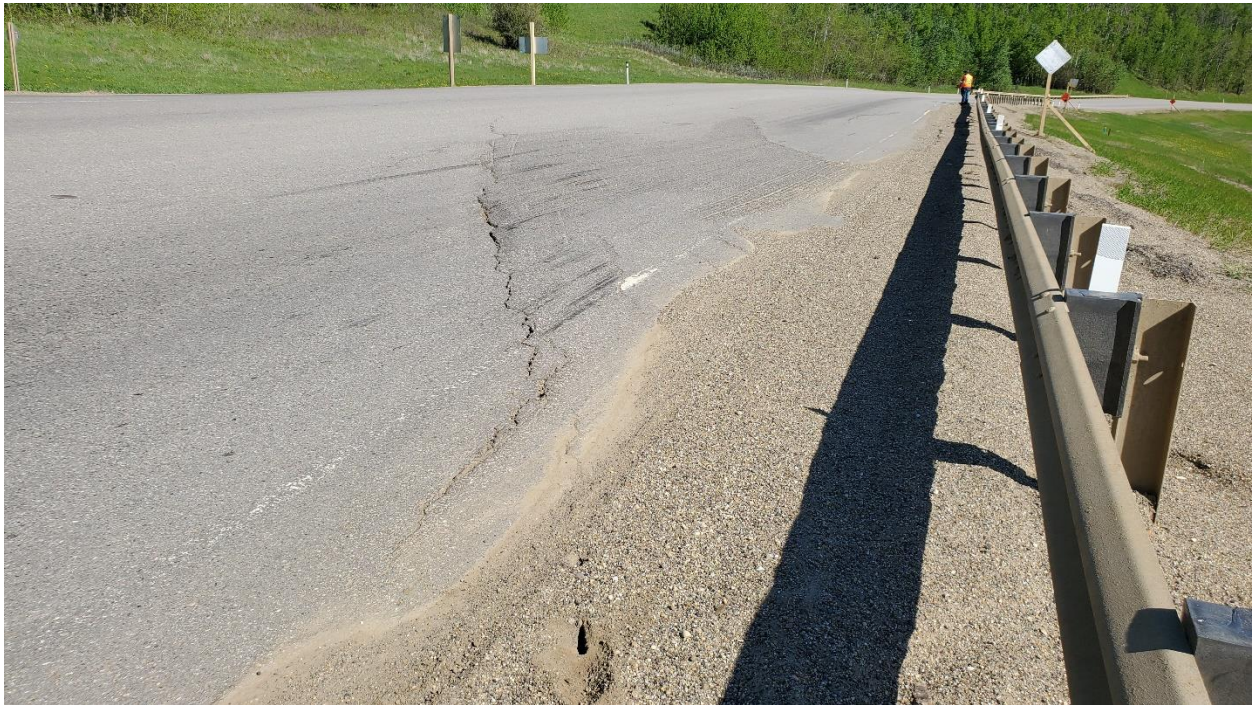
Photo 8 – Cracks across highway at south end of site.
