**ALBERTA TRANSPORTATION AND  
ECONOMIC CORRIDORS  
GEOHAZARD RISK MANAGEMENT PROGRAM  
PEACE REGION (PEACE RIVER DISTRICT)  
2025 INSPECTION**

Site Number	Location	Name	Hwy	km
SH004-1	South of Little Smoky River	Little Smoky River (South of Bridge)	49:12	2.3-2.6
<b>Legal Description</b>		<b>UTM Co-ordinates</b>		
W33-074-21-W5M		11 E 489,224	N	6,145,128

SH004-1: HWY 49:12 LITTLE SMOKY RIVER  
SOUTH OF BRIDGE  
2025 SITE INSPECTION PLAN - OVERALL

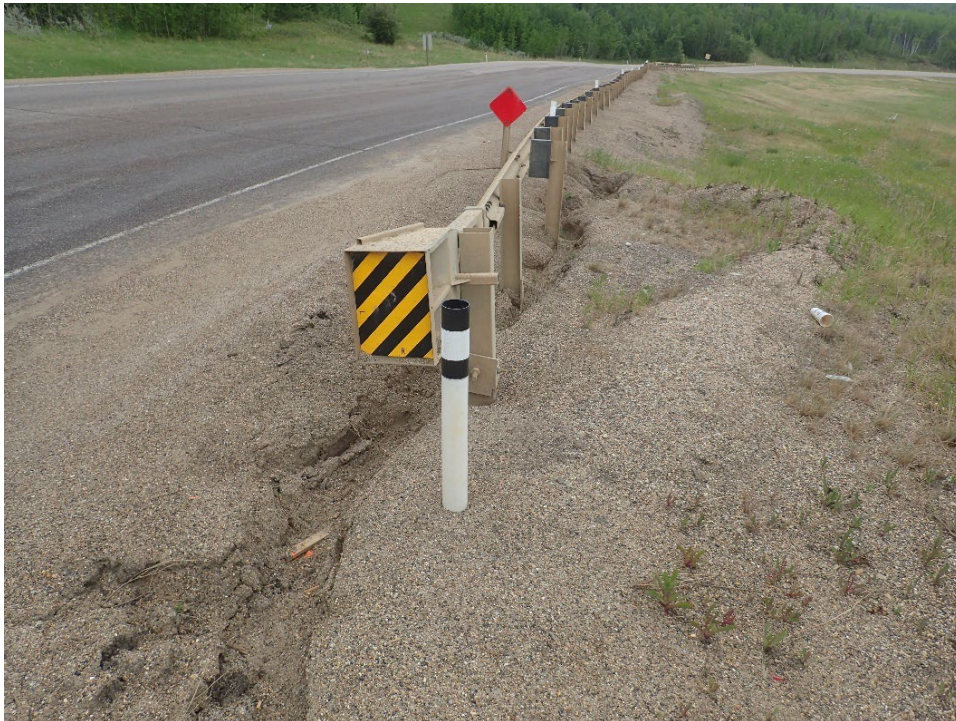
**Photo 1 – Looking north at an erosion gully that extends past south end of the guardrail.**

- Road maintenance consisting of milling and patching should continue as necessary (once or twice annually) to maintain the roadway surface in a safe condition. Crack sealing of the ACP should be done to limit infiltration of rain fall and snow melt into the extensive crack network. The bare areas on the downslope side of the highway to the north of the riprap apron have the potential to deteriorate further. This area could be regraded, topsoiled, seeded, and further secured with an erosion control blanket or seed-impregnated compost blanket. The second rill area near the north end of the site and the new gully at the south end of the guardrail could be repaired at the same time with the same methodology.

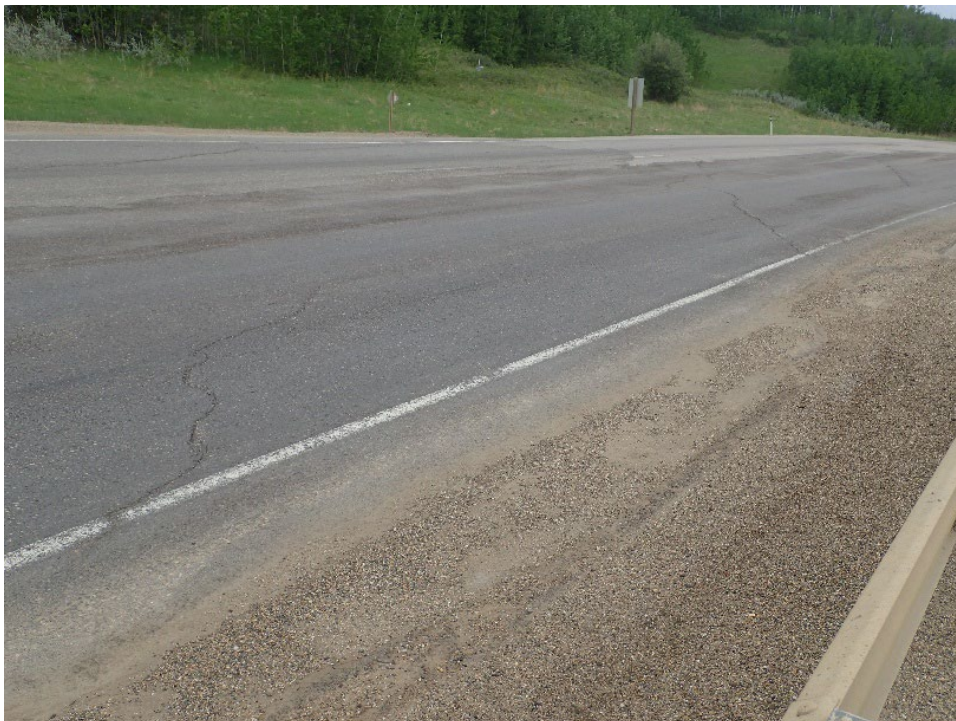
**Photo 2 – Looking north at the first set of scarp cracks at south end of the site.**

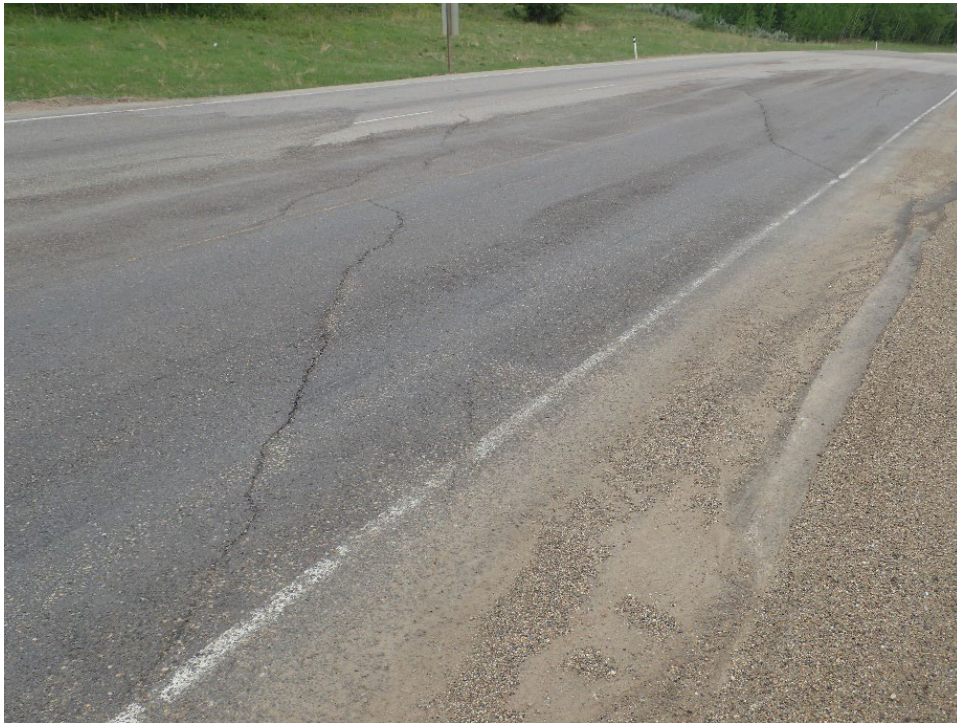
**Photo 3 – Looking north at second set of scarp cracks just north of Photo 2.**

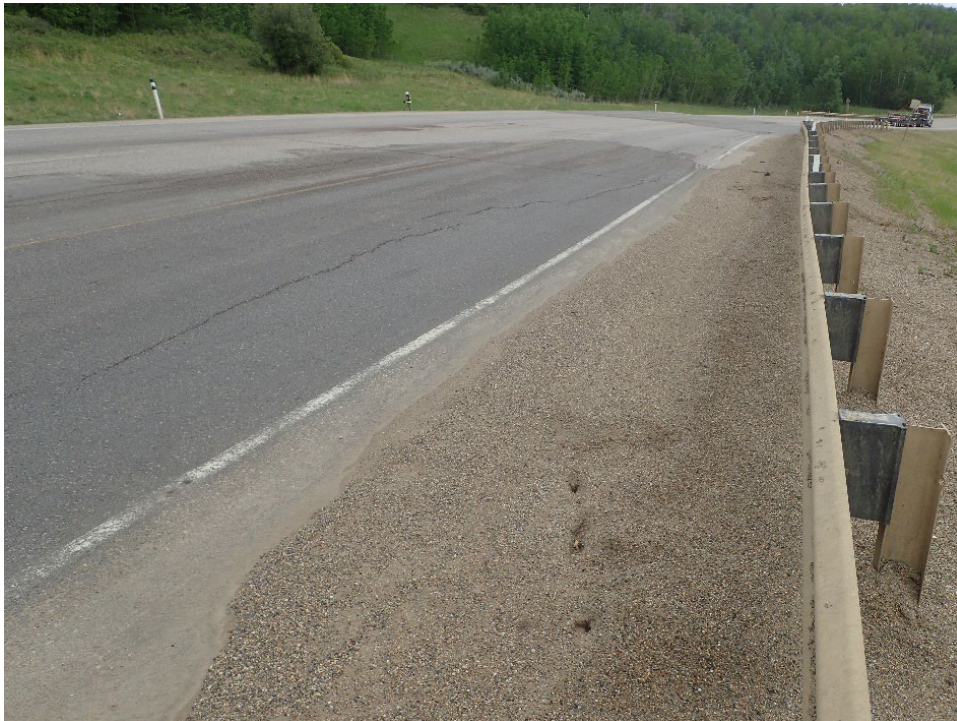
**Photo 4 – Looking north at extensions of cracks just north of Photo 3. Note small voids present on shoulder adjacent to guardrail.**

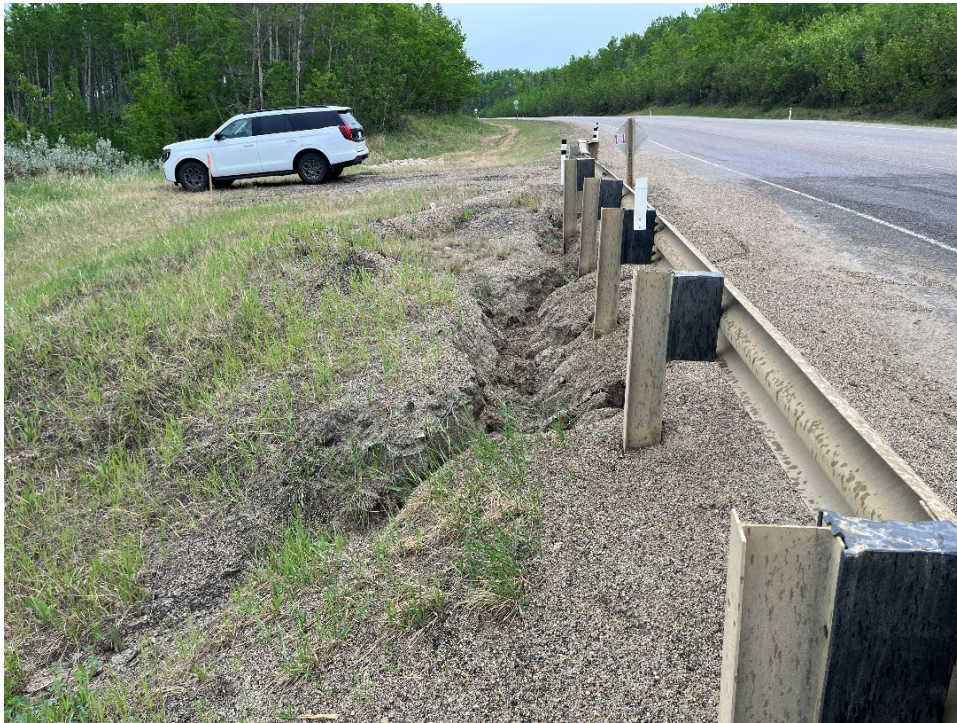
**Photo 5 – Looking south at an erosion gully present at the south end of the guardrail.**

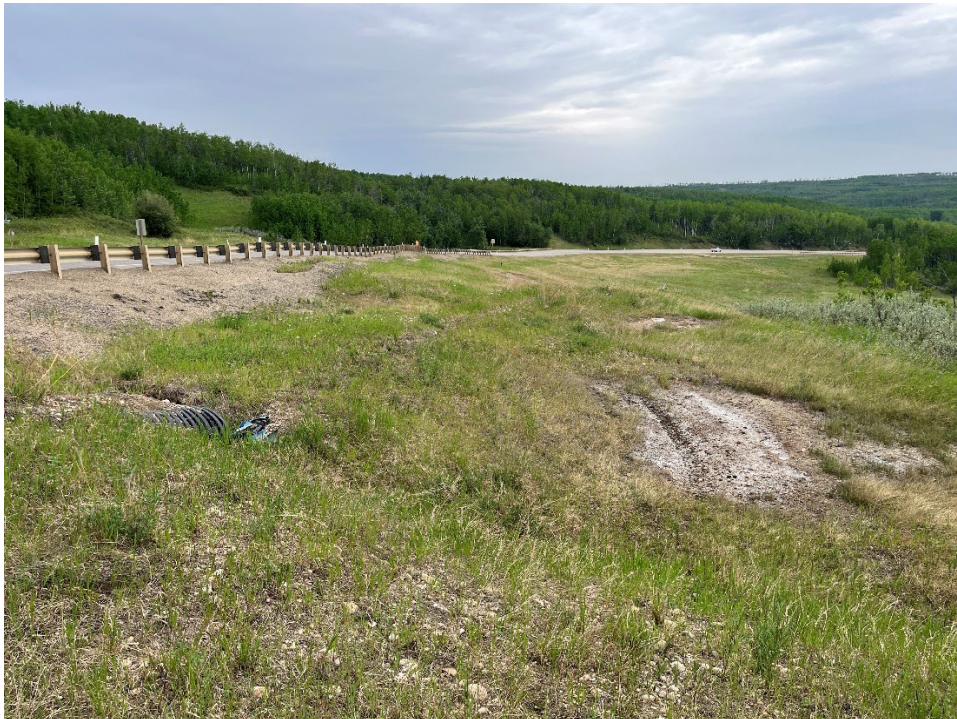
<input checked="" type="checkbox"/> Seepage	Evidence of seepage observed near culvert outlet at north end of site.	<input type="checkbox"/>
<input checked="" type="checkbox"/> Bridge/Culvert	Separation of plastic culvert.	<input type="checkbox"/>
<input type="checkbox"/> Other		<input type="checkbox"/>
<b>Instrumentation (Spring 2025):</b>		
VW07-2, VW07-2A, VW07-3, VW07-3A	Relatively stable and slightly decreasing over the last three years.	
Destroyed/Lost	VW07-2B and -3B (damaged Fall 2014); SI4A, SI01-6, SI01-7, SI01-2, SI07-3B, SI01-9, SI07-2B, PZ01-6, PZ01-2 (discontinued)	
<p><b>Assessment:</b></p> <p>The west and east valley slopes are prime examples of large scale, deep-seated retrogressive translational landslides. The overall west valley slope is moving as several separate slide blocks with numerous intermediate and main scarps, sag ponds, and differential movement zones. The highway alignment intersects these features which results in well established cracks crossing the highway and associated an uneven and tilted highway surface. The driving mechanism appears to be toe erosion by the Little Smoky River; a high ground water table may also be contributing. Based on GPS survey of the InSAR points conducted by Alberta Geological Survey (AGS Open Report 2013-14), this portion of the highway is located on landslide blocks moving relatively slower (5 mm to 40 mm per year) as compared to the eastside (SH003) or the bridge site (SH016). Drawing 32121-SH004-1-1 shows some of the local slide features that have been interpreted from the 2008 LiDAR imagery. Regrading of the slopes at this site has obscured the scarps of the larger slide blocks that are likely present beneath the highway alignment.</p> <p>The ongoing movement of the valley slope results in continued deformation of the highway surface that requires frequent widespread patching. An overlay was placed in the summer of 2020 to maintain the smoothness of the highway. Reportedly, the crack pattern in the highway started reflecting through the overlay in less than 24 hours. As the crack pattern became fully established, the increasing differential across the cracks required milling in 2021, 2022, and 2023. Patching was required in 2024 and, as shown on the Drawings, the crack pattern quickly became re-established. Similarly during the 2025 inspection, cracks started to reflect through recent patches. There are three main sets of scarp cracks crossing the highway on a NW-SE orientation and likely represent retrogressive movements of the valley-scale landslide blocks.</p> <p>The areas of rilling have slowly stabilized over the last two years. The erosion gully that formed at the south end of the site at the end of guardrail in 2023 has widened since.</p> <p>There is a break in the plastic culvert that handles downslope ditch flow from the south that is creating a sinkhole. The sinkhole has not changed in size significantly in the last few years. A second gap at a culvert joint was observed in 2019 about 25 m further north. Both of these gaps in the culvert were slightly wider in 2023 and 2024. The gaps have not changed during the 2025 inspection.</p> <p>The slope below an approach located at the south end of the site started to deteriorate in 2019. There was increased displacement and extension of the tension and scarp cracks on this slope and the gully in the centre of the feature continued to deepen. This area seems to have stabilized in 2023 and 2024. This area warrants continued monitoring as retrogression of the features toward the highway could occur relatively rapidly.</p> <p>UAV photos revealed minor scarps downslope and north of the east guardrail. During the 2025 inspection, these scarps were very faint on site, being mostly obscured by the vegetation present. The slope inclinations at these locations are not very steep but warrant monitoring if they continue to progress.</p>

**Photo 6 – Looking north at sideslope of highway at south end of site. The south culvert joint separation is on the left side of the photo.**

- The break in the culvert should be repaired to limit infiltration into the slope which could potentially result in slope movement or significant erosion. Alternatively, this culvert could be replaced with a more robust welded steel pipe, or a well anchored above-ground half-culvert.

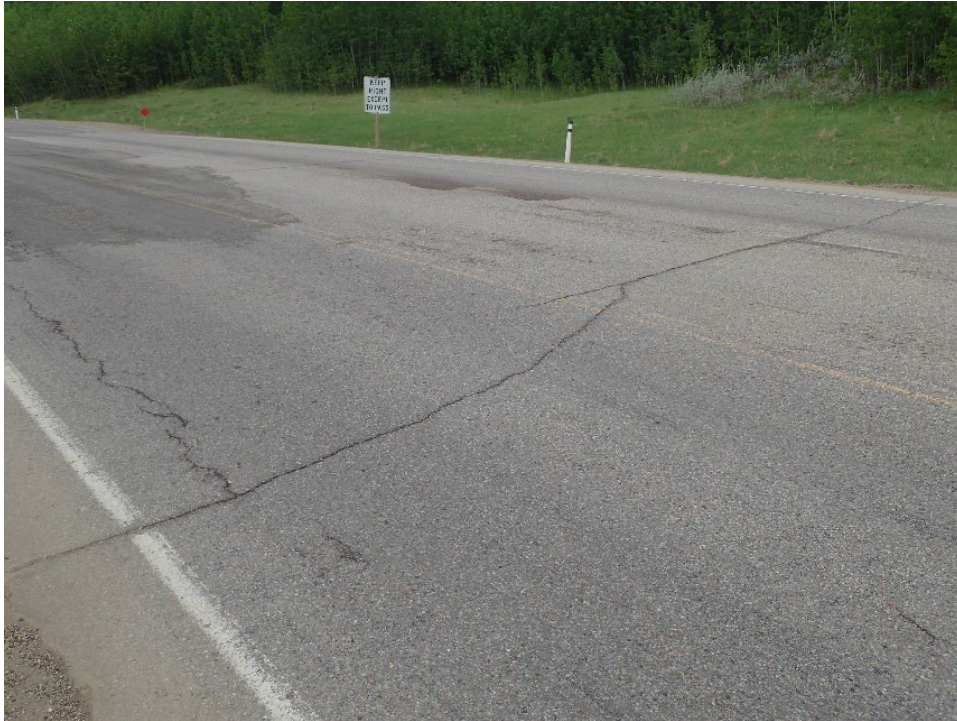
**Photo 7 – Looking west at cracks present outside of patched areas.**

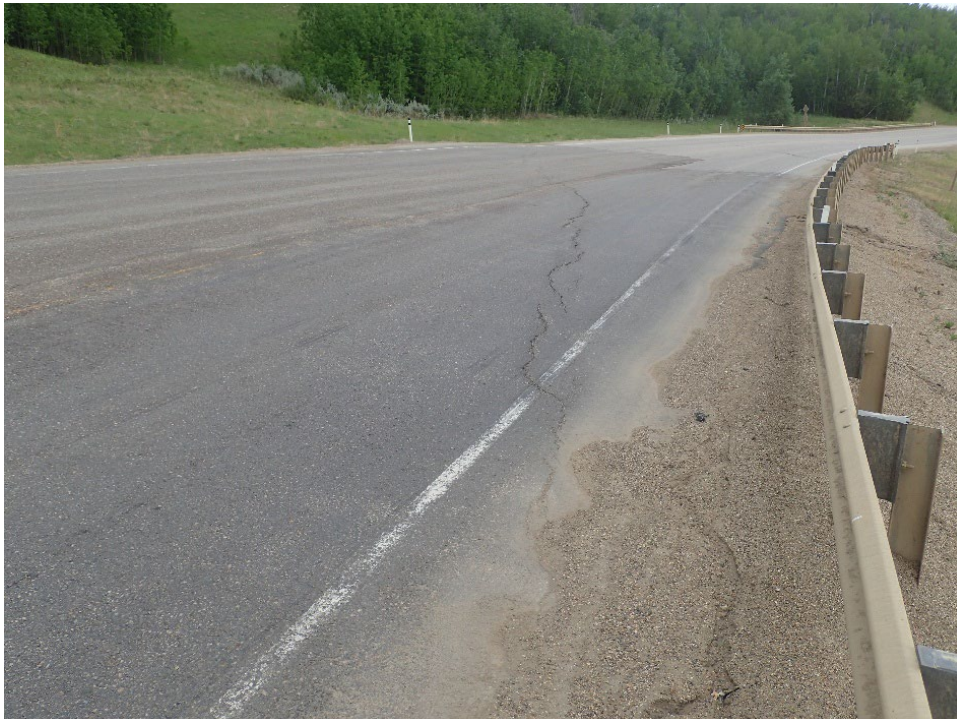
**Photo 8 – Looking north at third set of scarp cracks near the north end of the east guardrail.**

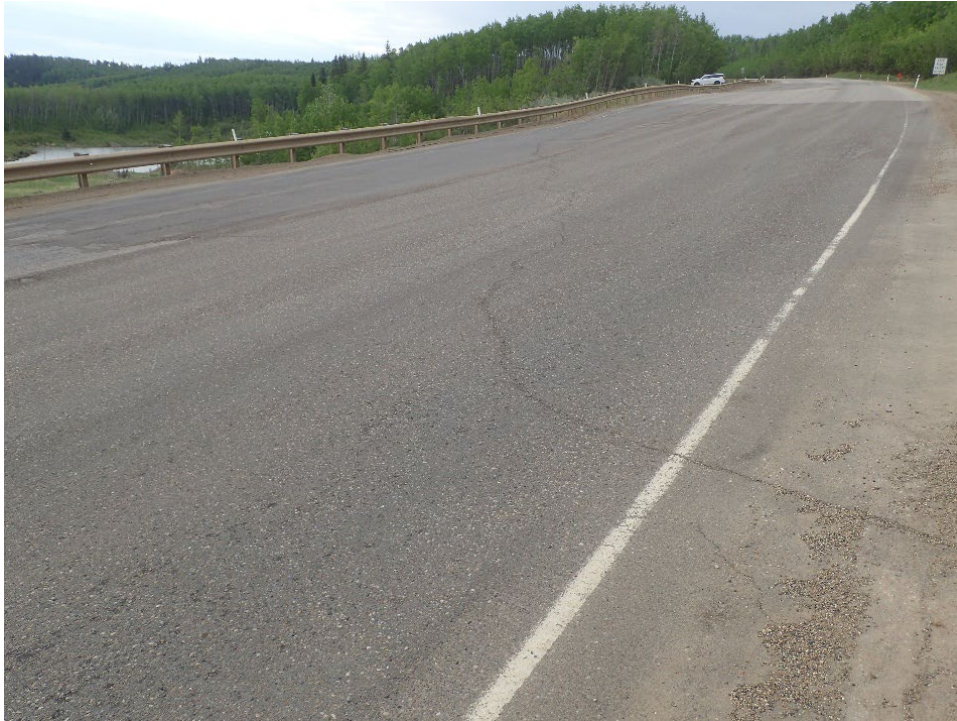
**Photo 9 – Looking south at third set of scarp cracks from north end of east guardrail.**

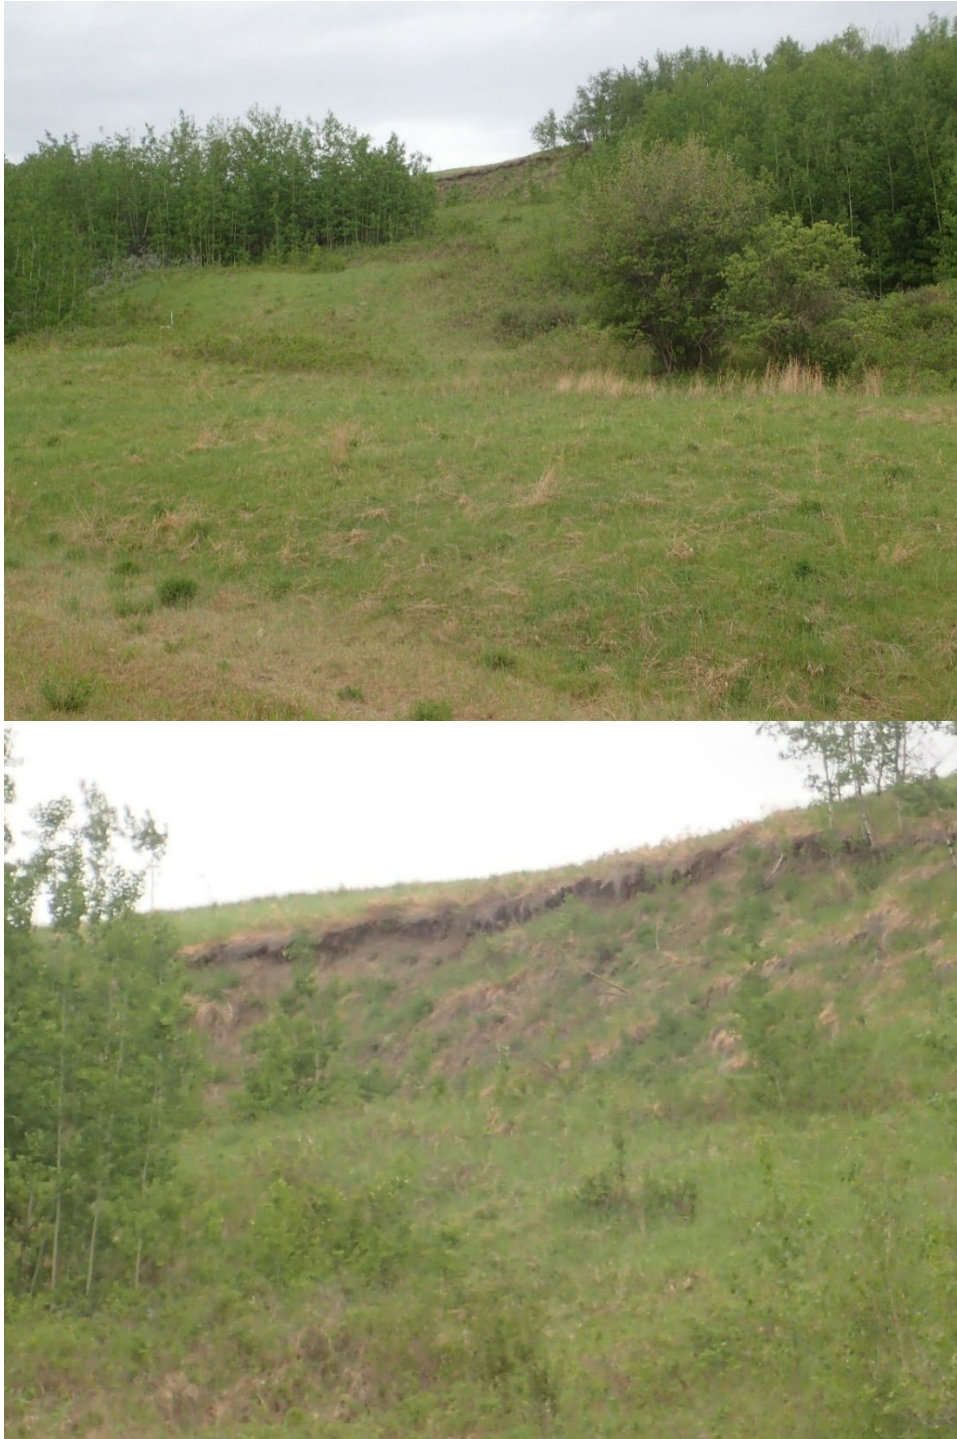
**Photo 10, 11 – Looking at the southwest slide movement in the backslope above the highway.**

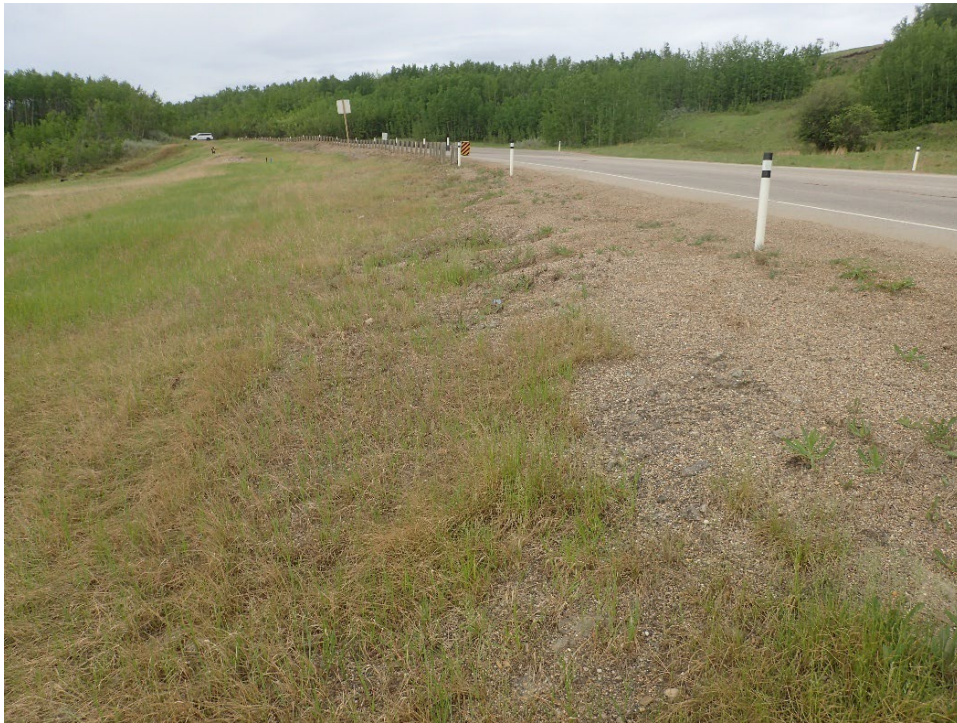
**Photo 12 – Looking south at downslope side of highway from the north end of the site.**

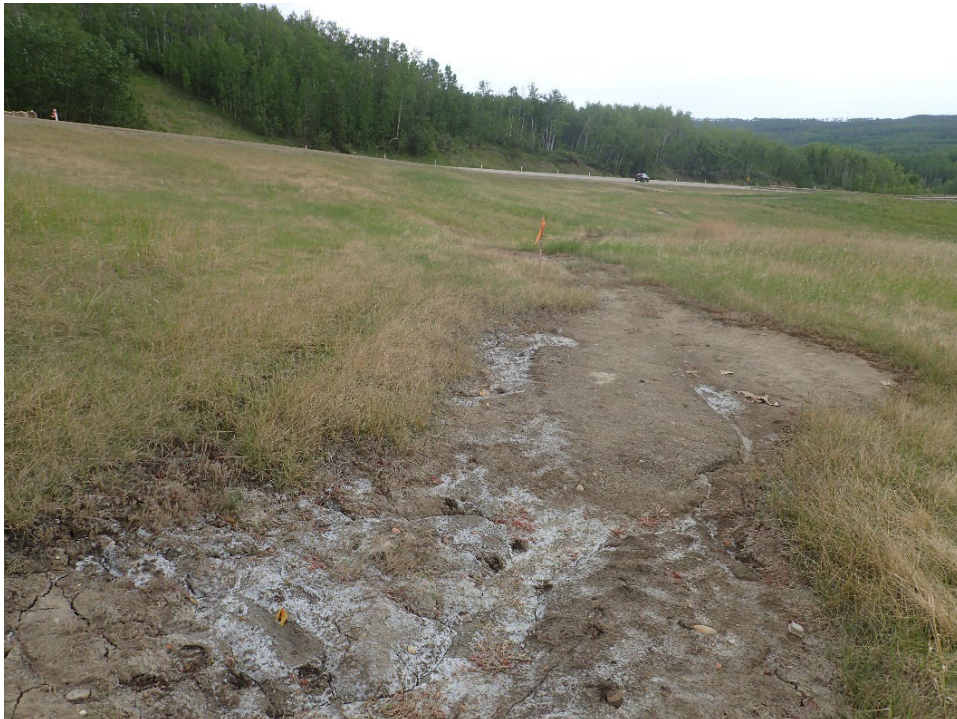
**Photo 13 – Looking north at bare area on sideslope with previously observed seepage. Area was observed to be dry in 2025.**

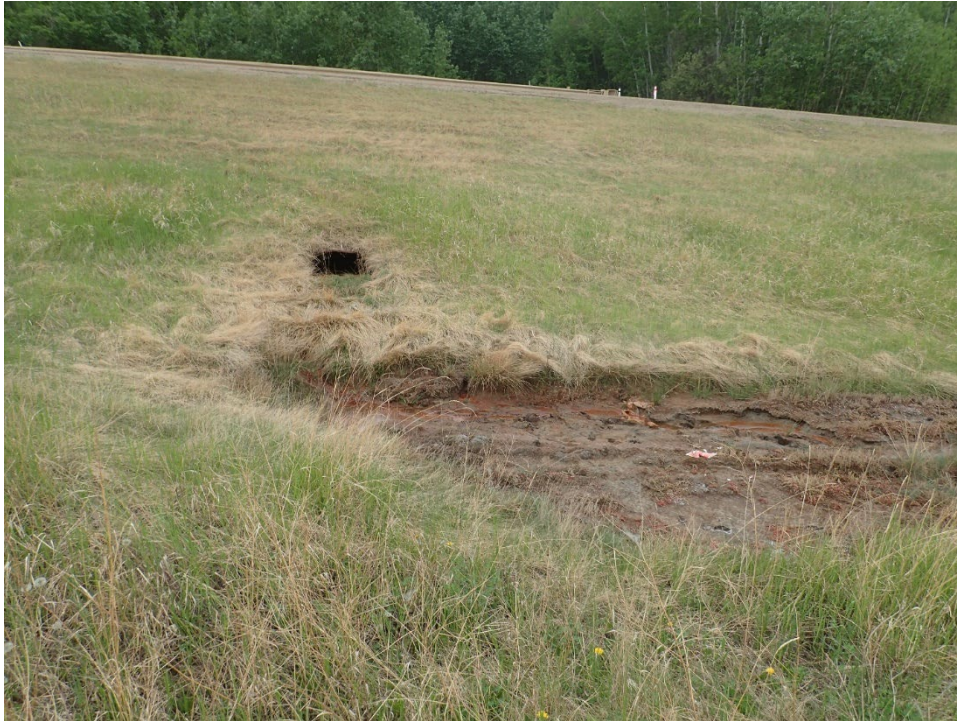
**Photo 14 – Looking west at culvert outlet with observed rust-stained area and soft ground.**

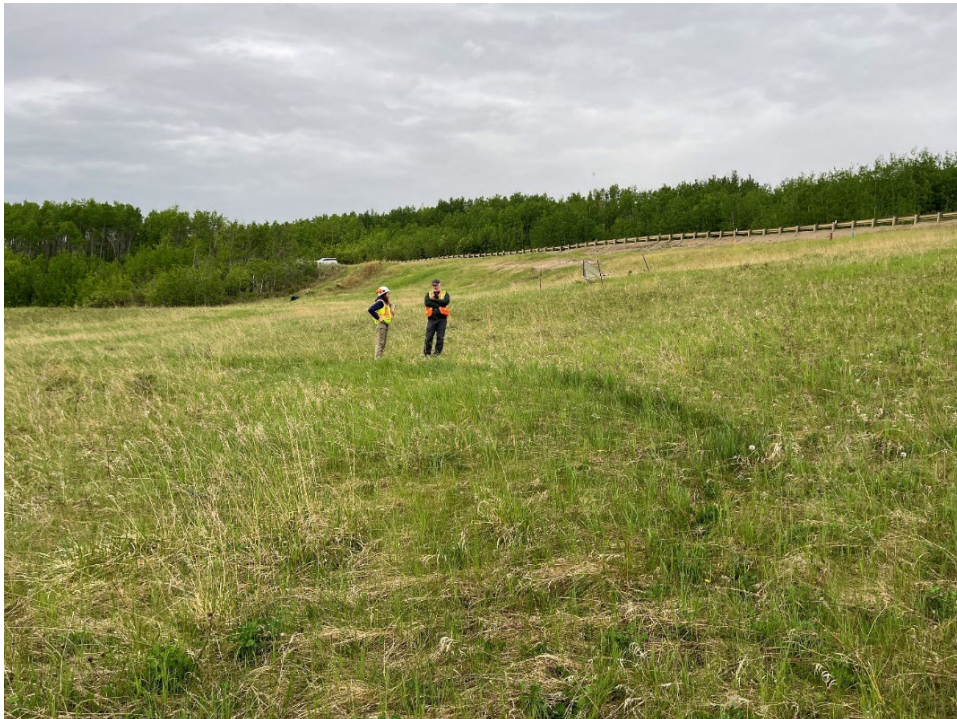
**Photo 15 – Looking south at faint scarps observed downslope of highway.**
