THURBER ENGINEERING LTD.

December 5, 2016

File: 13351

**GEOHAZARD ASSESSMENT PROGRAM
CALL-OUT INSPECTION
HWY 58:14 km 18 to km 19.5 – WEST OF GARDEN RIVER**

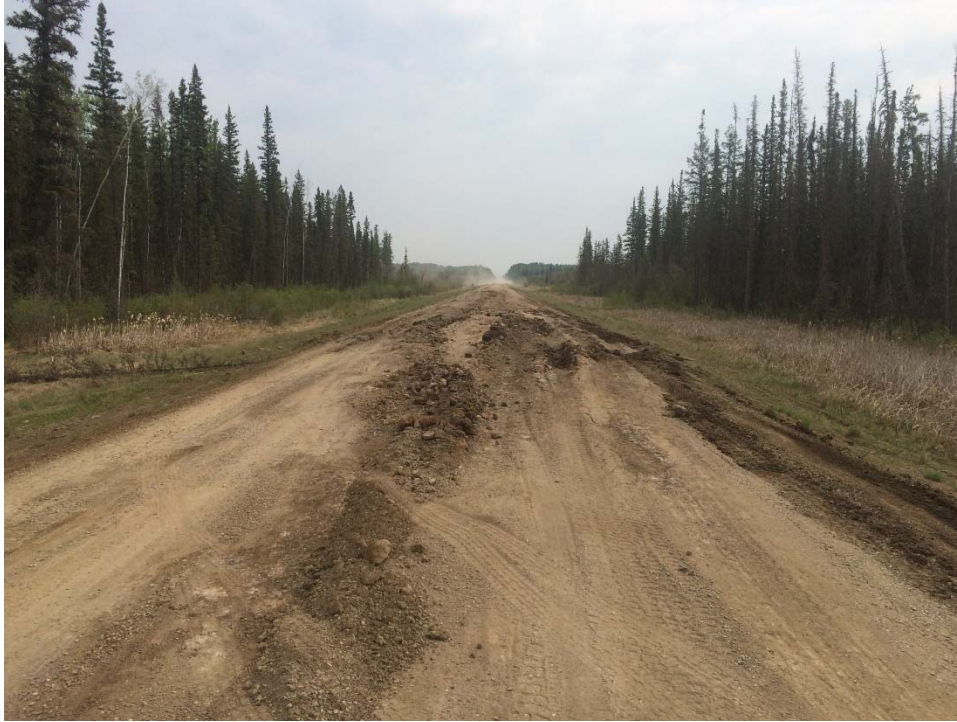
The site encompasses about 1.5 km of the gravel-surfaced Highway 58:14 between km 18 and km 19.5. The site is located about 18 km east of the Wentzel River and about 160 km east of High Level, Alberta. At the time the distress was noted (see attached May 2016 photos), the rutting was about 300 mm to 400 mm deep and had occurred during the spring melt. Mr. Catt had observed that the rutting commenced from the east end of the distressed area and moved to the west as the road deteriorated. At the time, there was significant fuel truck hauling occurring to the Little Red River Cree Nation settlement of Garden River located to the east beyond the end of Highway 58 (which is coincident with the western boundary of Wood Buffalo National Park, WBNP).

AT Photo 1: Distress in May 2016.

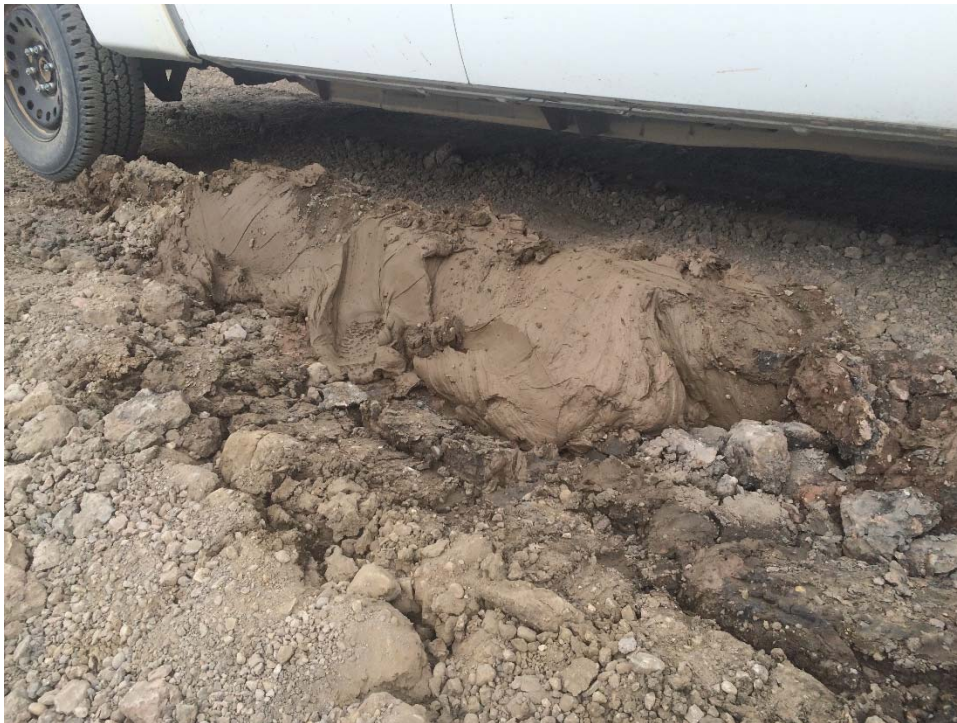
AT Photo 2: Closer view of May 2016 rut.

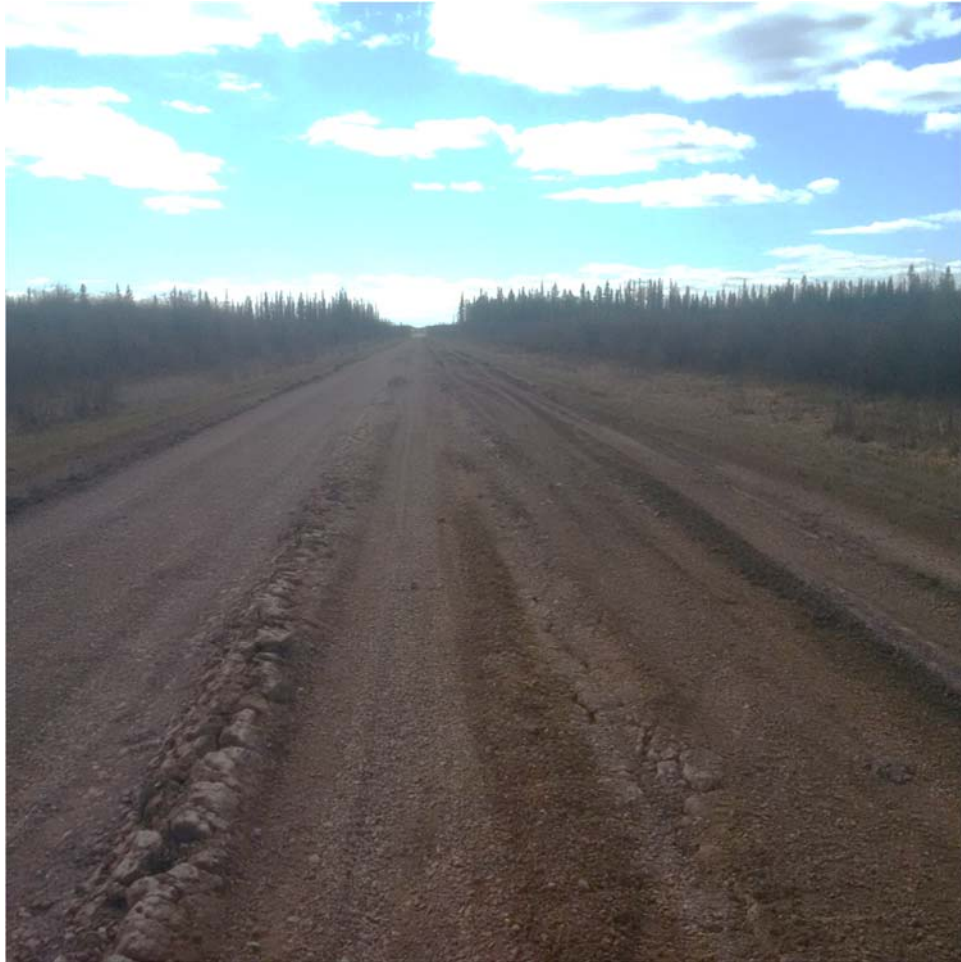
AT Photo 3: Distress in May 2016.

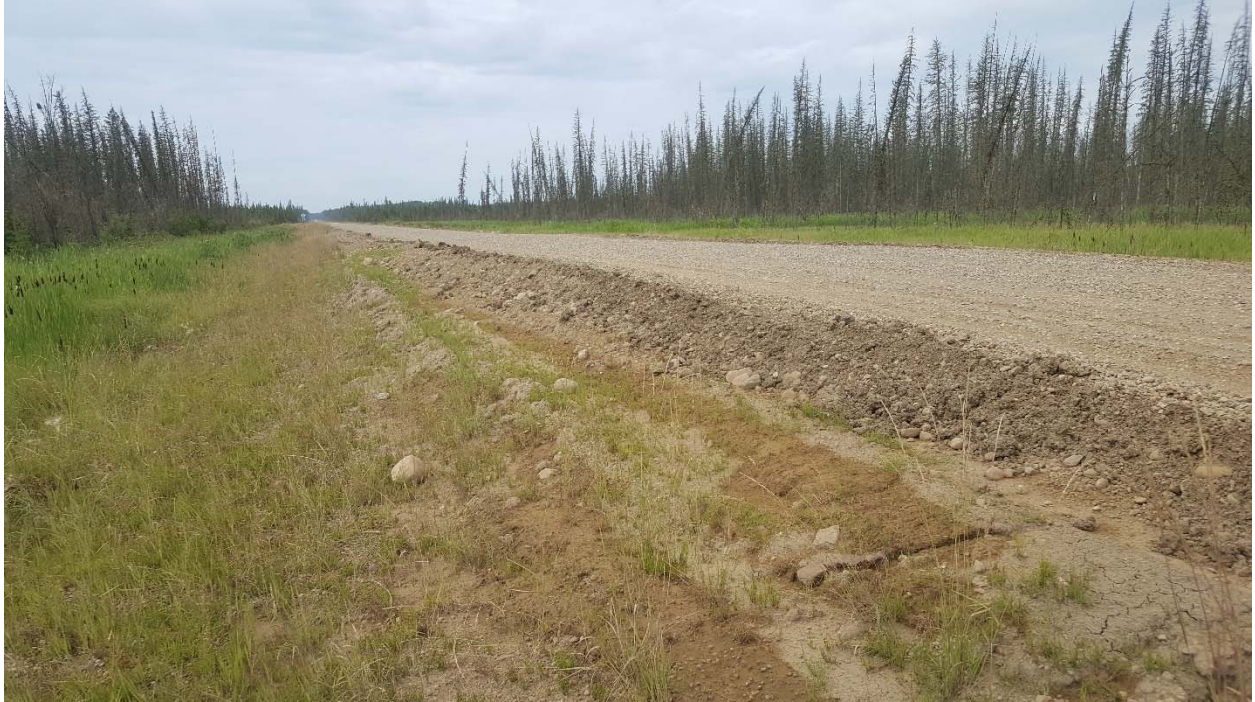
At the time of the site visit in July 2016, the road had already been repaired by the maintenance contractor under the direction of the MCI. According to Mr. Catt, they bridged the soft, rutted area by placing significant quantities of pitrun gravel over the existing surface (after grading out the ruts; however, there was no subexcavation undertaken). The thickness of gravel material placed was up to 0.9 m at the west end and 0.6 m at the east. Mr. Catt observed that the subgrade soils exposed during excavation were typically either very dry or saturated. He also noted that it did not appear that the muskeg had come up into the fill suggesting that the depth of failure did not extend into the subgrade (the native peat). Most of the highway surface through the distressed area appeared to be in good condition at the time of the site visit with some soft areas noted between km 18.34 and km 18.43 and at km 18.70.

TEL Photo 1: Looking east toward start of distressed and note the thickness of pitrun placed in May 2016.

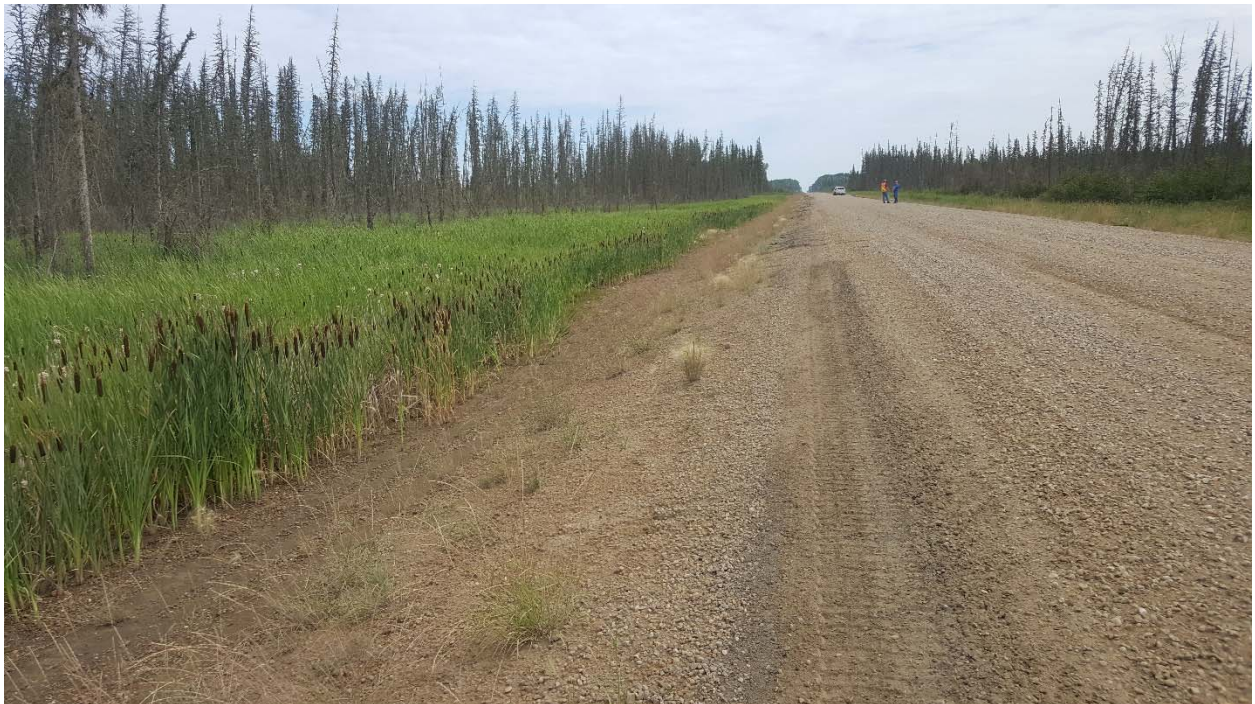
In general, the highway embankment was approximately 0.8 m in height, 8 m in width, with 3H:1V sideslopes. Where present, the ditches were shallow and with no distinguishable drainage path. There were numerous areas of ponded water adjacent to the highway. The surrounding terrain was predominantly peat (muskeg) with low spruce and willow vegetation with a few local areas of slightly higher ground. The terrain to the west of km 18 consists of similar organic deposits and vegetation while east of km 19.5 the ground rises a few metres in elevation and is predominantly tall pine and aspen. There were three centerline culverts identified through the 1.5 km section. The culverts were partially filled with ponded water and no flow was observed. Based on overall topography, the general flow patterns are from the Caribou Mountains to the north toward the Peace River in the south.

TEL Photo 2: Looking west along highway near west end of distress showing typical muskeg terrain.

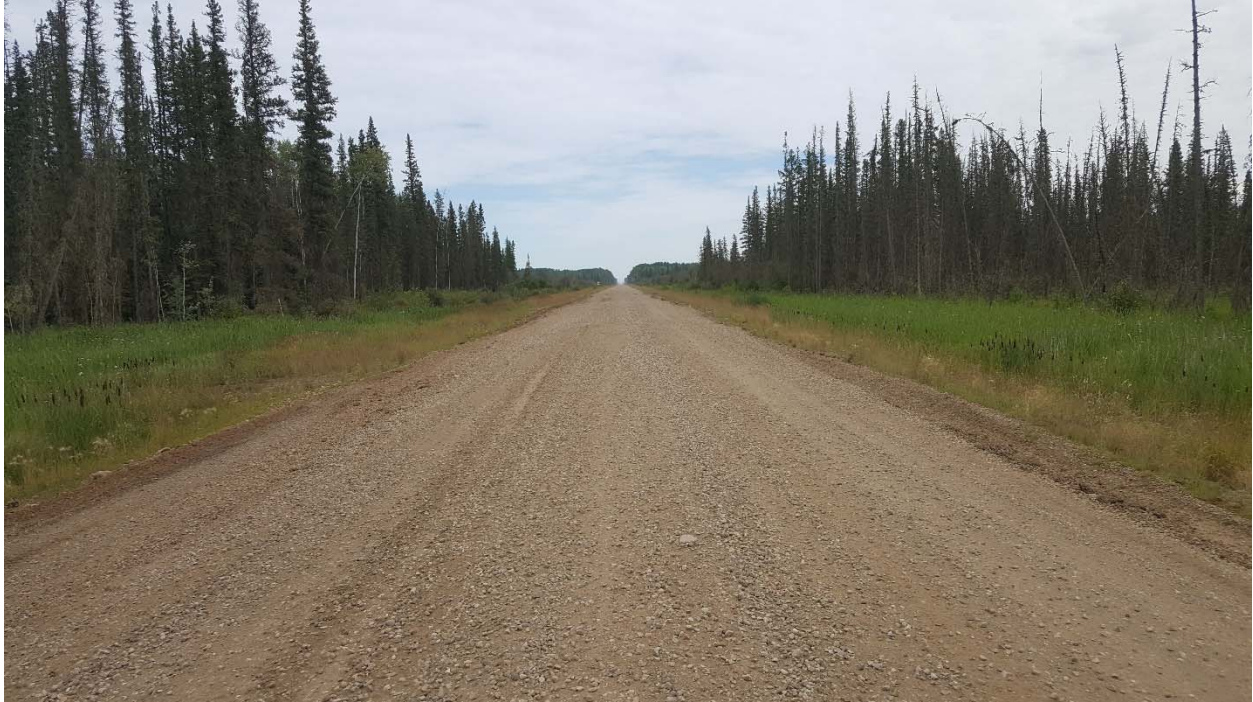
TEL Photo 3: Looking east toward slightly higher ground between km 18.34 and km 18.43.

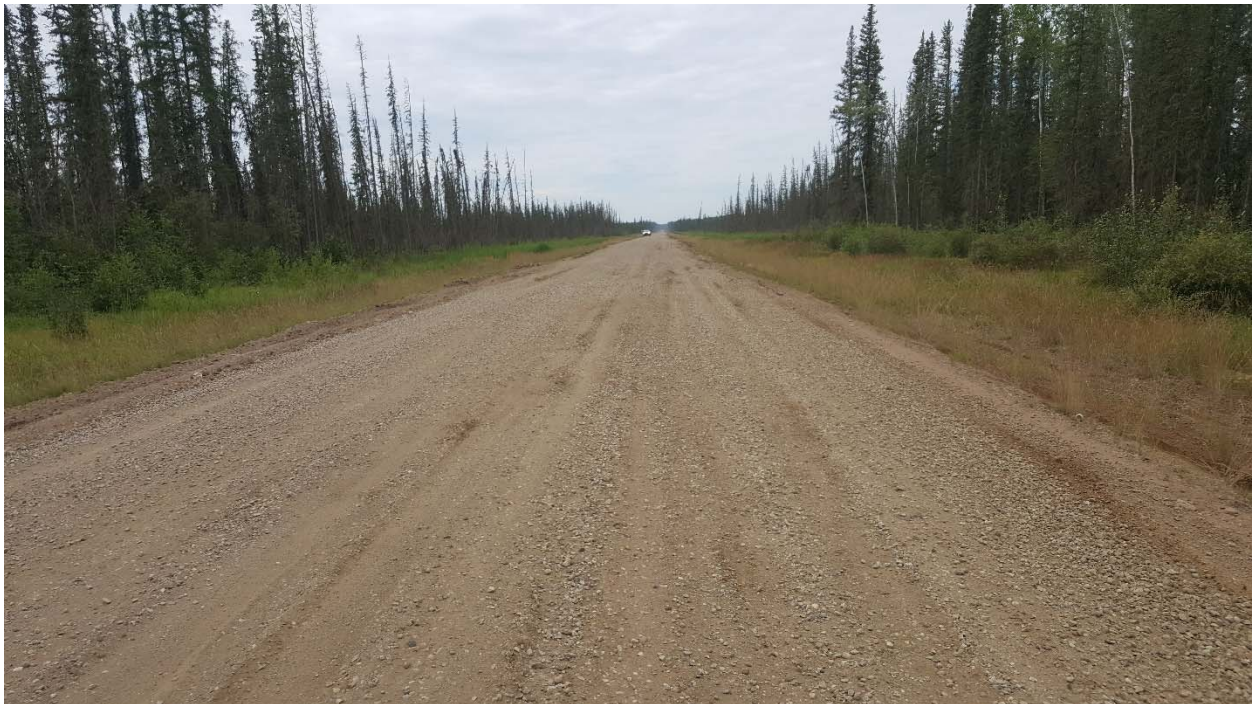
TEL Photo 4: Looking west at local soft spots between km 18.34 and km 18.43.

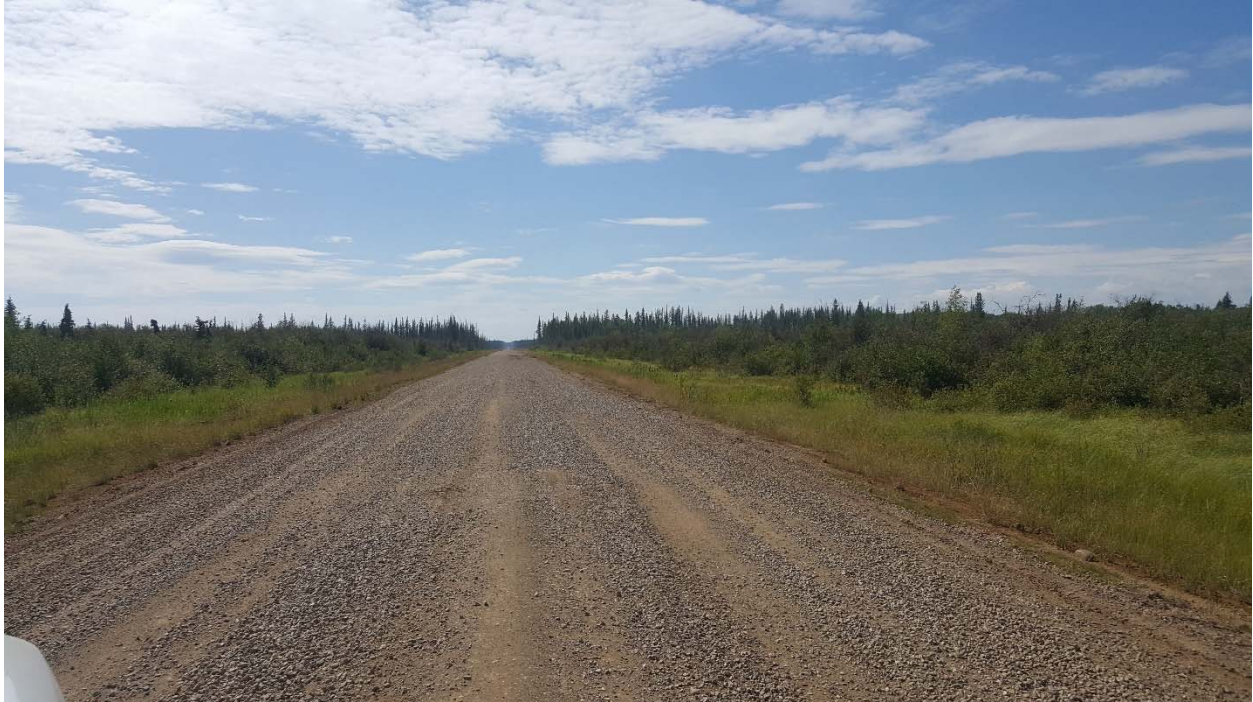
TEL Photo 5: Looking west from km 19.0. near east end of distressed area.

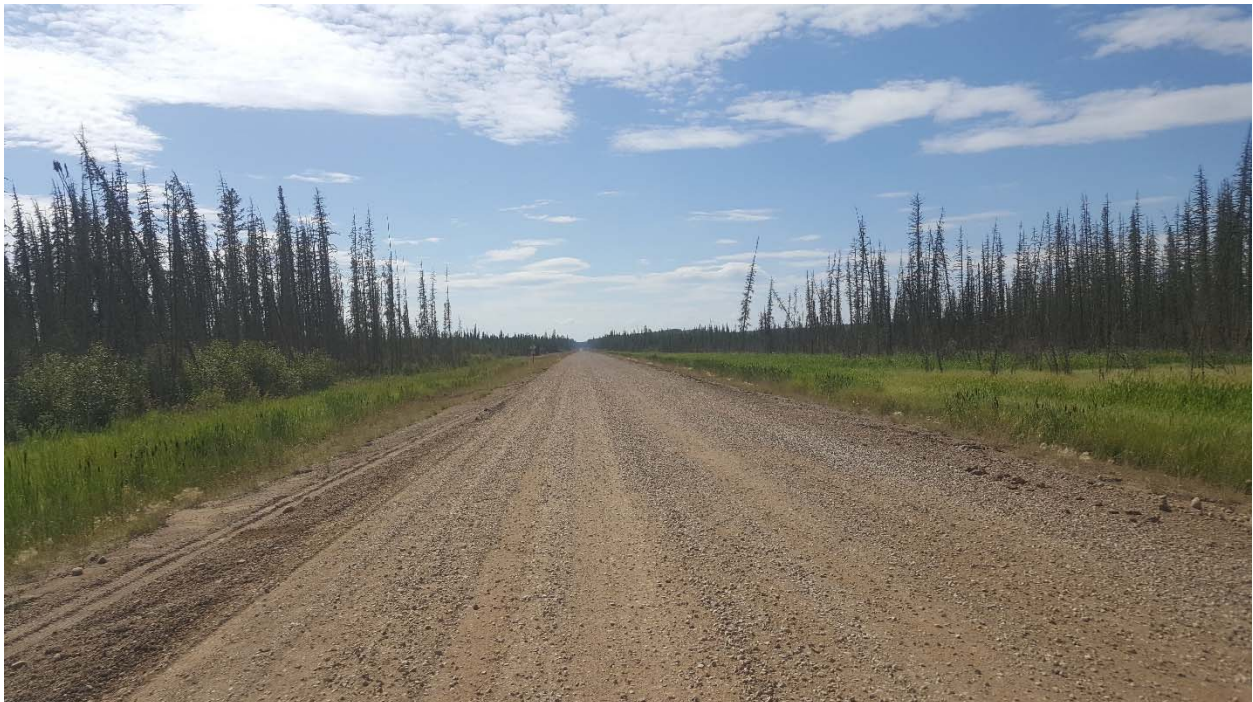
TEL Photo 6: Looking west from km 18.1 near west end of distressed area.

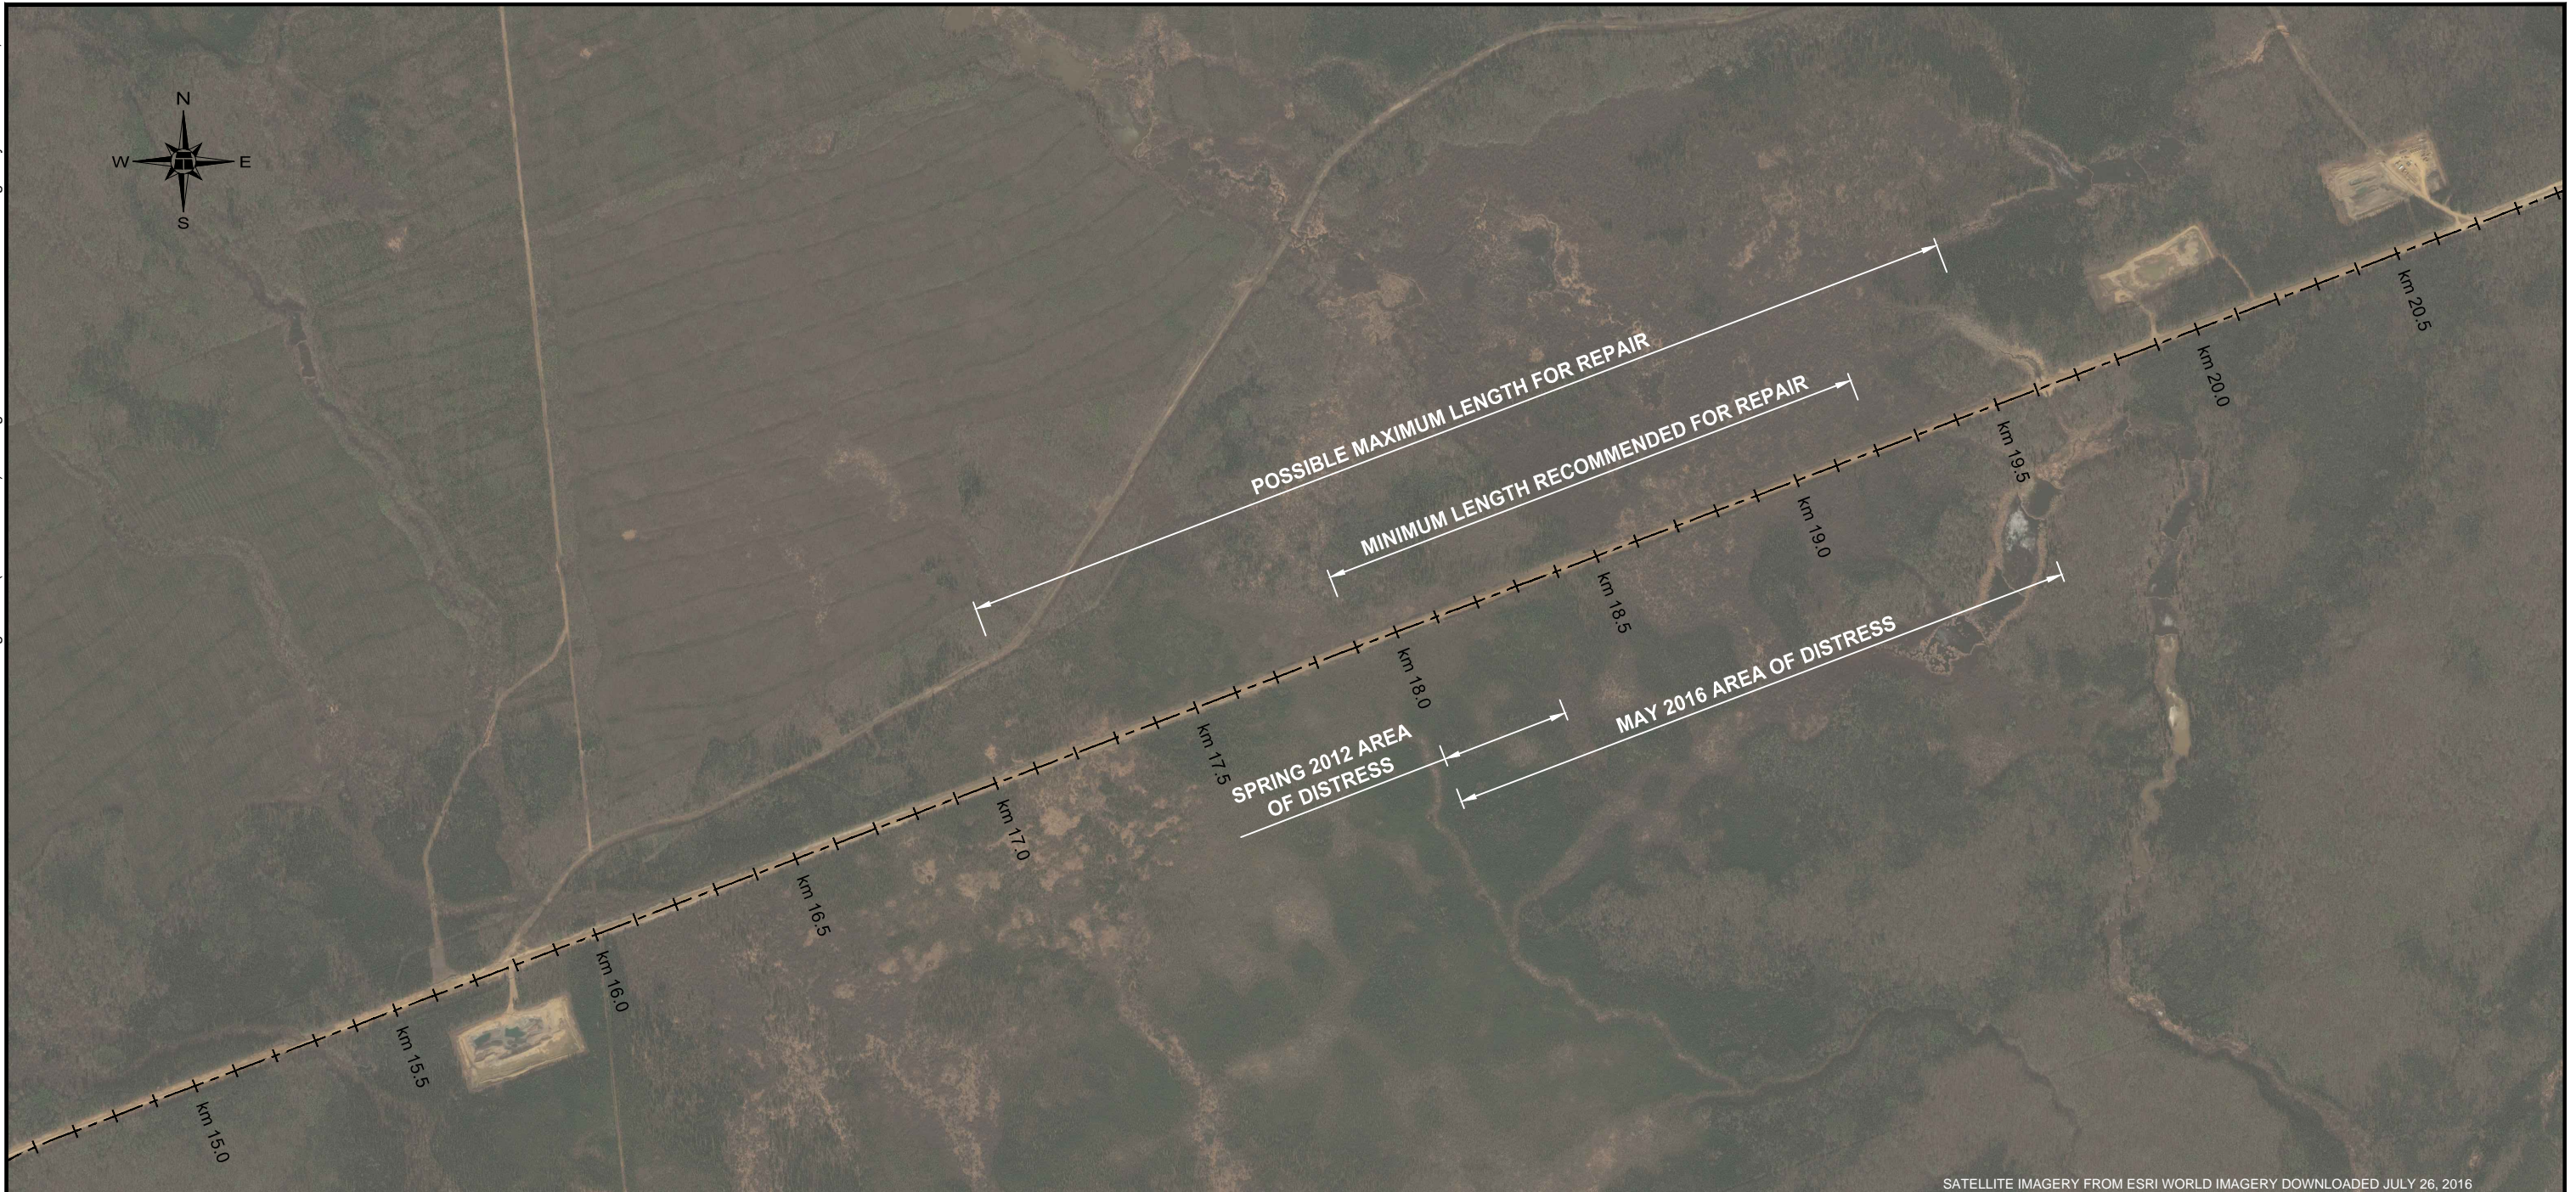
FIGURE 1

JULY 27, 2016 CALLOUT INSPECTION PLAN
