**ALBERTA TRANSPORTATION  
GEOHAZARD ASSESSMENT PROGRAM  
PEACE REGION – HIGH LEVEL  
2018 INSPECTION**

Site Number	Location	Name	Hwy	km
PH079-1	160 km east of High Level	West of Garden River	58:14	18-19.5
Legal Description		UTM Co-ordinates		
NW14-111-3-W5		11U E 651,925	N	6,502,976

**PH079-1: HWY 58:14 WEST OF GARDEN RIVER  
 2018 GEOHAZARD ASSESSMENT**

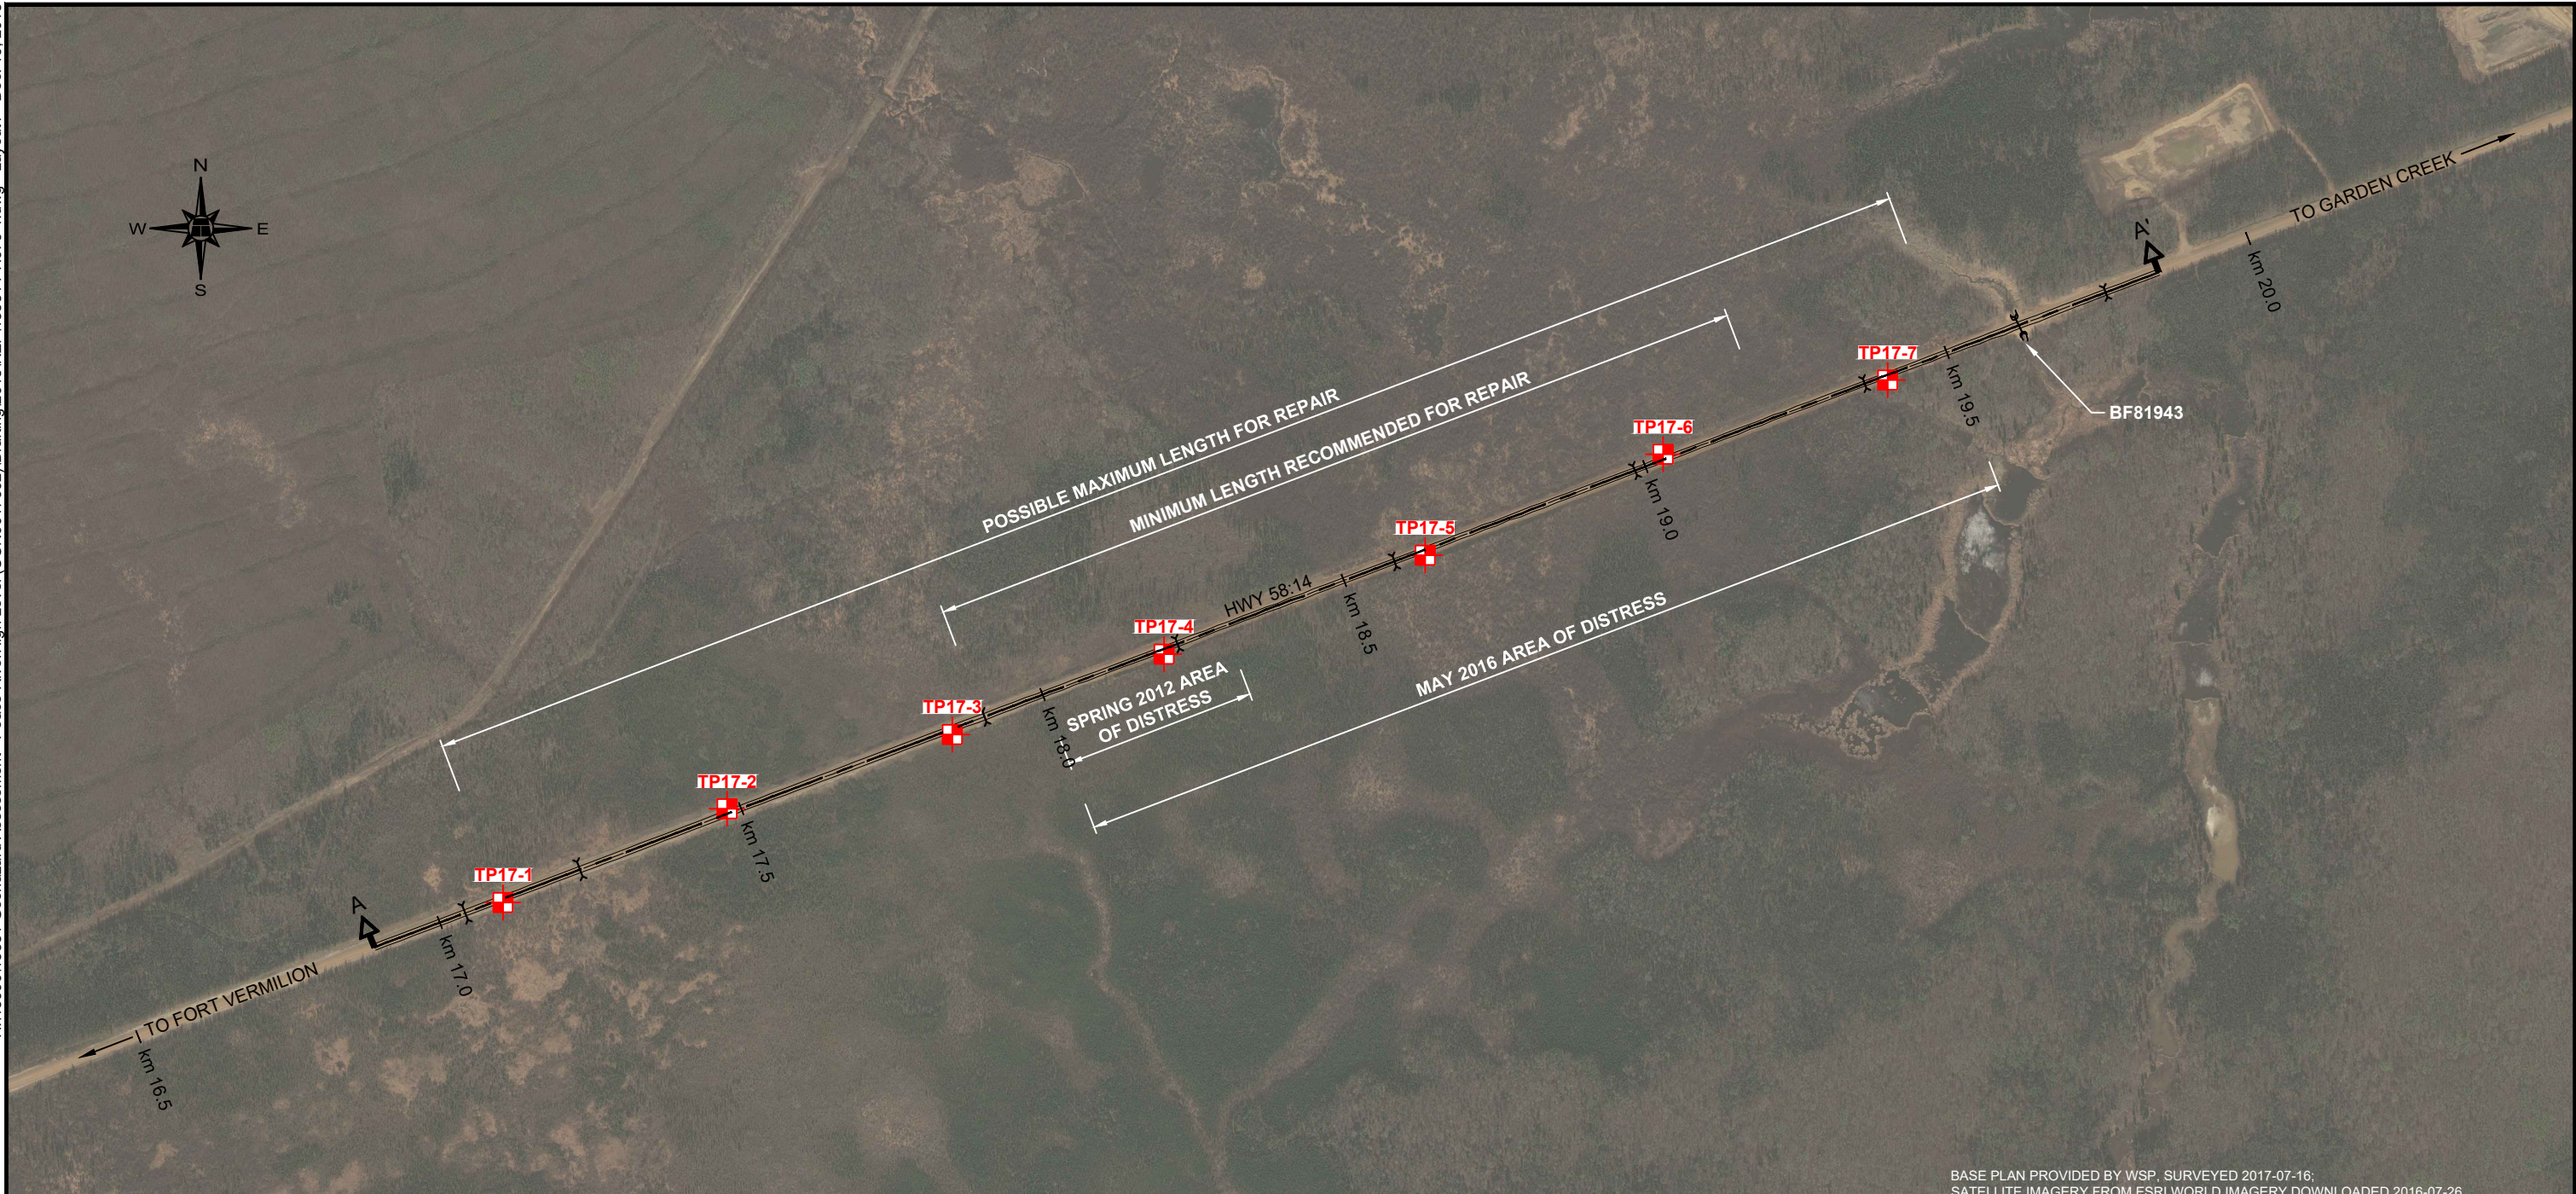
**DWG No. 13351-PH079-1-1**

Note that Thurber has completed test pitting and survey of this highway. Test pit logs and drawings (site plan and profile, Drawing 17288-1 and -2, respectively) are attached for information. The test pit program identified that the gravel fill was thinner than expected for the number of overlays that have been done and that the embankment fill consisted of clay shale over clay till in the western portion and clay till over silt in the eastern. The fill was underlain by organic soils, between 0.1 m and 0.5 m in thickness, which were not stripped prior to highway construction which overlies native clay. At the time of the investigation (June 2017), much of the peat soils and underlying clay were still frozen. The groundwater table appears to be at the top of the peat-to-fill contact.

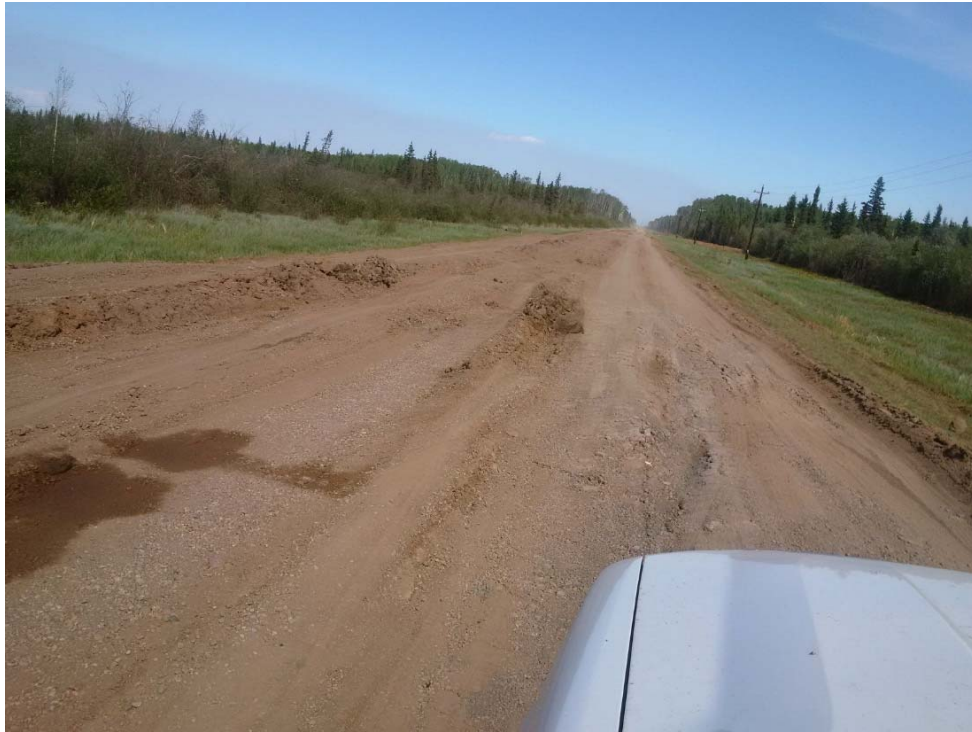
Photo 1 – Looking east at rutting on May 27, 2018 (AT photo)

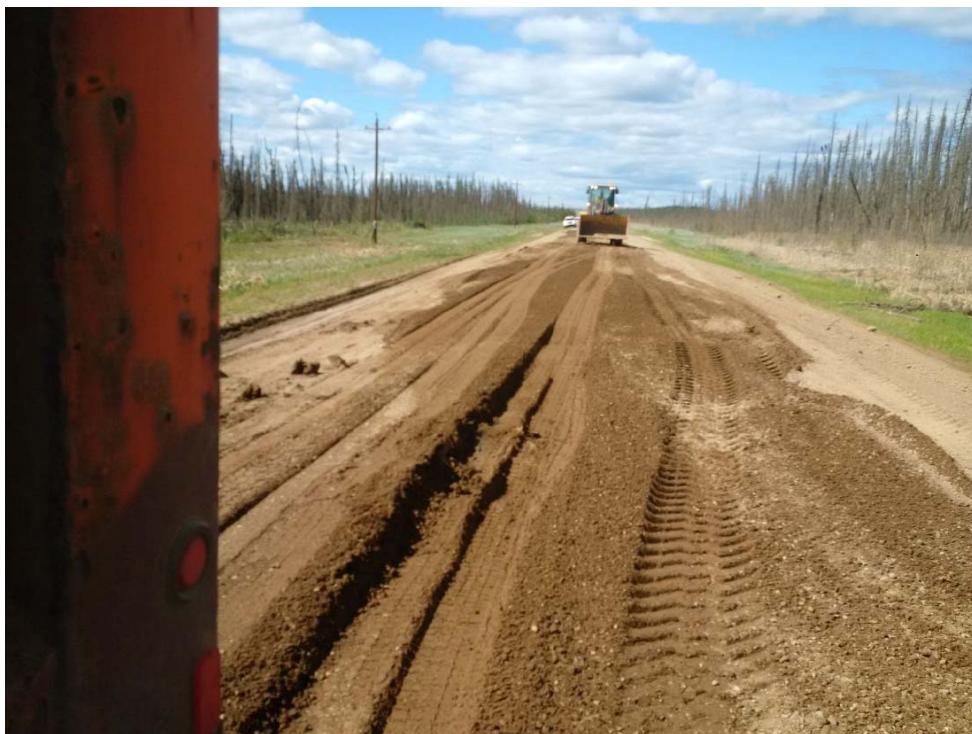
Photo 2 – Looking west at rutting during gravel placement on May 30, 2018 (AT photo)

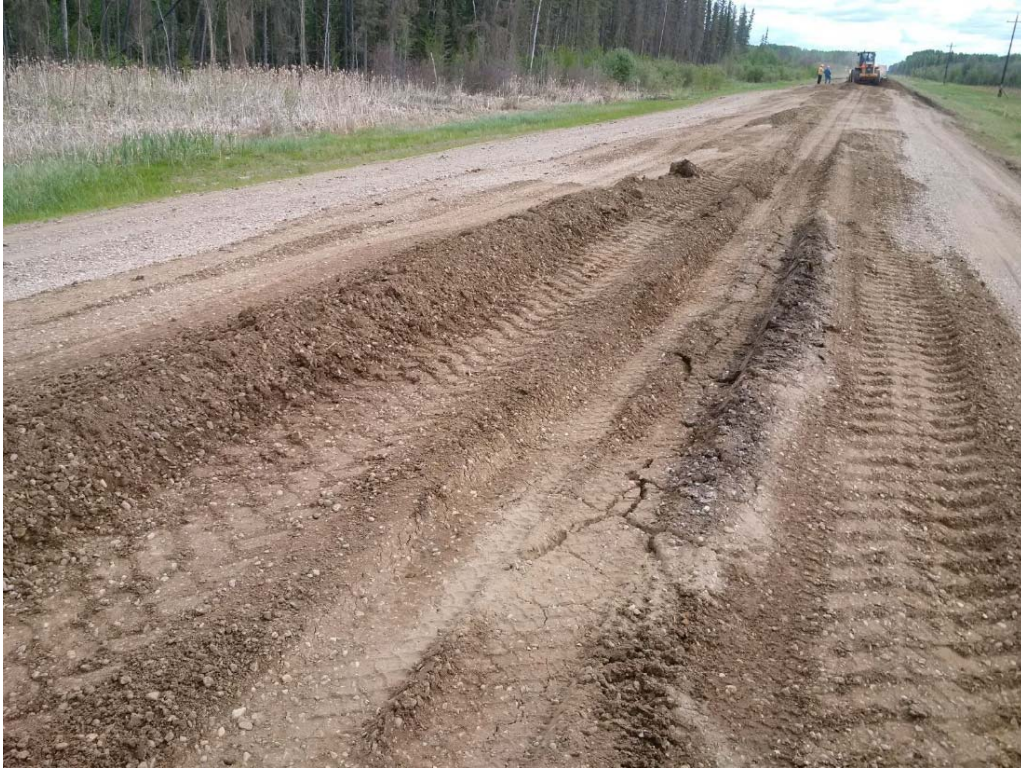
Photo 3 – Looking east at rutting during gravel placement on May 30, 2018 (AT photo).

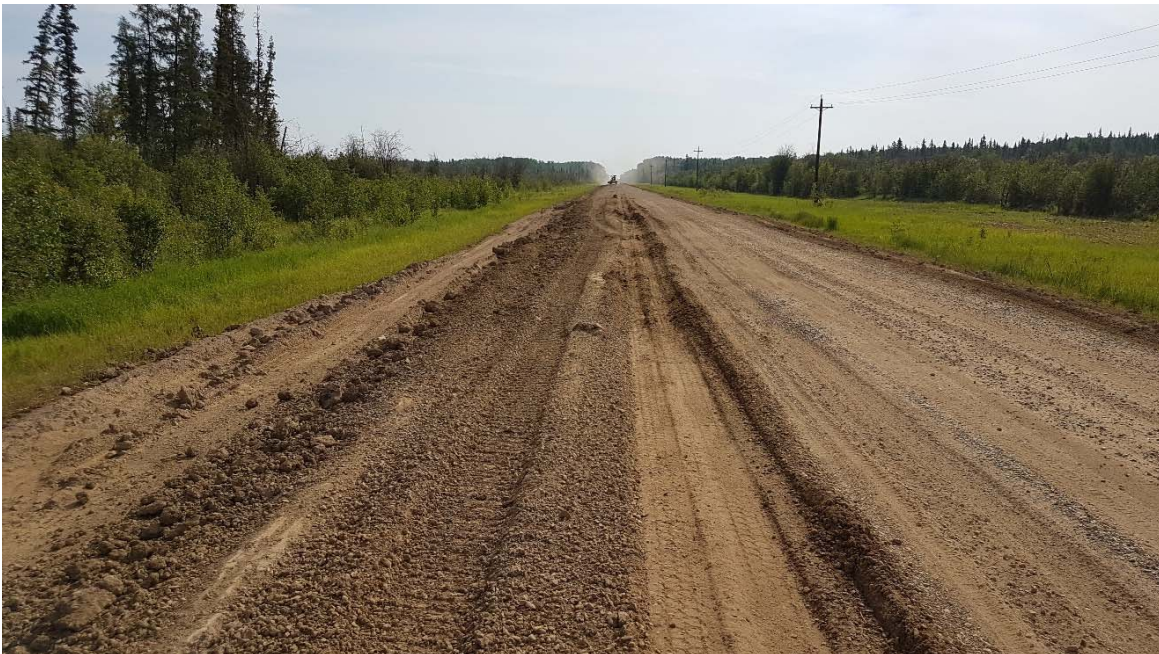
At the time of the 2018 inspection, the maintenance contractor was working on resurfacing the roadway. It was observed that the grader working the gravel was causing noticeable deflections of the highway surface and causing rutting with pumping of fine-grained subgrade to the surface through the ruts. Mr. Catt noted that some of the ruts and associated fines pumping had occurred that day in sections where grading the additional 0.6 m of gravel had been undertaken earlier. The material pumping up appeared to be saturated clayey silt. Rutting was up to 300 mm deep in freshly graded areas and over 500 mm in areas that had not yet been regraded.

Photo 4 – Looking west at grading underway. Ruts were produced by grader working the highway surface.

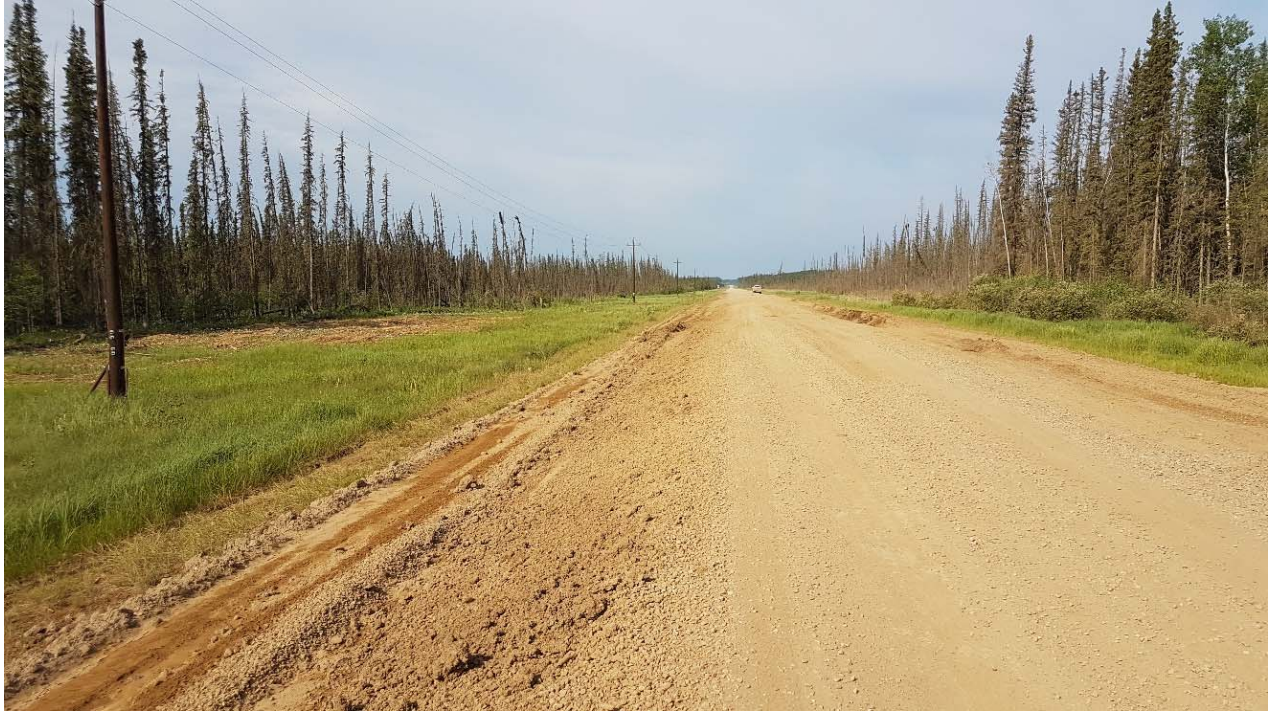
Photo 5 – Looking east at grading work. Note that shoulder (left side of photo) has been scraped back onto highway surface and rutting on the other shoulder (right side)

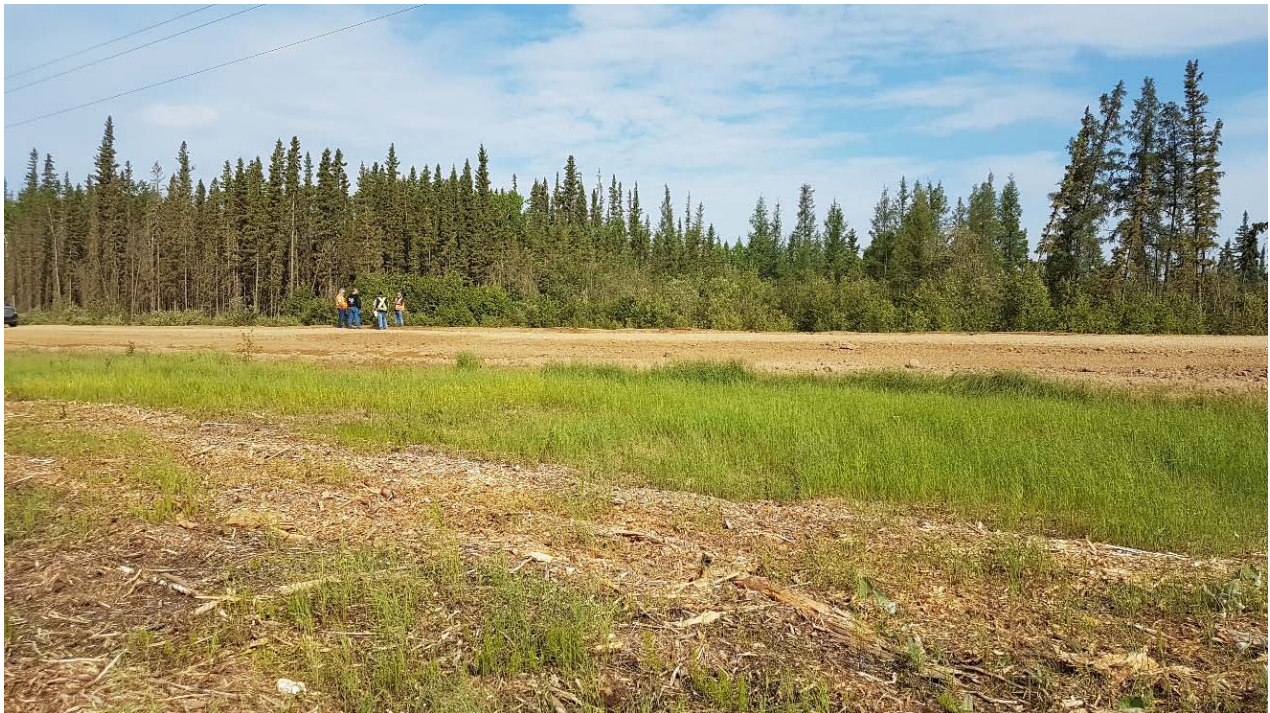
Photo 6 – Looking north from new powerline ROW at low height of highway embankment.

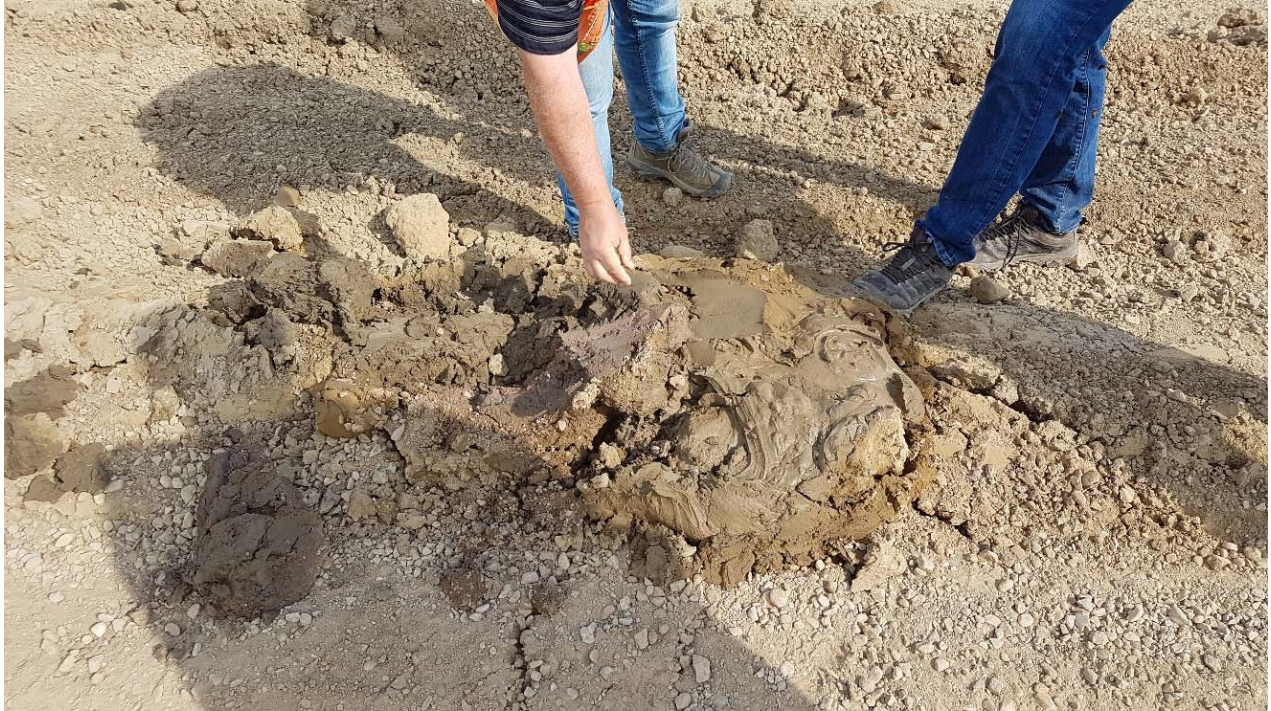
Photo 7 – Saturated silty material pushed up through rut by grader traffic.
